April 1, 2017

The Nepenthe Association
Bettsi Ledesma
1131 Commons Dr.
Sacramento, CA 95825
Phone: (916) 929-8380
Email: Bettsi.Ledesma@fsresidential.com

On March 27, 2017, I inspected several trees on the Nepenthe property during the monthly tree walk. The focus of the walk was to address resident/management concerns regarding mature trees on the property. The purpose of this report is to develop mitigation plans for the following trees and my recommendations are below. My recommendations are based on a Basic Visual Inspection. All decisions made based on the recommendations of this report are at the discretion of the Nepenthe Association.

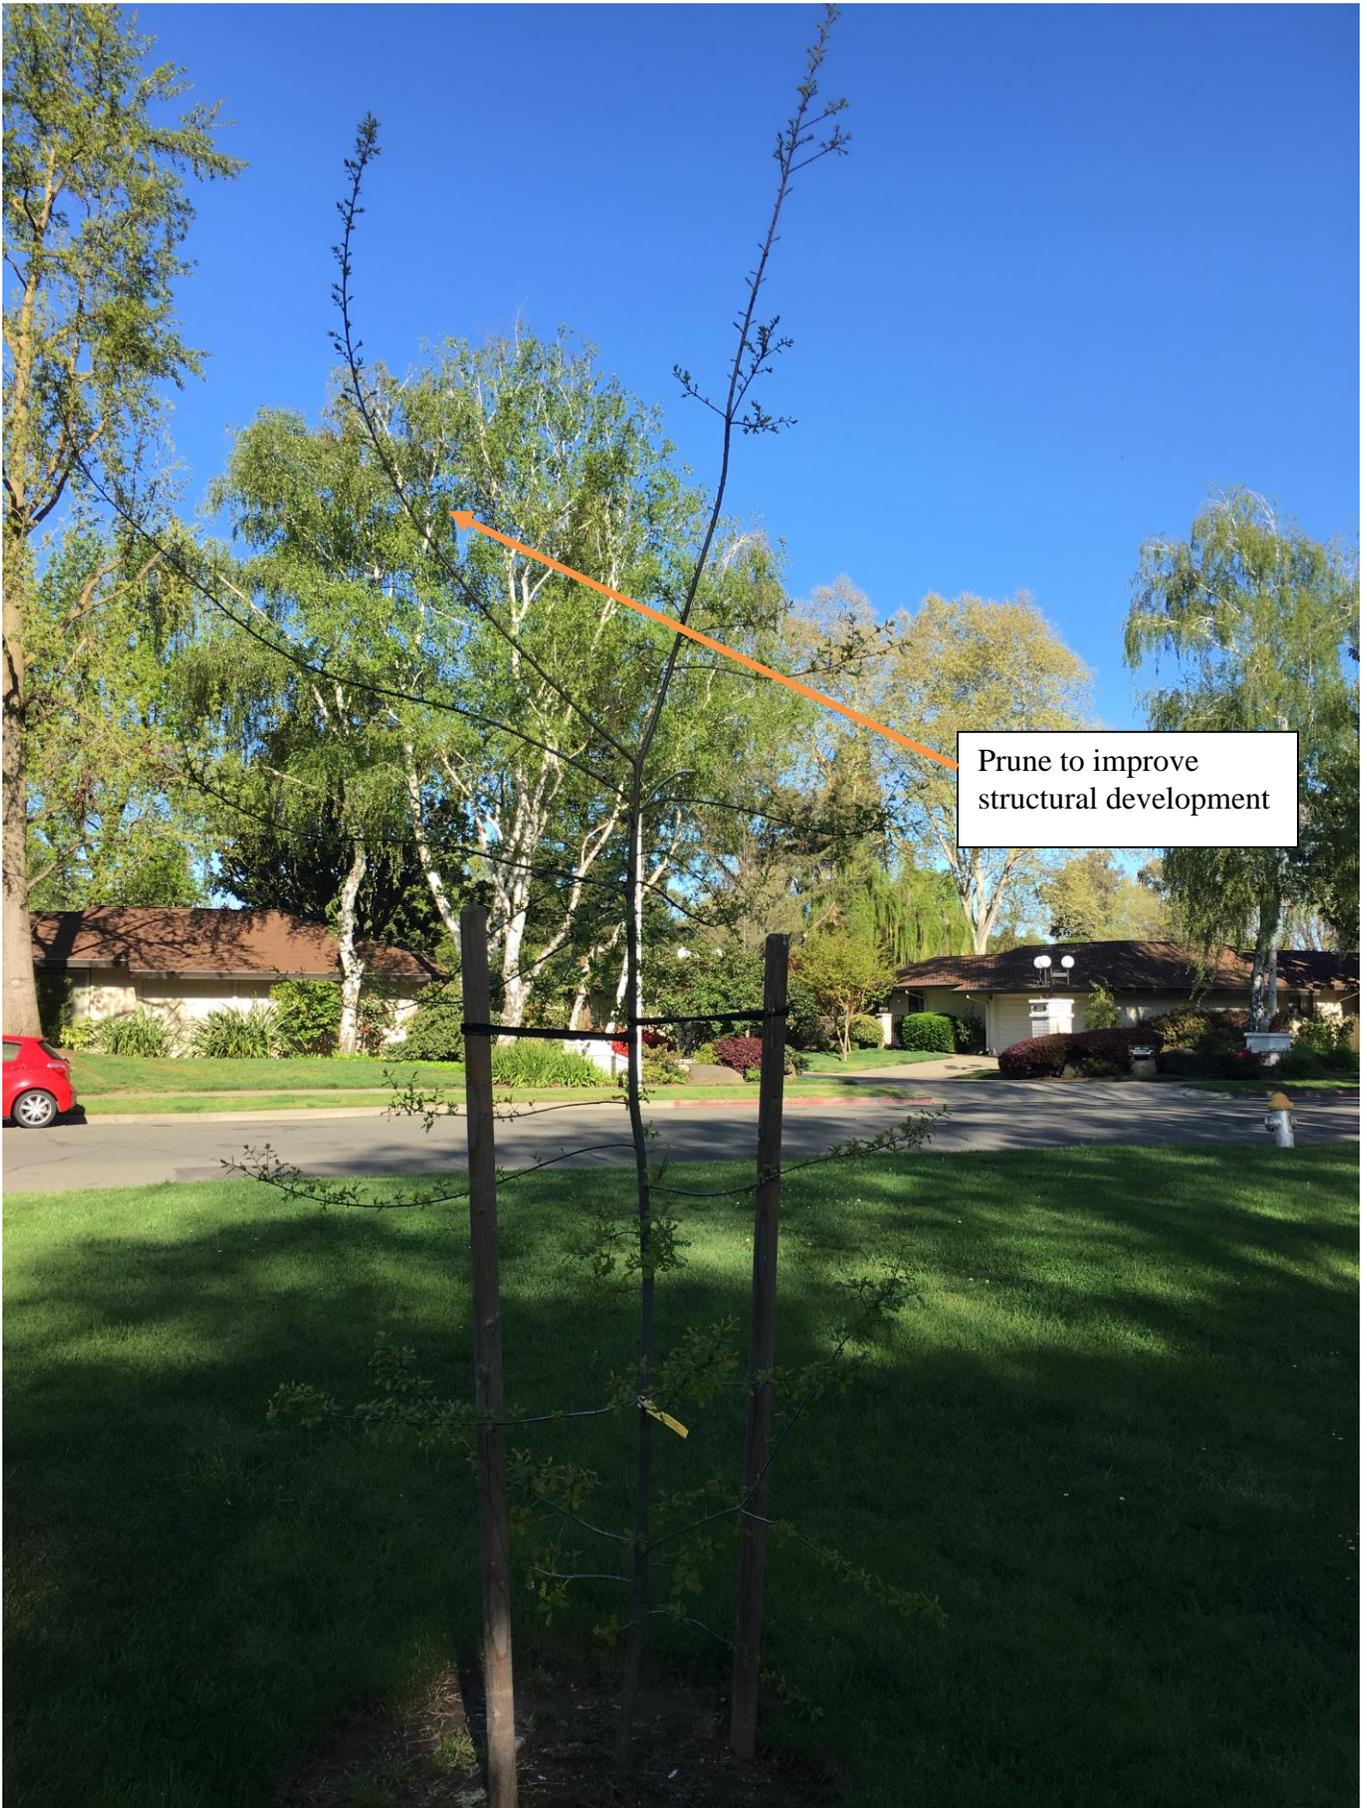
Figure 1

- (Zone 1) Tree # No Tag Valley Oak (*Quercus lobata*) next to 1101 Commons Dr. New Planting, needs structural pruning to encourage proper development (Figure 1).

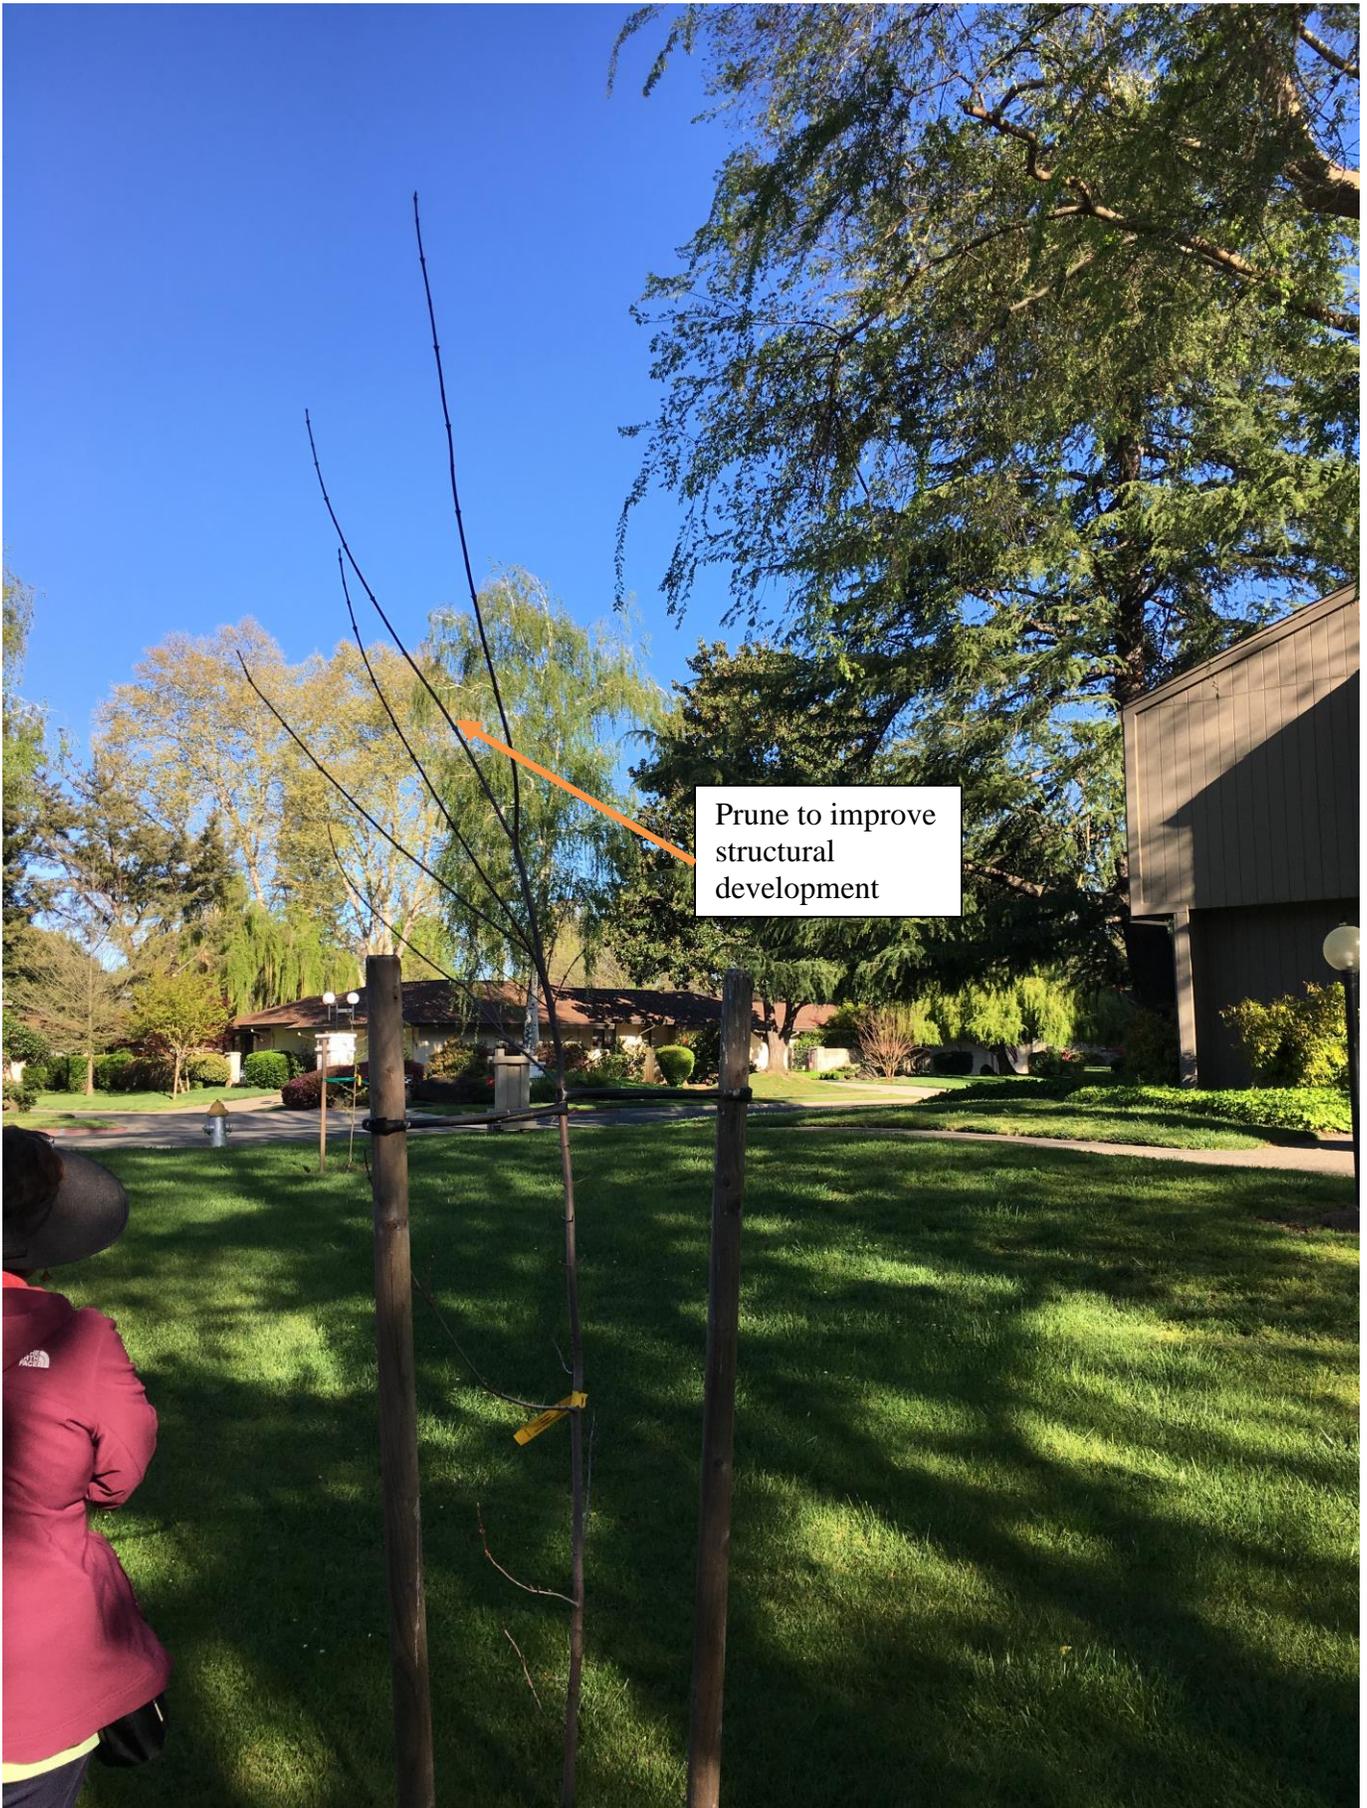
Figure 2

- (Zone 1) Tree # No Tag Red Maple (*Acer rubrum*) next to 1101 Commons Dr. New Planting, needs structural pruning to encourage proper development (Figure 2).

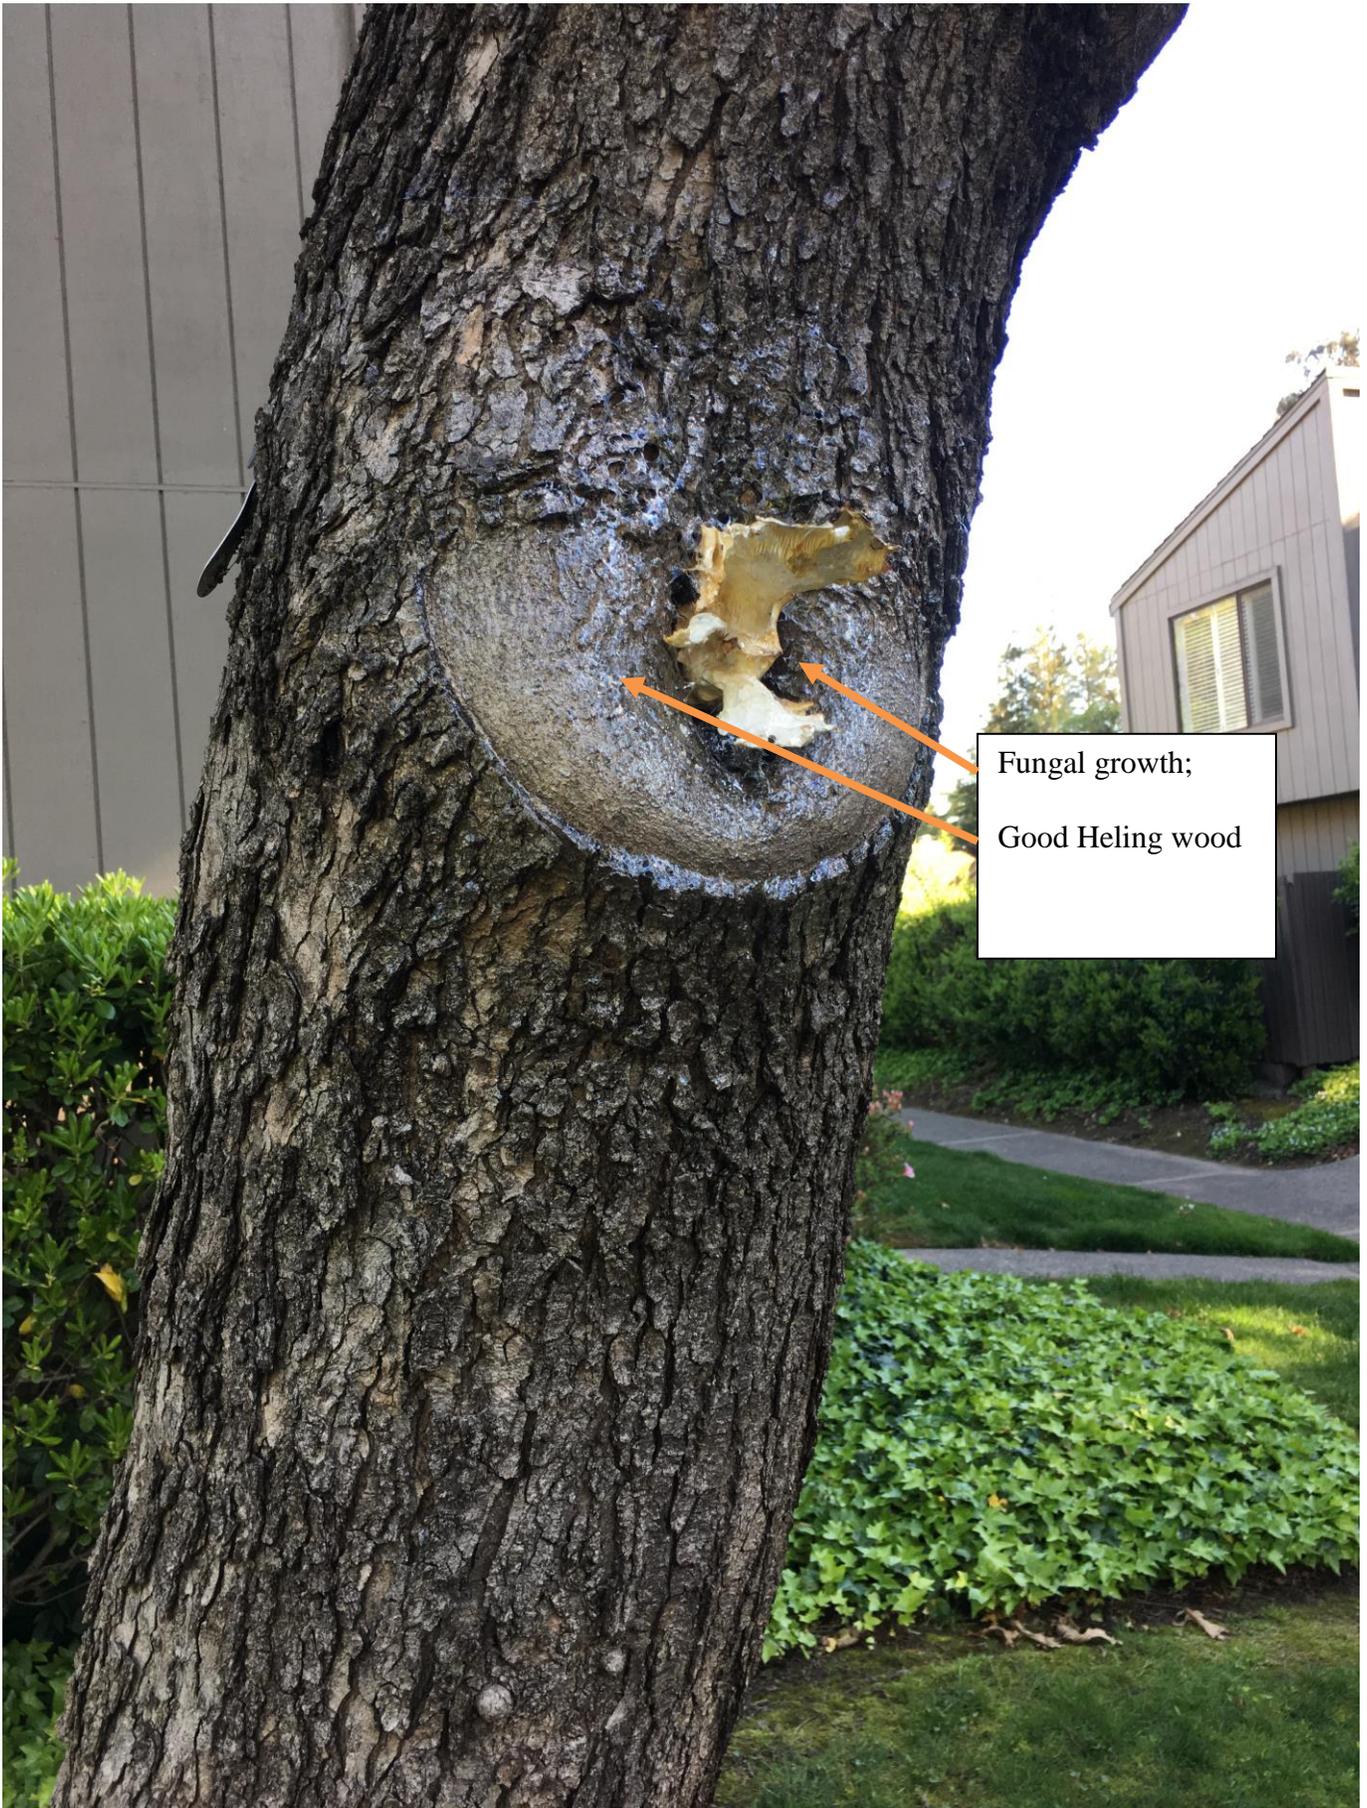
Figure 3

- (Zone 1) Tree #61 Chinese pistache (*Pistacia chinensis*) next to 1153 Commons Dr. Tree has noticeable fungal growth in a pruning wound on trunk (Figure 3). The tree is showing signs of good healing wood around that wound. Over all appears healthy. I determine this growth to be minimal and not affecting the internal wood of the tree. I recommend to retain and to monitor this tree going forward.

Fungal growth;
Good Heling wood

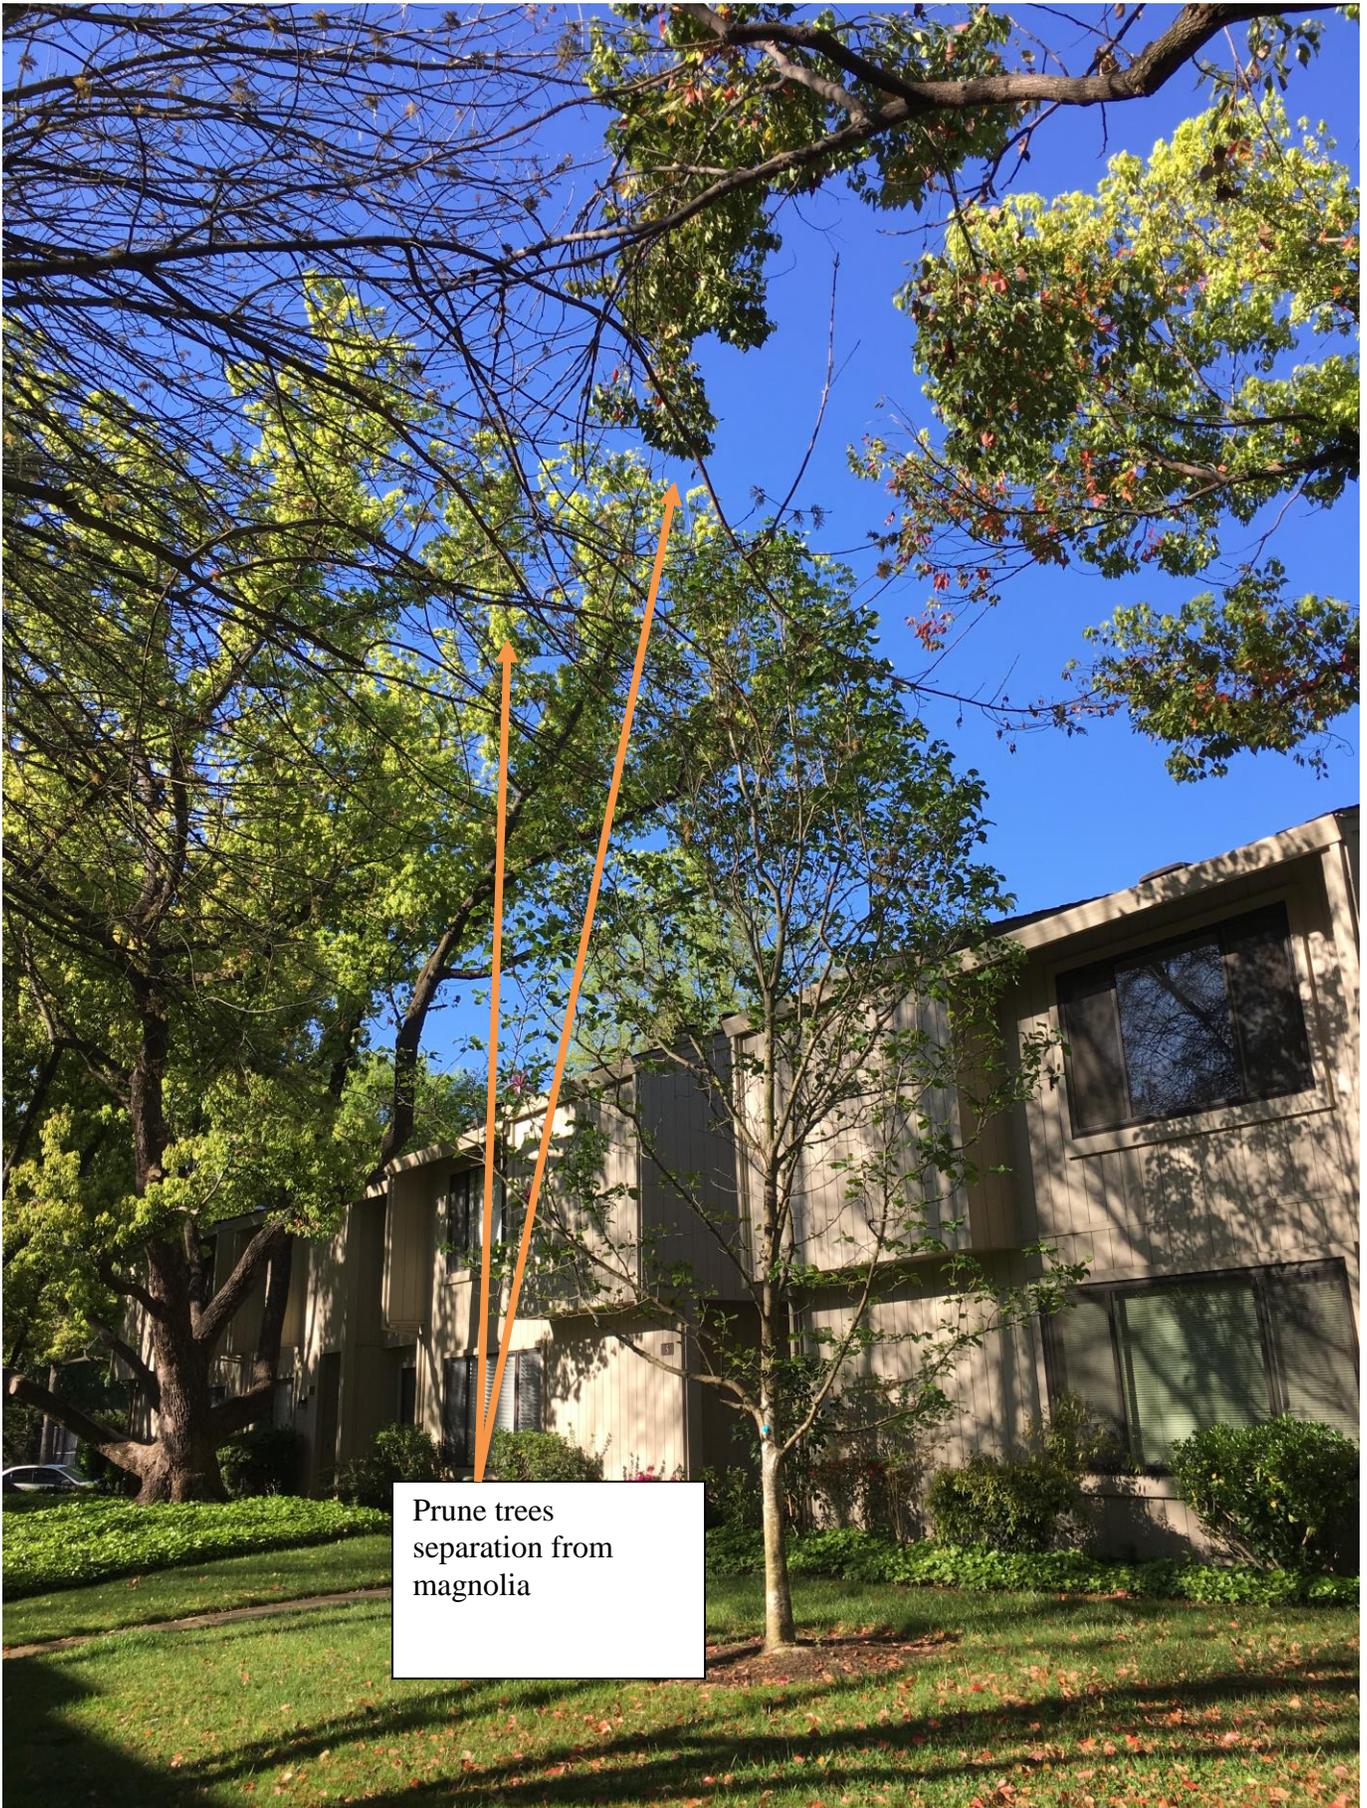
Figure 4

- (Zone 1) Tree #258 Chinese pistache (*Pistacia chinensis*), and Tree #273 camphor (*Cinnamomum camphora*) next to 13 and 9 Adelphi Ct. Trees have grown in to a magnolia (*Magnolia x soulangeana*), and have started to shade out the canopy of the magnolia causing some dieback (Figure 4). I recommend weight reduction pruning on the pistache and minor “tipping” back on the camphor tree.

Prune trees
separation from
magnolia

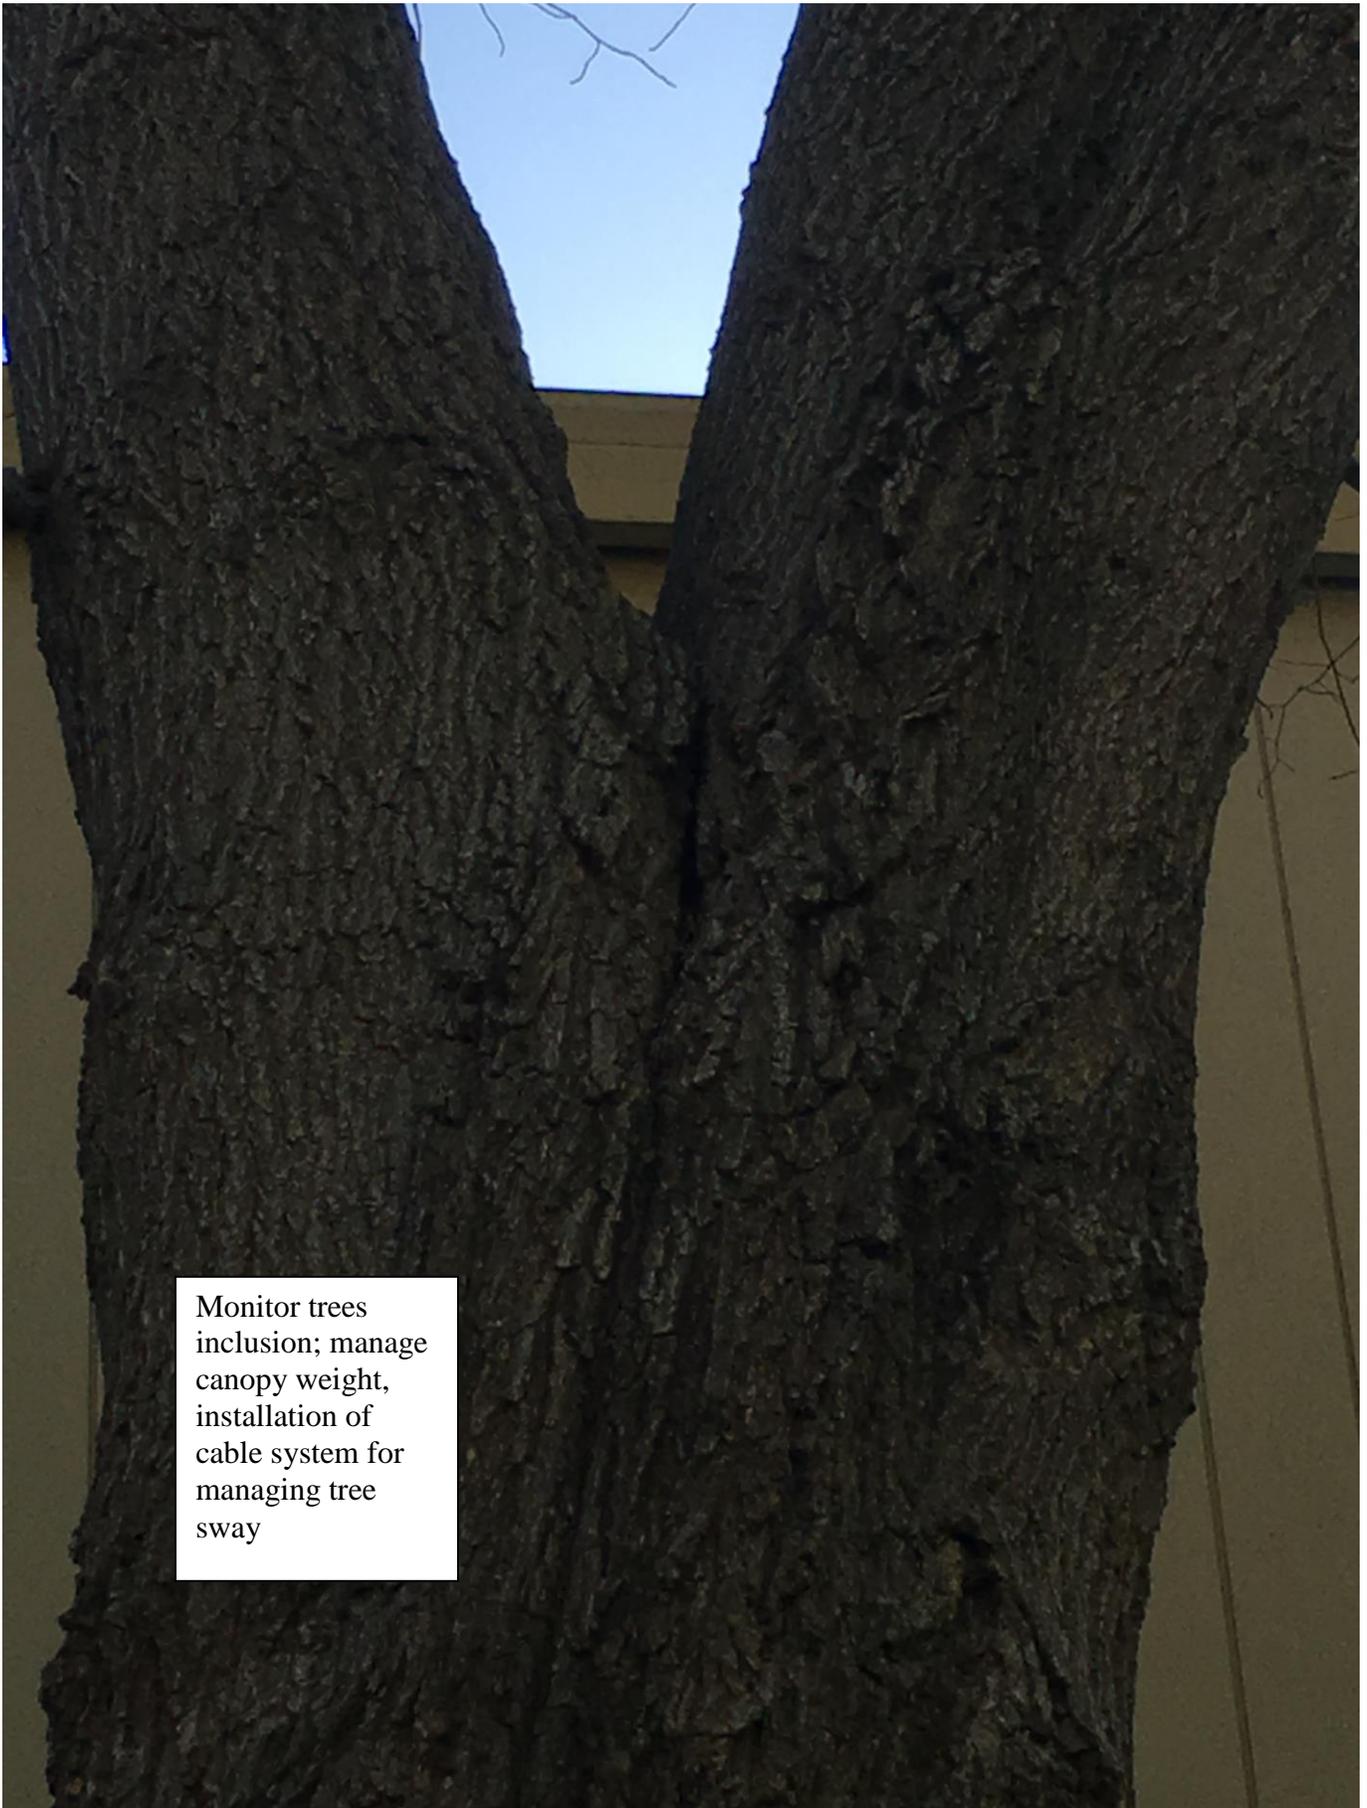
Figure 5

- (Zone 1) Tree #237 Willow Oak (*Quercus phellos*) next to 15 Adelphi Ct. Tree seems healthy and full. The tree has a large inclusion between two codominant stems (Figure 5). Both stems are over weighted. I Recommend weight reduction on heavy portions of canopy and installation of a cable system to help with the movement of the canopy.

Monitor trees
inclusion; manage
canopy weight,
installation of
cable system for
managing tree
sway

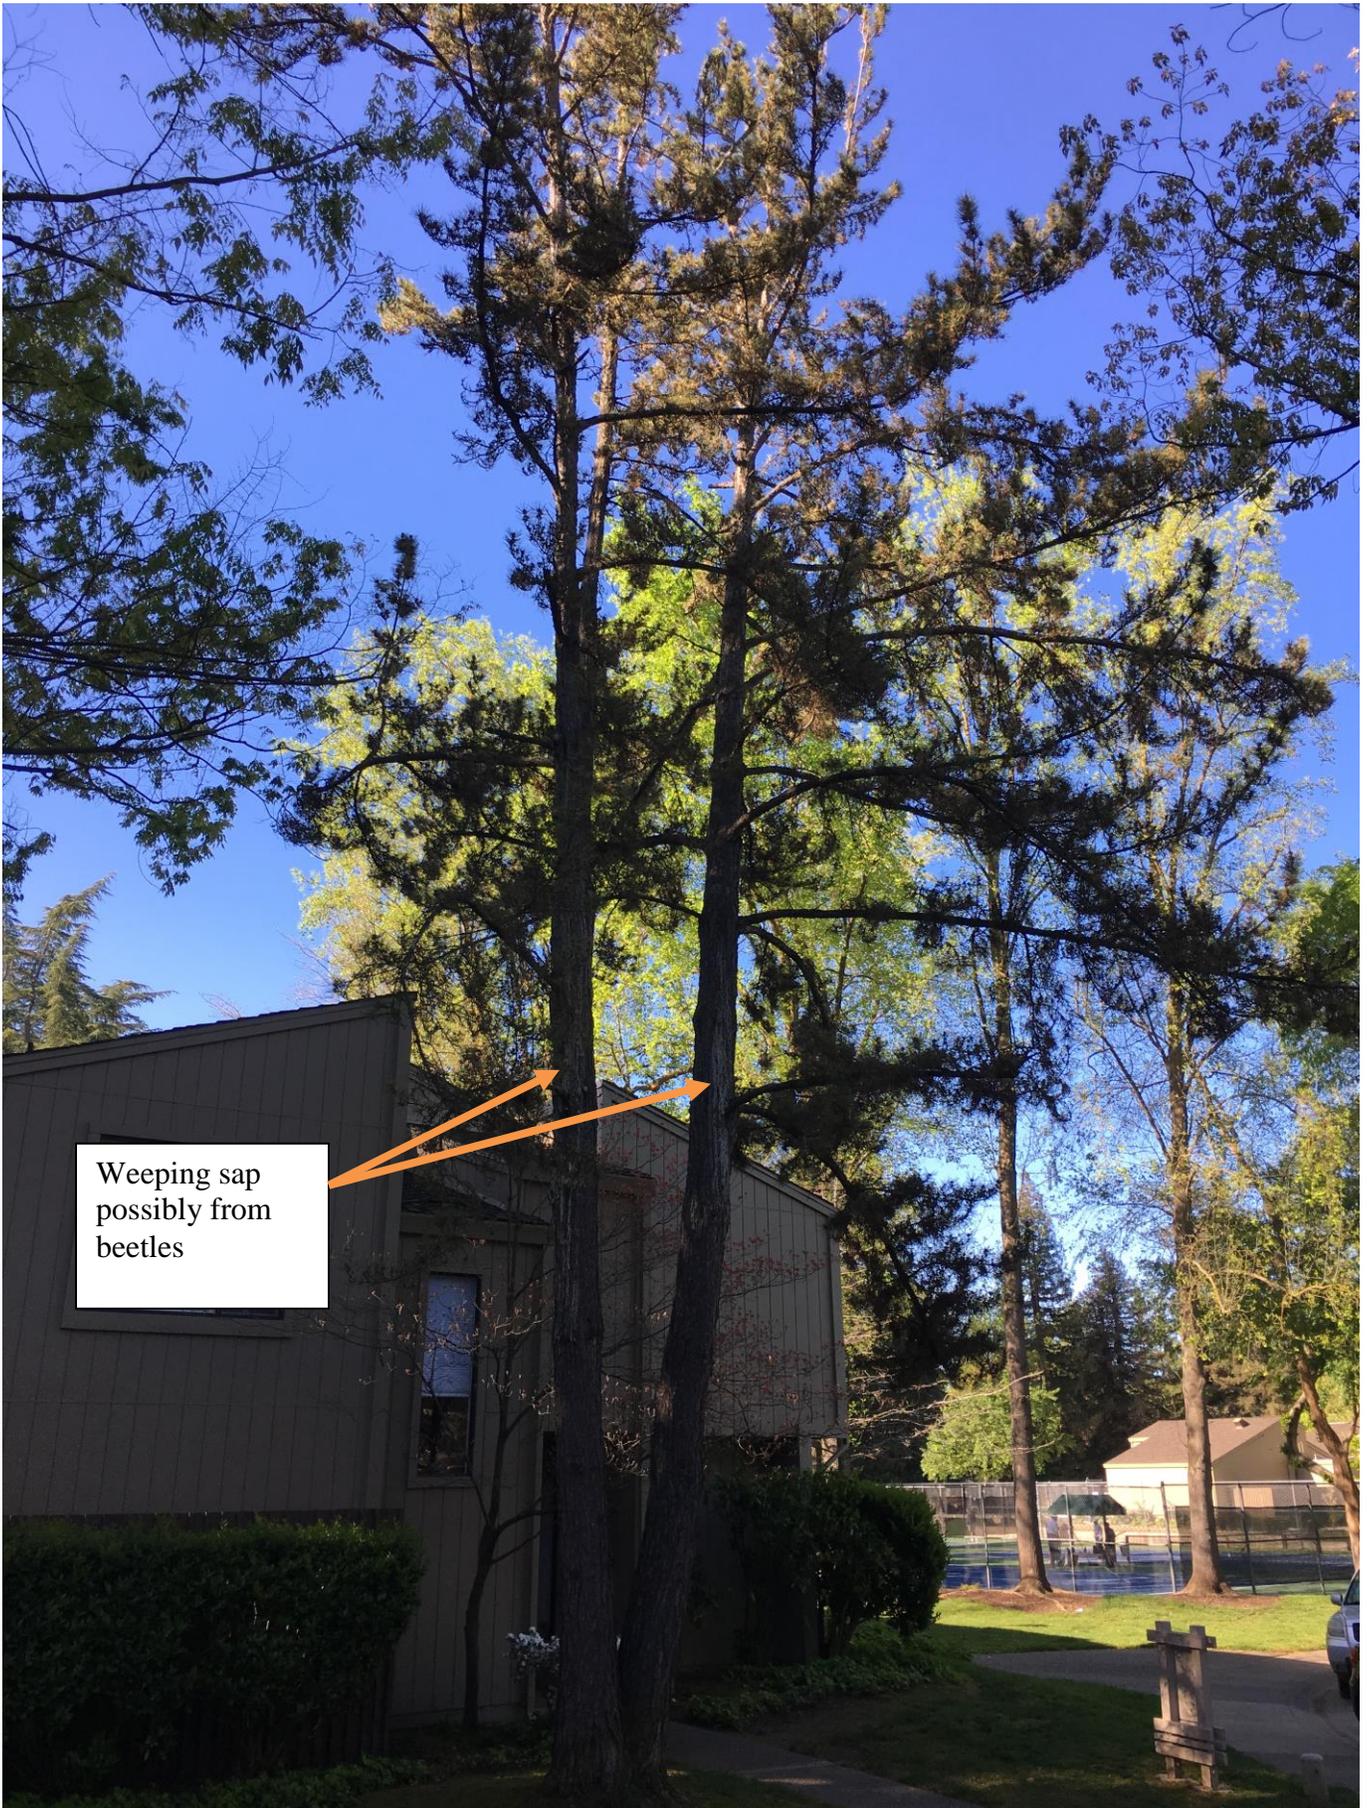
Figure 6

- (Zone 1) Tree #231 Pine (*Pinus*) 2 Adelphi Ct. Tree appears to be stressed. Portions of the canopy are browning out and the tree is weeping sap these are indications of beetle infestation (Figure 6). I Recommend Safari Drench to manage beetle, or removal and replacement.

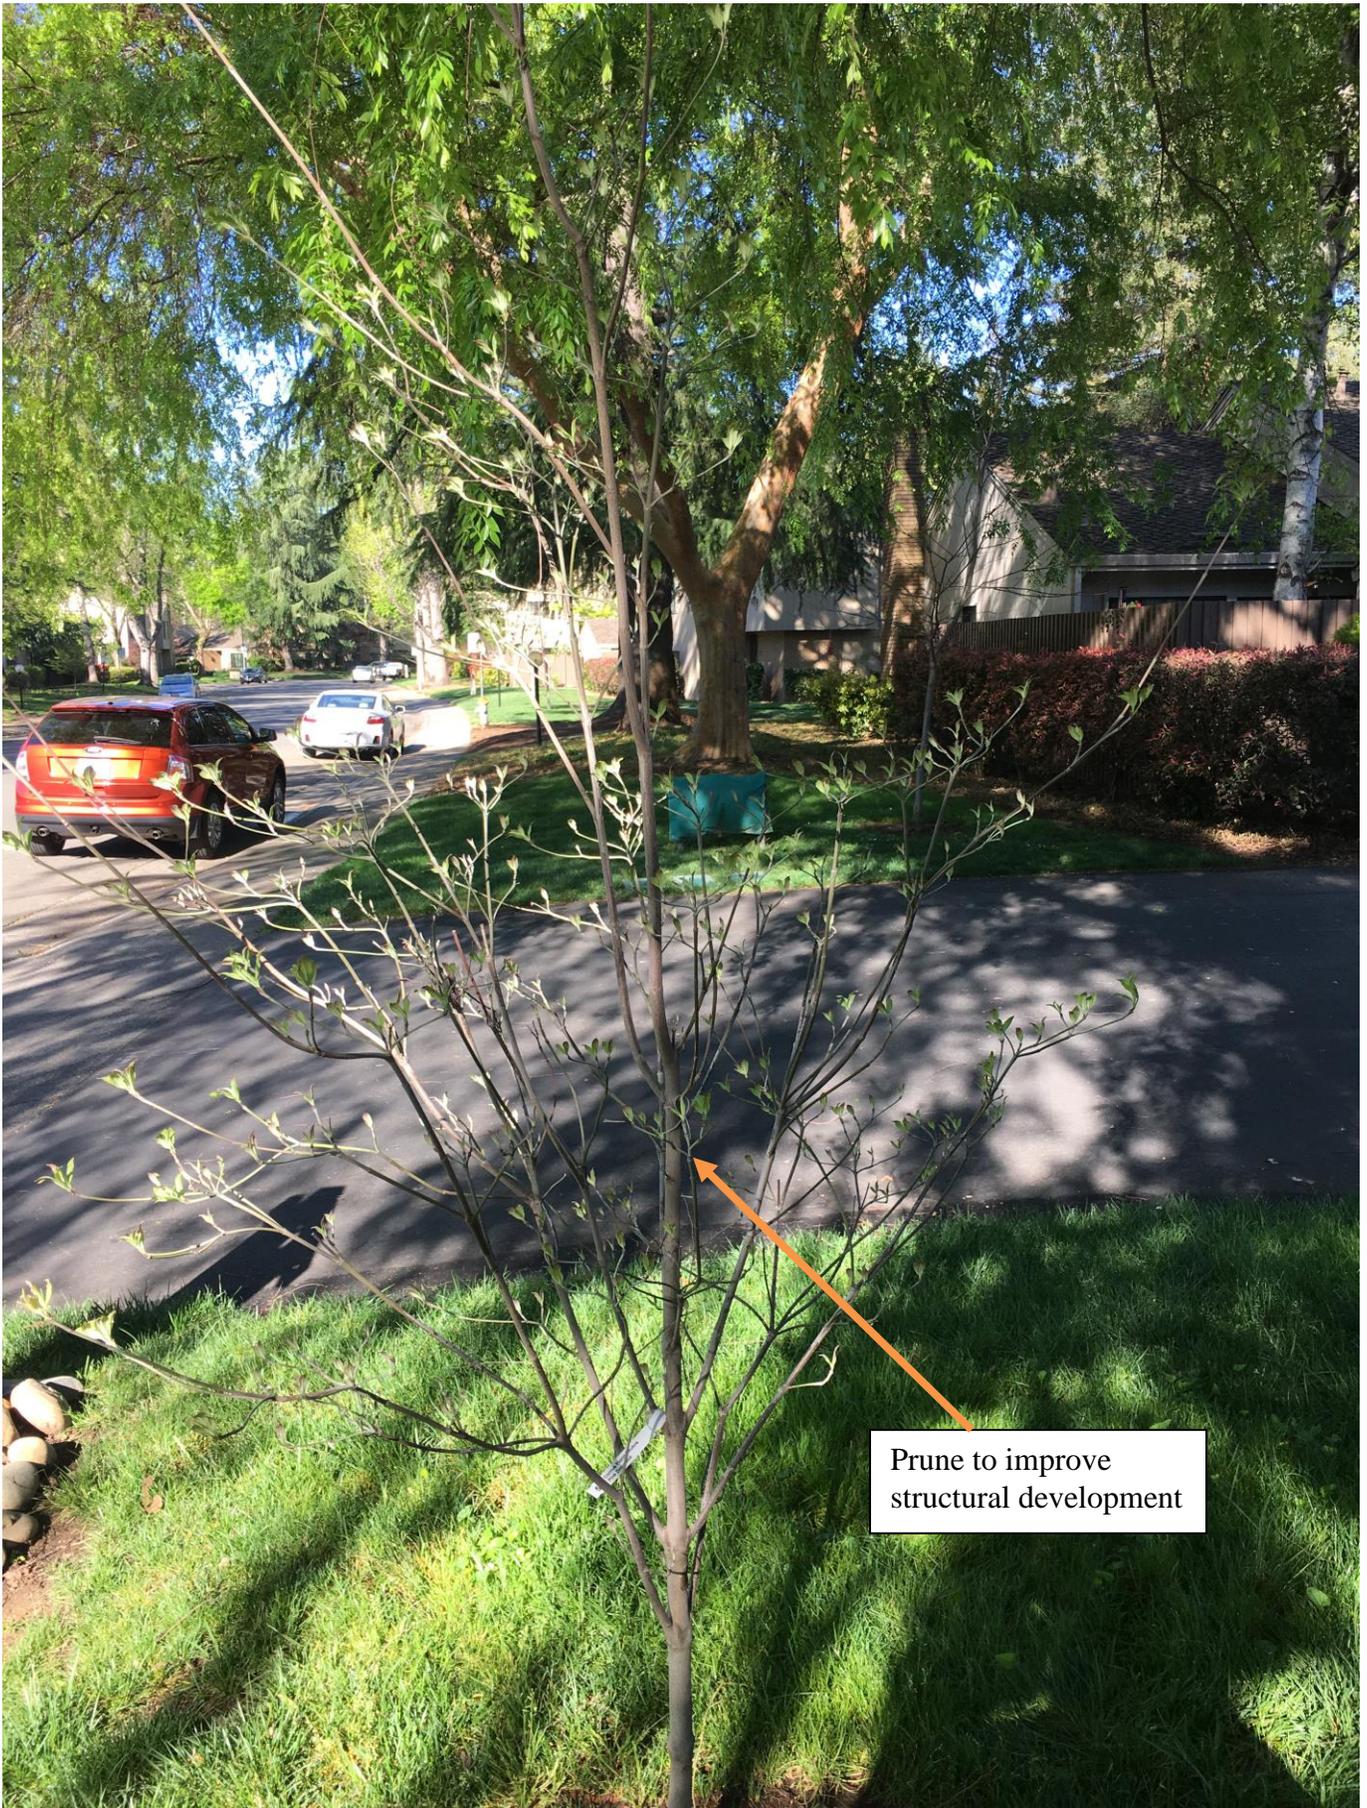
Figure 7

- (Zone 2) Tree #2257 dogwood (*Cornus florida*) next to 1292 Vanderbilt Way. New Planting, needs structural pruning to encourage proper development.(Figure 7)

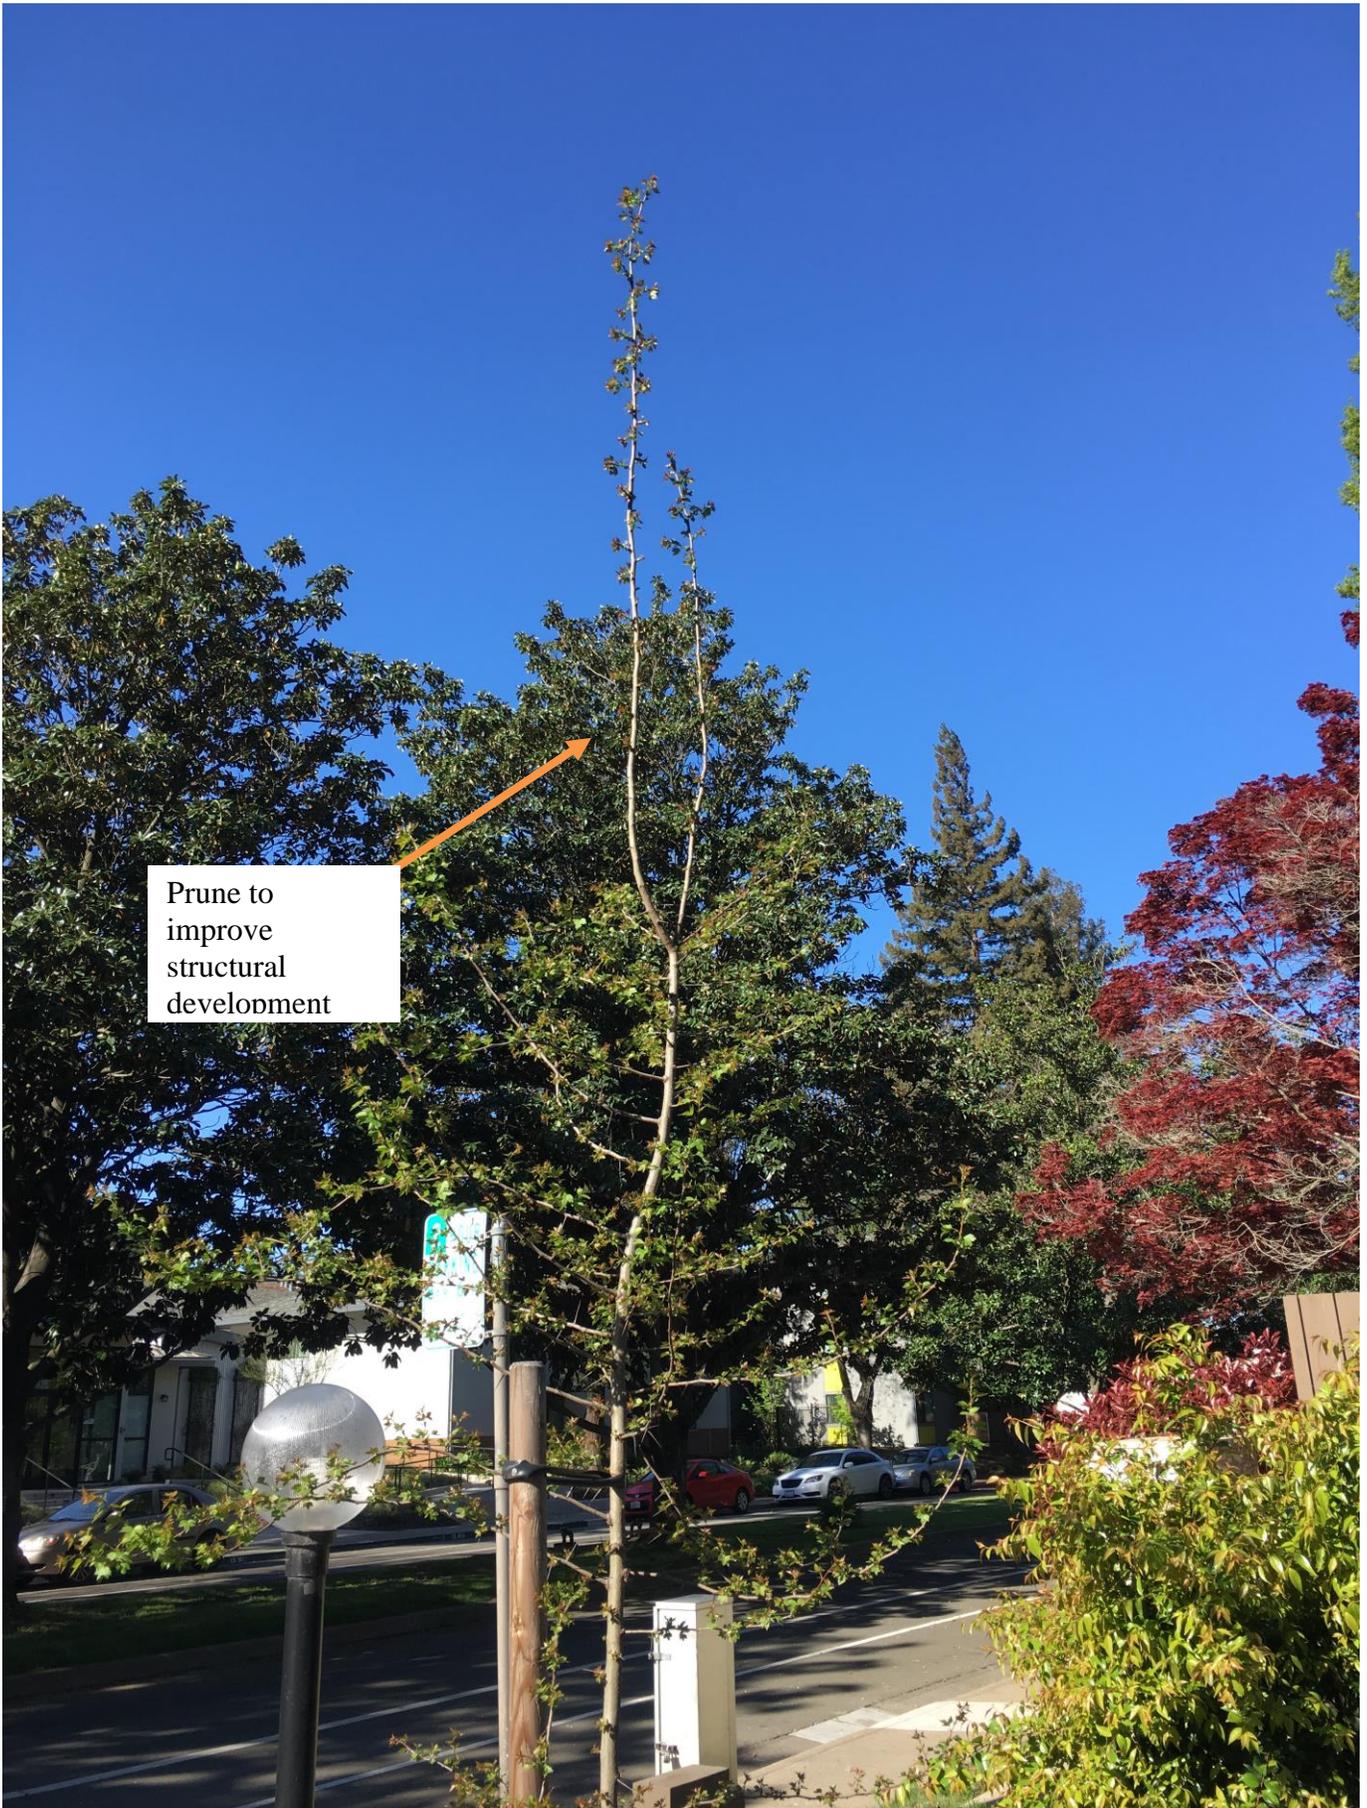
Figure 8

- (Zone 6) Tree #1752 hawthorne (*Crataegus laevigata*) next to 708 Elmhurst Circle. Tree needs structural pruning to encourage proper development (Figure 8).

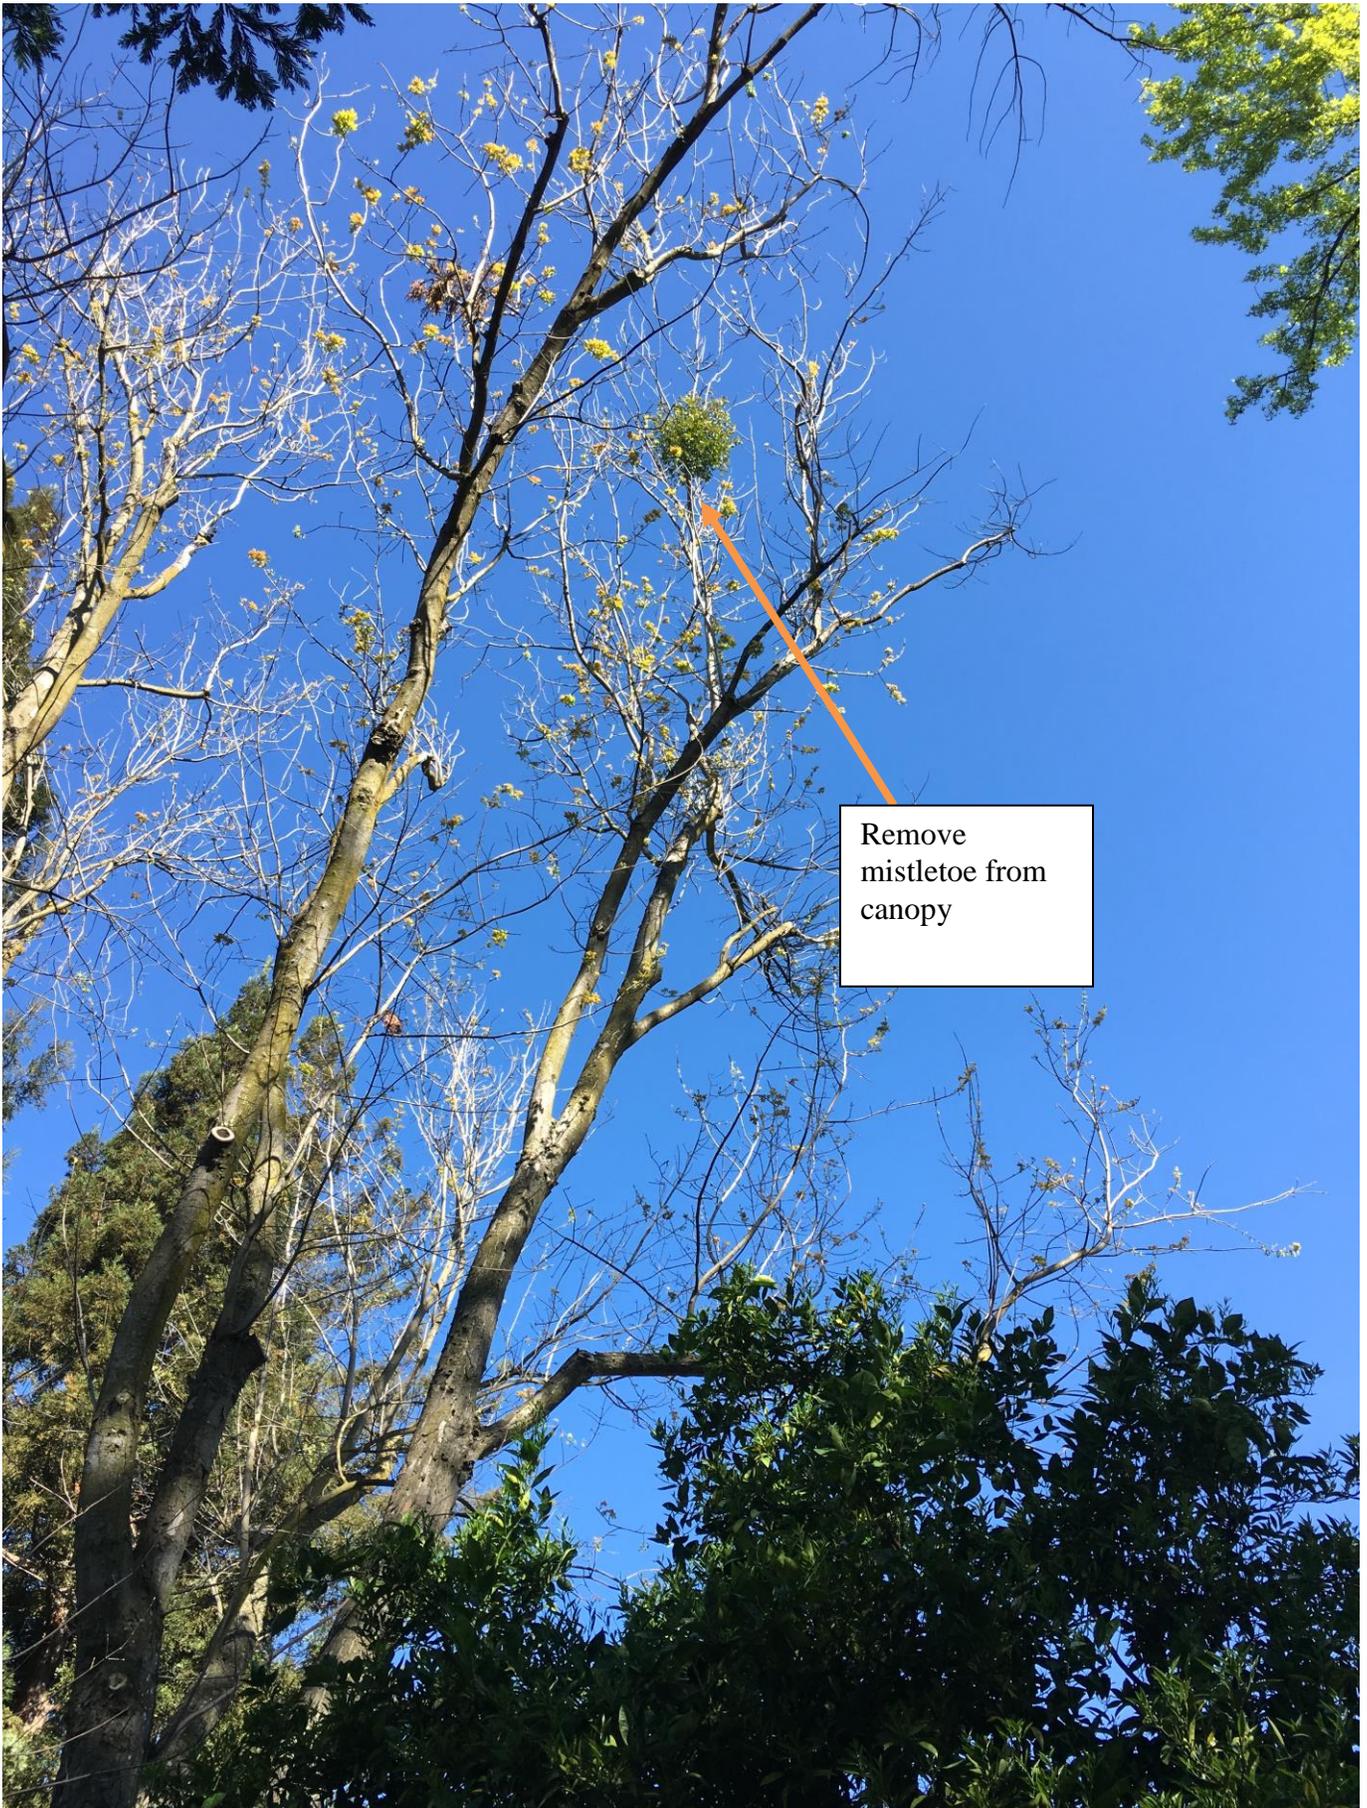
Figure 9

- (Zone 7) Tree #2201 silver maple (*Acer saccharinum*) next to 1455 University Ave. Tree has several spots of mistletoe in the upper canopy (Figure 9). I recommend the mistletoe and dead wood pruned out to slow the spread of the mistletoe.
