April 1, 2017

The Nepenthe Association
Bettsi Ledesma
1131 Commons Dr.
Sacramento, CA 95825
Phone: (916) 929-8380
Email: Bettsi.Ledesma@fsresidential.com

On March 27, 2017, I inspected several trees on the Nepenthe property during the monthly tree walk. The focus of the walk was to address resident/management concerns regarding mature trees on the property. The purpose of this report is to develop mitigation plans for the following trees and my recommendations are below. My recommendations are based on a Basic Visual Inspection. All decisions made based on the recommendations of this report are at the discretion of the Nepenthe Association.

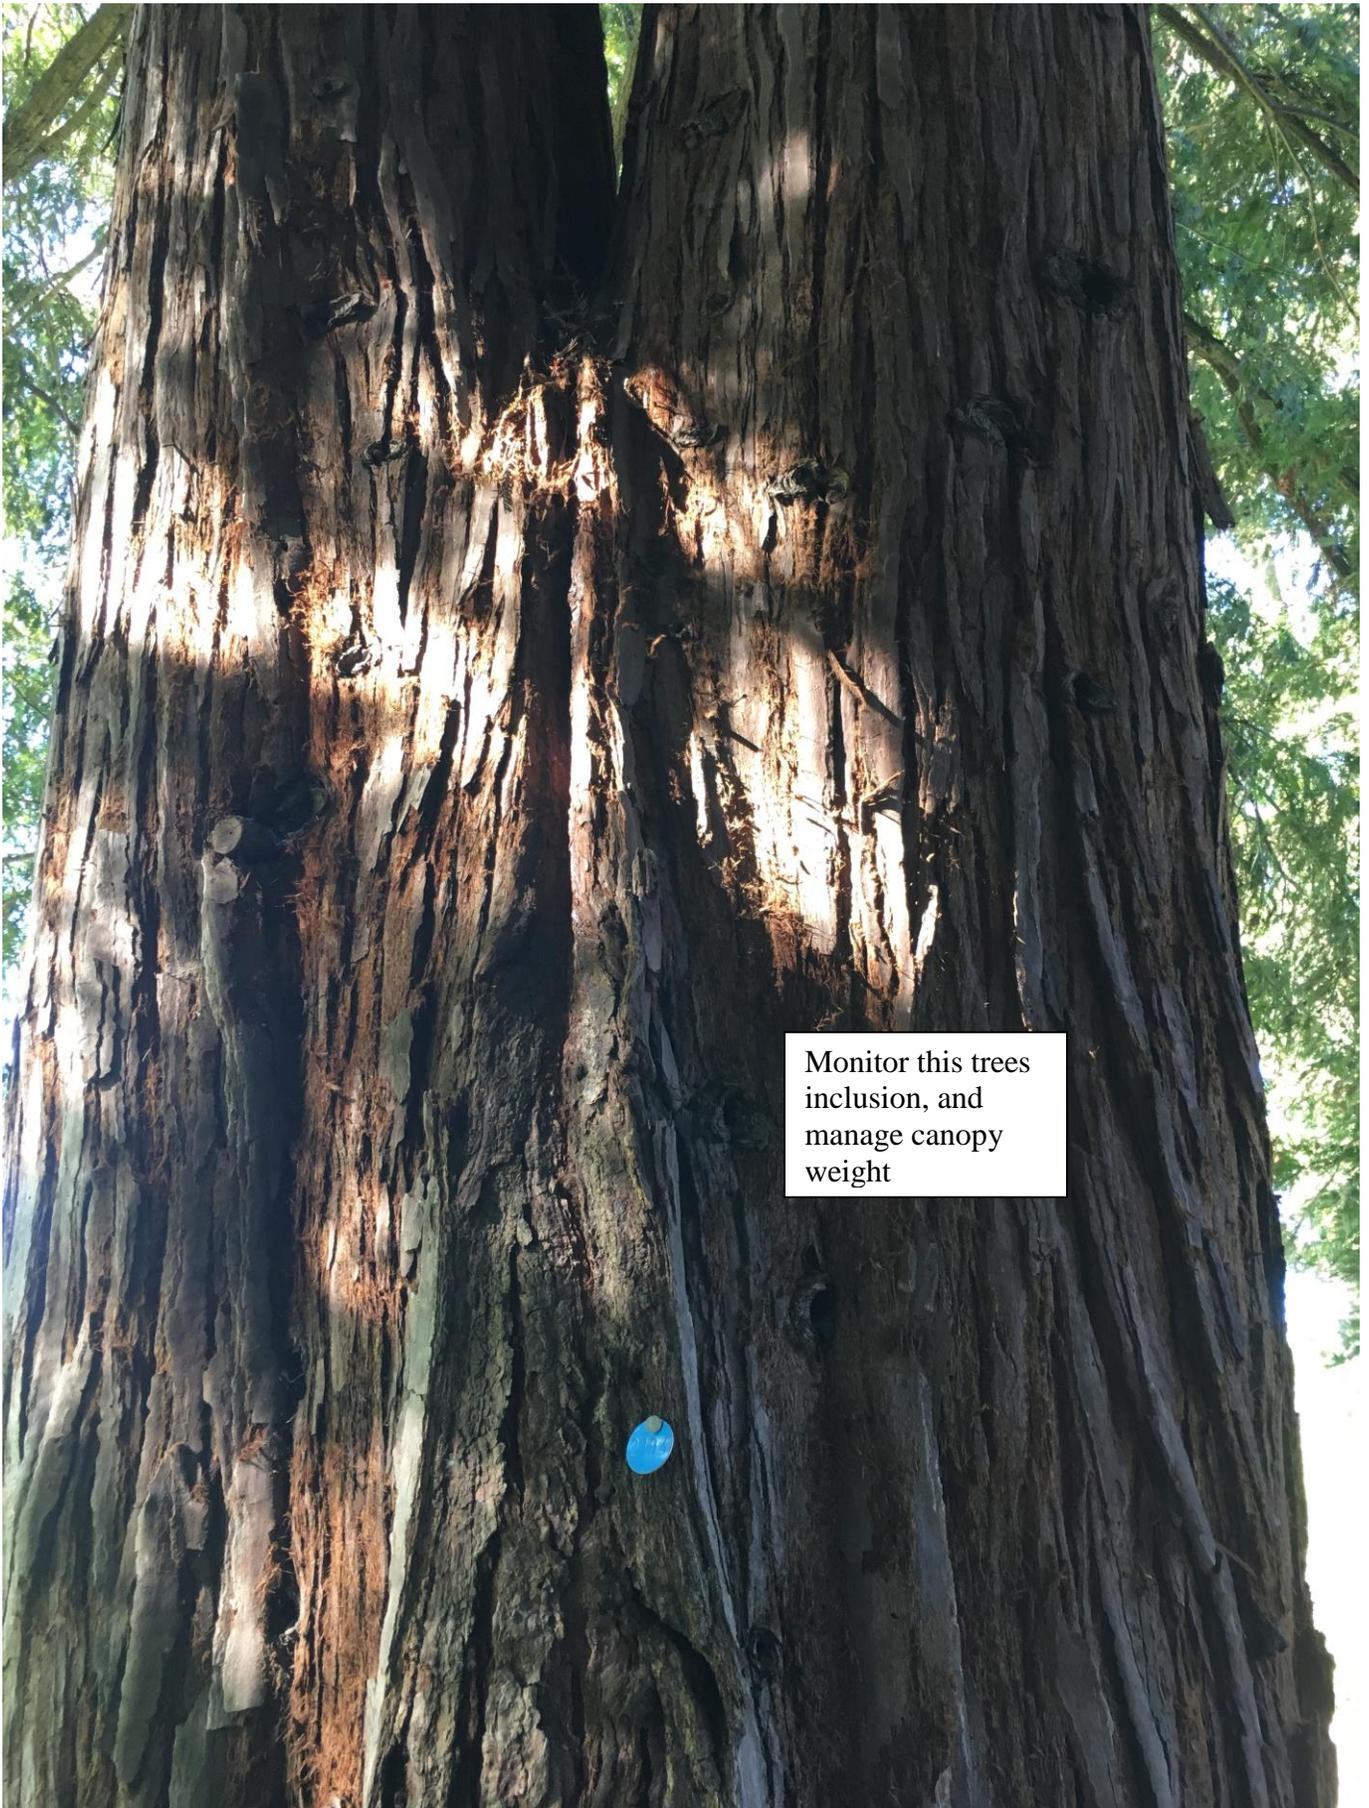
Figure 10

- (Zone 7) Tree #2193 redwood (*Sequoia sempervirens*) next to 1503 University Ave (Figure 10). Tree has large inclusion between included stems. Both stems are well developed and equal in aspect ratio. Reduction of one stem is a possibility however with the size of both stems any major reduction of one stem may cause damage to the remaining stem. I recommend we monitor this tree and manage canopy weight.

Monitor this trees inclusion, and manage canopy weight

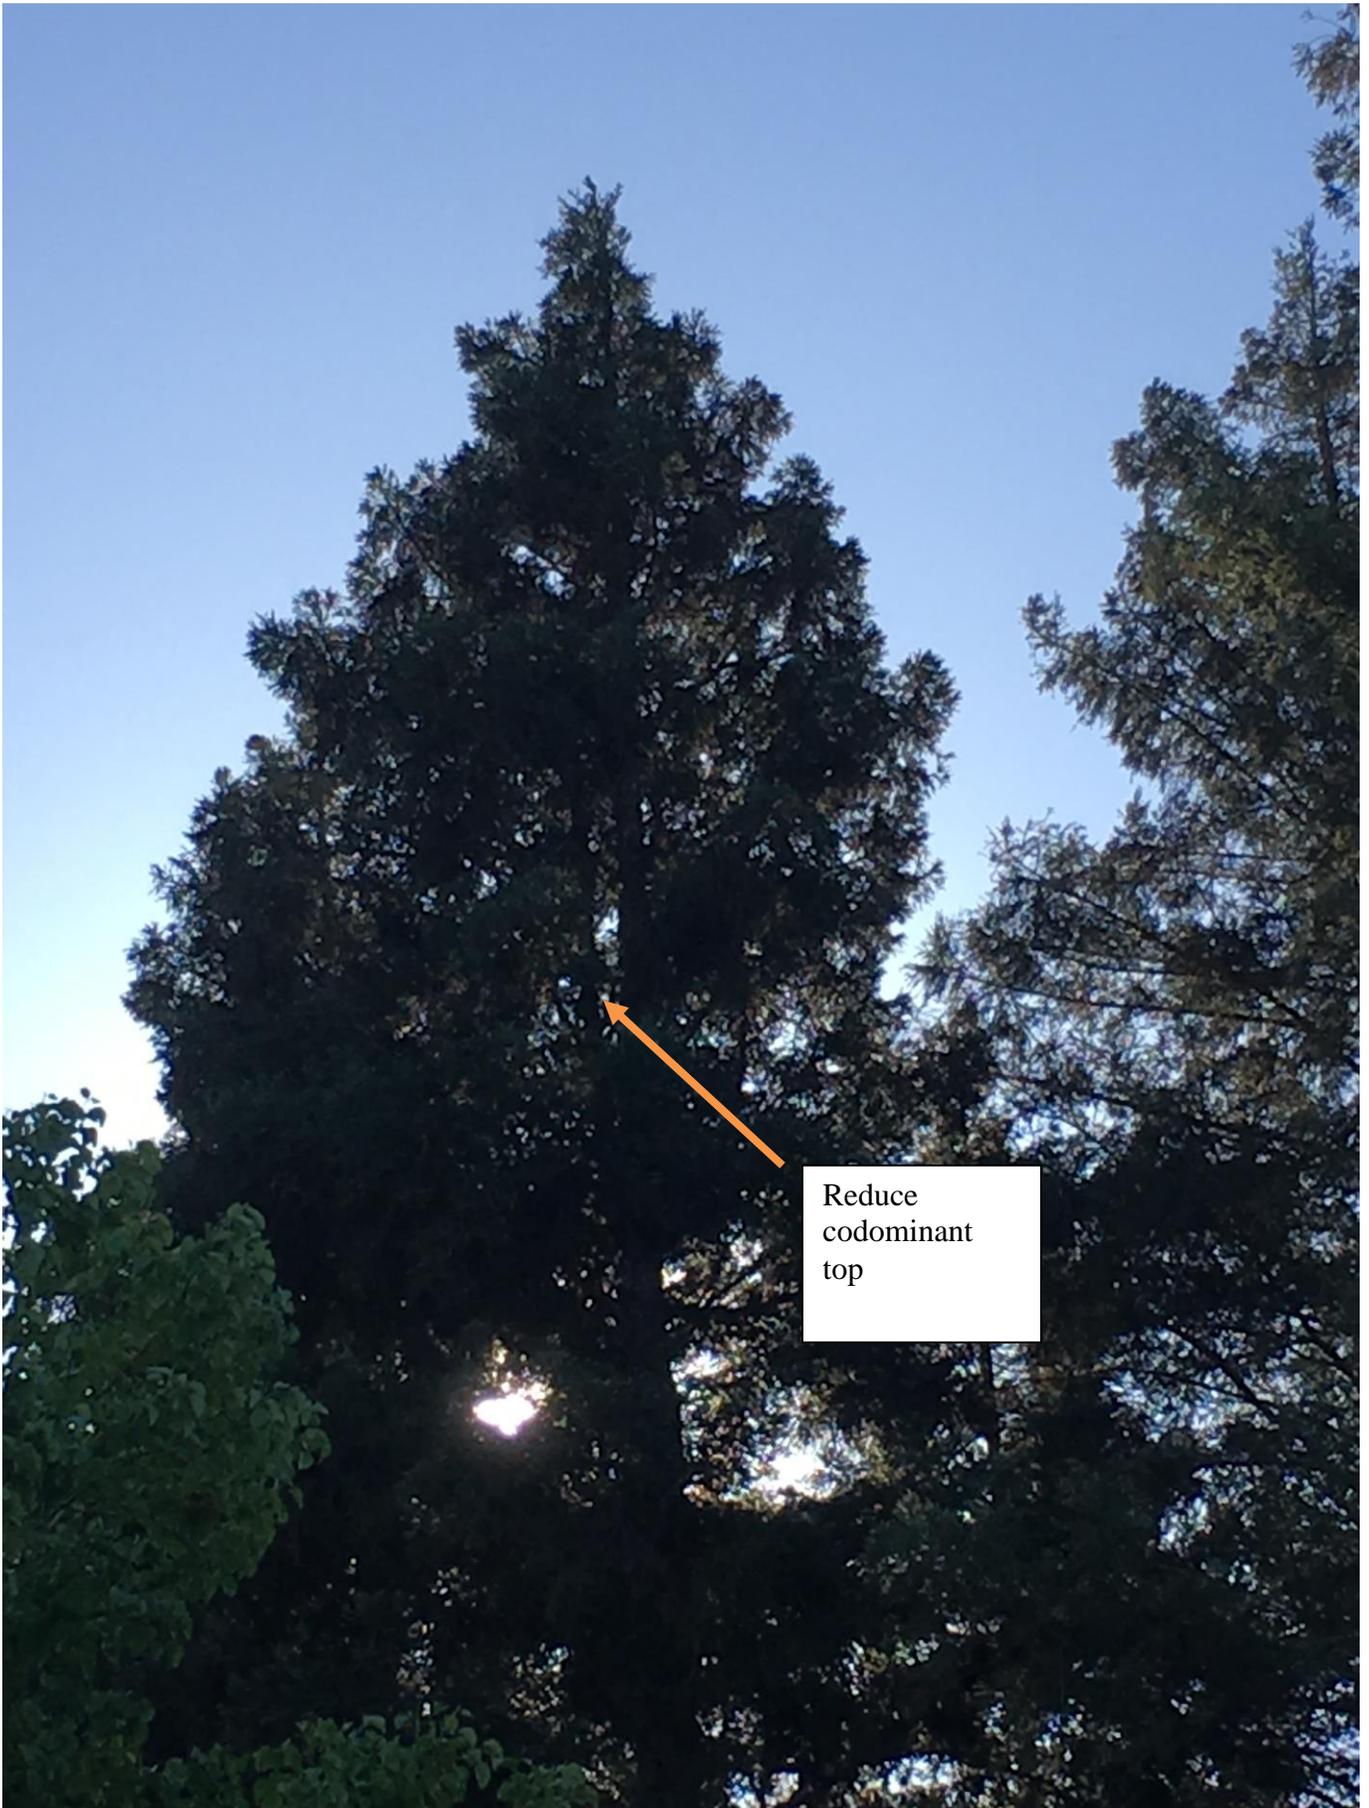
Figure 11

- (Zone 7) Tree #2190 redwood (*Sequoia sempervirens*) next to 1503 University Ave. Tree has codominant tops (Figure 11). This is a typical failure point of this species. Due to the exposure of high winds in this area, I recommend the smaller top be reduced to prevent failure.

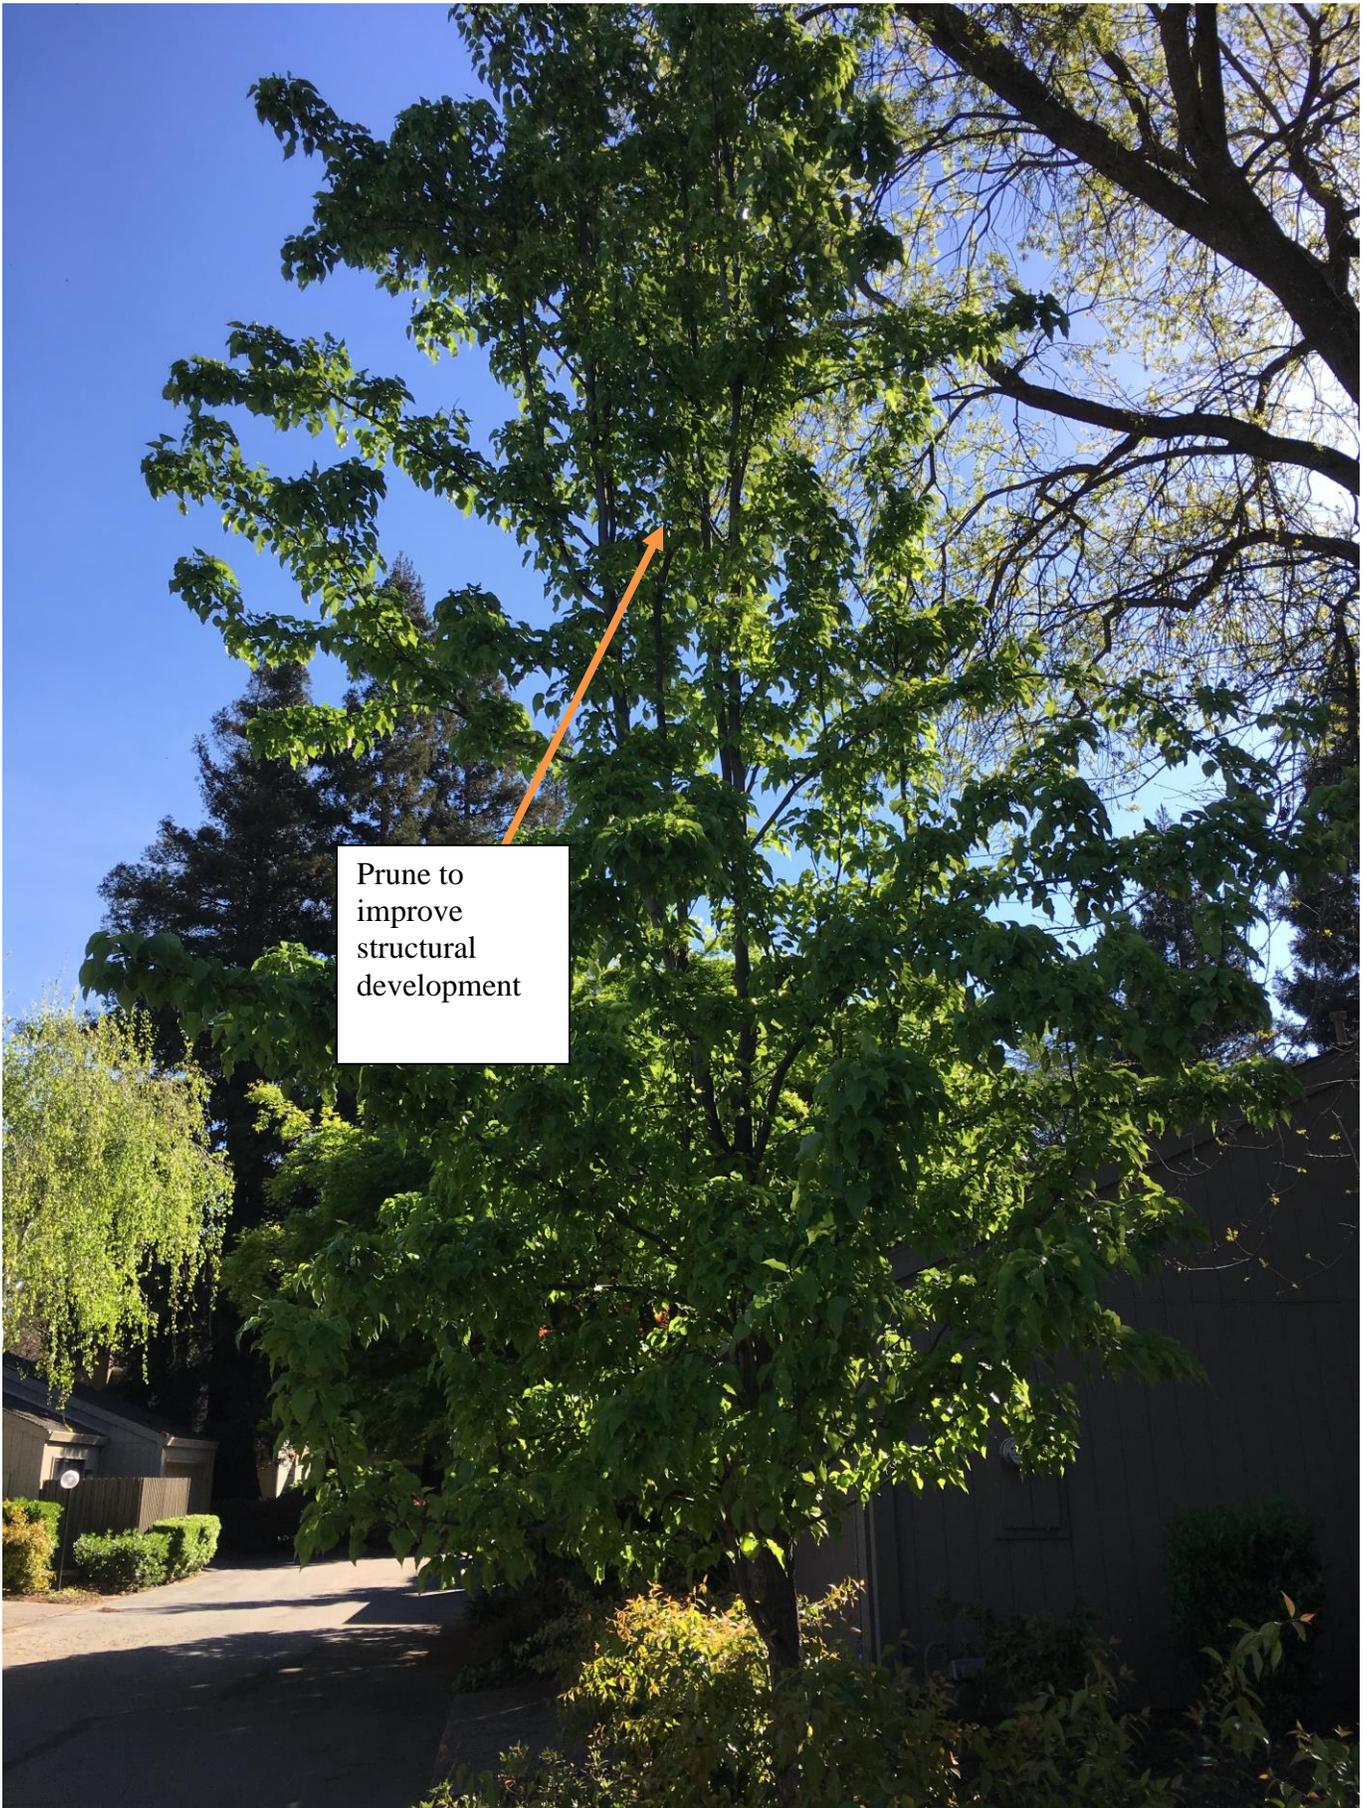
Figure 12

- (Zone 7) Tree #2051 pear (*Pyrus calleryana*) next to 1503 University Ave. Tree needs structural pruning to encourage proper development (Figure 12).

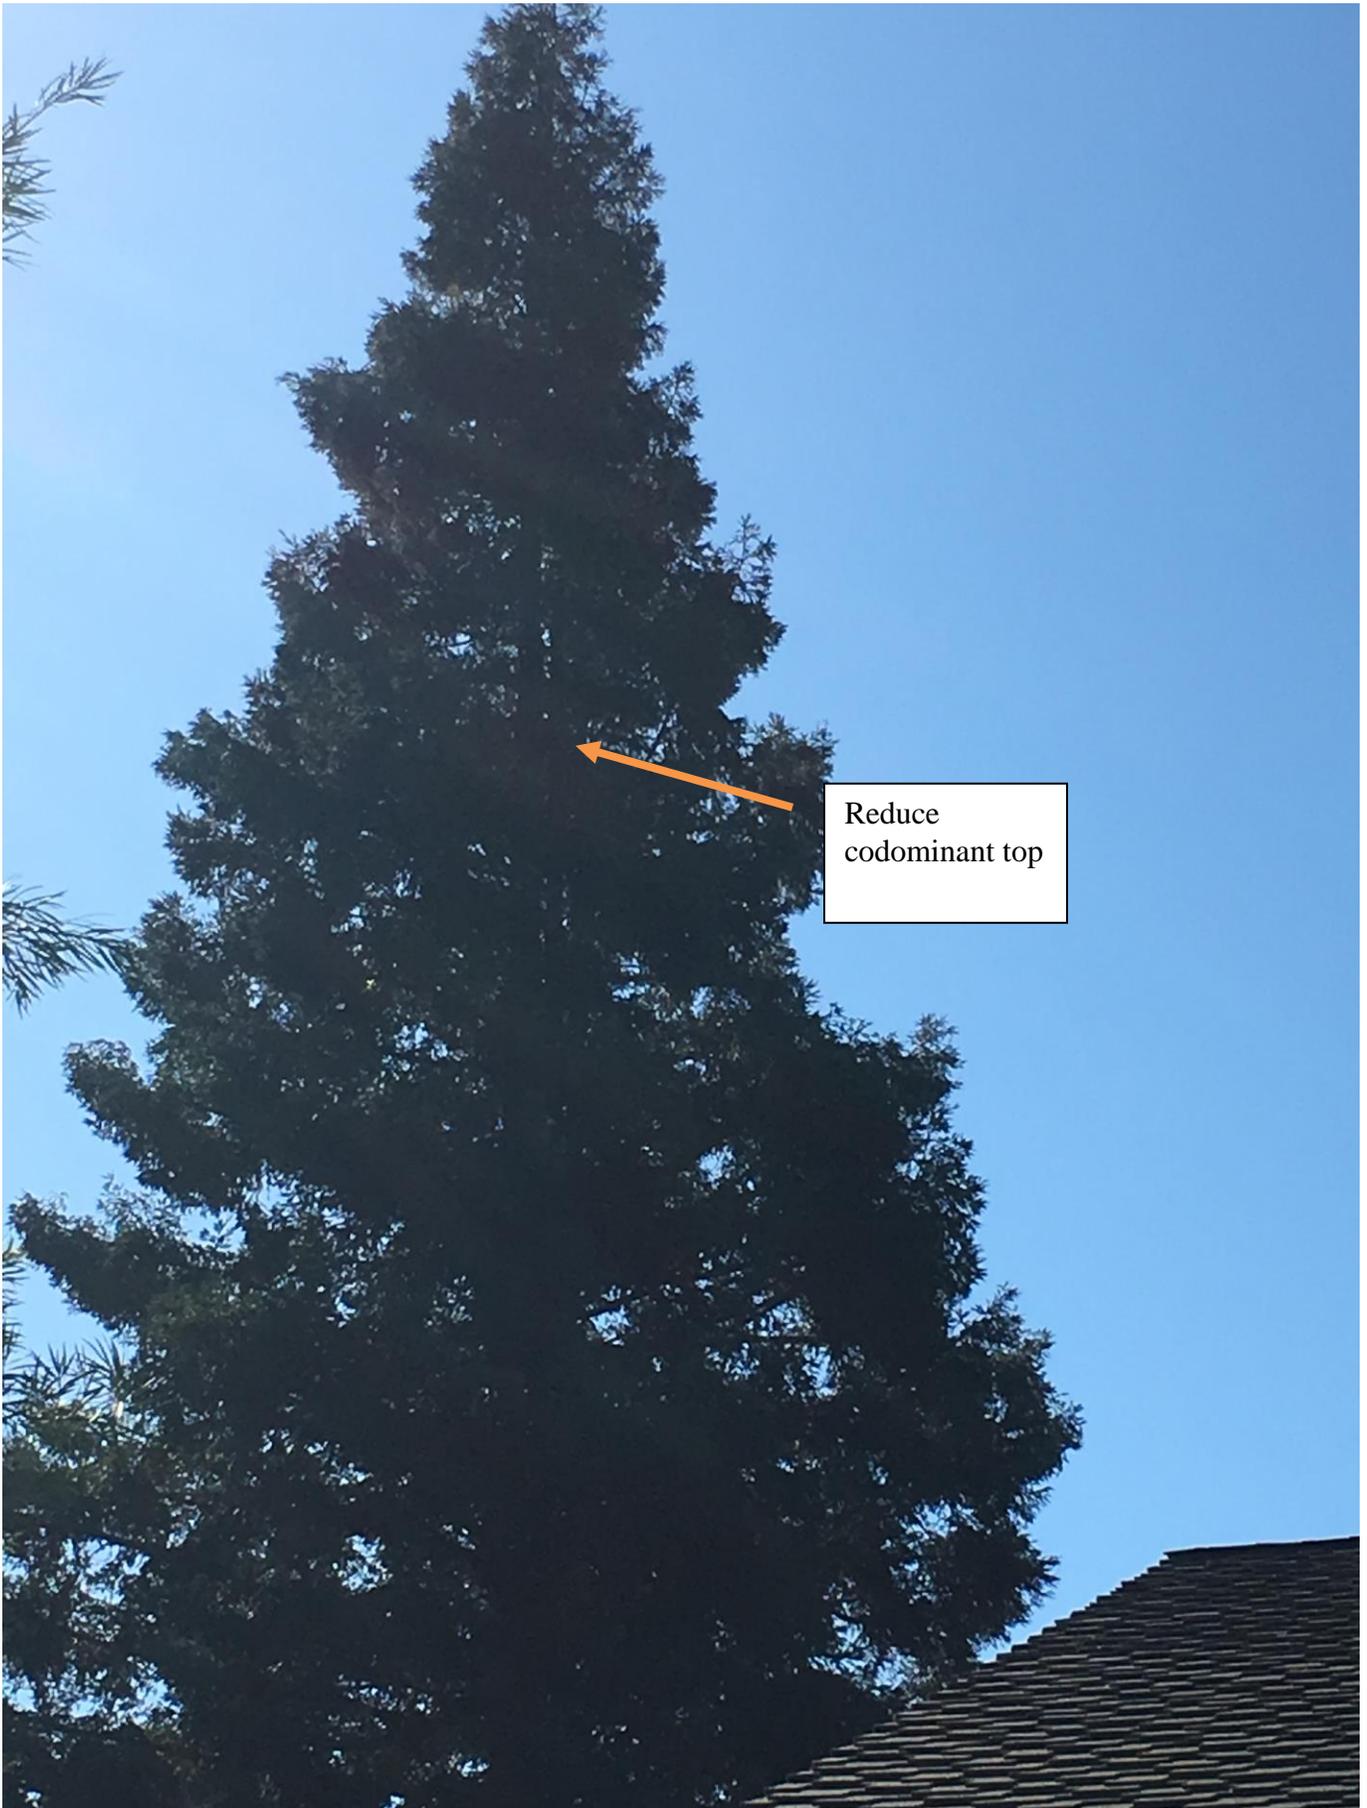
Figure 13

- (Zone 7) Tree #2184 redwood (*Sequoia sempervirens*) next to 1509 University Ave. Tree has codominant tops (Figure 13). This is a typical failure point of this species. Due to the exposure of high winds in this area, I recommend the smaller top be reduced to prevent failure.

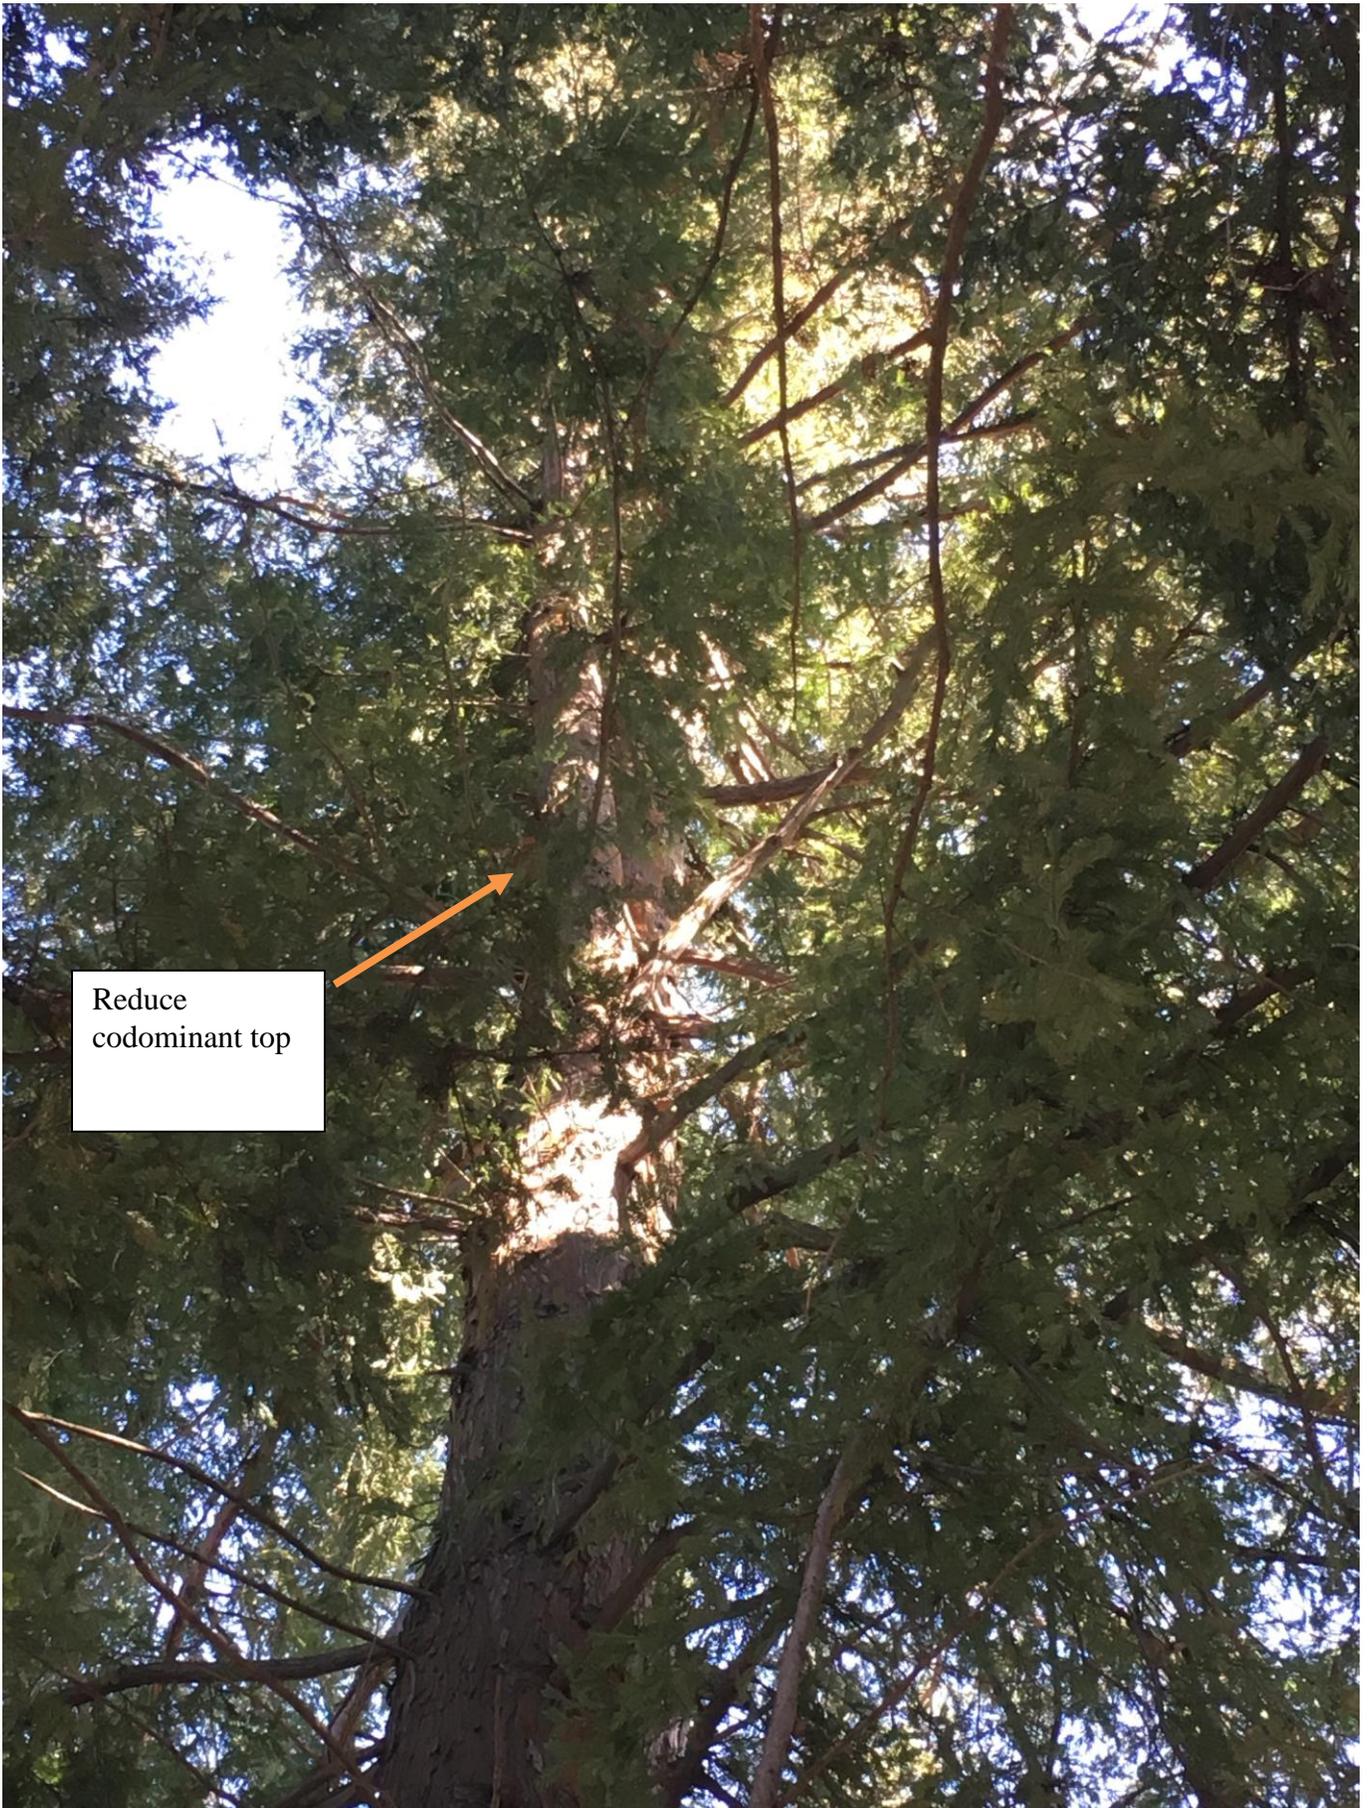
Figure 14

- (Zone 7) Tree #2161 redwood (*Sequoia sempervirens*) next to 1545 University Ave. Tree has codominant tops (Figure 14). This is a typical failure point of this species. Due to the exposure of high winds in this area, I recommend the smaller top be reduced to prevent failure.

Reduce
codominant top

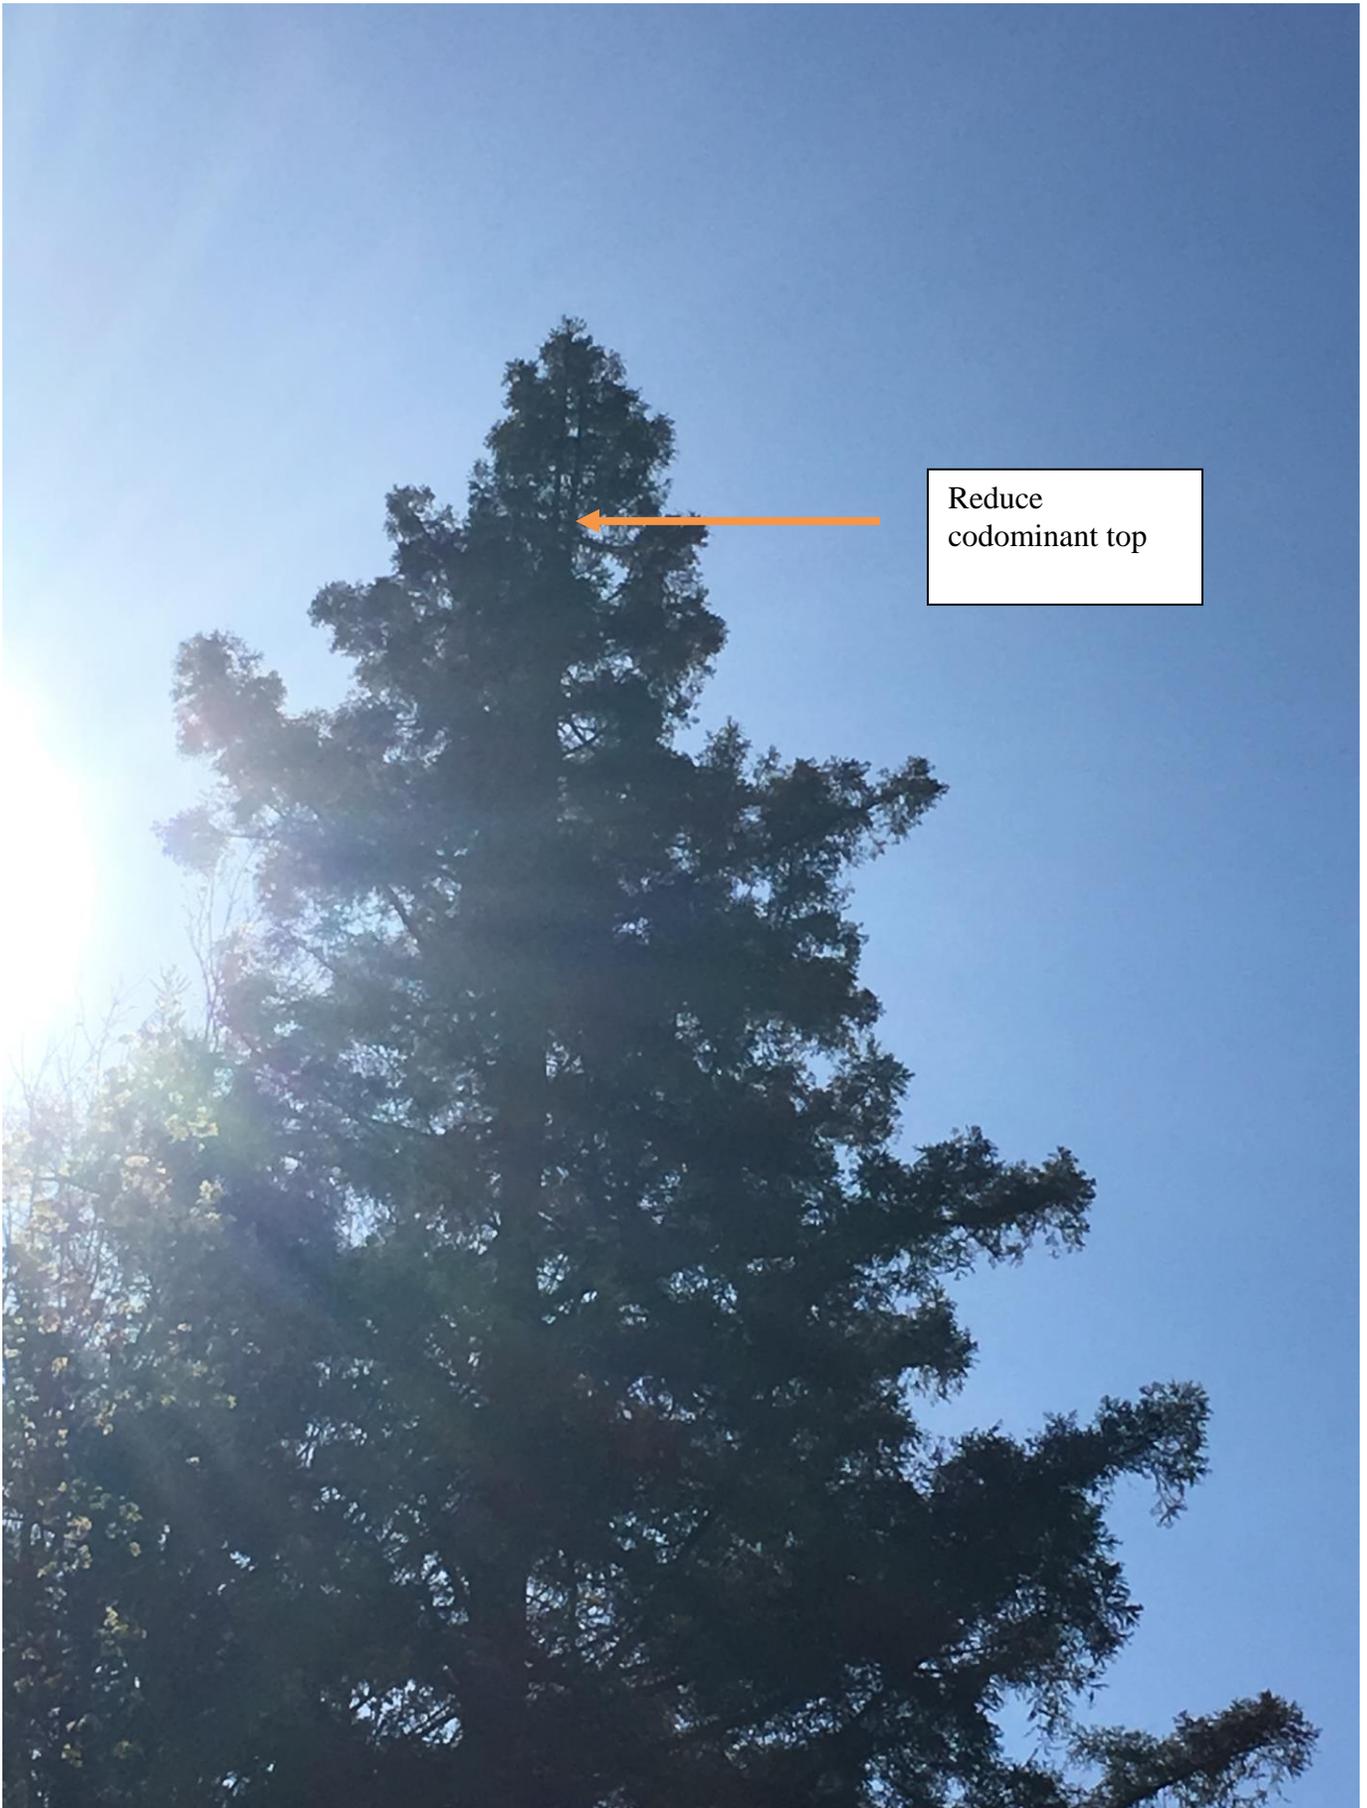
Figure 15

- (Zone 7) Tree #2169 redwood (*Sequoia sempervirens*) next to 1563 University Ave. Tree has codominant tops (Figure 15). This is a typical failure point of this species. Due to the exposure of high winds in this area, I recommend the smaller top be reduced to prevent failure.

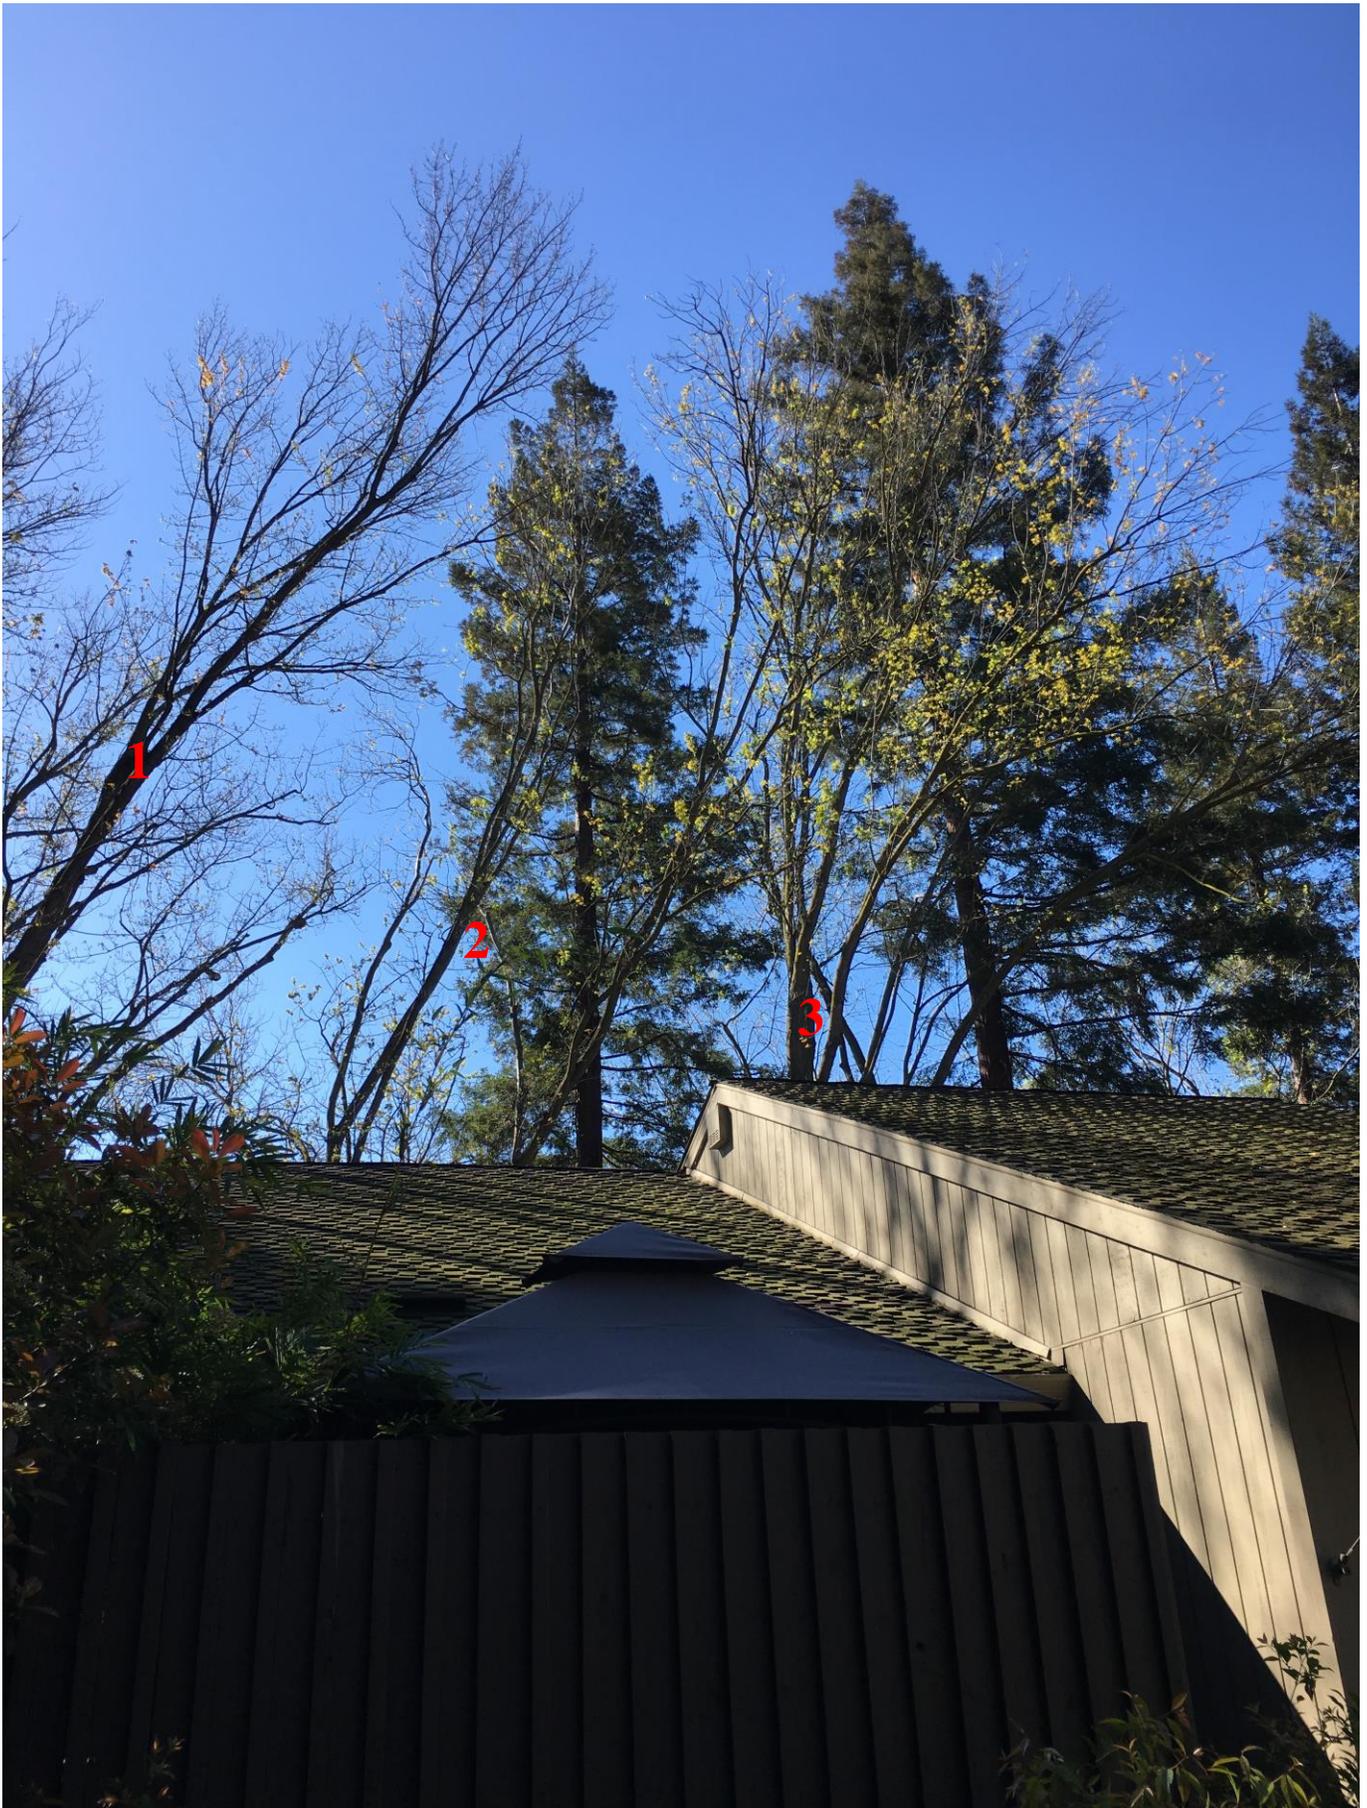
Figure 16

- (Zone 7) Trees #2167, 2168, 2170 silver maple (*Acer saccharinum*) behind 1563 and 1565 University Ave. Trees have experience limb failure this past winter (Figure 16). The trees have long overextended limbs over the houses and I recommend reduction pruning on these limbs to reduce potential of limb failure.
