May 1, 2017

The Nepenthe Association
Bettie Ledesma
1131 Commons Dr.
Sacramento, CA 95825
Phone: (916) 929-8380
Email: Bettie.Ledesma@fsresidential.com

On April 25, 2017, I inspected several trees on the Nepenthe property during the monthly tree walk. The focus of the walk was to address resident/management concerns regarding mature trees on the property. The purpose of this report is to develop mitigation plans for the following trees and my recommendations are below. My recommendations are based on a Basic Visual Inspection. All decisions made based on the recommendations of this report are at the discretion of the Nepenthe Association.

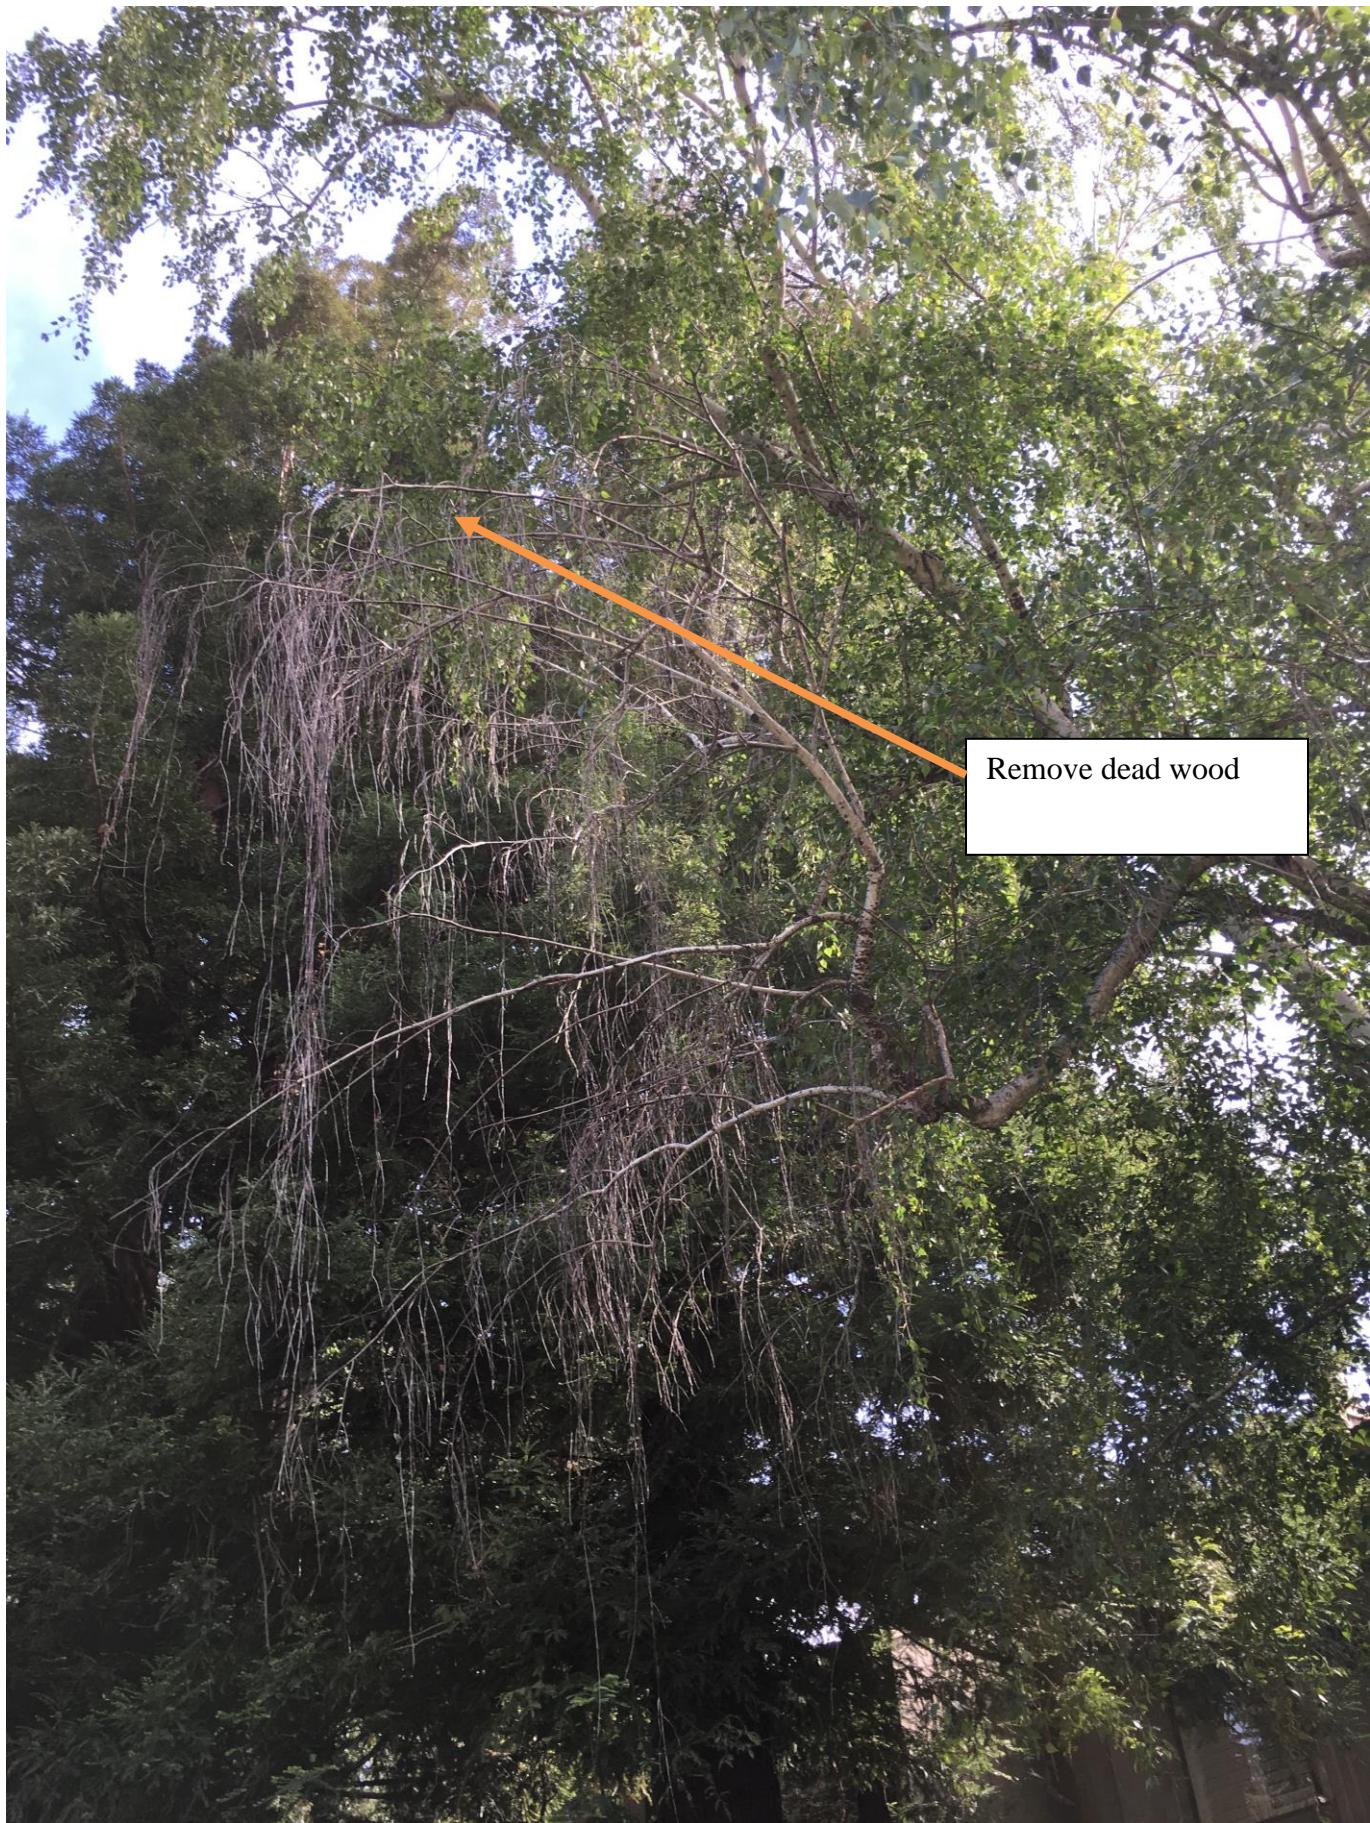
Figure 1

- (Zone 1) Tree # 310 Birch (*Betula pendula*) next to 1041 Commons Dr. Tree had some die back in crown, recommend pruning out dead wood and monitoring health (Figure 1).

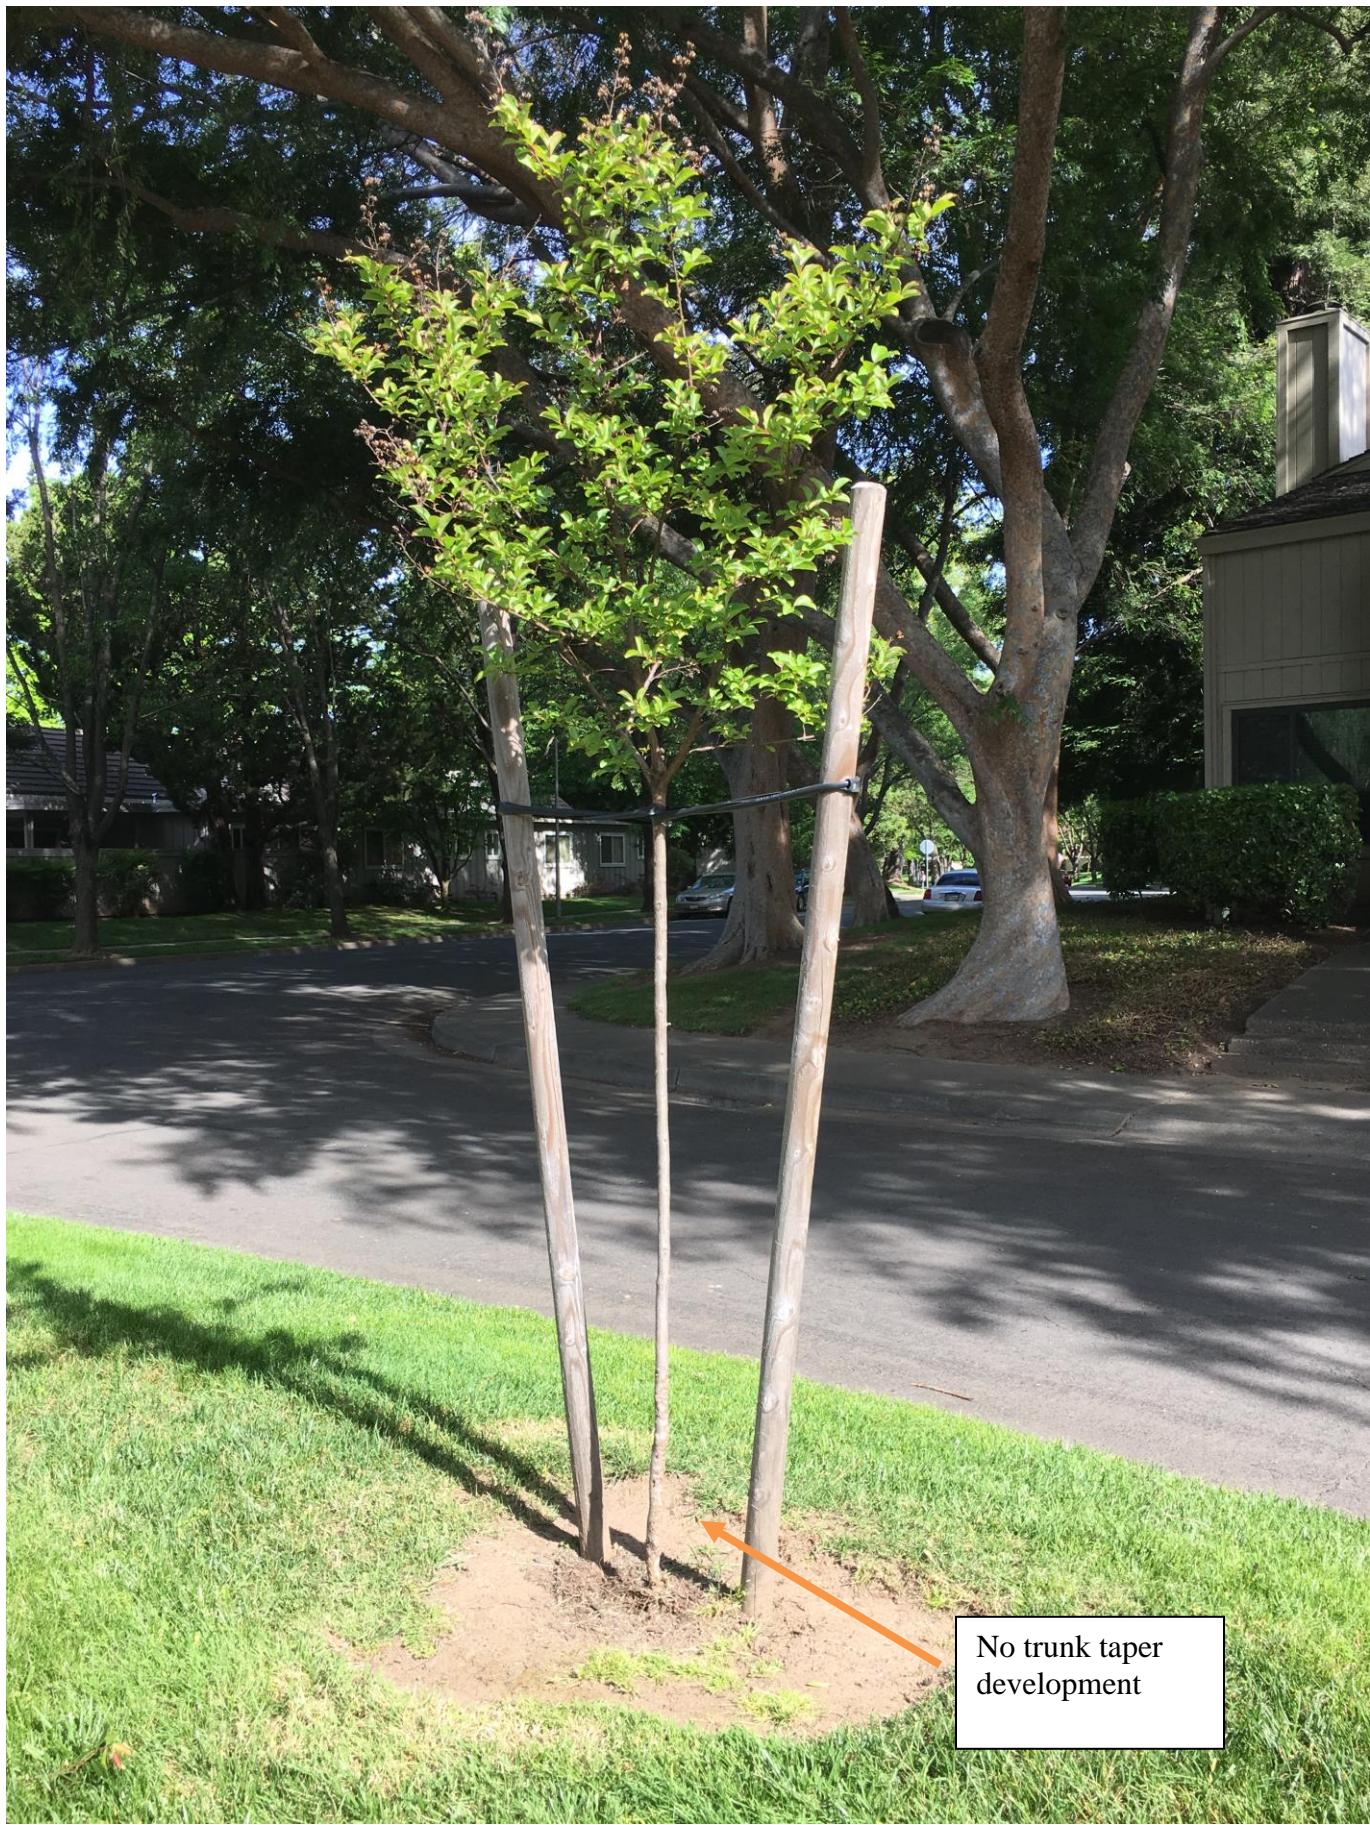
Figure 2

- (Zone 1) Tree # No Tag Crepe Myrtle (*Lagerstroemia indica*) on Island on Colby Ct. Tree planted about 2 years ago, has some damage along trunk, likely from string mower damage (Figure 2). The tree has developed little taper and is reliant on the tree stakes to hold upright (Figure 3). My recommendation is to transplant tree to container, allow tree to develop more root system for possible future replanting and replant island with new tree.

No trunk taper development

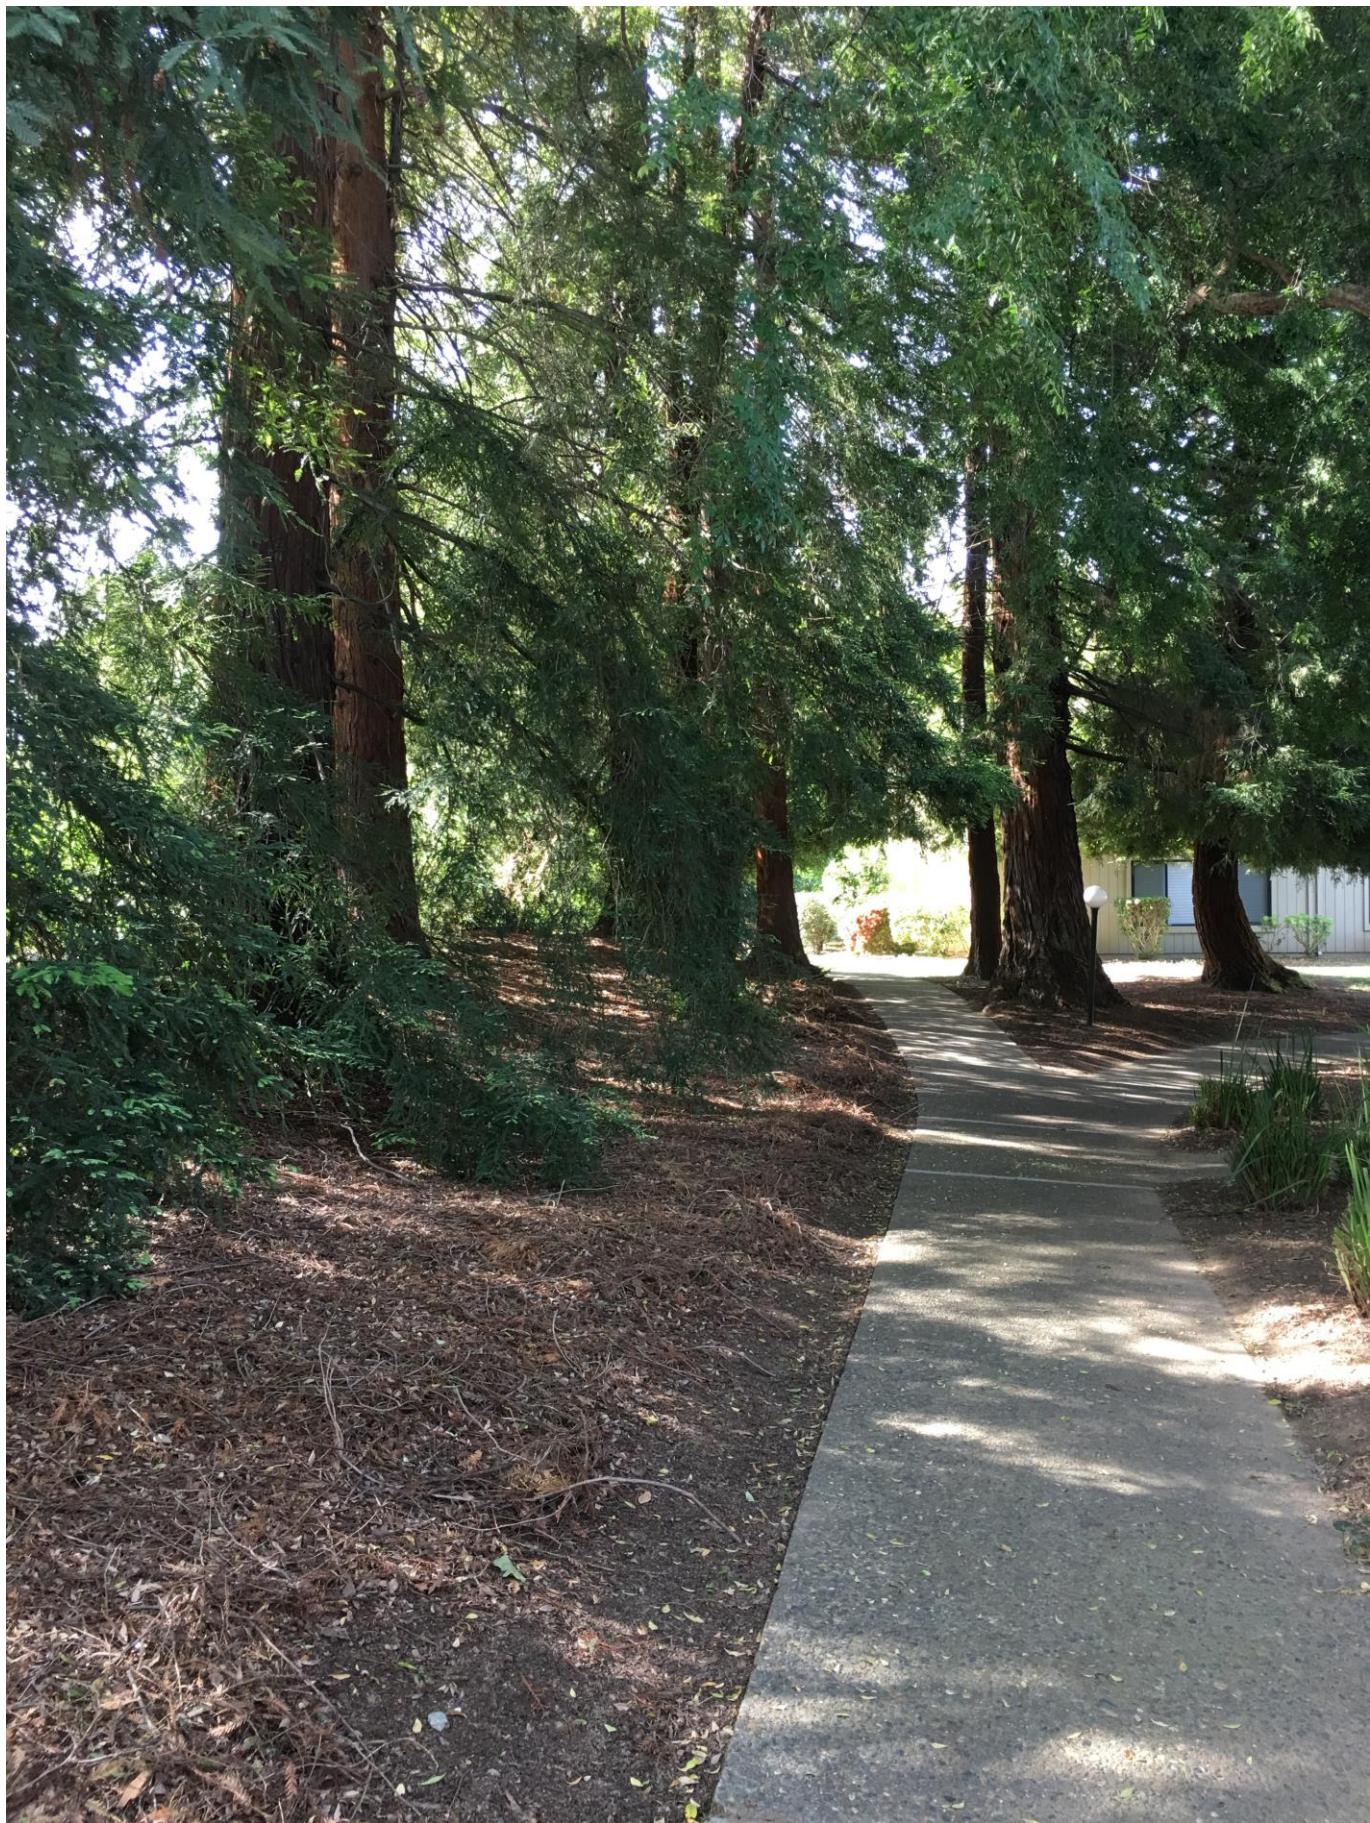
Figure 4

- (Zone 1) Tree's #24-#30 & #40-#42 Redwood (*Sequoia sempervirens*), 11 trees at the end of Colby Ct. starting next to 21 Colby Ct. Trees would benefit from deep root water root injection to rejuvenate and encourage root system development (Figure 4)

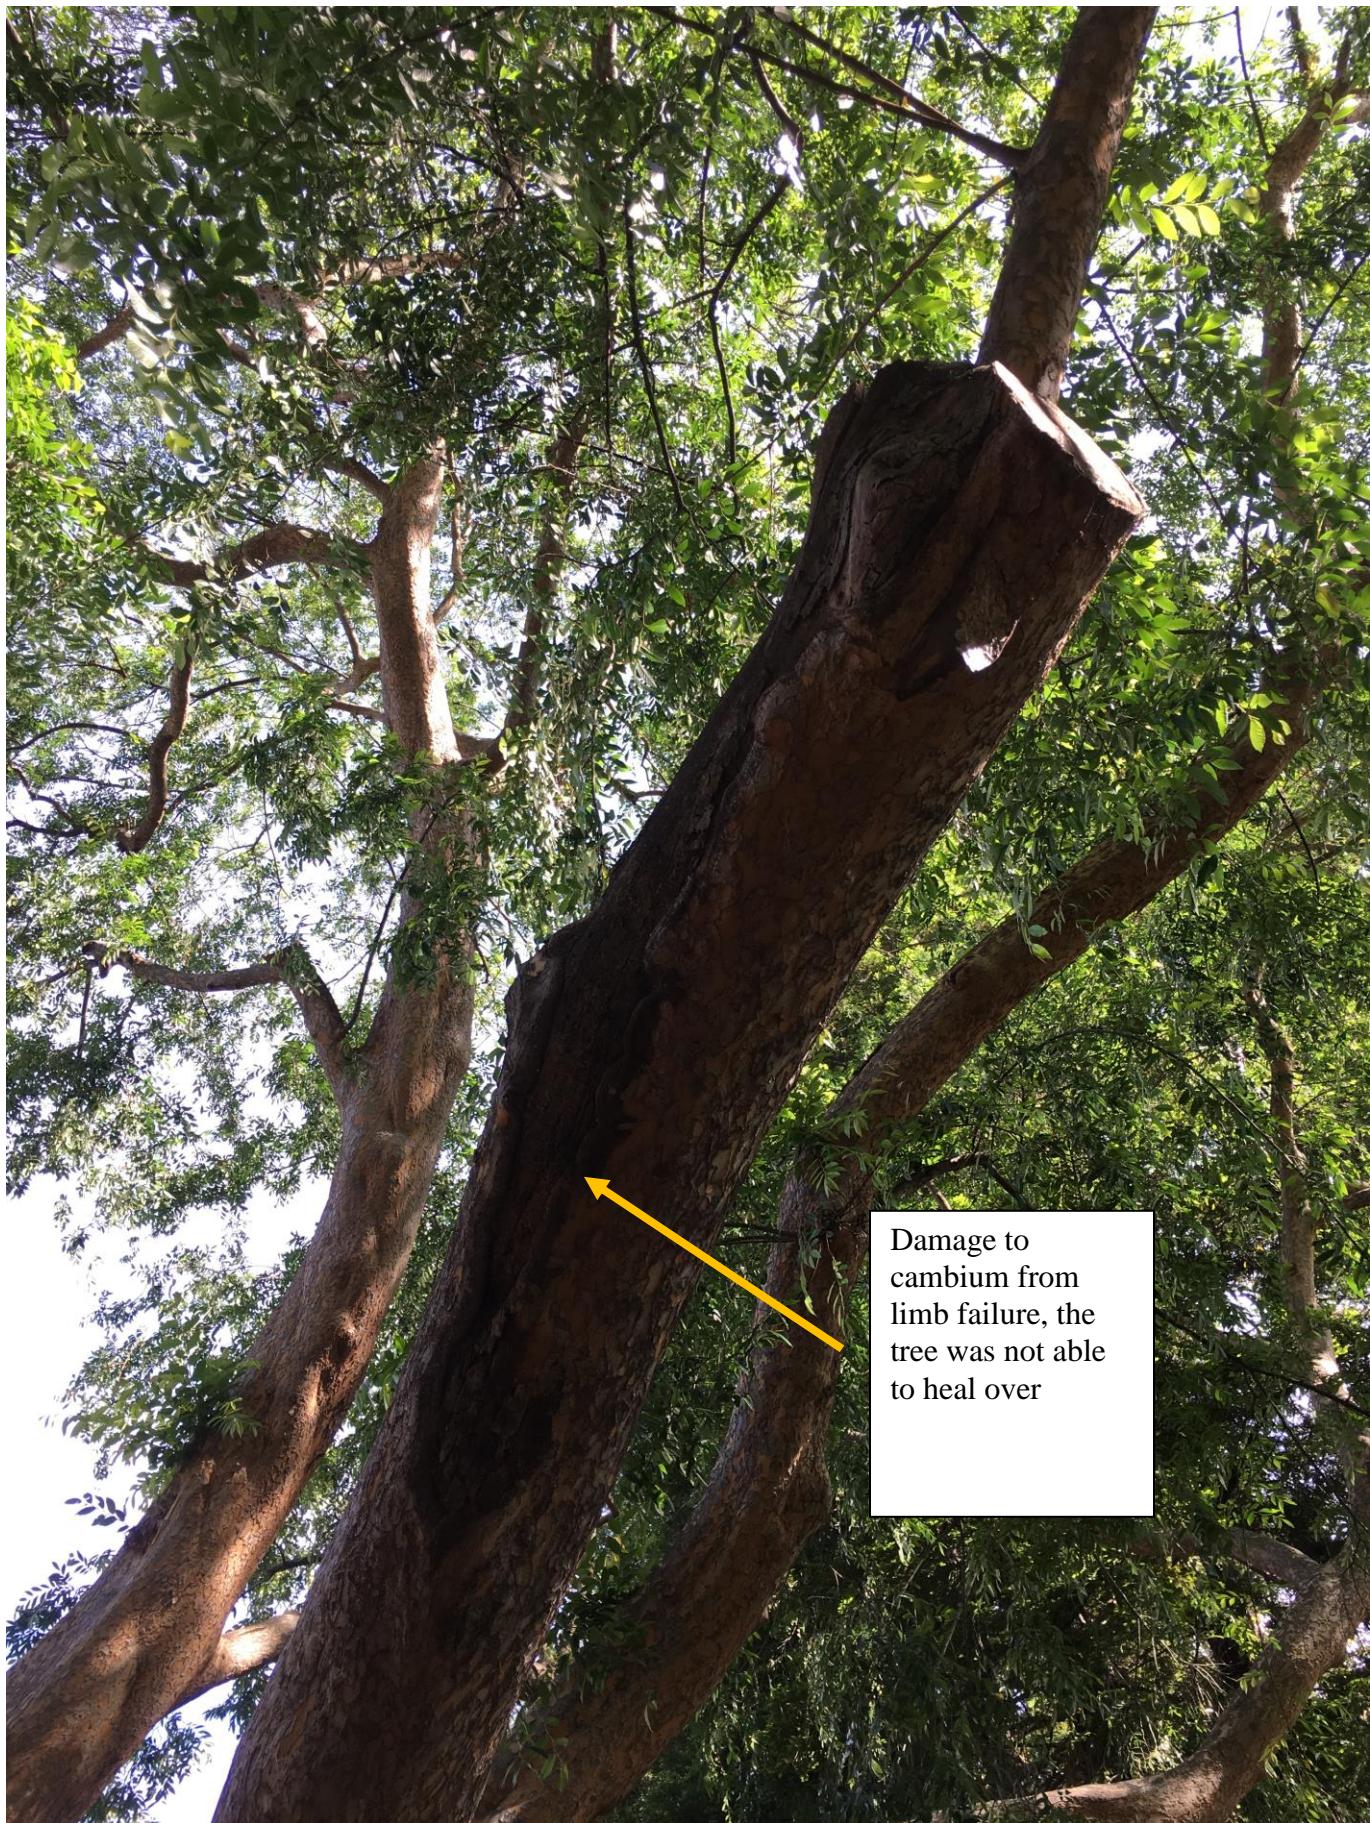
Figure 5

- (Zone 1) Tree #2 Chinese elm (*Ulmus parvifolia*), next to 19 Colby Ct. Lower limb on tree has had past damage likely from limb failure (Figure 5). The tree was unable to heal over wound exposing wood. I recommend removing this limb entirely and allowing the tree to close wound at trunk.

Damage to
cambium from
limb failure, the
tree was not able
to heal over

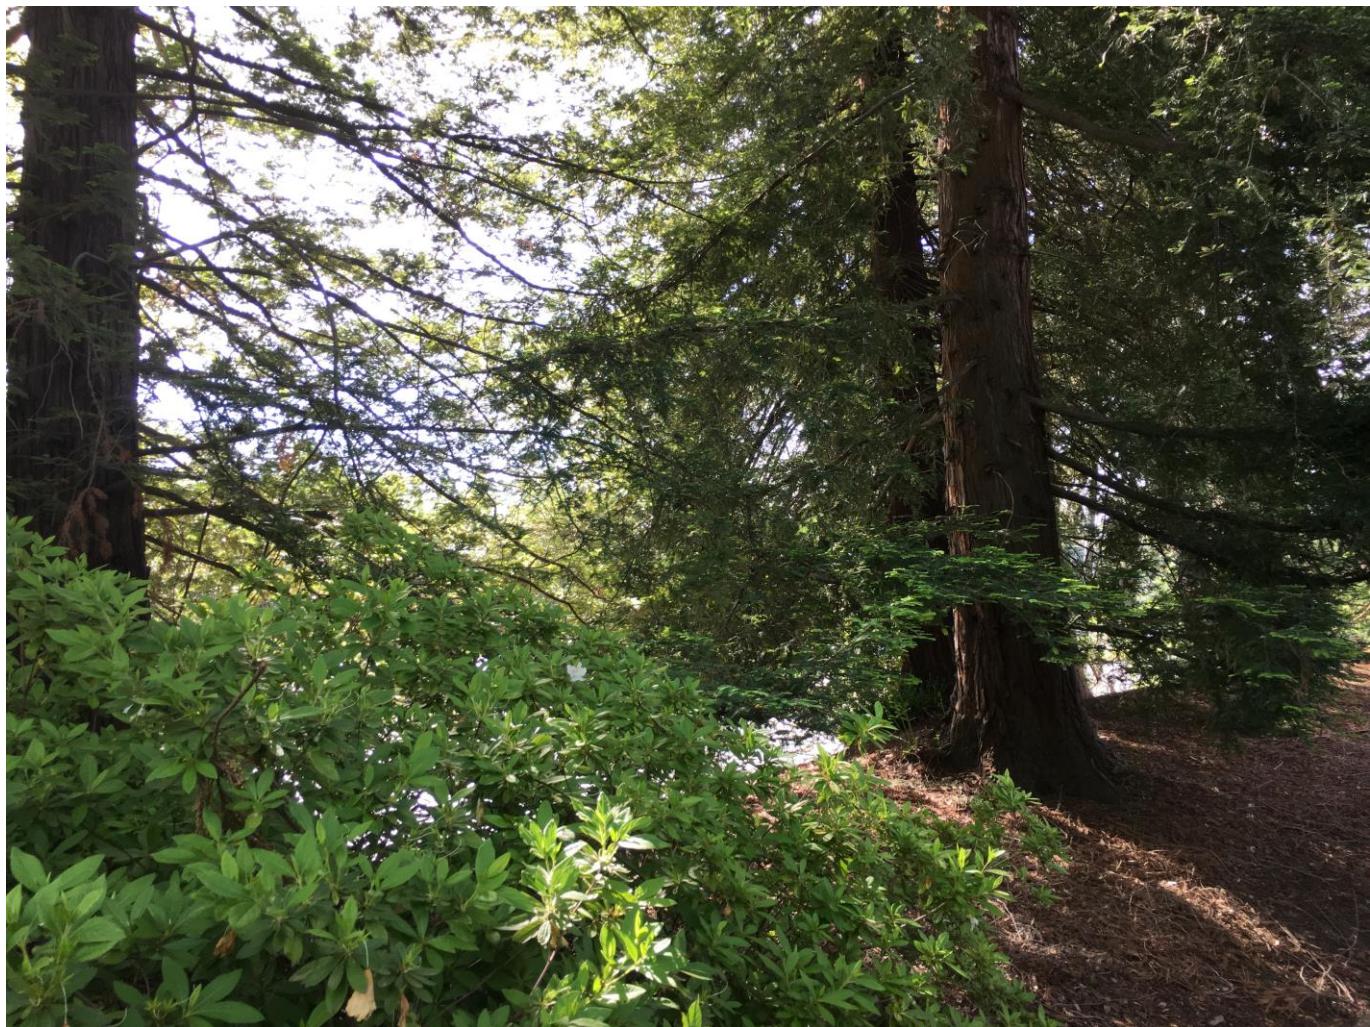
Figure 6

- (Zone 1) Tree's #3,#4 & #5 Redwood (*Sequoia sempervirens*), 3 trees next to 2320 American River Drive. Trees would benefit from deep root water root injection to rejuvenate and encourage root system development (Figure 6)

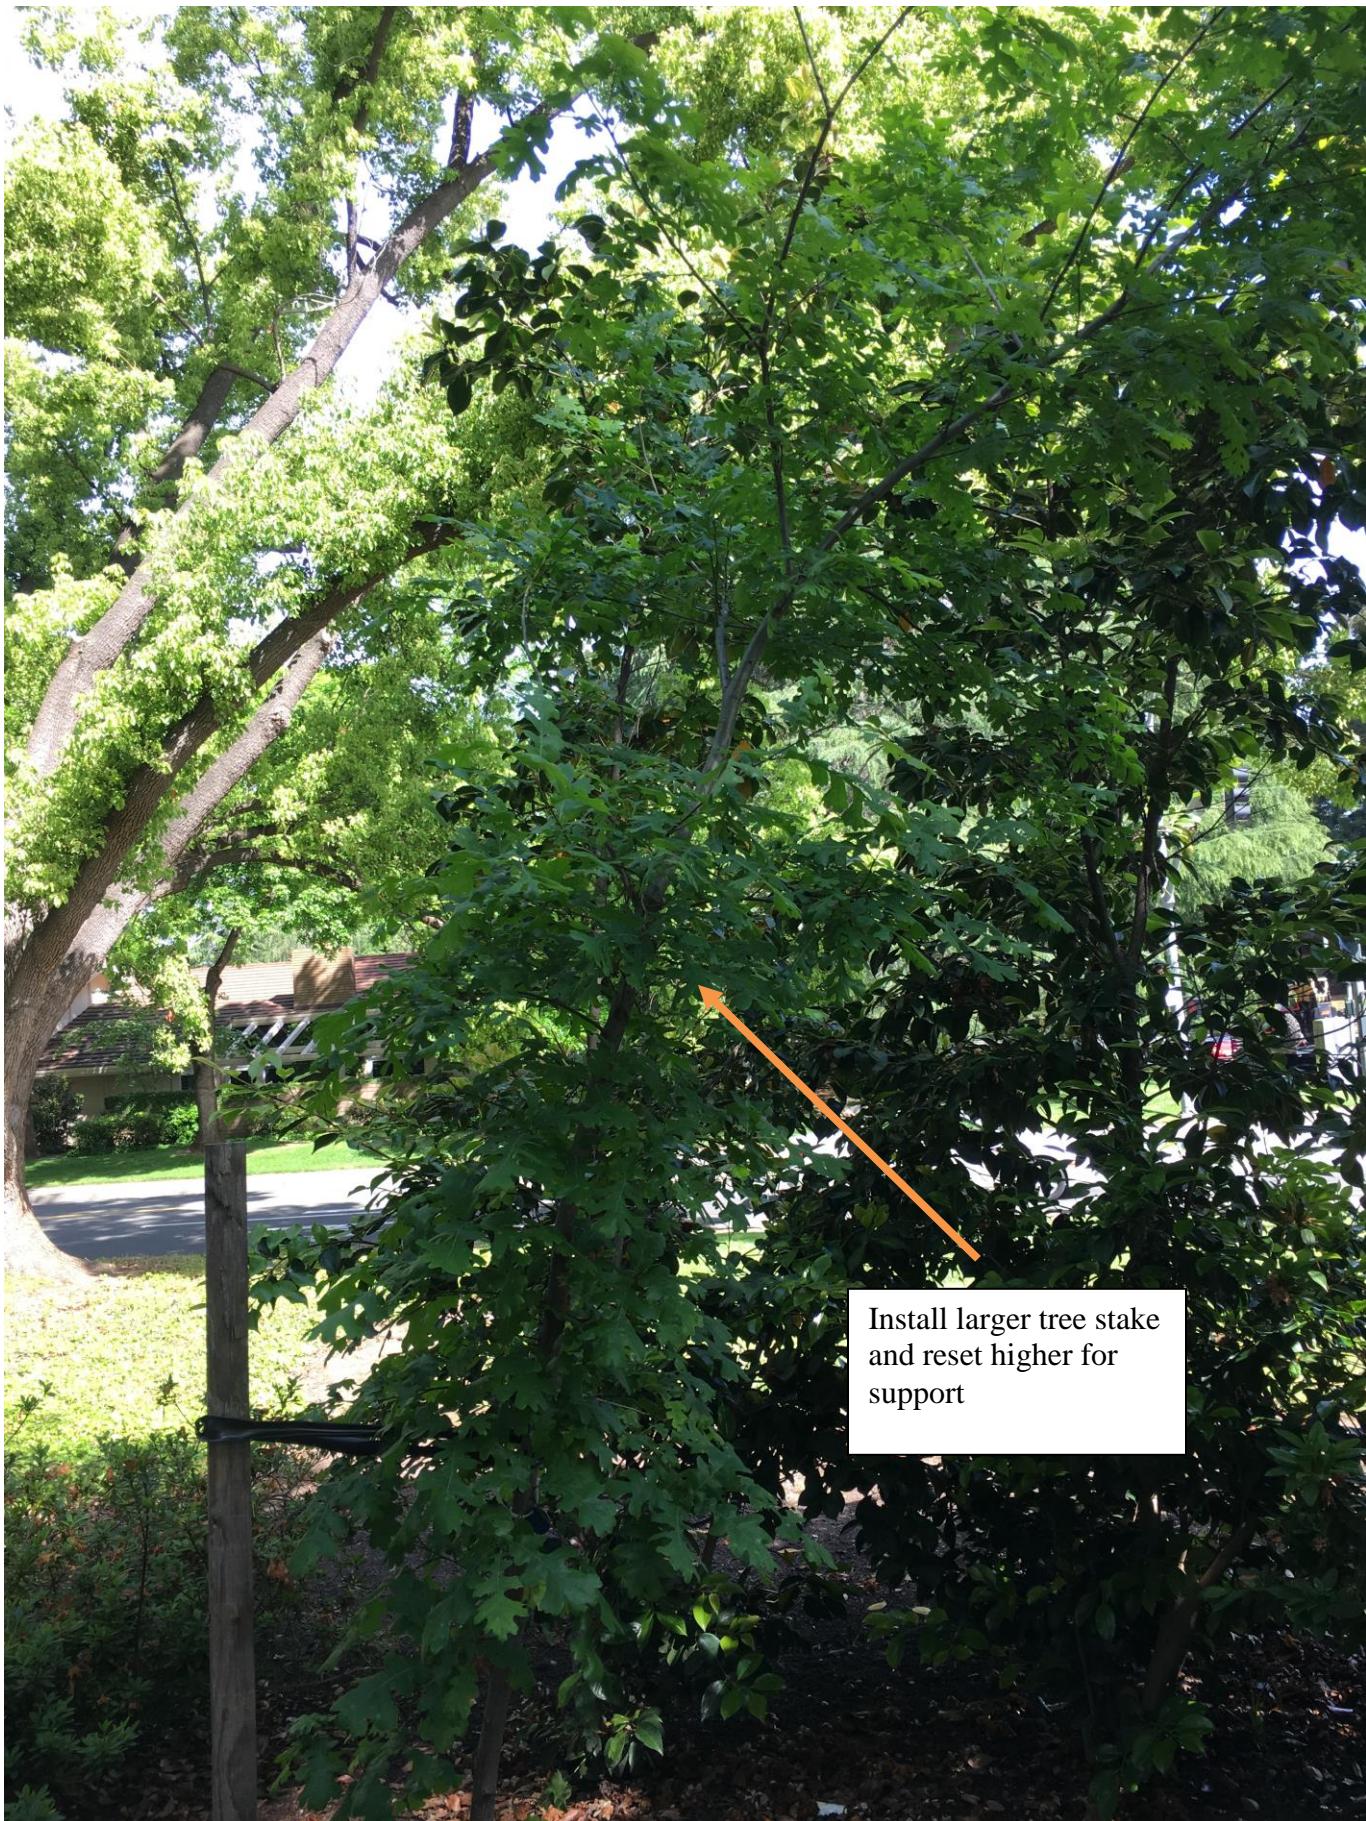
Figure 7

- (Zone 1) Tree #1 Valley Oak (*Quercus lobata*) next to 2320 American River Drive. New Planting, Tree needs to have taller tree stakes and have the support reset to support the tree.(Figure 7)

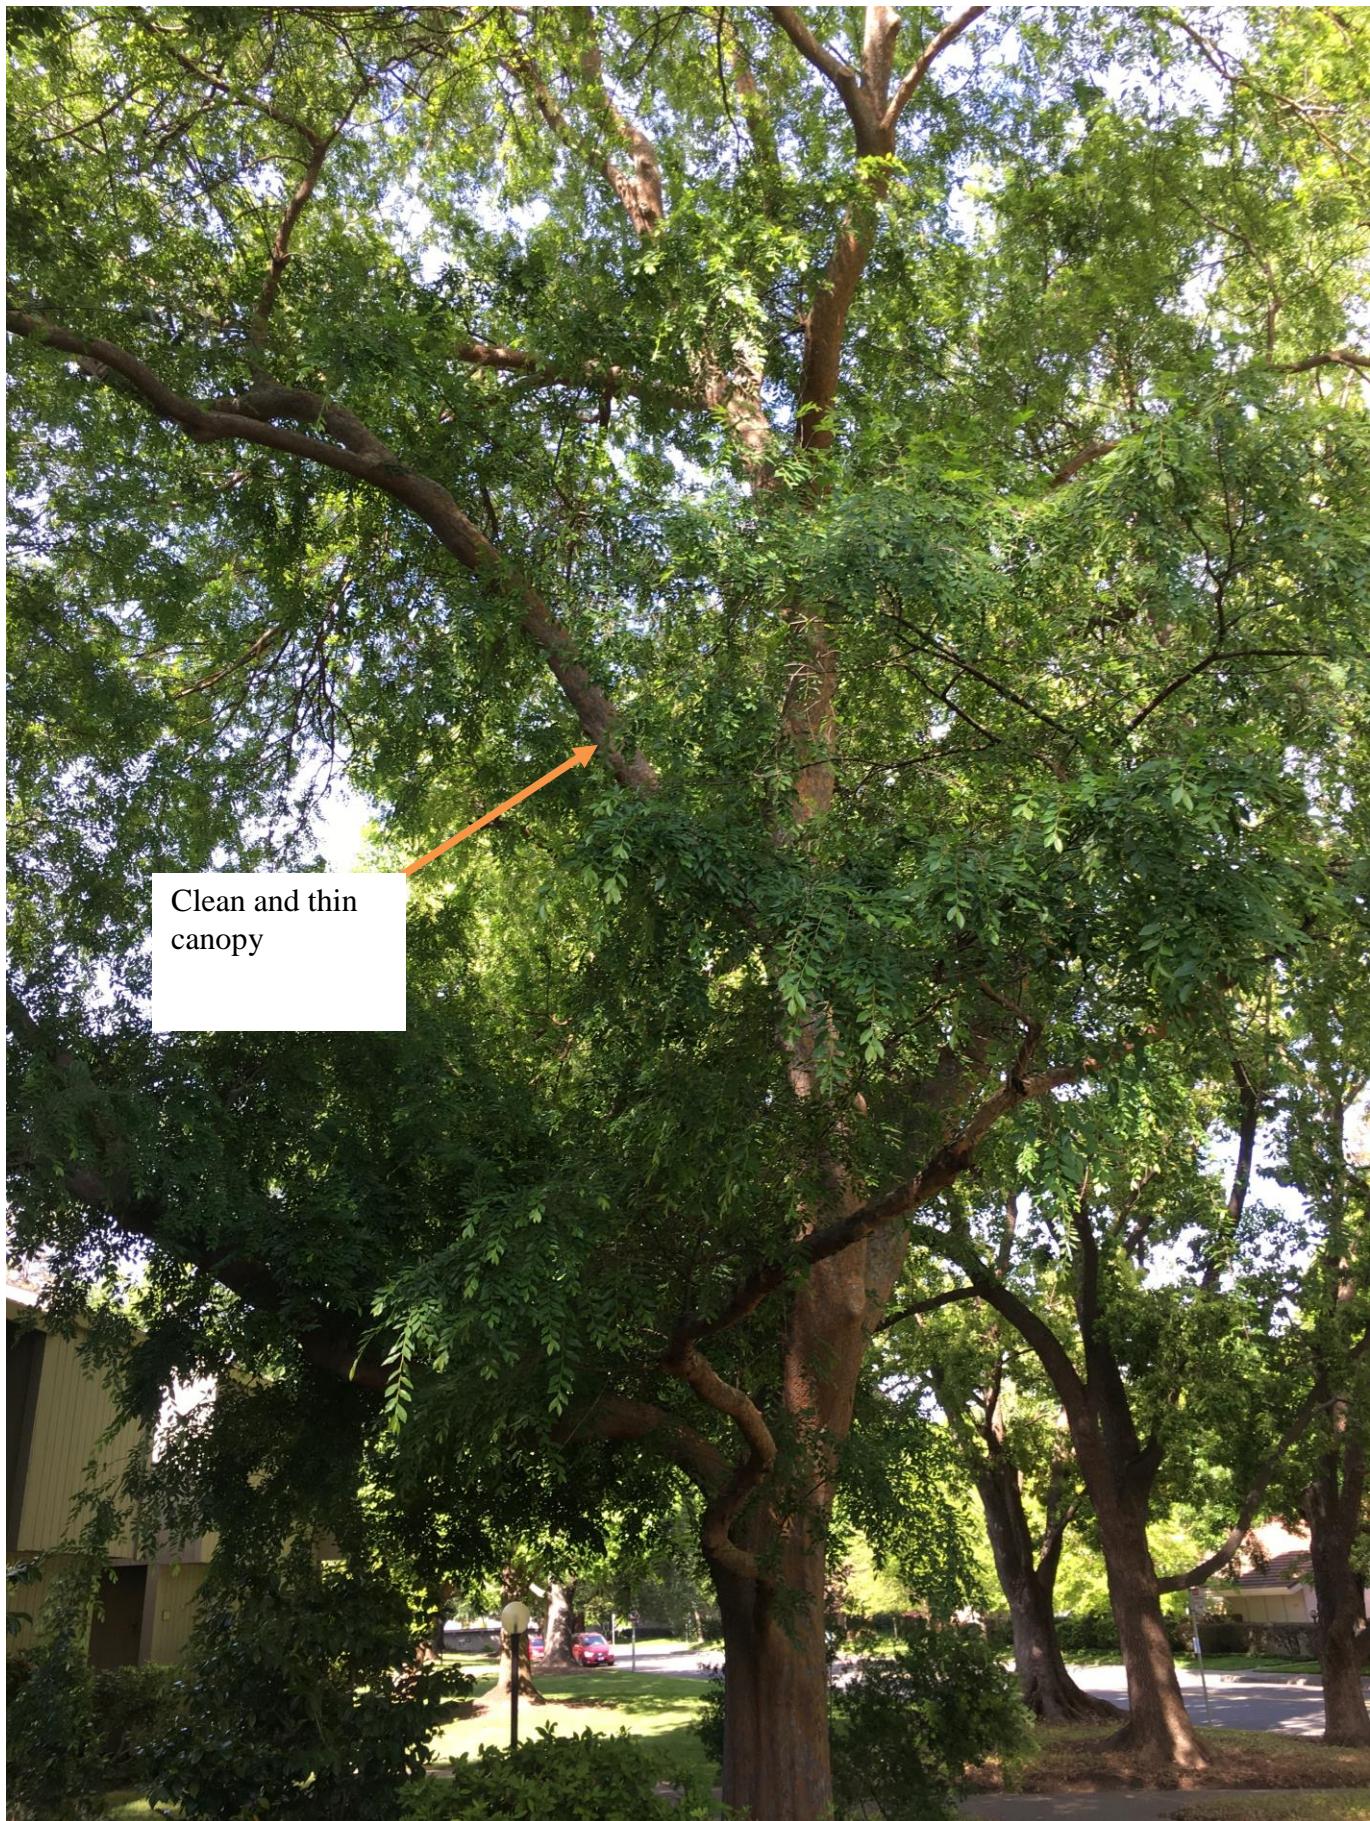
Figure 8

- (Zone 1) Tree #380 Chinese elm (*Ulmus parvifolia*), next to 2318 American River Drive. Tree has full and over weighted canopy as well as some dead wood (Figure 8). The tree also has a girdling root developing at base of tree (Figure 9), likely the cause of some canopy dieback. I recommend full prune of tree and pruning to correct girdling root.

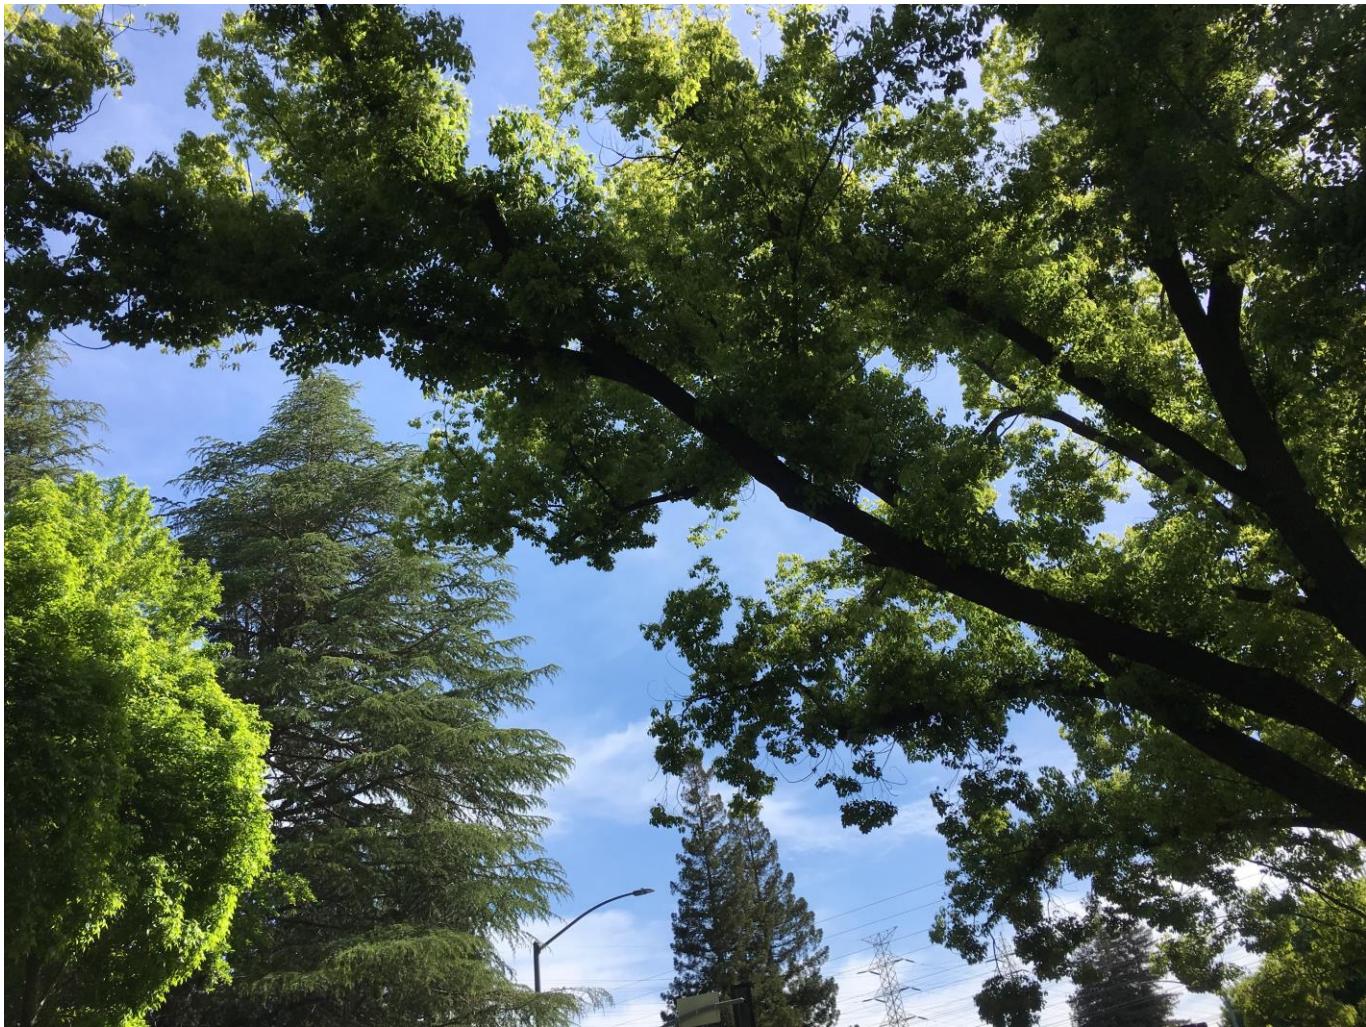
Figure 10

- (Zone 1) Trees #375-#379 Camphor (*Cinnamomum camphora*) next to 2318-2314 American River Drive. Trees have several large limbs that have recently died (Figure 10). As well as long overextended limbs over American River drive. I recommend the dead wood pruned out and to reduce the long overextended limbs to prevent limb failure into the street.

Reduce long
overextended
limbs over road

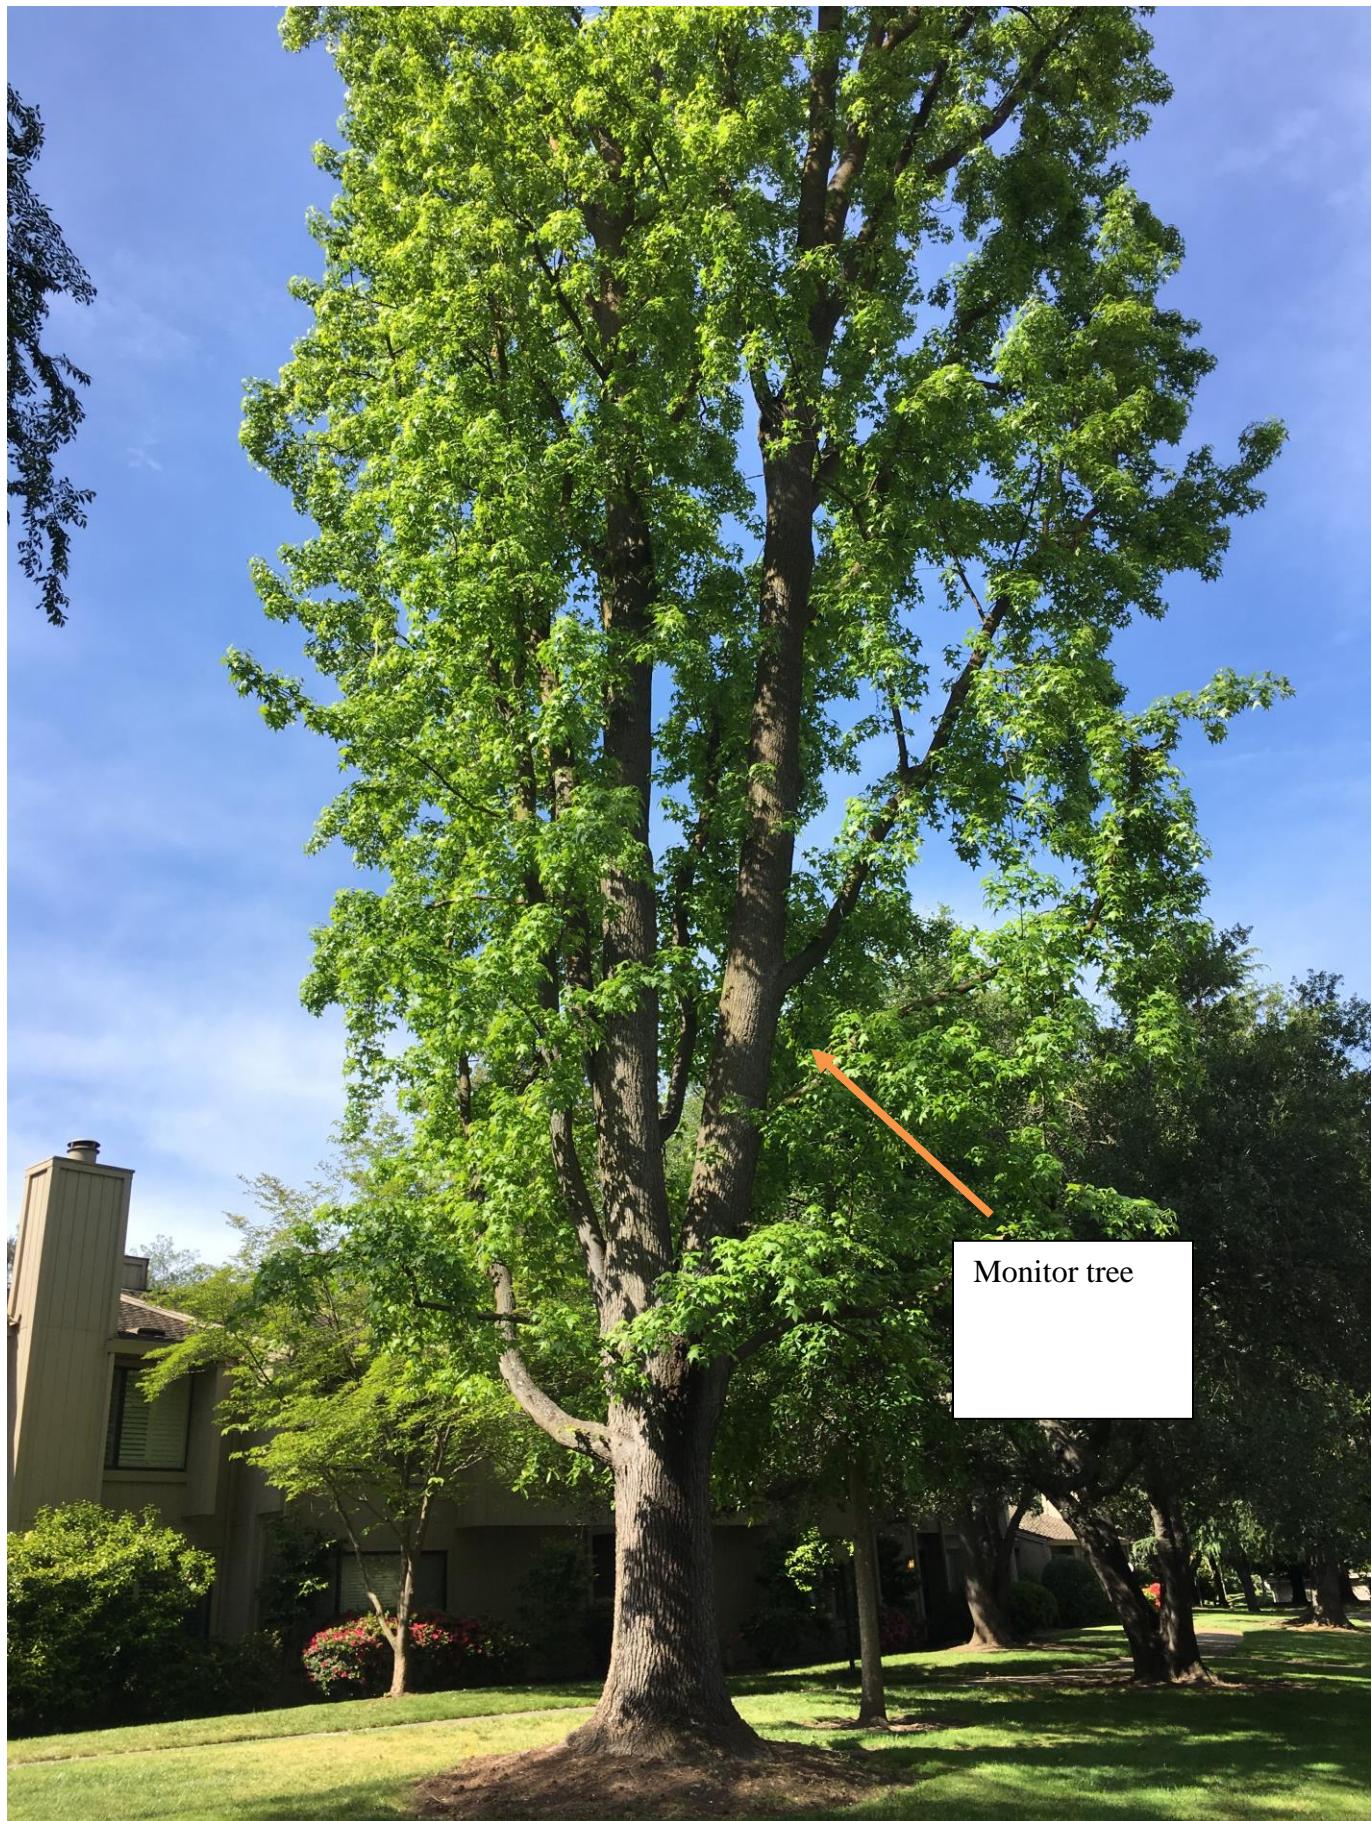
Figure 11

- (Zone 1) Tree #371 Sweetgum (*Liquidambar styraciflua*) next to 2310 American River Drive (Figure 11). Tree has large inclusion between main stems. Both stems are well developed and equal in aspect ratio. Last year we reduced the crown height and pruned for weight reduction. The tree managed well during the heavy winter storms. I recommend we monitor this tree and manage canopy weight as needed. Installing a cable system into this tree may be beneficial.
