May 1, 2017

The Nepenthe Association
Bettie Ledesma
1131 Commons Dr.
Sacramento, CA 95825
Phone: (916) 929-8380
Email: Bettie.Ledesma@fsresidential.com

On April 25, 2017, I inspected several trees on the Nepenthe property during the monthly tree walk. The focus of the walk was to address resident/management concerns regarding mature trees on the property. The purpose of this report is to develop mitigation plans for the following trees and my recommendations are below. My recommendations are based on a Basic Visual Inspection. All decisions made based on the recommendations of this report are at the discretion of the Nepenthe Association.

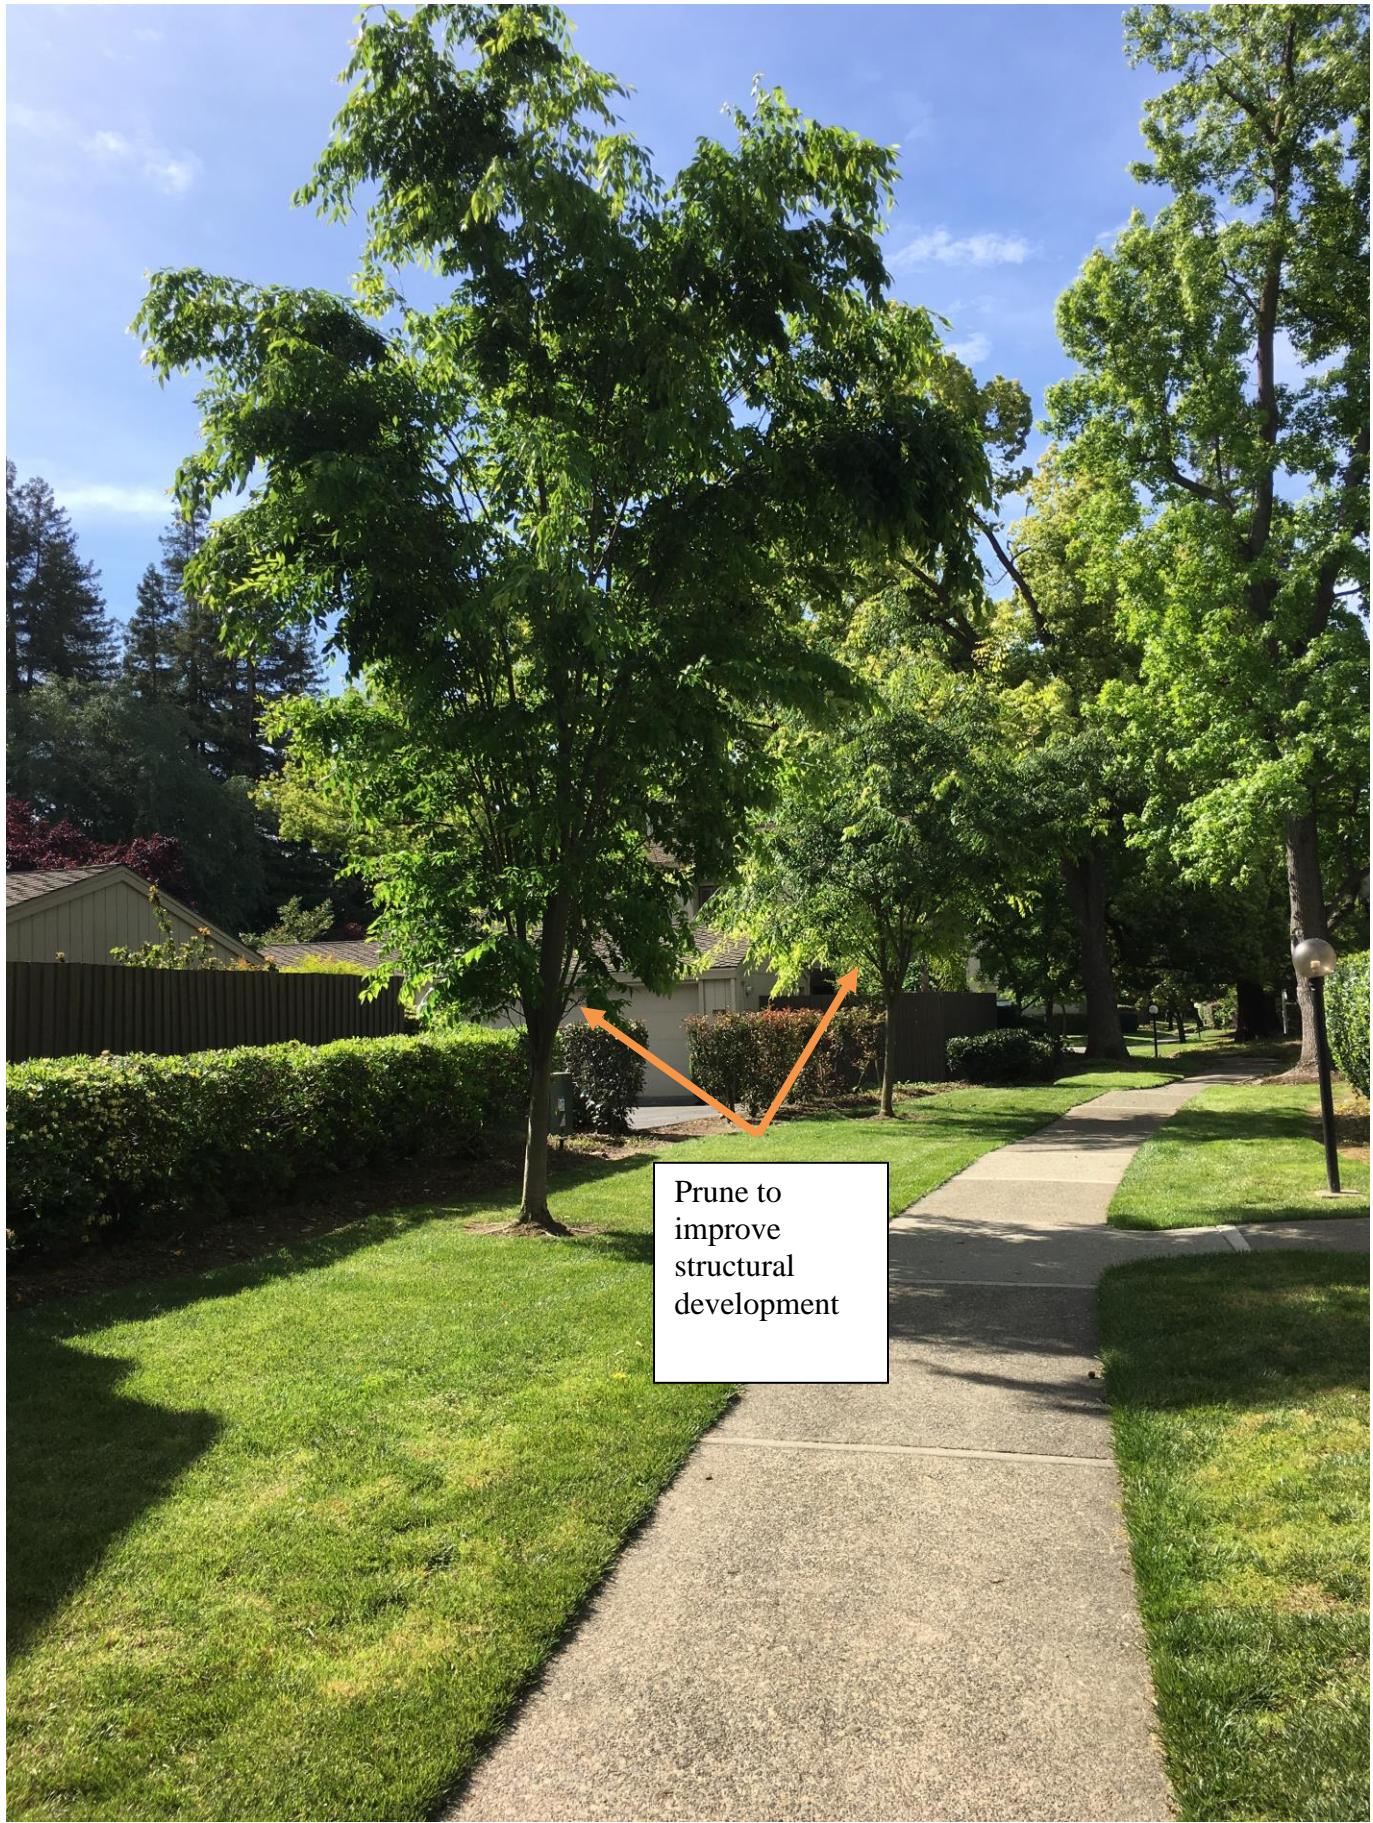
Figure 12

- (Zone 1) Trees #338 & #340 Zelcova (*Zelcova serrata*) next to 2310 American River Drive. Young trees need corrective pruning to develop properstructure and branch spacing (Figure 12).

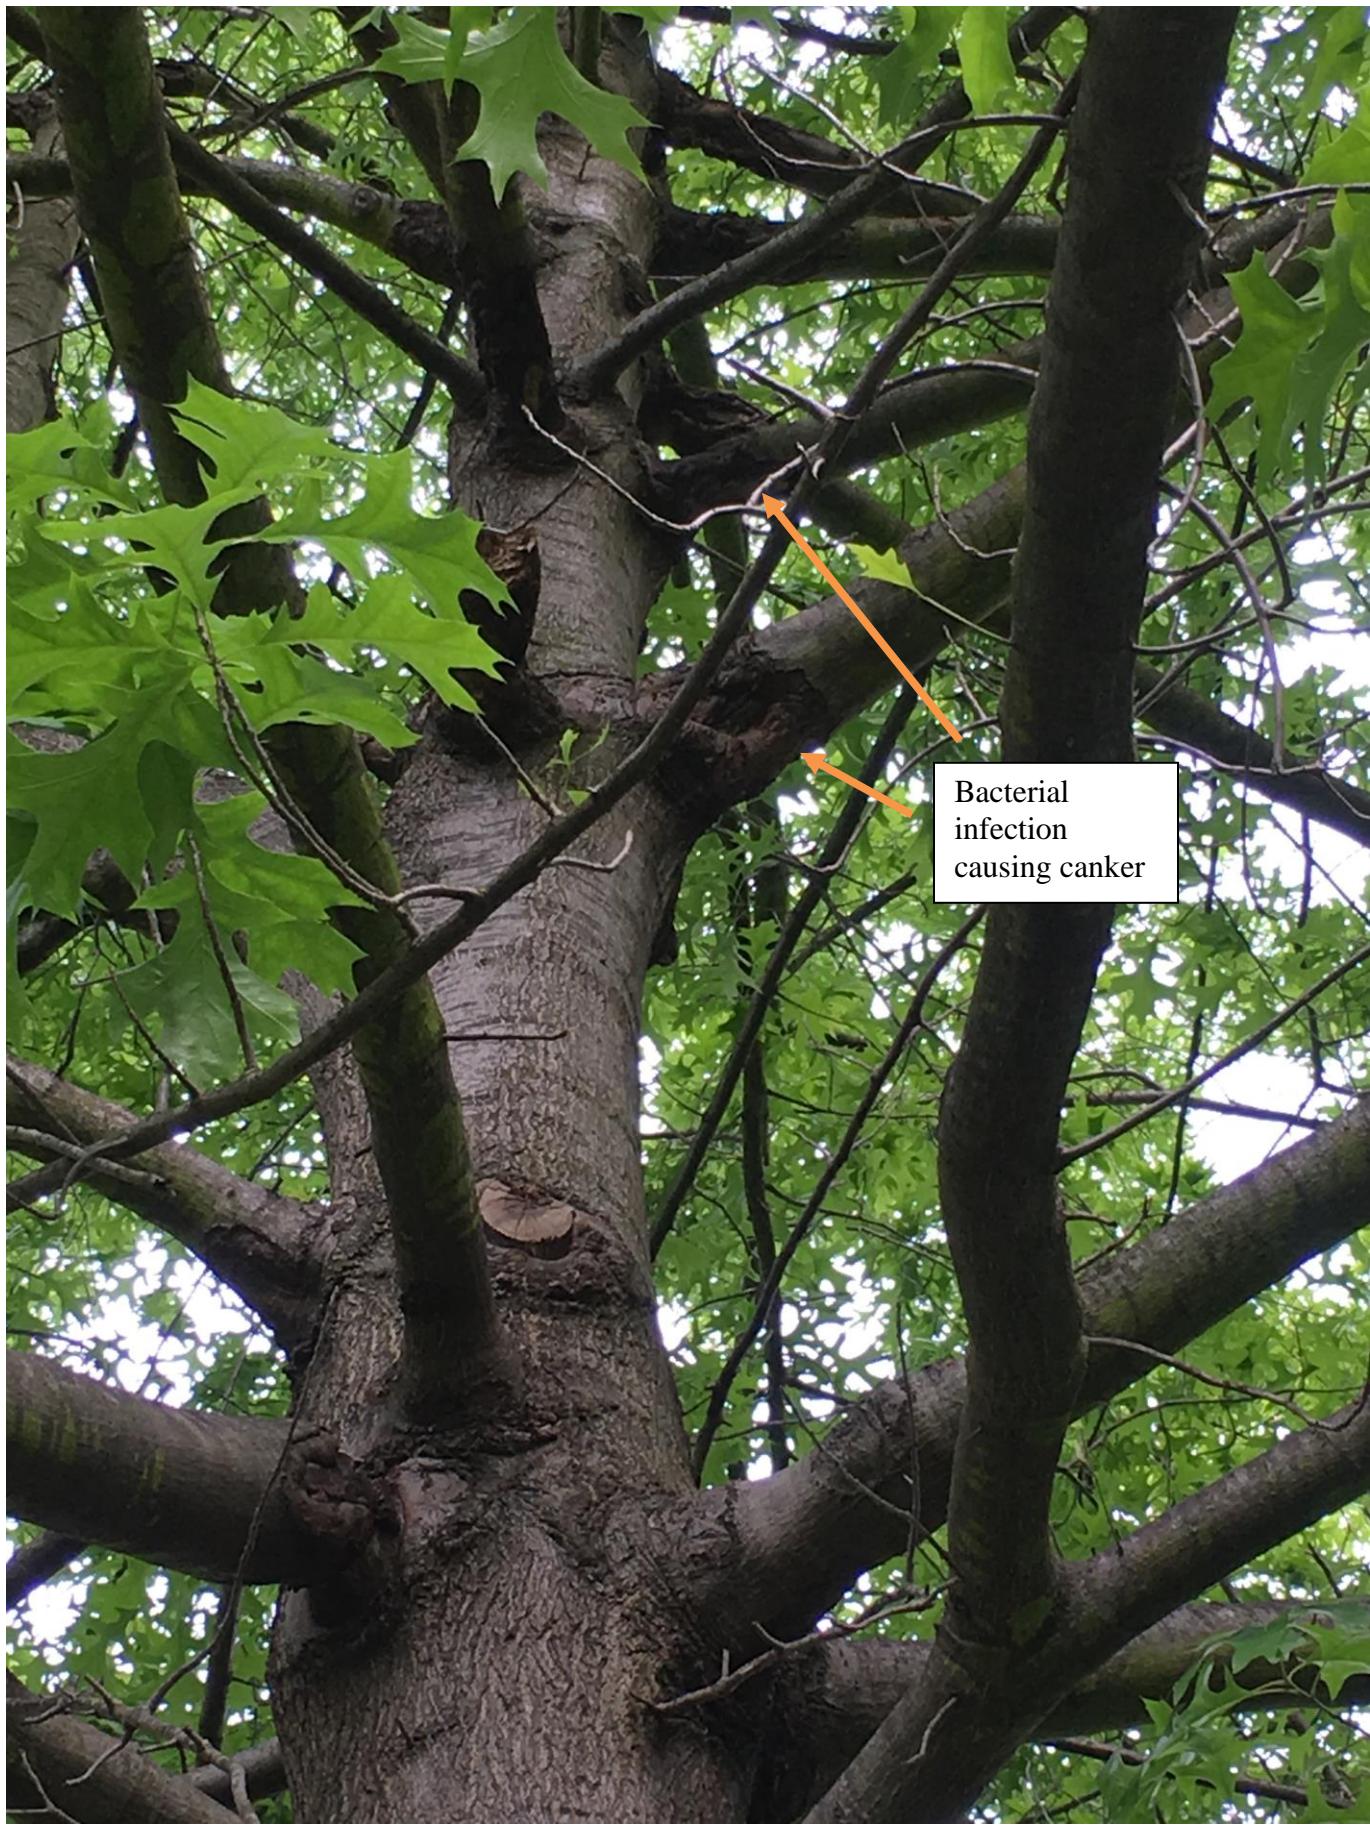
Figure 13

- (Zone 1) Tree #73 Red Oak (*Quercus Rubra*) next to 1111 Commons Dr. Tree has a bacterial infection causing canker at the branch collar (Figure 13). The tree has suffered limb failure from this. I will look into possible treatment options for this infection.

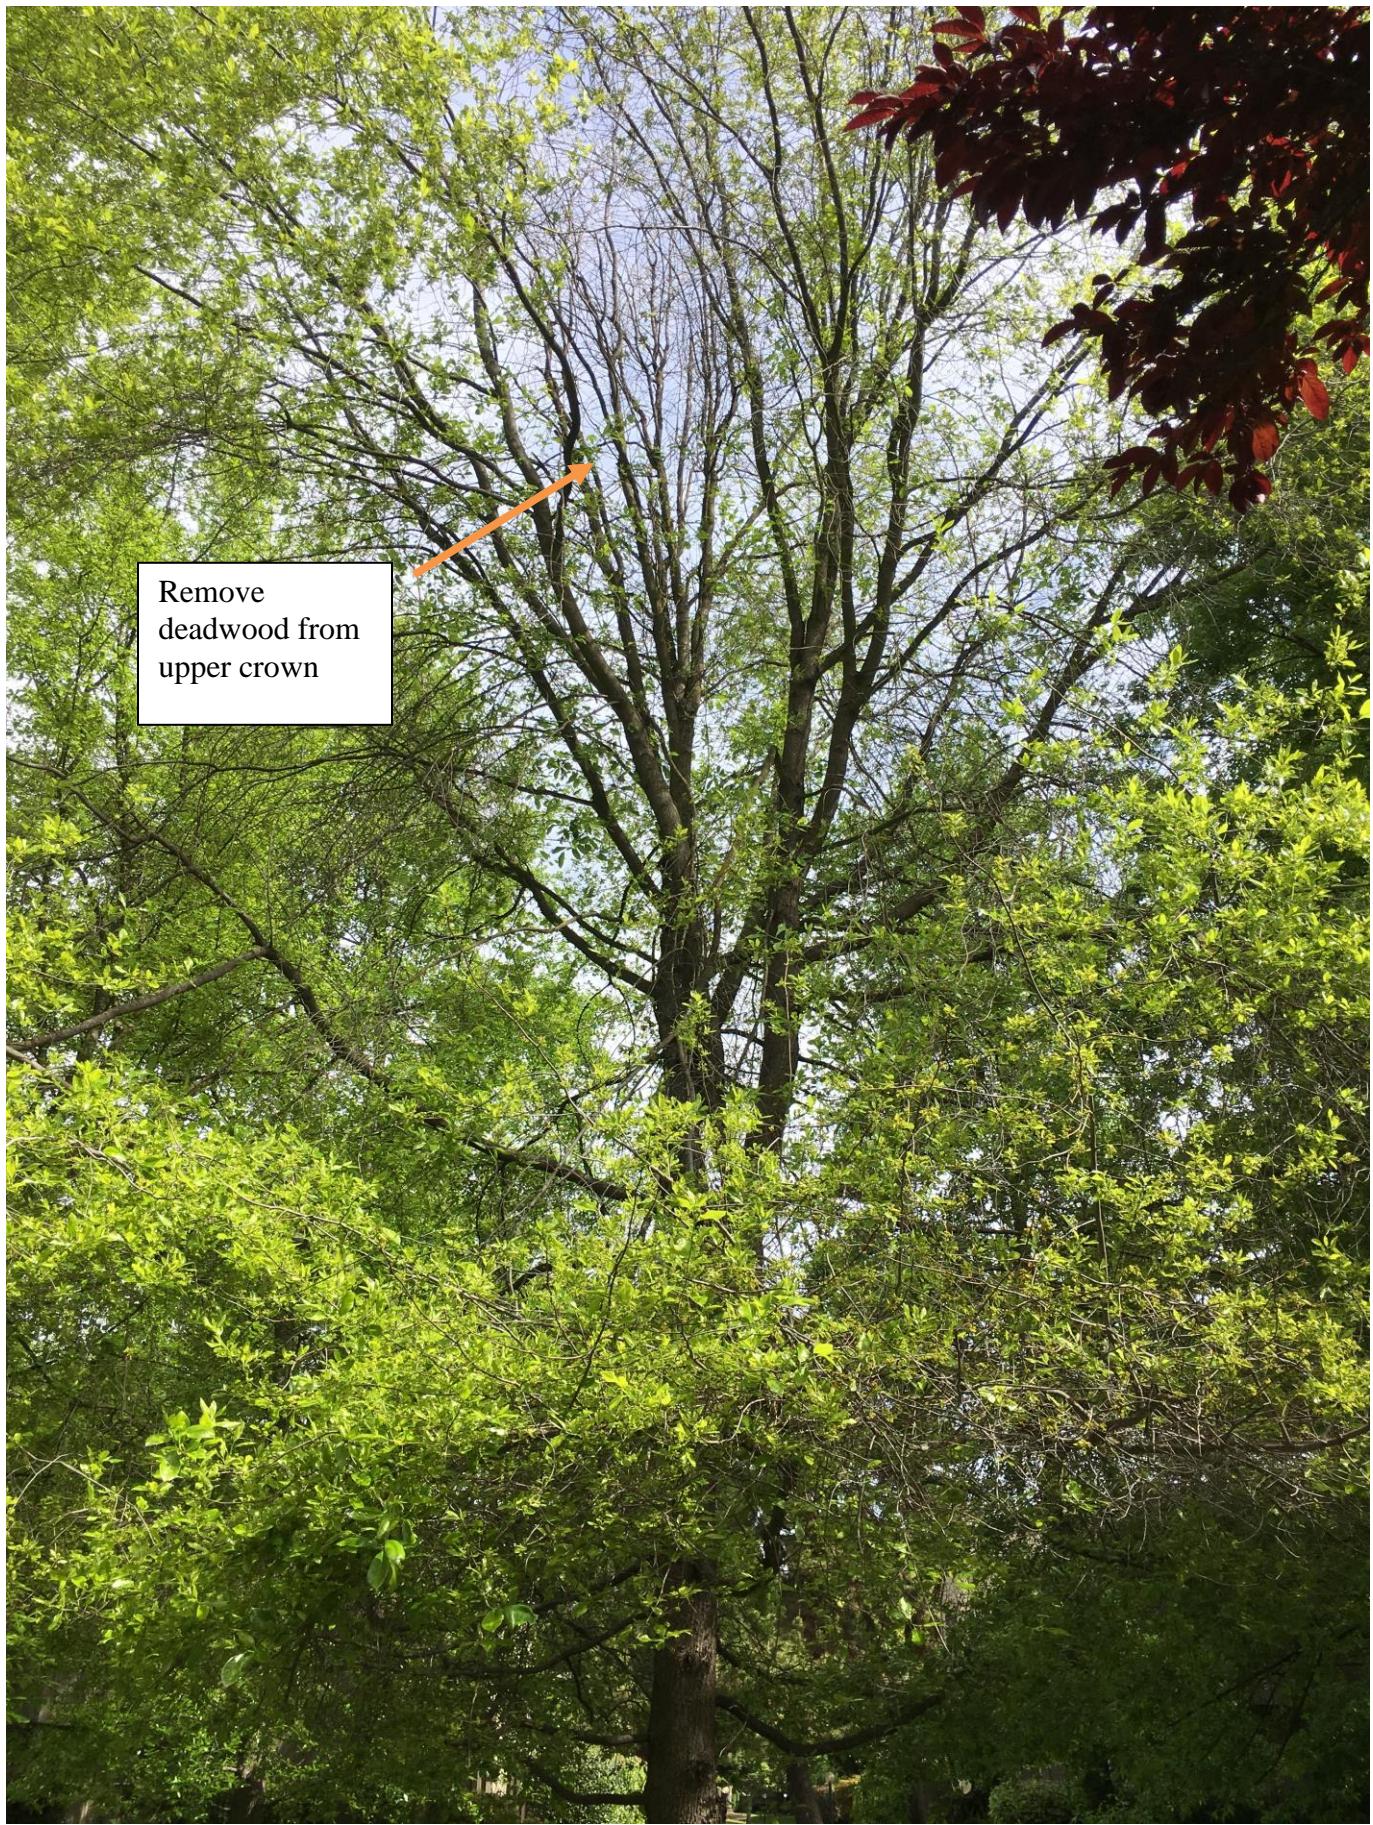
Figure 14

- (Zone 1) Tree #72 Ash (*Fraxnis angustifolia*) next to 1111 Commons Dr. Tree has large deadwood in upper canopy as well as some structural issues (Figure 14), I recommend removing the dead wood and corrective pruning.

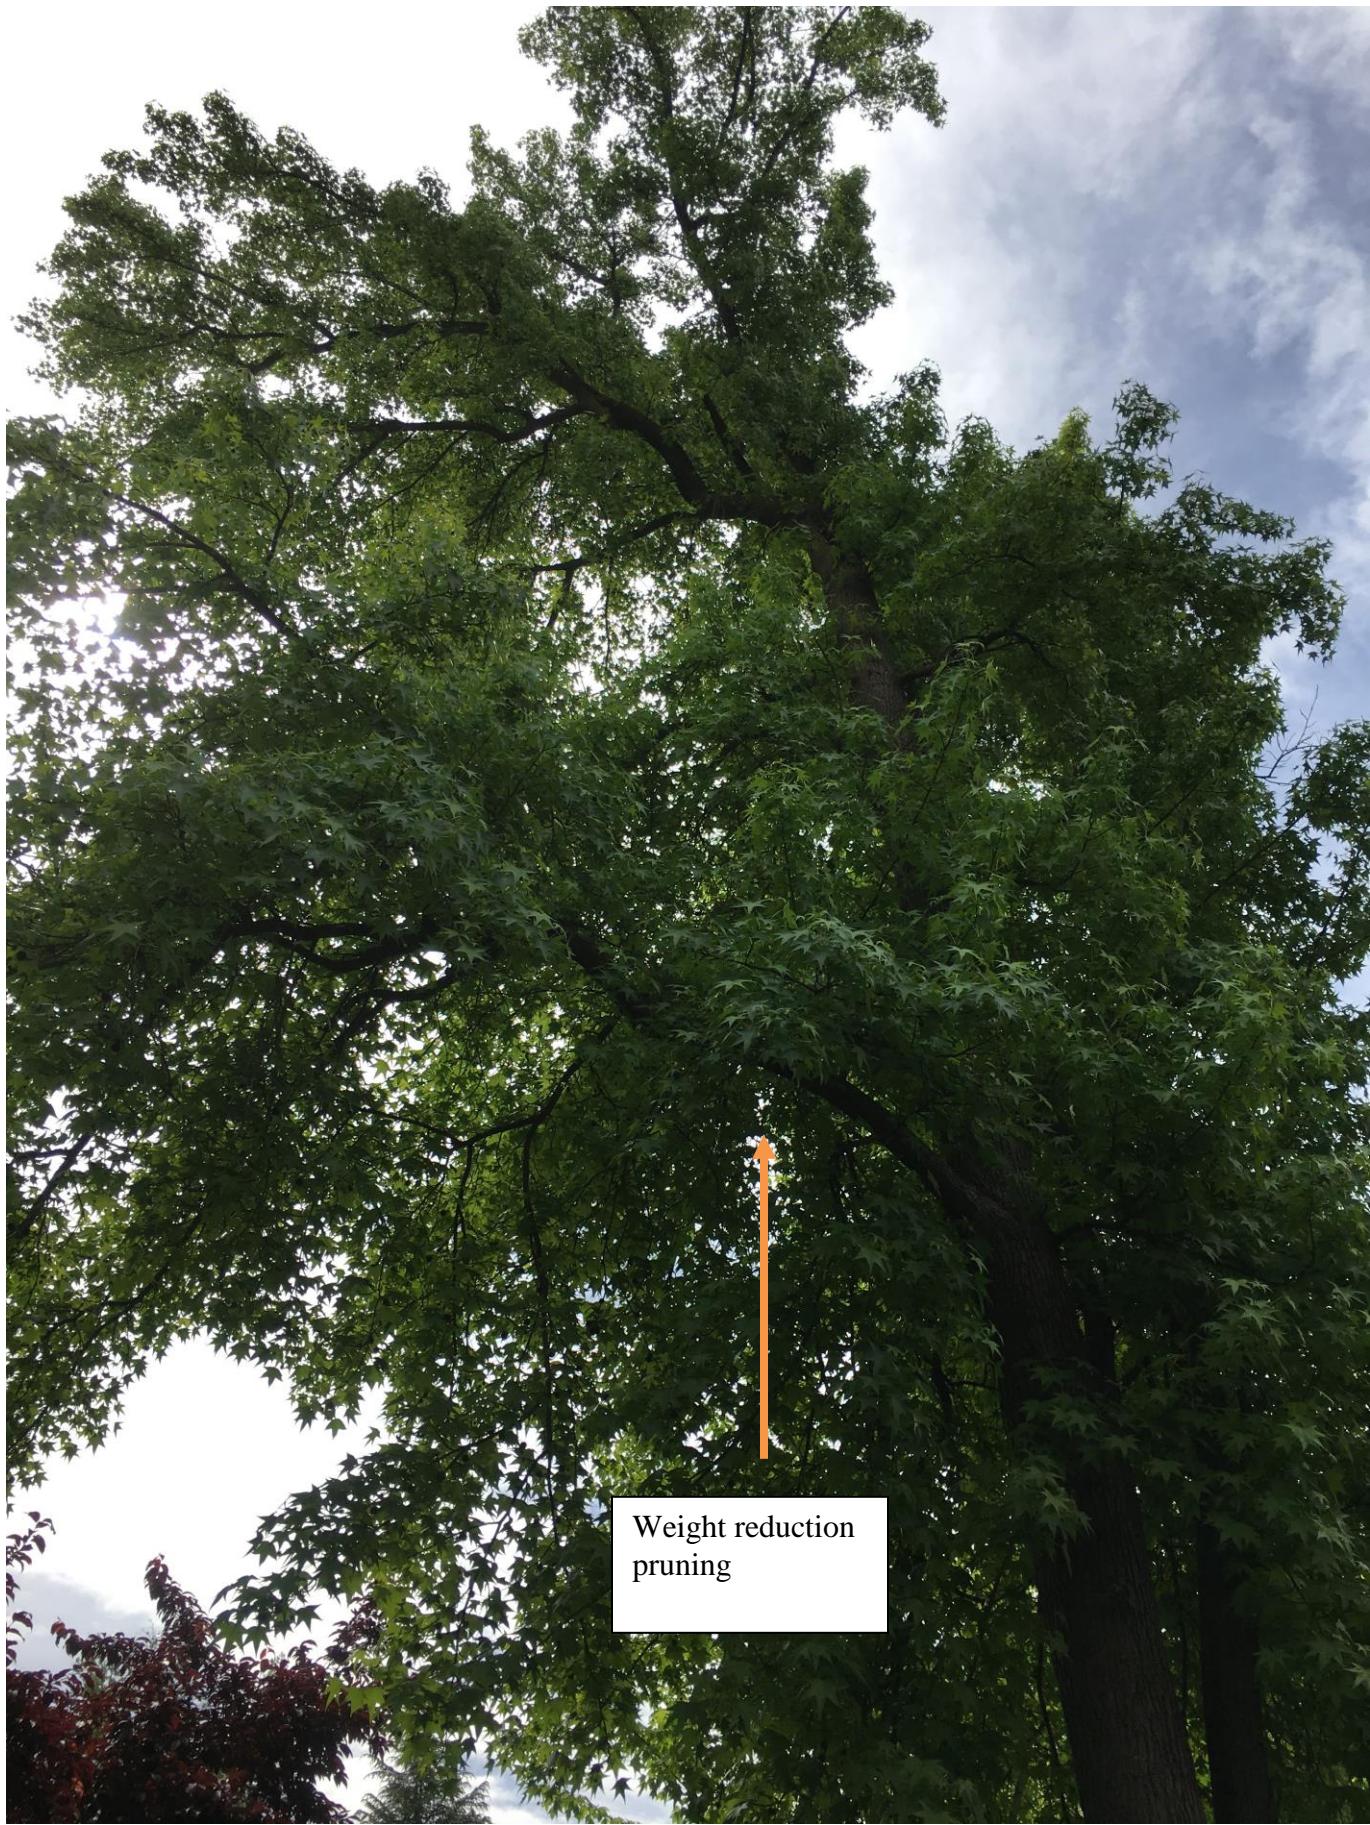
Figure 15

- (Zone 1) Tree #266 Sweetgum (*Liquidambar styraciflua*) next to 1111 Commons Dr. Tree has full over weighted canopy (Figure 15). This is a typical failure point of this species. I recommend weight reduction pruning.

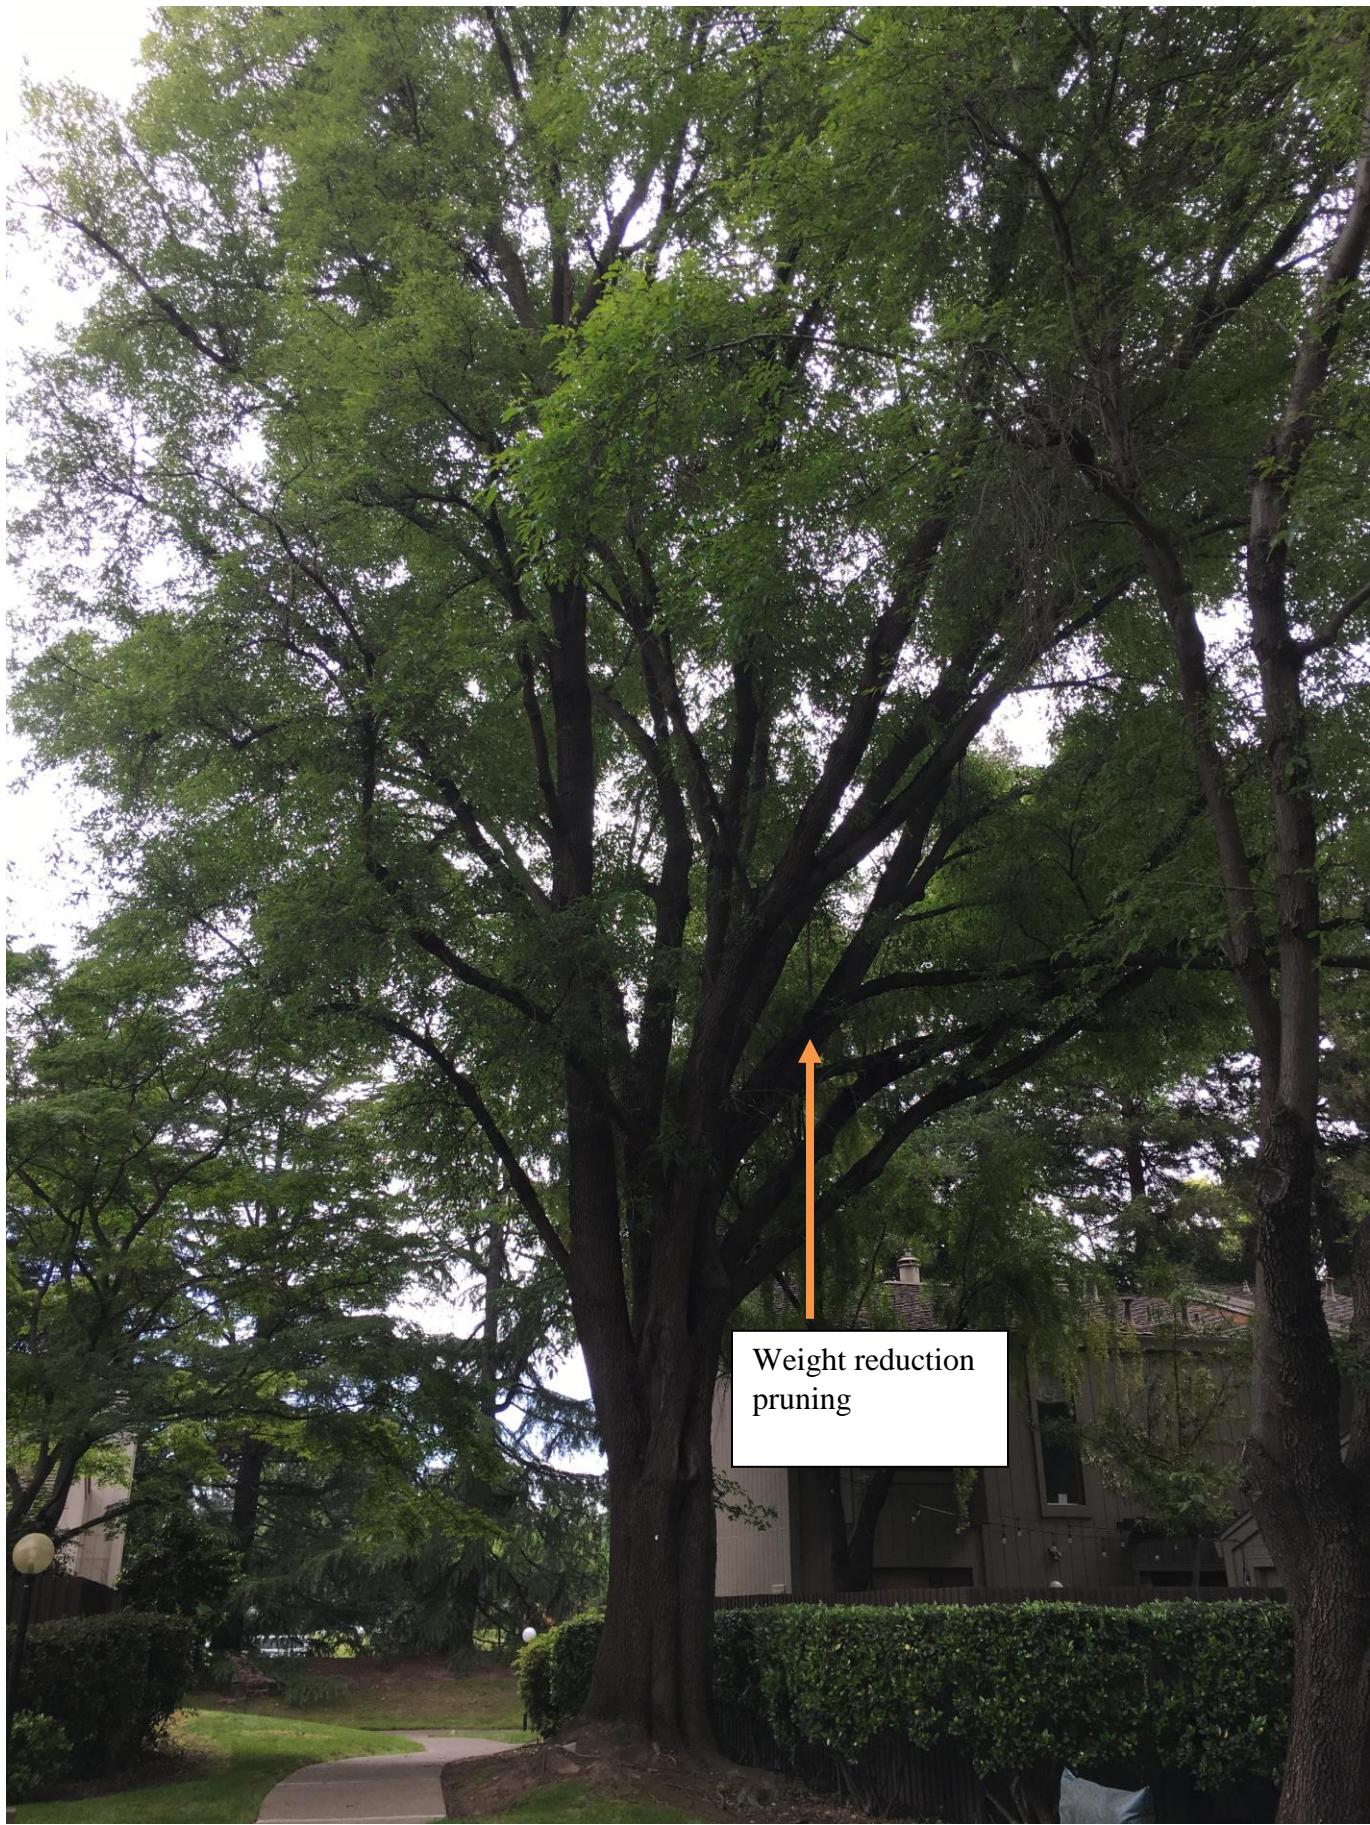
Figure 16

- (Zone 1) Tree #243 Ash (*Fraxis velutina*) next to 30 Adelphi Ct. Tree has full over weighted canopy (Figure 16). This is a large mature tree that has not been pruned in some time. I recommend weight reduction pruning and cleaning the canopy of dead wood.

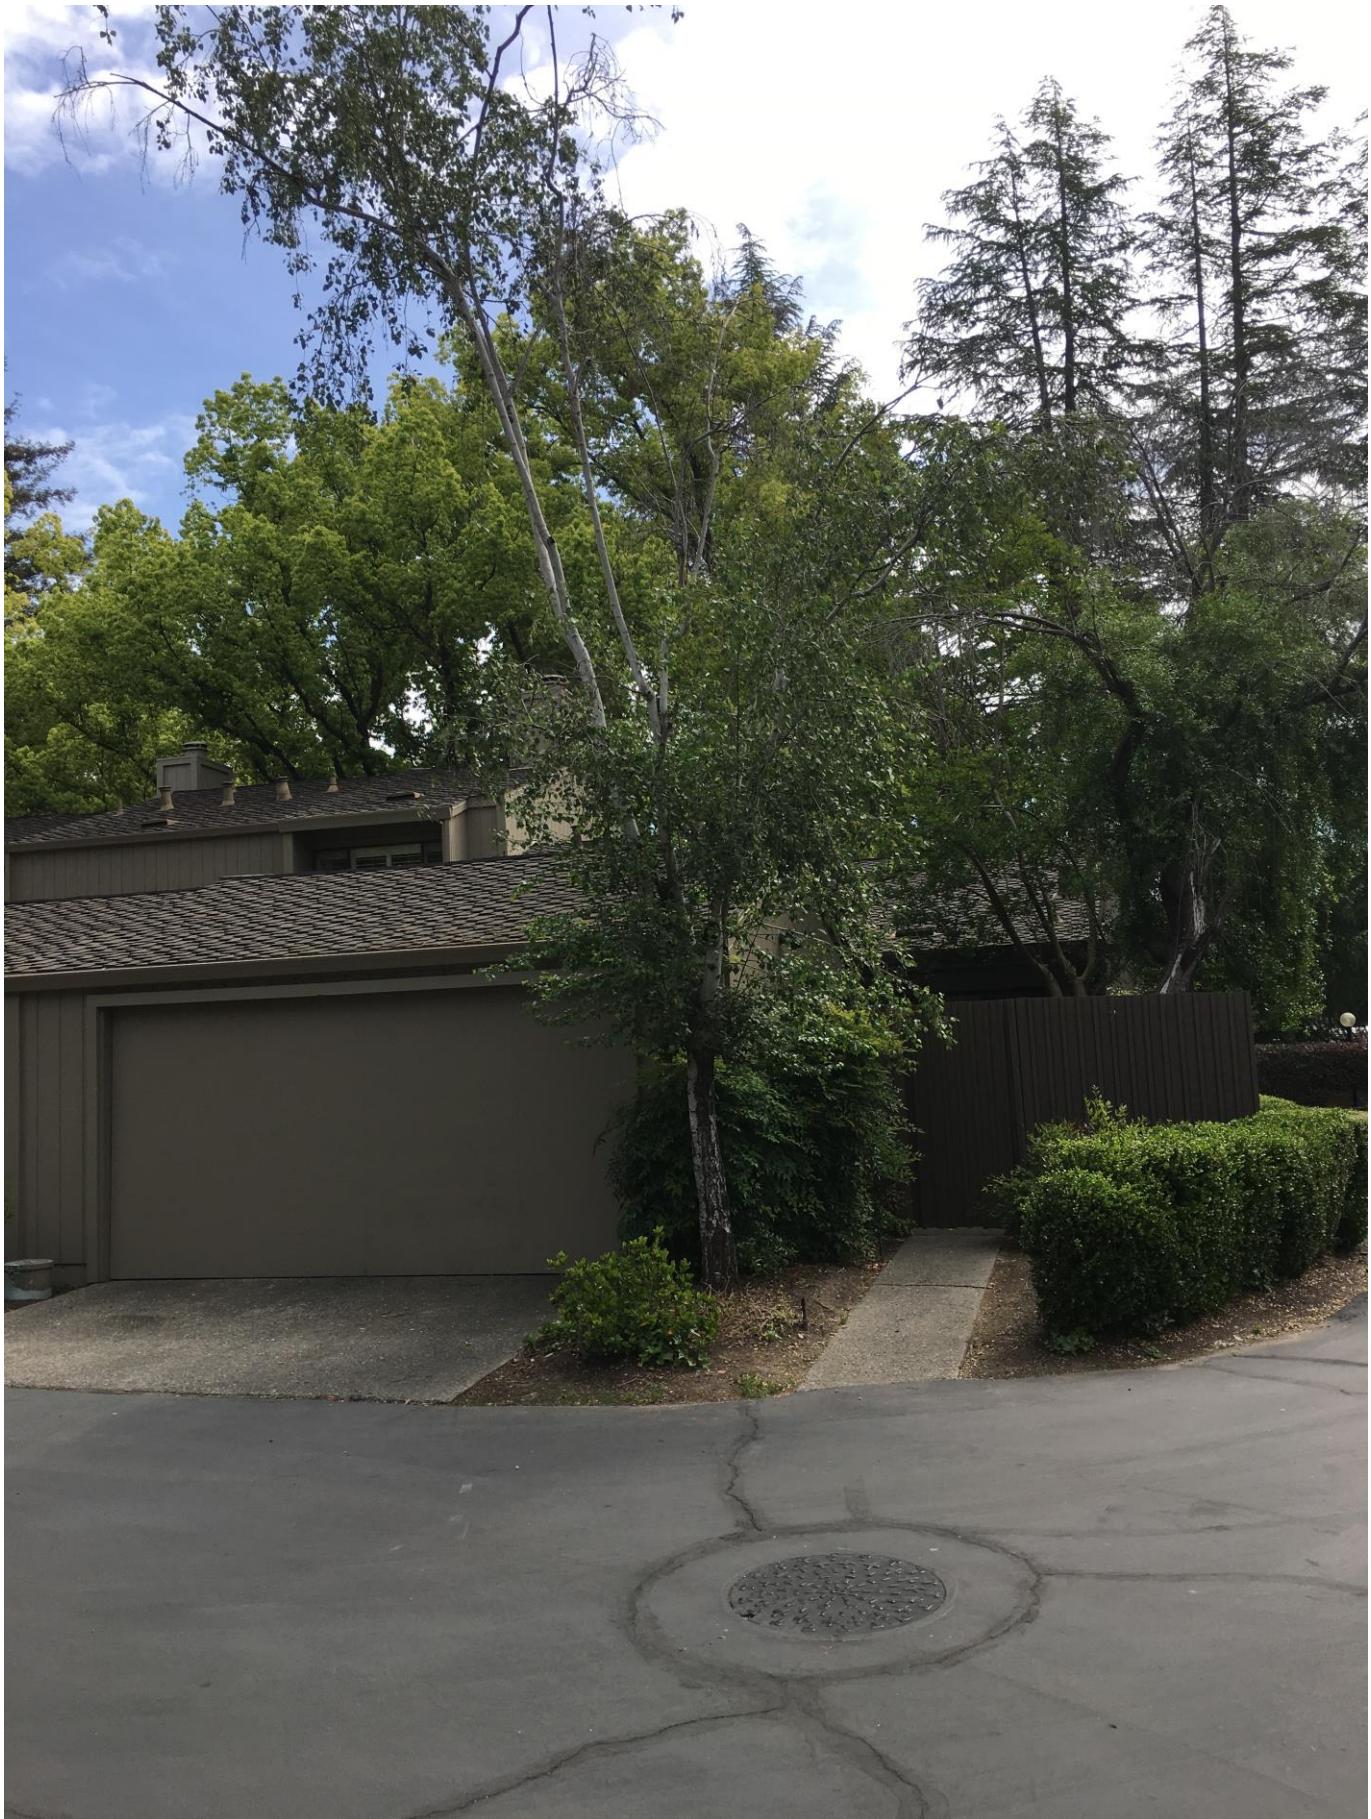
Figure 17

- (Zone 1) Tree # 237 Birch (*Betula pendula*) next to 16 Adelphi Ct. Tree has die back in crown, appears to be in declining health, I recommend removal and replacement. (Figure 17).
-

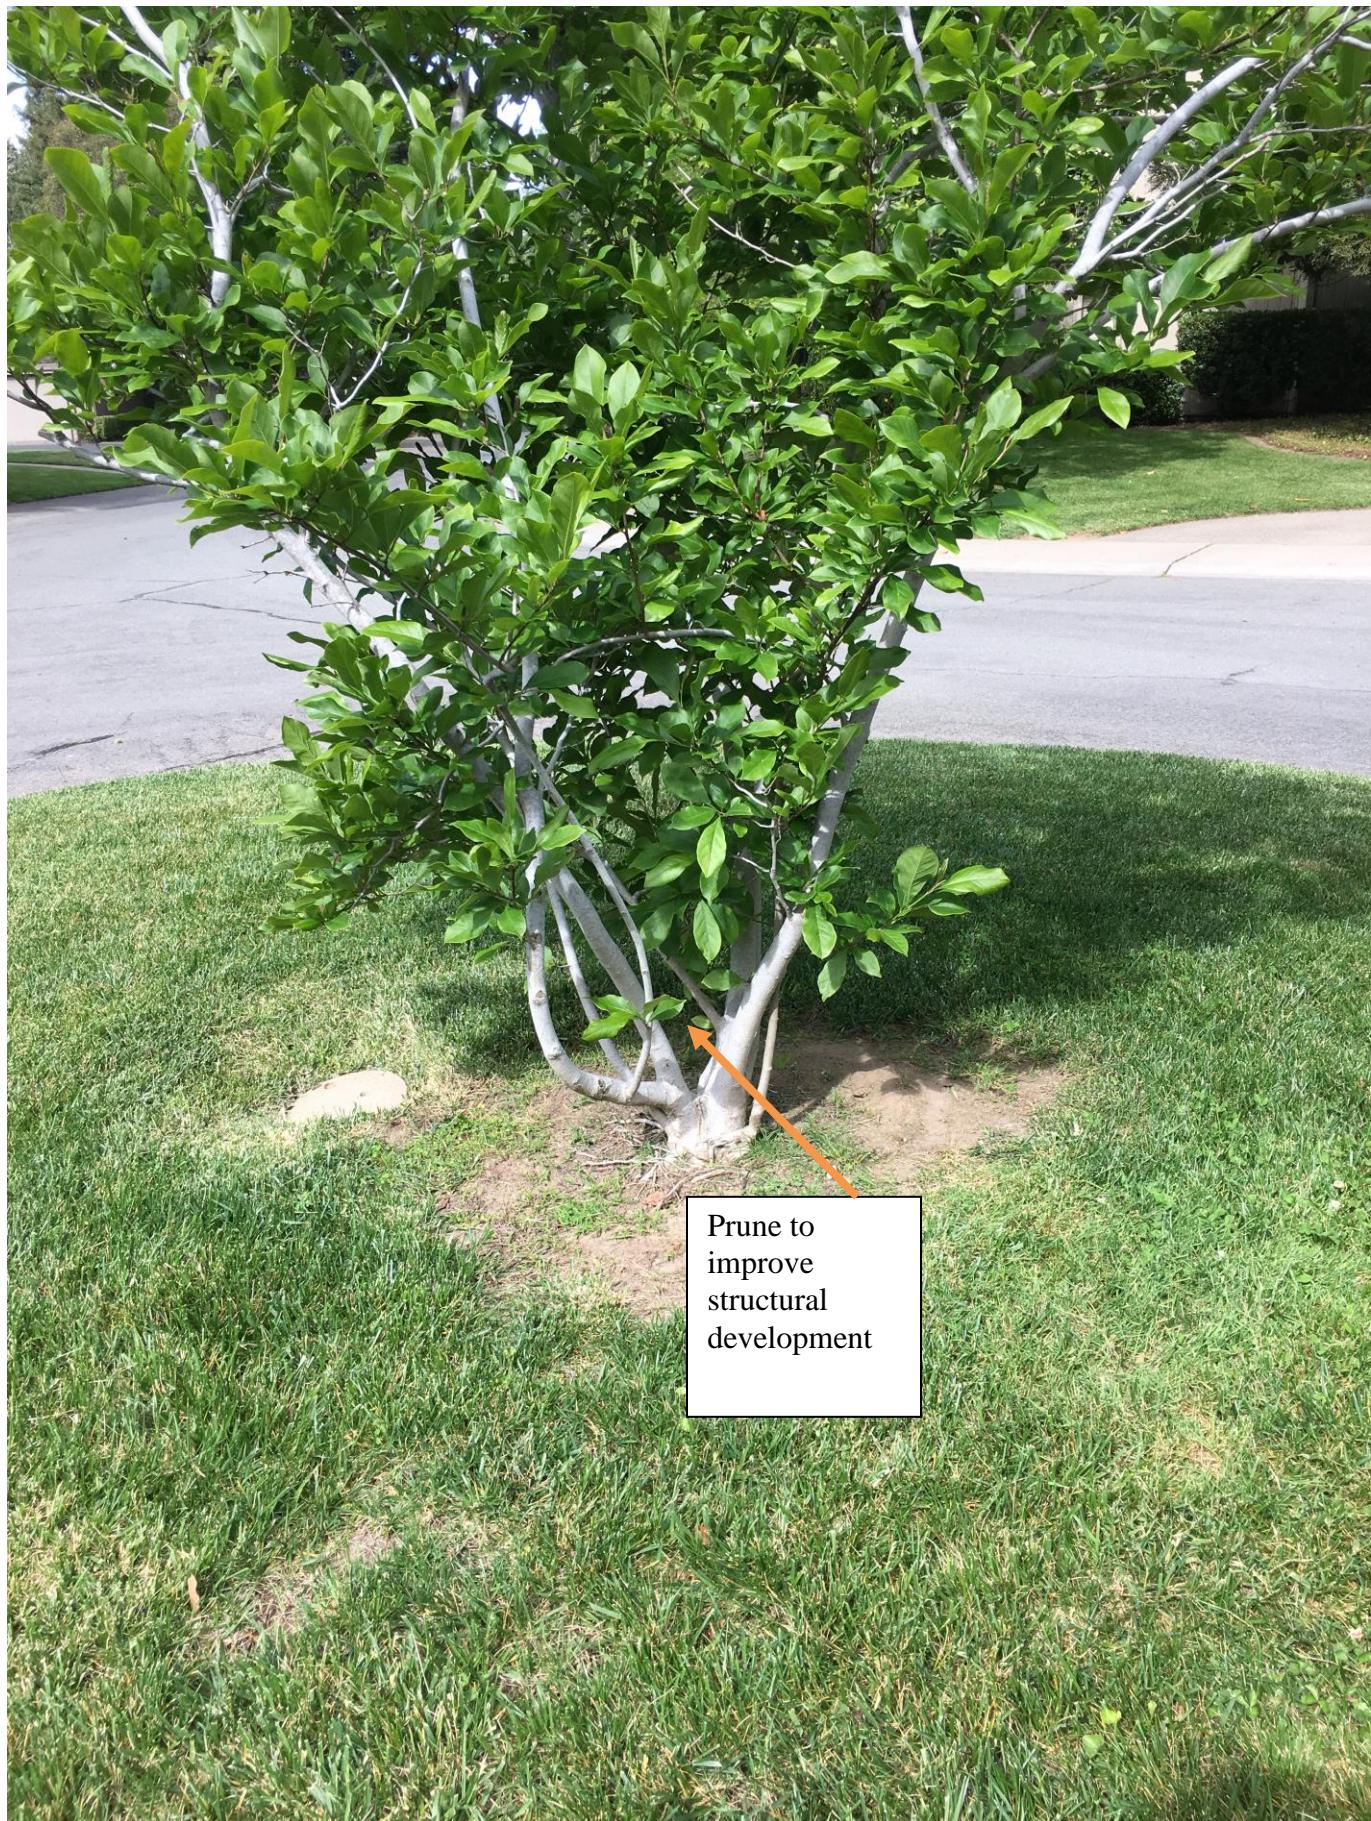
Figure 18

- (Zone 1) Tree #328 Saucer Magnolia (*Magnolia soulangeana*) on island on Colby Ct. Tree needs some corrective pruning to develop good structure. Tree has some girdling roots that need to be corrected as well. (Figure 18)
- (Zone 1) Tree's #318 & #319 Pine (*Sequoia sempervirens*), 2 trees next to 1109 Commons Drive (Figure 19). Trees would benefit cleaning canopy of dead wood. Trimming should be done in fall to prevent sap.
- (Zone 1) No Tree Tag Japanese Blueberry tree (*Elaeocarpus decipens*) Next to club house in pool area (Figure 20). This tree is healthy and full and needs some corrective pruning to develop good structure.
