August 13, 2020

The Nepenthe Association  
1131 Commons Dr.  
Sacramento, CA 95825  
Phone: (916) 929-8380  
Email: [Bettsi.Ledesma@fsresidential.com](mailto:Bettsi.Ledesma@fsresidential.com)

On August 12, 2020, I inspected several trees on the Nepenthe property during the monthly tree walk. The focus of the walk was to address resident/management concerns regarding mature trees on the property. The purpose of this report is to develop mitigation plans for the following trees and my recommendations are below. My recommendations are based on a Basic Visual Inspection. All decisions made based on the recommendations of this report are at the discretion of the Nepenthe Association.

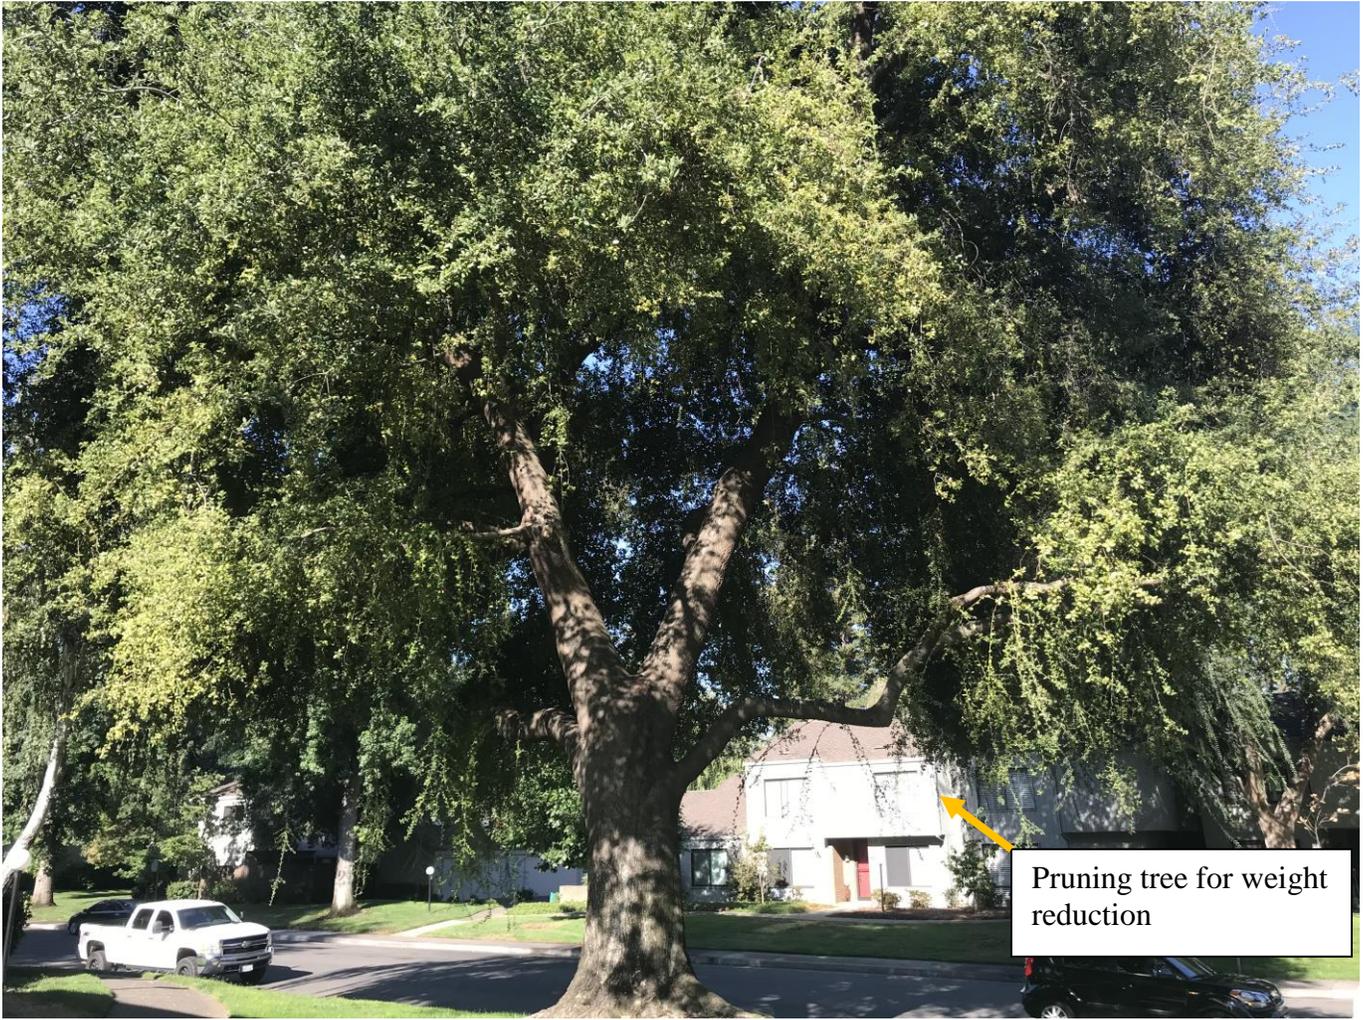
Figure 1

- (Zone 3) Tree #895 Interior Live Oak (*Quercus wislizeni*) 1329 Commons Dr.(Figure 1) This tree is one we monitor yearly due to cable system in the tree. The tree canopy is full and healthy I recommend weight reduction pruning to reduce pressure on cable system.

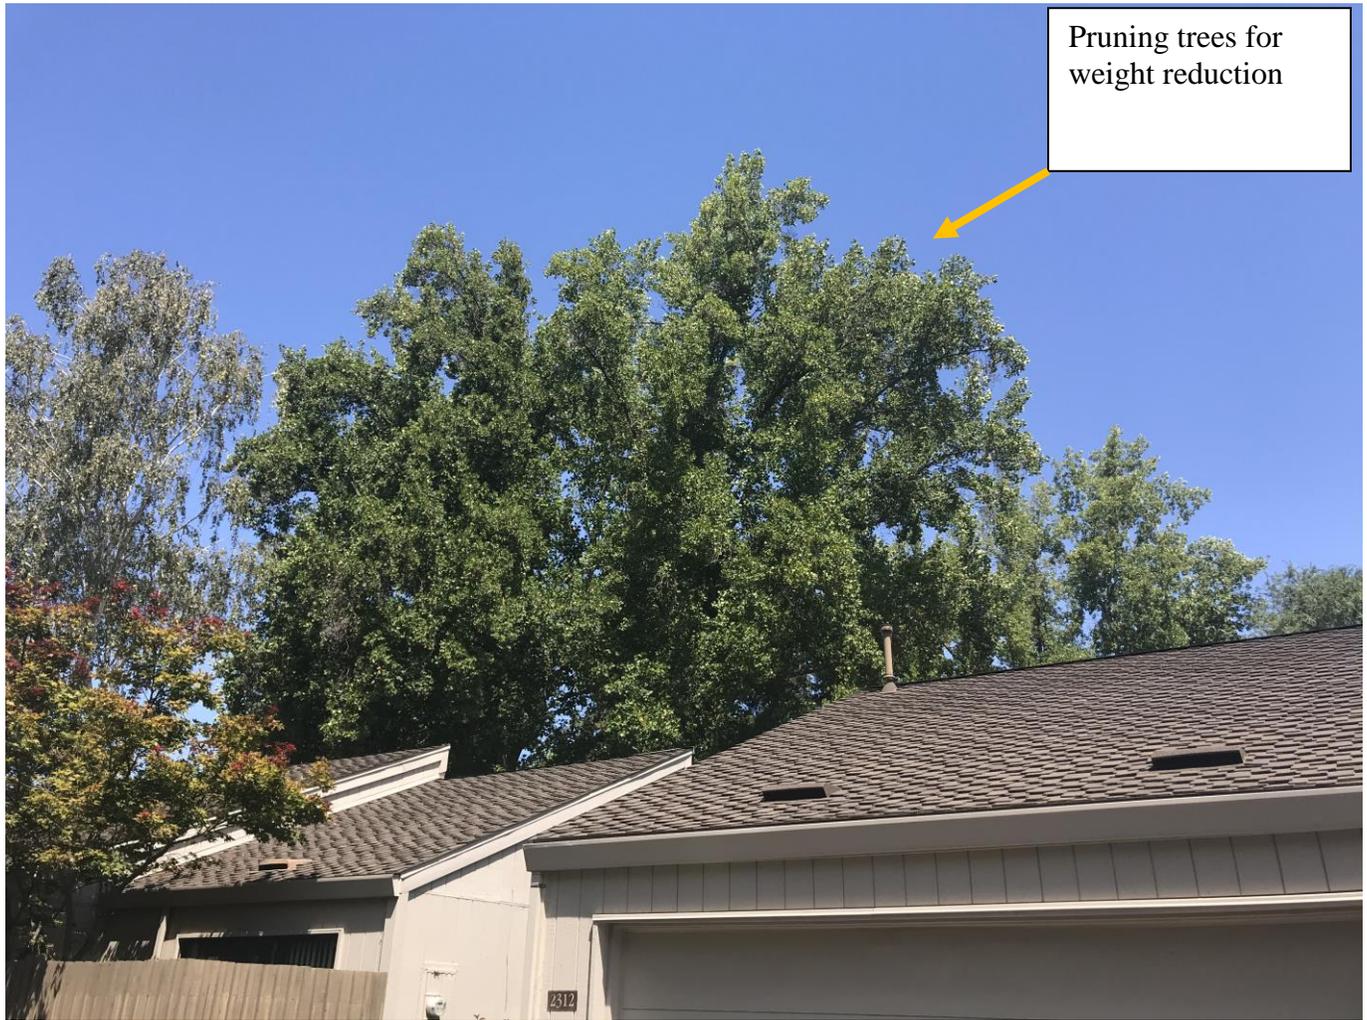
Figure 2

- (Zone 3) Trees #938, #936 & 935 Tulip tree (*Liriodendron tulipifera*), 2310 Swarthmore (Figure 2) Trees 938 and 935 the canopy are full and heavy I recommend weight reduction pruning. Tree #936 has a root that is causing lifting of the walk way in the patio of 2310 Swarthmore (Figure 3-4), I recommend root pruning to alleviate the root lifting issue.

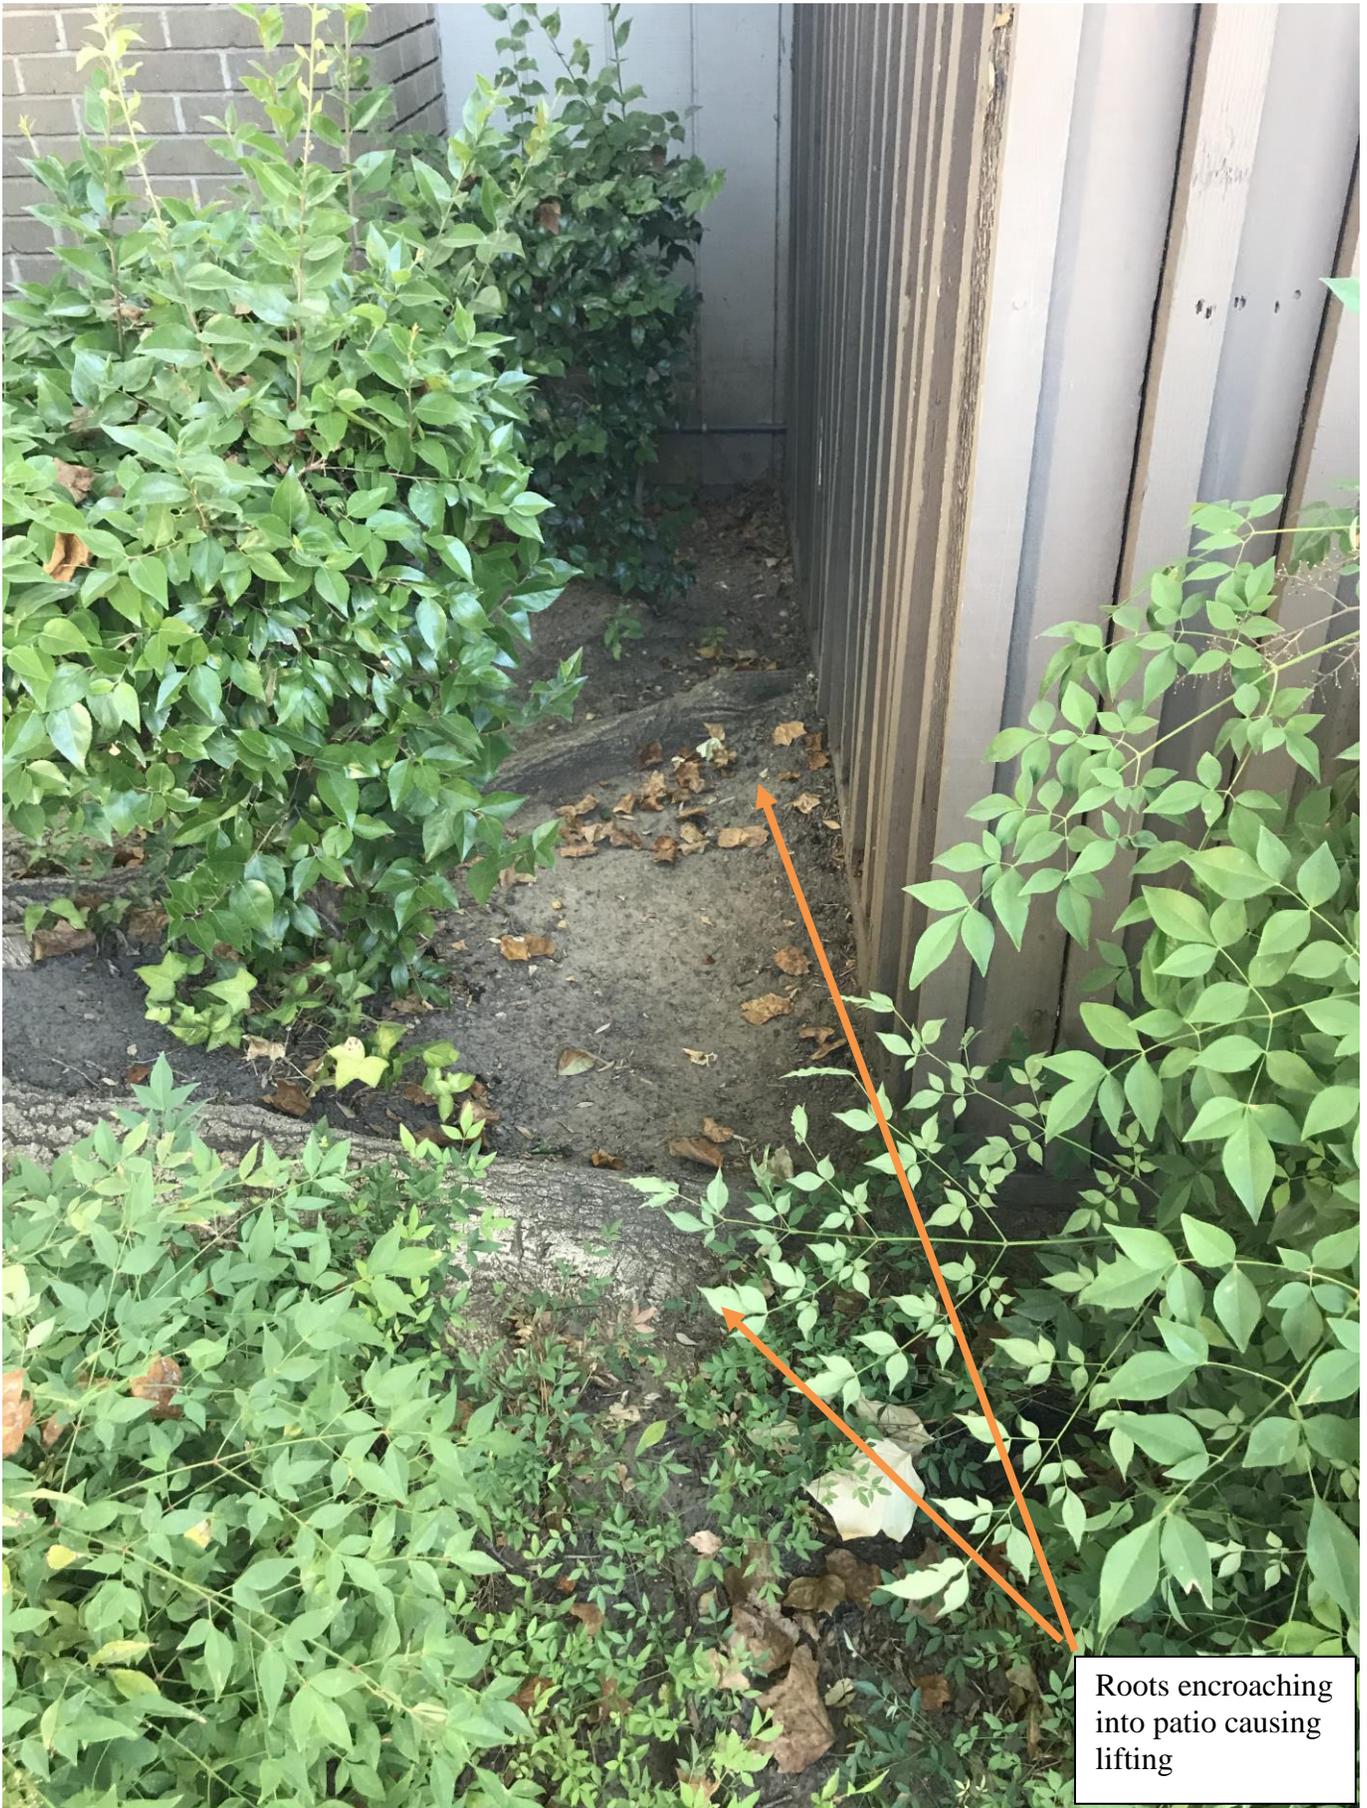
Figure 3

Roots encroaching into patio causing lifting

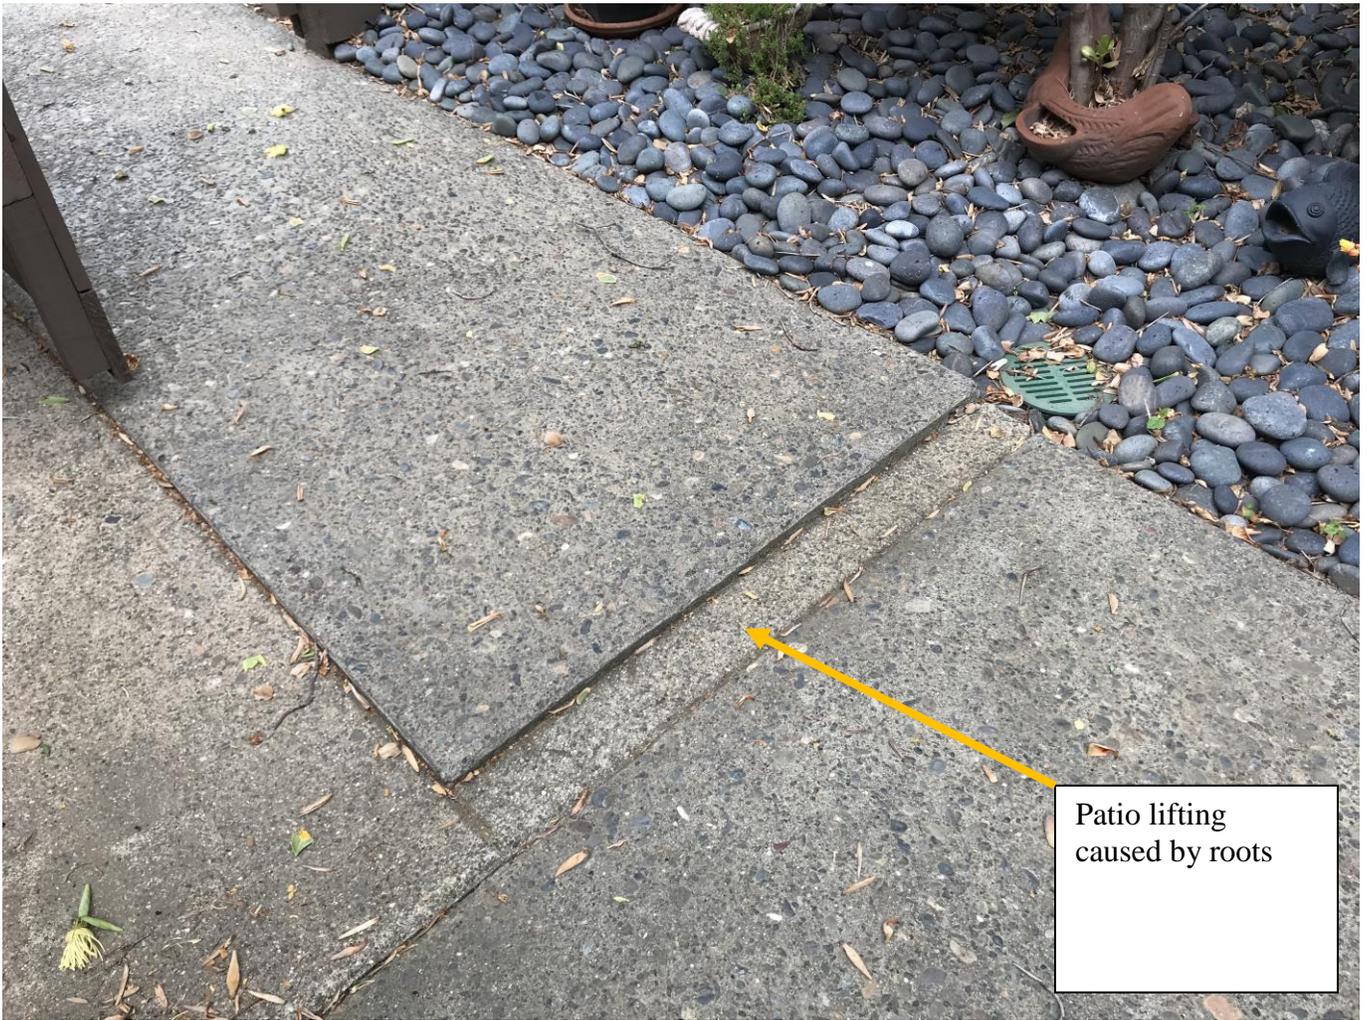
Figure 4

Patio lifting  
caused by roots

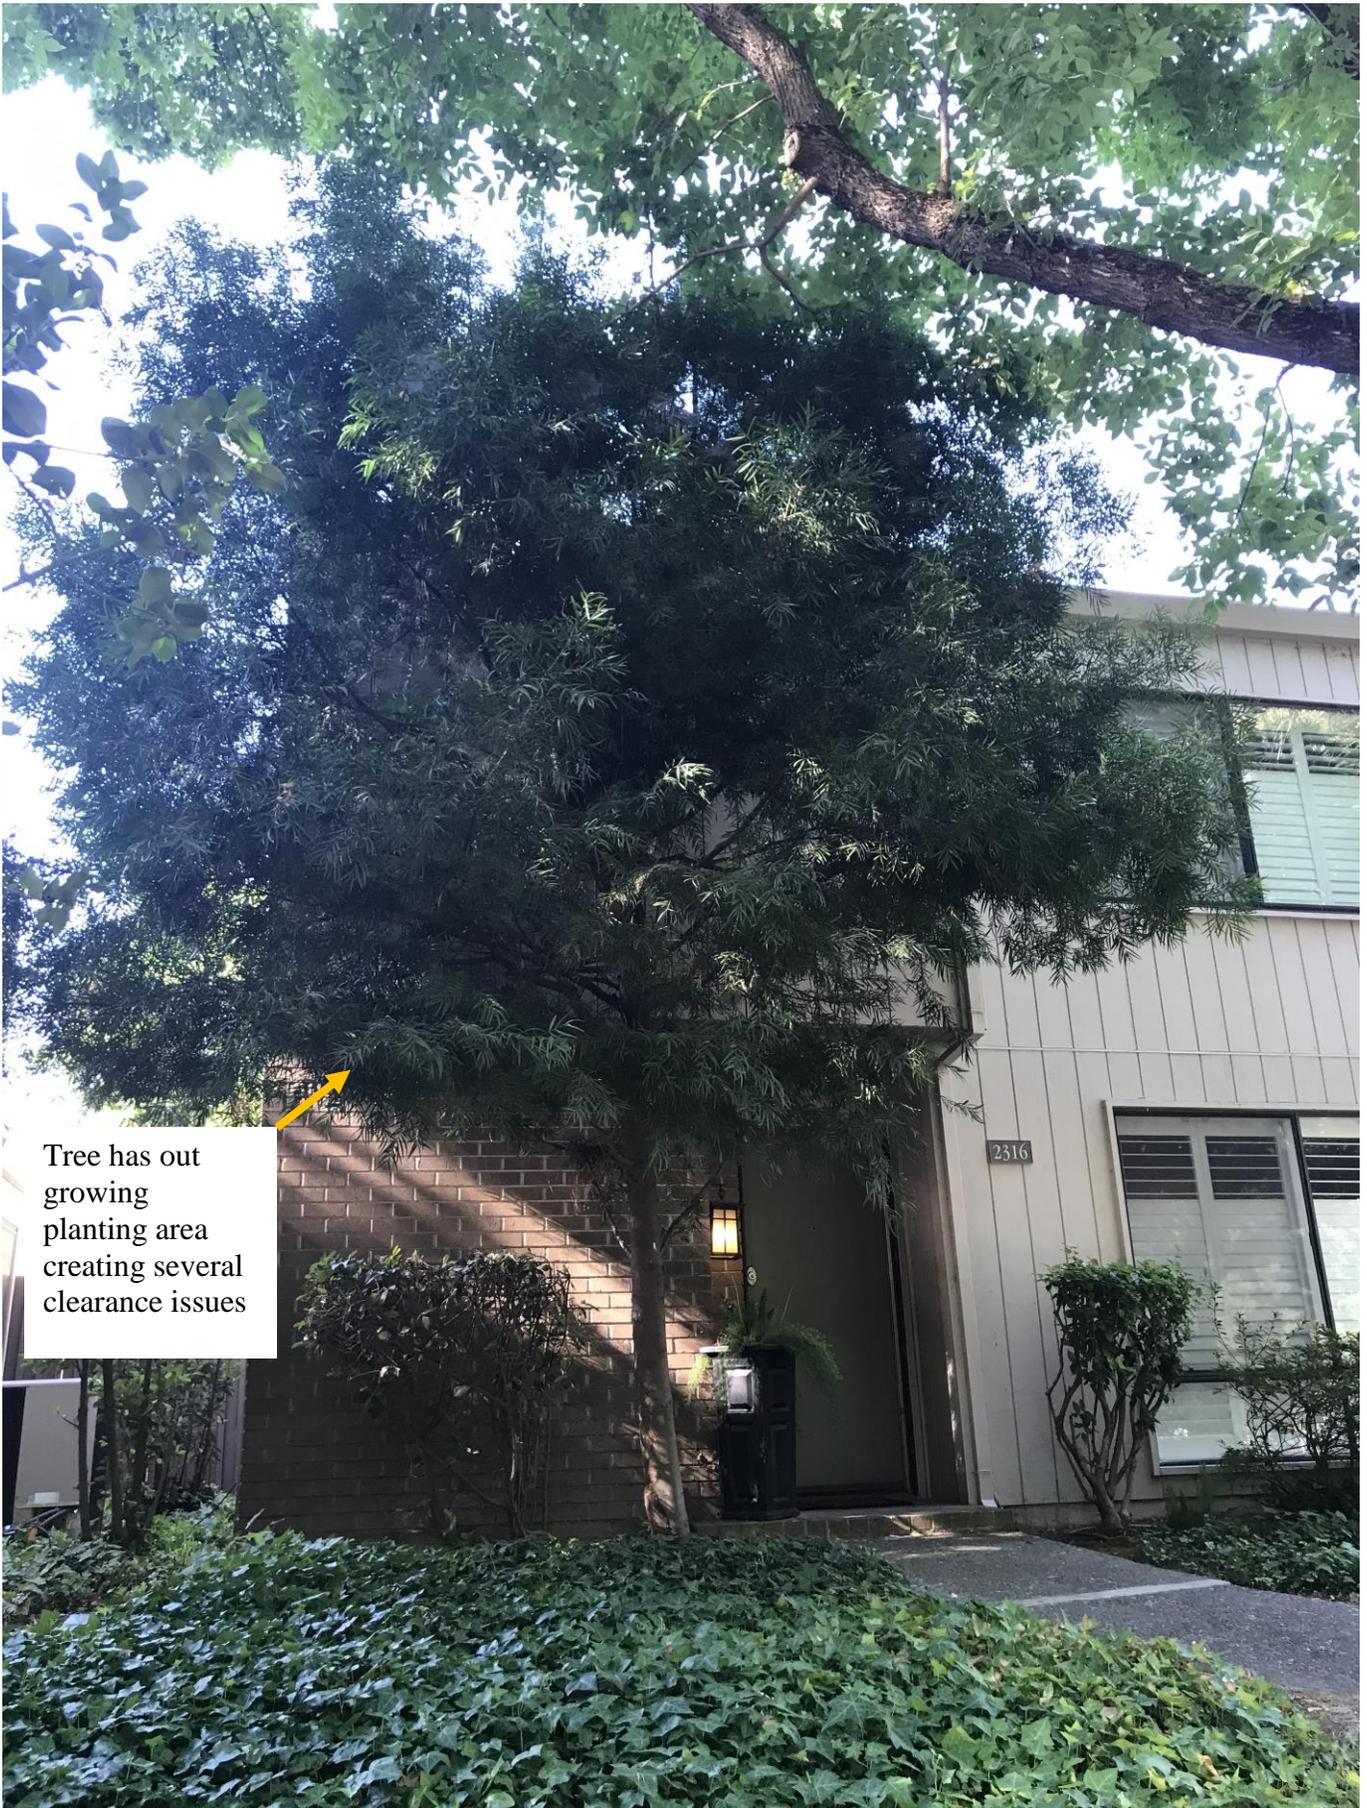
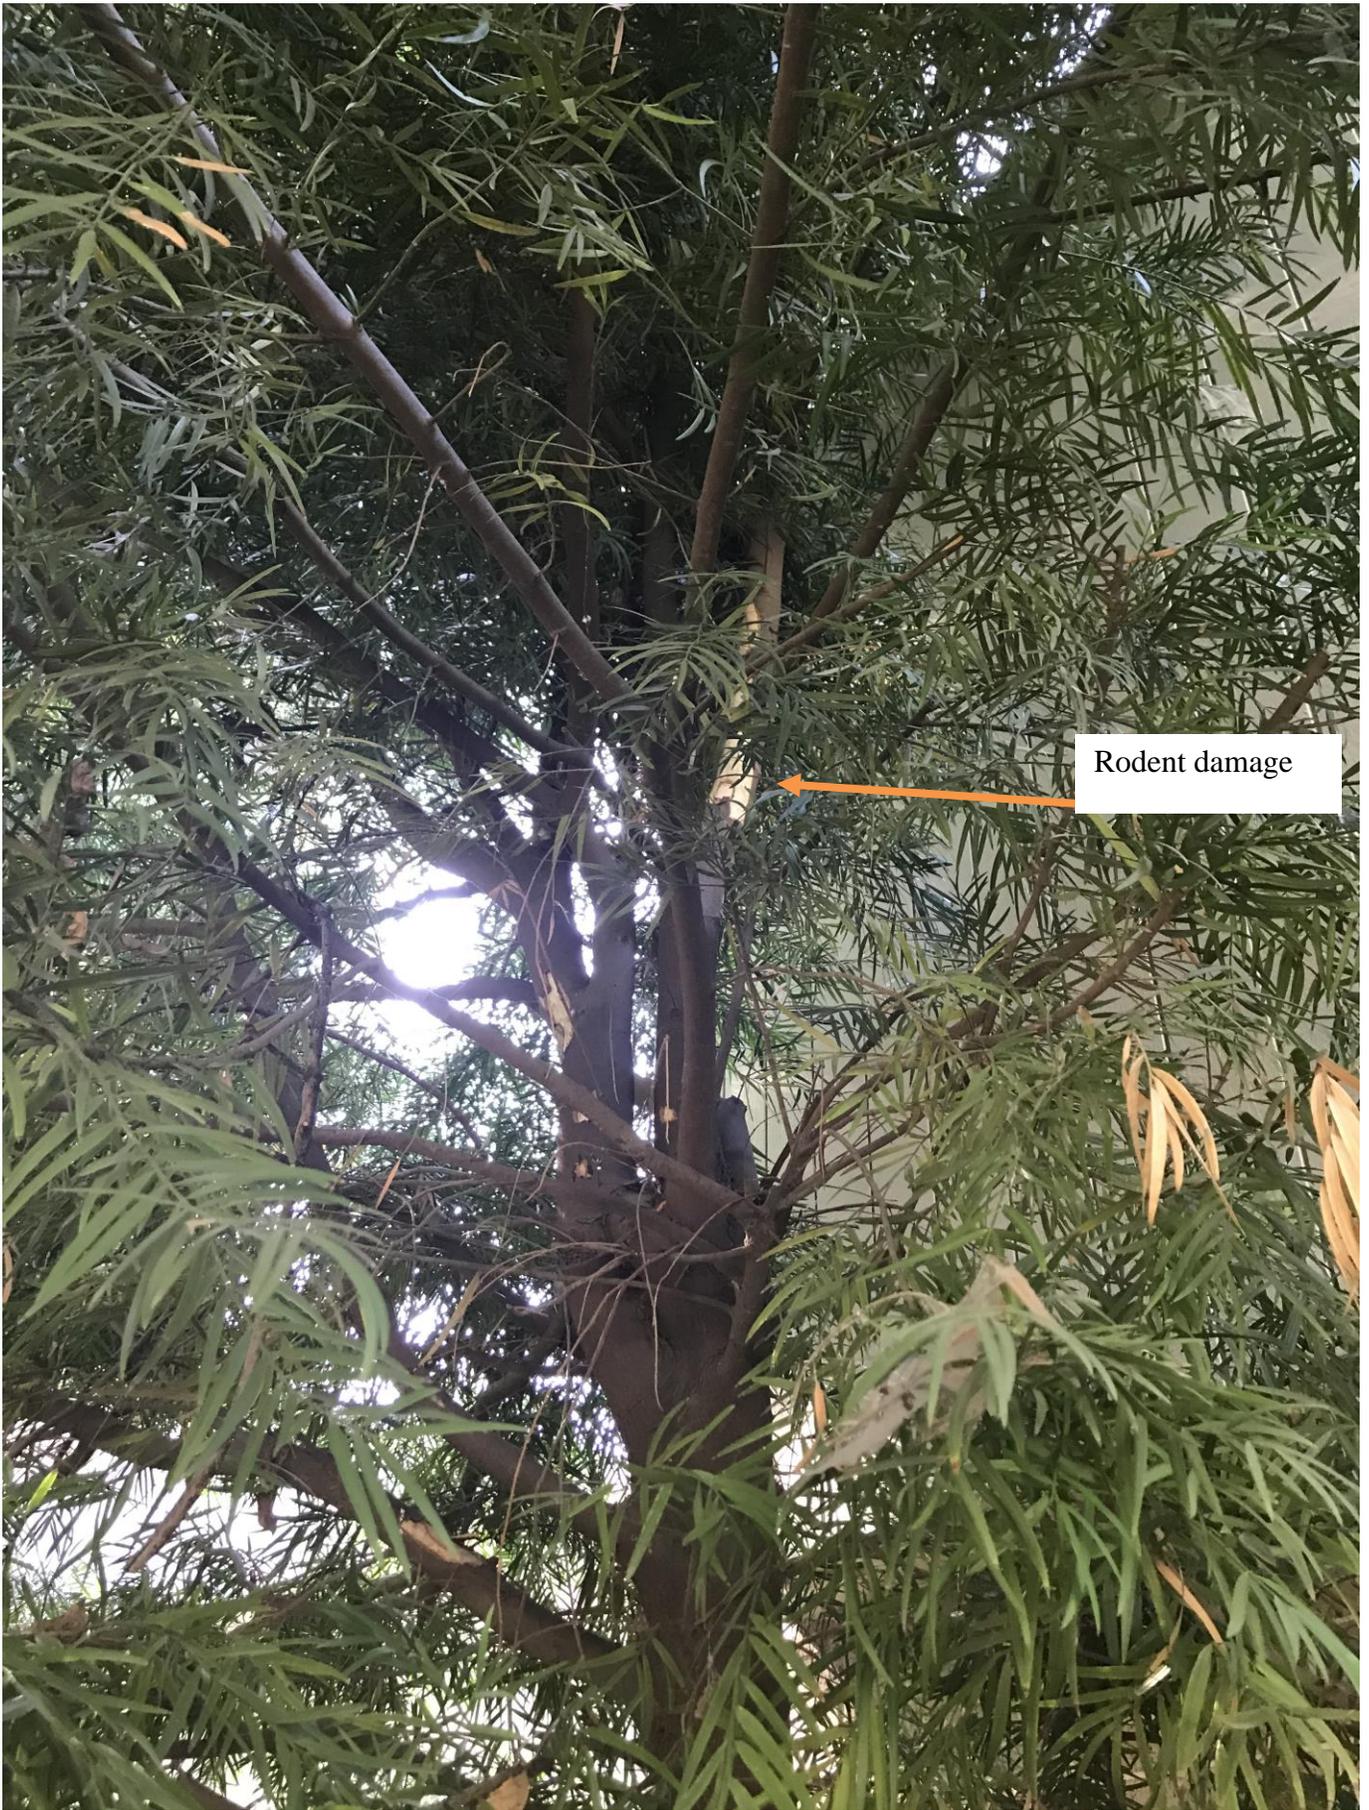
- (Zone 3) Tree #No Tag, Podocarpus (*Podocarpus neriifolius*), 2316 Swarthmore. Tree has out grown planting location and is building clearance issue as well as pathway for rodents to the roof and has sustained major damage due to rodents stripping bark. (Figure 5-6) I recommend removal.

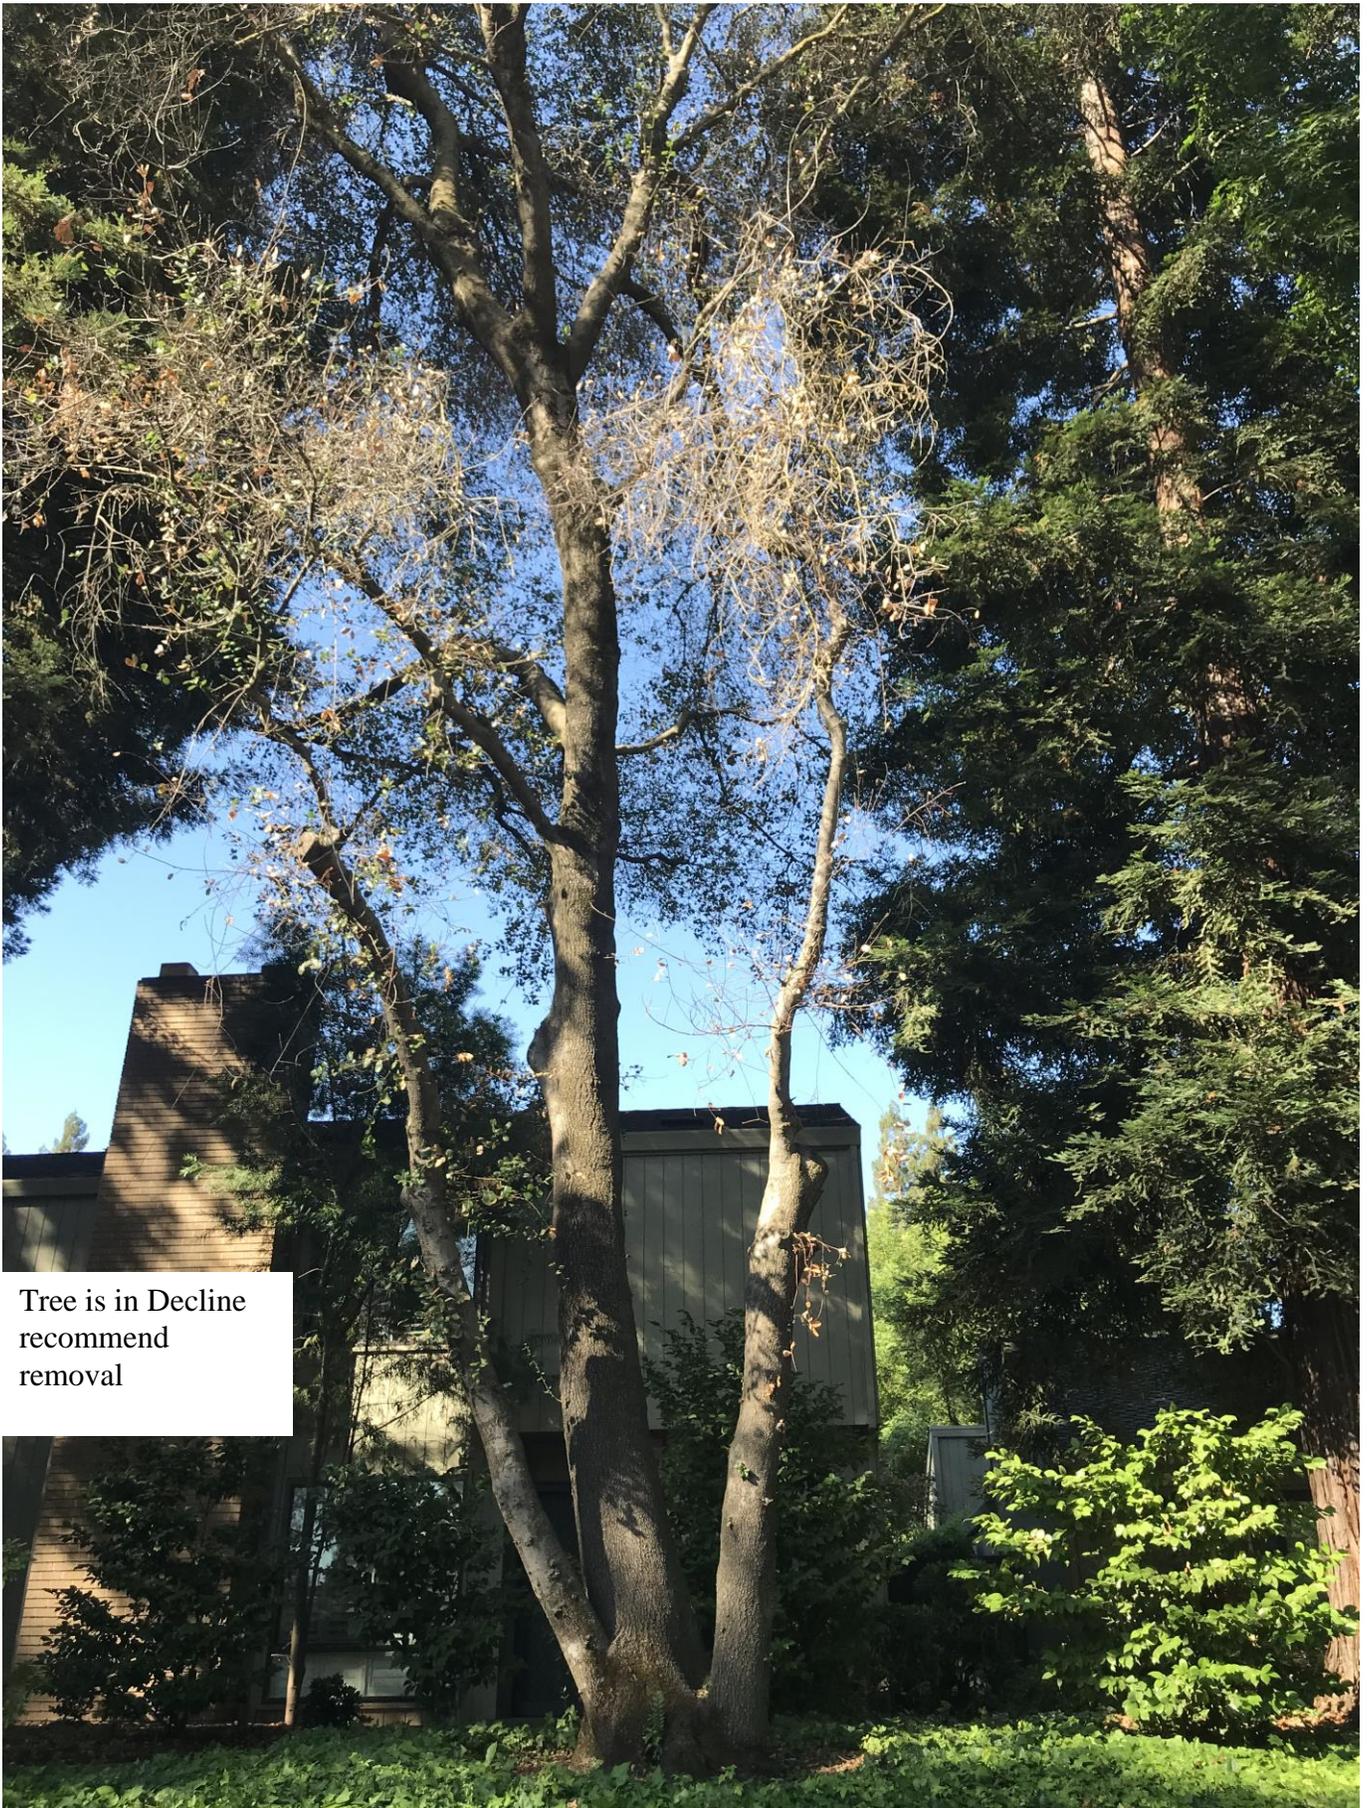
Figure 7

- (Zone 3) Tree #875 Interior Live Oak (*Quercus wislizeni*), 2322 Swarthmore, (Figure 7) this tree has major dieback in canopy and appears in decline. I recommend removal of this tree due to current condition. There is another podocarpus (*Podocarpus neriifolius*), at this address as well and the tree has out grown planting location and is building clearance issue I recommend removal (Figure 8).

Tree is in Decline  
recommend  
removal

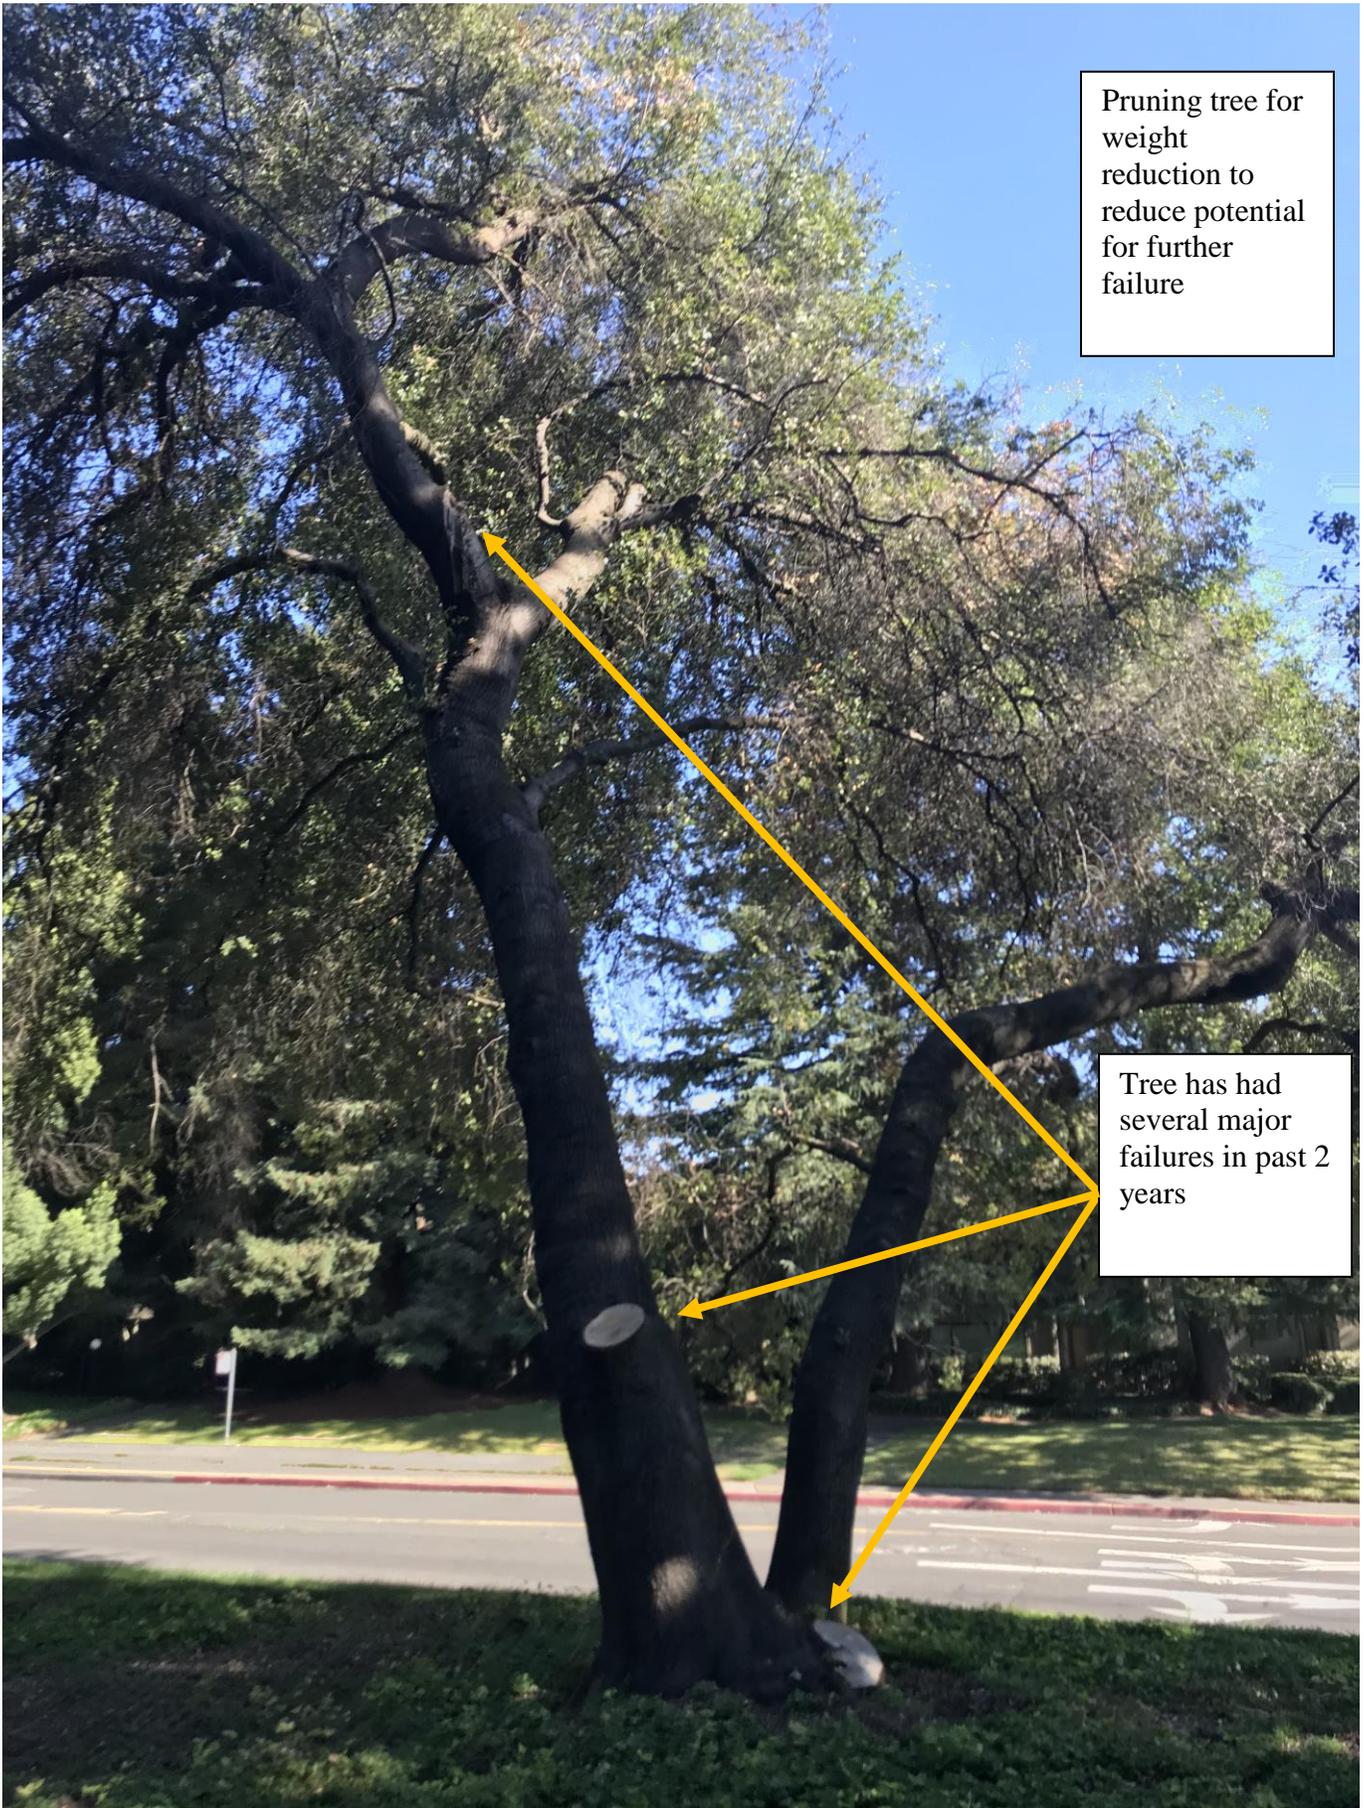
Figure 9

- (Zone 3) Tree #867 Interior Live Oak (*Quercus wislizeni*), 2326 Swarthmore (Figure 9). This tree has sustained 3 major failures in the past 2 years. I recommend weight reduction pruning on the remaining canopy to retain the tree and prevent further failure.

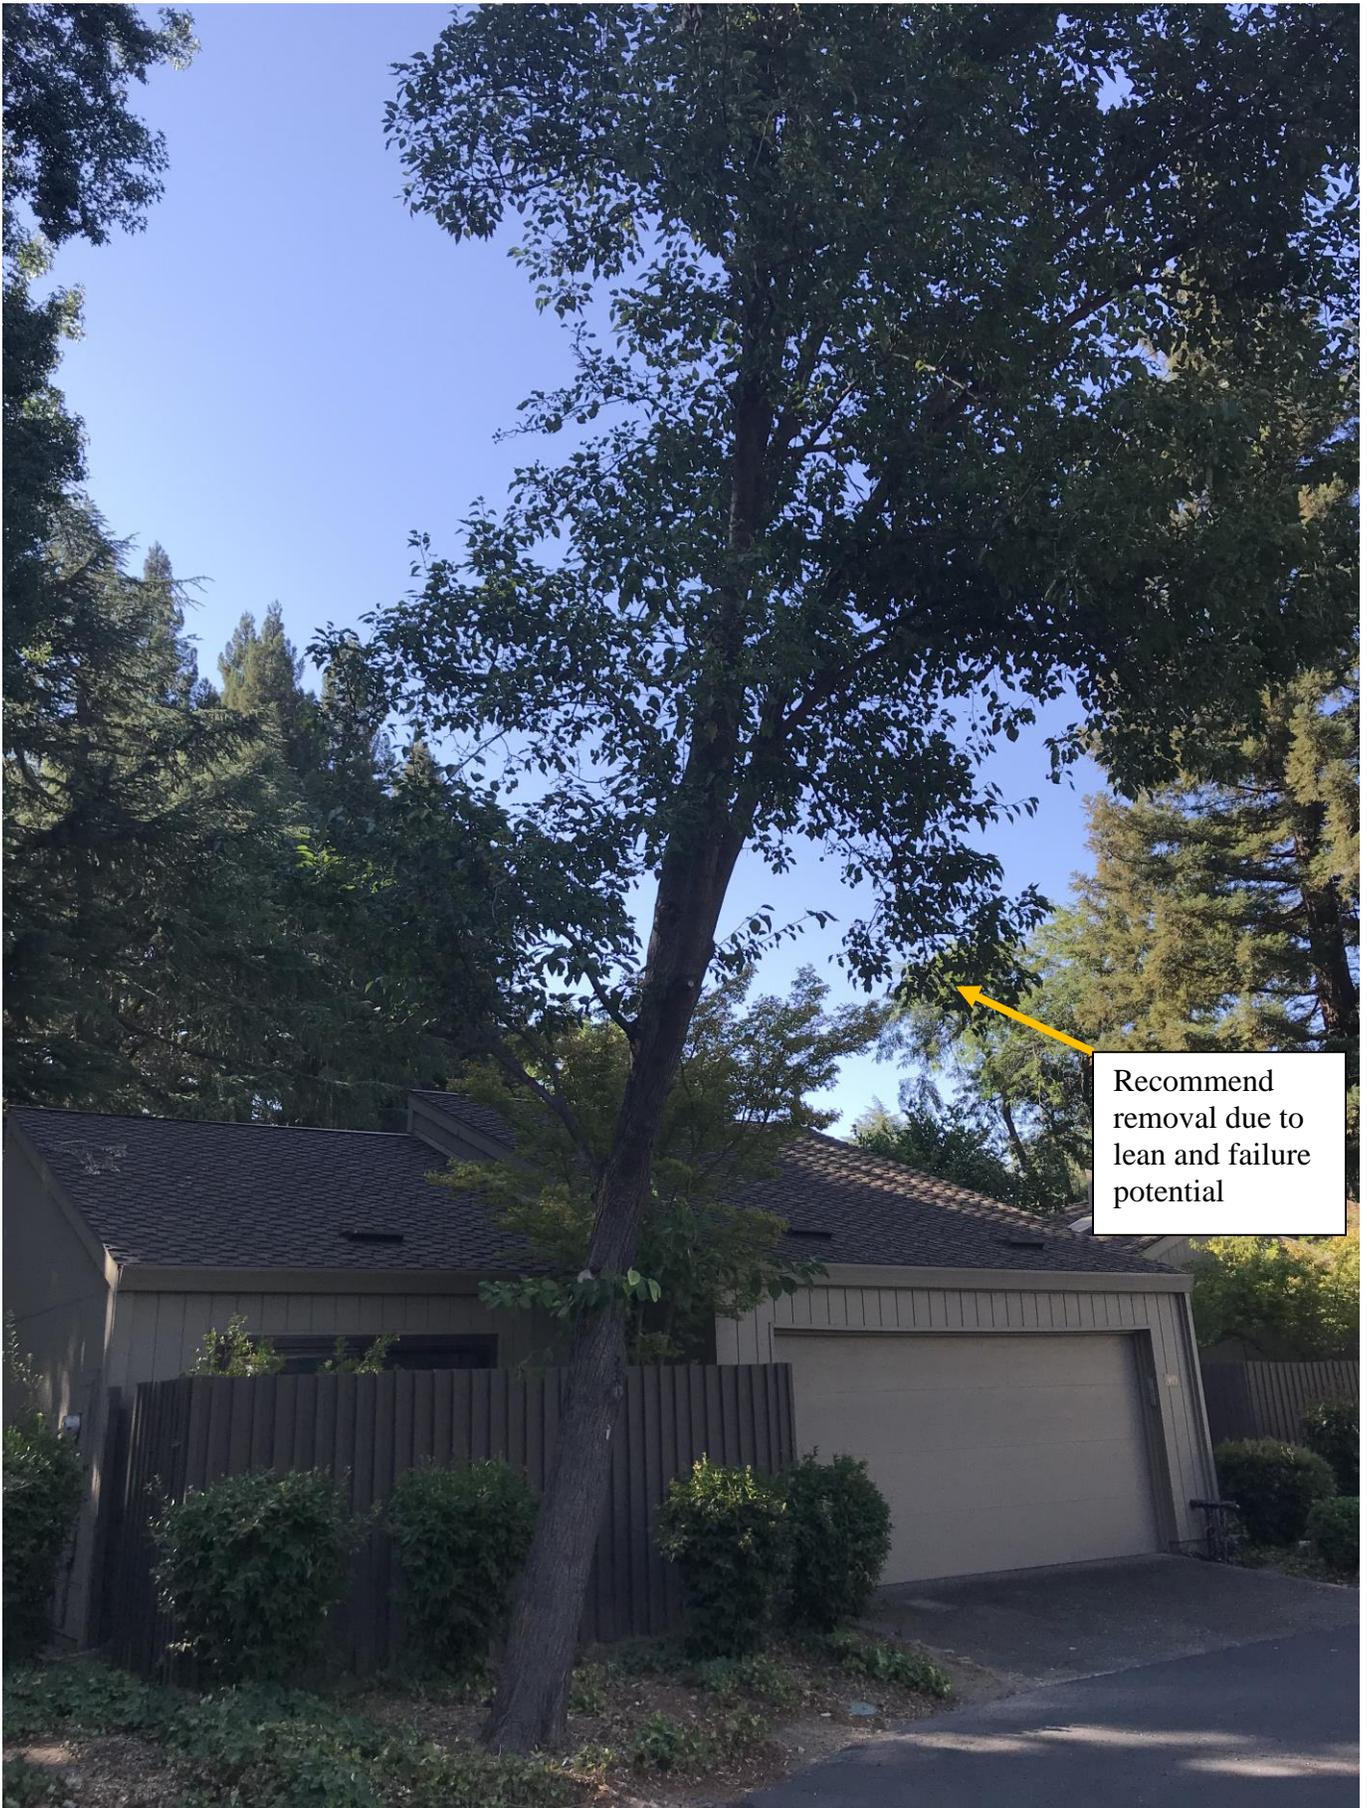
Figure 10

- (Zone 3) Tree #966, Bradford Pear (*Pyrus calleryana*), next to 409 Dunbarton Circle. (Figure 10-11). This tree has a major lean with no self-correction and there is soil bulging at the base on the back side of the lean. These signs are usually associated with a tree that is in process of uprooting and I believe the tree is a failure risk. I recommend removal.

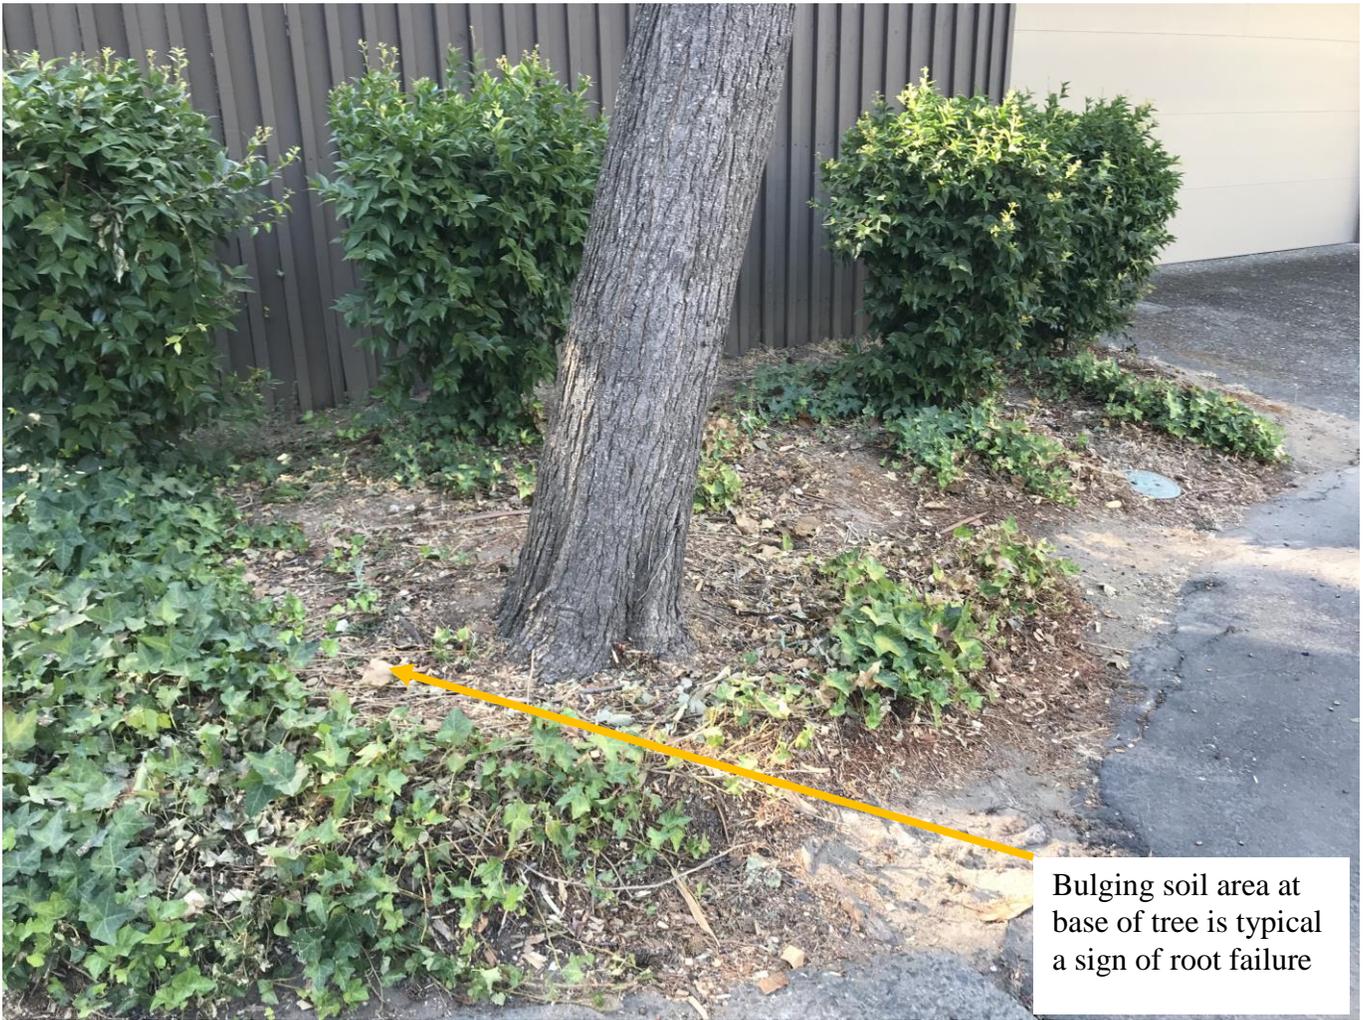
Figure 11

Bulging soil area at base of tree is typical a sign of root failure
