August 13, 2020

The Nepenthe Association  
1131 Commons Dr.  
Sacramento, CA 95825  
Phone: (916) 929-8380  
Email: [Bettsi.Ledesma@fsresidential.com](mailto:Bettsi.Ledesma@fsresidential.com)

On August 12, 2020, I inspected several trees on the Nepenthe property during the monthly tree walk. The focus of the walk was to address resident/management concerns regarding mature trees on the property. The purpose of this report is to develop mitigation plans for the following trees and my recommendations are below. My recommendations are based on a Basic Visual Inspection. All decisions made based on the recommendations of this report are at the discretion of the Nepenthe Association.

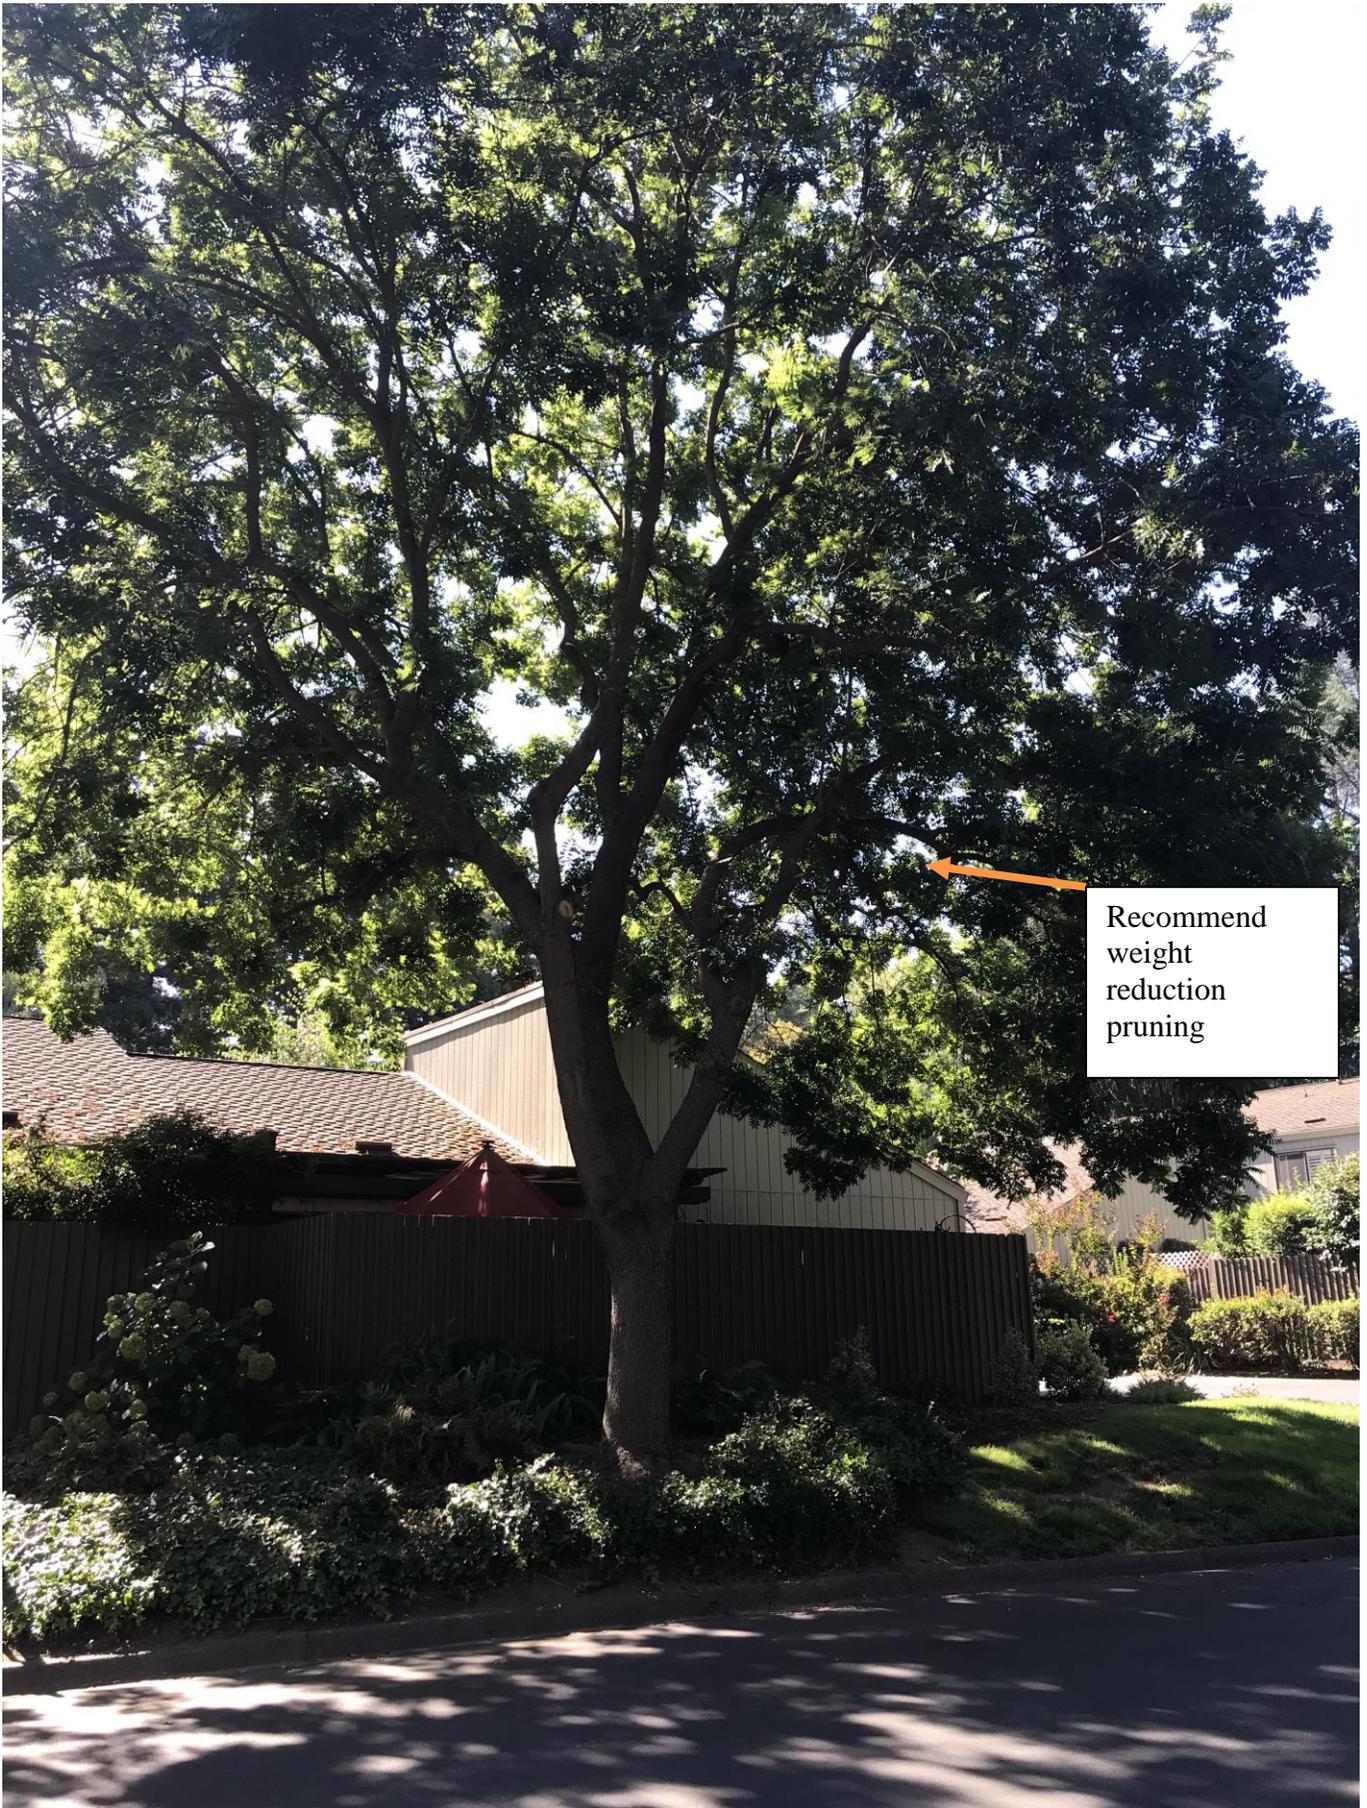
Figure 12

- (Zone 3) Tree #985 Chinese pistache (*Pistacia chinensis*), 601 Dunbarton Circle. Trees have full and over weighted canopy (Figures 12). I recommend full prune of trees Canopy.

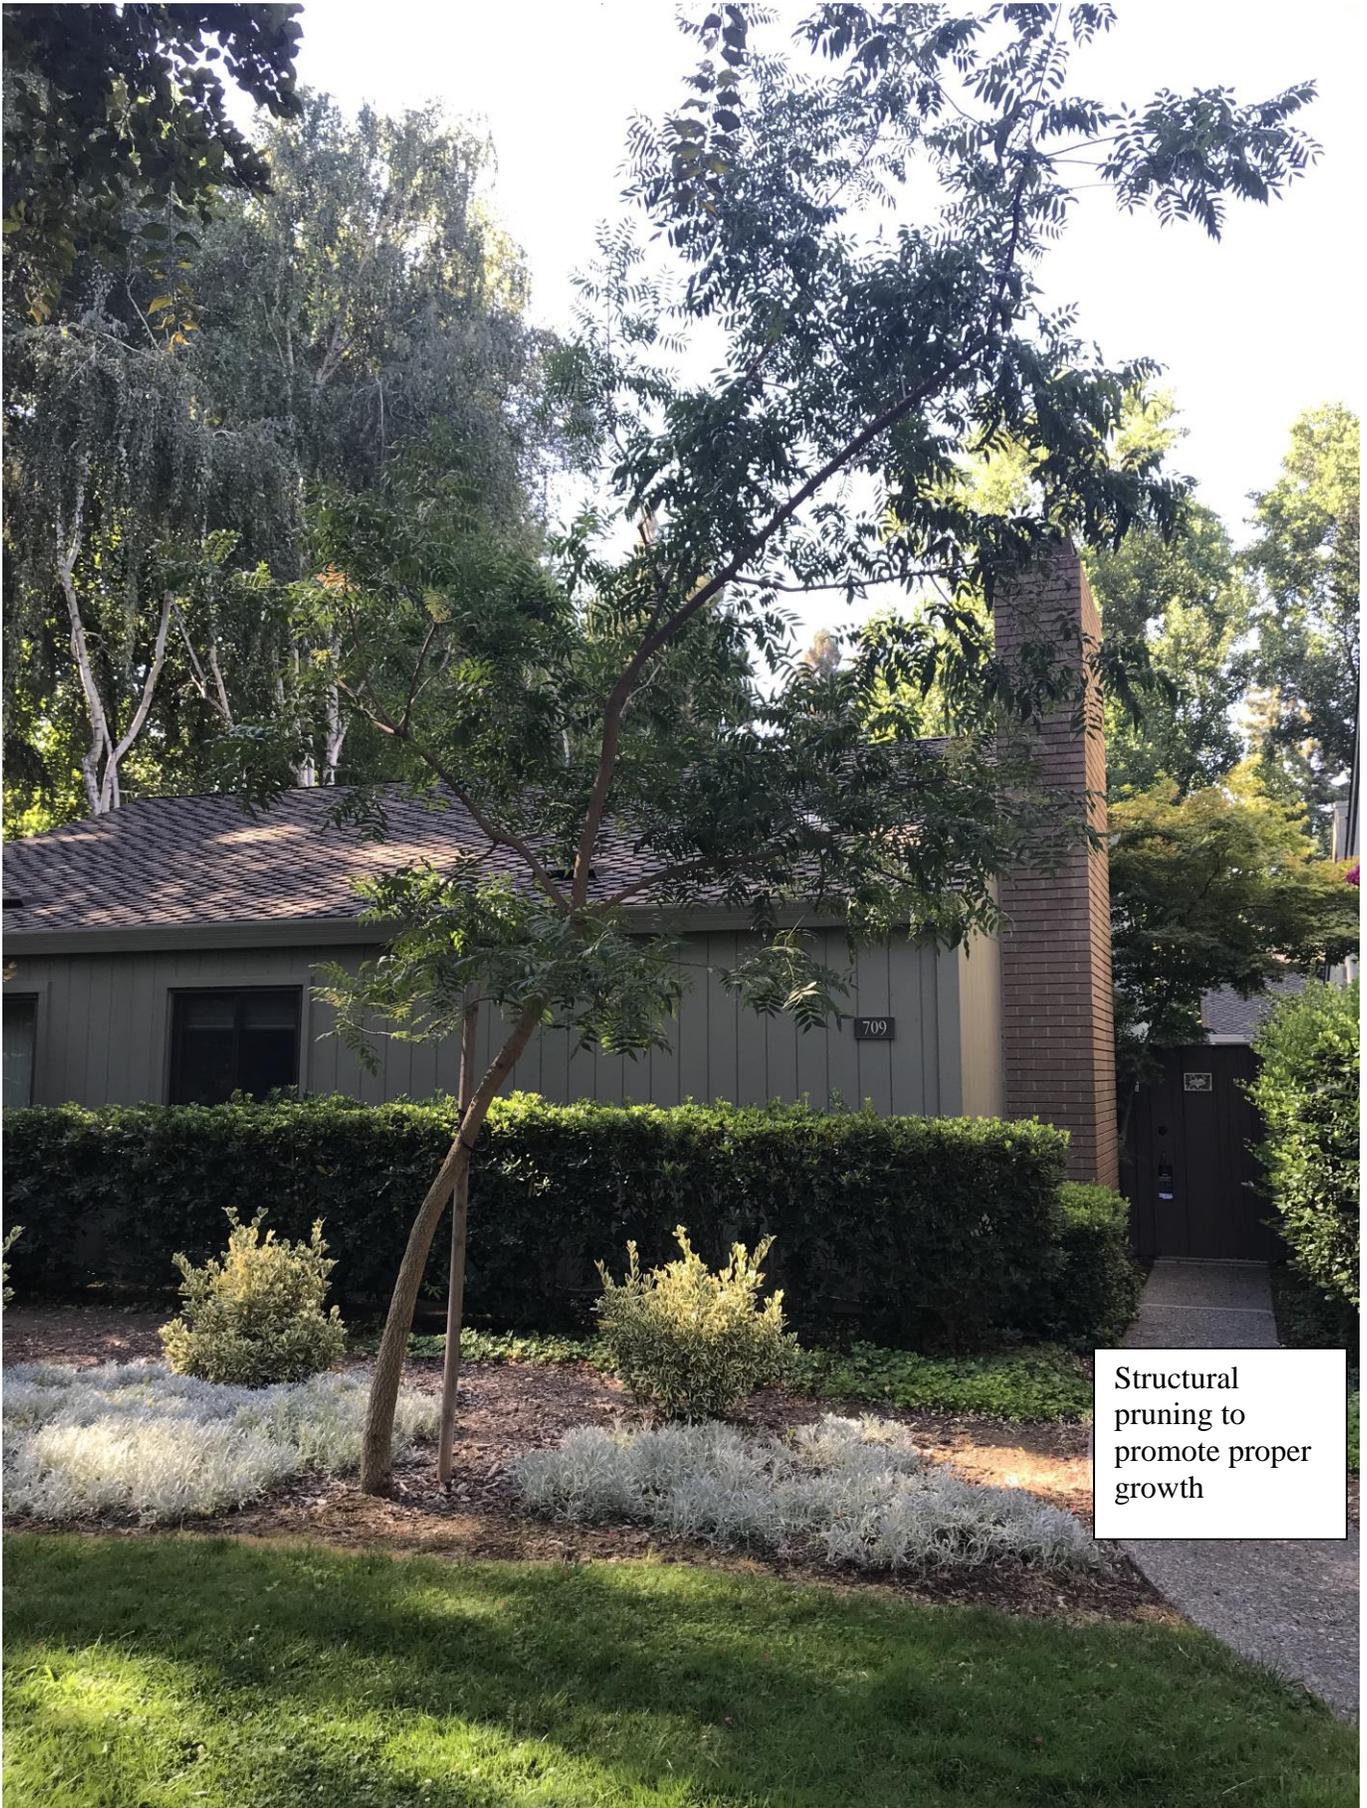
Figure 13

- (Zone 3) Trees No Tag Chinese pistache (*Pistacia chinensis*), 709 Dunbarton Circle. (Figure 13) This tree has had issues with stability and we've been pruning this tree for growth training. We recommend additional pruning to direct growth to retain tree.

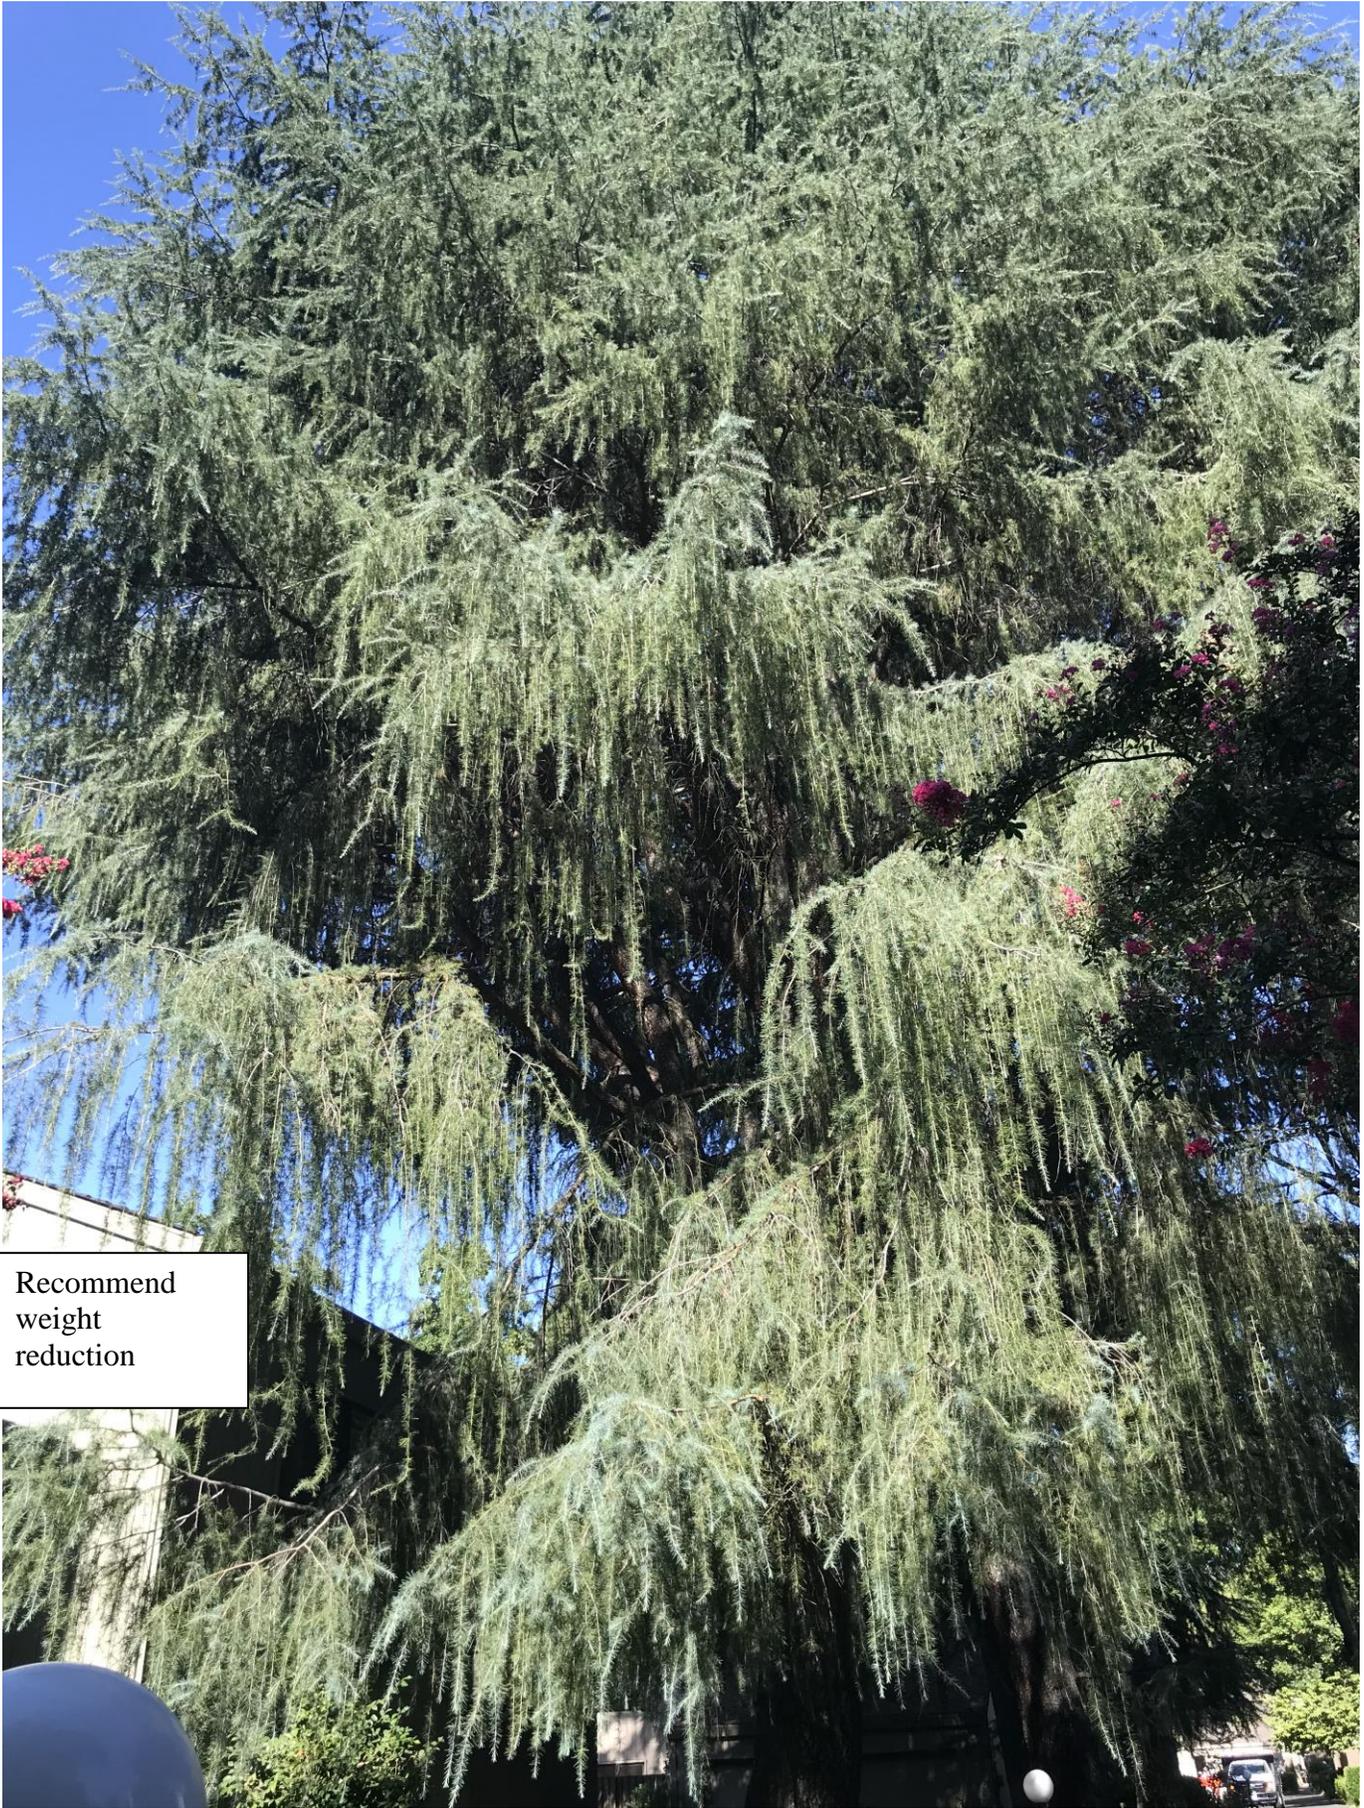
Figure 14

- (Zone 3) Tree# 996 Deodar cedar (*Cedrus deodara*) 707 Dunbarton Circle (Figure 14) his tree has full and heavy canopy I recommend weight reduction pruning. This tree should be monitored going forward as there is a significant cavity at the base of the tree with signs of internal decay (Figure 15).

Recommend  
weight  
reduction

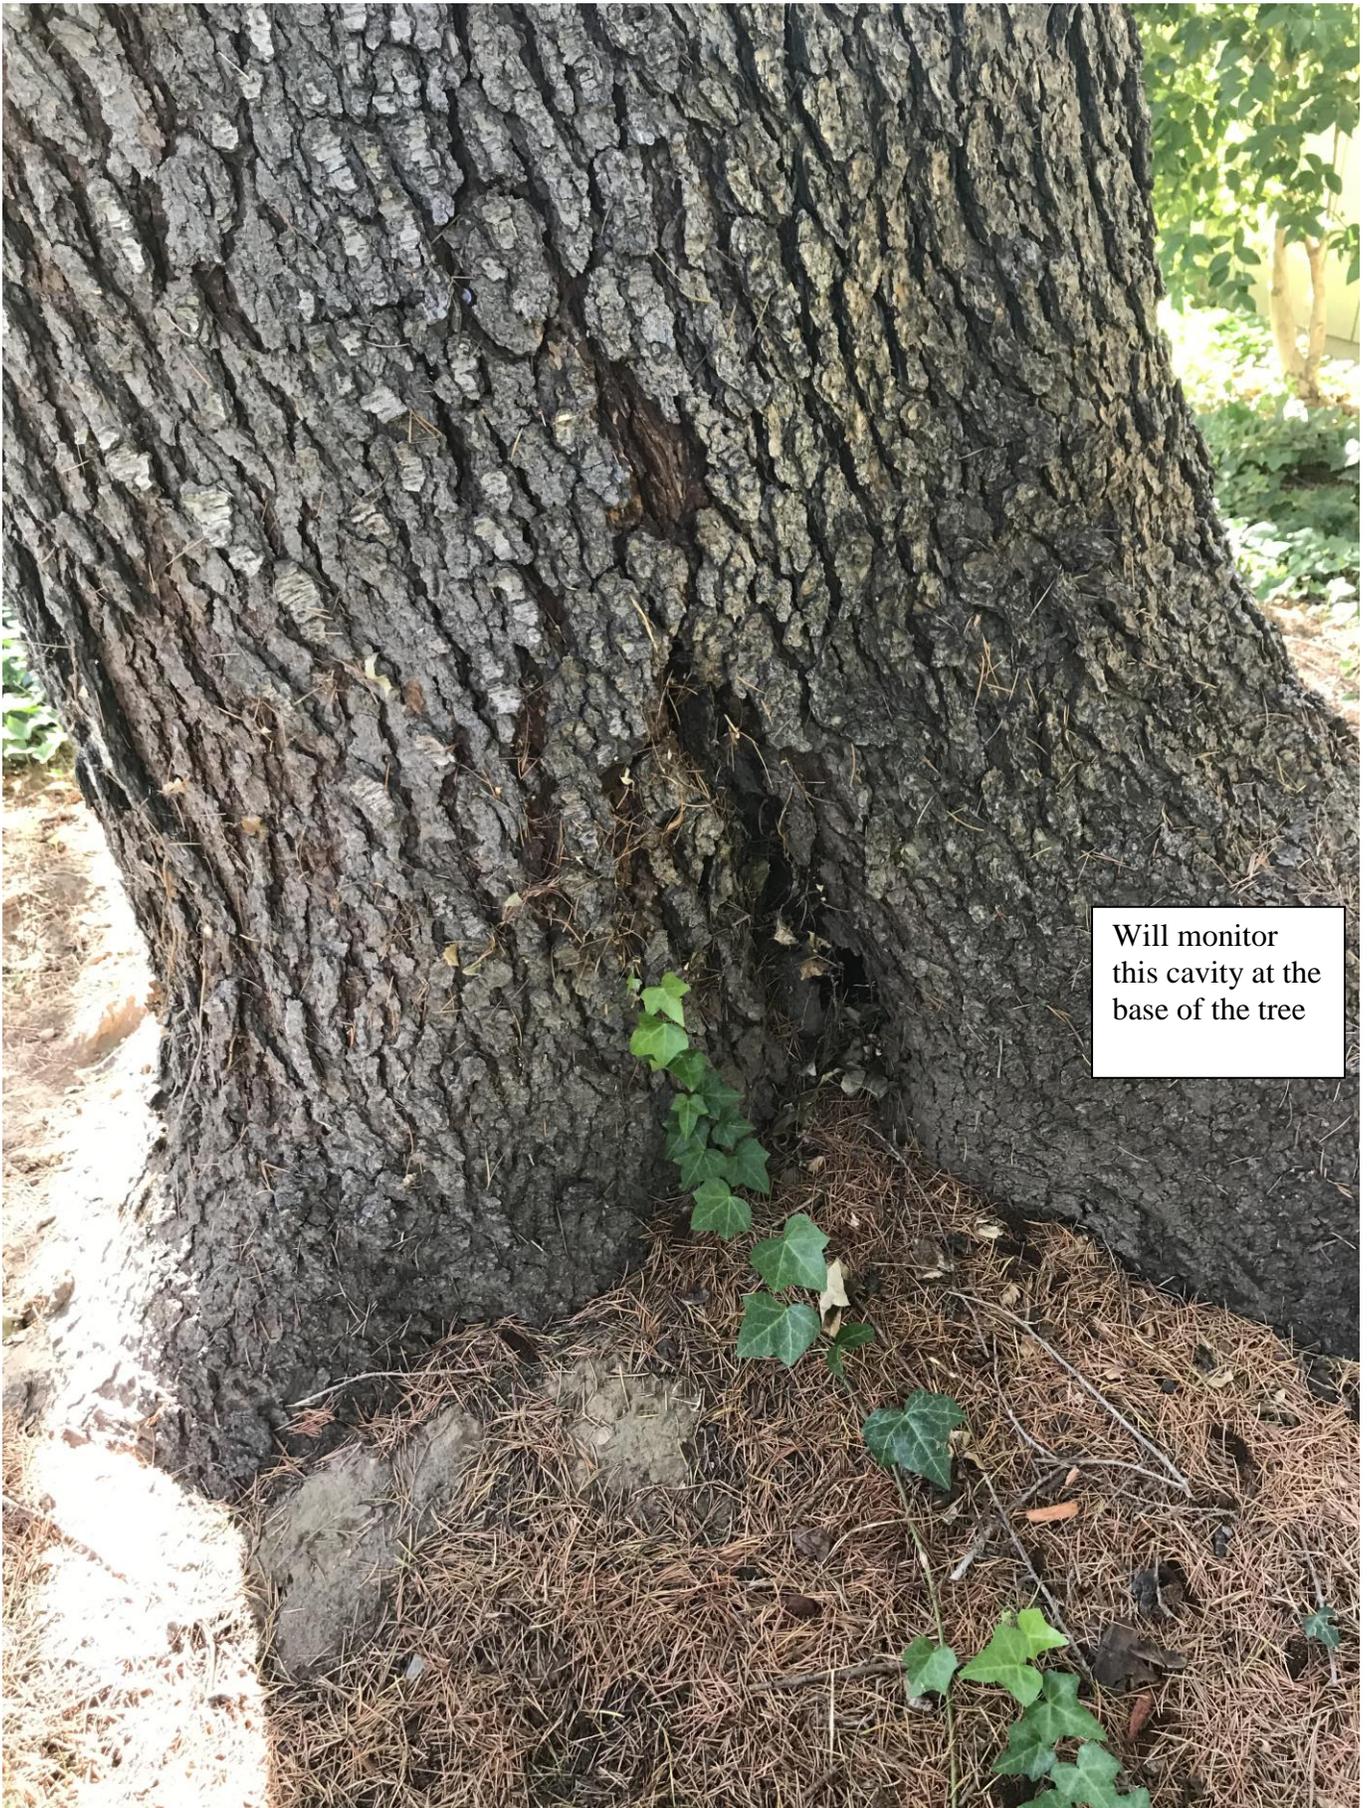
Figure 15

Will monitor  
this cavity at the  
base of the tree

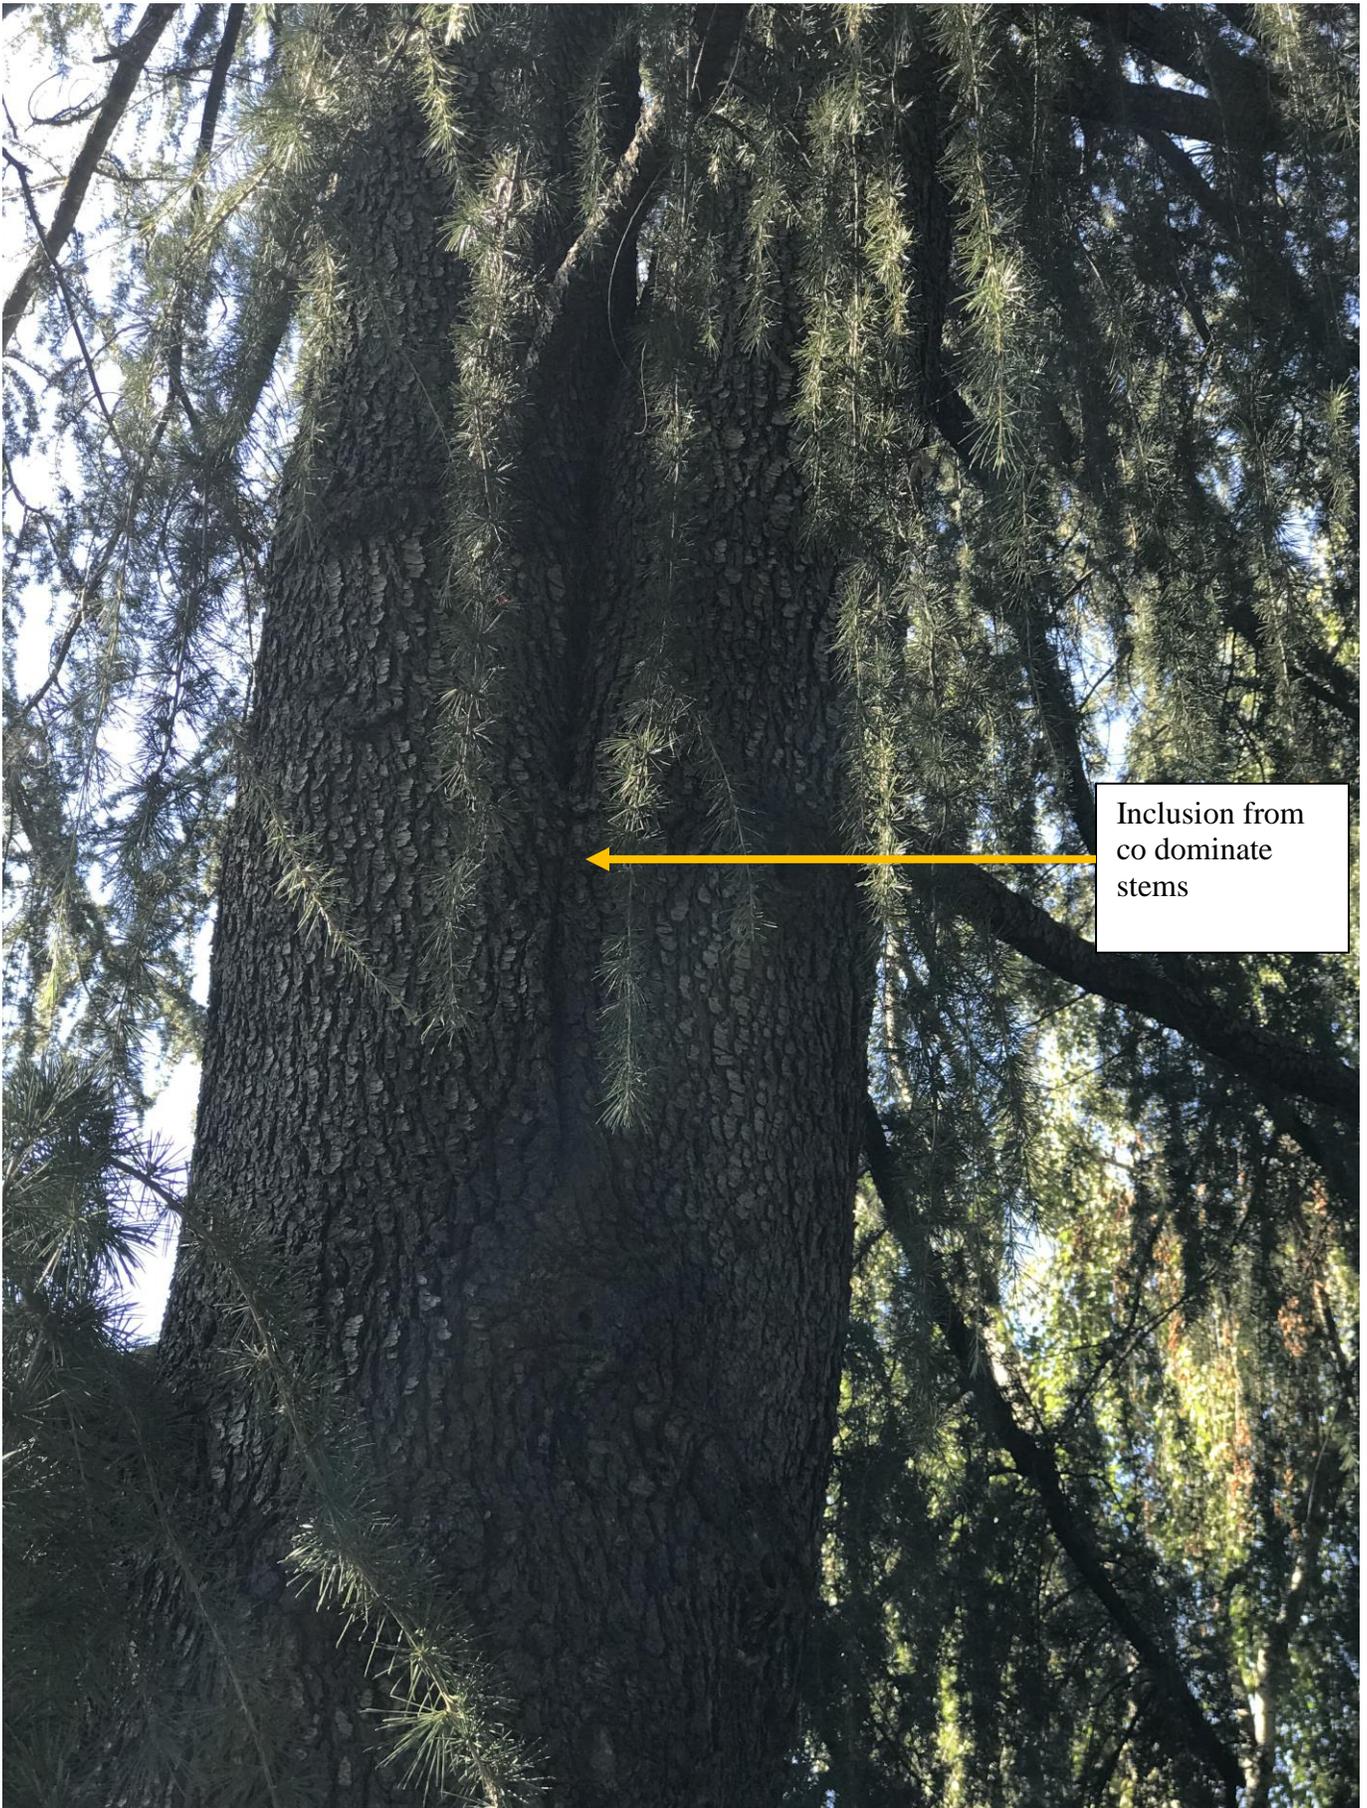
Figure 16

- (Zone 3) Tree# 1030 Deodar cedar (*Cedrus deodara*) 801 Dunbarton Circle. The tree a signifigant inclusion and is co dominate and also has an old cable system installed in the tree that is now in a place that is insufficient to add the necessary support (Figure 16-17). In addition The canopy is heavy and I recommend weight reduction pruning and inspecting the cable, removing the cable and re installing at a proper height if needed.

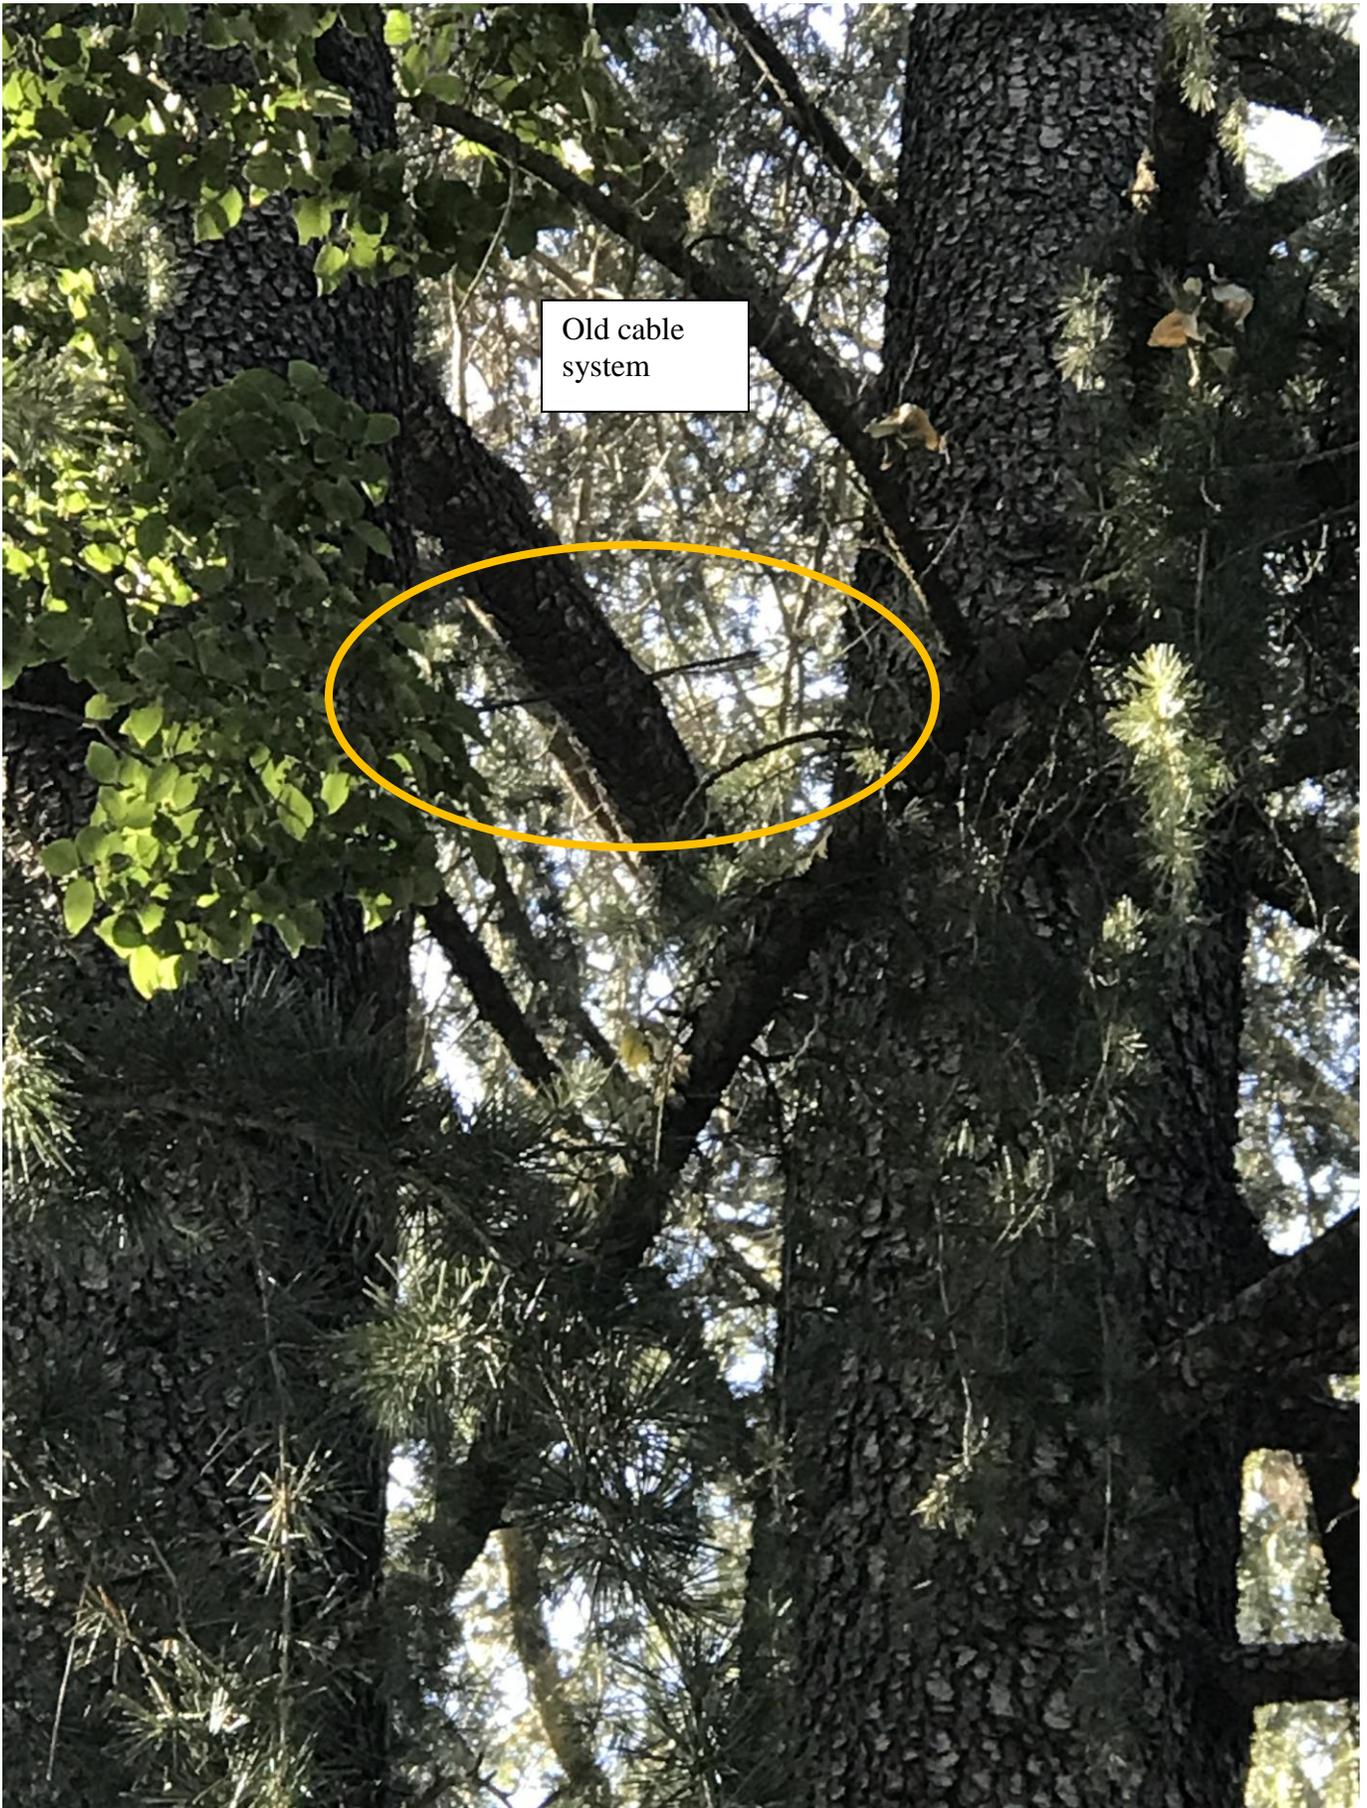
Figure 17

Old cable  
system

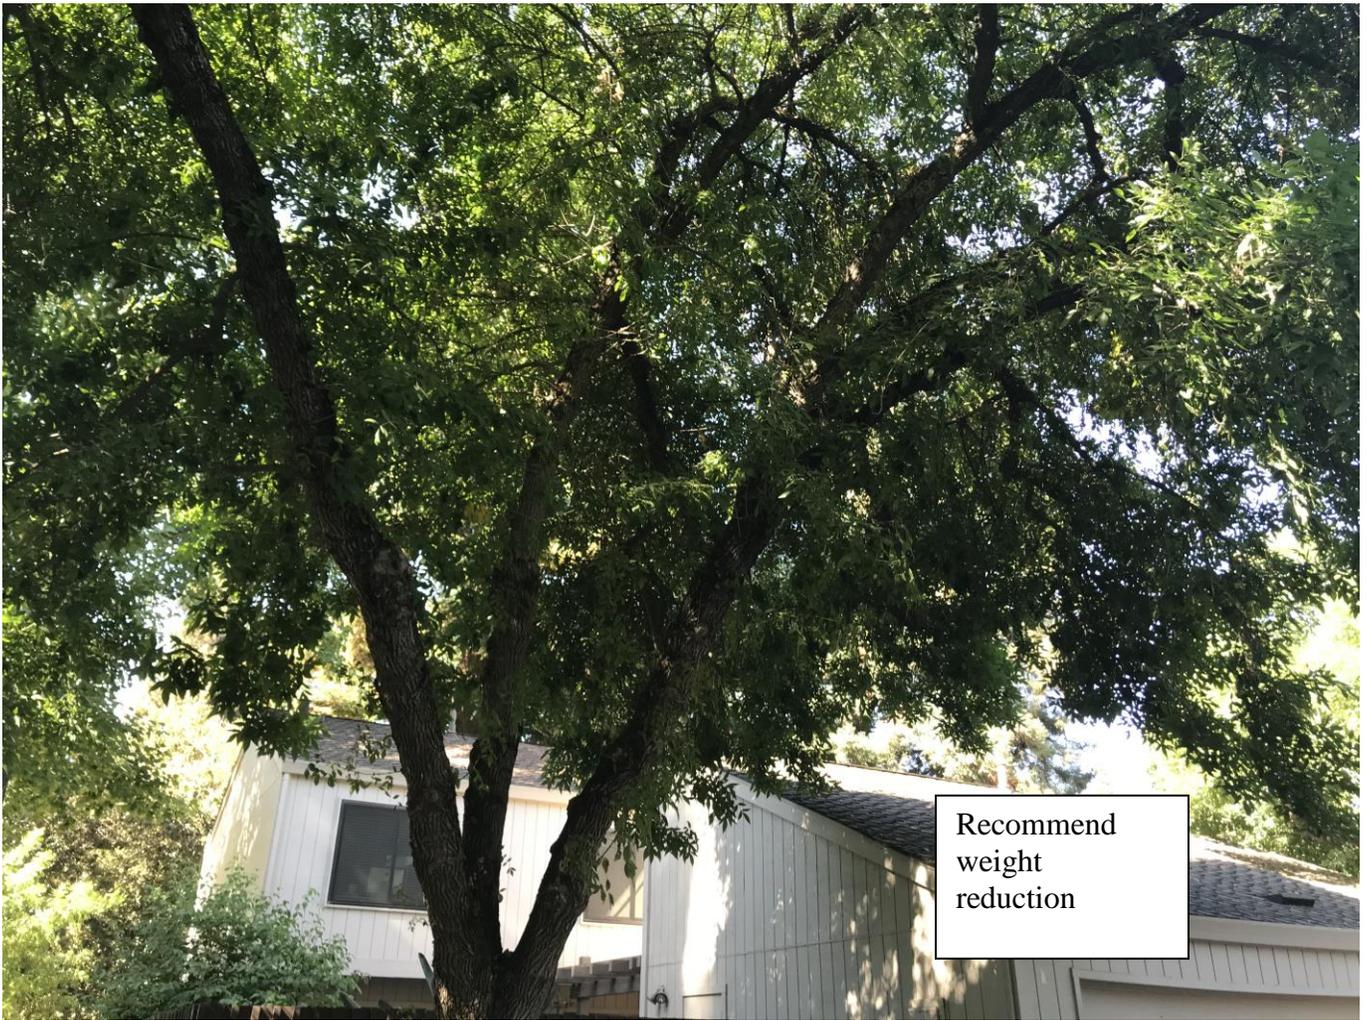
Figure 18

- (Zone 3) Tree # No Tag Ash (*Fraxnis angustifolia*) 813 Dunbarton Circle. (Figure 18) The tree canopy is full and heavy I recommend weight reduction pruning.

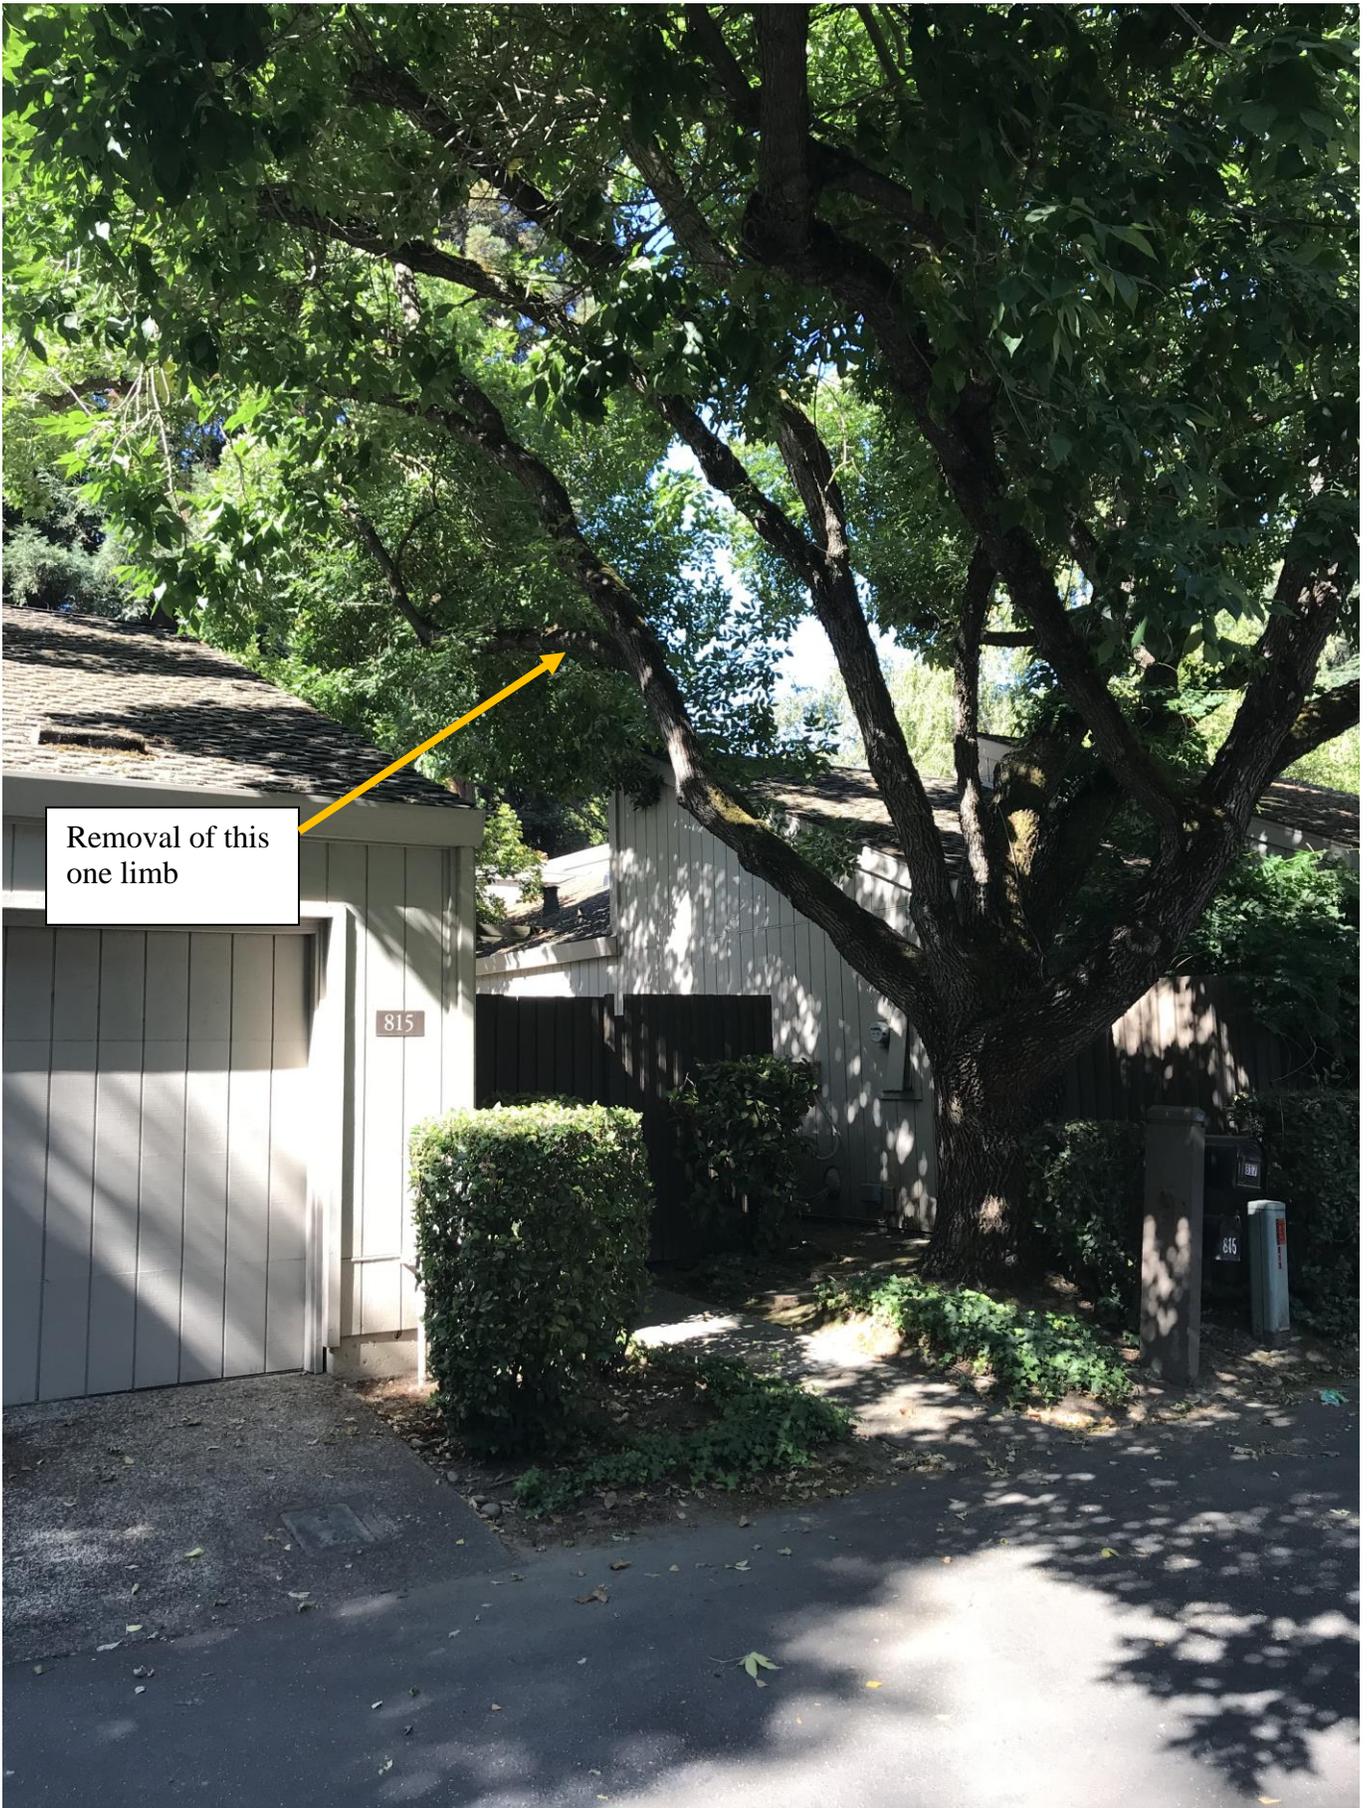
Figure 19

- (Zone 3) Tree #1036 Ash (*Fraxnis angustifolia*) 817 Dunbarton Circle. The tree has one long heavy limb that I propose to remove to reduce failure (Figure 19).

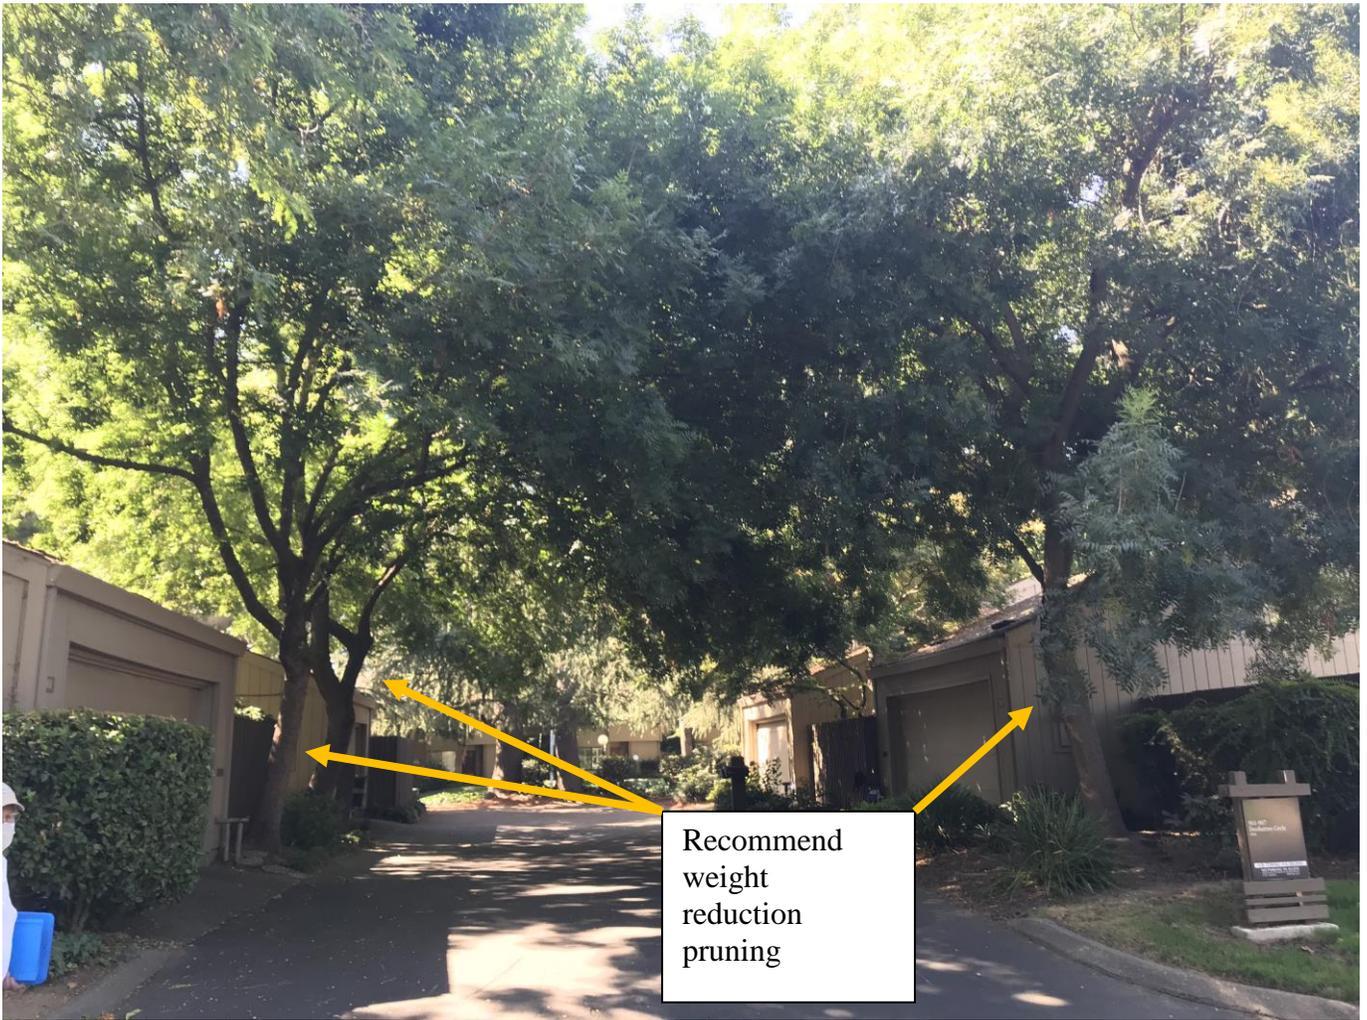
Figure 20

- (Zone 3) Trees # 1046, #1047, #1048 Chinese pistache (*Pistacia chinensis*). 901, 903, 907 Dunbarton Circle, (Figure 20). These trees have full and over weighted canopy I recommend weight reduction pruning to reduce the potential of limb failure. Due to concerns for the trees and the pruning, all pruning on these trees will have the Arborist on site to direct the crew pruning operations for this location.

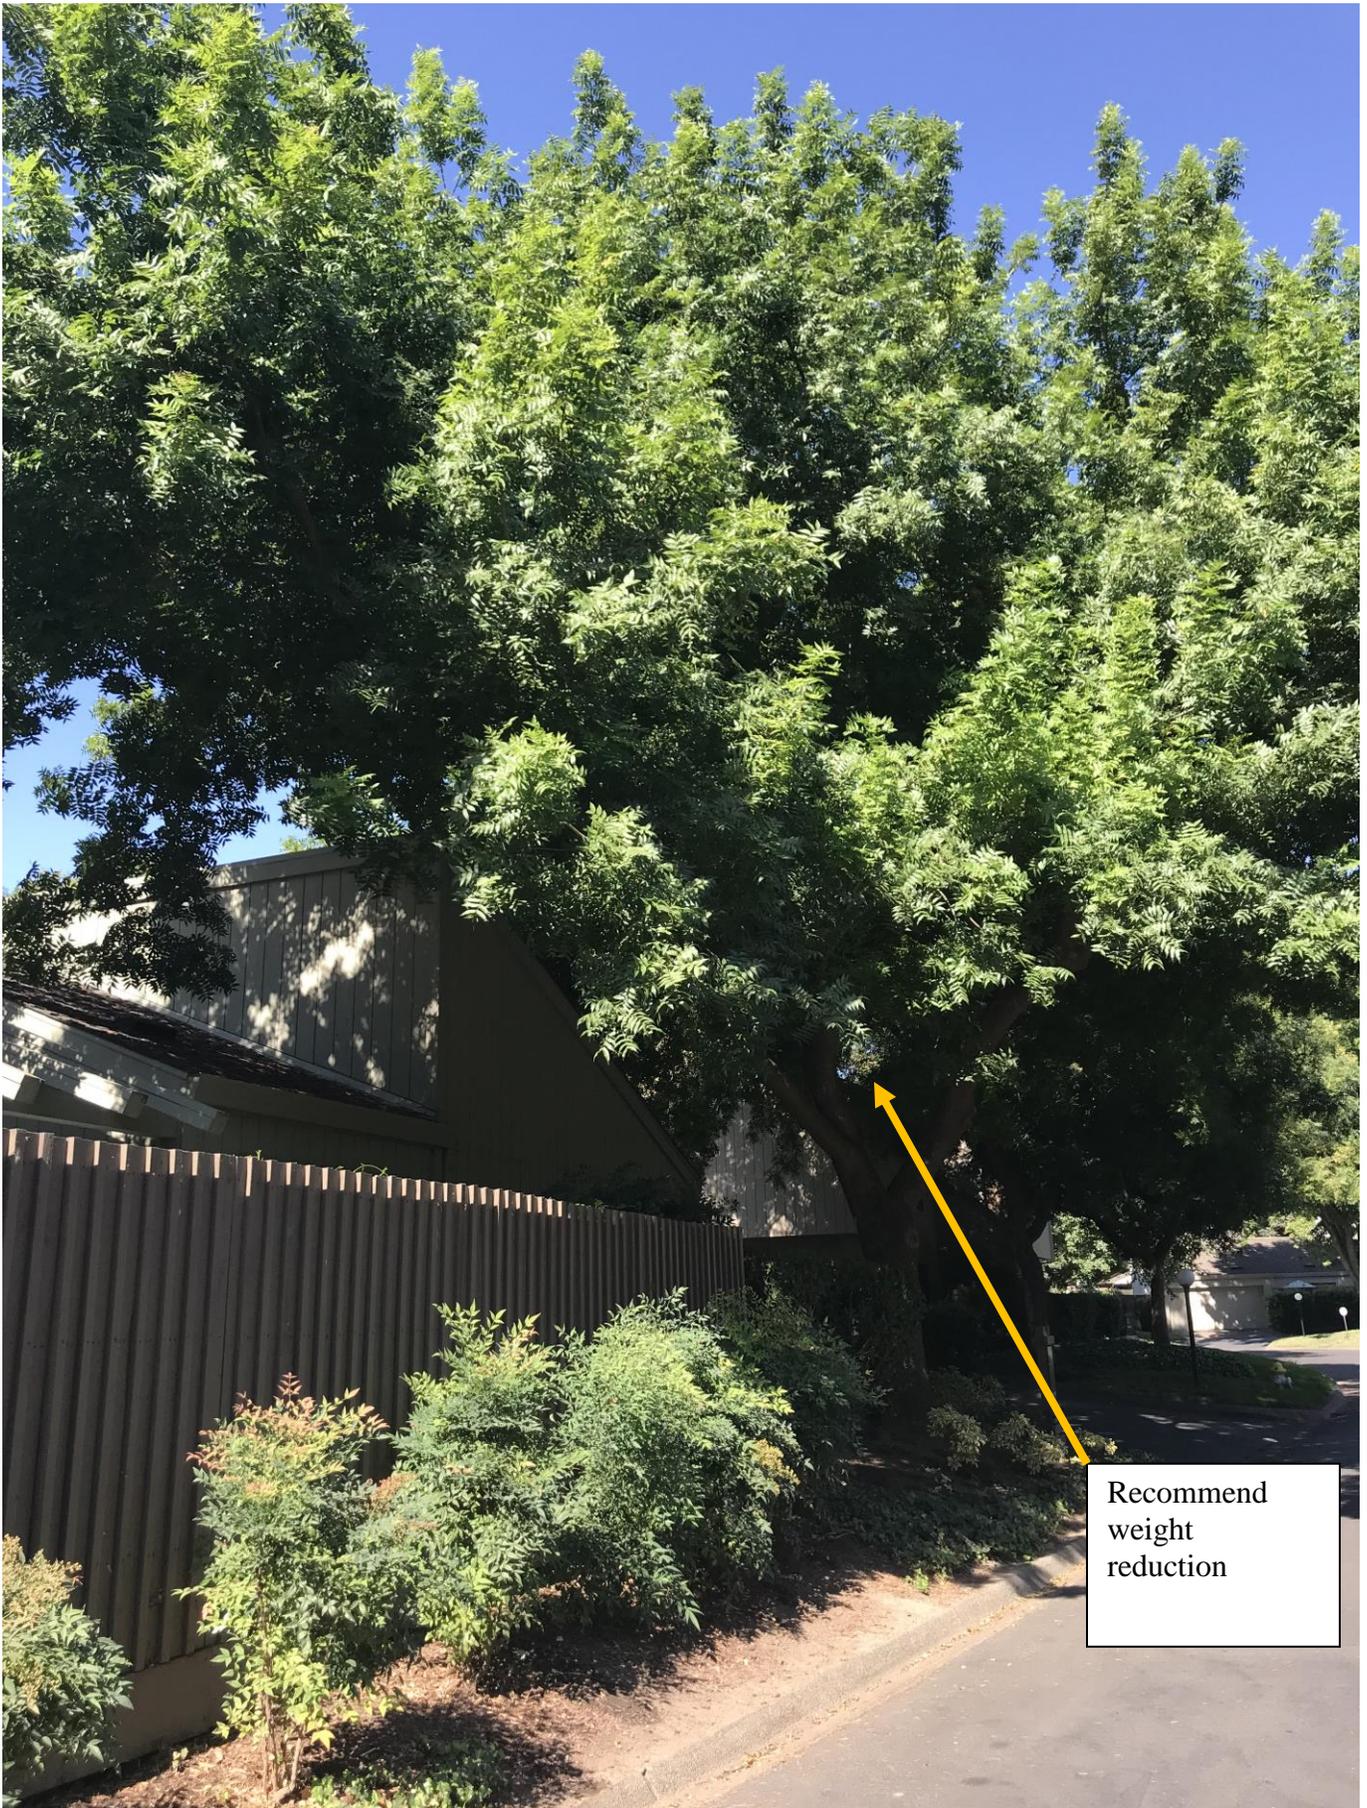
Figure 21

- (Zone 3) Tree #1051, Chinese pistache (*Pistacia chinensis*), next to 101 Dunbarton Circle. (Figure 21). The tree canopy is full and heavy I recommend weight reduction pruning.
