August 13, 2020

The Nepenthe Association  
1131 Commons Dr.  
Sacramento, CA 95825  
Phone: (916) 929-8380  
Email: [Bettsi.Ledesma@fsresidential.com](mailto:Bettsi.Ledesma@fsresidential.com)

On August 12, 2020, I inspected several trees on the Nepenthe property during the monthly tree walk. The focus of the walk was to address resident/management concerns regarding mature trees on the property. The purpose of this report is to develop mitigation plans for the following trees and my recommendations are below. My recommendations are based on a Basic Visual Inspection. All decisions made based on the recommendations of this report are at the discretion of the Nepenthe Association.

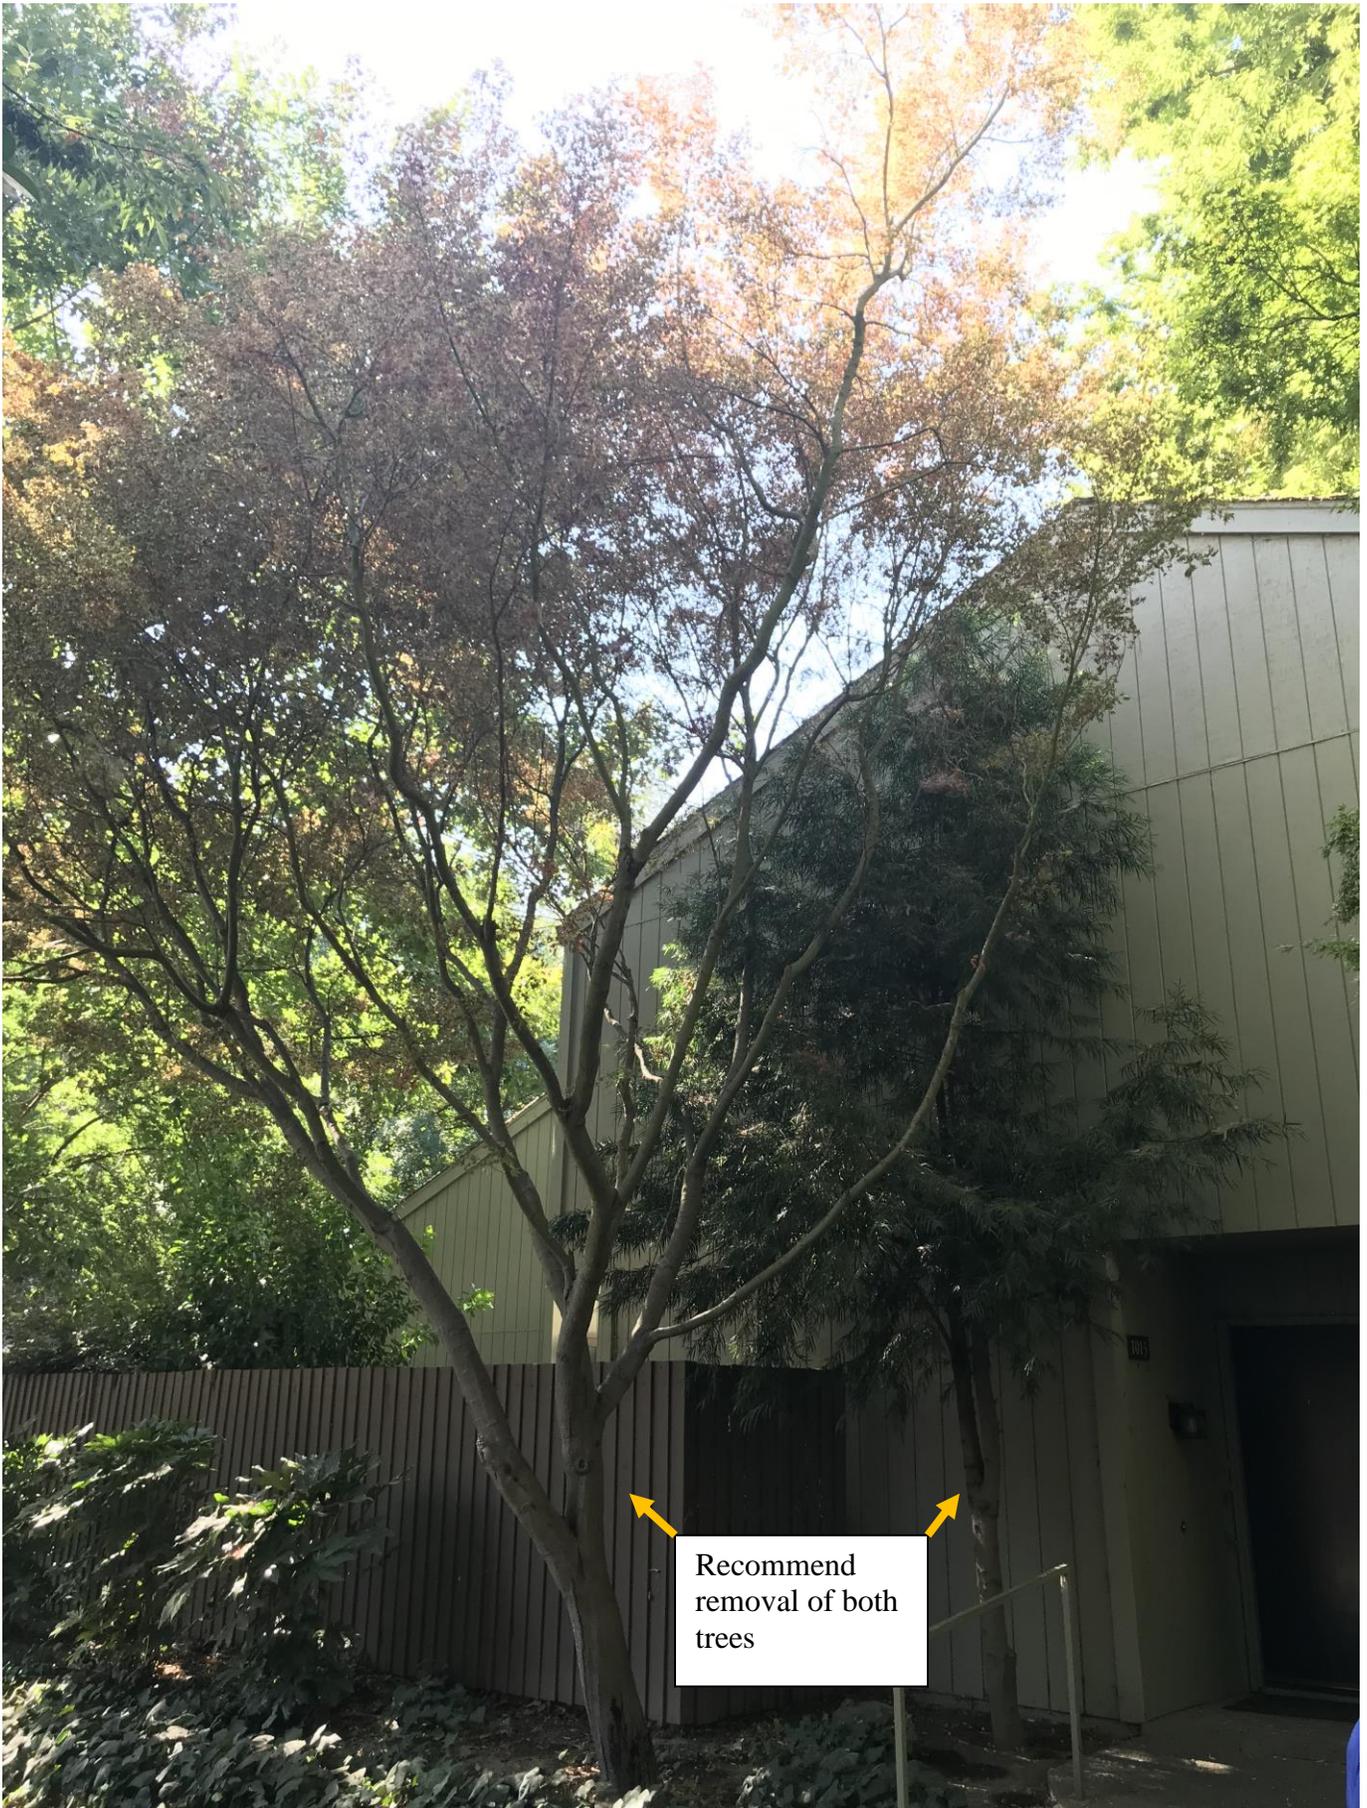
Figure 22

- (Zone 3) Tree #1056 Japanese maple (*Acer palmatum*) 1013 Dunbarton Circle, (Figure 22) this tree has died due to verticillium wilt I recommend removal of this tree. There is another podocarpus (*Podocarpus neriifolius*), at this address as well and the tree has out grown planting location and is building clearance issue I recommend removal.

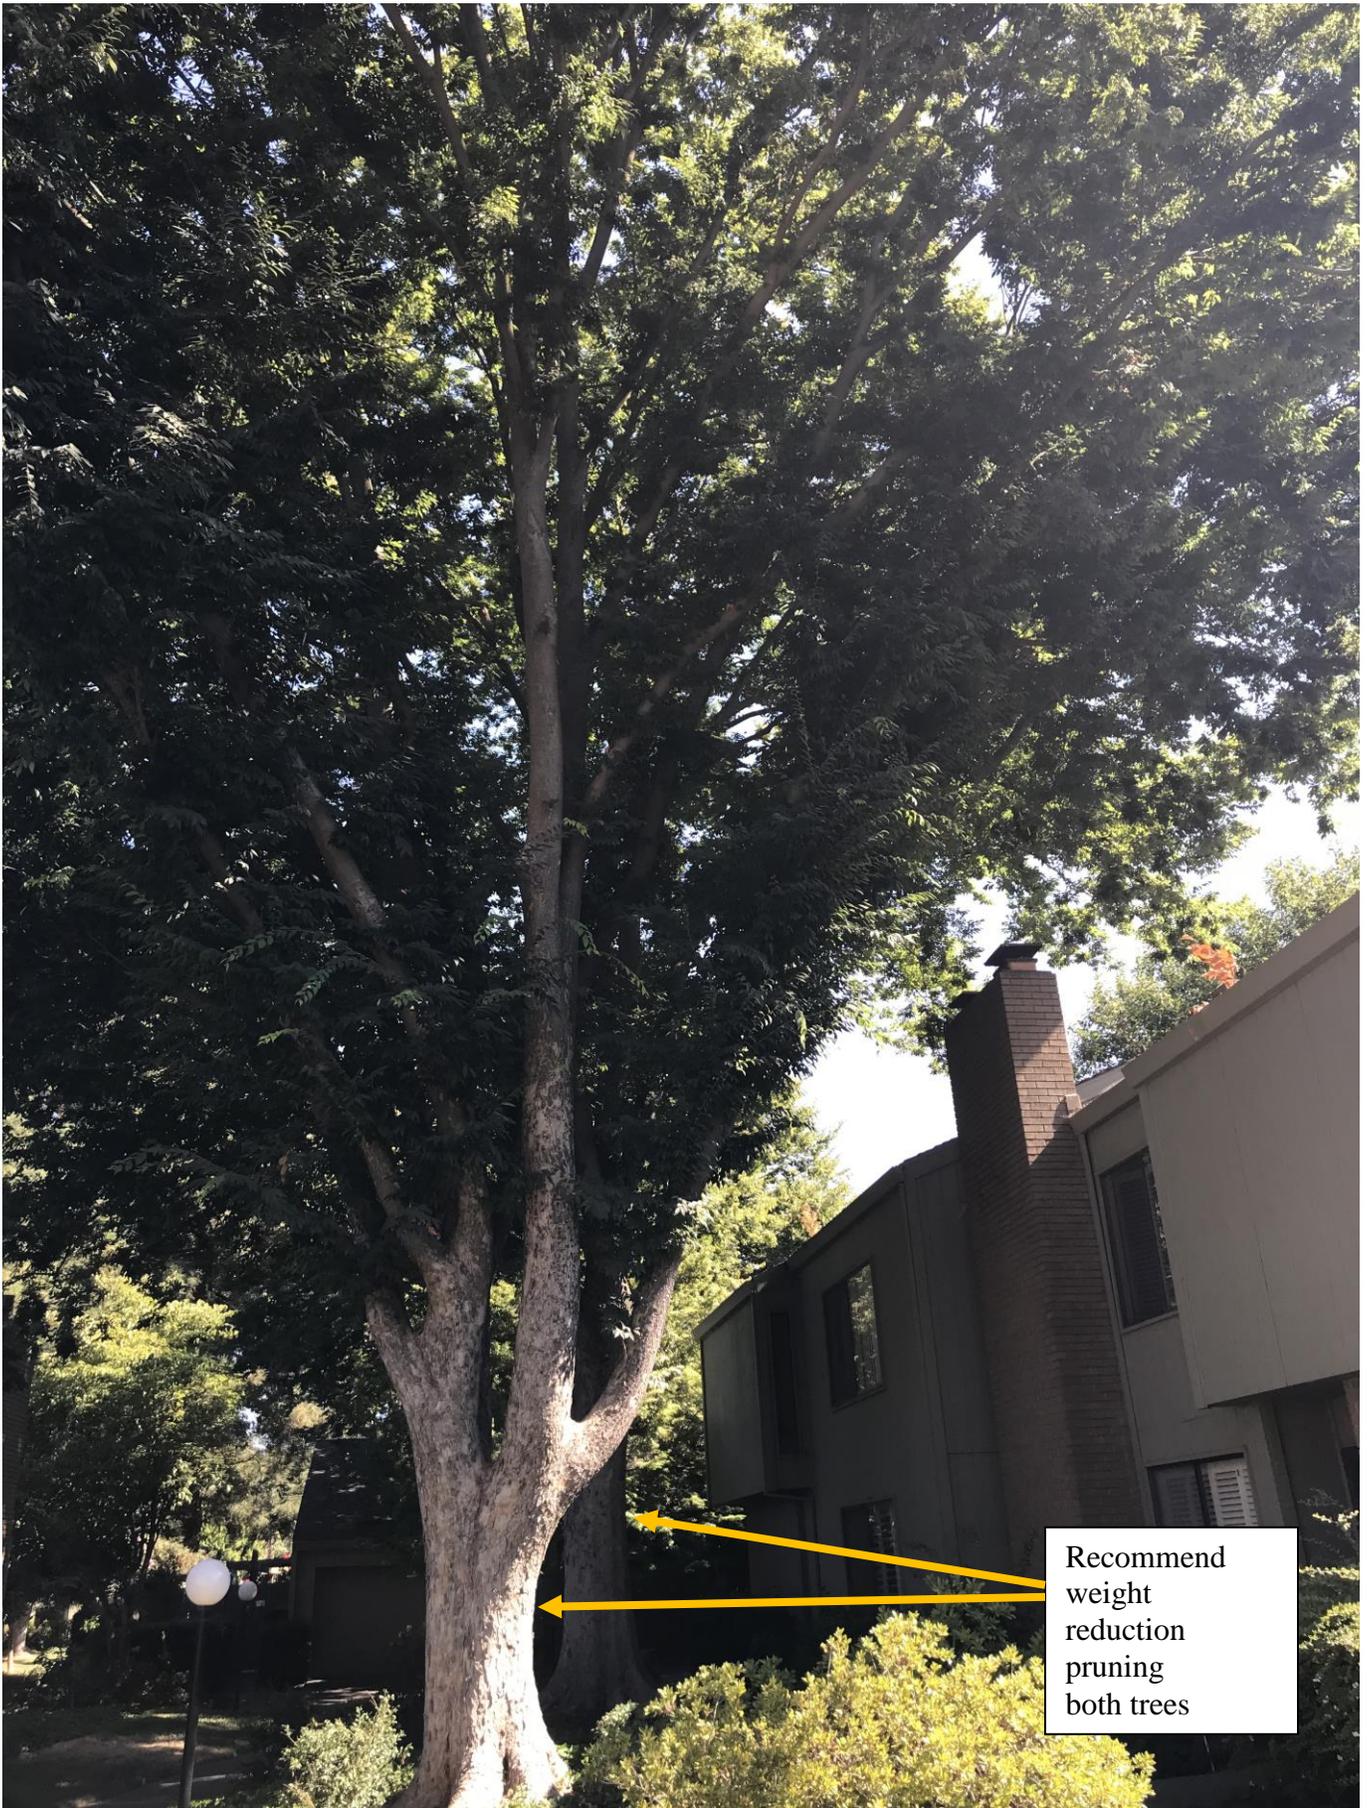
Figure 23

- (Zone 3) Trees #1058, #1059 Zelcova (*Zelcova serrata*), 1011 Dunbarton Circle (Figure 23). These trees have full and over weighted canopy I recommend weight reduction pruning to reduce the potential of limb failure.

Recommend  
weight  
reduction  
pruning  
both trees

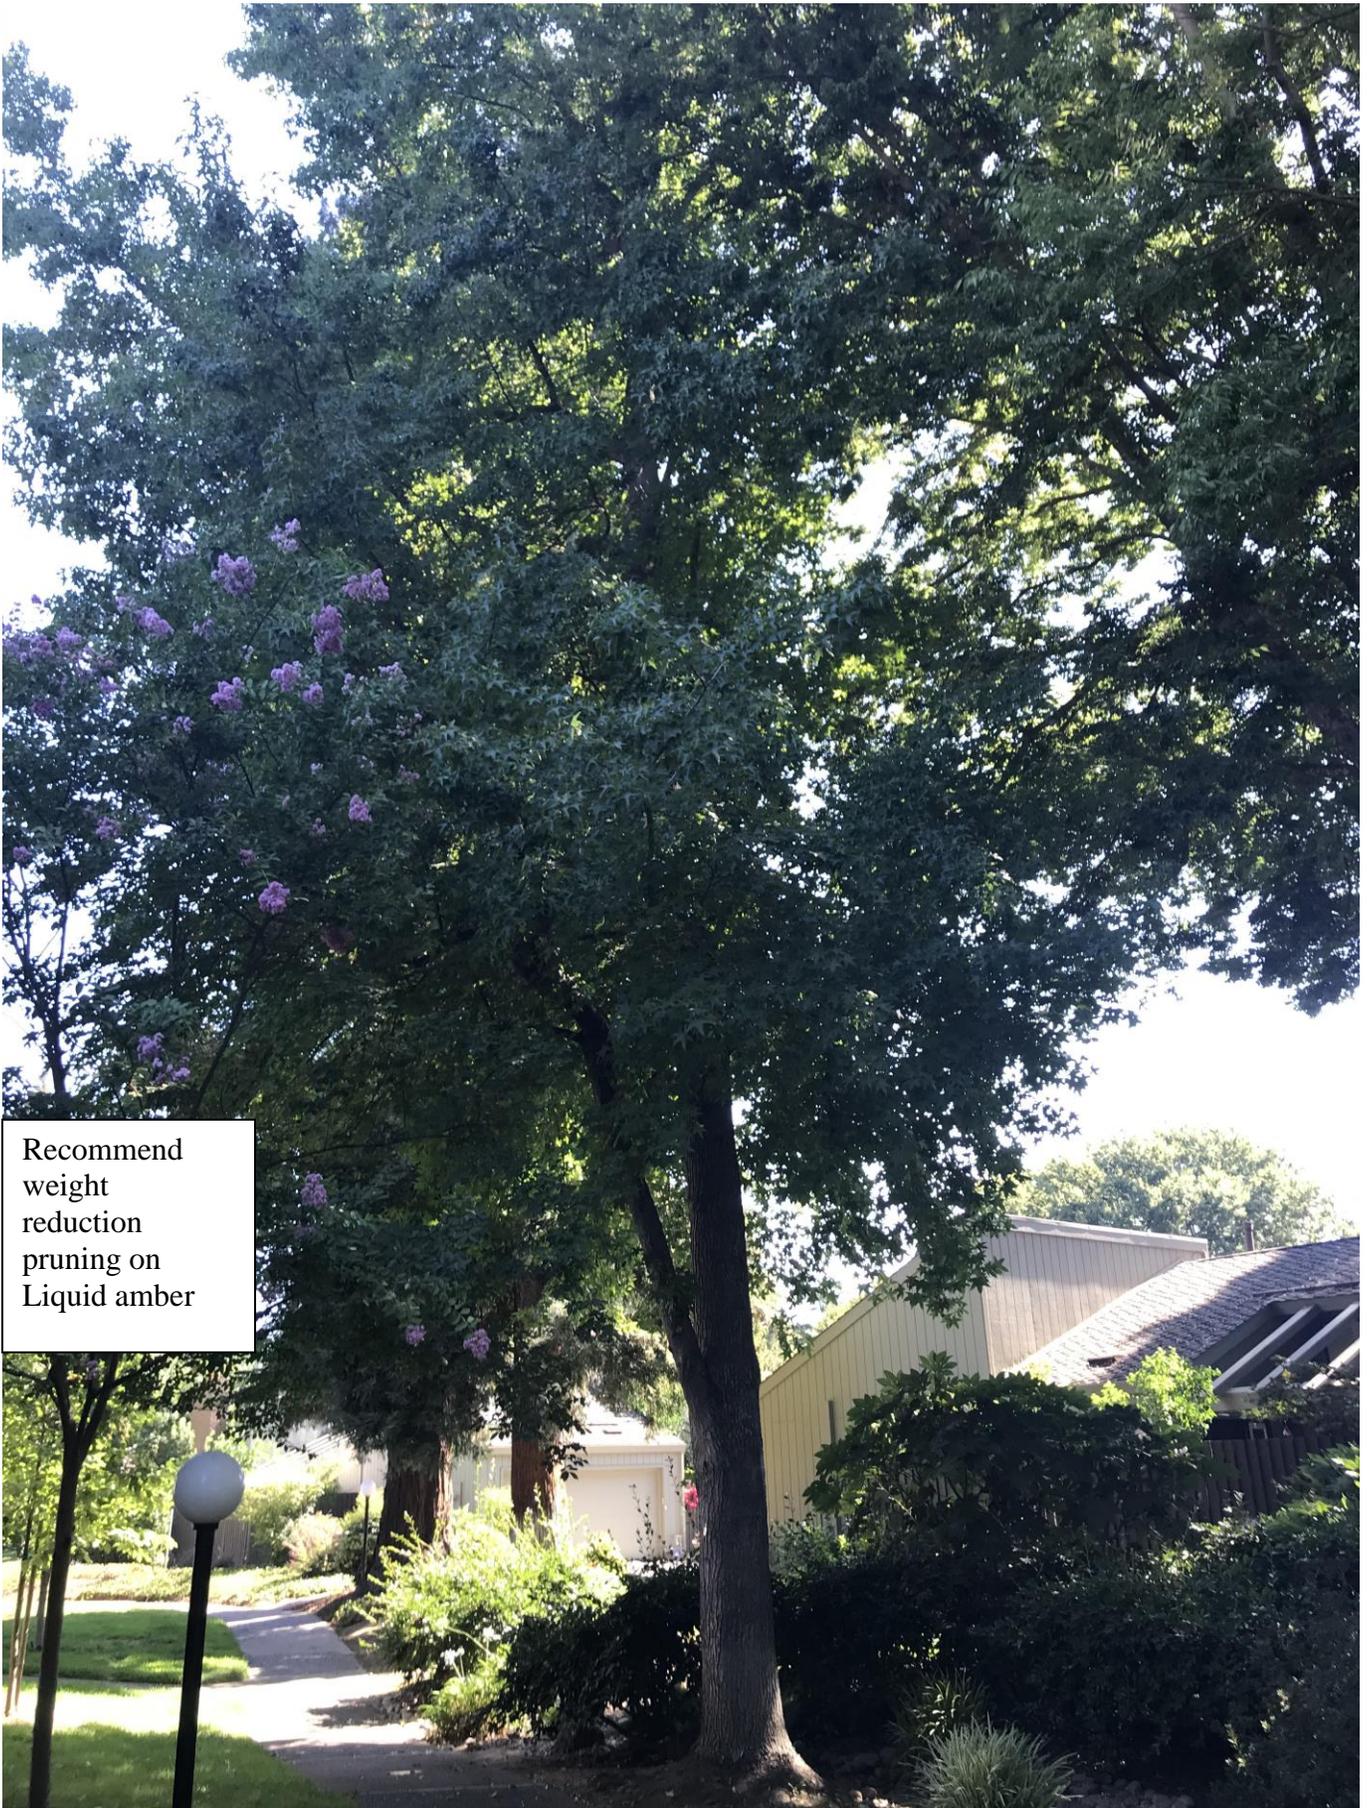
Figure 24

- (Zone 3) Trees #684 Sweet Gum (*Liquidambar styraciflua*), #686 Zelcova (*Zelcova serrata*), #687 Tulip tree (*Liriodendron tulipifera*) 1113 Dunbarton Circle (Figure 24-25). The trees canopy are full and heavy I recommend weight reduction pruning. On tree #686 Zelcova (*Zelcova serrata*) I recommend selective limbs to be removed due to recent failure.

Recommend  
weight  
reduction  
pruning on  
Liquid amber

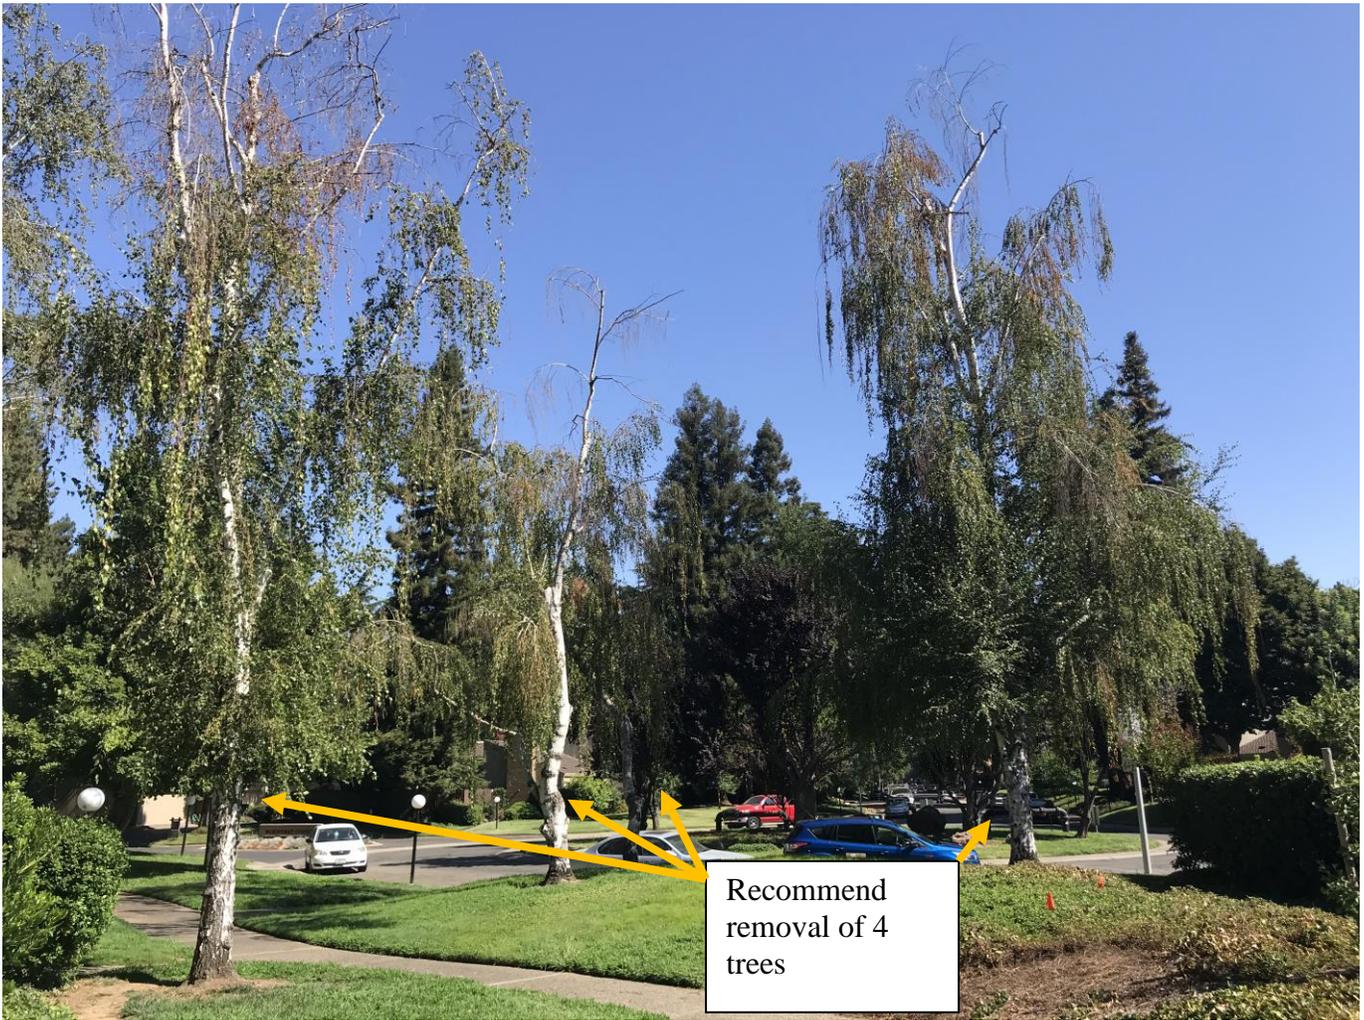
Figure 26

- (Zone 3) Trees #676, #677, #679, #1703 White Birch (*Betula pendula*), next to 1433 Commons. (Figure 26). The trees in this location are in decline, there is noticeable decline of the canopy in all these trees believe decline will continue I recommend the trees removal and a replacement of a suitable variety

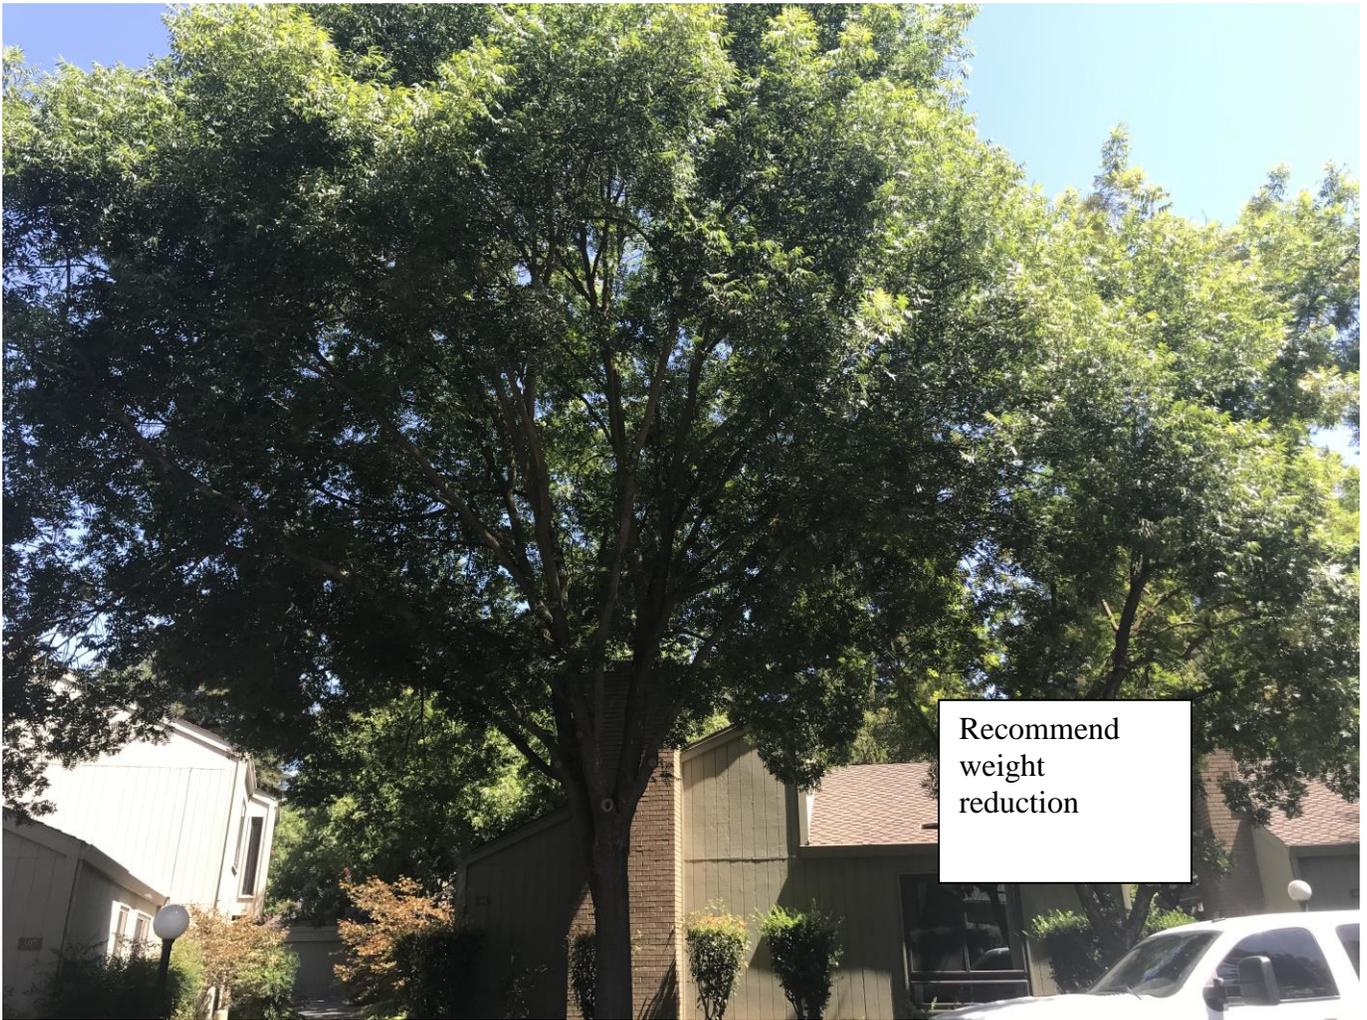
Figure 27

- (Zone 3) Tree #960, Chinese pistache (*Pistacia chinensis*), next to 401 Dunbarton Circle. (Figure 27-28). The tree has a pronounced inclusion in the main branching to reduce failure risk since the trees canopy is full and heavy I recommend weight reduction pruning.

Recommend  
weight  
reduction

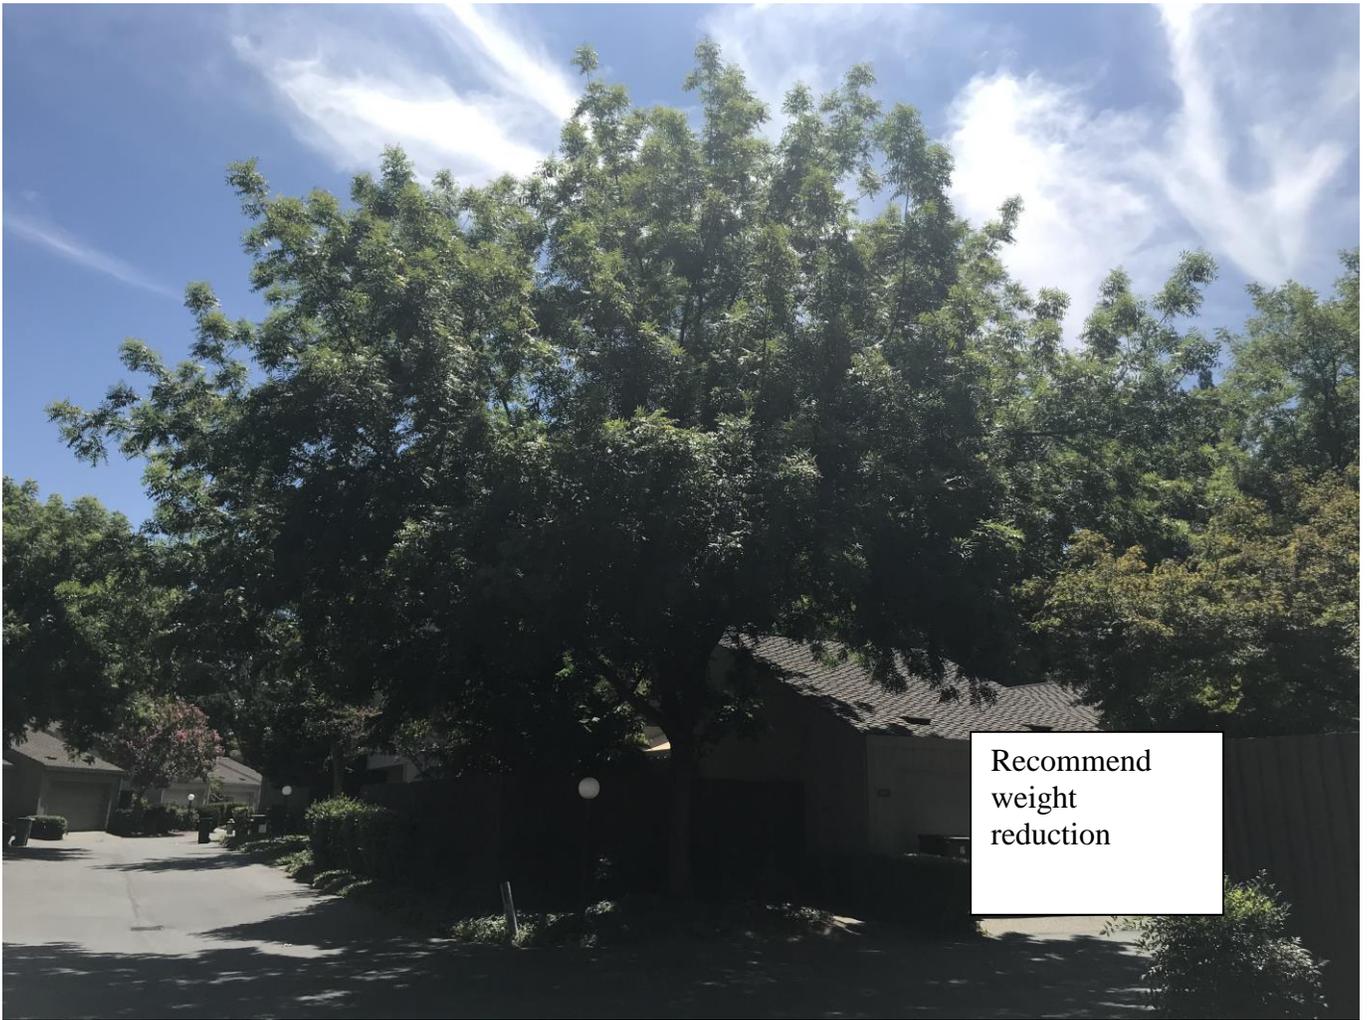
Figure 29

- (Zone 3) Tree #958, Chinese pistache (*Pistacia chinensis*), next to 305 Dunbarton Circle. (Figure 29). The tree canopy is full and heavy I recommend weight reduction pruning.

Recommend  
weight  
reduction

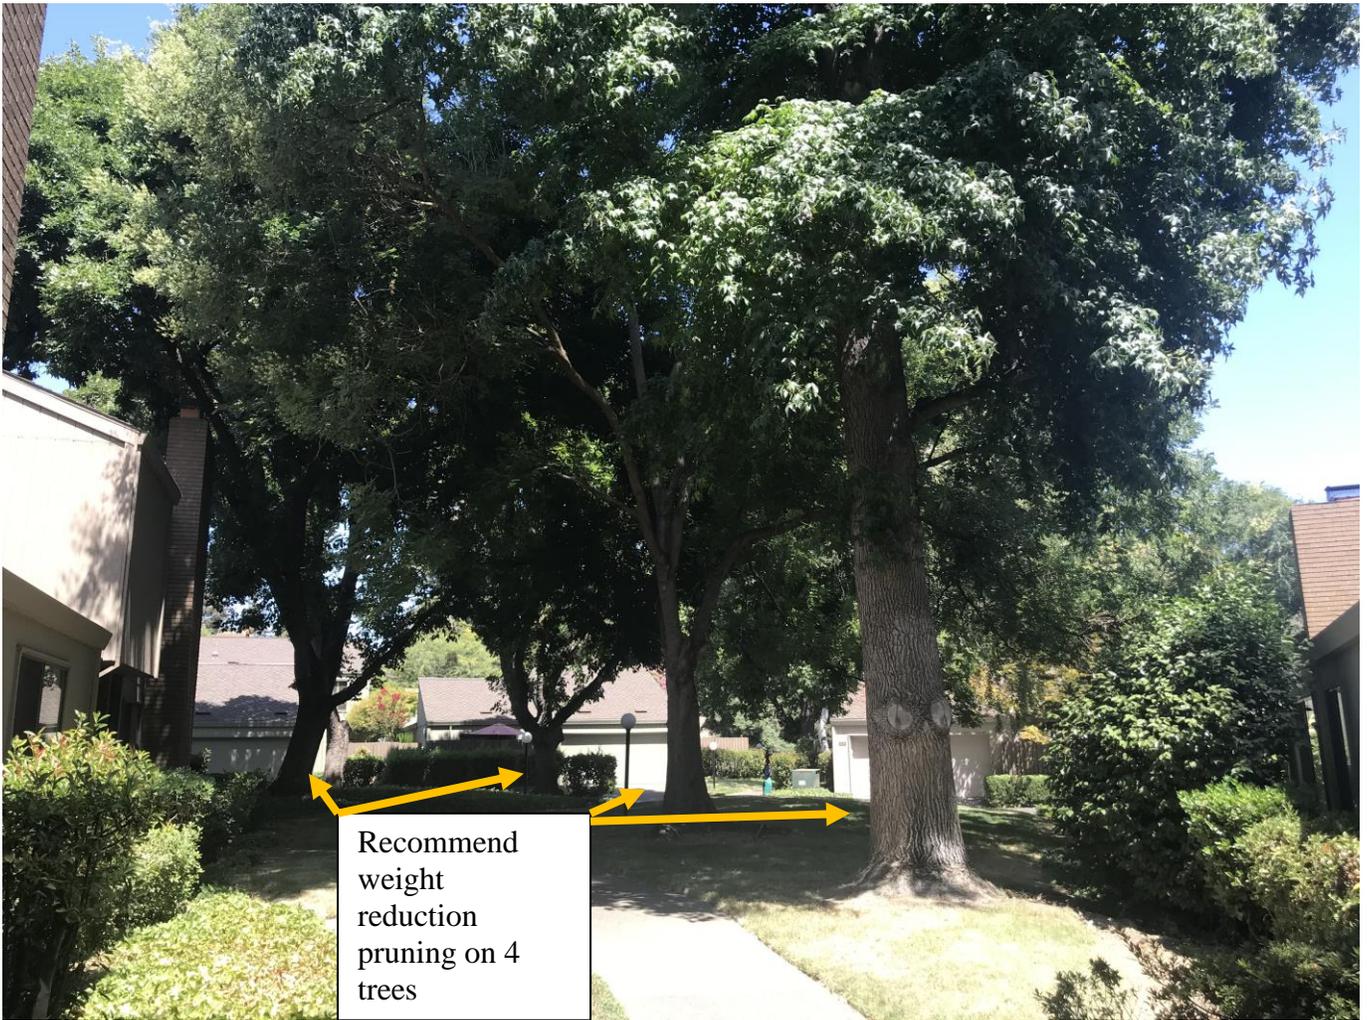
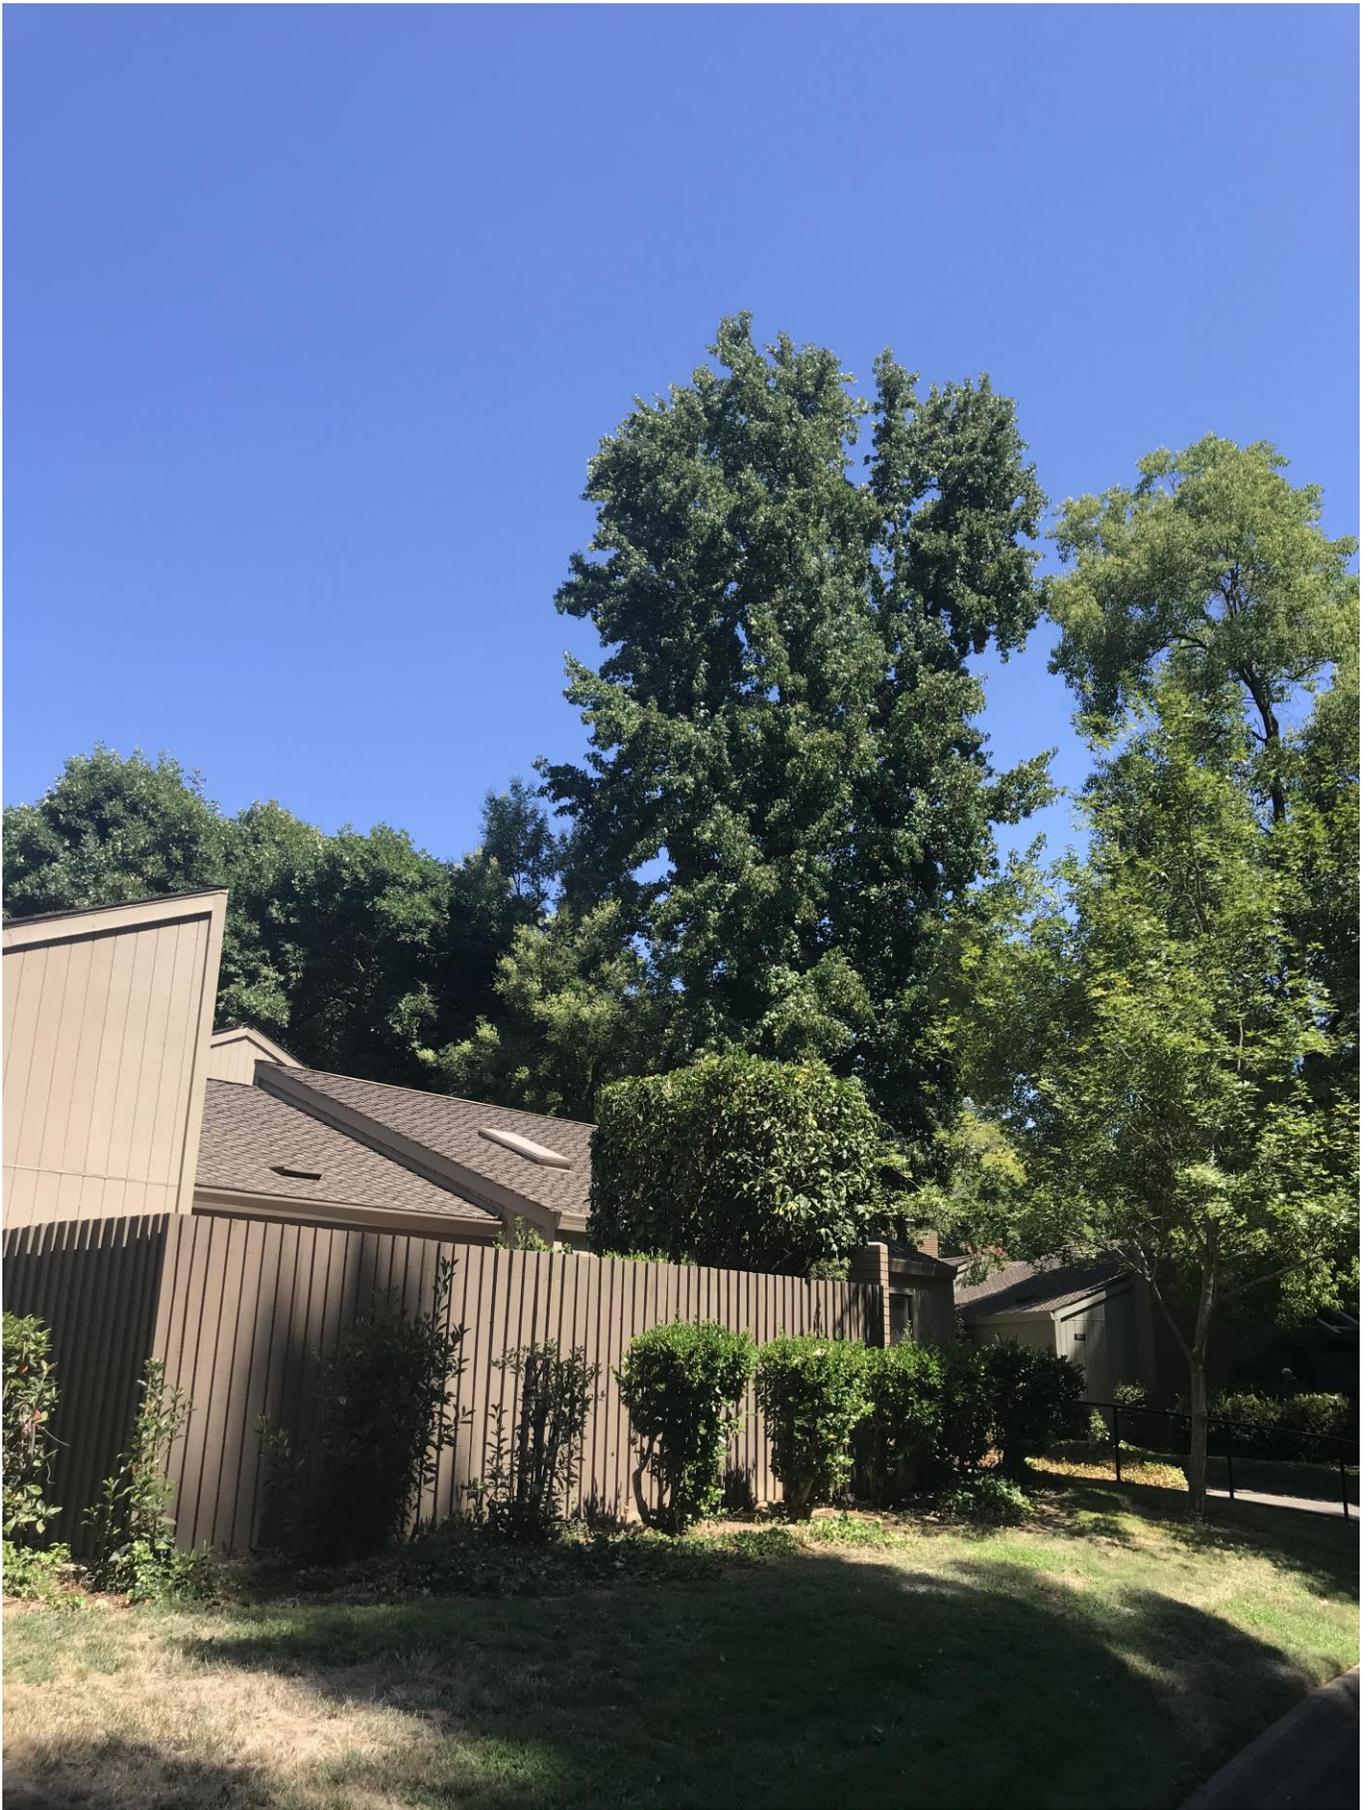
- (Zone 3) Trees #942, #941 Ash (*Fraxinus angustifolia*), #940 Goldfinch Rain (*Koeleria paniculata*), #939 Sweet Gum (*Liquidambar styraciflua*), Trees in Greenbelt near 205 Dunbarton Circle (Figure 30-31). The tree's canopies appear full and heavy I recommend weight reduction pruning.

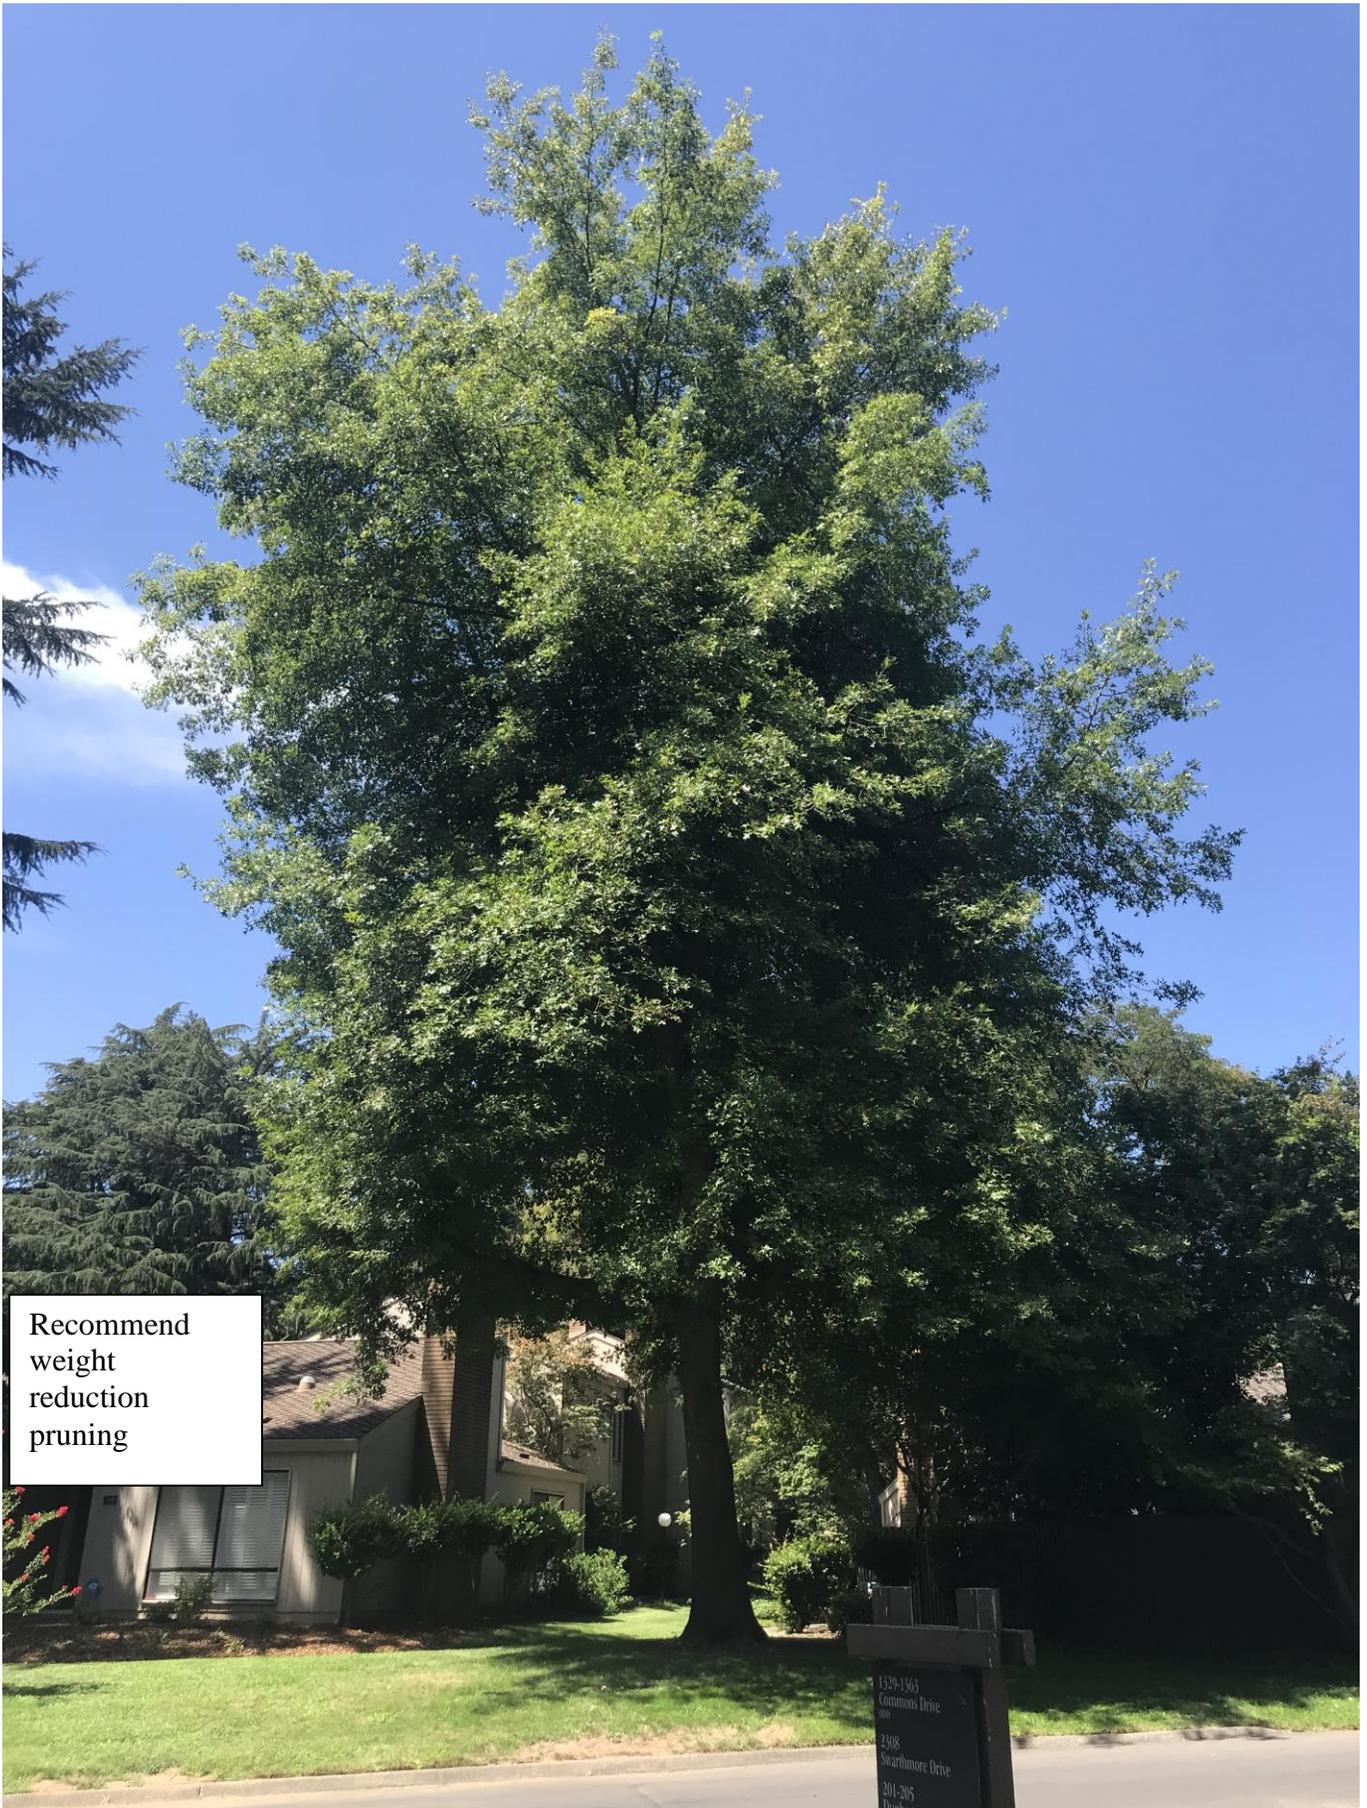
Figure 32

- (Zone 3) Tree # Tag, Red Oak (*Quercus rubra*), 109 Dunbarton Circle. (Figure 32). The tree canopy is full and heavy I recommend weight reduction pruning.

Recommend  
weight  
reduction  
pruning
