July 9, 2020

The Nepenthe Association
1131 Commons Dr.
Sacramento, CA 95825
Phone: (916) 929-8380
Email: Bettsi.Ledesma@fsresidential.com

On July 2, 2020, I inspected several trees on the Nepenthe property during the monthly tree walk. The focus of the walk was to address resident/management concerns regarding mature trees on the property. The purpose of this report is to develop mitigation plans for the following trees and my recommendations are below. My recommendations are based on a Basic Visual Inspection. All decisions made based on the recommendations of this report are at the discretion of the Nepenthe Association.

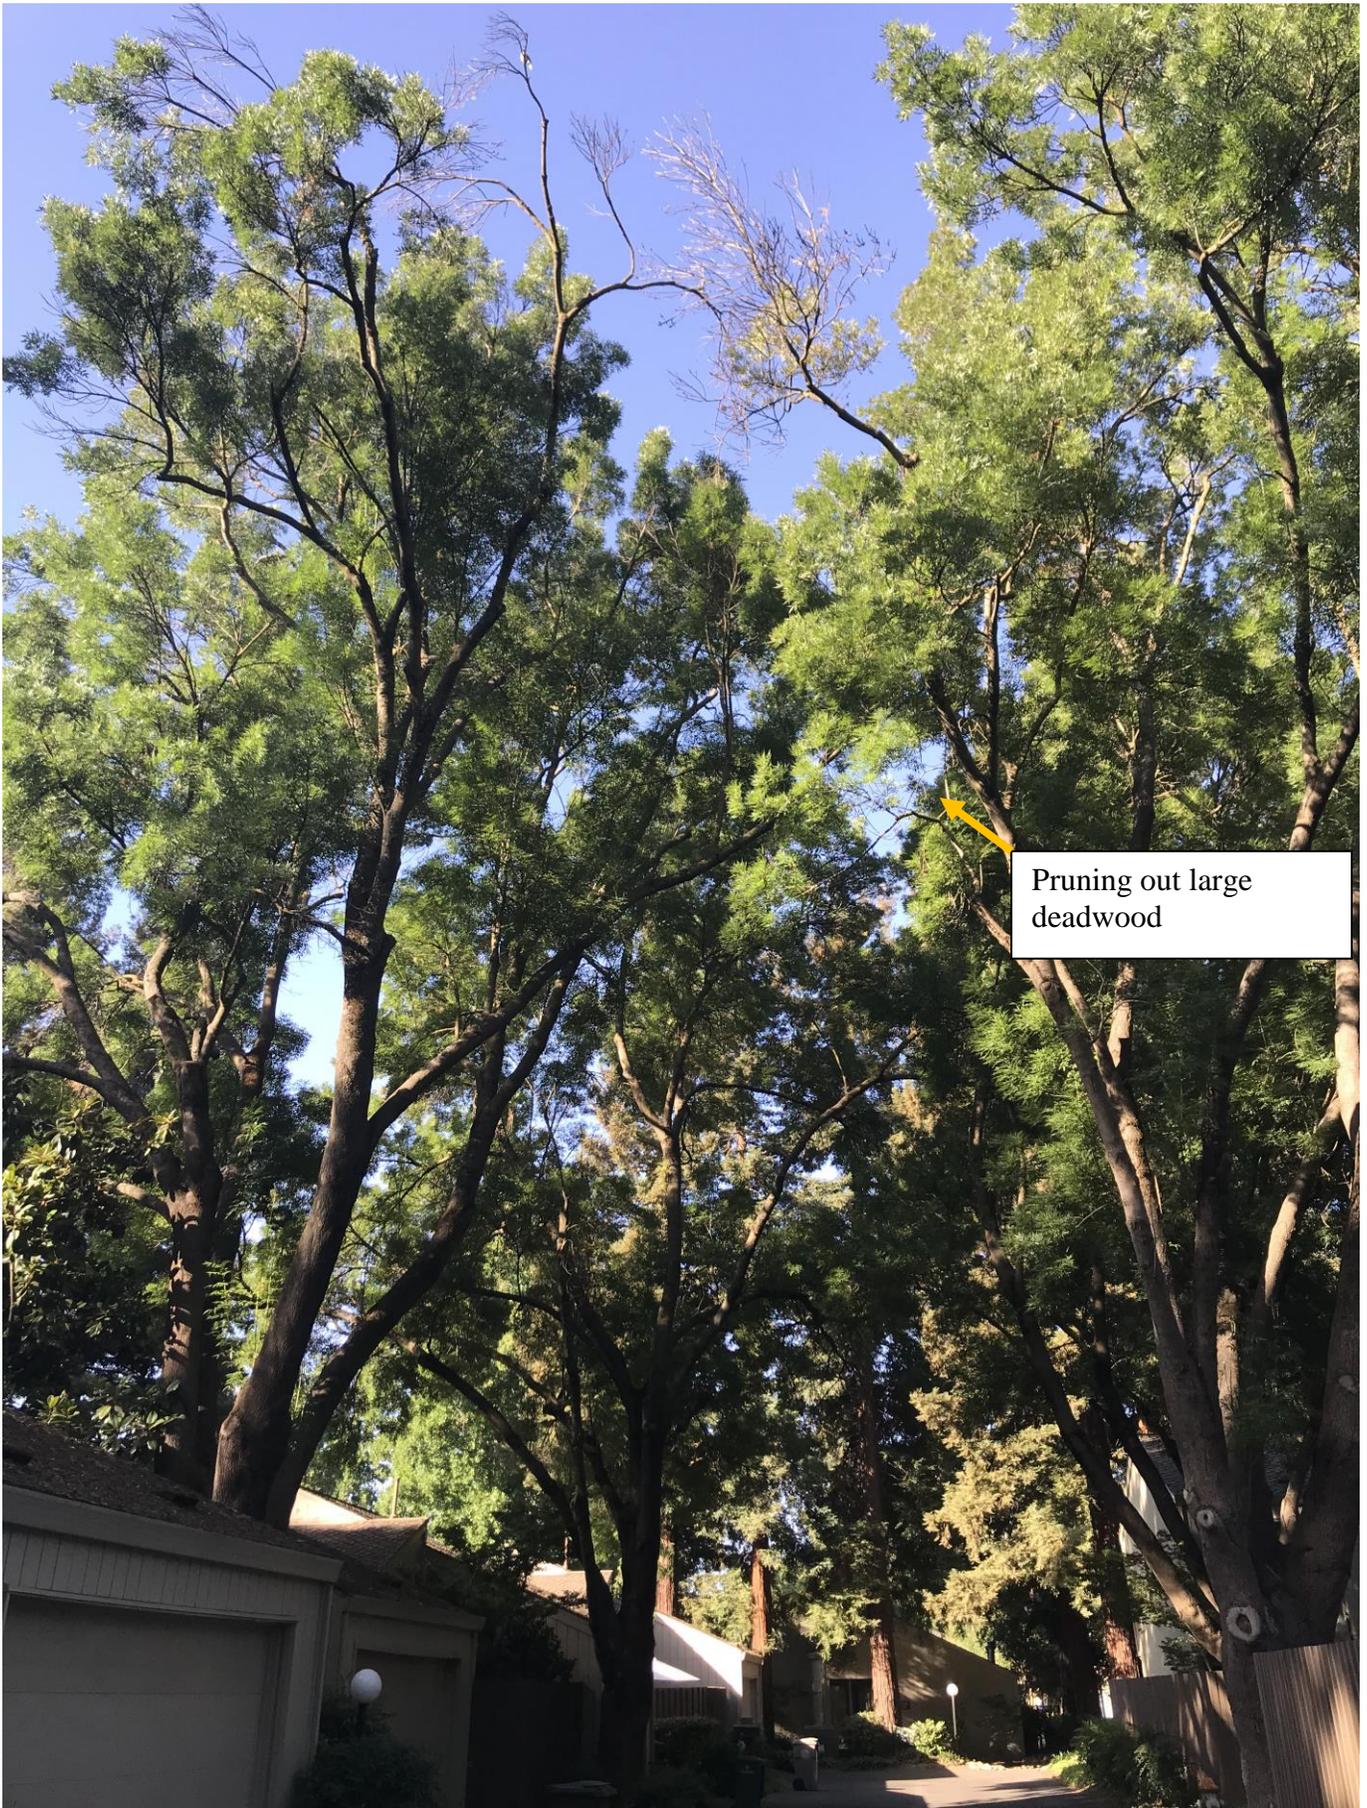
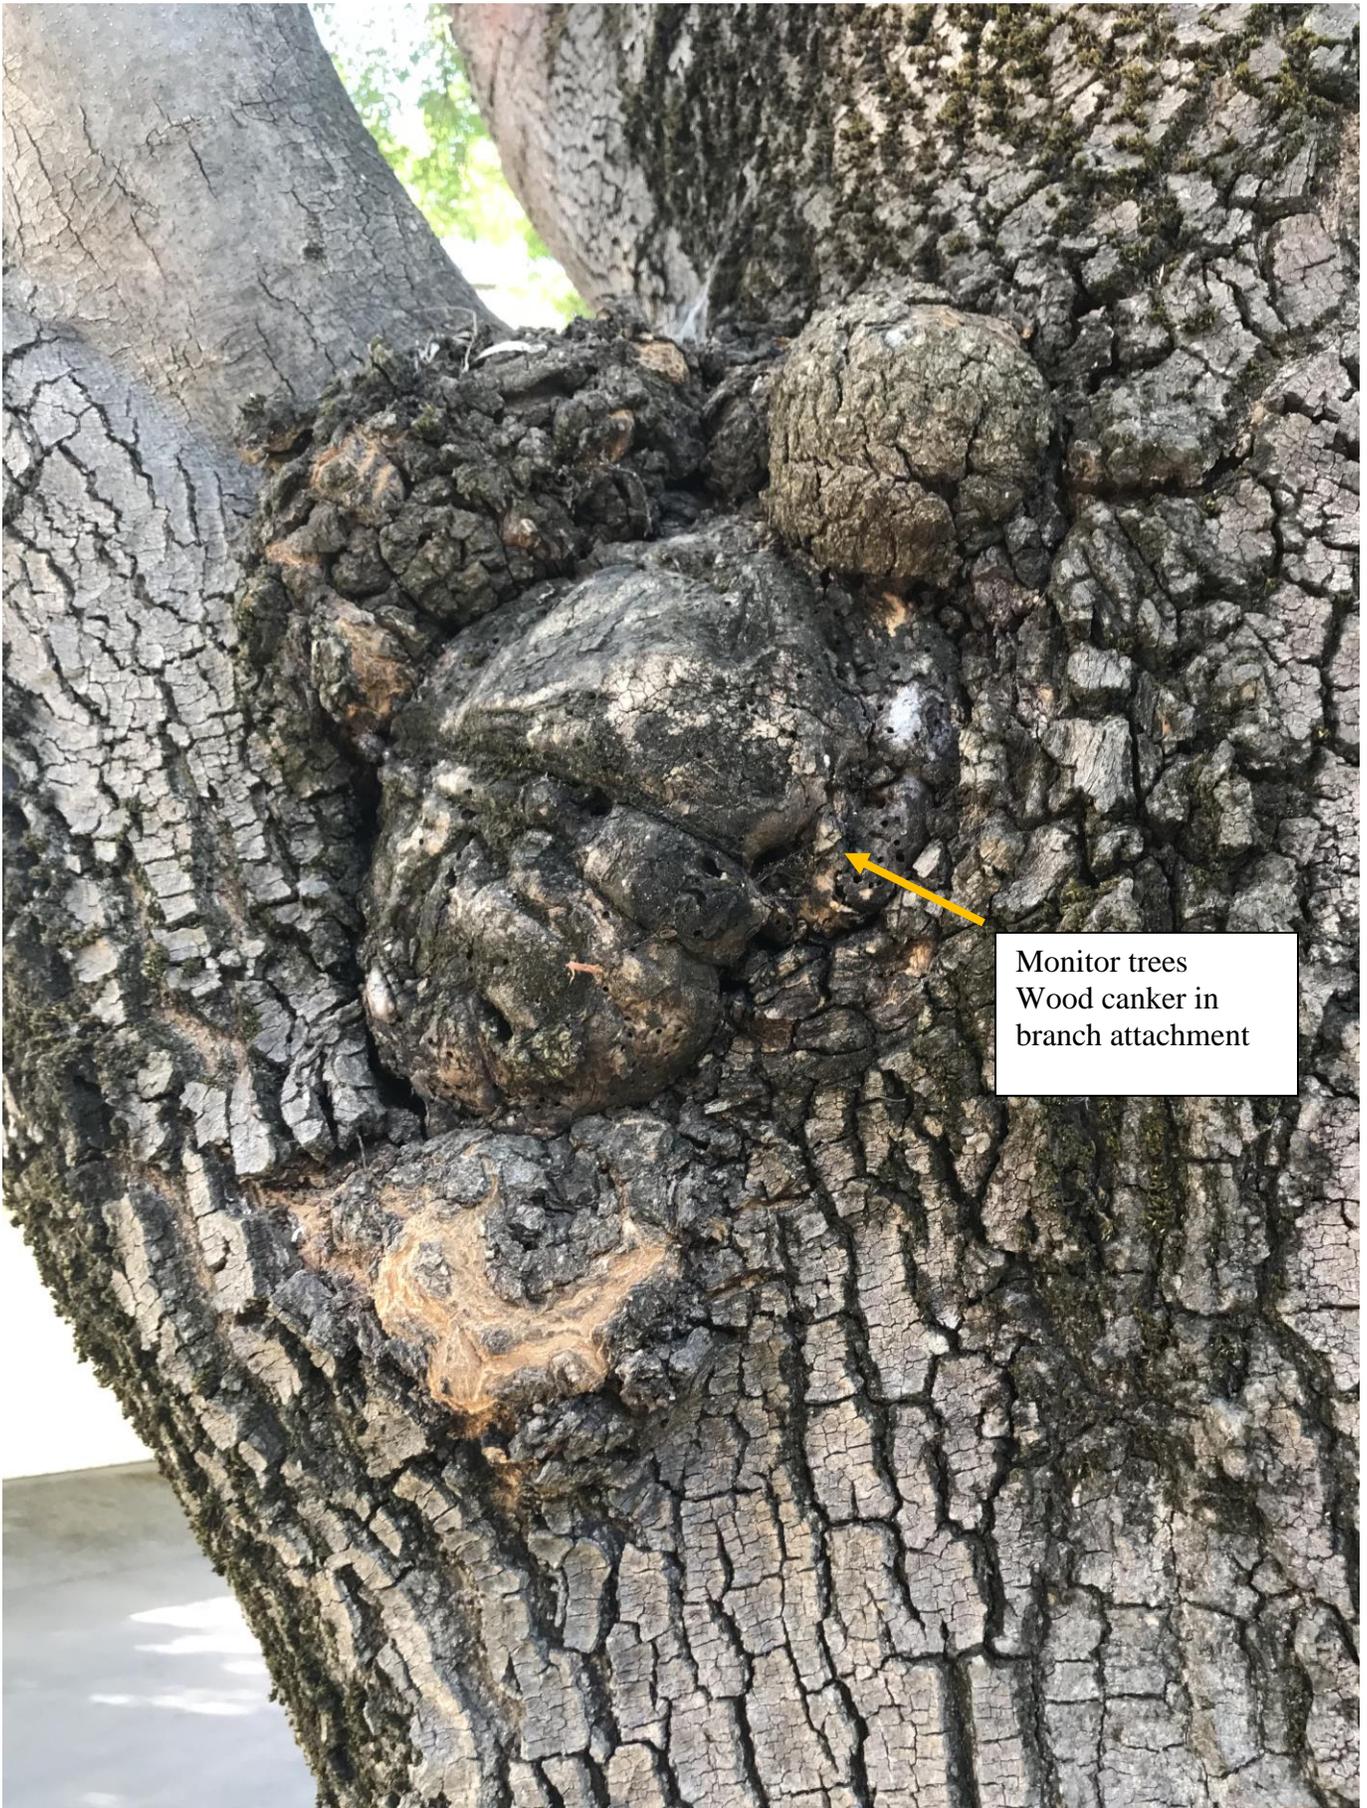
- (Zone 4) Trees #1198, #1204, #1199 Ash (*Fraxnis angustifolia*) 208,210,214 Dunbarton Circle. The trees were pruned for building clearance this past winter removing minor deadwood as well. Several of the trees have had recent large dieback in canopy. The deadwood is large enough that we will need to take extra caution in removing it. (Figure 1) I recommend cleaning the deadwood from the canopy. One of the trees in front of 202 Dunbatron has a large canker development in the main branching (Figure 2) the canker is formed by the trees response to seal off a bacterial issue and that forms the bulbous growth. We will continue to monitor this tree

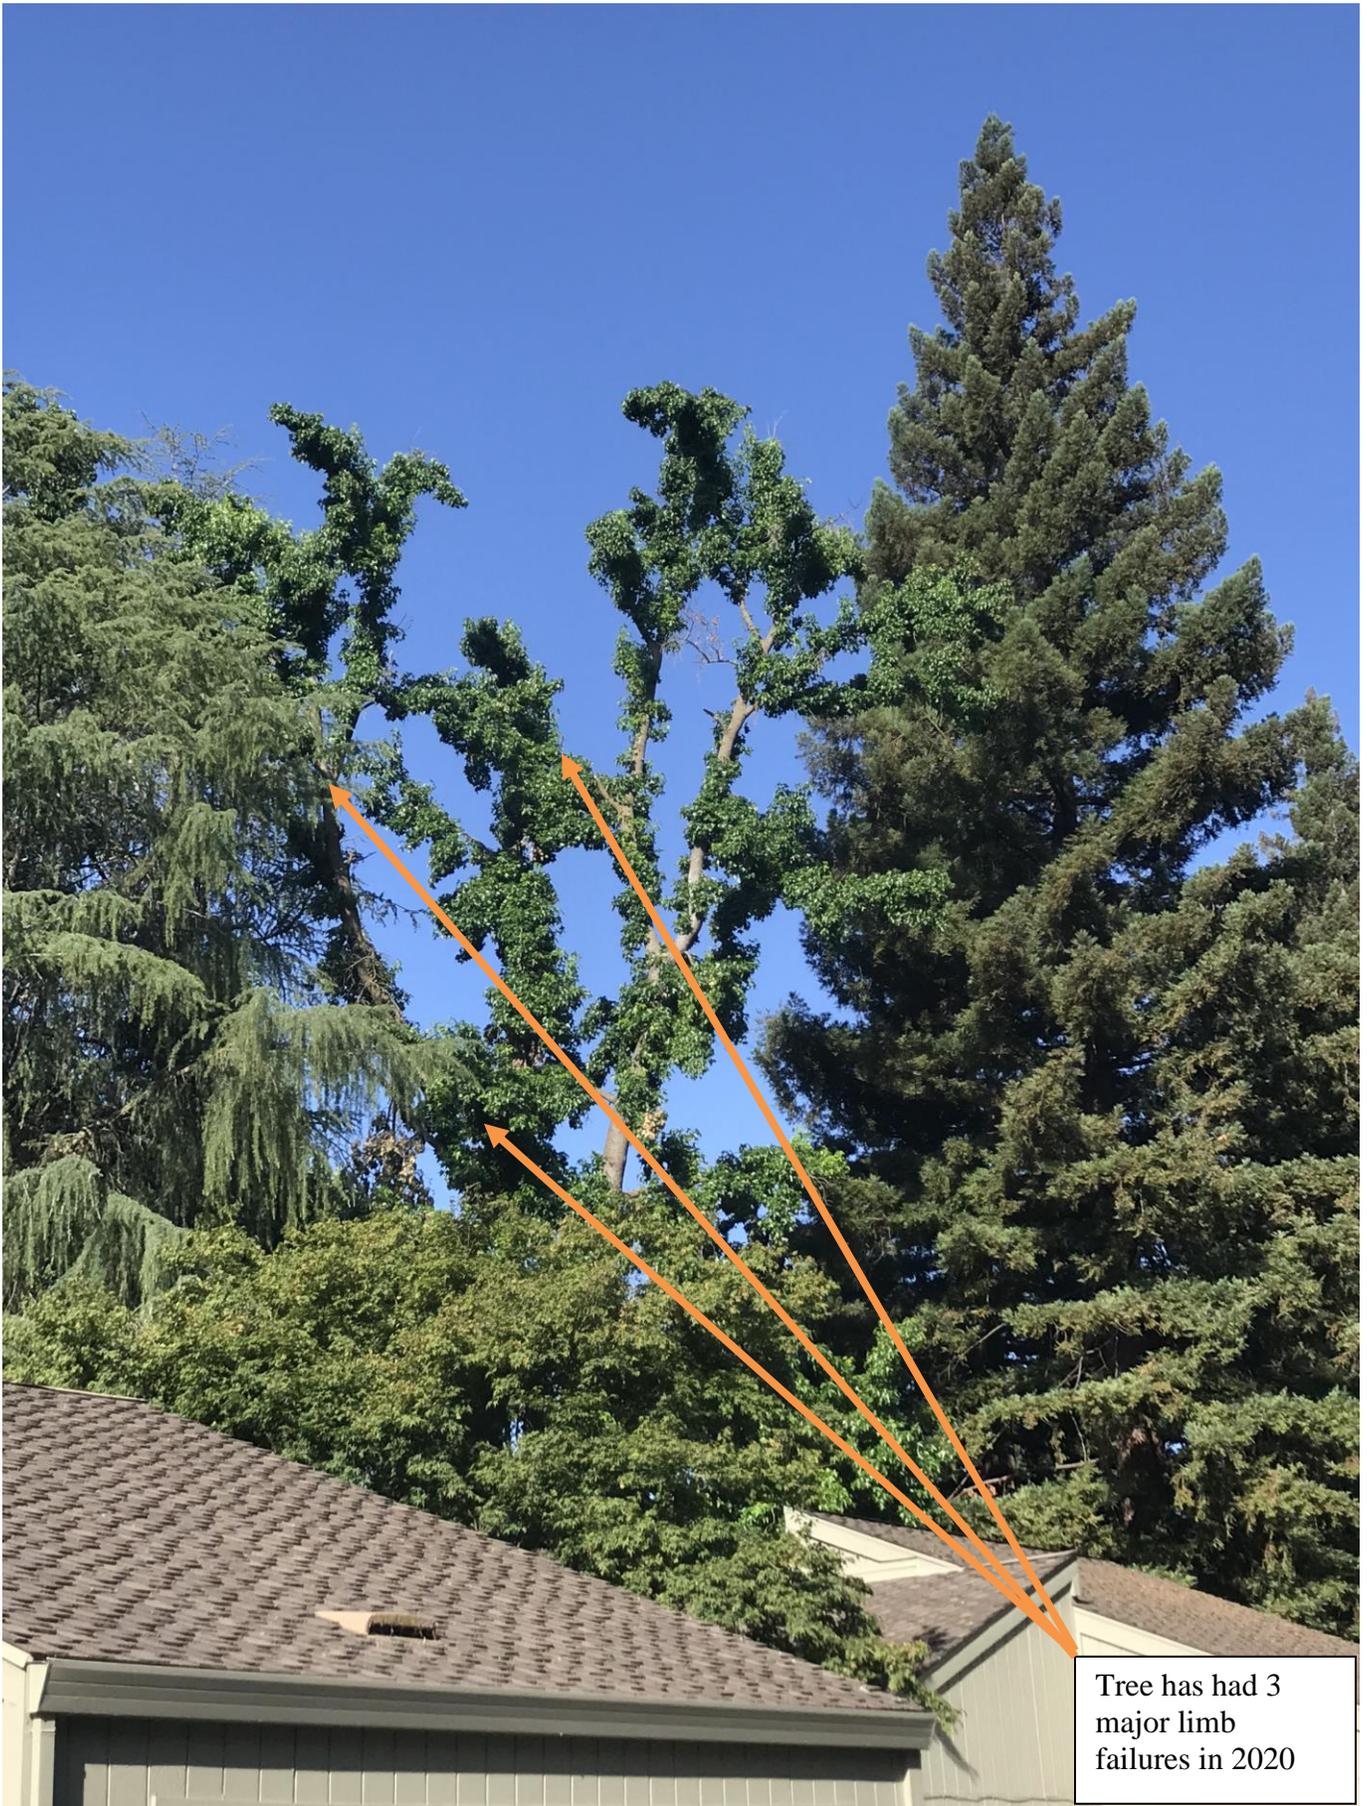
Figure 3

- (Zone 4) Tree #1248 Sweetgum (*Liquidambar styraciflua*), 510 Dunbarton Circle. Tree has been recently pruned in 2019 for weight reduction in hopes to mitigate against limb failure. However the tree did not respond well to the pruning and has had 3 major limb failure events on to or around the 510 property. Due to the existing structure, and after the most recent failures, this tree cannot be salvaged through additional pruning. With its long history of limb failure I recommend removal of the tree and a replacement of a suitable variety. (Figure 3).

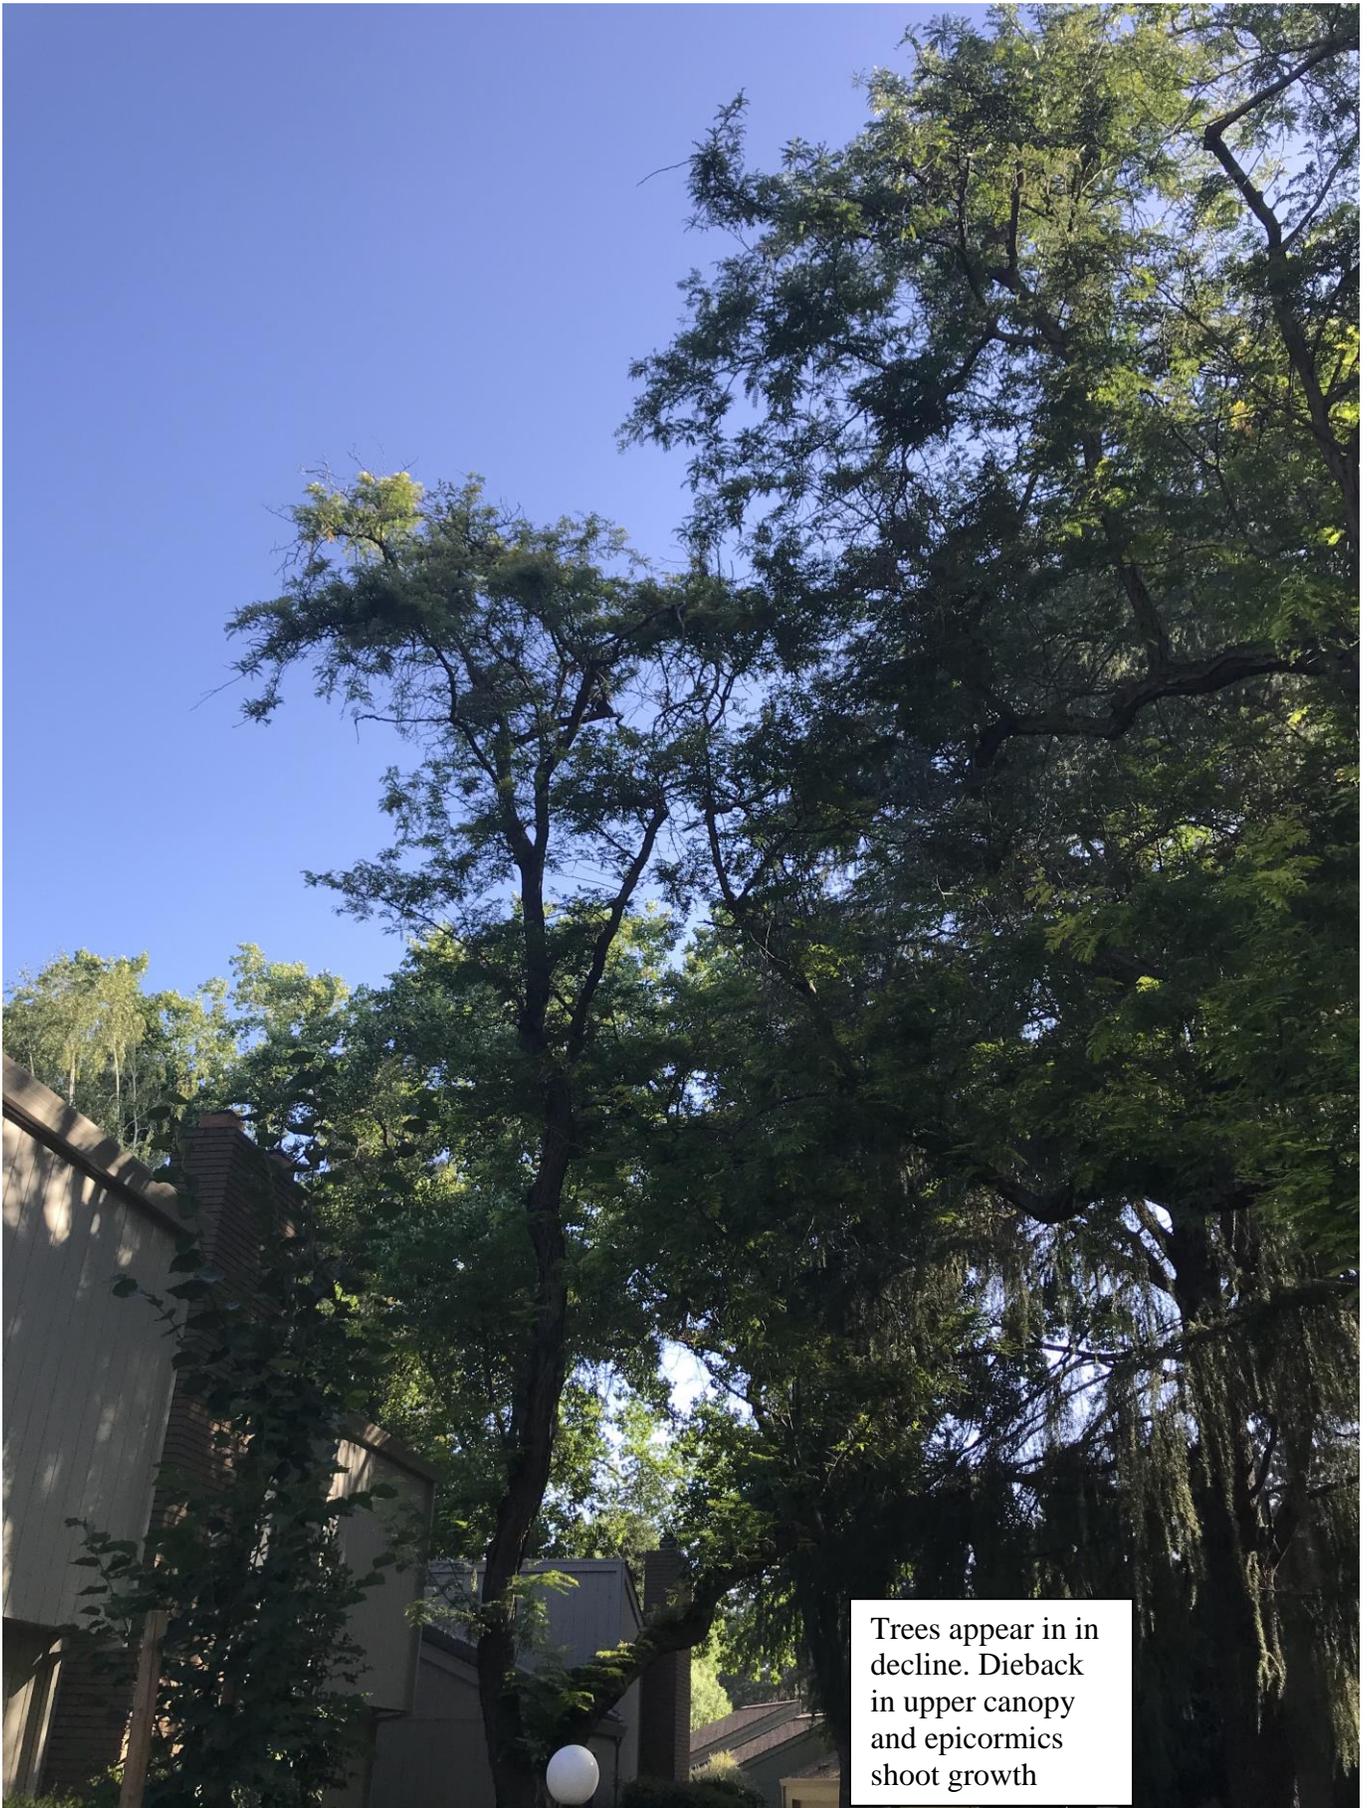
Figure 4

- (Zone 4) Tree #1193, #1194 Locust (*Robinia pseudoacacia*), next to 208 Dunbarton Circle. Both of the trees canopy are sparse with significant amount of dieback and both appears to be in decline. One of the trees has a large cavity in the main branching that has a noncable wood decay fungus growth (Figures 4-5). With the dieback in the canopy the trees also have epicormic sprout growth along the trunk and branching that is another sign of decline. I recommend the removal and a replacement of a suitable variety.

Trees appear in in decline. Dieback in upper canopy and epicormics shoot growth

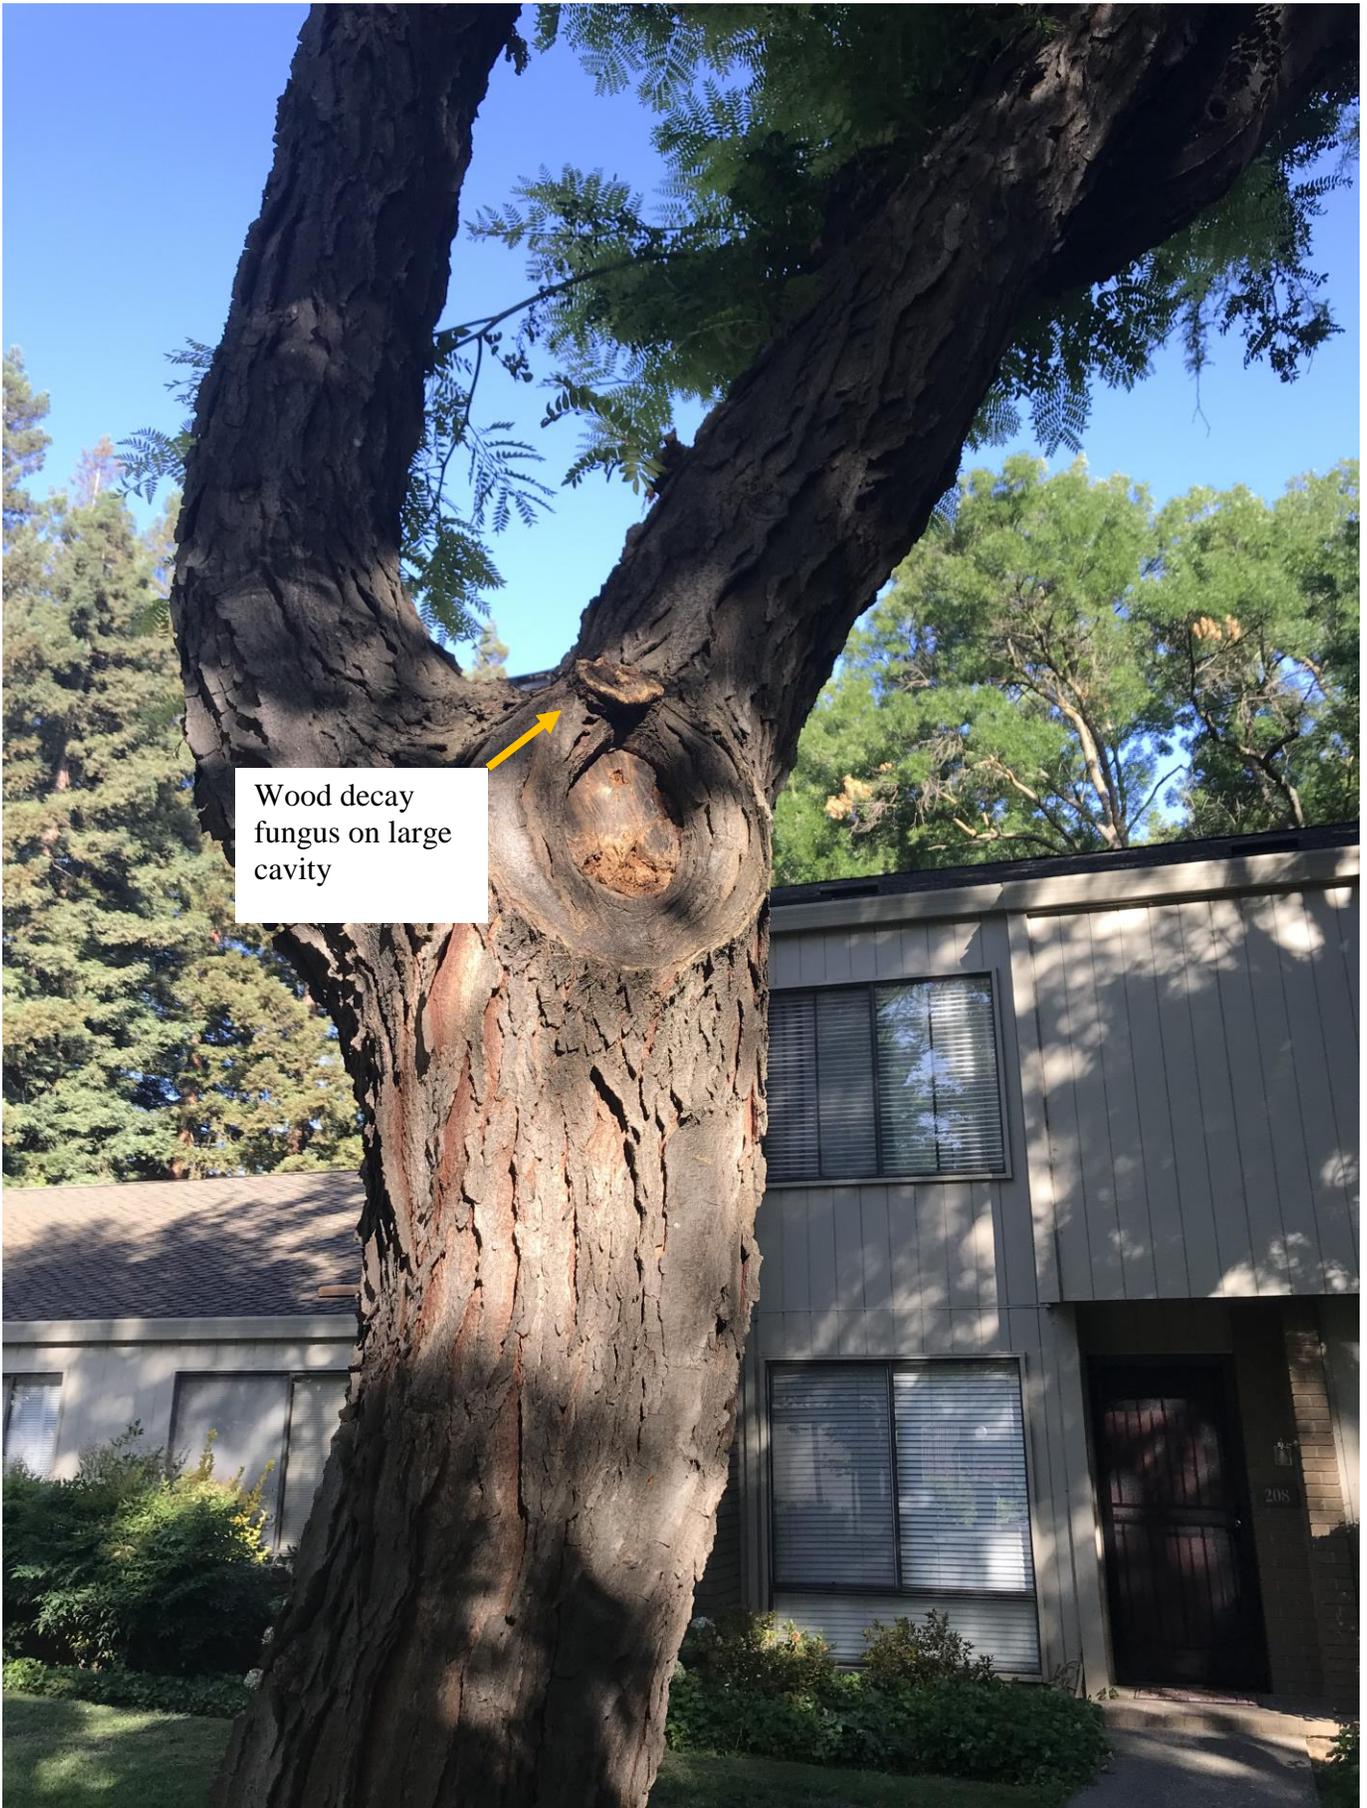
Figure 5

Wood decay
fungus on large
cavity

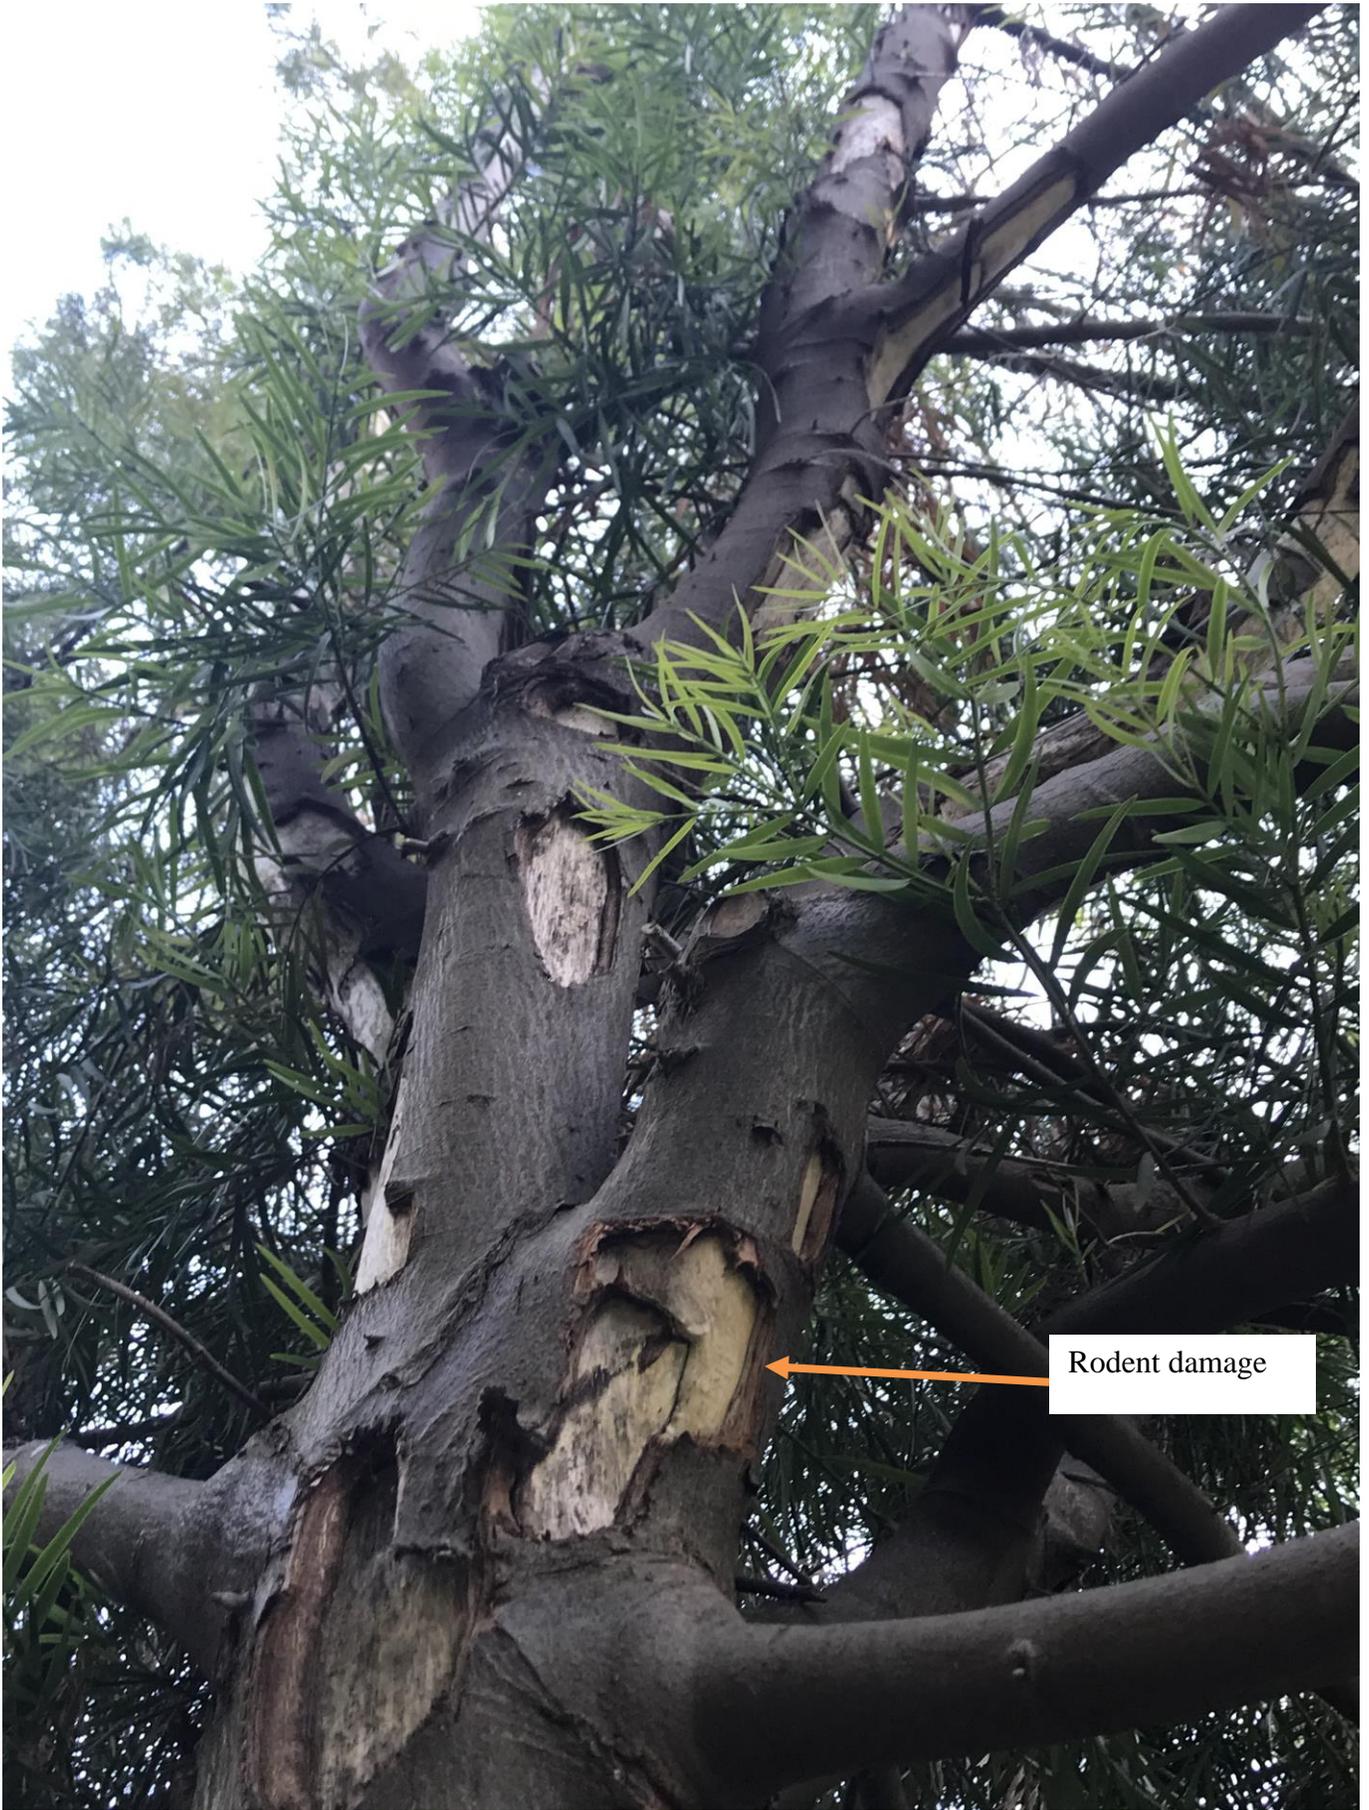
Figure 6

- (Zone 4) Trees #No Tag, Podocarpus (*Podocarpus neriifolius*), 308 Dunbarton Circle. Tree has sustained major damage due to rodents stripping bark. (Figure 6-7) I recommend removal.

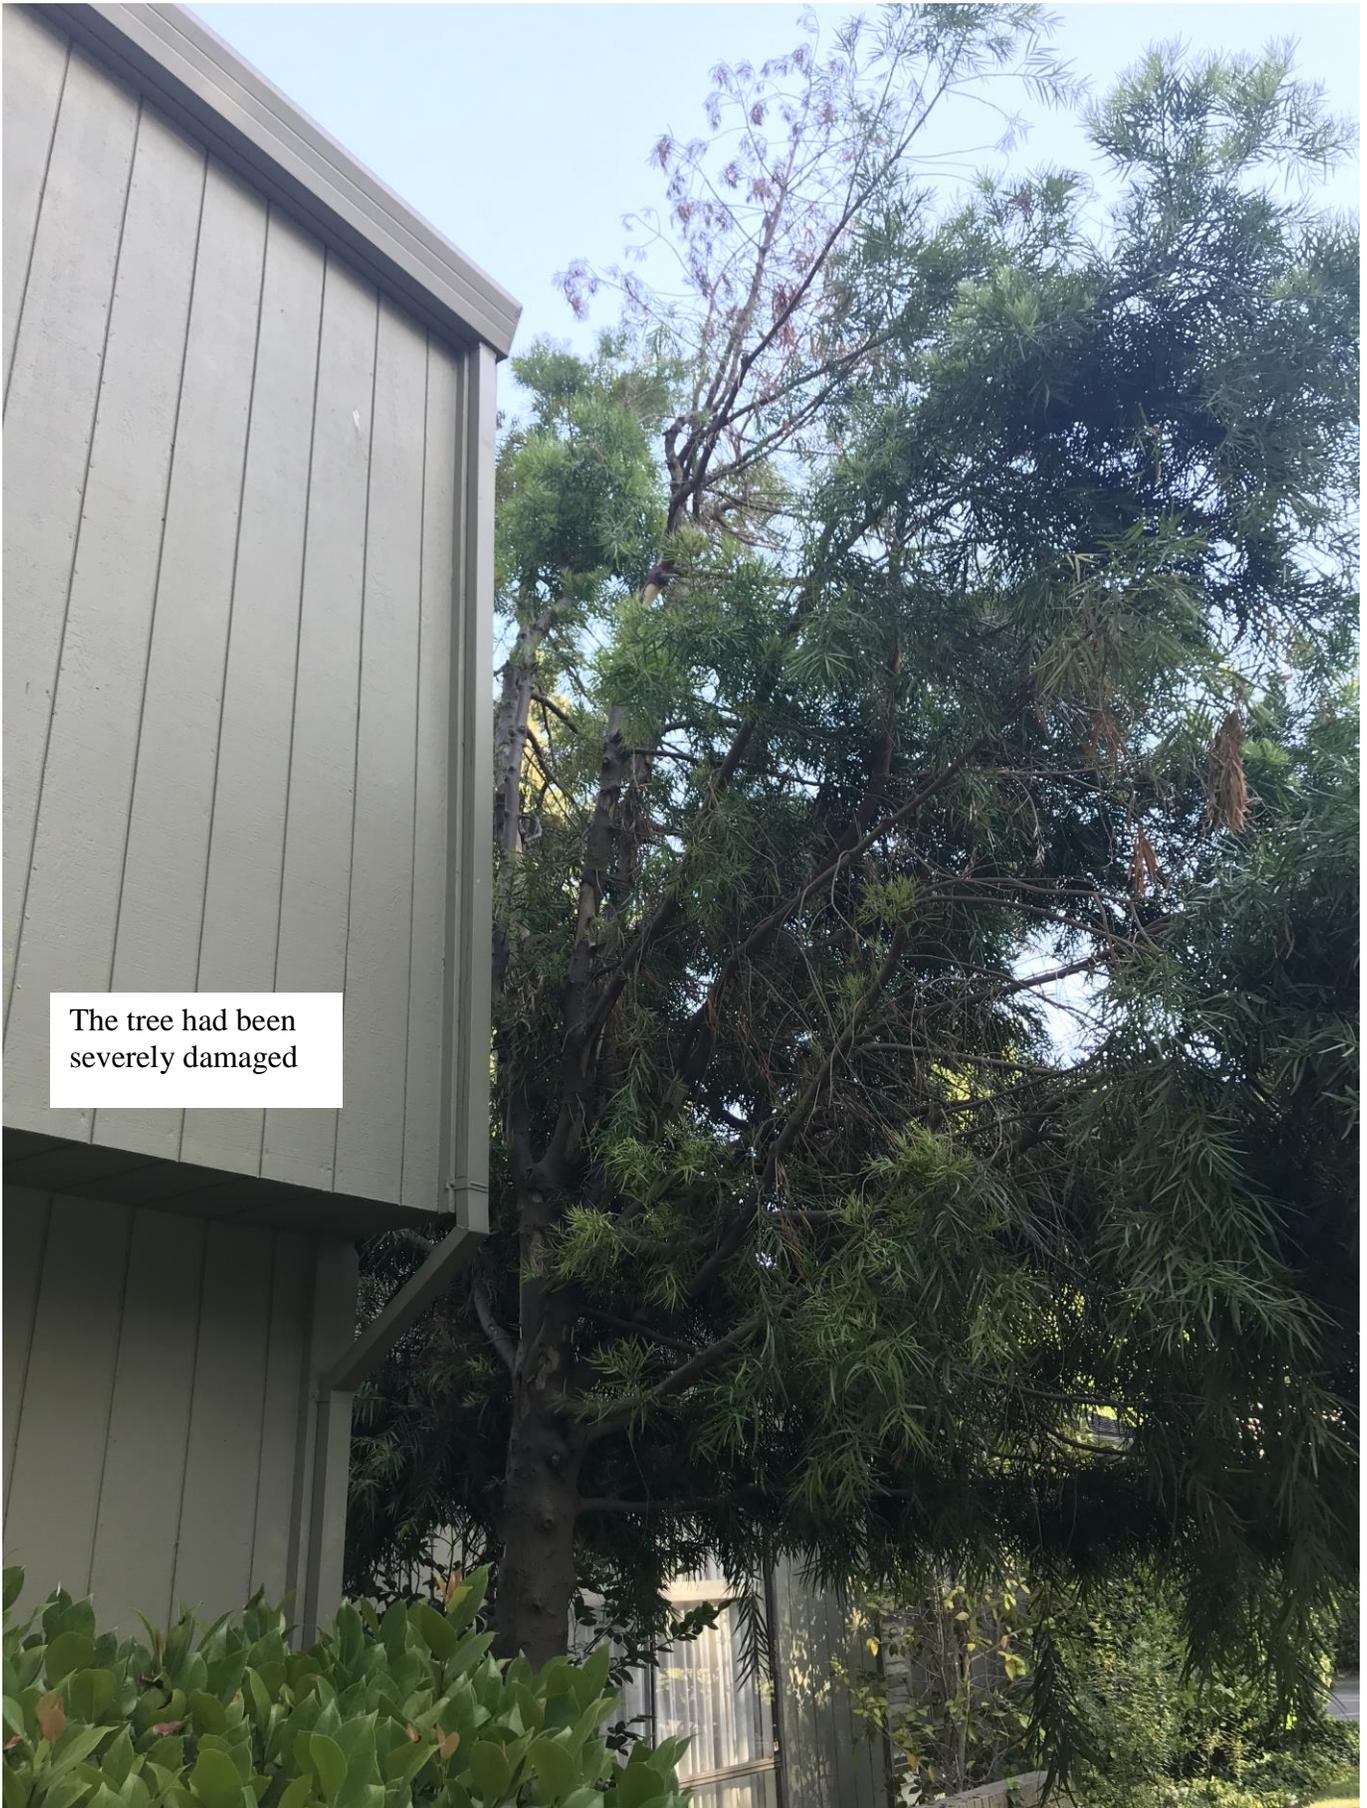
Figure 7

The tree had been severely damaged

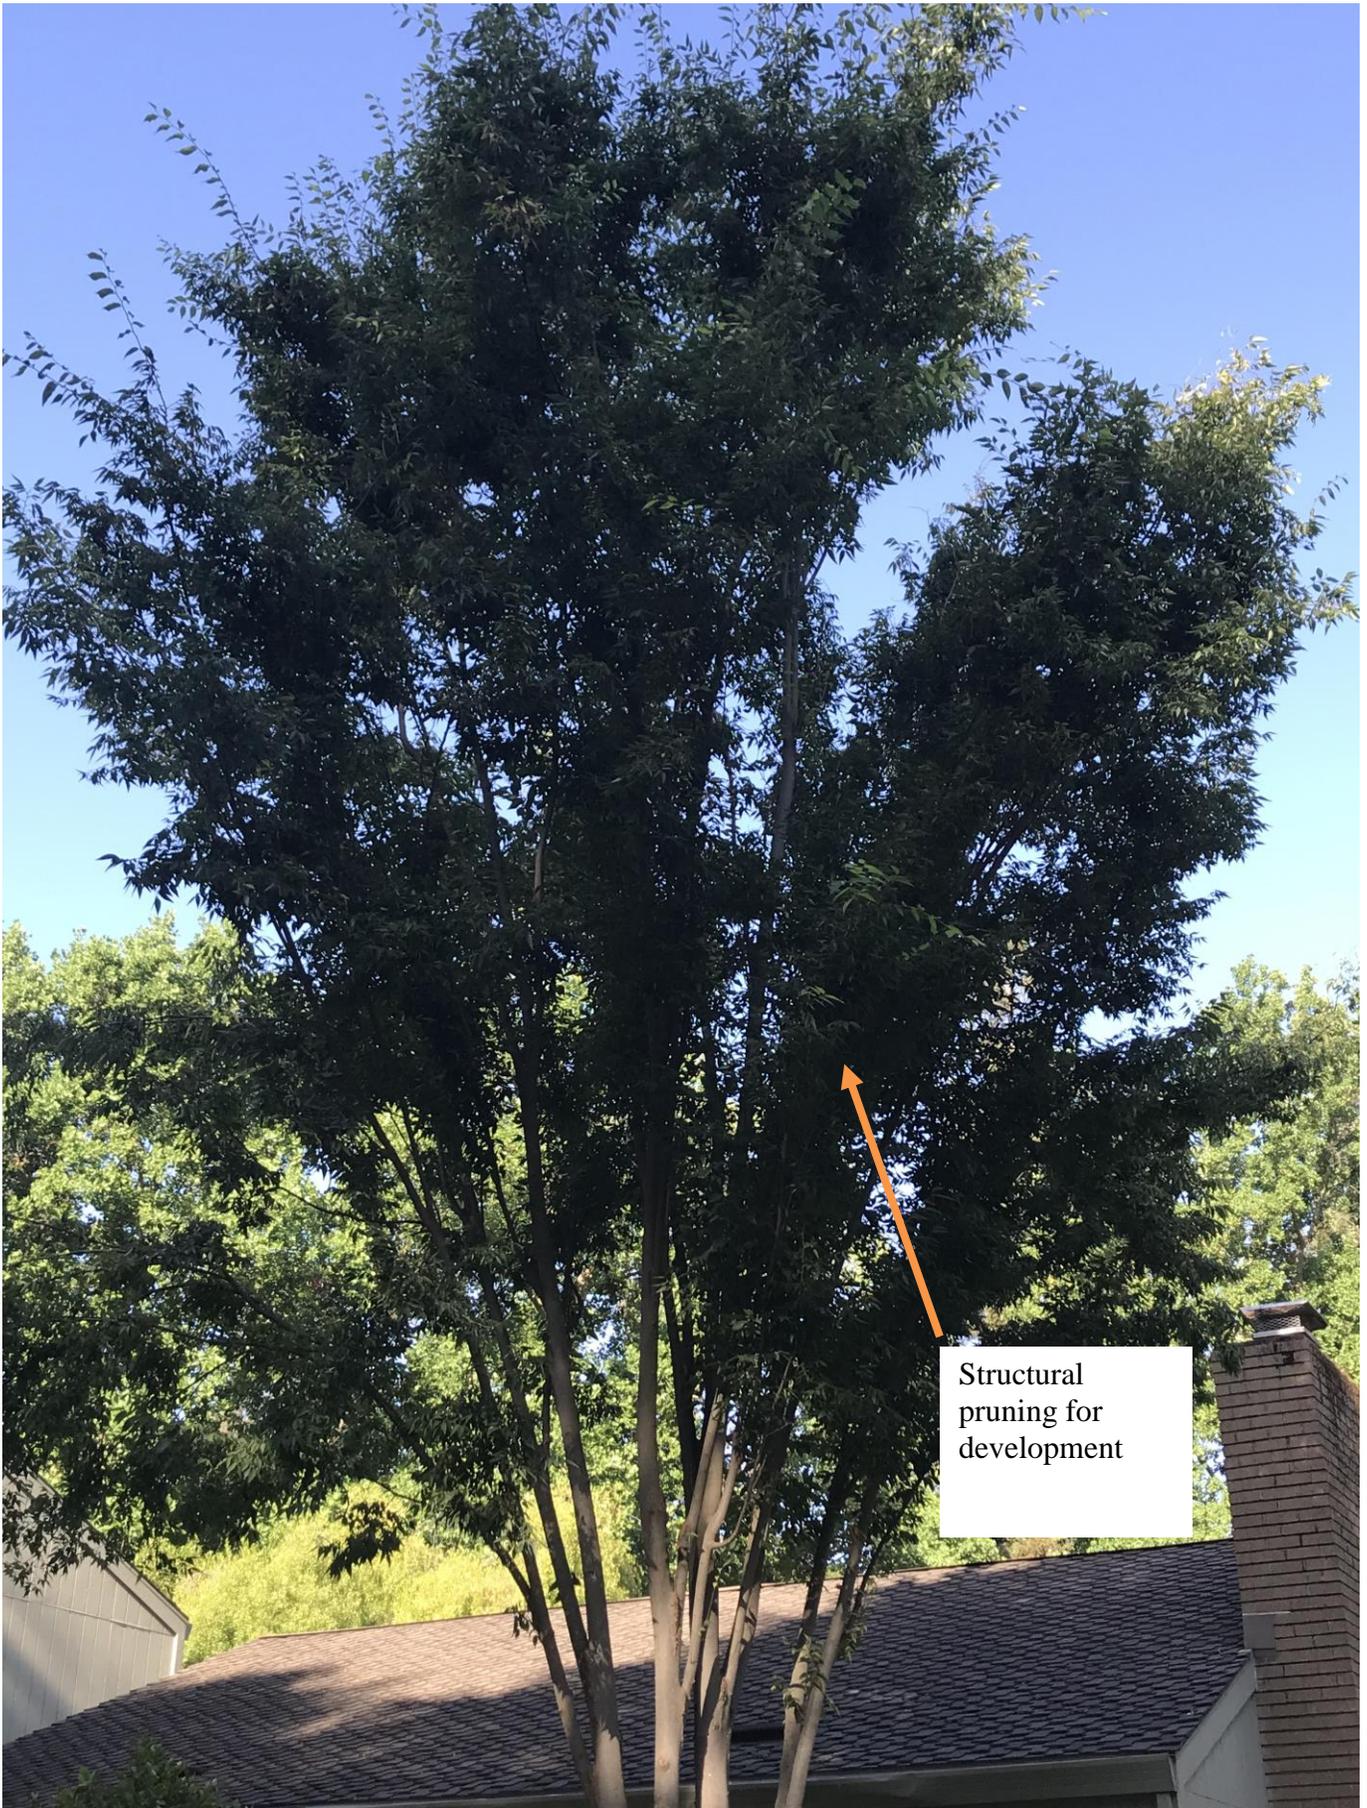
Figure 8

- (Zone 4) Tree #1215 Zelcova (*Zelcova serrata*), in front of 306 Dunbarton Circle. Young tree need structural pruning to encourage proper development. (Figure 8-9).

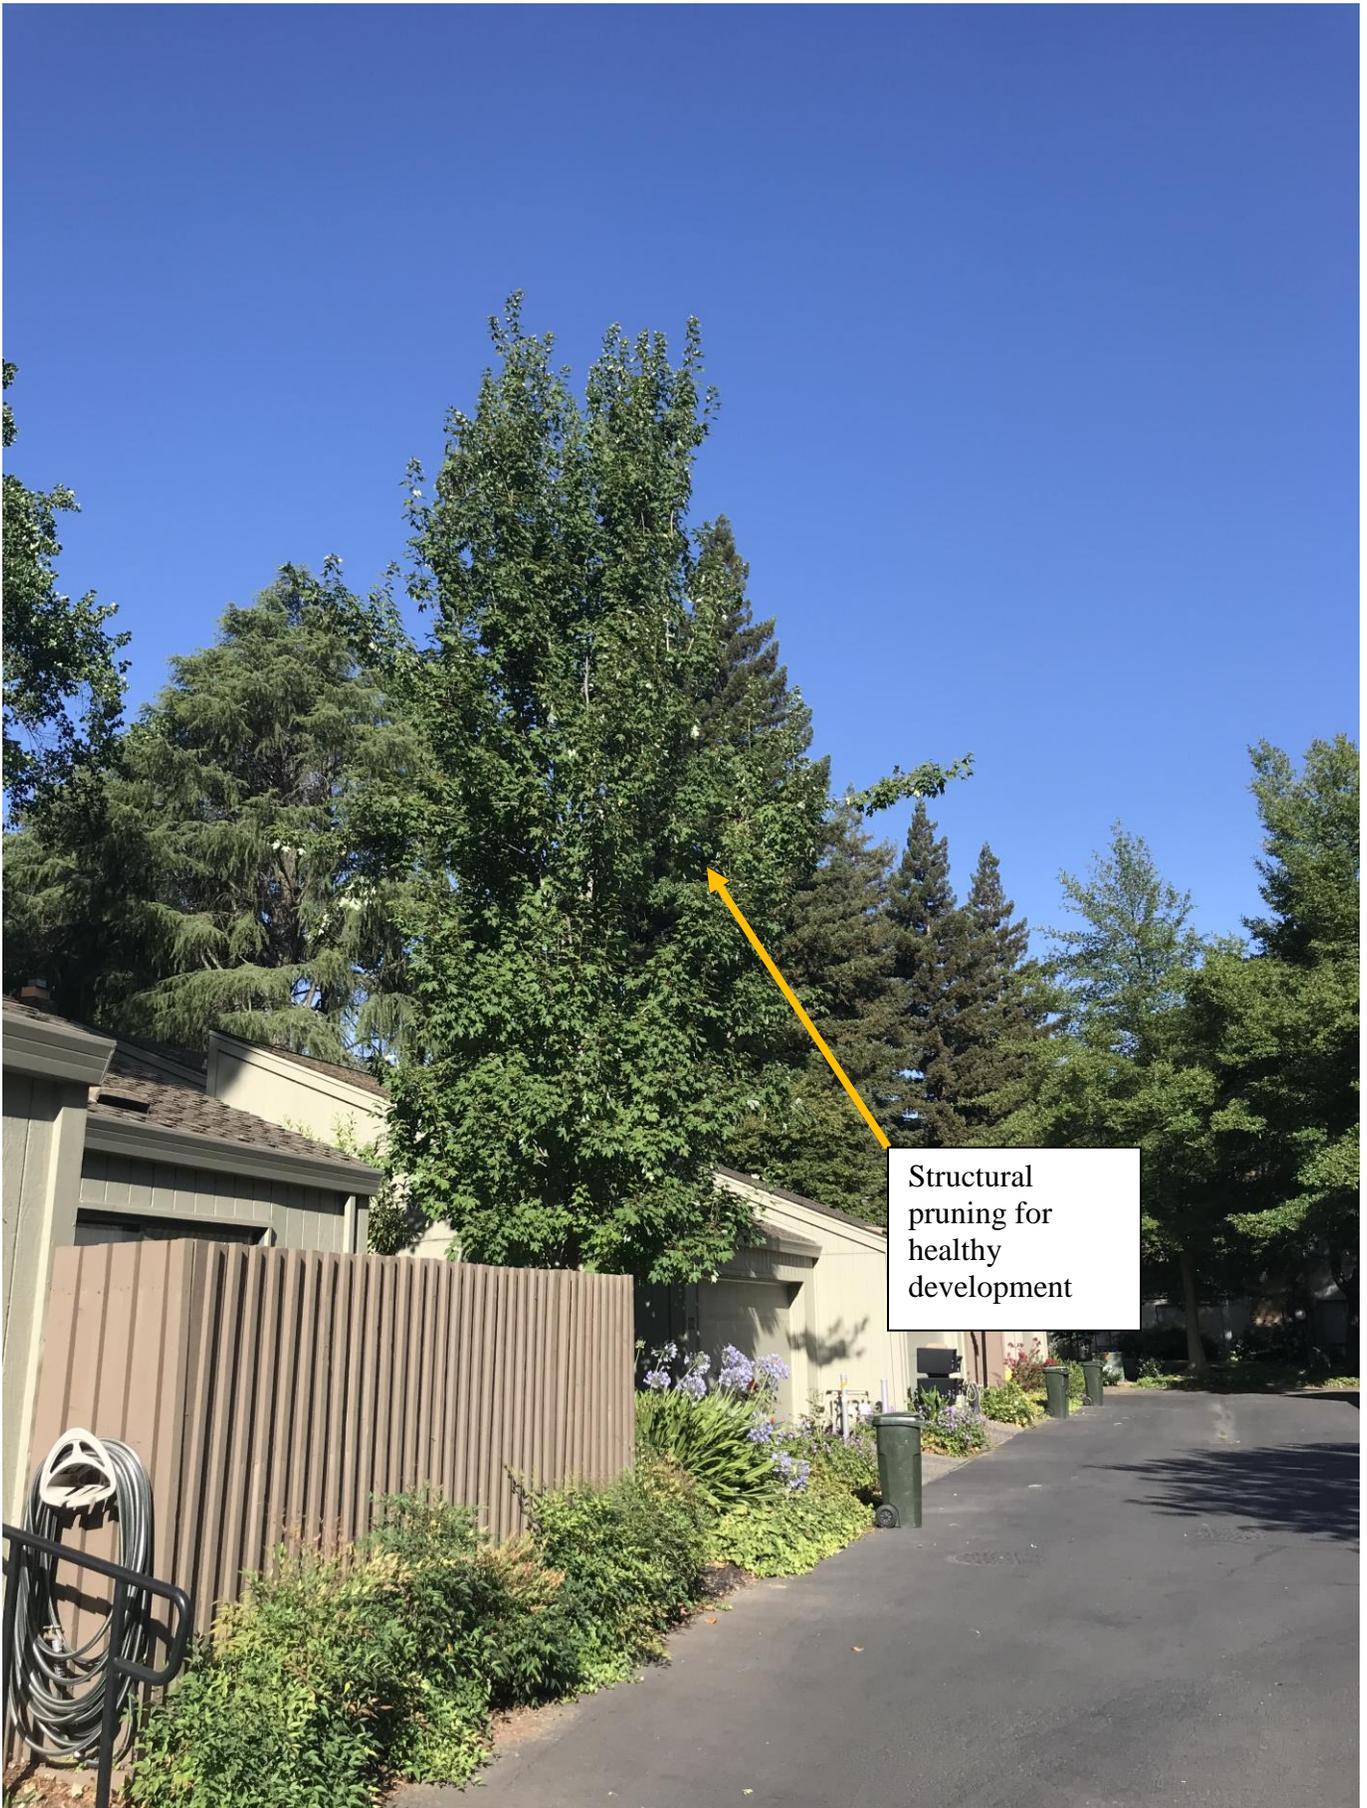
Figure 10

- (Zone 4) Tree # No Tag Maple (*Acer Rubrum*) next to 514 Dunbarton Circle (Figure 10). Young trees need corrective pruning to develop proper structure and branch spacing.
