July 9, 2020

The Nepenthe Association
1131 Commons Dr.
Sacramento, CA 95825
Phone: (916) 929-8380
Email: Bettsi.Ledesma@fsresidential.com

On July 2, 2020, I inspected several trees on the Nepenthe property during the monthly tree walk. The focus of the walk was to address resident/management concerns regarding mature trees on the property. The purpose of this report is to develop mitigation plans for the following trees and my recommendations are below. My recommendations are based on a Basic Visual Inspection. All decisions made based on the recommendations of this report are at the discretion of the Nepenthe Association.

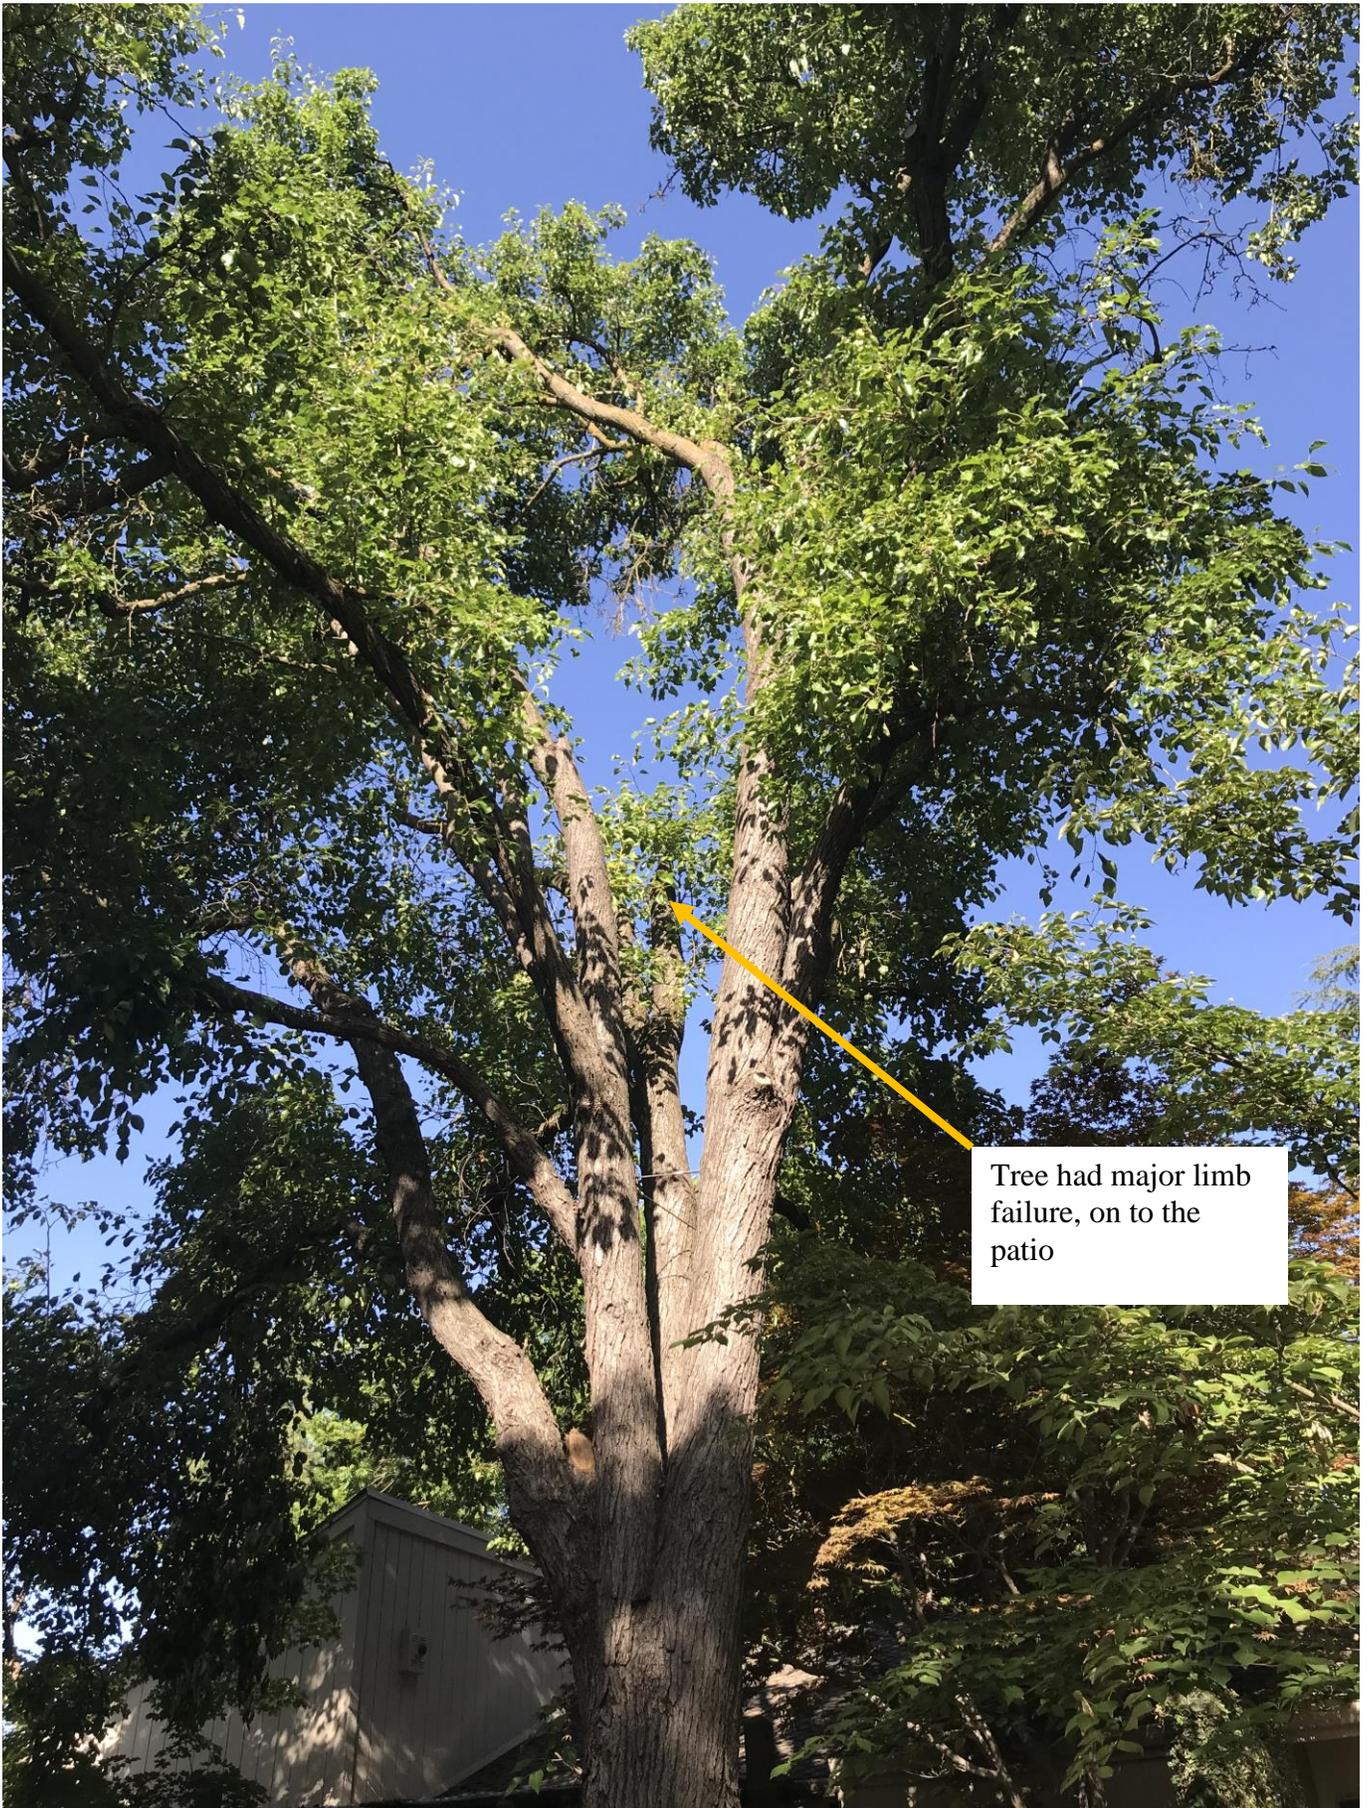
Figure 11

- (Zone 4) Tree #1266, Bradford Pear (*Pyrus calleryana*), next to 700 Dunbarton Circle. (Figure 11). This tree just had a significant limb failure onto the patio of the home. Tree has several included limb attachments as well a cable support system that is installed incorrectly to be sufficient support. Due the species the likely hood of limb failure is high with this type of tree, size and age. The defects present cannot be mitigated through pruning. I recommend removal of this tree and replacement with a more suitable variety.

Tree had major limb failure, on to the patio

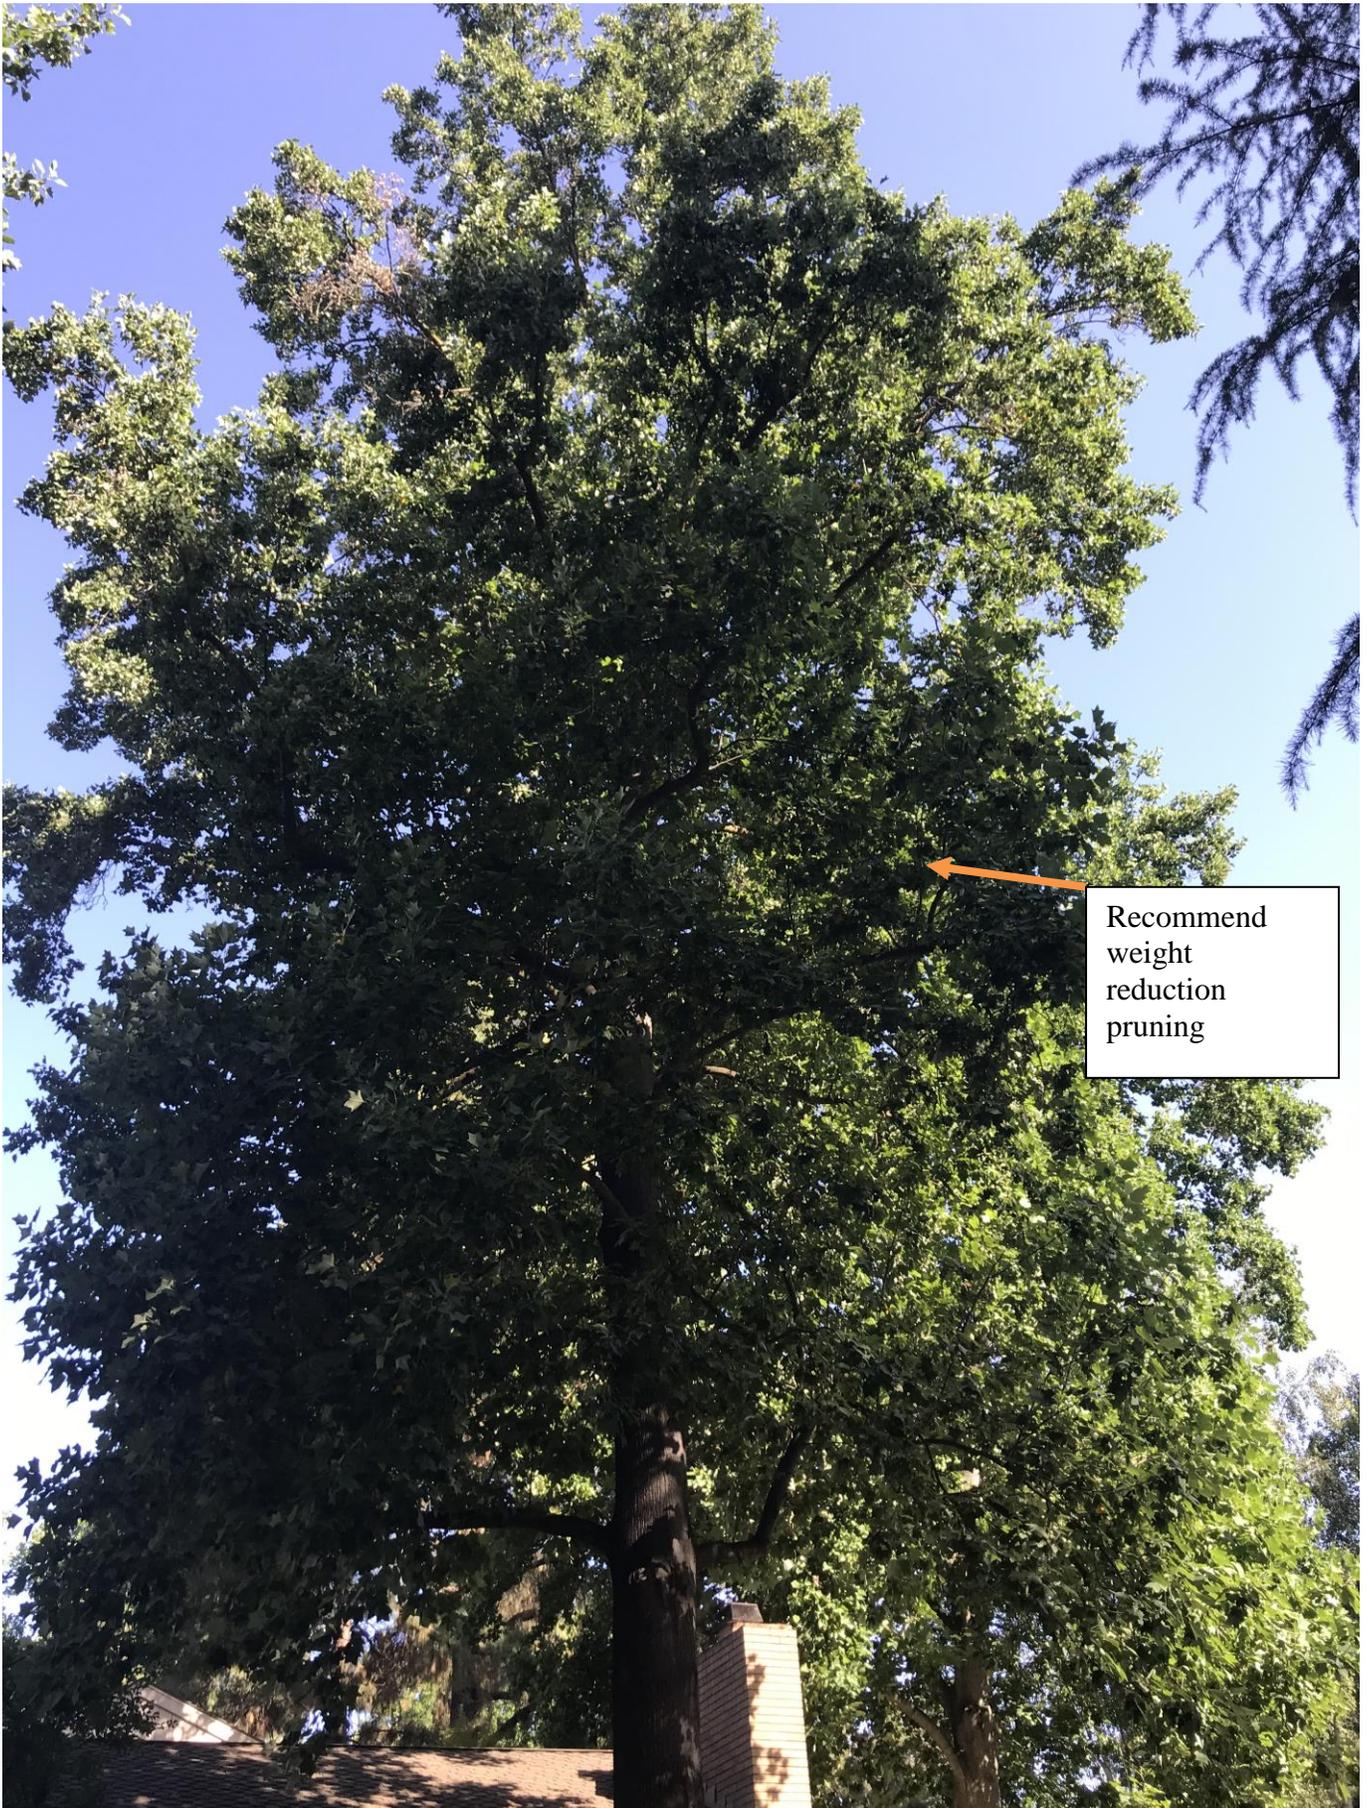
Figure 12

- (Zone 4) Trees #1283 & 1284, #1291 & 1292 Tulip tree (*Liriodendron tulipifera*) next to 800 & 812 Dunbarton Circle. Trees have full and over weighted canopy as well as some dead wood (Figures 12-14). I recommend full prune of trees Canopy.

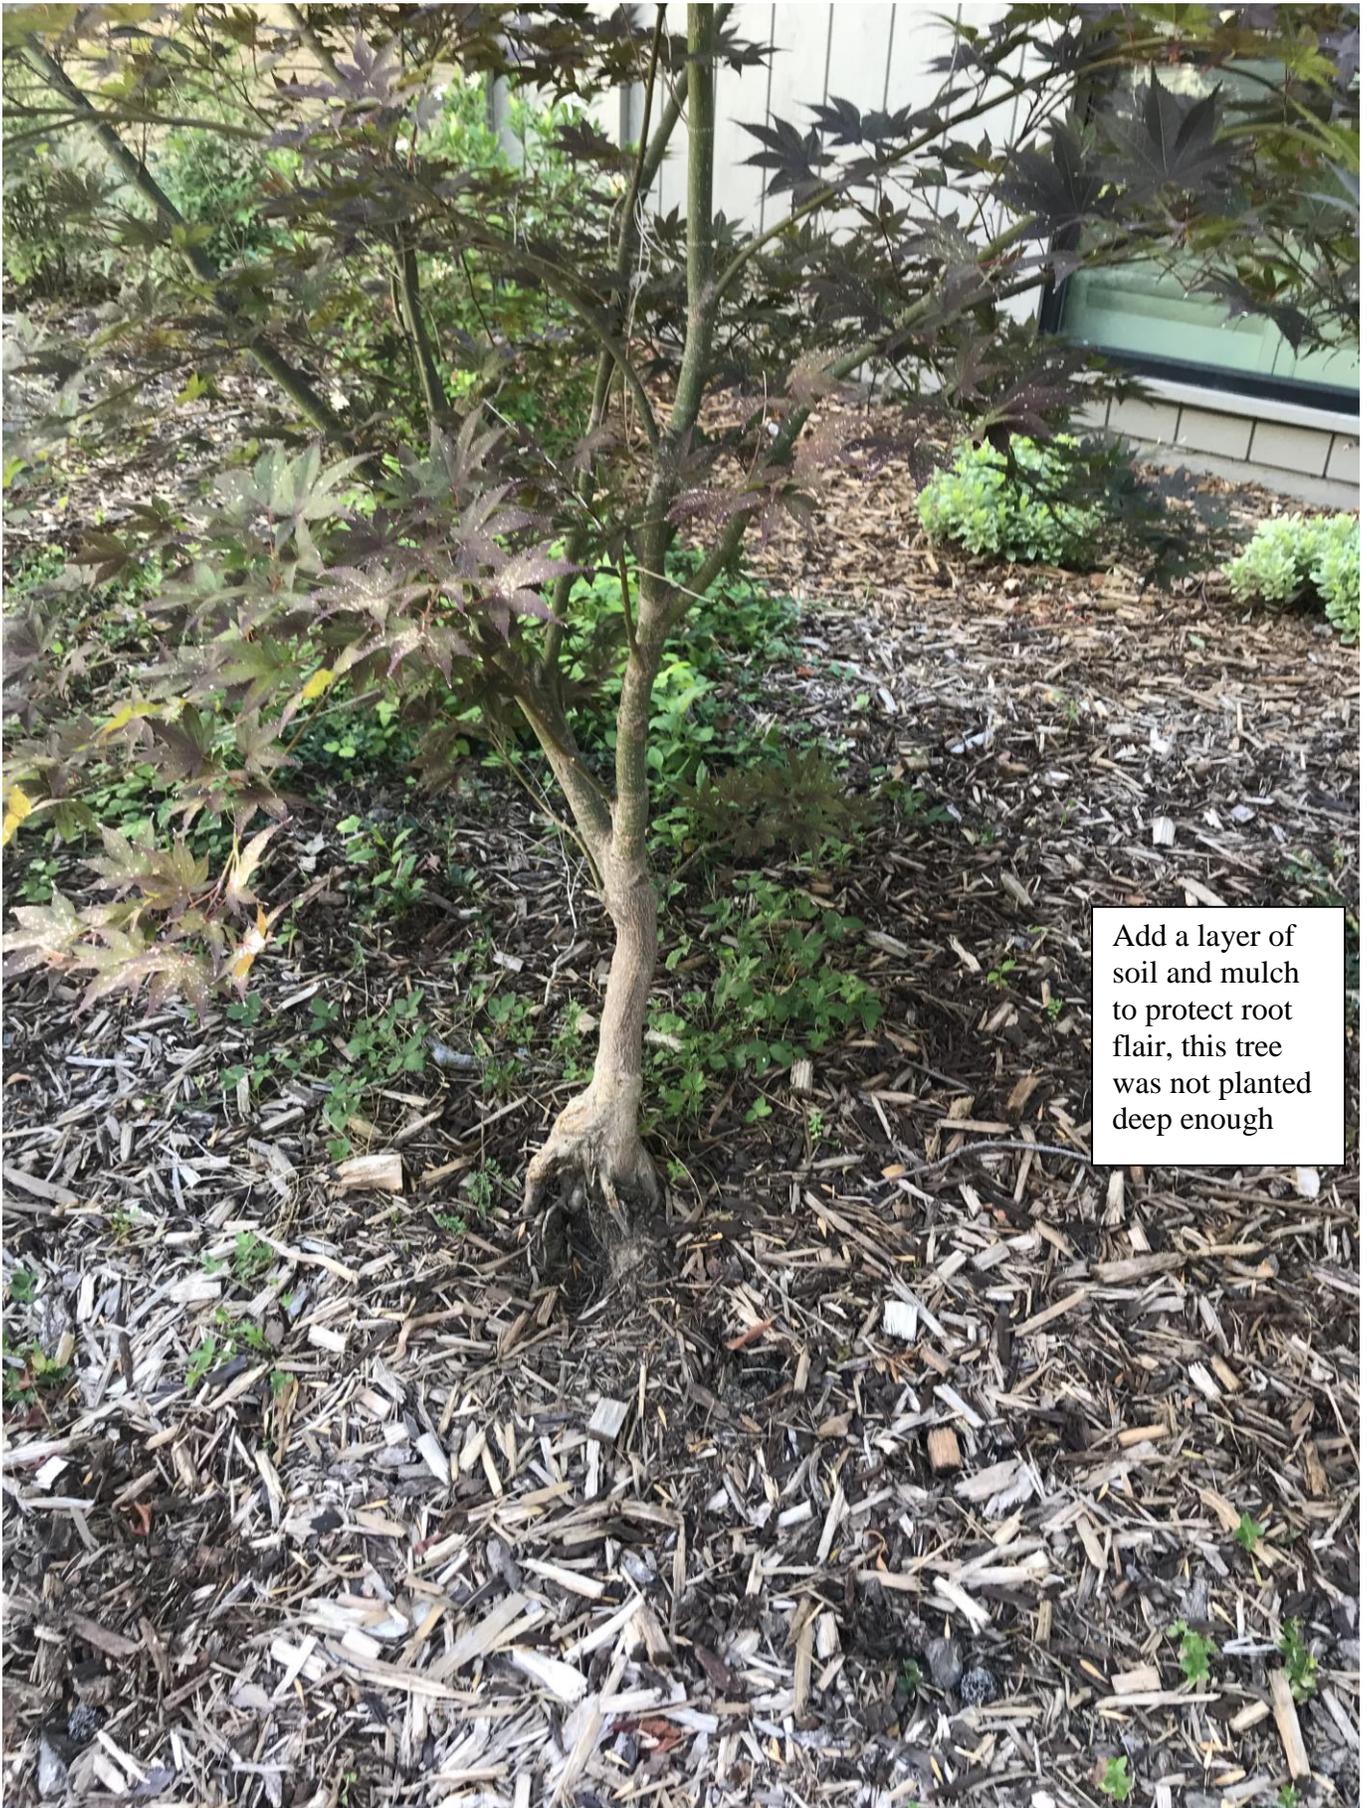
Figure 15

- (Zone 4) Trees No Tag Japanese Maple (*Acer rubrum*) 810 & 1106 Dunbarton Circle. Trees need some soil care. The tree in (Figure 15) was not planted deep enough and has some exposure in the root flair needs a bit of soil and mulch. The tree in (Figure 16) needs some mulch to keep the tree well established and free of turf and this helps to limit the possibility of accidental damage by a mower of weed eater.

Add a layer of soil and mulch to protect root flair, this tree was not planted deep enough

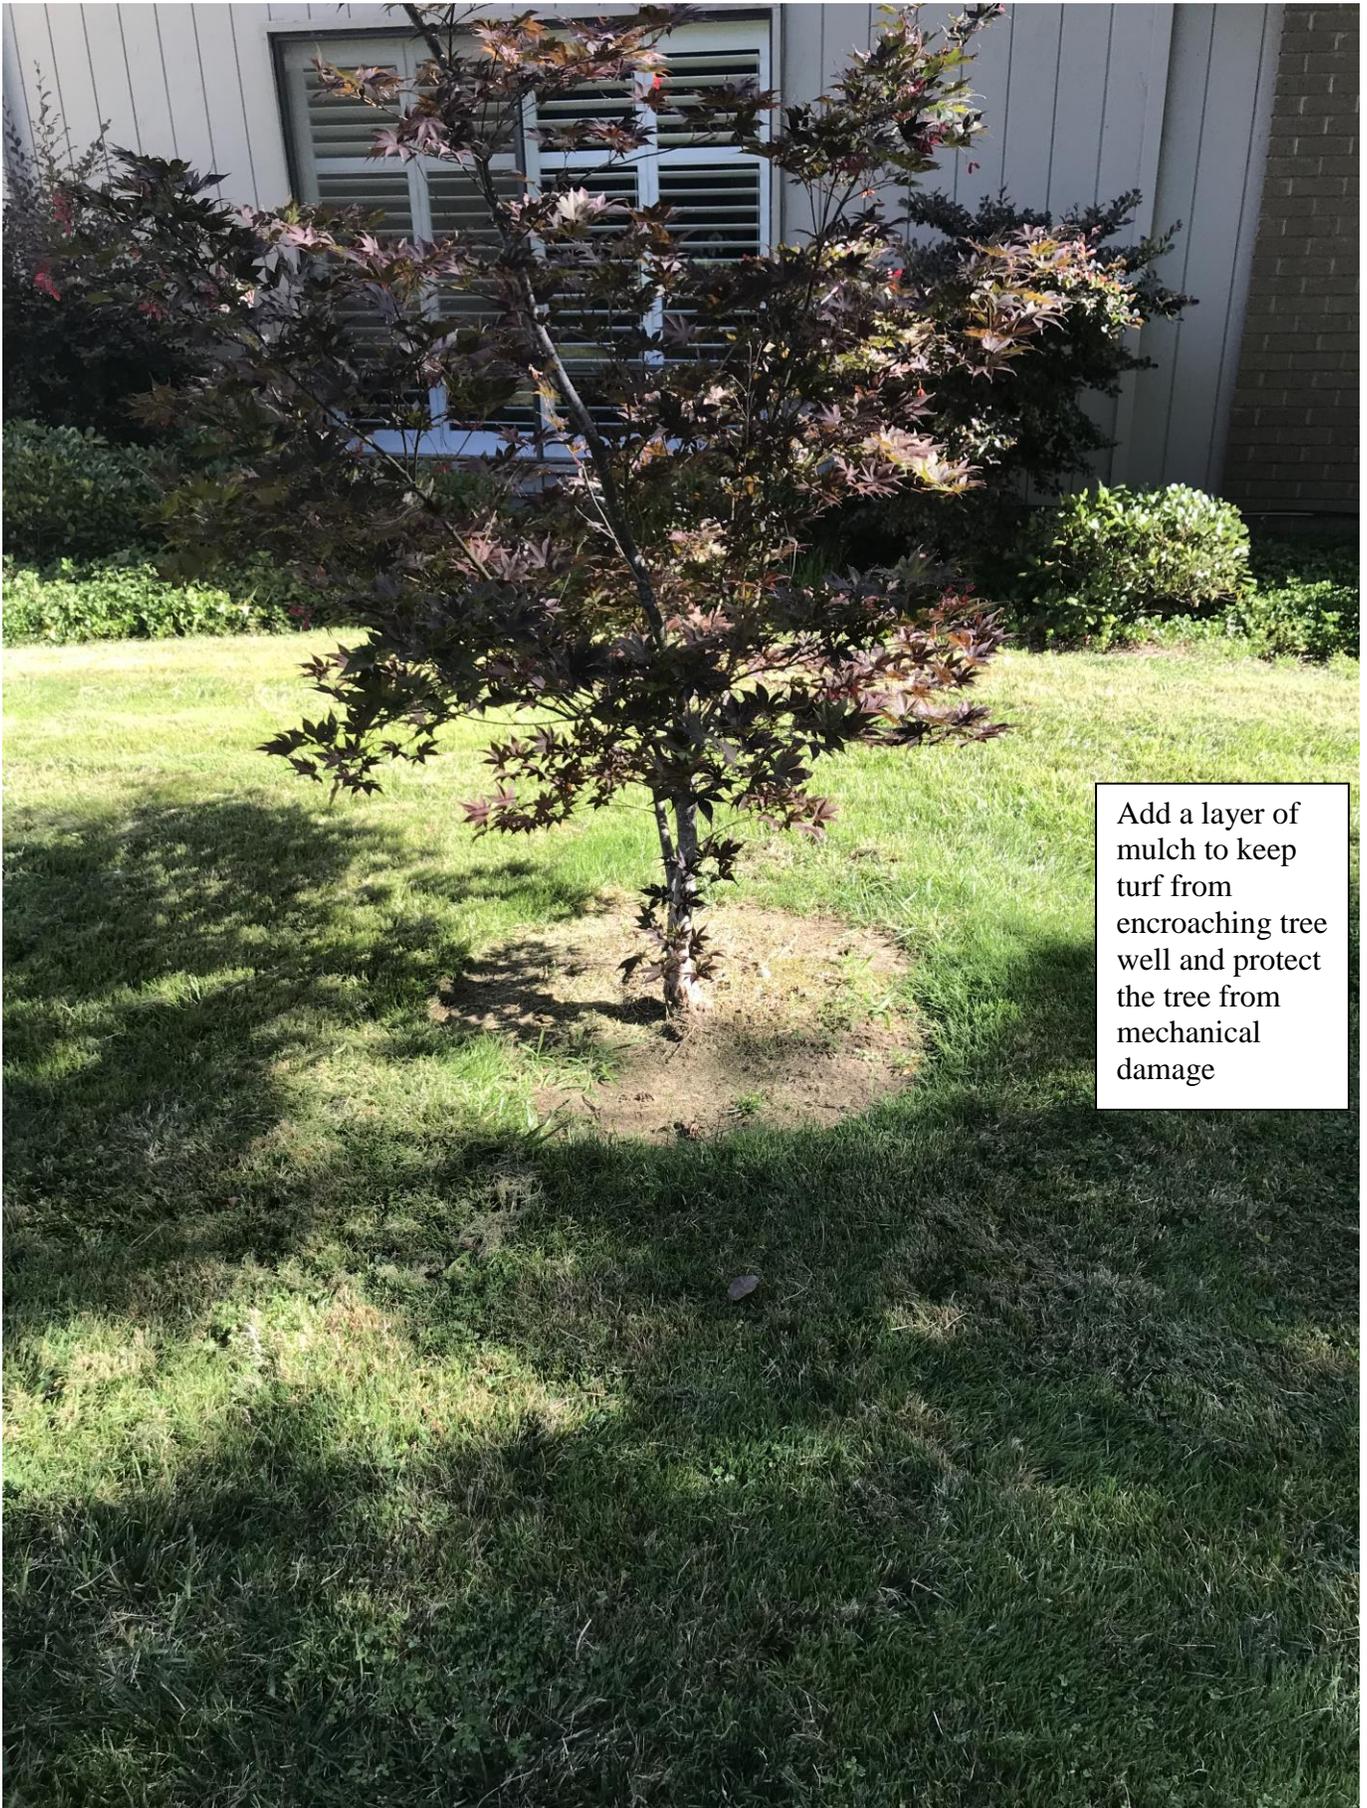
Figure 16

Add a layer of mulch to keep turf from encroaching tree well and protect the tree from mechanical damage

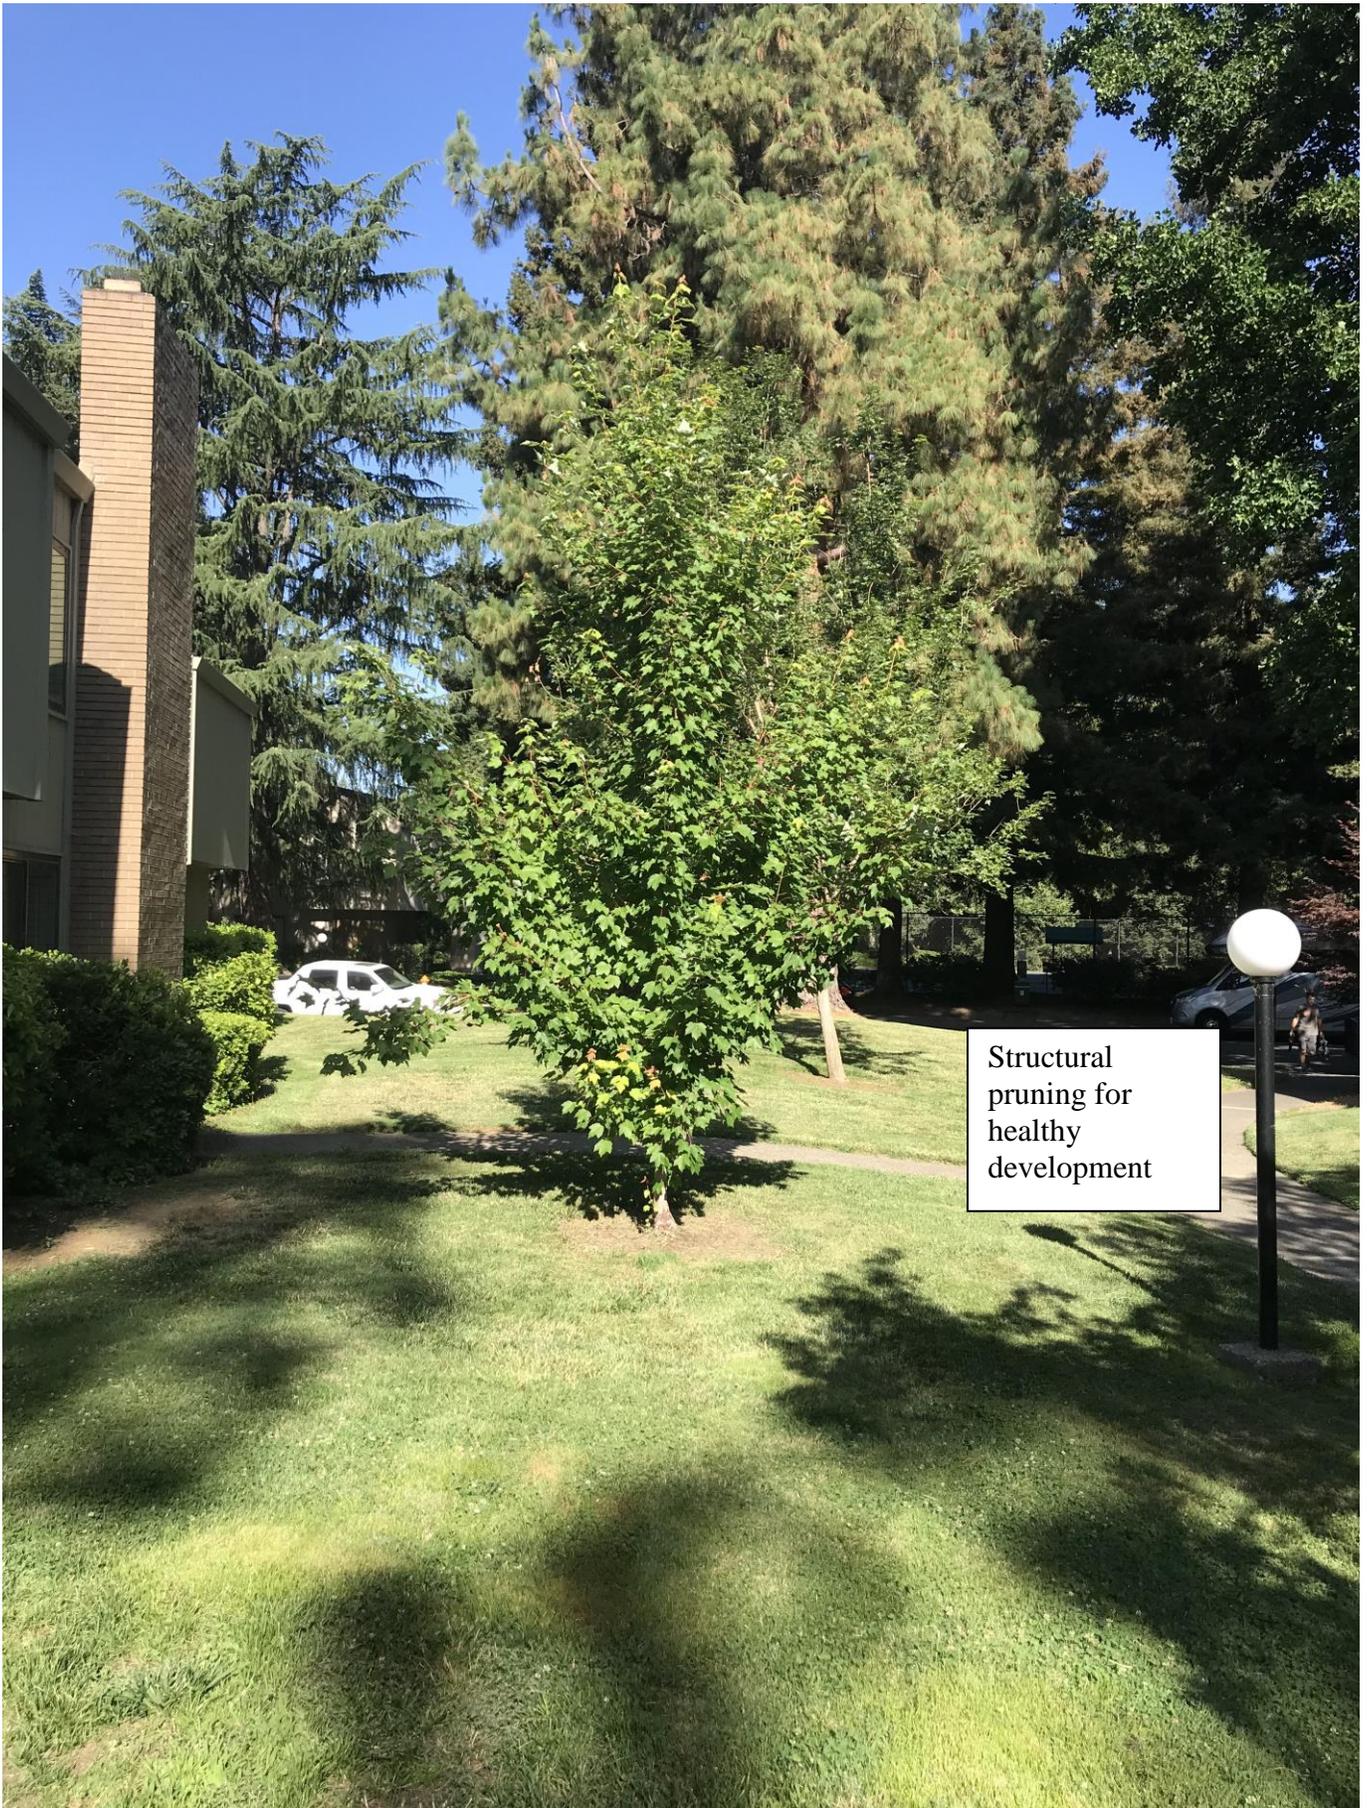
Figure 17

- (Zone 4) Tree No Tag Red Maple (*Acer rubrum*) 1110 Dunbarton Circle. Young trees need corrective pruning to develop proper structure and branch spacing. (Figure 17).

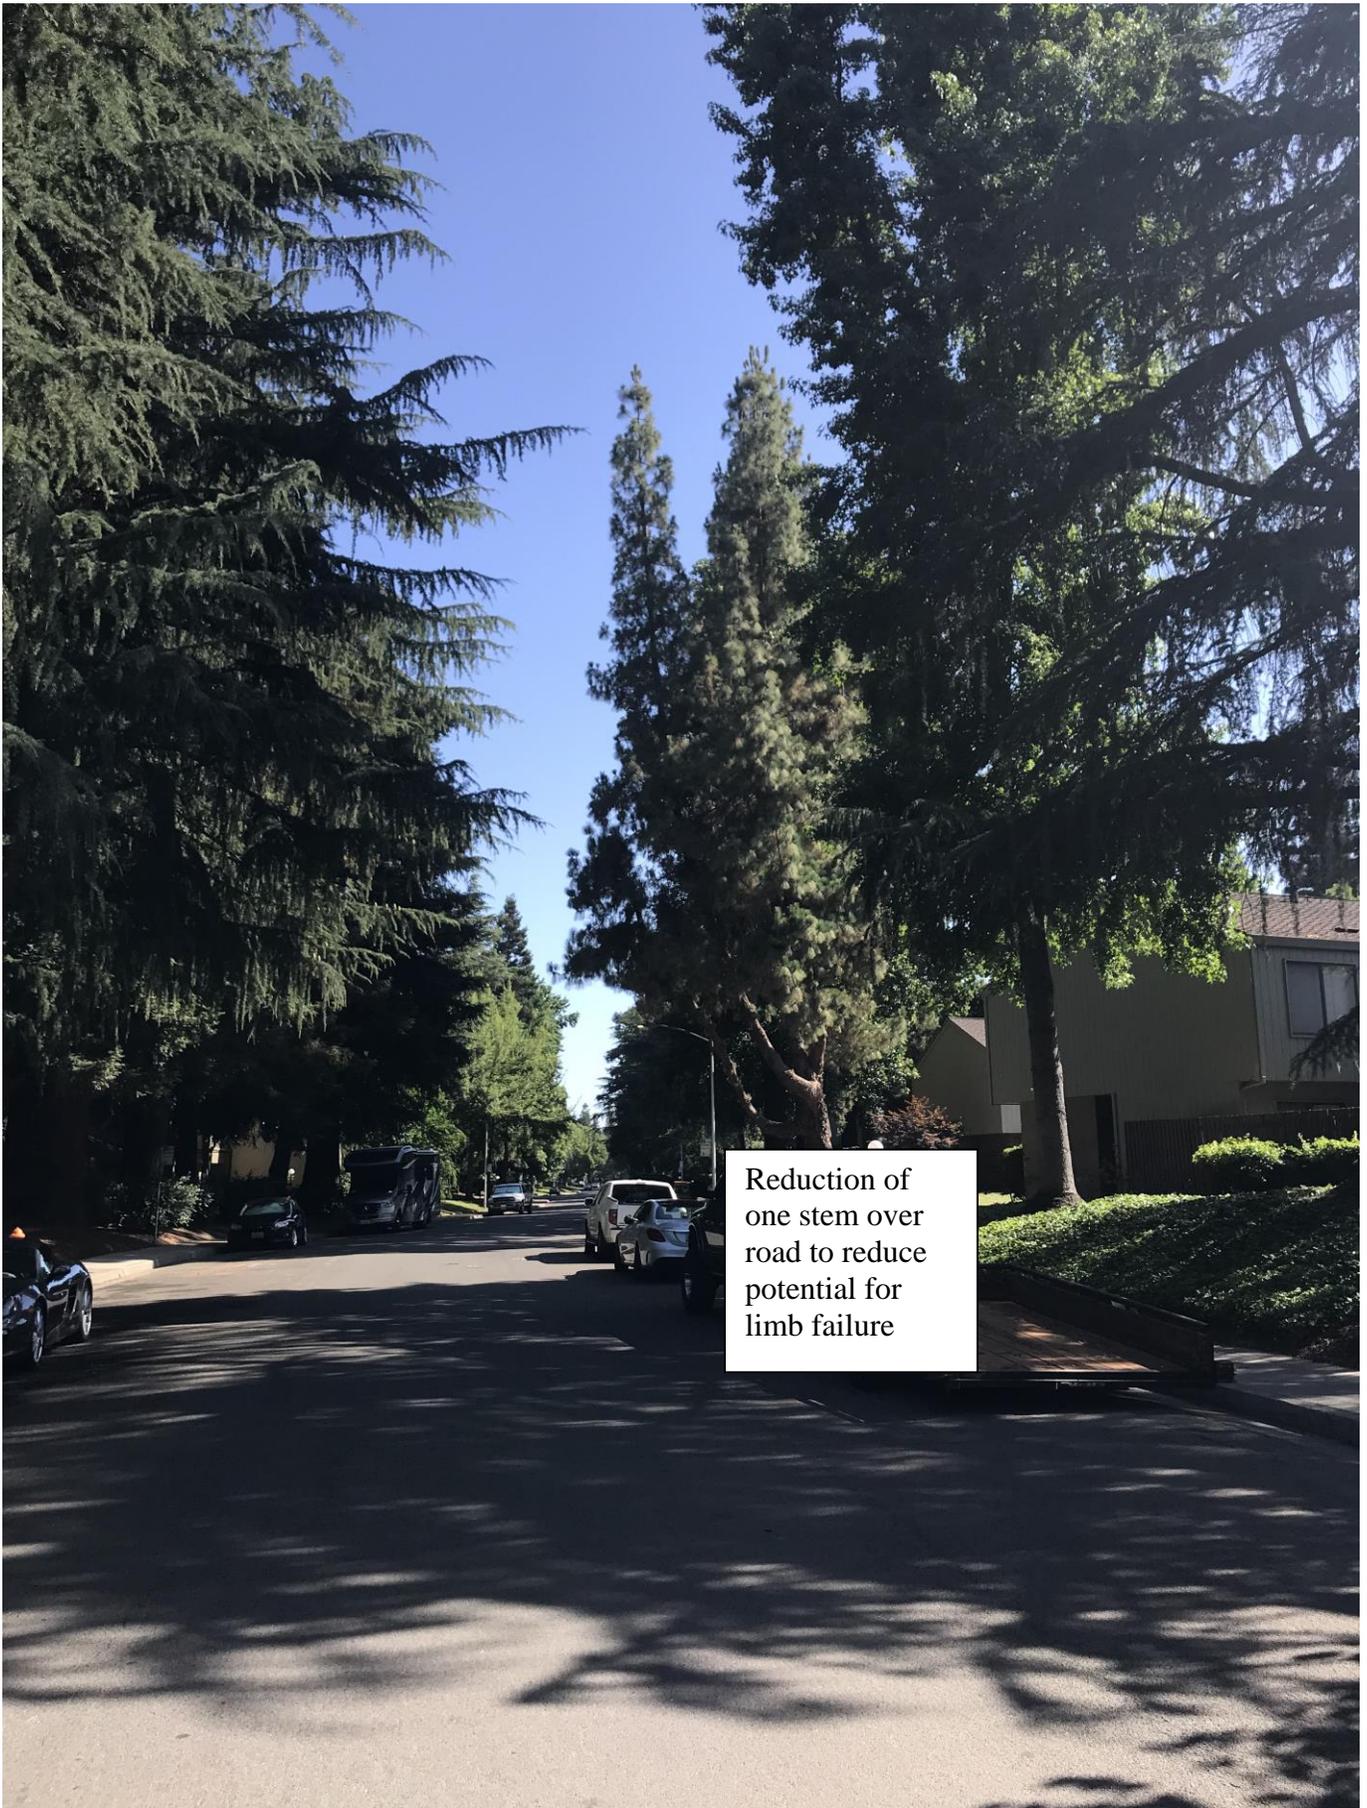
Figure 18

- (Zone 4) Tree #1095 Canary Island Pine (*Pinus canarisnsis*) 1417 Commons. The tree had unusual branch growth and has a large limb that extends over commons. To help reduce the potential of limb failure I propose to reduce the limb by ¼ to stunt the development. (Figure 18).

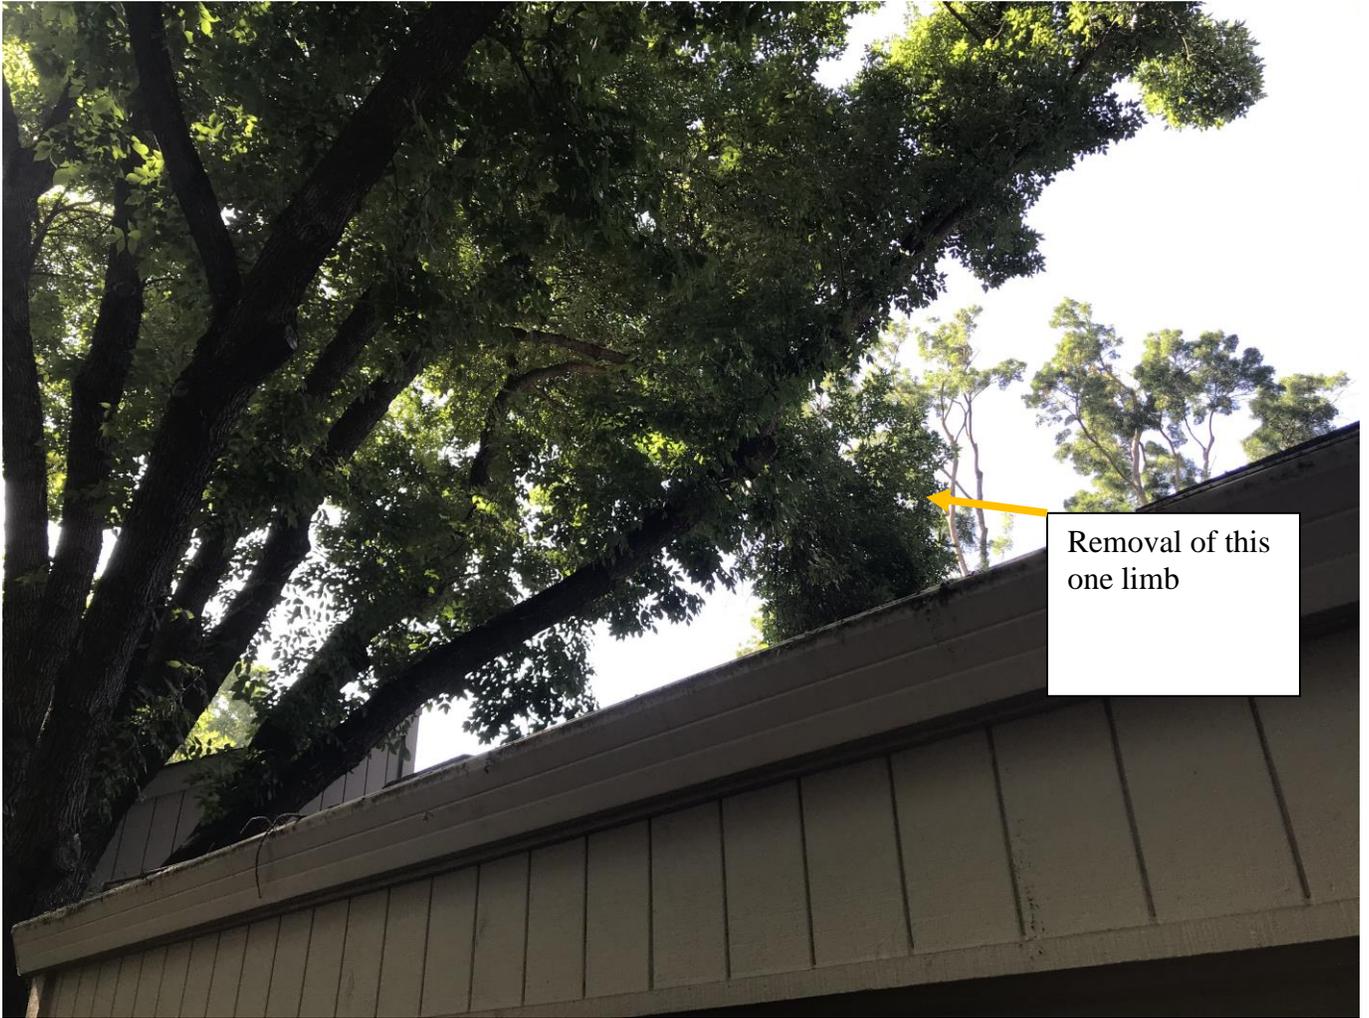
Figure 19

- (Zone 4) Trees #1114 Ash (*Fraxnis angustifolia*) 114/116 Dunbarton Circle. The tree has one long heavy limb that I propose to remove to reduce failure (Figure 19).

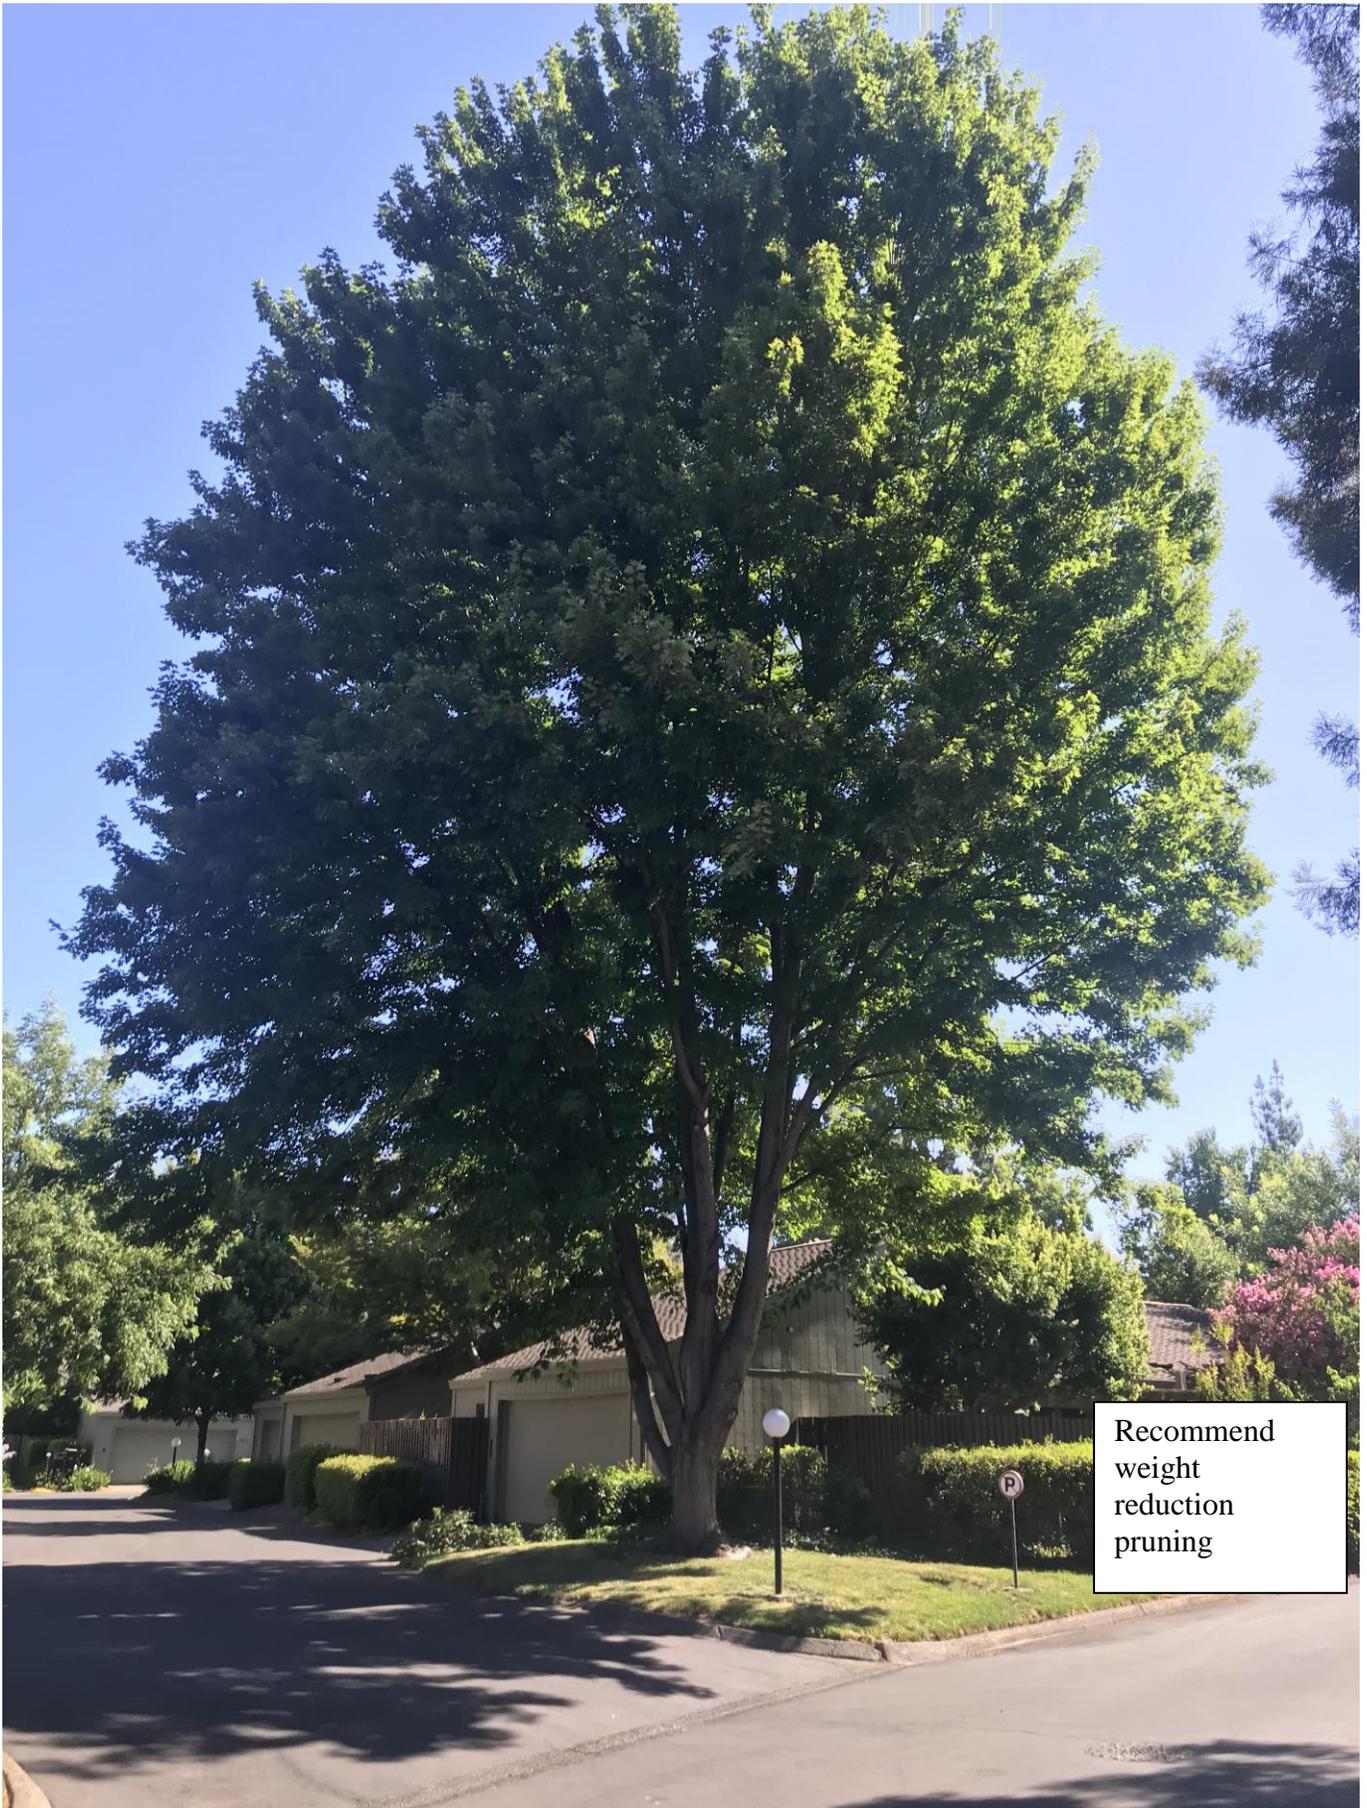
Figure 20

- (Zone 4) Tree #1133 Red Maple (*Acer rubrum*) 110 Dunbarton Circle. Tree has several points of included branch connections and has full and over weighted canopy I recommend weight reduction pruning. (Figure 20).

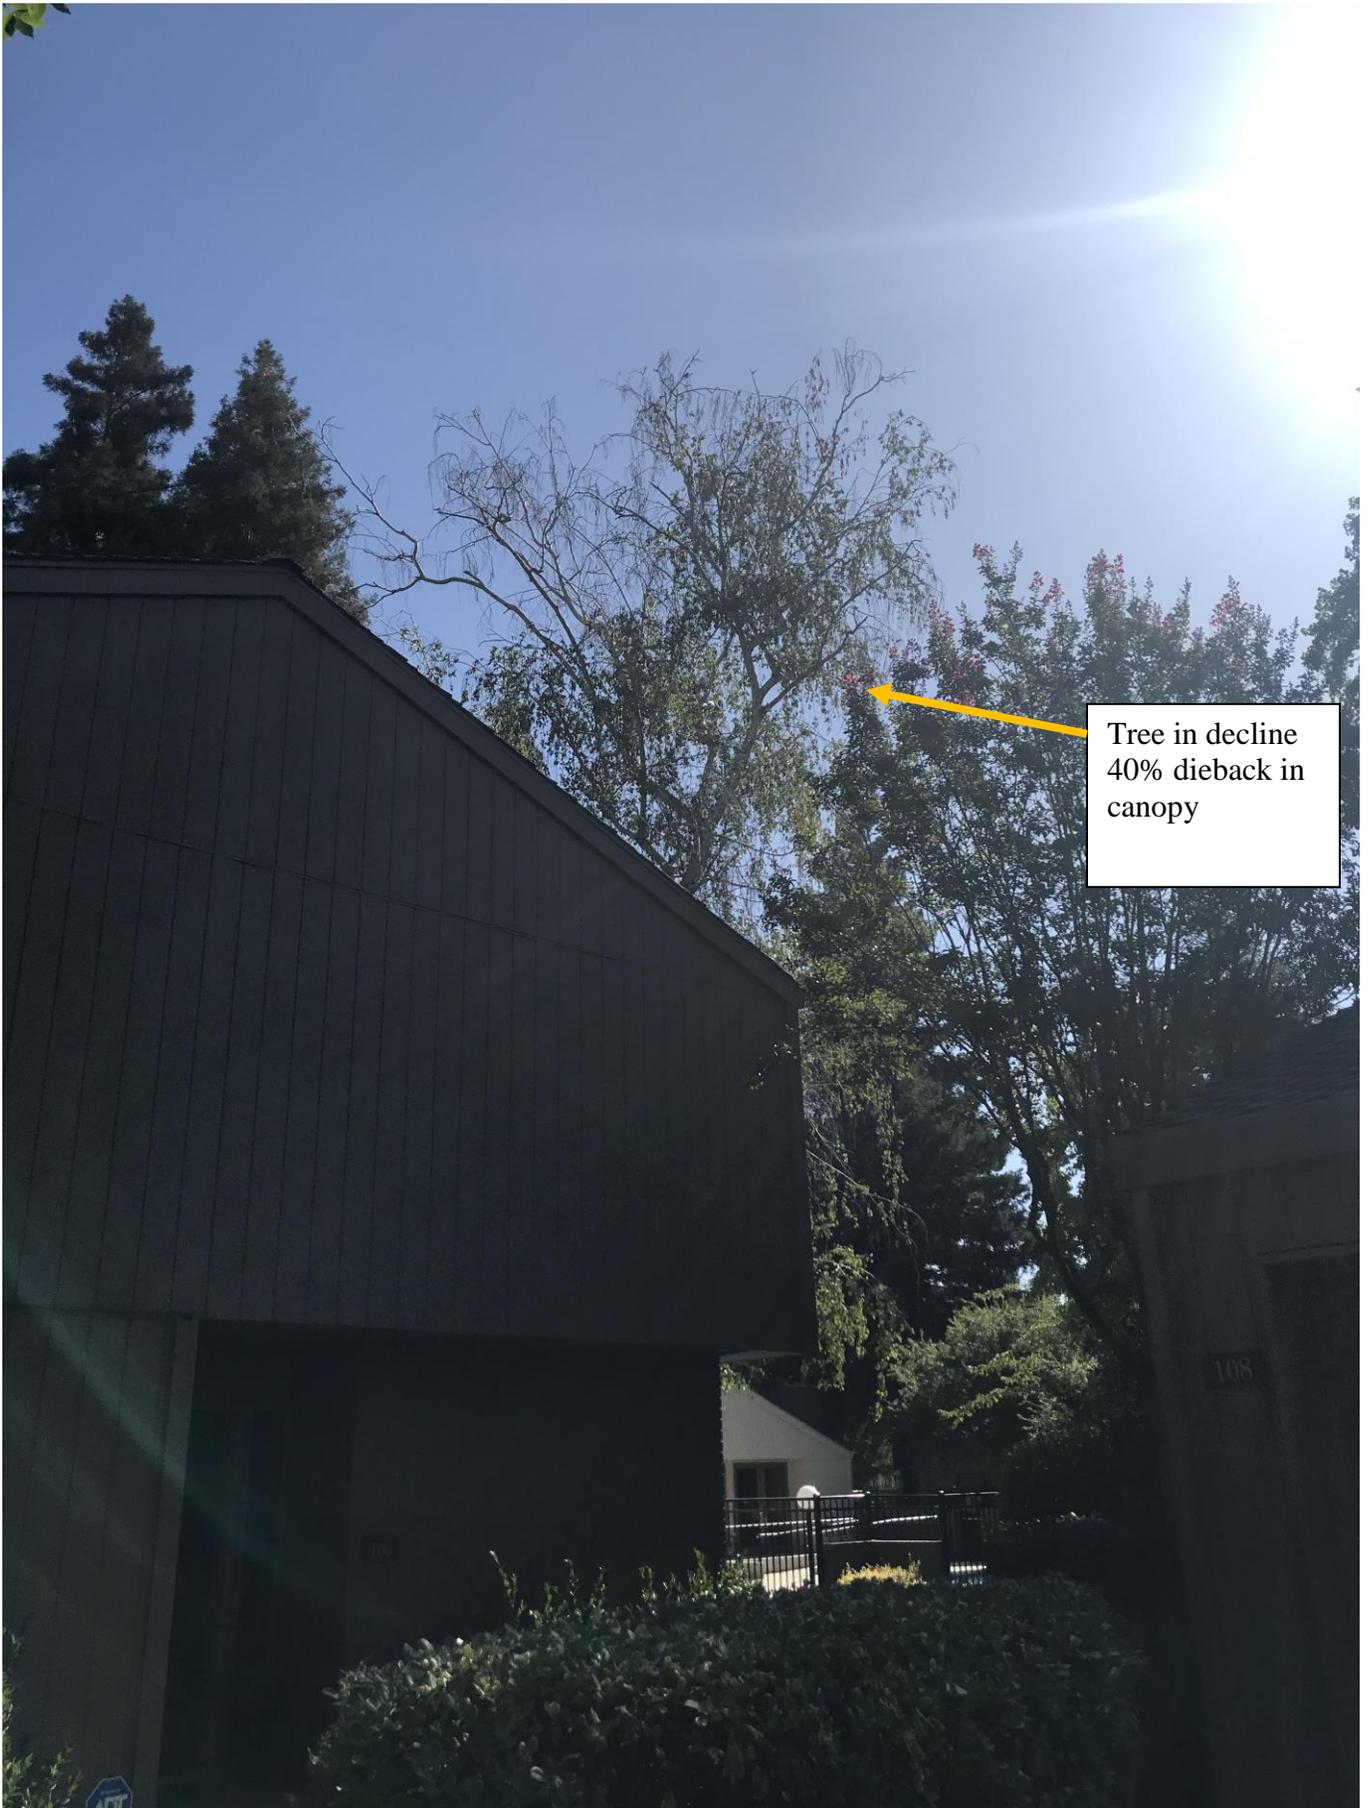
Figure 21

- (Zone 4) Tree #1161, White Birch (*Betula pendula*), next to 106 Dunbarton Circle. (Figure 21). Tree is in decline, 40% of the canopy appears to have died due to age of tree, I recommend the trees removal and a replacement of a suitable variety

Tree in decline
40% dieback in
canopy
