July 9, 2020

The Nepenthe Association
1131 Commons Dr.
Sacramento, CA 95825
Phone: (916) 929-8380
Email: Bettsi.Ledesma@fsresidential.com

On July 2, 2020, I inspected several trees on the Nepenthe property during the monthly tree walk. The focus of the walk was to address resident/management concerns regarding mature trees on the property. The purpose of this report is to develop mitigation plans for the following trees and my recommendations are below. My recommendations are based on a Basic Visual Inspection. All decisions made based on the recommendations of this report are at the discretion of the Nepenthe Association.

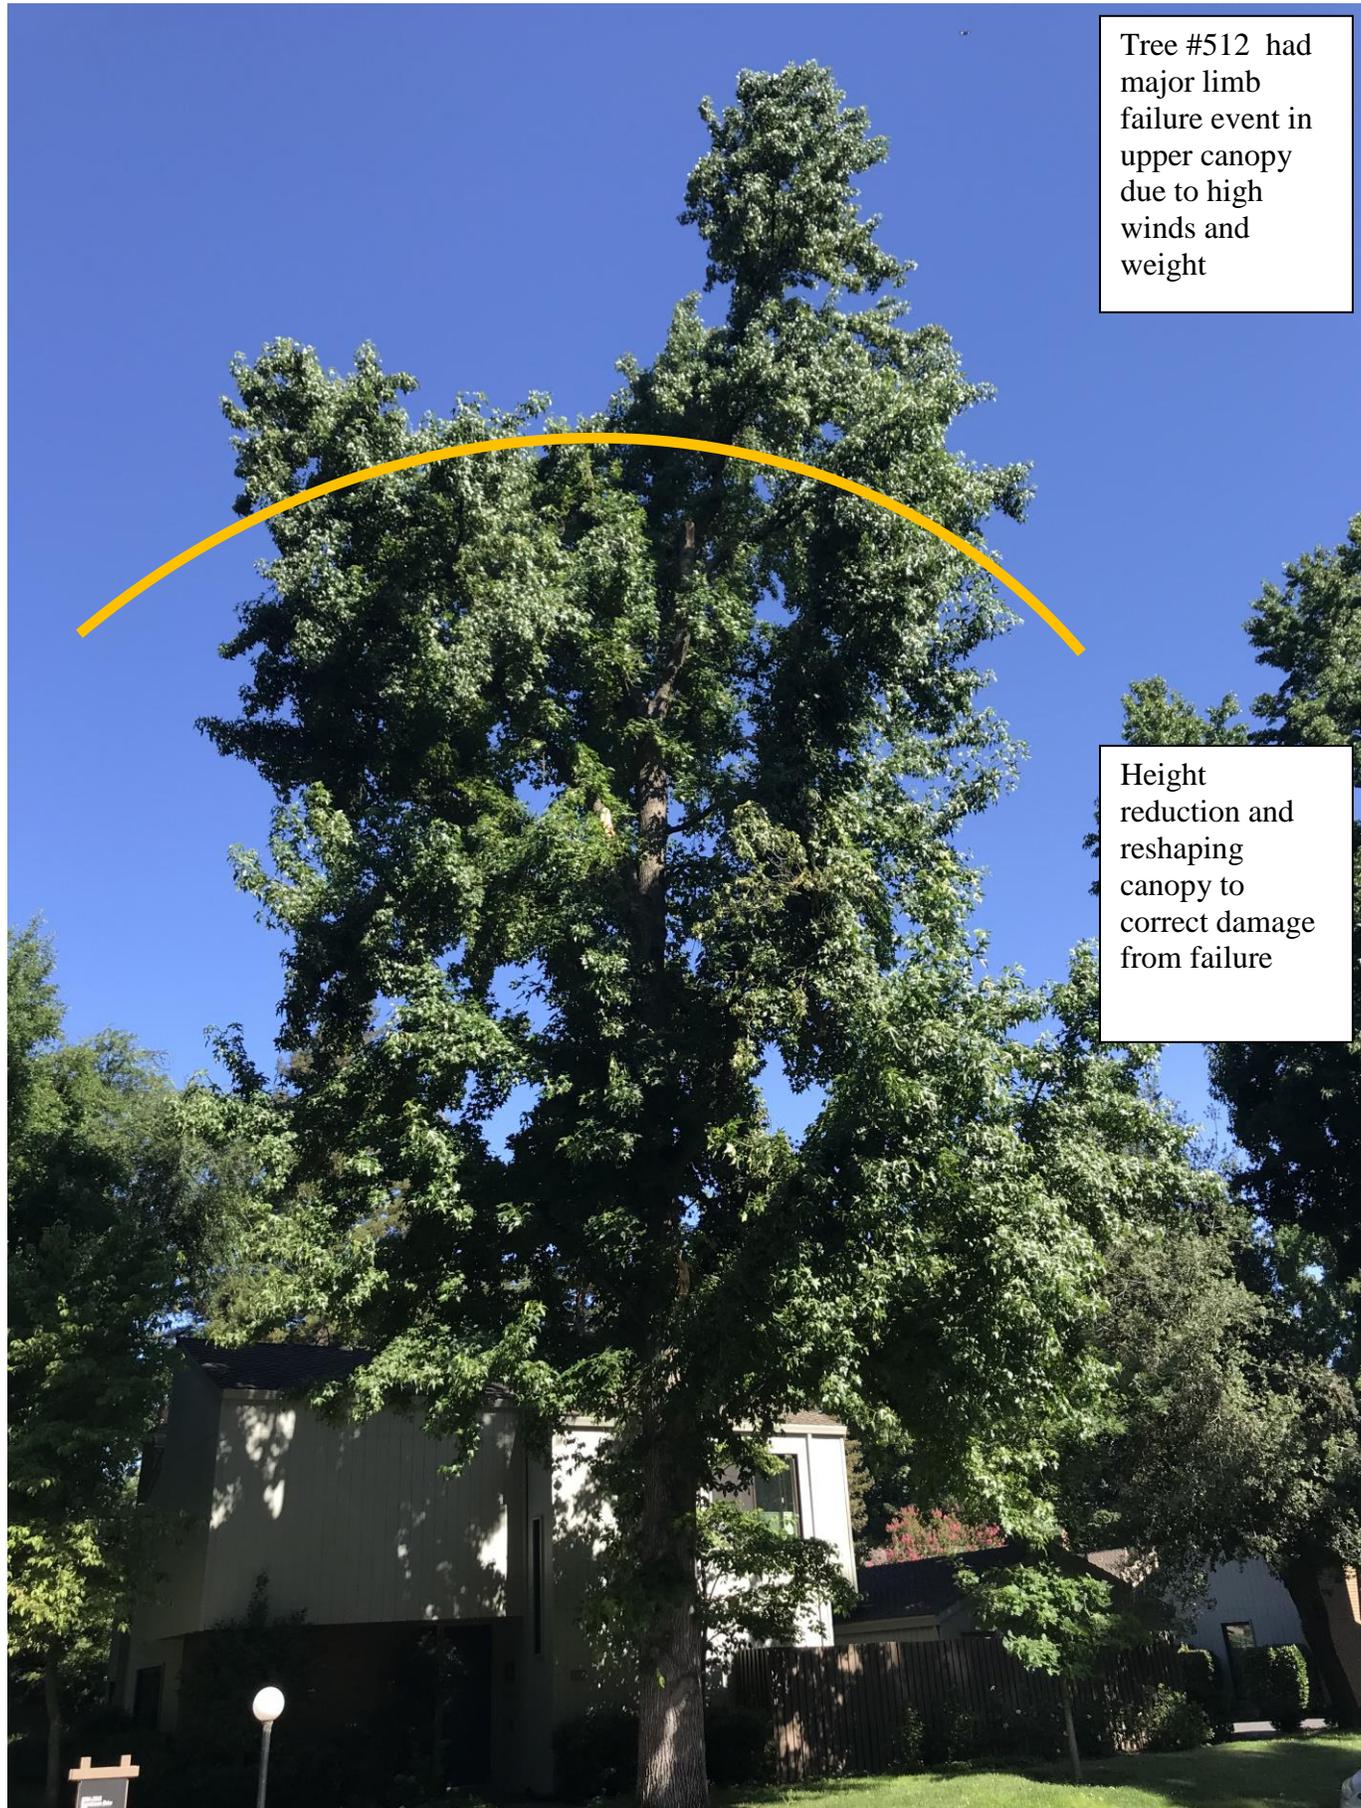
Figure 22

- (Zone 2) Trees #507, 512, 548, 549, 552, 553, Sweet Gum (*Liquidambar styraciflua*) next to 1338, 1366, 1378 Commons Dr. The trees have been pruned for clearance and deadwood 2016, and weight reduction pruning in 2018. Tree #512 had a major limb failure during a wind event in late June. The tree lost several large limbs that fell on to the street causing damage to a vehicle. This species of tree is prone to limb failure to the vigor of growth and the soft brittle wood structure. In addition the fruit development can cause additional weight to the branch ends. We treat the trees annually for the fruit reduction in addition to pruning can help to reduce limb failure (Figures 22-23). I recommend weight reduction pruning of the listed trees canopy.

Tree #512 had major limb failure event in upper canopy due to high winds and weight

Height reduction and reshaping canopy to correct damage from failure

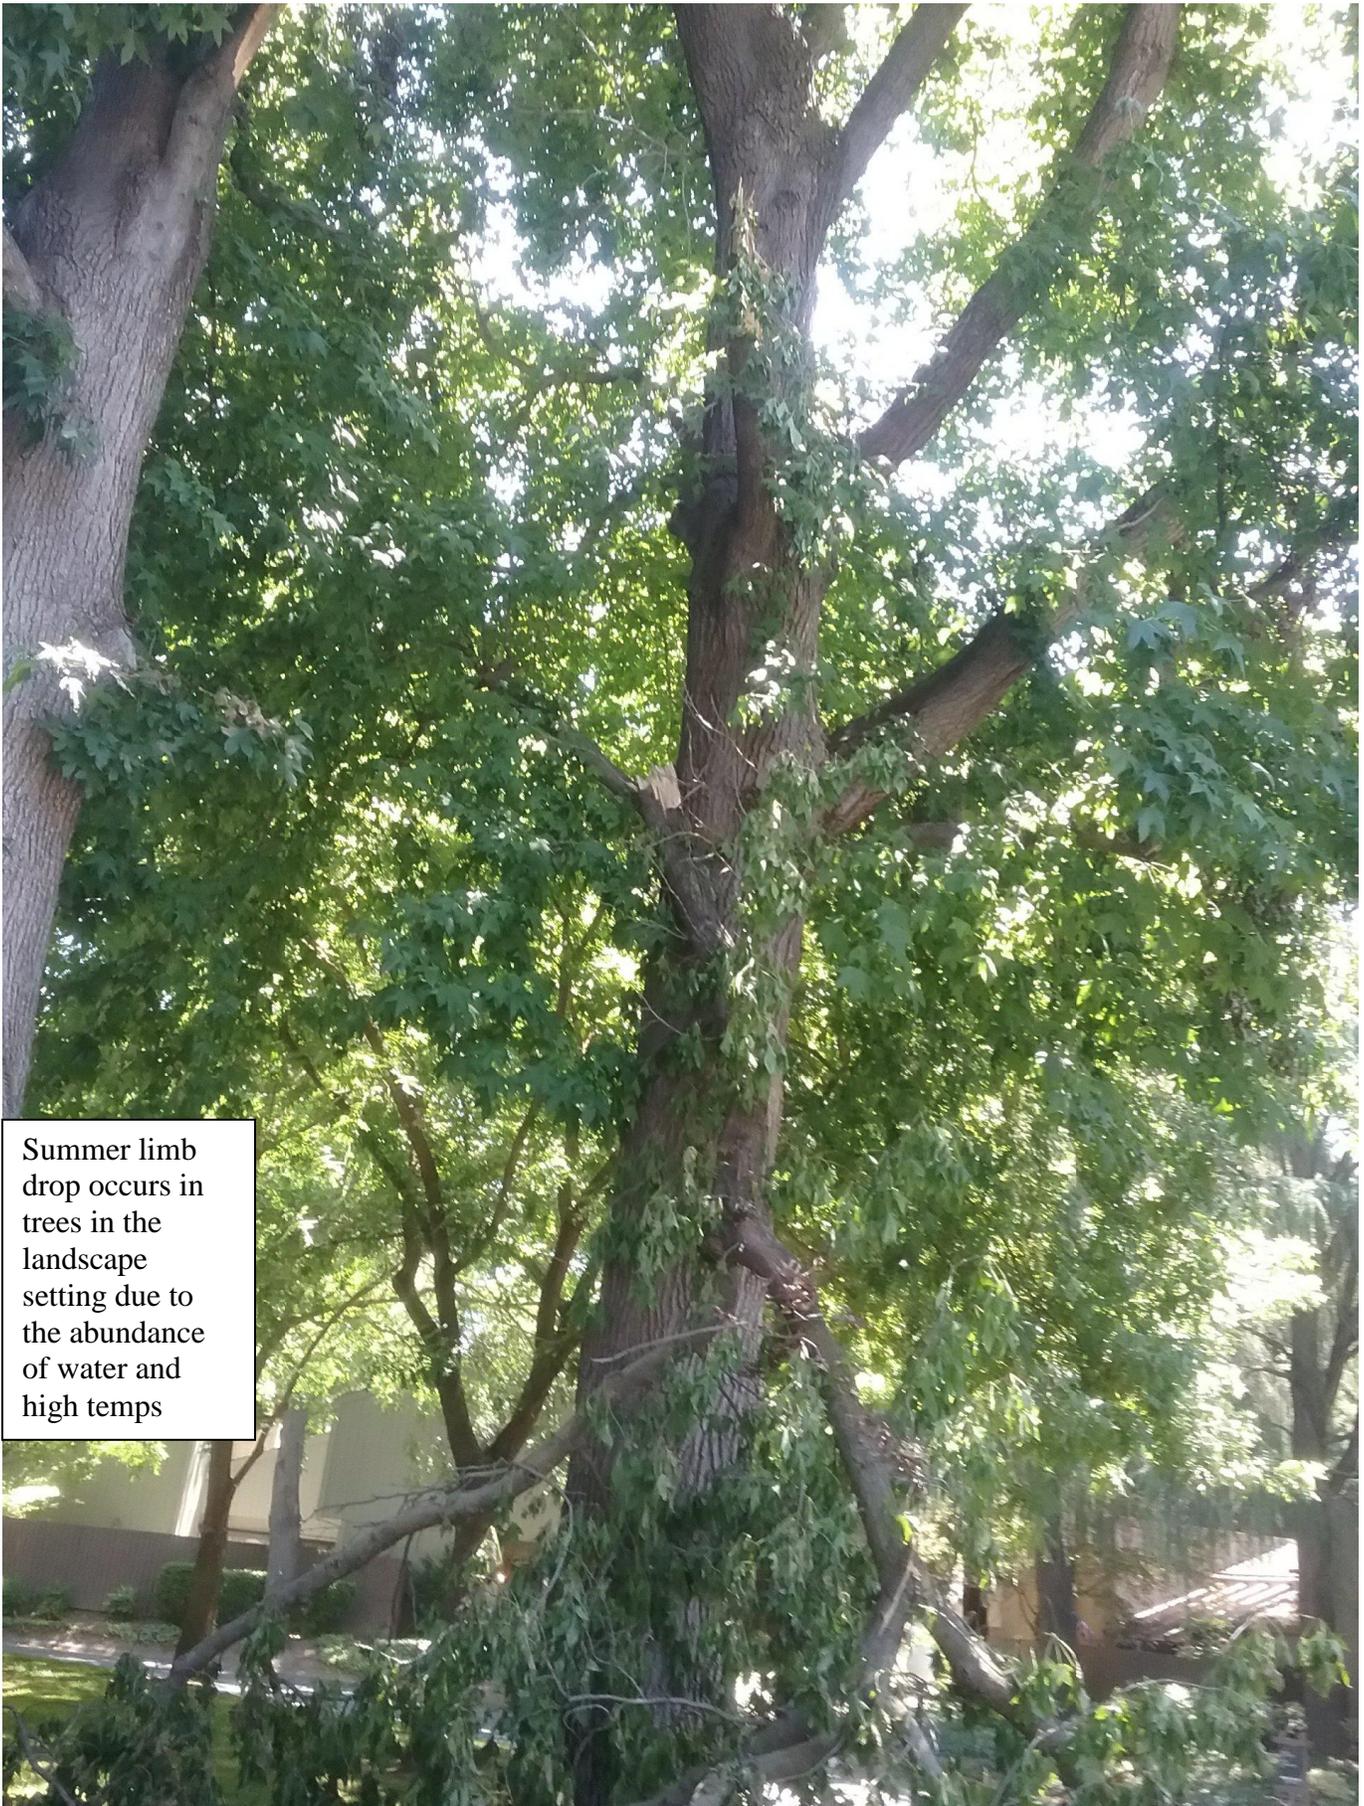
Figure 24

- (Zone 3)) Trees #921-#925 Sweetgum (*Liquidambar styraciflua*), 1395 Dunbarton Circle.5 These trees were last pruned for weight reduction in 2017 and last week had a major limb failure. The

trees don't appear to be overly weighted in the canopy I believe this to be related to a summer limb drop due to excess heat and moisture buildup in the wood tissue (Figure 24). The summer limb drop effect is common in landscape trees due to the abundance of water year round leading to heavy uptake by the tree and when we have heat spells in the high 90's to 100's we tend to see failures like this. I recommend full prune of tree canopy to clean up any damage and selective end weight reduction.

Summer limb drop occurs in trees in the landscape setting due to the abundance of water and high temps
