May 10, 2023

The Nepenthe Association  
1131 Commons Dr.  
Sacramento, CA 95825  
Phone: (916) 929-8380  
Email: [Nepenthe.HOA@fsresidential.com](mailto:Nepenthe.HOA@fsresidential.com)

On April 24, 2023 I inspected several trees on the Nepenthe property during the monthly tree walk. The focus of the walk was to address resident/management concerns regarding mature trees on the property. The purpose of this report is to develop mitigation plans for the following trees and my recommendations are below. My recommendations are based on a Basic Visual Inspection. All decisions made based on the recommendations of this report are at the discretion of the Nepenthe Association.

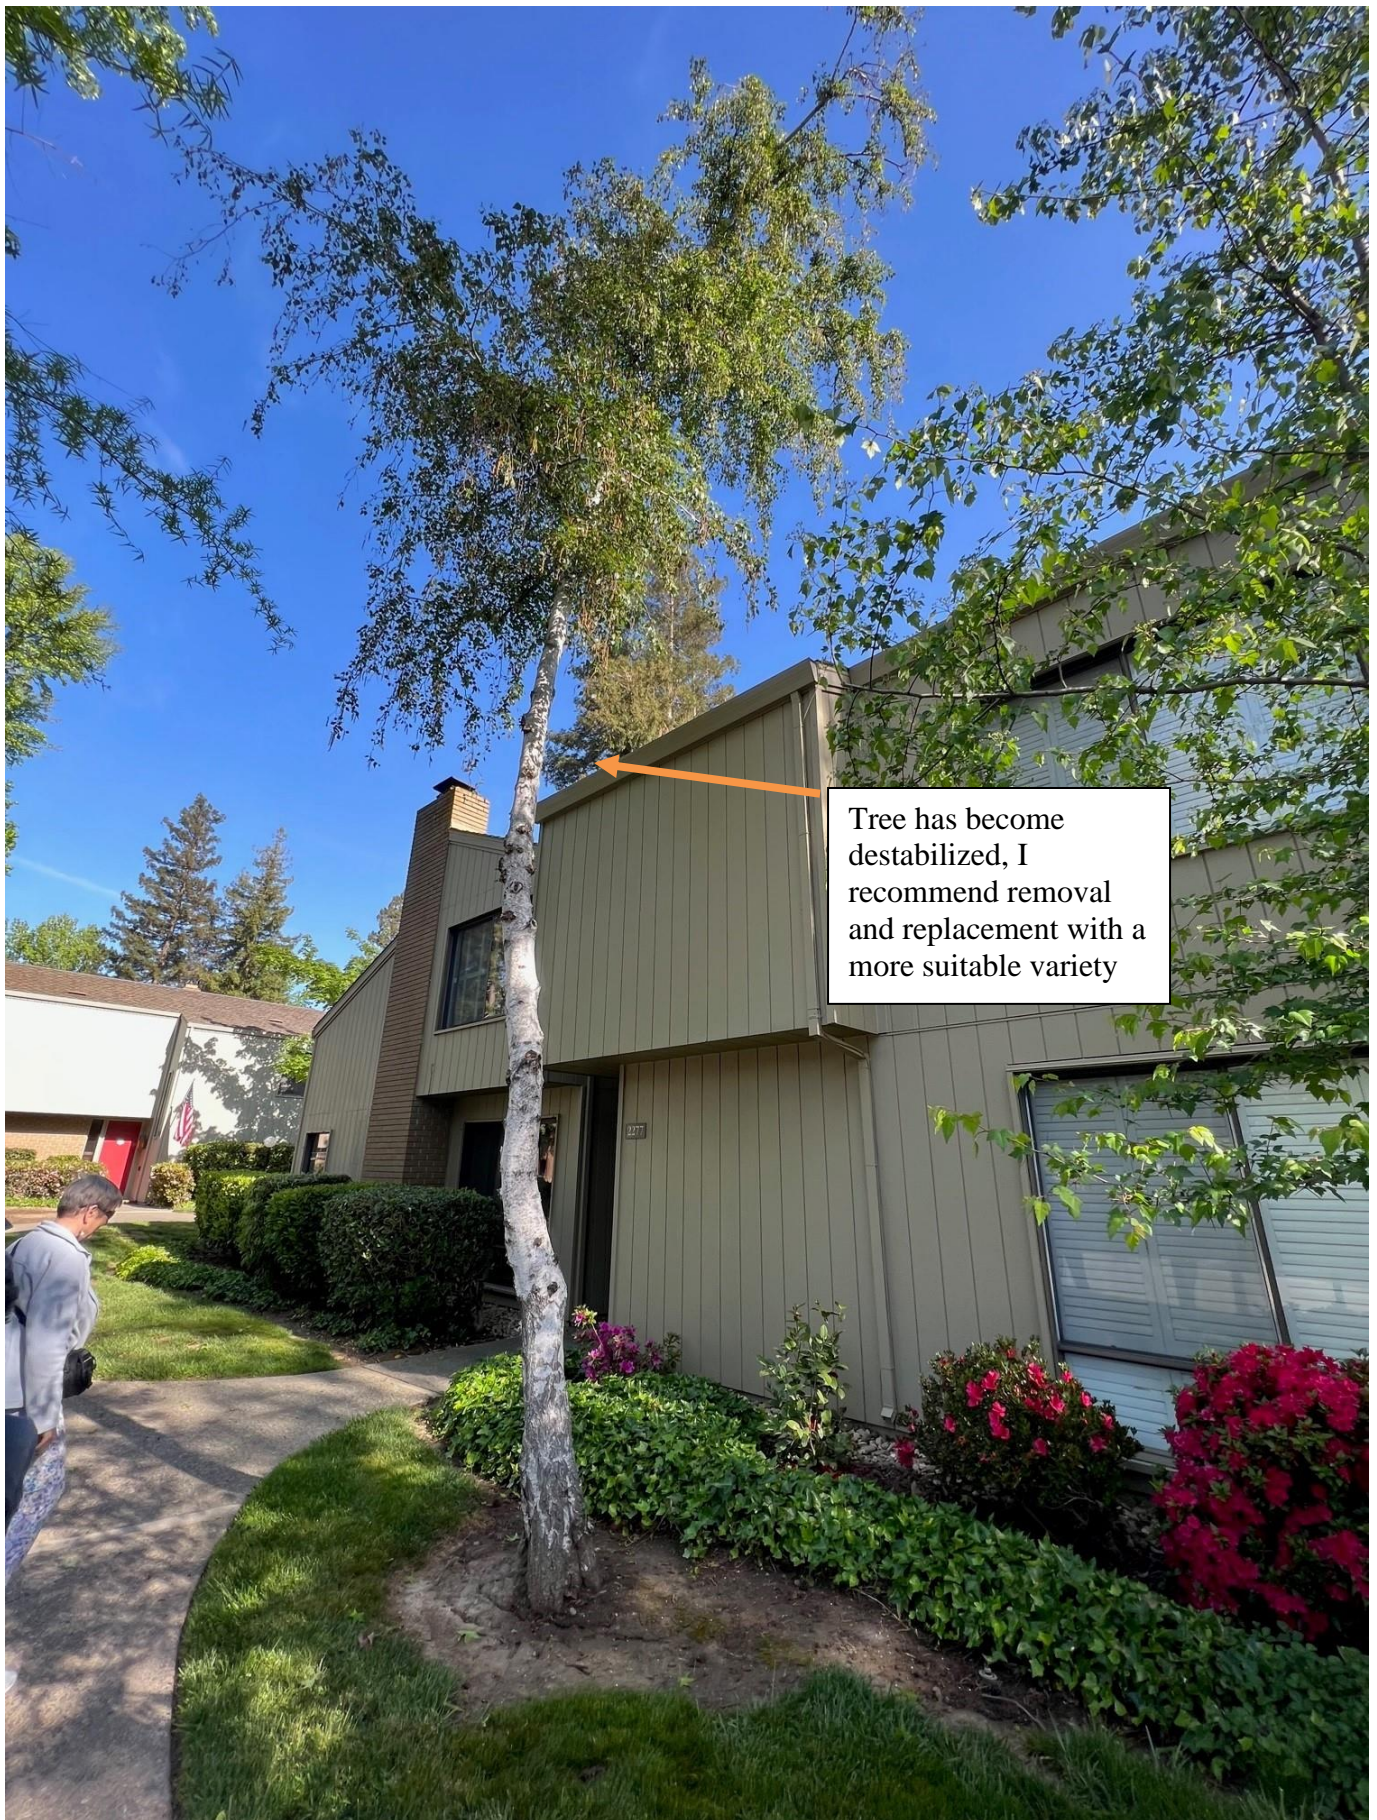
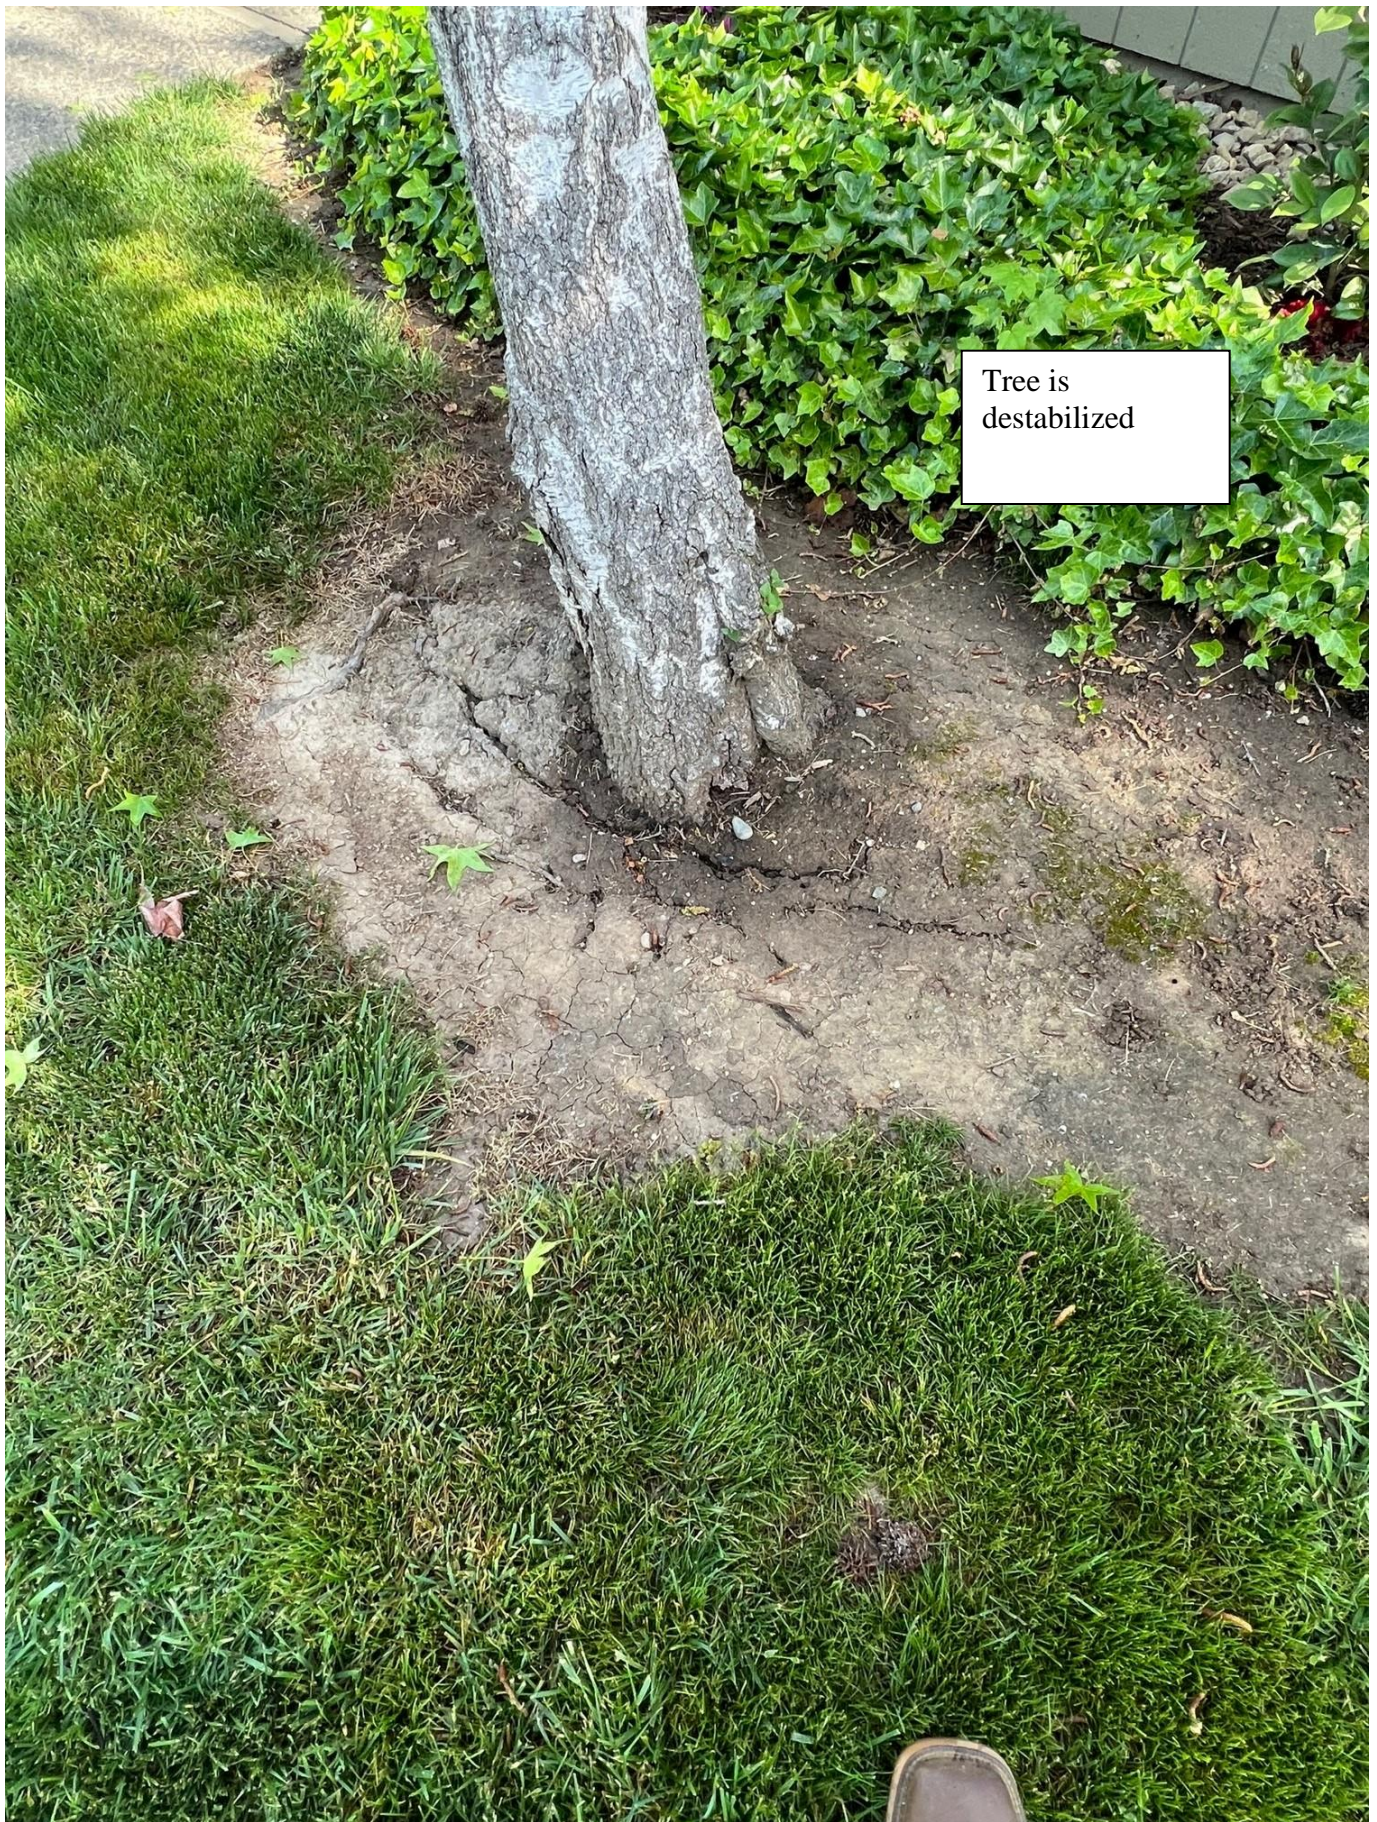
- (Zone 2) Tree #No Tag Birch (*Betula pendula*) In front of 2277 Swarthmore Dr. The tree has become destabilized at the base and is at risk of failure. I recommend removal due to a safety risk (Figure 1-2).

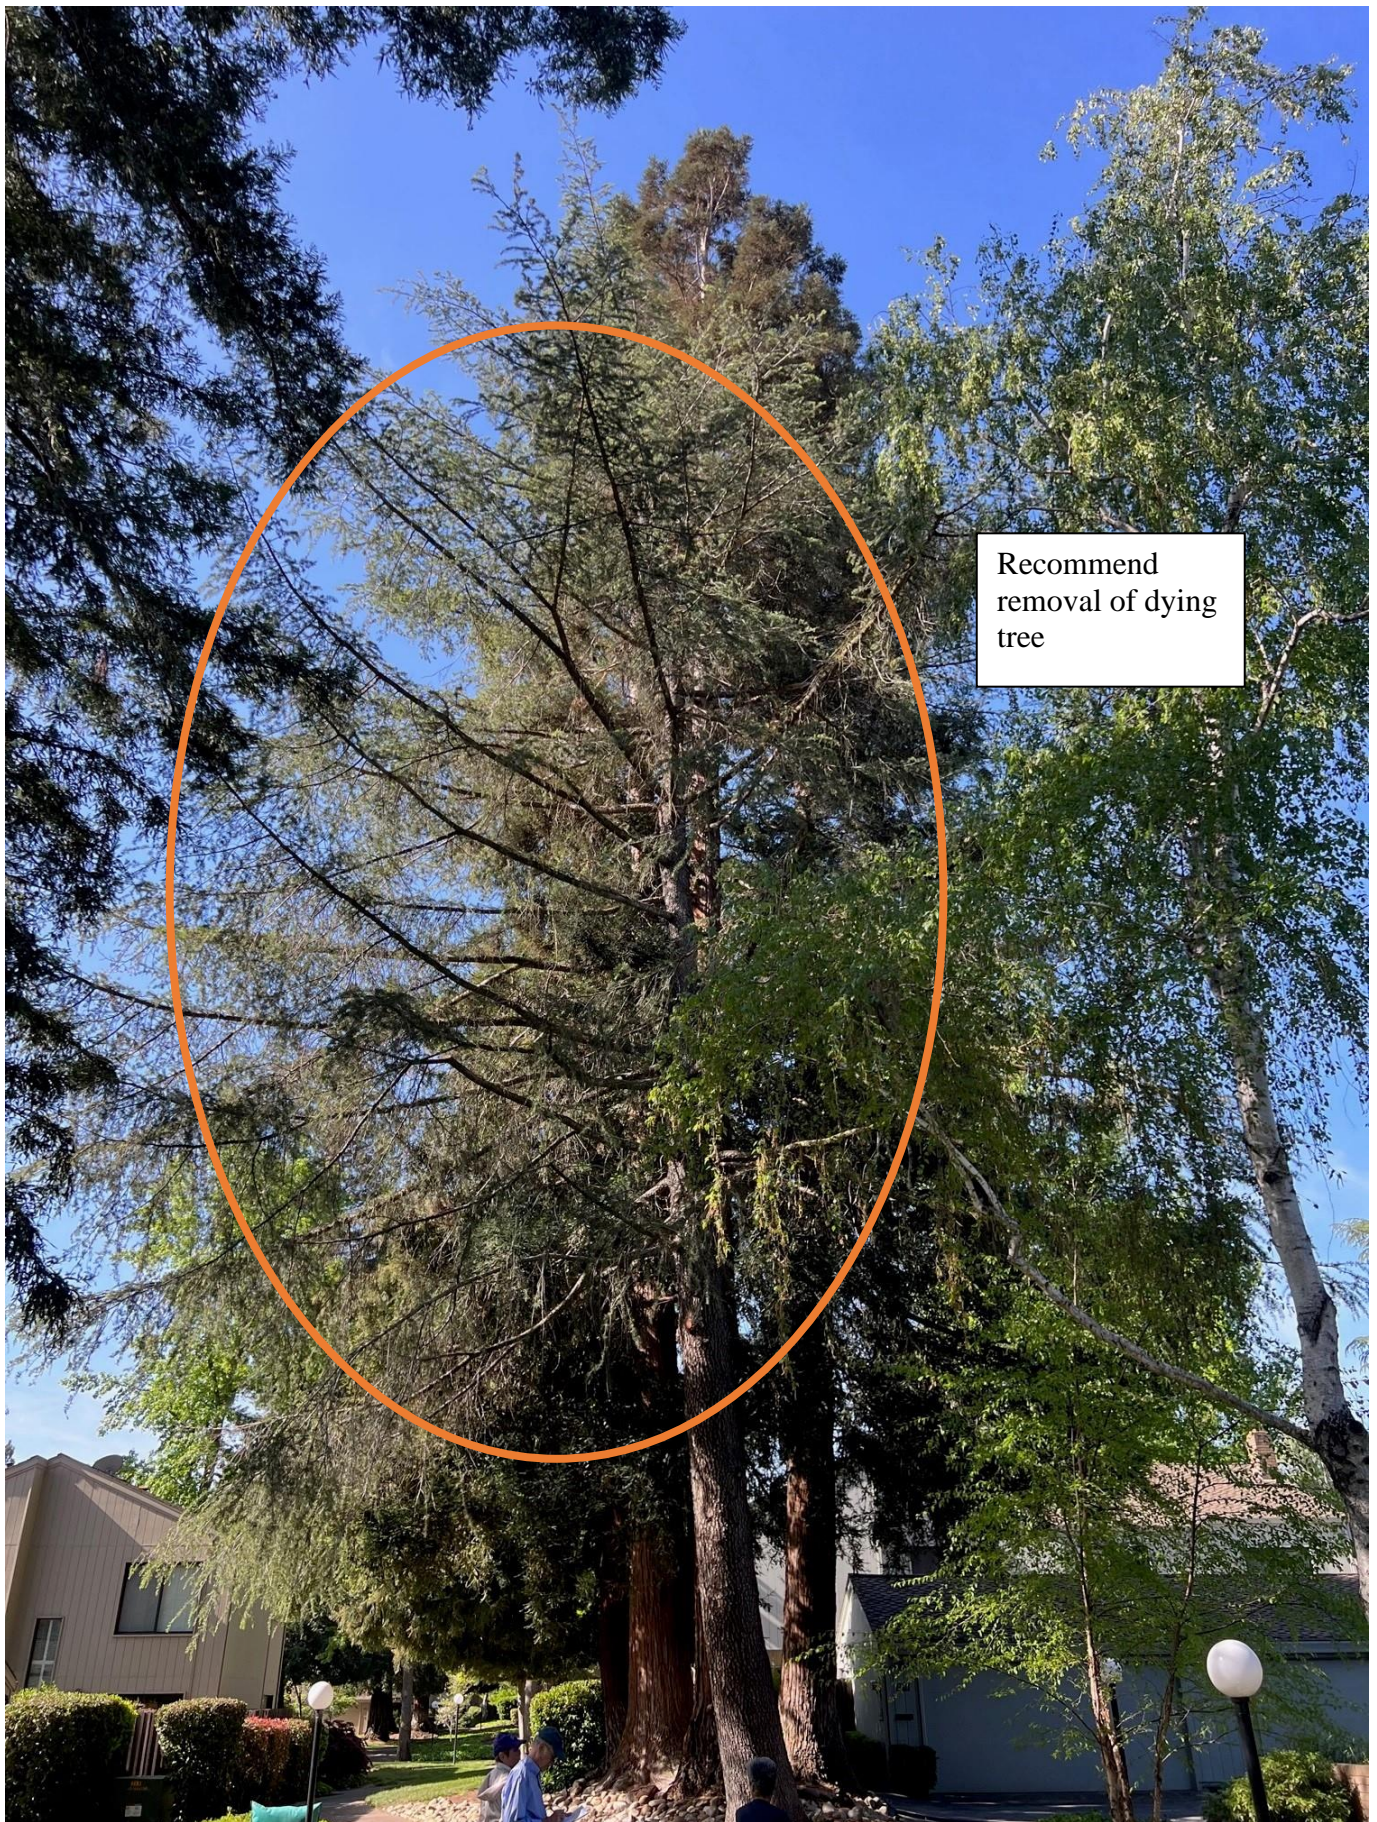
Figure 3

- (Zone 2) Tree #412 Cedar (*Cedrus deodara*) near to 2265 Swarthmore Dr. The tree is in a narrow planter with several larger redwoods, and due to the limited rooting and growing space the tree has started to decline due to nutrient and light competition. The trees canopy is sparse and has a noticeable amount of deadwood throughout the canopy. This tree will continue to decline. I recommend removal due to a safety risk (Figure 3).

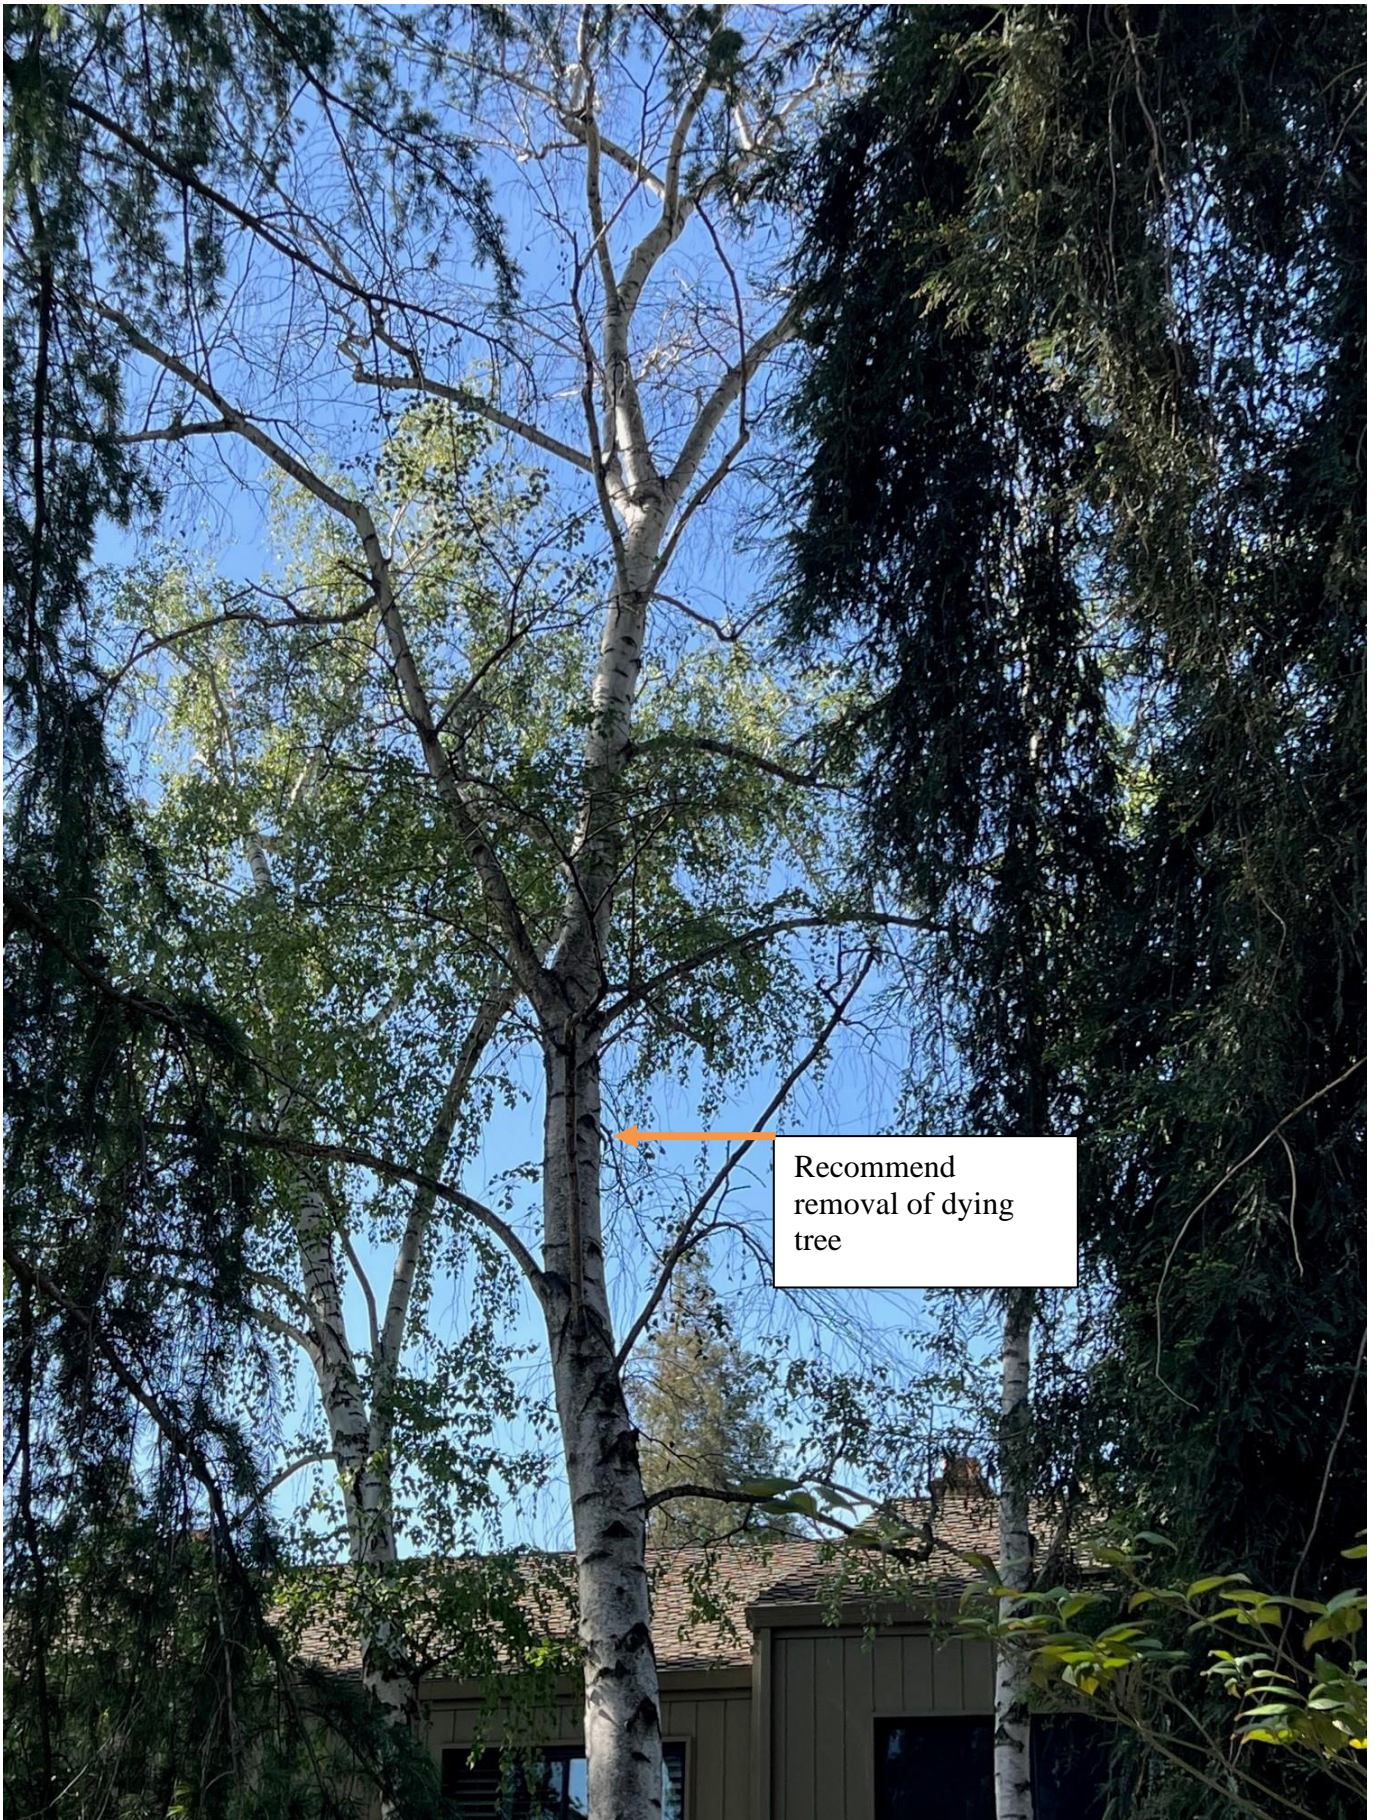
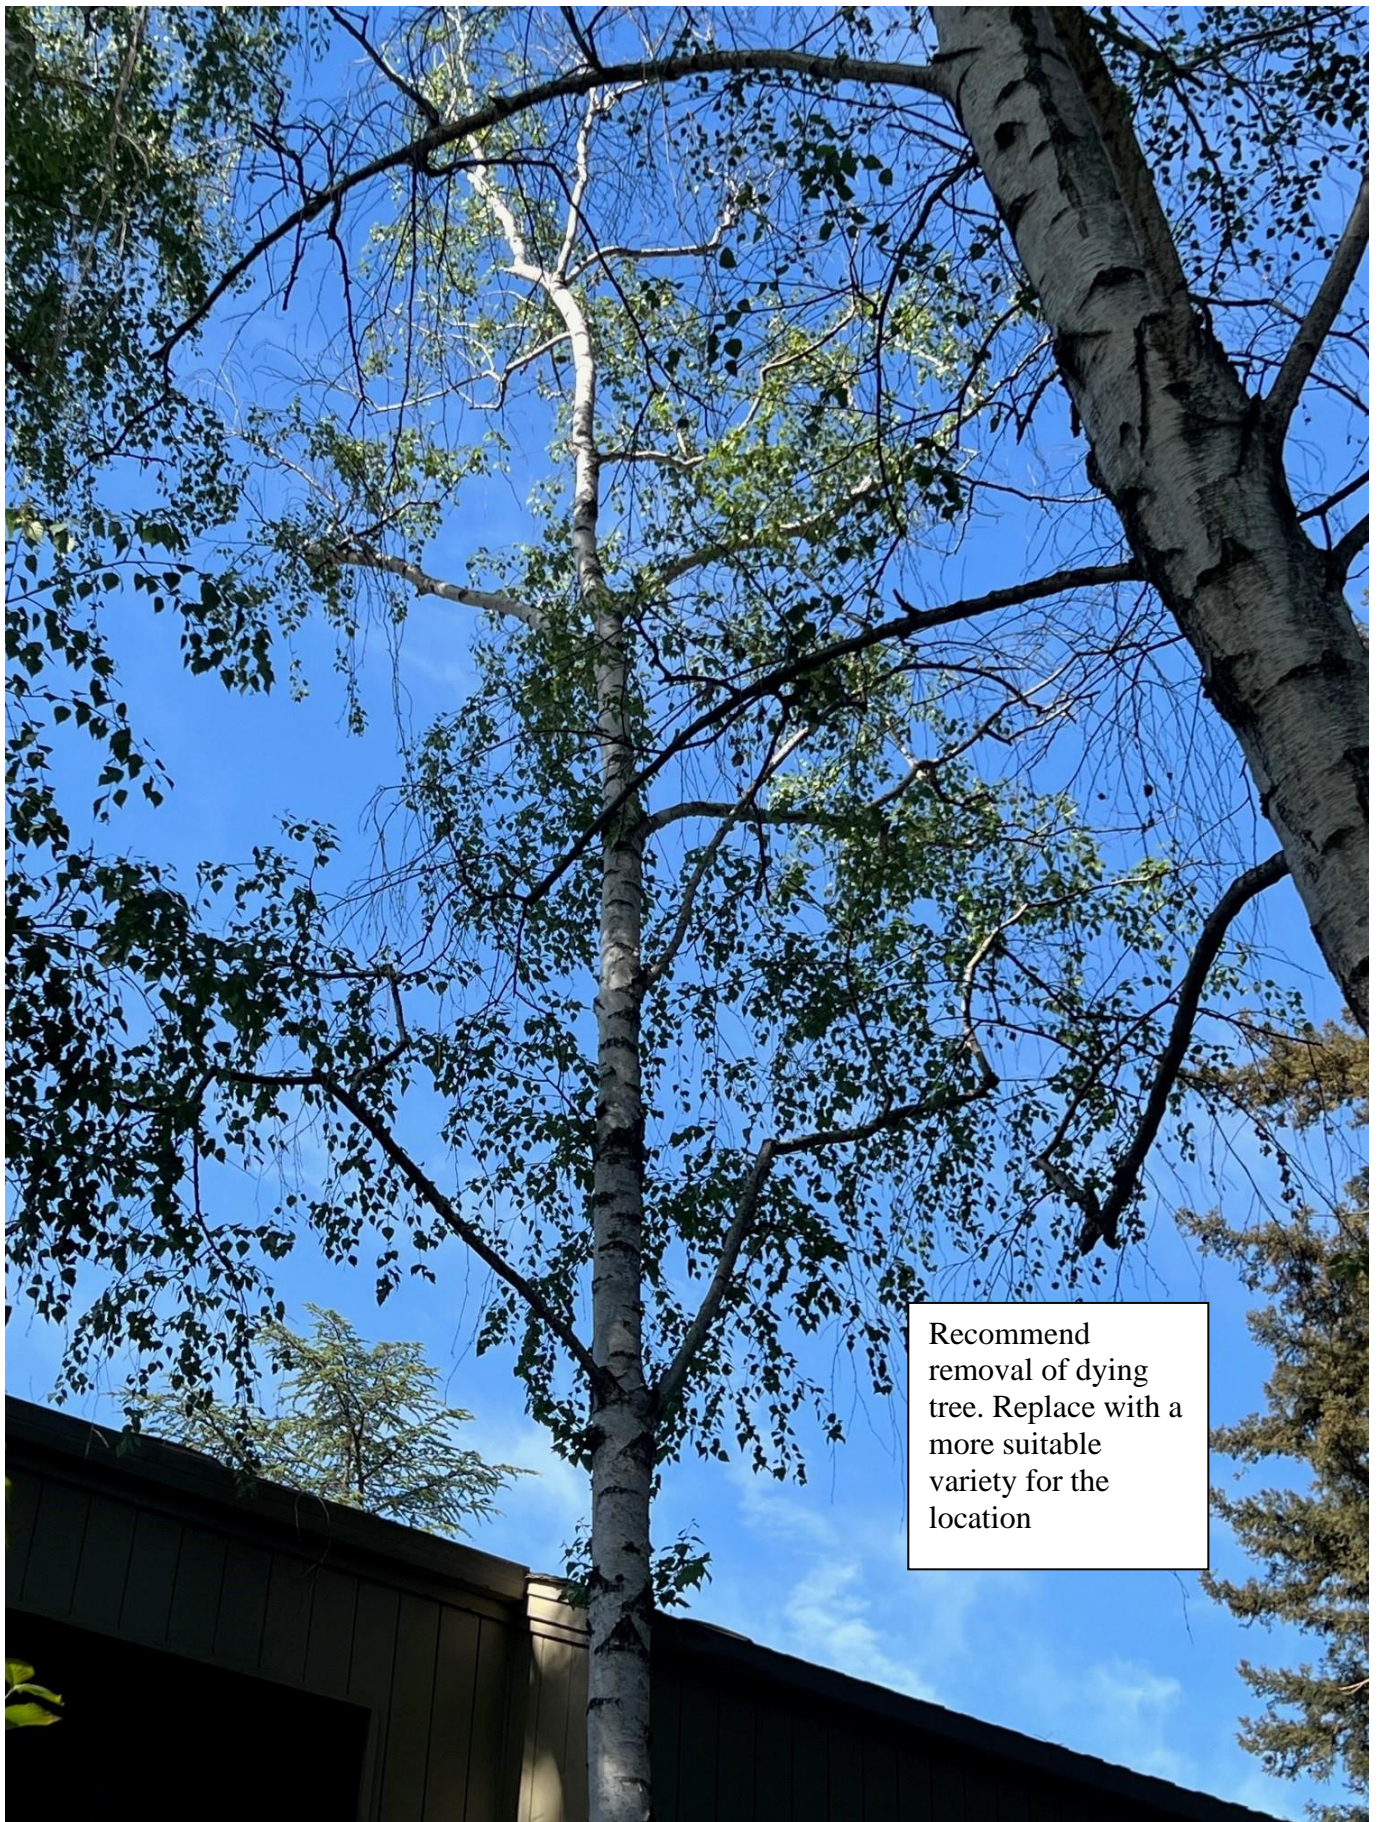
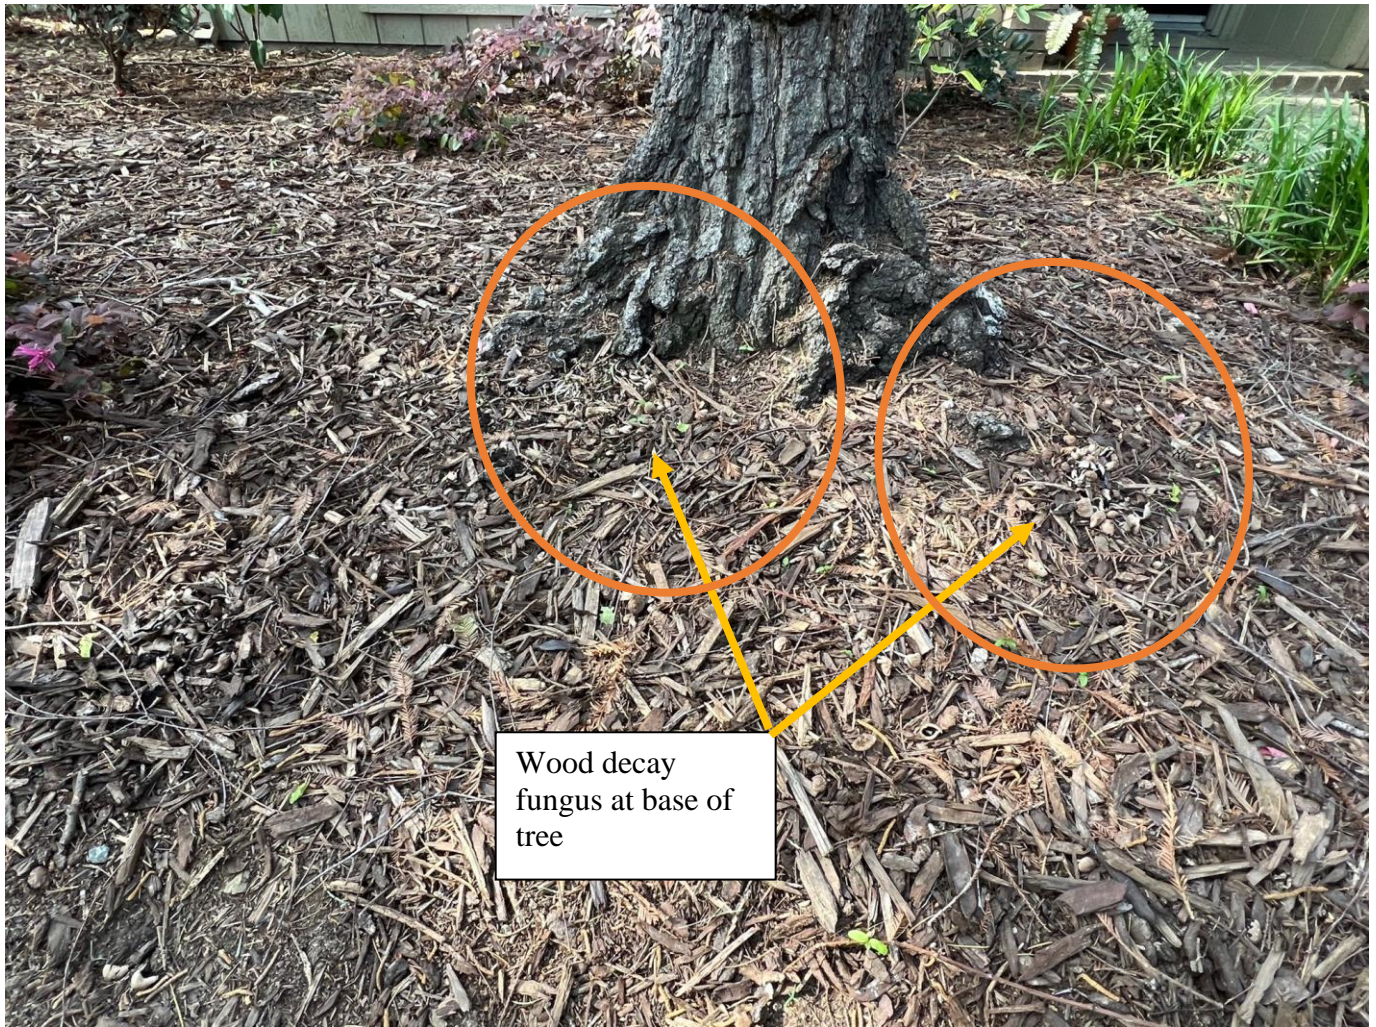
- (Zone 2) 2 Trees #461, #80 Birch (*Betula pendula*) In landscape area near 2236 Swarthmore Dr. The tree closet to 2236 has been in decline for some time, there is wood decay fungus present on the trunk of the tree. And the larger tree in the landscape area is 95% dead. I recommend removal of both trees due to a safety risk (Figure 4-6).

Recommend removal of dying tree. Replace with a more suitable variety for the location

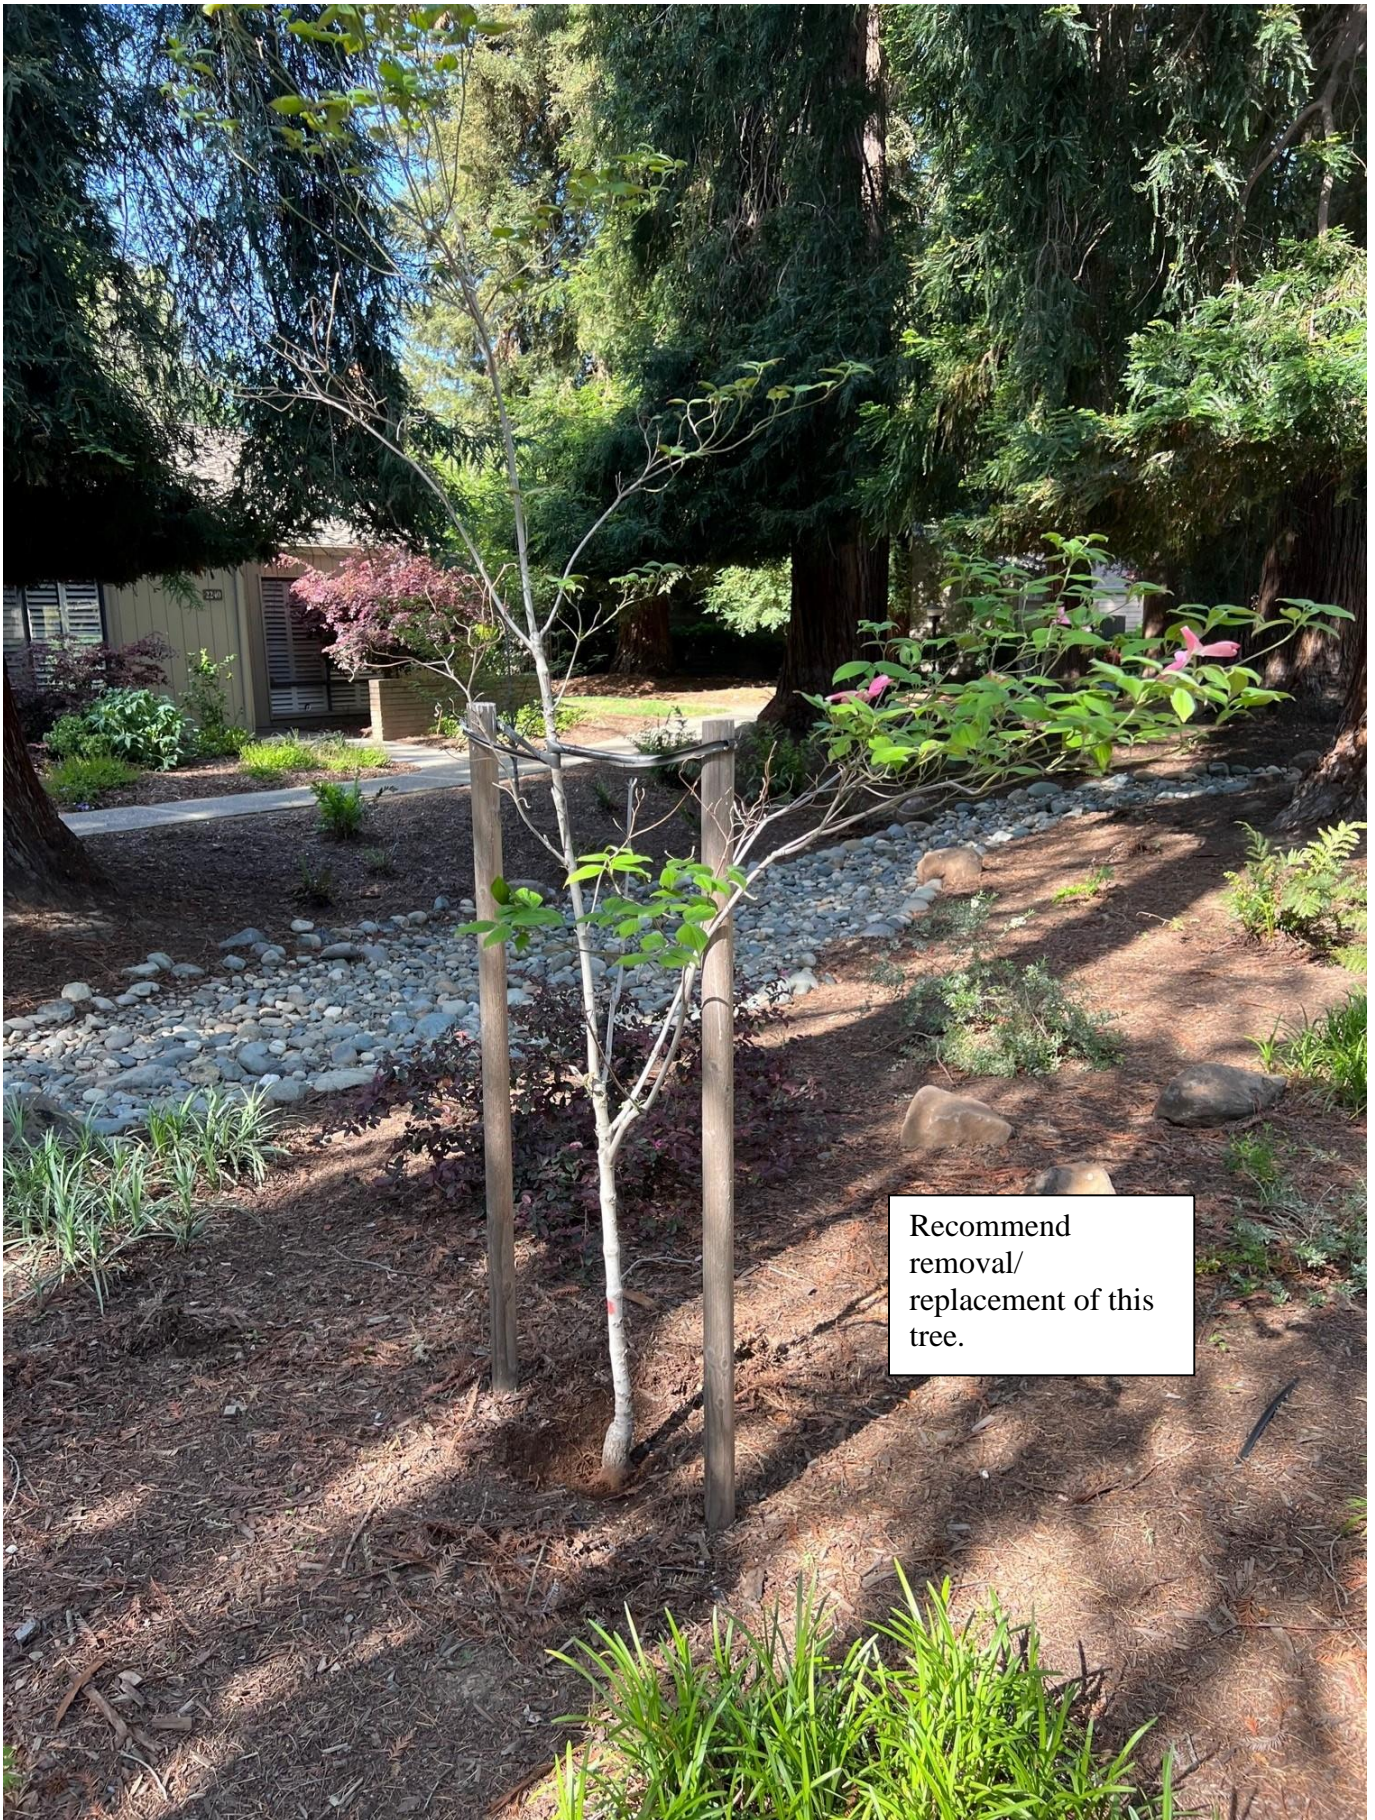
Figure 7

- (Zone 2) Tree #No Tag Dogwood (*Cornus florida*) In front of 2243 Swarthmore Dr. The tree was installed incorrectly, planted too deep causing the suffocation of the root flair. This tree has not performed since being planted and is severely stressed. I recommend removing this tree and replanting it with a healthier specimen (Figure 7-8).

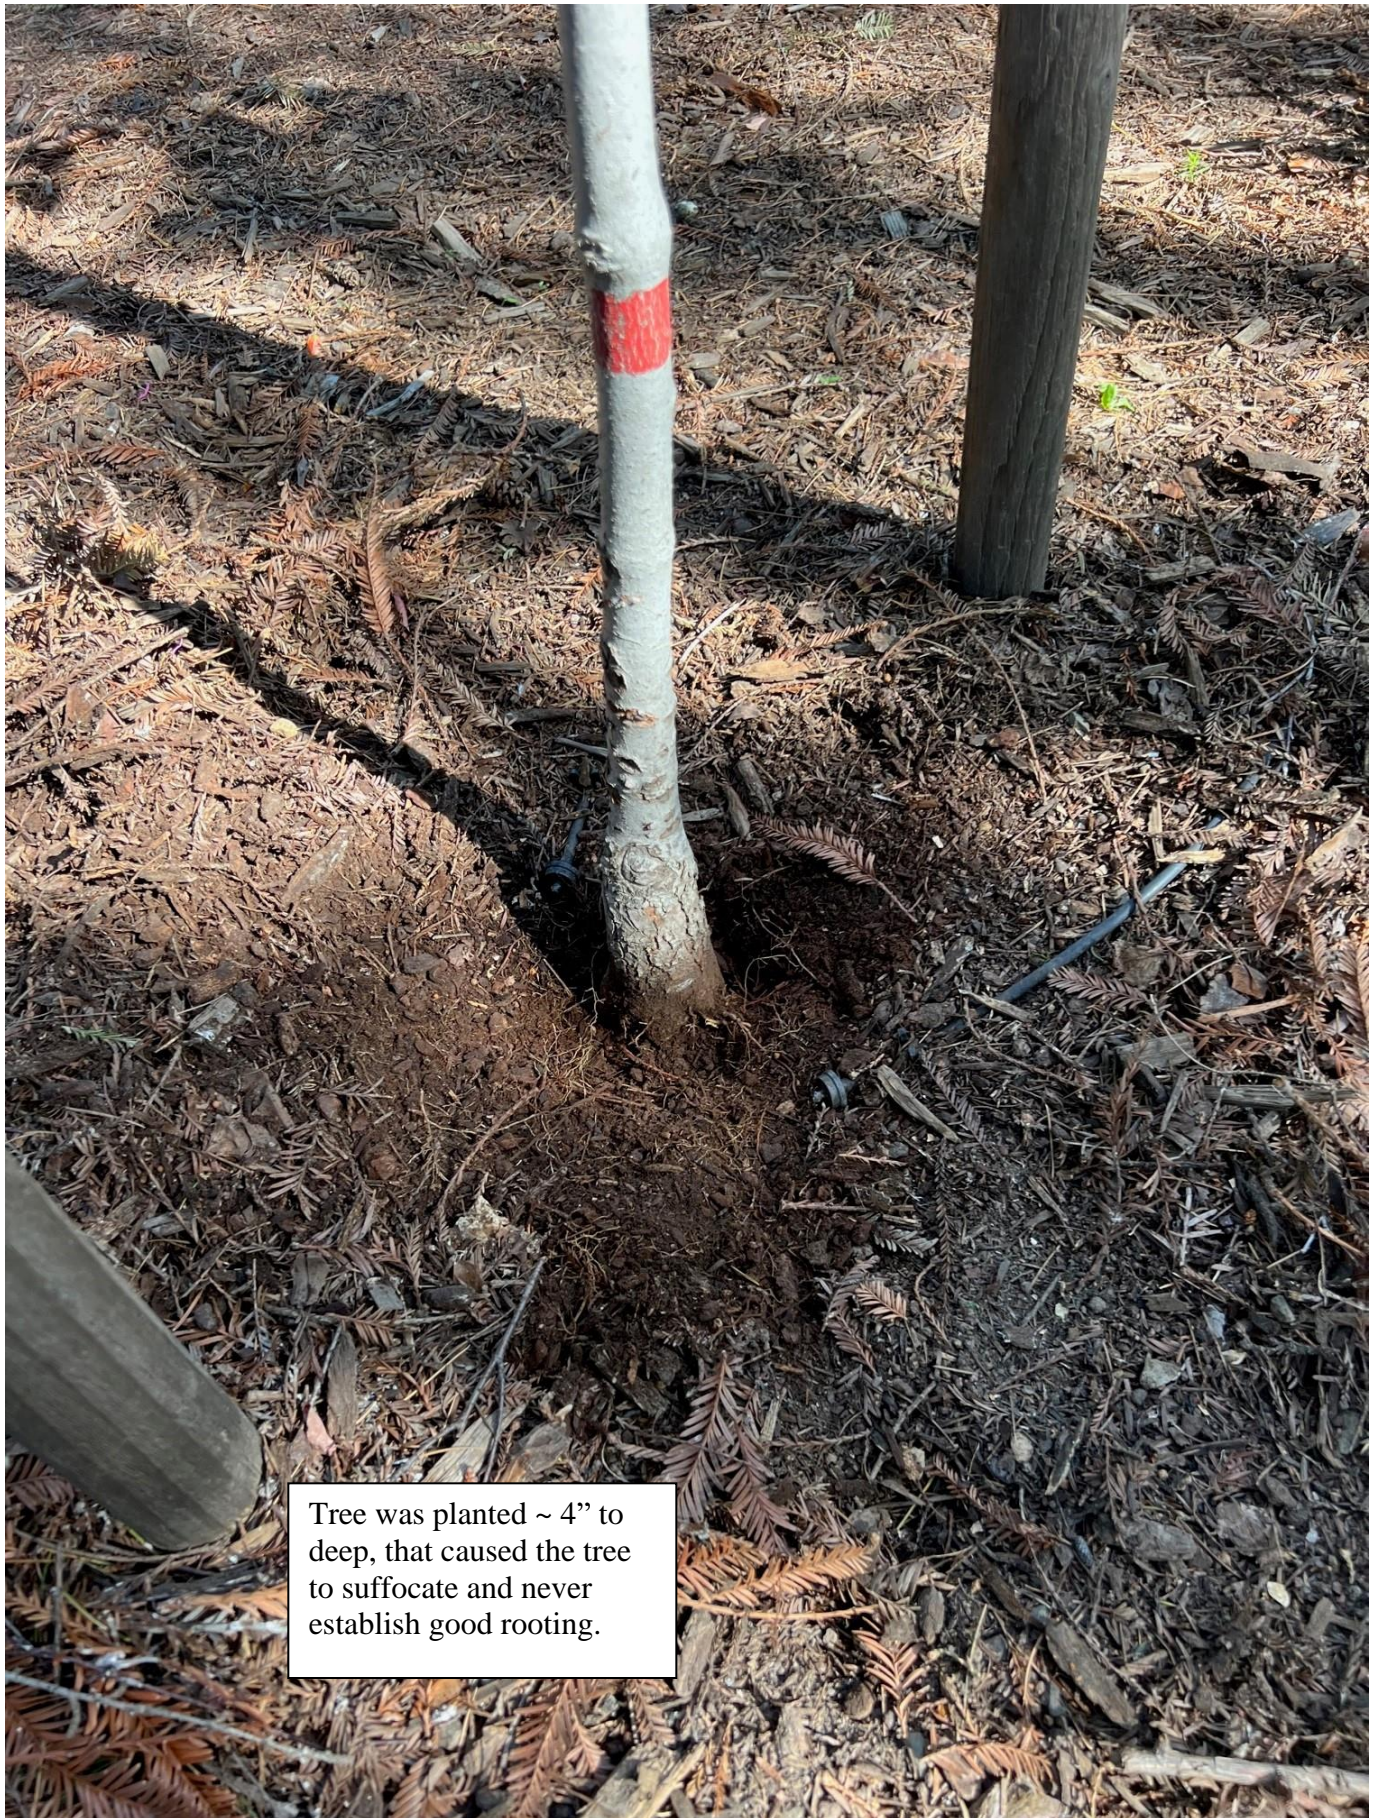
Figure 8

Tree was planted ~ 4" to deep, that caused the tree to suffocate and never establish good rooting.

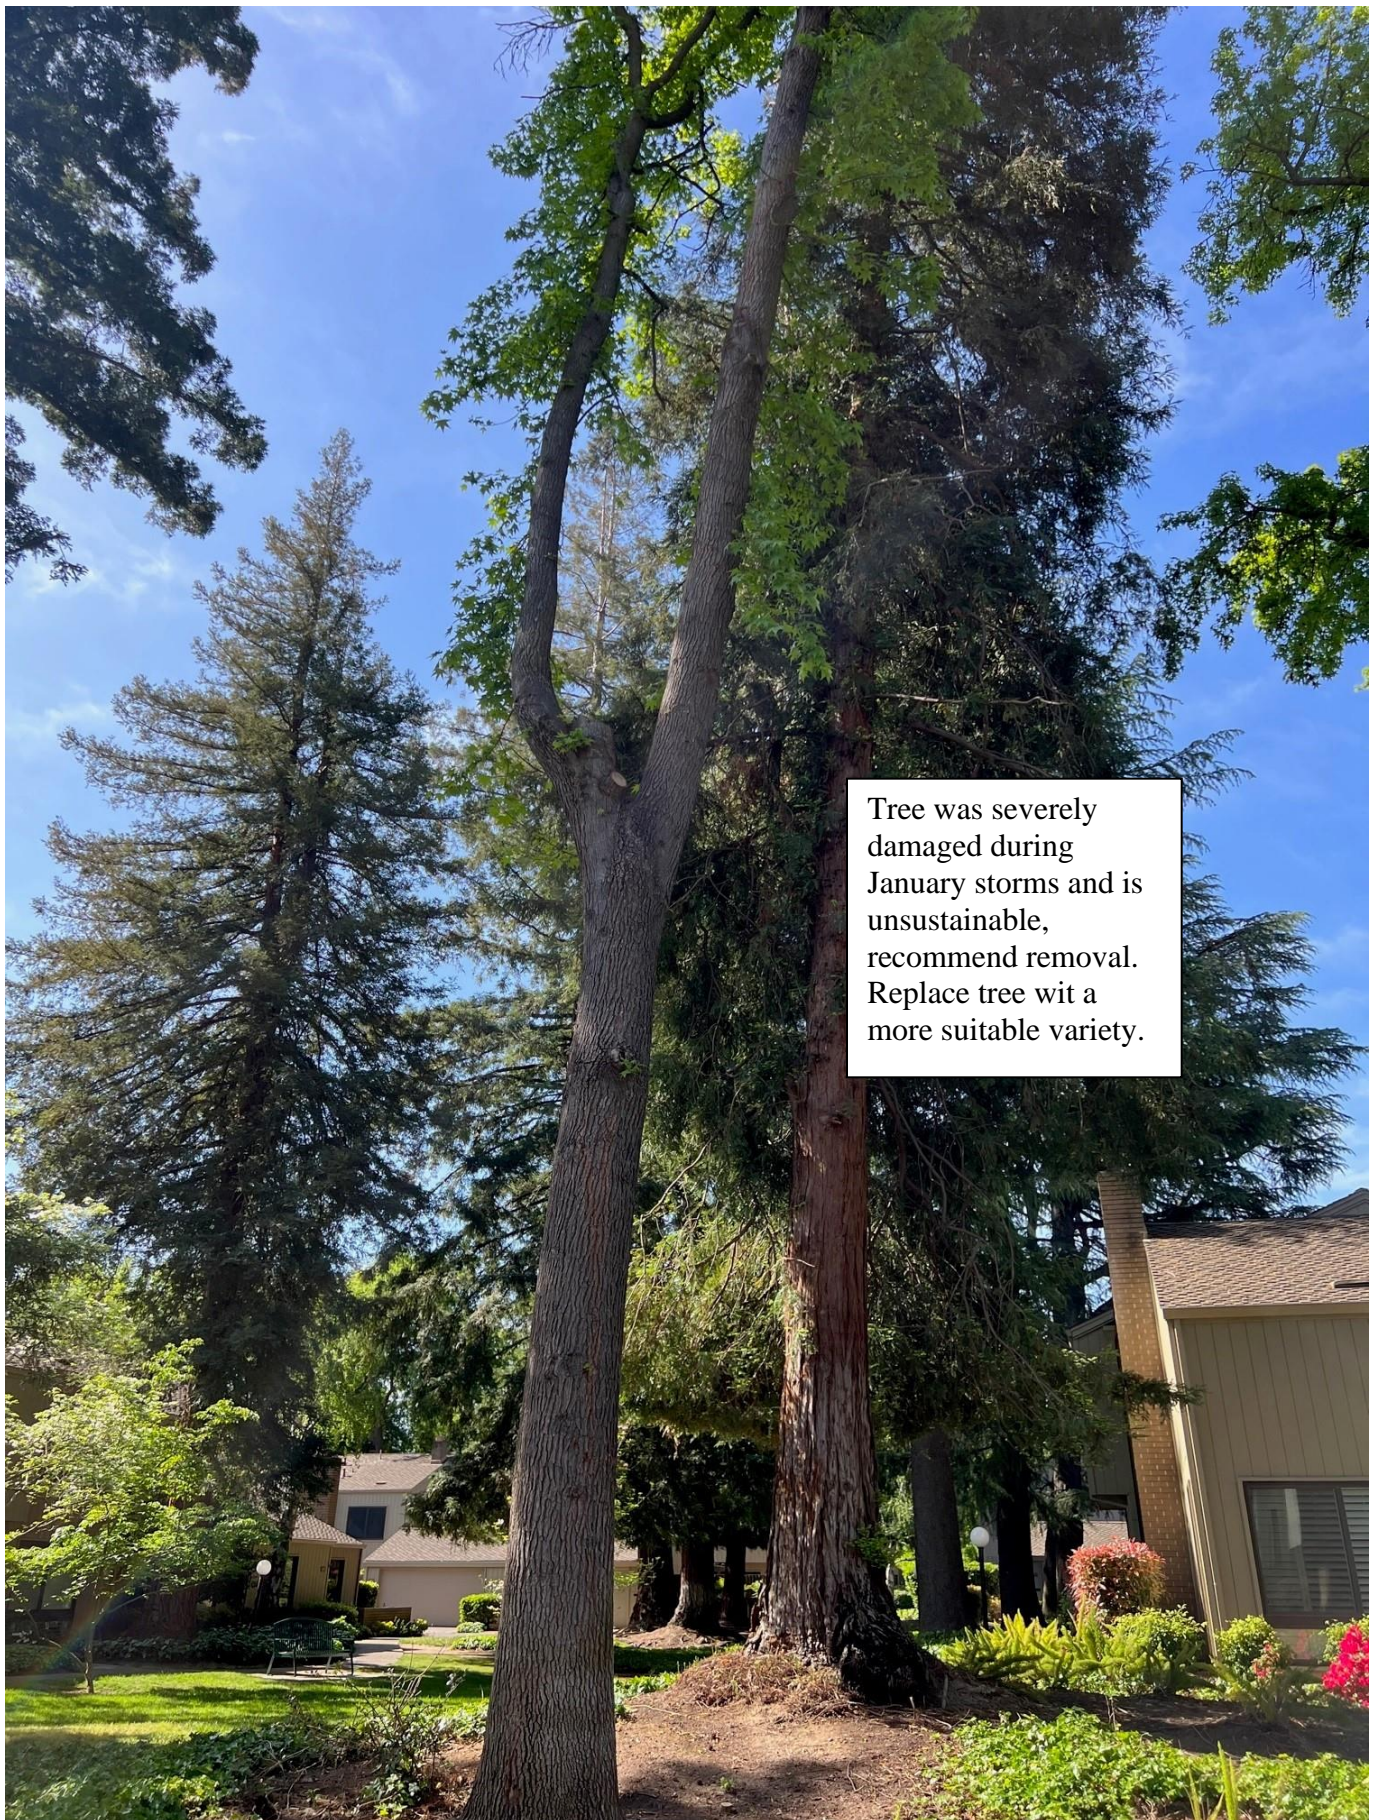
Figure 9

- (Zone 2) Tree #No Tag Liquid amber (*Liquidambar styraciflua*) In front of 2264 Swarthmore Dr. The tree had been severely damaged during the January storms by another tree that fell into it. The tree is no longer viable in its current state and poses a safety risk to the property. I recommend removal due to a safety risk (Figure 9).

Tree was severely damaged during January storms and is unsustainable, recommend removal. Replace tree with a more suitable variety.
