May 10, 2023

The Nepenthe Association  
1131 Commons Dr.  
Sacramento, CA 95825  
Phone: (916) 929-8380  
Email: [Nepenthe.HOA@fsresidential.com](mailto:Nepenthe.HOA@fsresidential.com)

On April 24, 2023 I inspected several trees on the Nepenthe property during the monthly tree walk. The focus of the walk was to address resident/management concerns regarding mature trees on the property. The purpose of this report is to develop mitigation plans for the following trees and my recommendations are below. My recommendations are based on a Basic Visual Inspection. All decisions made based on the recommendations of this report are at the discretion of the Nepenthe Association.

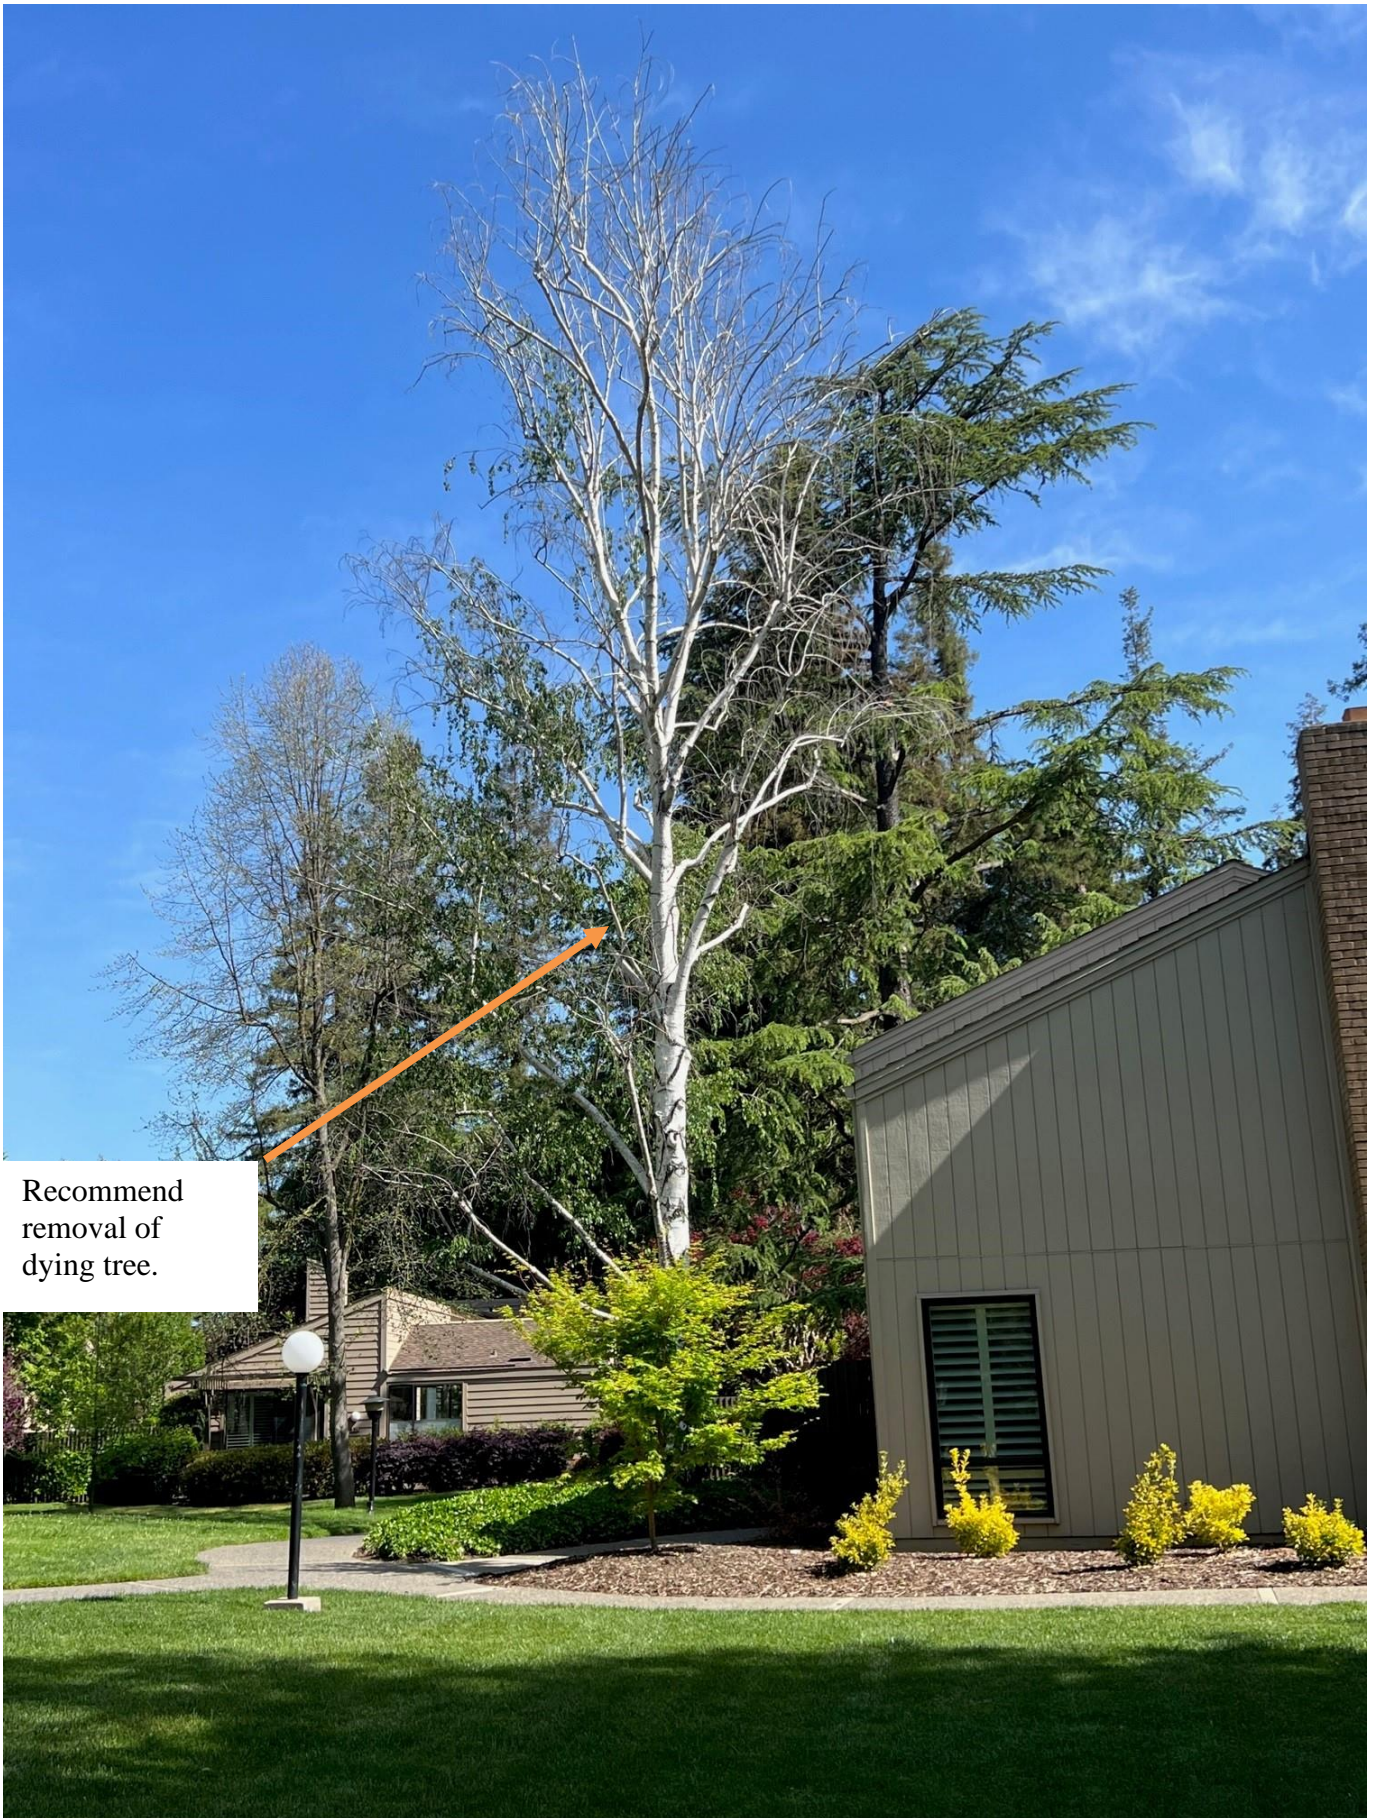
Figure 10

- (Zone 2) Tree #529 Tag Birch (*Betula pendula*) In front of 2242 Swarthmore Dr. The tree is 95% dead and is at risk of failure. I recommend removal due to a safety risk (Figure 10).

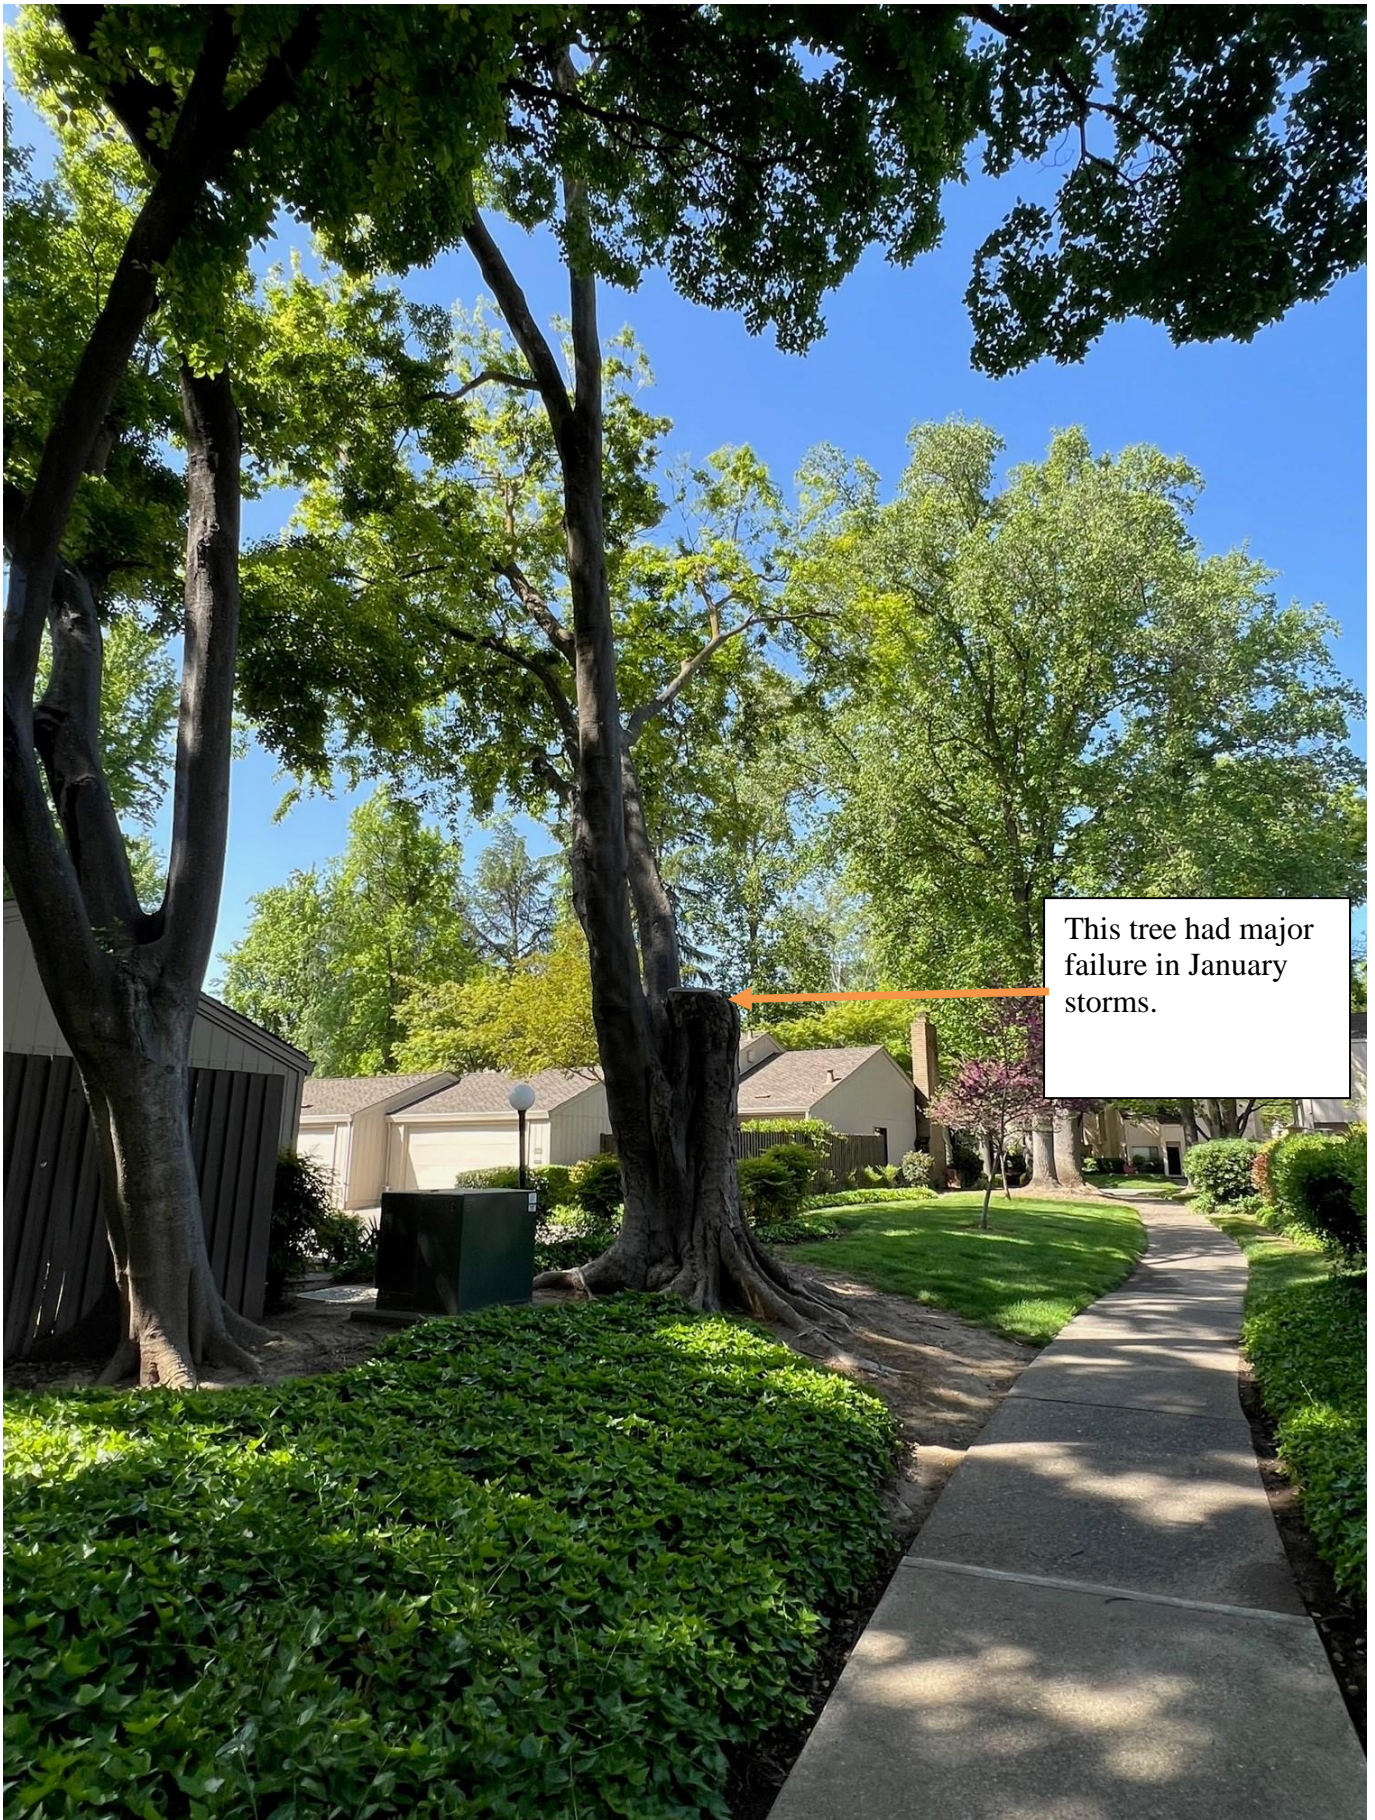
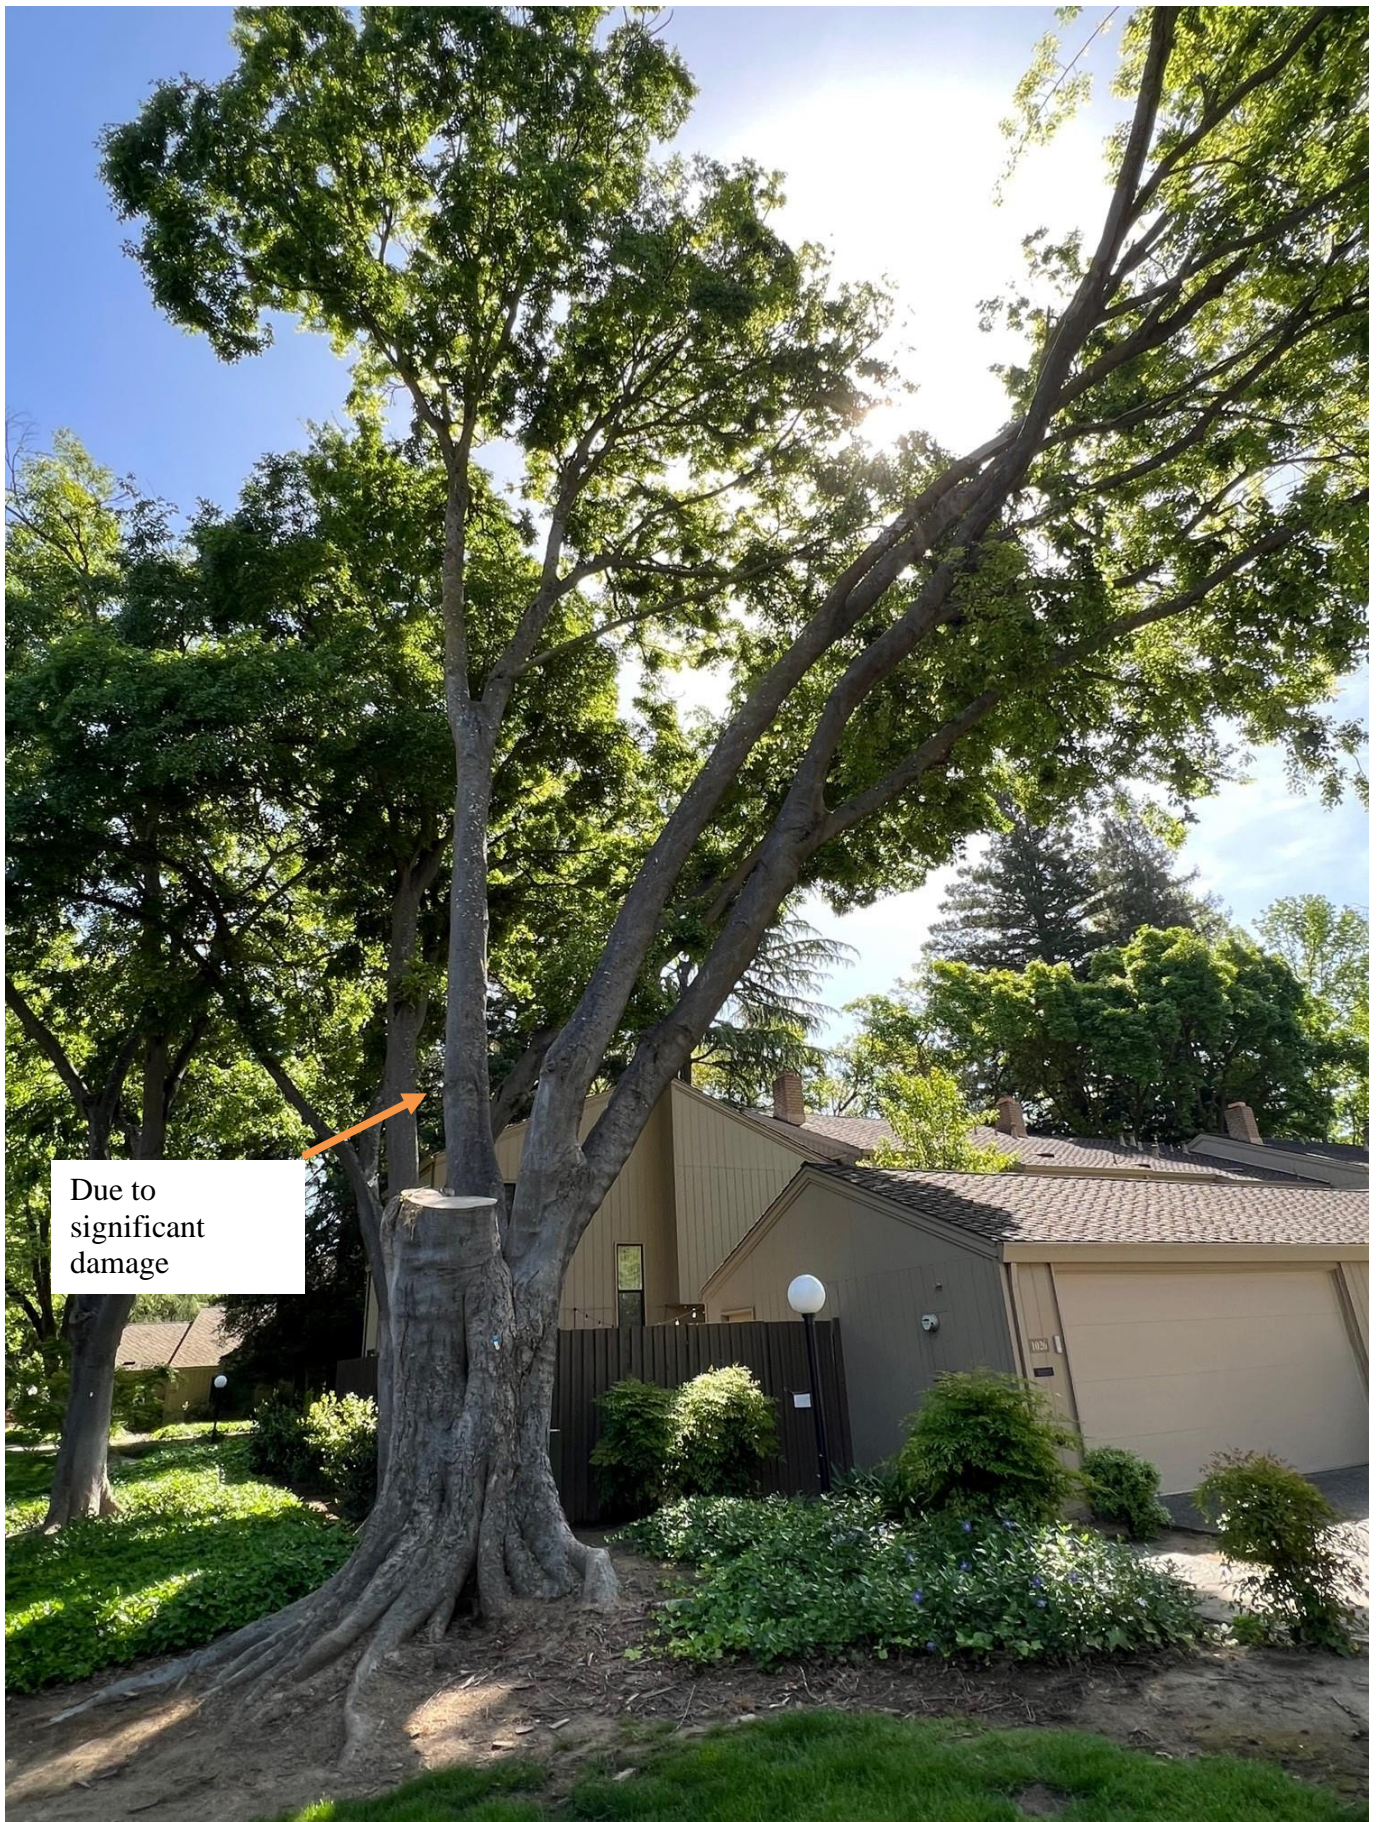
- (Zone 2) Tree #659 Hackberry (*Celtis occidentalis*) Next to 1026 Vanderbilt Dr. The tree had been severely damaged during the January storms. The tree is no longer viable in its current state and poses a safety risk to the property. I recommend removal due to a safety risk (Figure 11-12).

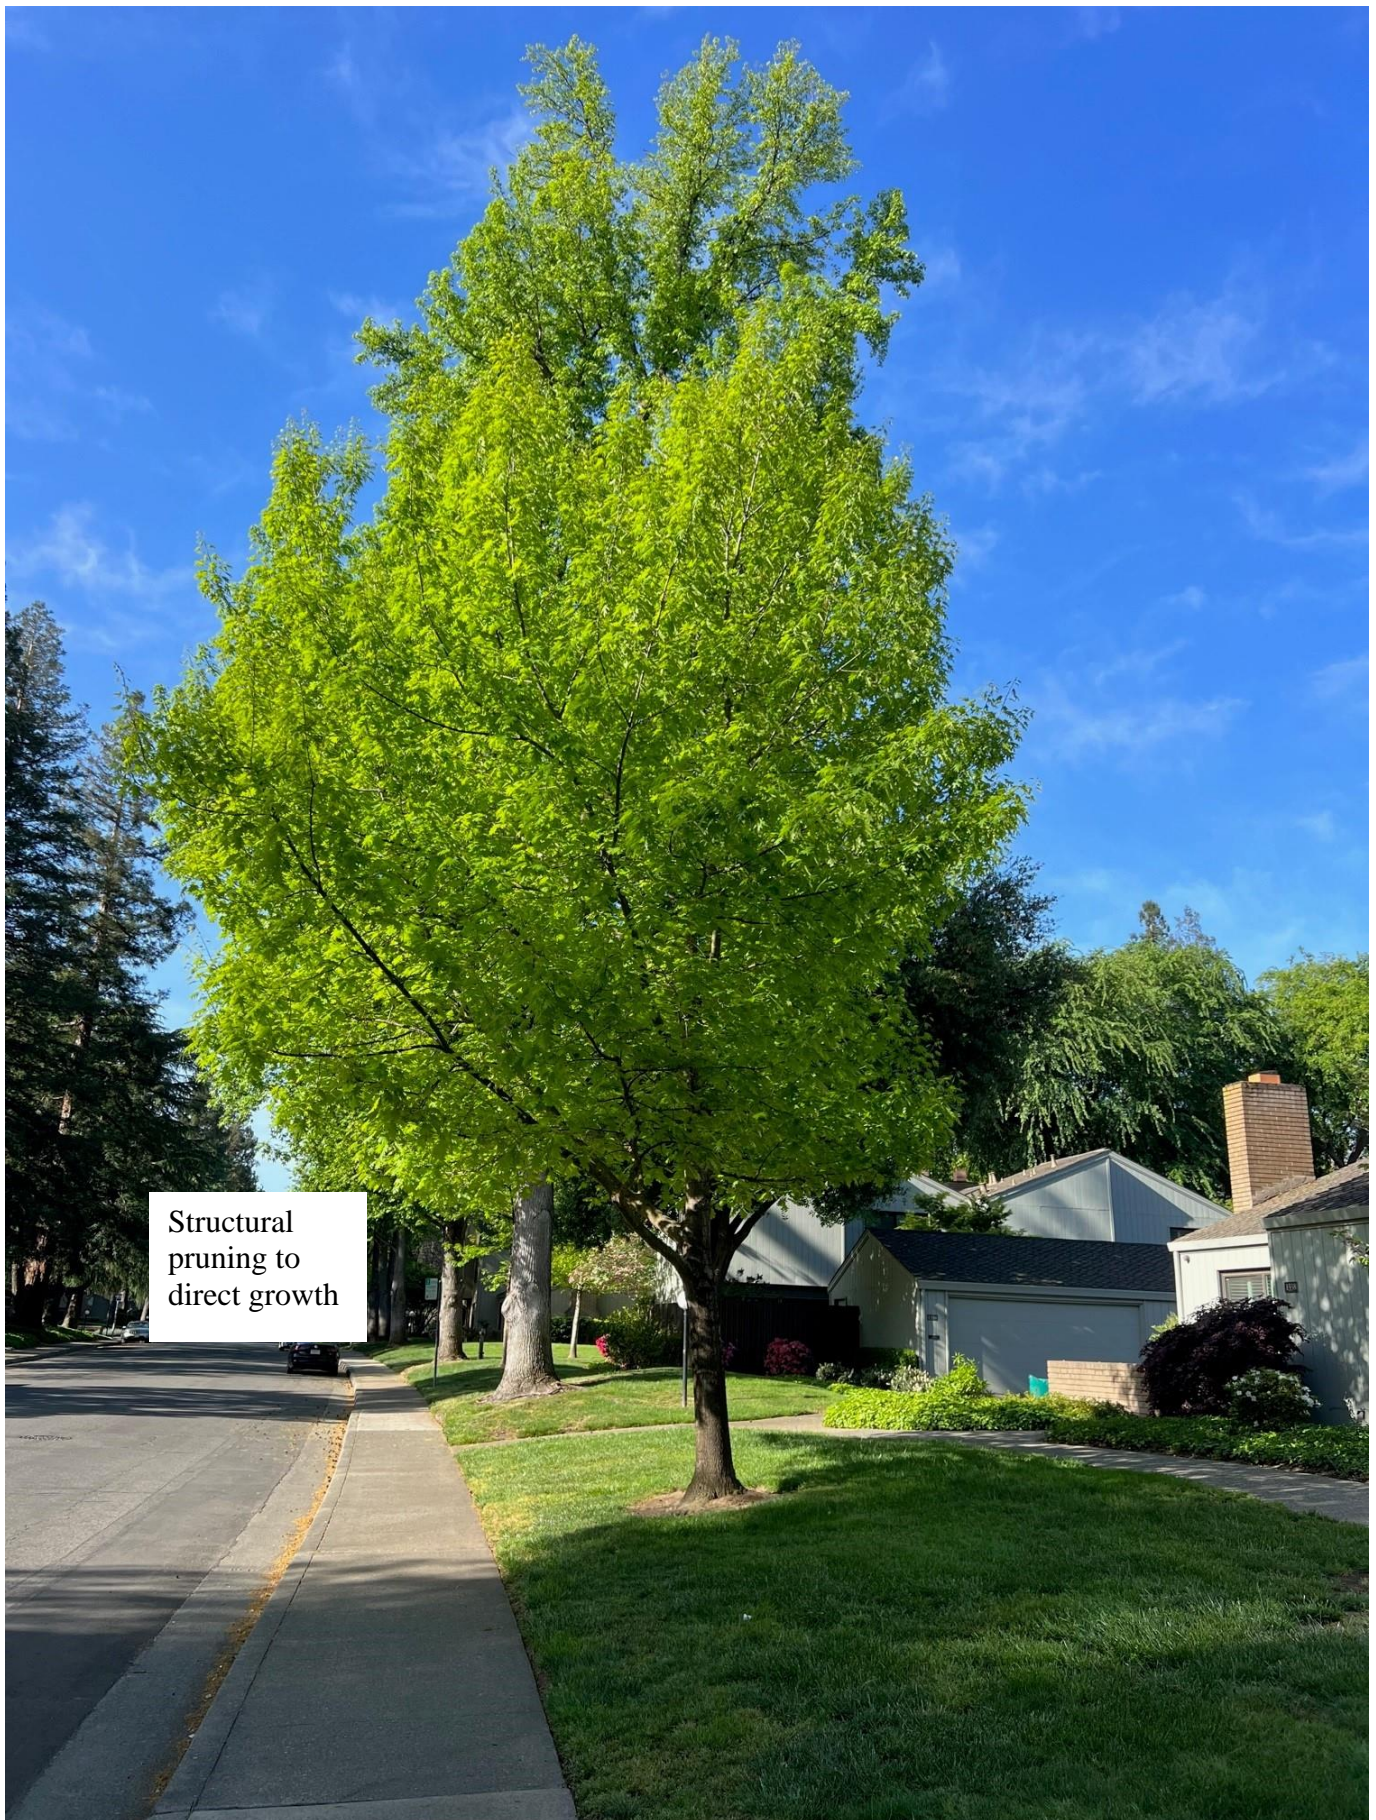
Figure 13

- (Zone 2) Tree #No Tag English Oak (*Quercus robur*), in front of 1334 Commons Dr. This tree will require structural pruning to help with direction of growth and healthy canopy development (Figure 13).

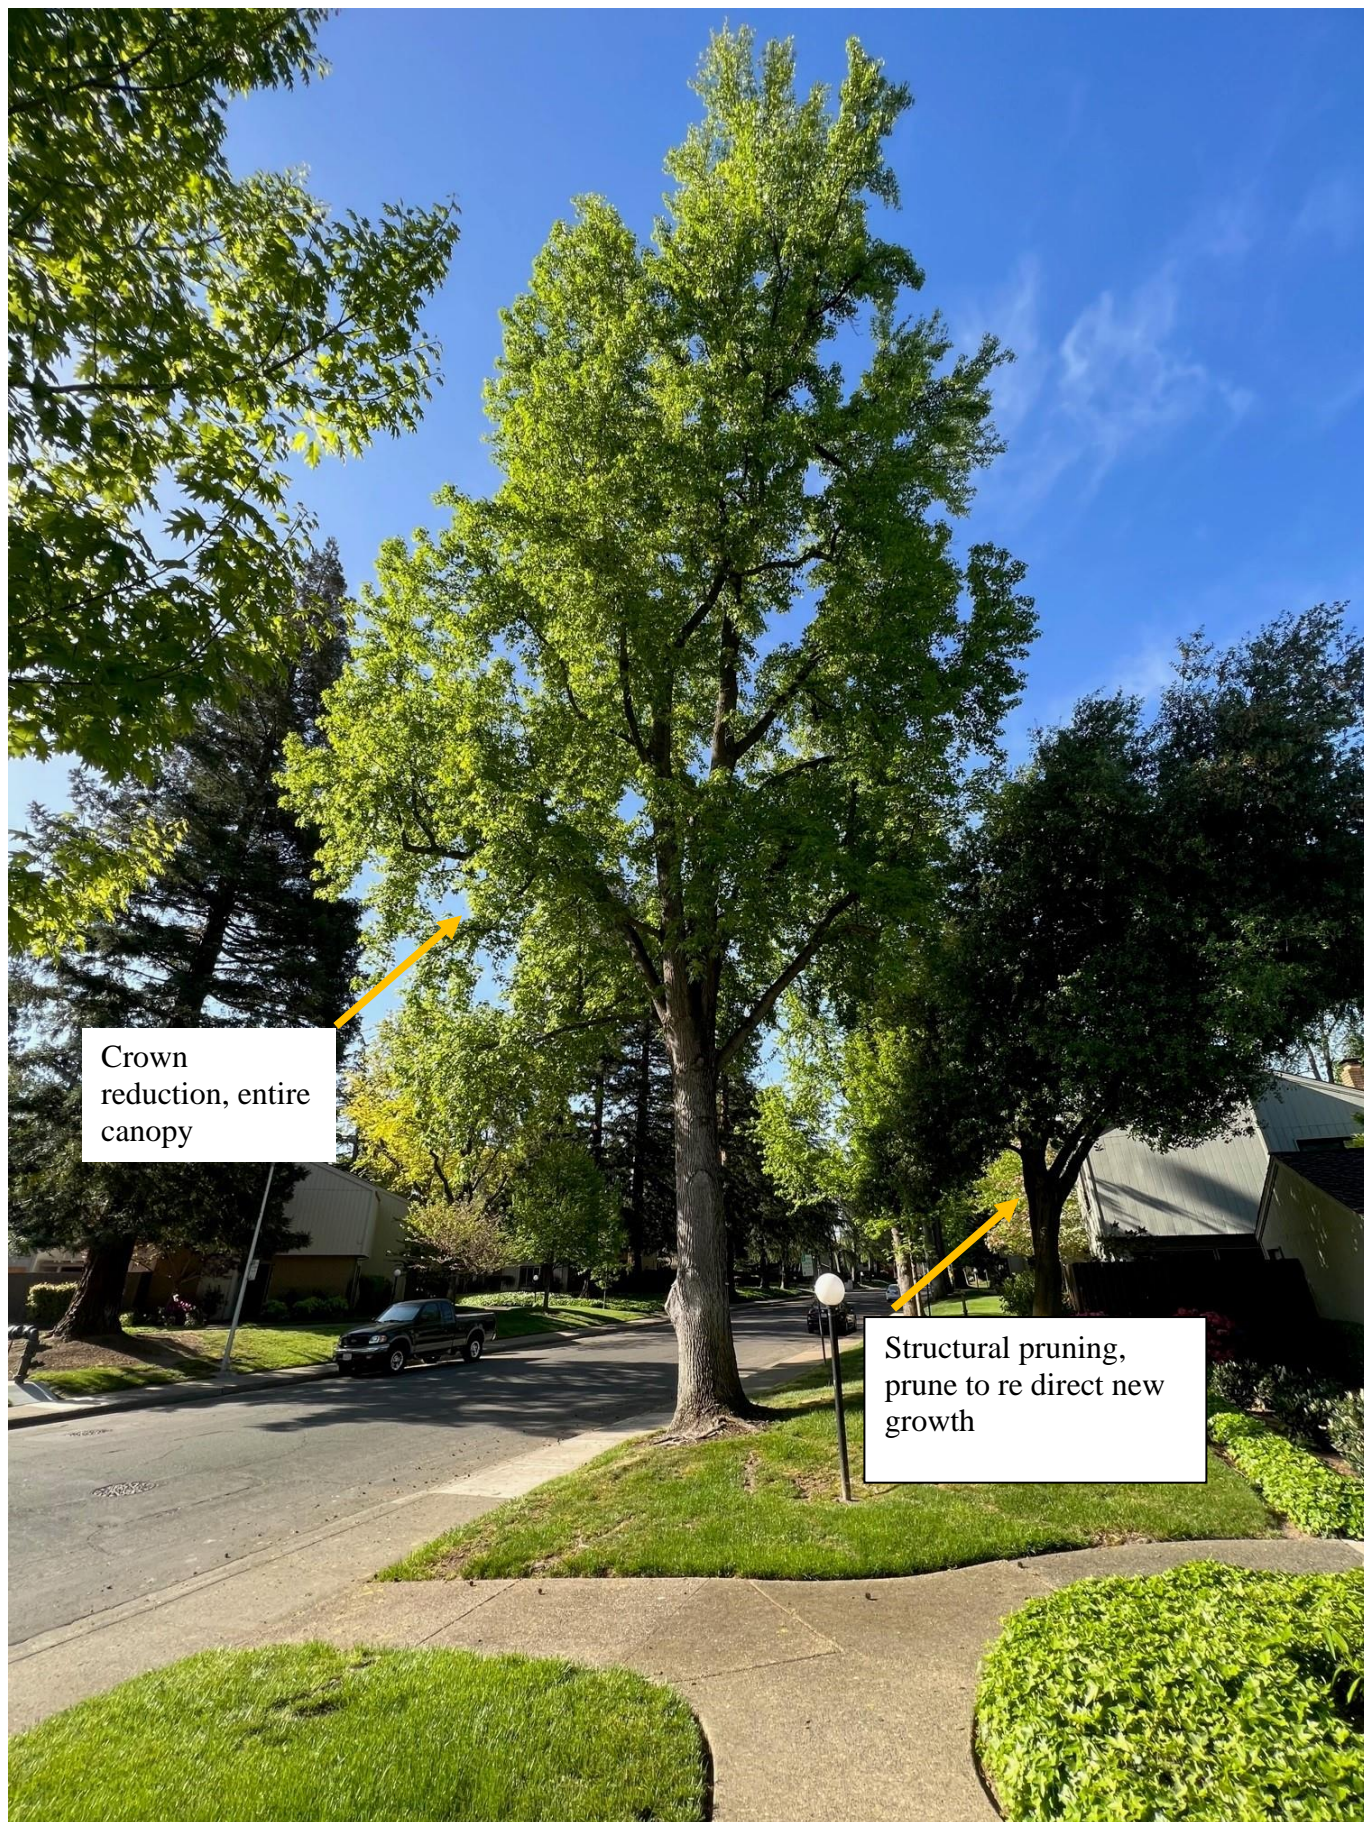
Figure 14

- (Zone 2) Tree #No Tag Liquid amber (*Liquidambar styraciflua*) In front of 1350 Commons Dr. This tree has an over weighted canopy and requires reduction pruning on branches throughout the tree canopy (Figure 14).

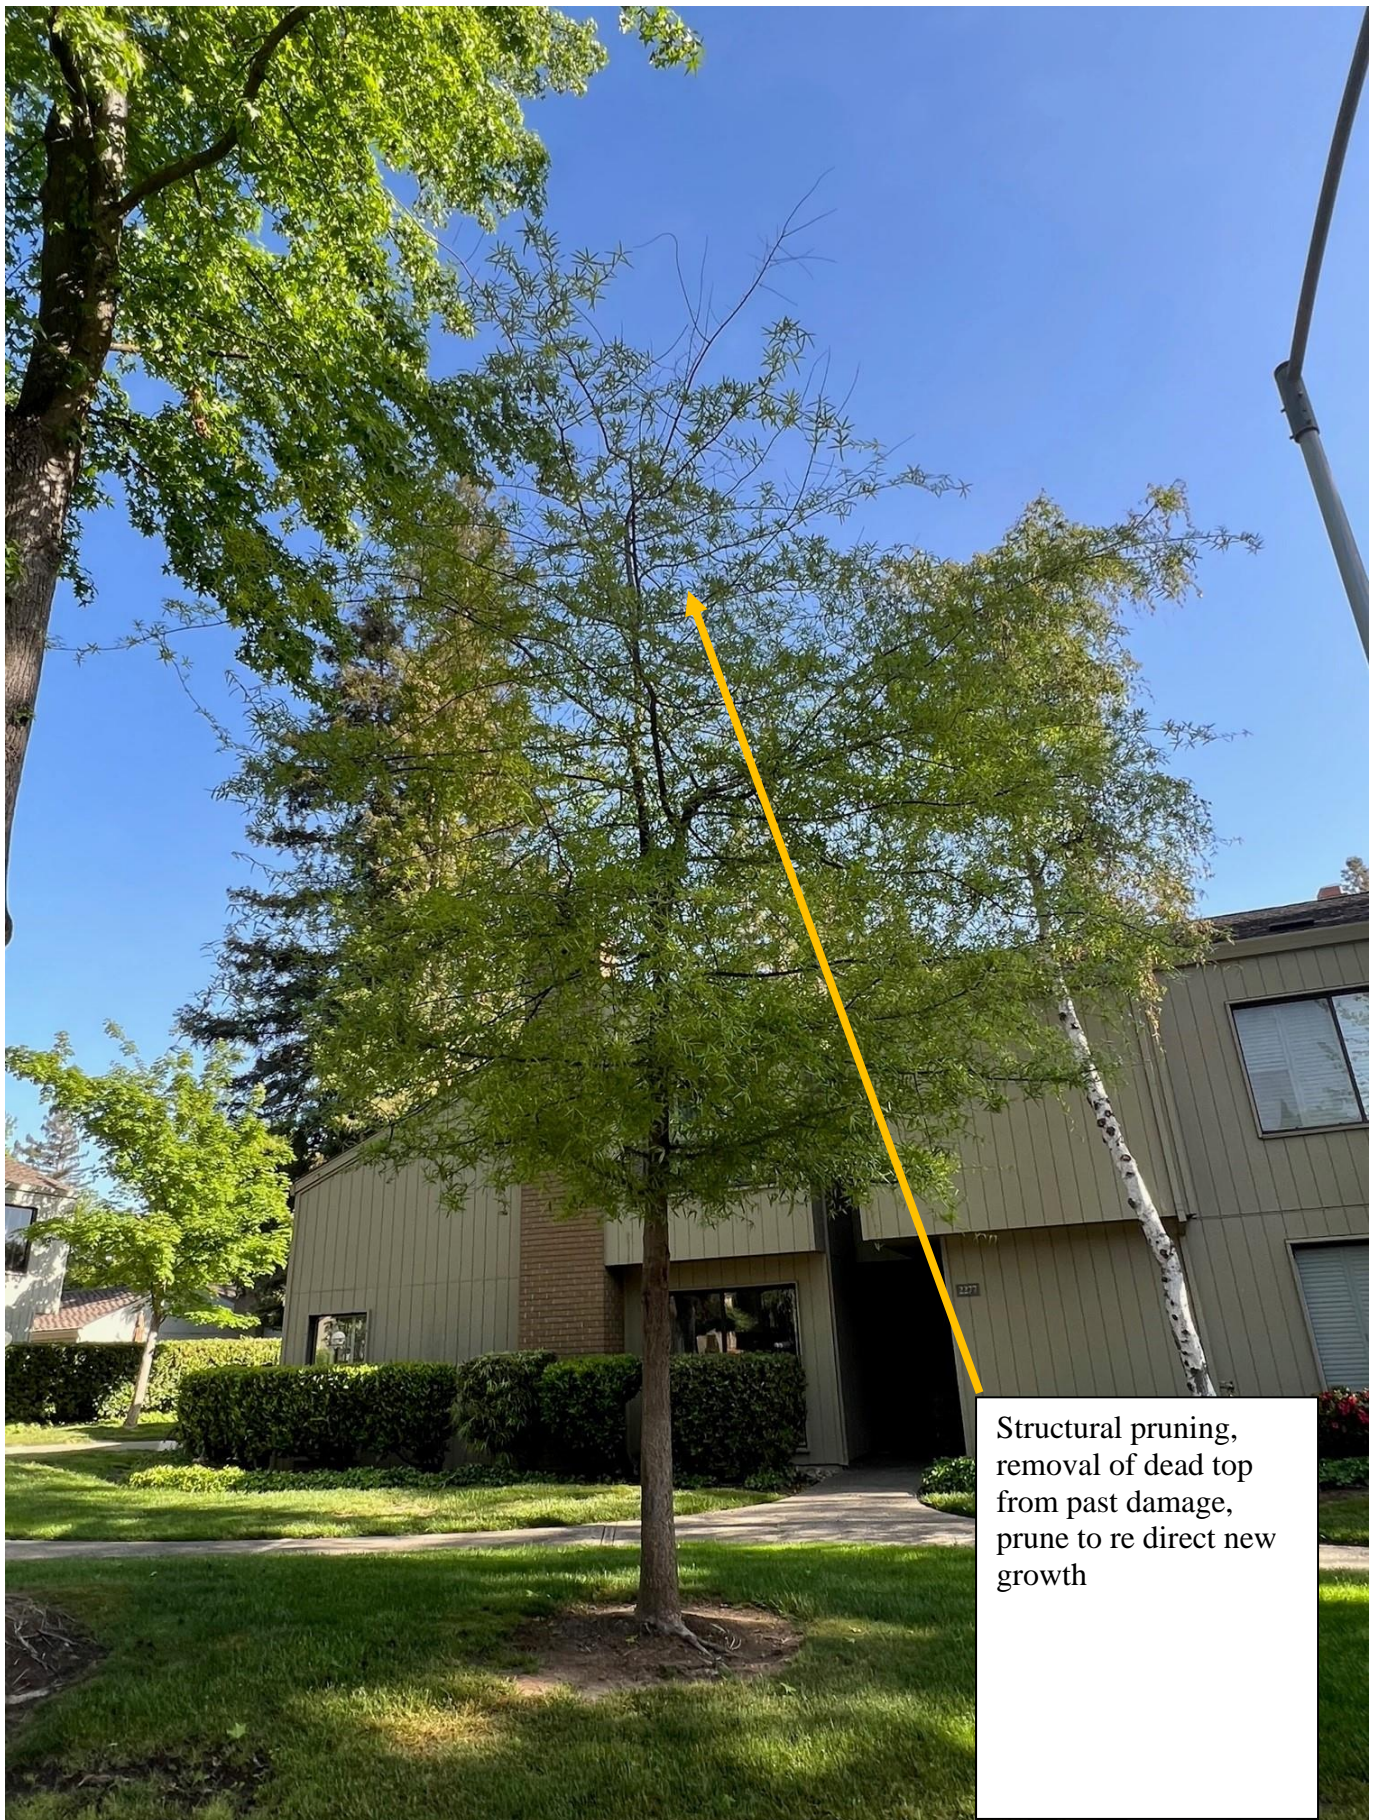
Figure 15

- (Zone 2) Tree #No Tag Willow oak (*Quercus phellos*), In front of 2277 Swarthmore Dr. This tree will require structural pruning to help with direction of growth due to the natural top dying back due to damage. The pruning will help to reestablish a new leader and healthy canopy development (Figure 15).

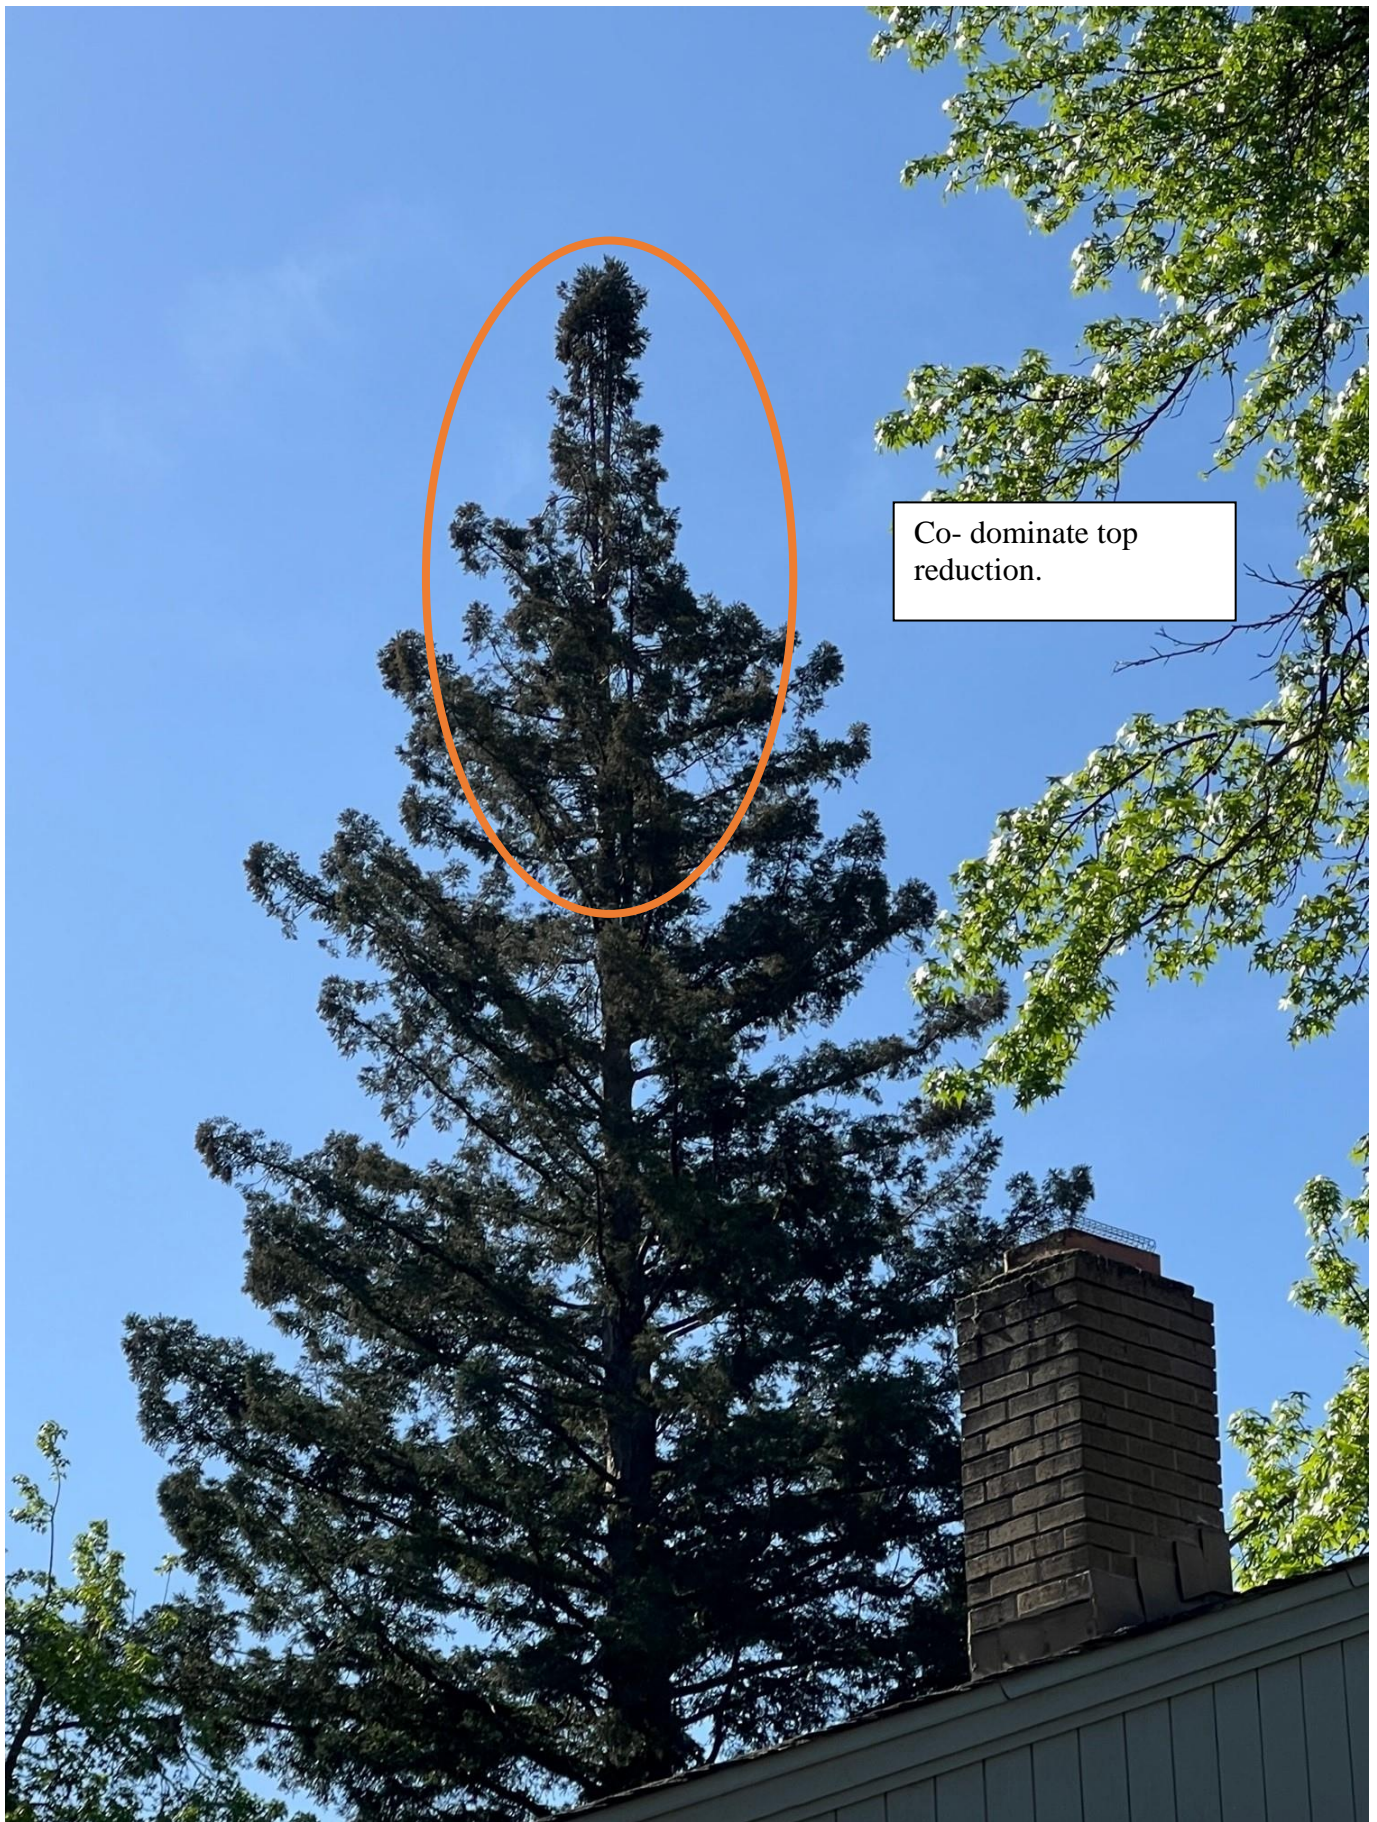
Figure 16

- (Zone 2) Tree #No Tag, Redwood (*Sequoia sempervirens*) In front of 2266 Swarthmore Dr. This tree has multiple included co dominate tops. Due to the failure potential, I recommend reduction pruning of the co dominate top to help reduce failure (Figure 16-17).

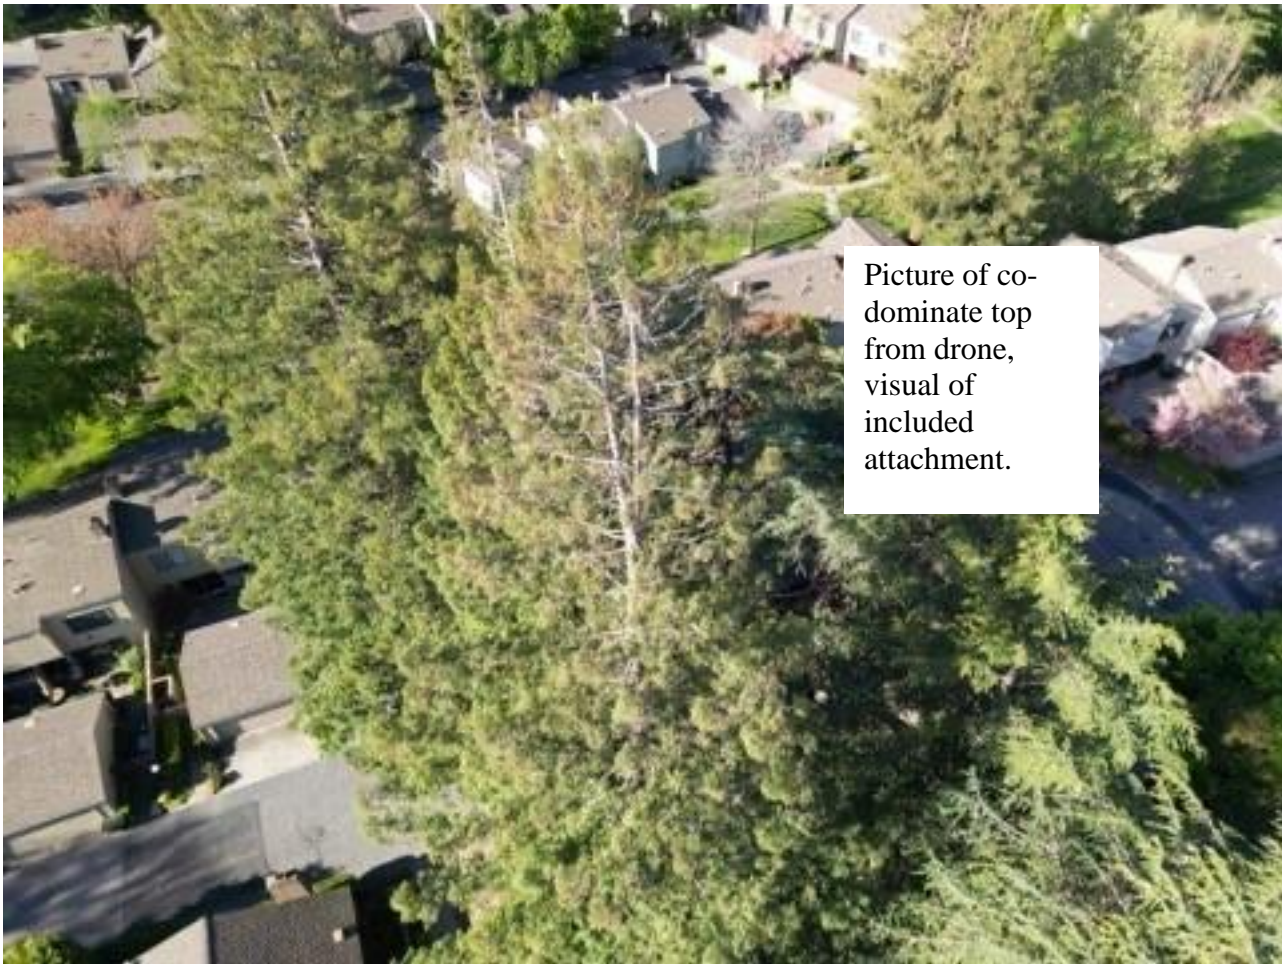
Figure 17

Picture of co-  
dominate top  
from drone,  
visual of  
included  
attachment.

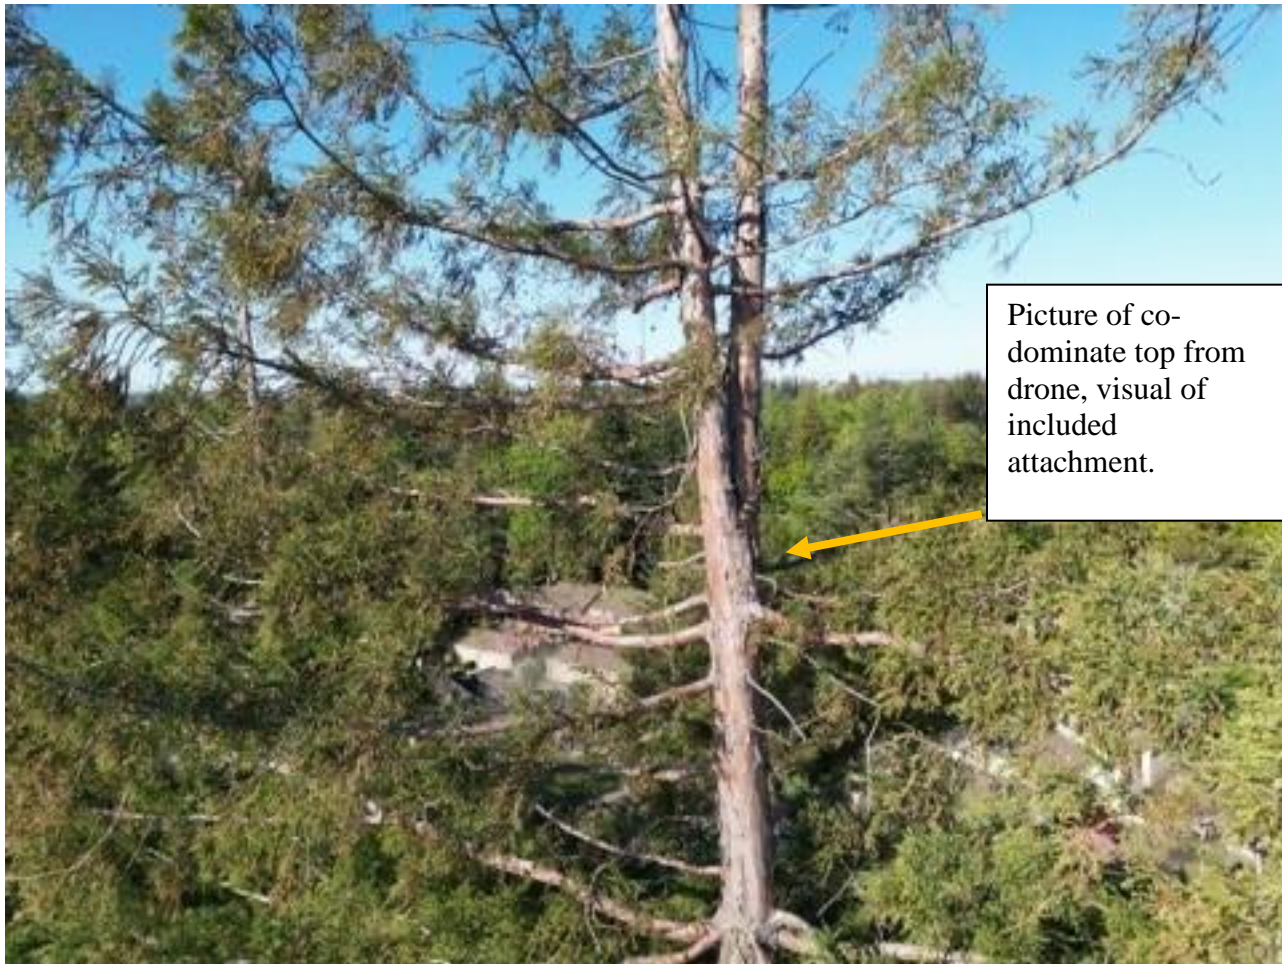
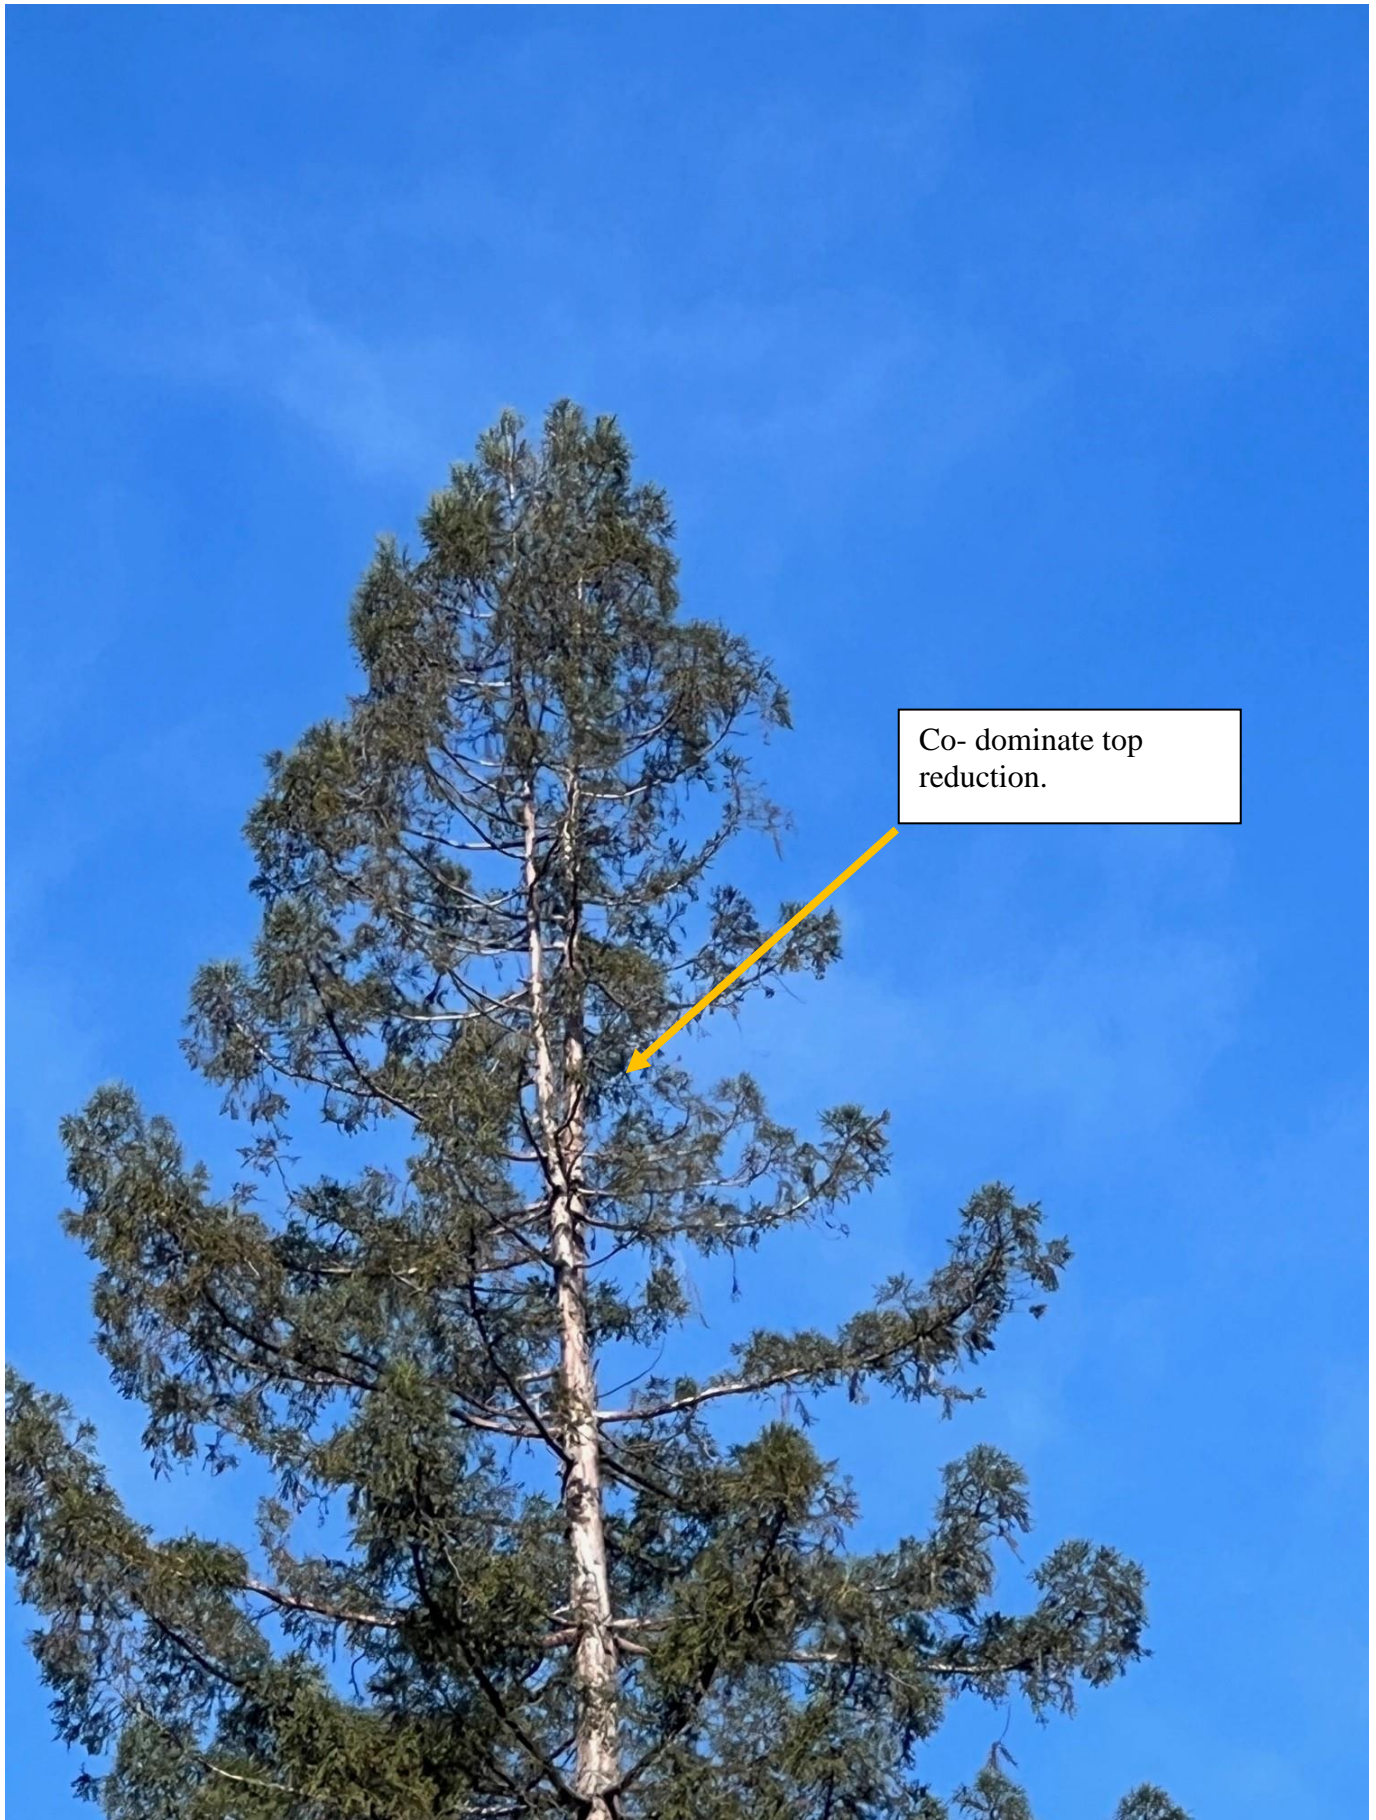
- (Zone 2) Tree #No Tag, Redwood (*Sequoia sempervirens*) In front of 2270 Swarthmore Dr. This tree has an included co dominate top. Due to the failure potential, I recommend reduction pruning of the co dominate top to help reduce failure (Figure 18-19).
