May 10, 2023

The Nepenthe Association  
1131 Commons Dr.  
Sacramento, CA 95825  
Phone: (916) 929-8380  
Email: [Nepenthe.HOA@fsresidential.com](mailto:Nepenthe.HOA@fsresidential.com)

On April 24, 2023 I inspected several trees on the Nepenthe property during the monthly tree walk. The focus of the walk was to address resident/management concerns regarding mature trees on the property. The purpose of this report is to develop mitigation plans for the following trees and my recommendations are below. My recommendations are based on a Basic Visual Inspection. All decisions made based on the recommendations of this report are at the discretion of the Nepenthe Association.

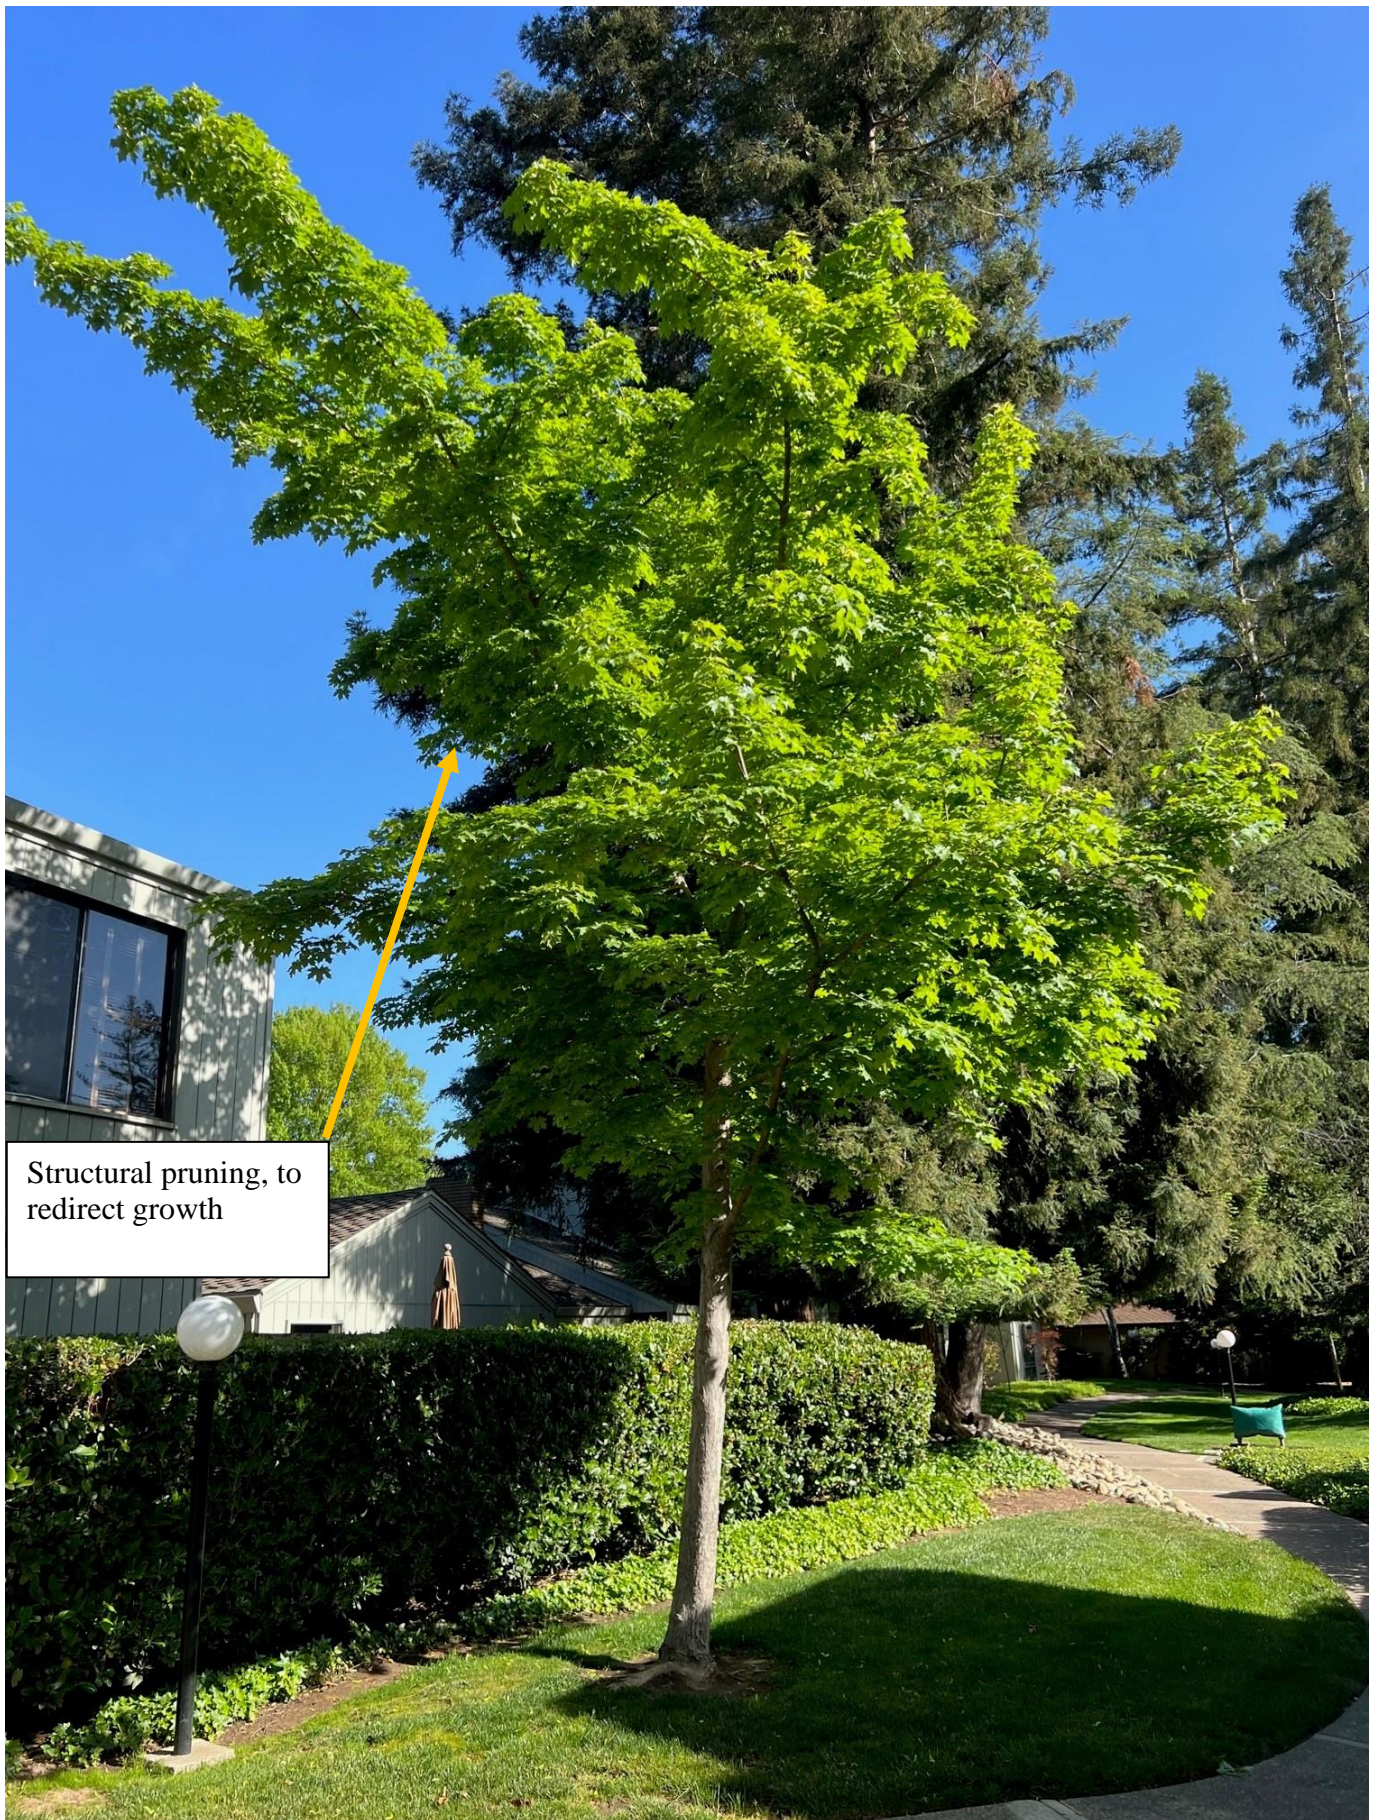
Figure 20

- (Zone 2) Tree #417 Trident maple (*Acer buergerianum*), in front of 2271 Swarthmore Dr. This tree will require structural pruning to help with direction of growth and healthy canopy development (Figure 20).

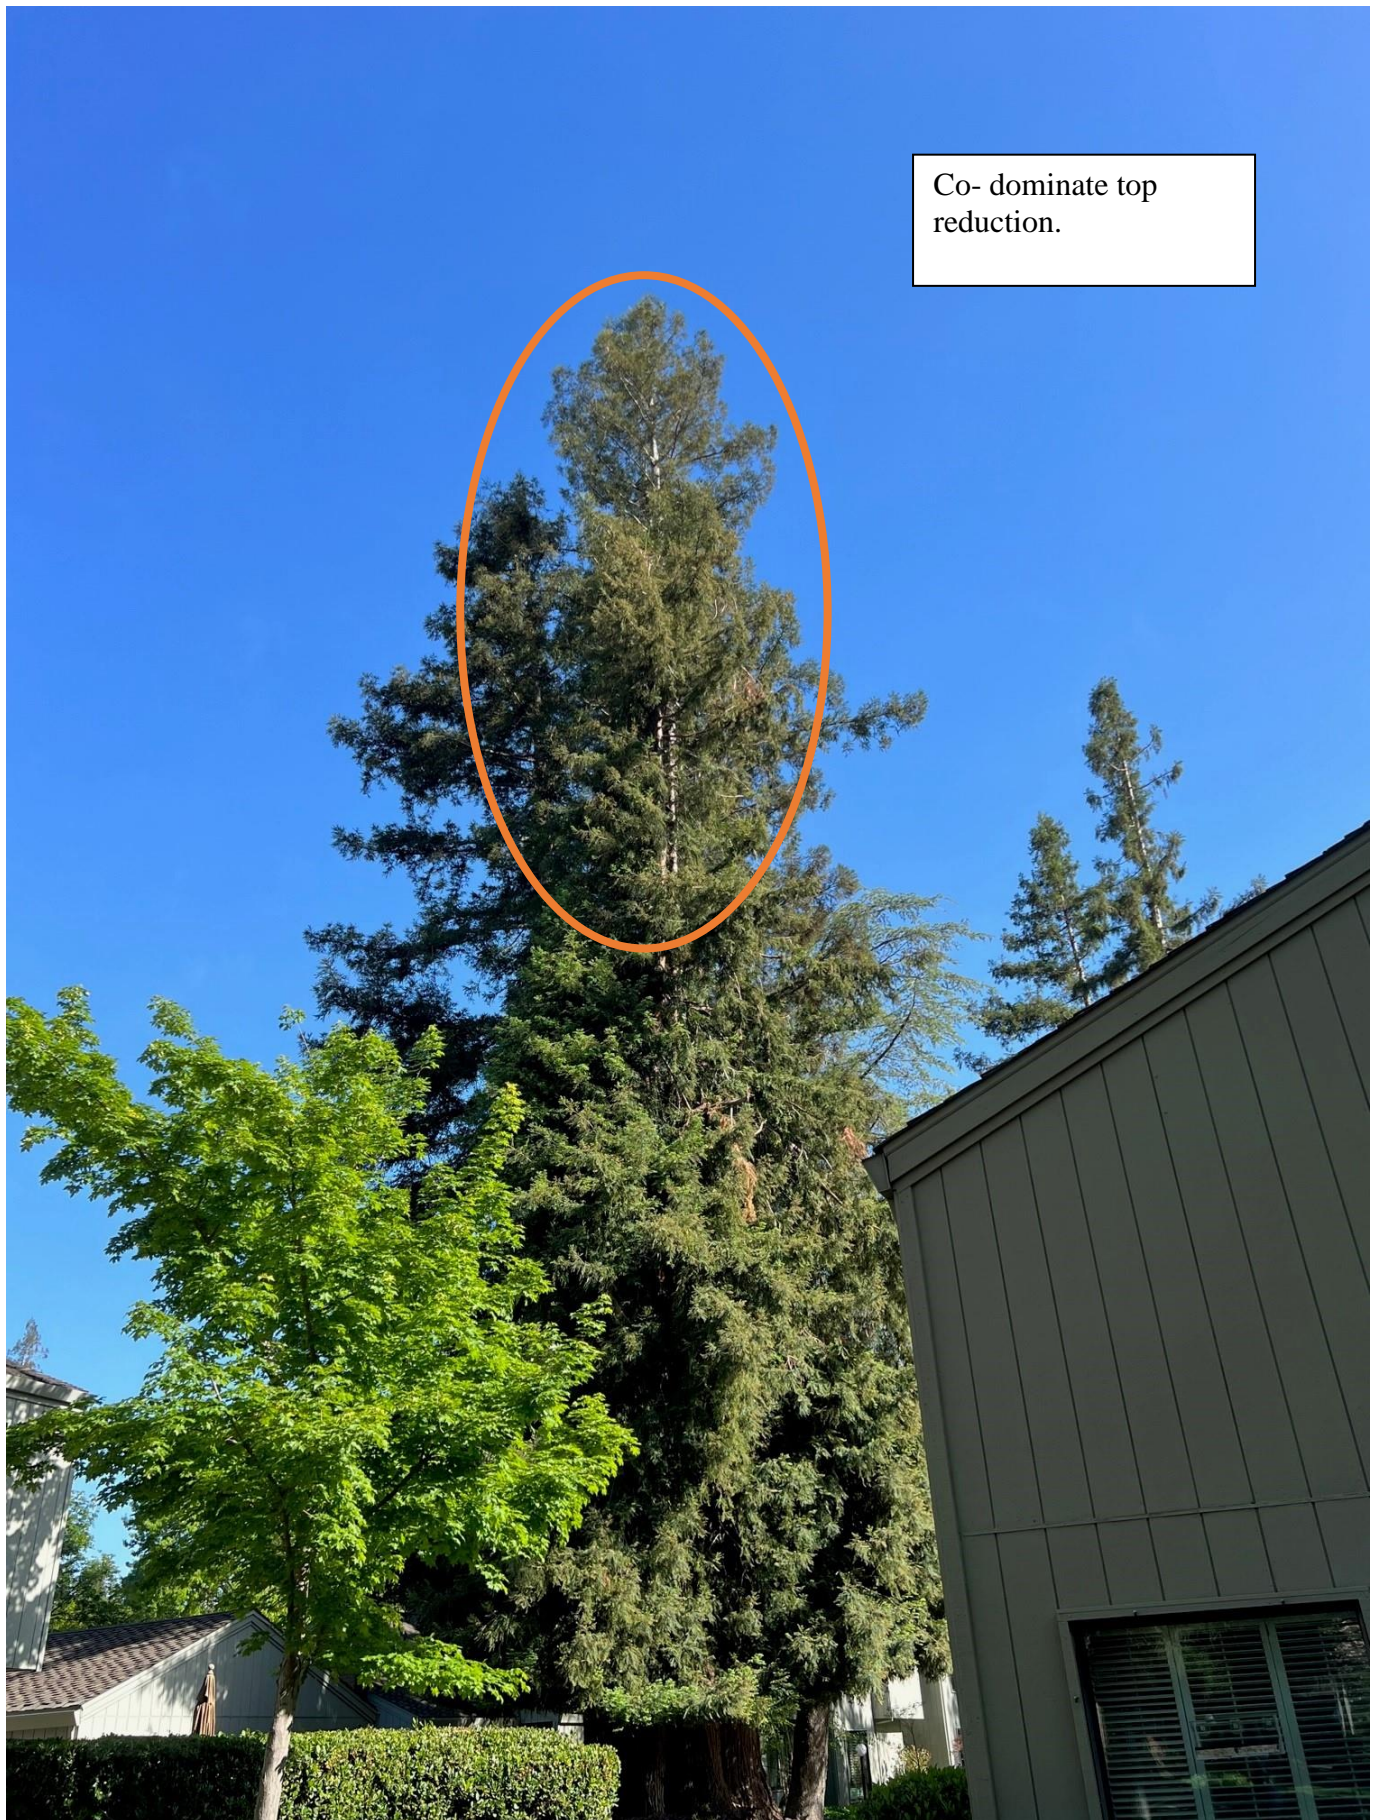
Figure 21

- (Zone 2) 3 Trees #414, 415, 416, Redwood (*Sequoia sempervirens*) Near 2271 Swarthmore Dr. These trees have multiple included co dominate tops. Due to the failure potential, I recommend reduction pruning of the co dominate top to help reduce failure (Figure 21).

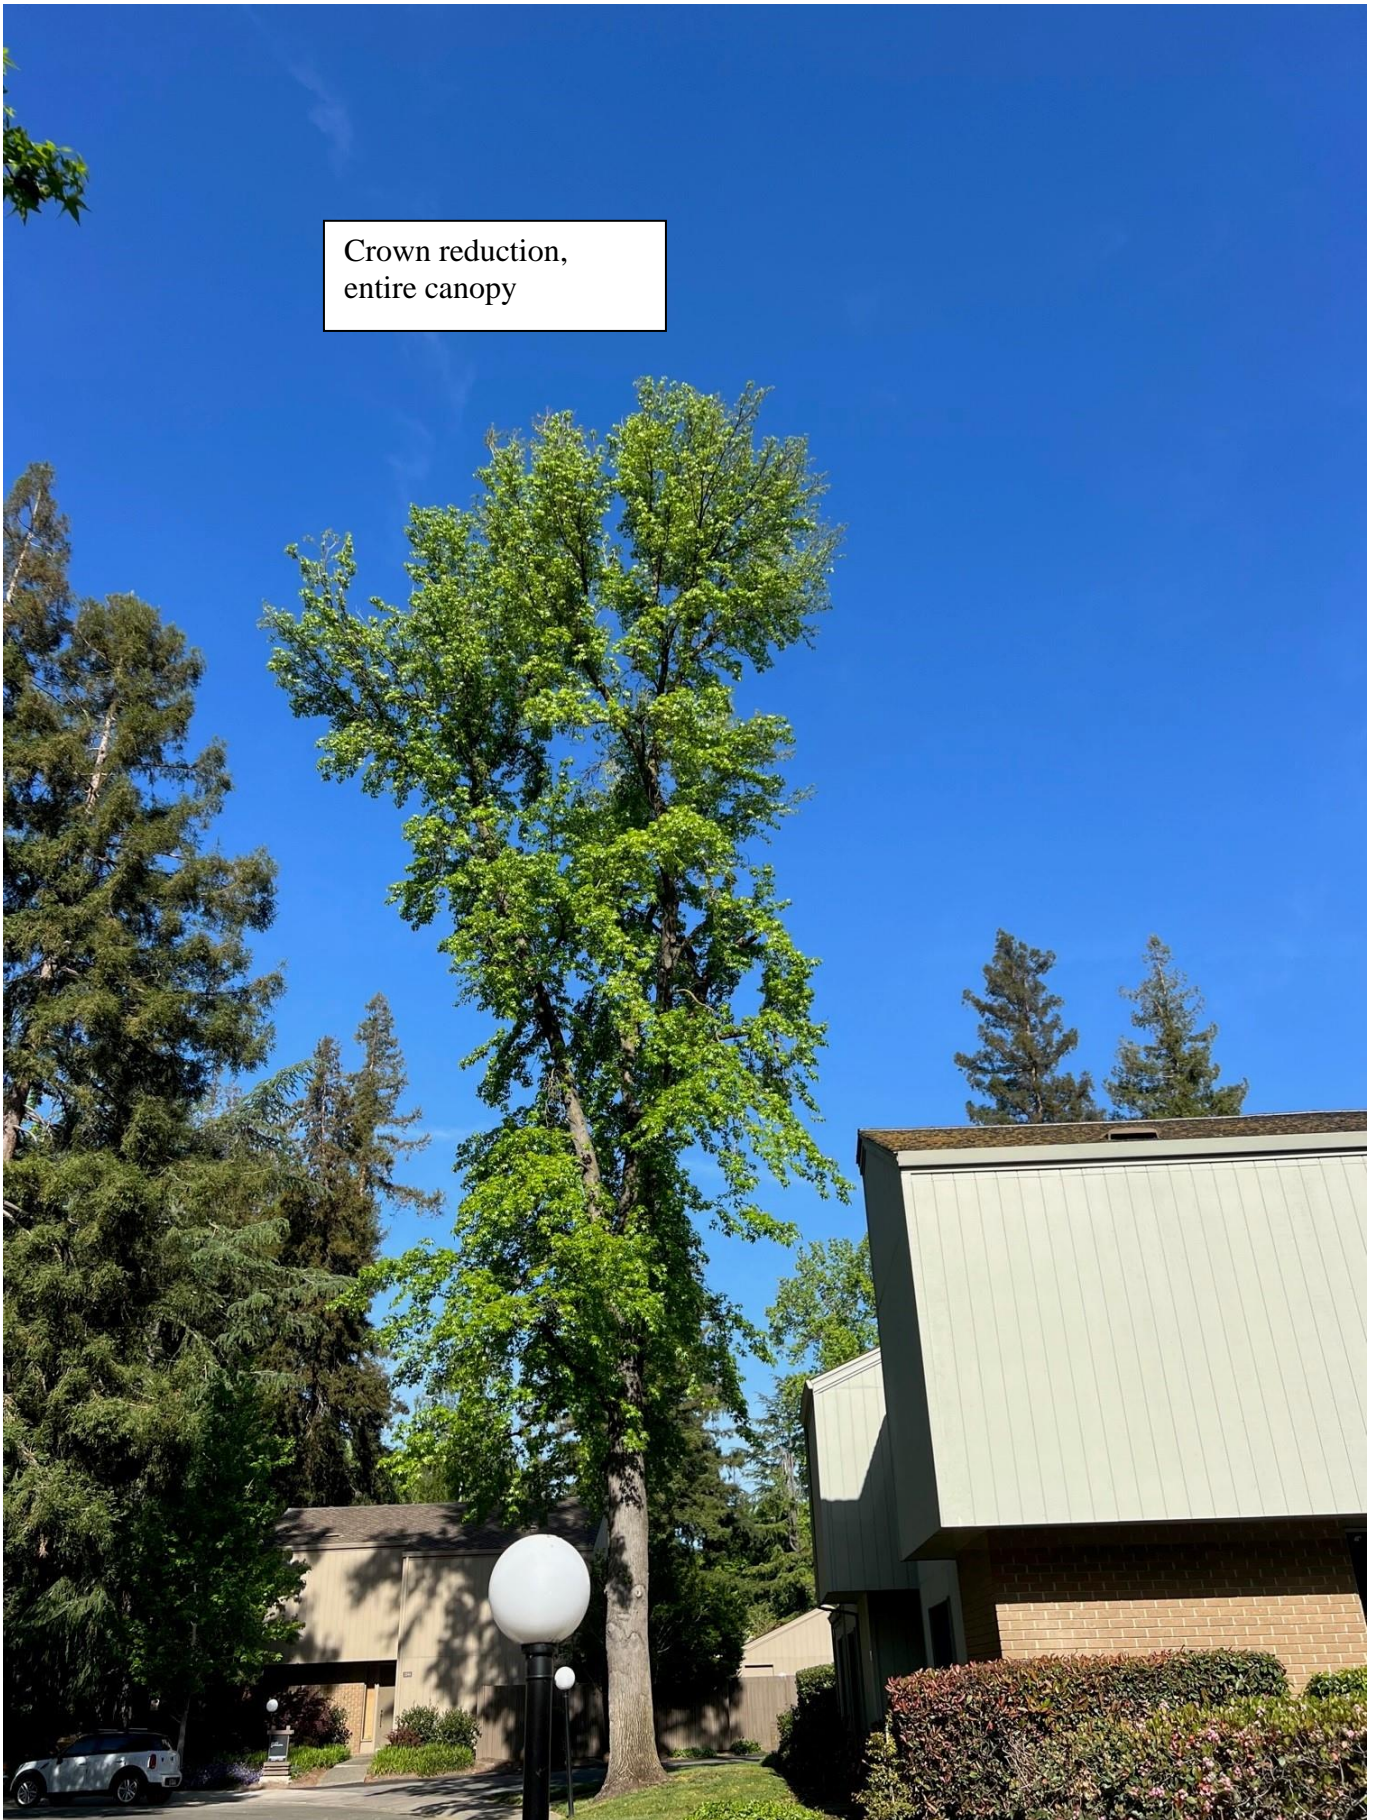
Figure 22

- (Zone 2) Tree #No Tag Liquid amber (*Liquidambar styraciflua*) In front of 2267 Swarthmore Dr. This tree has an over weighted canopy and requires reduction pruning on branches throughout the tree canopy (Figure 22).

Crown reduction,  
entire canopy

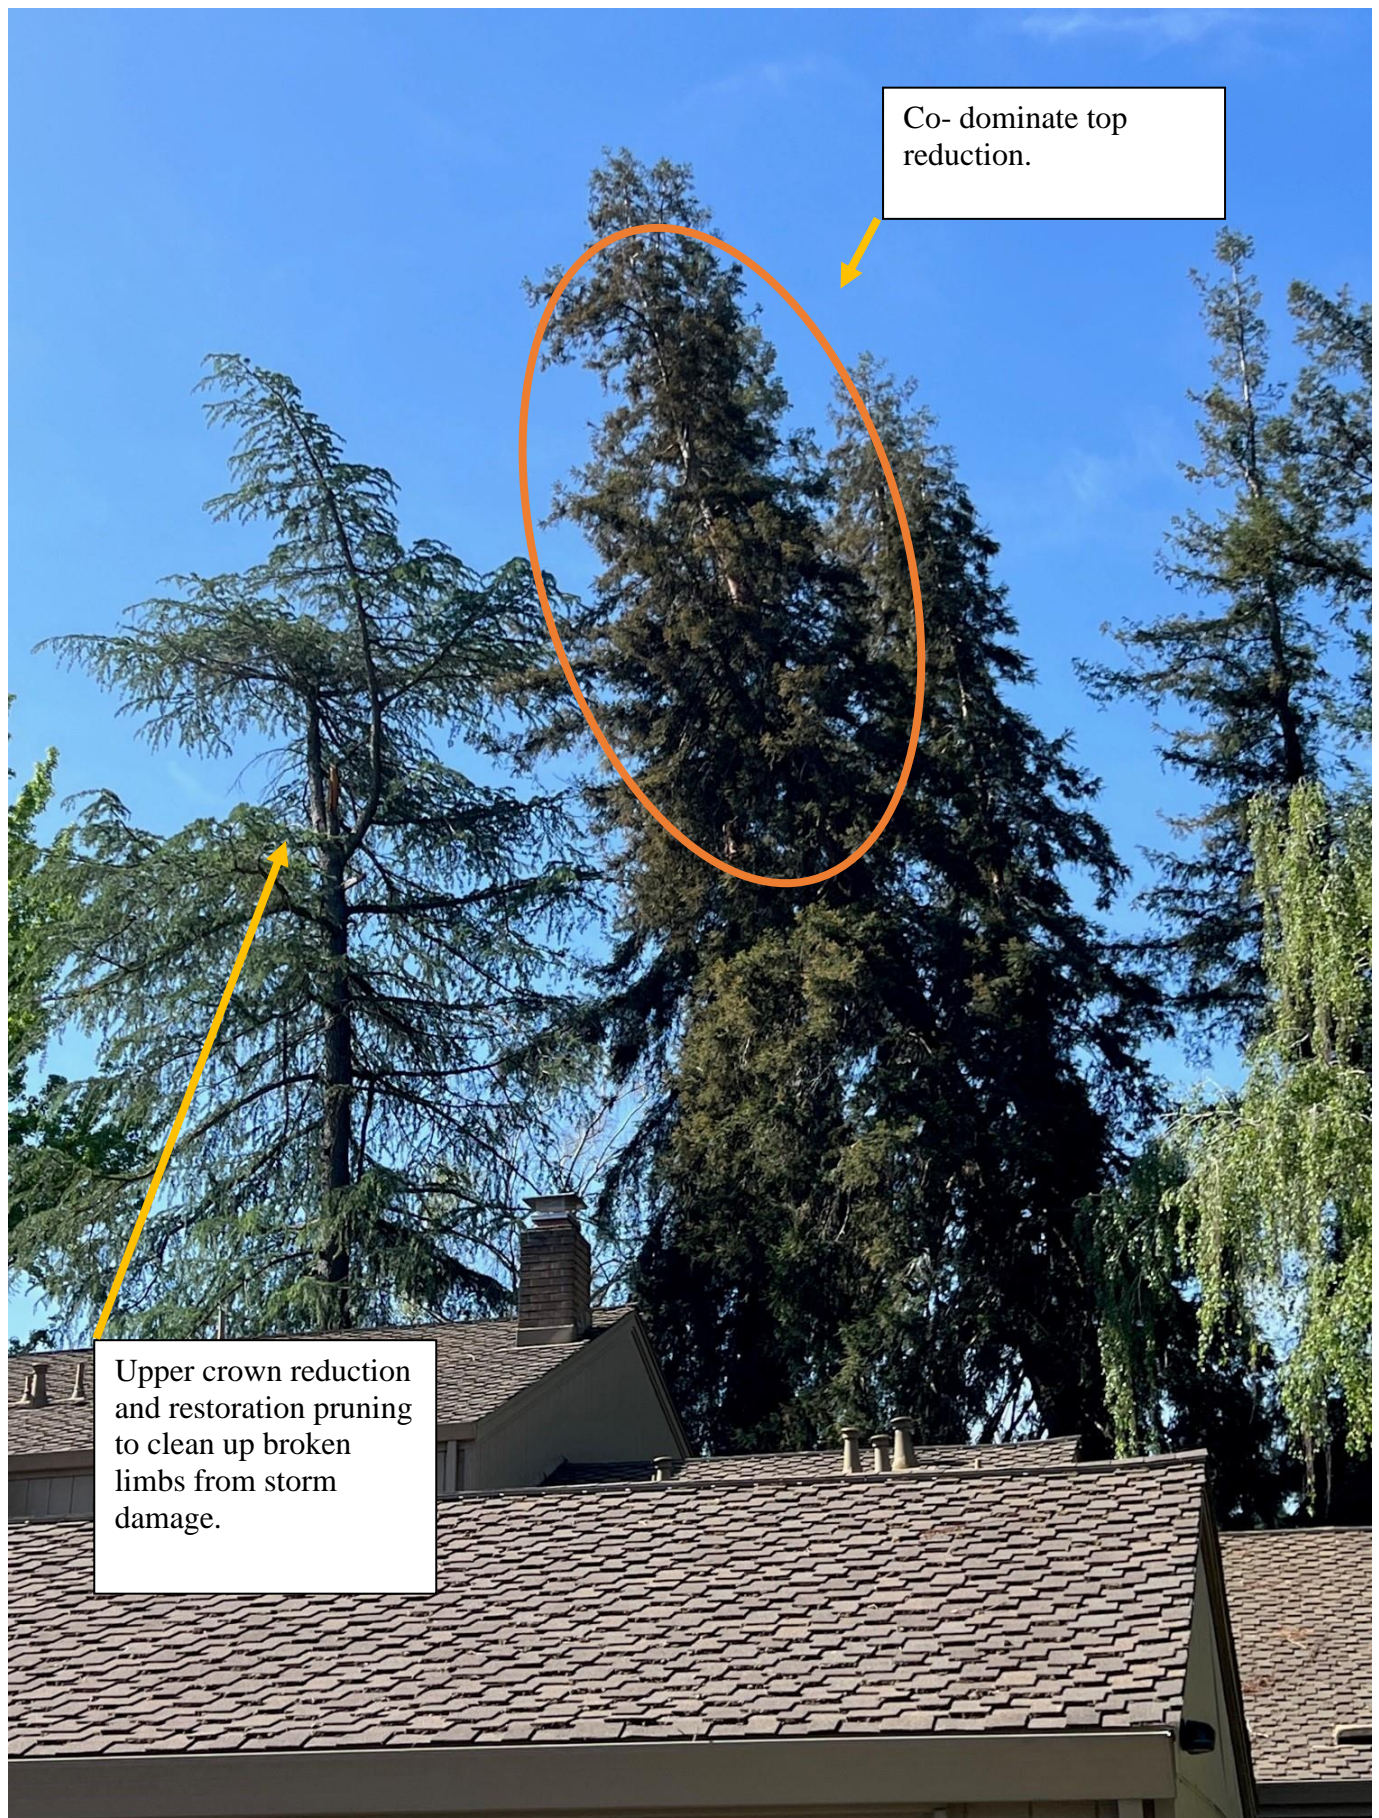
Figure 23

- (Zone 2) Tree #No Tag, Redwood (*Sequoia sempervirens*) In front of 2245 Swarthmore Dr. This tree has multiple included co dominate tops. Due to the failure potential, I recommend reduction pruning of the co dominate top to help reduce failure (Figure 23).

- (Zone 2) Tree #412 Cedar (*Cedrus deodara*) near to 2245 Swarthmore Dr. This tree has an over weighted canopy and requires reduction pruning on branches throughout the tree canopy. This tree had limb failure during the January storms and needs to have some restoration pruning done to clean up the broken limbs. (Figure 23).

Co- dominate top  
reduction.

Upper crown reduction  
and restoration pruning  
to clean up broken  
limbs from storm  
damage.

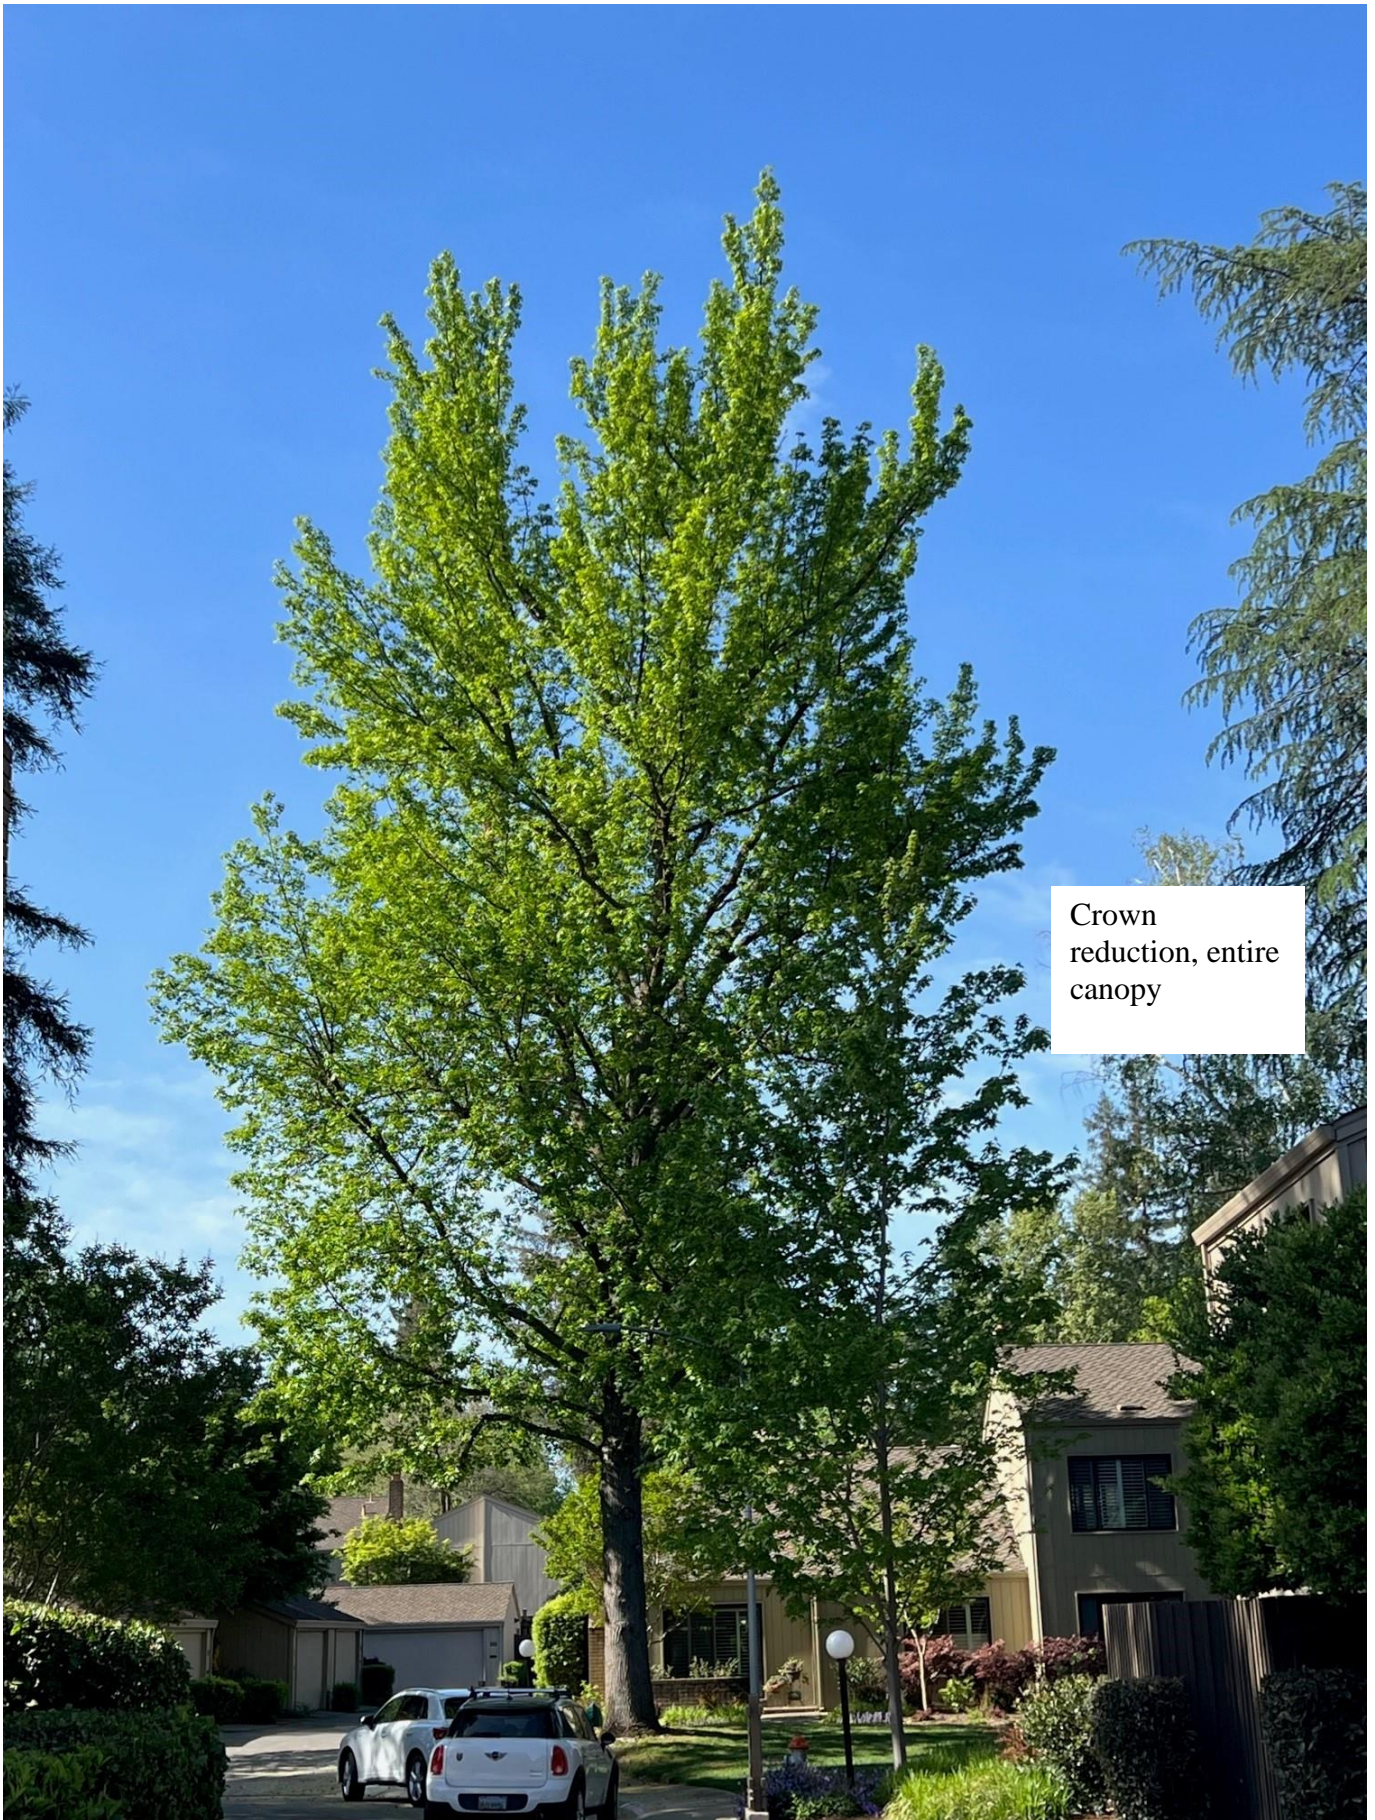
Figure 24

- (Zone 2) Tree #No Tag Liquid amber (*Liquidambar styraciflua*) In front of 2232 Swarthmore Dr. This tree has a over weighted canopy and requires reduction pruning on branches throughout the tree canopy (Figure 24).

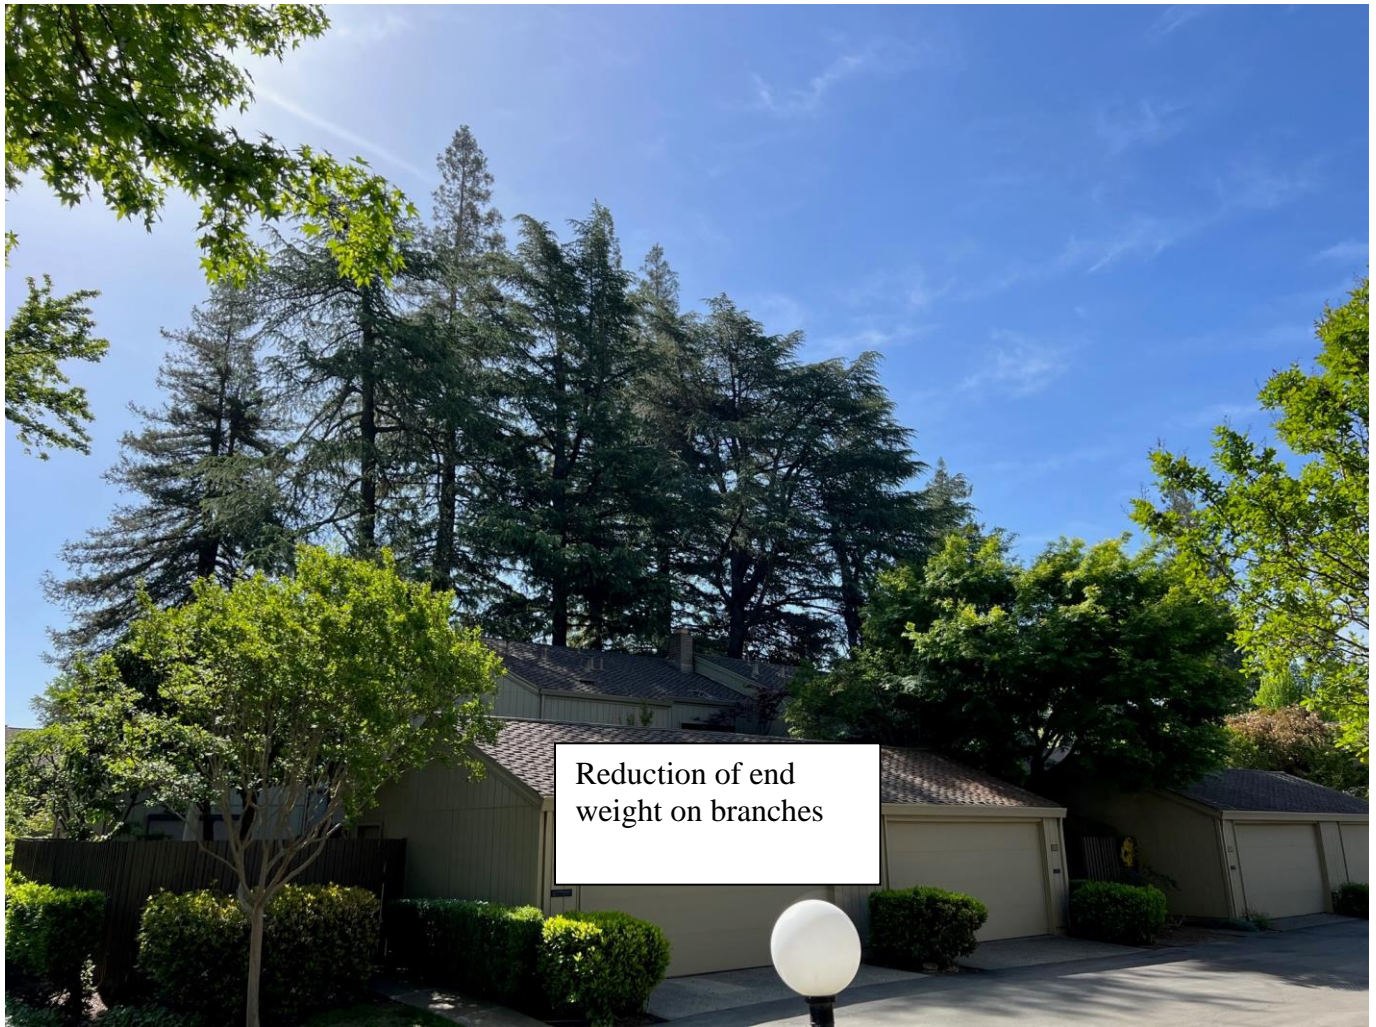
Figure 25

- (Zone 2) 4 Trees 3 No Tag, #476 Cedar (*Cedrus deodara*) In front of 2258, 2260, 2262 Swarthmore Dr. These trees have over weighted canopies and require reduction pruning on branches throughout the tree canopy to reduce limb failure (Figure 25).

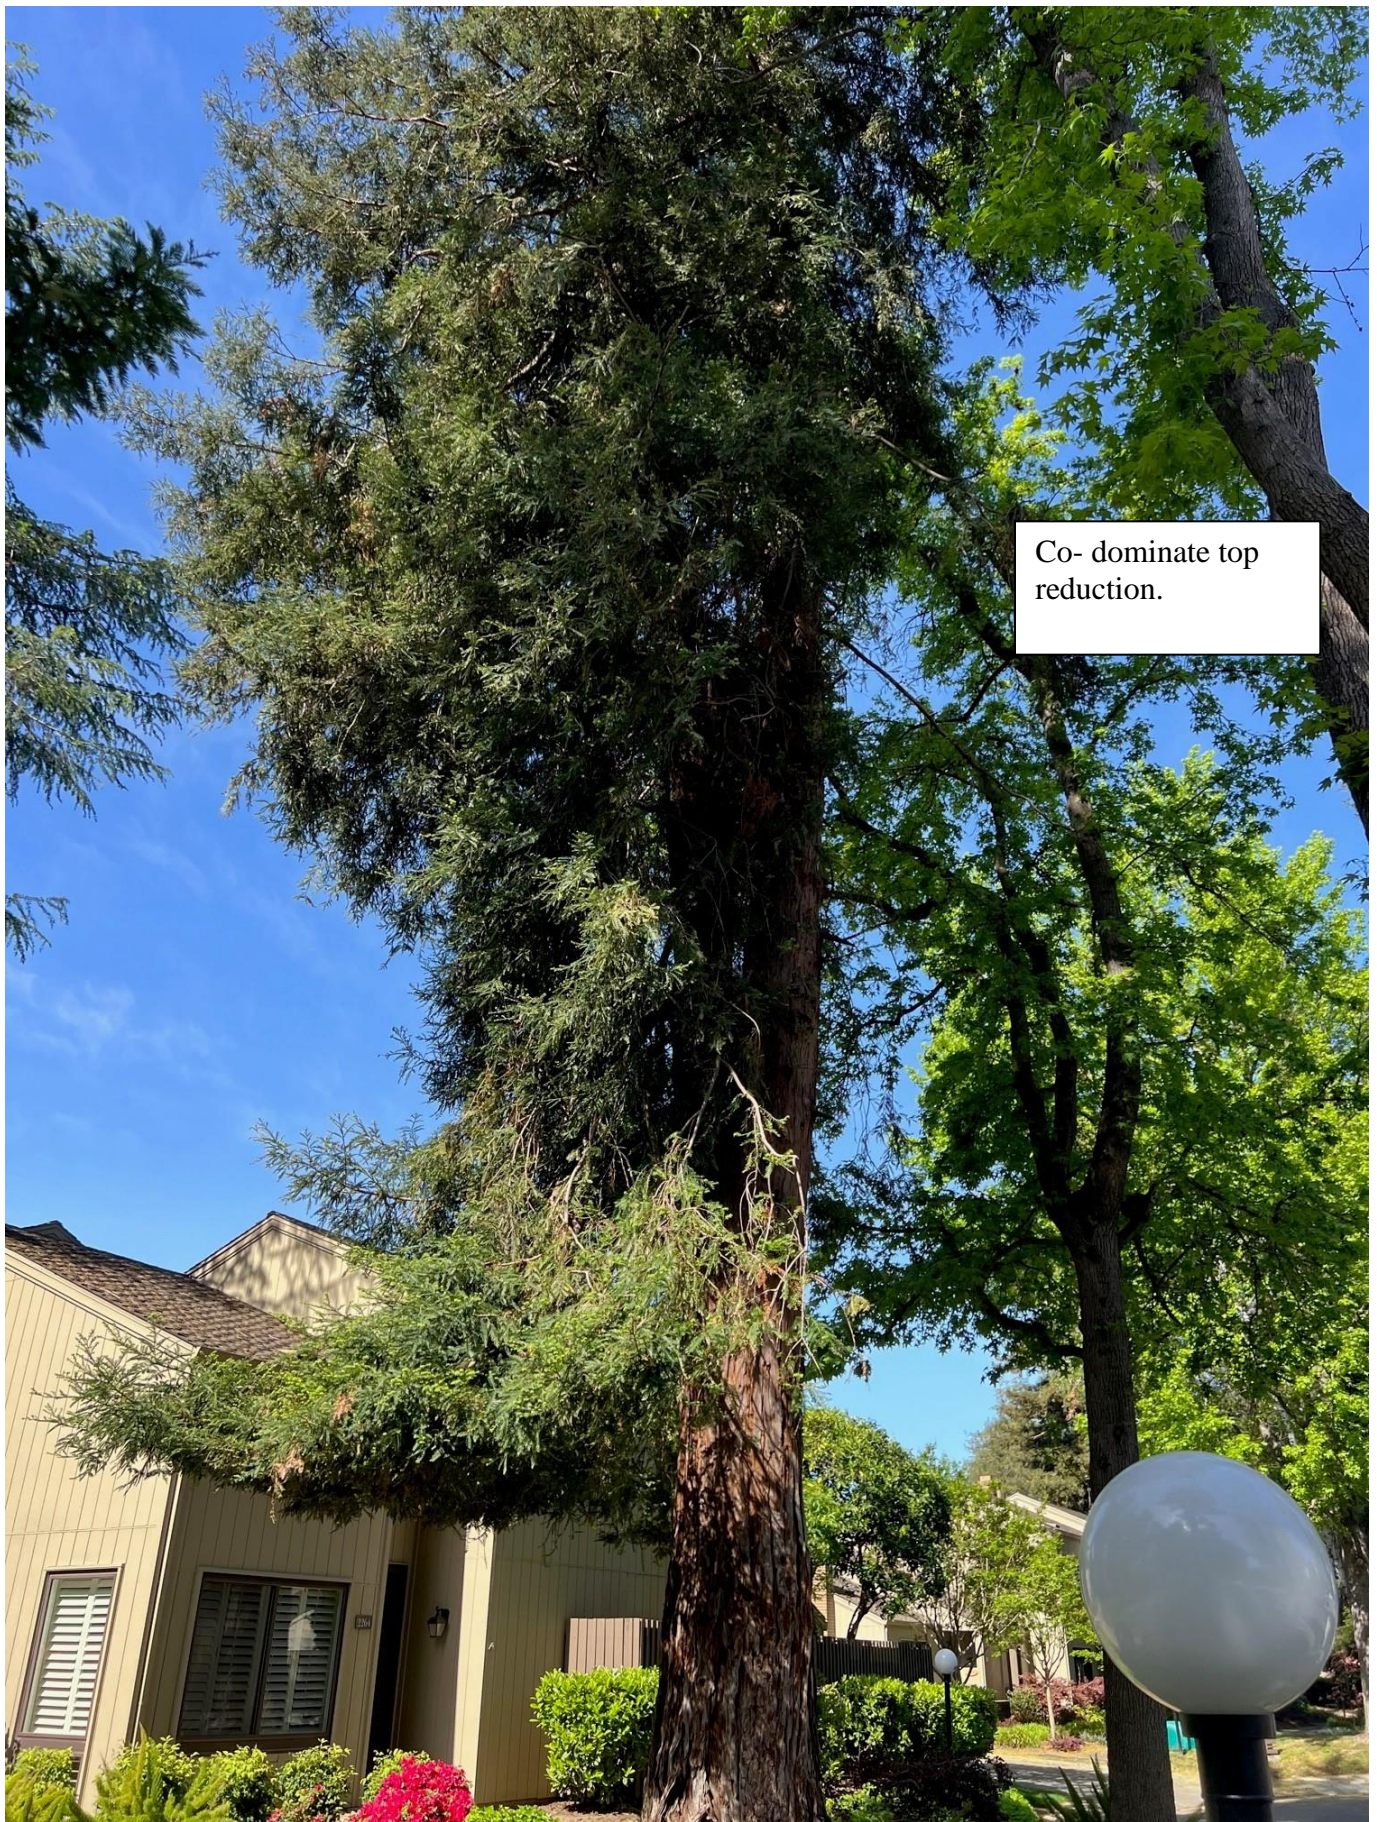
Figure 26

- (Zone 2) Tree #22 Redwood (*Sequoia sempervirens*) In front of 2250 Swarthmore Dr. This tree has multiple included co dominate tops. Due to the failure potential, I recommend reduction pruning of the co dominate top to help reduce failure (Figure 26).

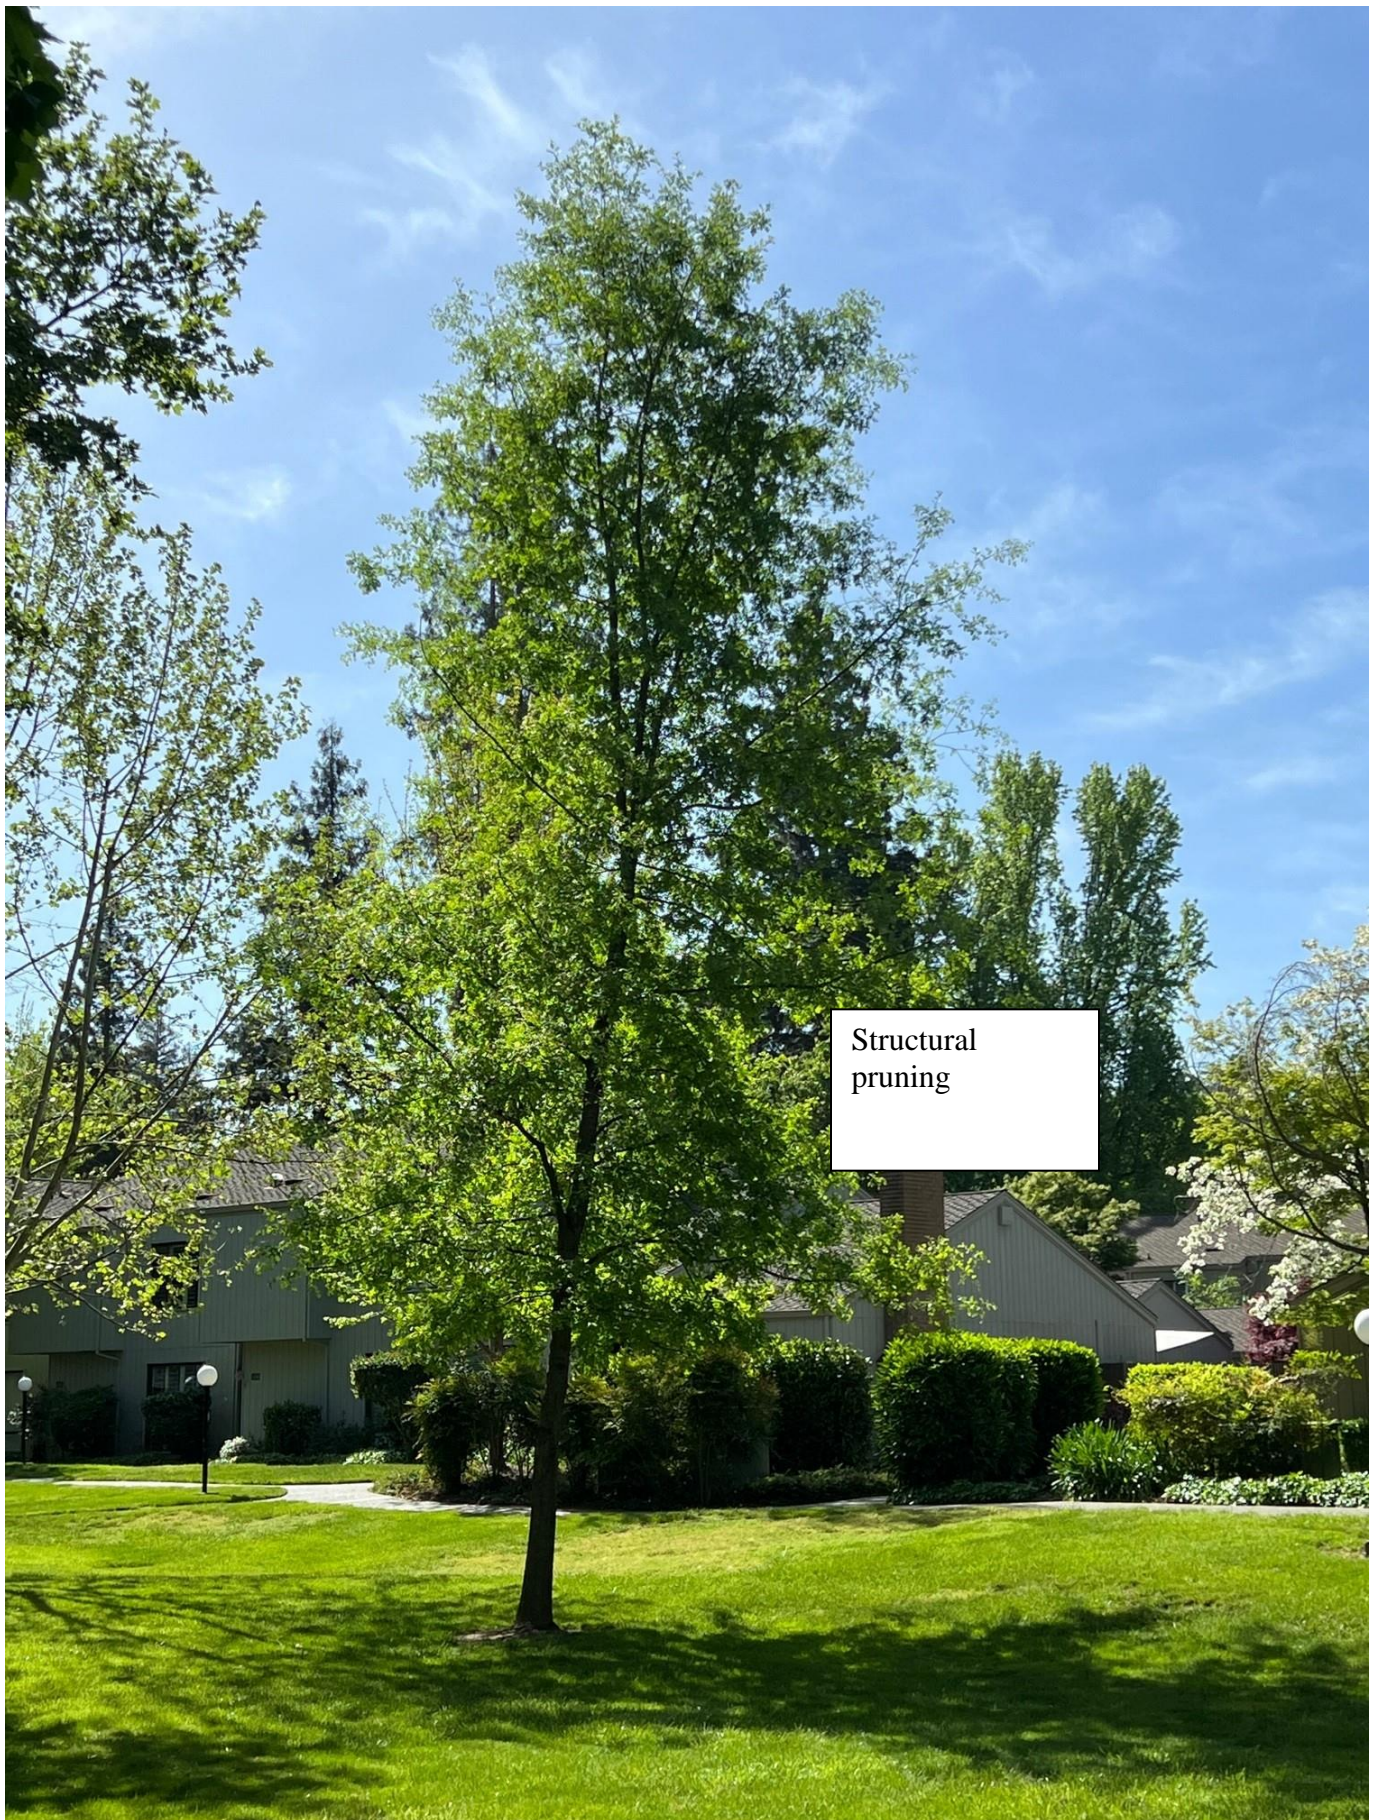
Figure 27

- (Zone 2) Tree #No Tag Valley oak (*Quercus lobatta*), In greenbelt near 2246 Swarthmore Dr. This tree will require structural pruning to help with direction of growth and healthy canopy development (Figure 27).

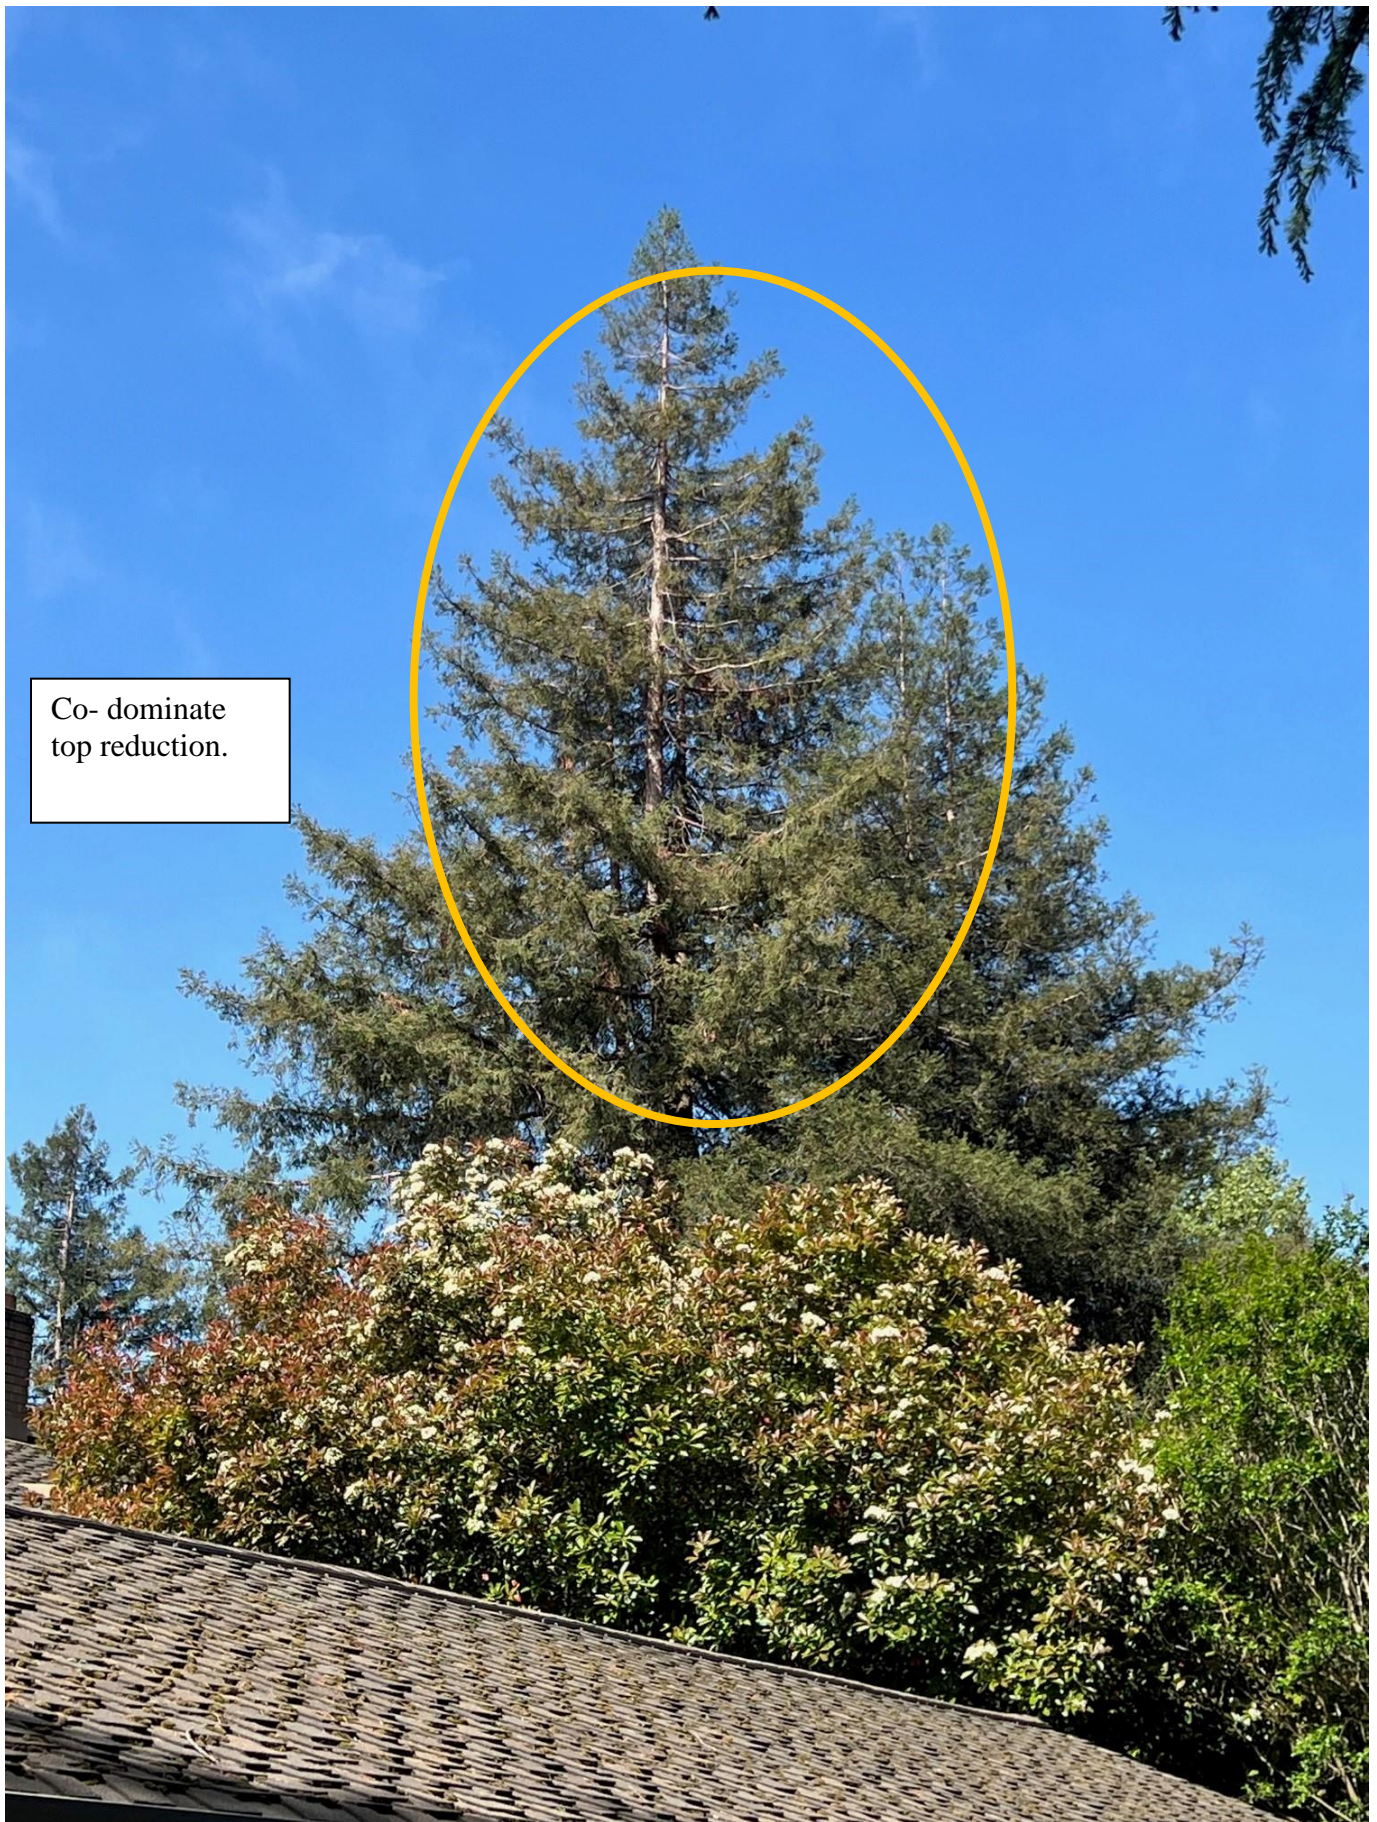
Figure 28

- (Zone 2) Tree #612 Redwood (*Sequoia sempervirens*) in front of 1230 Vanderbilt Dr. This tree has an included co dominate top. Due to the failure potential, I recommend reduction pruning of the co dominate top of this tree to help reduce failure (Figure 28)
