May 10, 2023

The Nepenthe Association  
1131 Commons Dr.  
Sacramento, CA 95825  
Phone: (916) 929-8380  
Email: [Nepenthe.HOA@fsresidential.com](mailto:Nepenthe.HOA@fsresidential.com)

On April 24, 2023 I inspected several trees on the Nepenthe property during the monthly tree walk. The focus of the walk was to address resident/management concerns regarding mature trees on the property. The purpose of this report is to develop mitigation plans for the following trees and my recommendations are below. My recommendations are based on a Basic Visual Inspection. All decisions made based on the recommendations of this report are at the discretion of the Nepenthe Association.

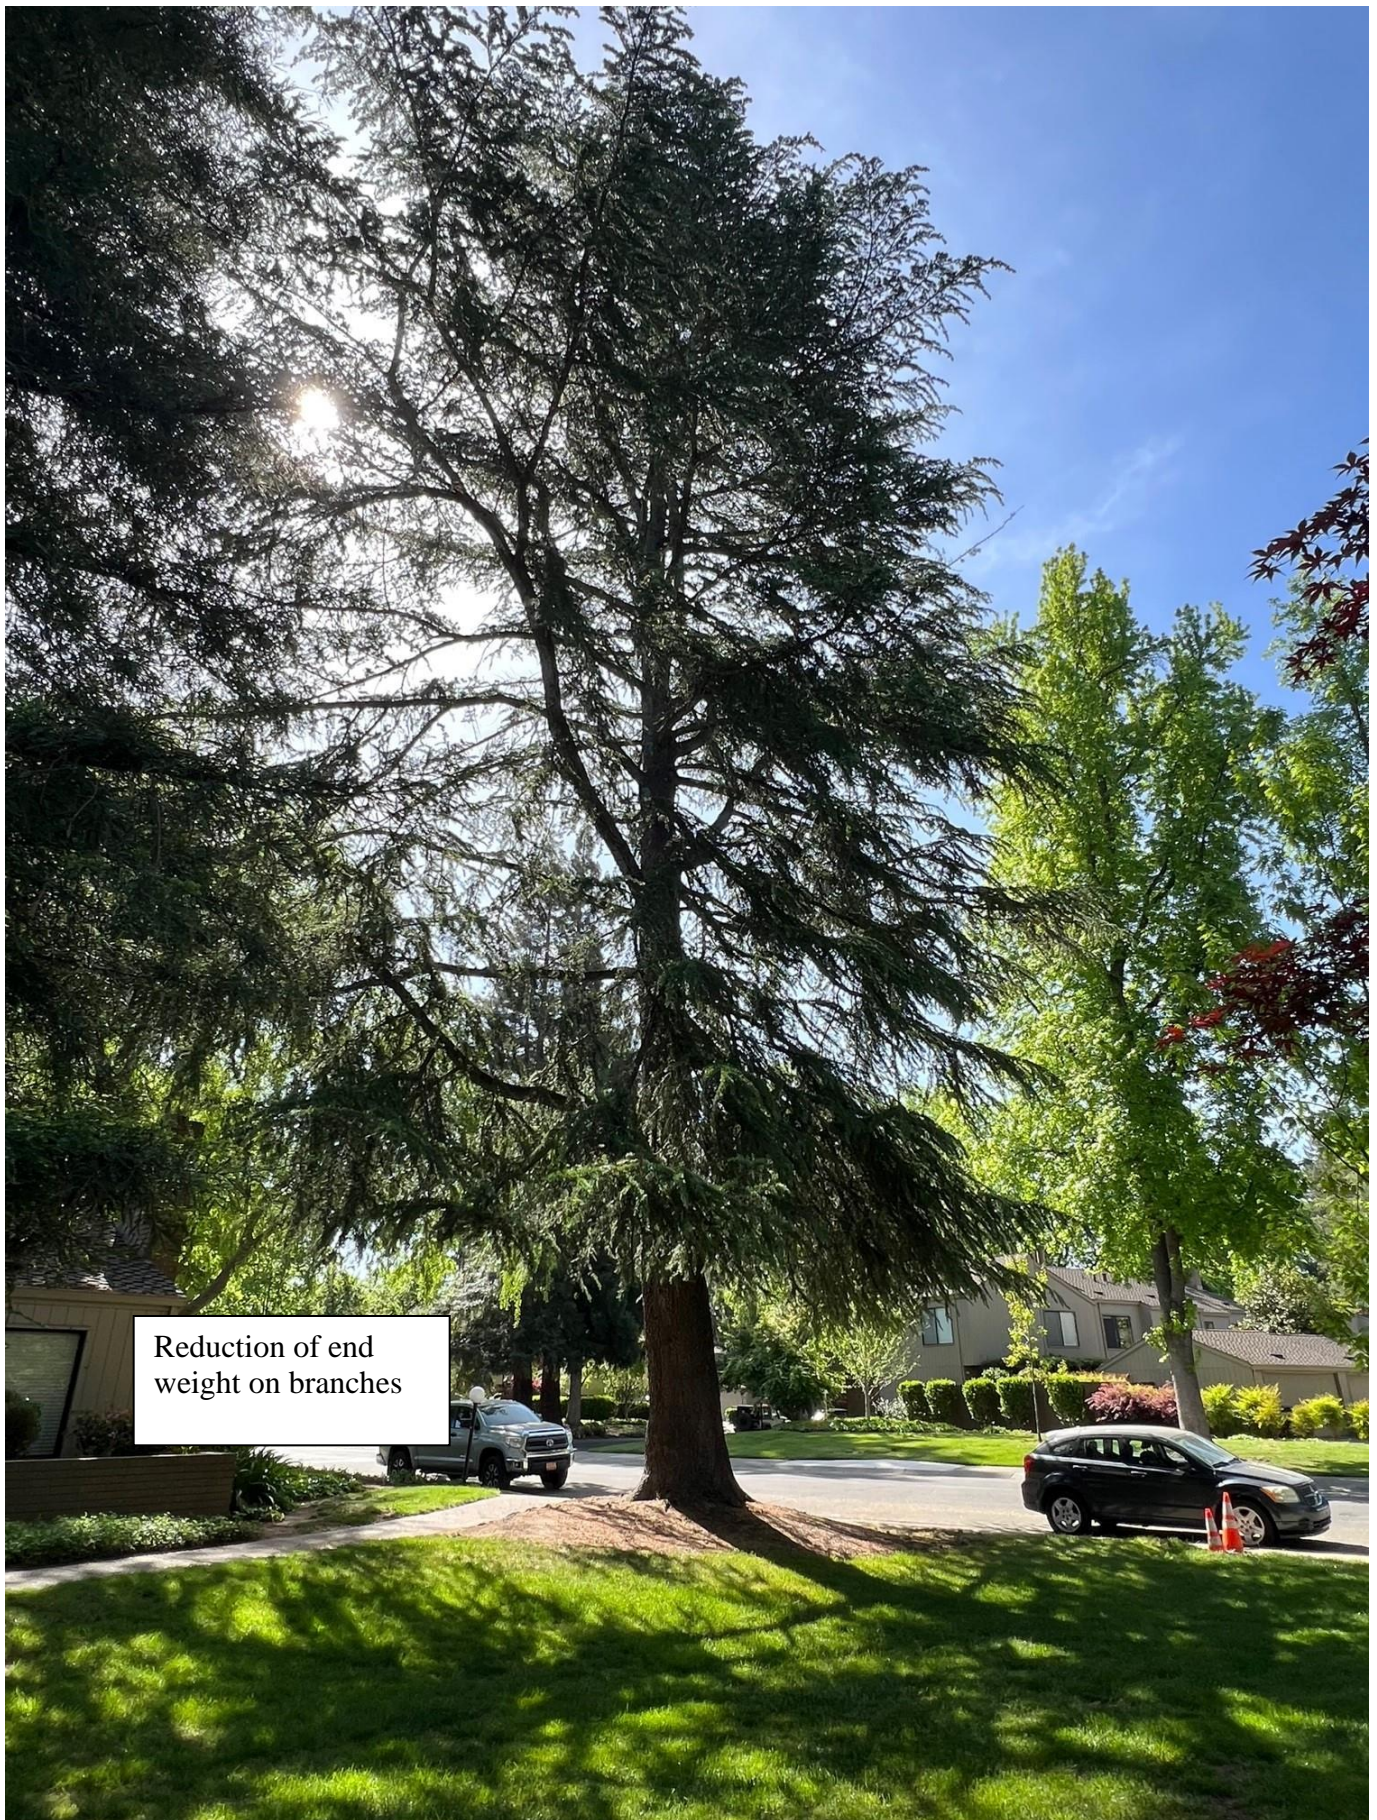
Figure 29

- (Zone 2) Tree #3415 Cedar (*Cedrus deodara*), in front of 1206 Vanderbilt Dr. This tree has an over weighted canopy and requires reduction pruning on branches throughout the tree canopy (Figure 29).

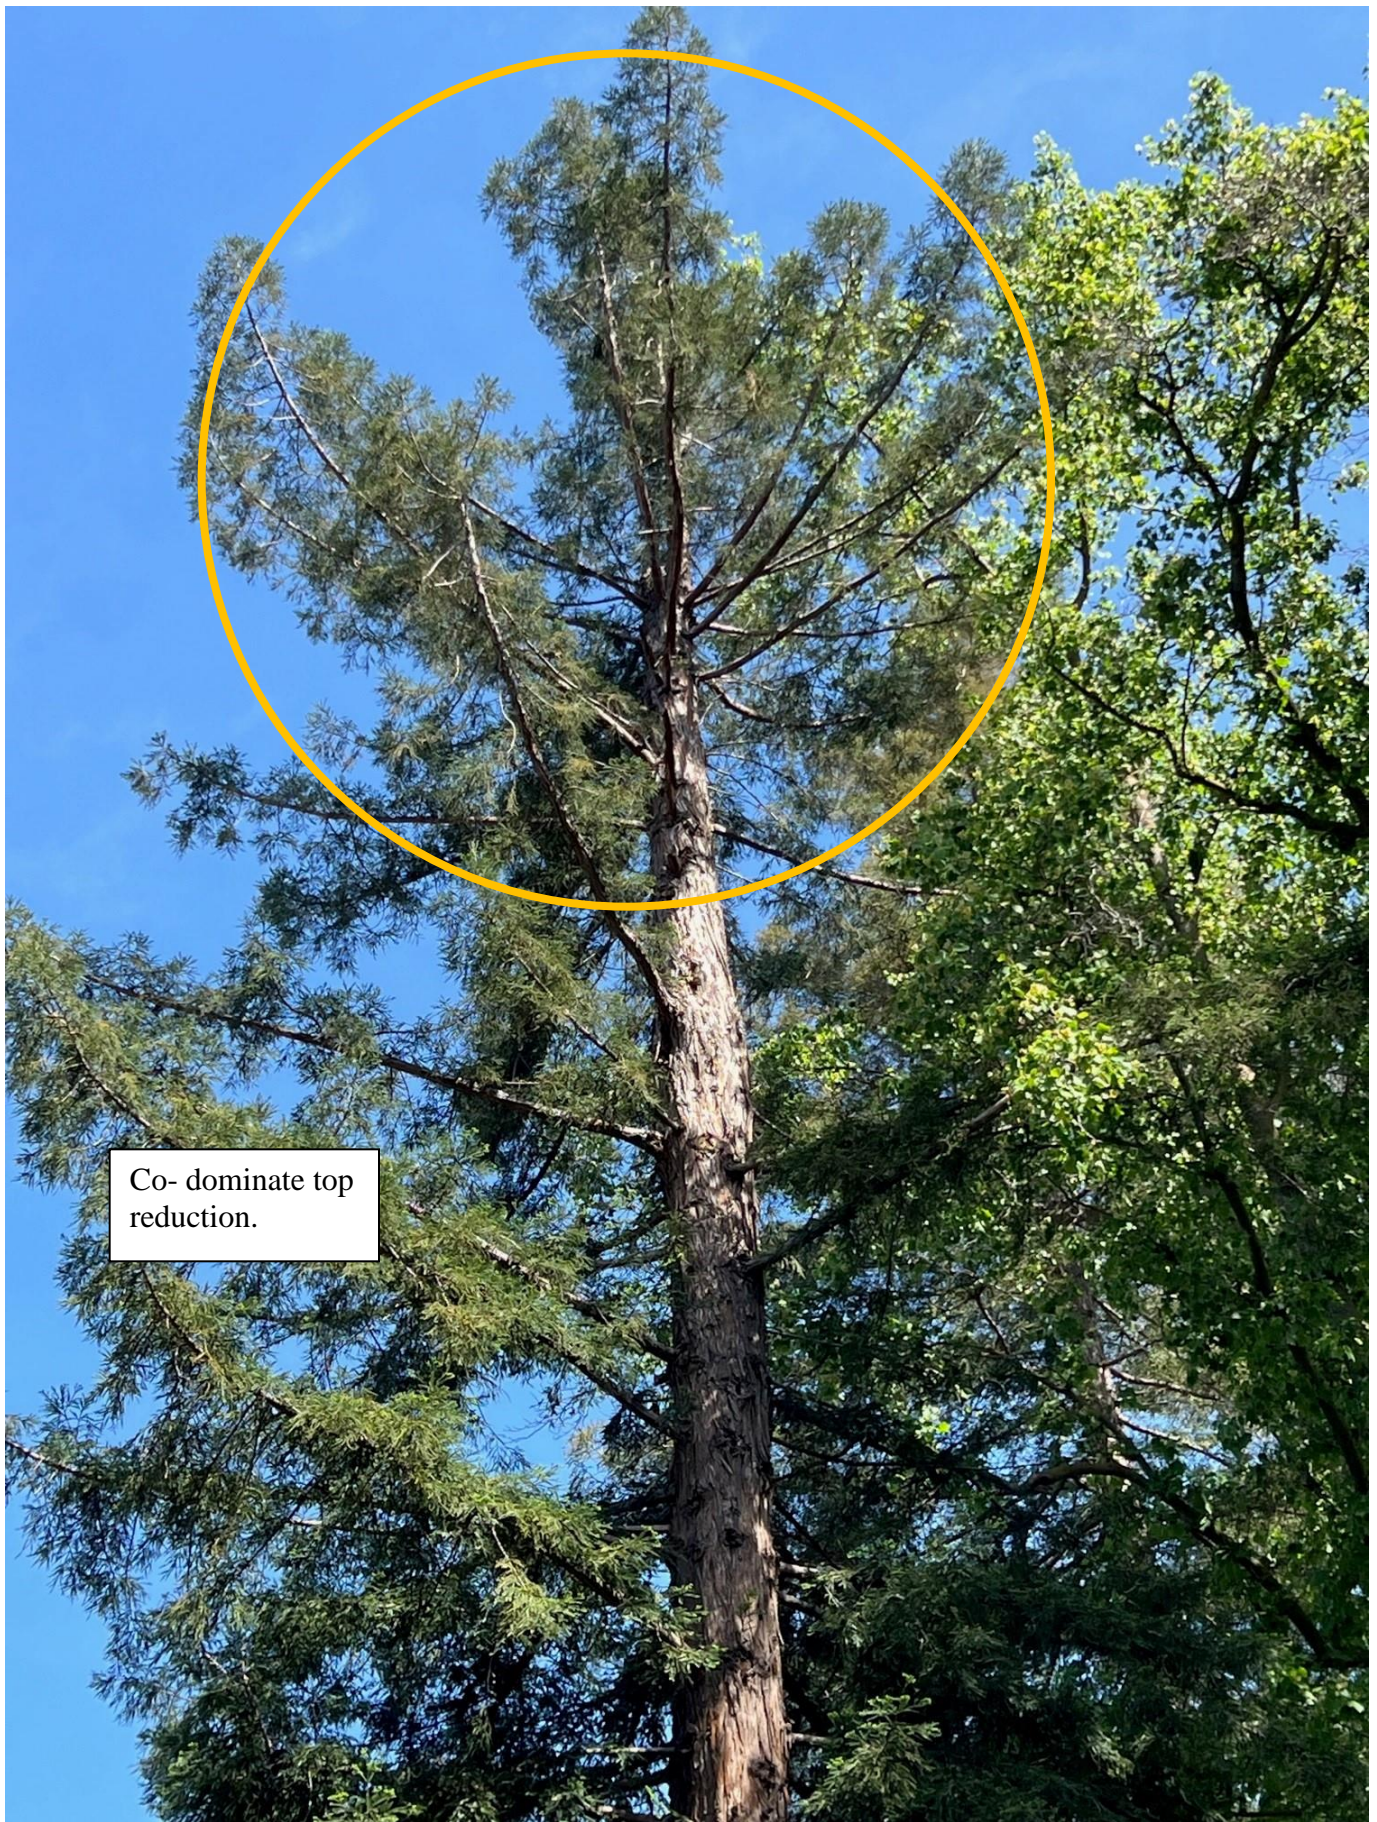
Figure 30

- (Zone 2) Tree #No Tag Redwood (*Sequoia sempervirens*) in front of 1106 Vanderbilt Dr. This tree has an included co dominate top. Due to the failure potential, I recommend reduction pruning of the co dominate top of this tree to help reduce failure (Figure 30)

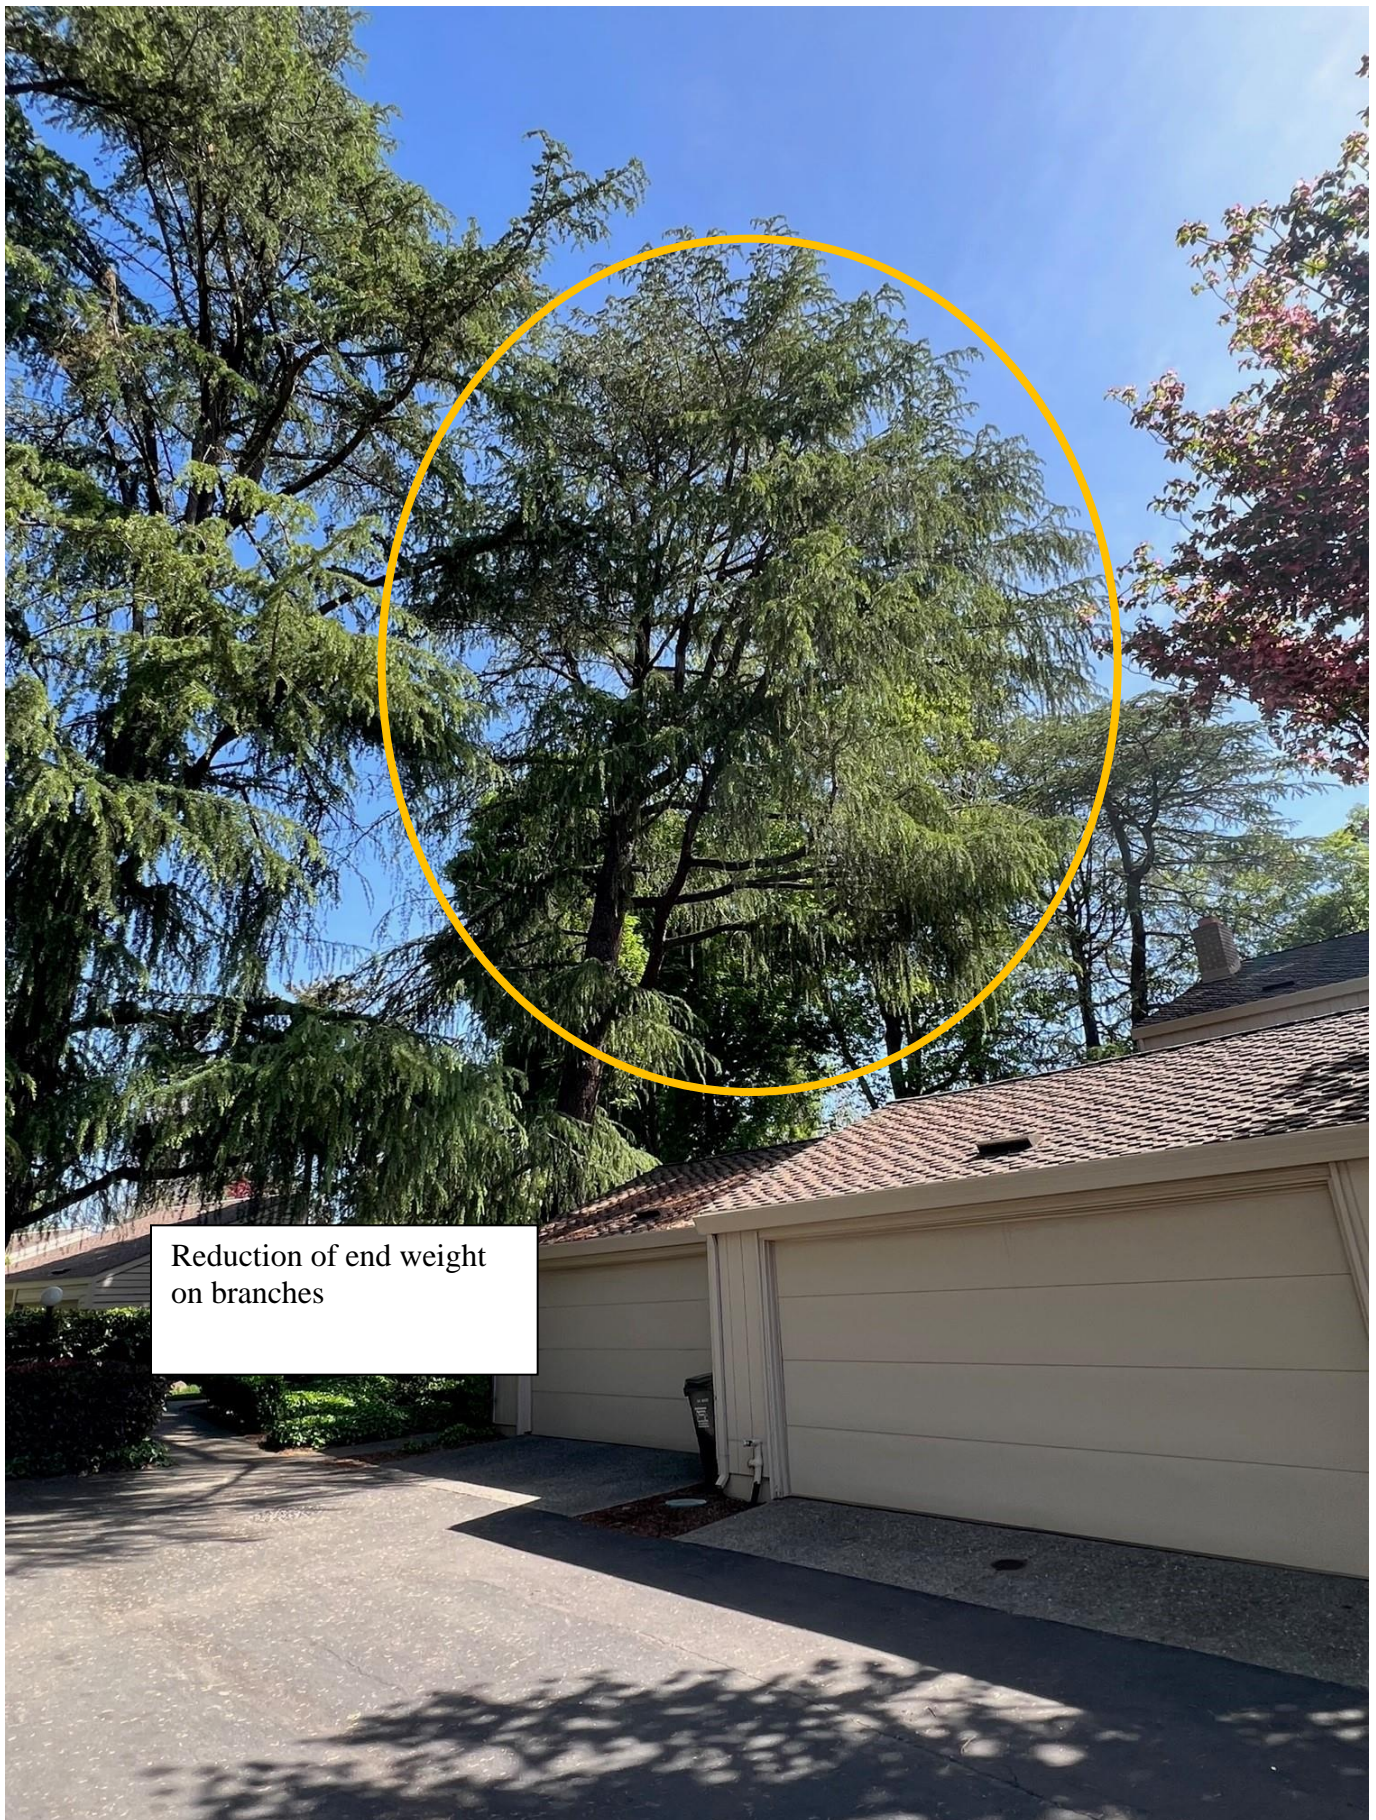
Figure 31

- (Zone 2) Tree #3415 Cedar (*Cedrus deodara*), in front of 1146 Vanderbilt Dr. This tree has an over weighted canopy and requires reduction pruning on branches throughout the tree canopy (Figure 31).
