September 7, 2023

On August 29, 2023, I inspected several trees on the Nepenthe property during the monthly tree walk. The focus of the walk was to address resident/management concerns regarding mature trees on the property. The purpose of this report is to develop mitigation plans for the following trees and my recommendations are below. My recommendations are based on a Basic Visual Inspection. All decisions made based on the recommendations of this report are at the discretion of the Nepenthe Association.

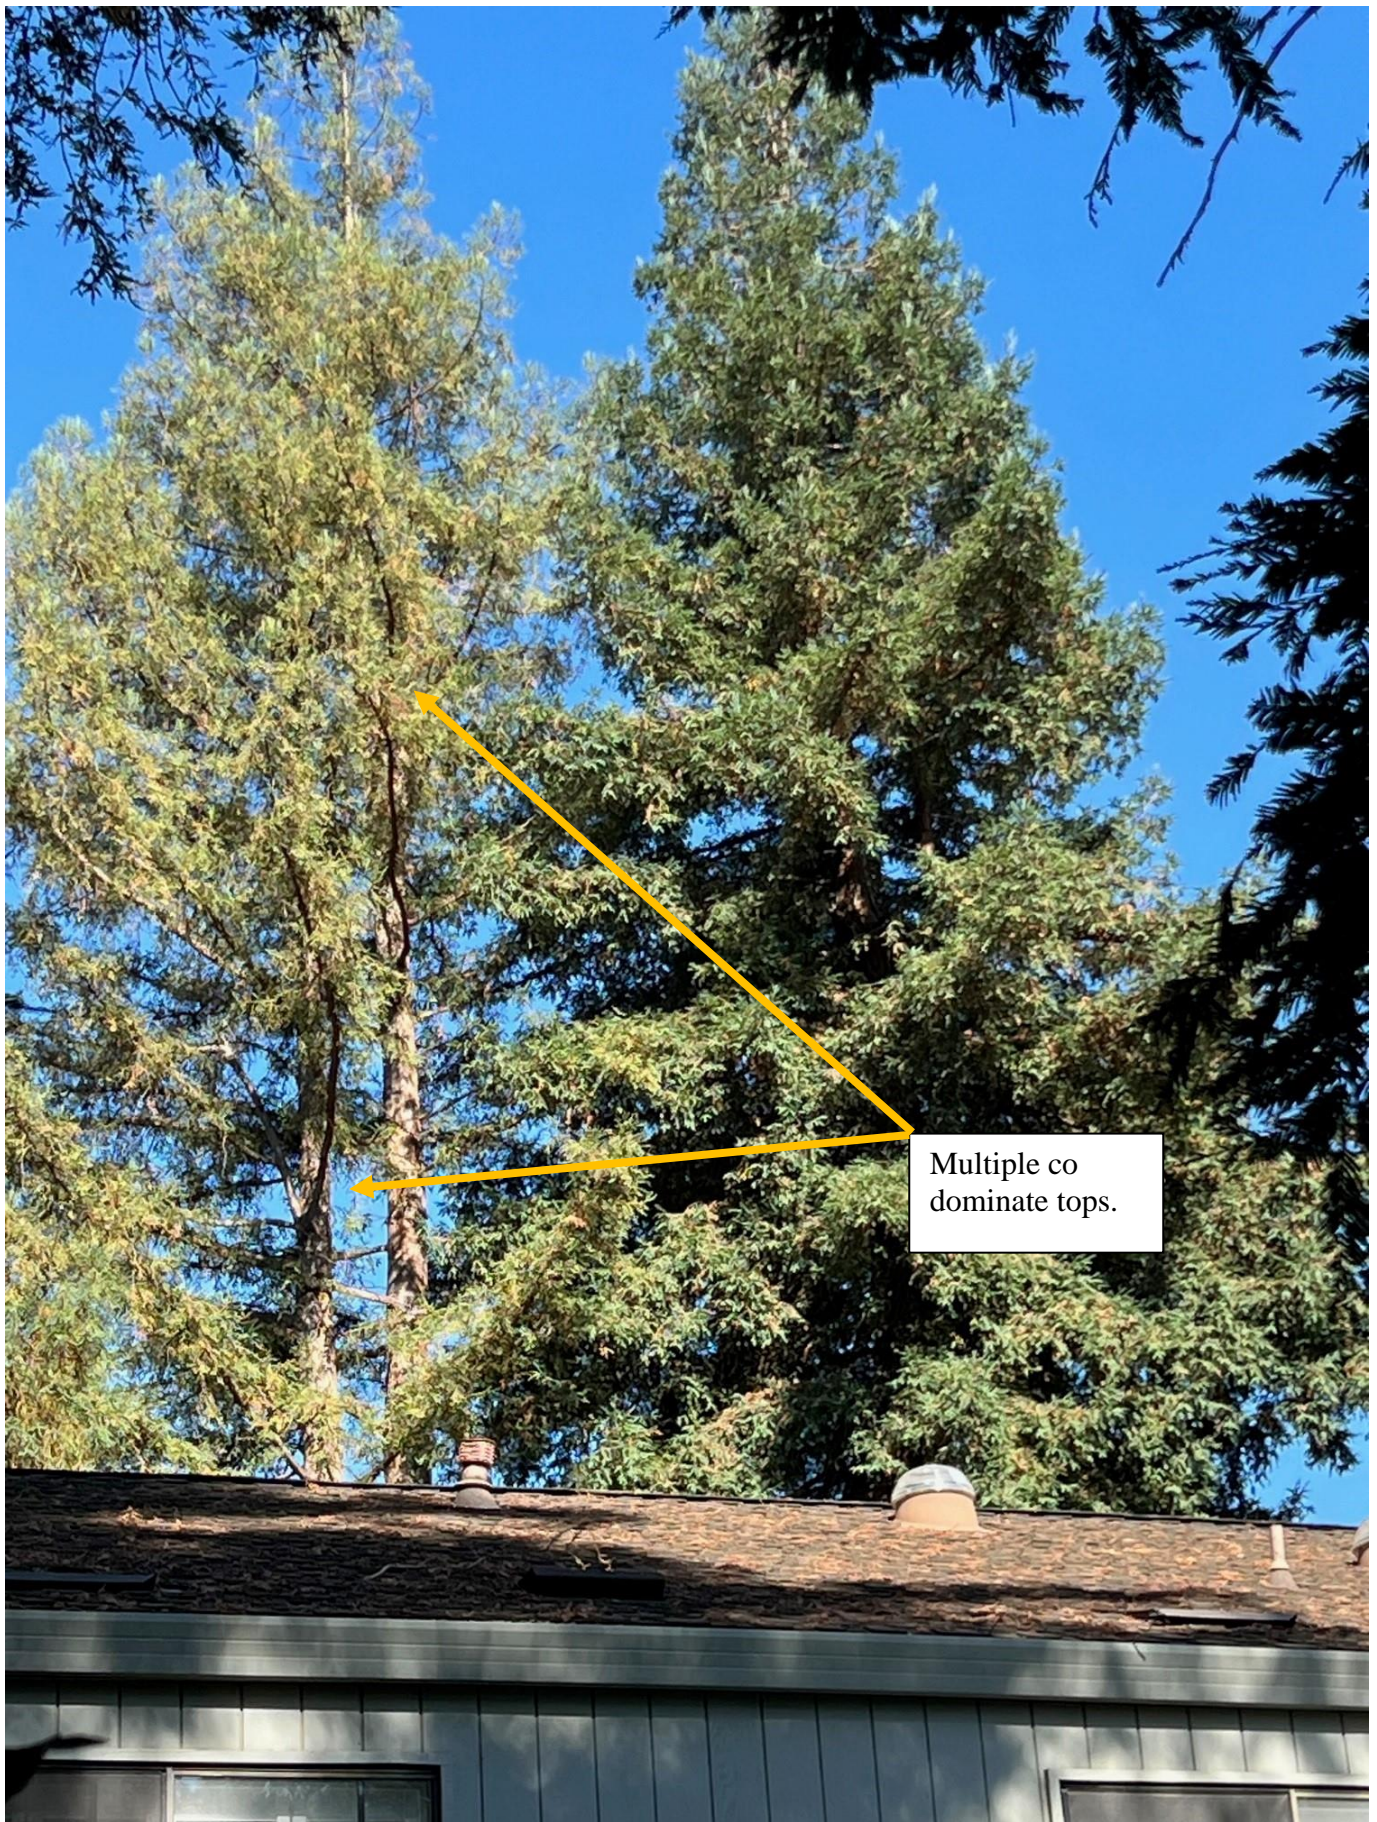
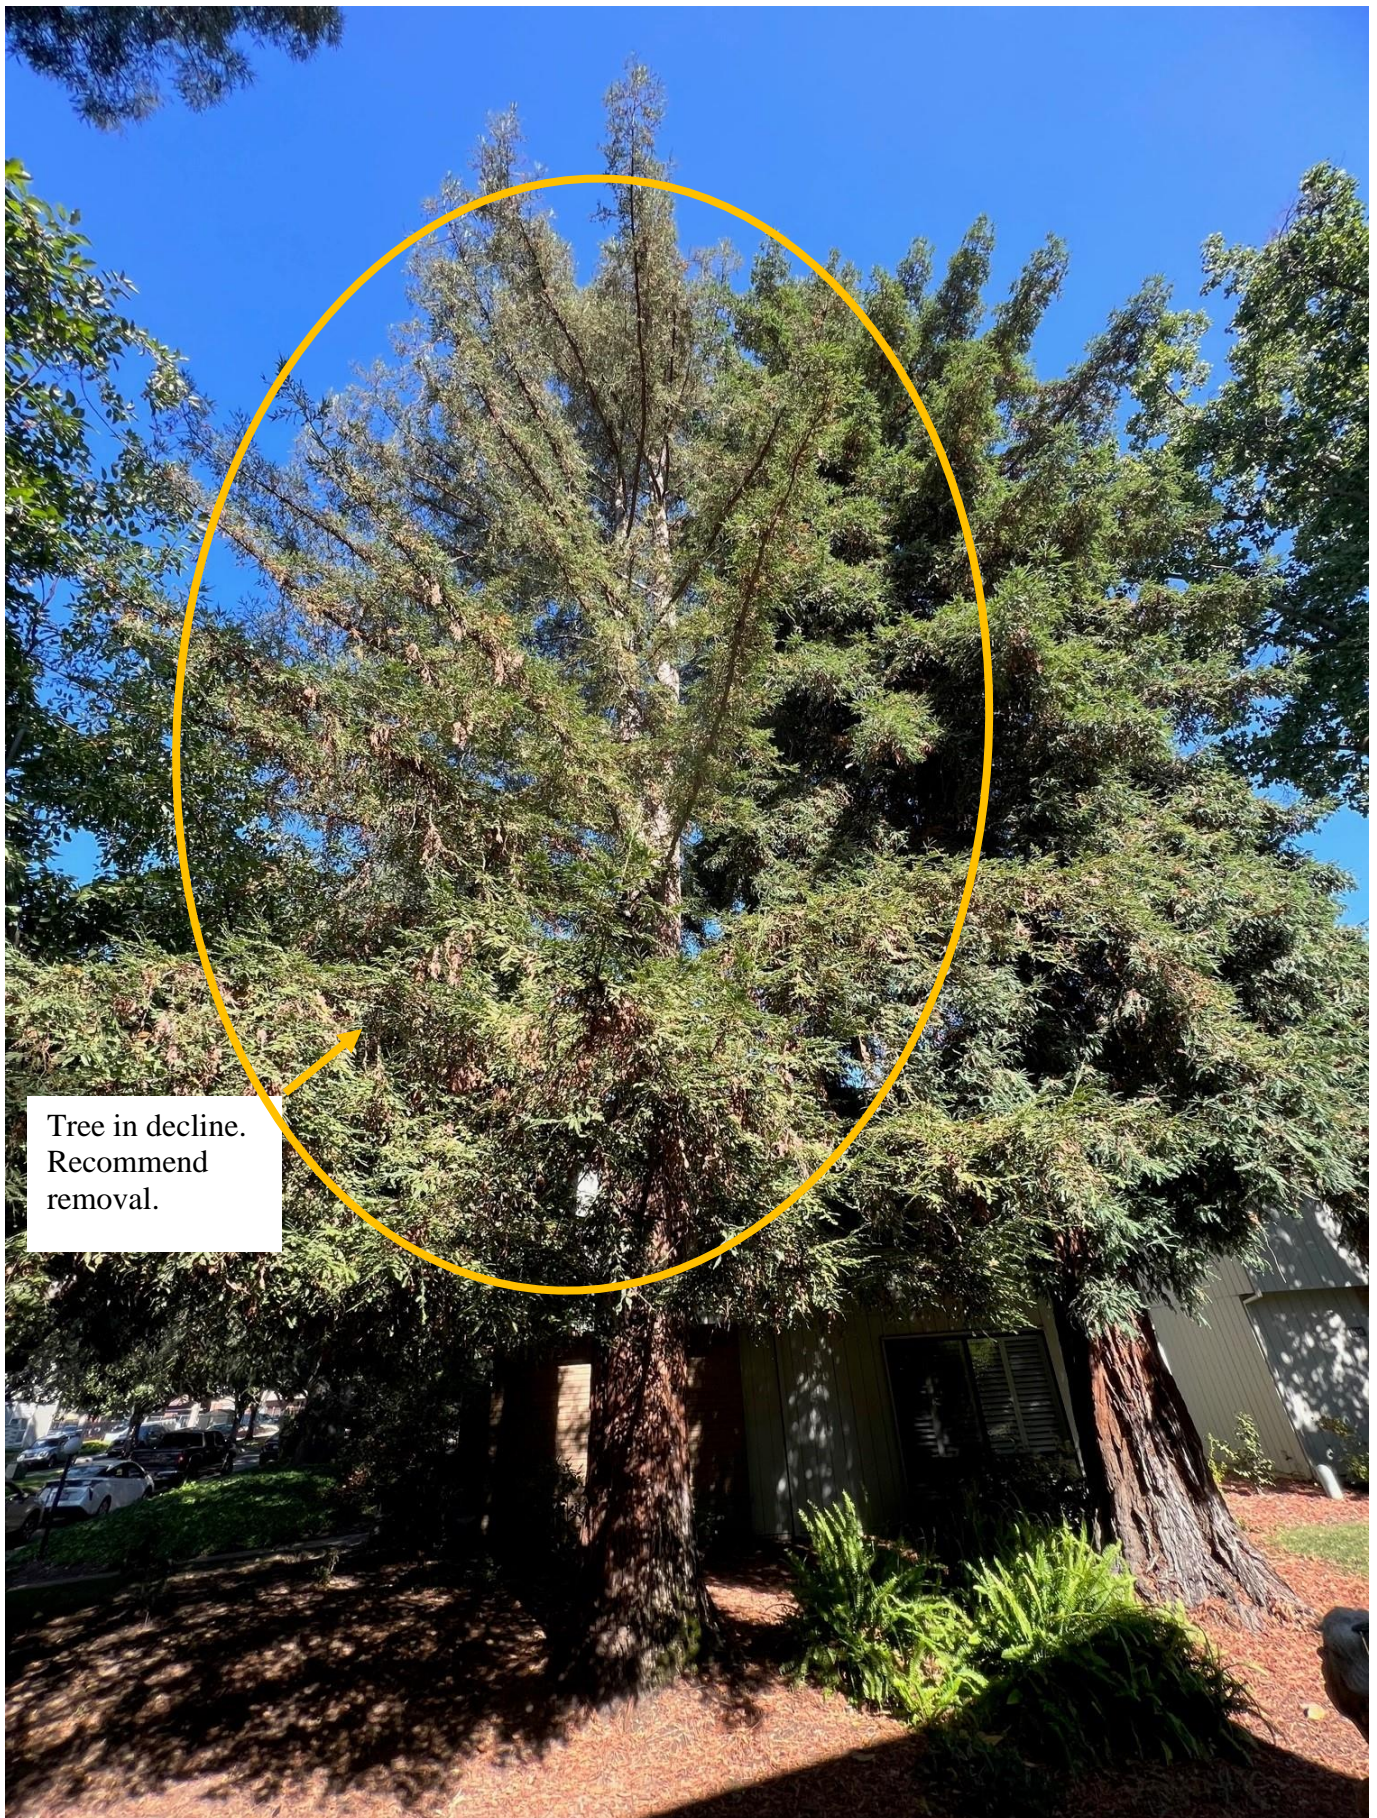
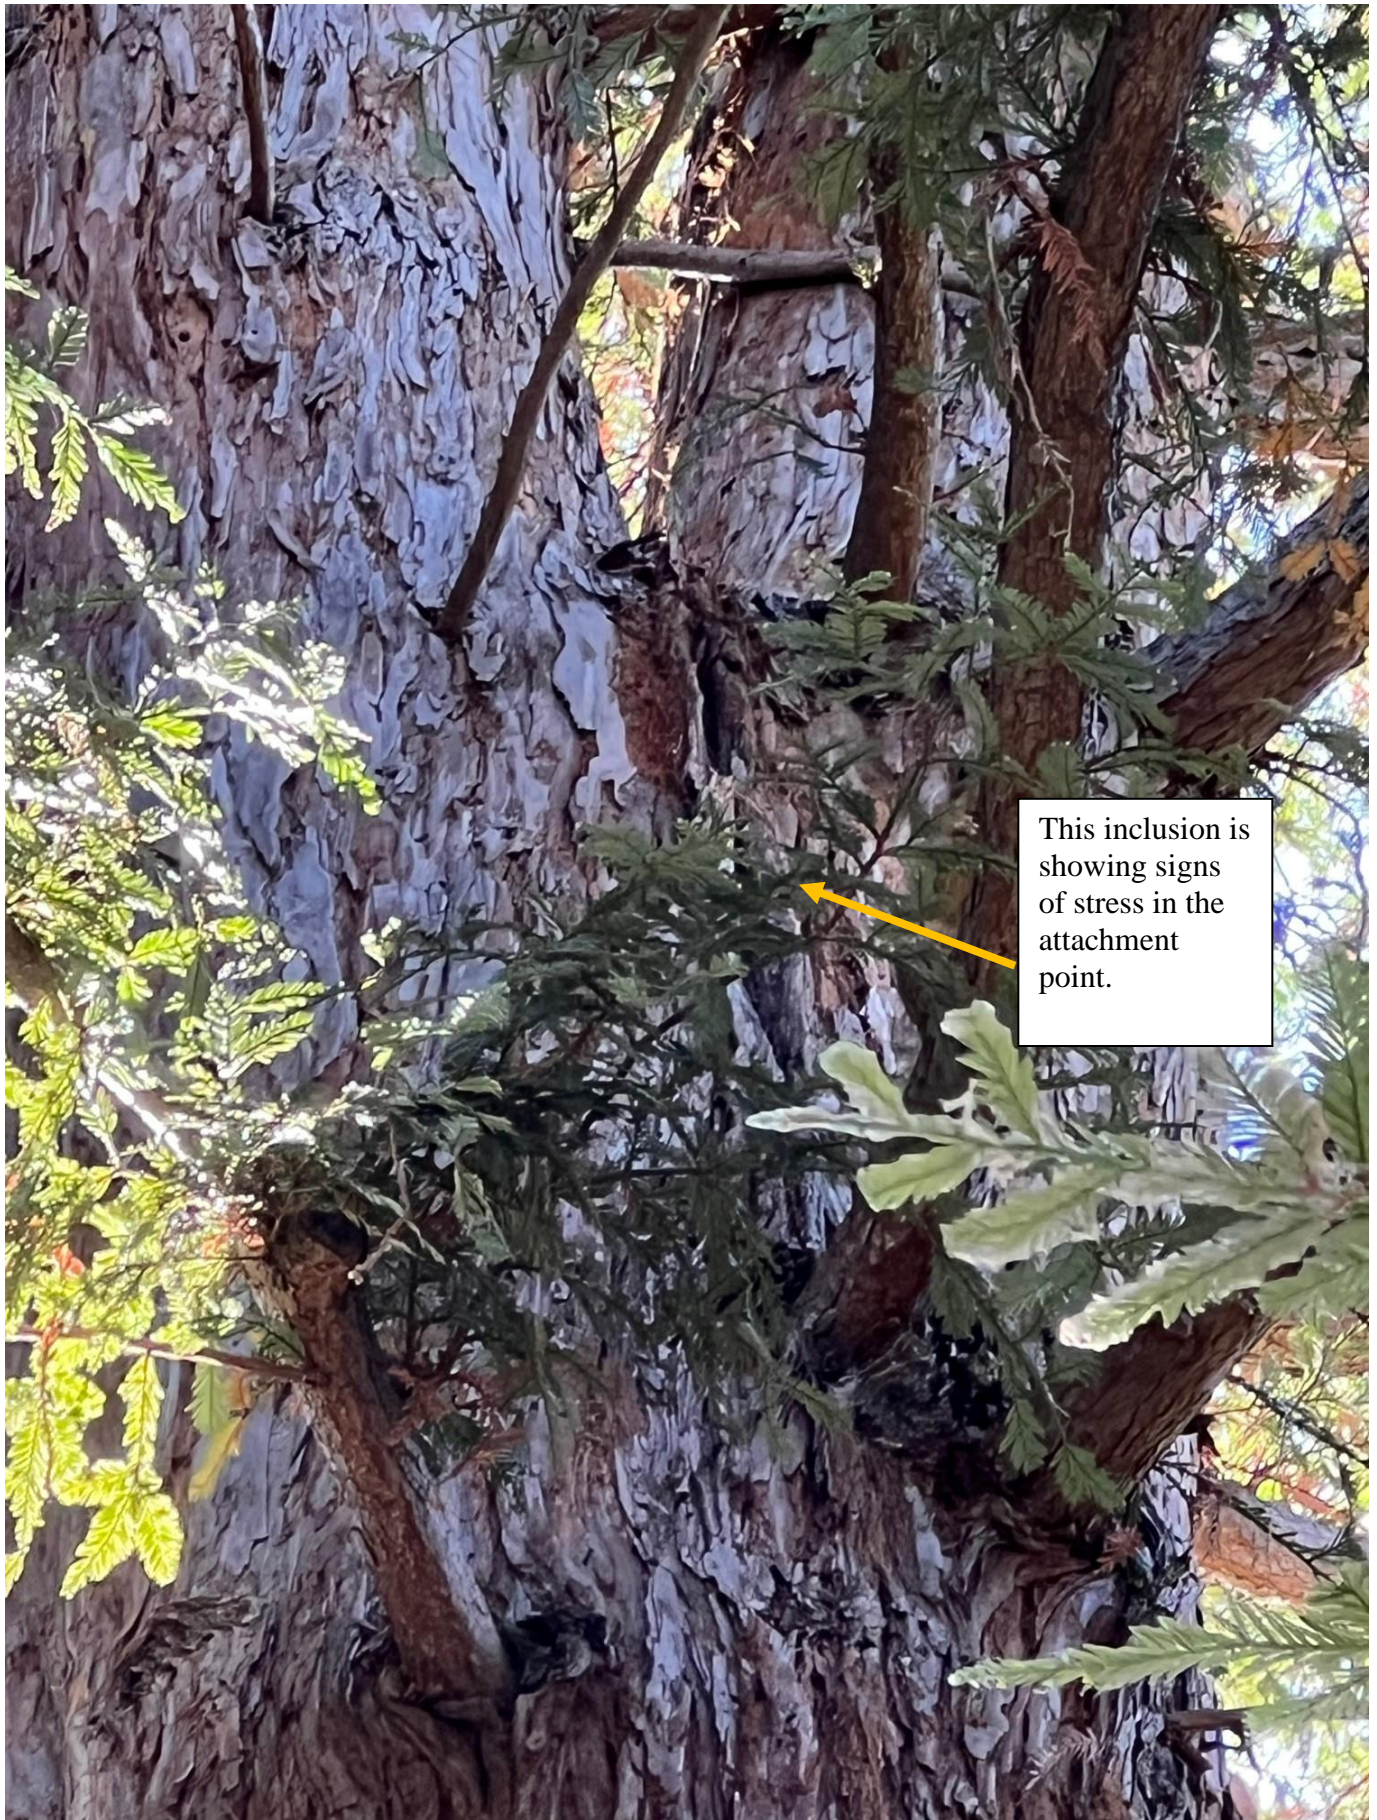
- (Zone 6) Tree #1818 Redwood (*Sequoia sempervirens*) In front of 408 Elmhurst Circle. This tree has multiple included co dominate tops. In addition, the tree appears to be stressed and in decline. The canopy appears to be thinning and chlorotic. Each of the co dominate stems has codominant tops. Pruning to reduce the co dominate growth will add additional stress to the tree. Additionally, the inclusion at the main codominant split appears to show signs of damage with discoloration at the junction and a bulge of the wood. Pruning of the co dominate top to help reduce failure of this tree is not an option as this will add to the trees decline. I recommend removal of the tree due to a safety risk (Figure 1-3).

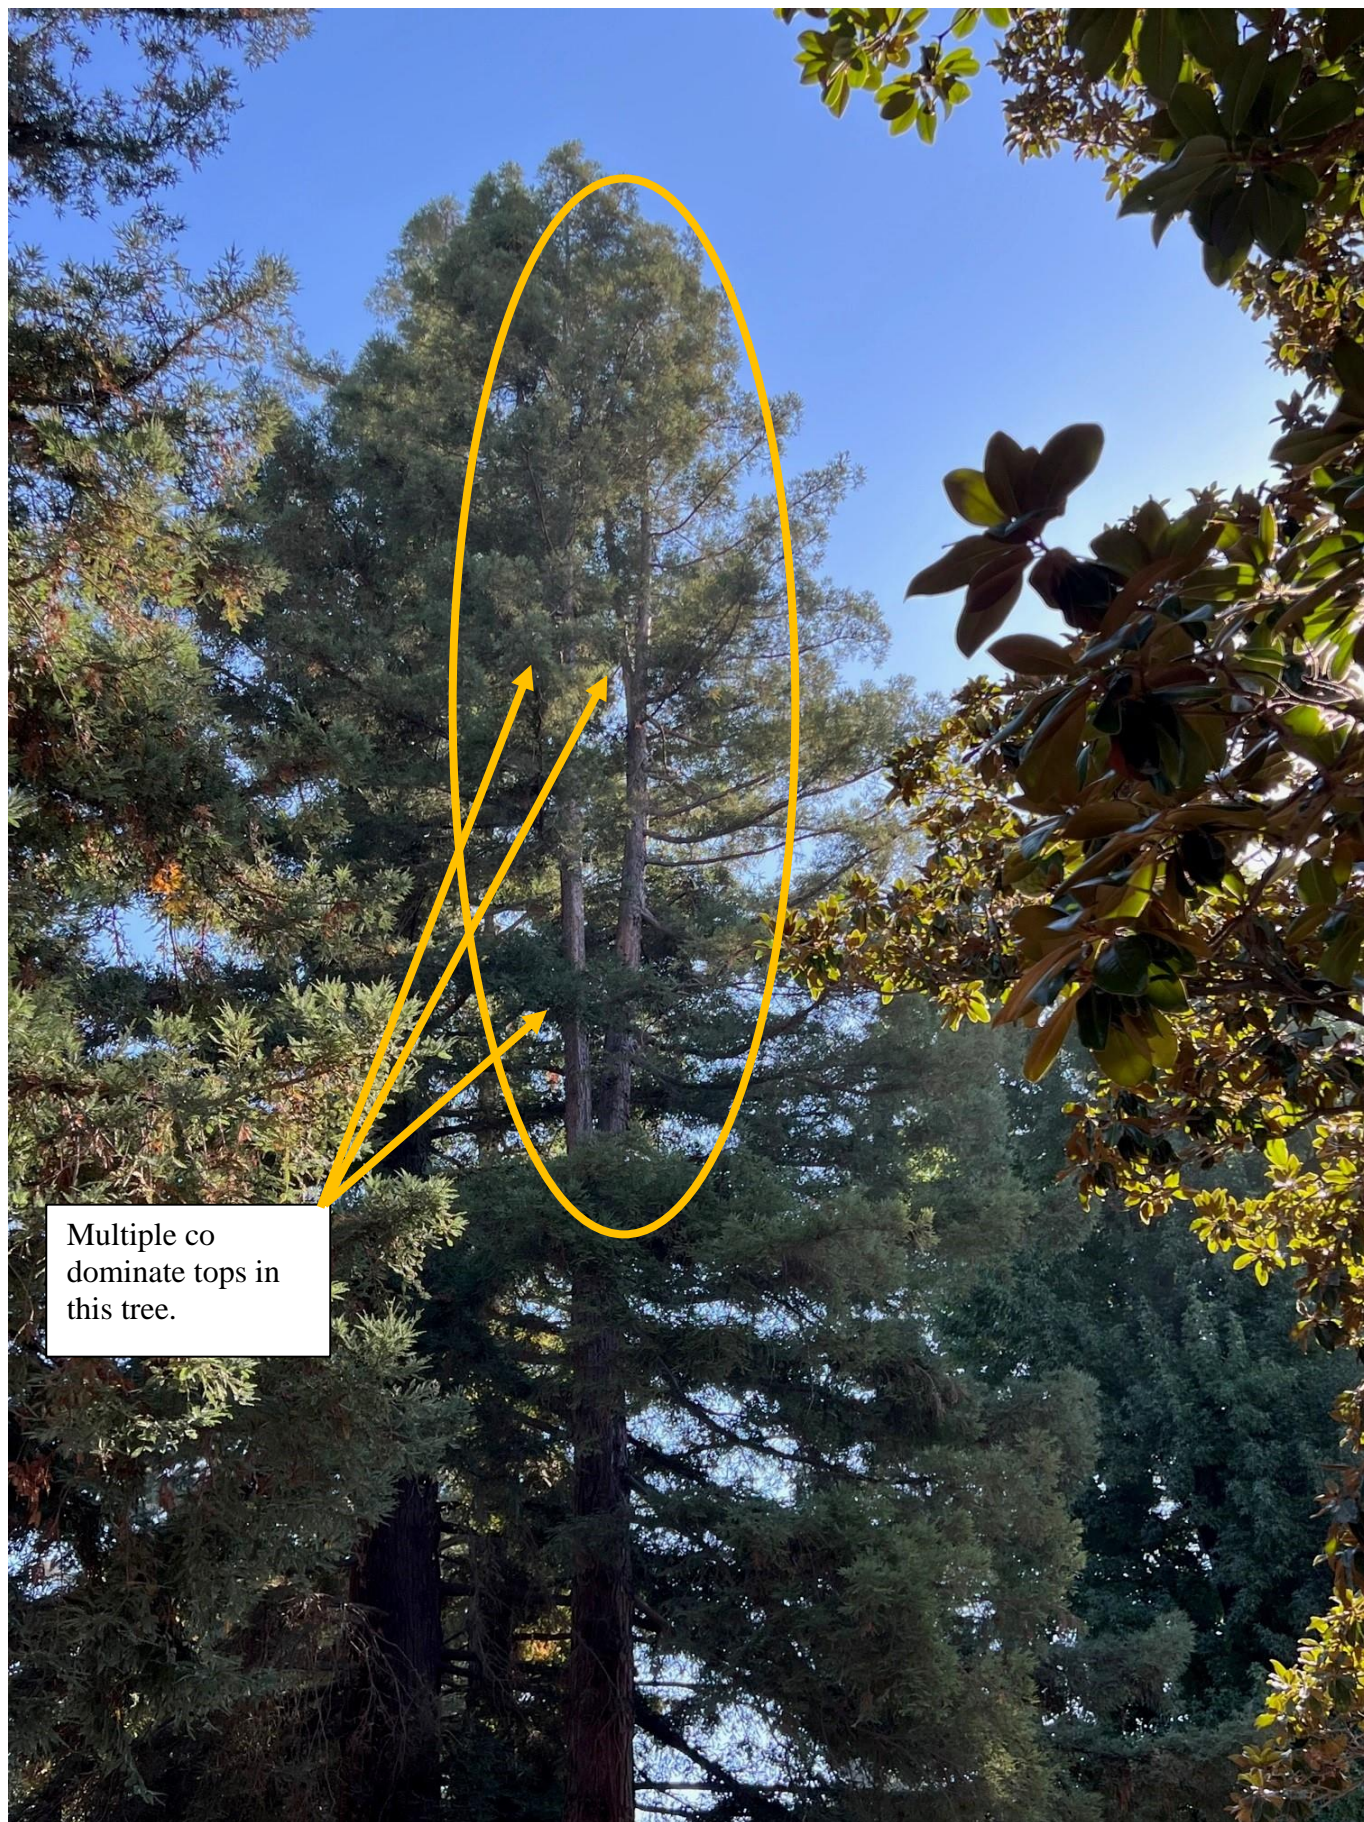
Figure 4

- (Zone 6) Tree #1810 Redwood (*Sequoia sempervirens*) In front of 504 Elmhurst Circle. This tree has multiple included co dominate tops. Each of the co dominate stems has codominant tops. Pruning to reduce the co dominate growth is not an option for this tree. Additionally, the inclusion at the main codominant split appears to show signs of damage with discoloration at the junction and a bulge of the wood. Pruning of the co dominate top to help reduce failure of this tree is not an option, I recommend removal of the tree due to a safety risk (Figure 4-5).

Multiple co
dominate tops in
this tree.

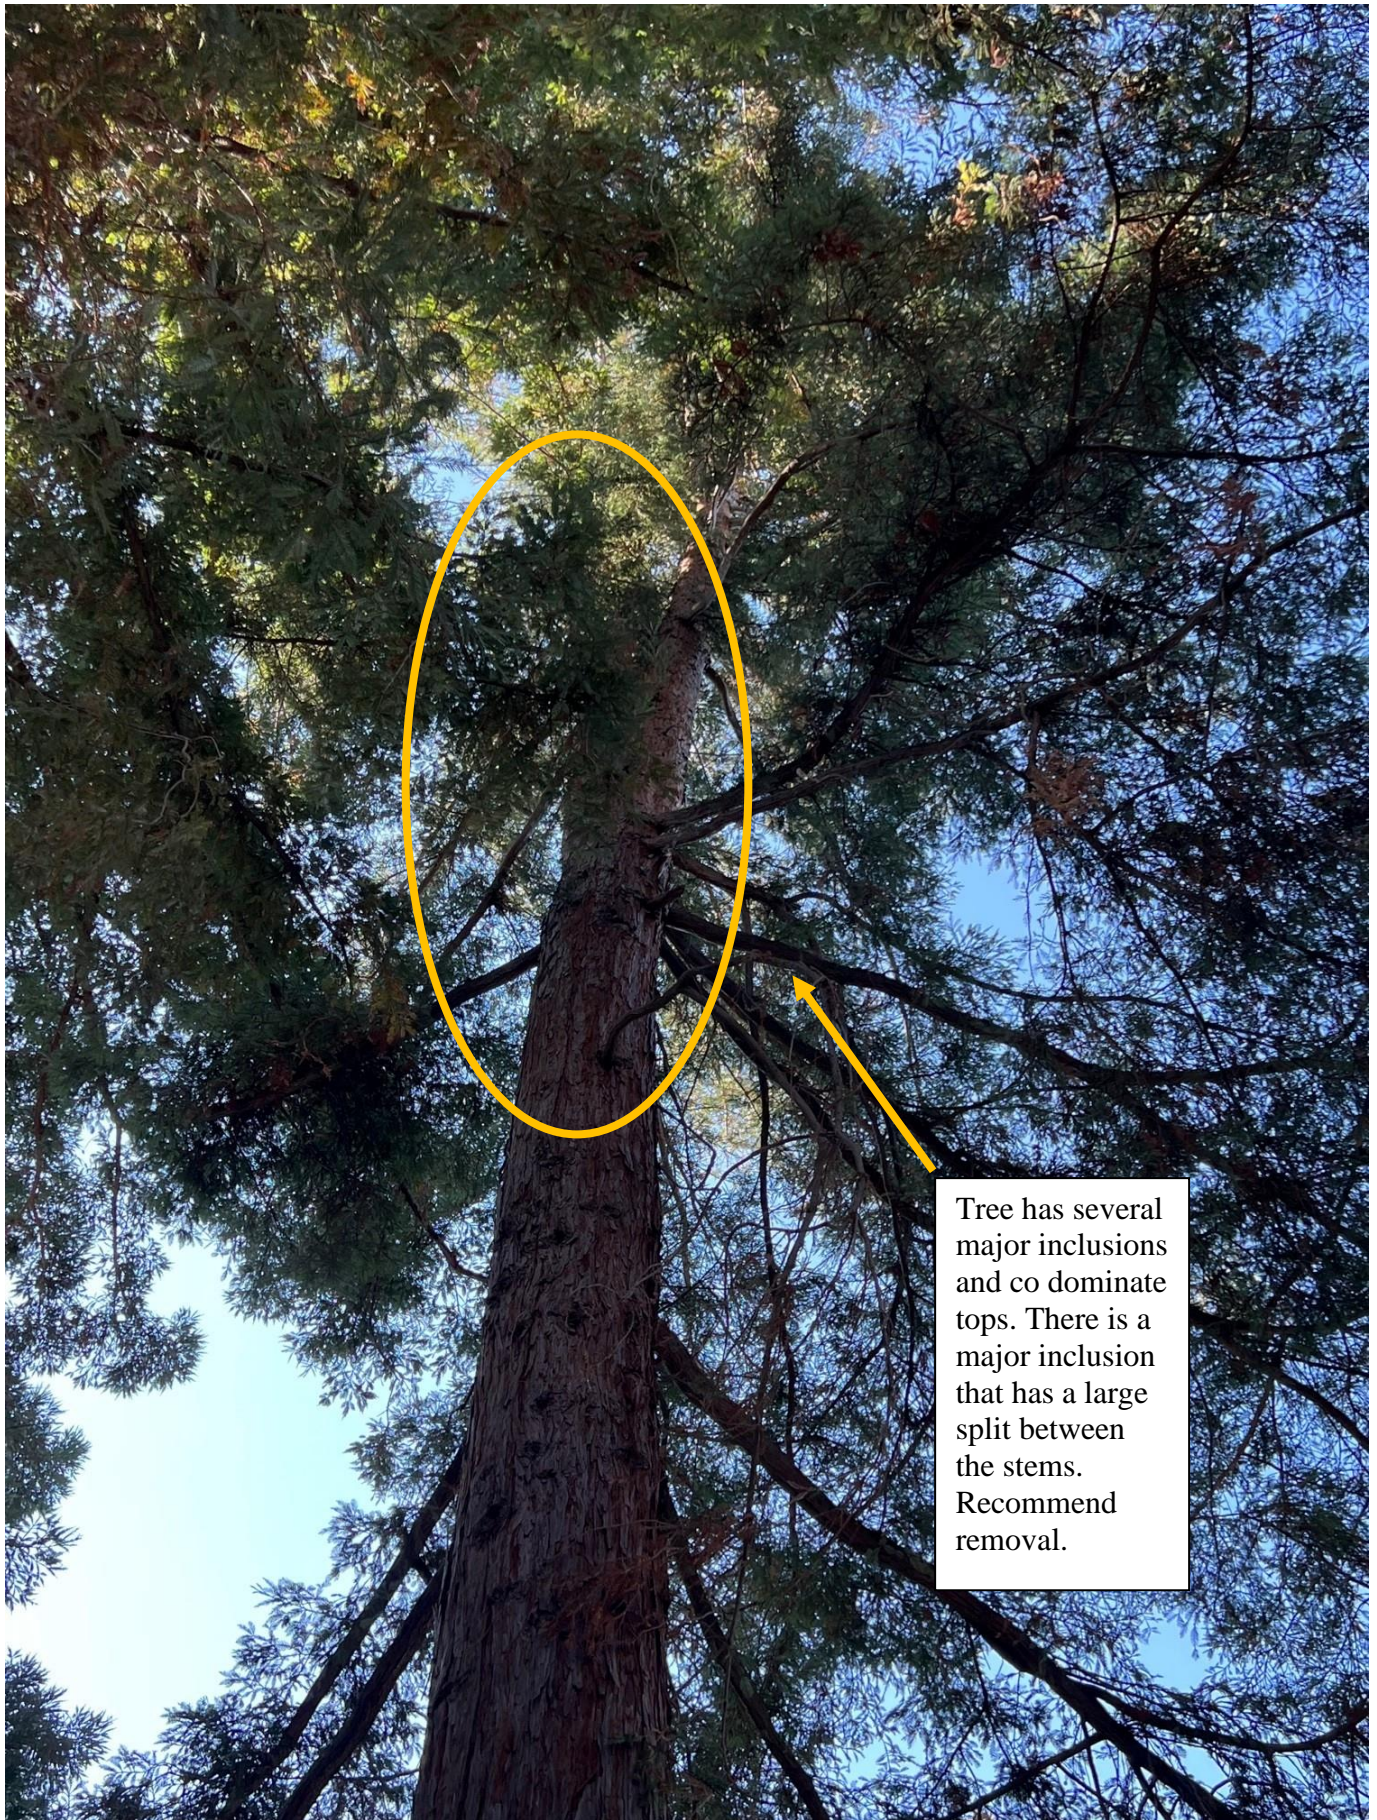
Figure 5

Tree has several major inclusions and co dominate tops. There is a major inclusion that has a large split between the stems. Recommend removal.

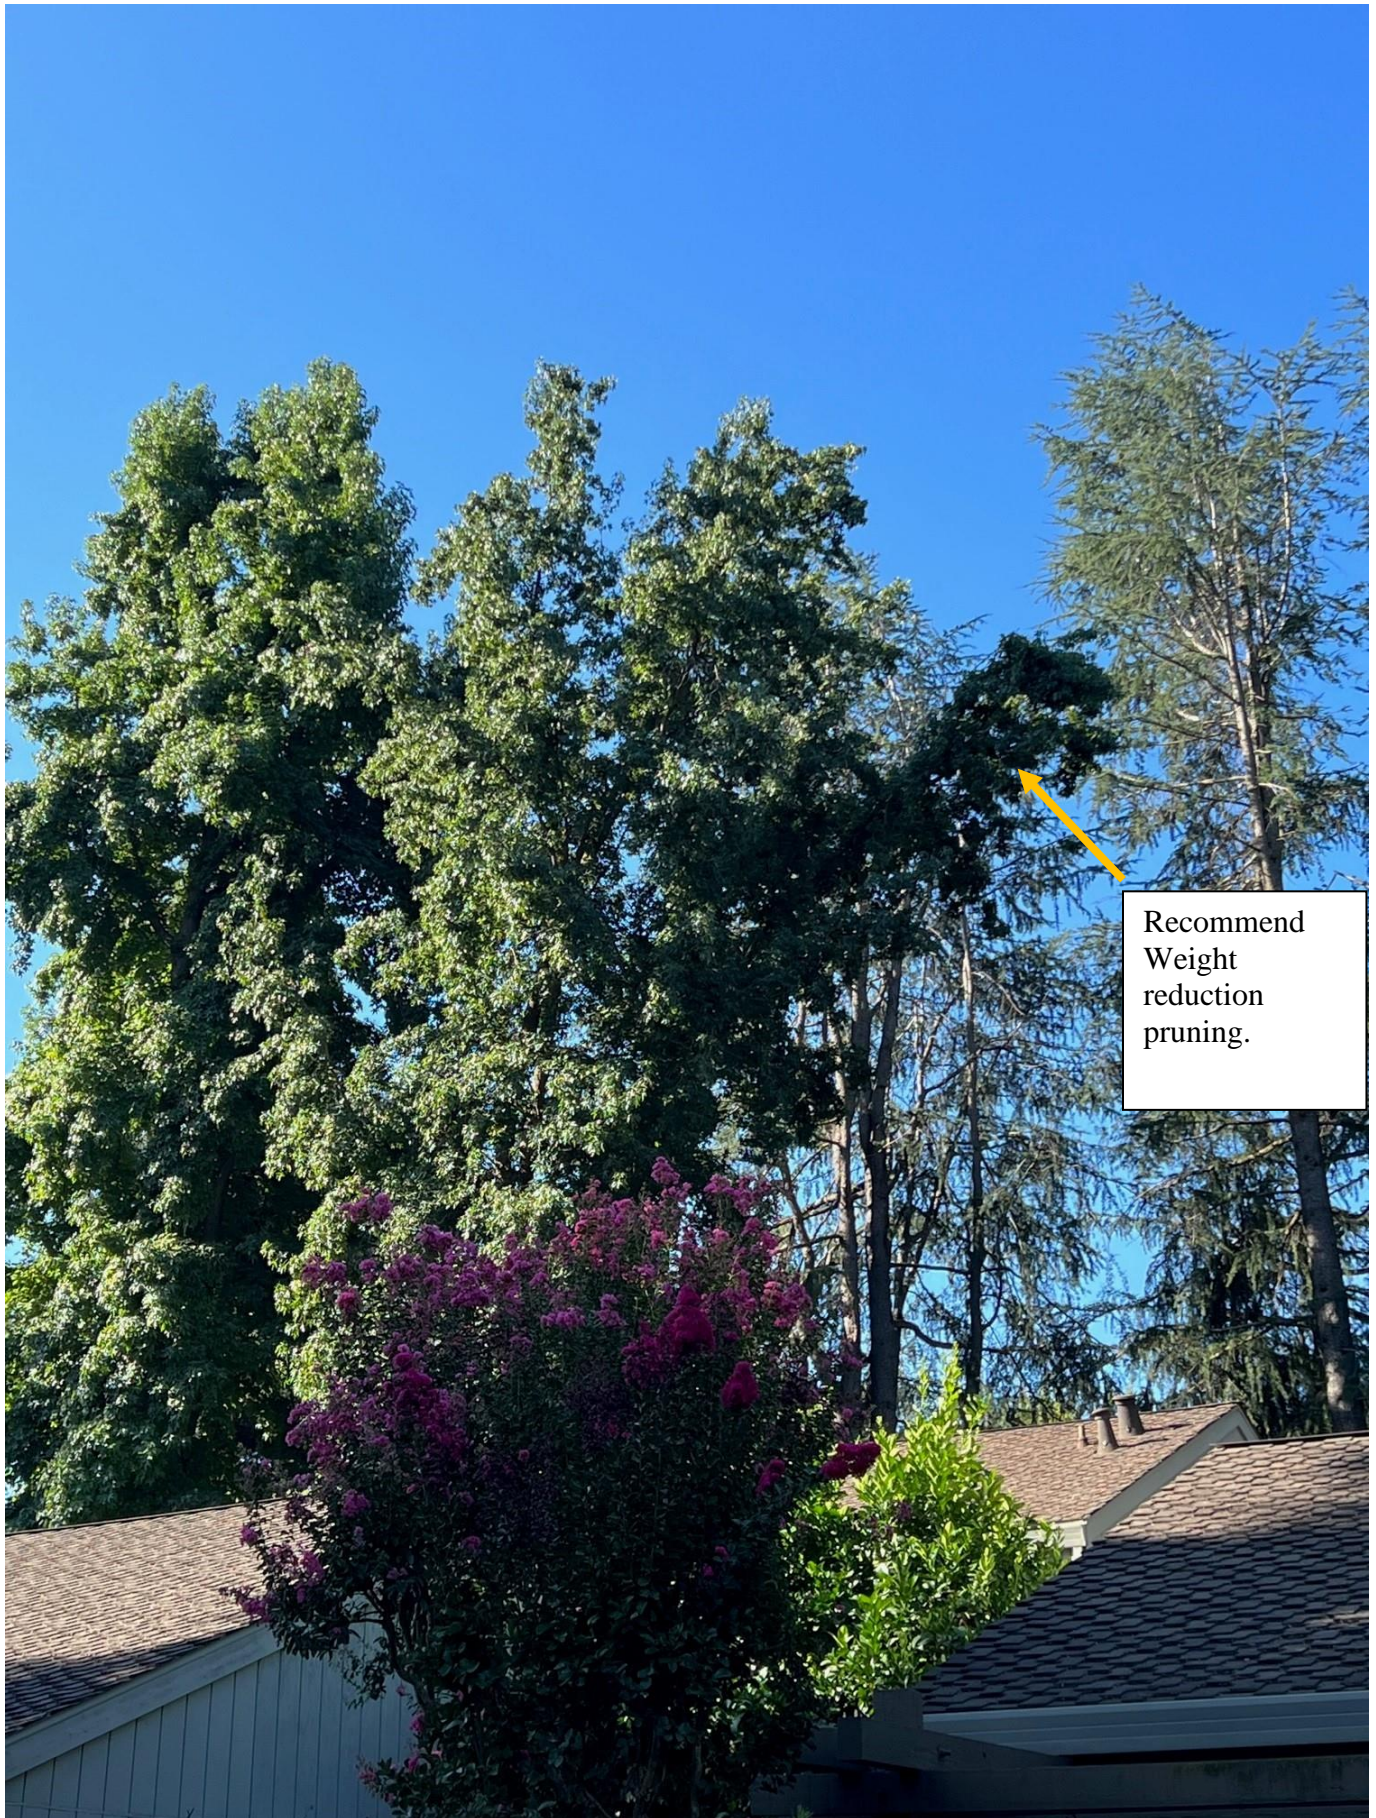
Figure 6

- (Zone 6) Tree #1961 Liquid amber (*Liquidambar styraciflua*), 104 Elmhurst Circle. Tree has a full over weighted canopy and requires reduction pruning on branches throughout the tree canopy, making cuts no larger than 1"-2" on the branch ends reducing the total length by 3'-4' throughout the canopy. Reduction of total live canopy by 25% and removing deadwood larger than 2". (Figure 6).

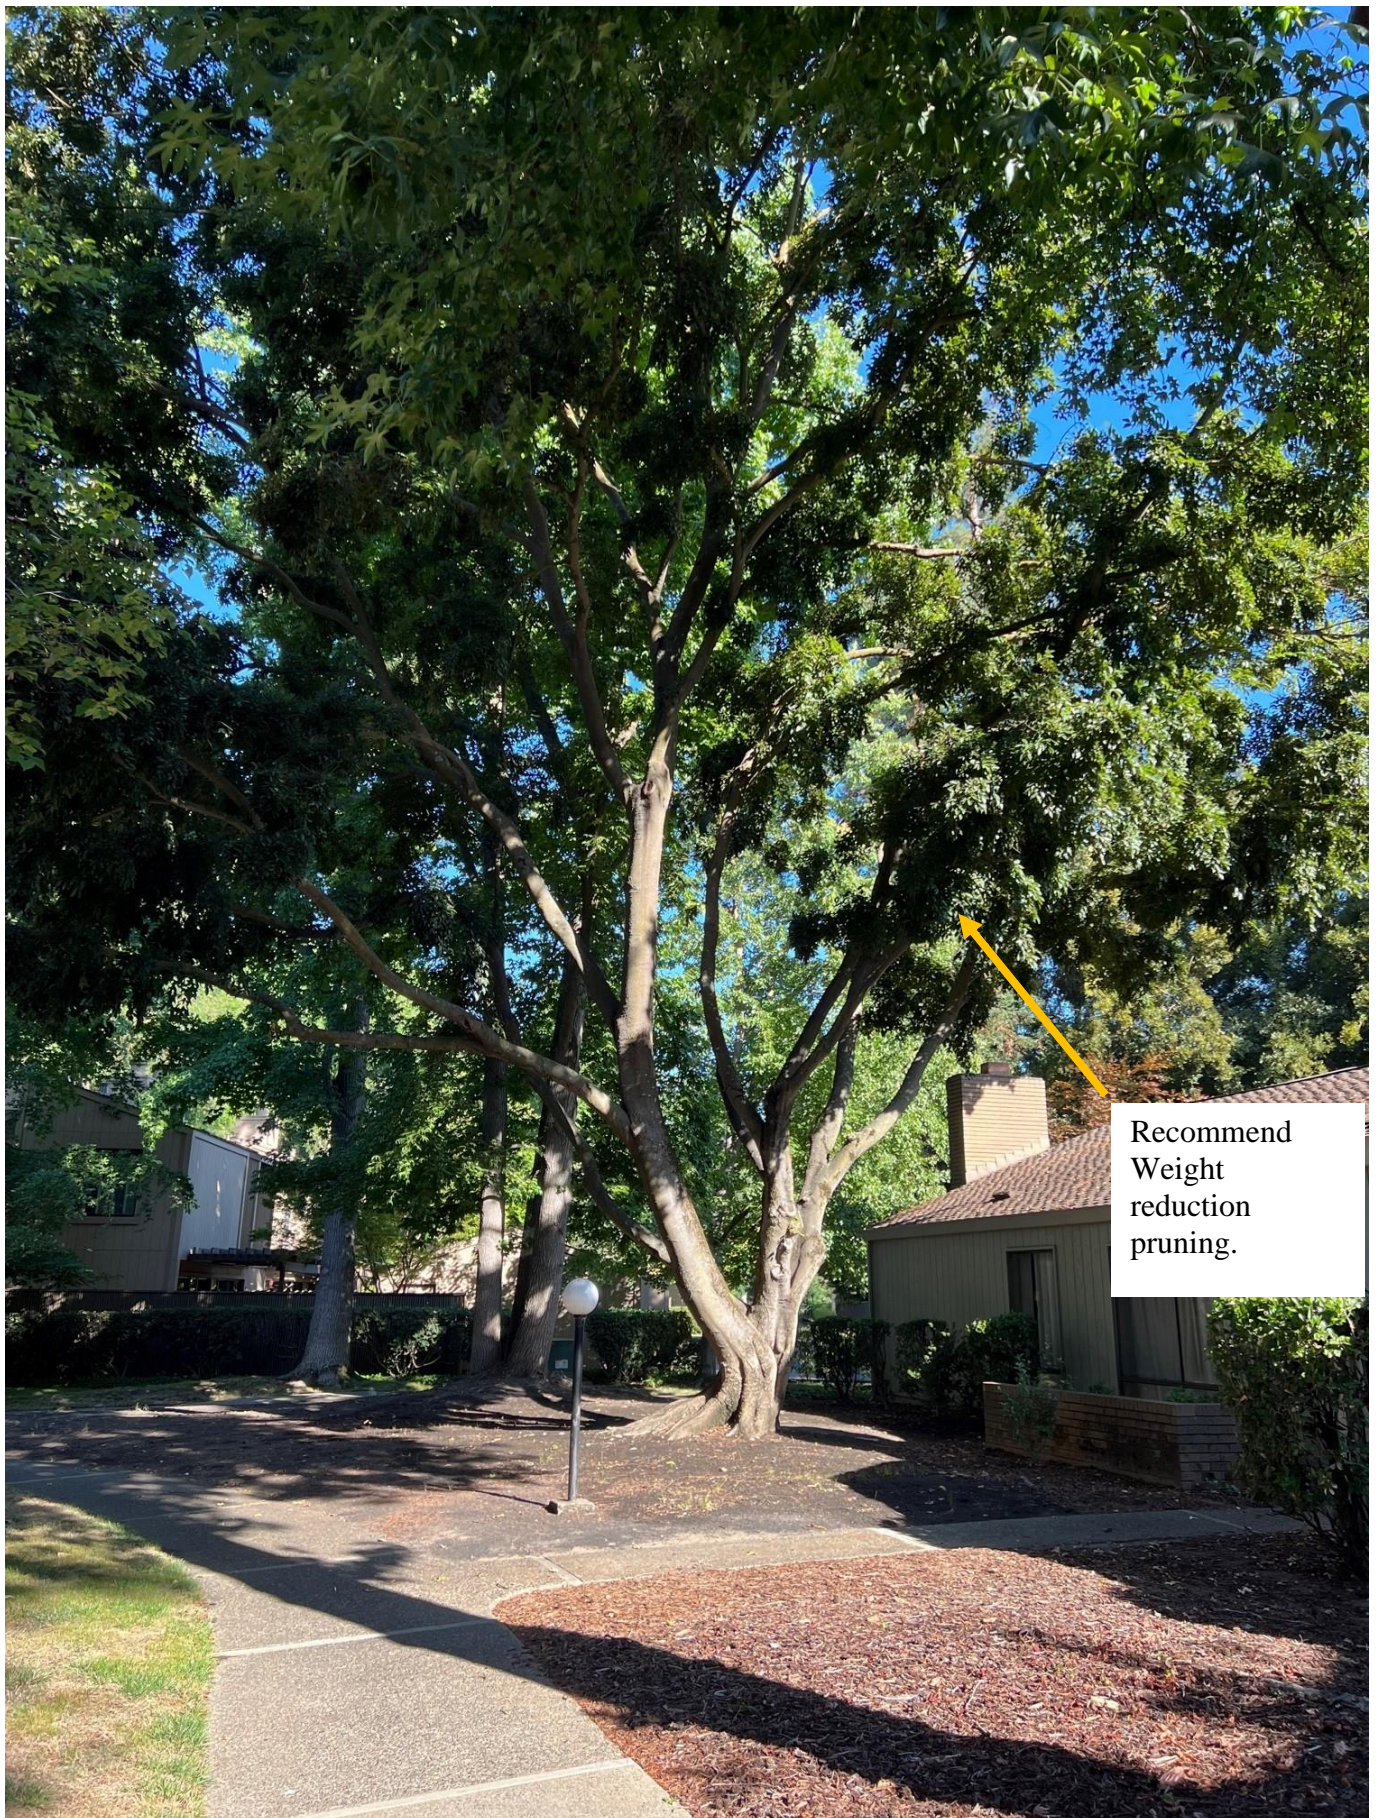
Figure 7

- (Zone 6) Tree #1965 Hackberry (*Celtis occidentalis*), 108 Elmhurst Circle. Tree has a full over weighted canopy and requires reduction pruning on branches throughout the tree canopy, making cuts no larger than 1"-2" on the branch ends reducing the total length by 3'-4' throughout the canopy. Reduction of total live canopy by 20% and removing deadwood larger than 2". (Figure 7).

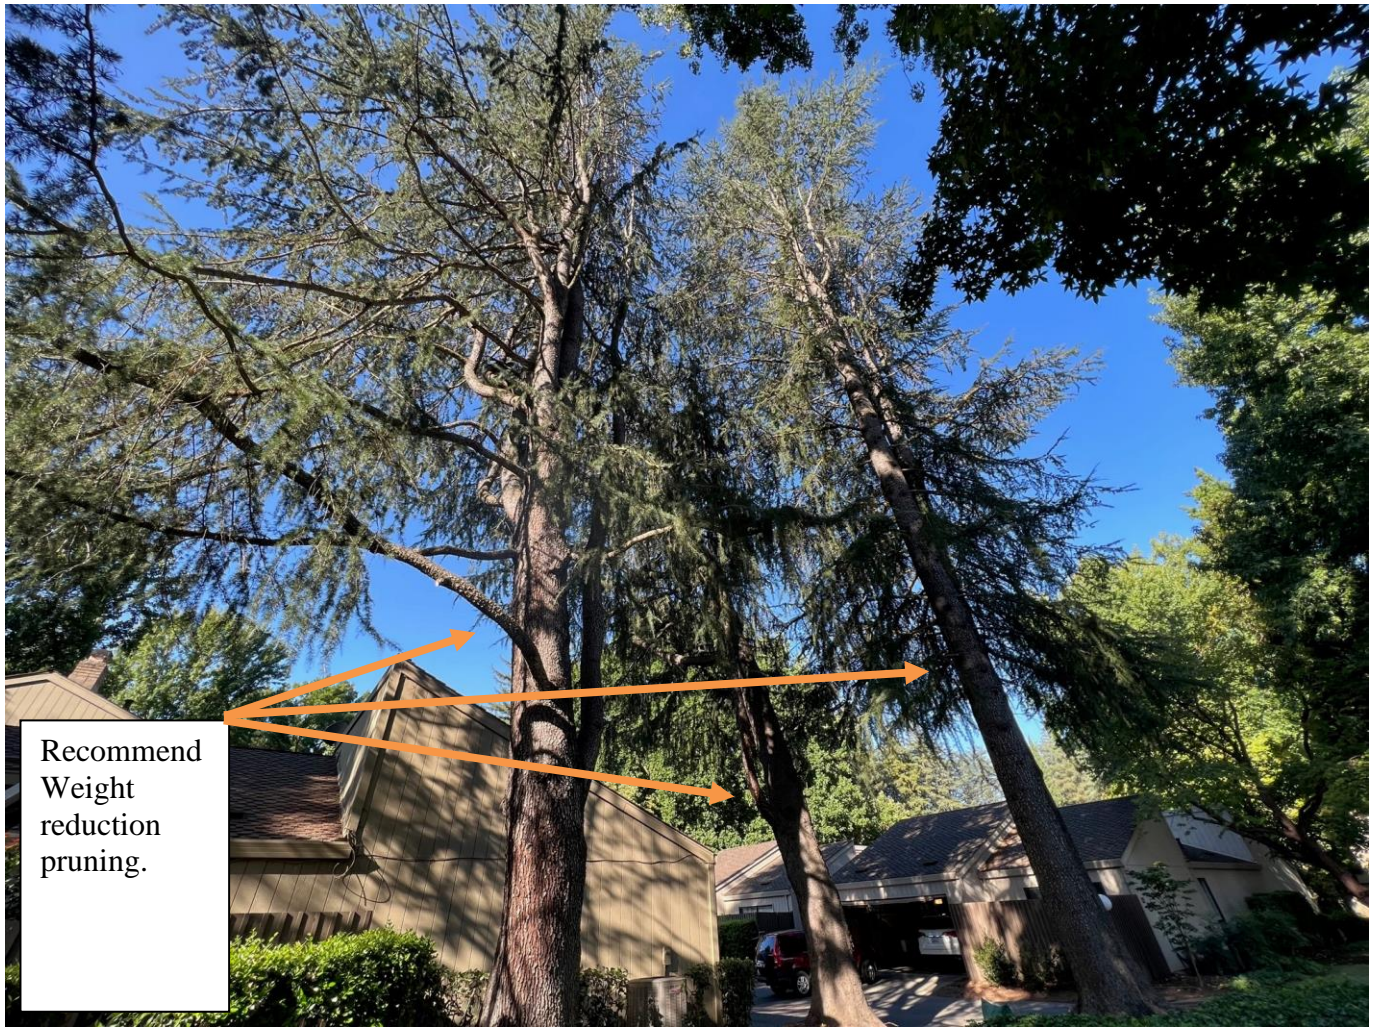
Figure 8

- (Zone 6) 4 Trees #1954, 1955, 1956, 1958 Cedar (*Cedrus deodara*) In front of 200 Elmhurst Circle. These trees have over weighted canopies and requires reduction pruning on branches throughout the tree canopy, making cuts no larger than 1"-2" on the branch ends reducing the total length of branched by 1'-3' on 60% of the trees total canopy. Reduction of total live canopy by 20% and deadwood larger than 2" (Figure 8).

Recommend
Weight
reduction
pruning.

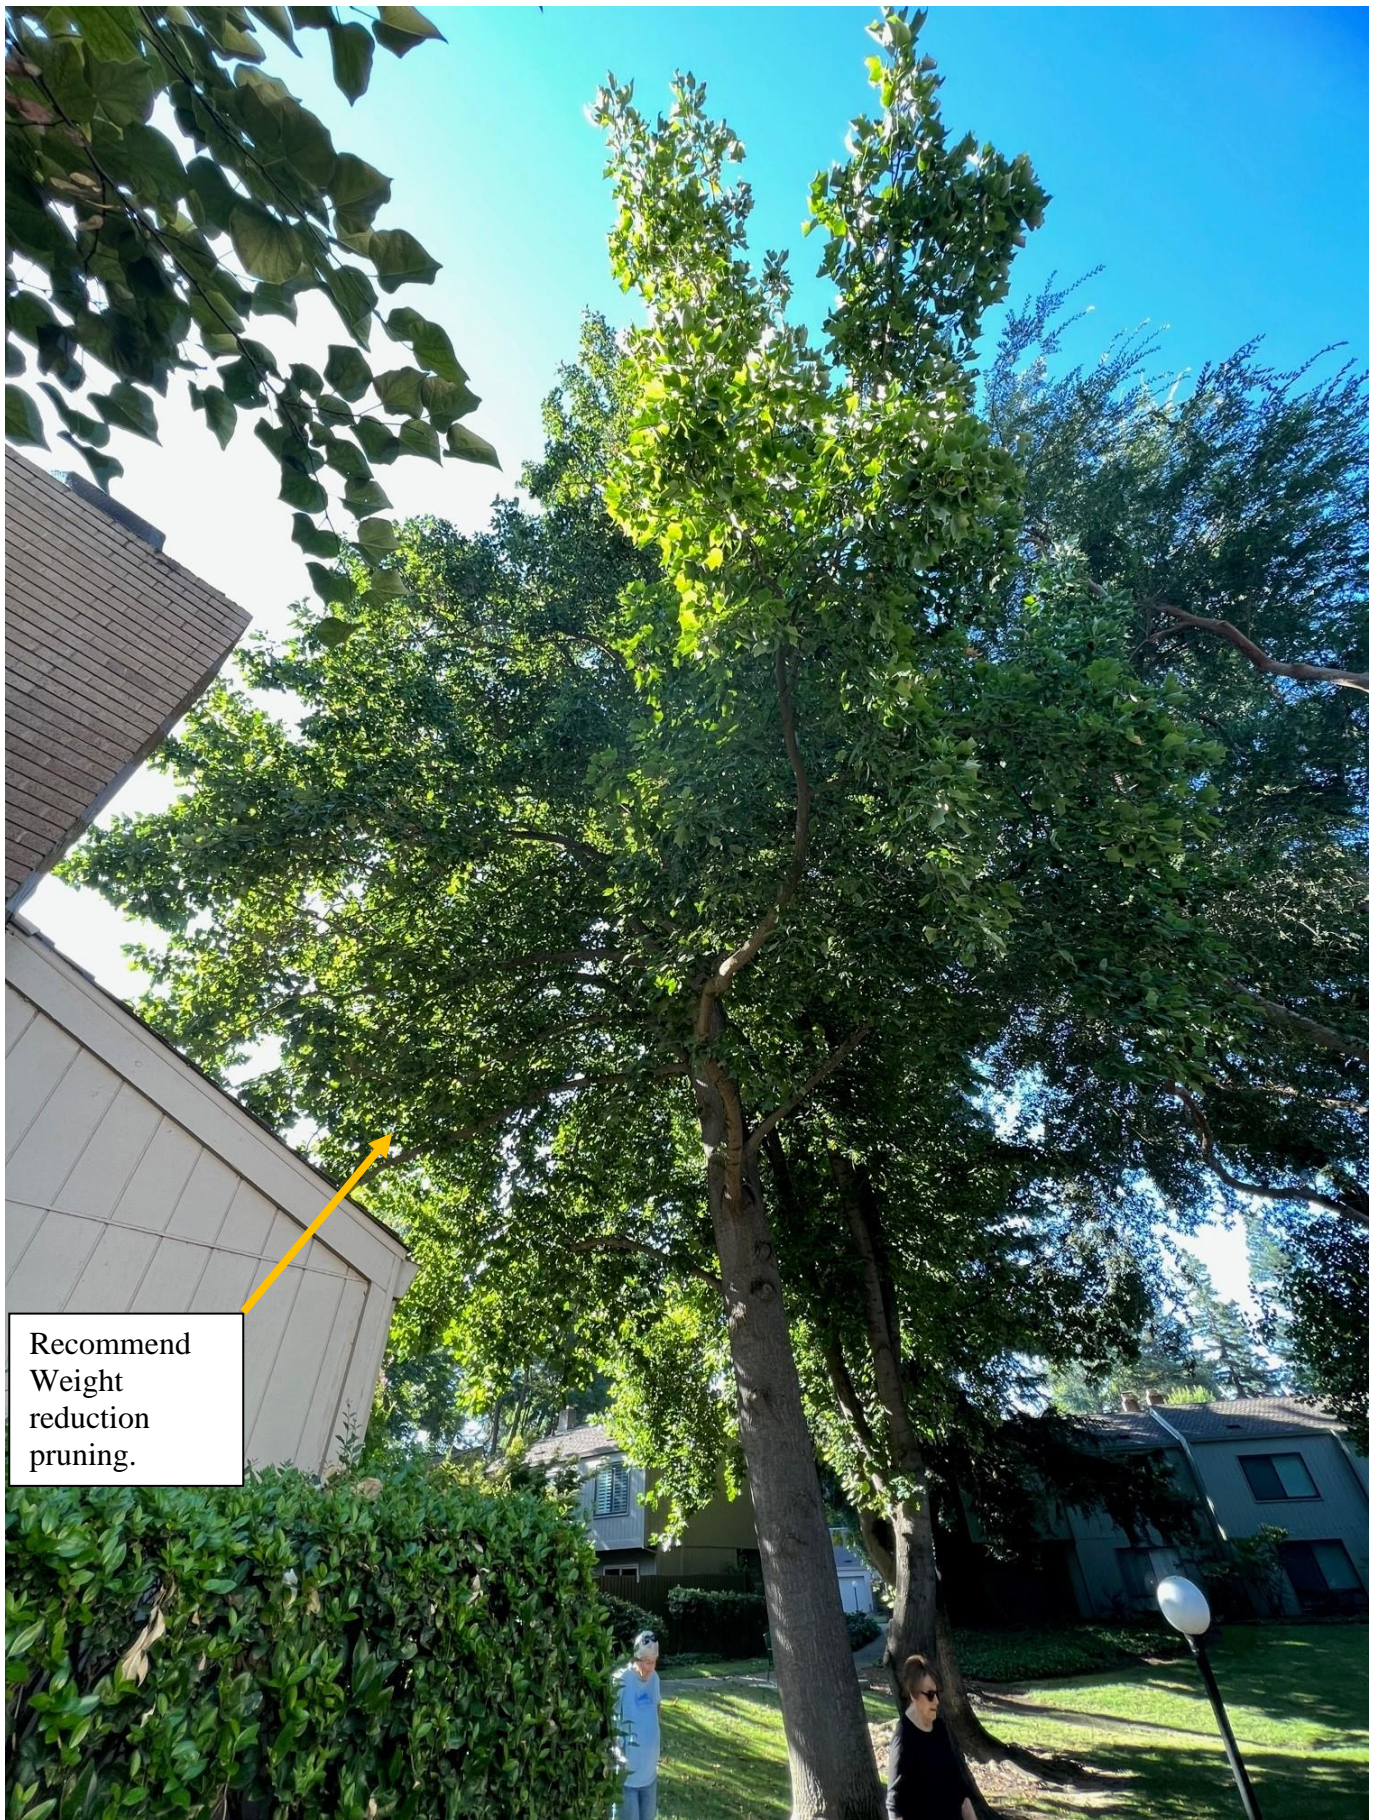
Figure 9

- (Zone 6) Tree #1927 Tulip tree (*Liriodendron tulipifera*), 206 Elmhurst Circle. Tree has a full over weighted canopy and requires reduction pruning on branches throughout the tree canopy, making cuts no larger than 1"-2" on the branch ends reducing the total length by 3'-4' throughout the canopy. Reduction of total live canopy by 25% and removing deadwood larger than 2" (Figure 9).
