September 7, 2023

On August 29, 2023, I inspected several trees on the Nepenthe property during the monthly tree walk. The focus of the walk was to address resident/management concerns regarding mature trees on the property. The purpose of this report is to develop mitigation plans for the following trees and my recommendations are below. My recommendations are based on a Basic Visual Inspection. All decisions made based on the recommendations of this report are at the discretion of the Nepenthe Association.

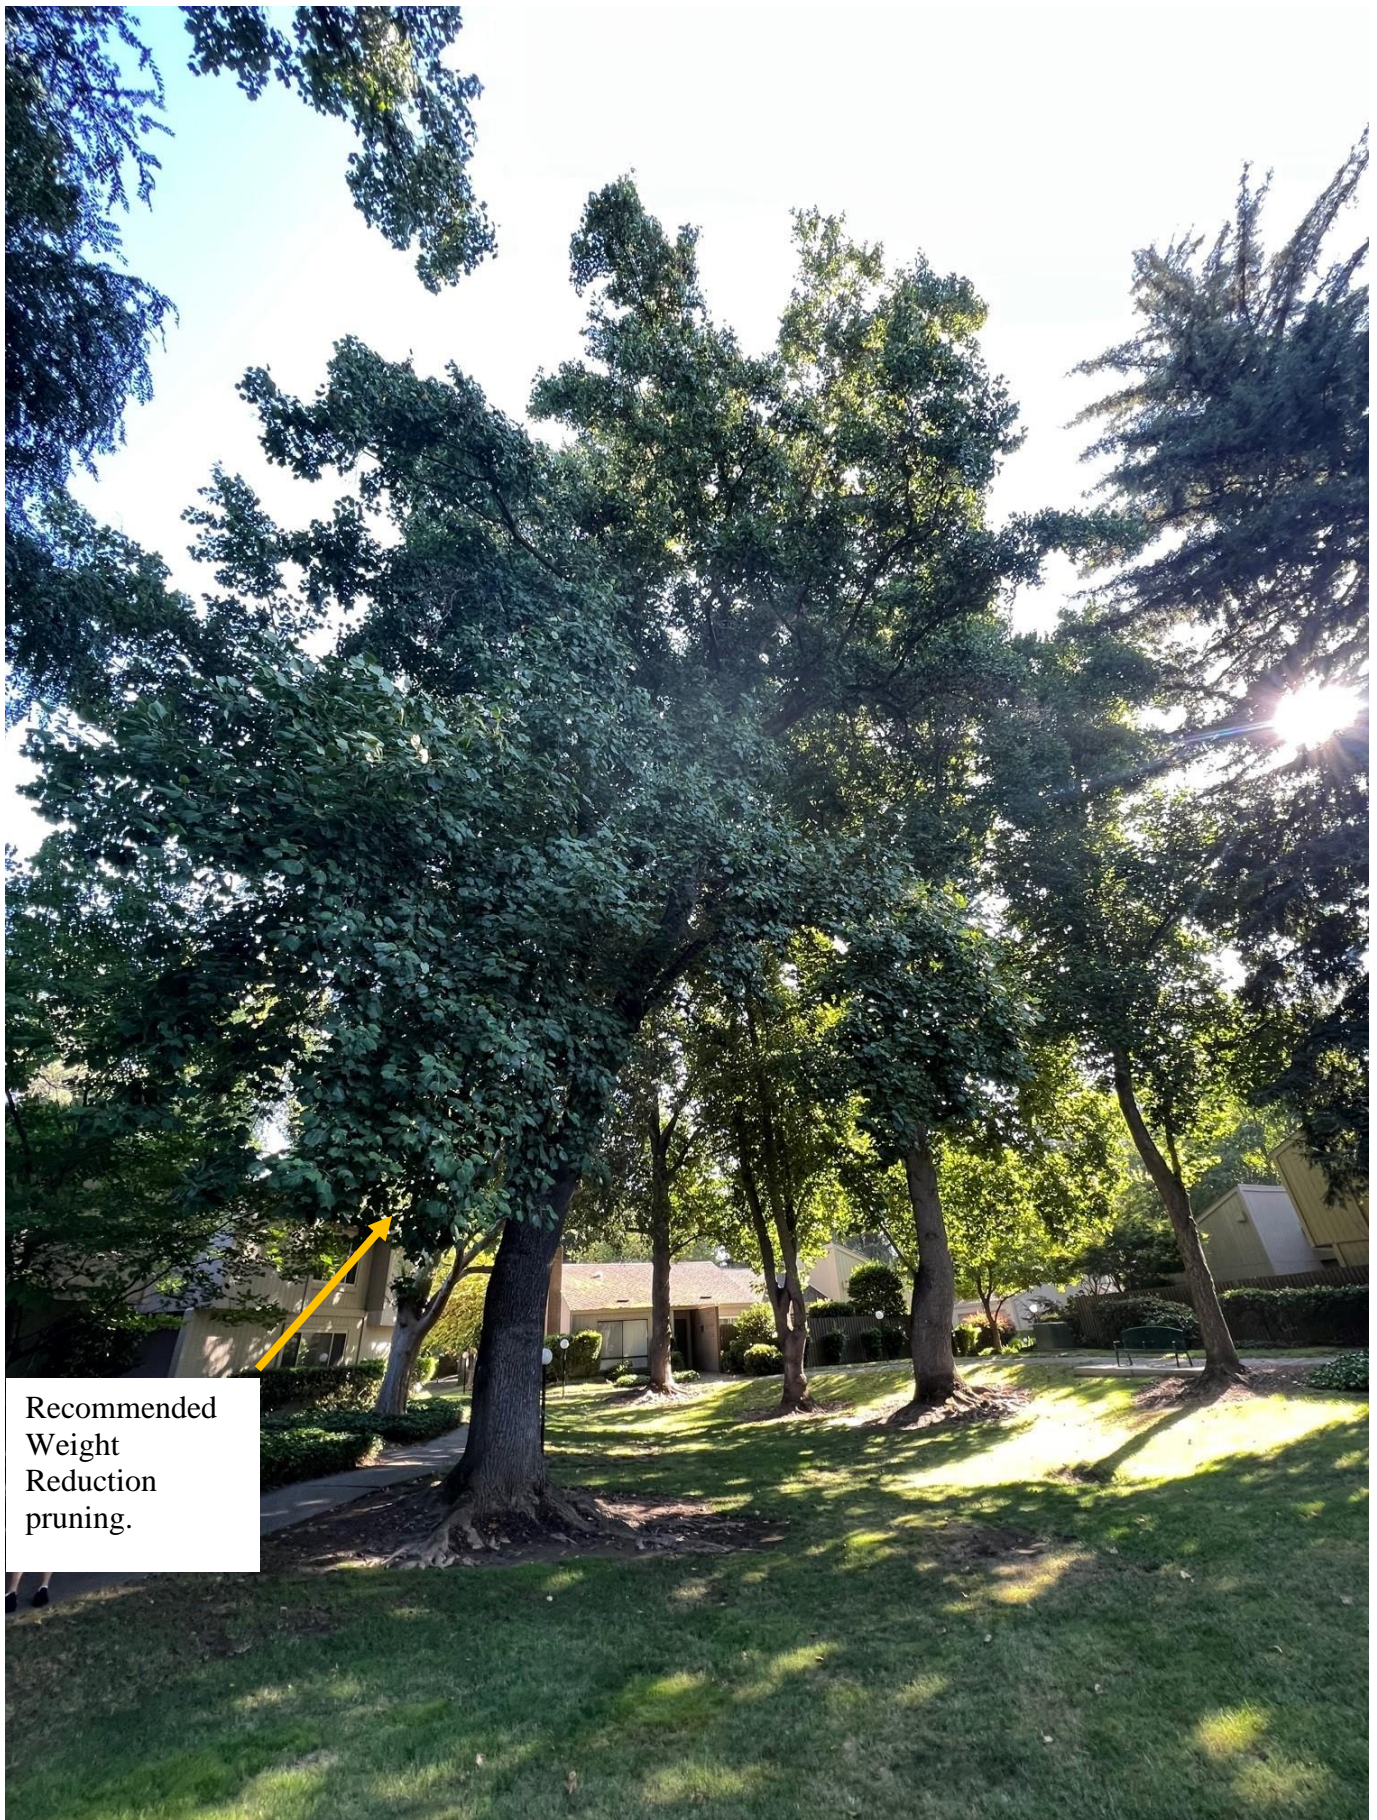
Figure 10

- (Zone 6) Tree #1926 Tulip tree (*Liriodendron tulipifera*), 208 Elmhurst Circle. Tree has a full over weighted canopy and requires reduction pruning on branches throughout the tree canopy, making cuts no larger than 1"-2" on the branch ends reducing the total length by 3'-4' throughout the canopy. Reduction of total live canopy by 25% and removing deadwood larger than 2" (Figure 10).

Recommended
Weight
Reduction
pruning.

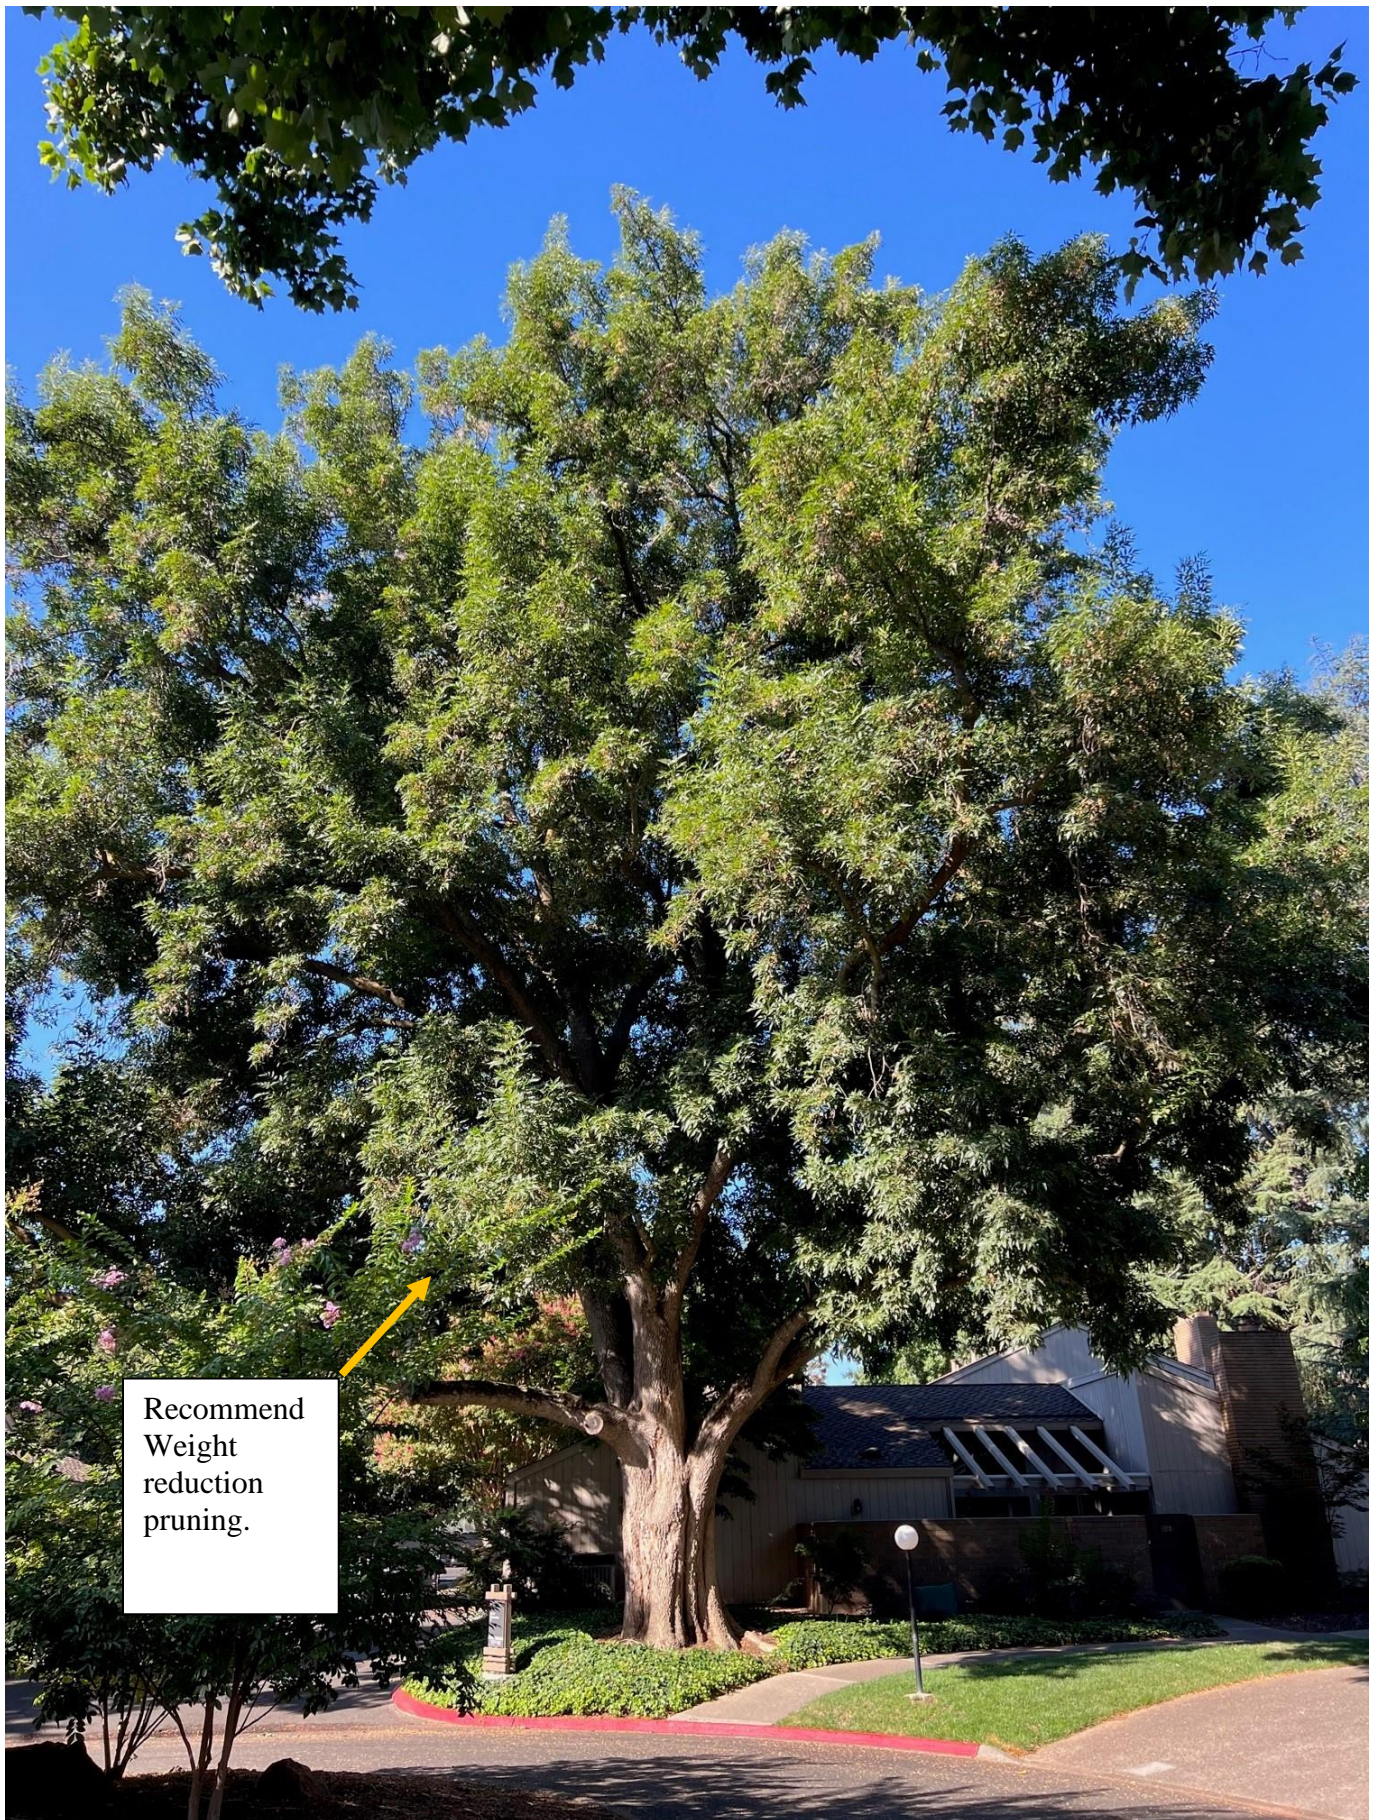
Figure 11

- (Zone 6) Tree #1937 Ash (*Fraxnis angustifolia*), next to 210 Elmhurst. Tree has a full over weighted canopy and requires reduction pruning on branches throughout the tree canopy, making cuts no larger than 1"-2" on the branch ends reducing the total length by 3'-4' throughout the canopy. Reduction of total live canopy by 25% and removing deadwood larger than 2" (Figure 11).

Recommend
Weight
reduction
pruning.

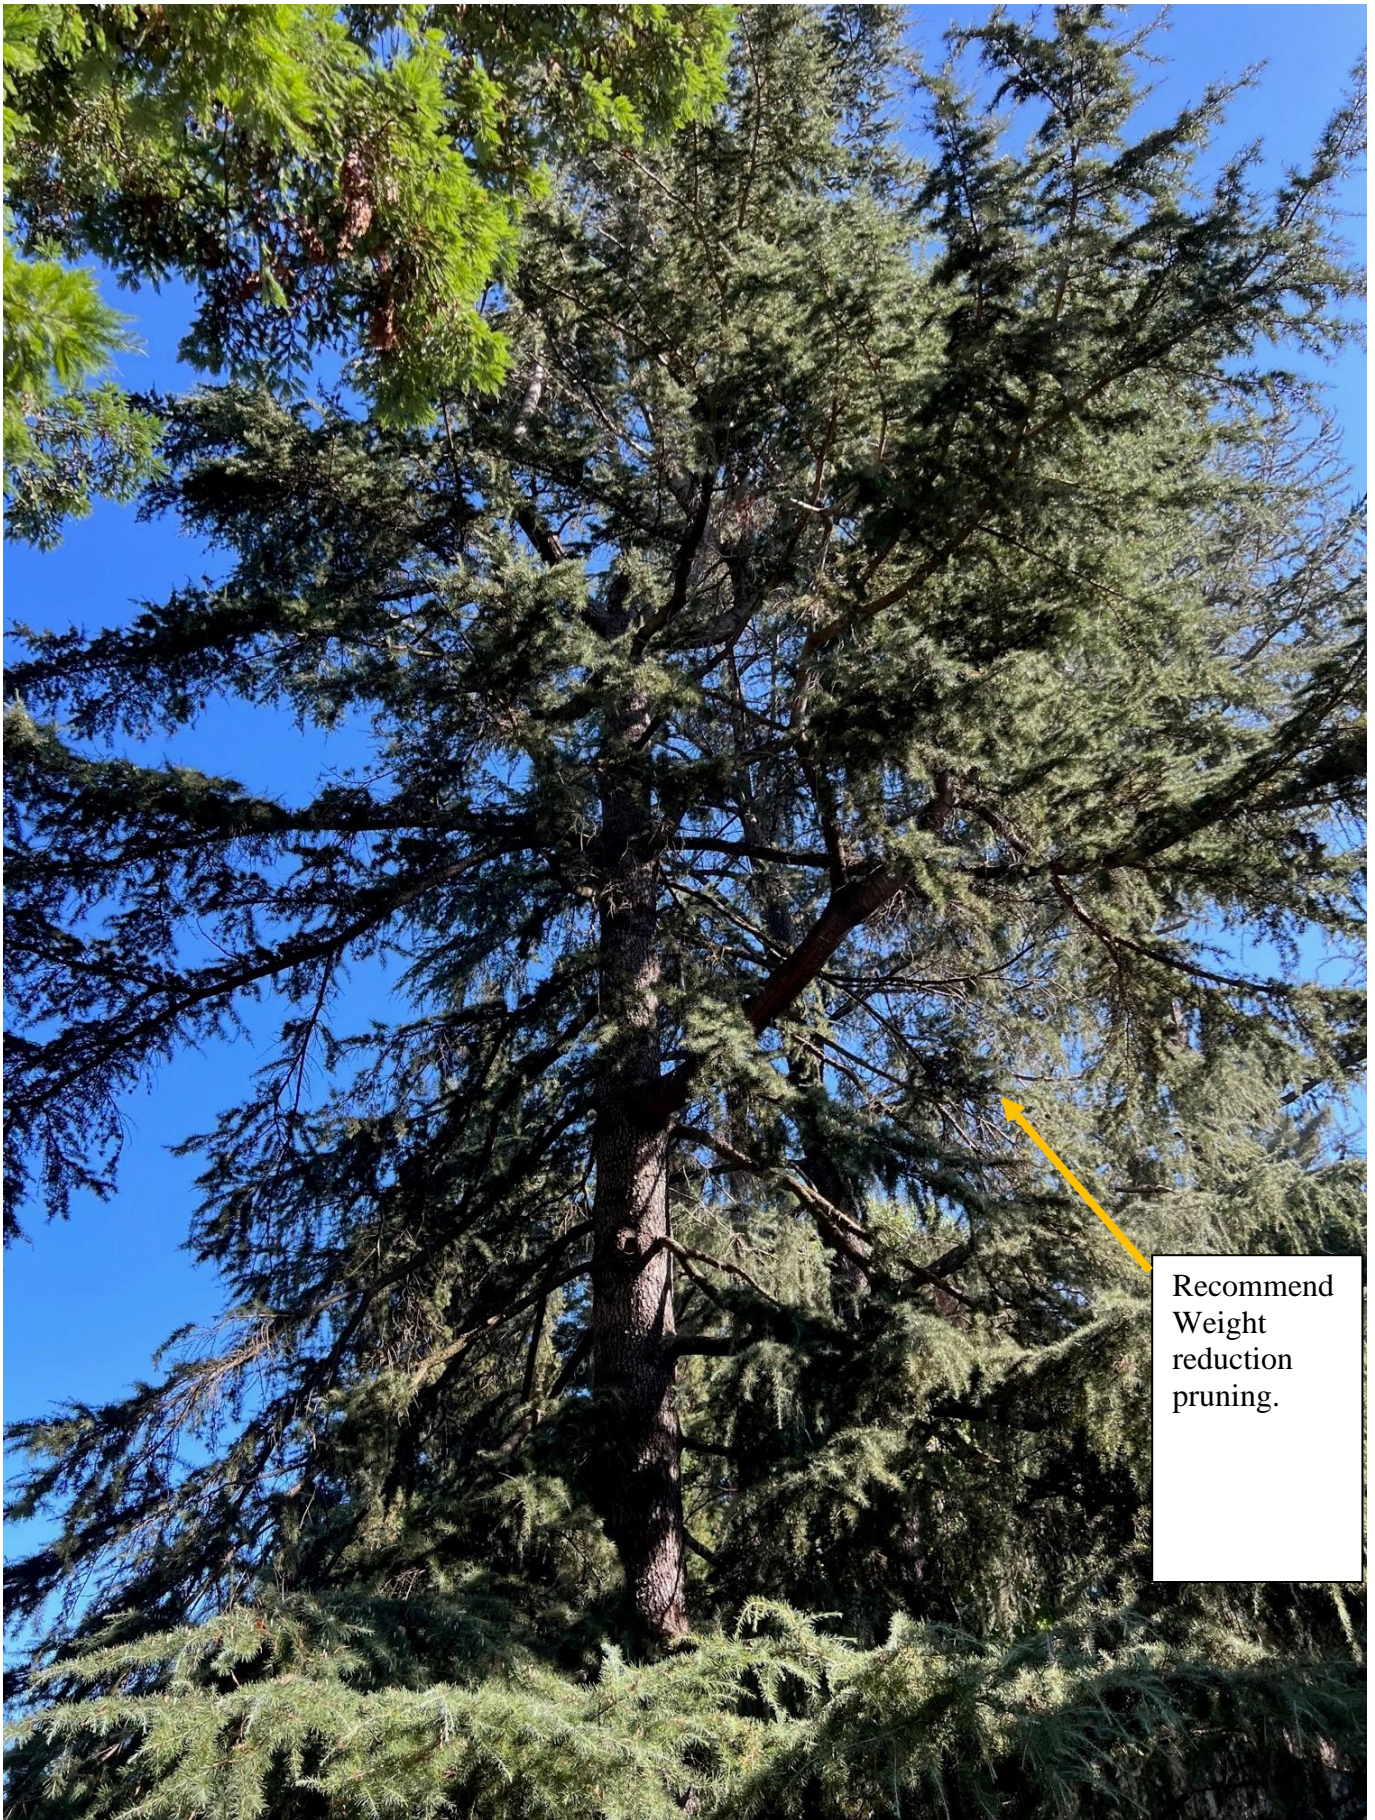
Figure 12

- (Zone 6) Tree #1889 Cedar (*Cedrus deodara*) In front of 314 Elmhurst Circle. Tree has a full over weighted canopy and requires reduction pruning on branches throughout the tree canopy, making cuts no larger than 1"-2" on the branch ends reducing the total length by 3'-4' throughout the canopy. Reduction of total live canopy by 20% and removing deadwood larger than 2" (Figure 12).

Recommend
Weight
reduction
pruning.

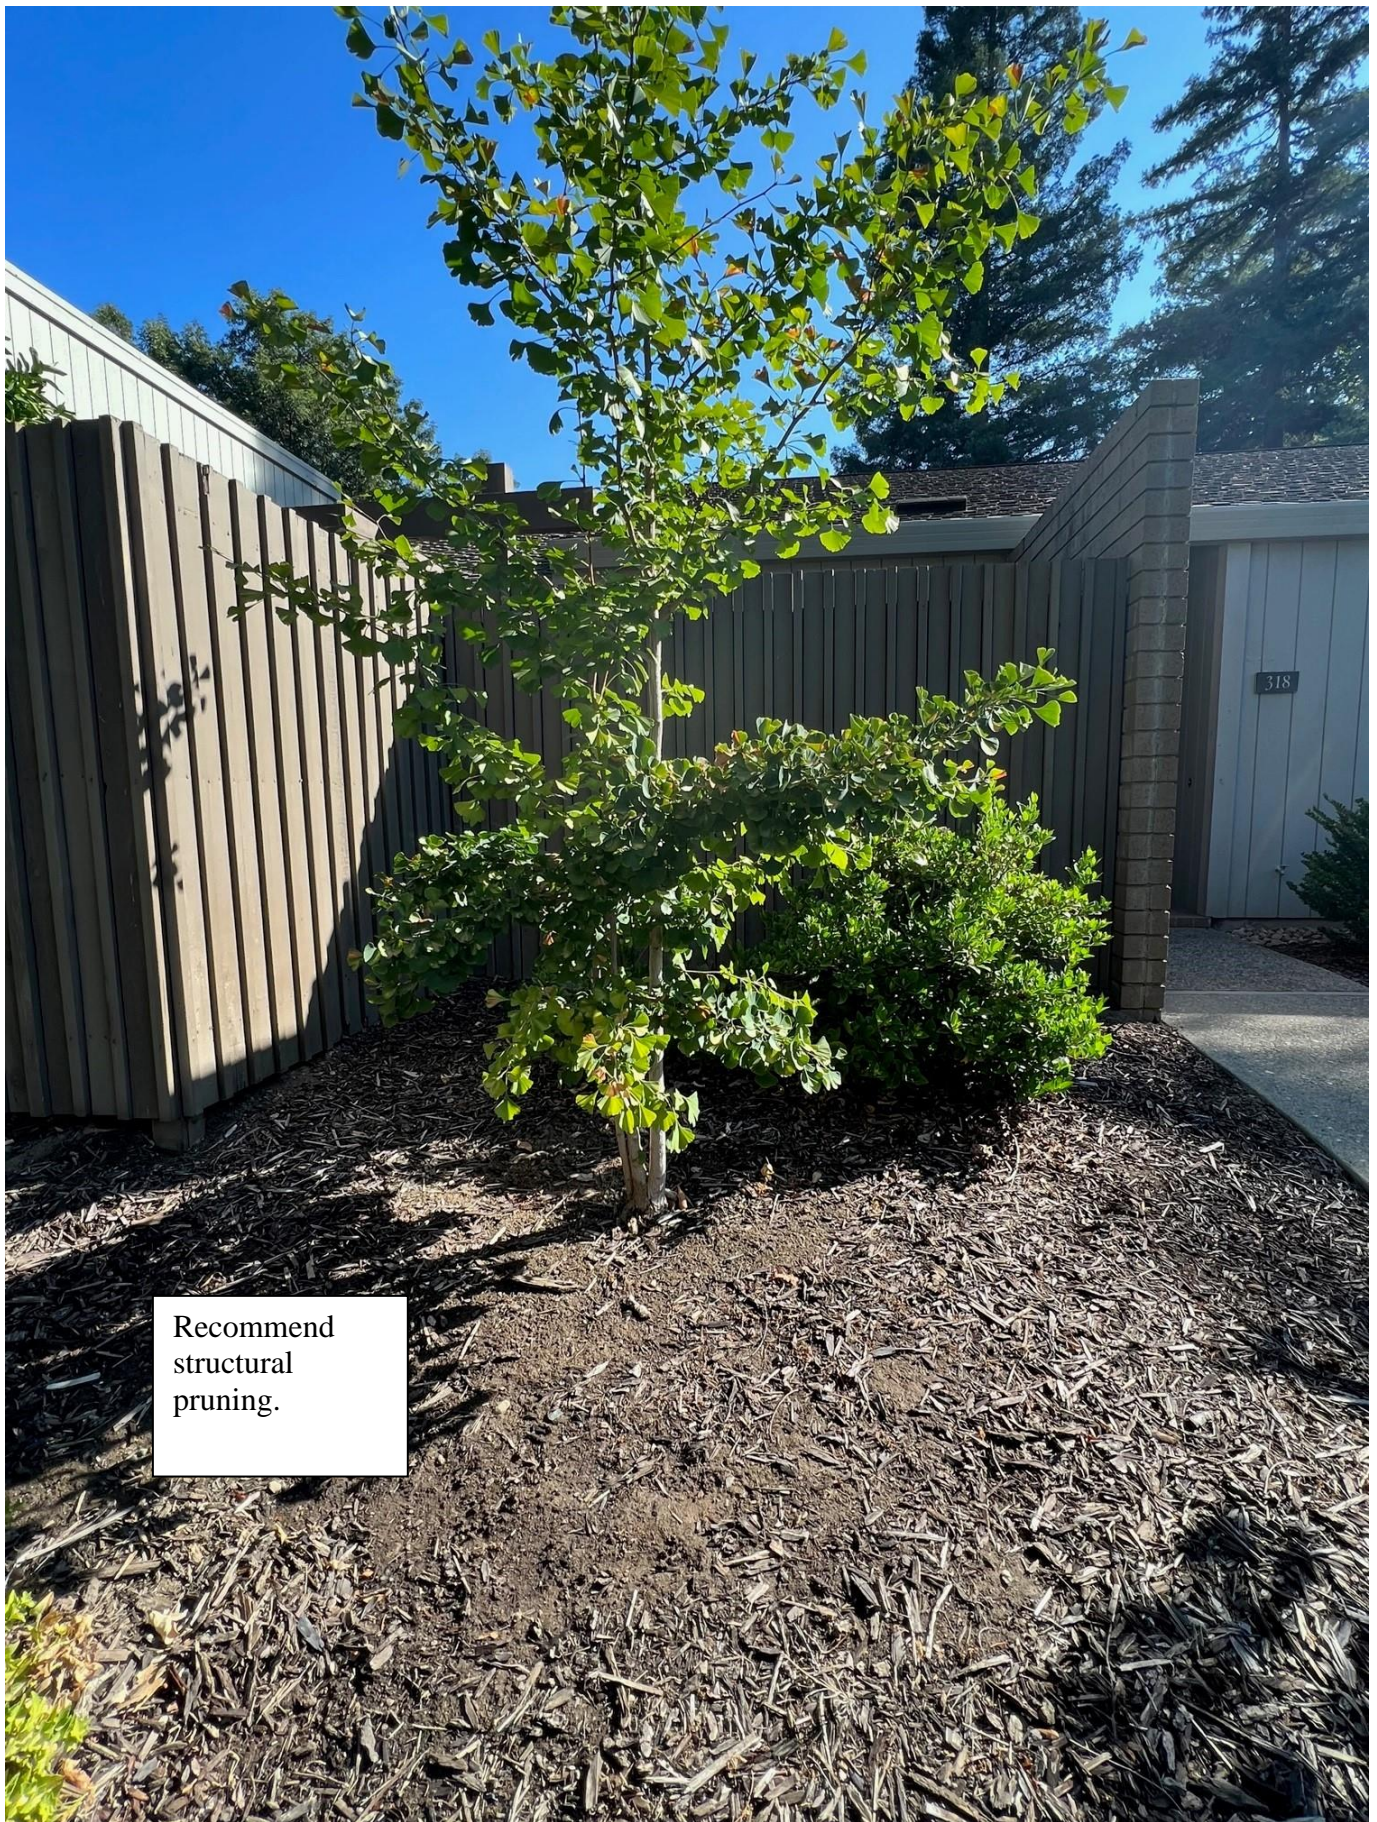
Figure 13

- (Zone 6) Tree #No Tag Ginkgo biloba (*Ginkgo biloba*), in front of 318 Elmhurst Circle. This tree will require structural pruning to help with direction of growth and healthy canopy development, pruning to remove co dominate stem. (Figure 13-14).

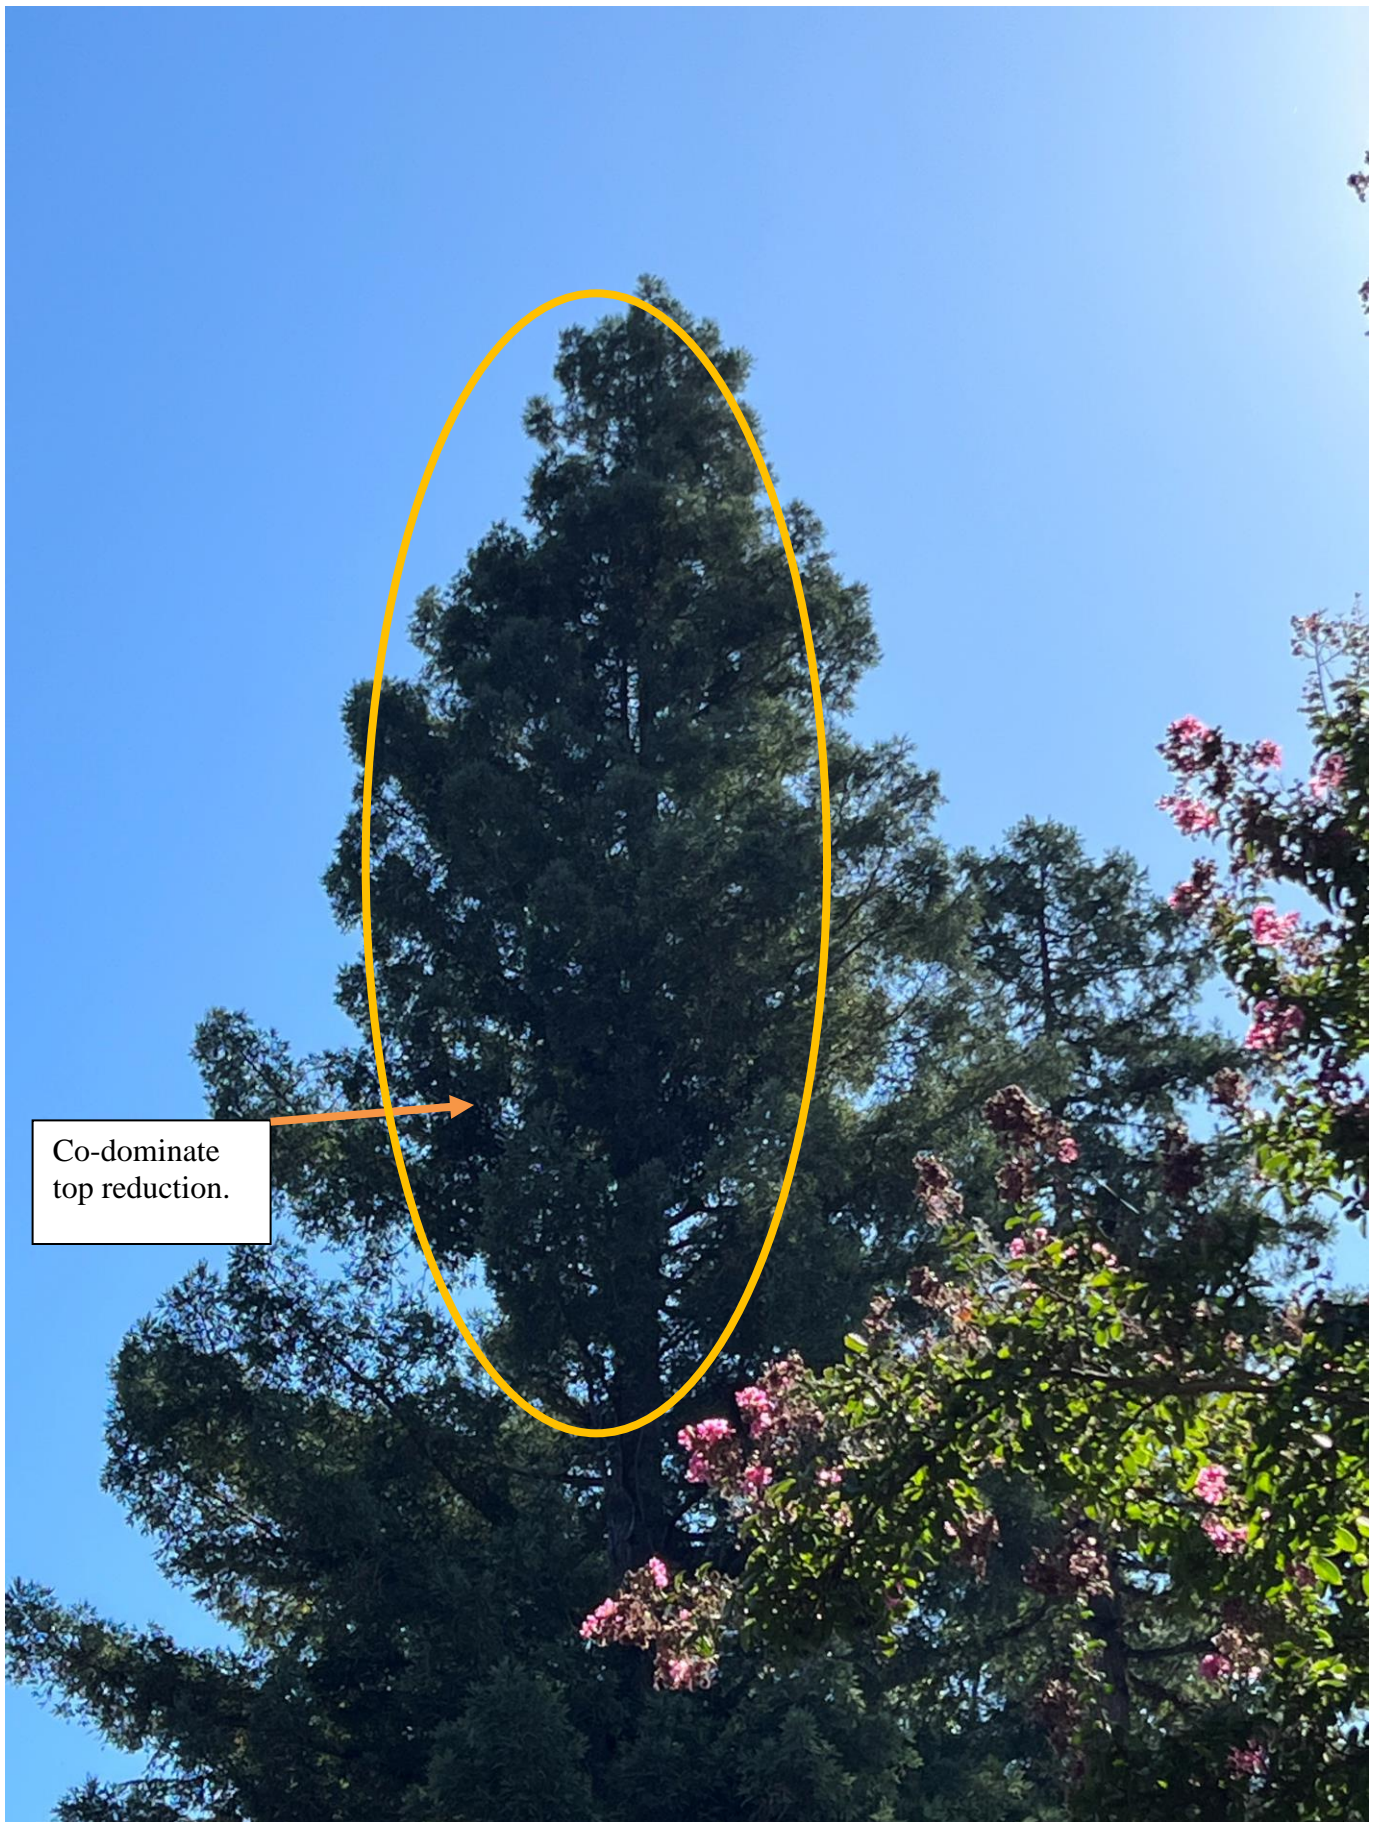
Figure 15

- (Zone 6) Tree #1851 Redwood (*Sequoias sempervirens*), 320 Elmhurst Circle. This tree has multiple included co dominate tops. Due to the failure potential, I recommend reduction pruning of the co dominate top to help reduce failure. Climber will reduce the smaller of the codominant tops by 1/2 or eliminate based on the climber's recommendation (Figure 15).

Co-dominate
top reduction.

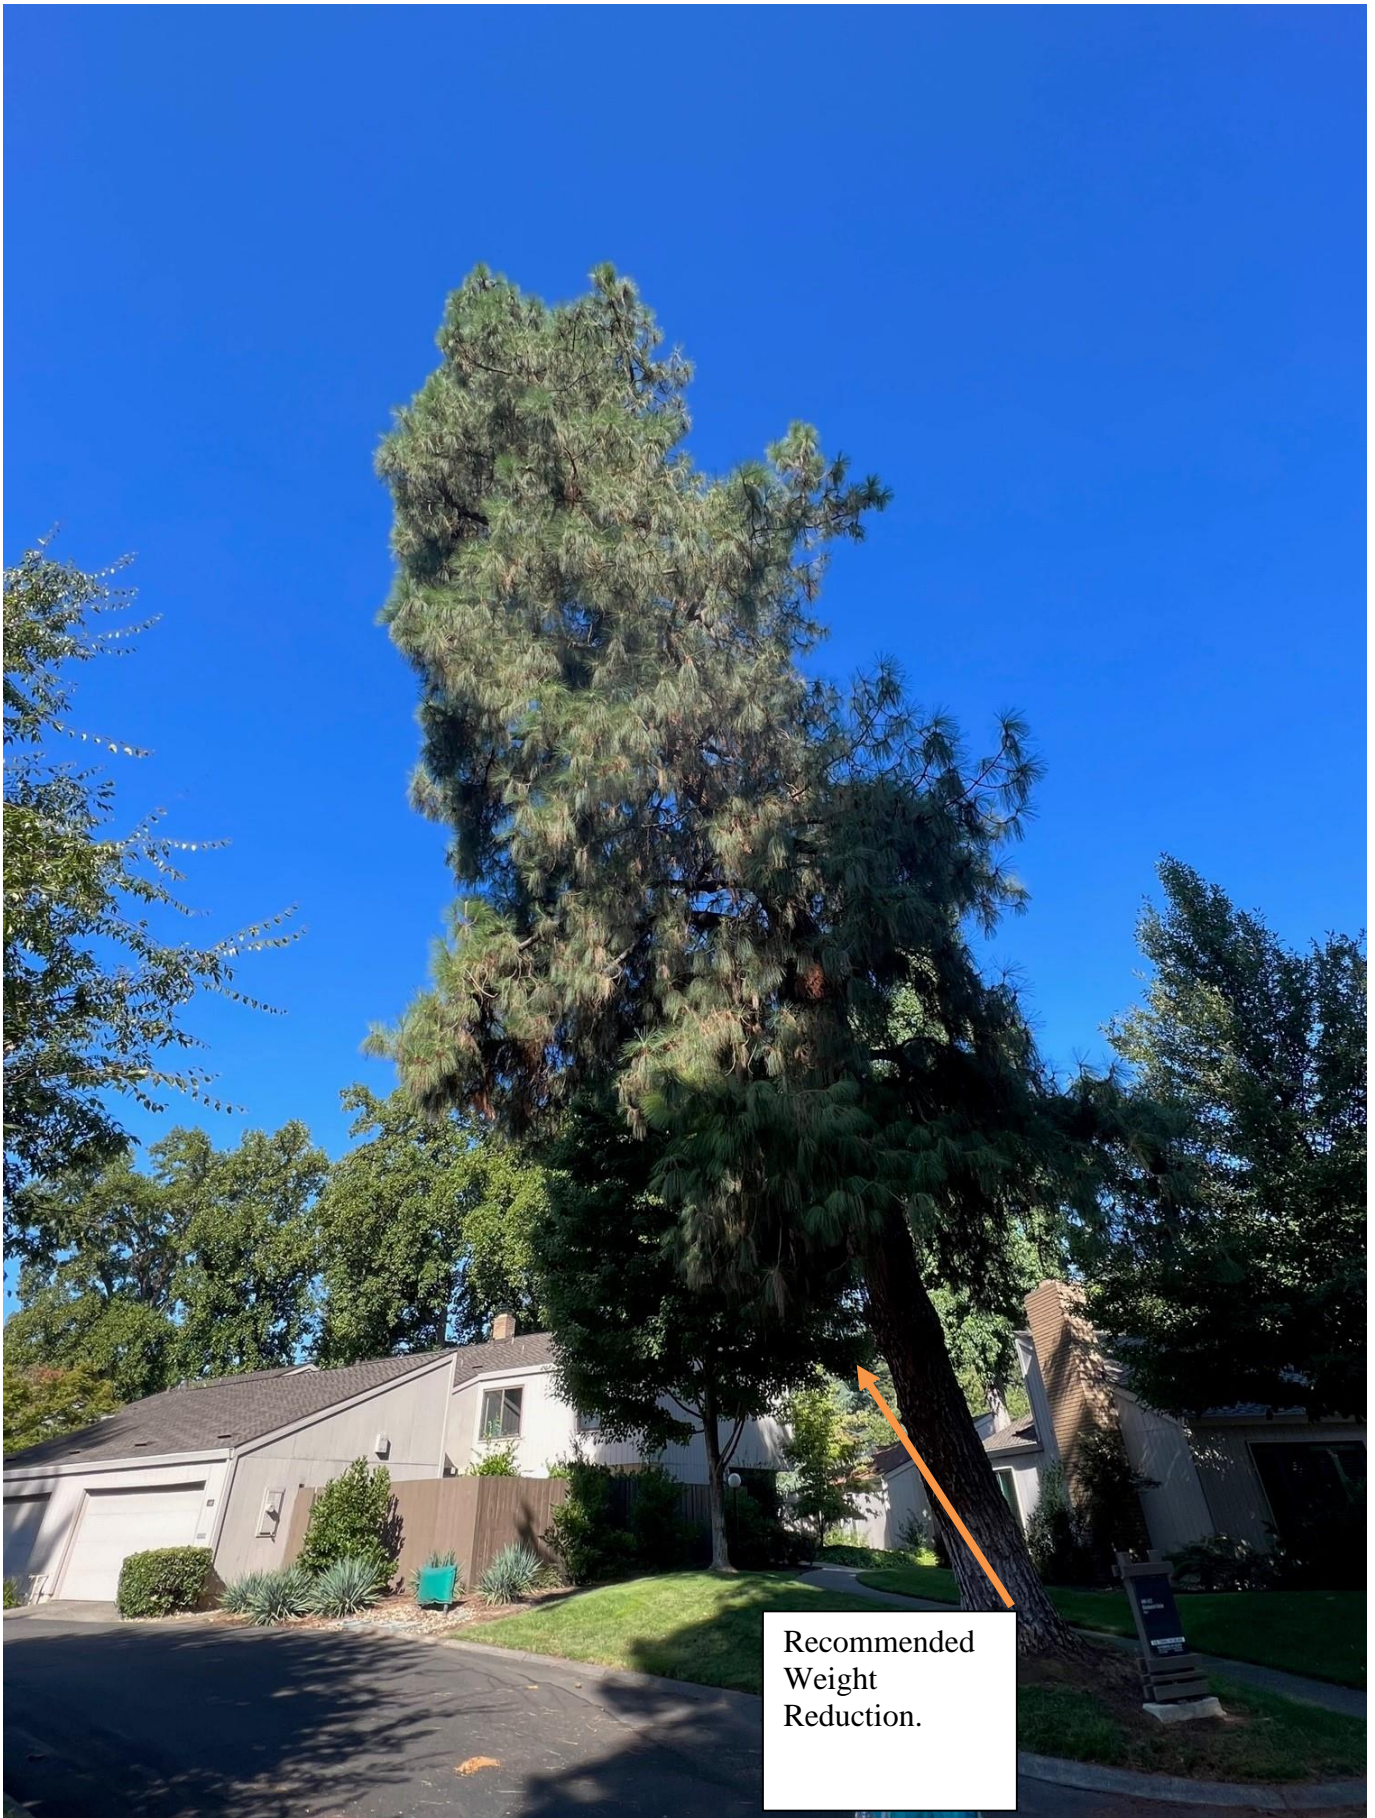
Figure 16

- (Zone 6) Tree #1823, Canary Island Pine (*Pinus canarisnsis*), 400 Elmhurst Circle. This tree has an included co dominate top. Due to the failure potential, I recommend reduction pruning of the co dominate top to help reduce failure. Climber will reduce the smaller of the codominant tops by 1/2 or eliminate based on the climber's recommendation. In addition, this tree has developed a lean and we monitor this tree and manage the lean through the canopy weight. The tree has a full over weighted canopy and requires reduction pruning on branches throughout the tree canopy, making cuts no larger than 1"-2" on the branch ends reducing the total length by 3'-4' throughout the canopy. Reduction of total live canopy by 20% and removing deadwood larger than 2". (Figure 16).

Recommended
Weight
Reduction.

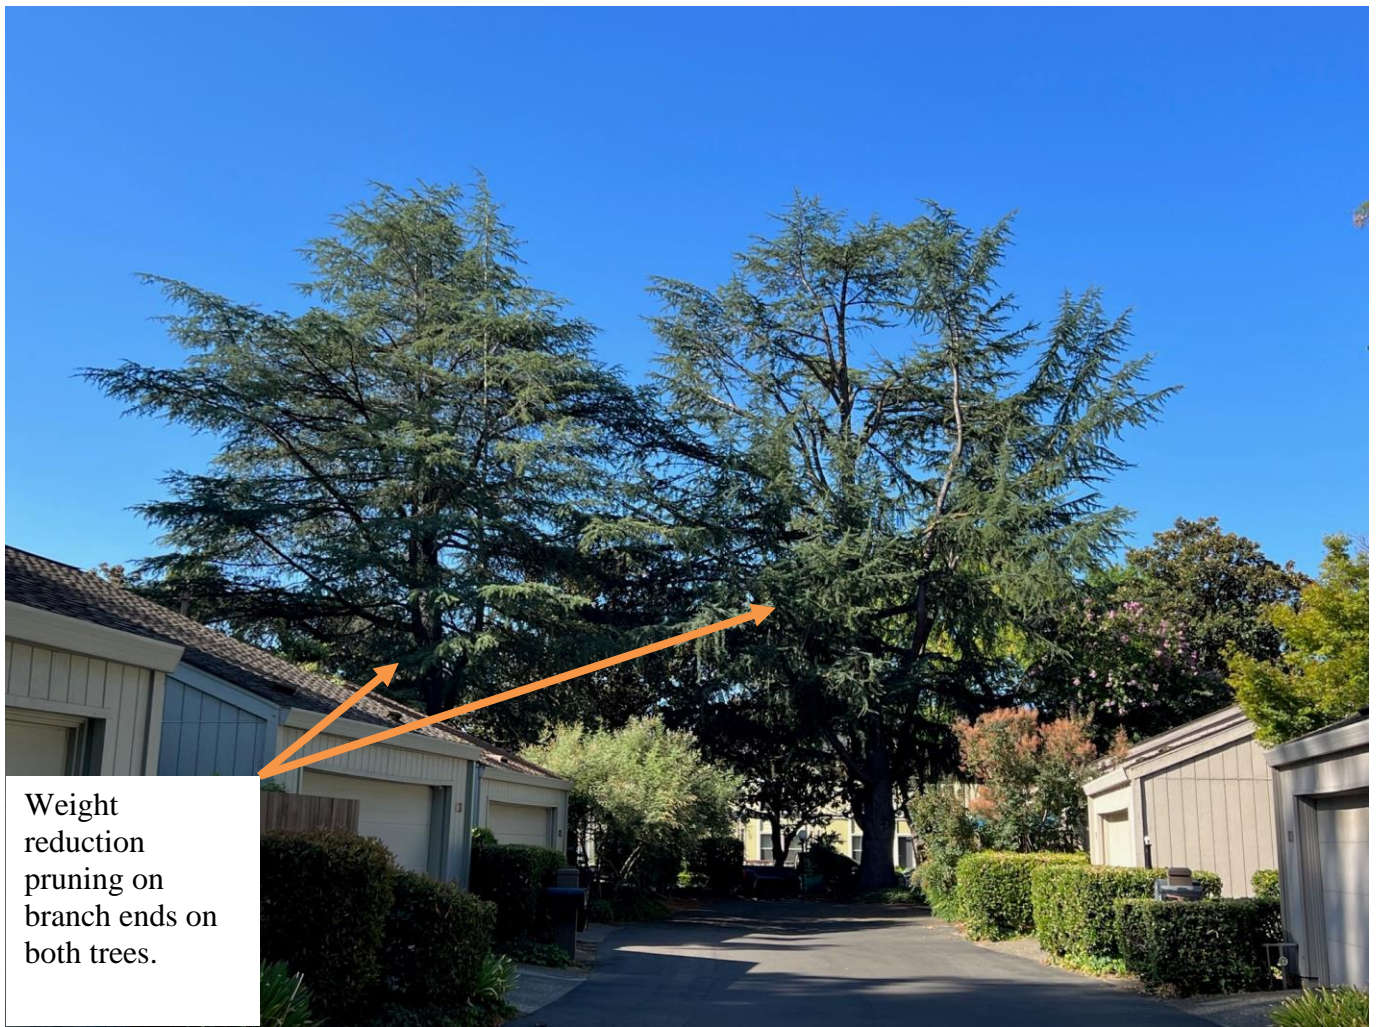
Figure 17

- (Zone 6) 2 Trees #1827,1829 Cedar (*Cedrus deodara*) End of ally between 408/406 Elmhurst Circle. These trees have over weighted canopies and requires reduction pruning on branches throughout the tree canopy, making cuts no larger than 1"-2" on the branch ends reducing the total length of branched by 1'-3' on 60% of the trees total canopy. Reduction of total live canopy by 20% and deadwood larger than 2" (Figure 17).

Weight
reduction
pruning on
branch ends on
both trees.

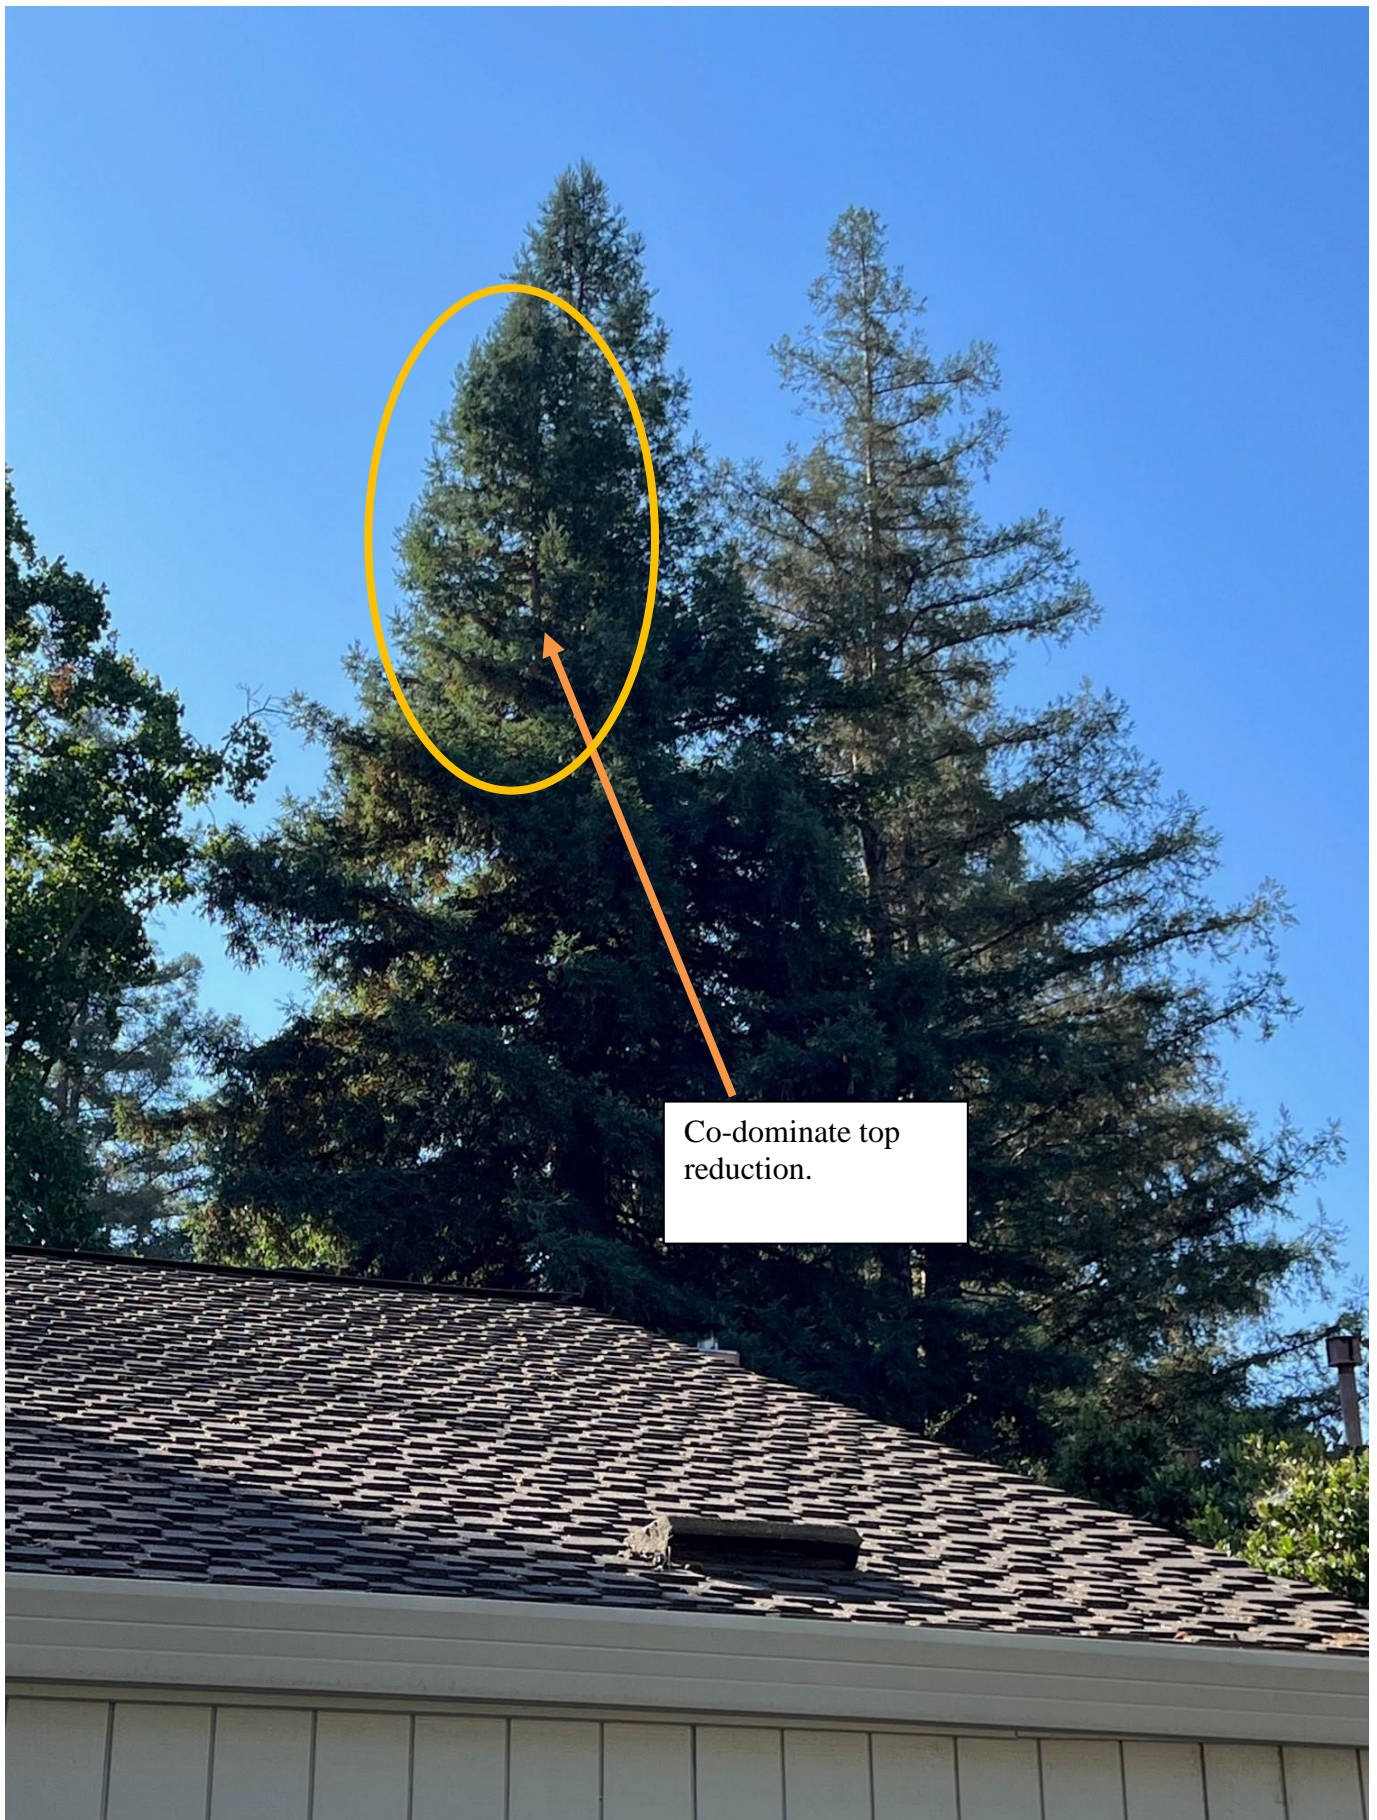
Figure 18

- (Zone 6) Tree #1817 Redwood (*Sequoias sempervirens*), 408 Elmhurst Circle. This tree has multiple included co dominate tops. Due to the failure potential, I recommend reduction pruning

of the co dominate top to help reduce failure. Climber will reduce the smaller of the codominant tops by 1/2 or eliminate based on the climber's recommendation (Figure 18).

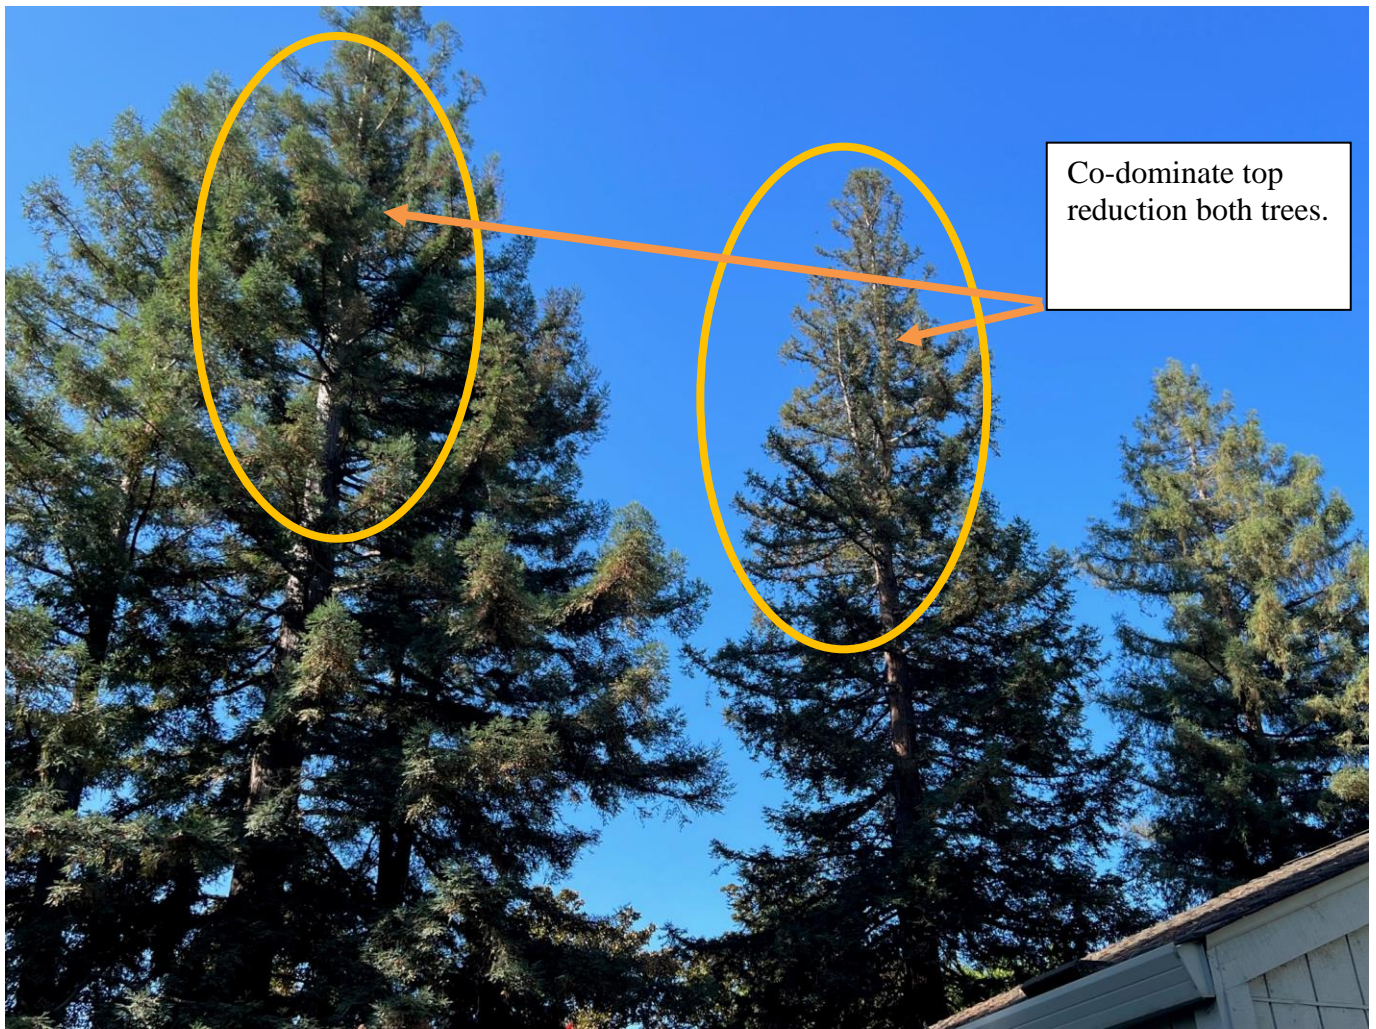
Figure 19

- (Zone 6) 2 Tree's #1809 #1811 Redwood (*Sequoias sempervirens*), 504 Elmhurst Circle. The trees have multiple included co dominate tops. Due to the failure potential, I recommend reduction pruning of the co dominate top to help reduce failure. Climber will reduce the smaller of the codominant tops by 1/2 or eliminate based on the climber's recommendation (Figure 19).
