September 7, 2023

On August 29, 2023, I inspected several trees on the Nepenthe property during the monthly tree walk. The focus of the walk was to address resident/management concerns regarding mature trees on the property. The purpose of this report is to develop mitigation plans for the following trees and my recommendations are below. My recommendations are based on a Basic Visual Inspection. All decisions made based on the recommendations of this report are at the discretion of the Nepenthe Association.

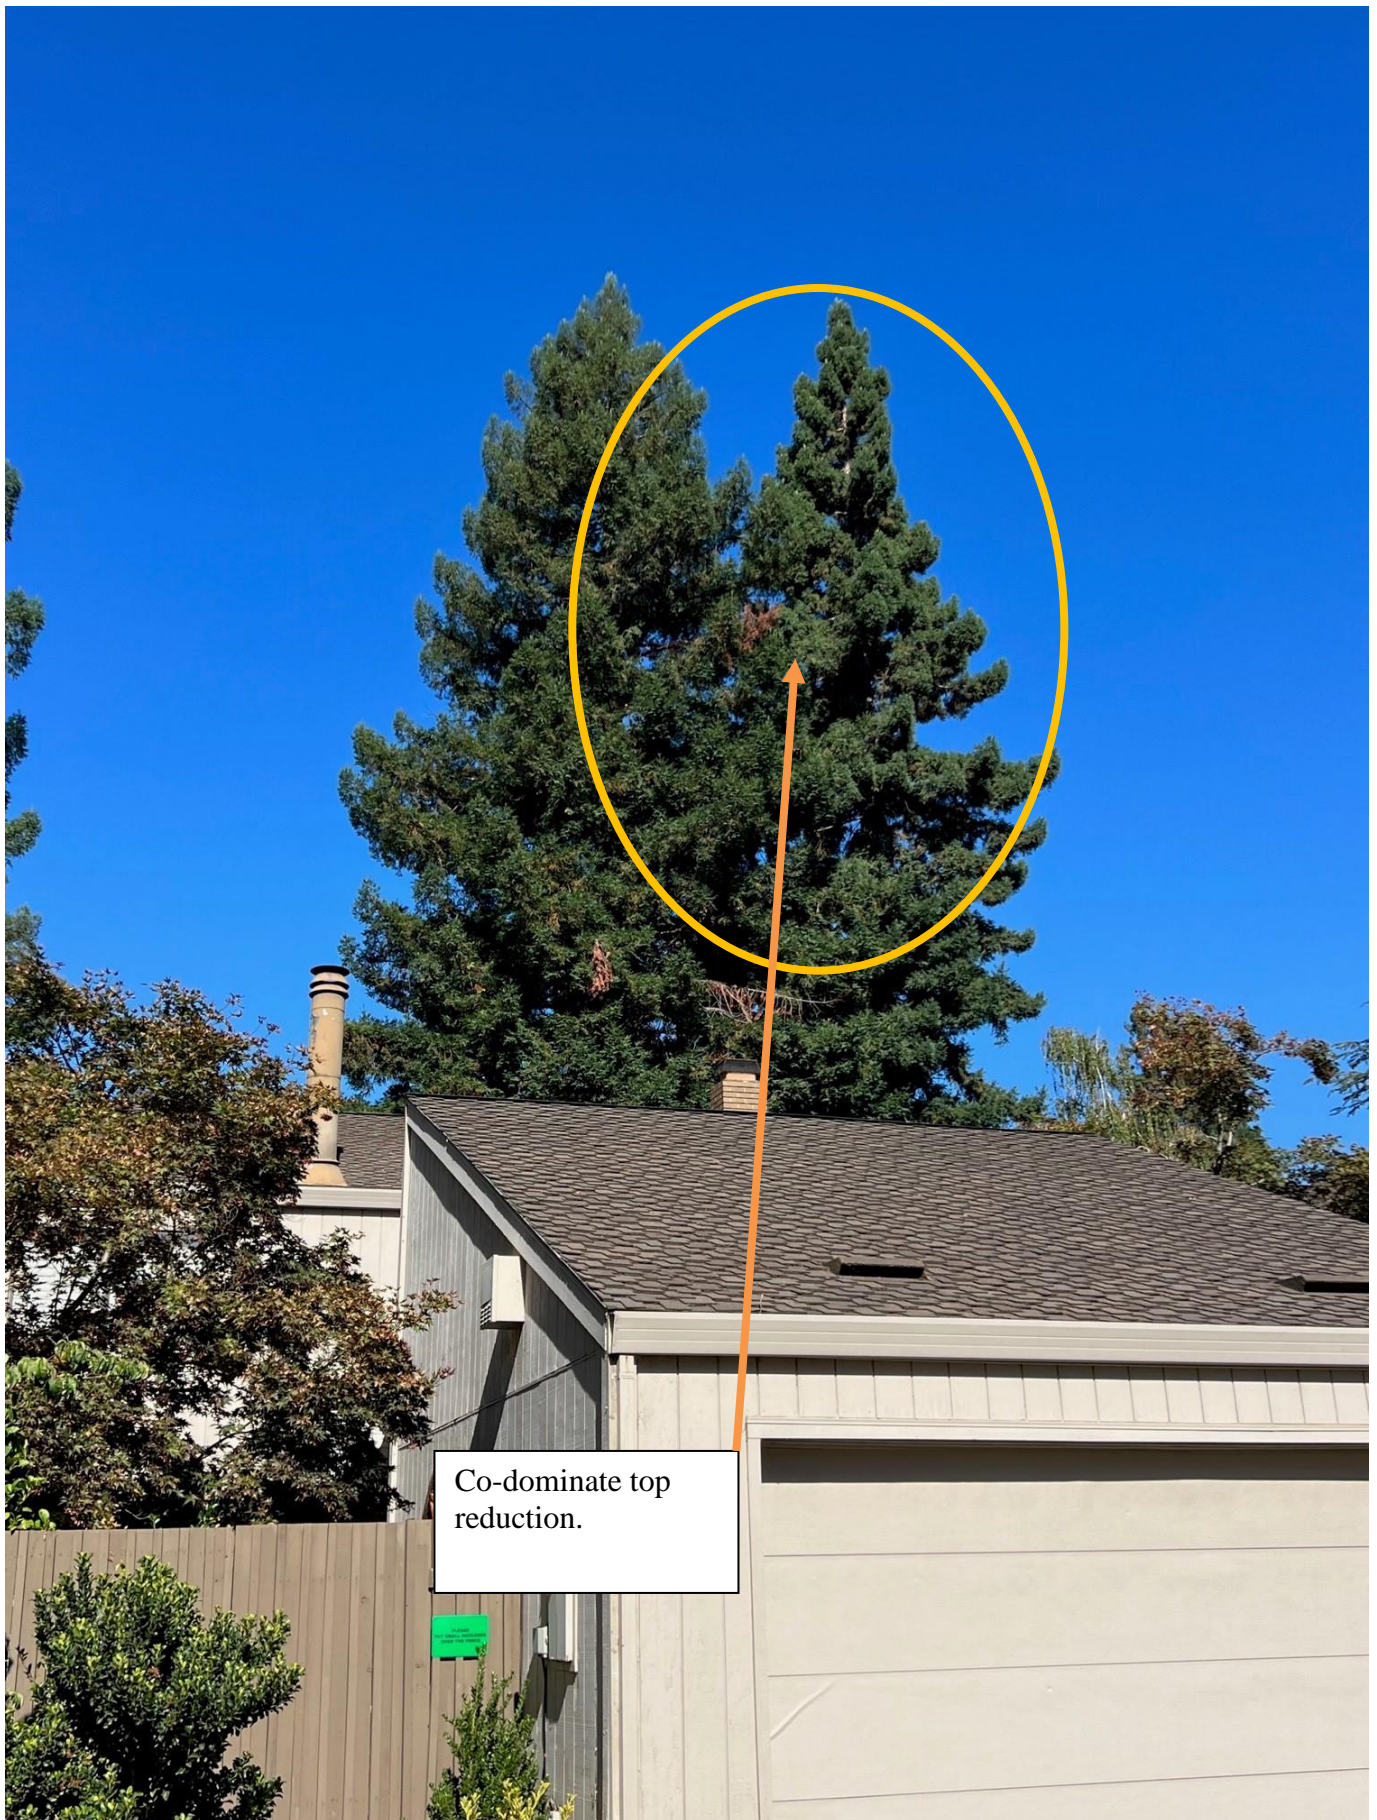
Figure 20

- (Zone 6) Tree #1755 Redwood (*Sequoias sempervirens*), 600 Elmhurst Circle. This tree has multiple included co dominate tops. Due to the failure potential, I recommend reduction pruning of the co dominate top to help reduce failure. Climber will reduce the smaller of the codominant tops by 1/2 or eliminate based on the climber's recommendation (Figure 20).

Co-dominate top
reduction.

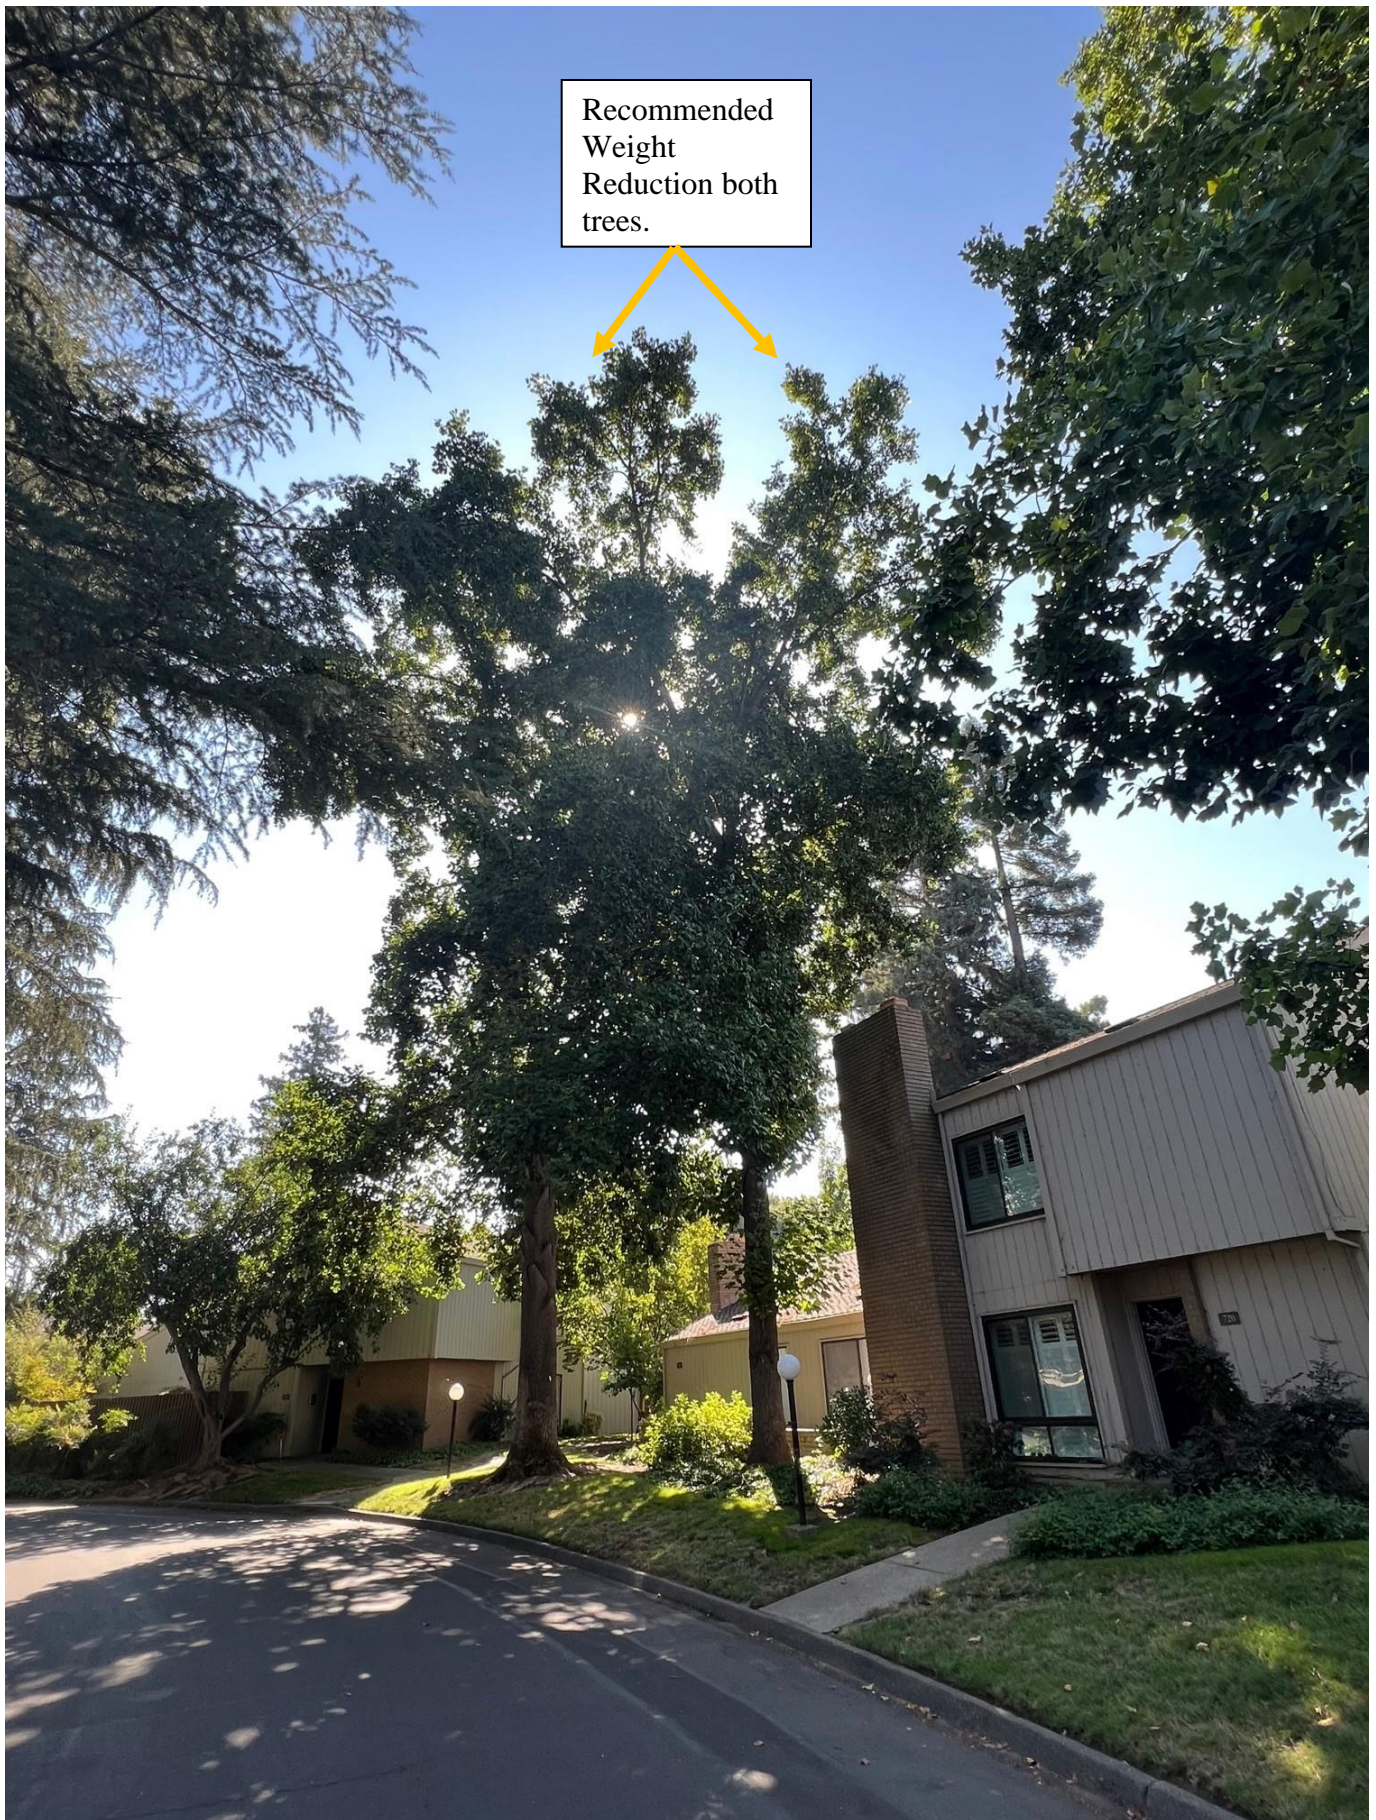
Figure 21

- (Zone 6) 2 Trees #1728, 1729 Tulip tree (*Liriodendron tulipifera*), In front of 720/722 Elmhurst Circle. These trees have over weighted canopies and requires reduction pruning on branches throughout the tree canopy, making cuts no larger than 1"-2" on the branch ends reducing the total length of branched by 1'-3' on 60% of the trees total canopy. Reduction of total live canopy by 25% and deadwood larger than 2" (Figure 21).

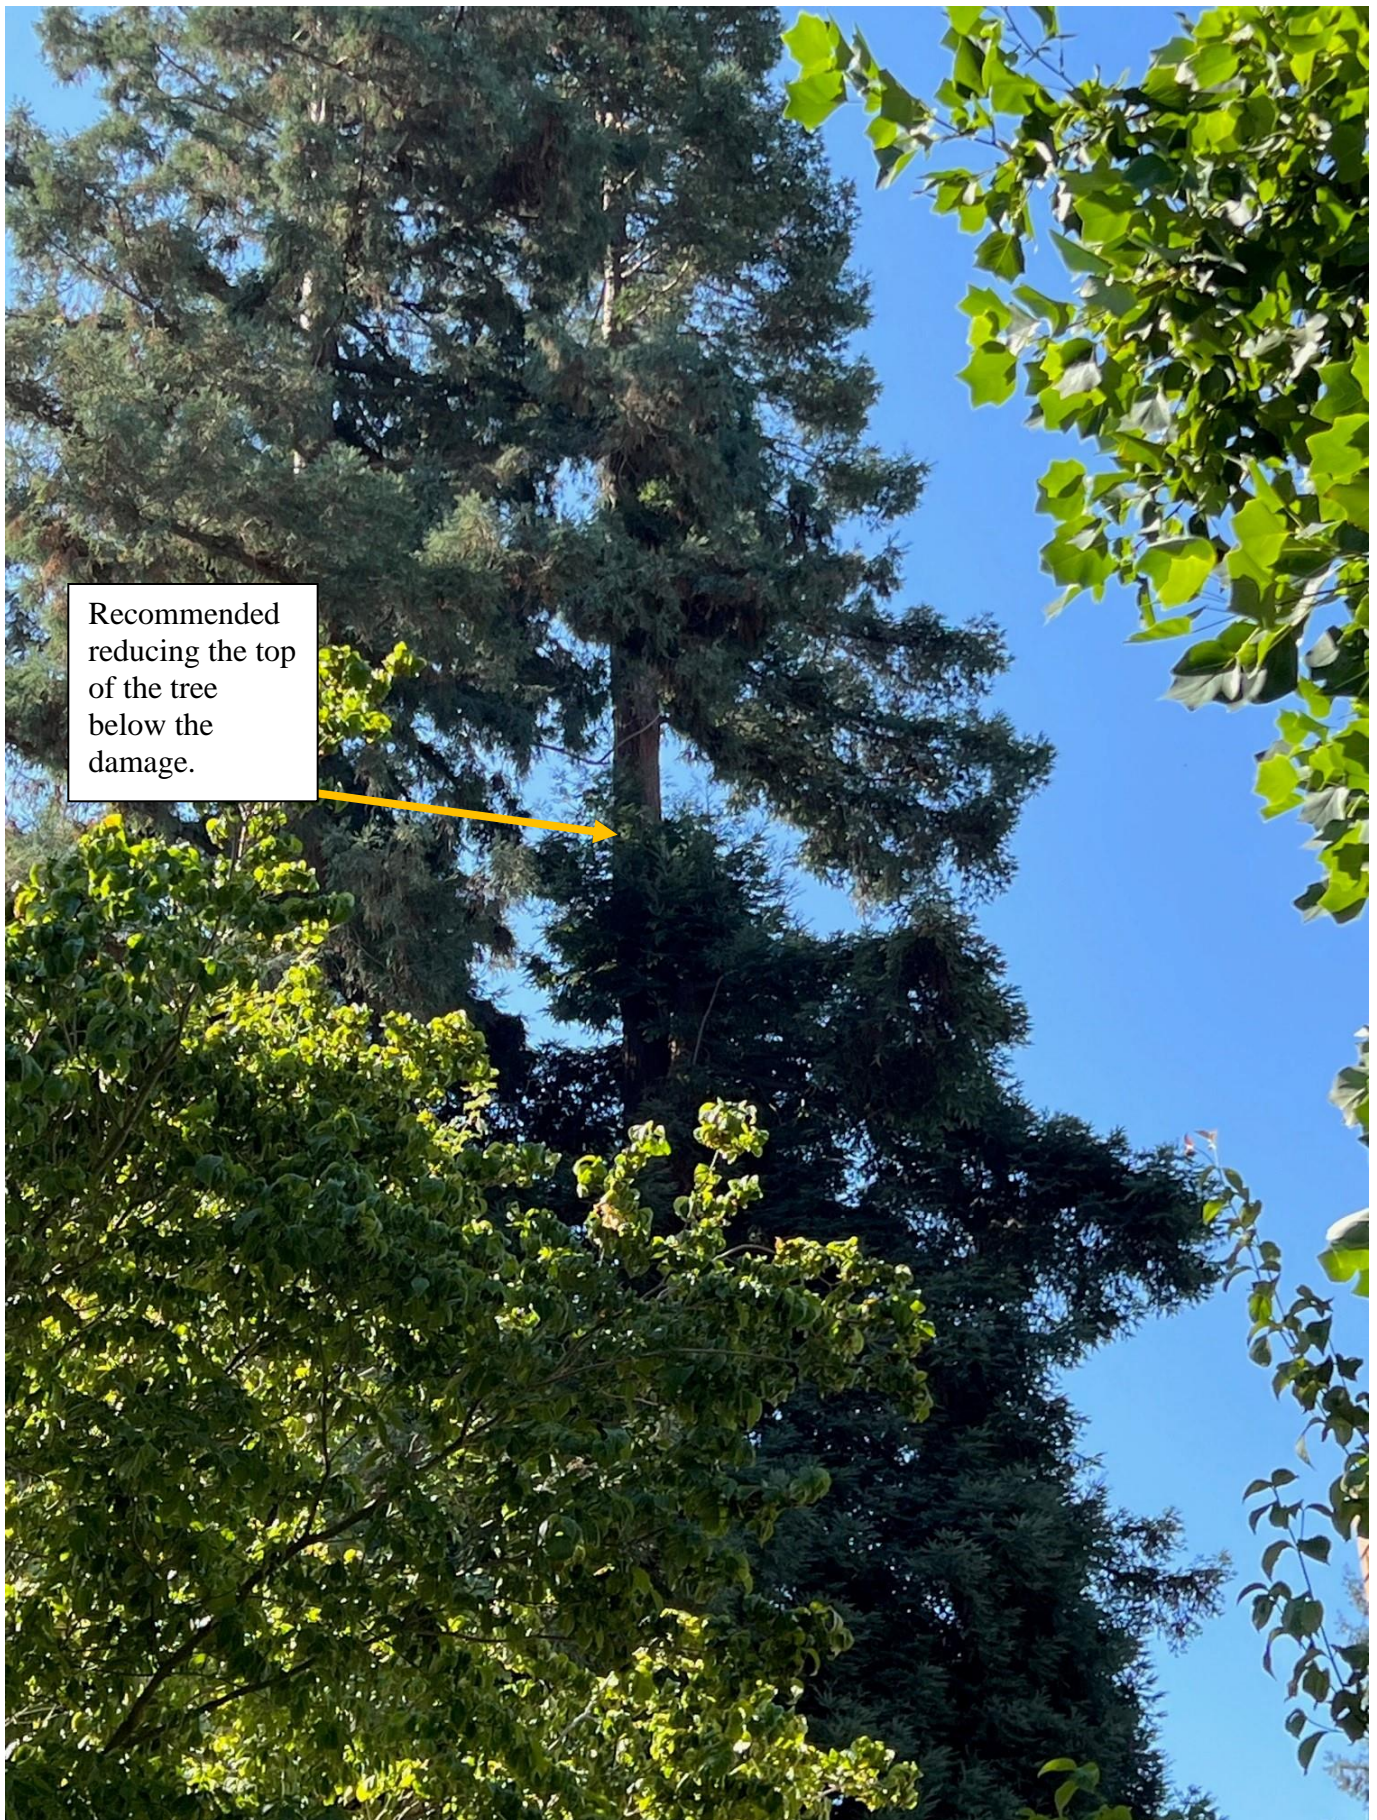
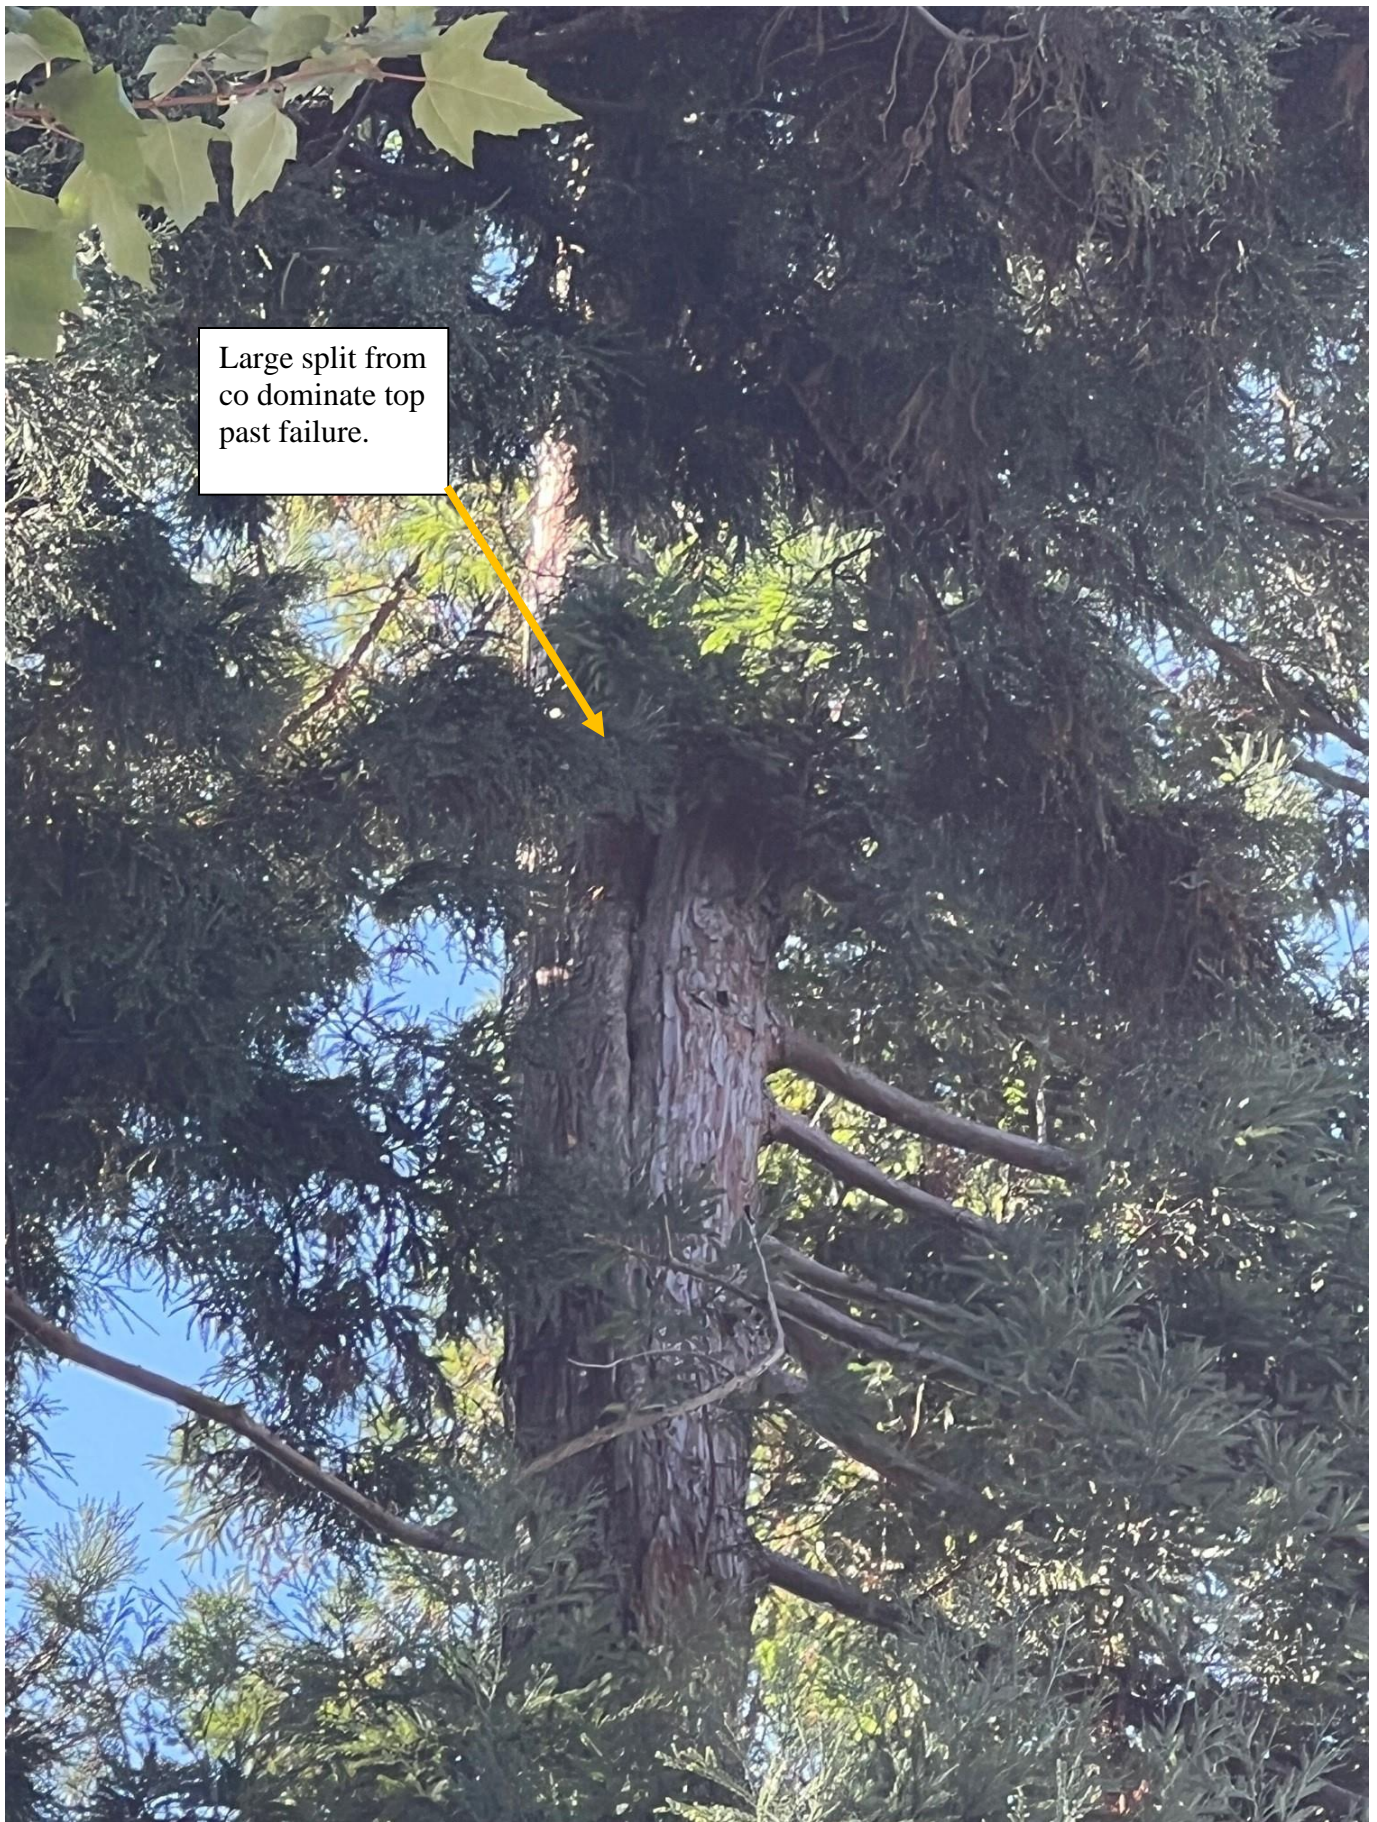
- (Zone 6) Tree #No Tag Redwood (*Sequoias sempervirens*), near garage 722 Elmhurst Circle. This tree has a failure of an included co dominate top. Due to the failure, there is damage to the trunk and the remaining top is vulnerable to another failure. There seems to be a large split in the wood running down the trunk. I recommend reduction of the top to below the damage to help reduce failure. (Figure 22-23).

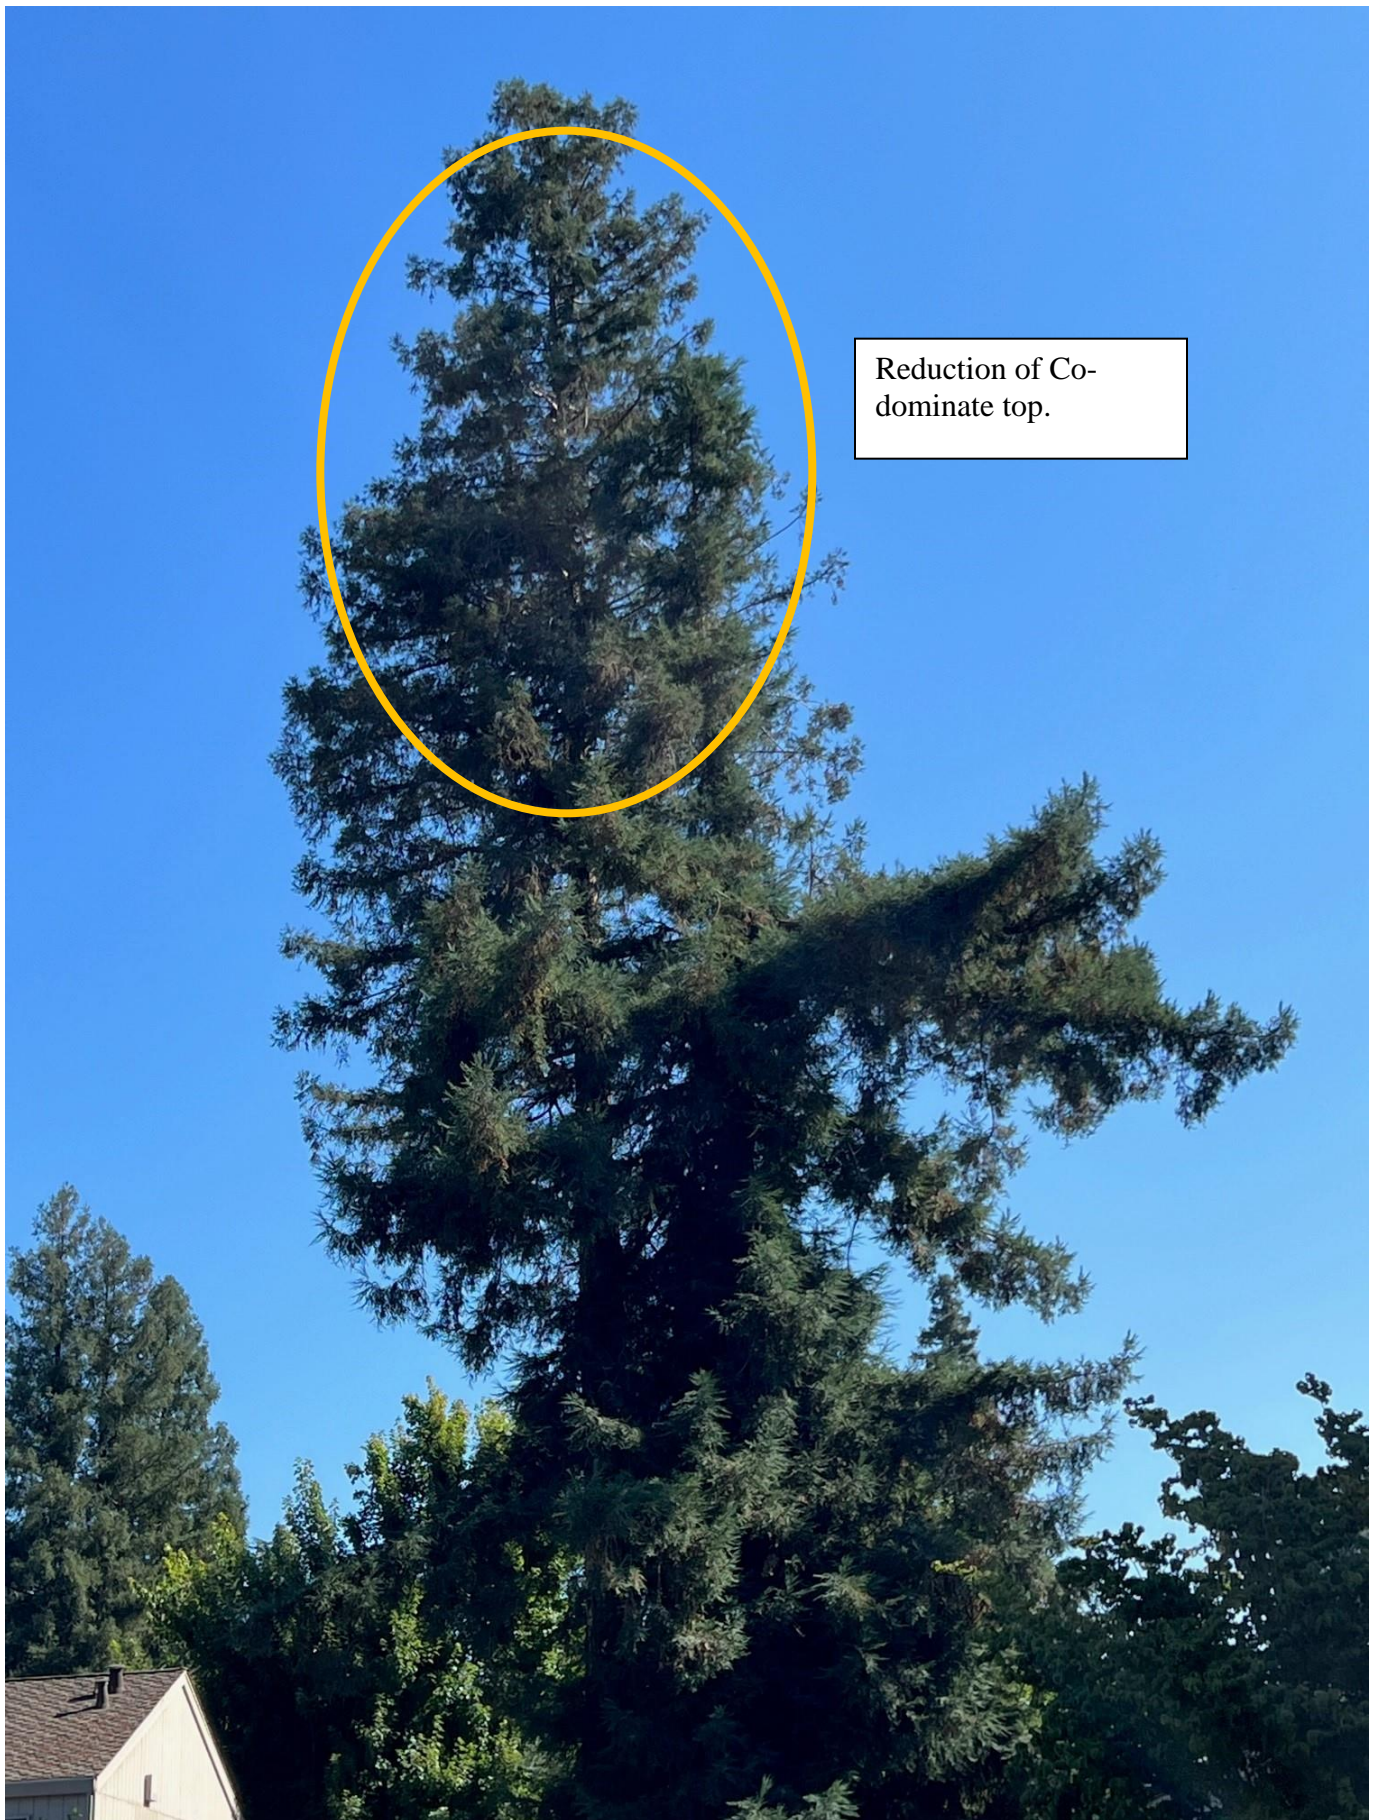
Figure 24

- (Zone 6) Tree #1732 Redwood (*Sequoias sempervirens*), 804 Elmhurst Circle. This tree has multiple included co dominate tops. Due to the failure potential, I recommend reduction pruning of the co dominate top to help reduce failure. Climber will reduce the smaller of the codominant tops by 1/2 or eliminate based on the climber's recommendation (Figure 24).

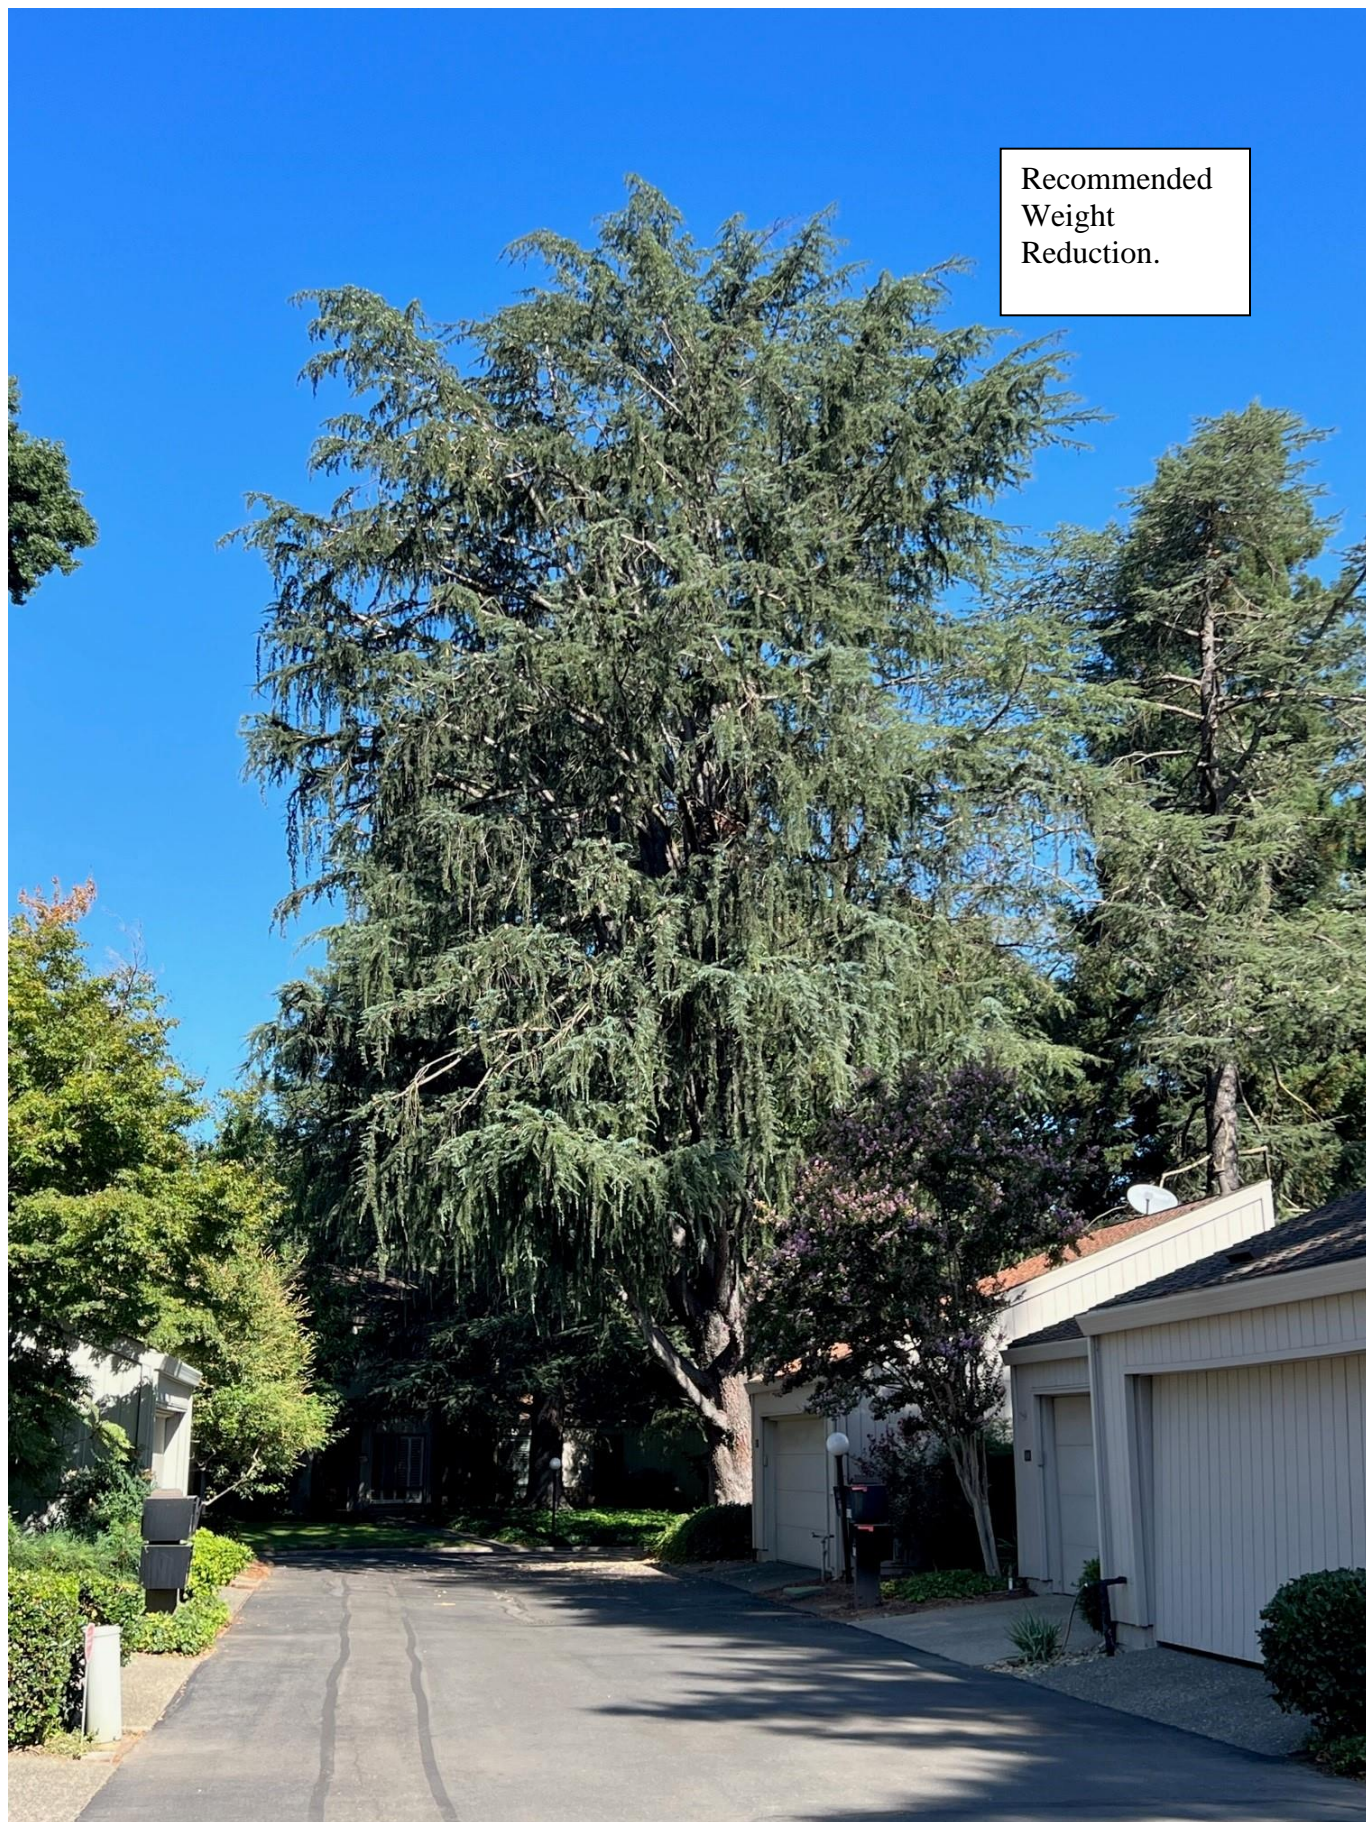
Figure 25

- (Zone 6) Tree #13 Redwood (*Sequoias sempervirens*), 804 Elmhurst Circle. This tree has multiple included co dominate tops. Due to the failure potential, I recommend reduction pruning of the co dominate top to help reduce failure. Climber will reduce the smaller of the codominant tops by 1/2 or eliminate based on the climber's recommendation (Figure 25).

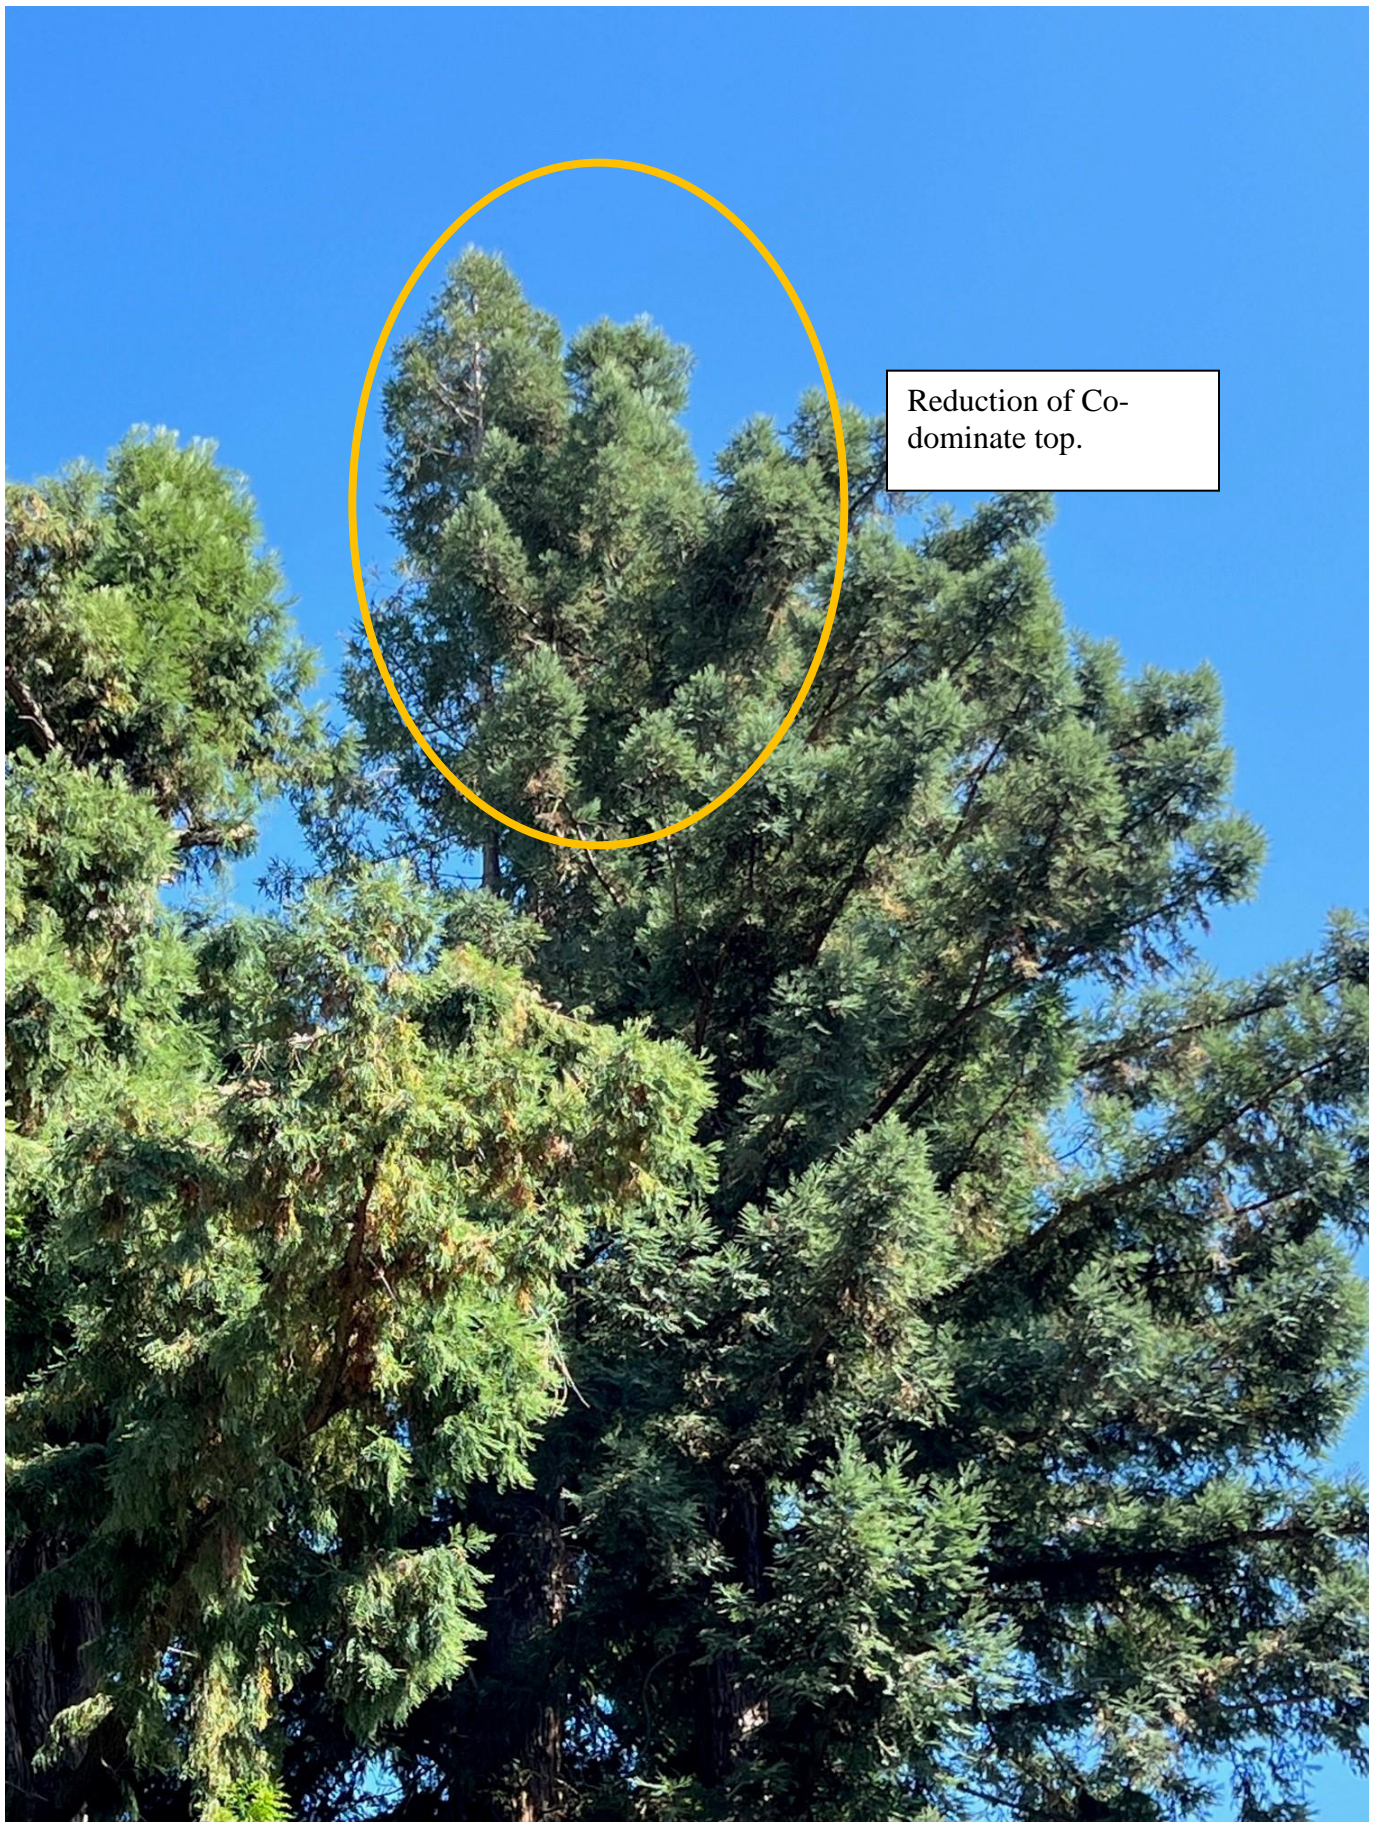
Figure 26

- (Zone 6) Tree #1690 Deodar cedar (*Cedrus deodara*) 804 Elmhurst Circle. The tree has an over weighted canopy and requires reduction pruning on branches throughout the tree canopy, making cuts no larger than 1"-2" on the branch ends reducing the total length of branched by 1'-3' on 60% of the trees total canopy. Reduction of total live canopy by 20% and deadwood larger than 2" (Figure 26).
