October 11, 2023

On September 25, 2023, I inspected several trees on the Nepenthe property during the monthly tree walk. The focus of the walk was to address resident/management concerns regarding mature trees on the property. The purpose of this report is to develop mitigation plans for the following trees and my recommendations are below. My recommendations are based on a Basic Visual Inspection. All decisions made based on the recommendations of this report are at the discretion of the Nepenthe Association.

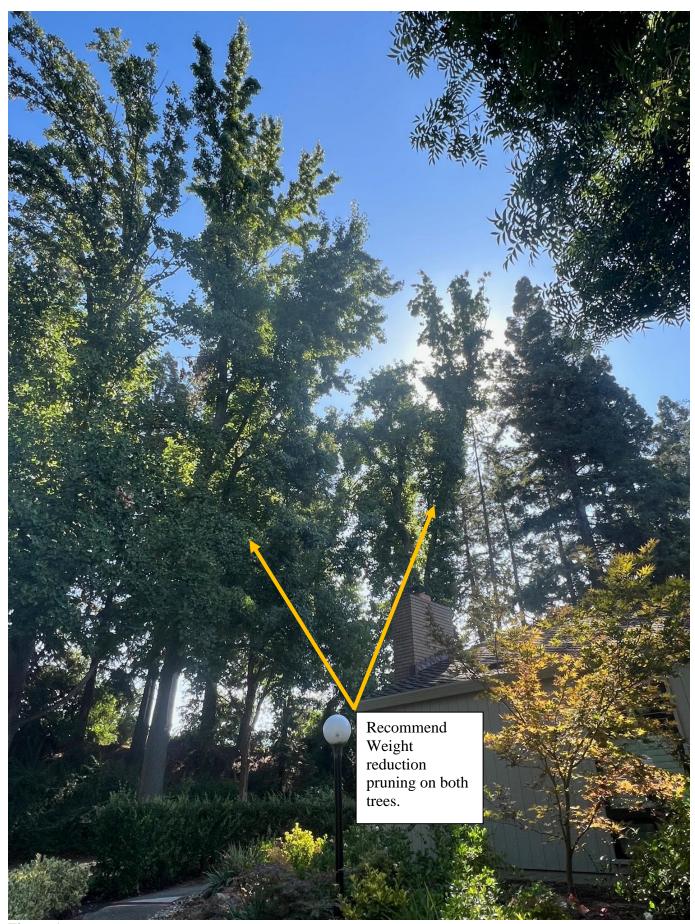
Figure 1

- (Zone 7) (2) Trees #2126, 1 No Tag, Liquid amber (*Liquidambar styraciflua*), 1653 University. These trees have a full over weighted canopy that requires reduction pruning on branches throughout the tree canopy, making cuts no larger than 1"-2" on the branch ends reducing the total length by 3'-4' throughout the canopy. Reduction of total live canopy by 25% and removing deadwood larger than 2". (Figure 1).

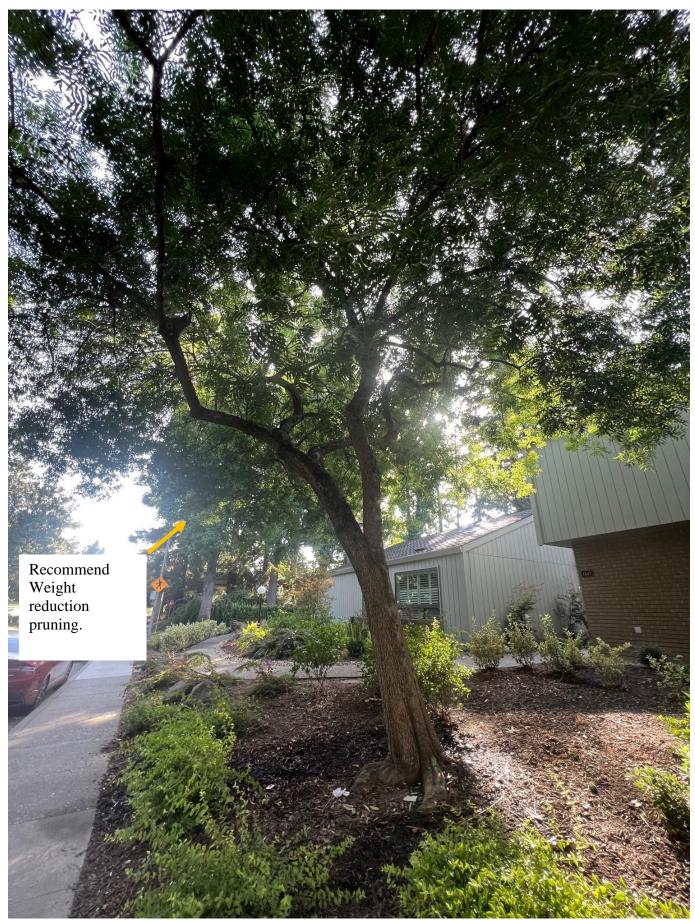
Figure 2

- (Zone 7) Tree #No Tag Chinese pistashe (*Pistacia chinensis*), 1647 University. Tree has a full over weighted canopy and requires reduction pruning on branches throughout the tree canopy, making cuts no larger than 1"-2" on the branch ends reducing the total length by 3'-4' throughout the canopy. Reduction of total live canopy by 25% and removing deadwood larger than 2" (Figure 2).

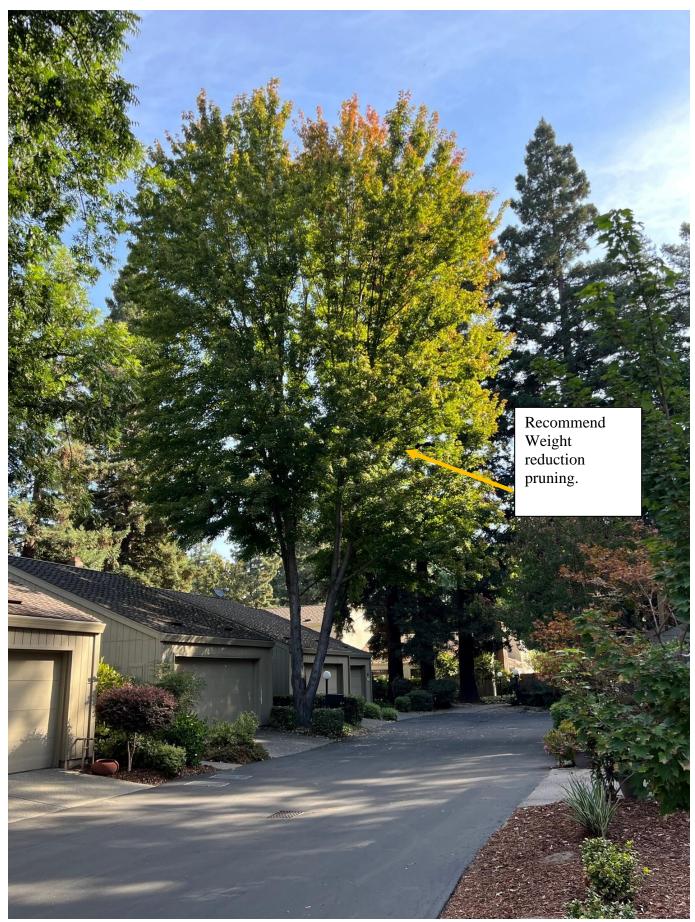
Figure 3

- (Zone 7) Tree #No Tag Maple (*Acer rubrum*), next to garage of 1581 University. Tree has a full over weighted canopy and requires reduction pruning on branches throughout the tree canopy, making cuts no larger than 1"-2" on the branch ends reducing the total length by 3'-4' throughout the canopy. Reduction of total live canopy by 25% and removing deadwood larger than 2". (Figure 3).

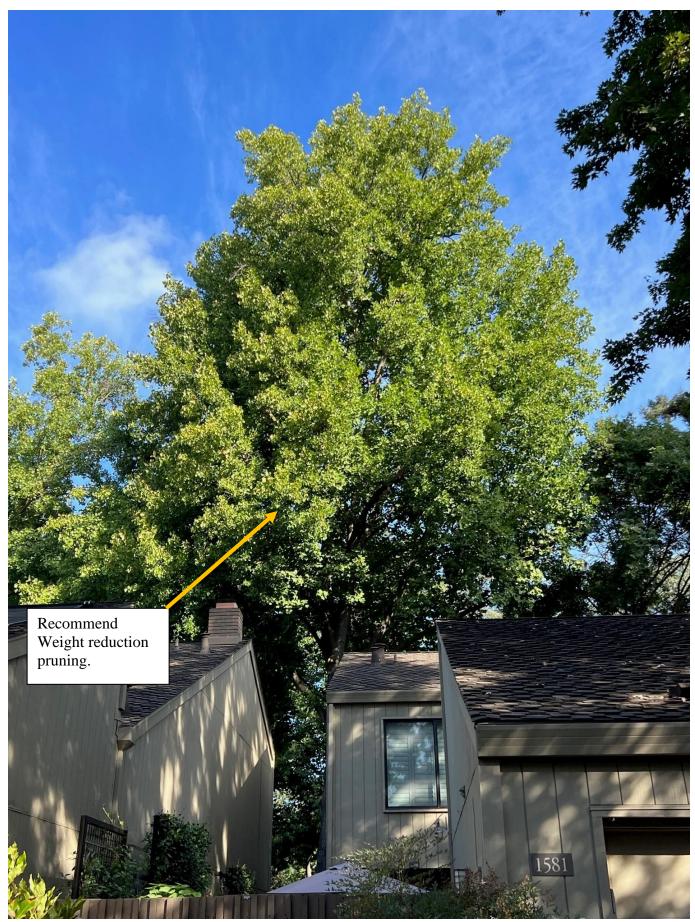
Figure 4

- (Zone 7) Tree #2084 Tulip tree (*Liriodendron tulipifera*), in front of 1581 University. Tree has a full over weighted canopy and requires reduction pruning on branches throughout the tree canopy, making cuts no larger than 1"-2" on the branch ends reducing the total length by 3'-4' throughout the canopy. Reduction of total live canopy by 25% and removing deadwood larger than 2". (Figure 4).

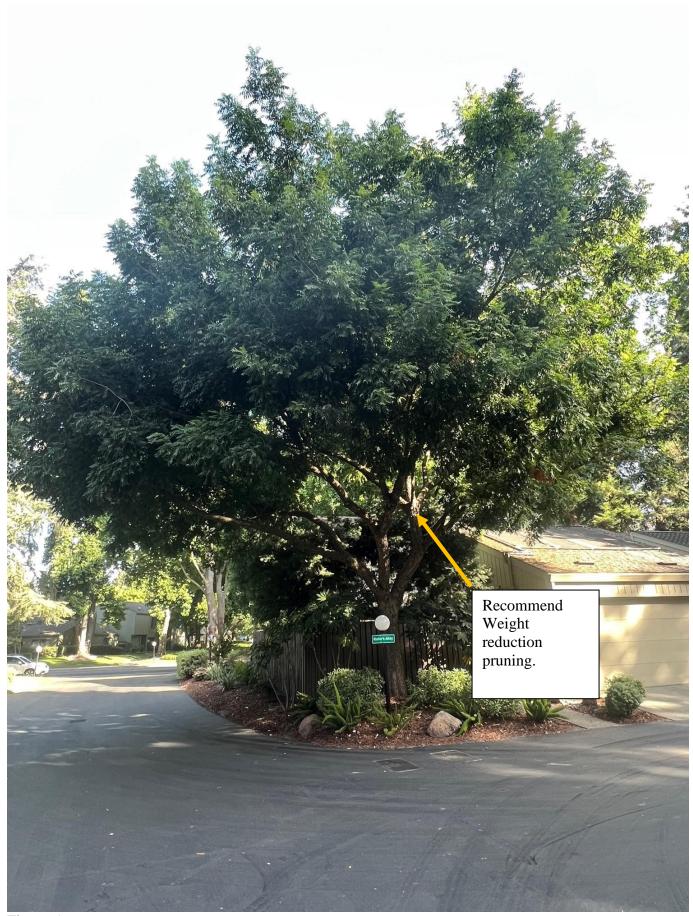
Figure 5

- (Zone 7) Tree #No Tag Chinese pistashe (*Pistacia chinensis*), 1575 University, next to alley. Tree has a full over weighted canopy and requires reduction pruning on branches throughout the tree canopy, making cuts no larger than 1"-2" on the branch ends reducing the total length by 3'-4' throughout the canopy. Reduction of total live canopy by 25% and removing deadwood larger than 2" (Figure 5).

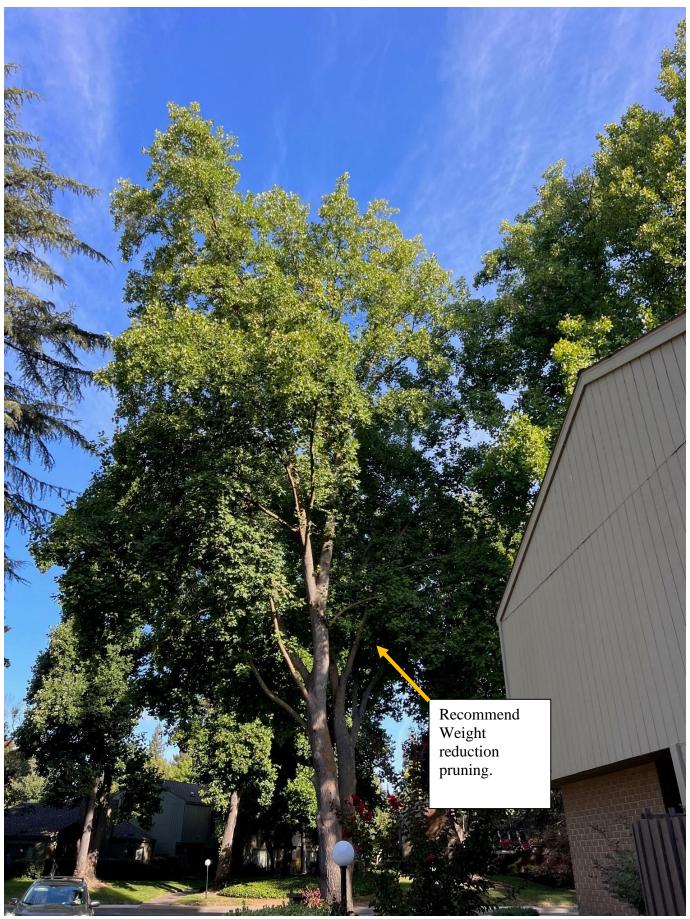
Figure 6

- (Zone 7) Tree #2082 Tulip tree (*Liriodendron tulipifera*), in front of 1575 University. Tree has a full over weighted canopy and requires reduction pruning on branches throughout the tree canopy, making cuts no larger than 1"-2" on the branch ends reducing the total length by 3'-4' throughout

the canopy. Reduction of total live canopy by 25% and removing deadwood larger than 2". (Figure 6).

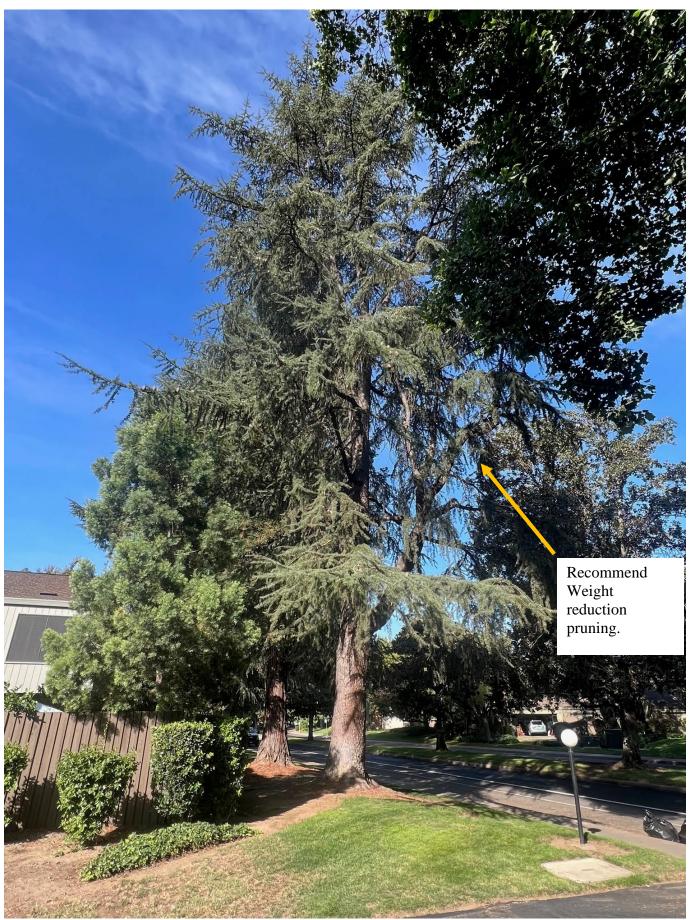
Figure 7

- (Zone 7) Tree #2072 Cedar (*Cedrus deodara*) In front of 1539 University. Tree has a full over weighted canopy and requires reduction pruning on branches throughout the tree canopy, making cuts no larger than 1"-2" on the branch ends reducing the total length by 3'-4' throughout the canopy. Reduction of total live canopy by 20% and removing deadwood larger than 2" (Figure 7).

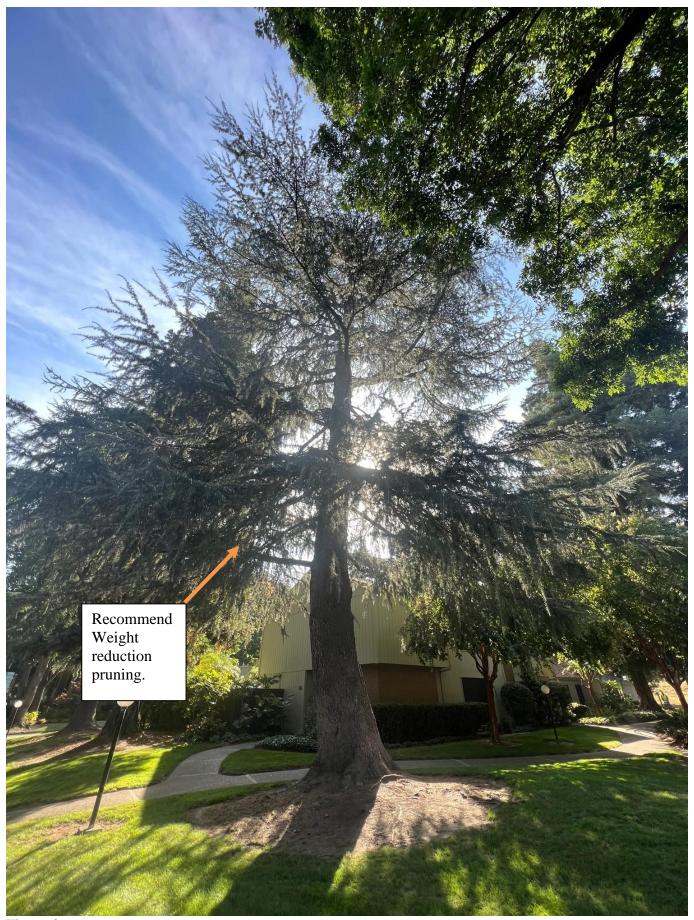
Figure 8

- (Zone 7) Tree #No Tag Cedar (*Cedrus deodara*) In front of 1533 University. Tree has a full over weighted canopy and requires reduction pruning on branches throughout the tree canopy, making cuts no larger than 1"-2" on the branch ends reducing the total length by 3'-4' throughout the canopy. Reduction of total live canopy by 20% and removing deadwood larger than 2" (Figure 8).

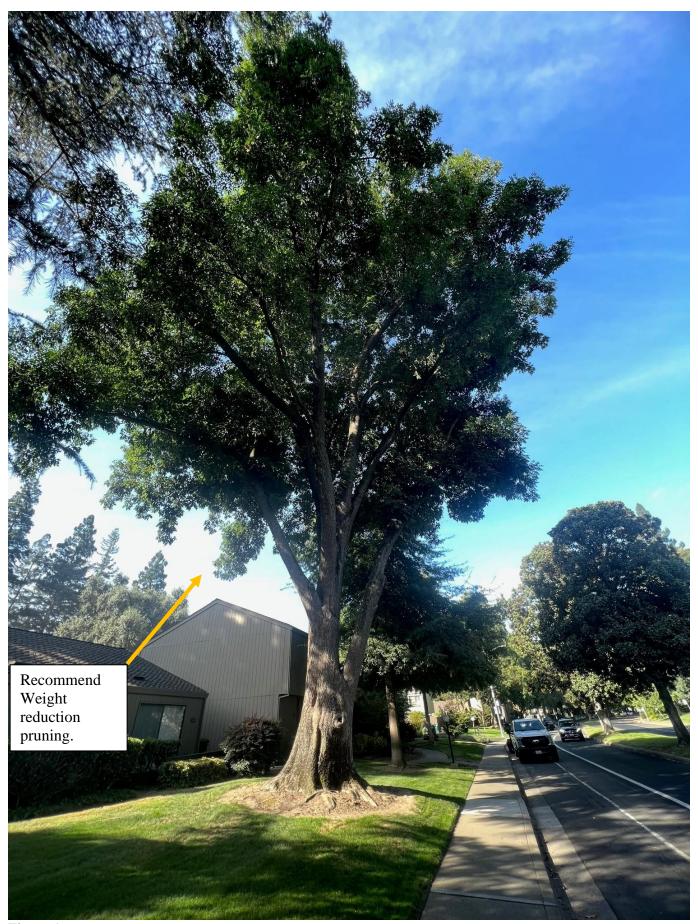
Figure 9

- (Zone 7) Tree #2058 Ash (*Fraxnis latifolia*) near 1533 University. Tree has a full over weighted canopy and requires reduction pruning on branches throughout the tree canopy, making cuts no larger than 1"-2" on the branch ends reducing the total length by 3'-4' throughout the canopy. Reduction of total live canopy by 25% and removing deadwood larger than 2". (Figure 9).

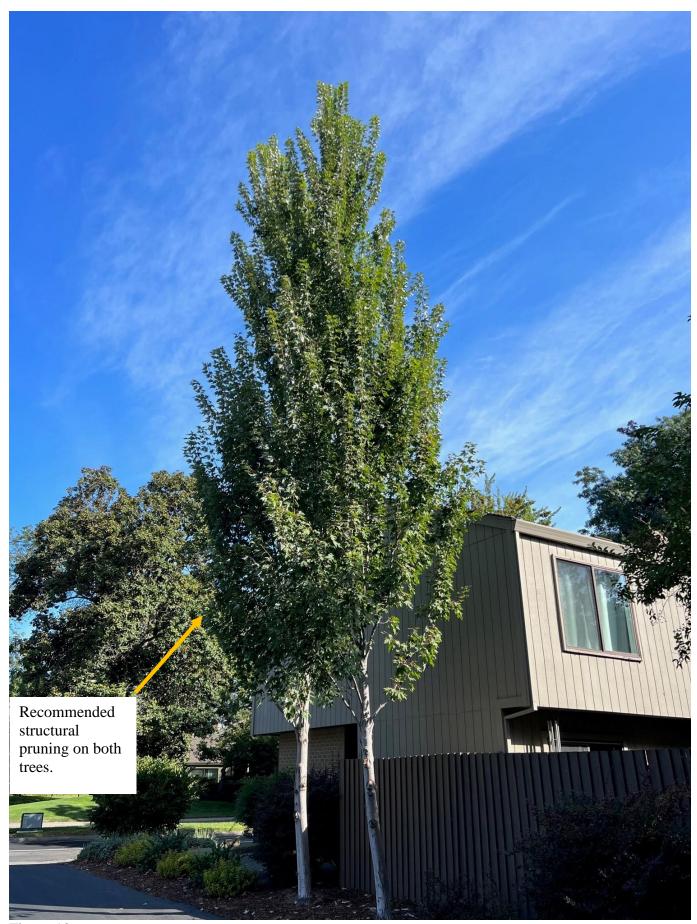
Figure 10

- (Zone 7) (2) Trees #No Tag Maple (*Acer rubrum*) near 1515 University. These trees are young and still developing and to assist with proper canopy development, the trees require structural pruning to help with direction of growth and healthy canopy development (Figure 10).

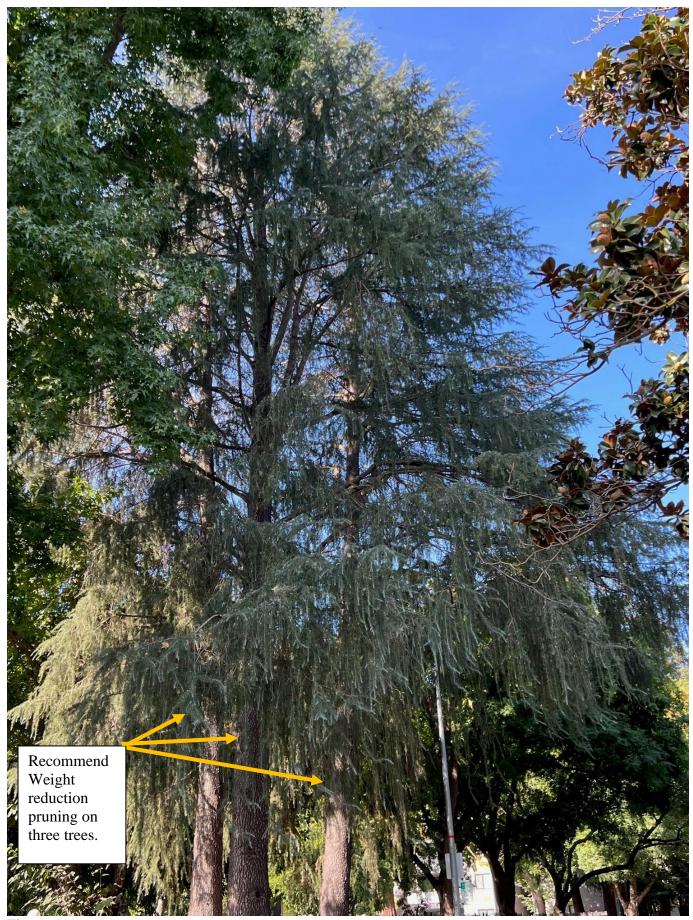
Figure 11

- (Zone 7) 3 Trees #2000, 2001, 2002 Cedar (*Cedrus deodara*). Next to 1425 University. These trees have over weighted canopies and requires reduction pruning on branches throughout the tree canopy, making cuts no larger than 1"-2" on the branch ends reducing the total length of branched by 1'-3' on 60% of the trees total canopy. Reduction of total live canopy by 20% and deadwood larger than 2" (Figure 11).

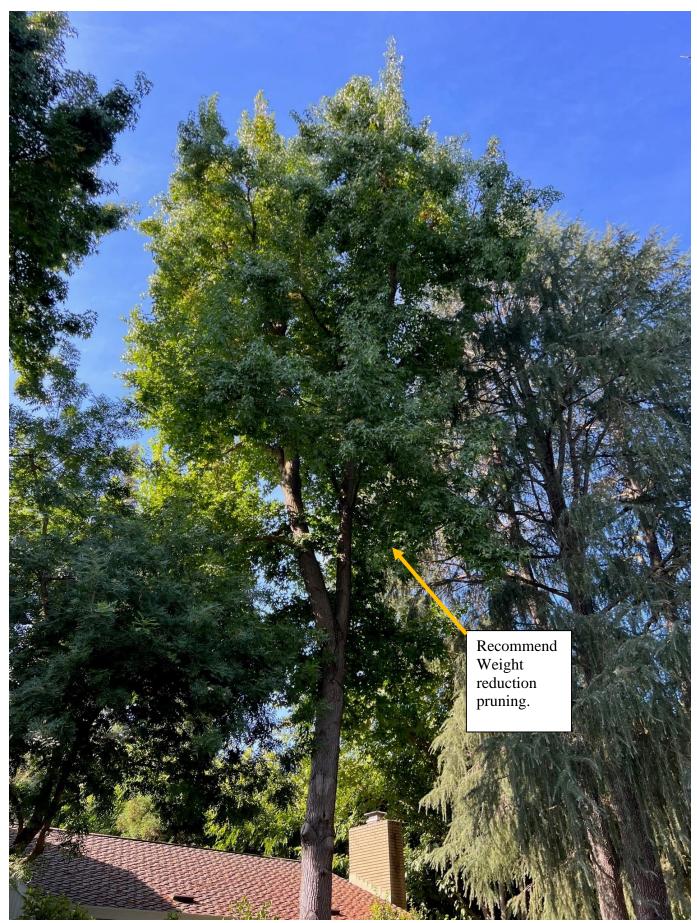
Figure 12

- (Zone 7) Tree #2003, Liquid amber (*Liquidambar styraciflua*), in front of 1425 University. Tree has a full over weighted canopy and requires reduction pruning on branches throughout the tree canopy, making cuts no larger than 1"-2" on the branch ends reducing the total length by 3'-4' throughout the canopy. Reduction of total live canopy by 25% and removing deadwood larger than 2". (Figure 12).

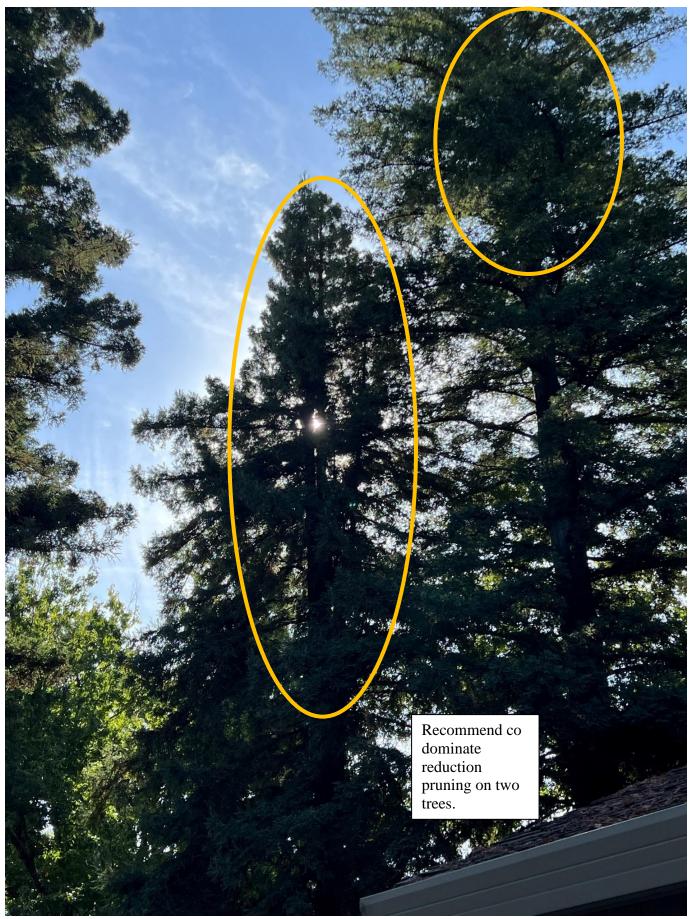
Figure 13

- (Zone 7) (2) Tree's #2203 #2017 Redwood (*Sequoias sempervirens*), in alley near 1449 University. The trees have multiple included co dominate tops. Due to the failure potential, I recommend reduction pruning of the co dominate top to help reduce failure. Climber will reduce the smaller of the codominant tops by 1/2 or eliminate based on the climber's recommendation (Figure 13).

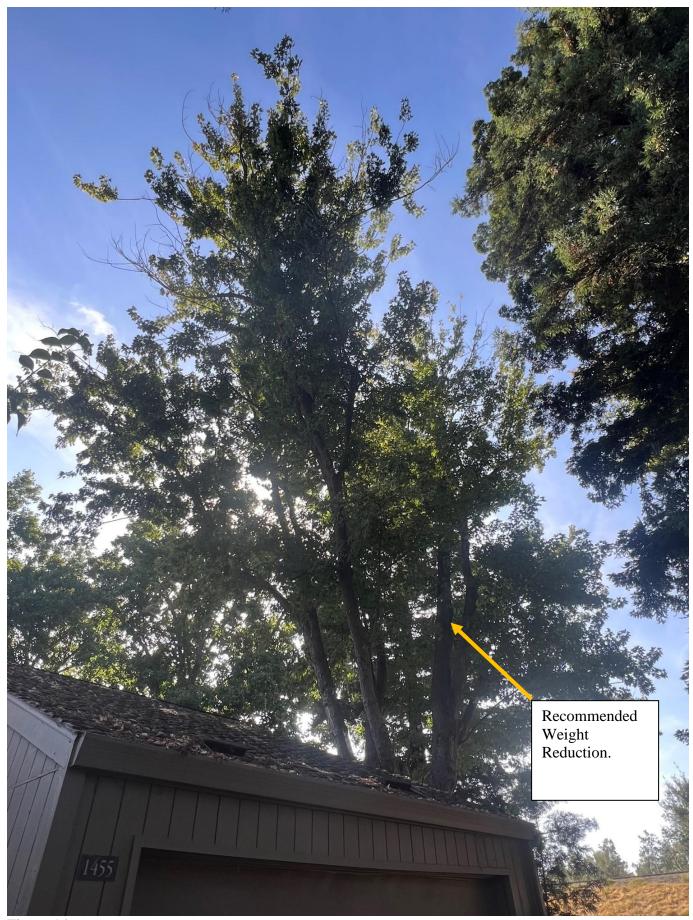
Figure 14

- (Zone 7) Tree #2201, Silver Maple (*Acer saccharum*) near berm behind 1455 University. Tree has a full over weighted canopy and requires reduction pruning on branches throughout the tree canopy, making cuts no larger than 1"-2" on the branch ends reducing the total length by 3'-4' throughout the canopy. Reduction of total live canopy by 25% and removing deadwood larger than 2". (Figure 14).

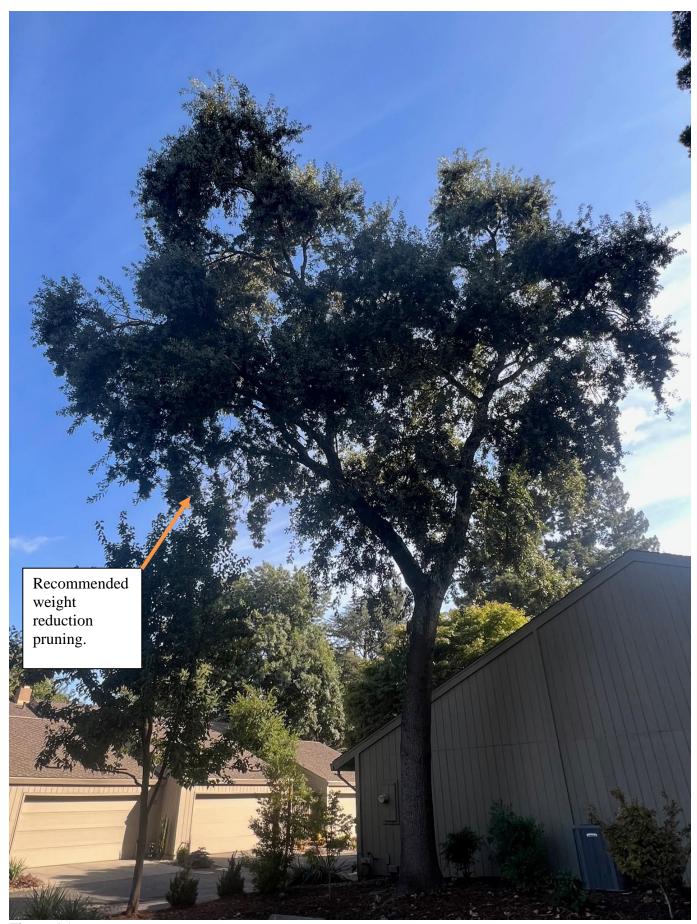
Figure 15

- (Zone 7) Tree #2050 Oak (*Quercus lobatta*), in alley next to 1503 University. Tree has a full over weighted canopy and requires reduction pruning on branches throughout the tree canopy, making cuts no larger than 1"-2" on the branch ends reducing the total length by 3'-4' throughout the canopy. Reduction of total live canopy by 20% and removing deadwood larger than 2". (Figure 15).

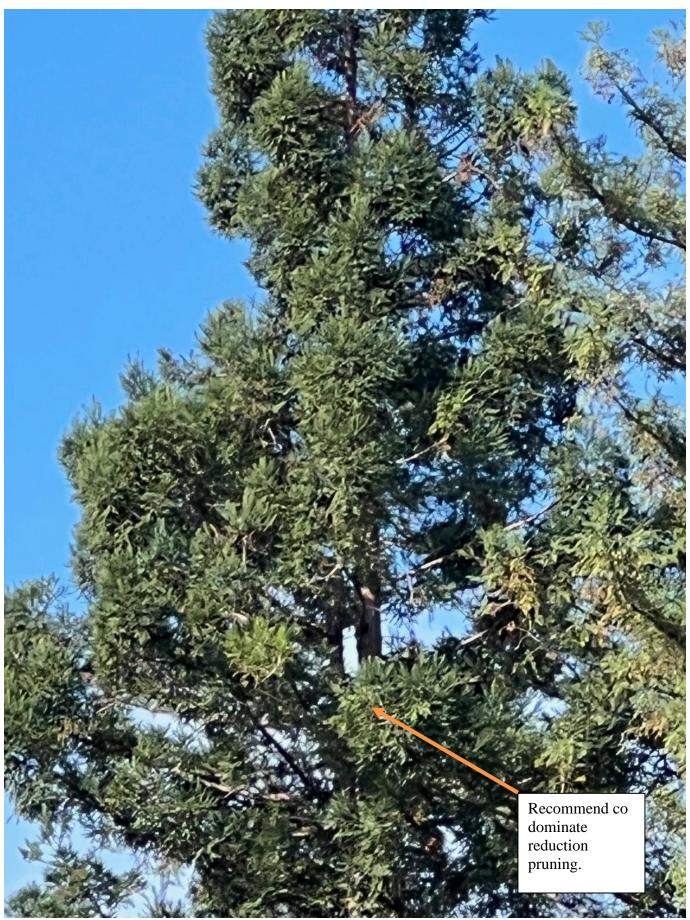
Figure 16

- (Zone 7) Tree #2193 Redwood (*Sequoias sempervirens*), behind 1503 University. This tree has multiple included co dominate tops. Due to the failure potential, I recommend reduction pruning of the co dominate top to help reduce failure. Climber will reduce the smaller of the codominant tops by 1/2 or eliminate based on the climber's recommendation (Figure 16).

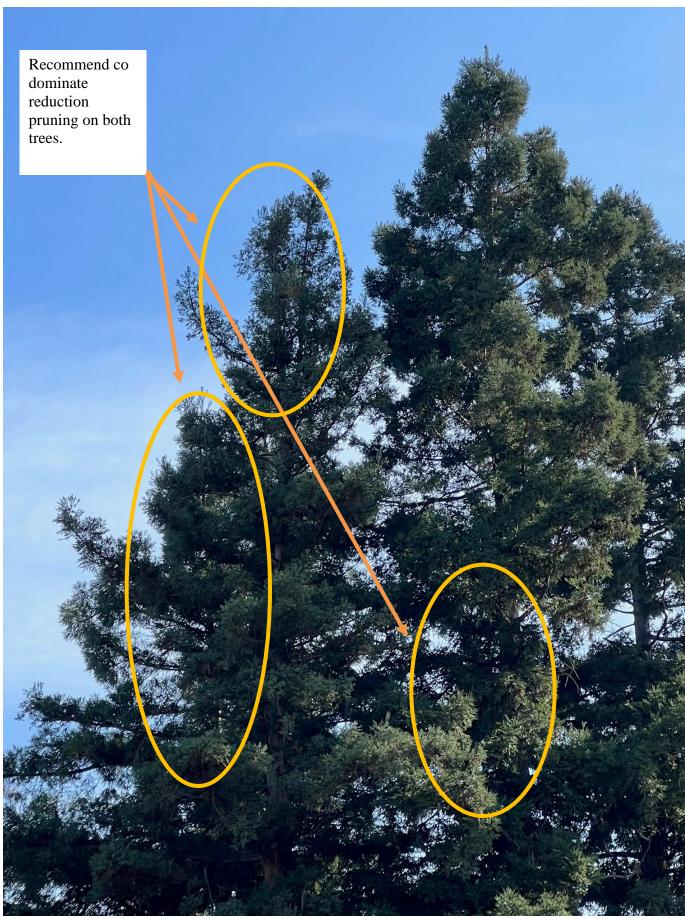
Figure 17

- (Zone 7) Tree #2184 Redwood (*Sequoias sempervirens*), end of alley near 1509 University. This tree has multiple included co dominate tops. Due to the failure potential, I recommend reduction pruning of the co dominate top to help reduce failure. Climber will reduce the smaller of the codominant tops by 1/2 or eliminate based on the climber's recommendation (Figure 17).

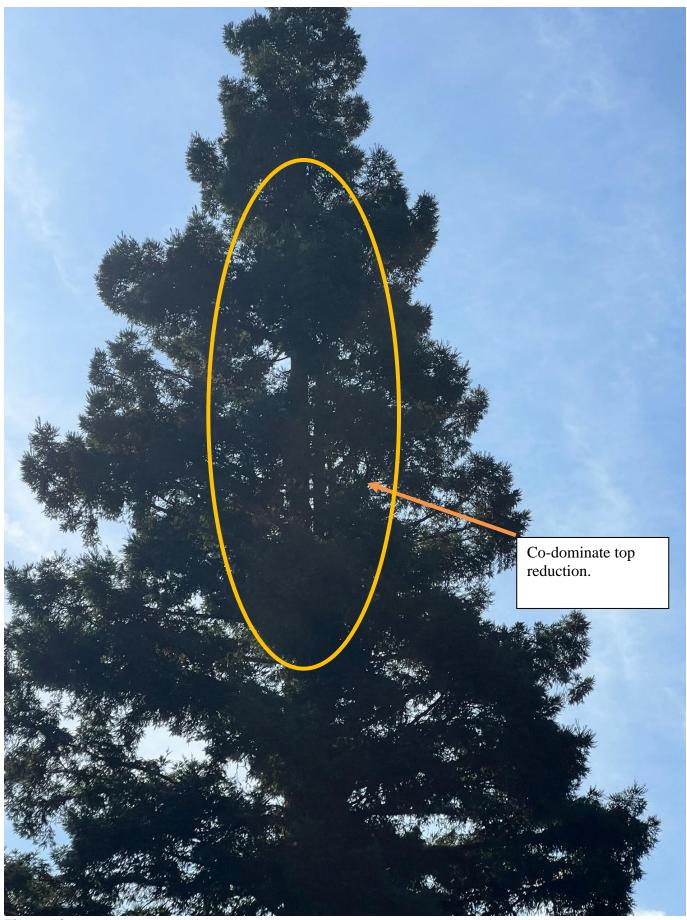
Figure 18

- (Zone 7) (3) Tree's #2061 #2062, 1 No Tag, Redwood (*Sequoias sempervirens*), in alley near 1533 University. The trees have multiple included co dominate tops. Due to the failure potential, I recommend reduction pruning of the co dominate top to help reduce failure. Climber will reduce the smaller of the codominant tops by 1/2 or eliminate based on the climber's recommendation (Figure 18).

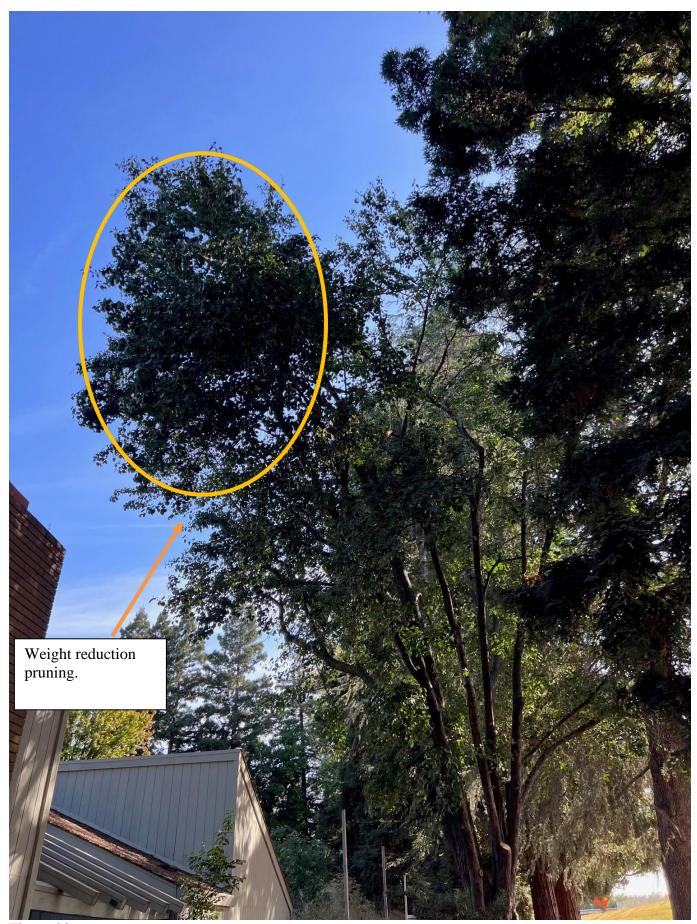
Figure 20

- (Zone 7) Tree #No Tag Cedar (*Cedrus deodara*) next to berm behind 1557 University. Tree has a full over weighted canopy and requires reduction pruning on branches throughout the tree canopy, making cuts no larger than 1"-2" on the branch ends reducing the total length by 3'-4' throughout the canopy. Reduction of total live canopy by 20% and removing deadwood larger than 2" (Figure 20).

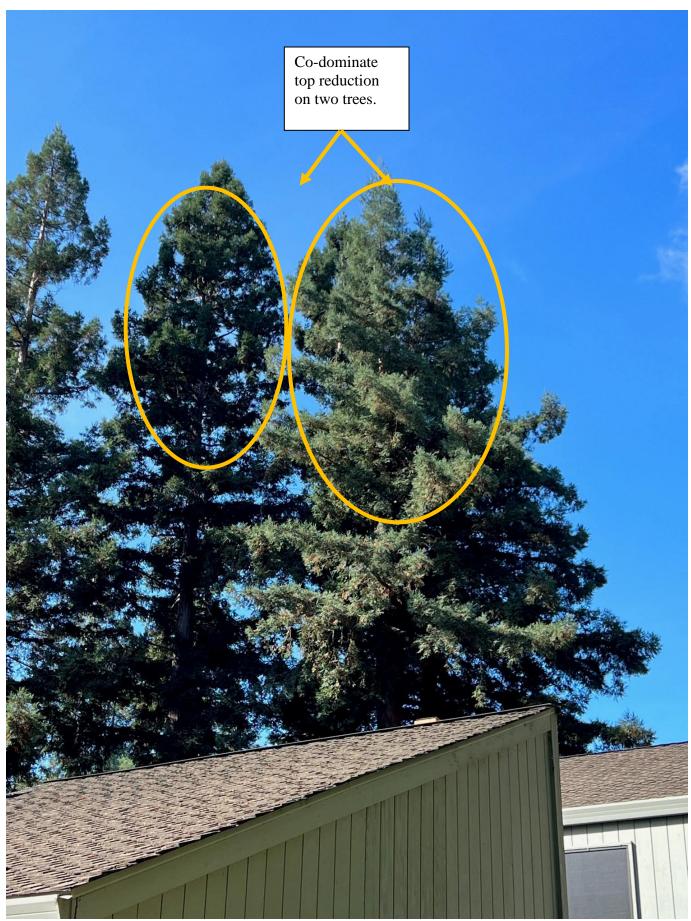
Figure 21

- (Zone 7) (2) 1 No Tag, #176 Redwood (*Sequoias sempervirens*), behind 1563 University. The trees have multiple included co dominate tops. Due to the failure potential, I recommend reduction pruning of the co dominate top to help reduce failure. Climber will reduce the smaller of the codominant tops by 1/2 or eliminate based on the climber's recommendation (Figure 21).

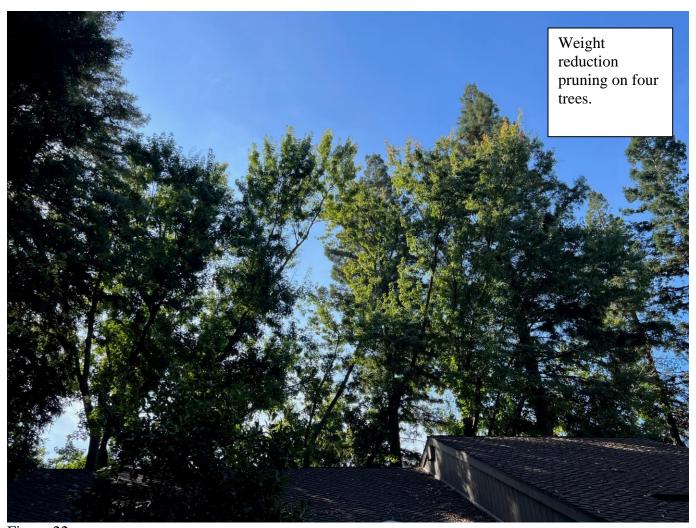
Figure 22

- (Zone 7) (4) Trees #2167, 2168, 2172, 1 No Tag, Silver Maple (*Acer saccharum*) behind 1563/1569 University. These trees have over weighted canopies and requires reduction pruning on branches throughout the tree canopy, making cuts no larger than 1"-2" on the branch ends reducing the total length of branched by 1'-3' on 60% of the trees total canopy. Reduction of total live canopy by 20% and deadwood larger than 2" (Figure 22).

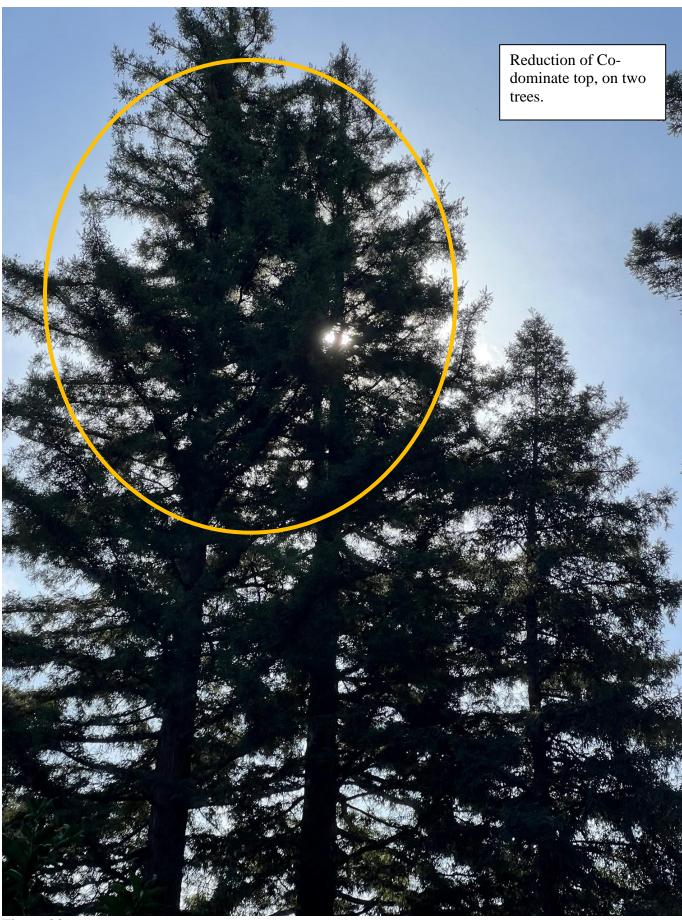
Figure 23

- (Zone 7) (2) Tree's #2099 #2100 Redwood (*Sequoias sempervirens*), behind 1611 University. The trees have multiple included co dominate tops. Due to the failure potential, I recommend reduction pruning of the co dominate top to help reduce failure. Climber will reduce the smaller of the codominant tops by 1/2 or eliminate based on the climber's recommendation (Figure 23).

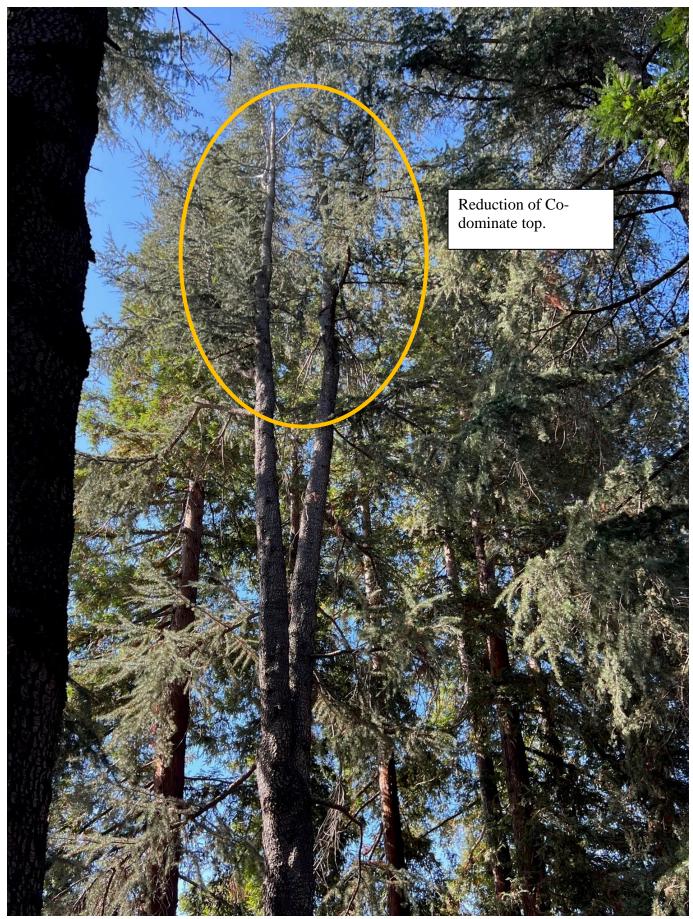
Figure 24

- (Zone 7) Tree #2147 Cedar (*Cedrus deodara*) behind 1629 University. This tree has an included co dominate top. Due to the failure potential, I recommend reduction pruning of the co dominate top to help reduce failure. Climber will reduce the smaller of the codominant tops by 1/2 or eliminate based on the climber's recommendation (Figure 24).
