April 15, 2020

The Nepenthe Association
Bettsi Ledesma
1131 Commons Dr.
Sacramento, CA 95825
Phone: (916) 929-8380
Email: Bettsi.Ledesma@fsresidential.com

On April 15, 2020, I inspected several trees on the Nepenthe property during the monthly tree walk. The focus of the walk was to address resident/management concerns regarding mature trees on the property. The purpose of this report is to develop mitigation plans for the following trees and my recommendations are below. My recommendations are based on a Basic Visual Inspection. All decisions made based on the recommendations of this report are at the discretion of the Nepenthe Association.

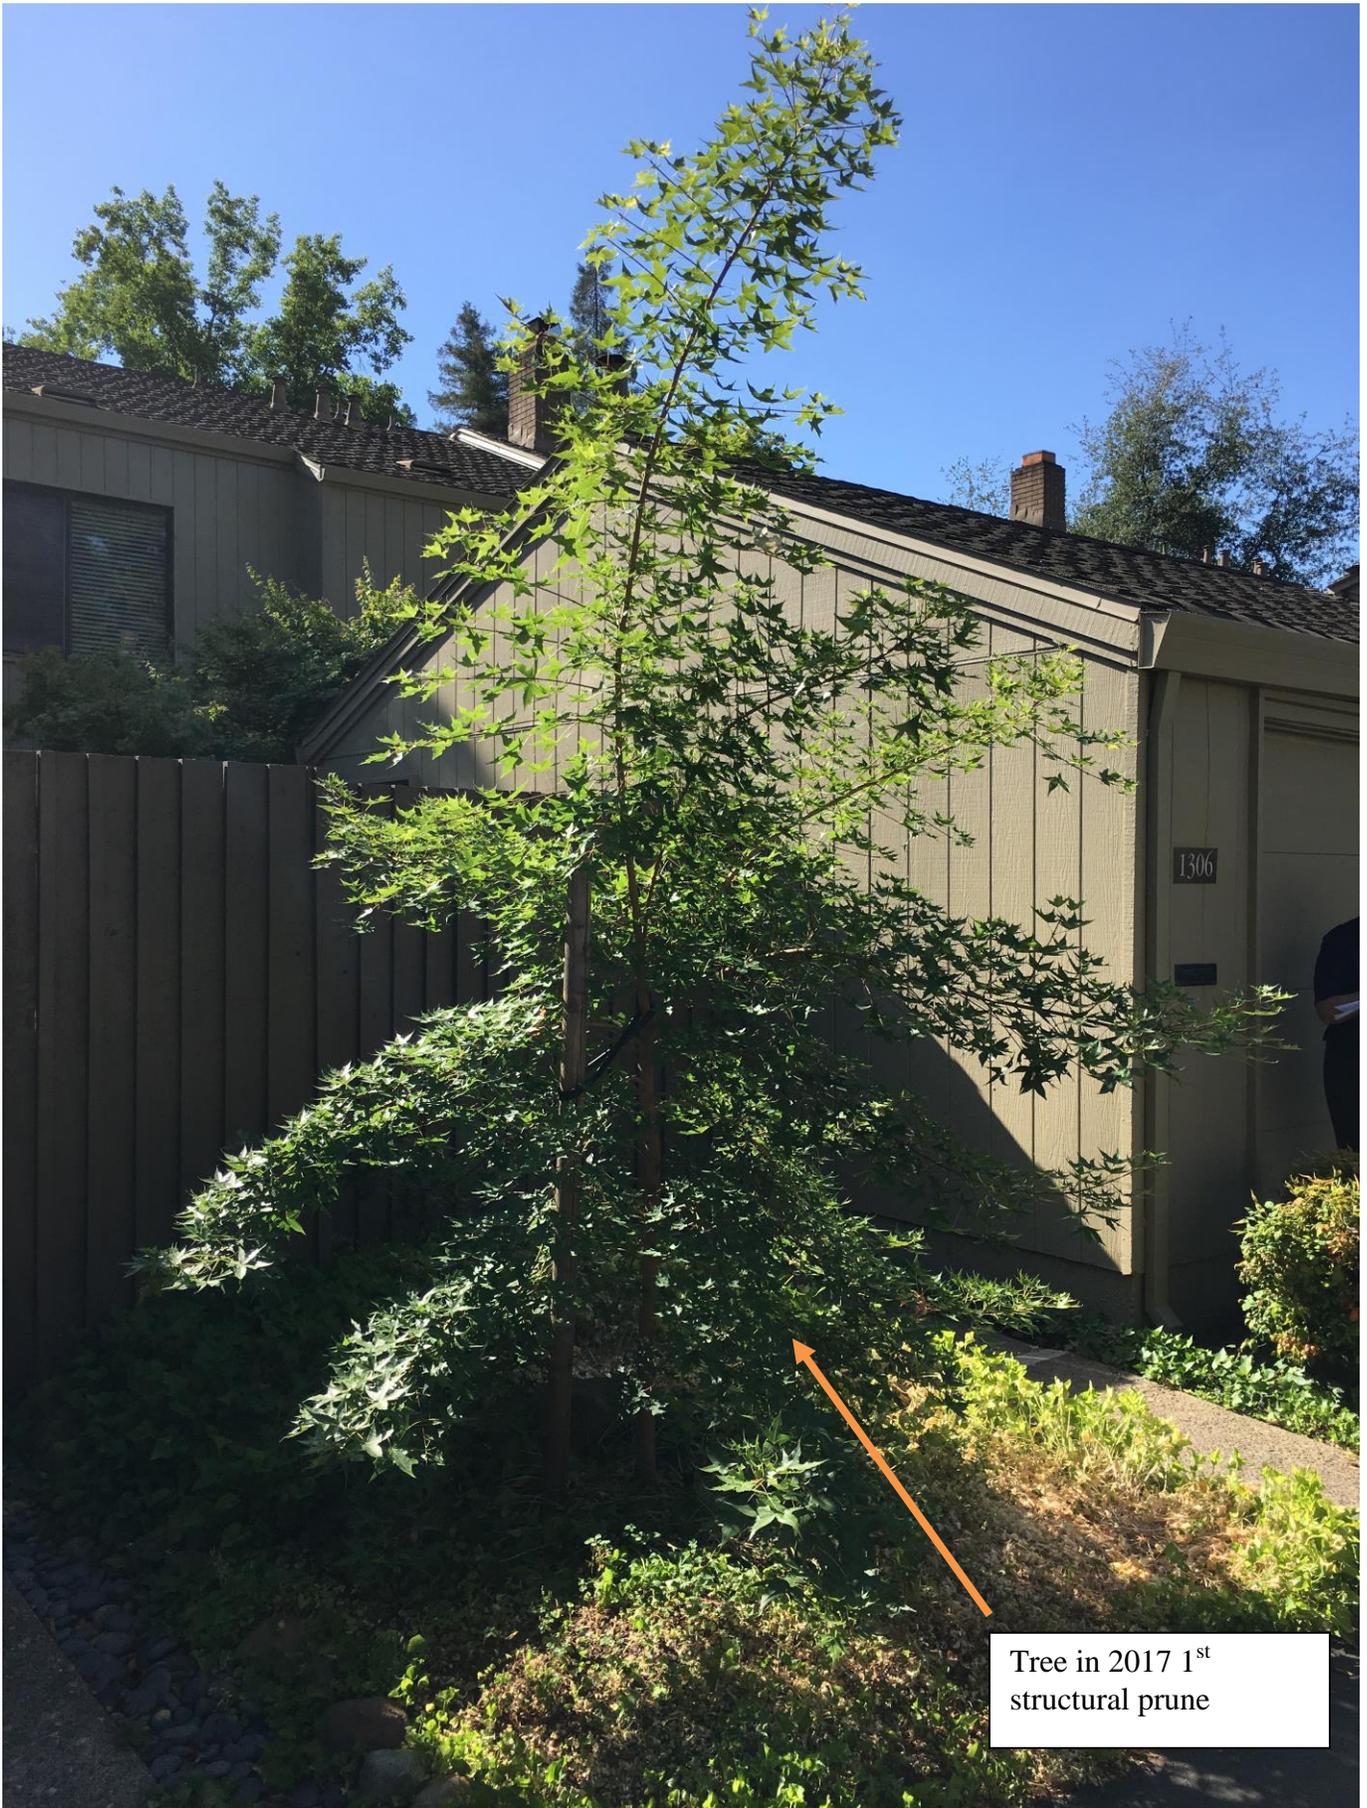
- (Zone 2) No Tag Trident Maple (*Acer buergerianum*) next to 1304 Commons Dr. Continue structure pruning to encourage proper development (Figures 1-2). Figure 1 pictures tree in 2017 prior to 1st pruning. Figure 2 shows the trees response to pruning. Further pruning to train the trees growth is recommended.

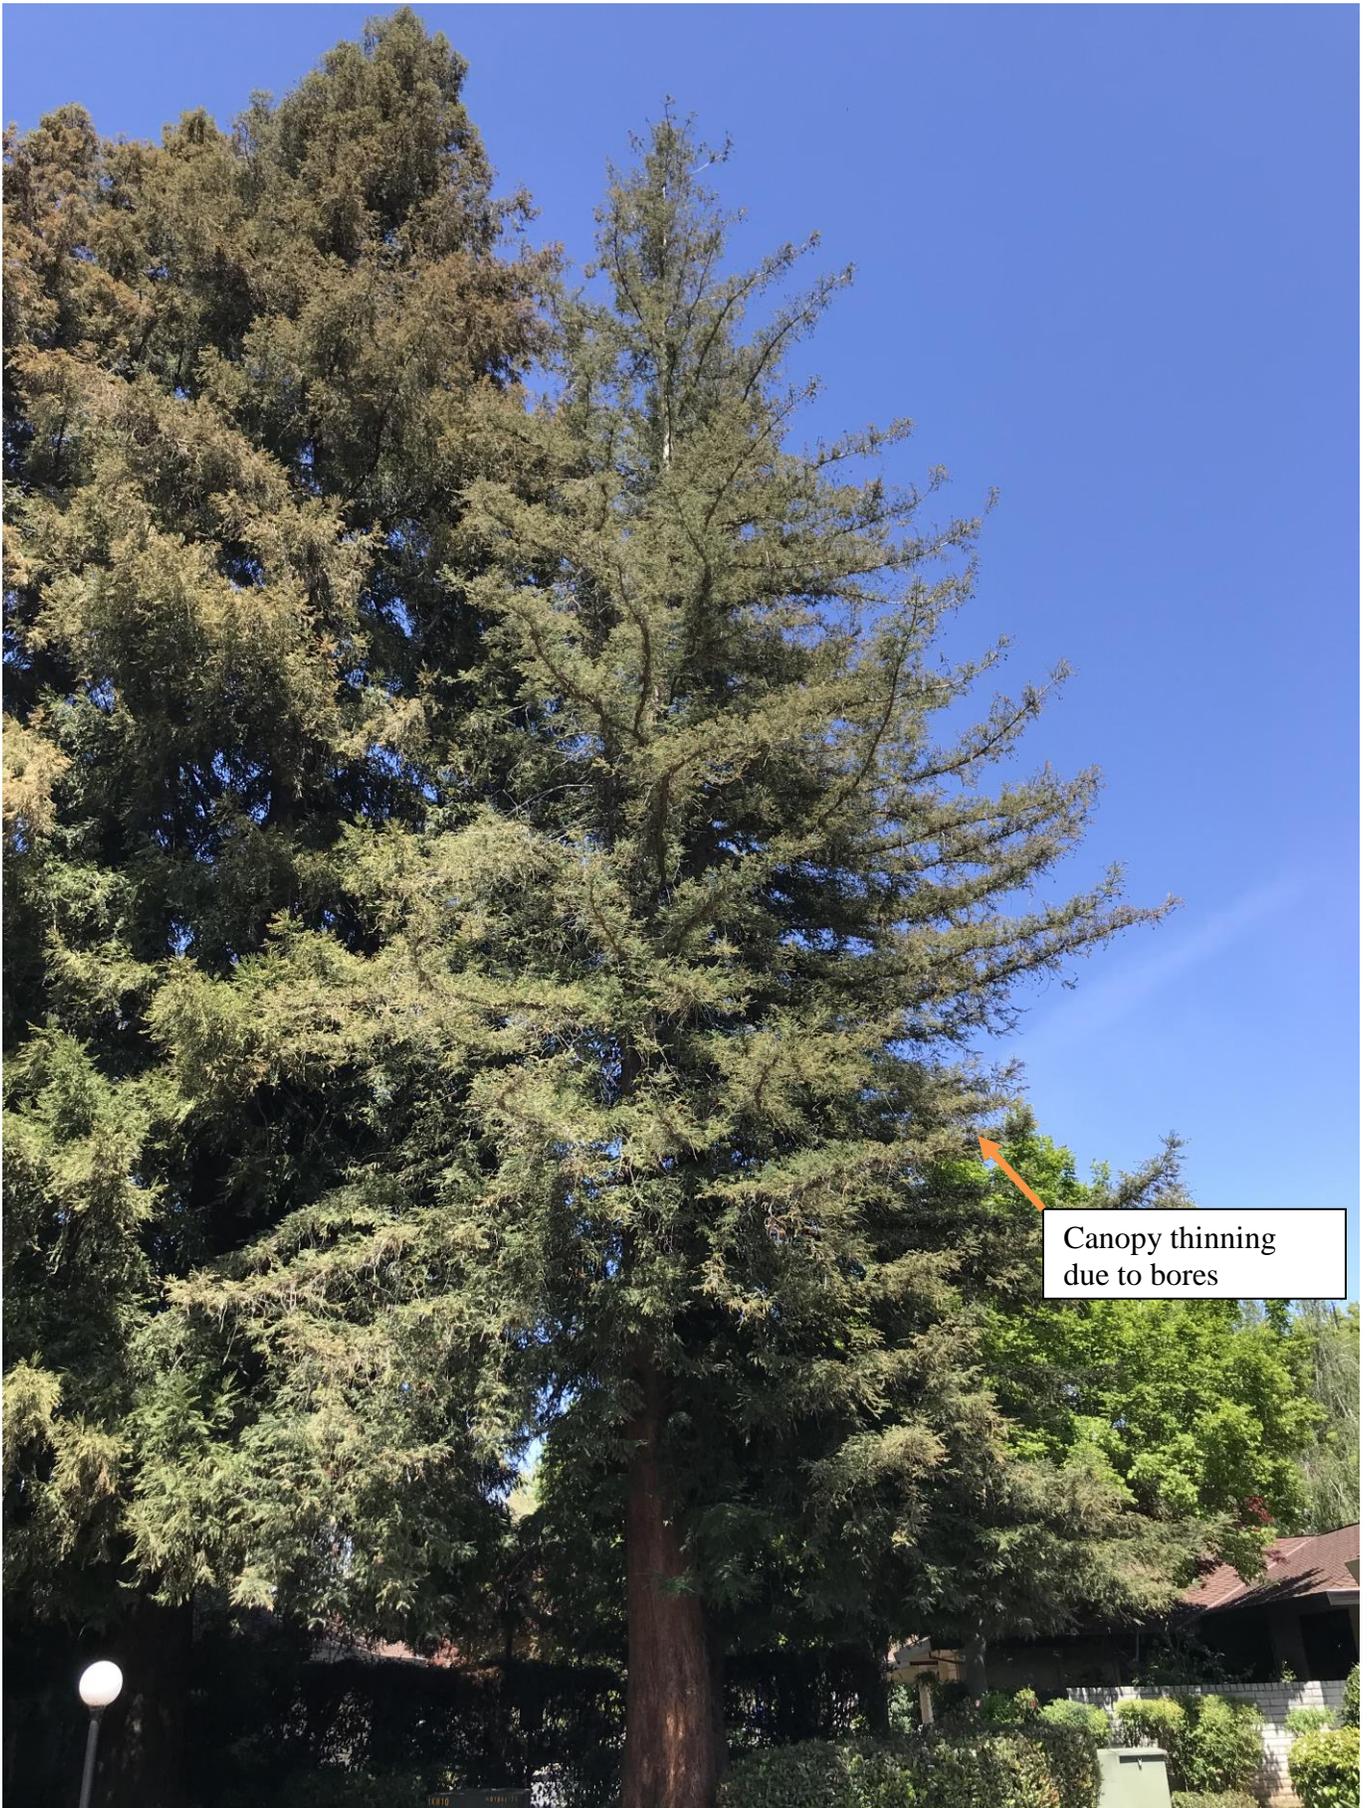
Figure 3

- (Zone 2) Tree #391 Redwood (*Sequoia sempervirens*), 1300 Commons Dr. Tree still has evidence of boring insects (Figures 3-4) I recommend Safari Drench application to counter the insects and will be added to list of trees for deep root water during the summer months to protect against further stress

Canopy thinning
due to bores

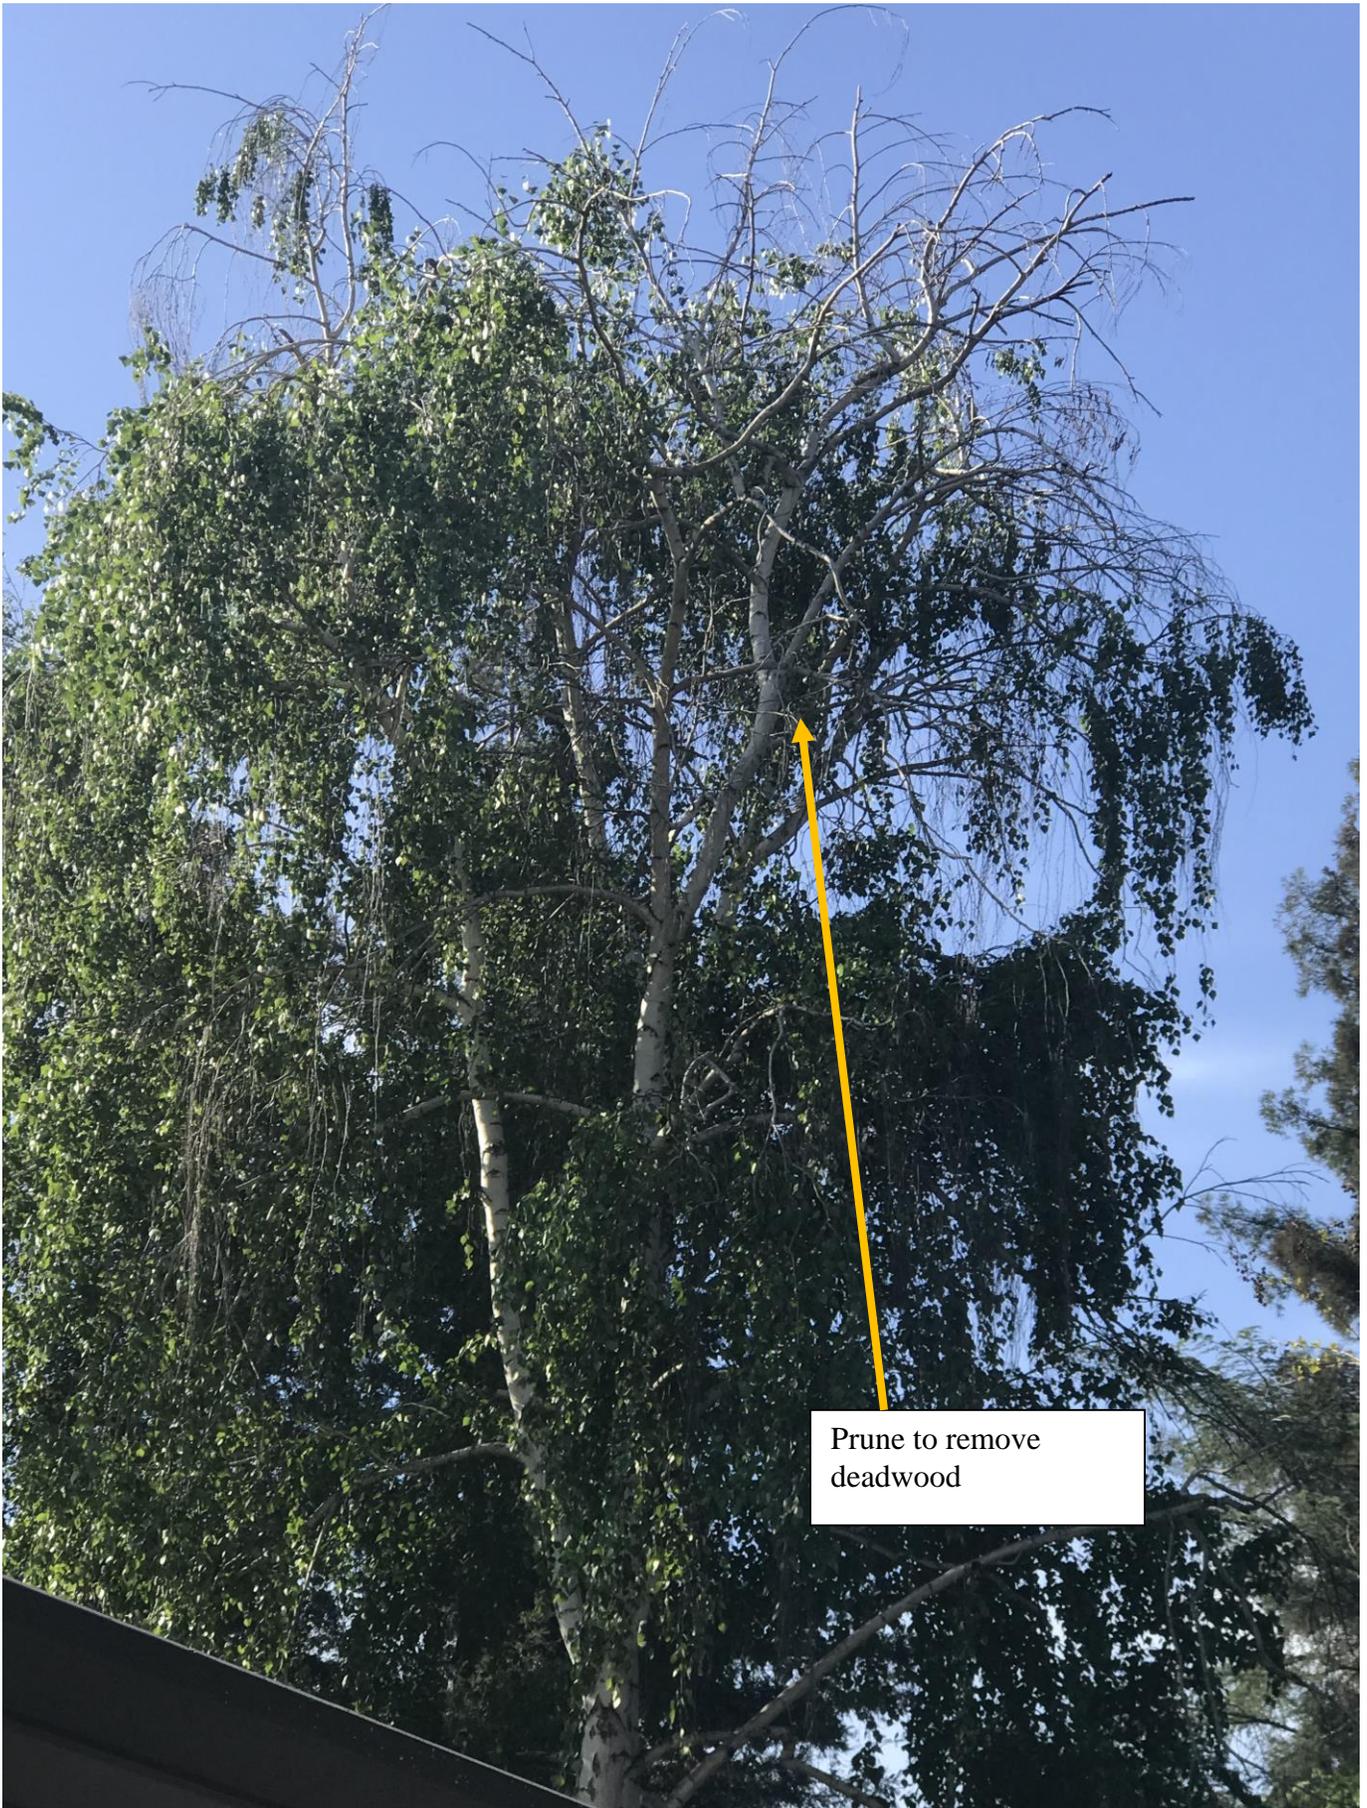
Figure 5

- (Zone 2) Tree # 403 Birch (*Betula pendula*) 2259 Swarthmore. (Figure 5) Tree has signs of decline in upper canopy. However the canopy still shows signs of vigor, I recommend pruning to remove the deadwood and retaining the tree and monitoring.

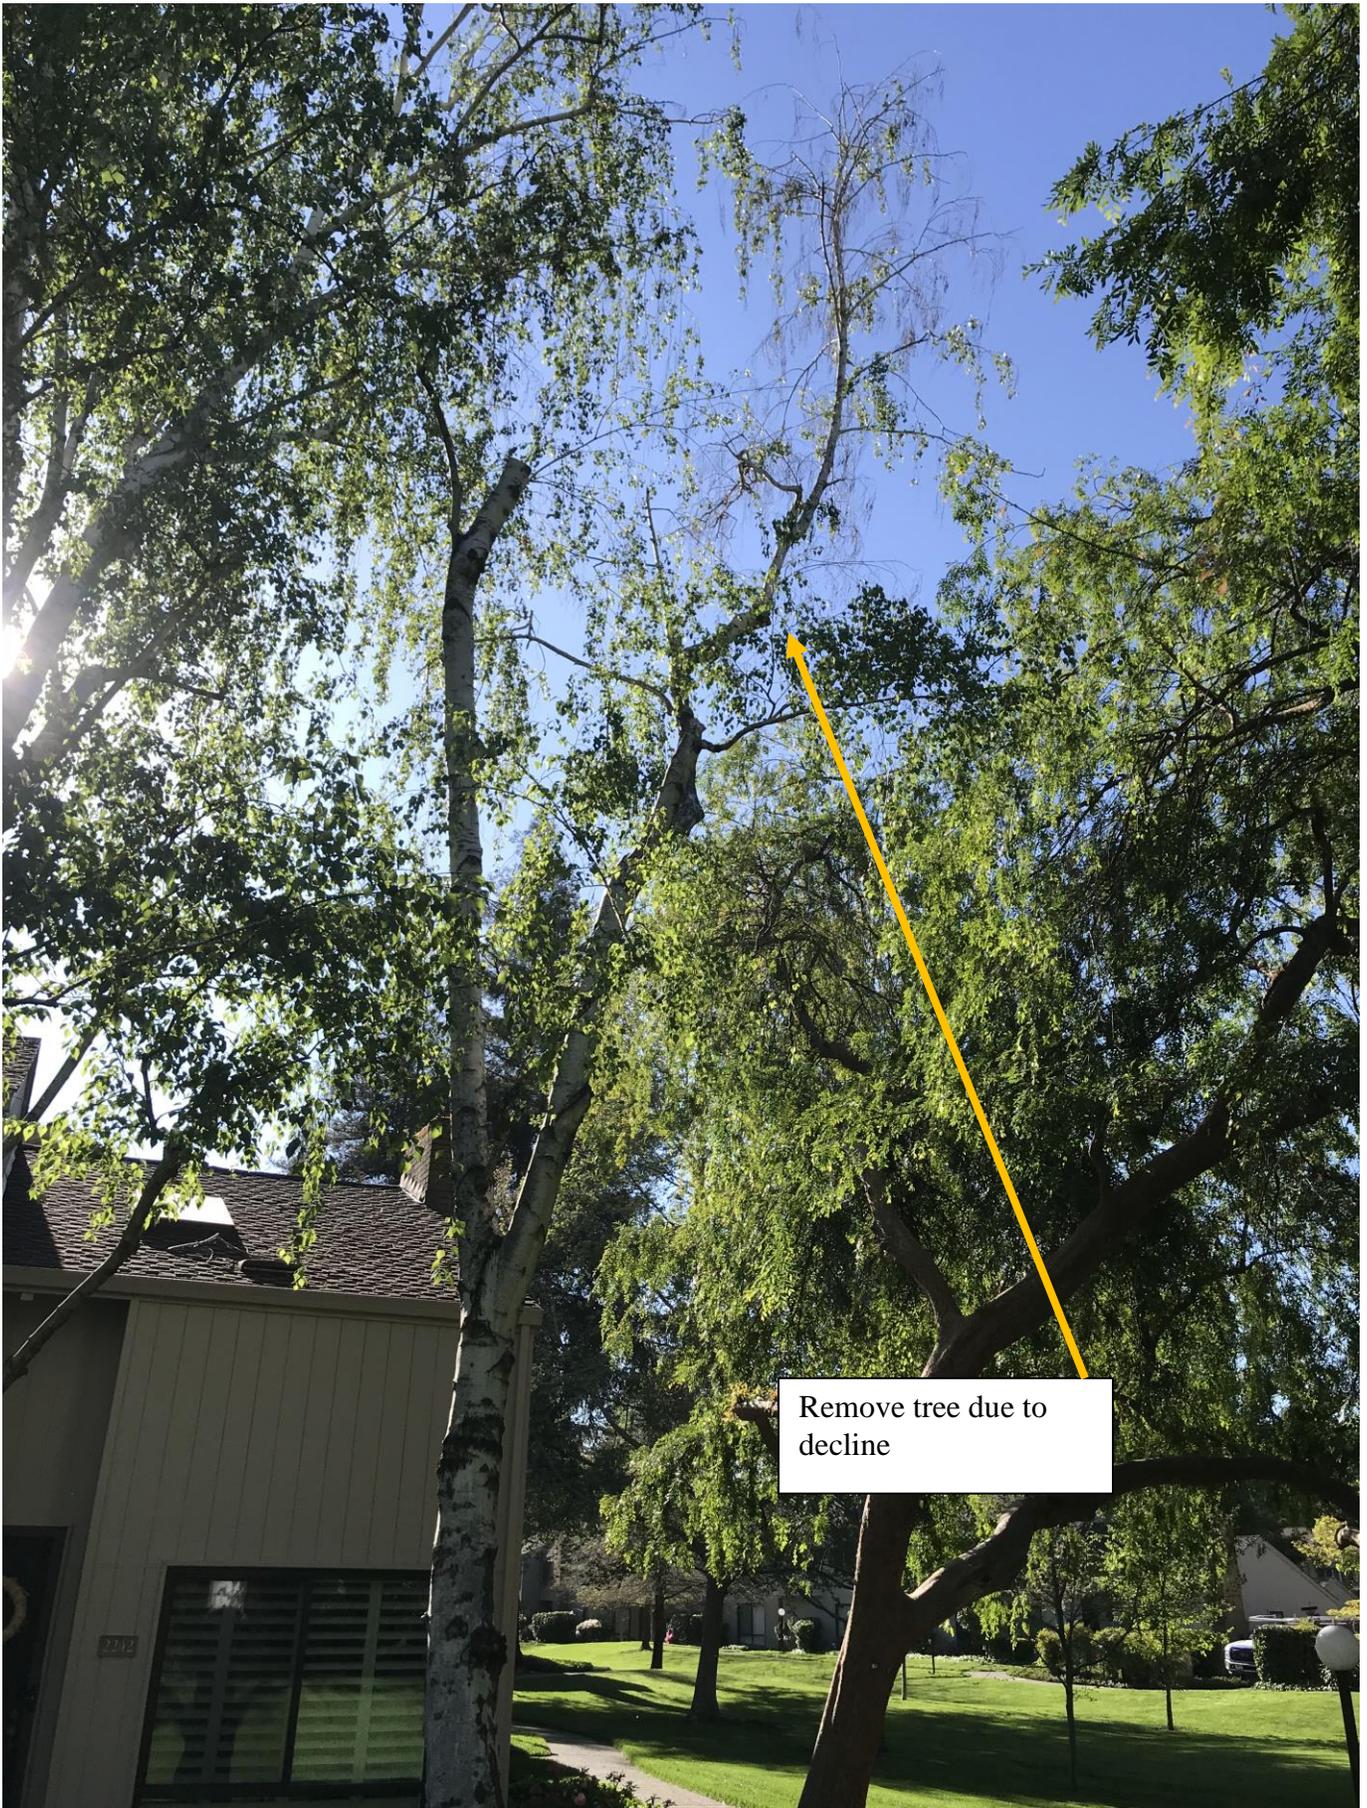
Figure 6

- (Zone 2) Tree # 530 Birch (*Betula pendula*) 2242 Swarthmore. Tree has been in decline for some time. (Figure 6) I recommend removal of this tree and replacement species of the ornamental variety.

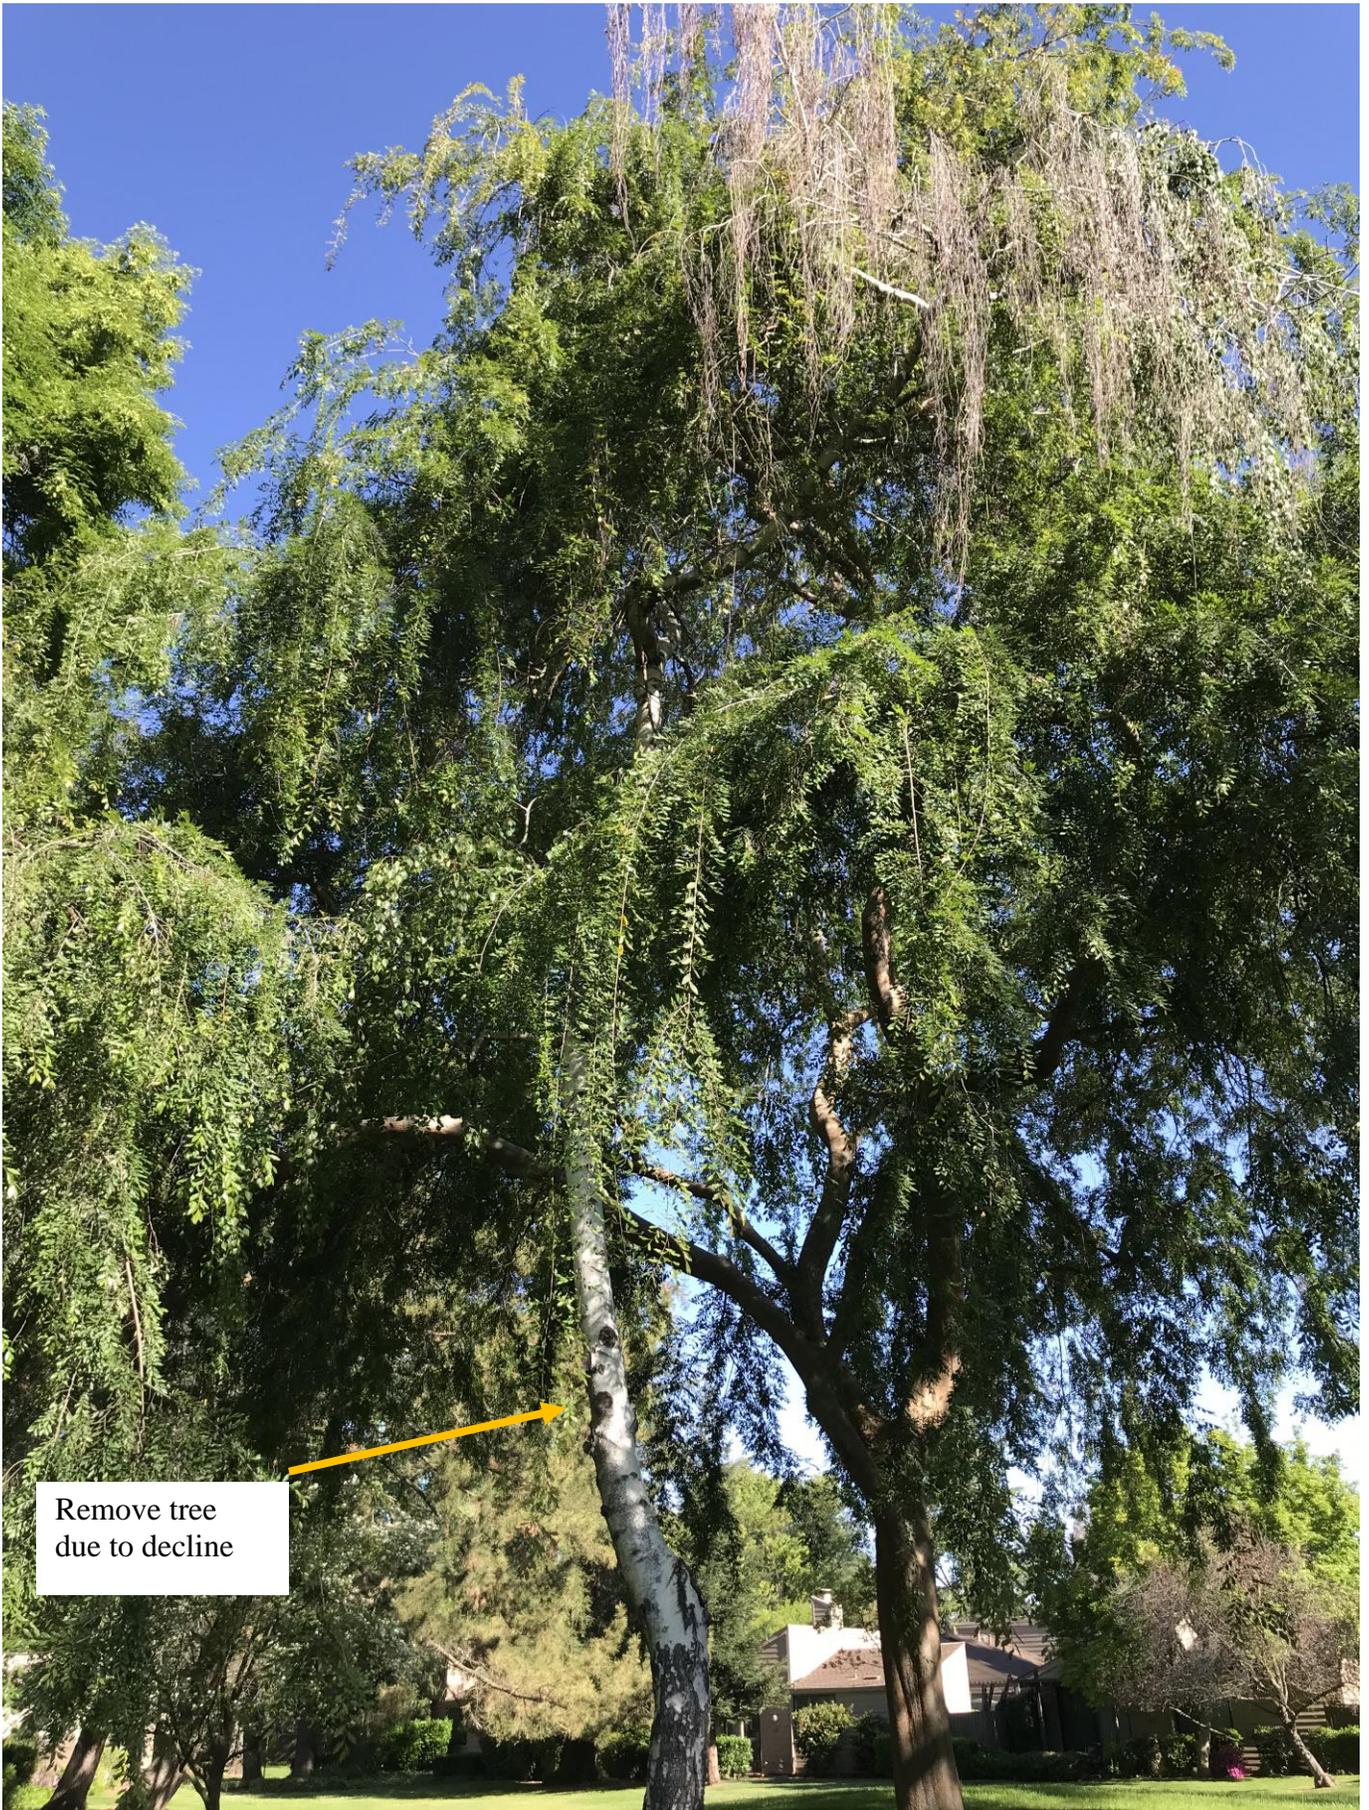
Figure 7

- (Zone 2) Tree # 532 Birch (*Betula pendula*) 2242 Swarthmore. (Figure 7) Tree has several open pockets of decay and has been in decline for some time. I recommend removal of this tree and replacement of a tree variety that is medium to large in size for the green belt area placed outside the dripline of the Elm in a better location

Remove tree
due to decline

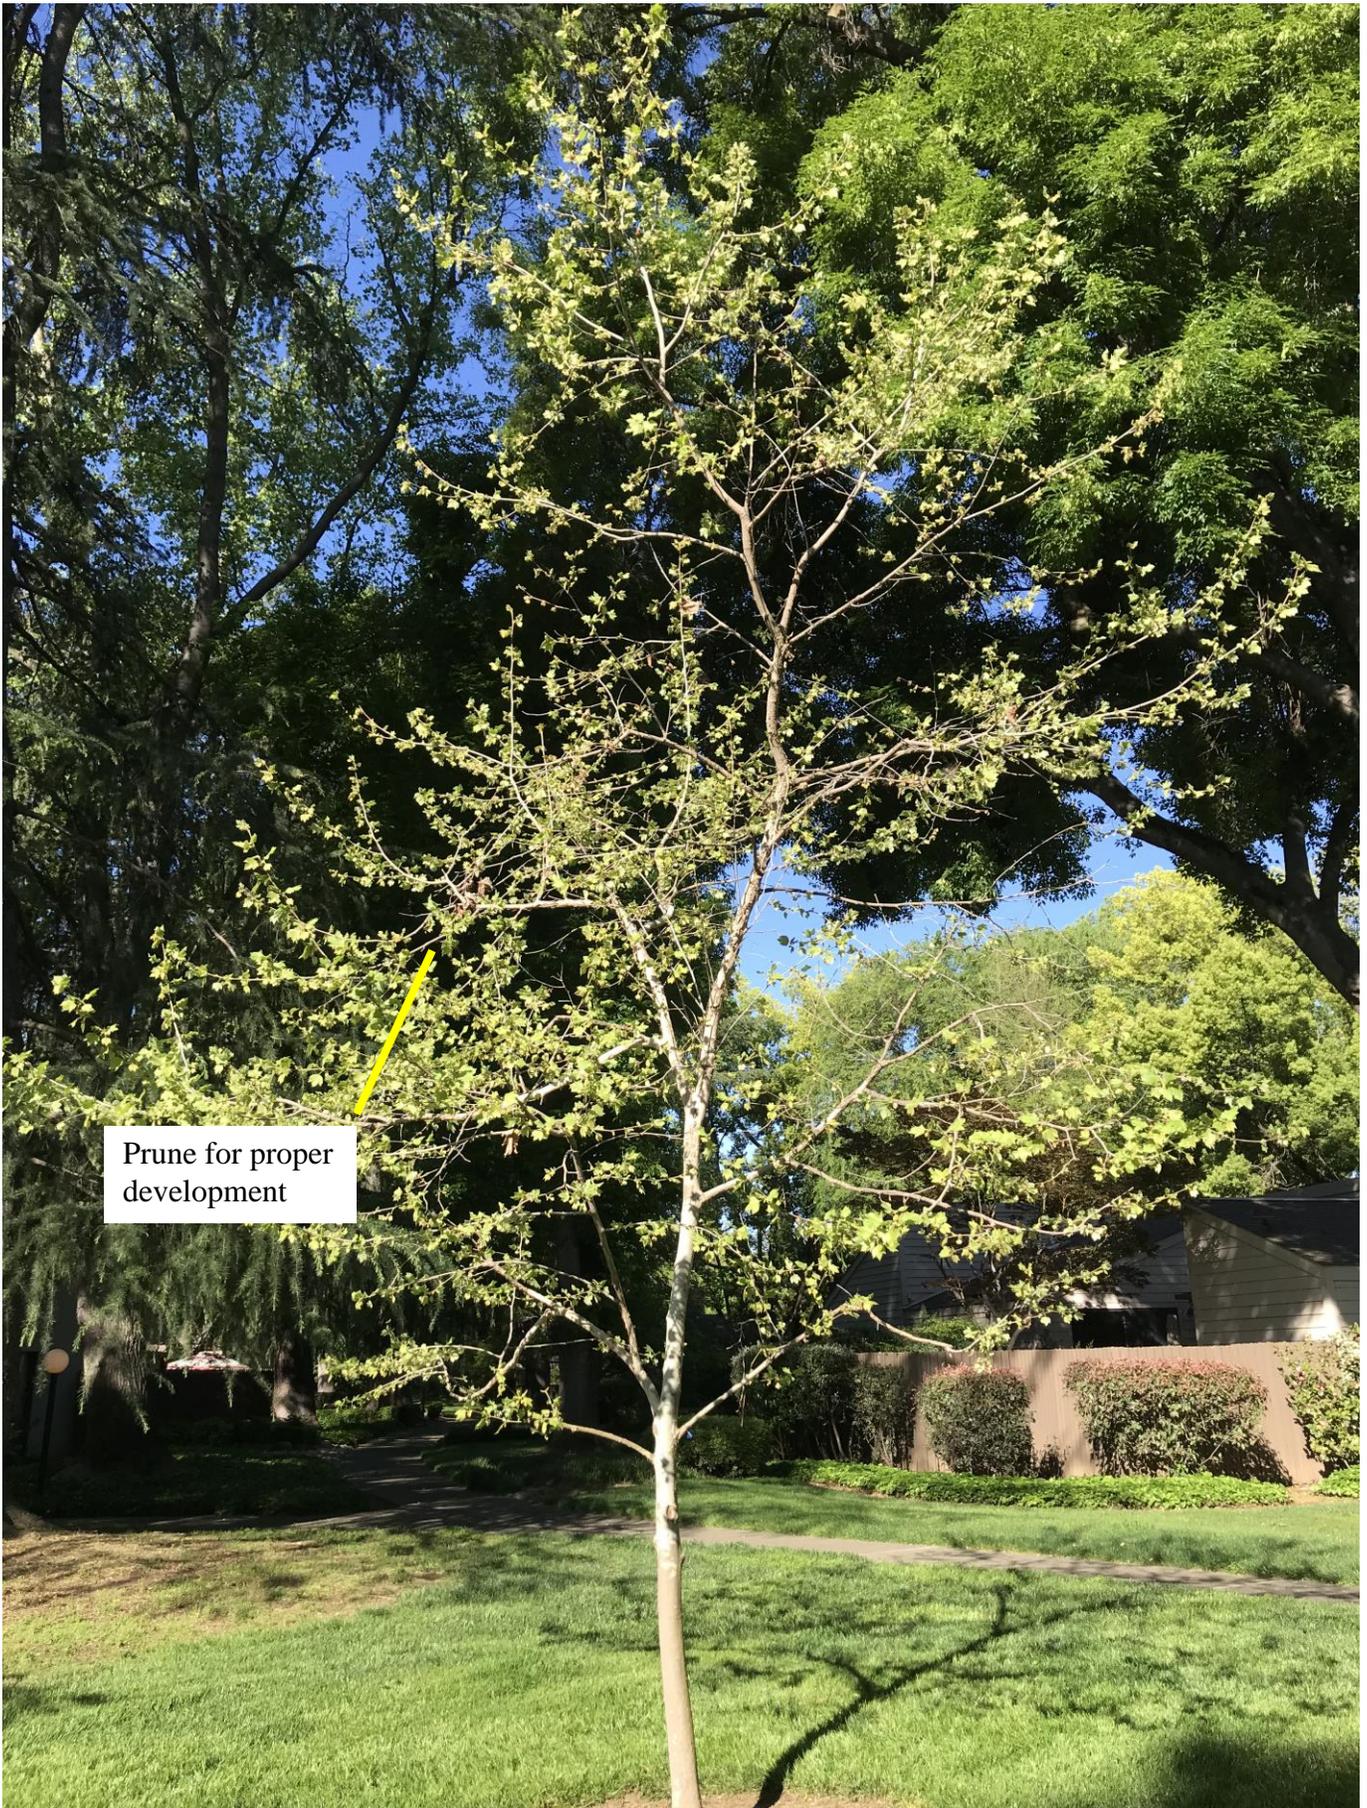
Figure 8

- (Zone 2) Tree #533 Sycamore (*Platanus acerifolia*) in greenbelt near 2242 Swarthmore Dr. (Figure 8) Young tree has need of structural pruning to encourage proper development

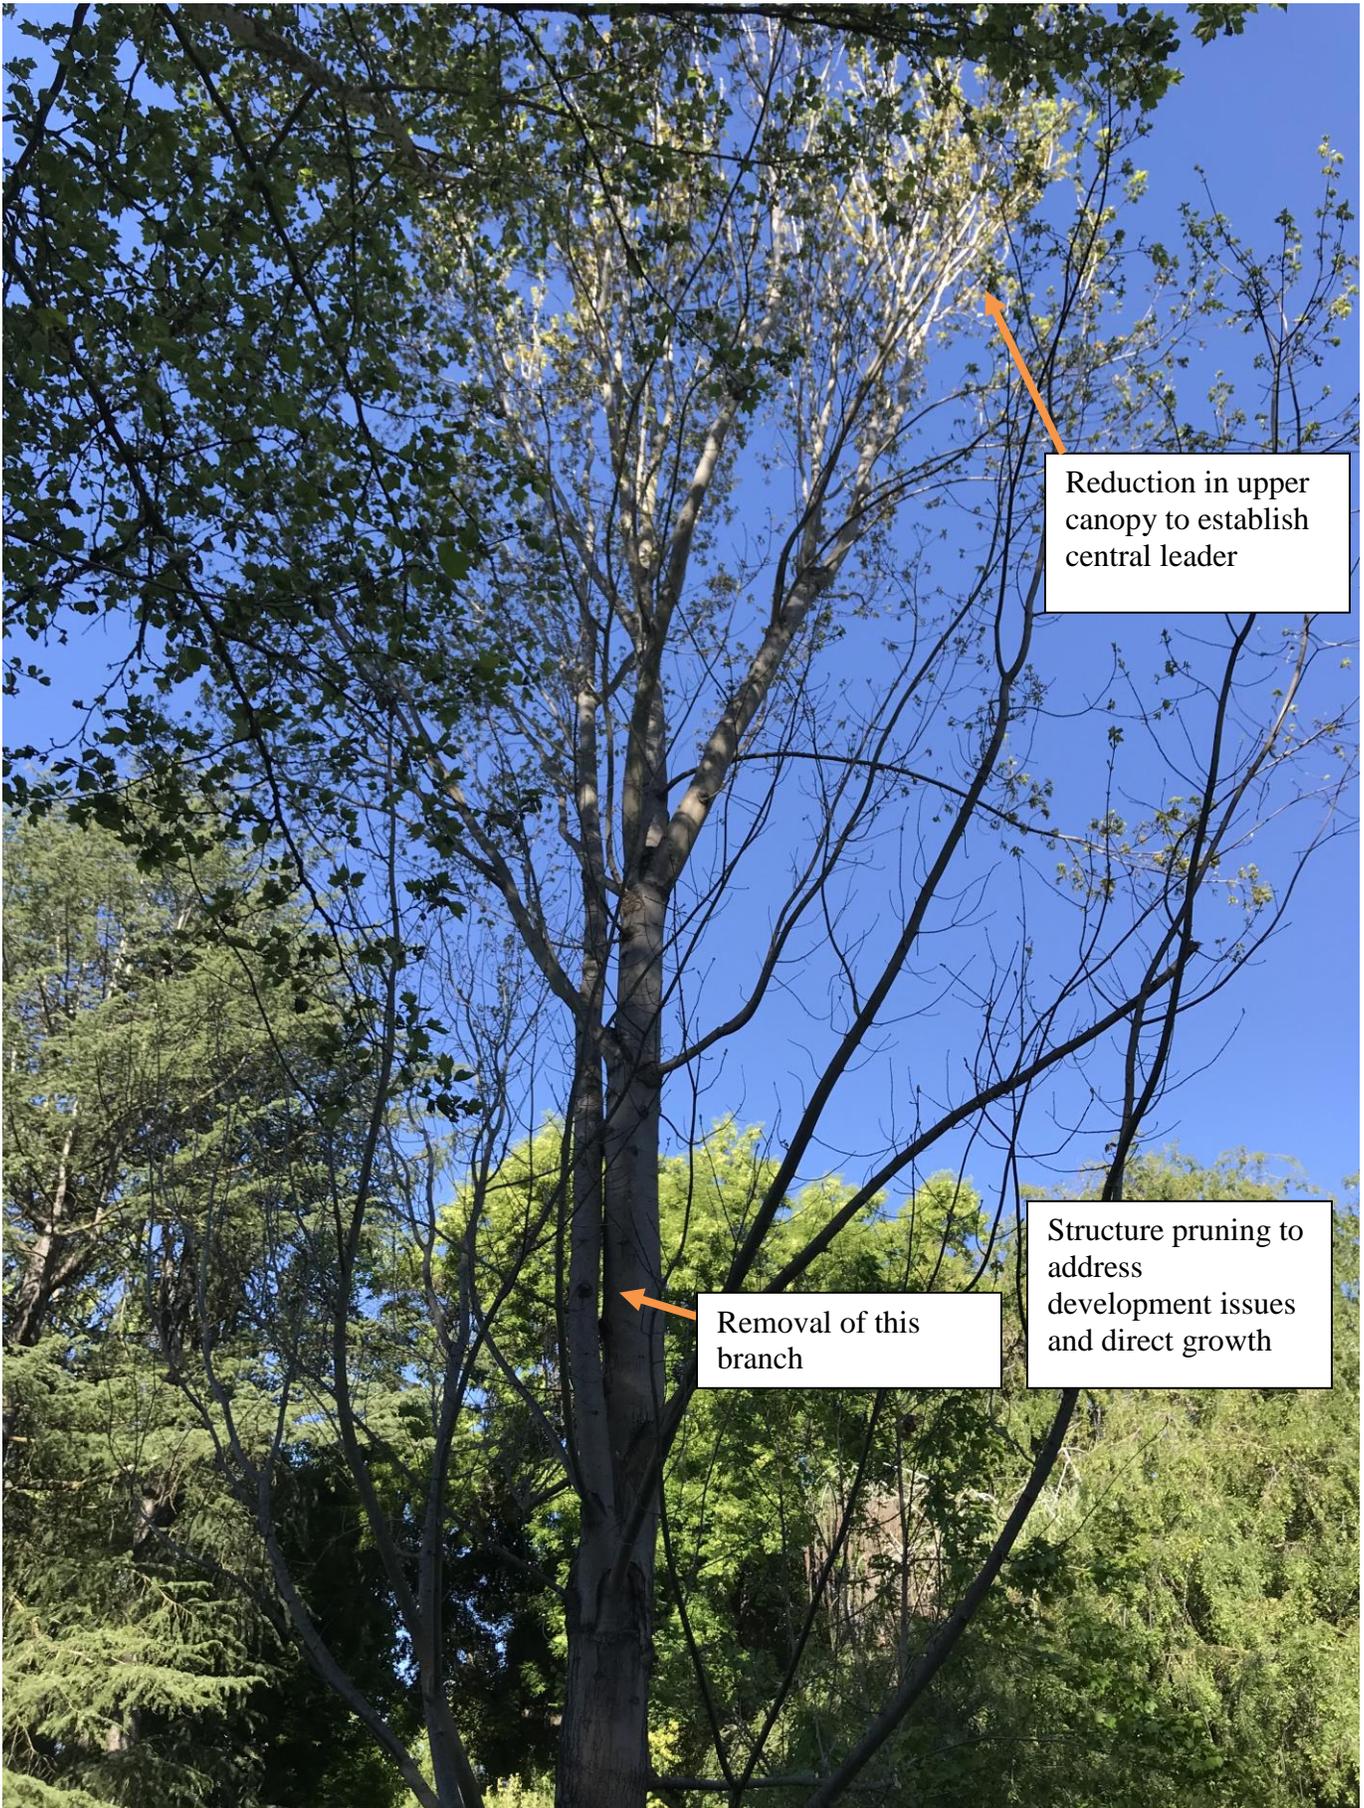
Figure 9

- (Zone 2) Tree # No Tag Maple (*Acer Rubrum*) in greenbelt near 2244 Swarthmore Dr. (Figure 9) The tree has need for structural pruning to thin out canopy of overgrowth and to establish healthy branching. The pruning will remove a large branch growing up through the canopy that is causing damage from rubbing on the main trunk. As well as selective reduction cuts in upper canopy to encourage a central leader. The pruning will look aggressive for a while until the tree responds to the pruning.

Reduction in upper canopy to establish central leader

Removal of this branch

Structure pruning to address development issues and direct growth

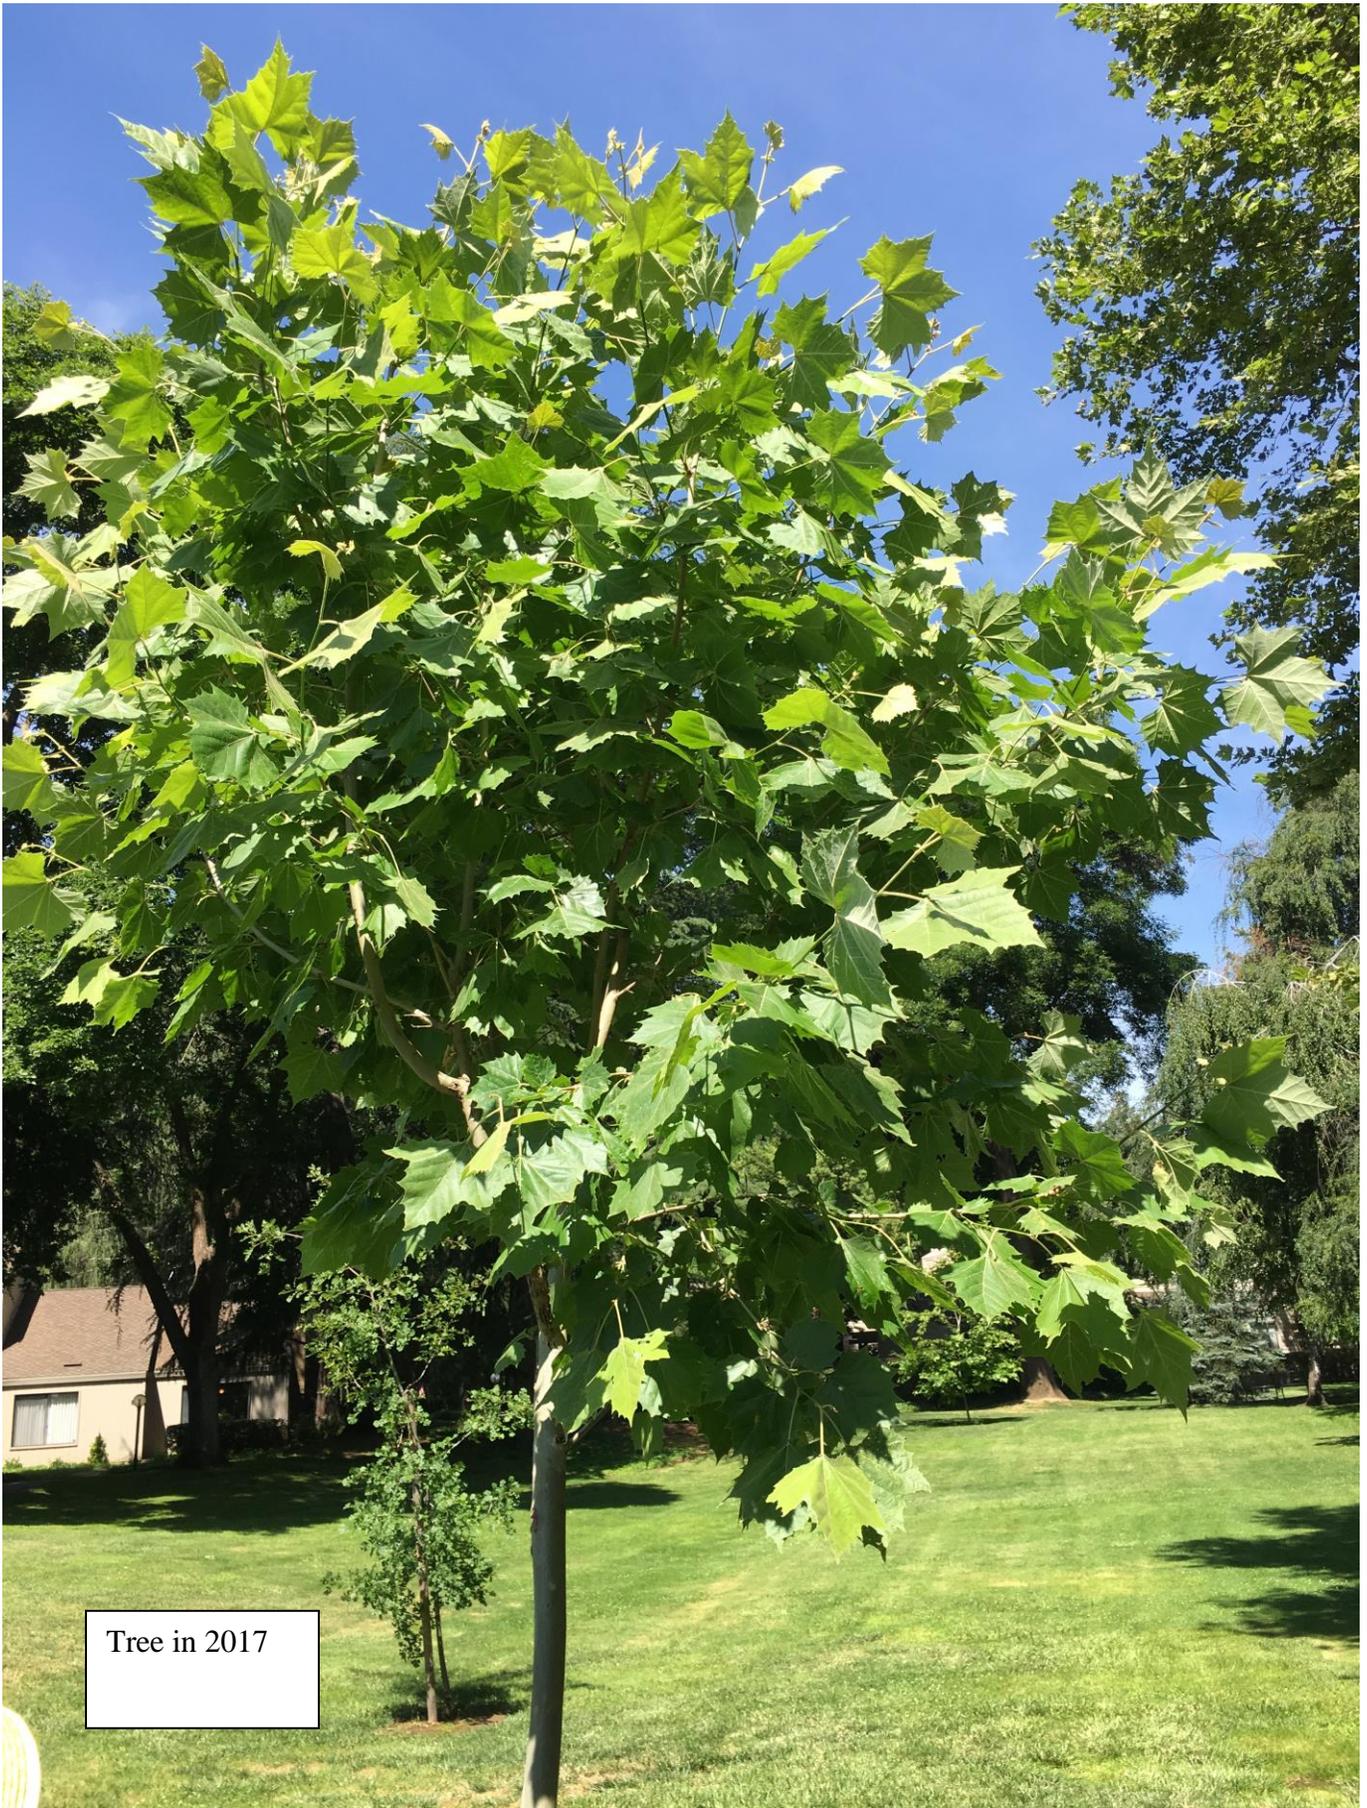
Figure 10

- (Zone 2) No Tag Sycamore (*Platanus acerifolia*) in greenbelt near 2250 Swarthmore Dr. This tree we have been pruning to encourage proper structure and development. (Figure 10, Tree in 2017) the tree had very little form, (Figure 11, Tree 2020) we can see the efforts of the pruning and the tree is now developing correctly. Further pruning to train the tree growth is recommended.

Tree in 2017

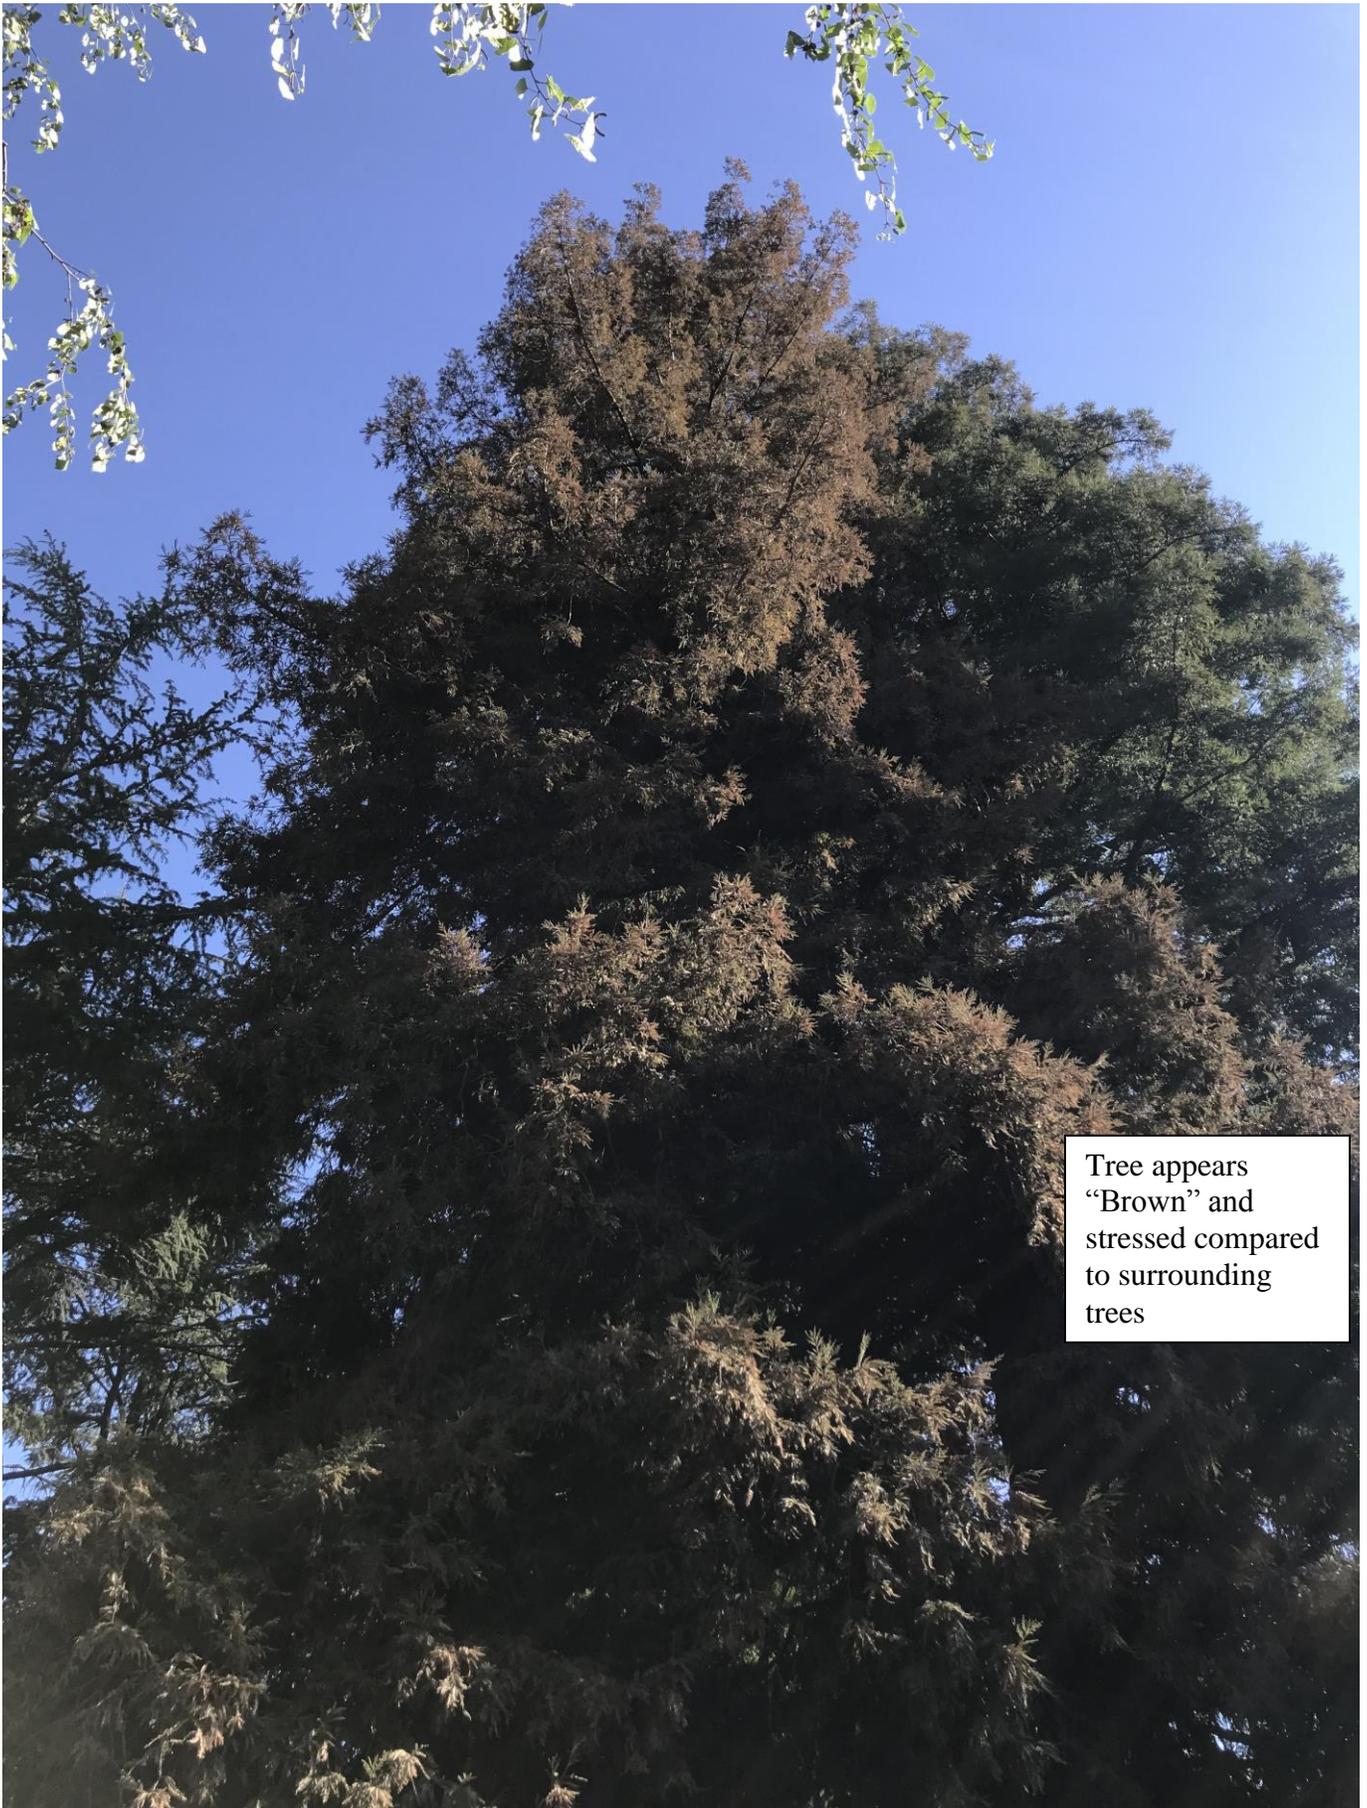
Figure 12

- (Zone 2) Tree #482 Redwood (*Sequoia sempervirens*) next to 2276 Swarthmore Dr. (Figure 12-13). I reviewed the tree in 2019 and it then looked to have been exposed to herbicide by the discoloration pattern of the needles as well as the dieback of new growth. Monitoring this tree again this year there are signs of new growth, however there also appears to have a bacterial needle blight issue that may be brought on due to stress and seasonal moisture. I will continue to monitor this tree. The tree will be added to the list of trees to receive the deep root water during the summer.

Tree appears
“Brown” and
stressed compared
to surrounding
trees
