April 15, 2020

The Nepenthe Association
Bettsi Ledesma
1131 Commons Dr.
Sacramento, CA 95825
Phone: (916) 929-8380
Email: Bettsi.Ledesma@fsresidential.com

On April 15, 2020, I inspected several trees on the Nepenthe property during the monthly tree walk. The focus of the walk was to address resident/management concerns regarding mature trees on the property. The purpose of this report is to develop mitigation plans for the following trees and my recommendations are below. My recommendations are based on a Basic Visual Inspection. All decisions made based on the recommendations of this report are at the discretion of the Nepenthe Association.

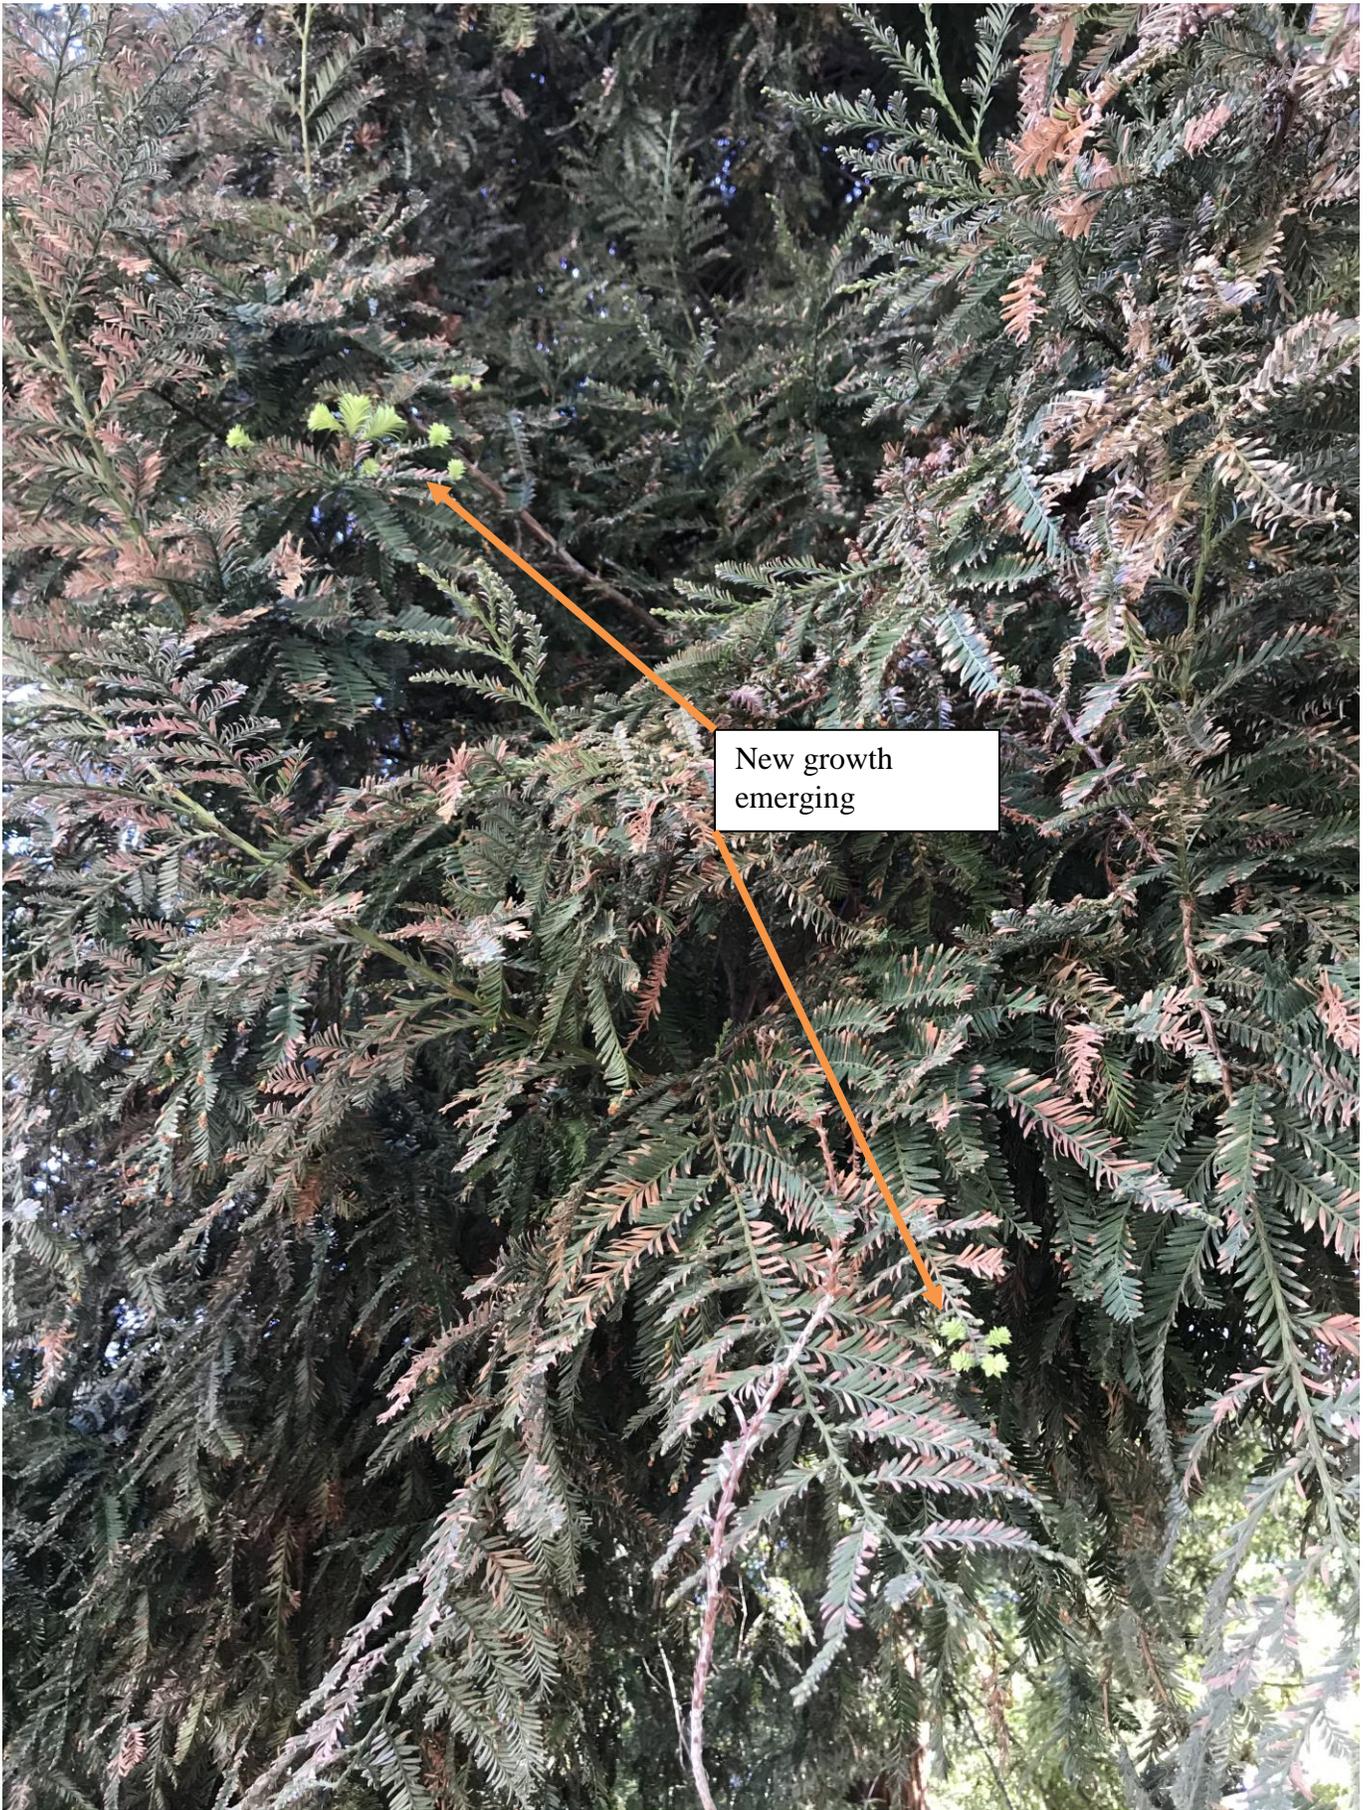
Figure 13

- (Zone 2) Tree #482 Redwood (*Sequoia sempervirens*) next to 2276 Swarthmore Dr. (Figure 12-13). I reviewed the tree in 2019 and it then looked to have been exposed to herbicide by the discoloration pattern of the needles as well as the dieback of new growth. Monitoring this tree again this year there are signs of new growth, however there also appears to have a bacterial needle blight issue that may be brought on due to stress and seasonal moisture. I will continue to monitor this tree. The tree will be added to the list of trees to receive the deep root water during the summer.

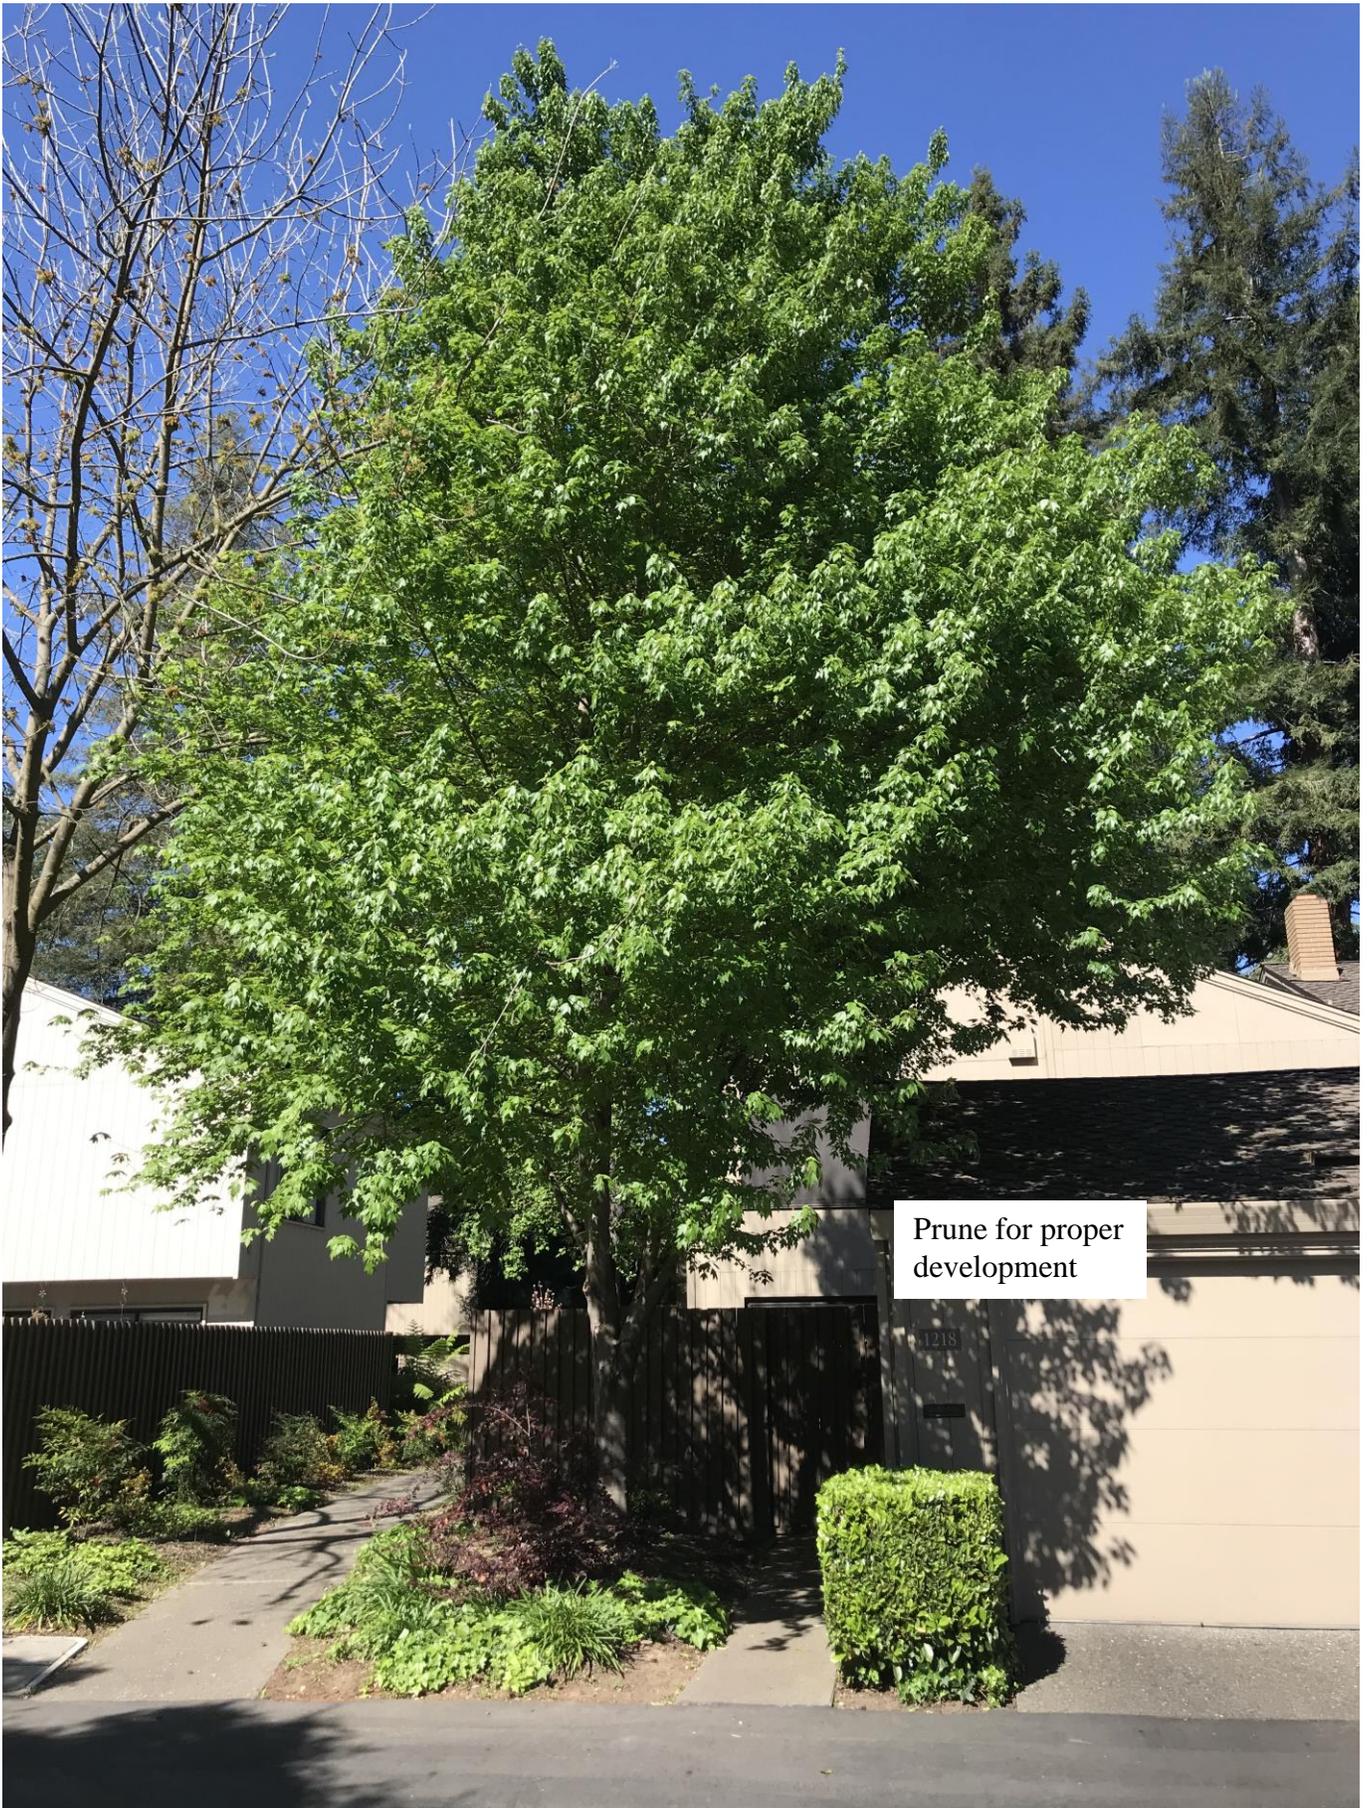
Figure 14

- (Zone 2) Tree #No Tag, Trident Maple (*Acer buergerianum*), next to 1218 Swarthmore Dr. (Figure 14). Young tree has need of structural pruning to thin out canopy of overgrowth and to establish healthy branching.

Prune for proper
development

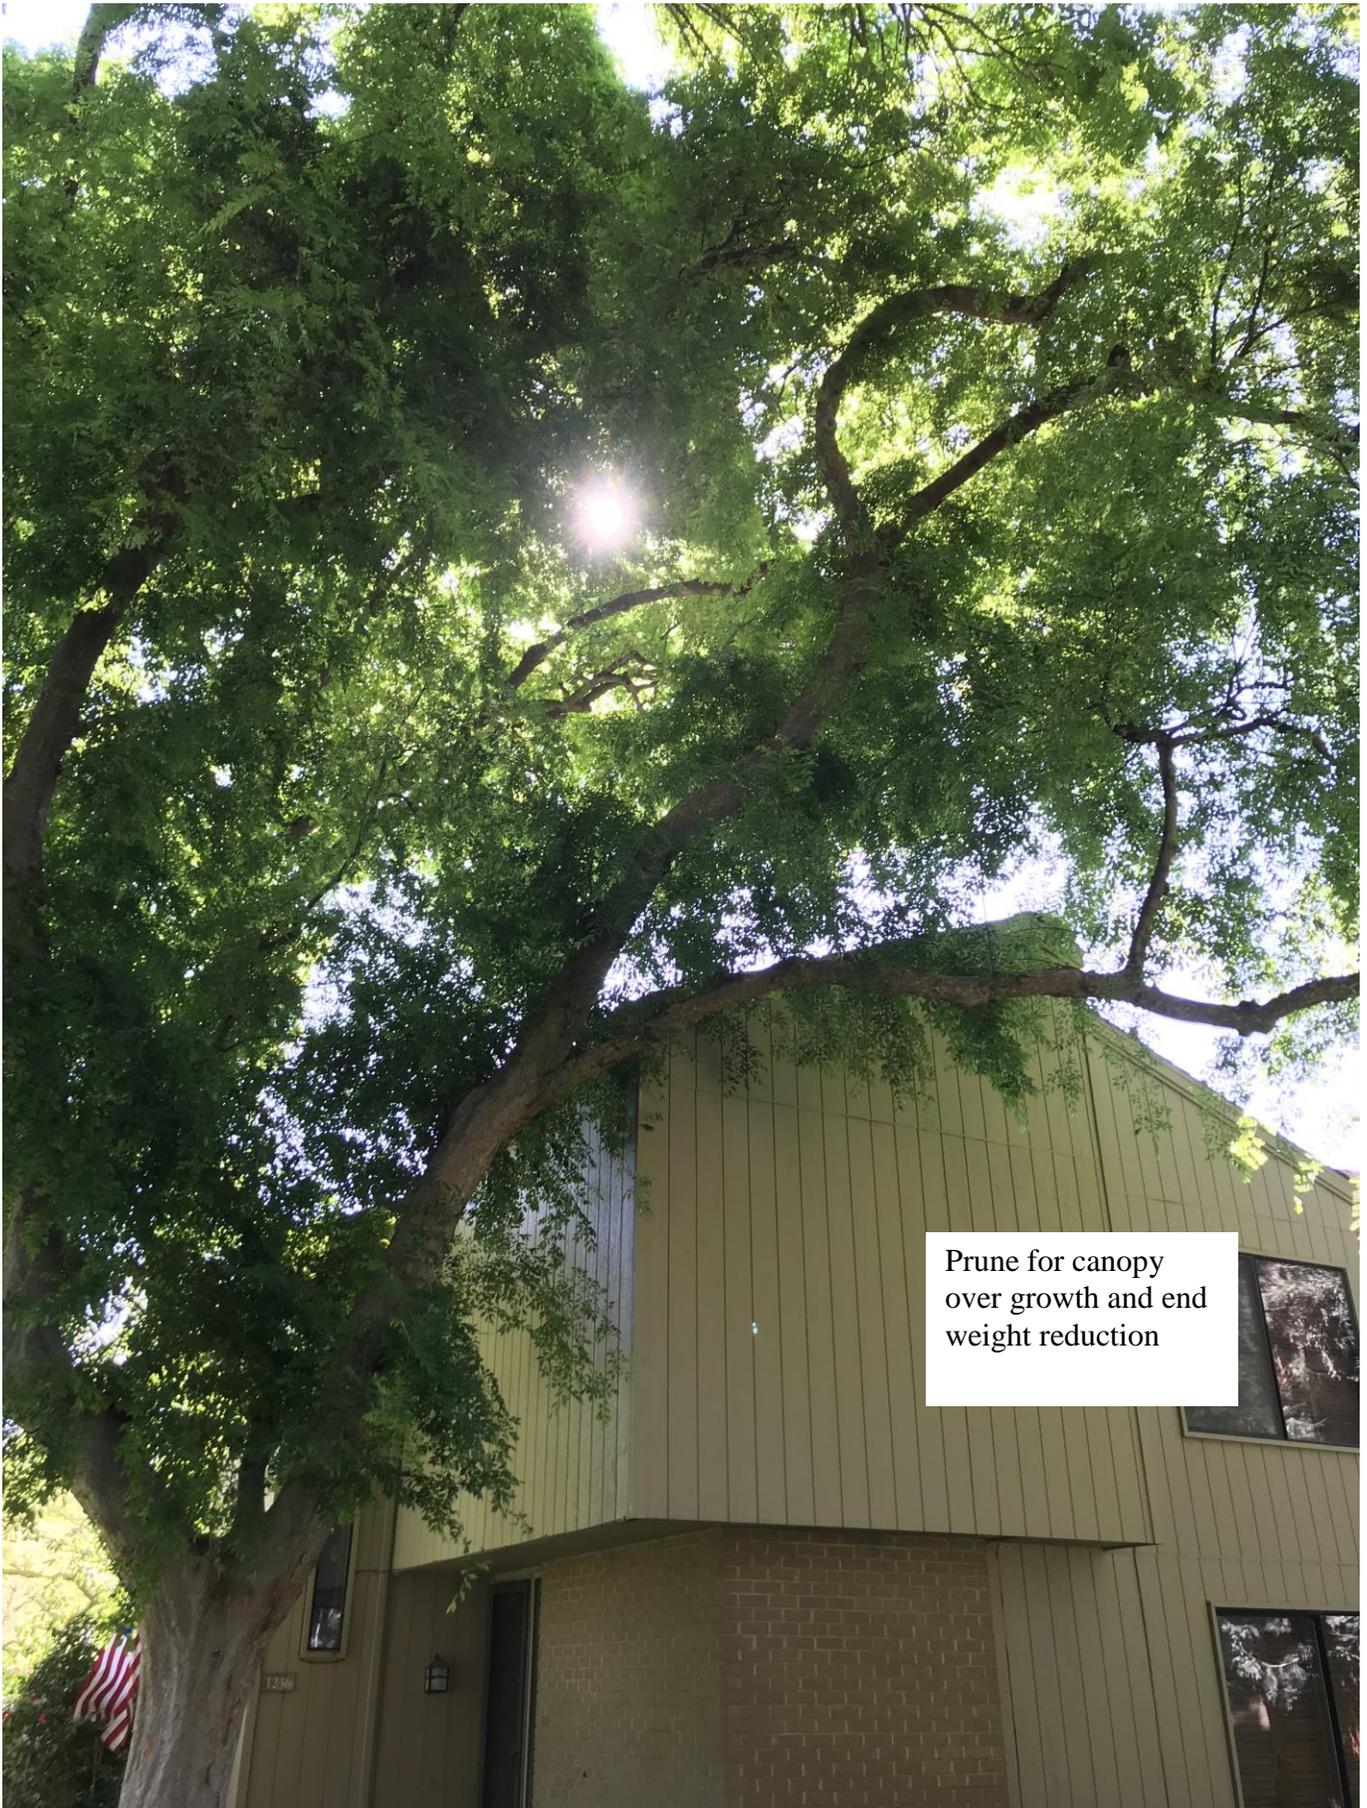
Figure 15

- (Zone 2) Trees #538 Elm (*Ulmus parvifolia*), next to 1236 Commons Dr. Tree has need of pruning to thin out canopy of overgrowth weight reduction and to establish healthy branching (Figure 15).

Prune for canopy
over growth and end
weight reduction

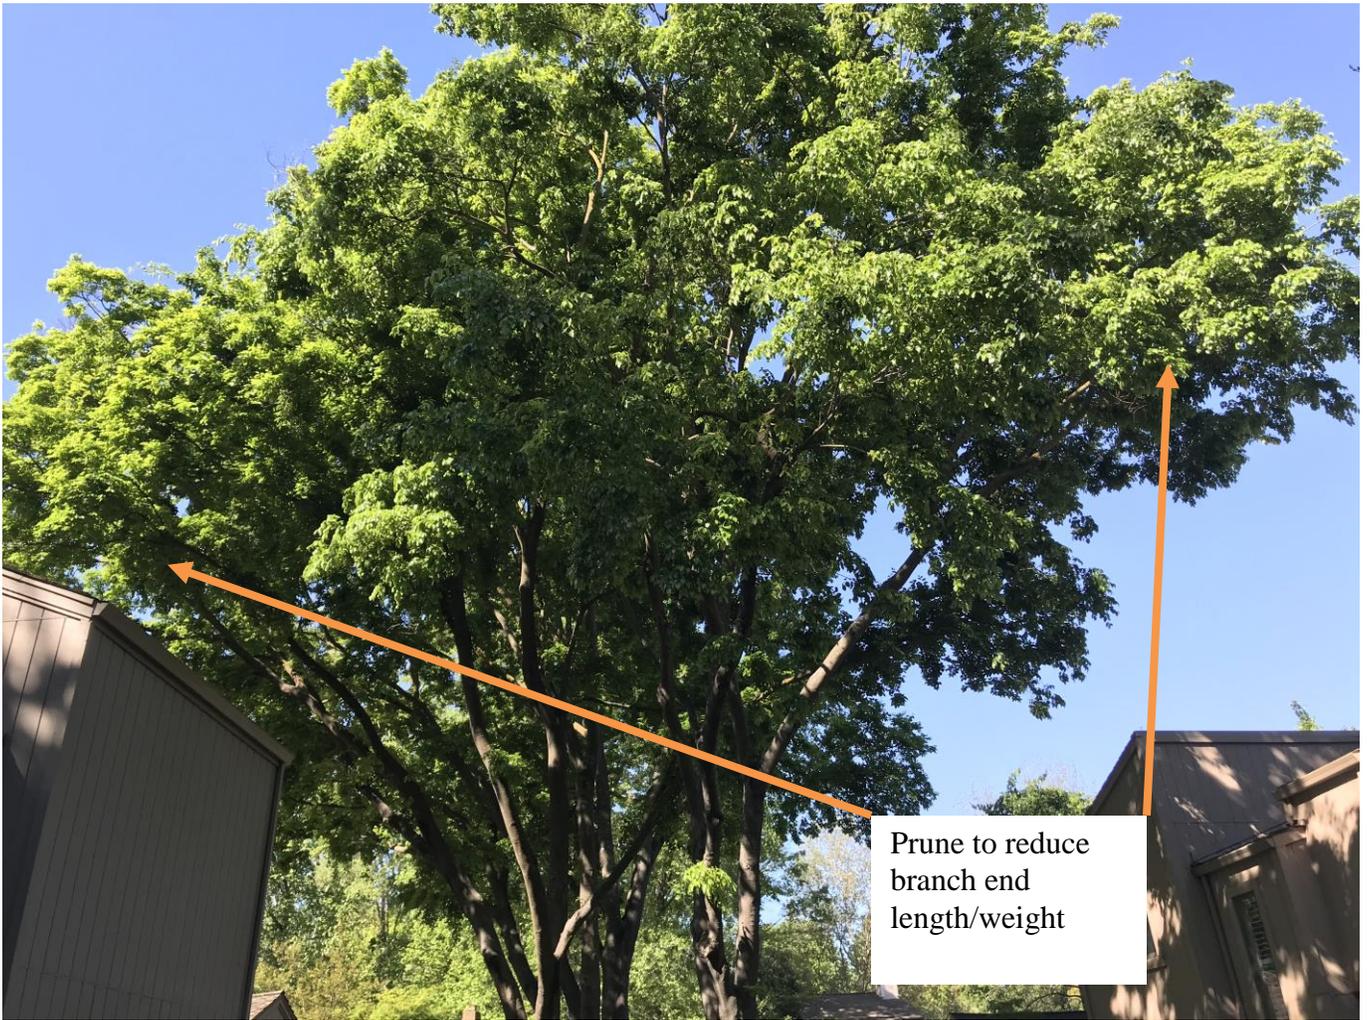
Figure 16

- (Zone 2) Trees #657,658,659 Chinese Hackberry (*Celtis sinensis*) next to 1026 Vanderbilt Way (Figure 16). Trees have large inclusions in main branching attachments. In 2017 one of the trees was in process of failure (Figure 17). We pruned the trees for weight reduction to prevent the full removal and we monitor these trees each year. The old wound has healed over as a result of the pruning and monitoring (Figure 18) I recommend further branch end reduction pruning on these trees to alleviate pressure on the inclusions and to continue to monitor these trees.

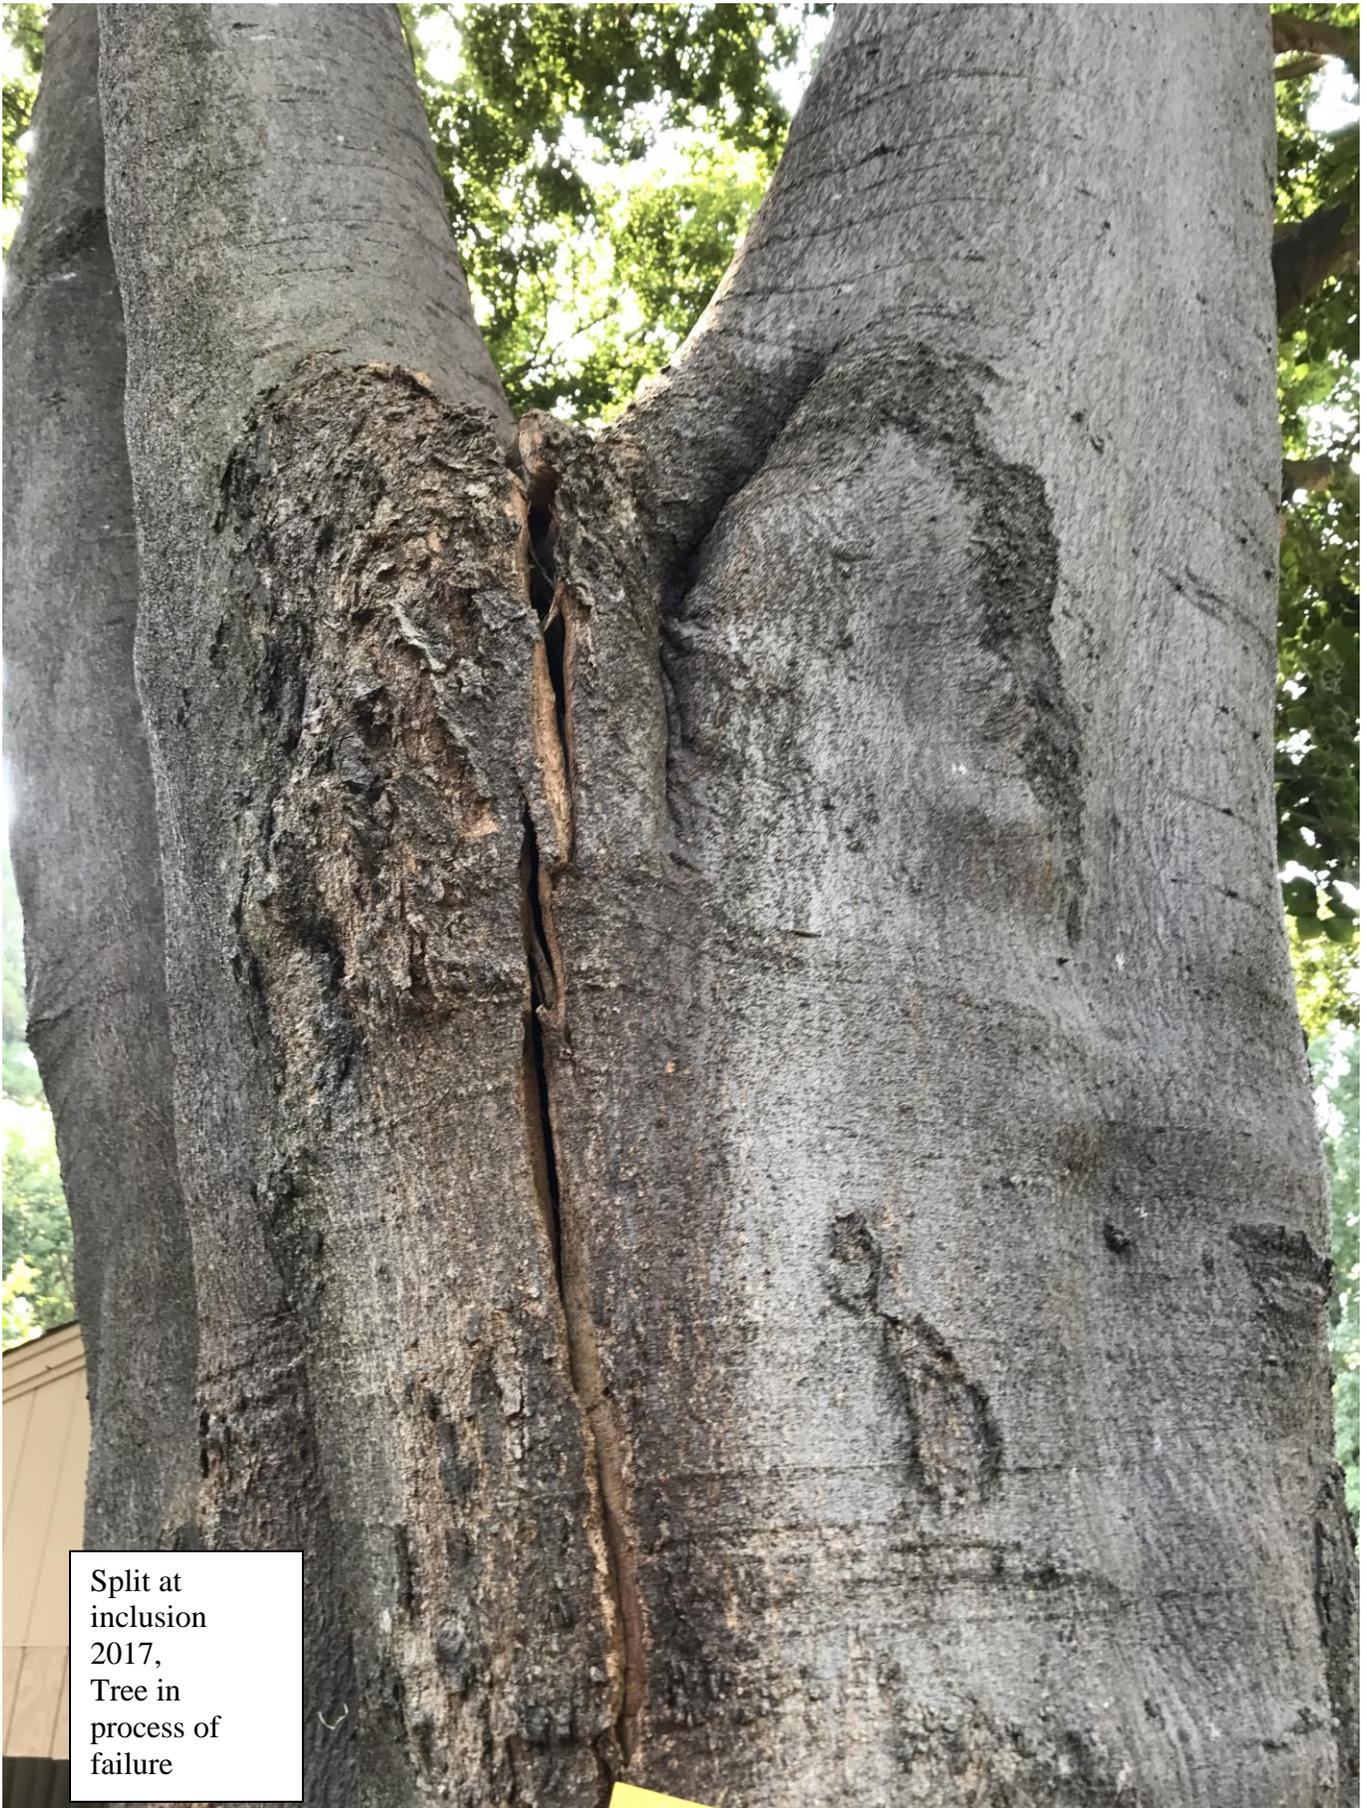
Figure 17

Split at
inclusion
2017,
Tree in
process of
failure

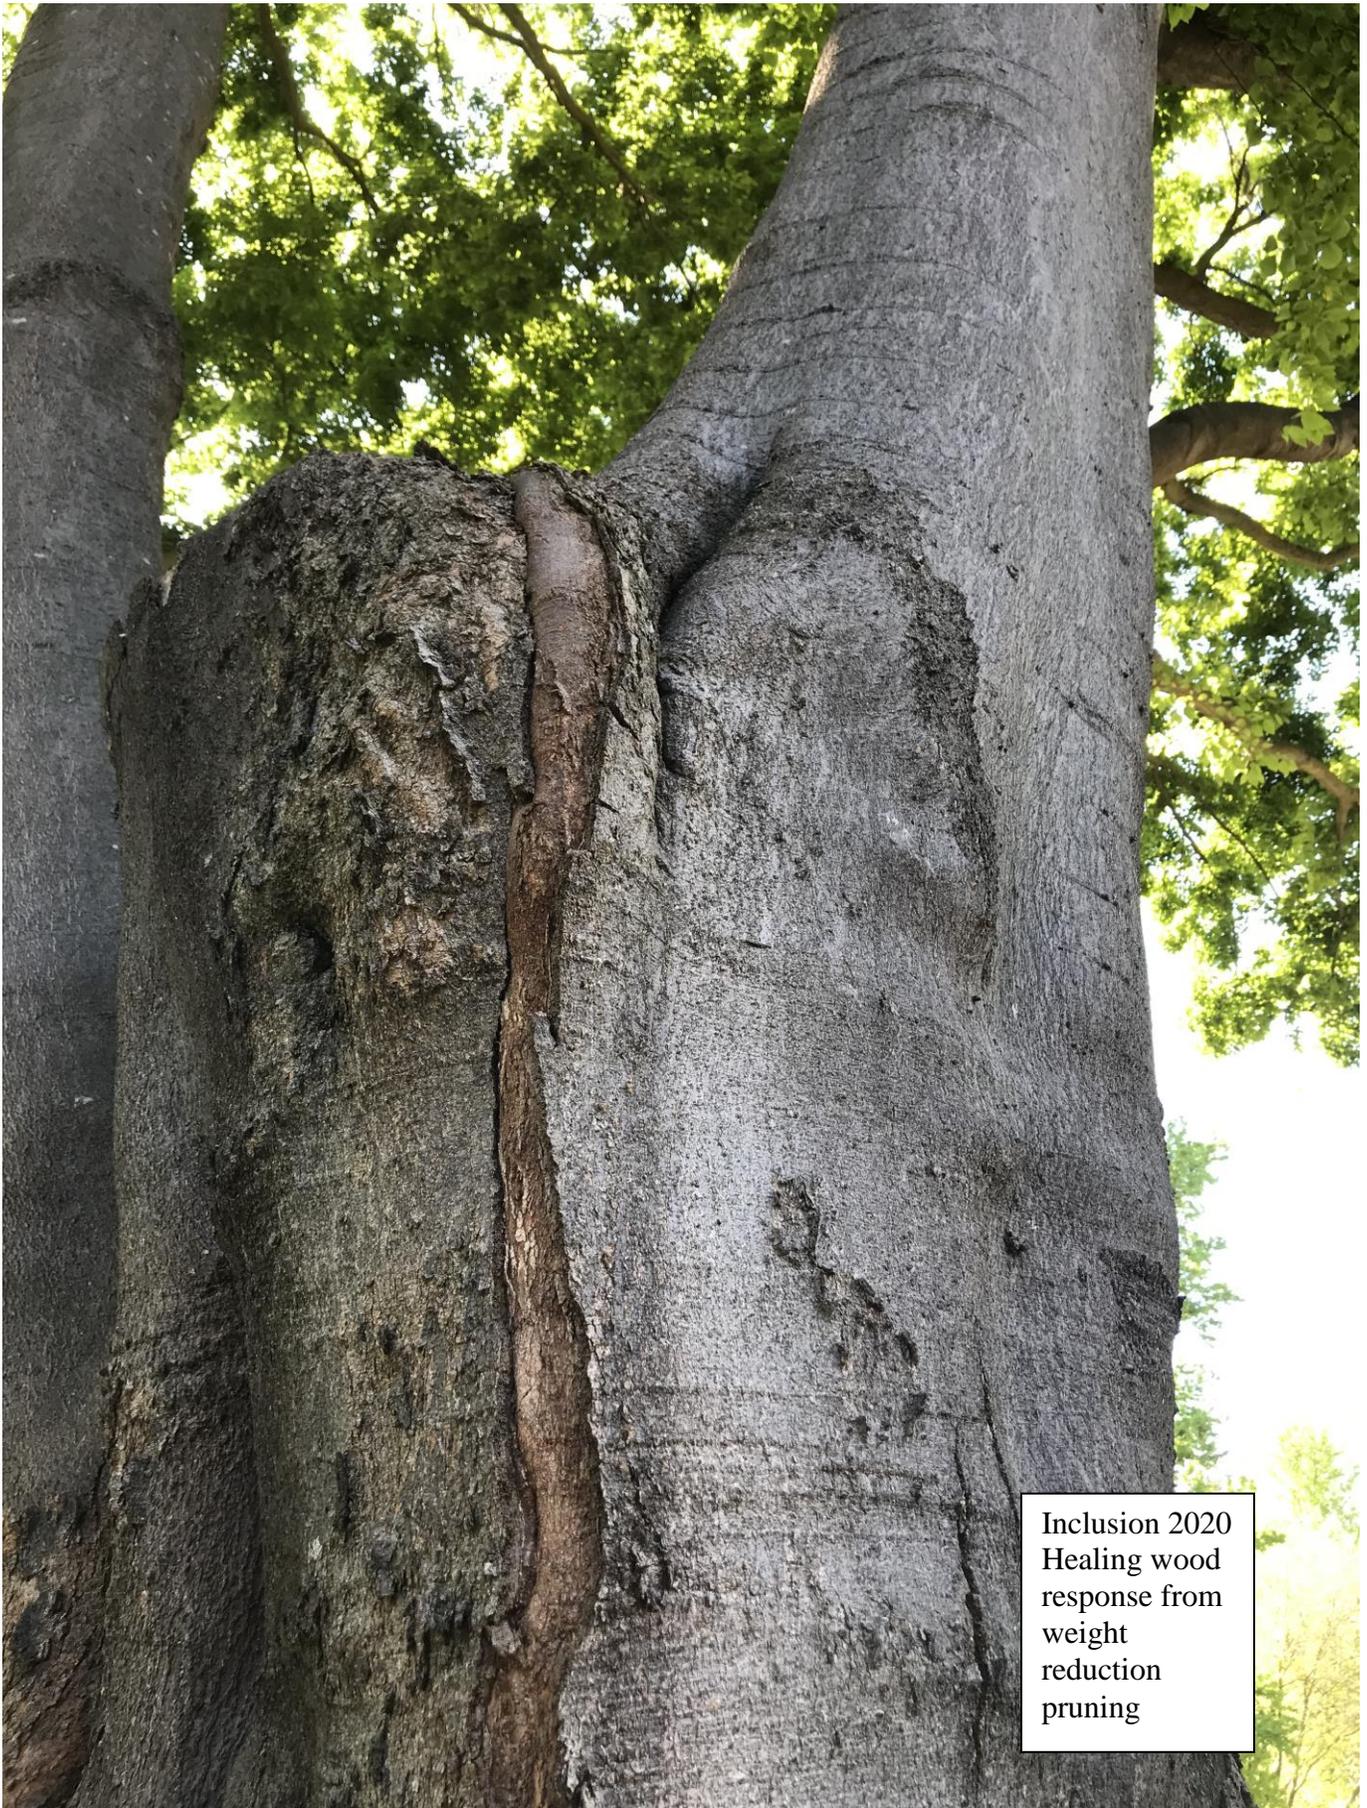
Figure 18

Inclusion 2020
Healing wood
response from
weight
reduction
pruning

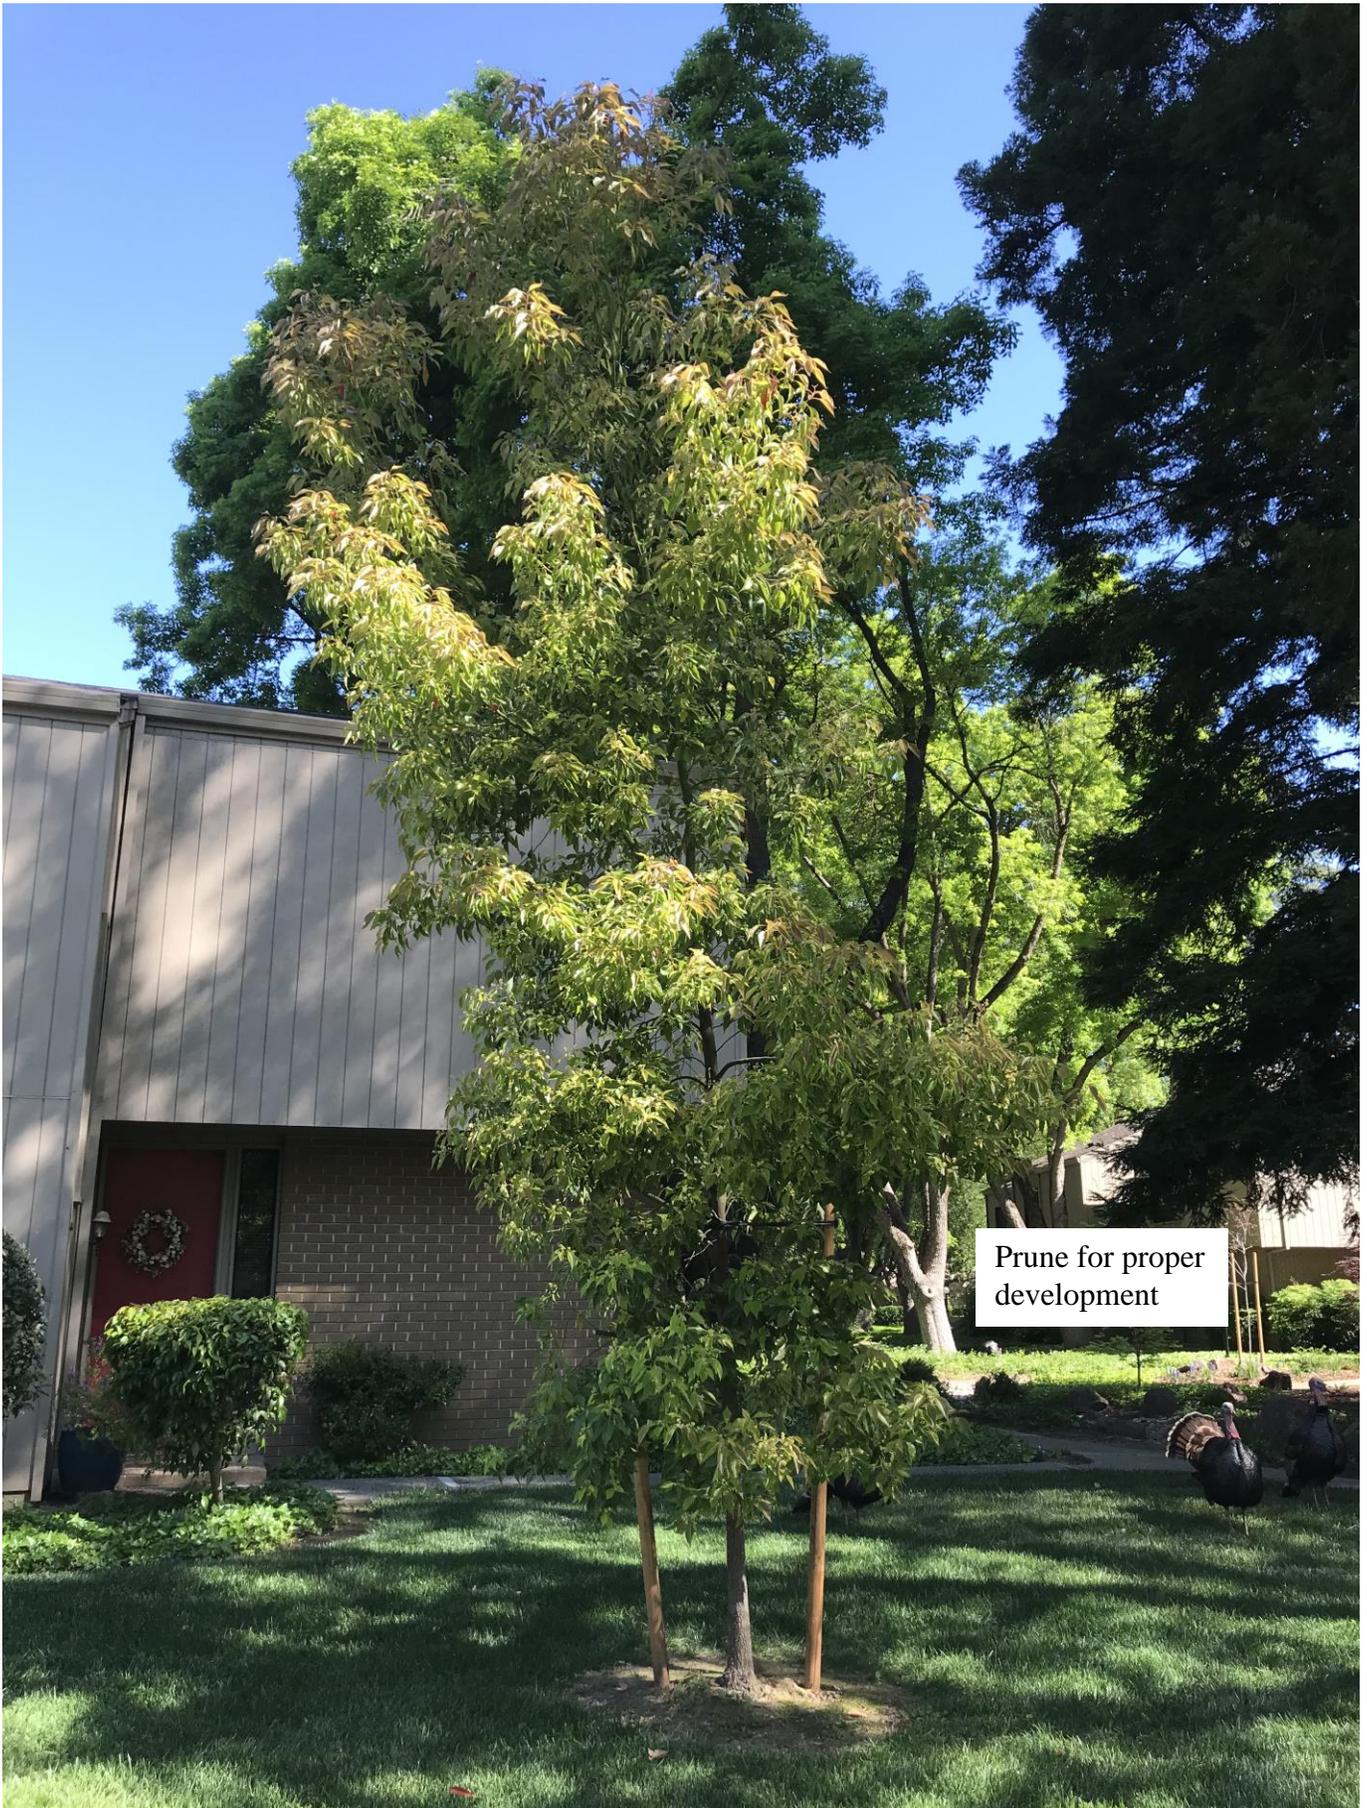
Figure 19

- (Zone 2) Tree #No Tag Camphor (*Cinnamomum camphora*) next to 1066 Vanderbilt Way. (Figure 19) New planting. Young tree need structural pruning to encourage proper development

Pruning to thin out the canopy of overgrowth and establish healthy branching.

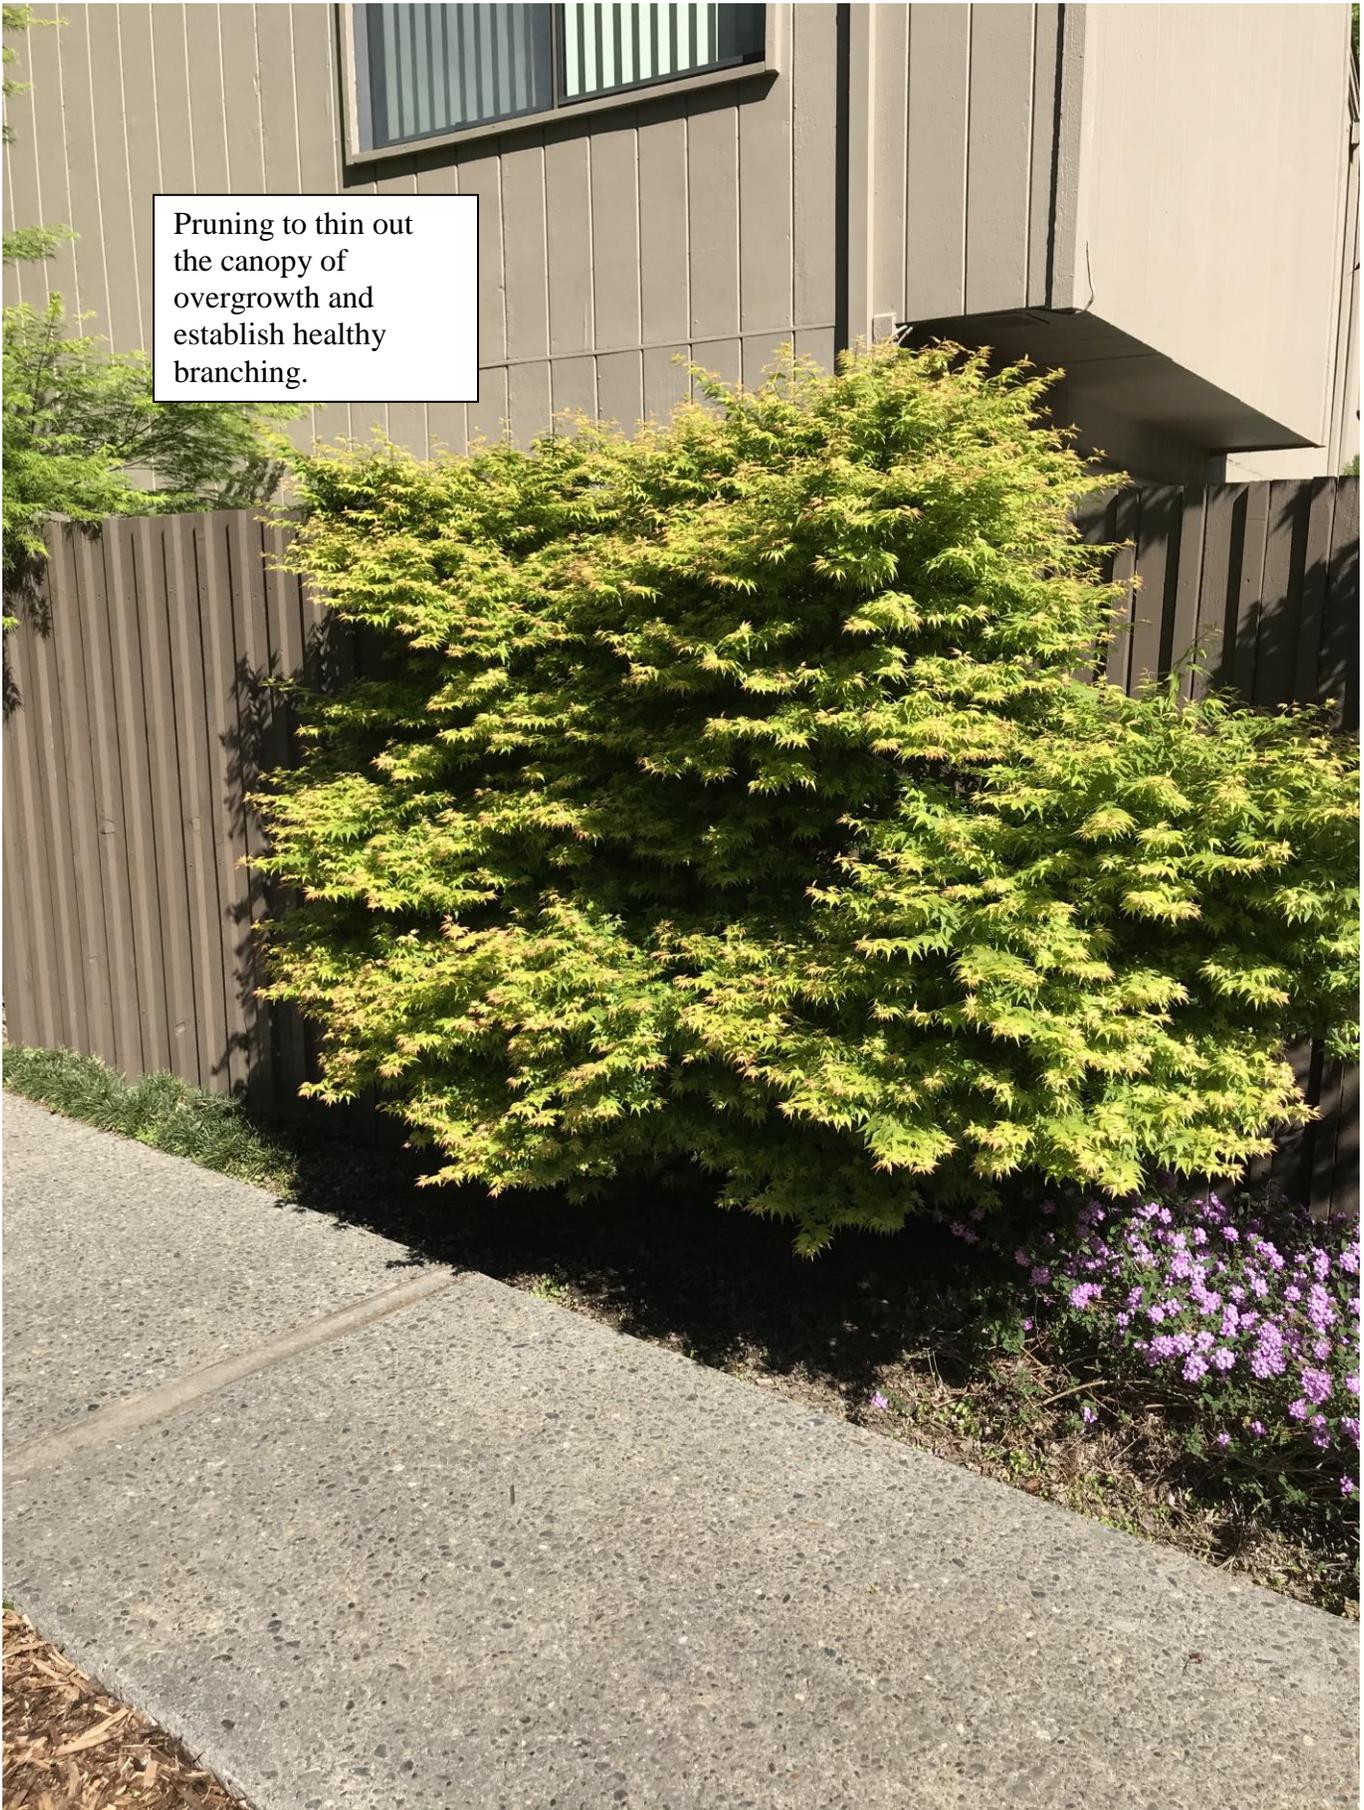
Figure 20

- (Zone 2) Tree #No Tag Maple (*Acer rubrum*) next to 1118 Commons Dr. (Figure 20) Young tree has need of structural pruning to thin out canopy of overgrowth and to establish healthy branching.

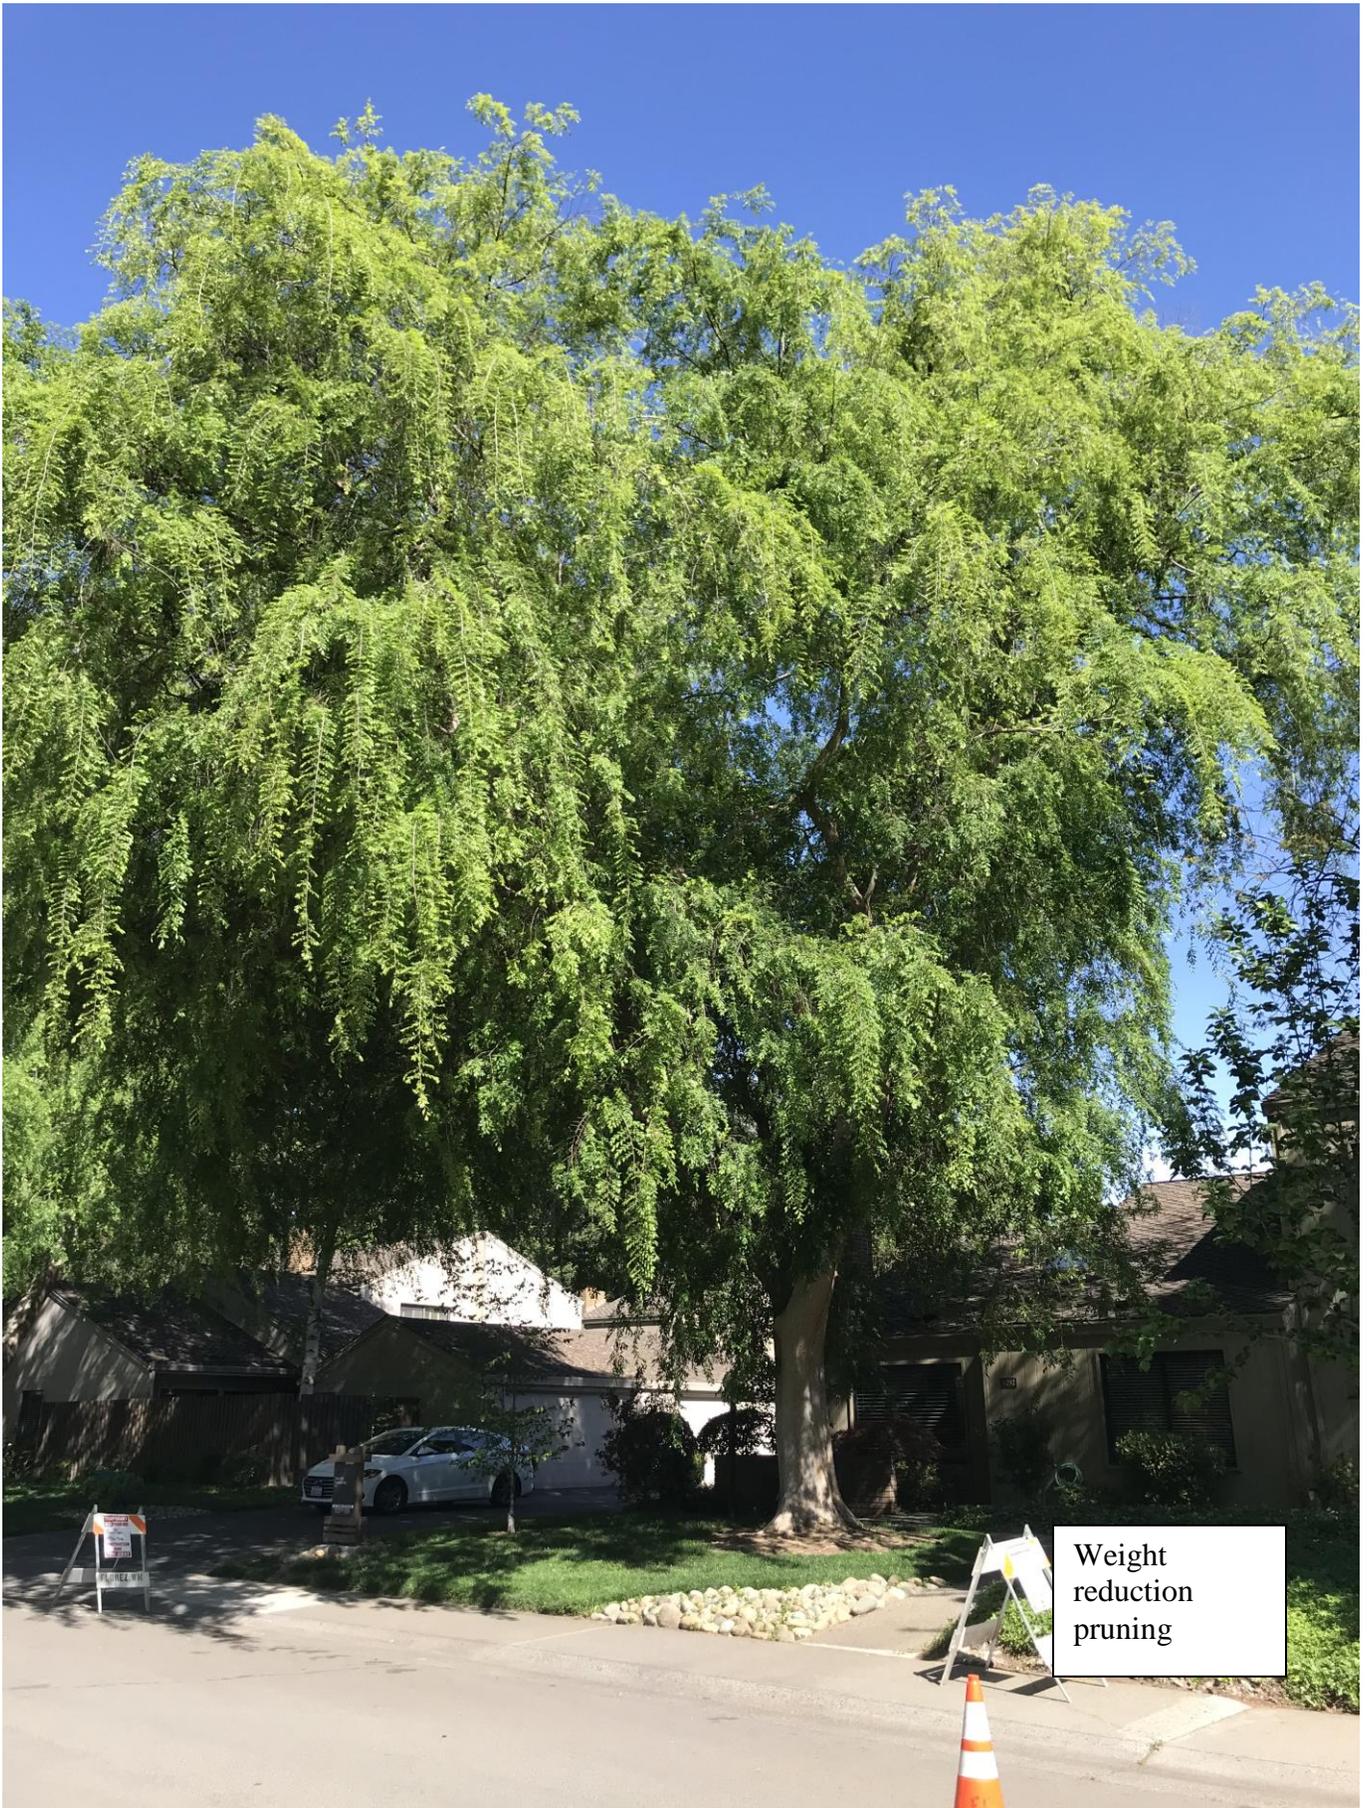
Figure 21

- (Zone 2) Trees #300 Elm (*Ulmus parvifolia*), next to 1192 Commons Dr. Tree has a full and over weighted canopy (Figure 21). I recommend full prune of trees canopy.

Weight
reduction
pruning
