April 15, 2020

The Nepenthe Association
Bettsi Ledesma
1131 Commons Dr.
Sacramento, CA 95825
Phone: (916) 929-8380
Email: Bettsi.Ledesma@fsresidential.com

On April 15, 2020, I inspected several trees on the Nepenthe property during the monthly tree walk. The focus of the walk was to address resident/management concerns regarding mature trees on the property. The purpose of this report is to develop mitigation plans for the following trees and my recommendations are below. My recommendations are based on a Basic Visual Inspection. All decisions made based on the recommendations of this report are at the discretion of the Nepenthe Association.

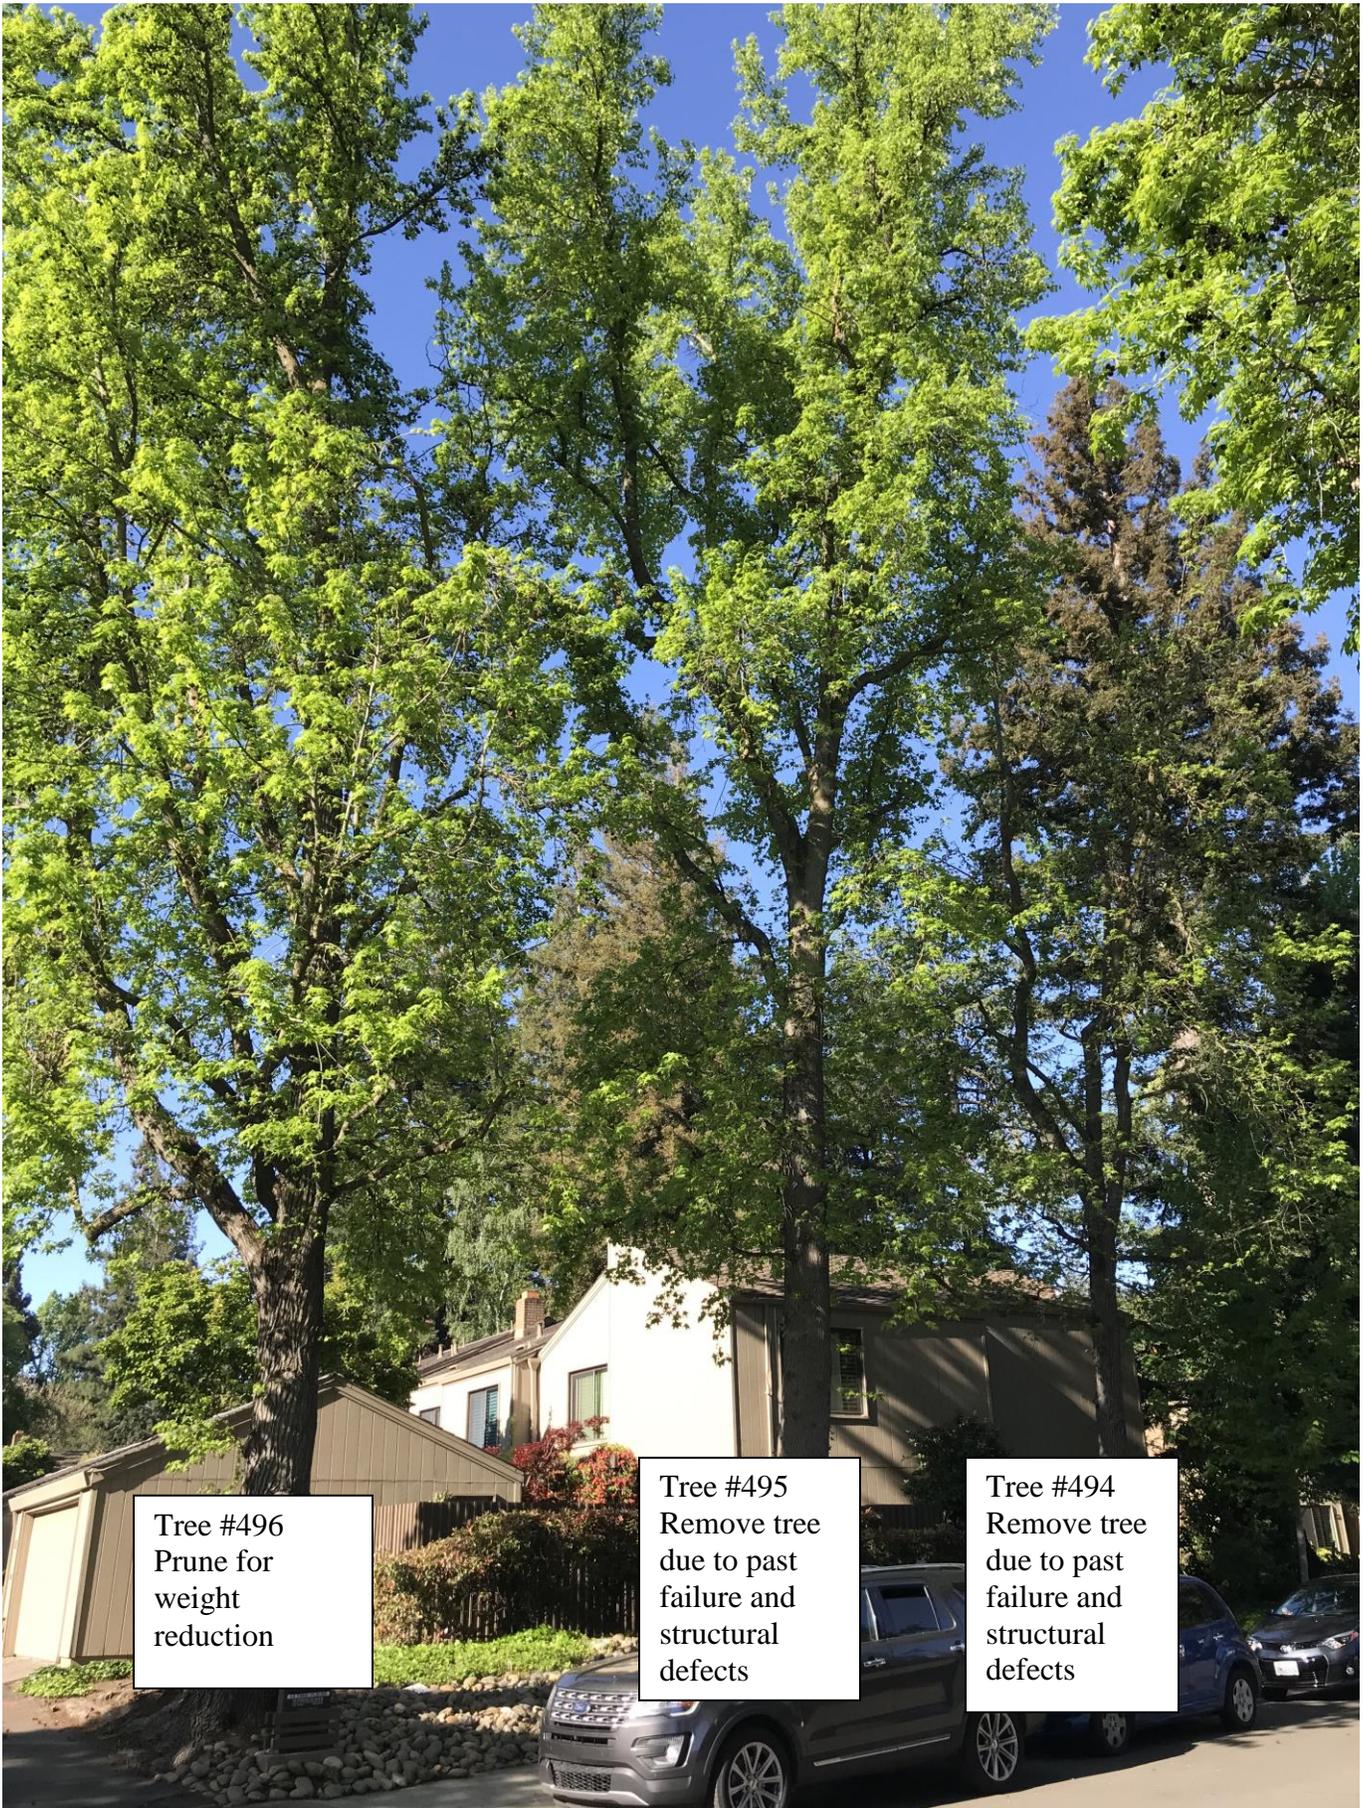
Figure 22

- (Zone 2) Trees #496, #495, #494 Sweetgum (*Liquidambar styraciflua*), 2266 Swarthmore Dr. (Figures 22-24). Tree #496 has full and over weighted canopy as well as some dead wood ,I recommend full prune of tree Canopy.
Trees #495 and #494 have both had sever major limb failures in the past few years resulting in major damage. Both trees had structural defects that cannot be mitigated through pruning therefor I recommend the full removal of these two trees.

Tree #496
Prune for
weight
reduction

Tree #495
Remove tree
due to past
failure and
structural
defects

Tree #494
Remove tree
due to past
failure and
structural
defects

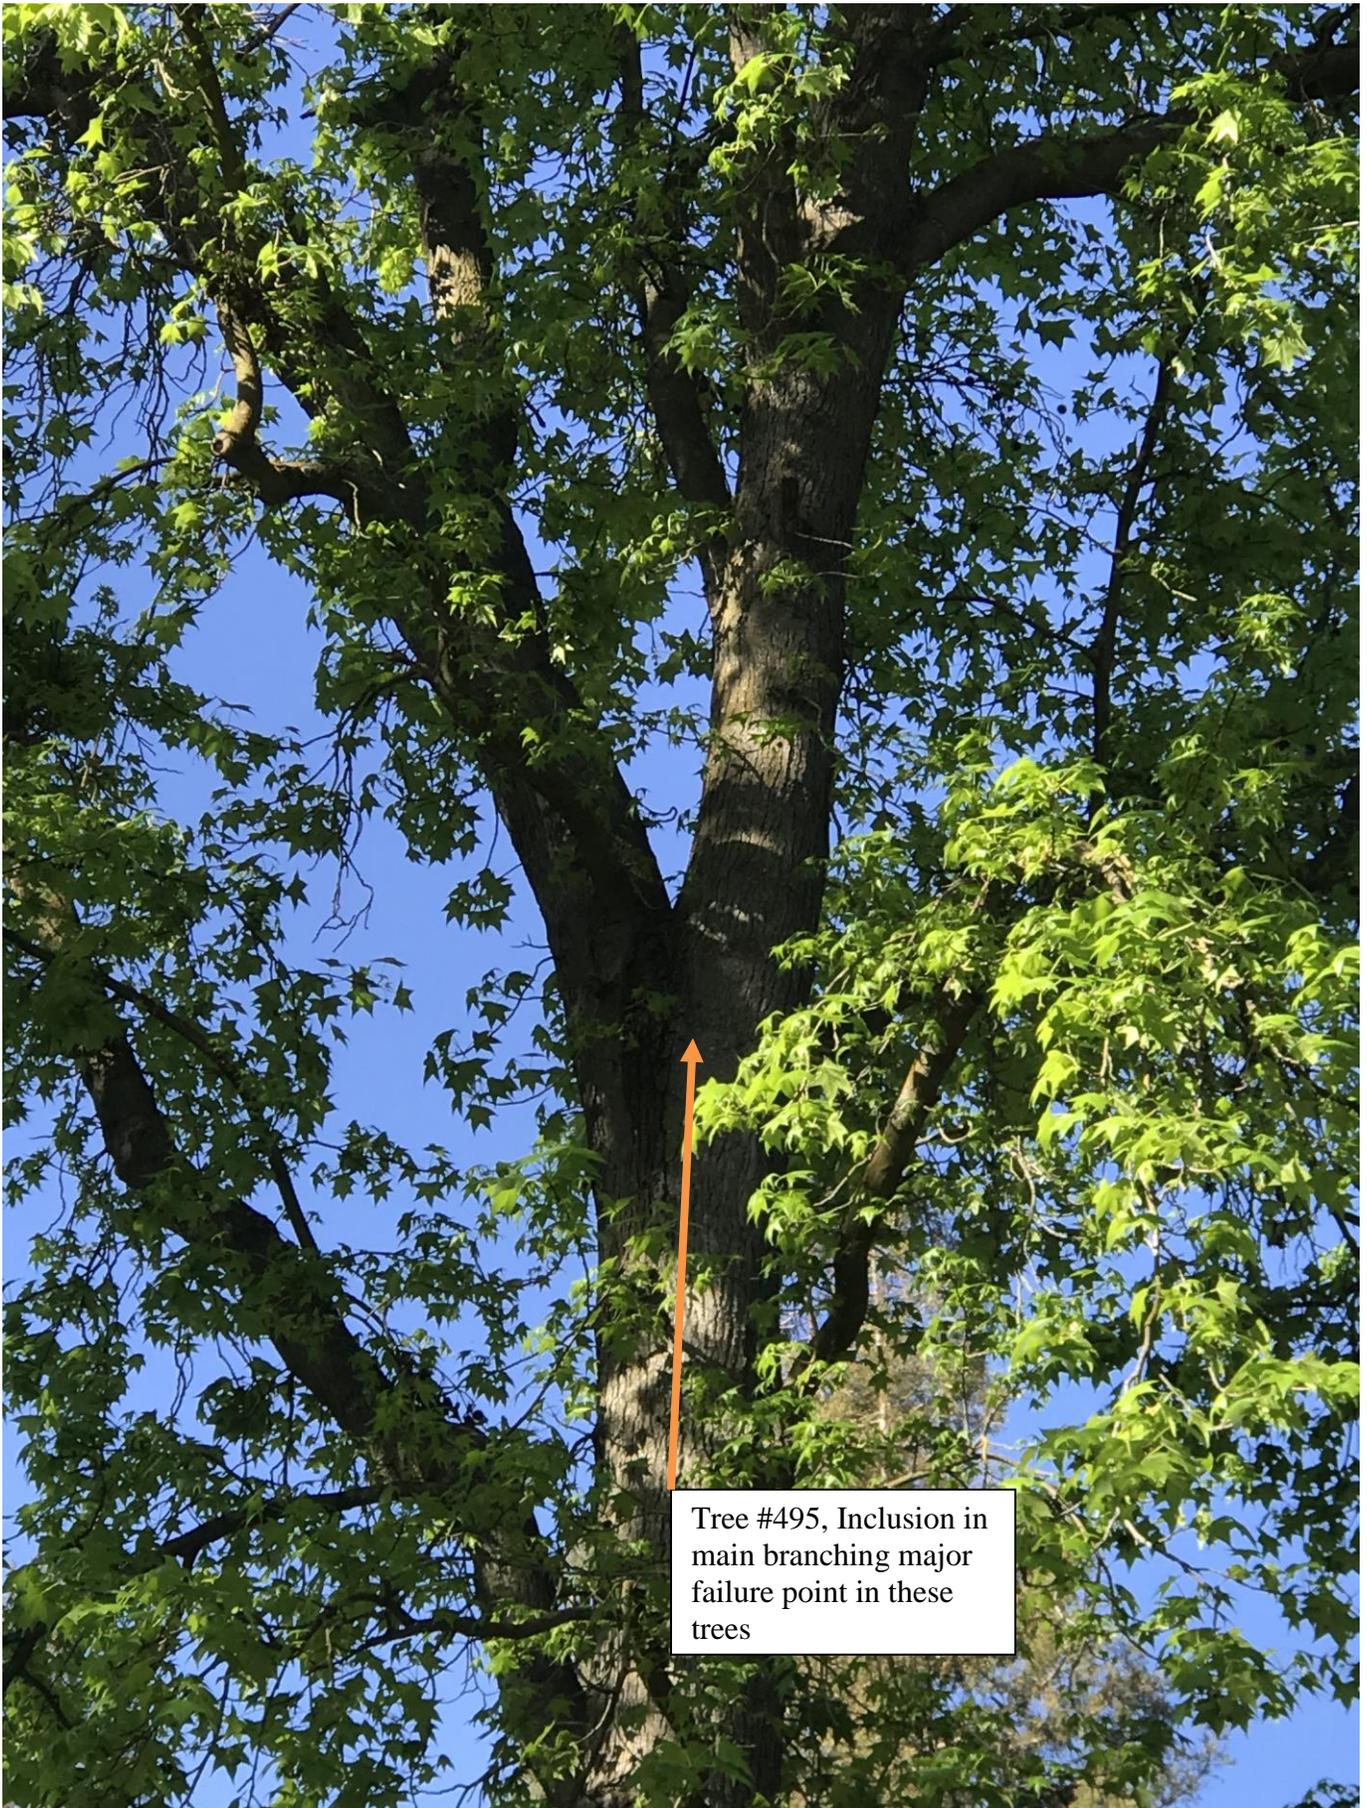
Figure 23

Tree #495, Inclusion in main branching major failure point in these trees

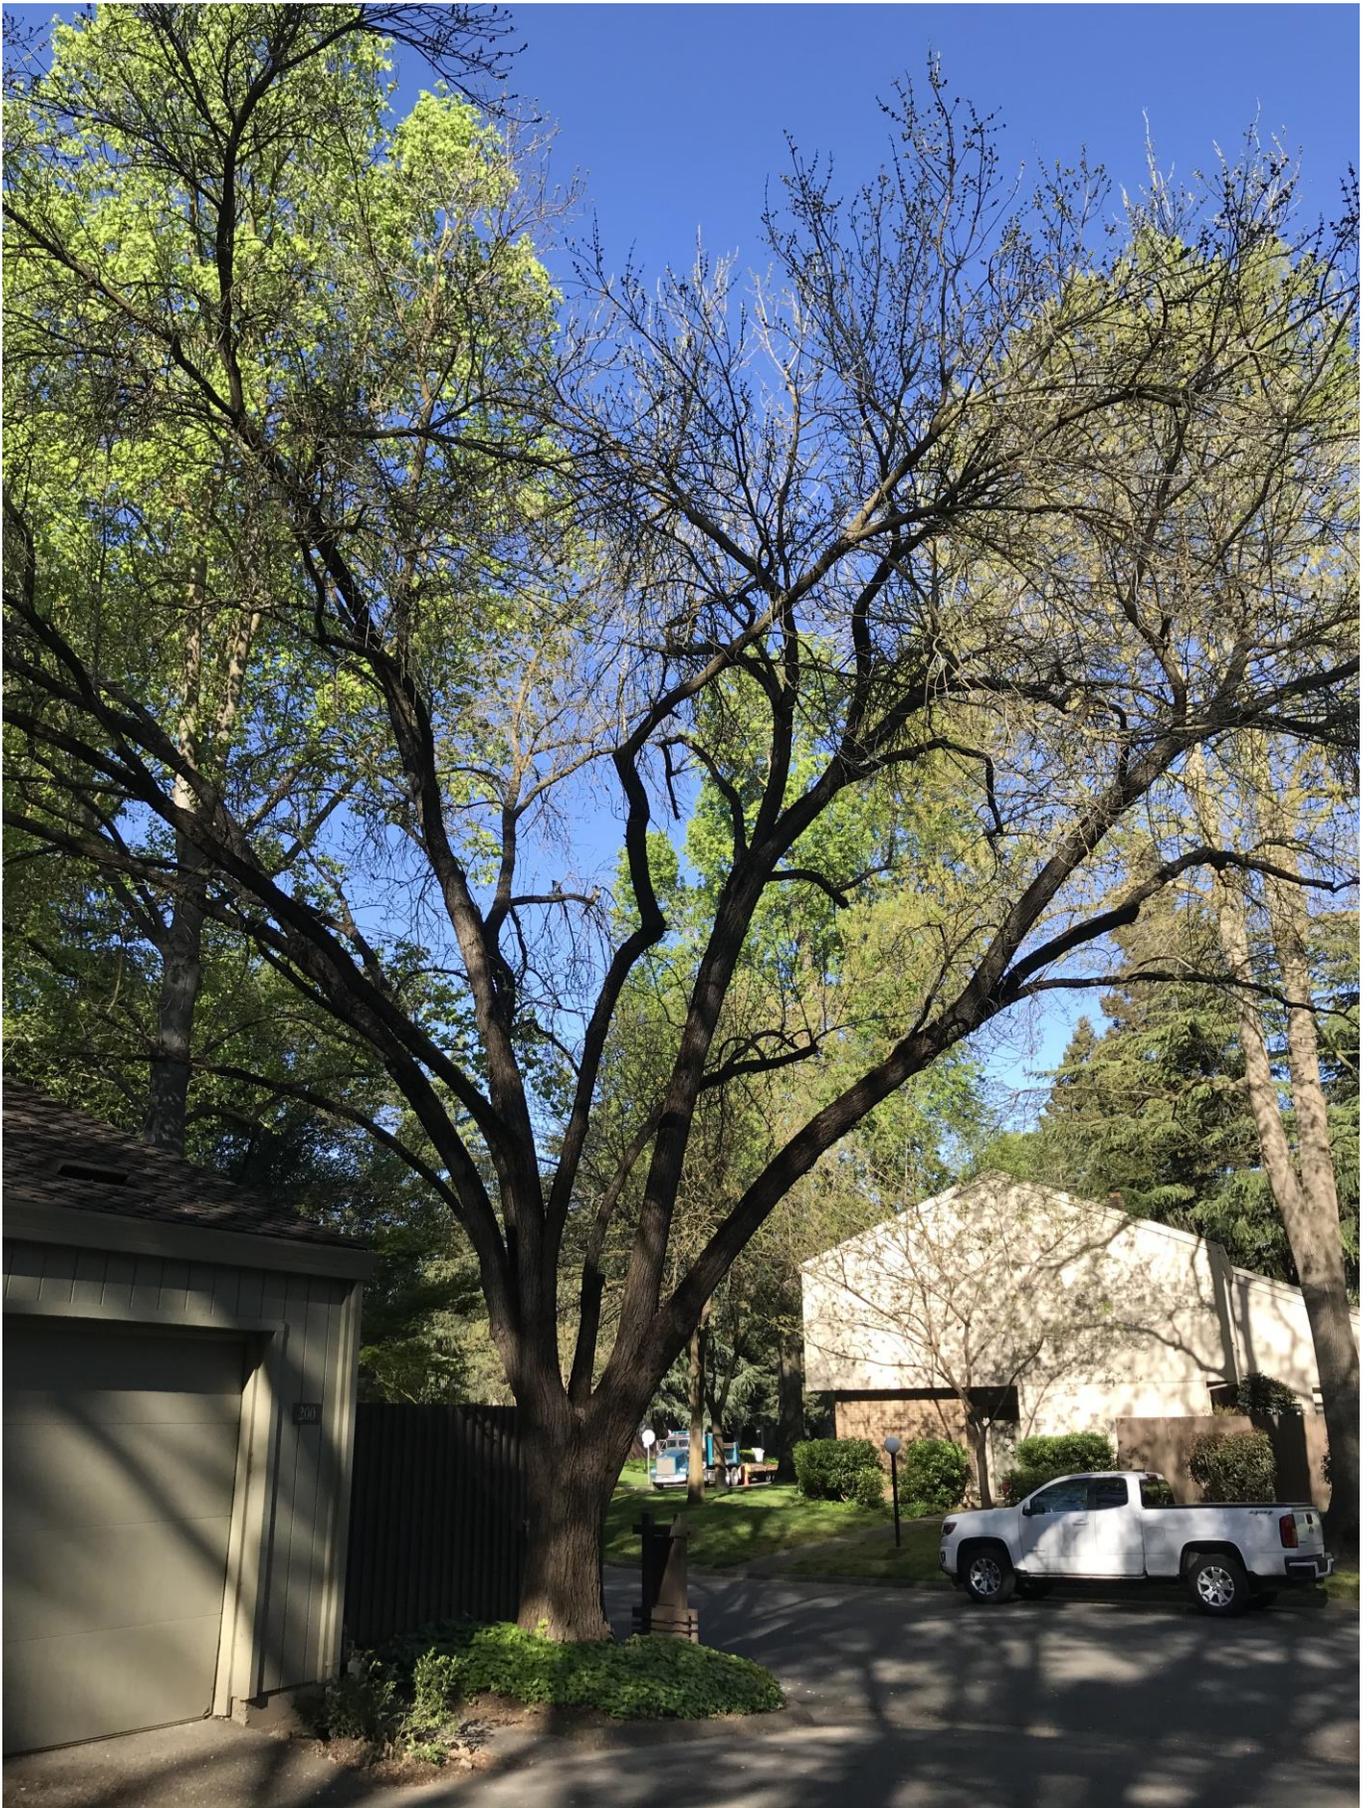
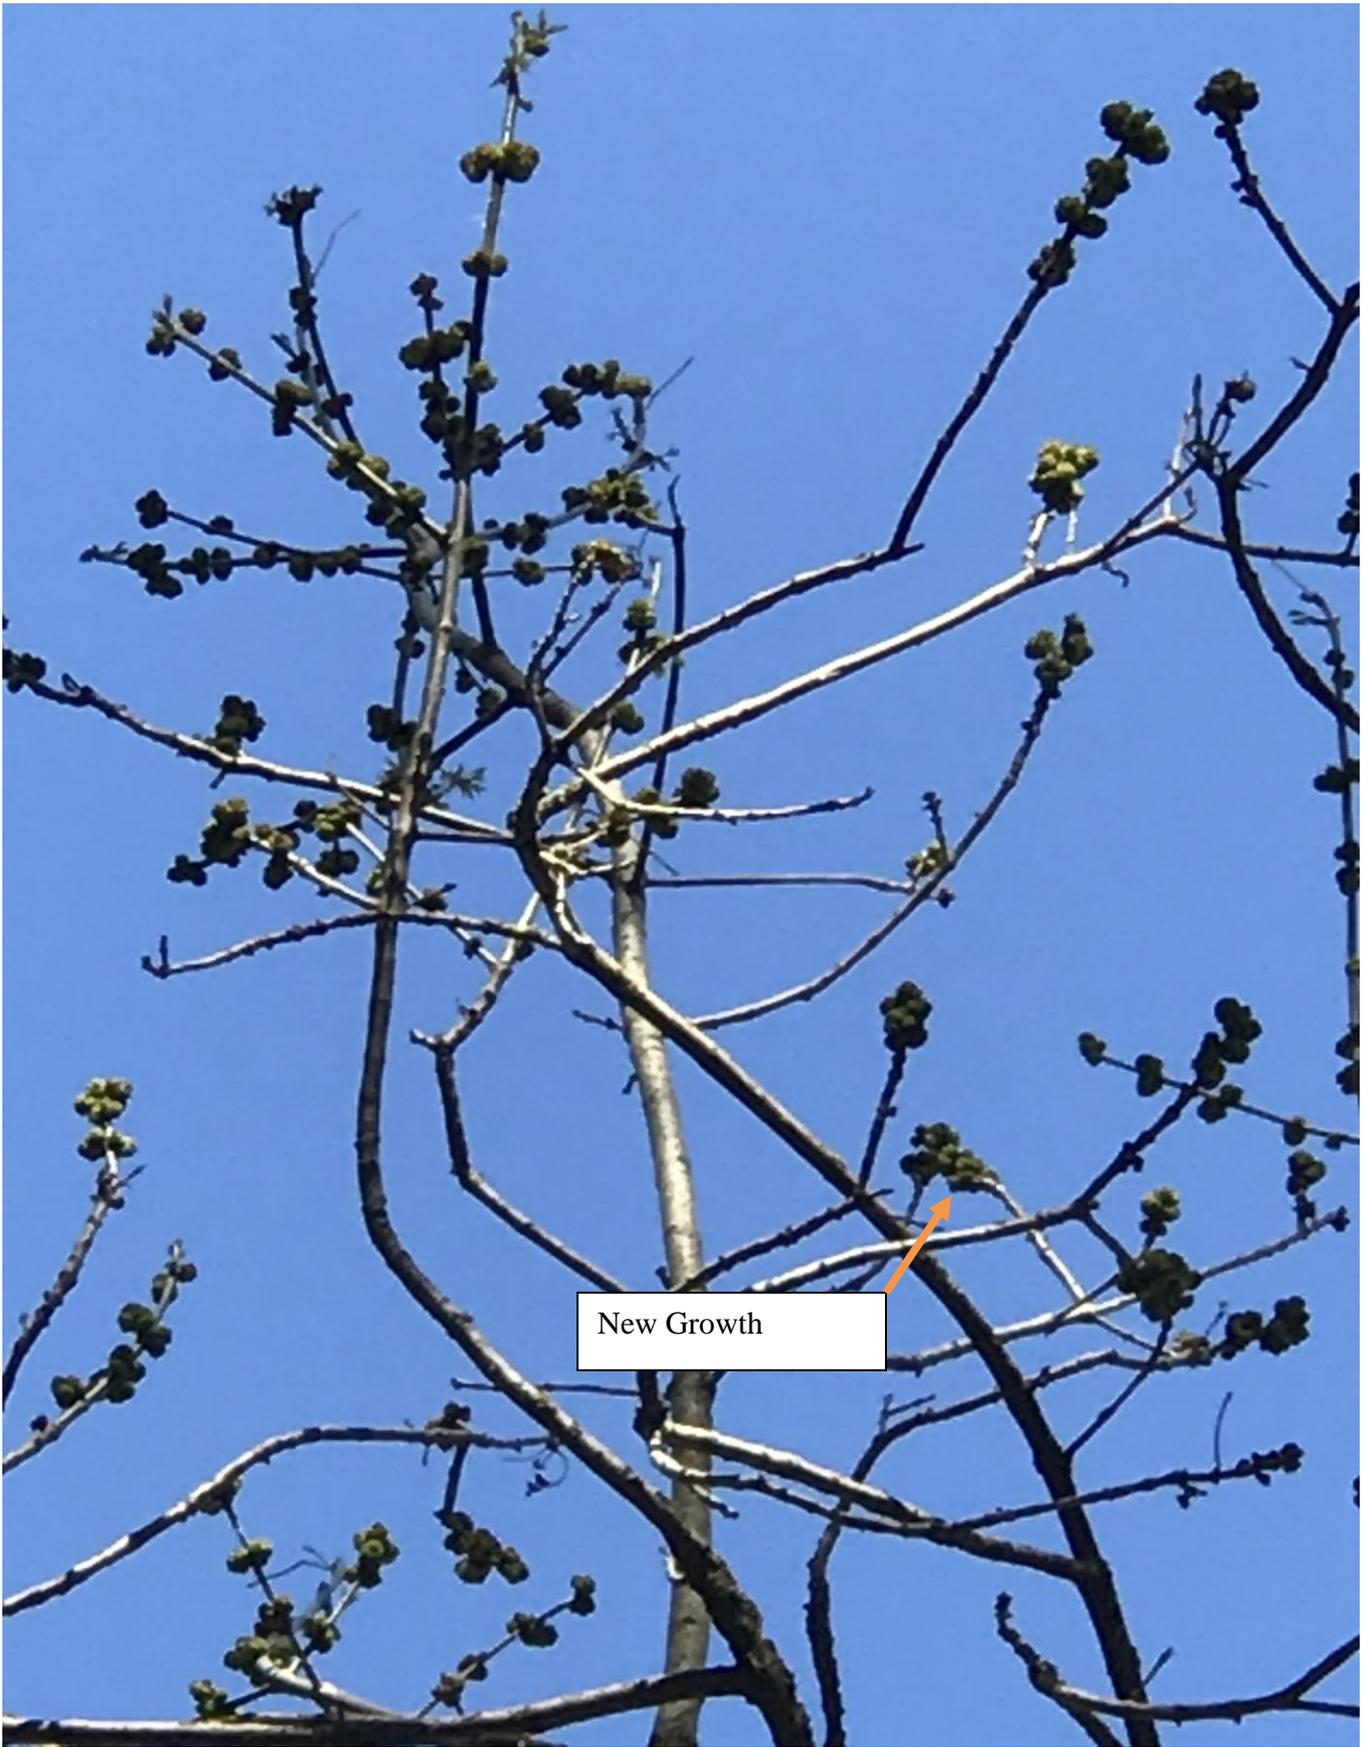
- 200 Dunbarton- check tree in alley and provide report on health of tree- **The Ash tree at this location we monitor each year during Zone 4 tree walk and it appears healthy. The tree has a later bud break than other Ash variety. (Figure 25-26)**

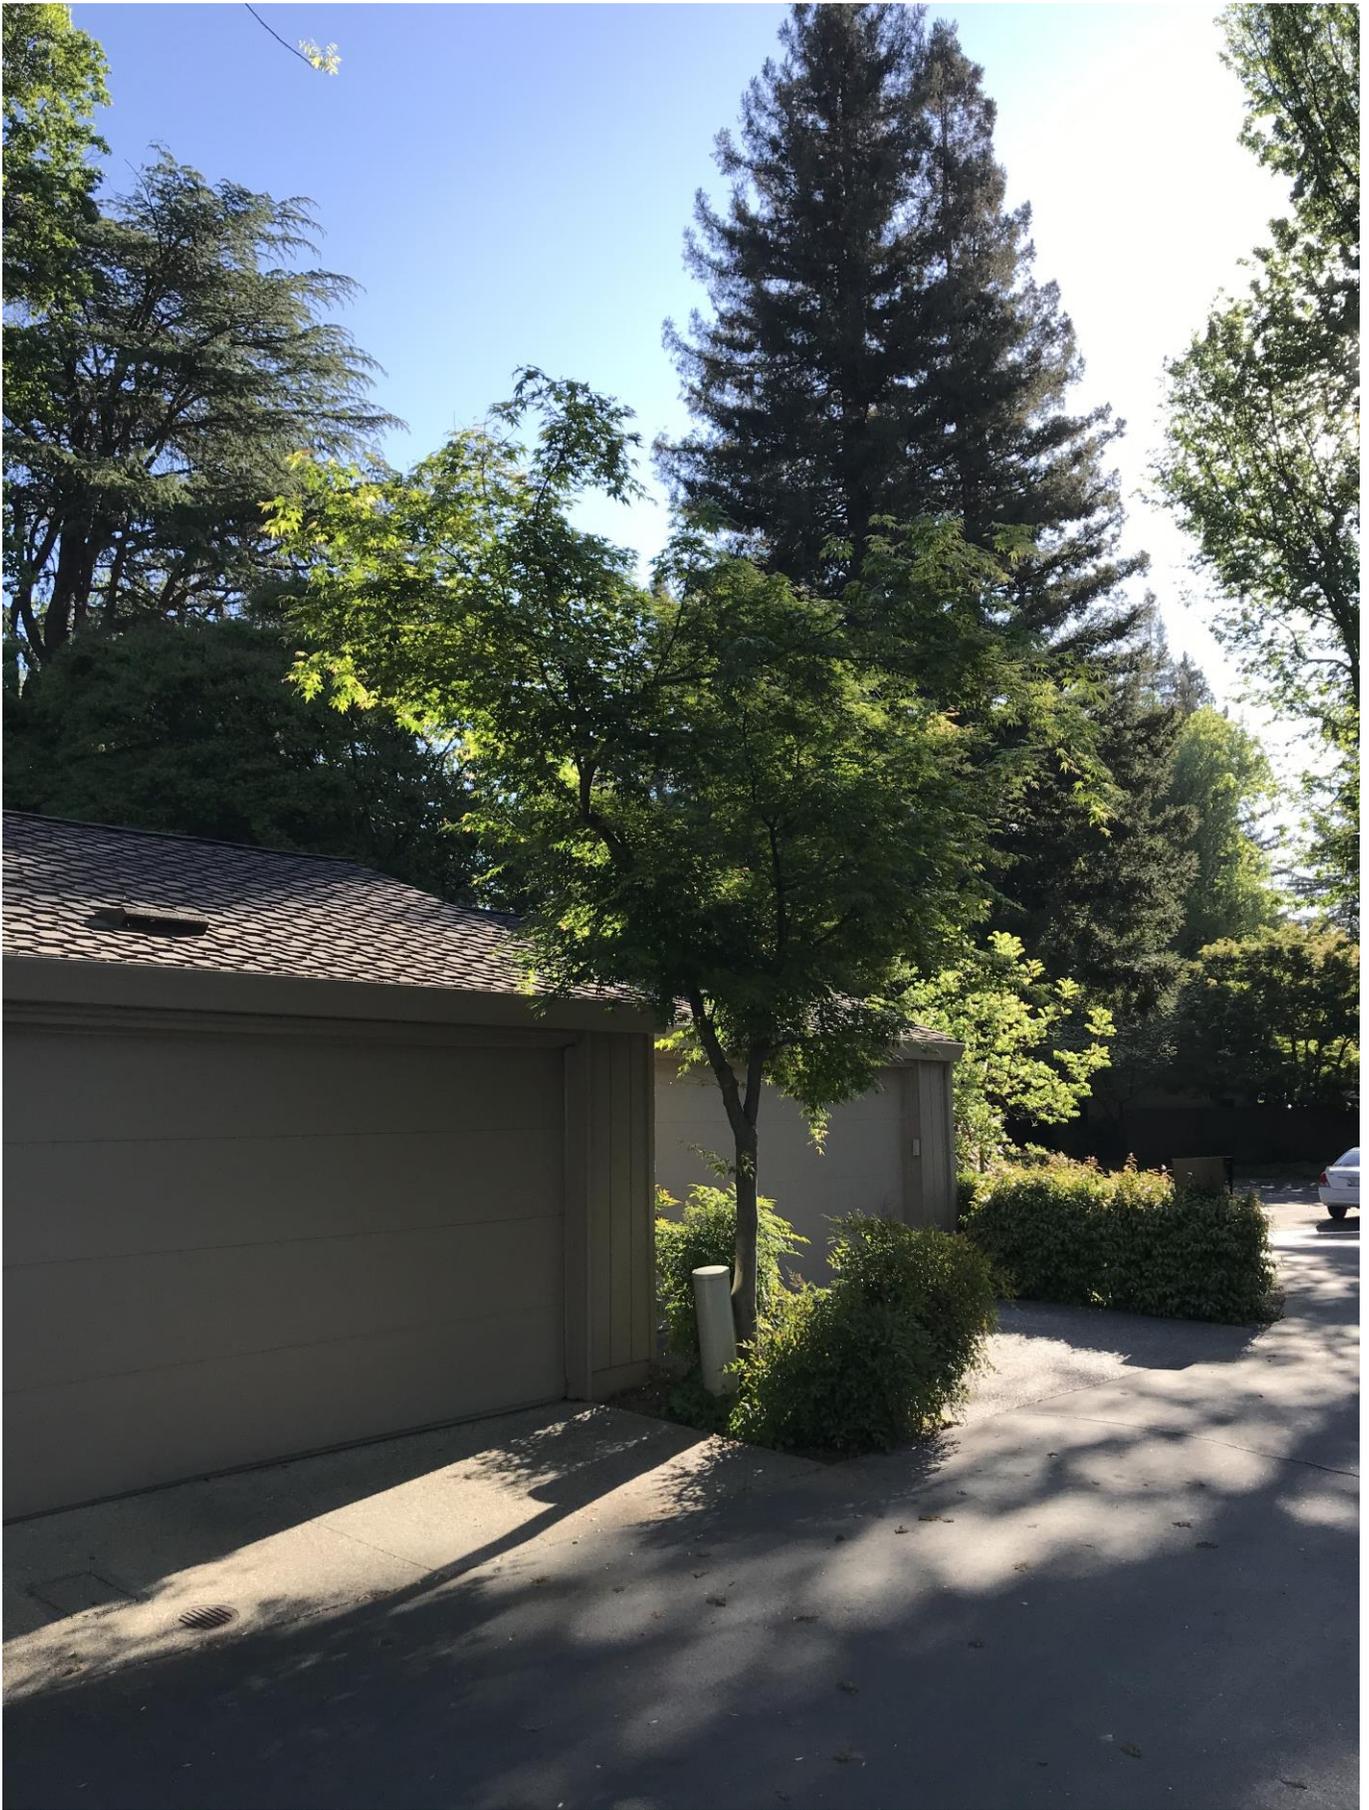
Figure 27

- 1207 Vanderbilt- tree next to driveway has lean- provide recommendations- **This tree (Figure 27 Japanese Maple) has been pruned in 2019 to address growth. The tree has developed in this way likely a response to light competition. I have no recommendations for work at this time, we can revisit this tree during the Zone 5 Tree walk**
