November 10, 2020

The Nepenthe Association
1131 Commons Dr.
Sacramento, CA 95825
Phone: (916) 929-8380
Email: Bettsi.Ledesma@fsresidential.com

On October 14, 2020, I inspected several trees on the Nepenthe property during the monthly tree walk. The focus of the walk was to address resident/management concerns regarding mature trees on the property. The purpose of this report is to develop mitigation plans for the following trees and my recommendations are below. My recommendations are based on a Basic Visual Inspection. All decisions made based on the recommendations of this report are at the discretion of the Nepenthe Association.

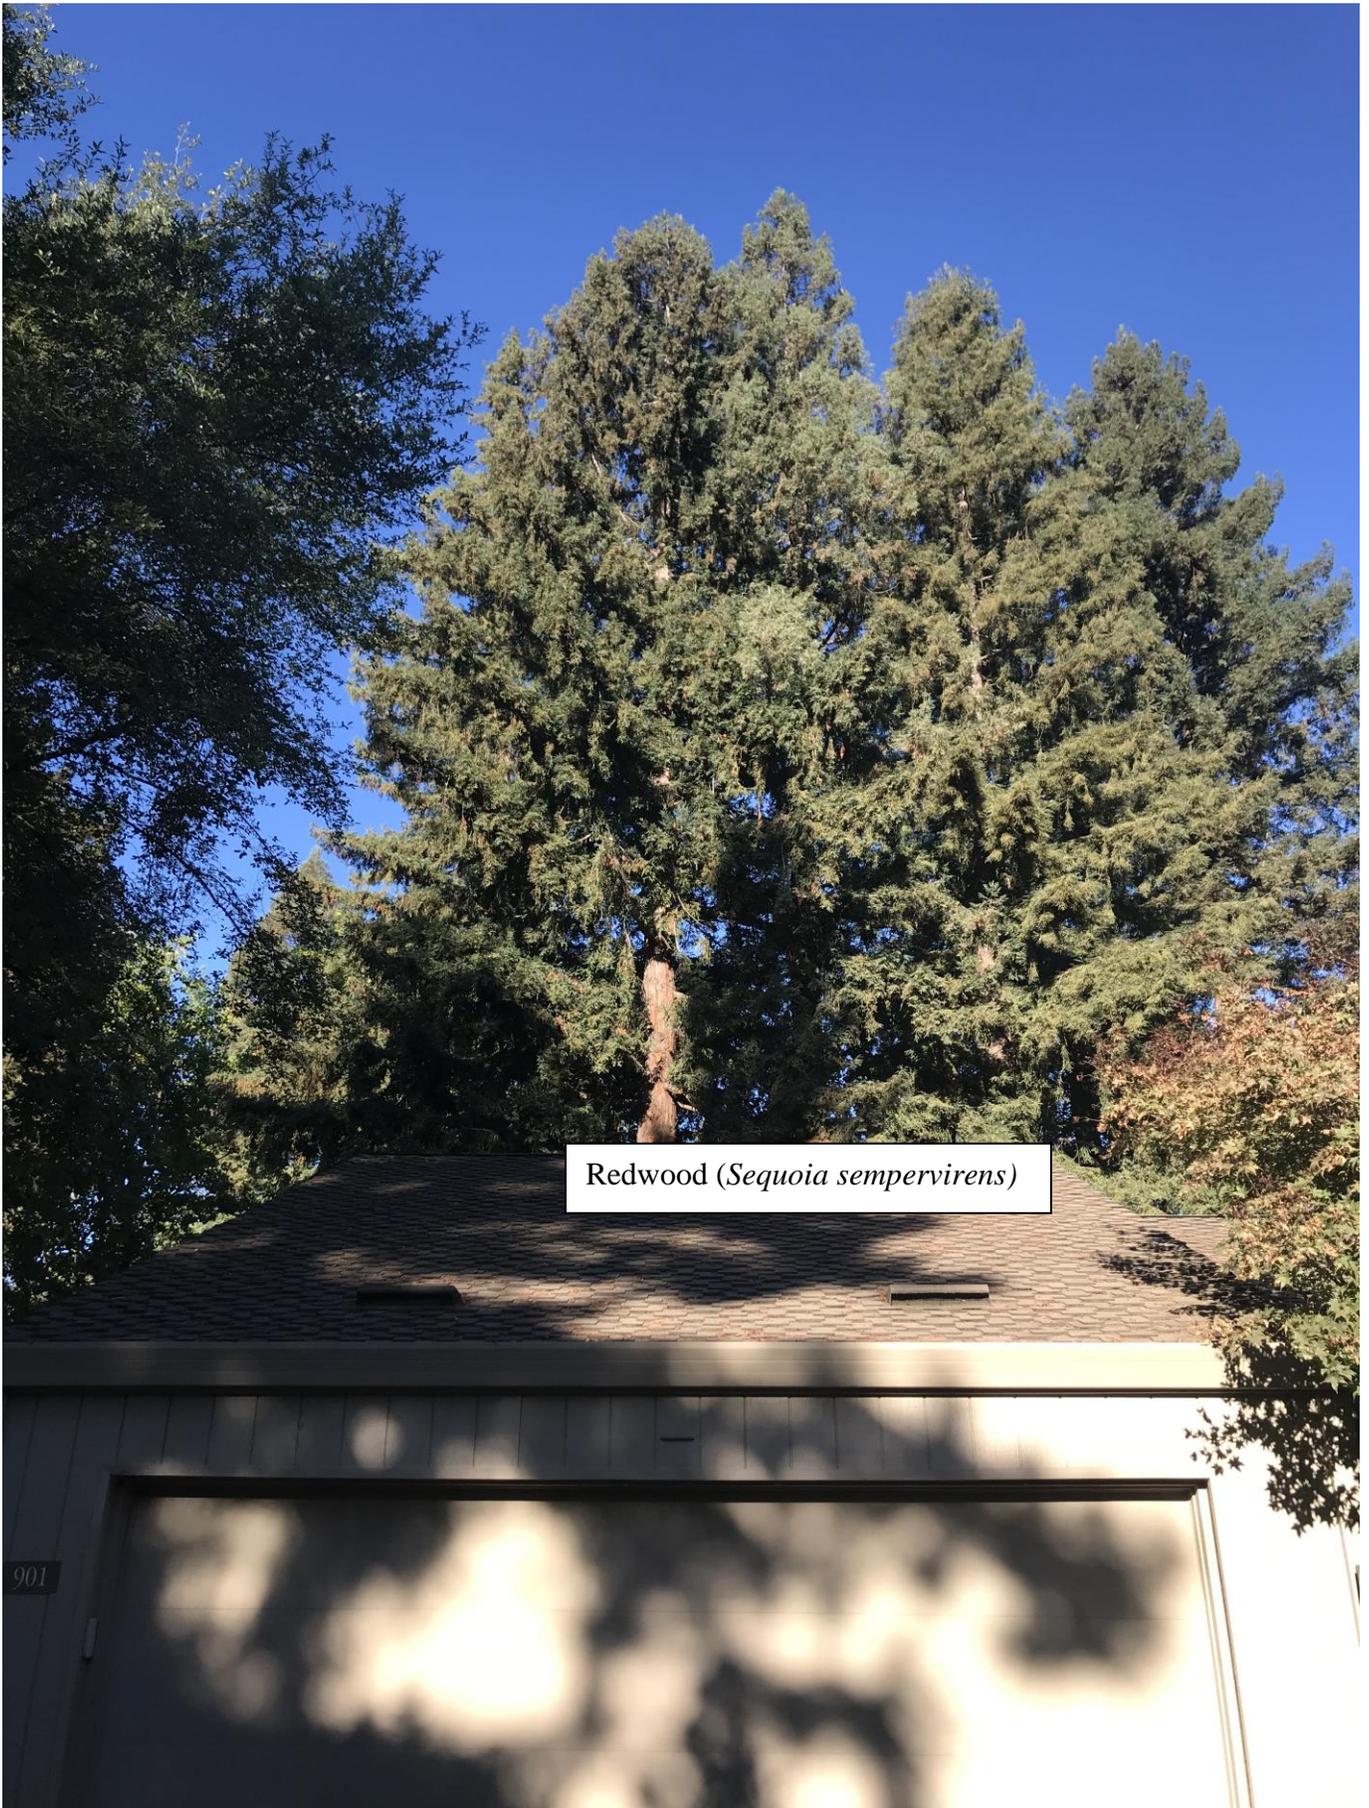
Figure 1

- Redwood (*Sequoia sempervirens*) (Figure 1). I wanted to highlight Nepenthes redwood tree population in regards to health, growth and pruning practice. Nepenthe has a healthy redwood tree population and the average age of these trees currently is between 40-80 years old, these are relatively young trees by redwood standards. Redwood trees are a tree typically found along the coast in the fog belt and are a California native. These trees typically grow in groups and can share root systems. The trees in Nepenthe have been getting supplemental watering every summer to help with the moisture loss during the hot months this helps to prevent stress to these trees that are a ways away from their native environment. Redwood trees can have an upward growth rate from 2'-4' per season were we can see about 4"-8" of growth on the side or branch tips per season as well. The pruning we recommend for redwoods is minimal, limited to general clearance pruning to prevent the trees from growing into the structures and the removal of deadwood. We have reduced several co dominate tops on select few of the trees as well as this is a common failure point for these trees. Due to the size of the tree people are often concerned with the whole tree failing, it is very rare for a redwood to fail at the base or up root. The most common failure of a redwood tree is limb failure or failure of a co dominate top. Redwood trees do not require thinning in the canopy that pruning can actually cause further risk to the trees associated with limb failure and heat stress. The canopy of a redwood is designed to help shade the tree and cool the tree as well as buffer the wind around the tall trees helping with stability. If the canopy is over thinned the wind can pass through the trees causing more branch movement and can actually create a higher risk of limb failure. We typically see limb failure on redwood trees after high wind events. The redwood branch attachments are not strongly attached to the tree. It requires little upward pressure to detach a relatively large limb; this also helps to reduce the wind sail effect on the tree if there is too much wind force on the tree the tree may shed a limb to reduce the sail. Over all these trees provide a great benefit to the community for their beauty and for the habitat they create for the native wildlife as well as contributing to reduce pollutants and helping to reduce temperatures in the community.

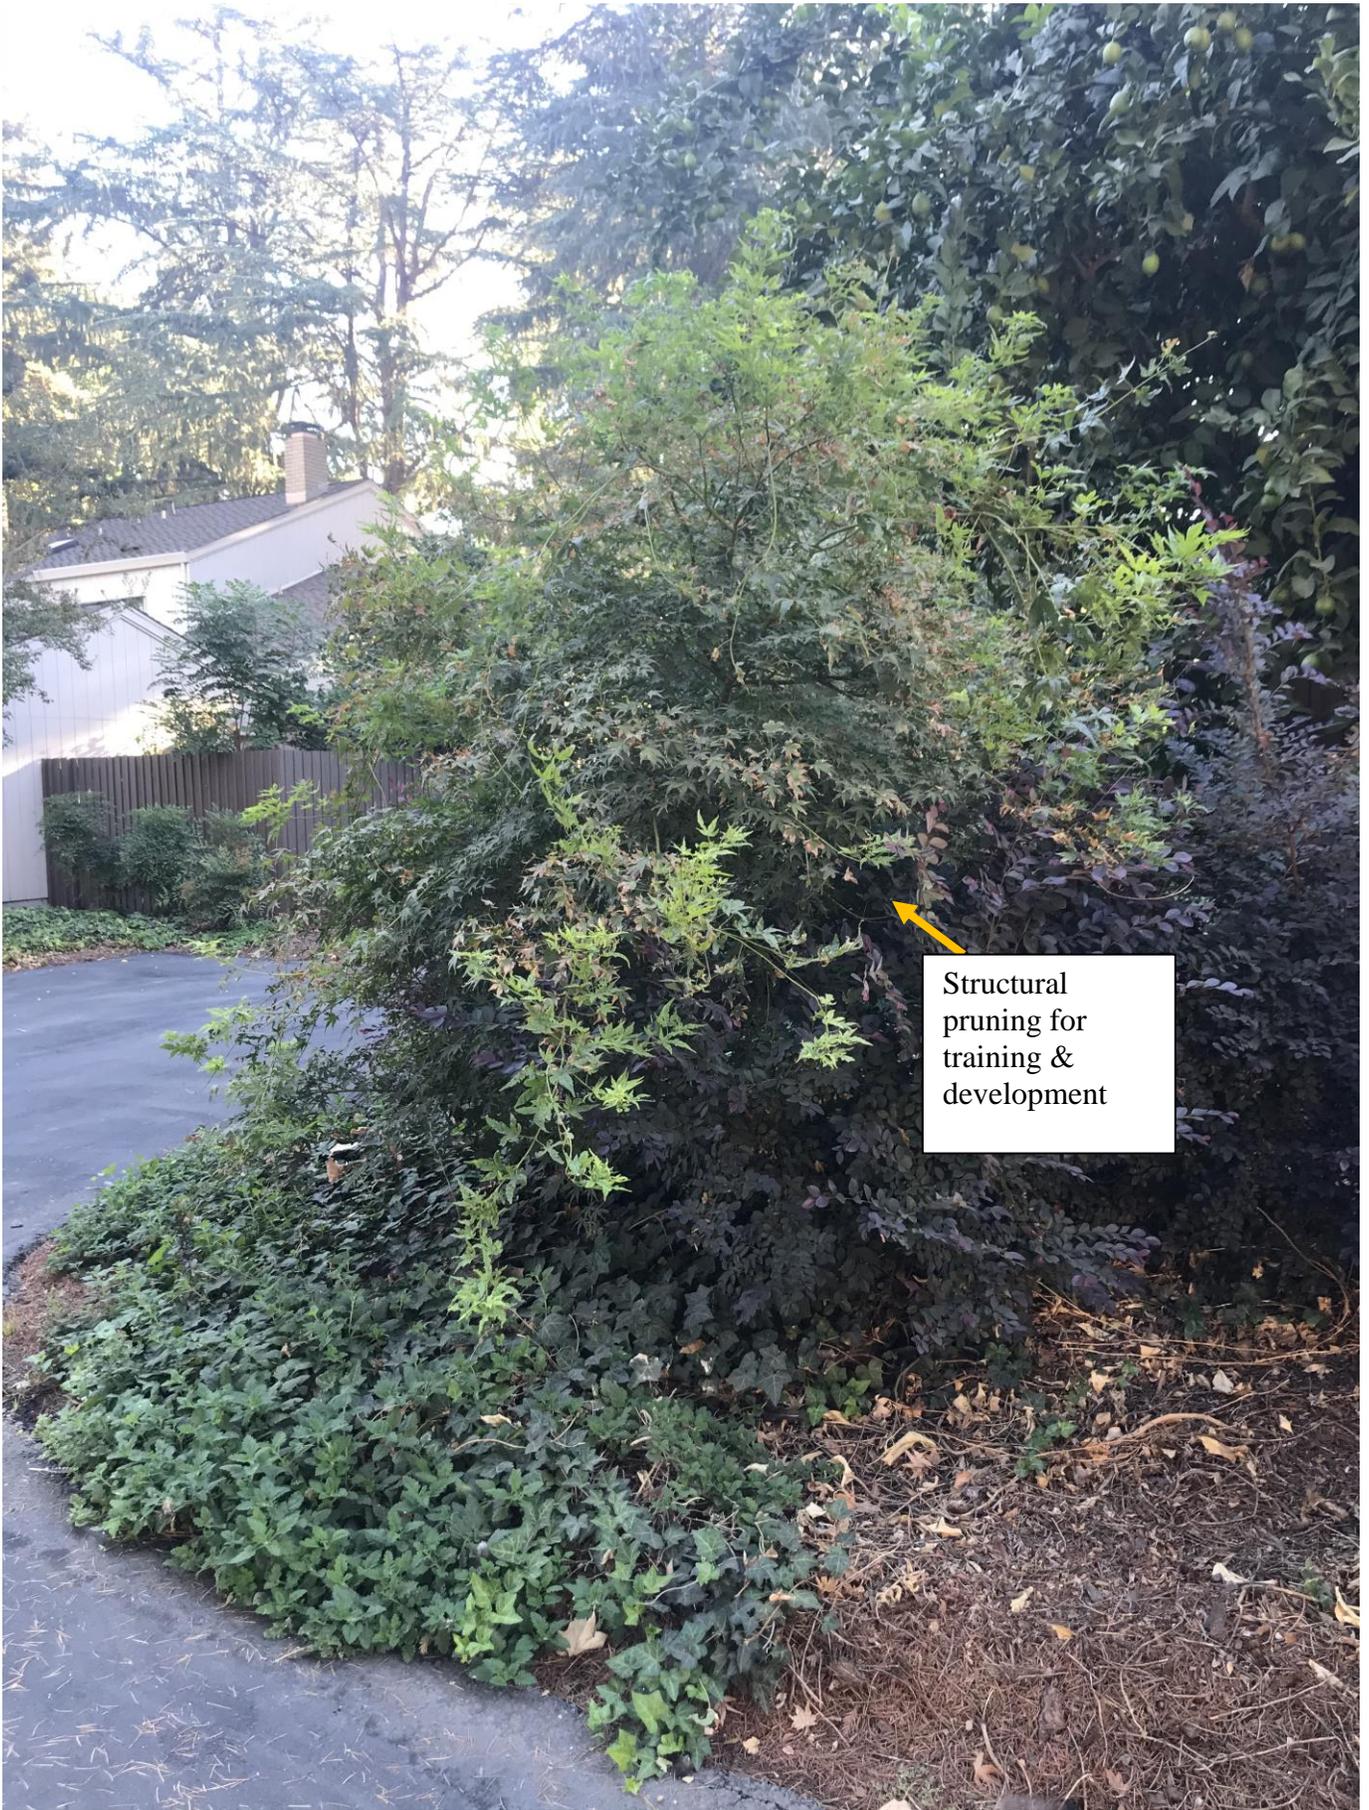
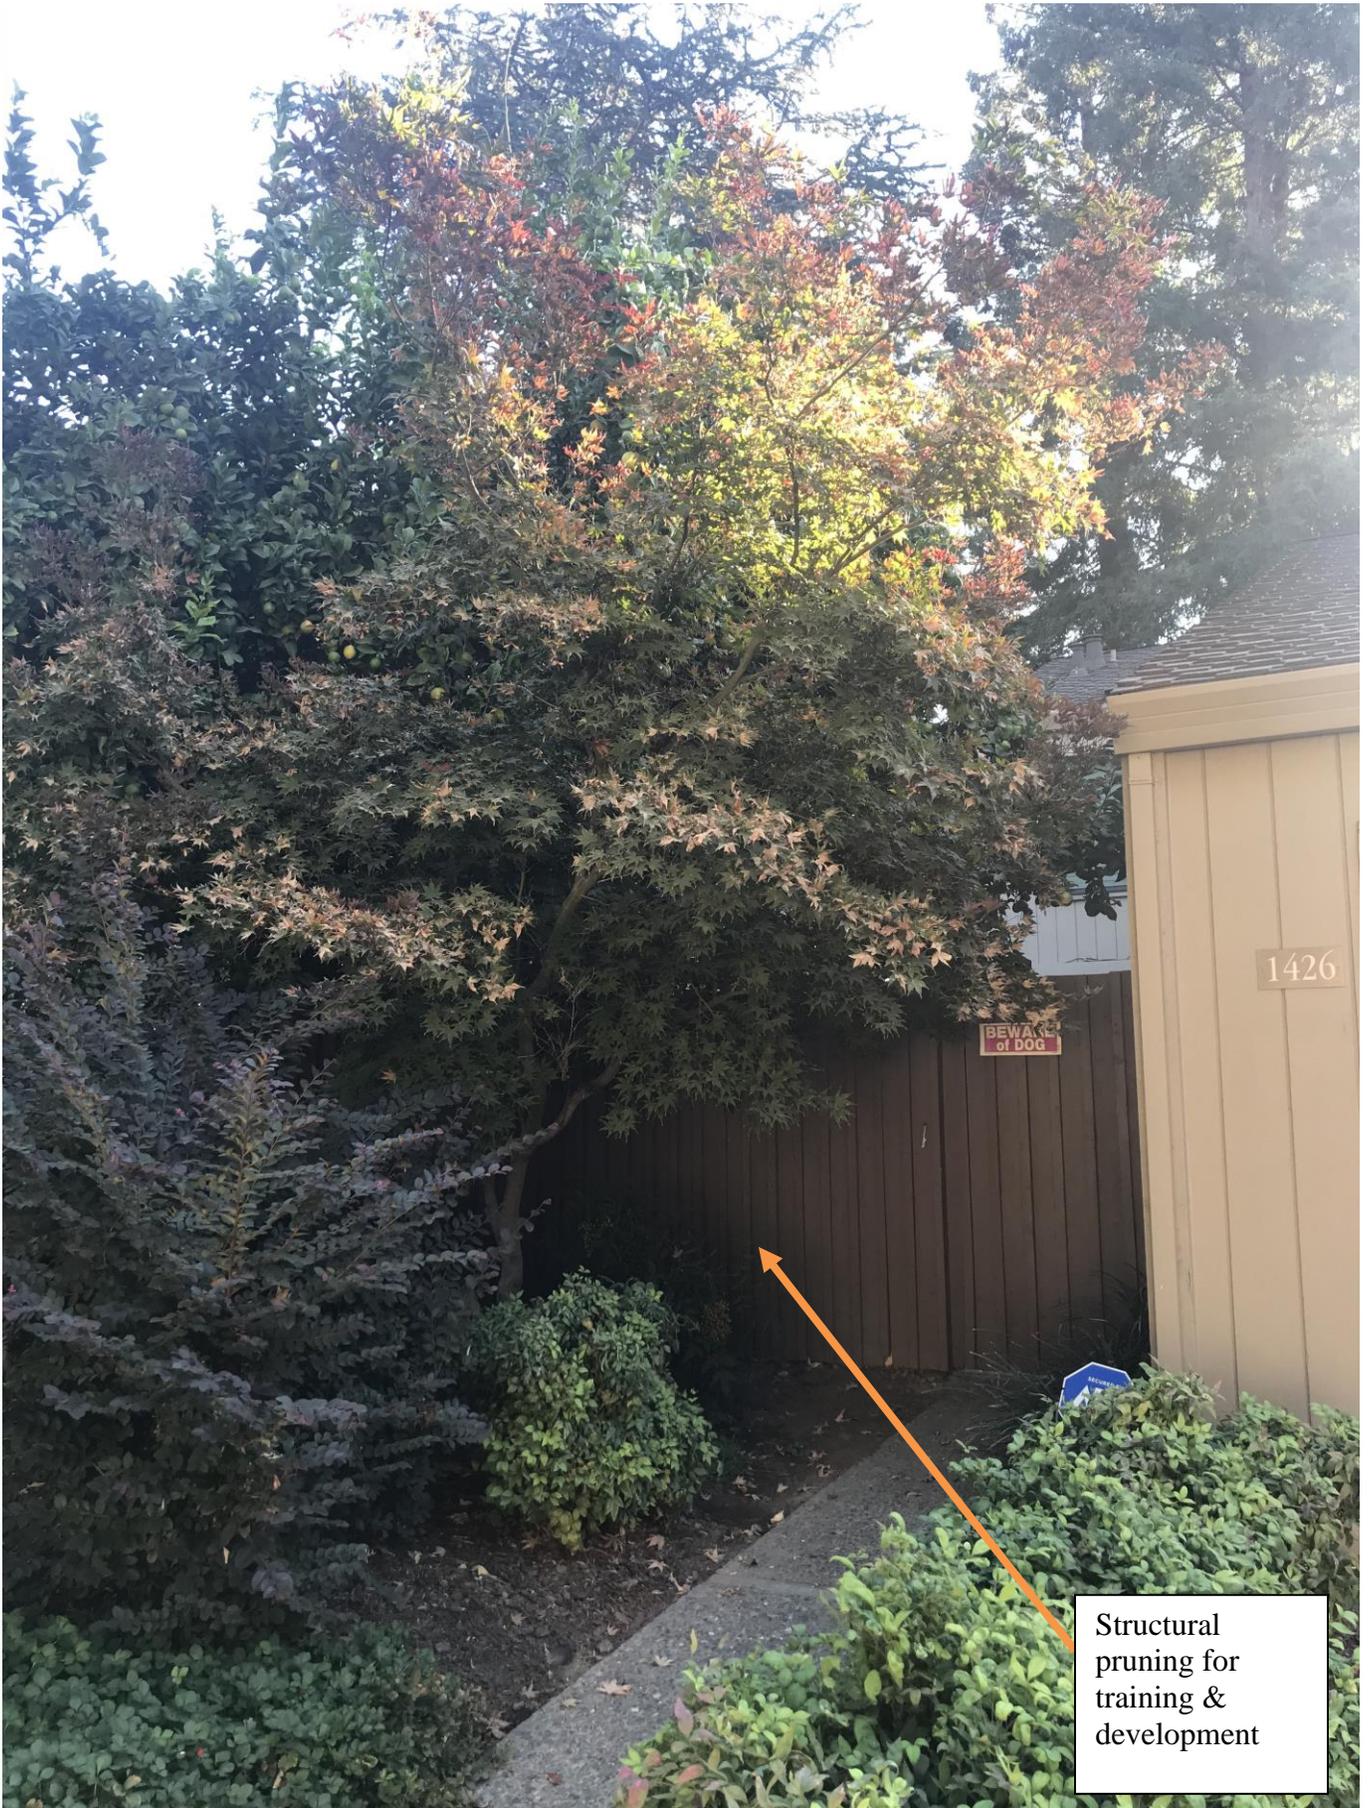
Figure 3

- (Zone 5) Trees #No Tag Japanese Maple (*Acer palmatum*), 1426 Commons (Figure 2-3) Two trees in planter area require structural pruning to help with direction of growth and healthy canopy development

Structural pruning for training & development

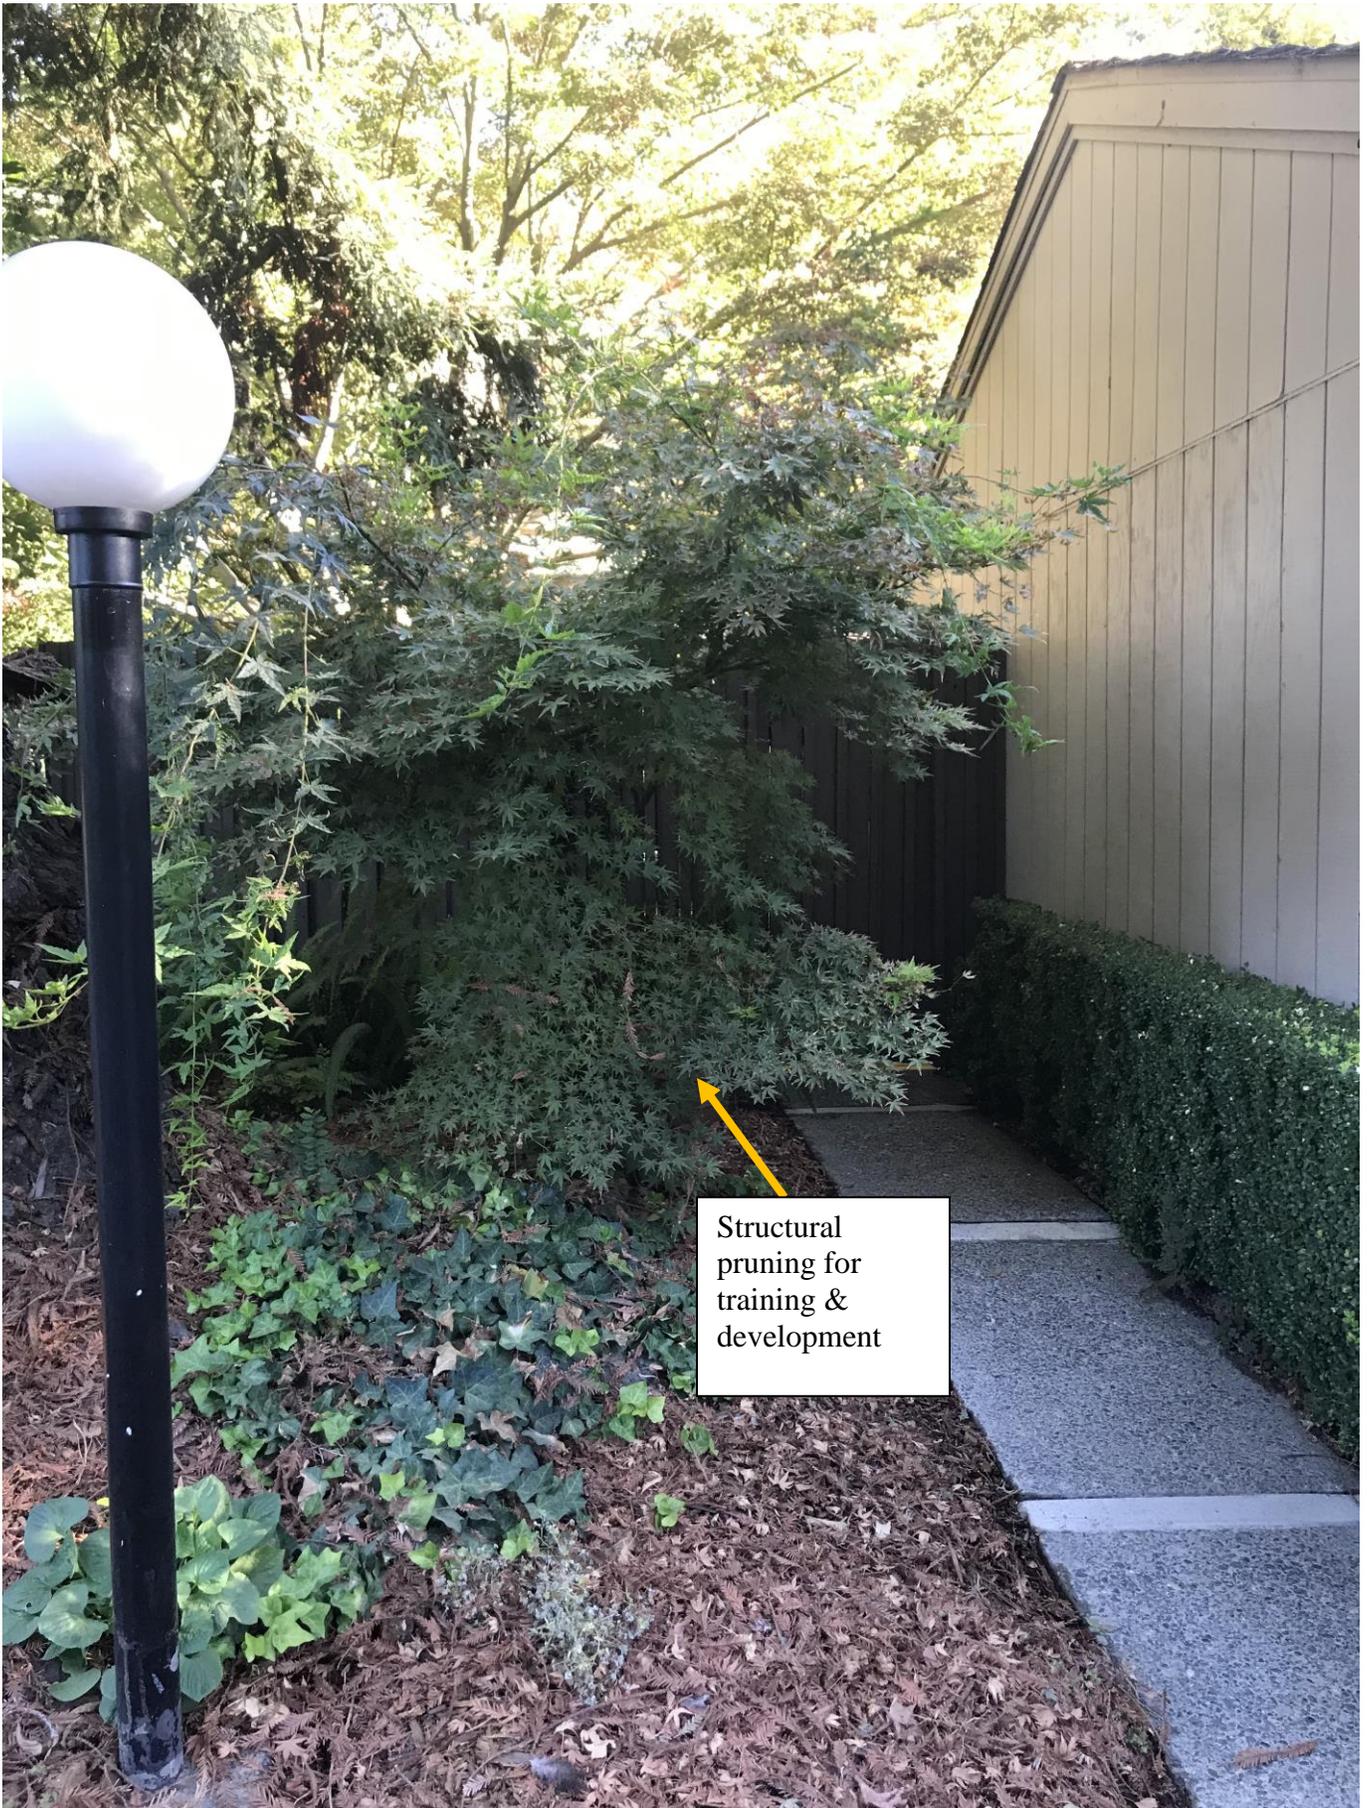
Figure 4

- (Zone 5) Trees #No Tag & #1320, Japanese Maple (*Acer palmatum*), 1245 Vanderbilt (Figure 4 & 7) One Tree near patio walk way and one tree next to front entrance requires structural pruning to help with direction of growth and healthy canopy development

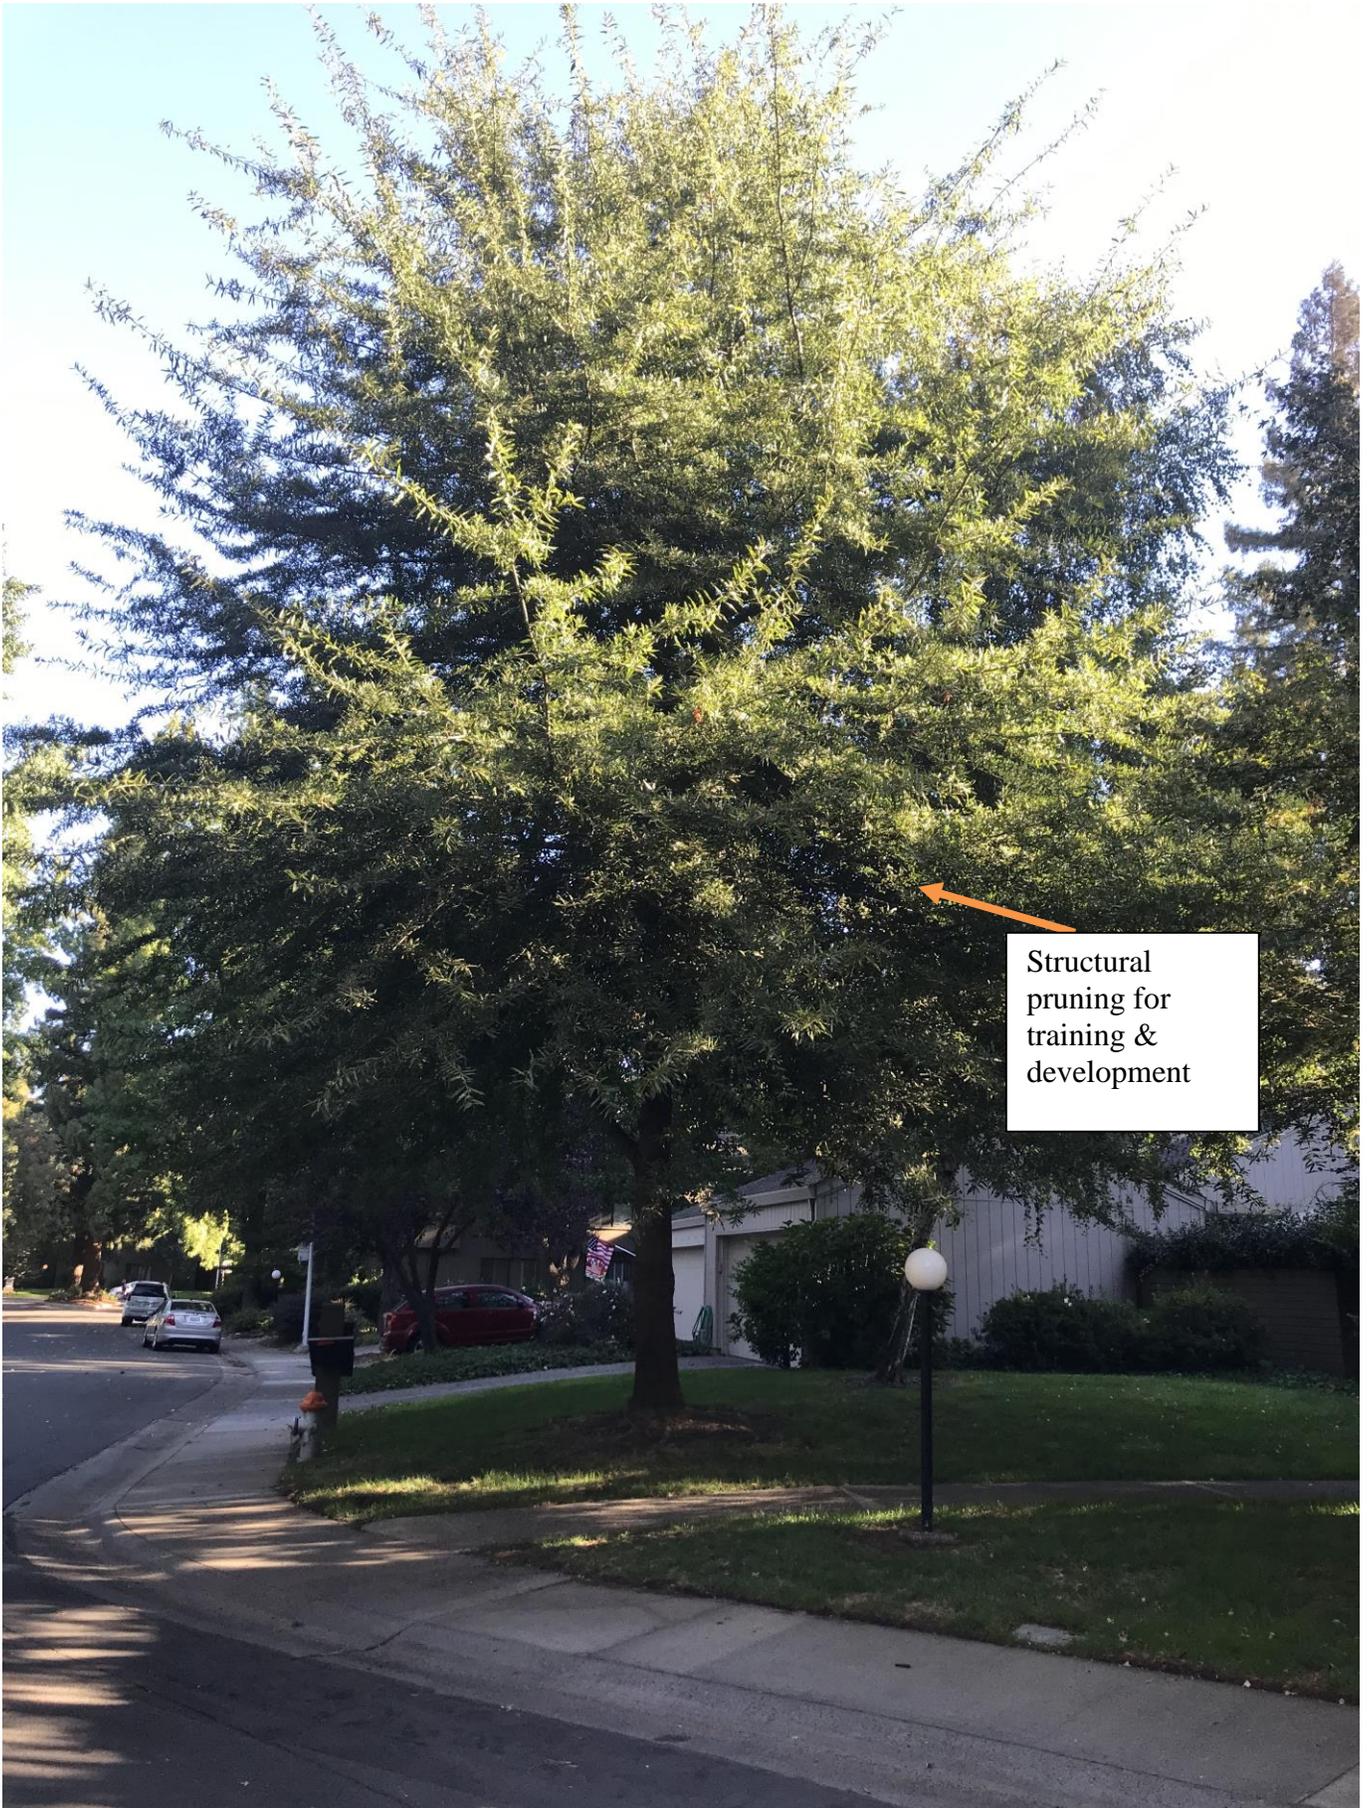
Figure 5

- (Zone 5) Tree #No Tag Willow Oak (*Quercus phellos*) in front 1269 Vanderbilt. Tree requires structural pruning to help with direction of growth and healthy canopy development (Figure 5).

Structural pruning for training & development

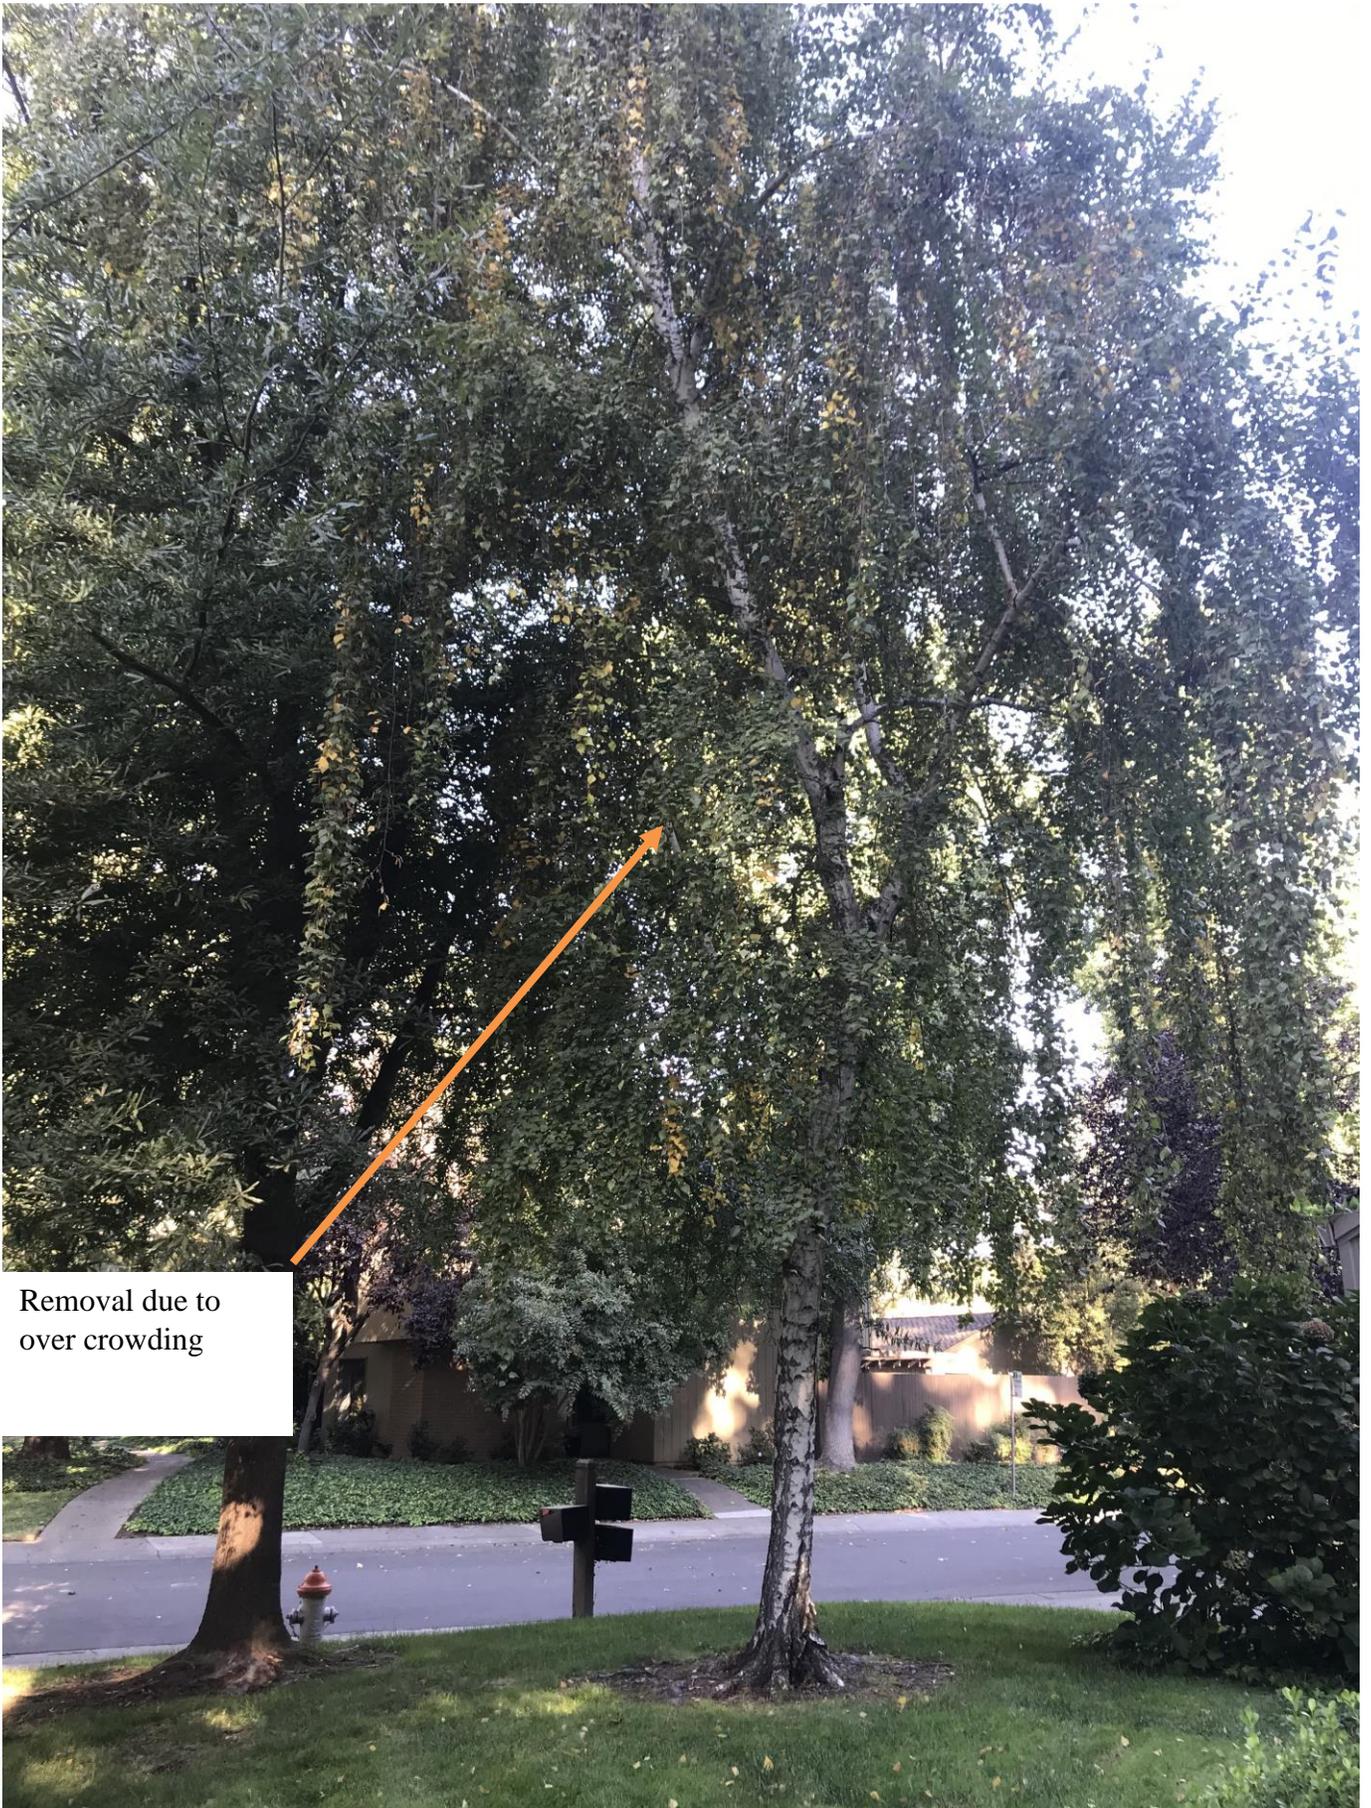
Figure 6

- (Zone 5) Tree #No Tag, White Birch (*Betula pendula*) next to 1269 Vanderbilt. (Figure 6) This tree has become stunted in growth due to over planting and is being crowded out by a more aggressive tree. I recommend the removal of this tree to allow for more development room of the healthier tree.

Removal due to
over crowding

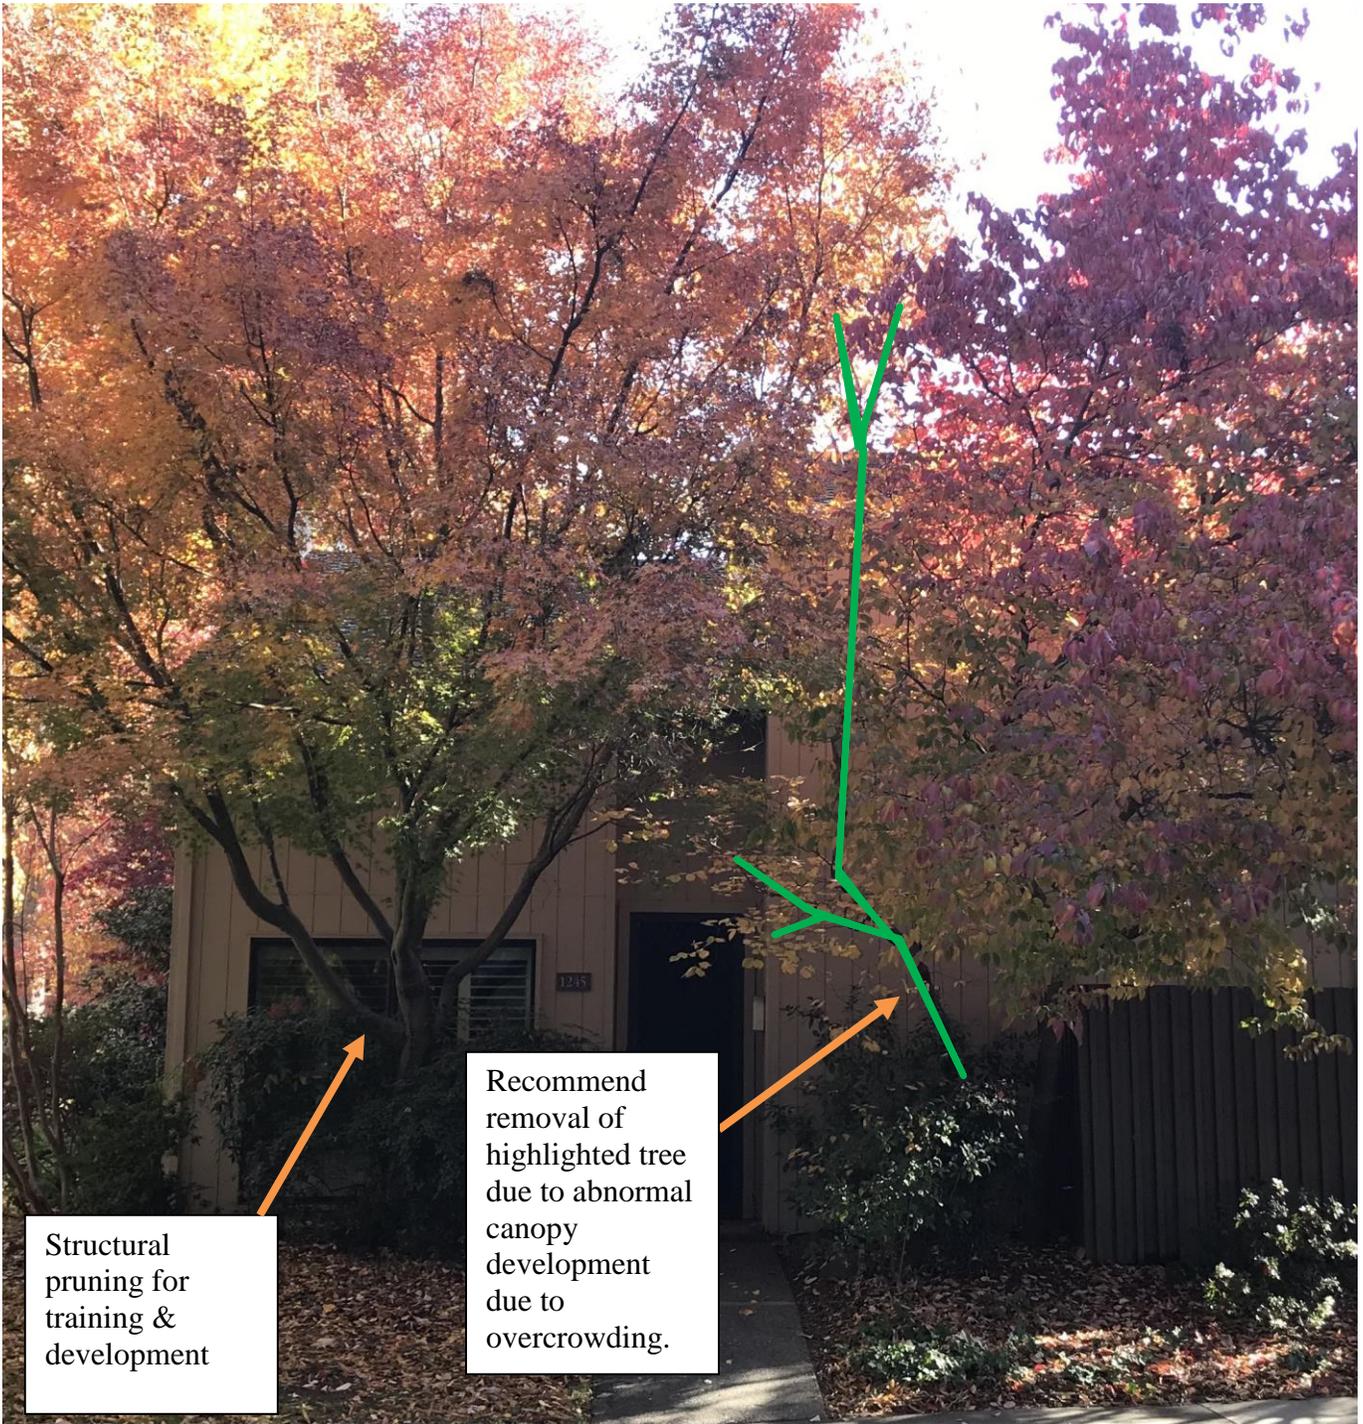
Figure 7

- (Zone 5) Tree No Tag Dogwood (*Cornus nuttallii*), 1245 Vanderbilt (Figure 7) Tree next to front entrance is overcrowded due to several other trees planted too closely. The tree has not developed a natural structure and the entire canopy is on the roof causing an ongoing clearance issue. I recommend removal of this tree due to the proximity to the home and to allow that other trees in the area more room to grow properly.

Structural pruning for training & development

Recommend removal of highlighted tree due to abnormal canopy development due to overcrowding.

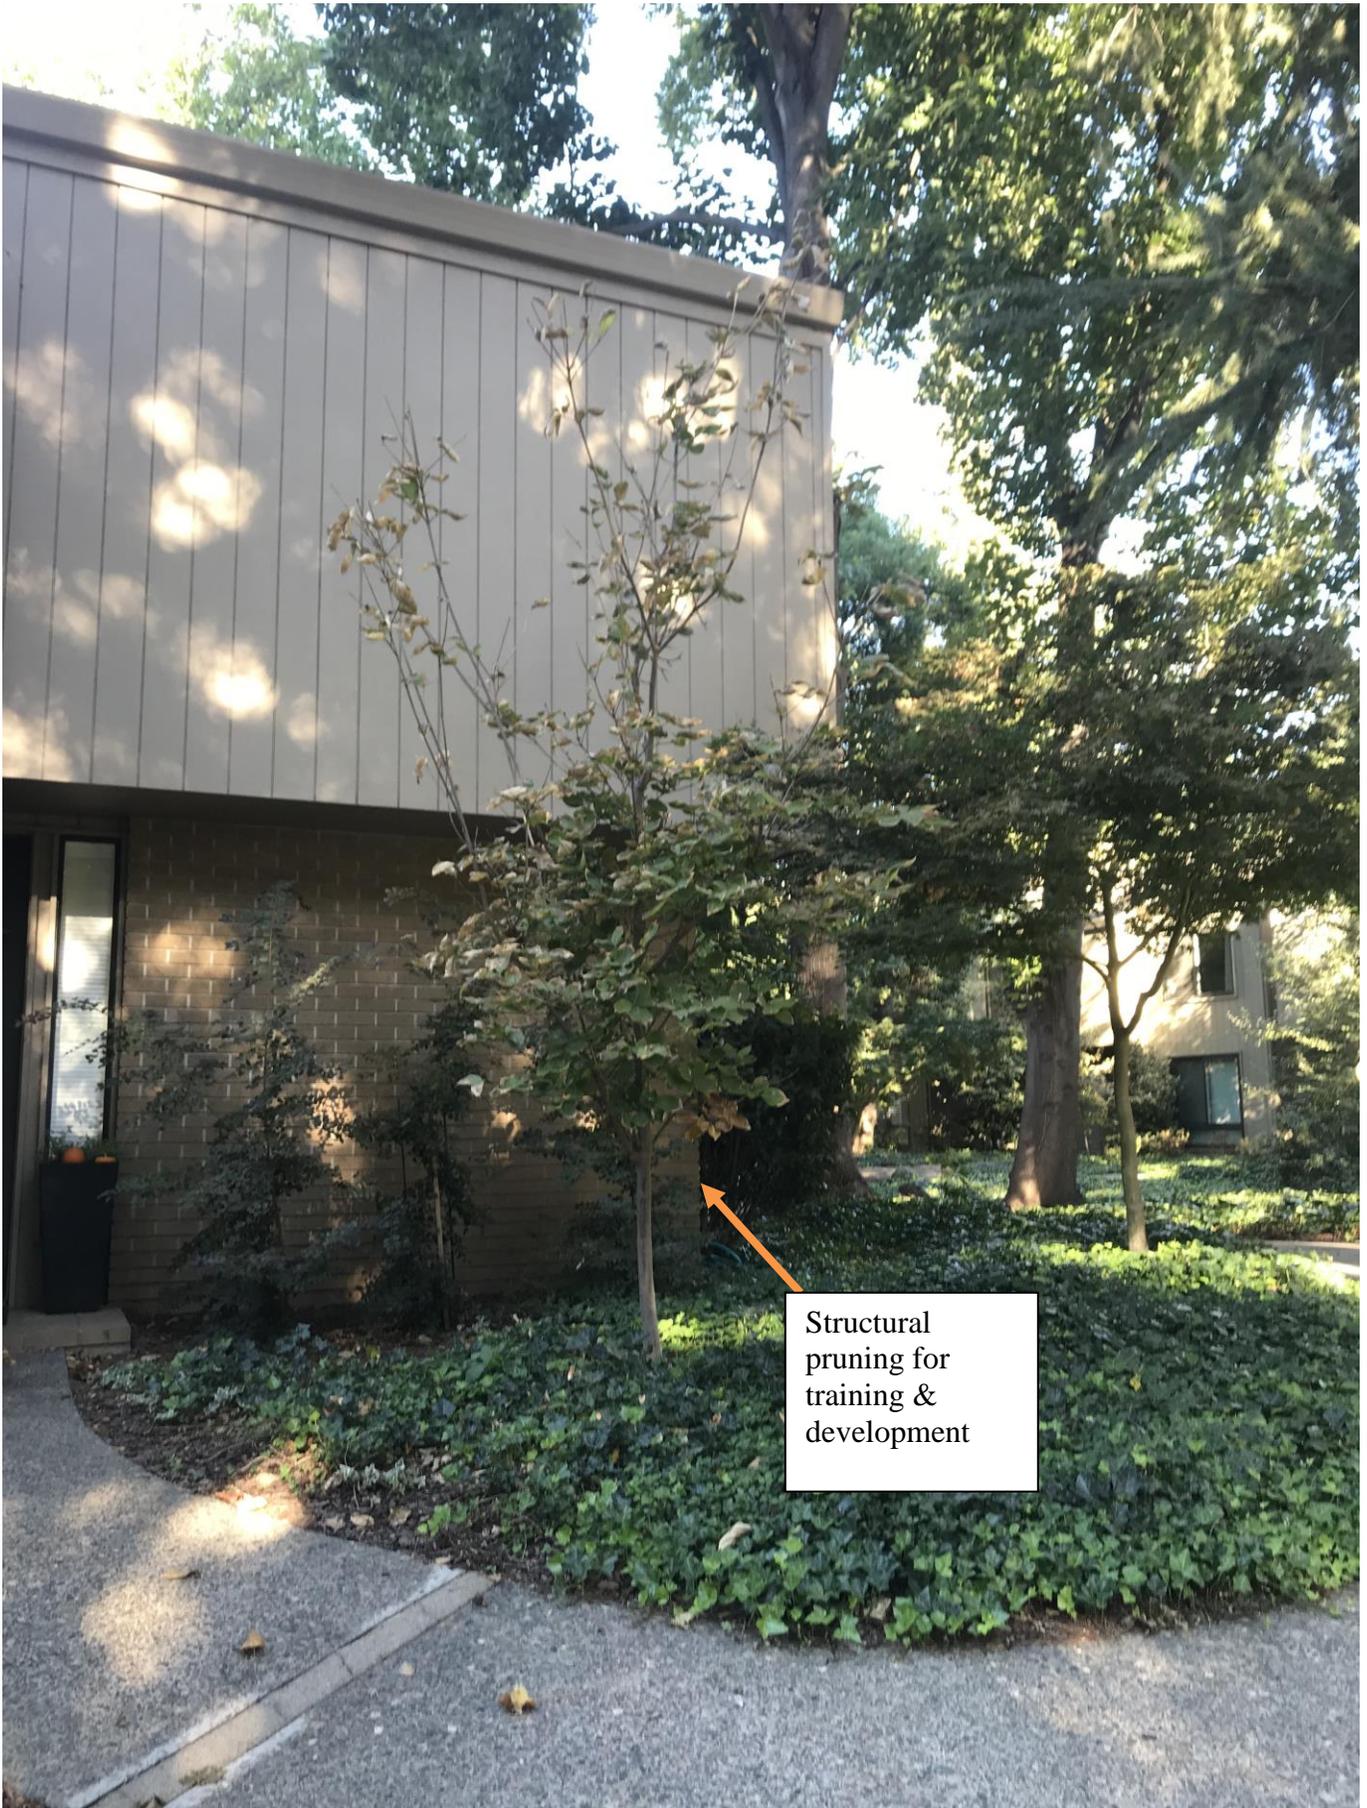
Figure 8

- (Zone 5) Tree No Tag Dogwood (*Cornus nuttallii*), 1207 Vanderbilt. (Figure 8) This tree requires structural pruning to help with direction of growth and healthy canopy development

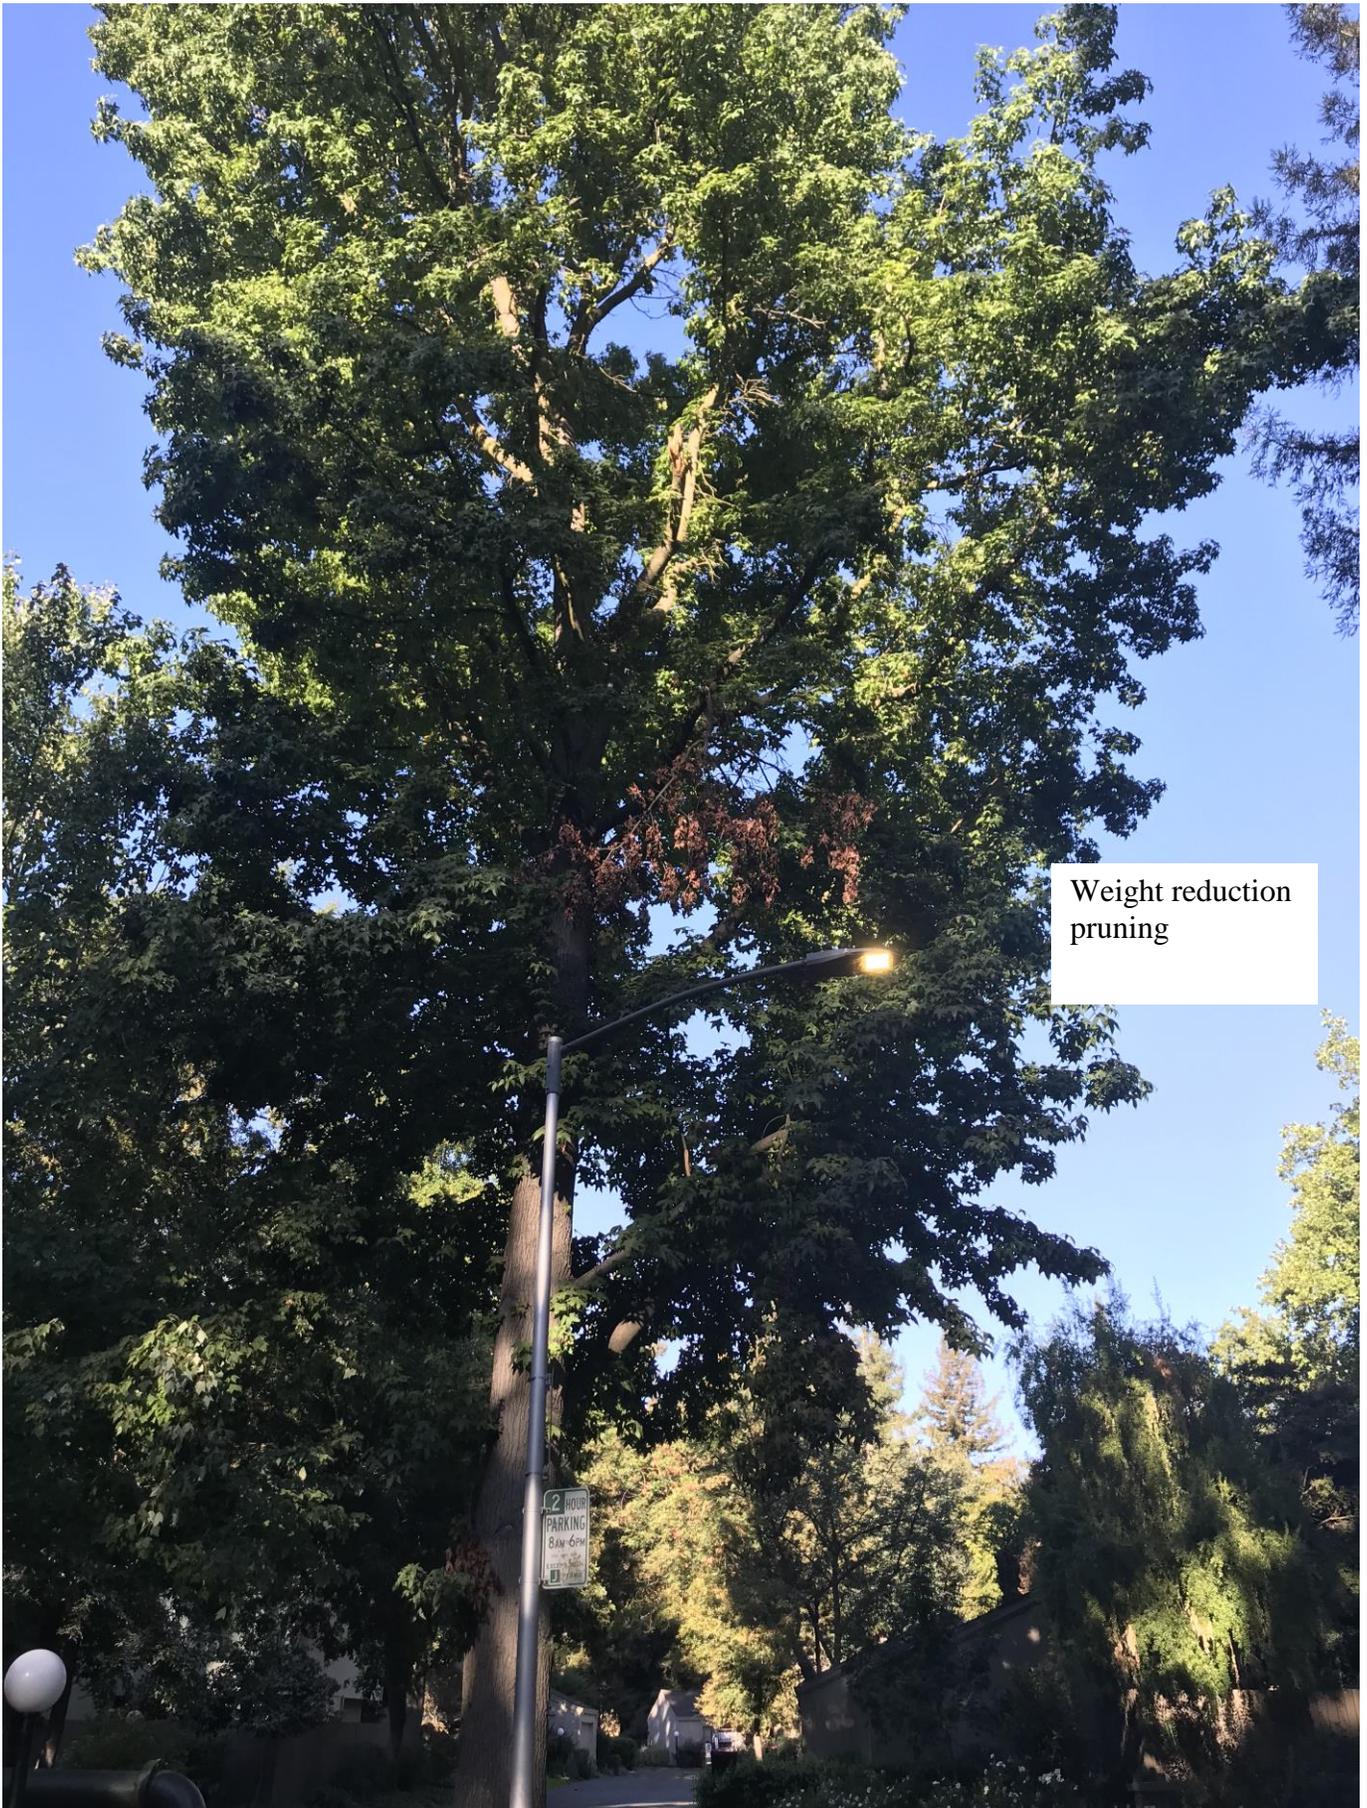
Figure 9

- (Zone 5) Tree #1325, Sweetgum (*Liquidambar styraciflua*), in front of 1235 Vanderbilt. (Figure 9). Tree has a full and heavy canopy I recommend weight reduction pruning.

Weight reduction
pruning
