November 10, 2020

The Nepenthe Association
1131 Commons Dr.
Sacramento, CA 95825
Phone: (916) 929-8380
Email: Bettsi.Ledesma@fsresidential.com

On October 14, 2020, I inspected several trees on the Nepenthe property during the monthly tree walk. The focus of the walk was to address resident/management concerns regarding mature trees on the property. The purpose of this report is to develop mitigation plans for the following trees and my recommendations are below. My recommendations are based on a Basic Visual Inspection. All decisions made based on the recommendations of this report are at the discretion of the Nepenthe Association.

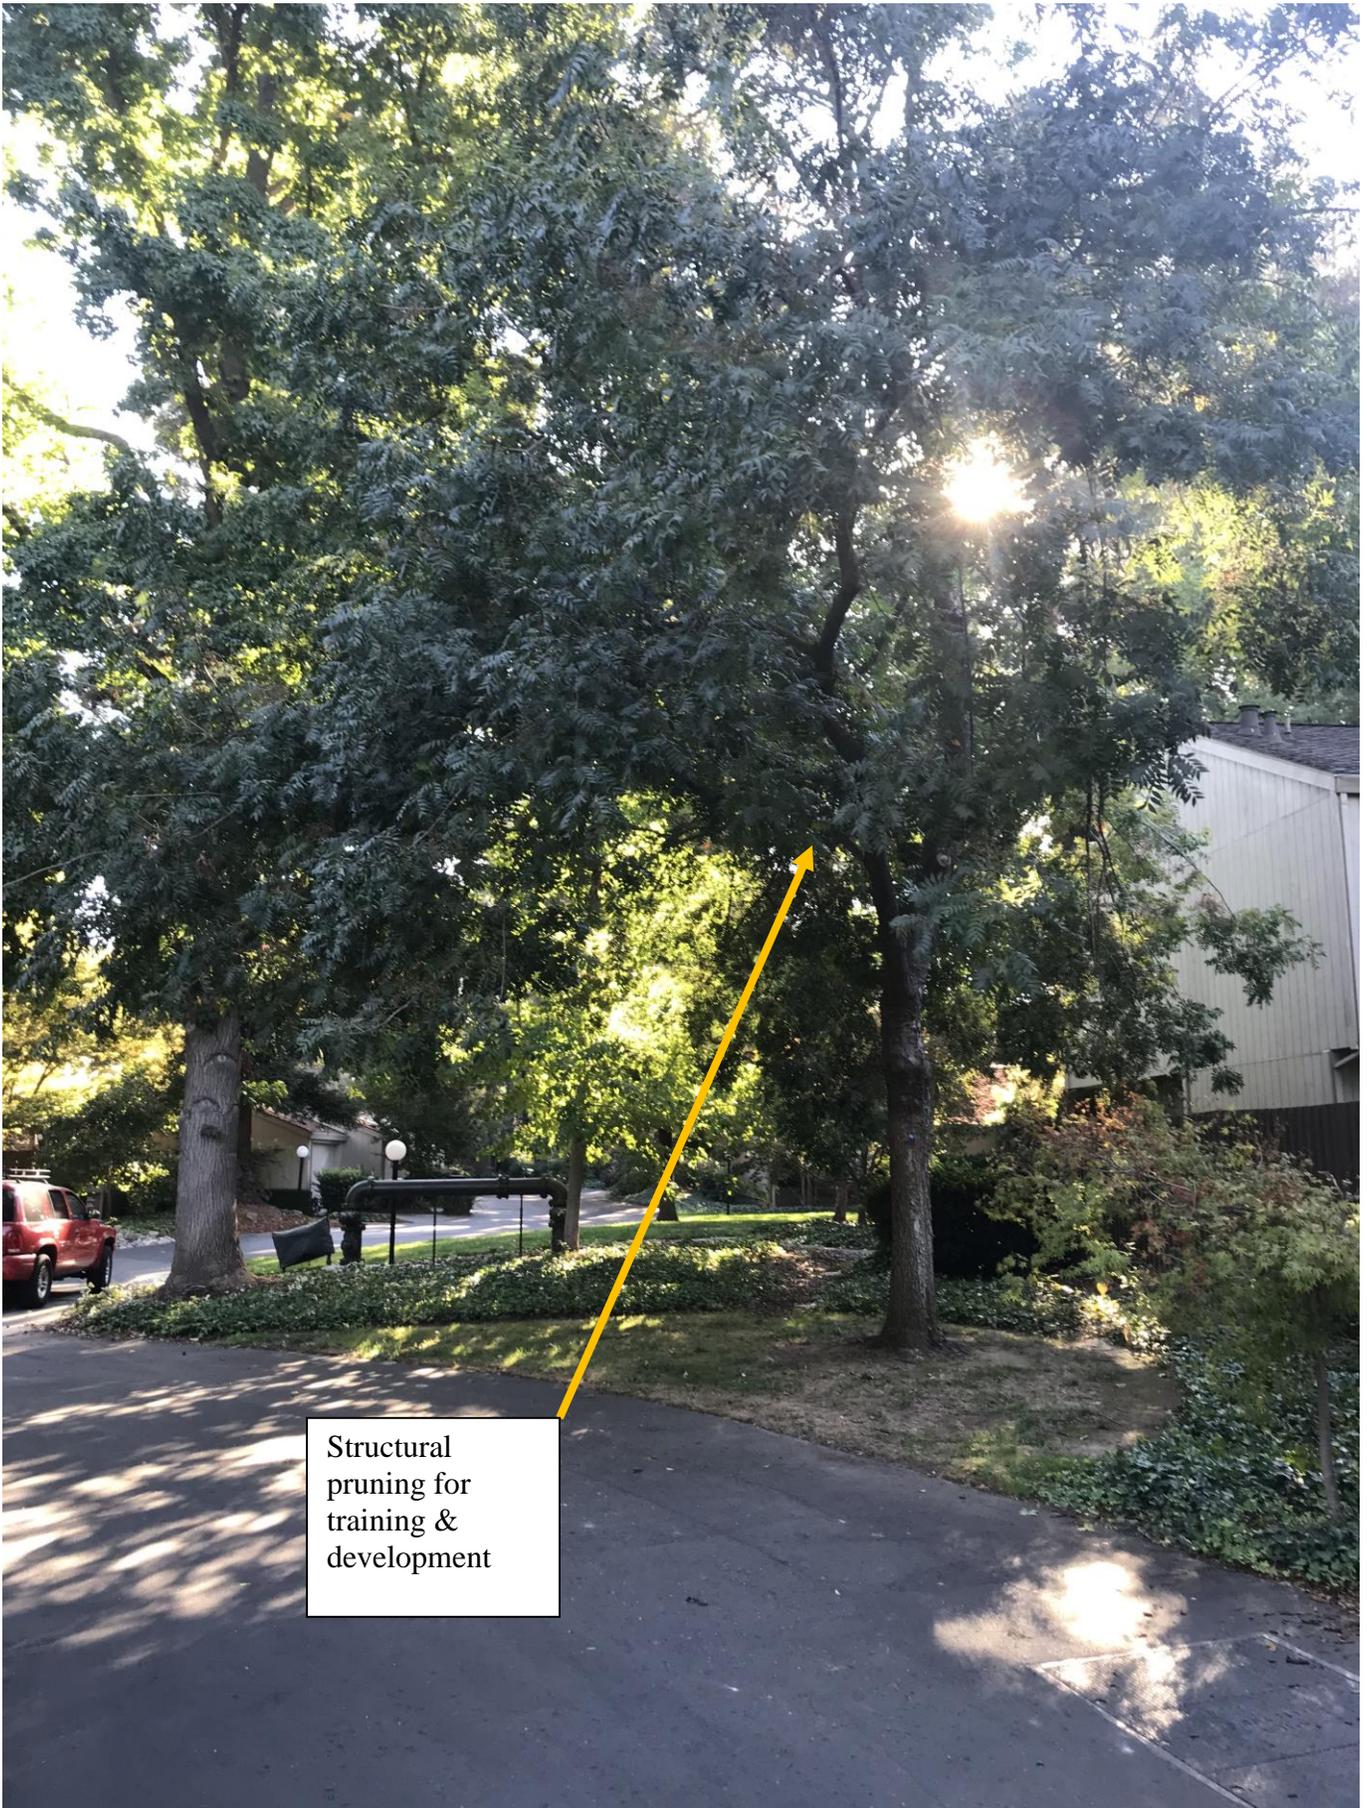
Figure 10

- (Zone 5) Tree #1326, Chinese pistache (*Pistacia chinensis*), (Figure 10) in front of 1235 Vanderbilt. Tree requires structural pruning to help with direction of growth and healthy canopy development

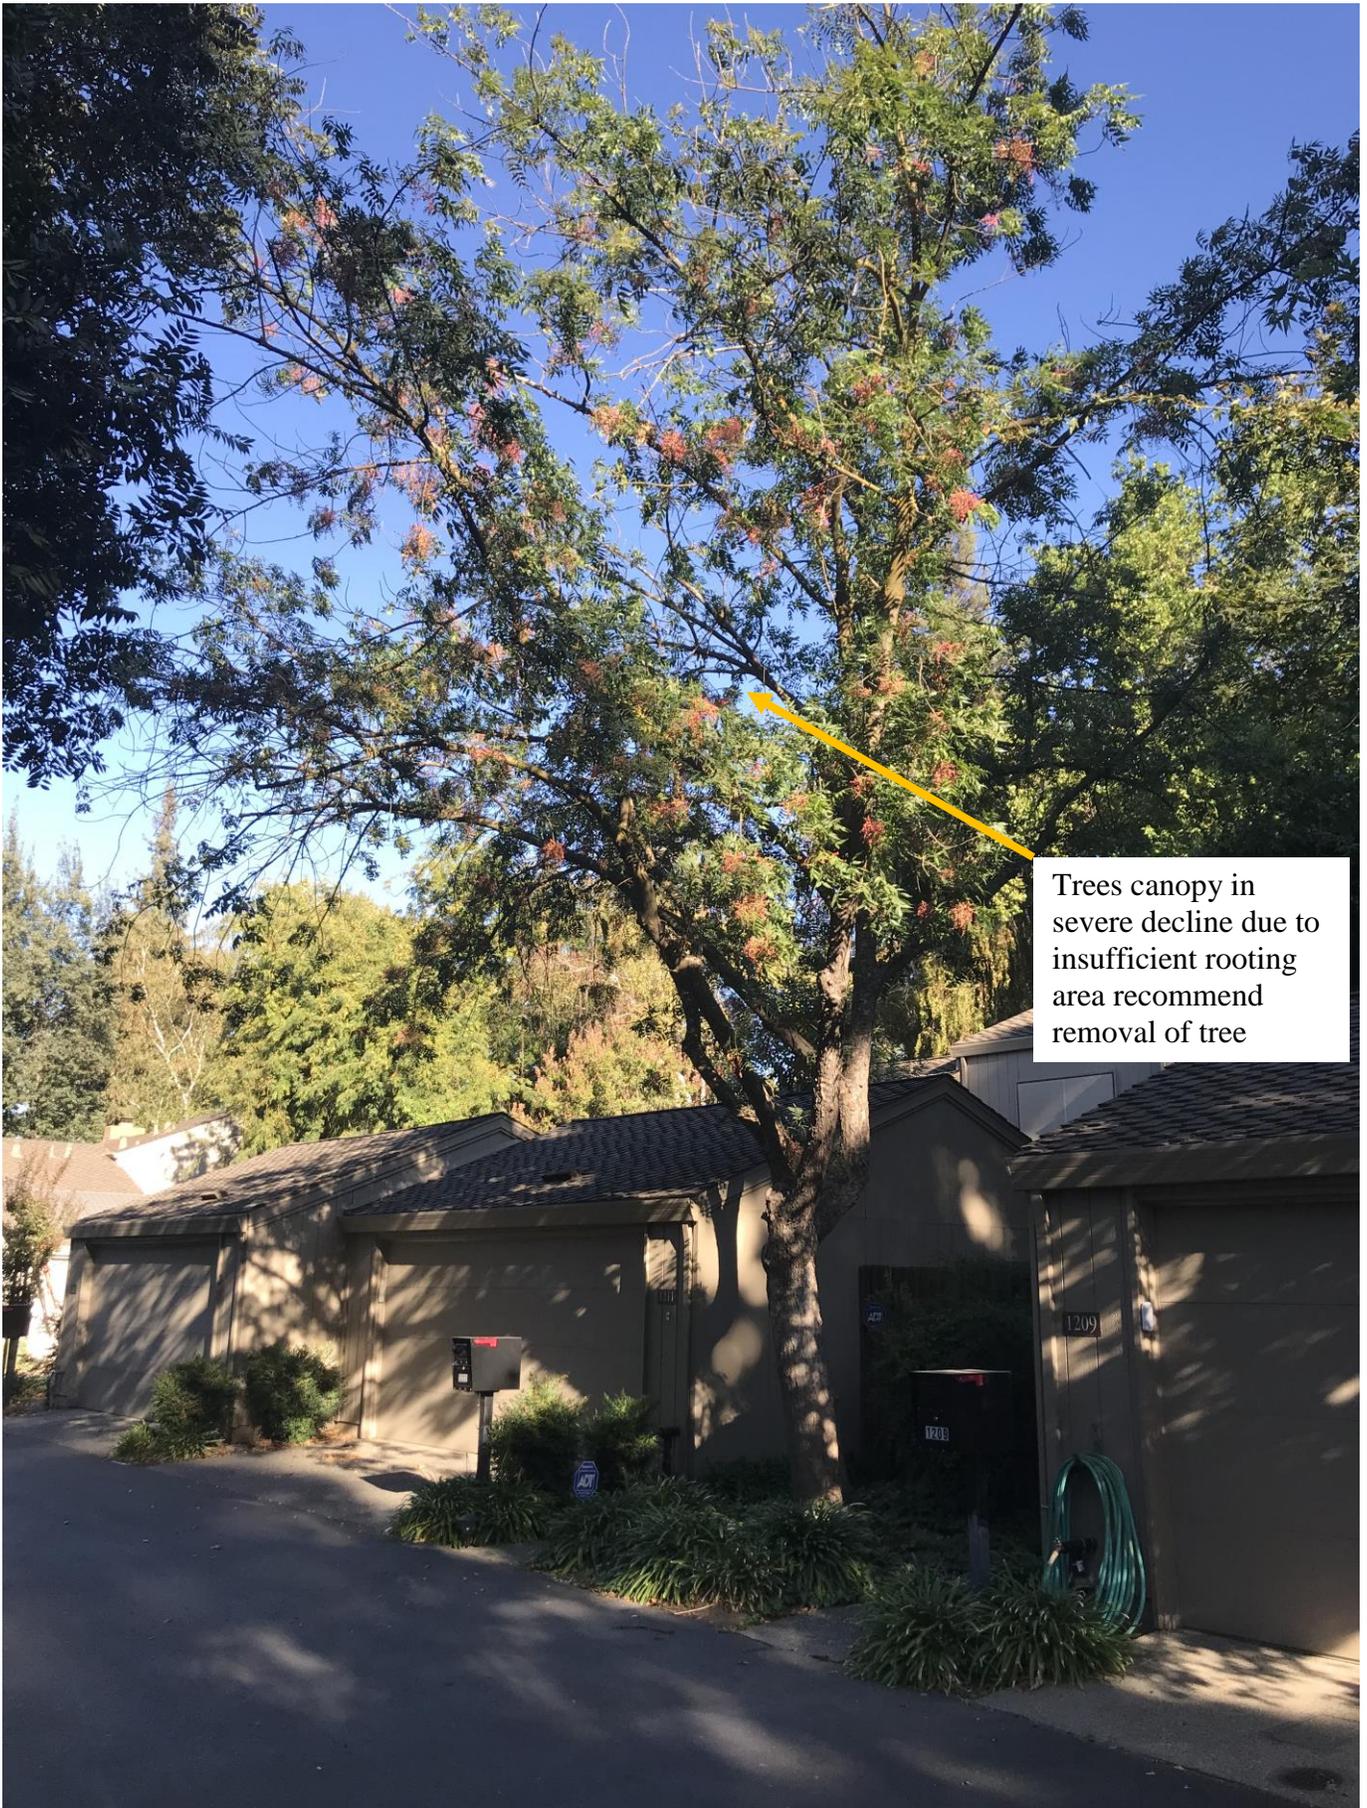
Figure 11

- (Zone 5) Trees #1586, Chinese pistache (*Pistacia chinensis*), (Figure 11) in front of 1211 Vanderbilt. Tree is in decline due to root related damage. The tree was likely planted root bound causing girdling roots to encircle the root ball causing portions of the root system to decline. I recommend removal and replacement of this tree.

Trees canopy in severe decline due to insufficient rooting area recommend removal of tree

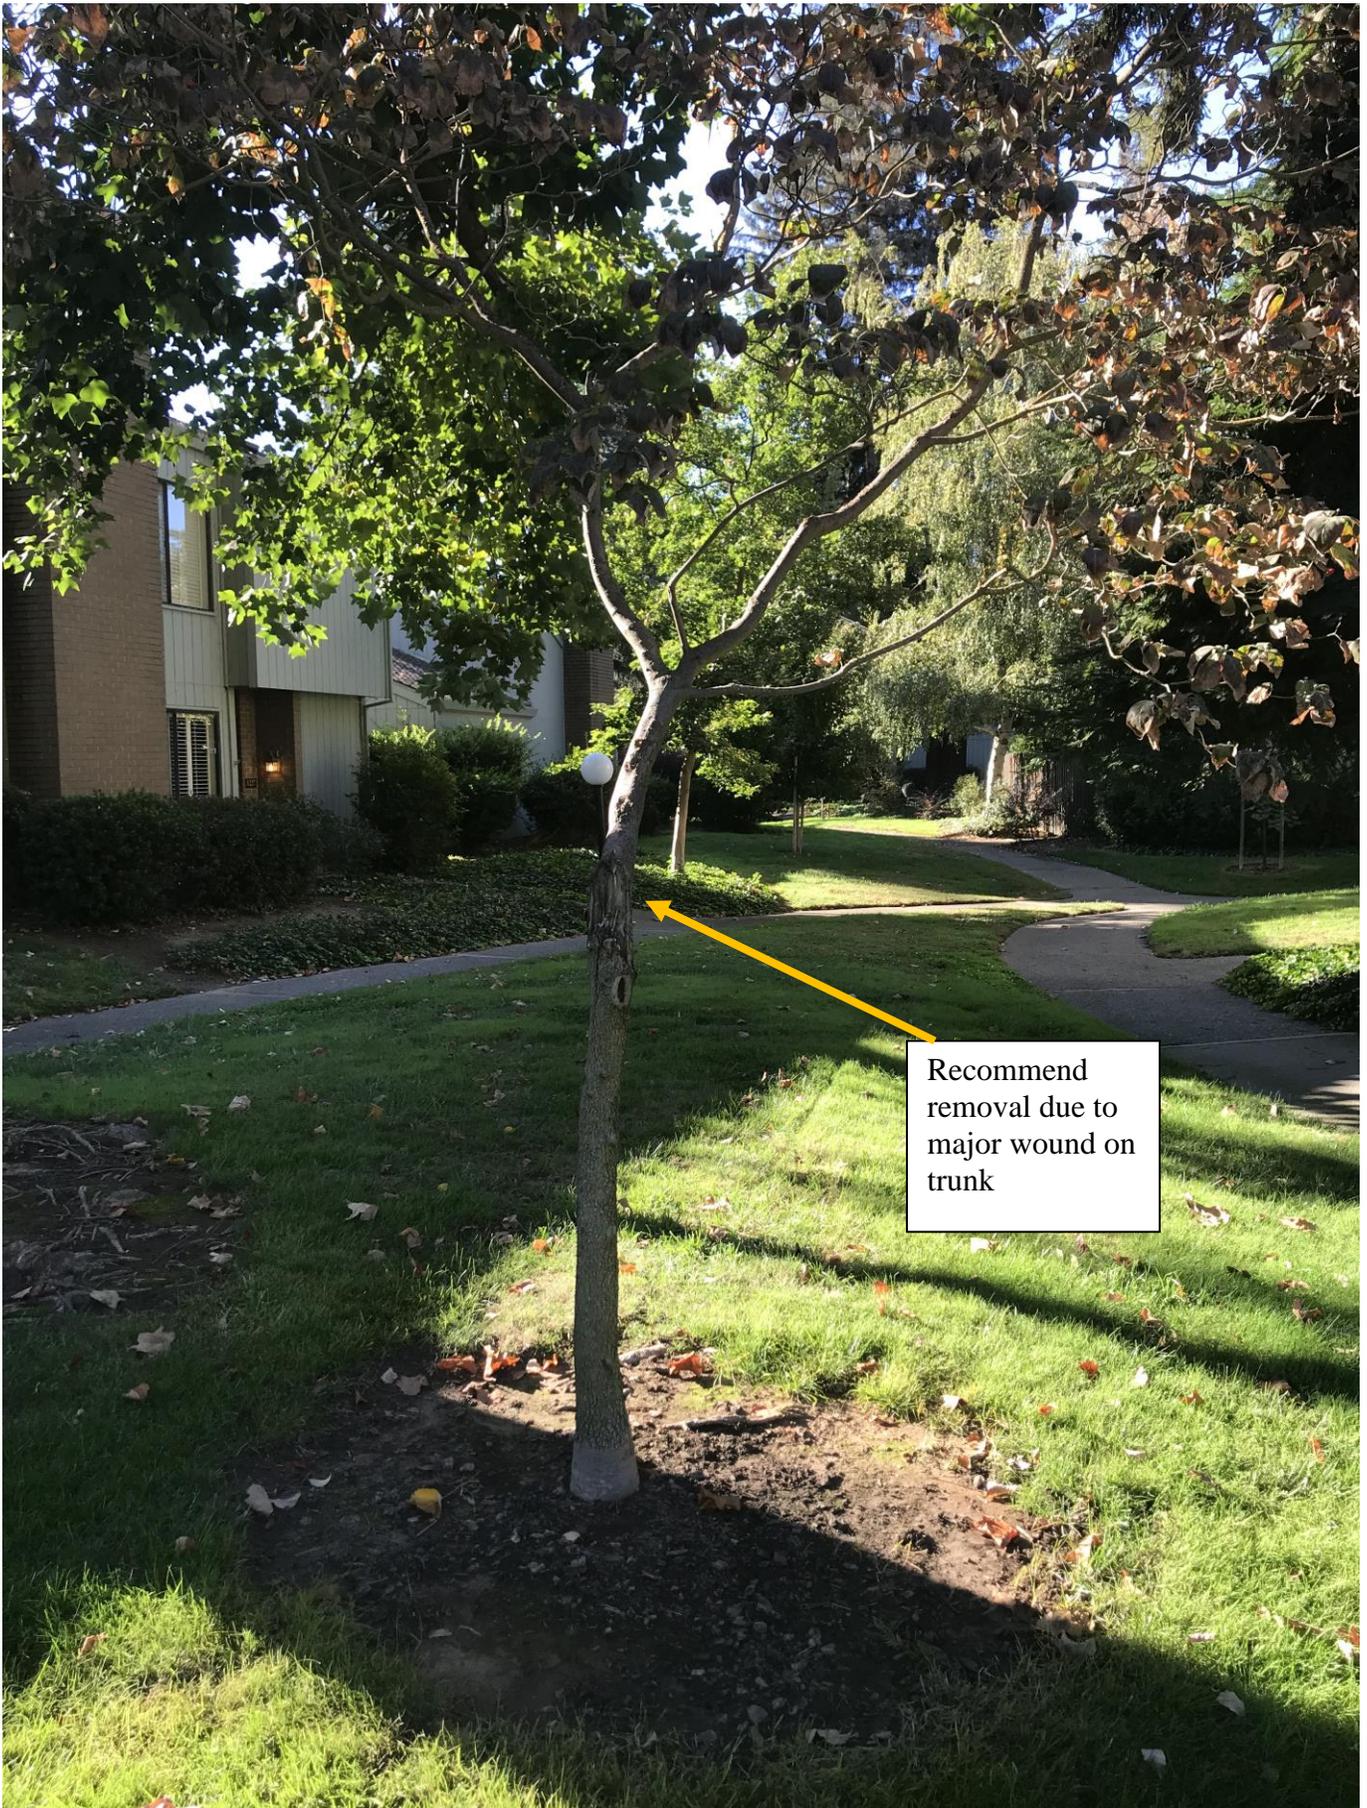
Figure 12

- (Zone 5) Tree # 1471 Dogwood (*Cornus nuttallii*), near 1225 Vanderbilt. (Figure 12) This tree has sustained a major injury and will not likely recover to reach full potential; I recommend removal and replacement of this tree.

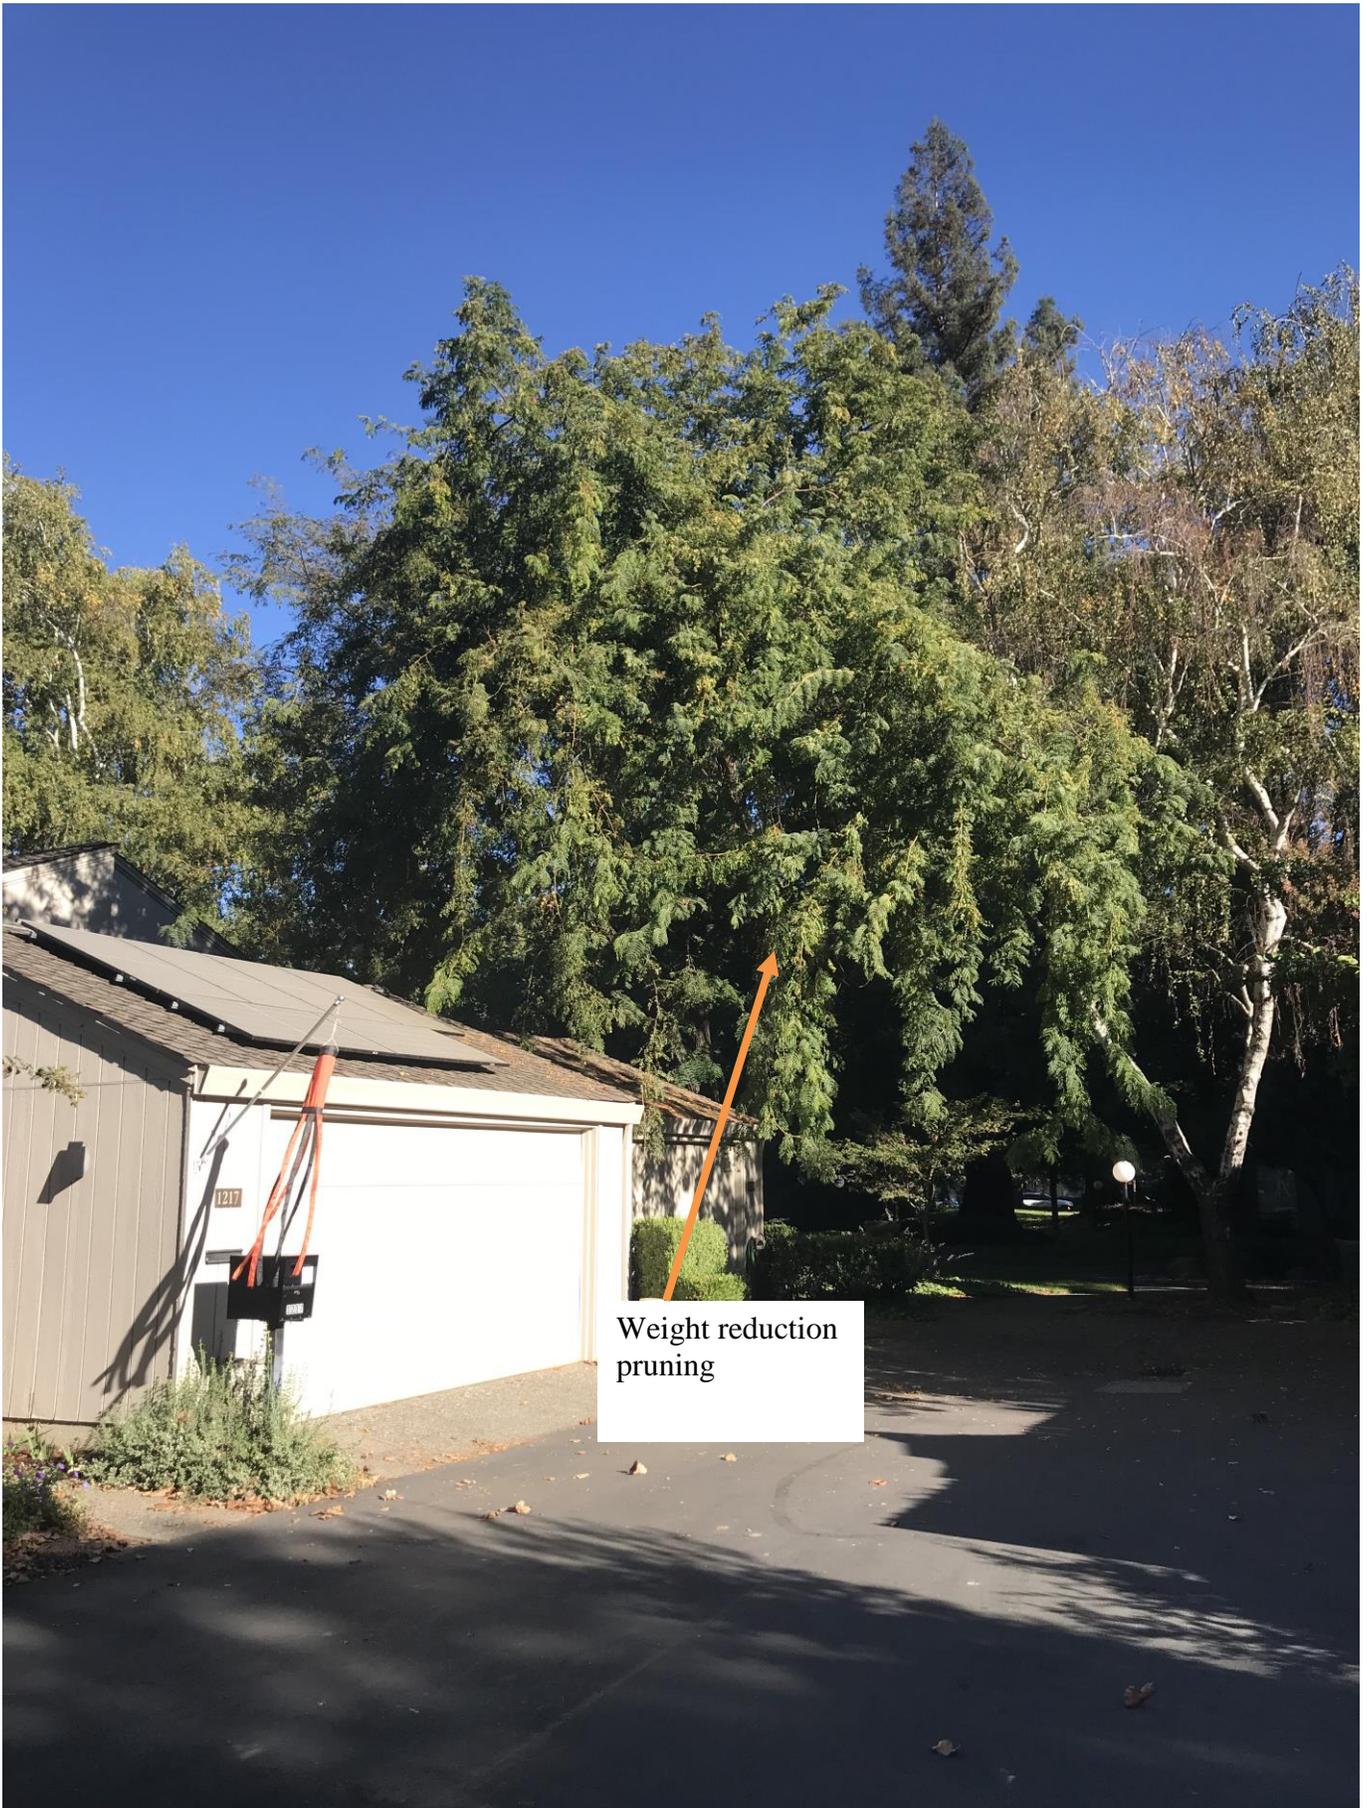
Figure 13

- (Zone 5) Tree #1573 Locust (*Robinia pseudoacacia*), 1215 Vanderbilt (Figure 13). This tree has full and over weighted canopy. I recommend full prune of trees Canopy.

Weight reduction
pruning

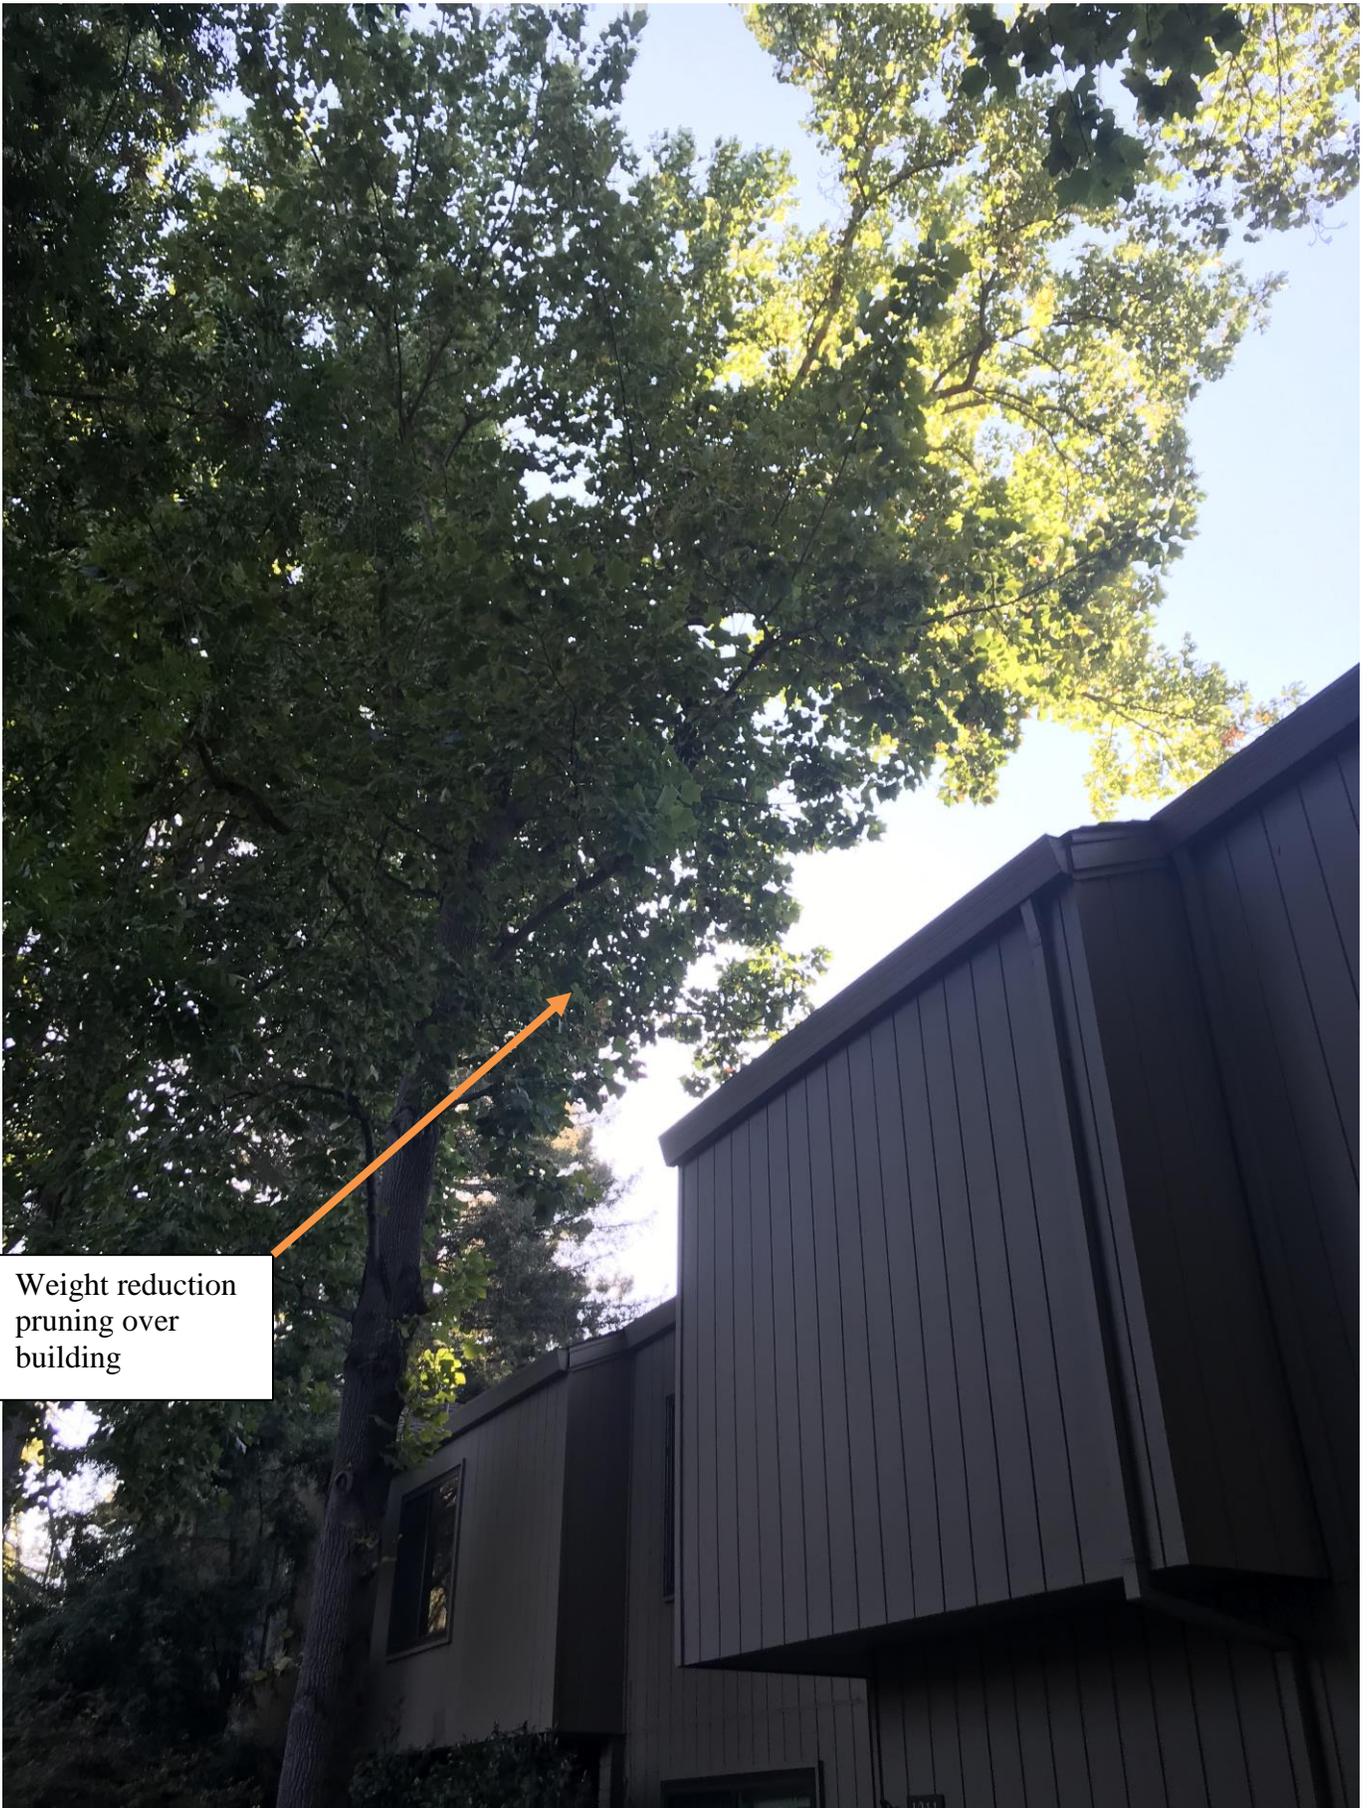
Figure 14

- (Zone 5) Tree #1582 Tulip tree (*Liriodendron tulipifera*), next to 1209 Vanderbilt. (Figure 14). This tree has full and over weighted canopy. I recommend full prune of trees canopy and weight reduction pruning on limb over the roof.

Weight reduction
pruning over
building

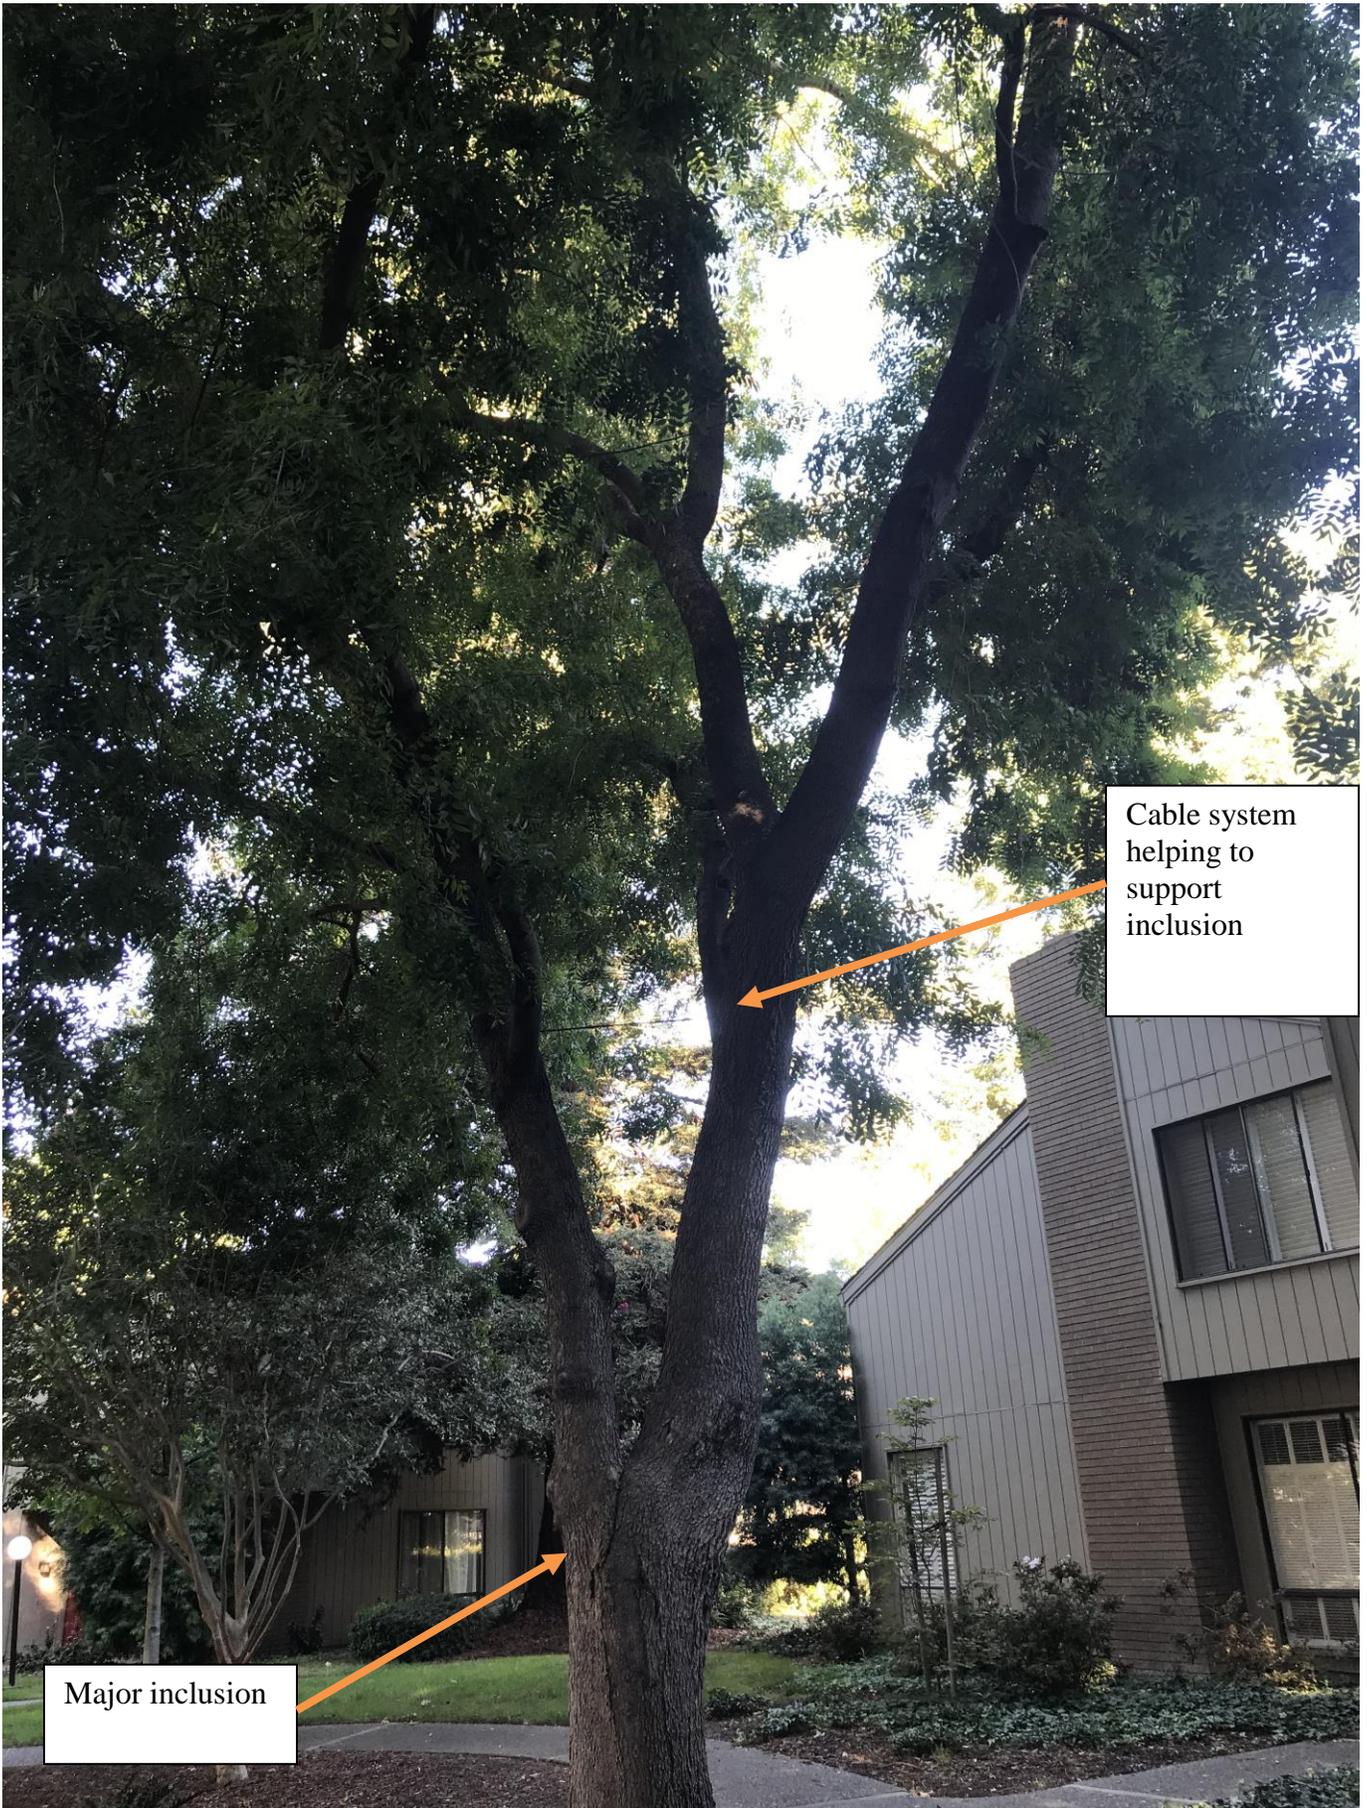
Figure 15

- (Zone 5) Tree #1564, Chinese pistache (*Pistacia chinensis*), (Figure 15) in green belt area between 1213 and 1155 Vanderbilt. Tree requires weight reduction pruning to help take pressure off of cable system and to prevent failure from inclusion.

Major inclusion

Cable system helping to support inclusion

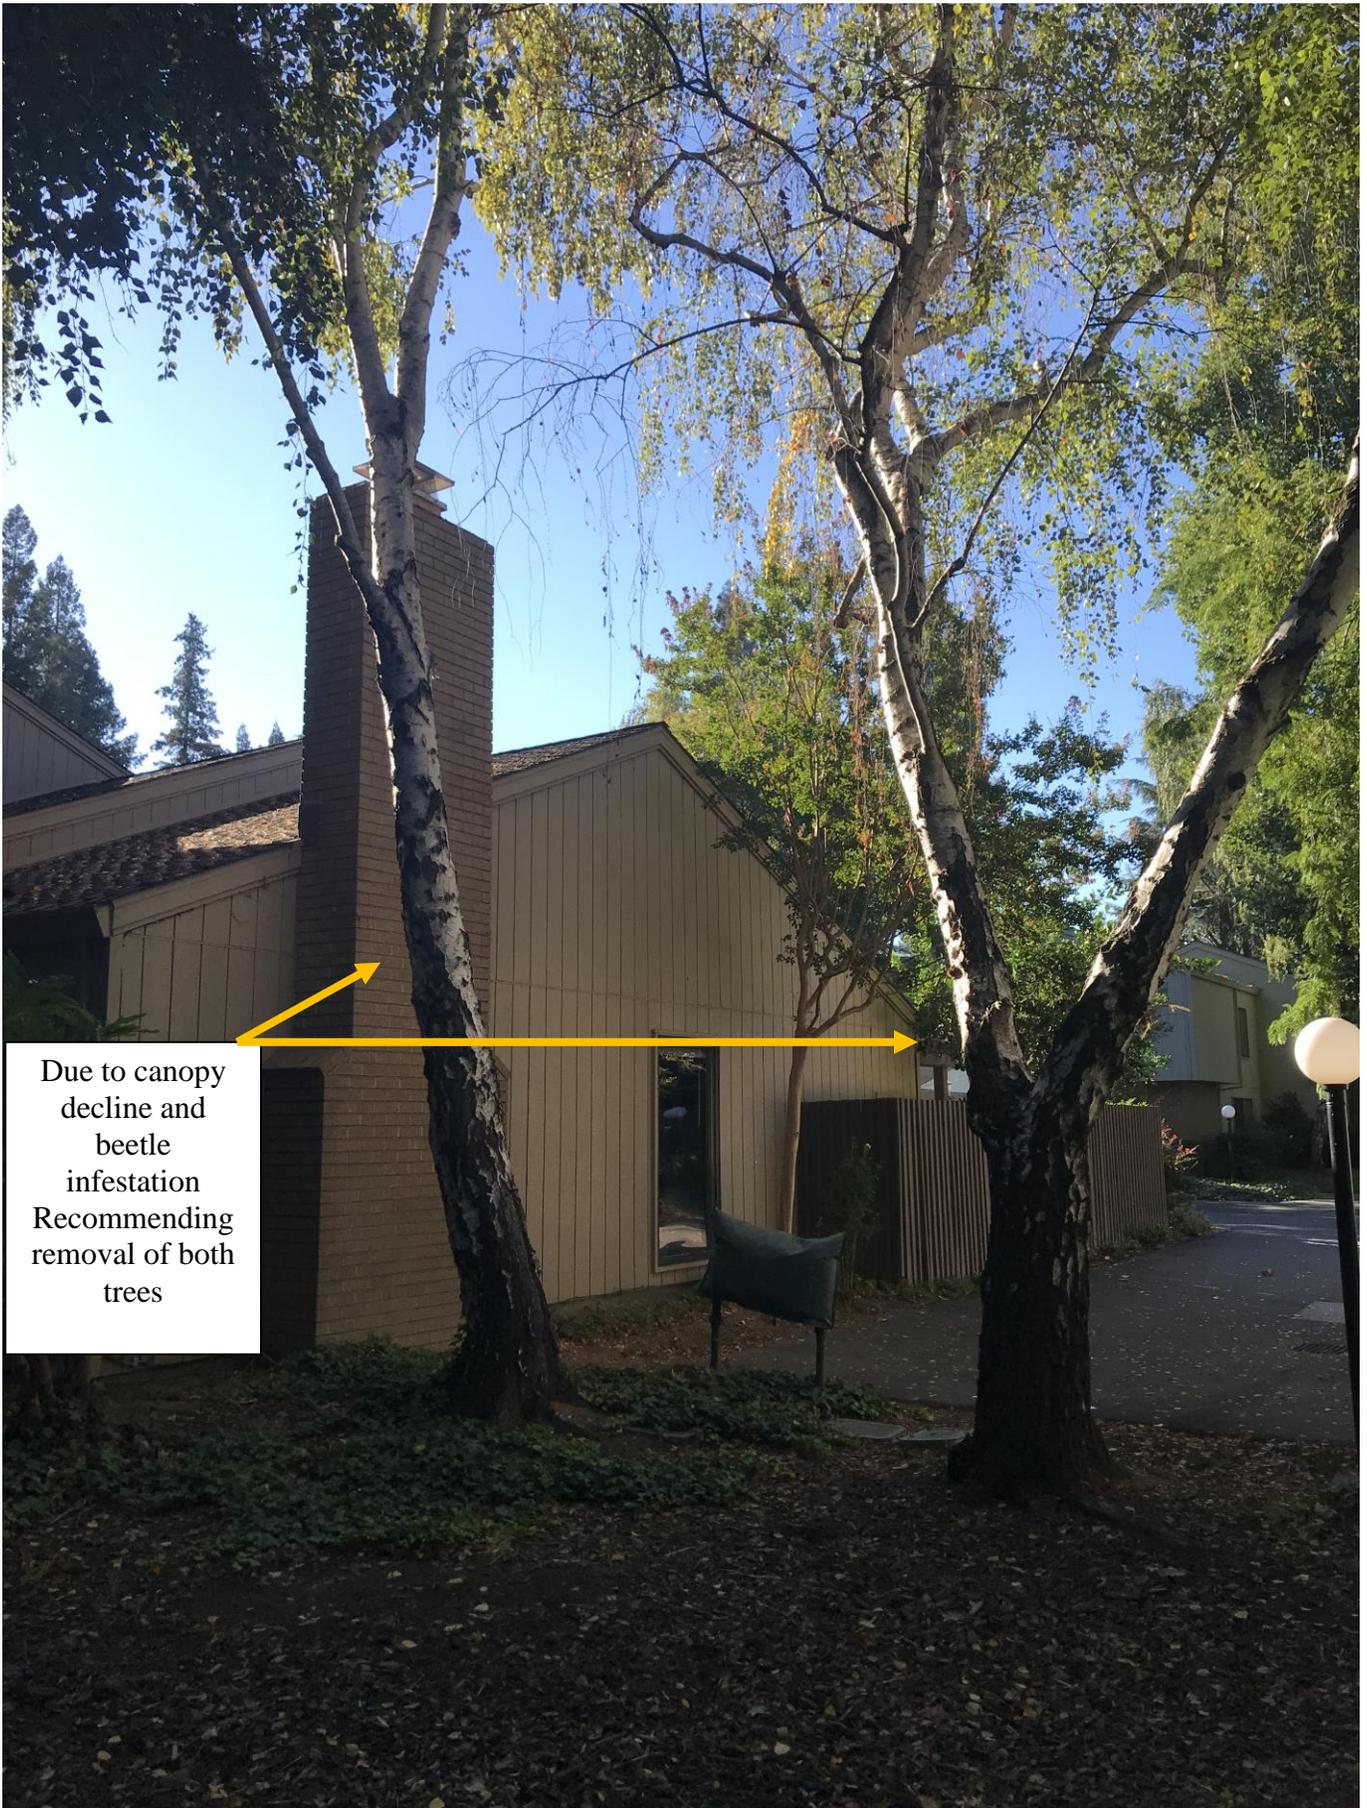
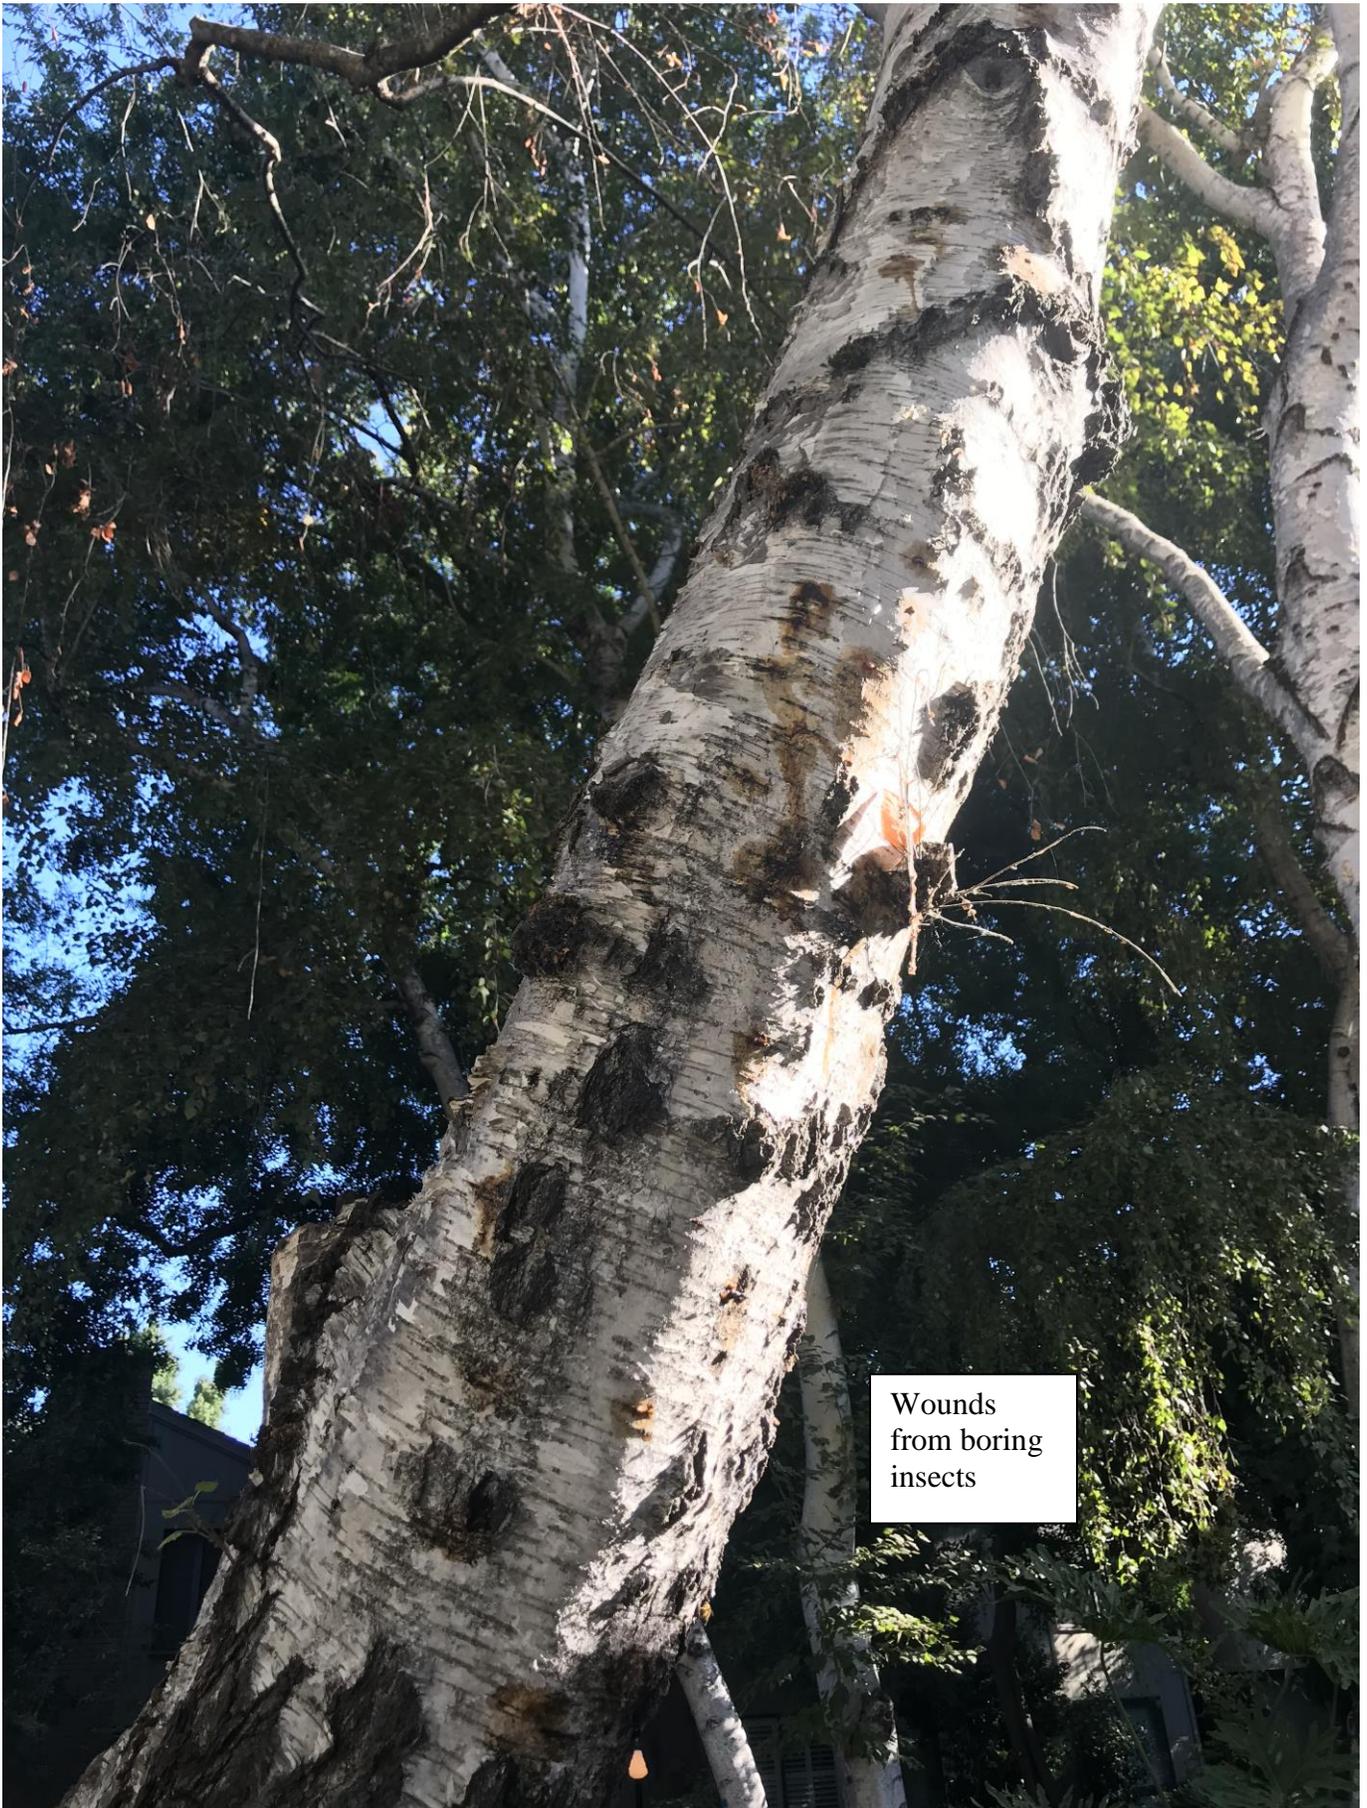
- (Zone 5) Trees #1575 #1576, White Birch (*Betula pendula*) (Figure 16-17) between 1213 & 1215 Vanderbilt. Trees have signs of decline in canopy as well as signs of boring insect infestation. I recommend removal and replacement of both trees.

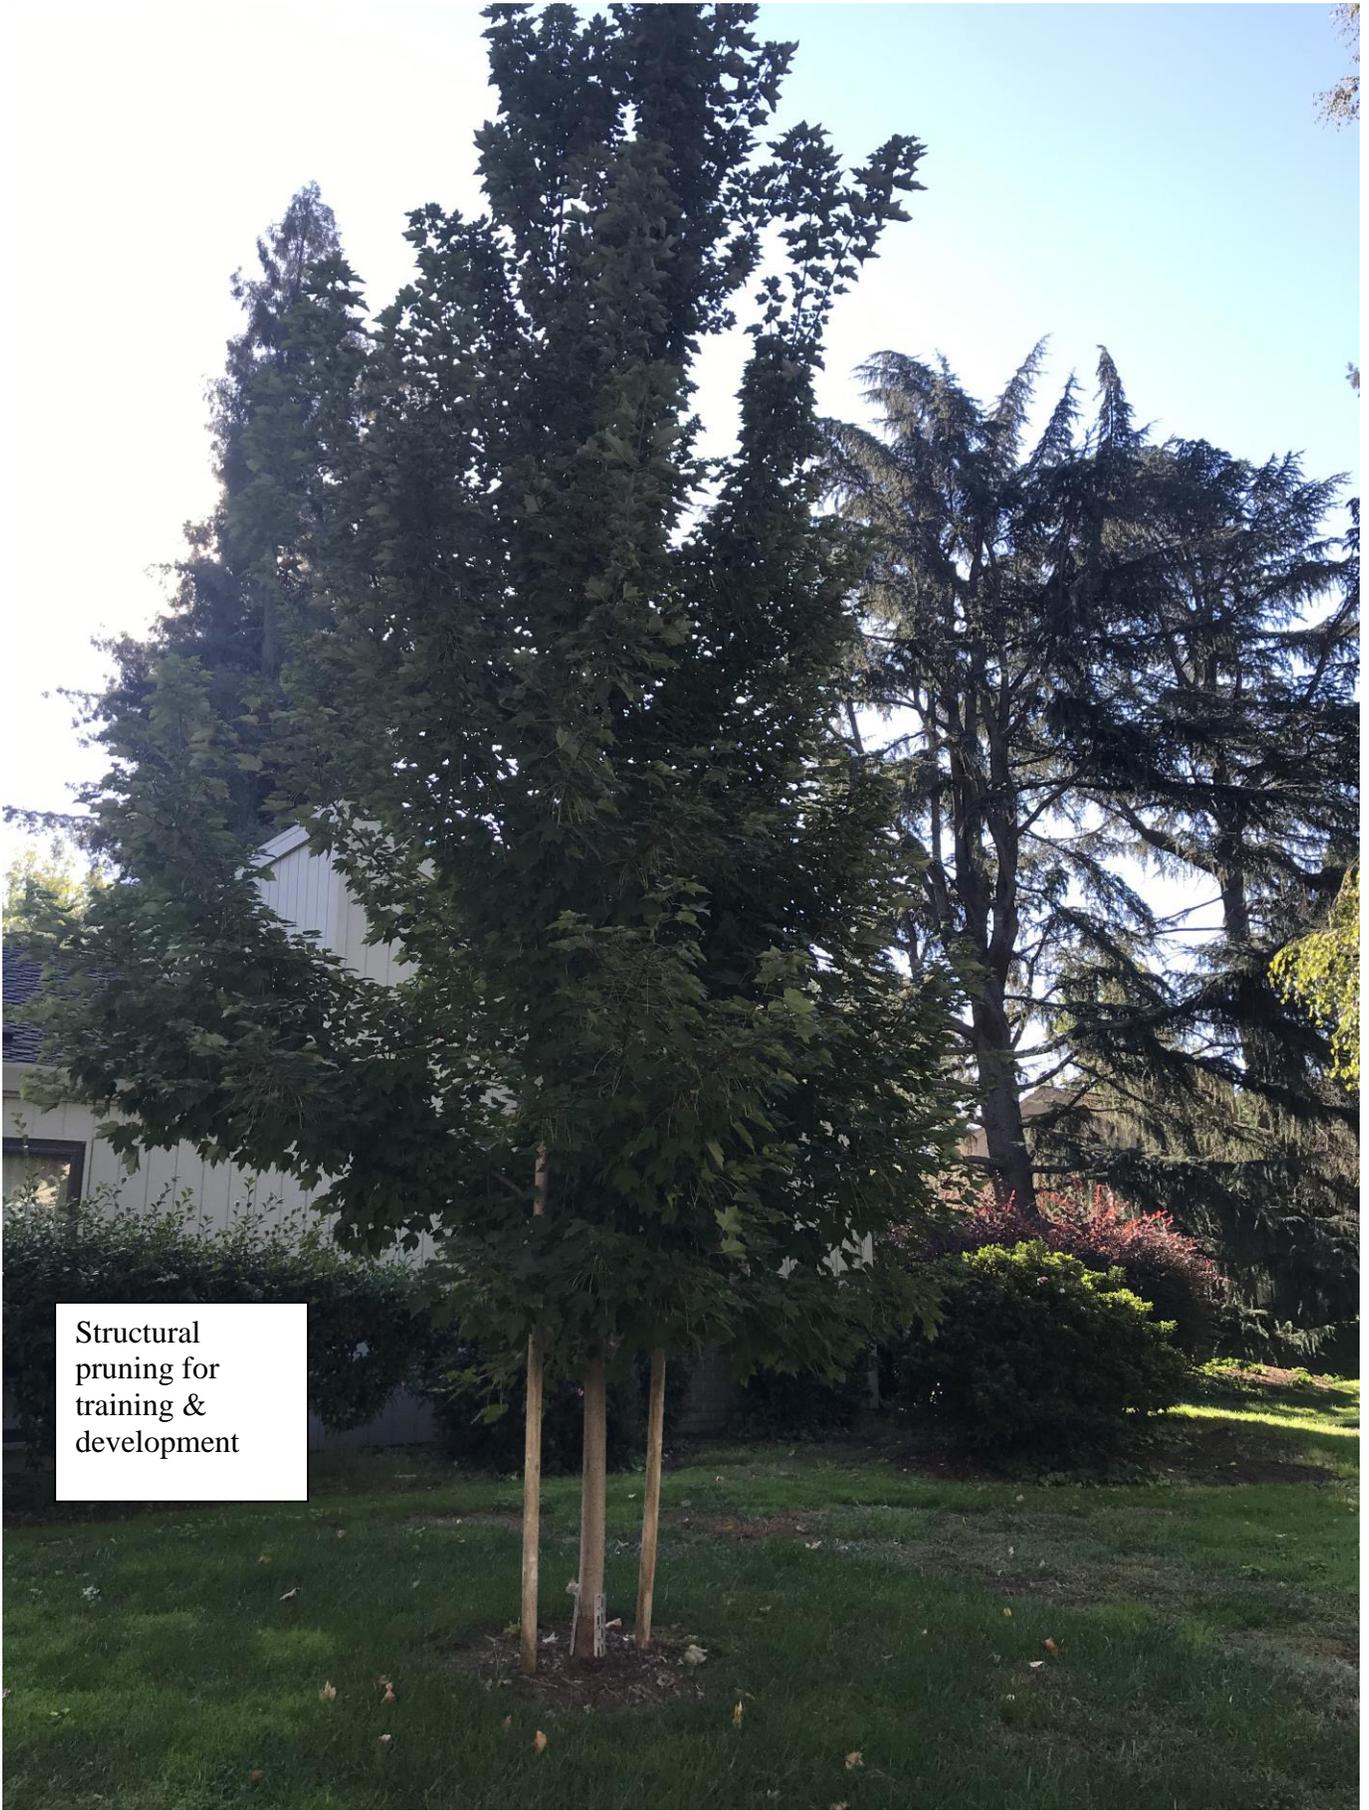
Figure 18

- (Zone 5) Tree #No Tag Maple (*Acer rubrum*) next to 1227 Vanderbilt. (Figure 18) Young tree need structural pruning to encourage proper development.
- (Zone 5) Tree #1463, Sweetgum (*Liquidambar styraciflua*), next to 607 Elmhurst. (Figure 19). The tree canopy is full and heavy I recommend weight reduction pruning.

Structural
pruning for
training &
development
