November 10, 2020

The Nepenthe Association
1131 Commons Dr.
Sacramento, CA 95825
Phone: (916) 929-8380
Email: Bettsi.Ledesma@fsresidential.com

On October 14, 2020, I inspected several trees on the Nepenthe property during the monthly tree walk. The focus of the walk was to address resident/management concerns regarding mature trees on the property. The purpose of this report is to develop mitigation plans for the following trees and my recommendations are below. My recommendations are based on a Basic Visual Inspection. All decisions made based on the recommendations of this report are at the discretion of the Nepenthe Association.

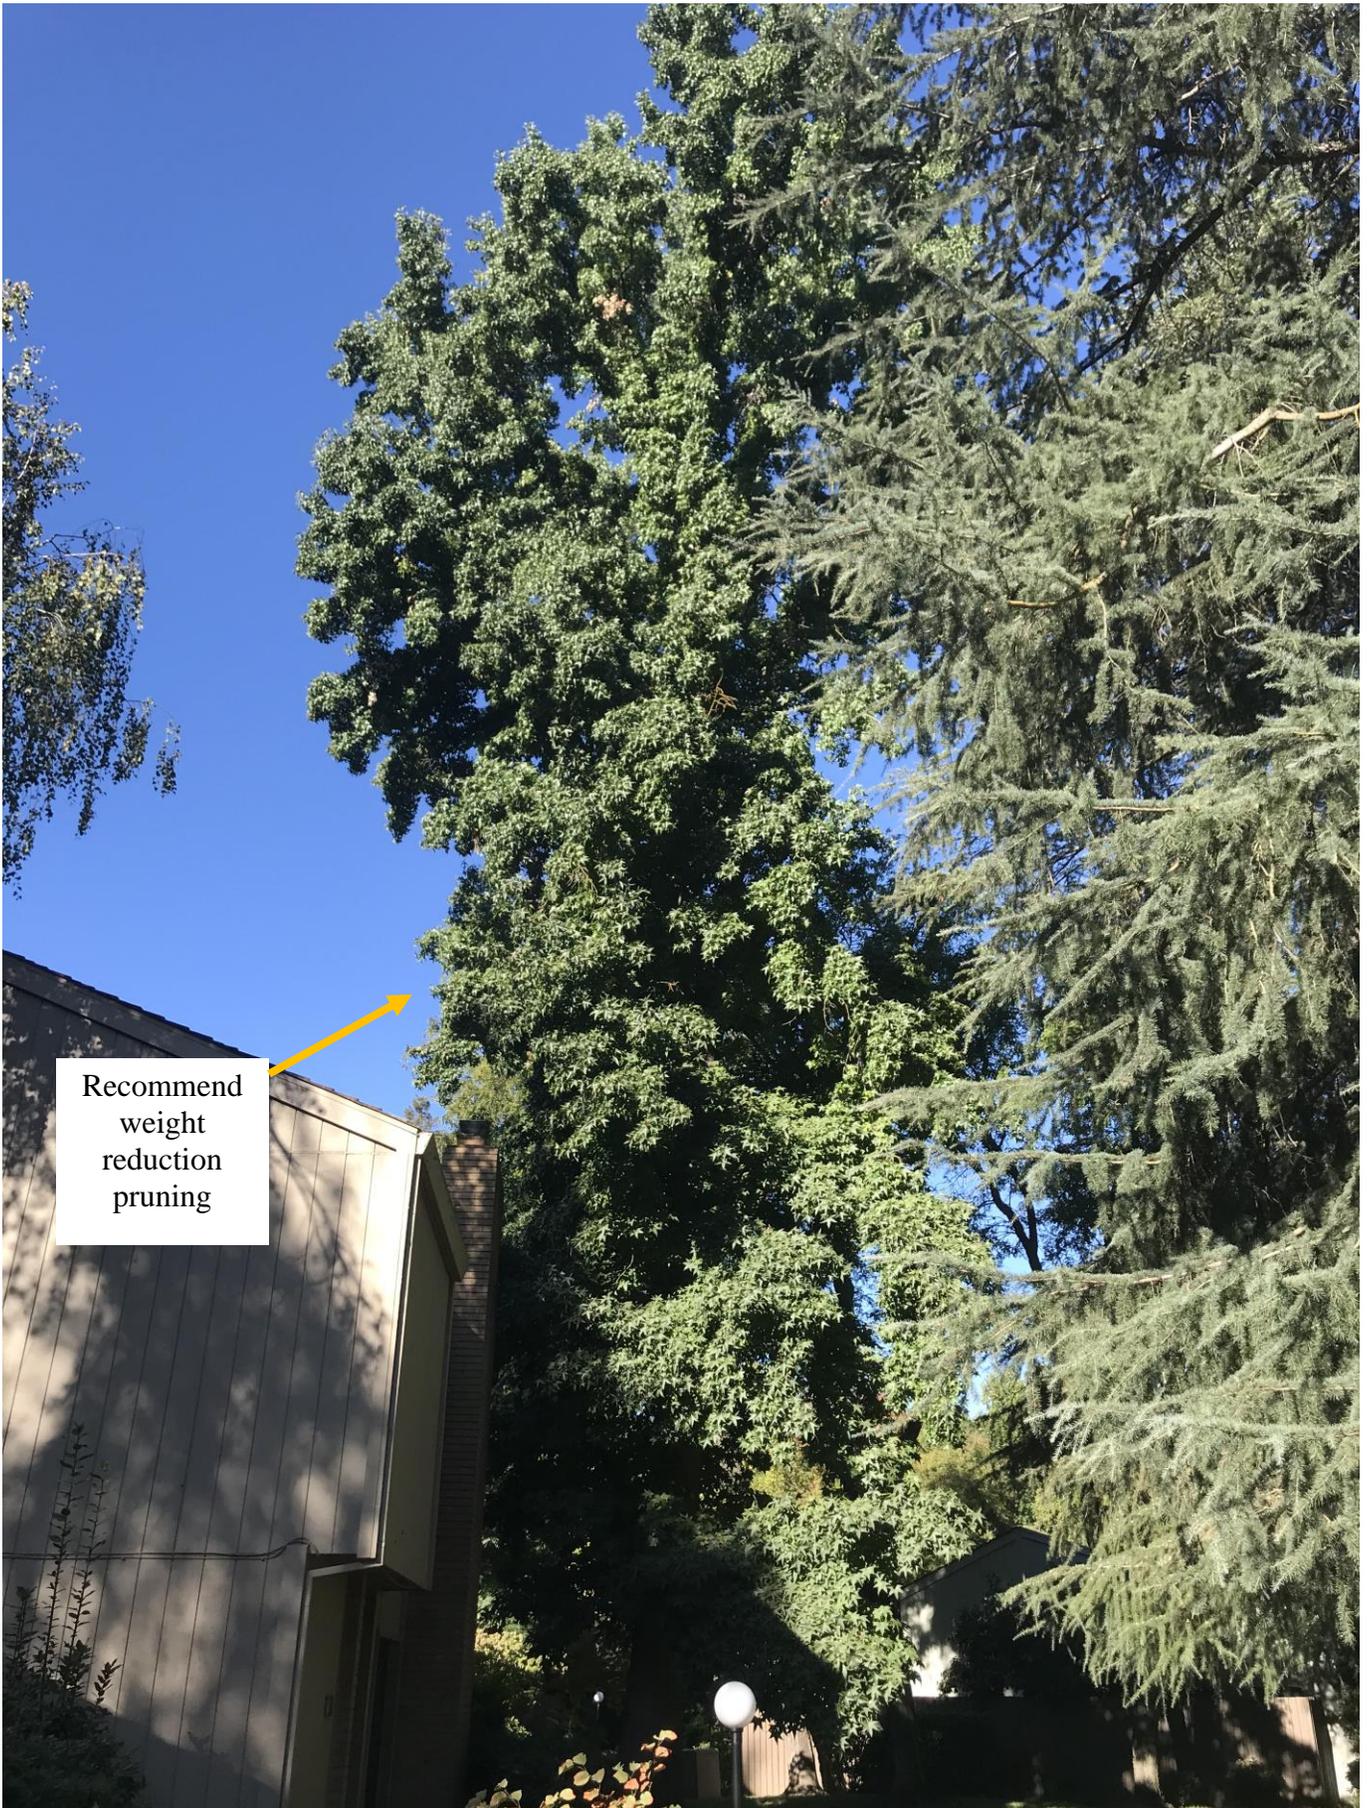
Figure 19

- (Zone 5) Tree #No Tag Maple (*Acer rubrum*) next to 1227 Vanderbilt. (Figure 18) Young tree need structural pruning to encourage proper development.
- (Zone 5) Tree #1463, Sweetgum (*Liquidambar styraciflua*), next to 607 Elmhurst. (Figure 19). The tree canopy is full and heavy I recommend weight reduction pruning.

Recommend
weight
reduction
pruning

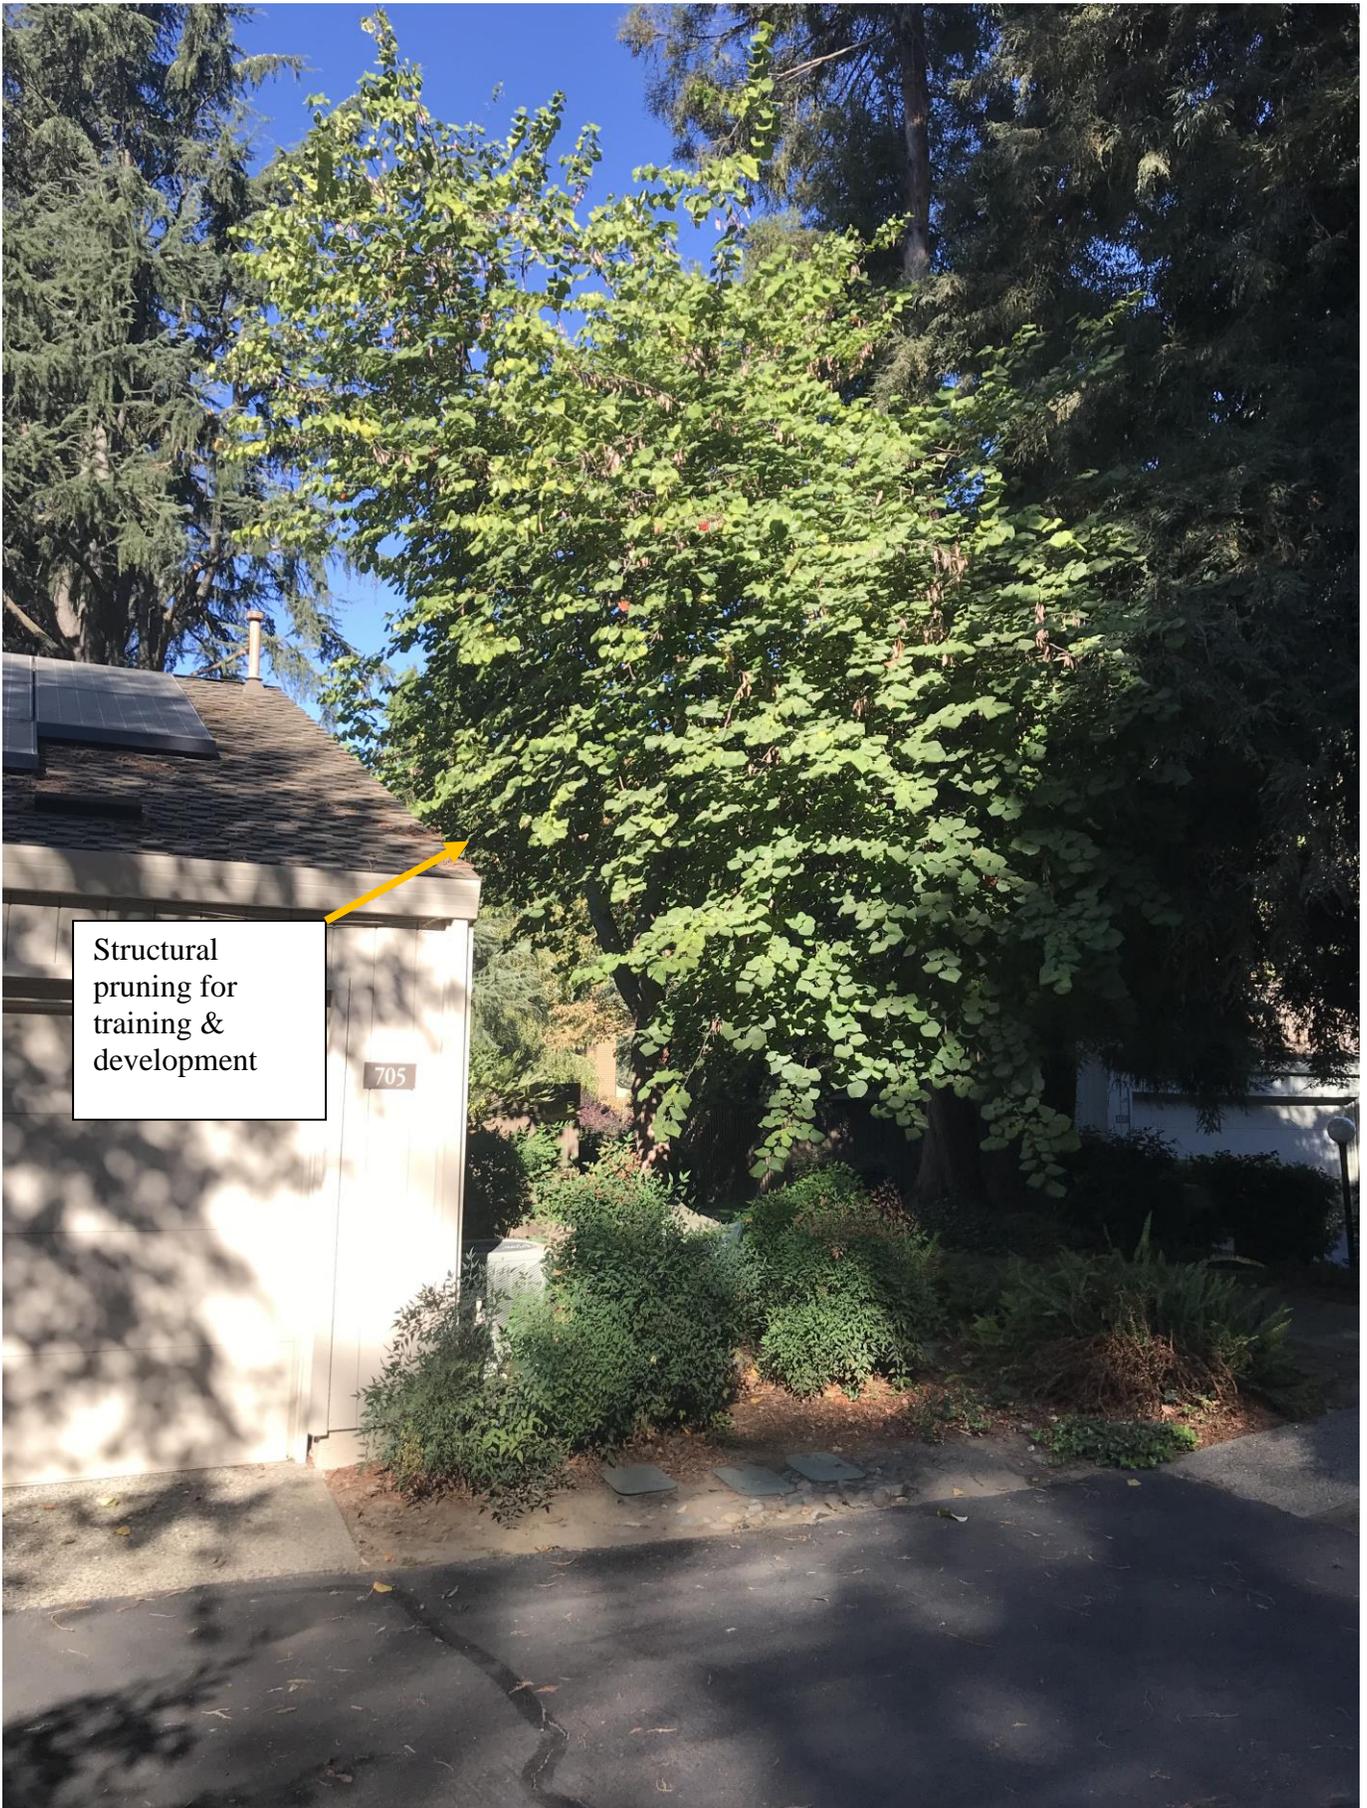
Figure 20

- (Zone 5) Tree #No Tag, Redbud (*Cercis occidentalis*), 705 Commons Dr. Tree requires structural pruning to help with direction of growth and healthy canopy development (Figure 20)

Structural
pruning for
training &
development

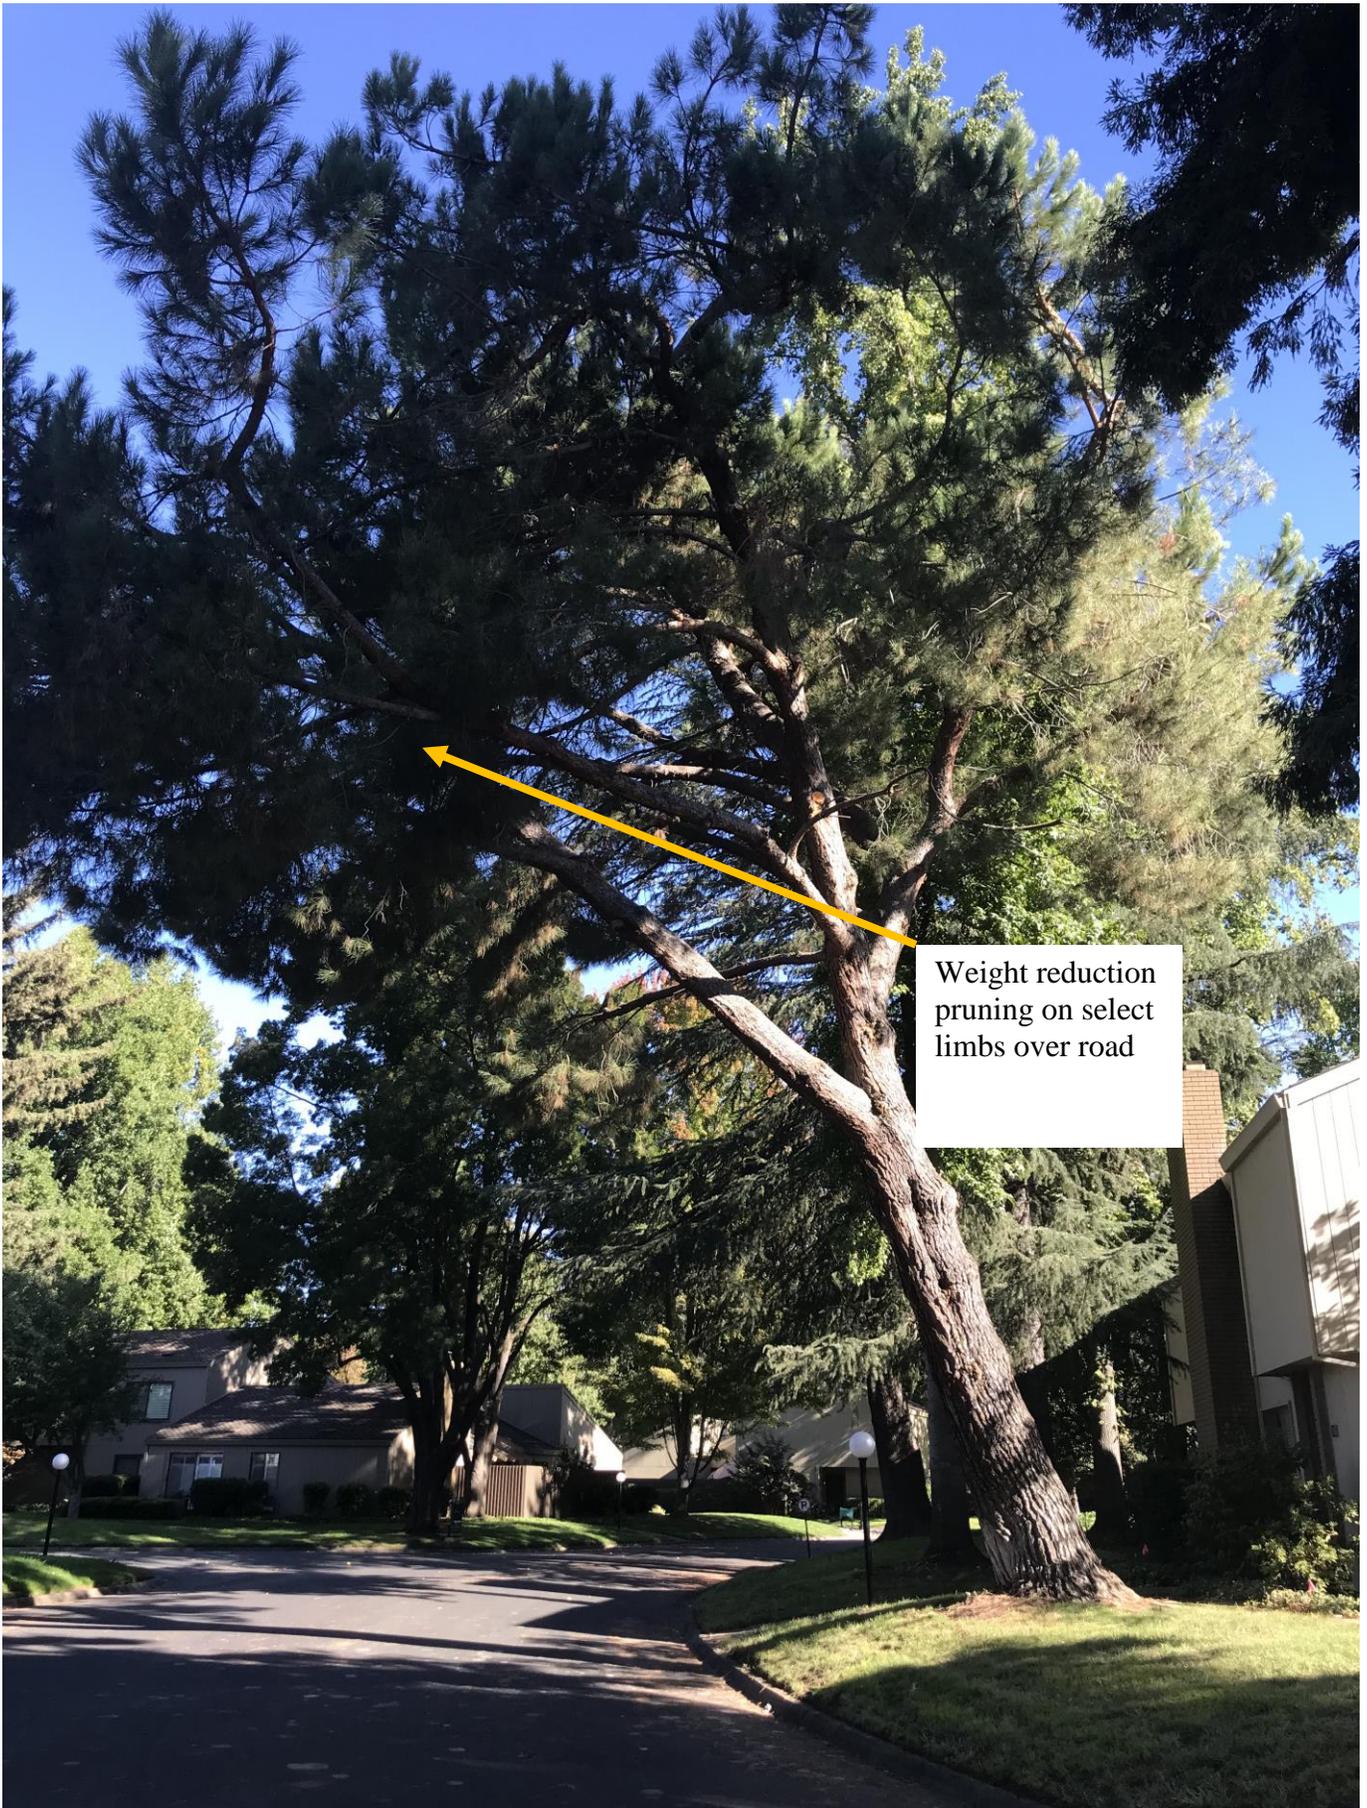
Figure 21

- (Zone 5) Tree #148 Aleppo Pine (*Pinus halepensis*) 503 Elmhurst Circle. (Figure 21) This tree is one we monitor closely due to the way this tree has developed. I recommend selective limb reduction to help manage canopy weight.

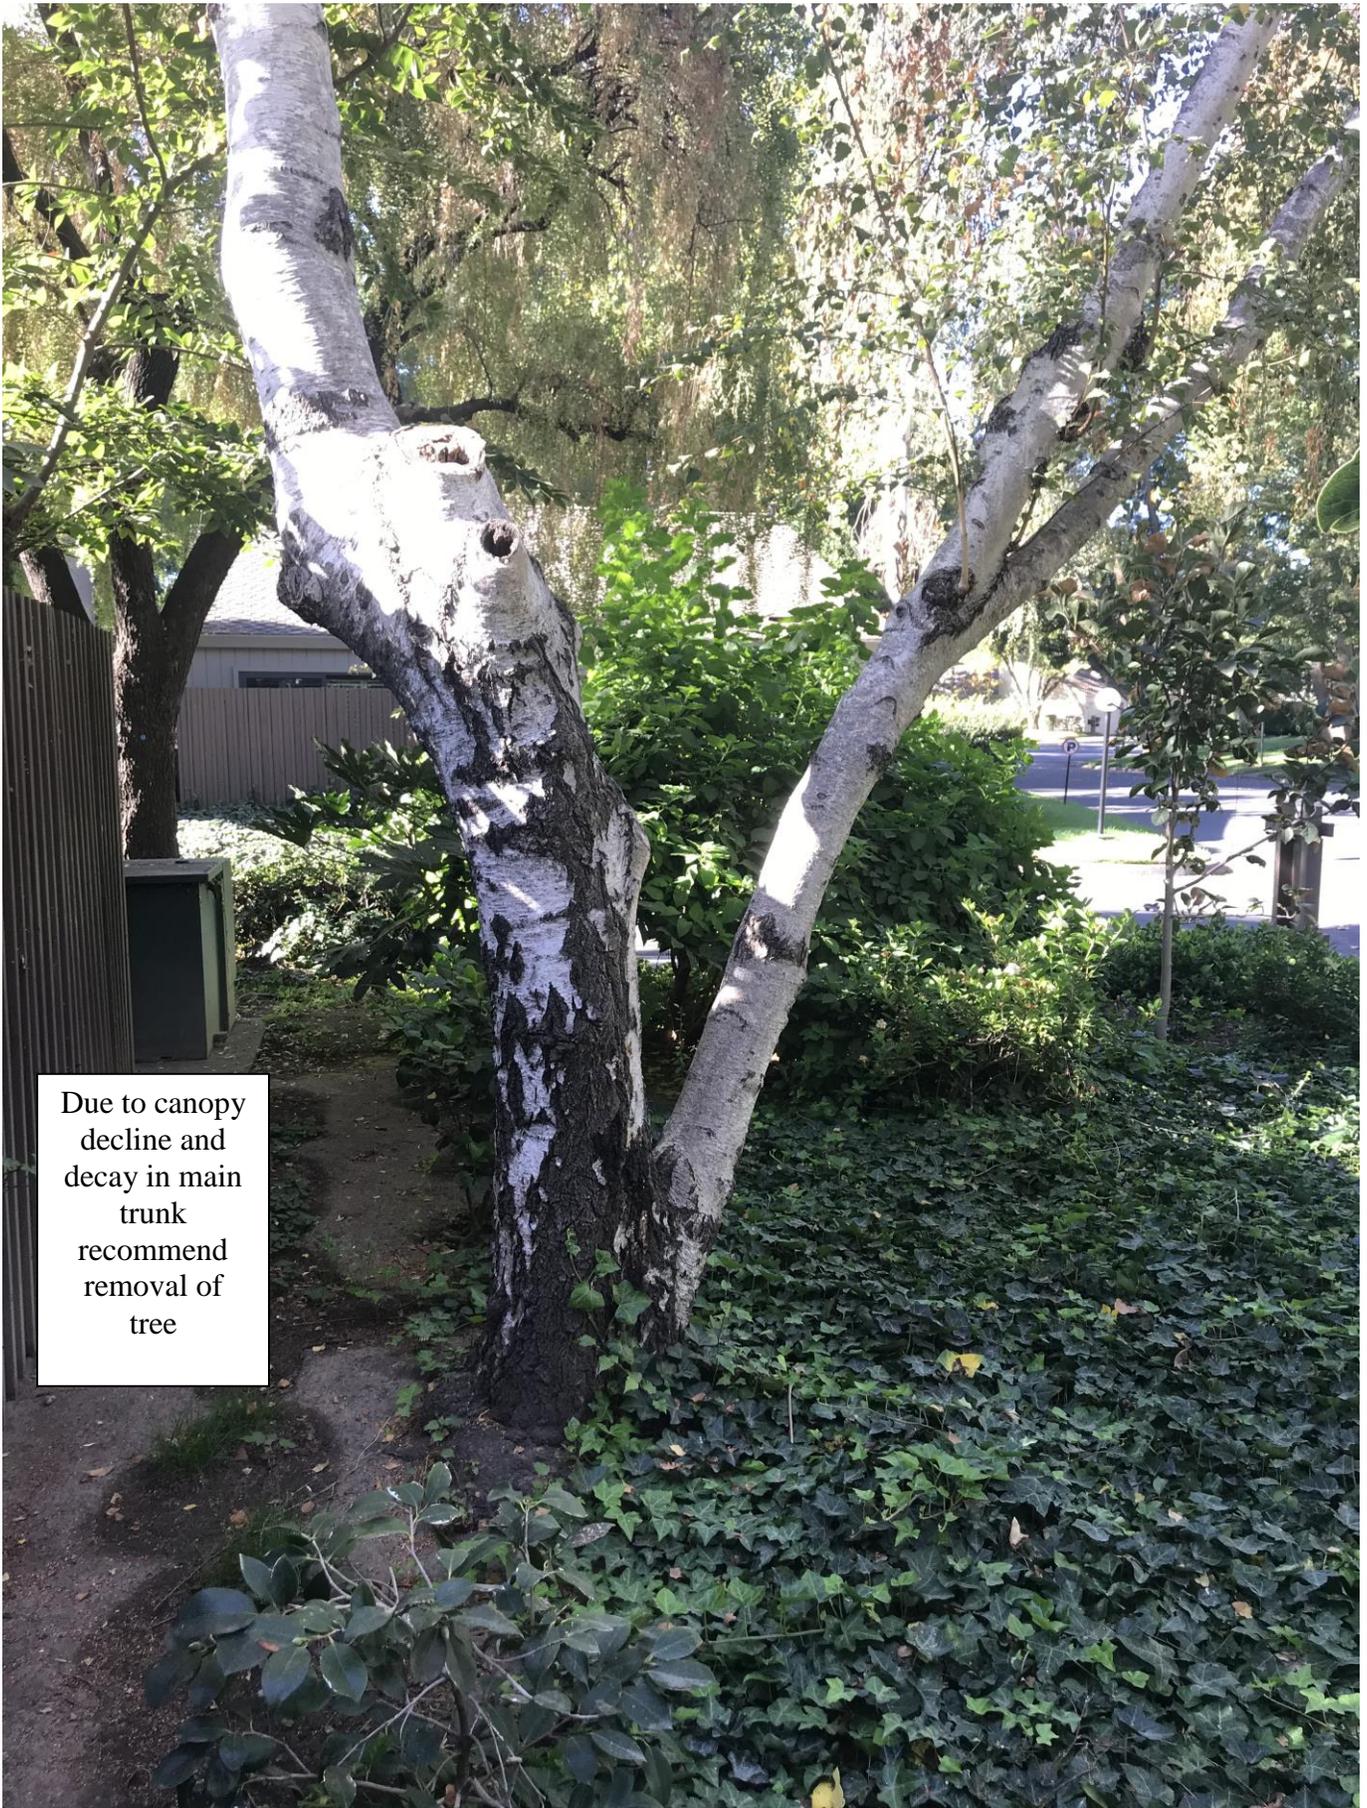
Figure 22

- (Zone 5) Trees #1452 #1450, White Birch (*Betula pendula*) (Figure 22) in front of 201 Elmhurst Circle. Trees have signs of decline in canopy as well as major cavities in the trunk. I recommend removal of these trees, no replacement needed as there are several magnolias already planted in area.

Due to canopy decline and decay in main trunk recommend removal of tree

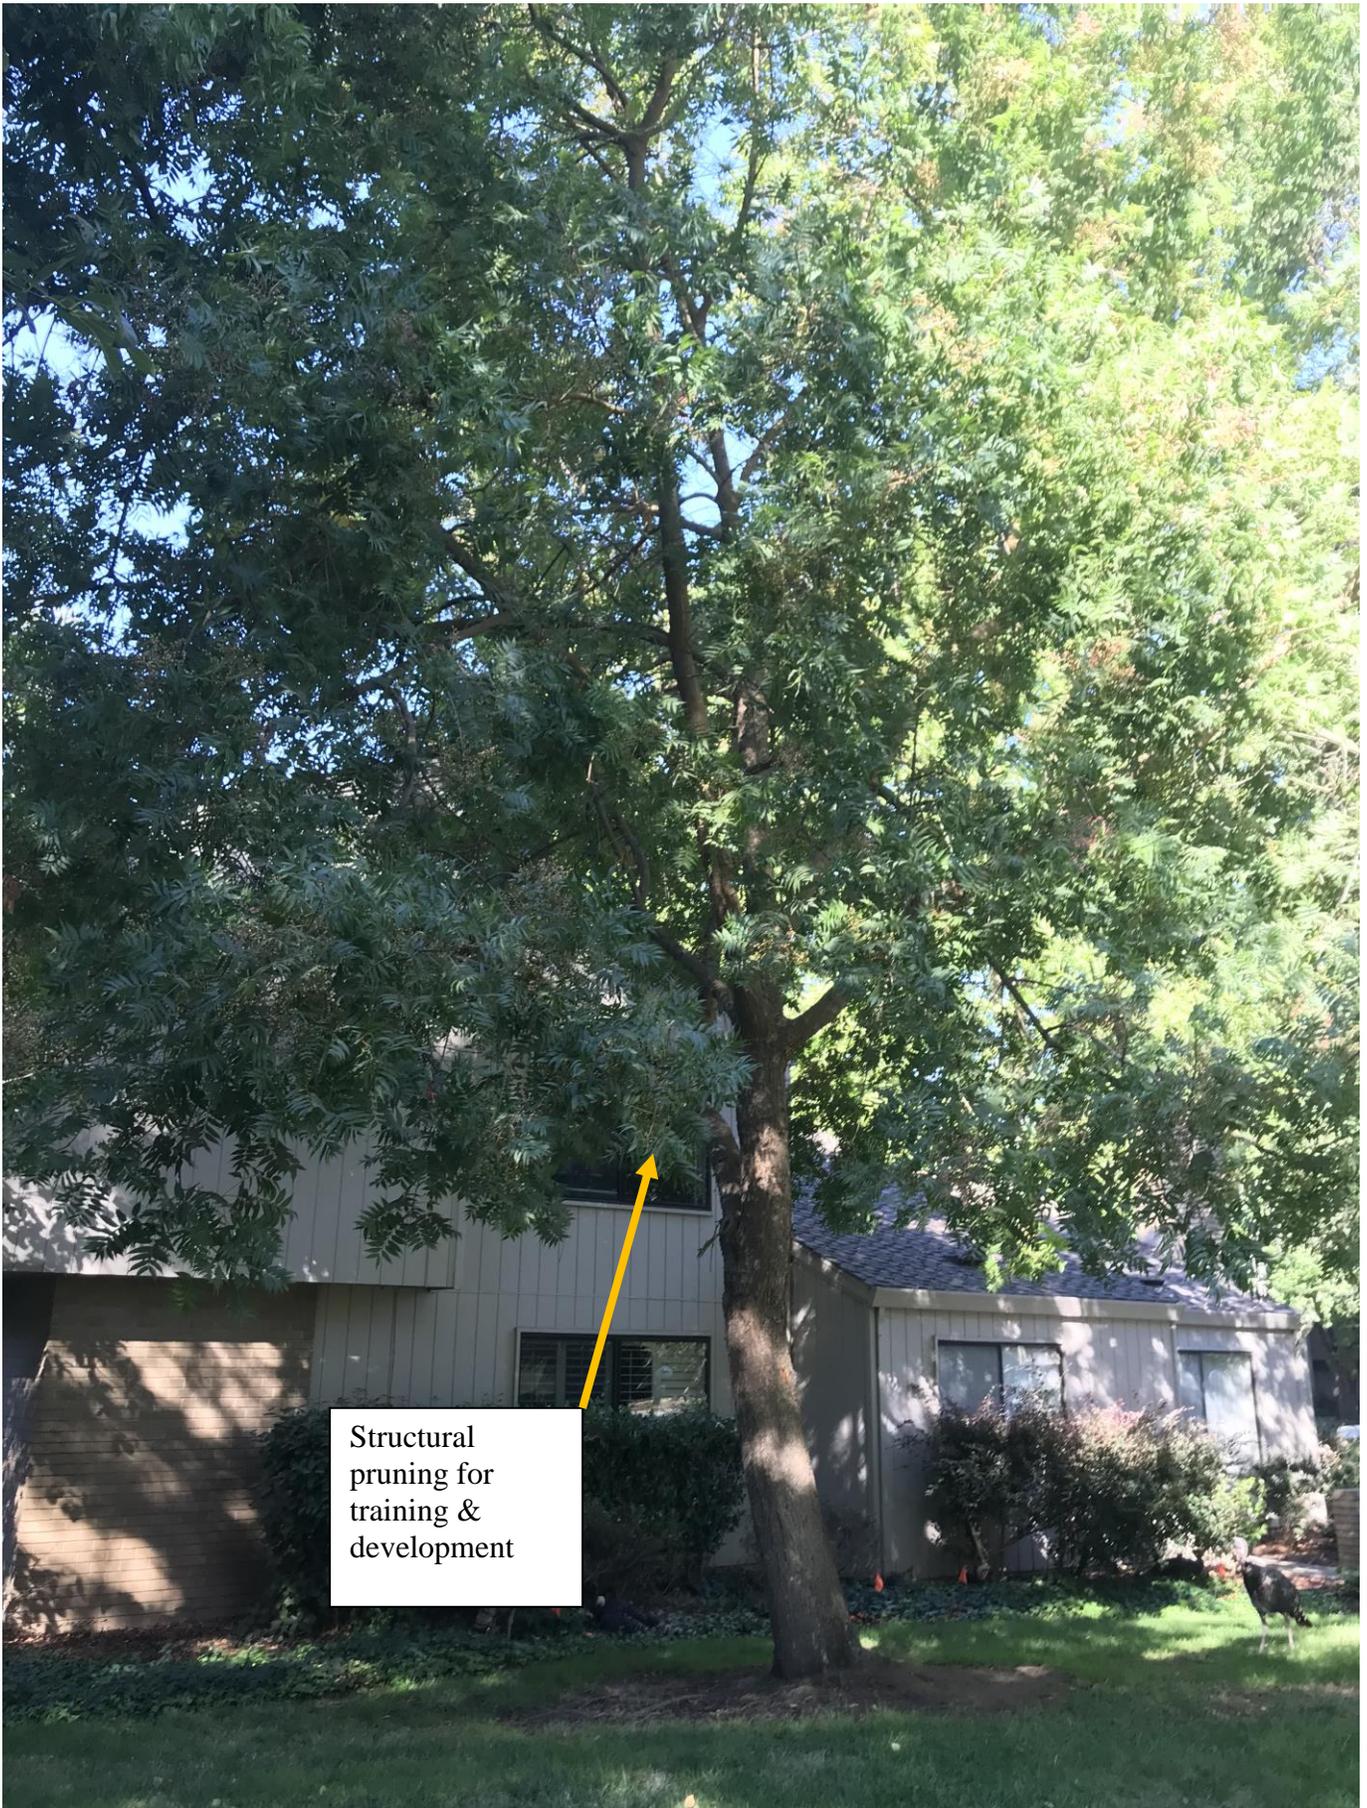
Figure 23

- (Zone 5) Tree #1518, Chinese pistache (*Pistacia chinensis*), next to 1119 Vanderbilt. Tree requires structural pruning to help with direction of growth and healthy canopy development (Figure 23)

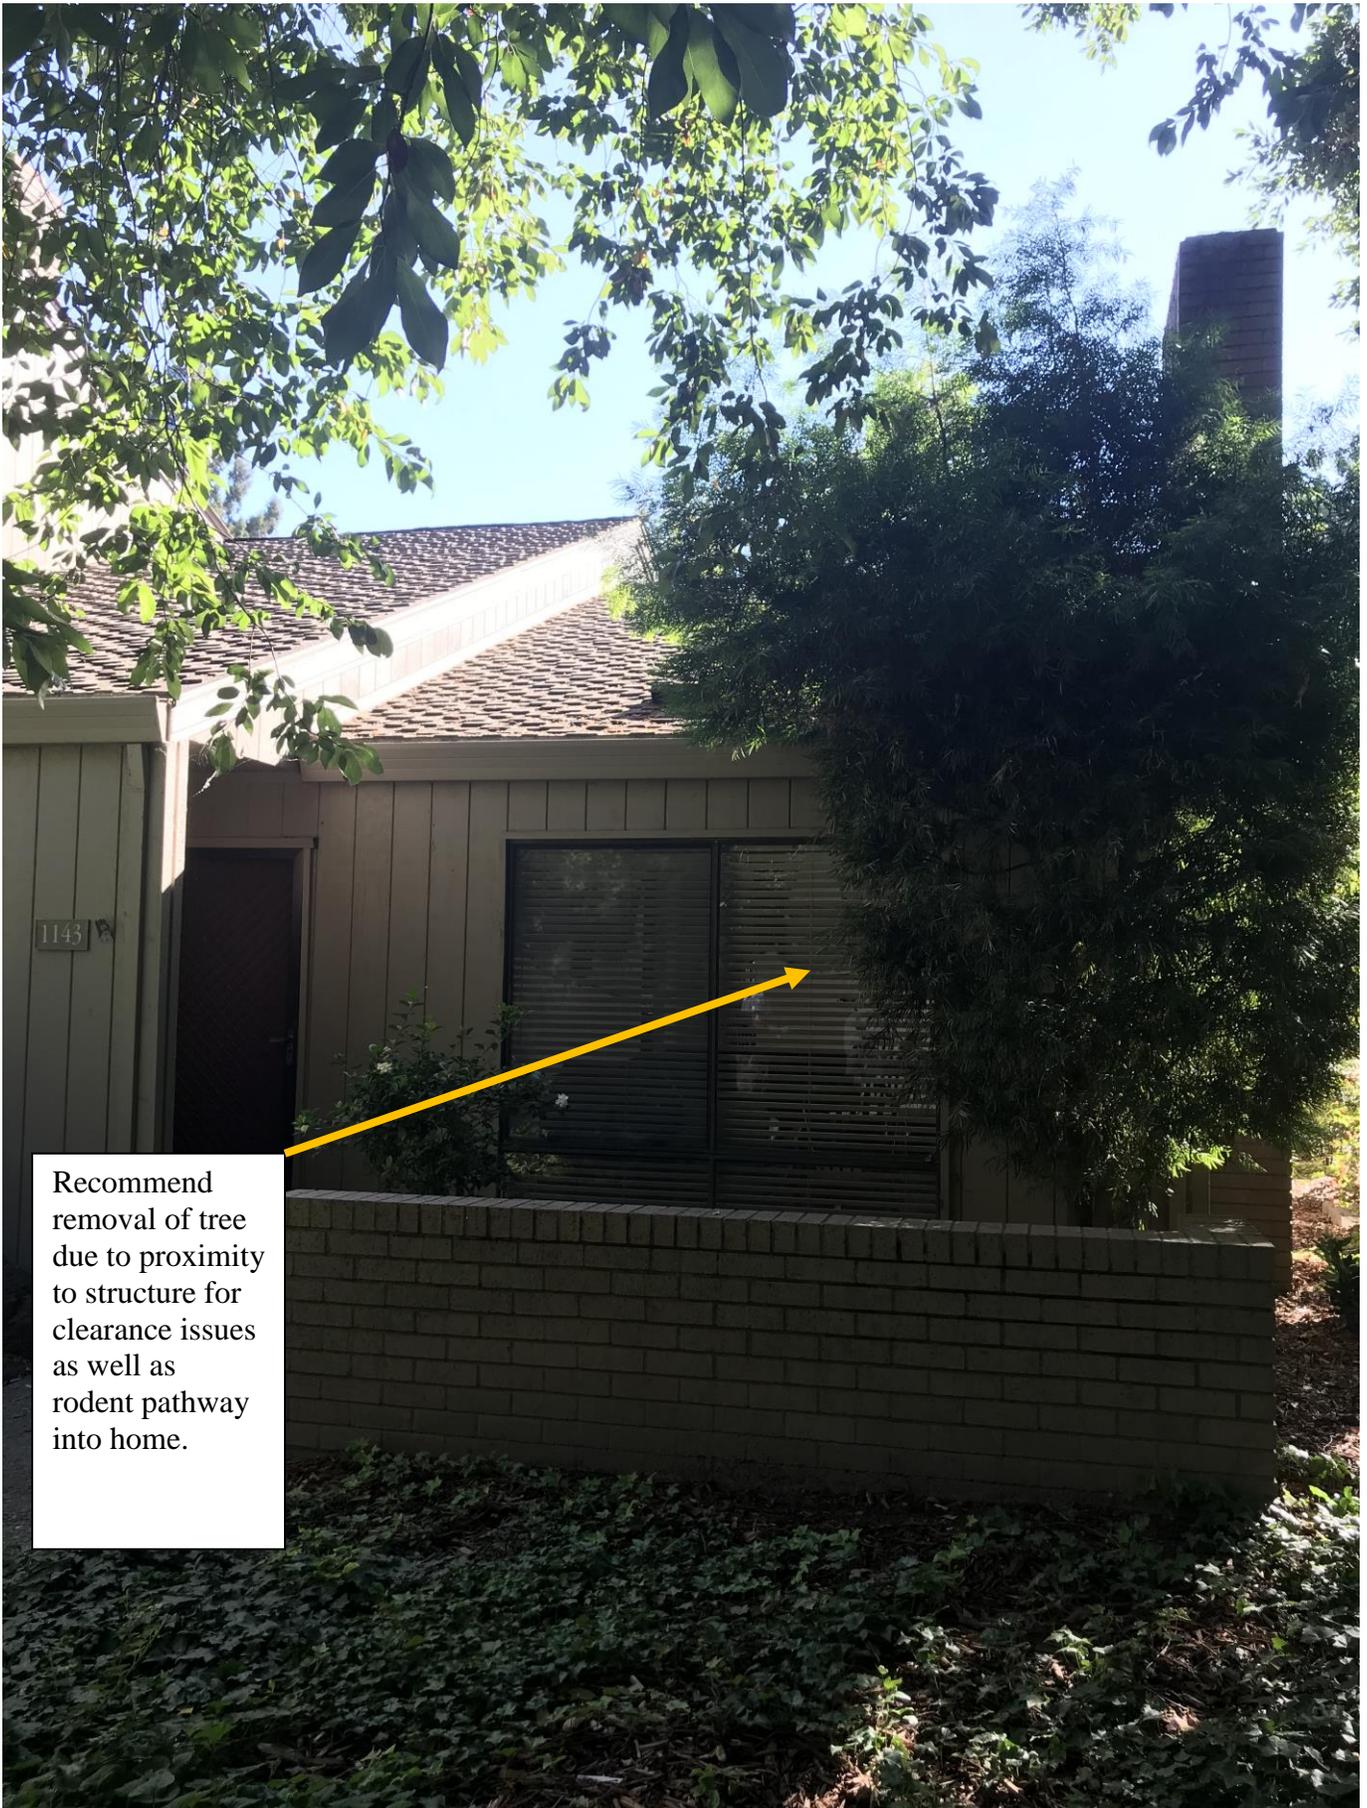
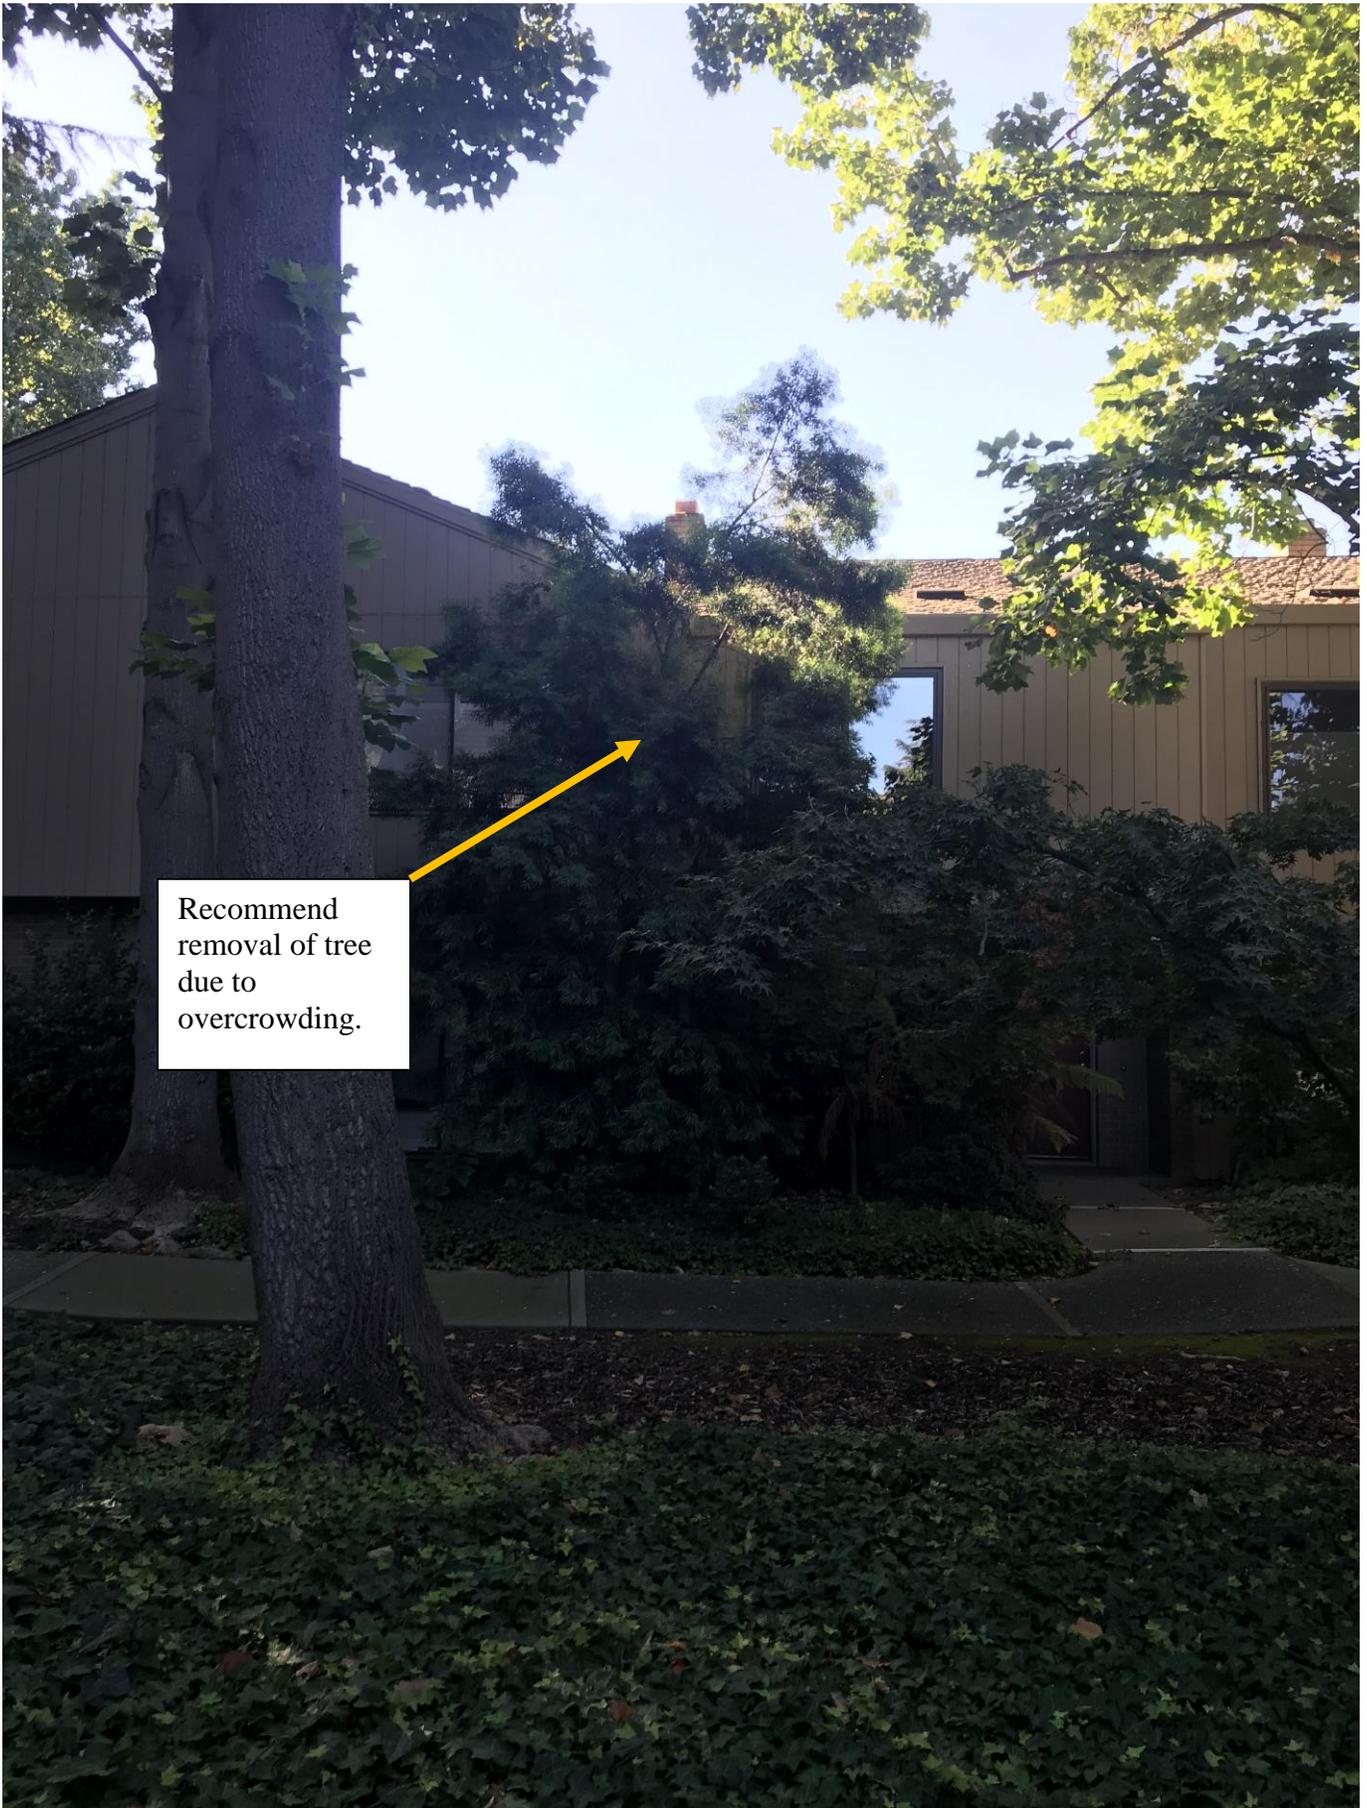
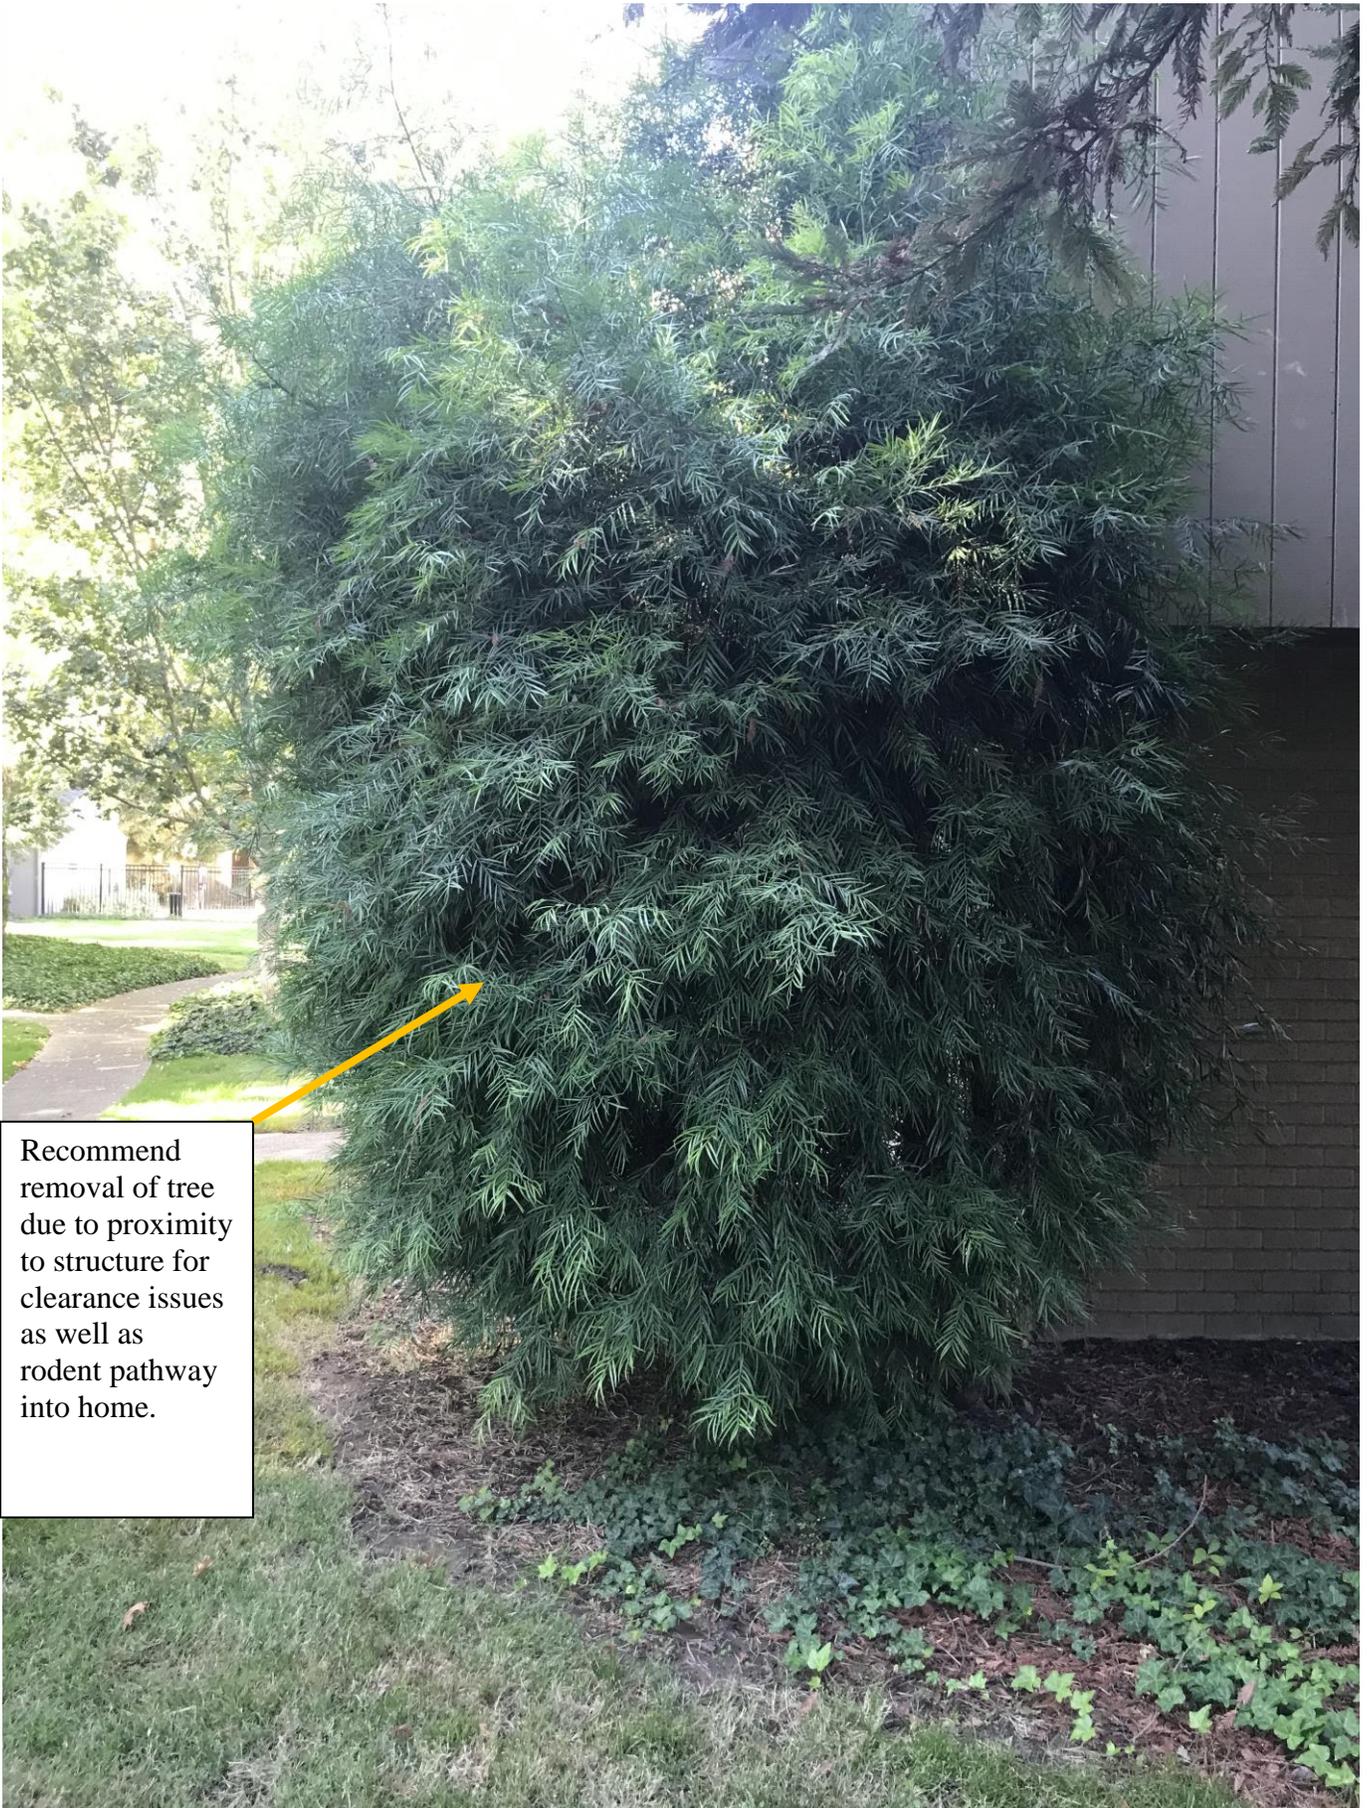
- (Zone 4) Trees #No Tag, Podocarpus (*Podocarpus neriifolius*), (Figures 24-26) trees are in front of the following addresses 1143, 1095, 1173 Vanderbilt. The Podocarpus trees planted around these homes have out grown the planting area and have become a clearance issue for the roof a gutters creating pathways for rodents into homes. I recommend removal of these trees as well as a review of the podocarpus trees planted in Nepenthe to help to mitigate further clearance issues and ongoing maintenance of these plants.

Recommend removal of tree due to proximity to structure for clearance issues as well as rodent pathway into home.

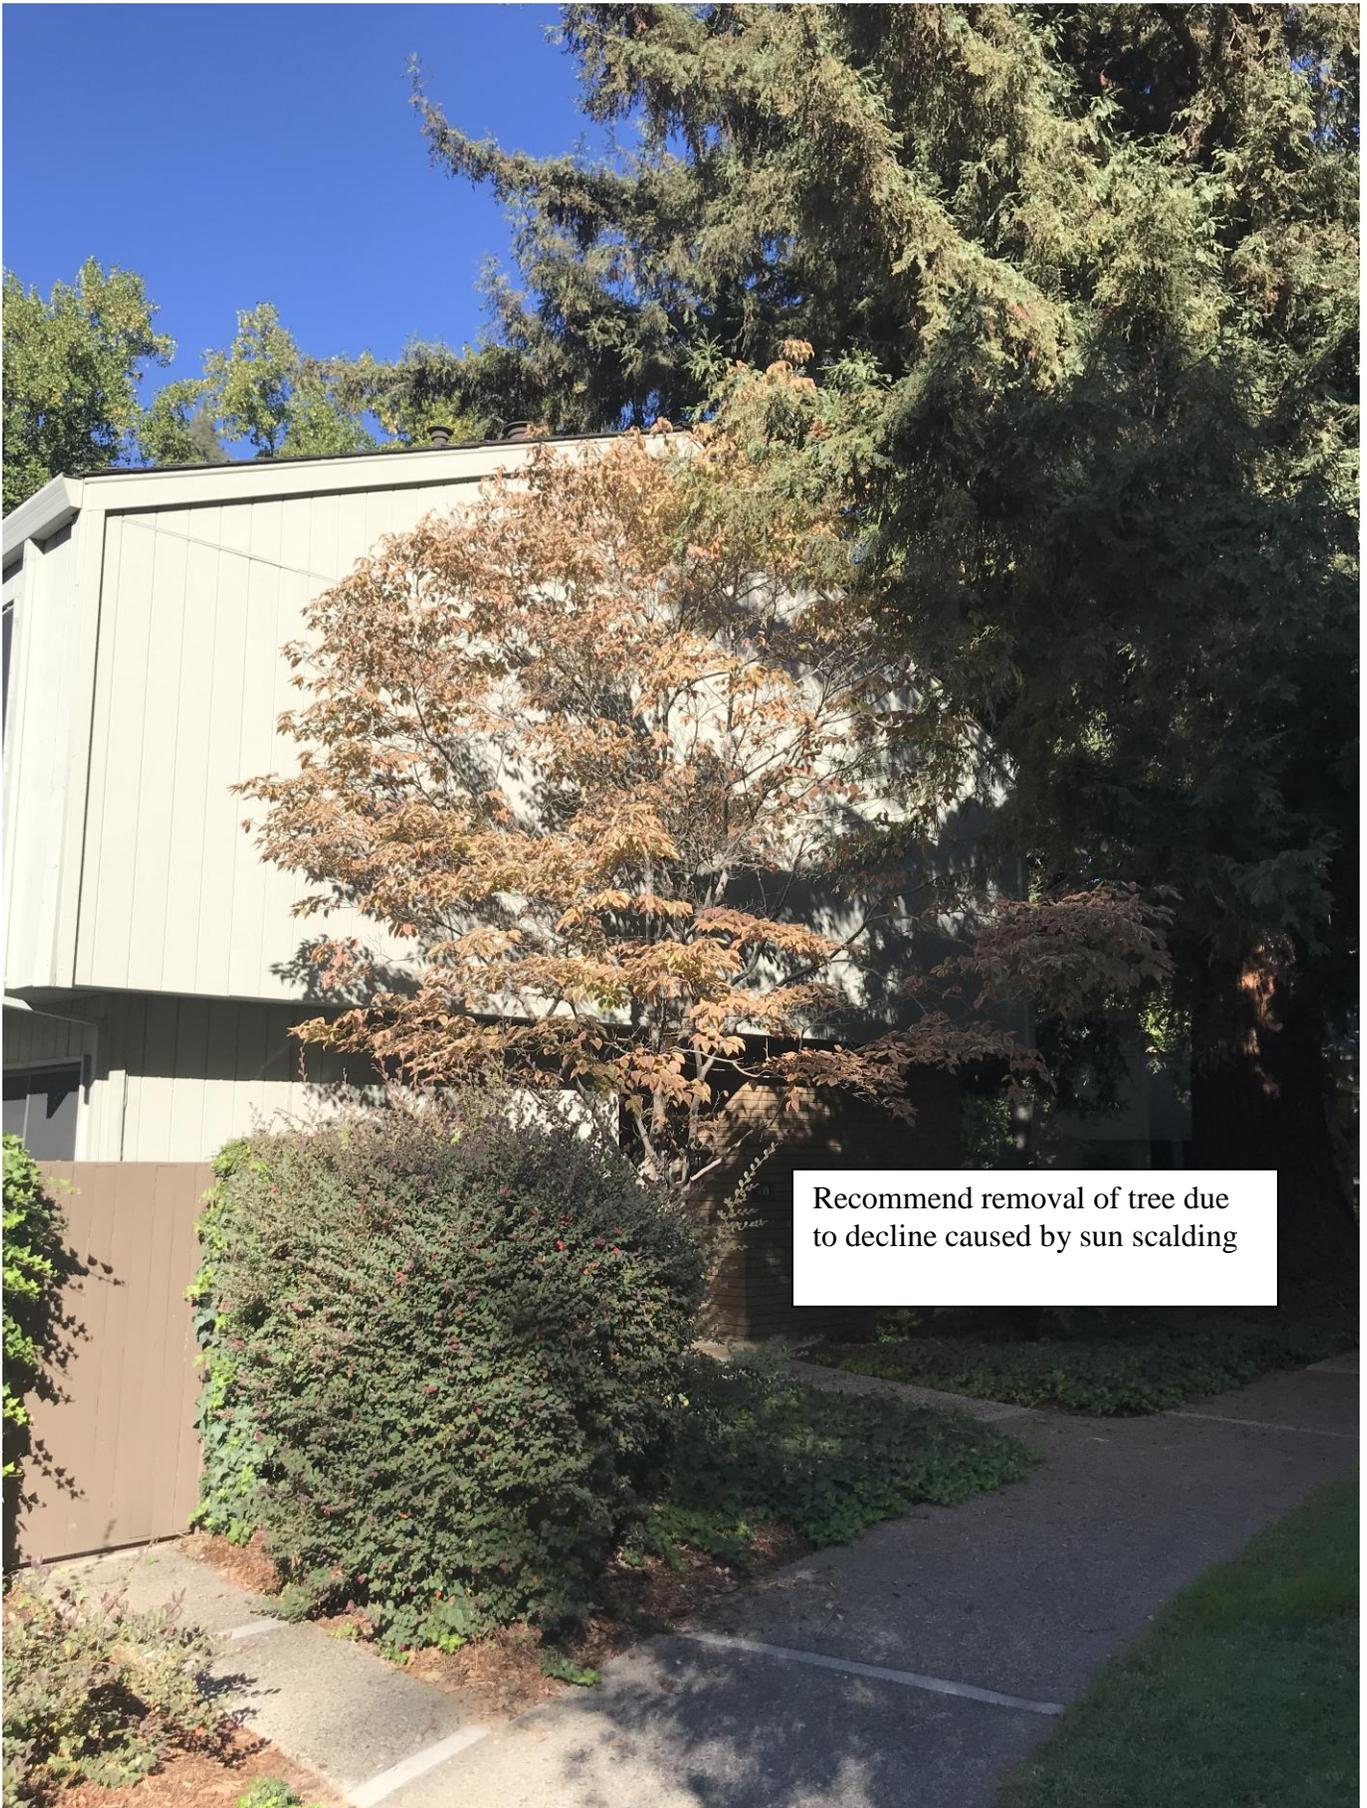
Figure 27

- (Zone 6) Tree # 1932 Dogwood (*Cornus nuttallii*), next to 300 Elmhurst. (Figure 27) This tree has been damaged by sun scalding and will not likely recover to reach full potential; I recommend removal and replacement of this tree.
