November 10, 2020

The Nepenthe Association
1131 Commons Dr.
Sacramento, CA 95825
Phone: (916) 929-8380
Email: Bettsi.Ledesma@fsresidential.com

On October 14, 2020, I inspected several trees on the Nepenthe property during the monthly tree walk. The focus of the walk was to address resident/management concerns regarding mature trees on the property. The purpose of this report is to develop mitigation plans for the following trees and my recommendations are below. My recommendations are based on a Basic Visual Inspection. All decisions made based on the recommendations of this report are at the discretion of the Nepenthe Association.

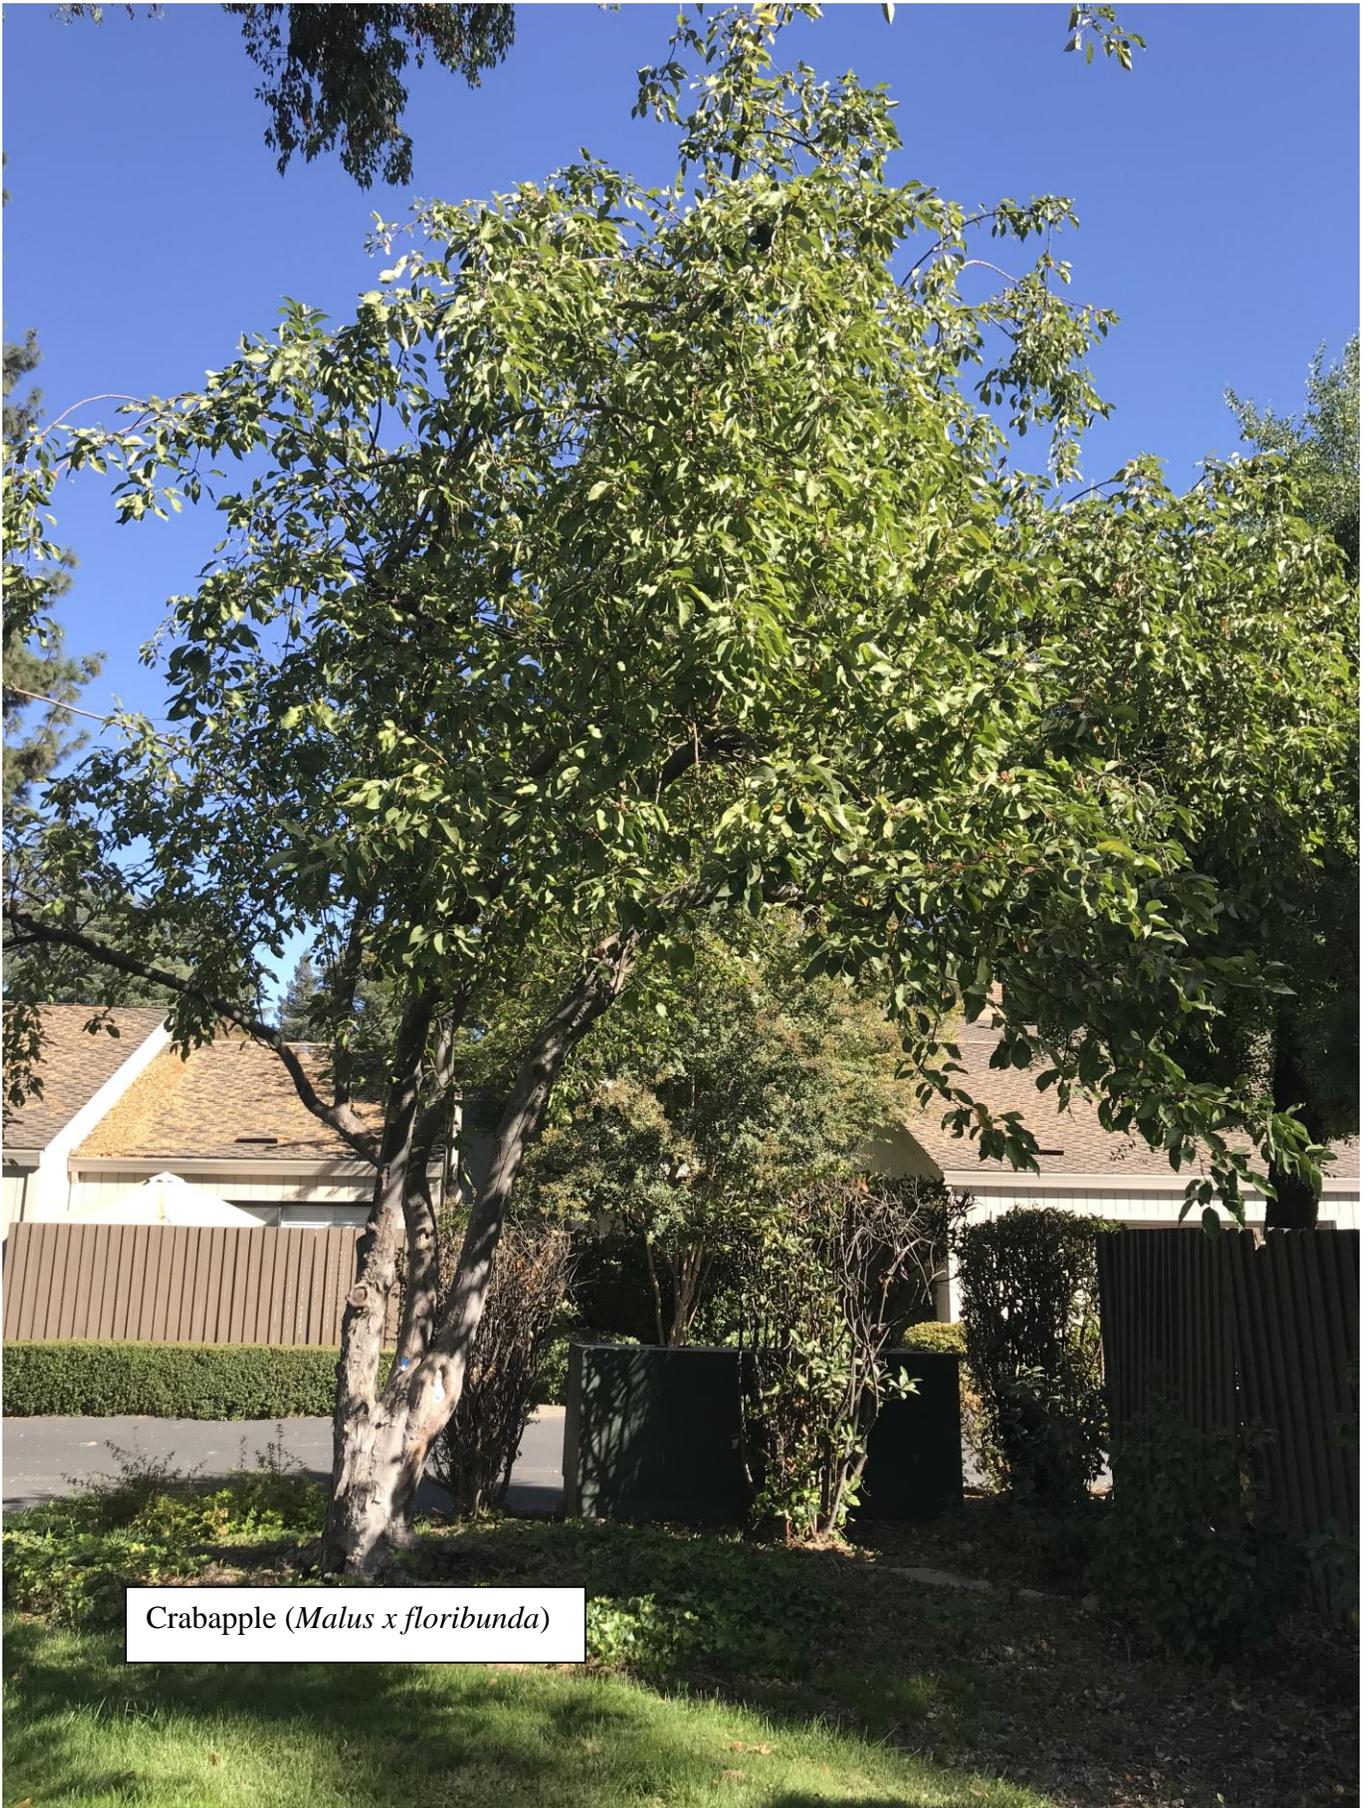
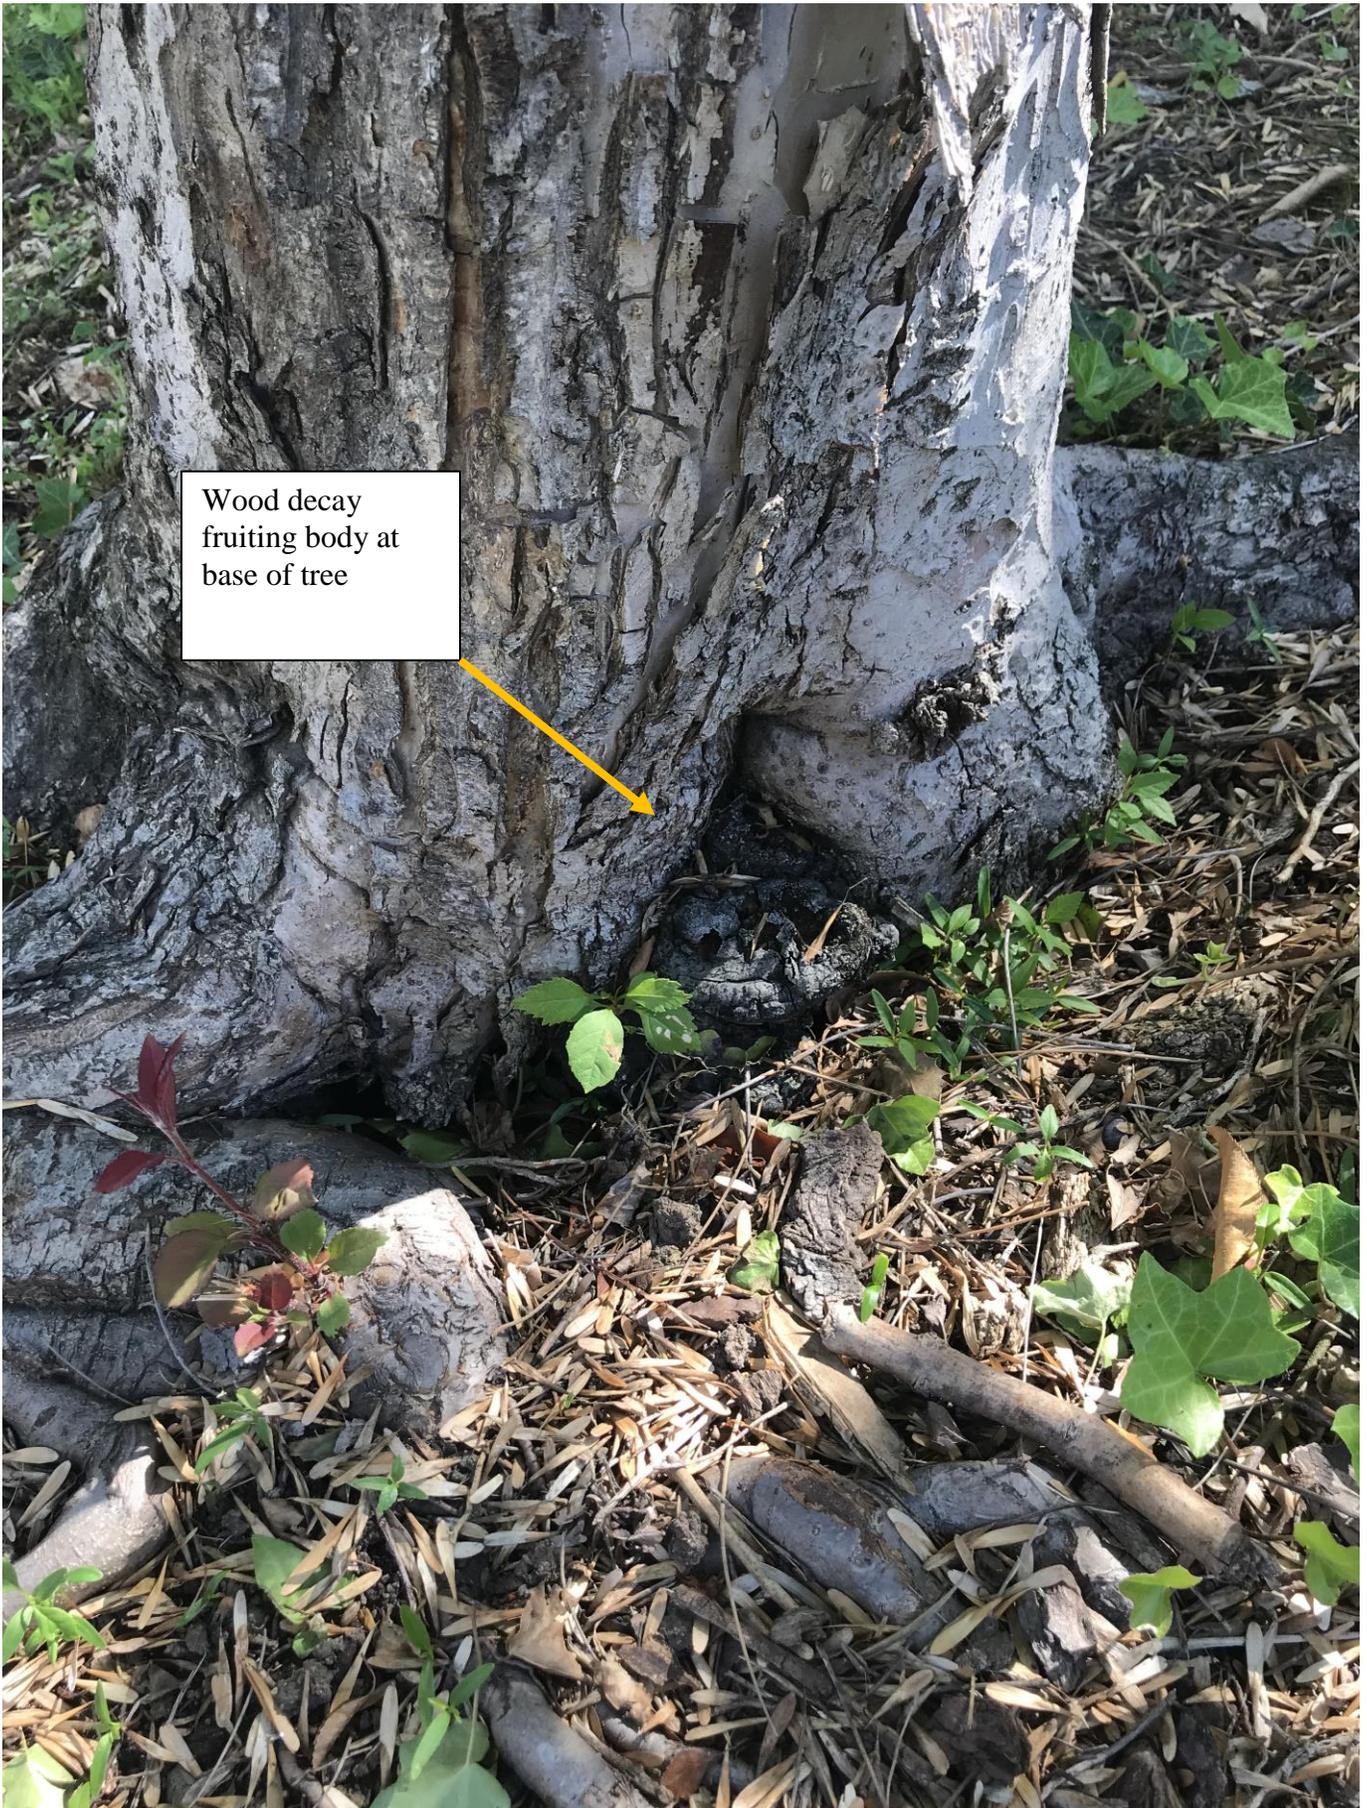
- (Zone 4) Tree #1290 Crabapple (*Malus x floribunda*) (Figures 28-29) next to 808 Dunbarton Circle. Tree has wood decay fungus present at base of the tree. This is likely cause of the decline in the foliage and cannot be treated. I recommend removal and replacement of this tree.

Wood decay
fruiting body at
base of tree

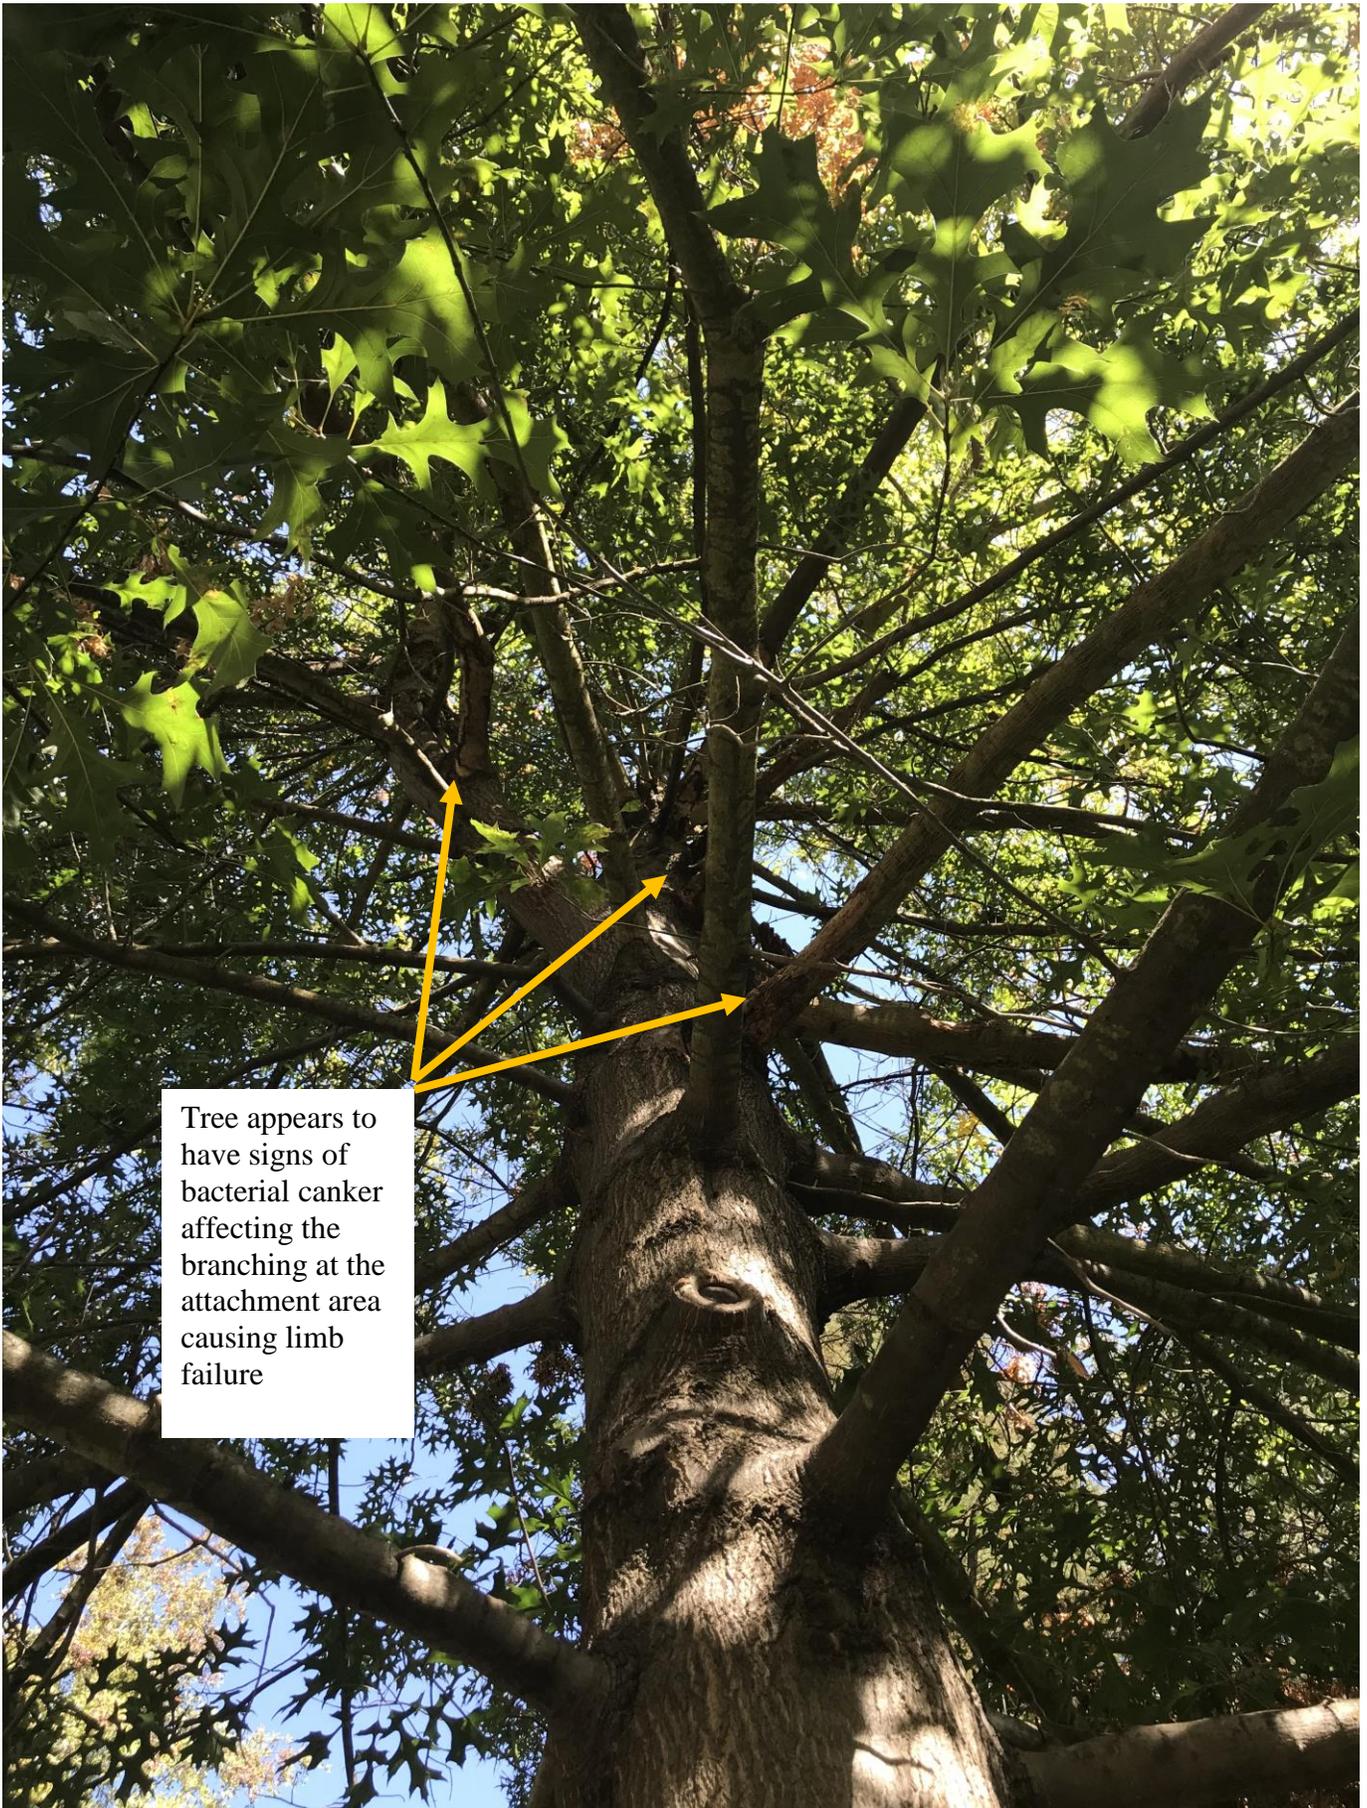
Figure 30

- (Zone 1) Tree #73, Scarlet oak (*Quercus coccinea*) (Figure 30) next to 1111 Commons Dr. This tree has been on our monitor list for some time now watching the trees response to a bacterial infection causing a canker at the branch attachments. This canker has now become more aggressive in the trees upper canopy causing several limb failures. This is not treatable an at this point I would recommend this trees removal

Tree appears to have signs of bacterial canker affecting the branching at the attachment area causing limb failure

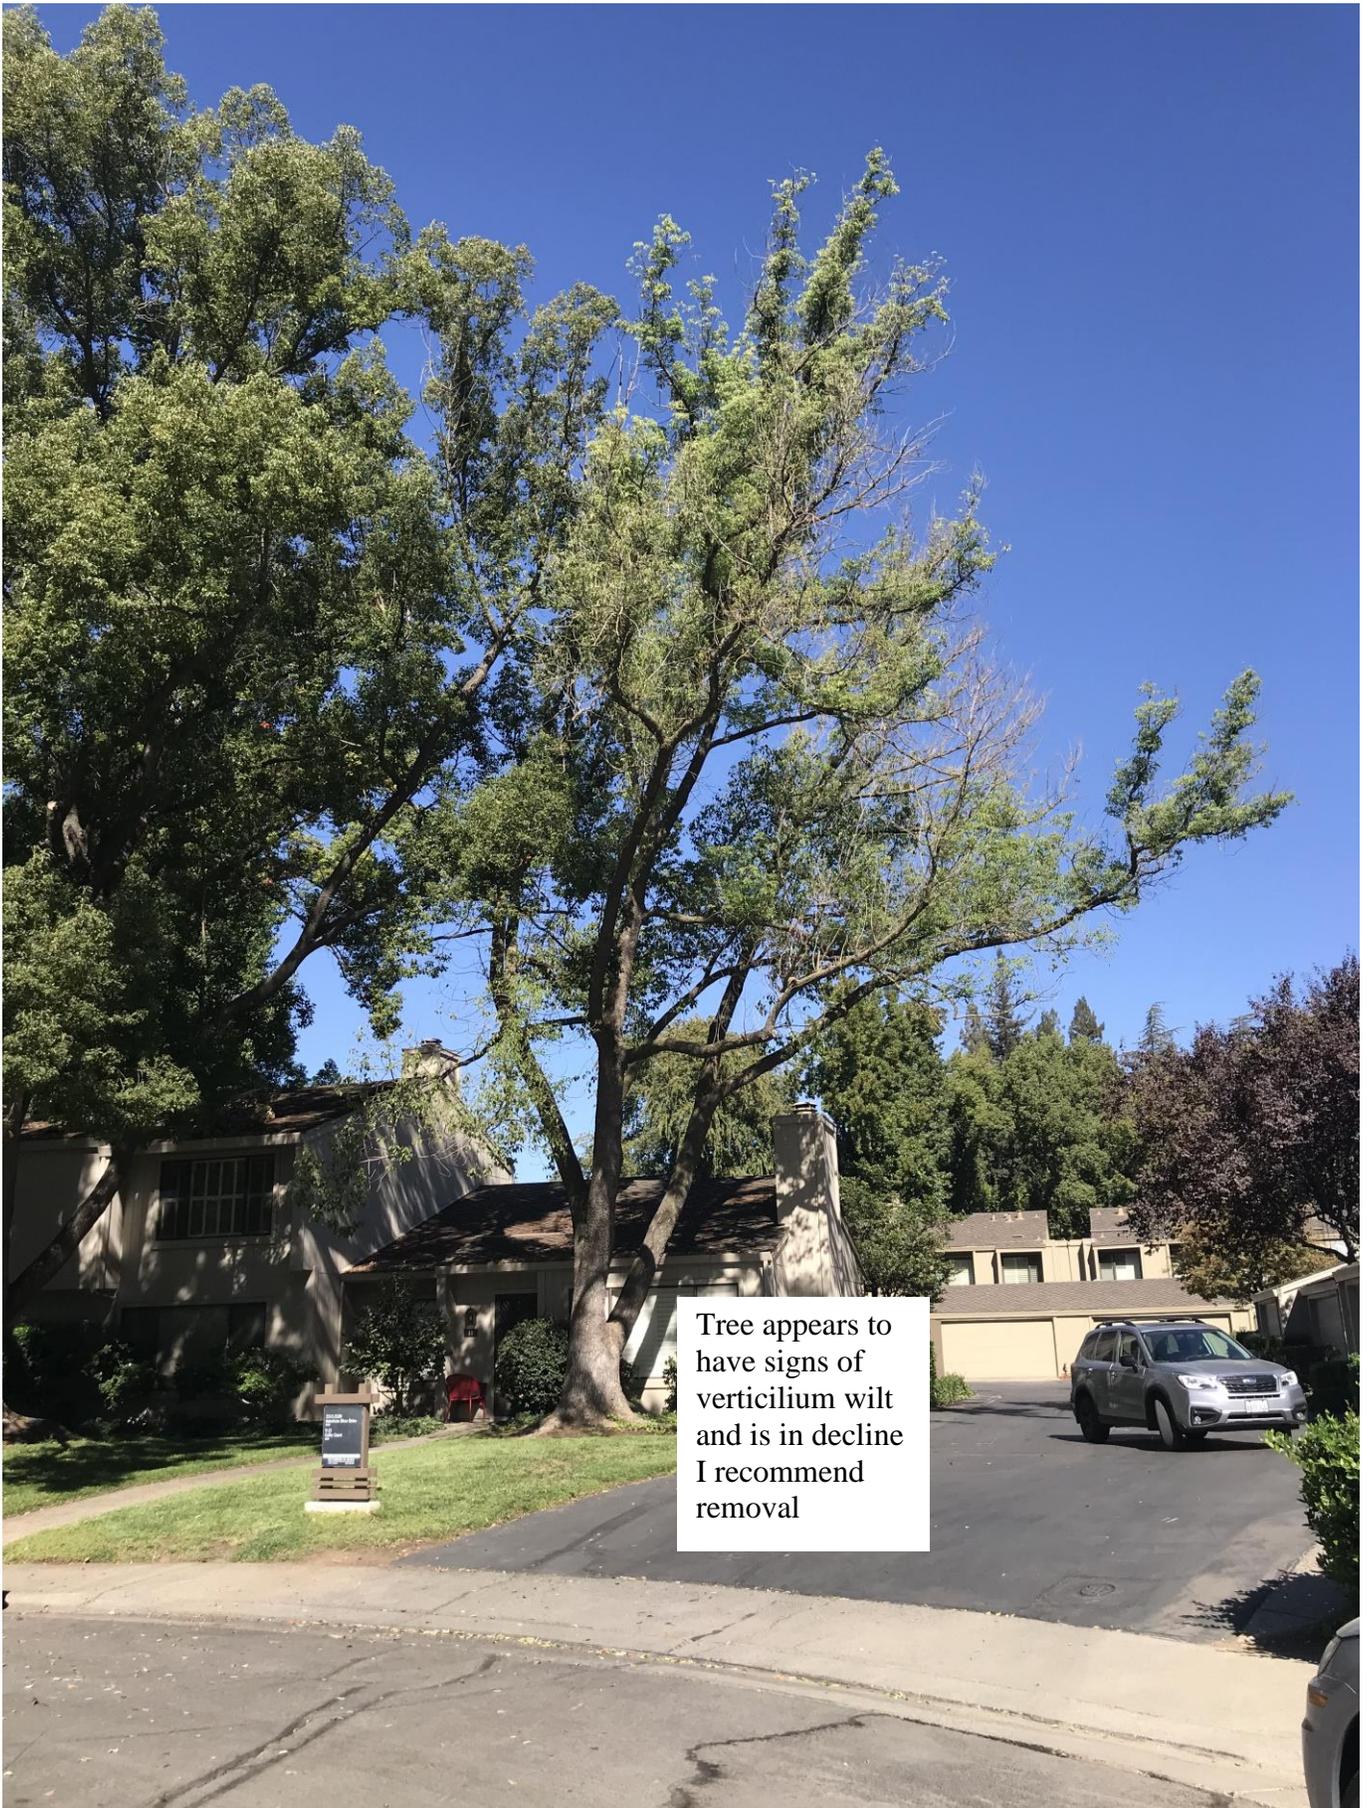
Figure 31

- (Zone 1) Tree #332 Camphor (*Cinnamomum camphora*) (Figure 31) in front of 11 Colby Ct. This tree is showing signs of decline in canopy with about 50% of the total canopy dead as well as major cavities in the trunk. Due to the extent of the decline I suspect verticillium wilt as a cause of this trees decline and recommend removal of this tree and replacement.
