September 9, 2020

The Nepenthe Association
1131 Commons Dr.
Sacramento, CA 95825
Phone: (916) 929-8380
Email: Bettsi.Ledesma@fsresidential.com

On September 3, 2020, I inspected several trees on the Nepenthe property during the monthly tree walk. The focus of the walk was to address resident/management concerns regarding mature trees on the property. The purpose of this report is to develop mitigation plans for the following trees and my recommendations are below. My recommendations are based on a Basic Visual Inspection. All decisions made based on the recommendations of this report are at the discretion of the Nepenthe Association.

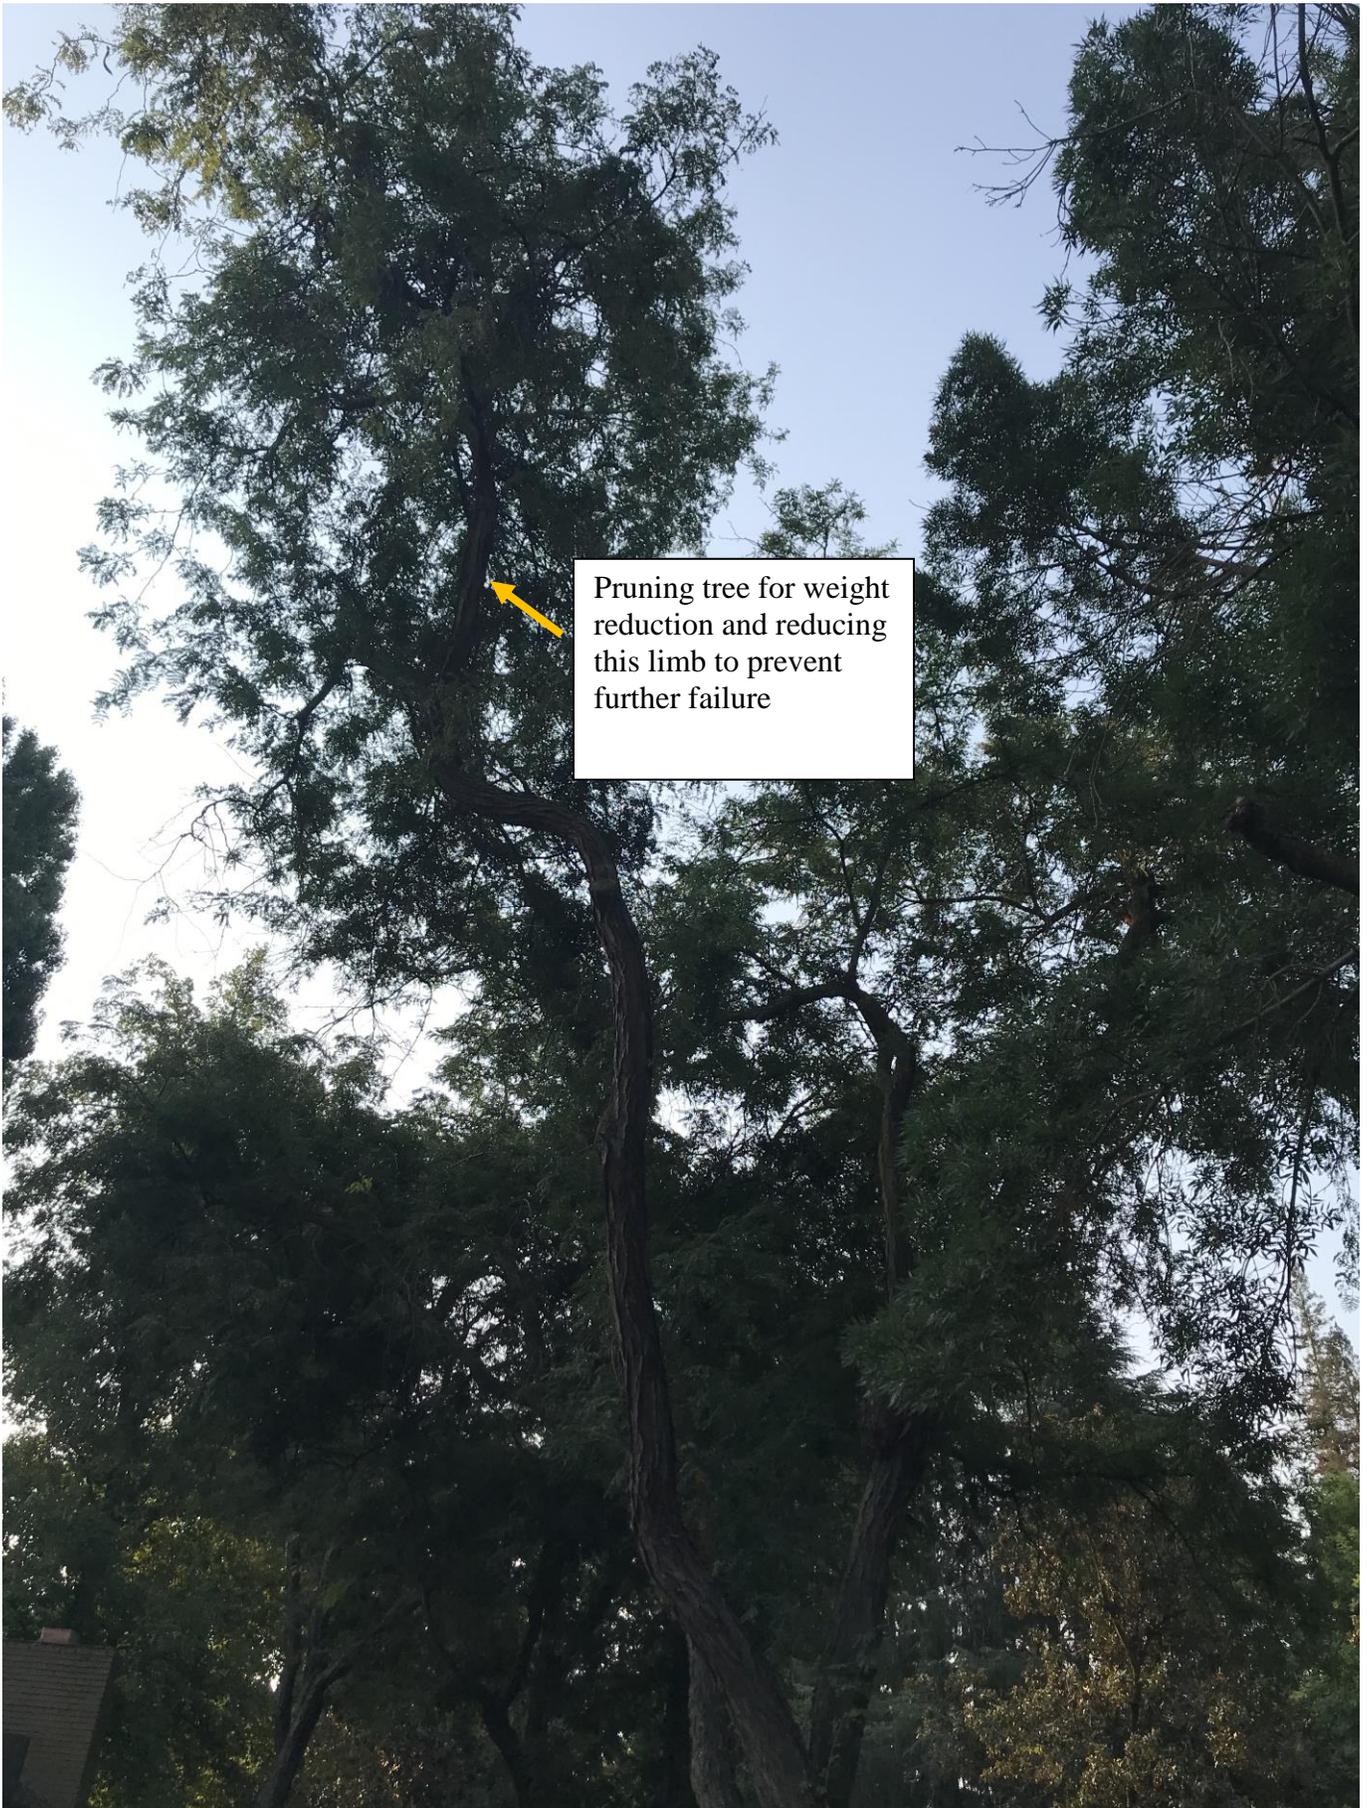
Figure 1

- (Zone 6) Tree #1716 Locust (*Robinia pseudoacacia*) 800 Elmhurst. (Figure 1). This tree has had several limb failures due to weight. The tree canopy is unbalanced due to these failures, I recommend reduction pruning to reduce pressure from weight on limbs.

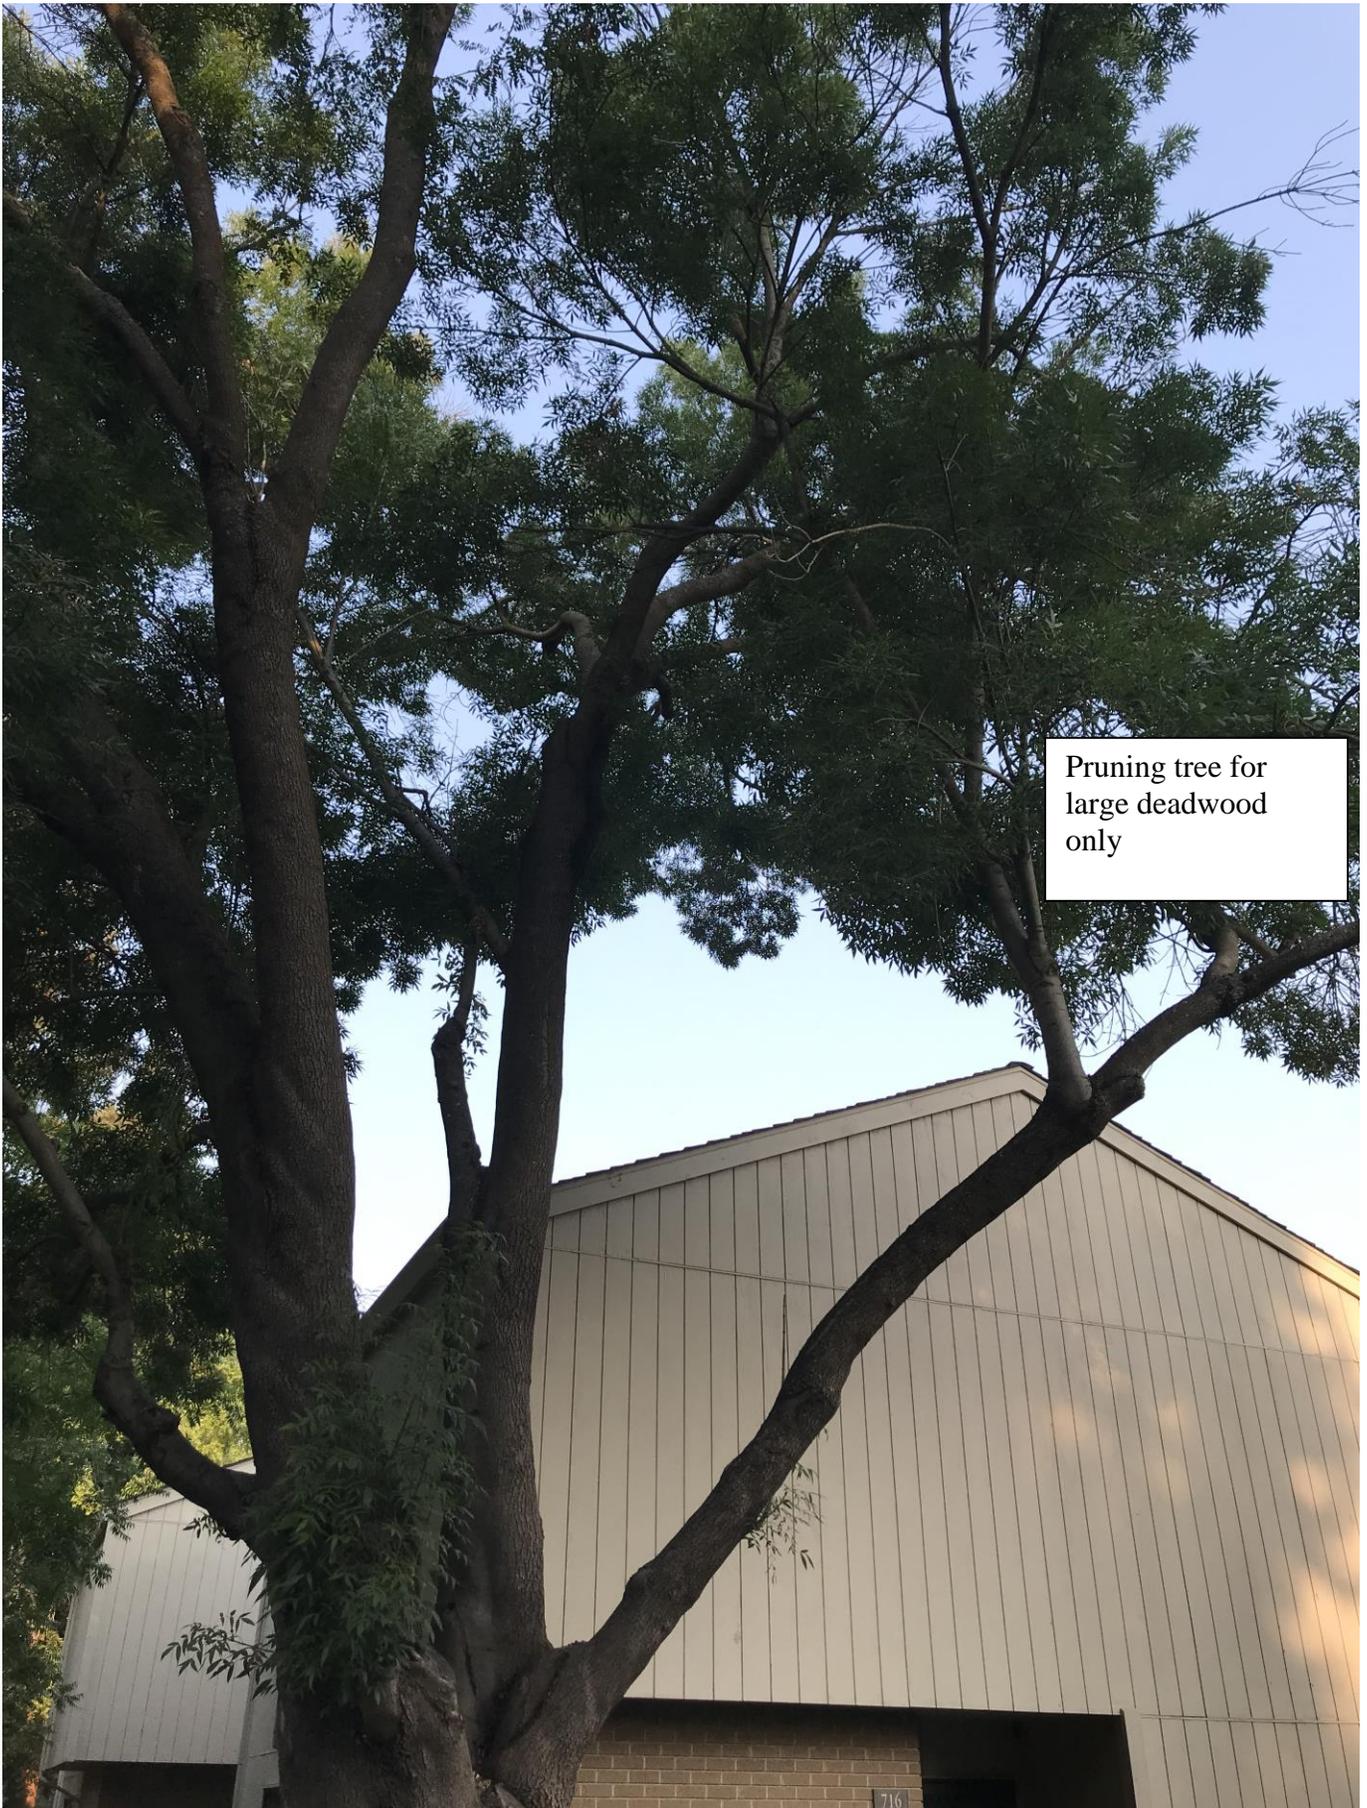
Figure 2

- (Zone 6) Trees #1743 Ash (*Fraxnis angustifolia*), 716 Elmhurst (Figure 2) We have been monitoring the decline rate in this tree by annual growth to deadwood ratio. The tree has several large dead limbs that require pruning to continue to monitor tree health

Pruning tree for large deadwood only

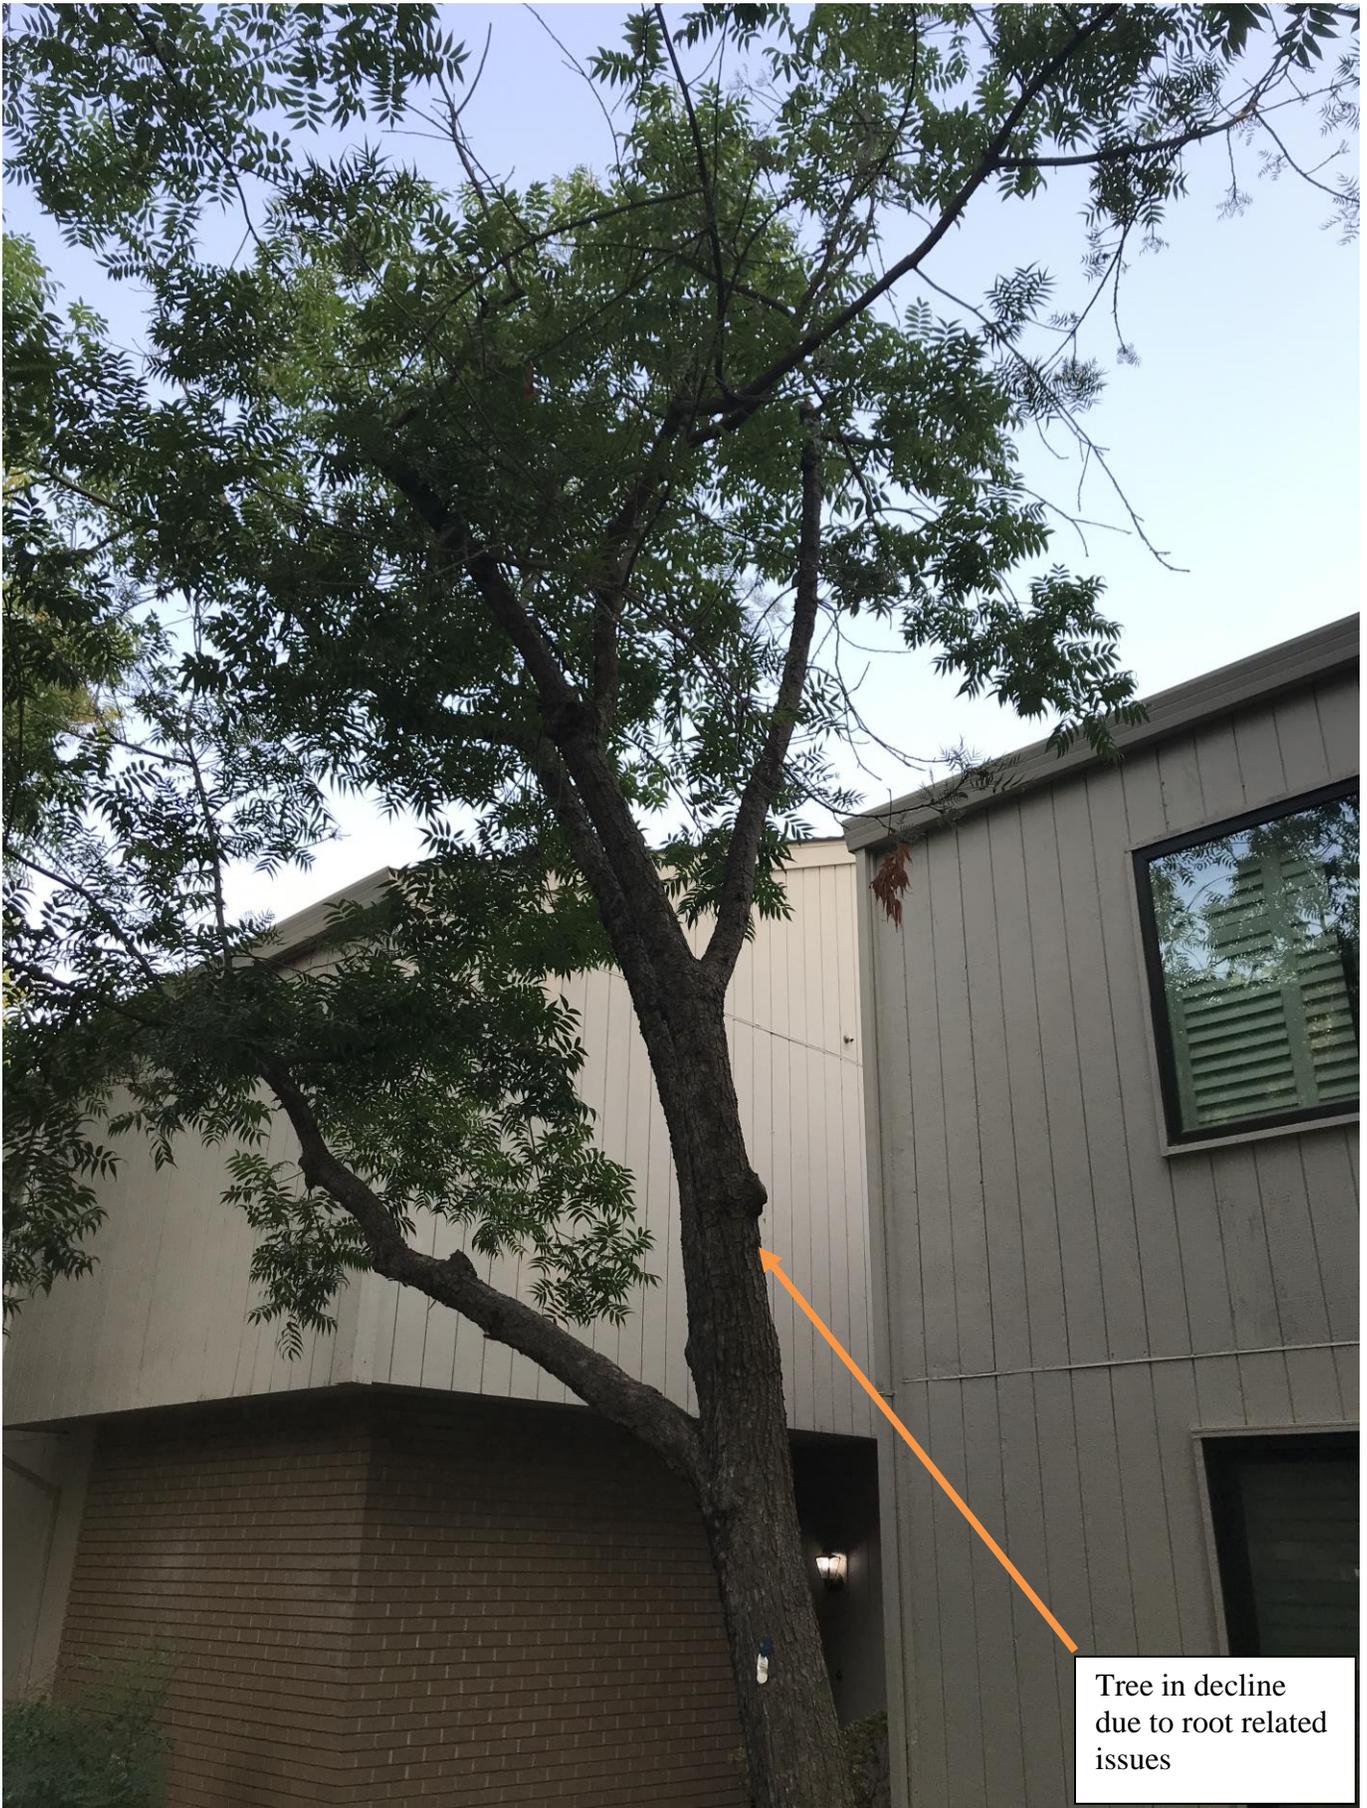
Figure 3

- (Zone 6) Trees #1714, 1745, Chinese pistache (*Pistacia chinensis*), 716 Elmhurst. Tree#1714 (Not Pictured) has full and over weighted canopy, I recommend full prune of trees Canopy. Tree #1745 (Figures 3-4), the canopy is in decline due to root related damage. The tree was likely planted root bound causing girdling roots to encircle the root ball causing portions of the root system to decline. I recommend removal and replacement of this tree.

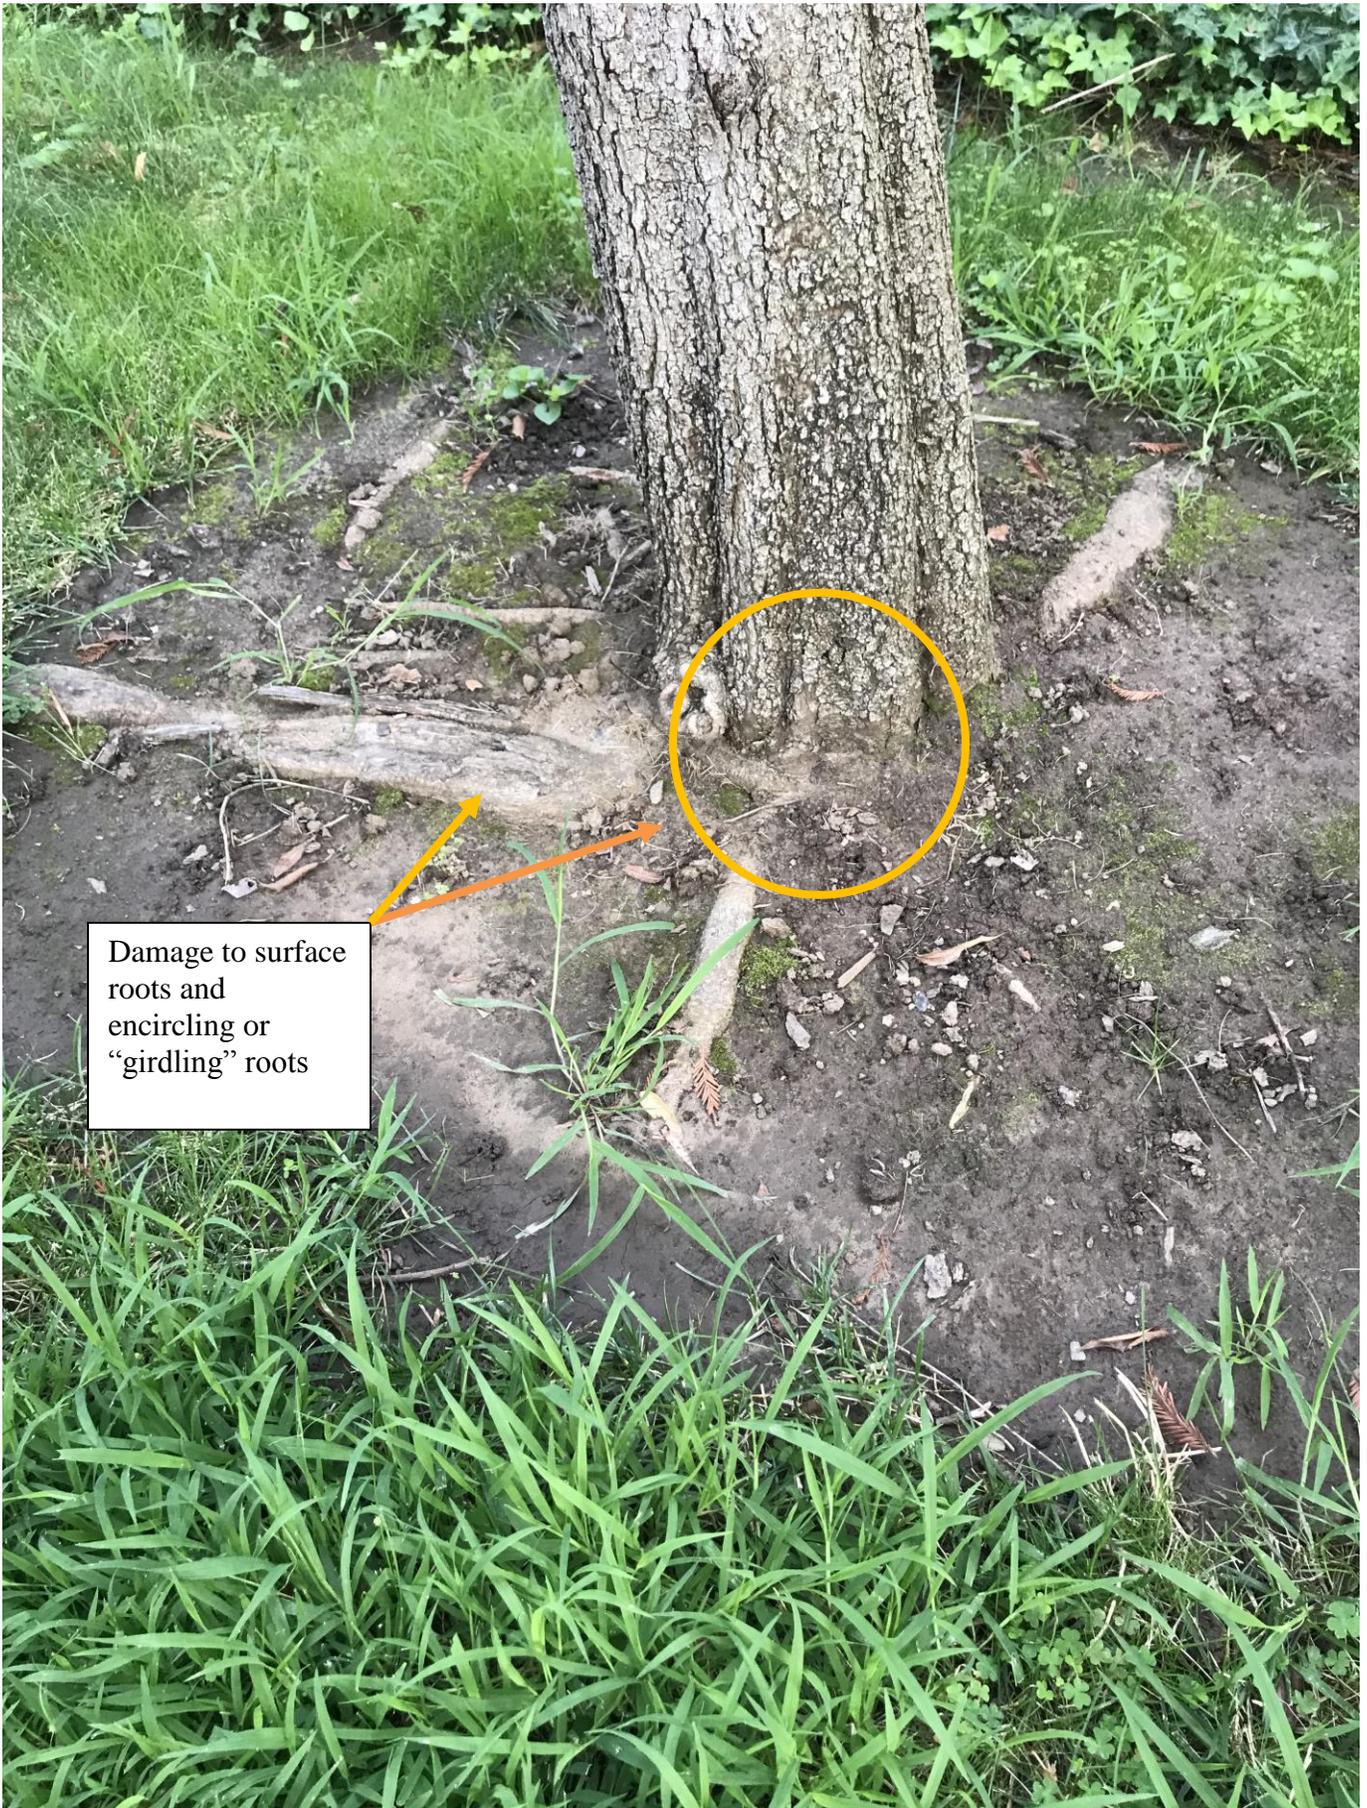
Figure 4

Damage to surface roots and encircling or "girdling" roots

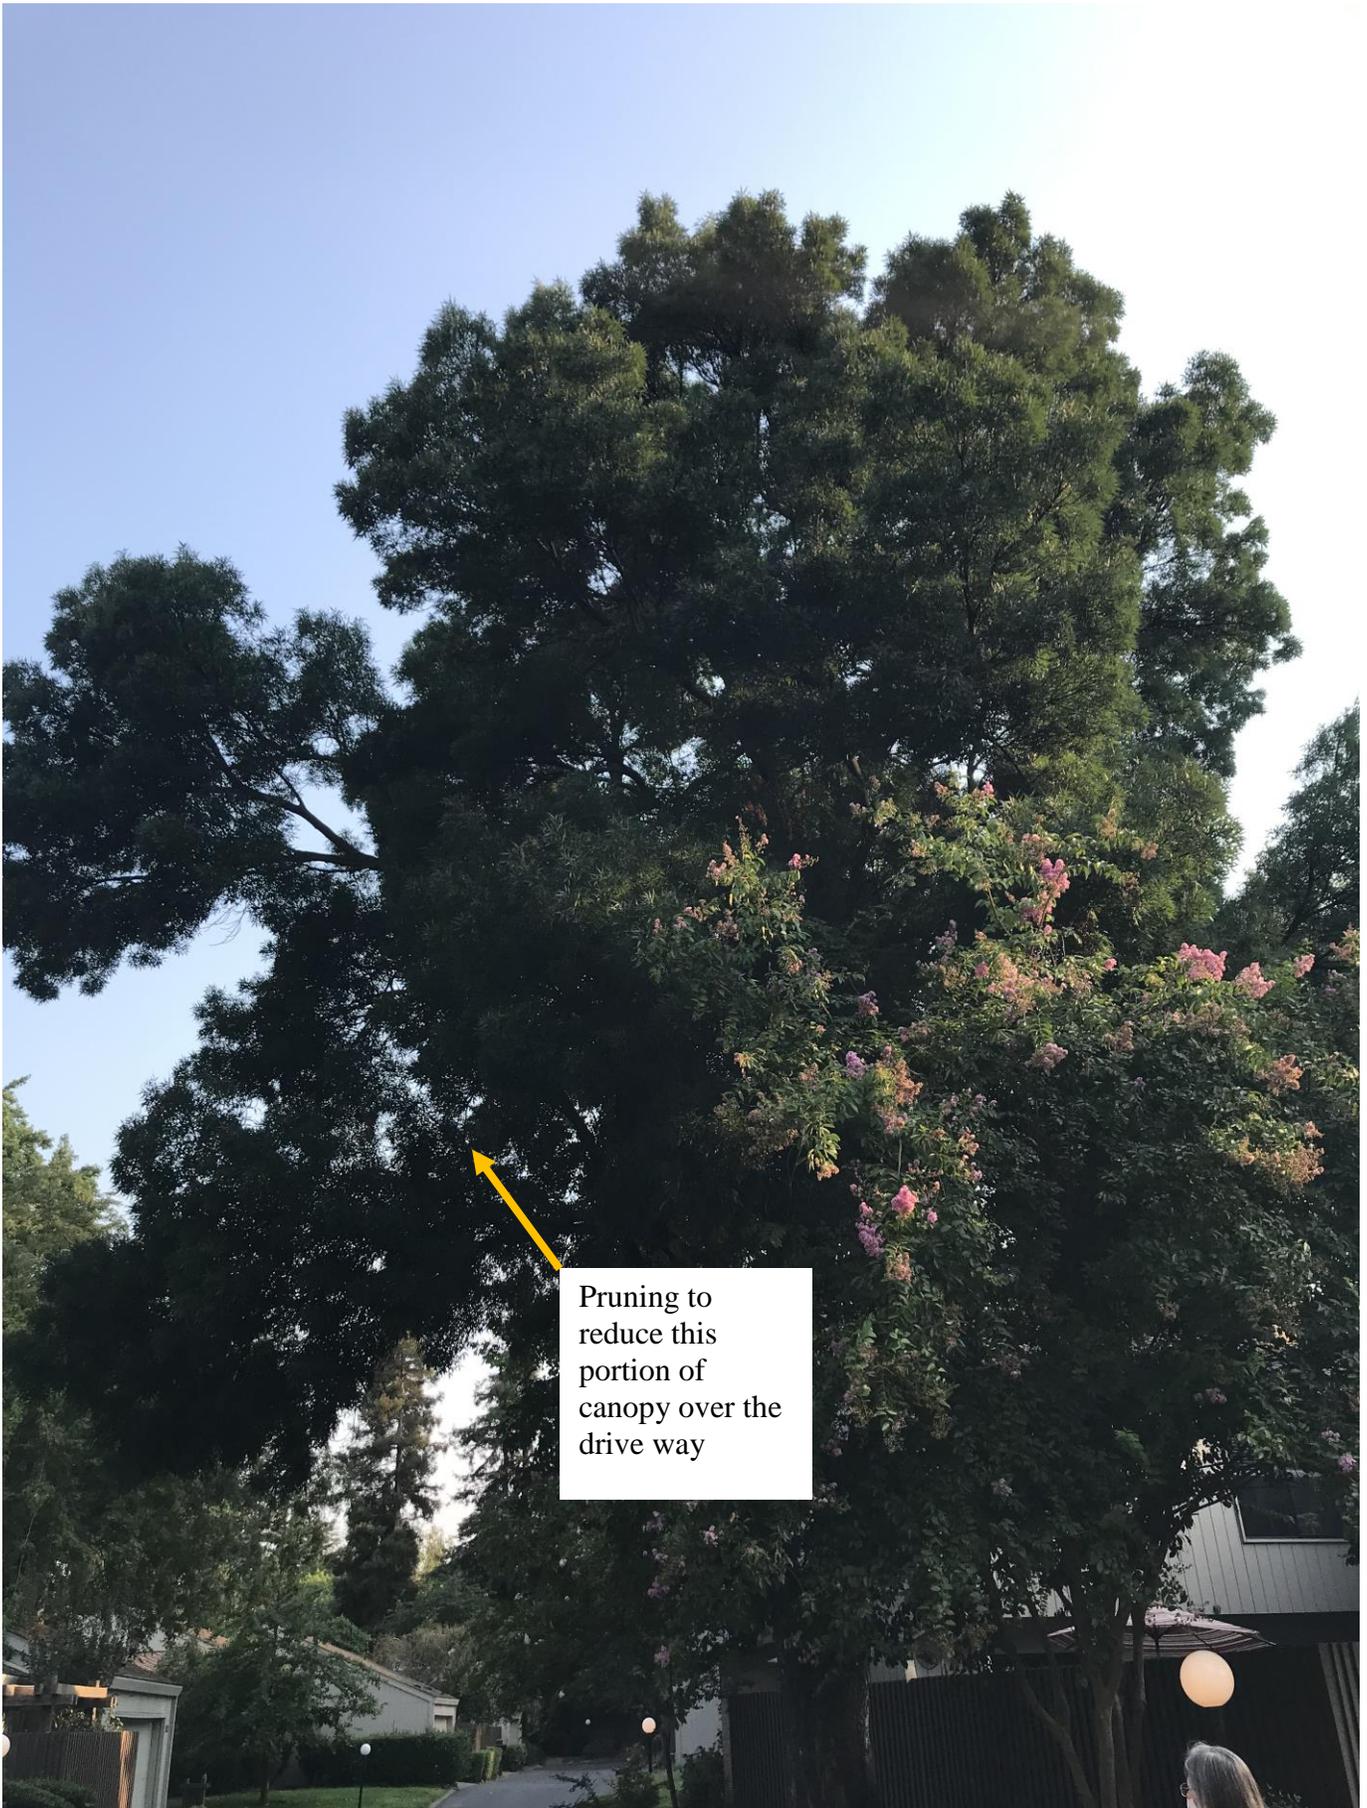
Figure 5

- (Zone 6) Tree #1737 Ash (*Fraxnis angustifolia*), 718 Elmhurst, (Figure 5) this tree has full canopy and has one over extended limb over the drive way I recommend to prune back to reduce limb failure

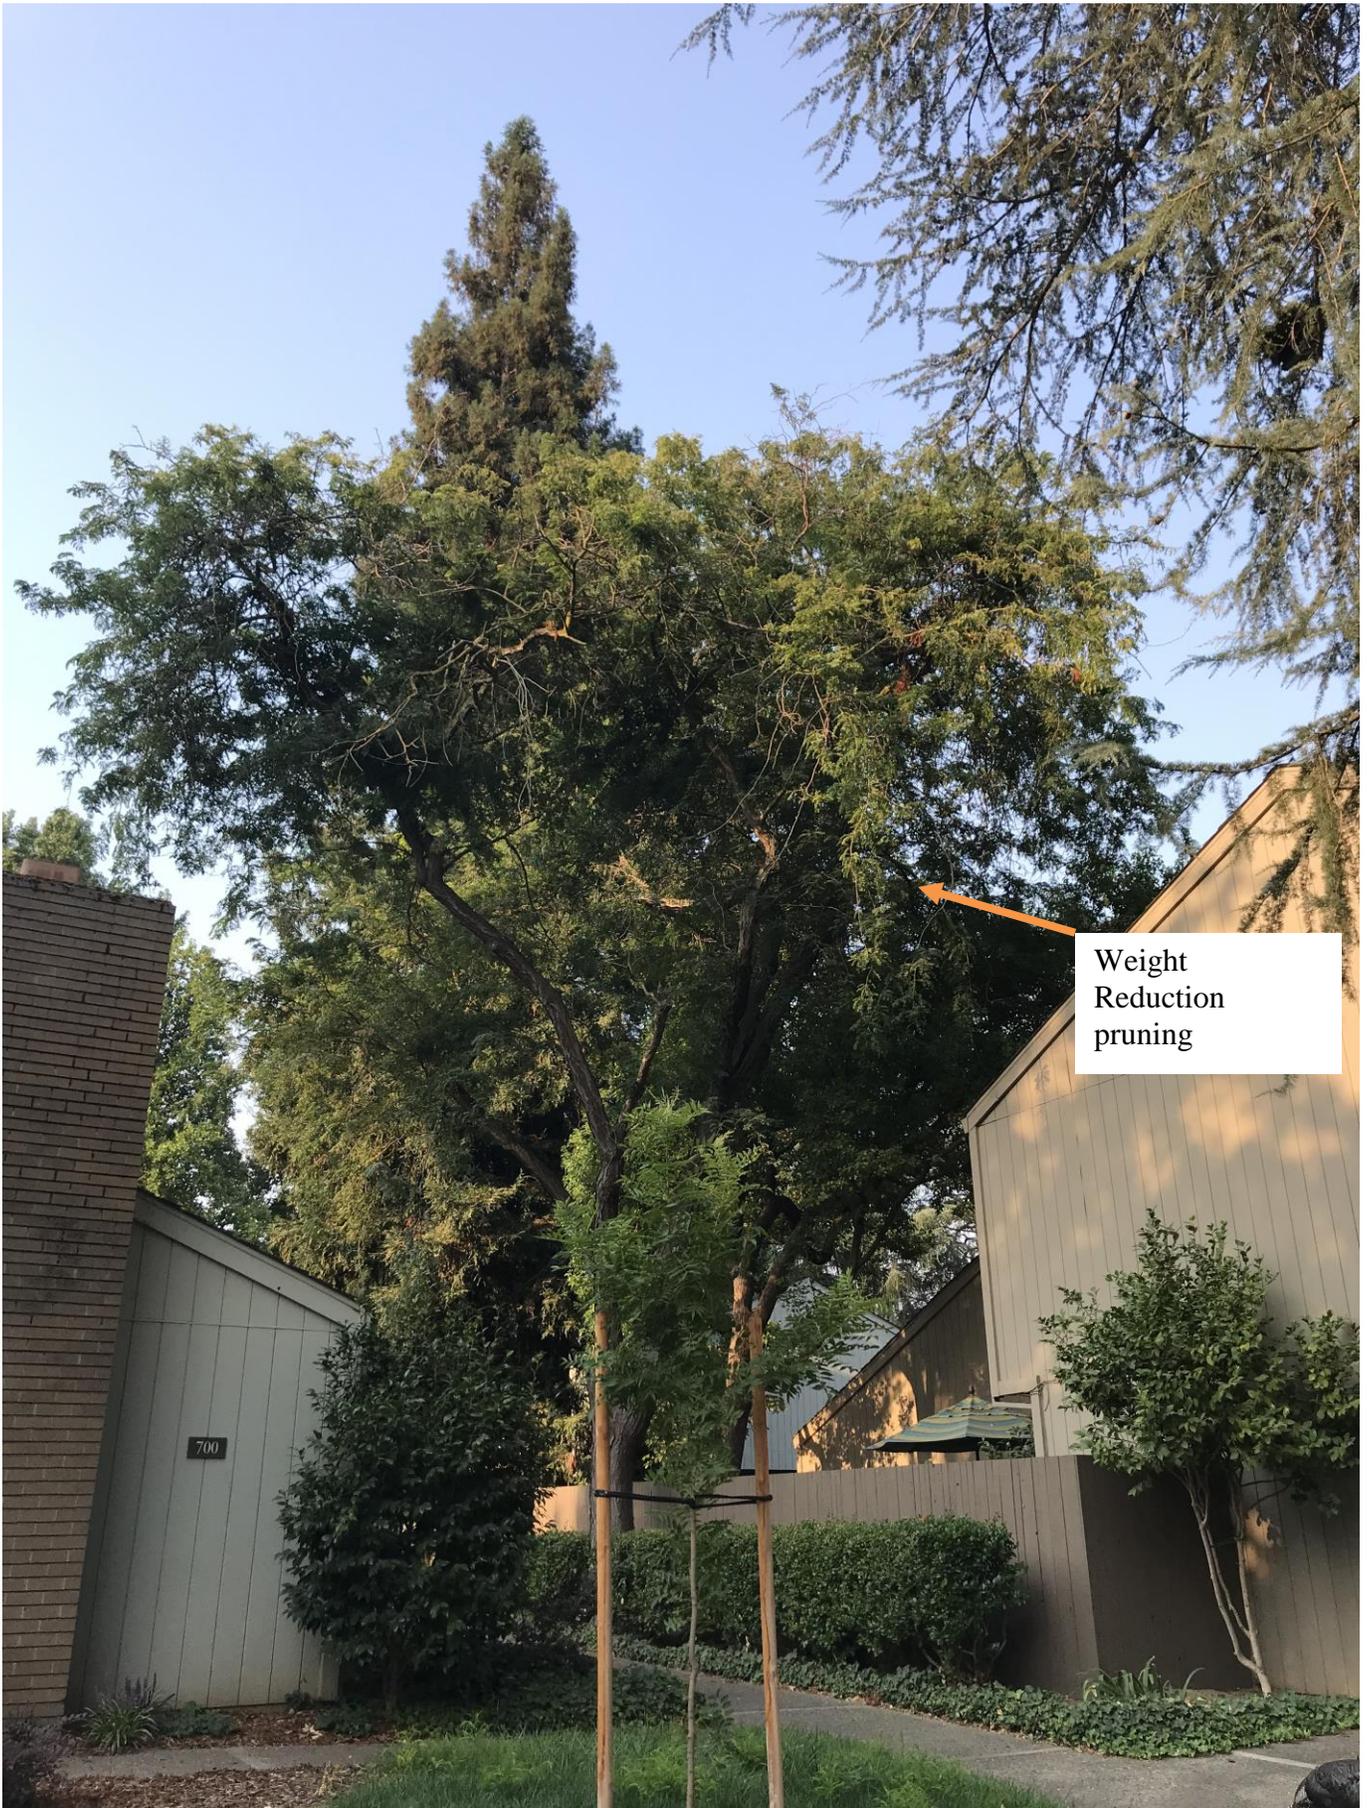
Figure 6

- (Zone 6) Tree #1766 Locust (*Robinia pseudoacacia*), 618 Elmhurst (Figure 6). This tree has full and over weighted canopy. I recommend full prune of trees Canopy.

Weight
Reduction
pruning

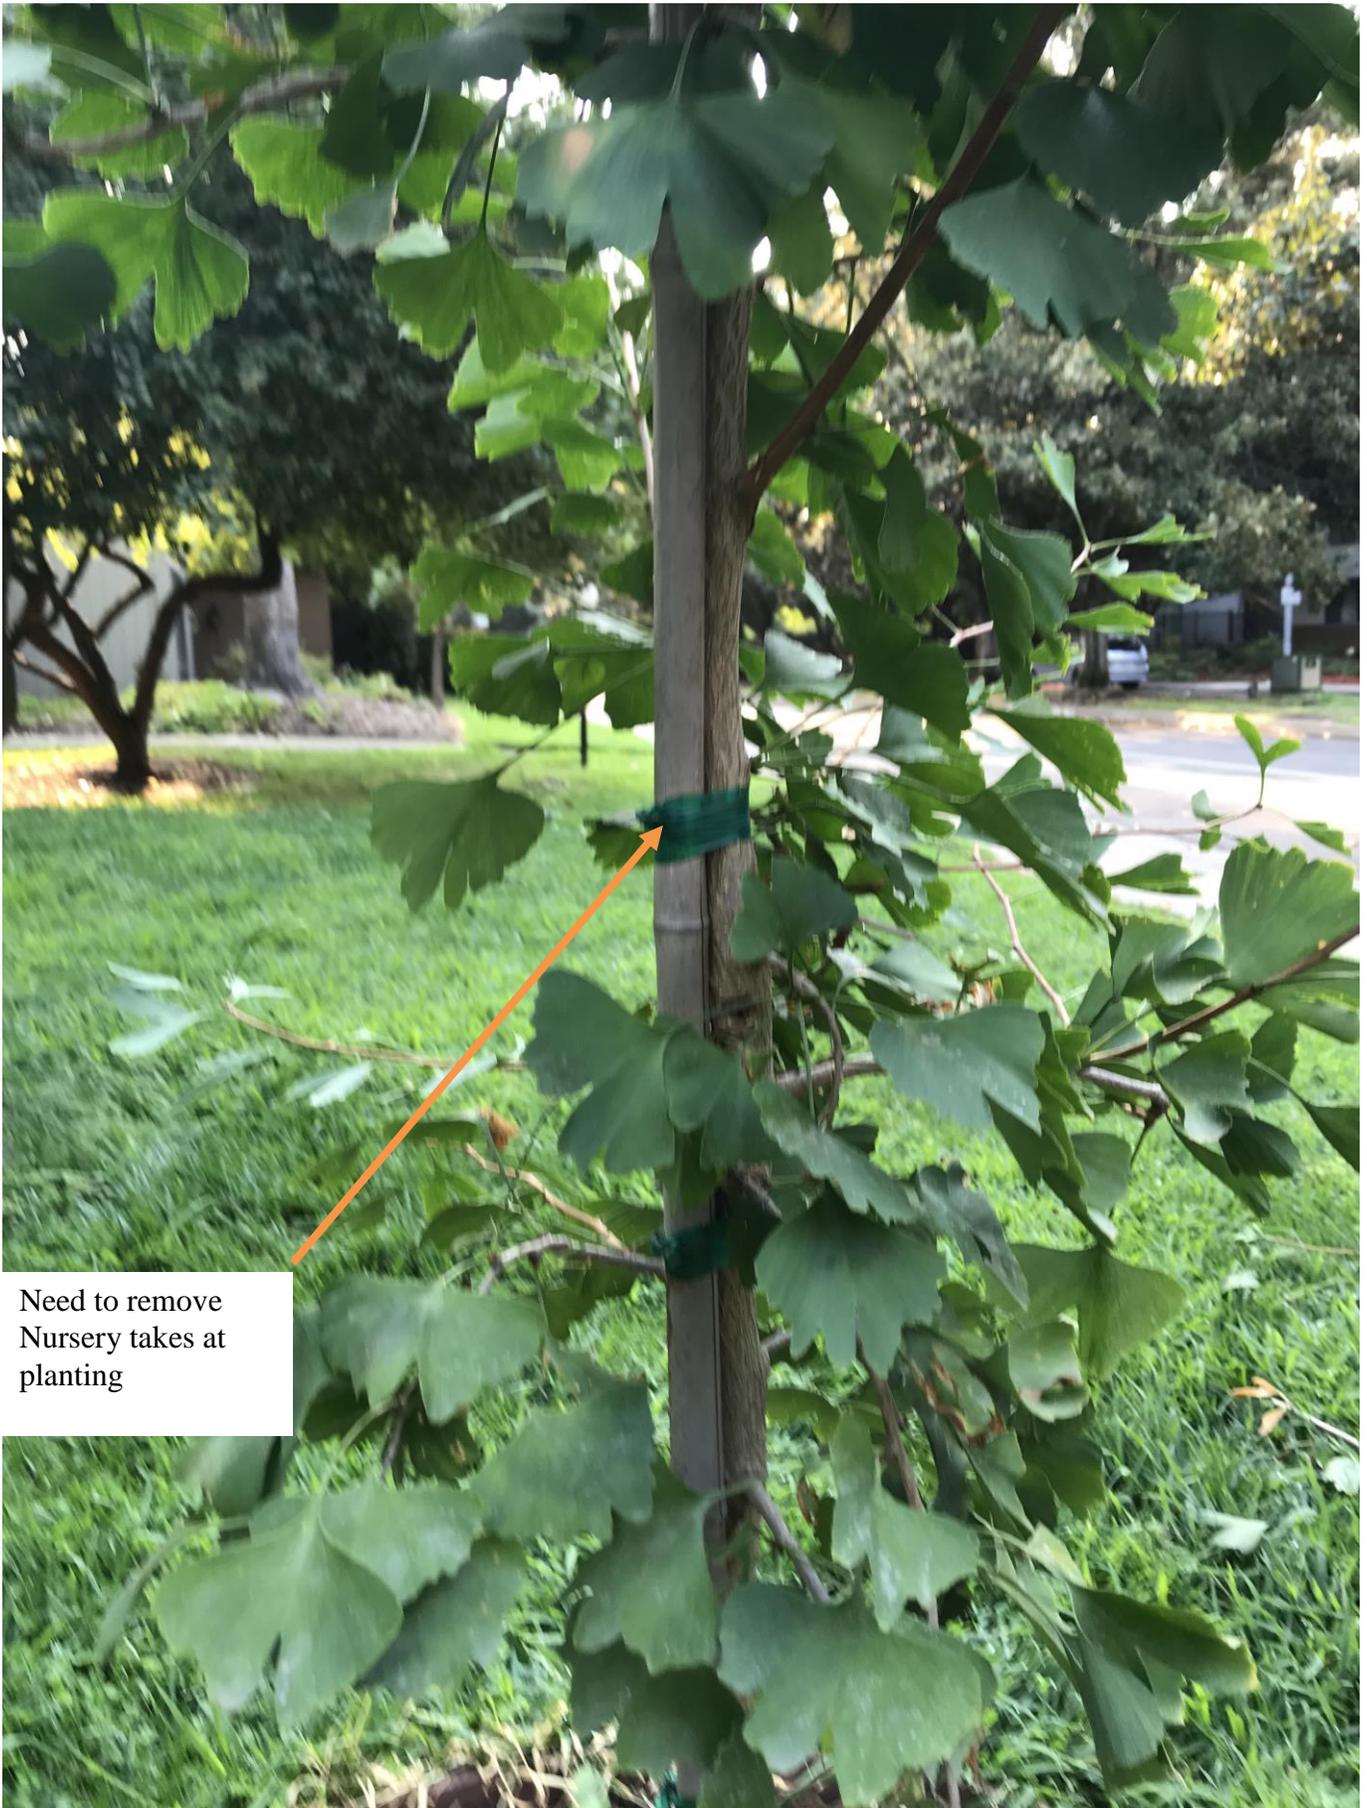
Figure 7

- (Zone 6) Tree No Tag Ginkgo (*Ginkgo biloba*), next to 708 Elmhurst. (Figure 7). This tree has the nursery stake still attached this should be removed immediately after planting unless absolutely necessary but should not stay on longer than 3 months after the tree is planted as it can cause damage to trunk development.

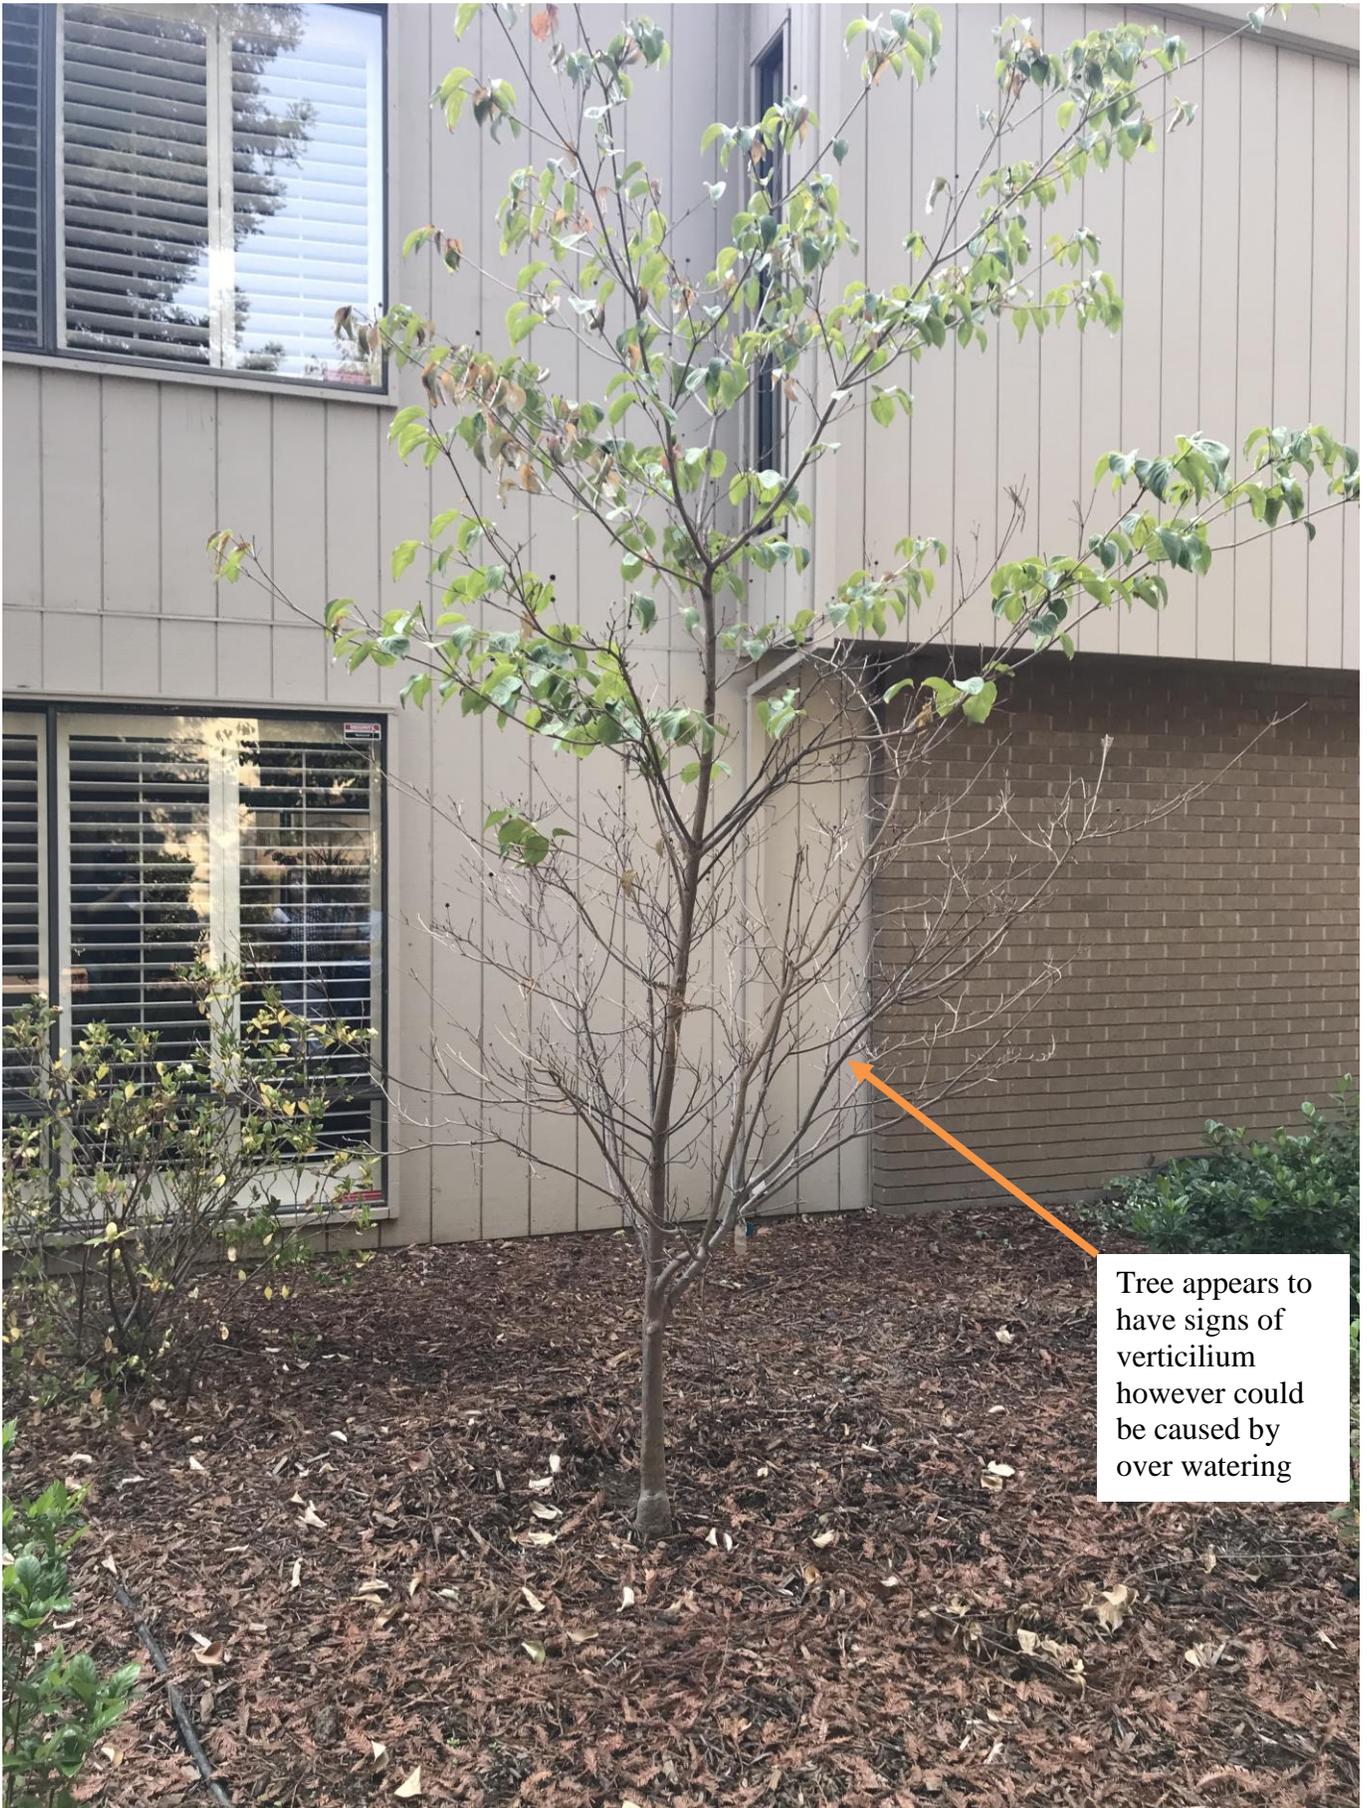
Figure 8

- (Zone 6) Tree No Tag Dogwood (*Cornus nuttallii*), 704 Elmhurst Circle. (Figure 8) This tree appears to be in decline and has signs of verticillium wilt this could be due to excess moisture in the soil. The tree should be removed and replaced

Tree appears to have signs of verticillium however could be caused by over watering

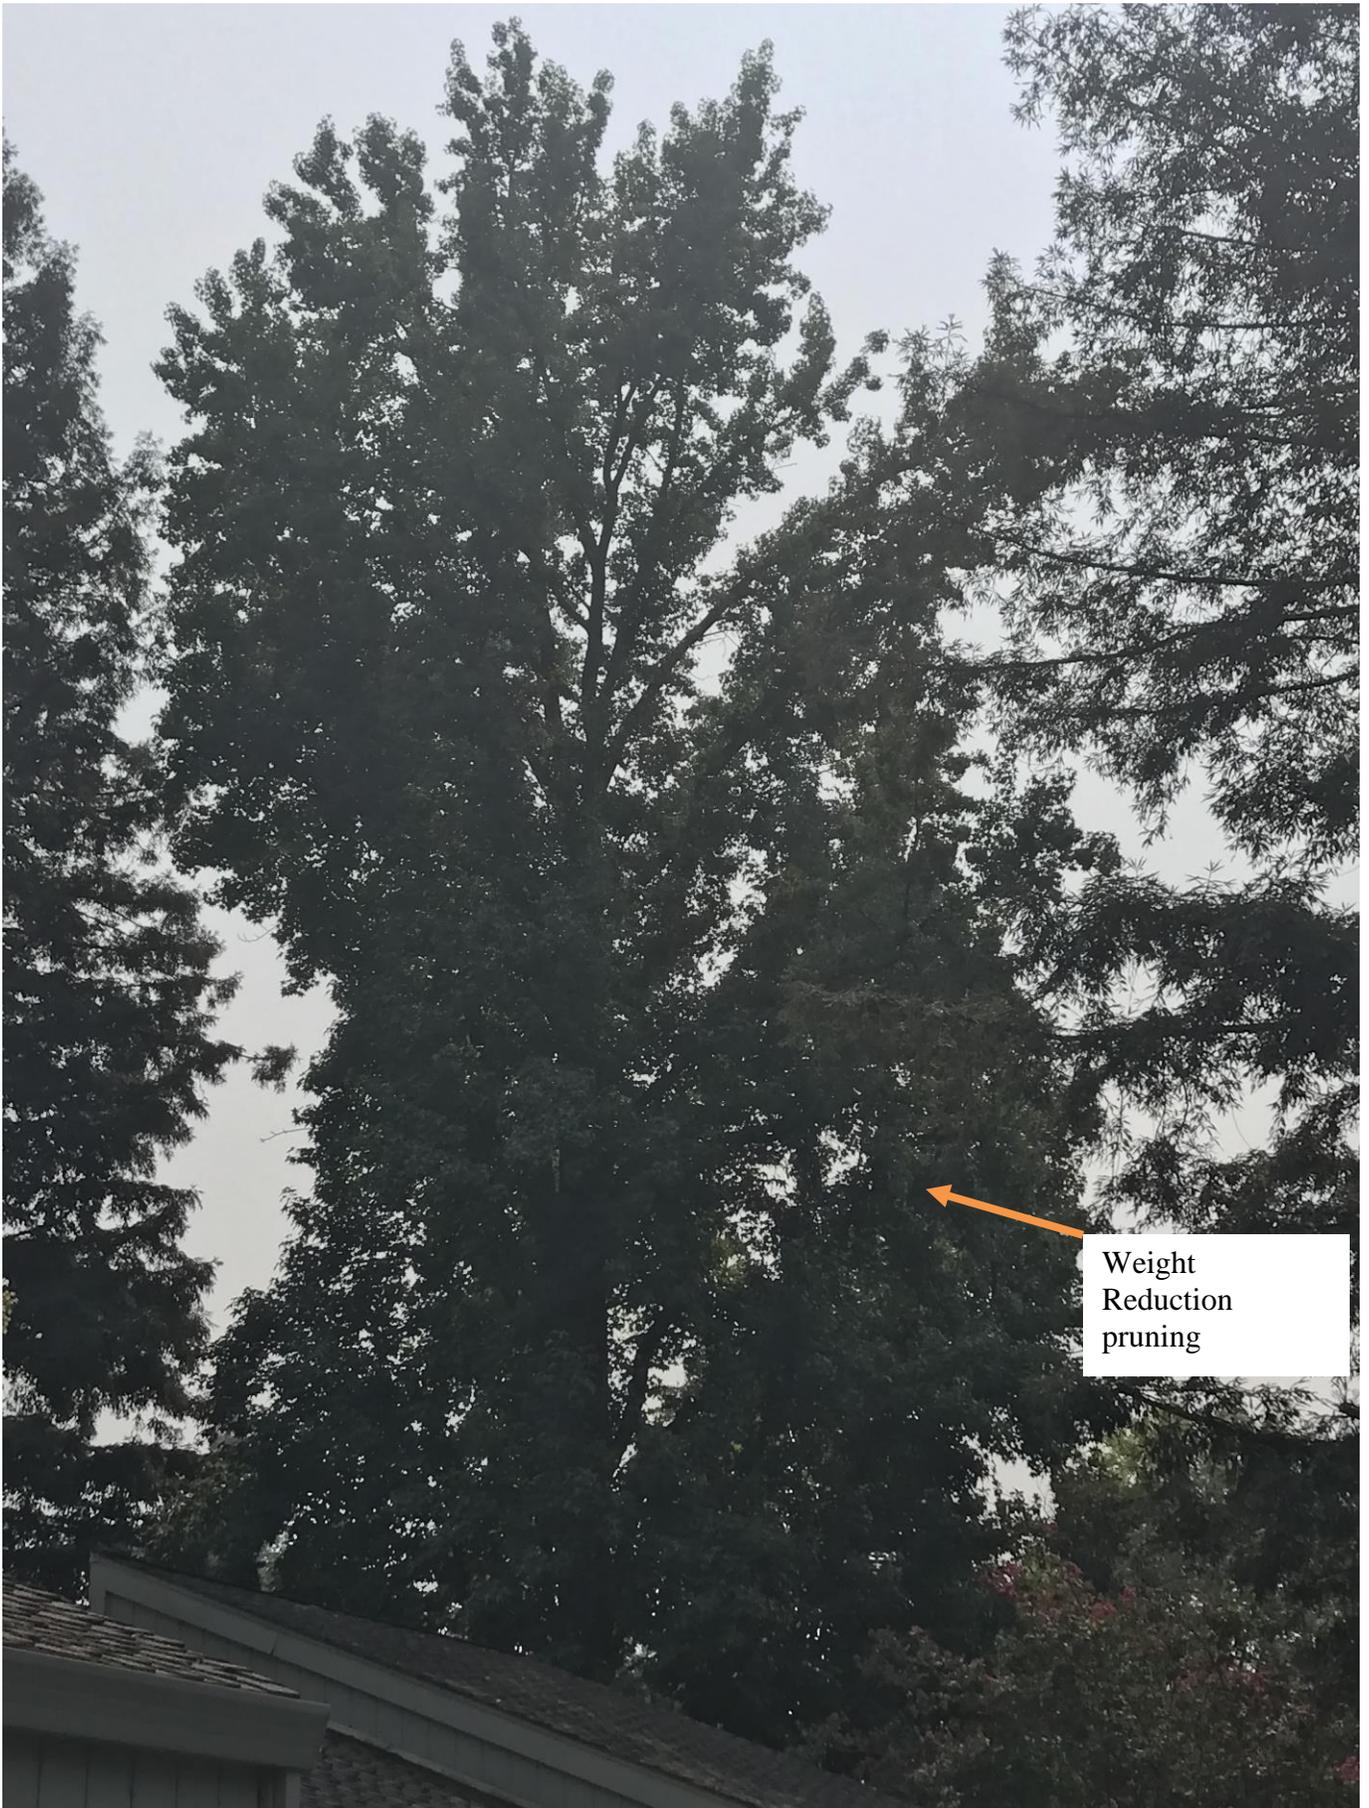
Figure 9

- (Zone 6) Tree #1806, Sweetgum (*Liquidambar styraciflua*), next to 506 Elmhurst Circle. (Figure 9). The tree canopy is full and heavy I recommend weight reduction pruning.
