September 9, 2020

The Nepenthe Association
1131 Commons Dr.
Sacramento, CA 95825
Phone: (916) 929-8380
Email: Bettsi.Ledesma@fsresidential.com

On September 3, 2020, I inspected several trees on the Nepenthe property during the monthly tree walk. The focus of the walk was to address resident/management concerns regarding mature trees on the property. The purpose of this report is to develop mitigation plans for the following trees and my recommendations are below. My recommendations are based on a Basic Visual Inspection. All decisions made based on the recommendations of this report are at the discretion of the Nepenthe Association.

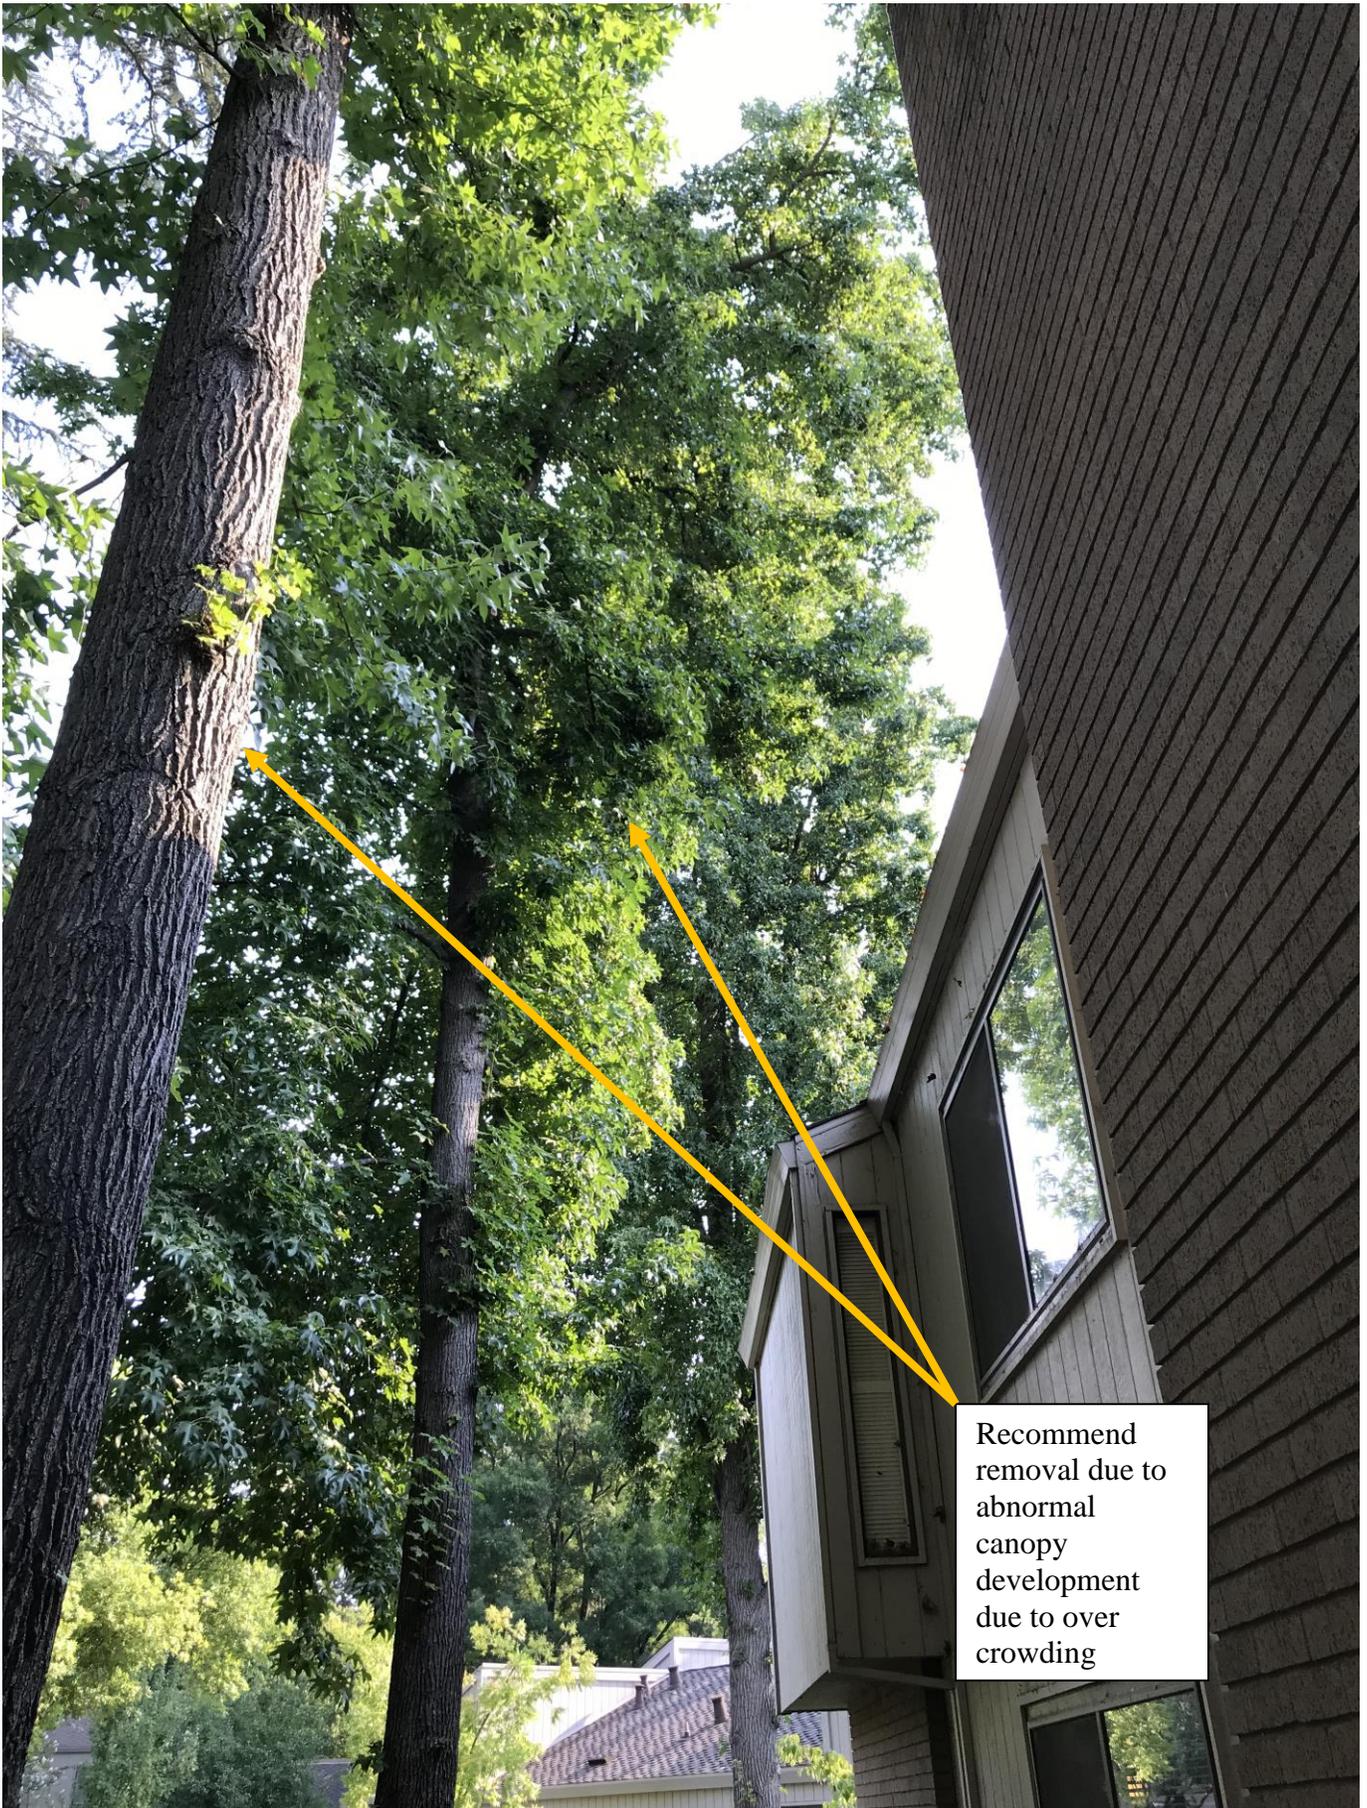
Figure 10

- (Zone 6) Trees # 1836, #1838 Sweetgum (*Liquidambar styraciflua*) 402 Elmhurst Circle (Figure 10-11) these two trees are roughly 3-4' from the side of the home and in an area that is very tree heavy. This has caused the trees to develop abnormal canopy. The trees have little development room side to side and the only available light is over the home causing the canopy to be heavier over the house. I recommend to remove these trees due to proximity to the home and the potential for the trees to cause damage to the home with limb failure.

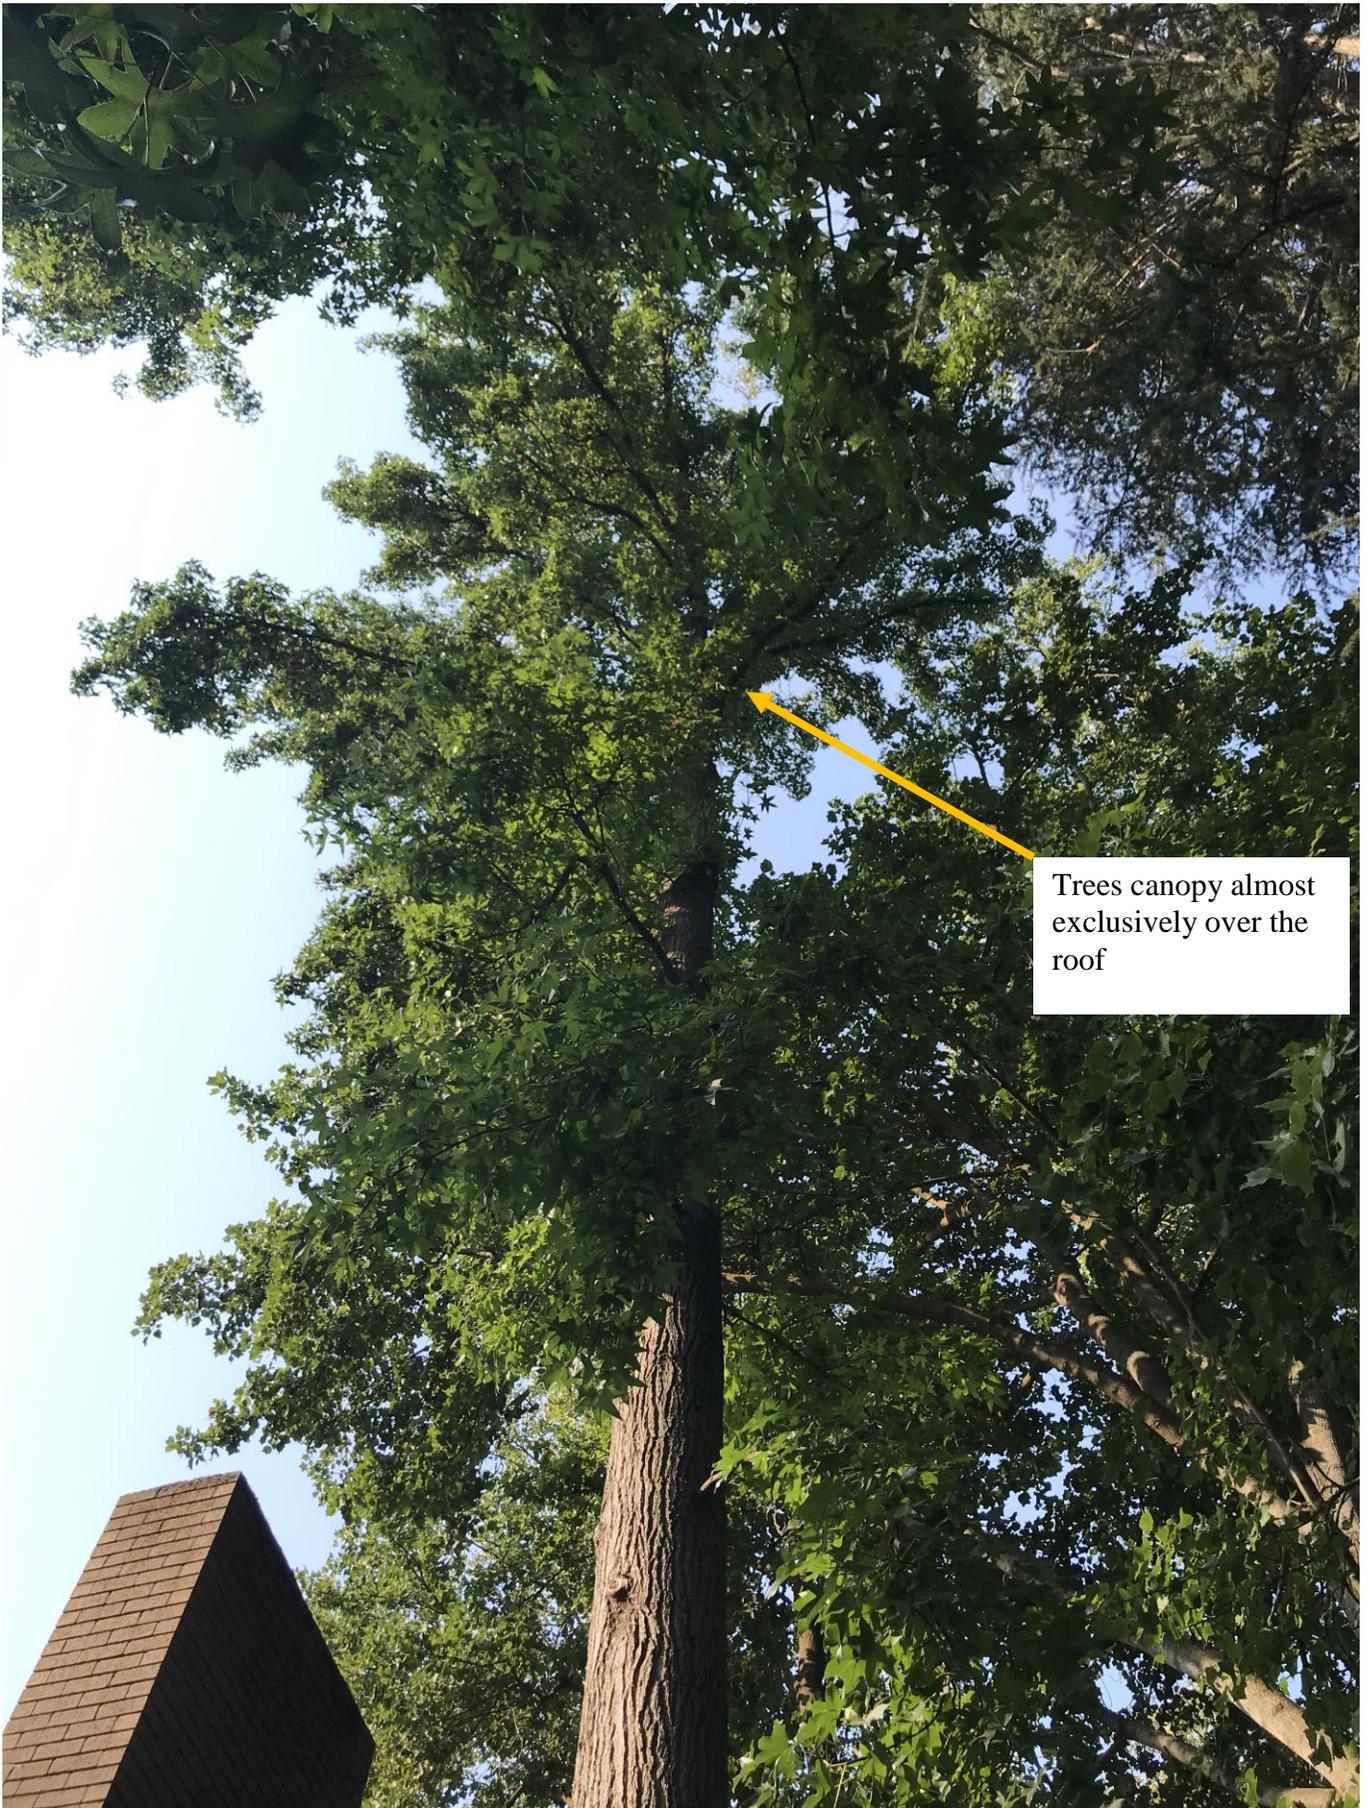
Figure 11

Trees canopy almost exclusively over the roof

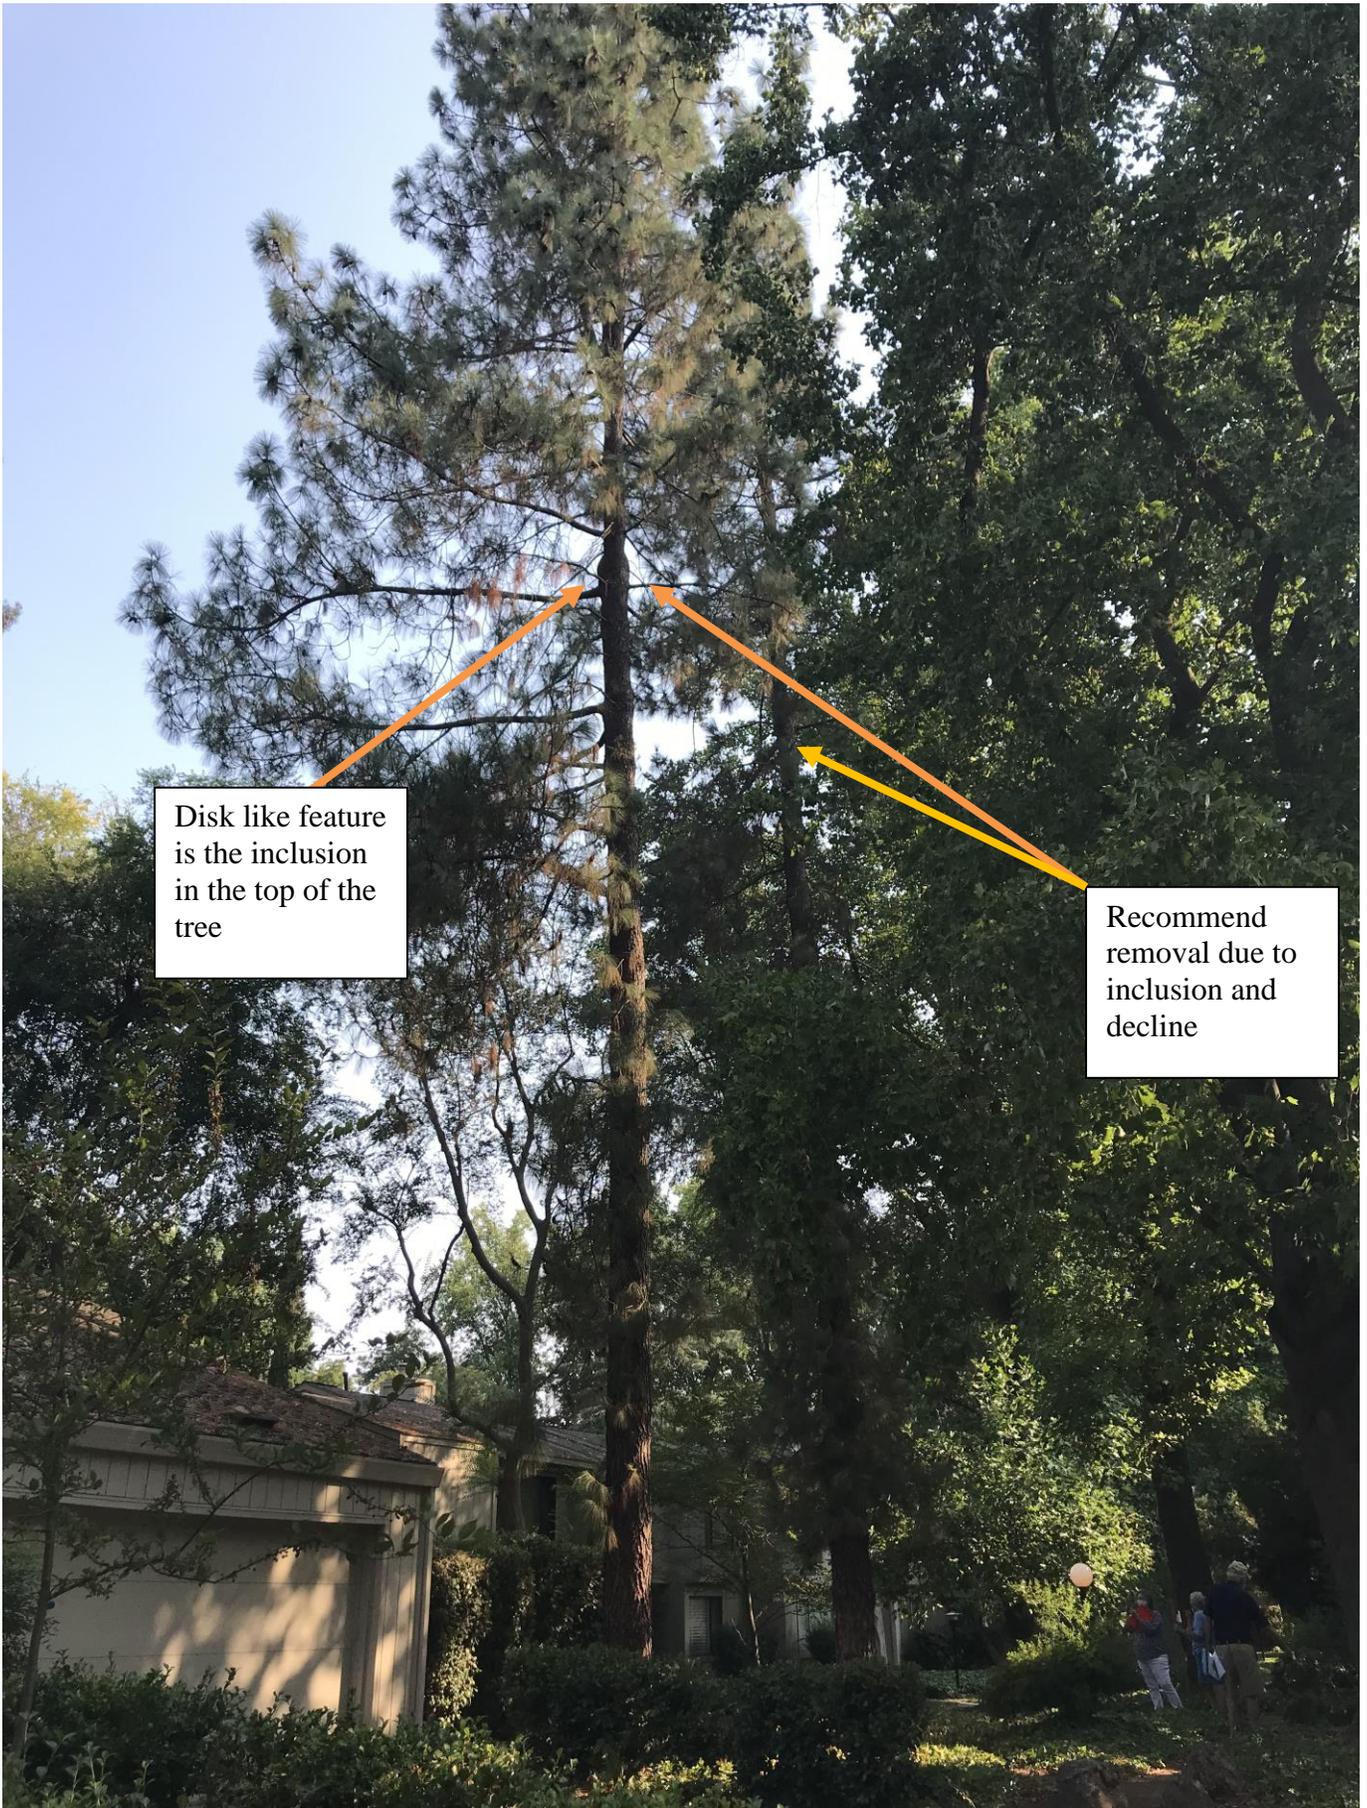
Figure 12

- (Zone 6) Trees #1866, #1914 Pine (*Pinus canariensis*) 306 Elmhurst Circle. (Figure 12) Tree #1866 has a significant inclusion and is co dominate and has a potential for failure due to the nature of the inclusion. Tree #1914 appears to be thin and in decline. I recommend removal and replacement of these trees with a a more suitable variety.

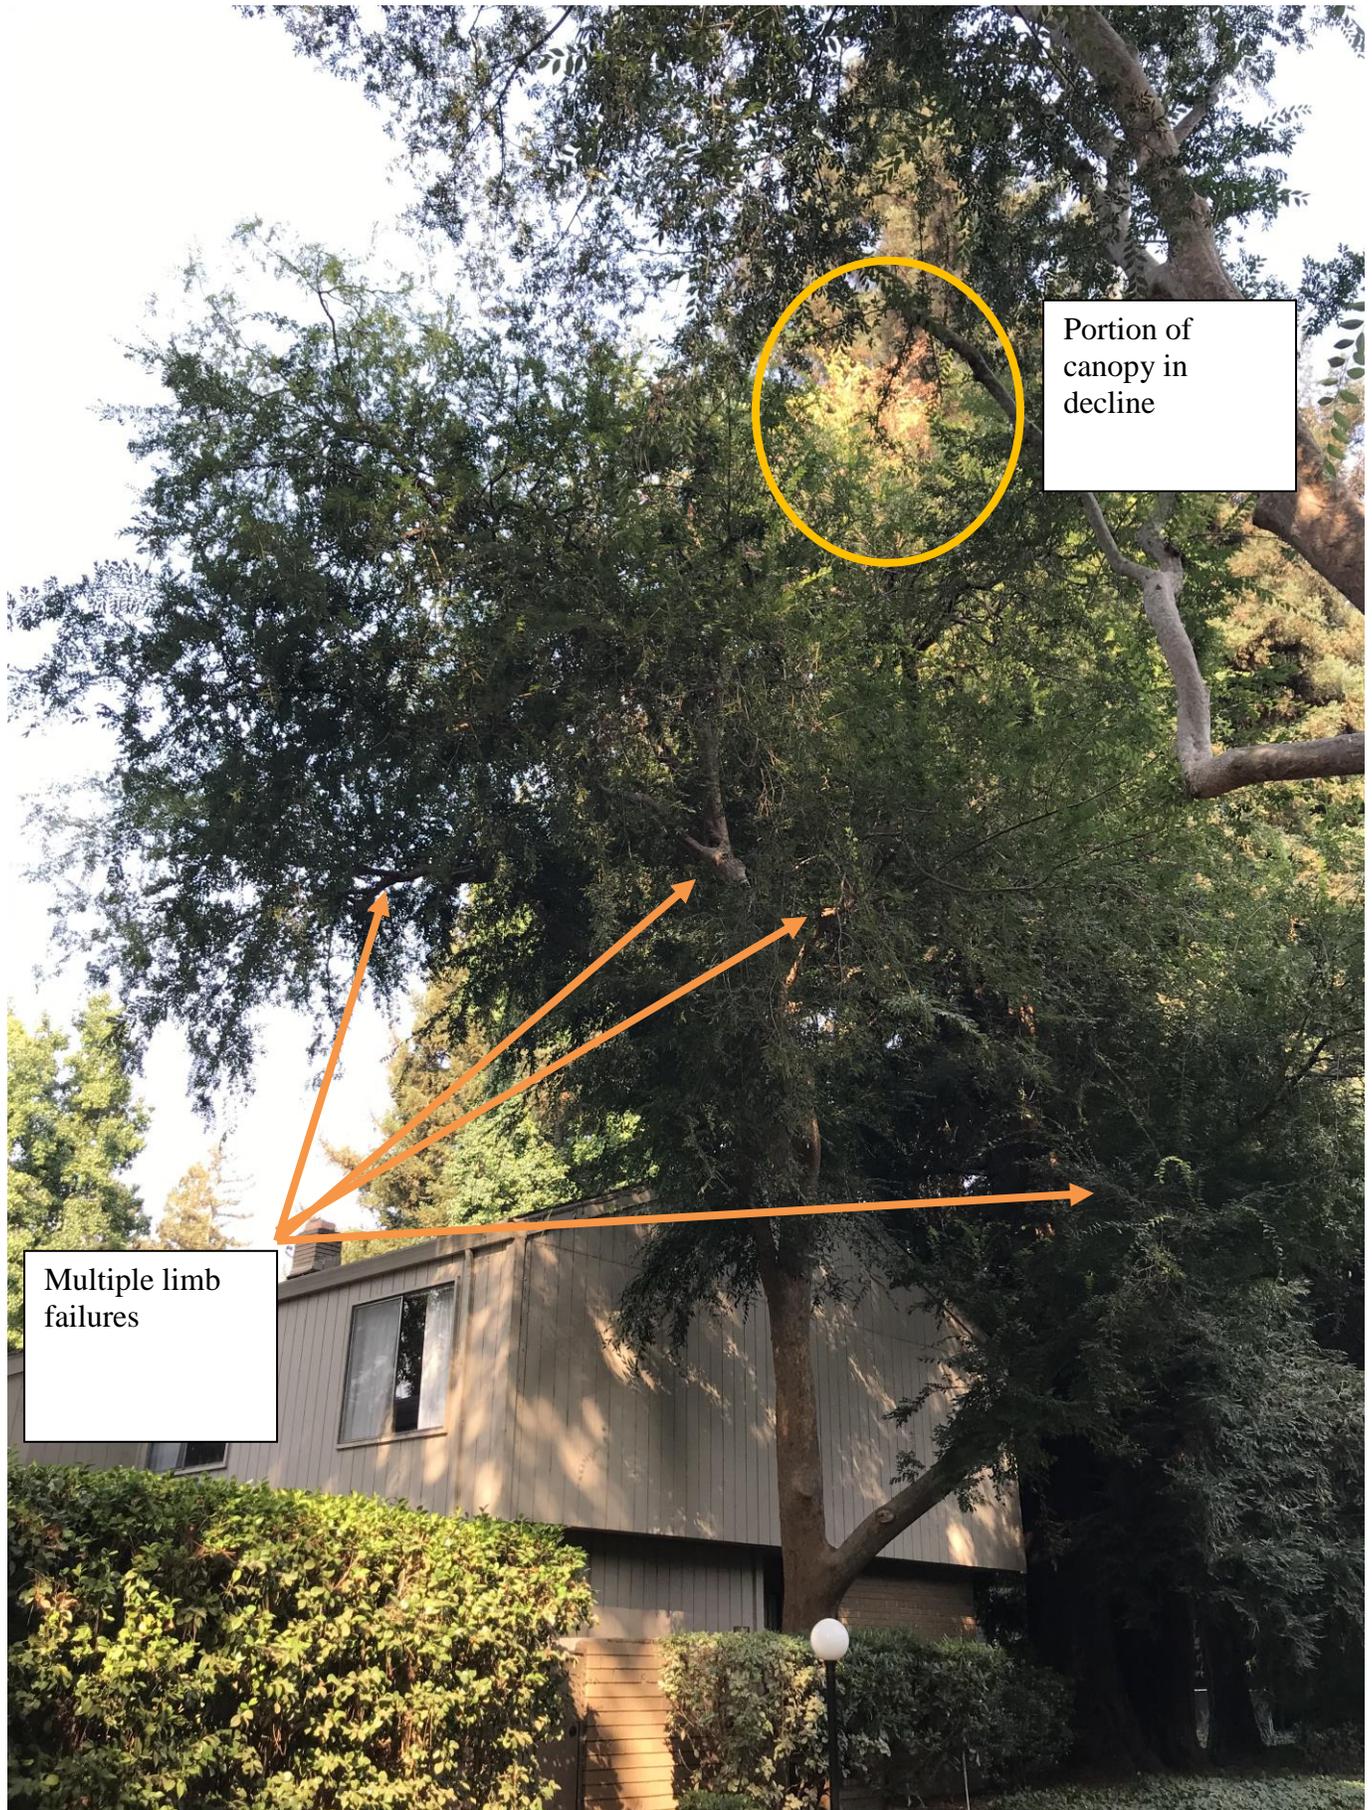
Figure 13

- (Zone 6) Tree # Elm (*Ulmus parvifolia*), 306 Elmhurst Circle. (Figure 13) This tree has had a history of limb failure and has several wounds in the upper canopy that have not healed leaving the tree susceptible for future failure. Due to the extent of damage to the canopy the failures have cause pruning the tree to correct the damage and have aesthetic appeal is not attainable. In addition the tree is in a small planter location approximately 2' from the main entrance and is likely going to cause damage to the walkway. I recommend removal and replacement with a more suitable variety.

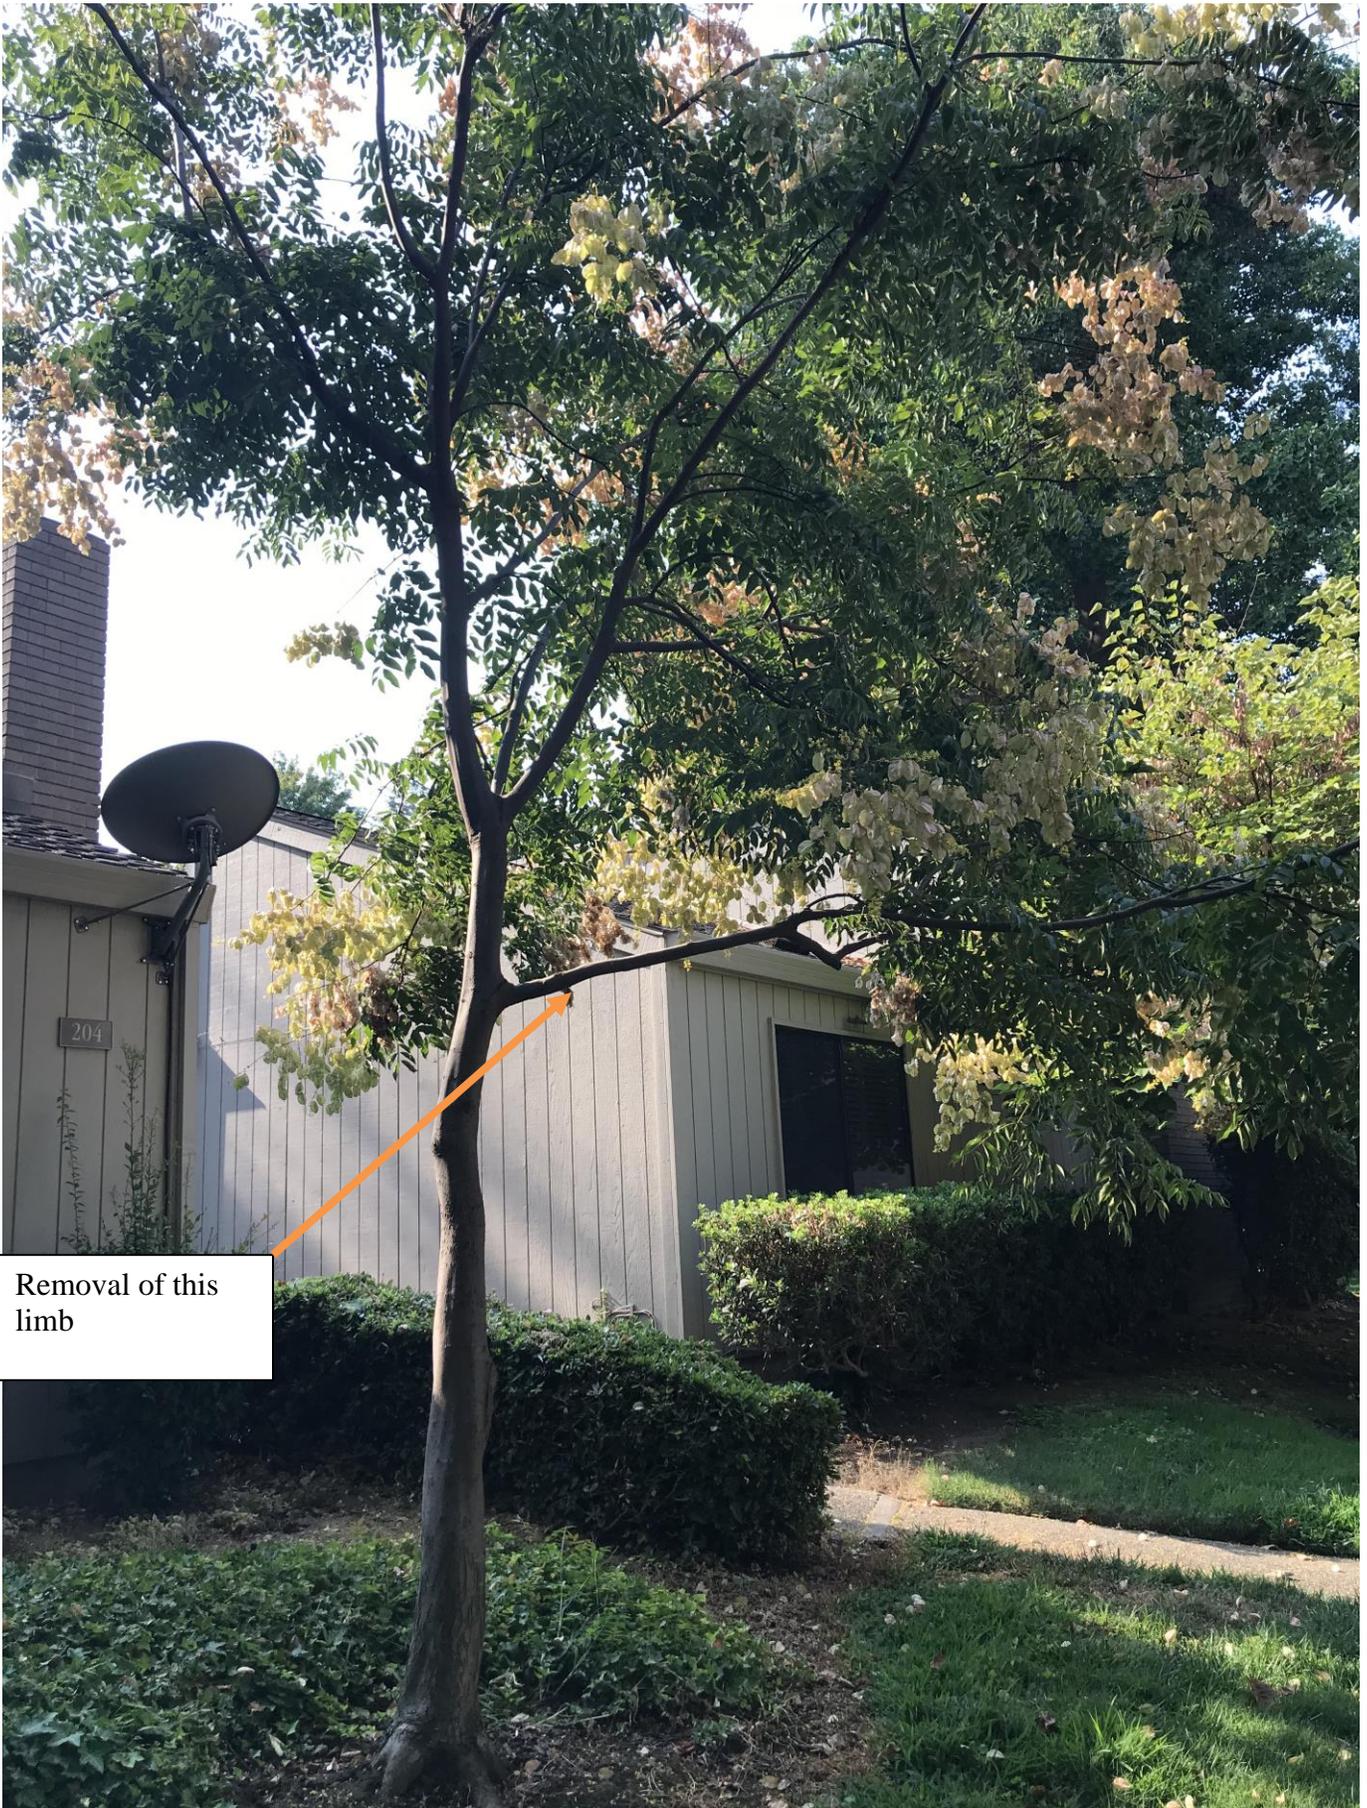
Figure 14

- (Zone 6) Tree #No Tag, Chinese flame tree (*Koelreuteria bipinnata*) 204 Elmhurst Dunbarton Circle. The tree has one long low limb that I propose to remove to redirect growth and development (Figure 14).

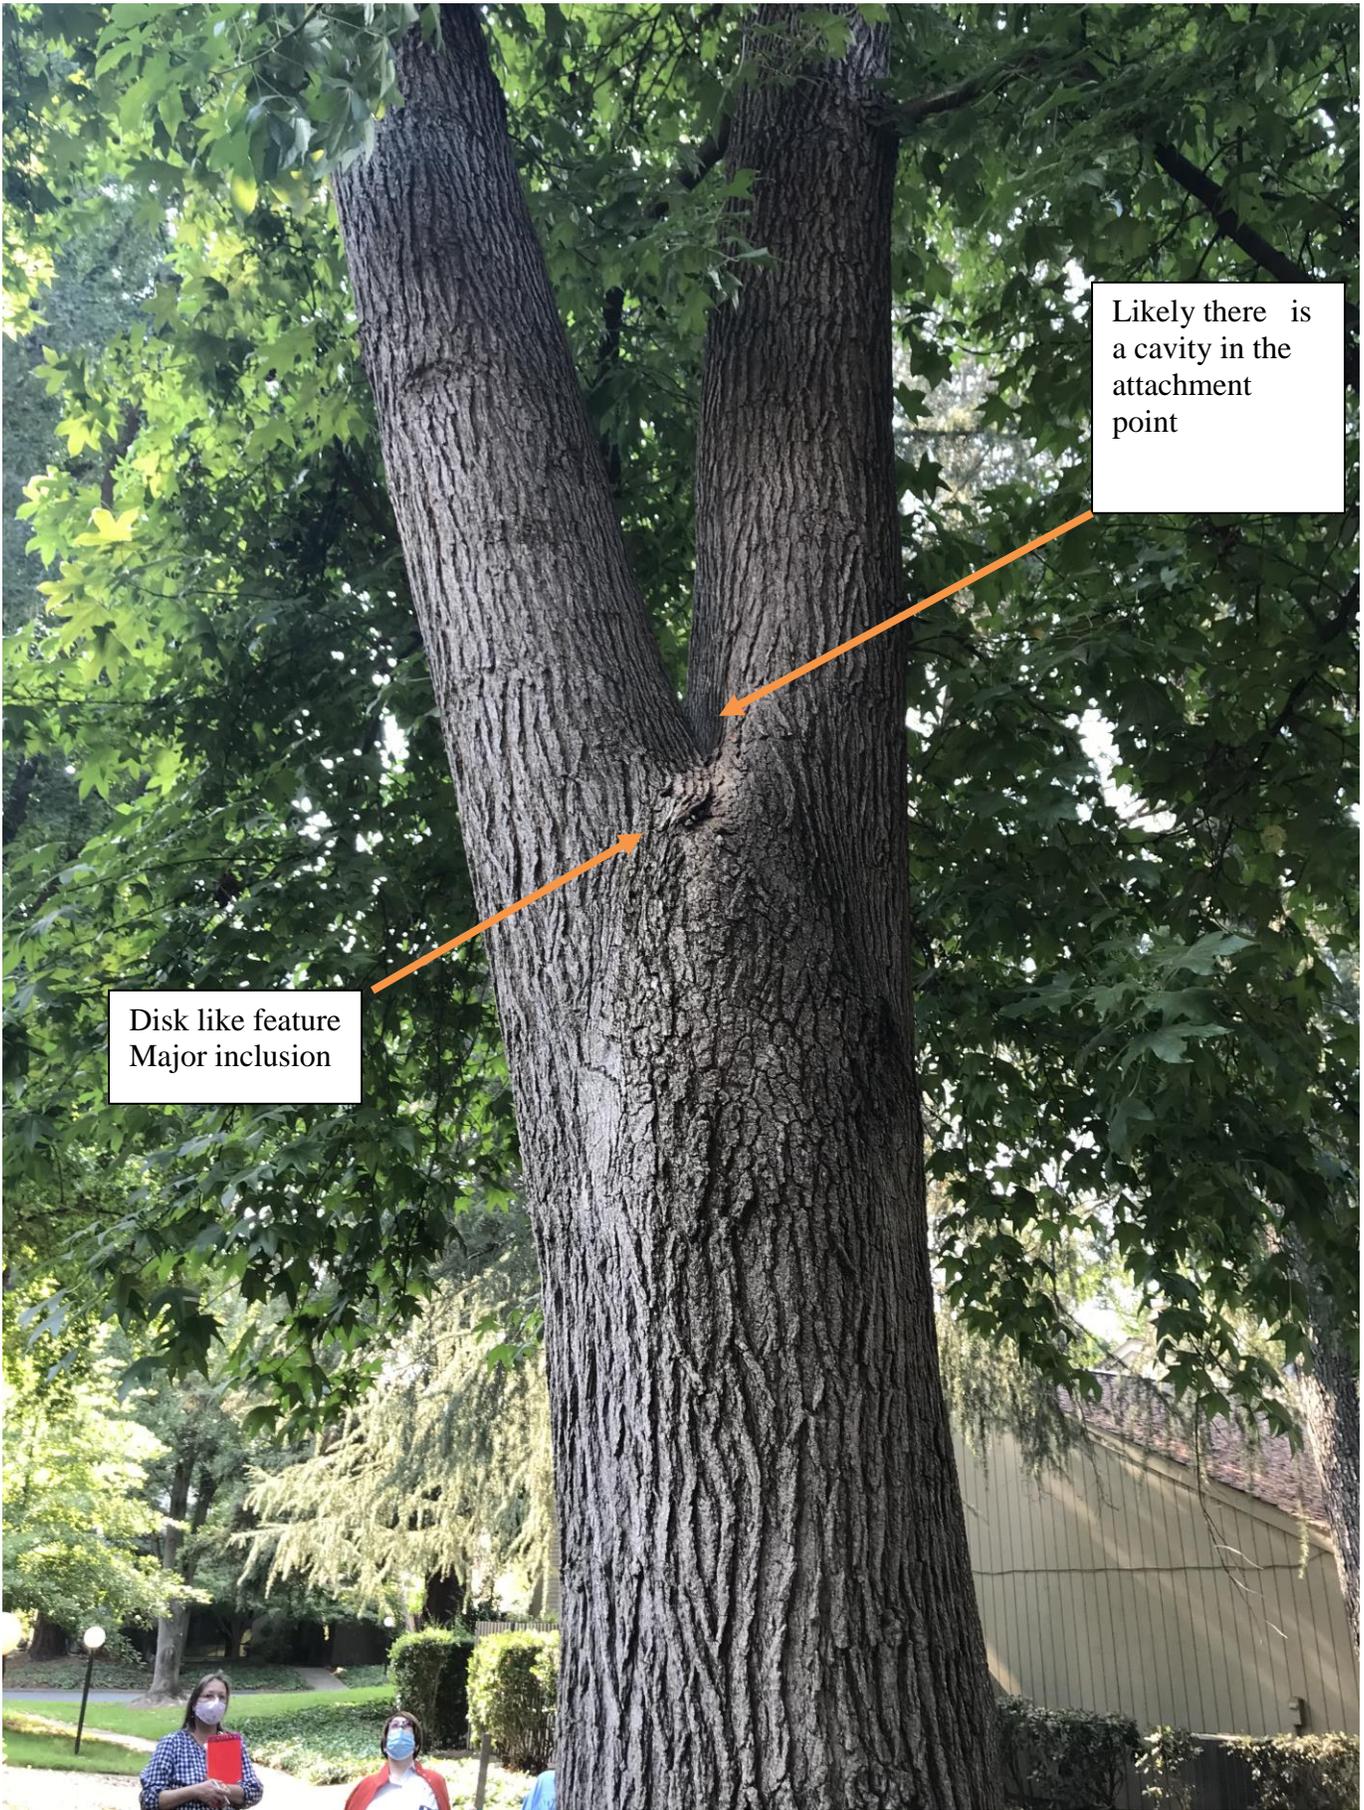
Figure 15

- (Zone 6) Trees #1964, #1962, Sweetgum (*Liquidambar styraciflua*), next to 106 Elmhurst Circle. (Figure 15-16). Tree #1964 has a full and heavy I recommend weight reduction pruning. Tree #1962 has a major inclusion between the main stems. One of the stems has a significant amount of weight over the home. Weight reduction pruning would not be efficient enough to prevent a failure. Due to the nature of the inclusion and the proximity to the home I recommend removal of this tree.

Disk like feature
Major inclusion

Likely there is
a cavity in the
attachment
point

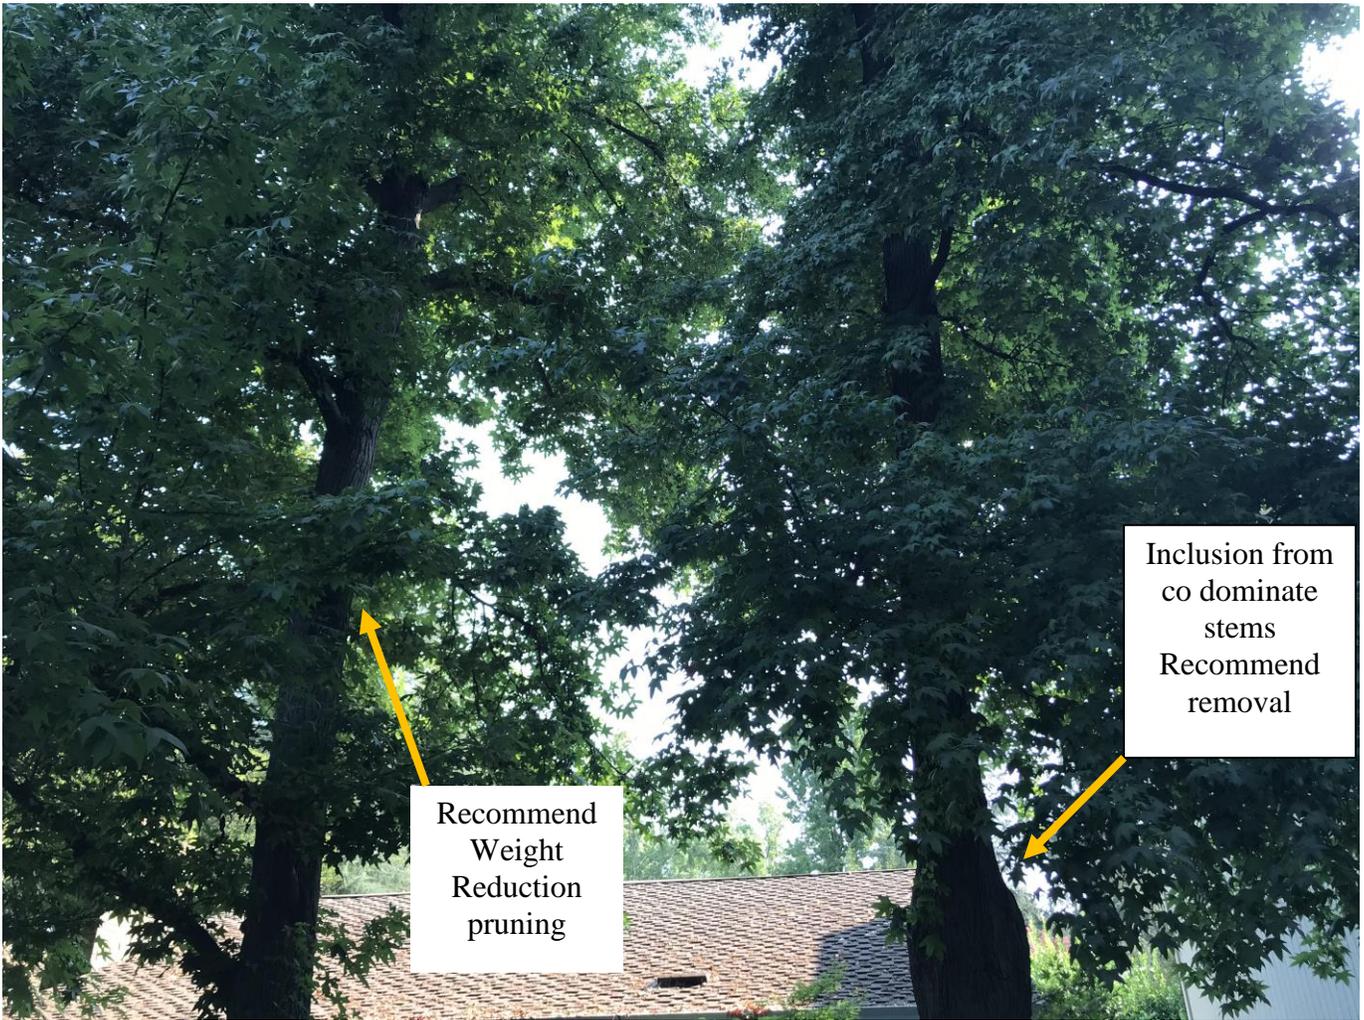
Figure 16

Recommend
Weight
Reduction
pruning

Inclusion from
co dominate
stems
Recommend
removal

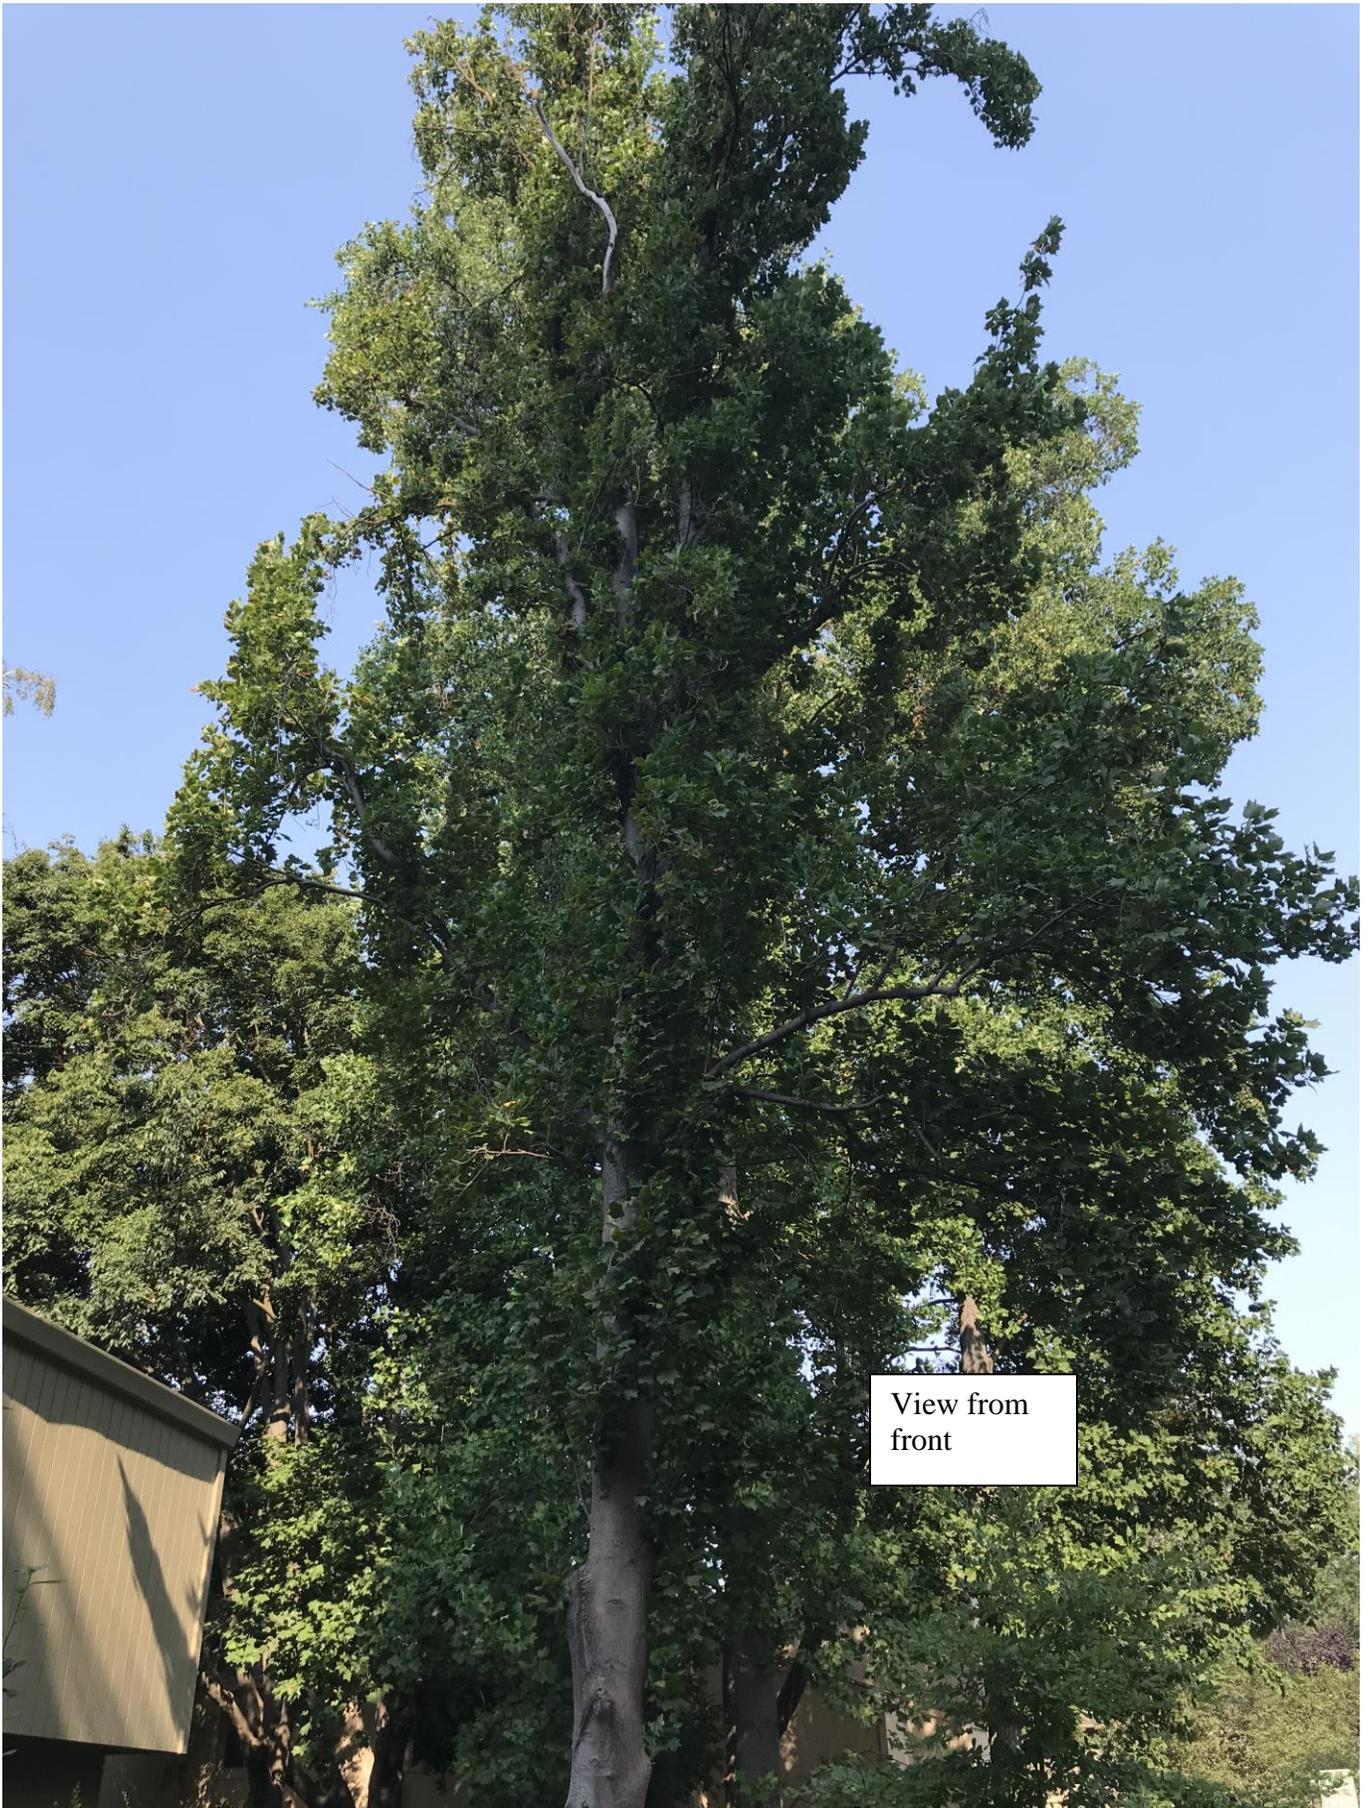
Figure 17

- (Zone 6) Tree #1967 Tulip tree (*Liriodendron tulipifera*) 1015 Elmhurst Circle, (Figure 17) this tree has developed an abnormal canopy due to overcrowding from other trees. However the tree that had been right next to it was removed leaving this tree susceptible to wind exposer. The tree has developed almost like a fan and there is no way to correct this growth through pruning. I recommend removal and replacement.

View from
front

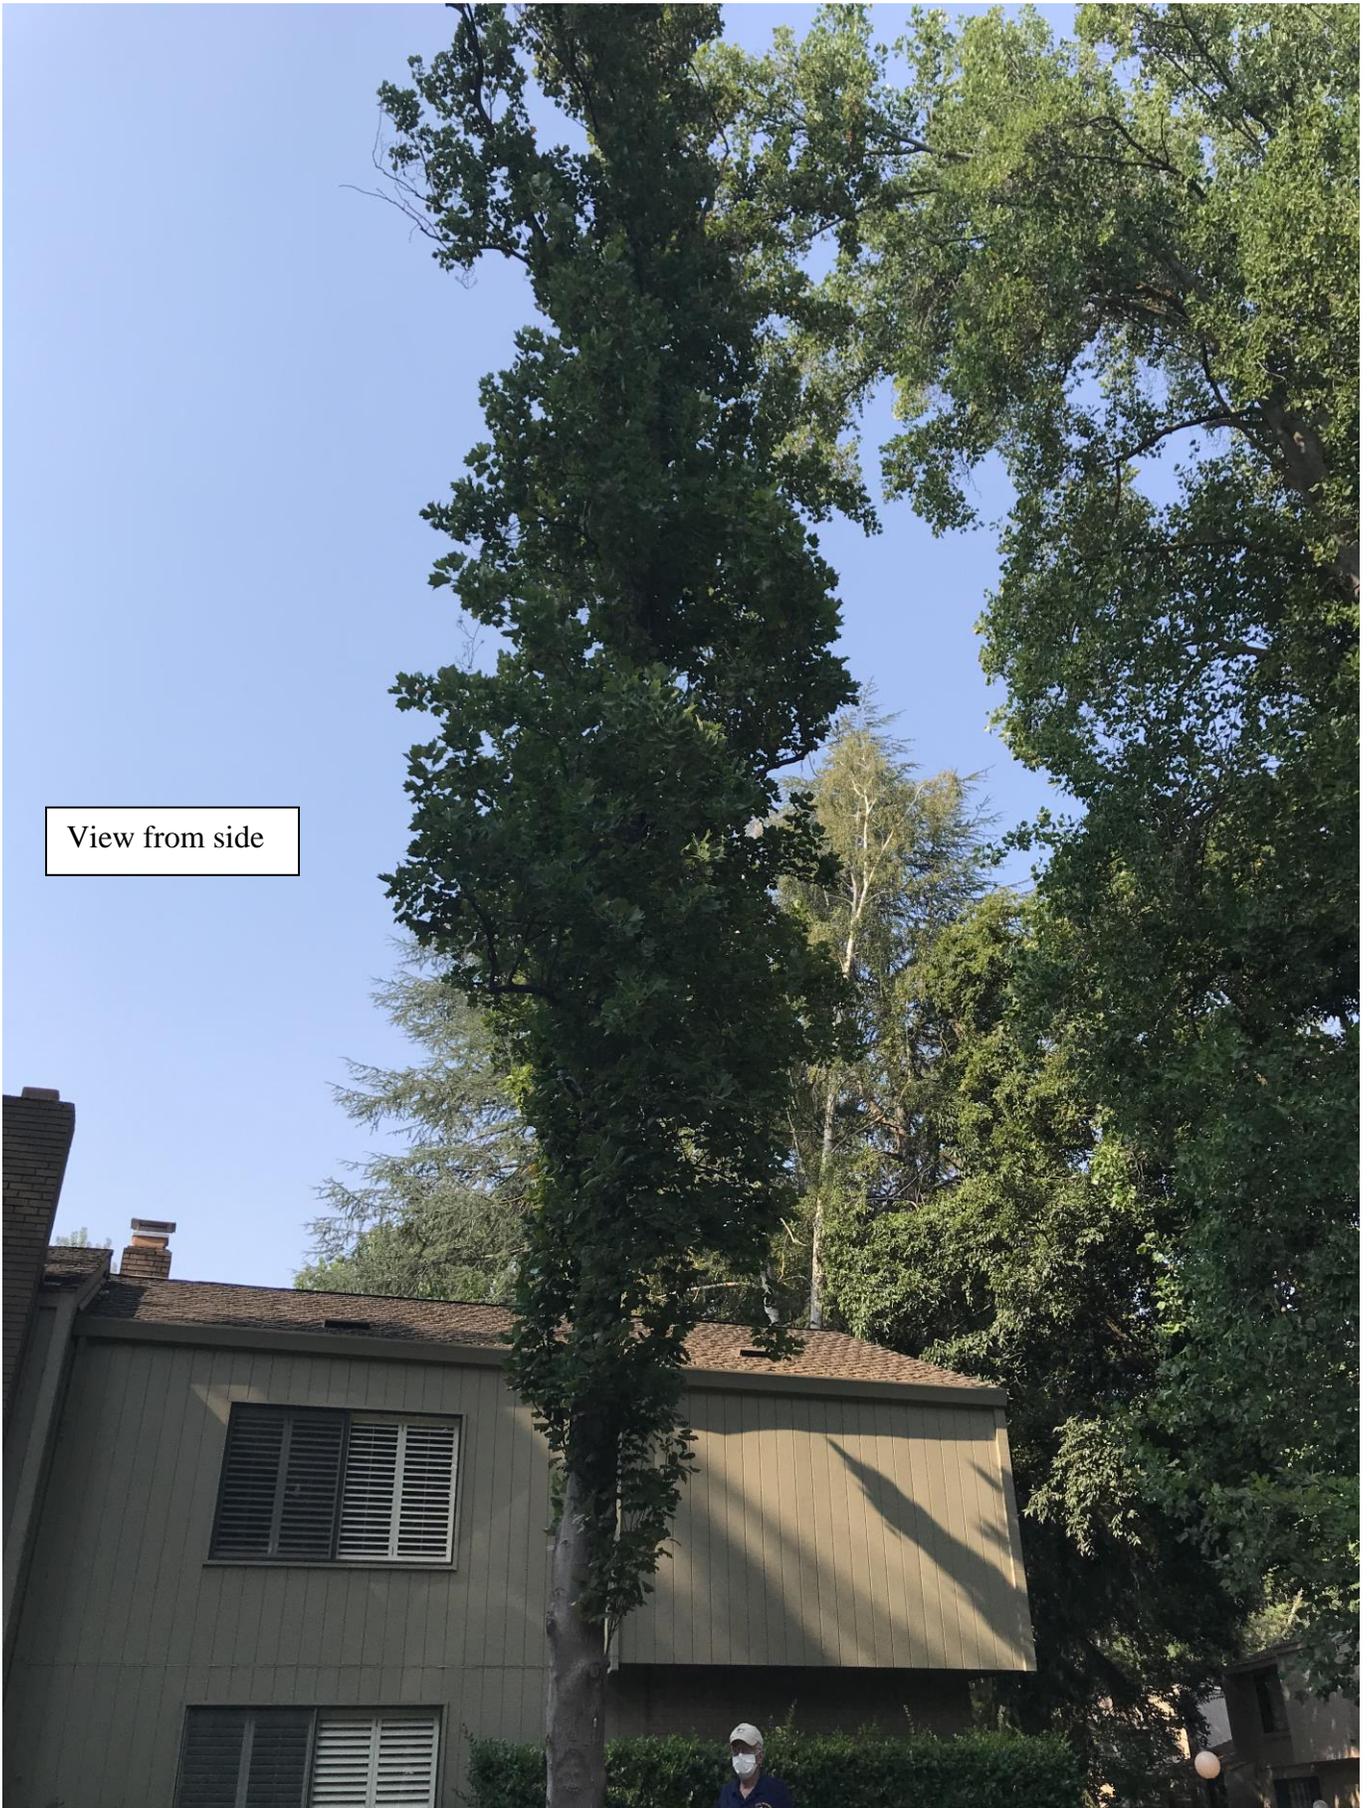
Figure 18

View from side
