June 3, 2021

The Nepenthe Association
Bettsi Ledesma
1131 Commons Dr.
Sacramento, CA 95825
Phone: (916) 929-8380
Email: Bettsi.Ledesma@fsresidential.com

On May 28, 2021, I inspected several trees on the Nepenthe property during the monthly tree walk. The focus of the walk was to address resident/management concerns regarding mature trees on the property. The purpose of this report is to develop mitigation plans for the following trees and my recommendations are below. My recommendations are based on a Basic Visual Inspection. All decisions made based on the recommendations of this report are at the discretion of the Nepenthe Association.

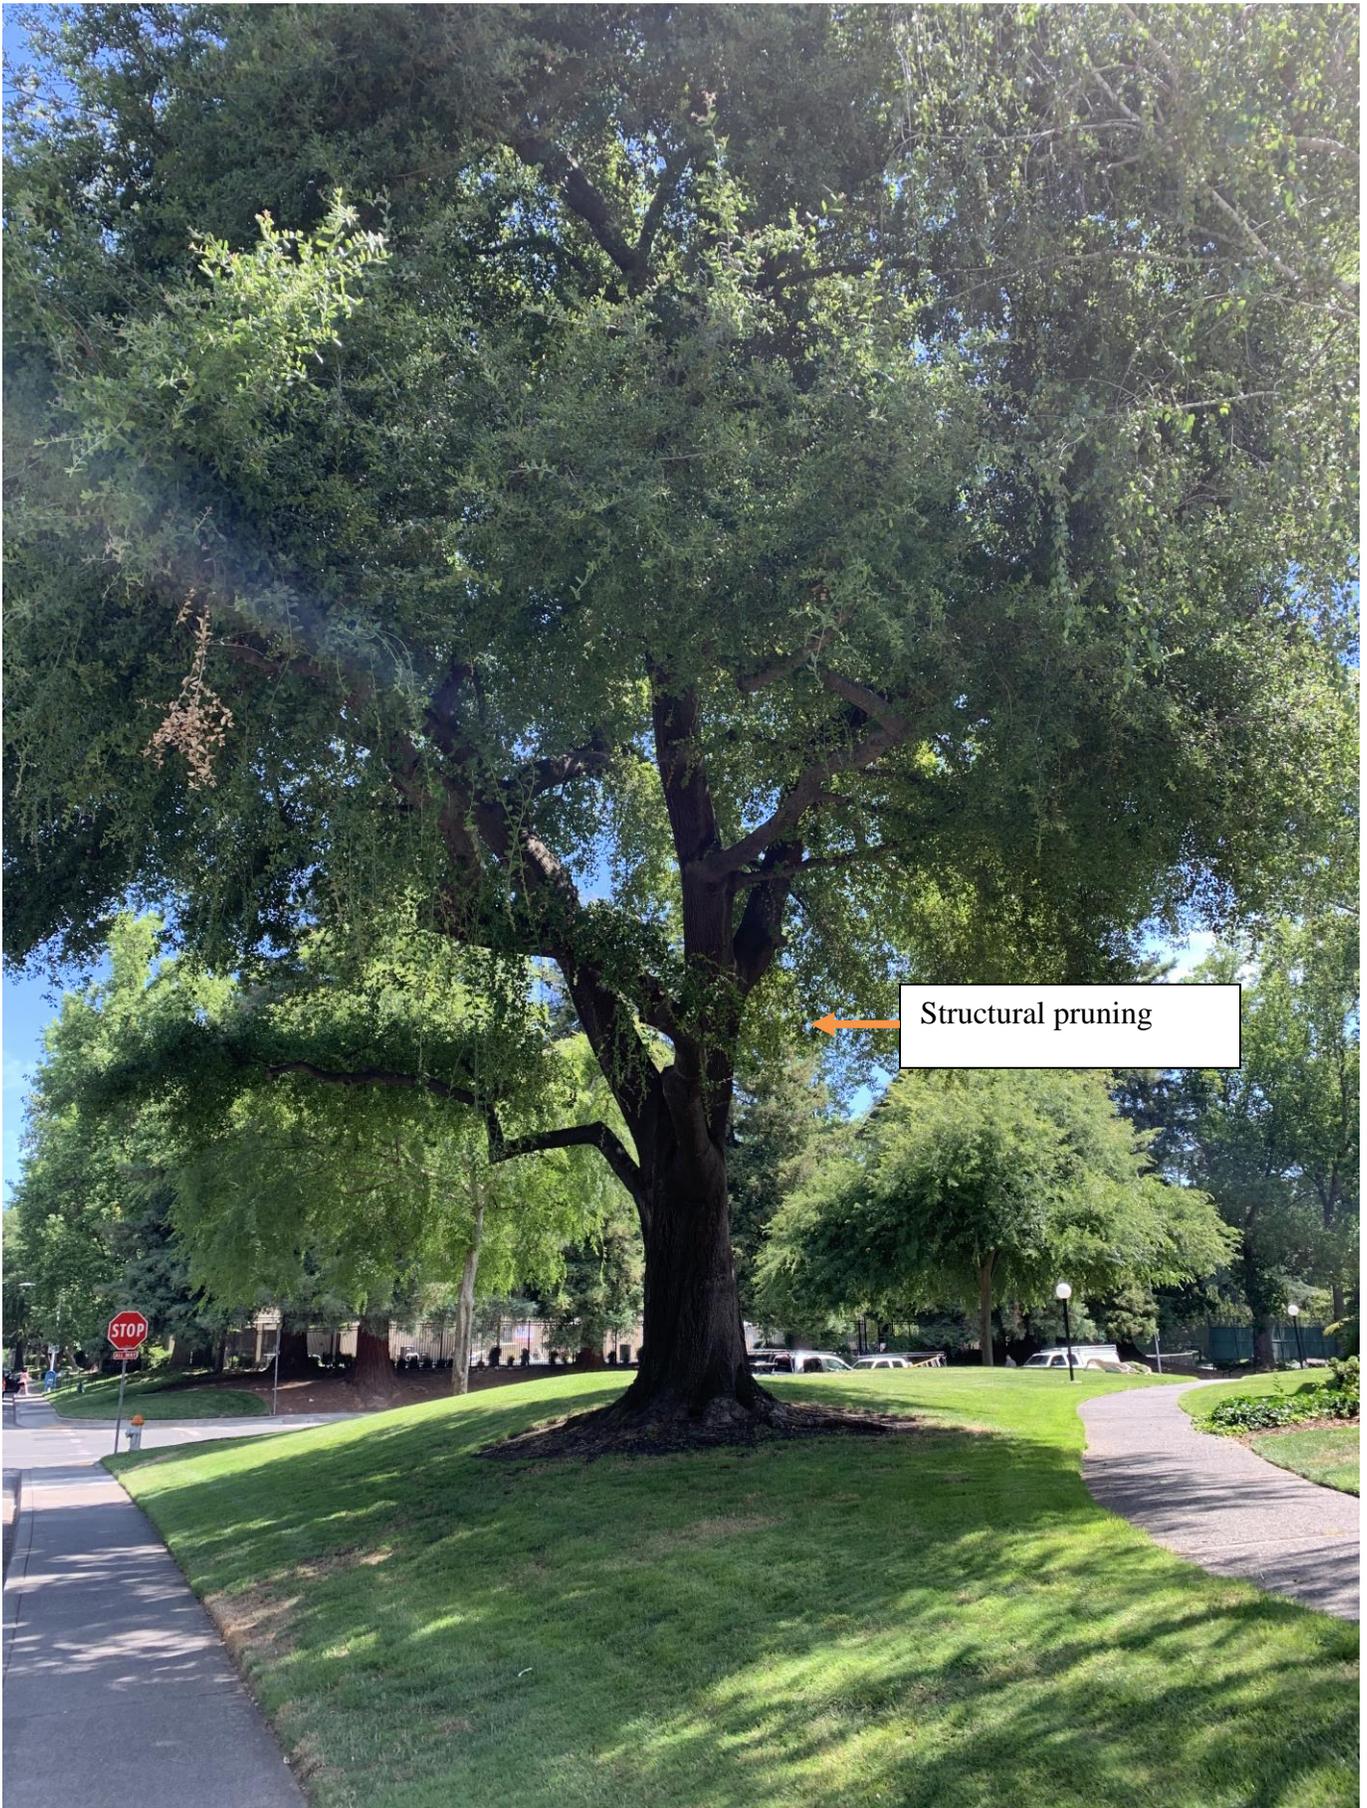
Figure 1

- (Zone 3) Tree #895 Interior Live Oak (*Quercus wislizeni*) 1331 Commons Dr. This tree is one we monitor yearly due to cable system in the tree. The tree canopy is full and healthy I recommend weight reduction pruning to reduce pressure on cable system. (Figure 1)

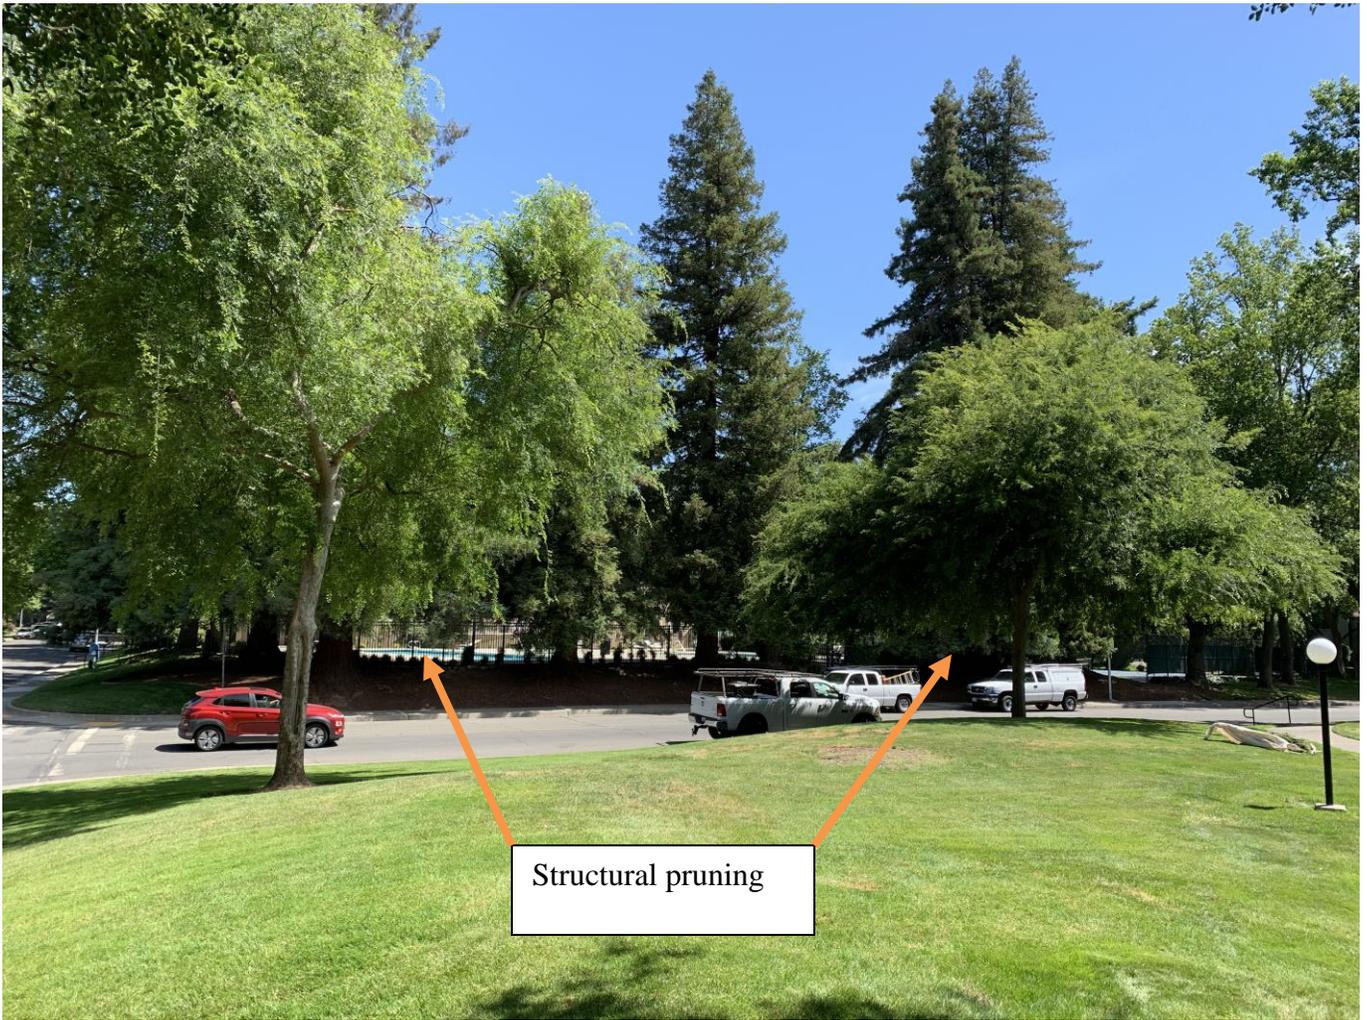
Figure 2

- (Zone 3) 2 Trees #893, #891 Chinese Elm (*Ulmus parvifolia*) in front of 1329 Commons Dr. (Figure 2). These 2 trees full and over weighted canopy I recommend full prune of trees canopy to help minimize limb failure due to excessive limb weight

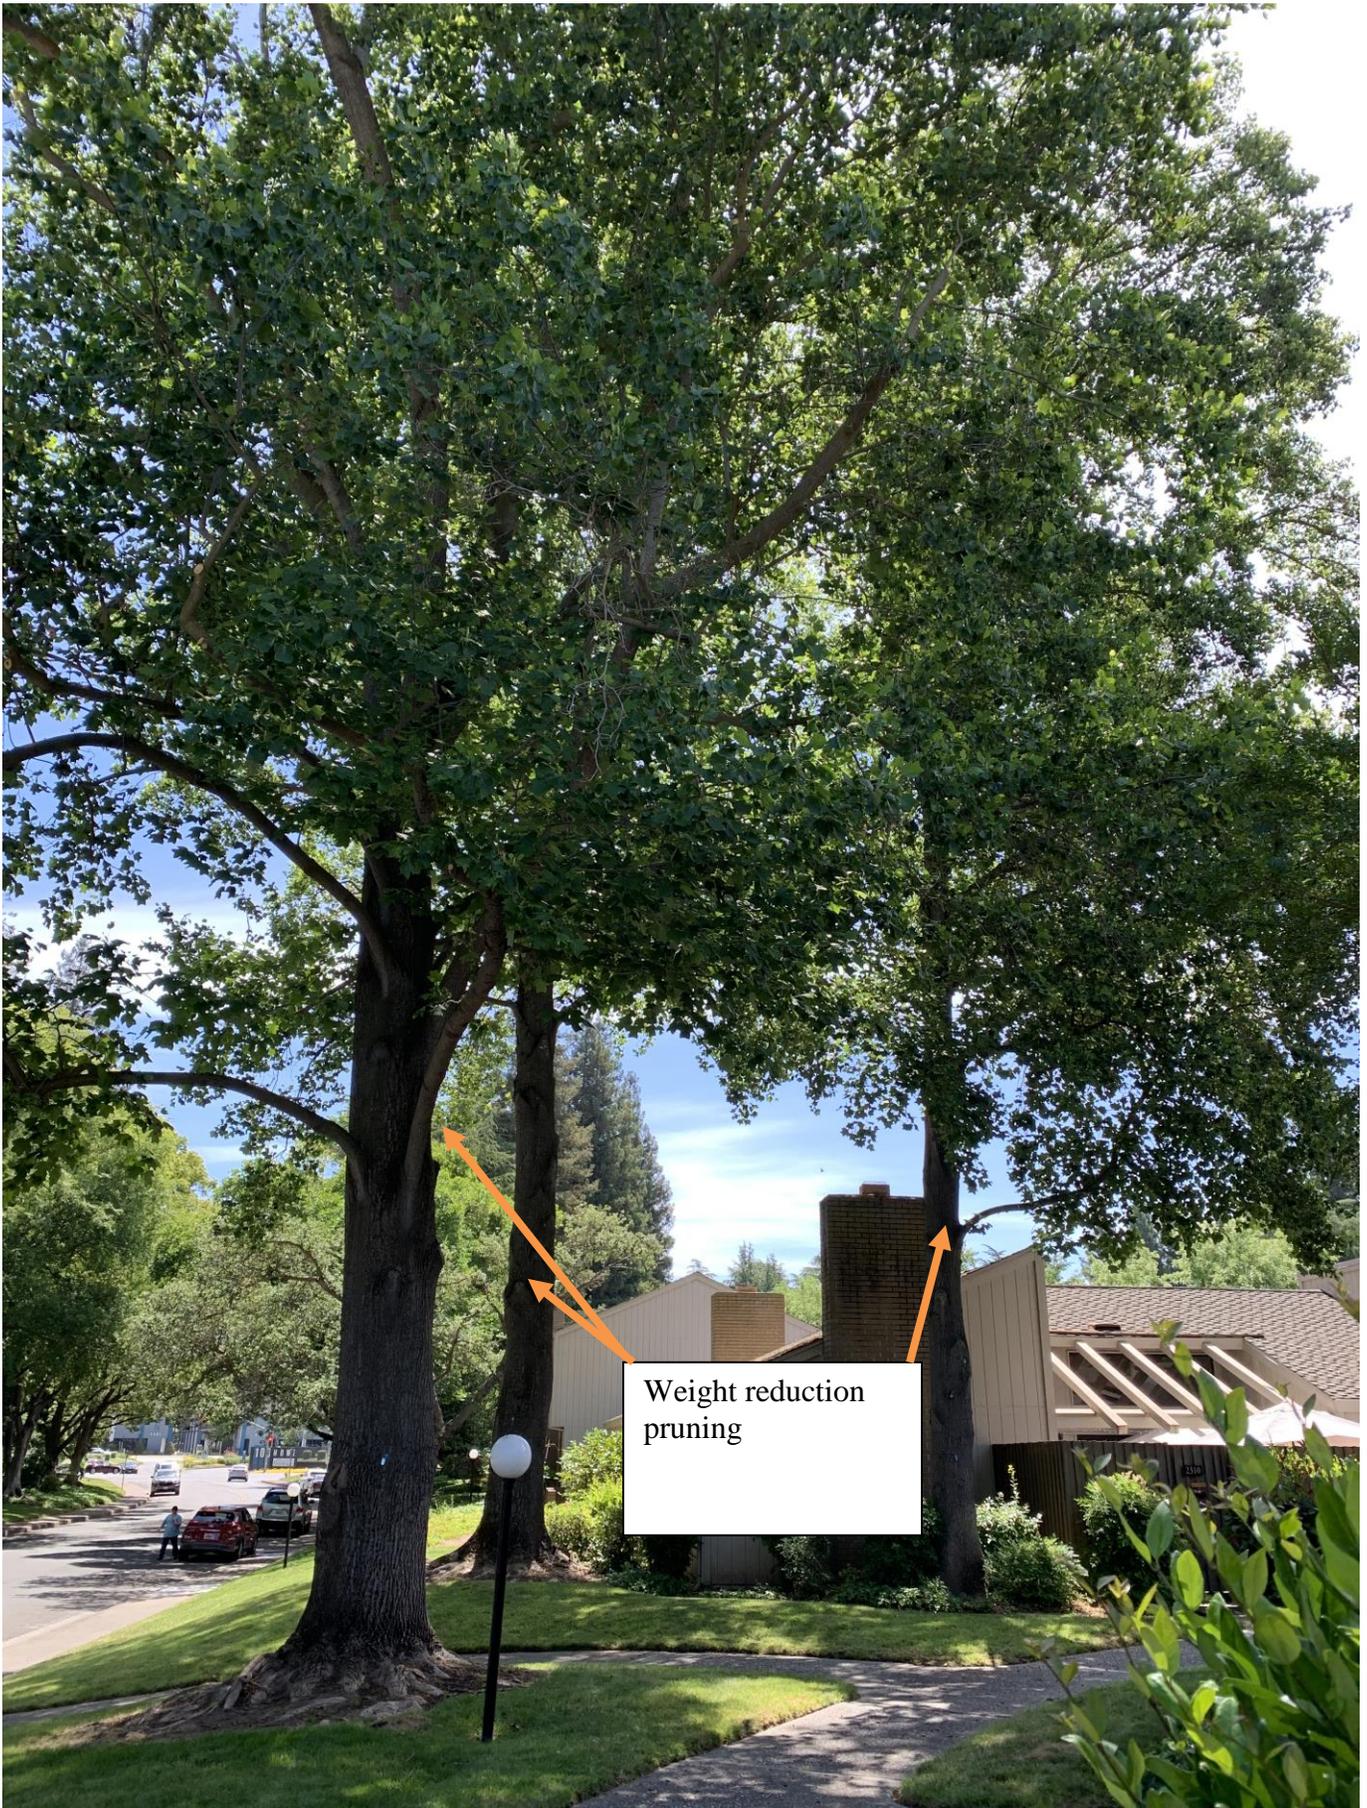
Figure 3

- (Zone 3) 3 Trees #938, #936 & 888 Tulip tree (*Liriodendron tulipifera*), 2310 Swarthmore (Figure 3) Trees canopy are full and heavy I recommend weight reduction pruning.

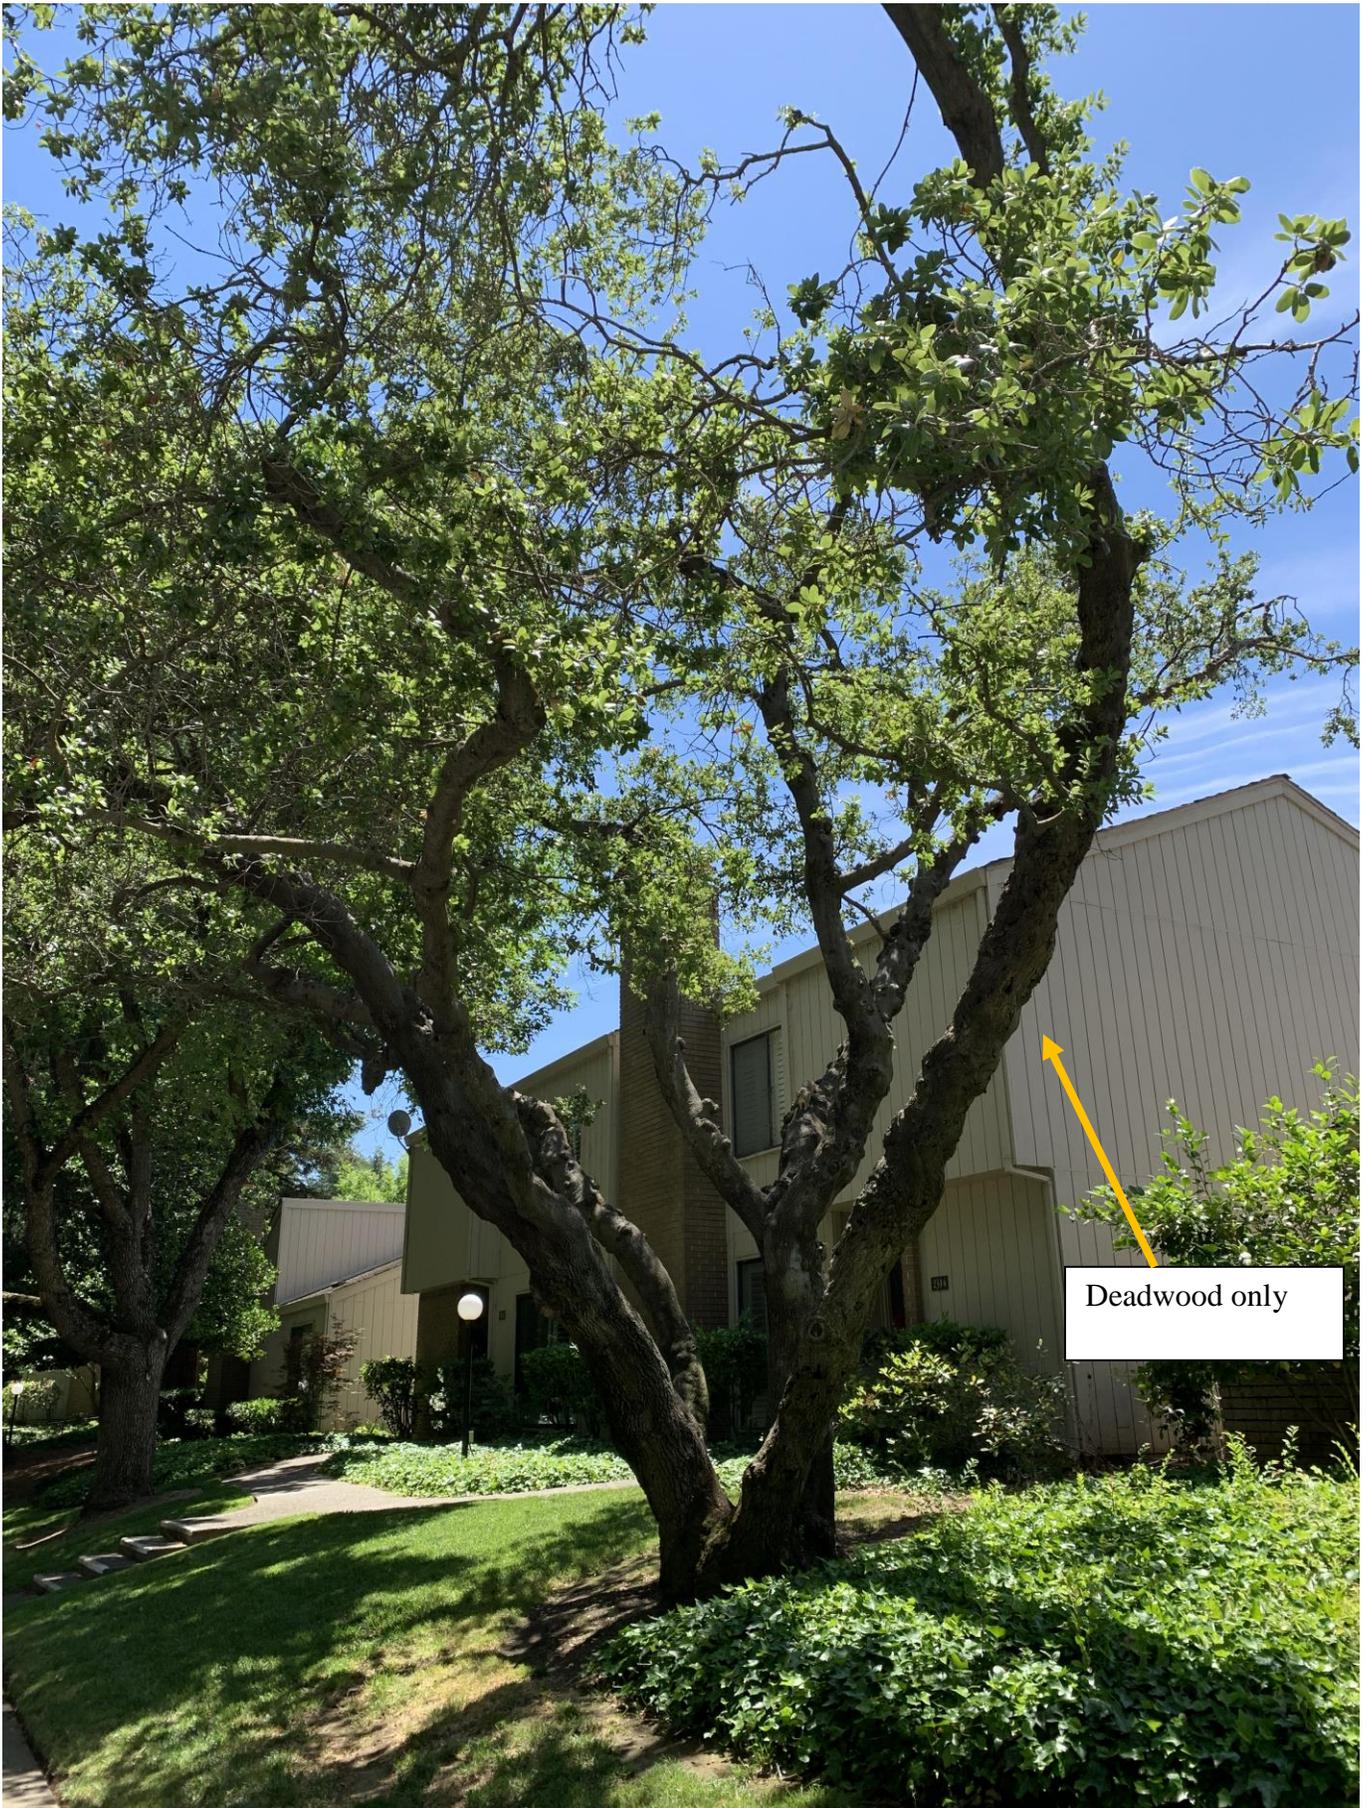
Figure 4

- (Zone 3) Tree #886, Live Oak (*Quercus agrifoli*), 1333 Commons Dr. Tree has a thin stressed canopy (Figure 4). The tree is still recovering from a change in the growing condition; there was another live oak that was removed in 2020 due to decline that partially crowded this tree. I recommend deadwood pruning only and to monitor this trees health going forward.

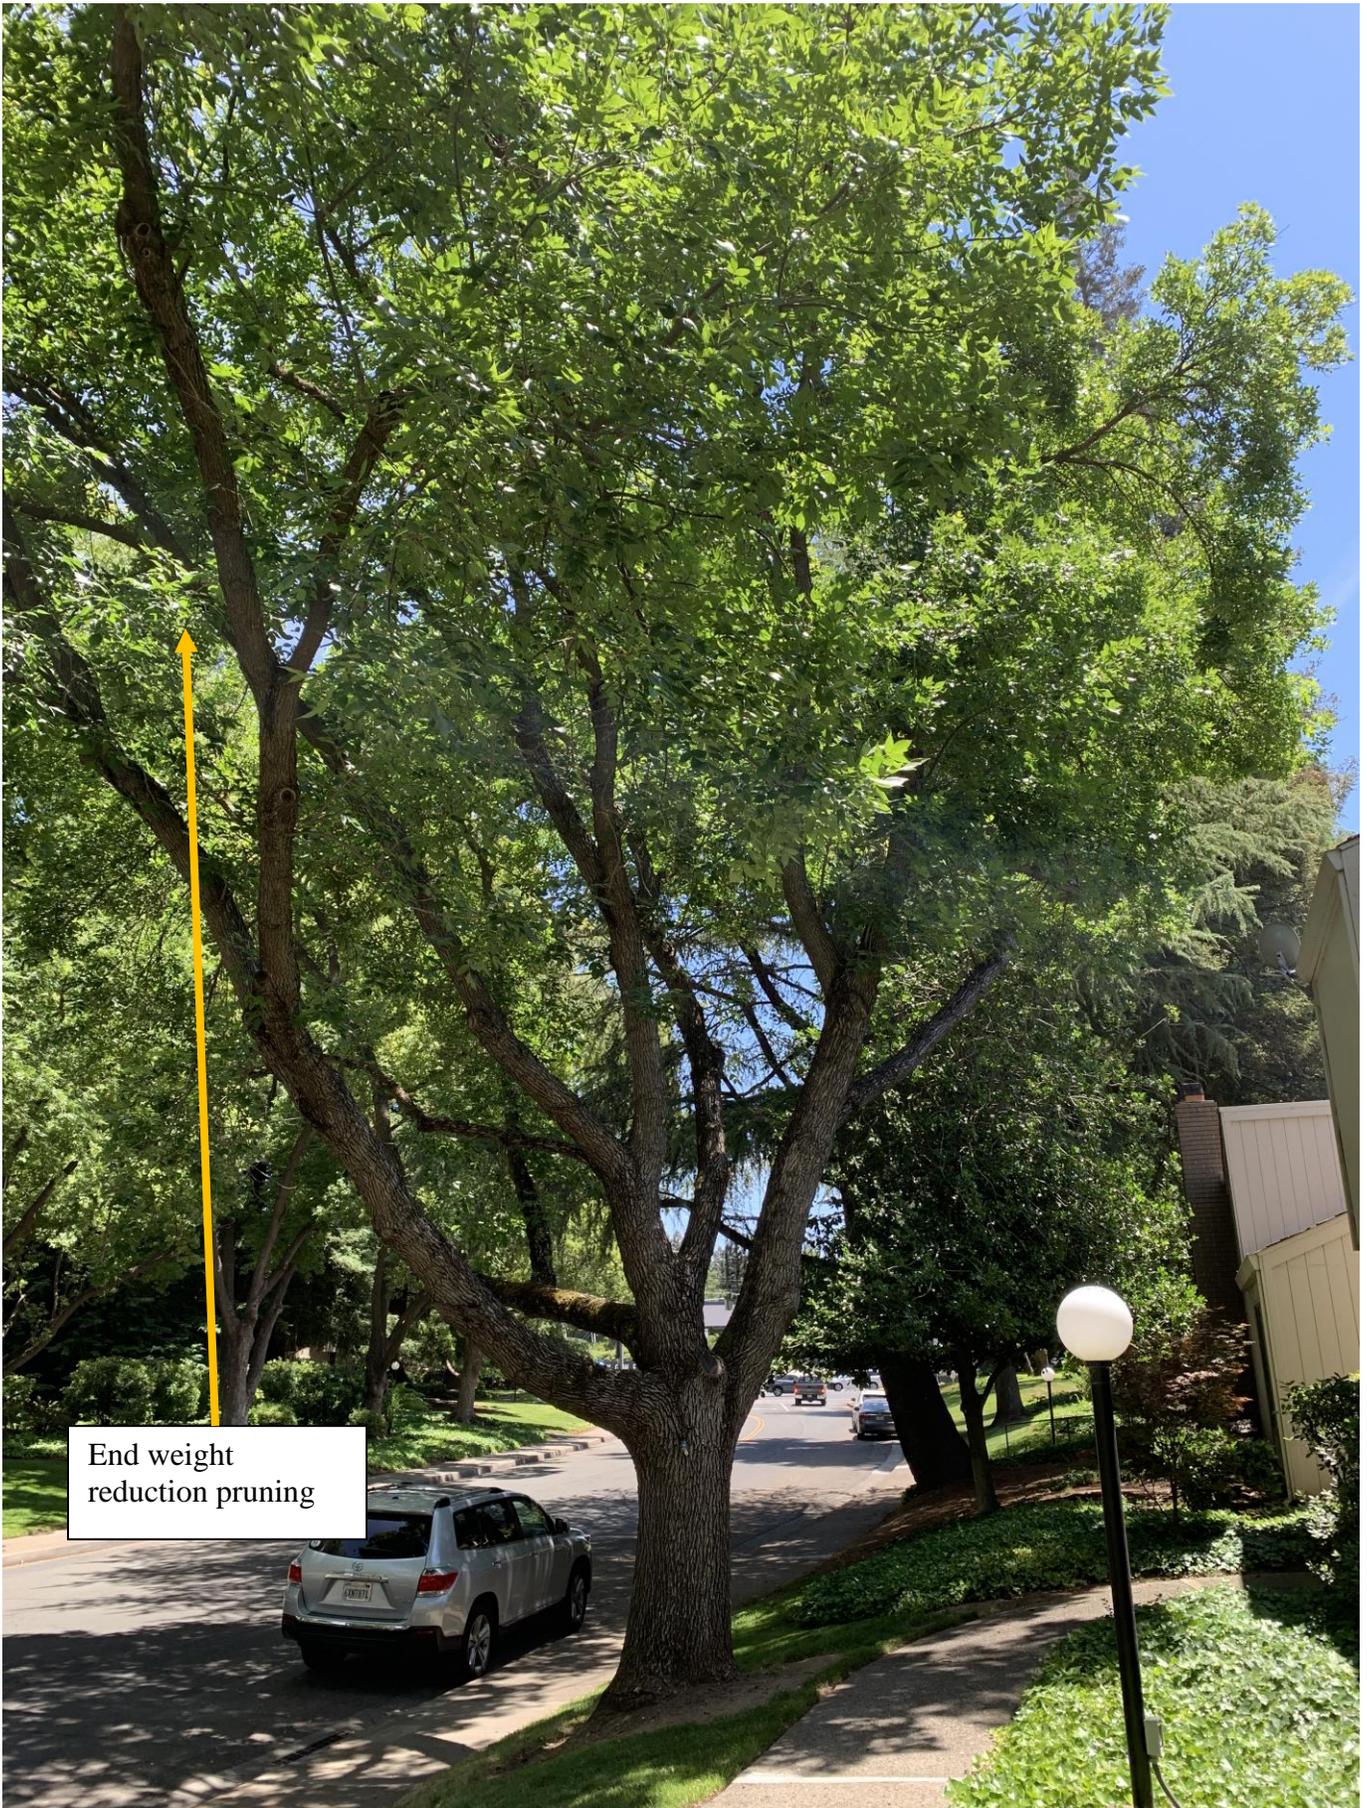
Figure 5

- (Zone 3) Tree #885 Ash (*Fraxnis angustifolia*) 2316 Swarthmore. (Figure 5) The tree canopy has long over extended limbs I recommend end weight reduction pruning.

End weight
reduction pruning

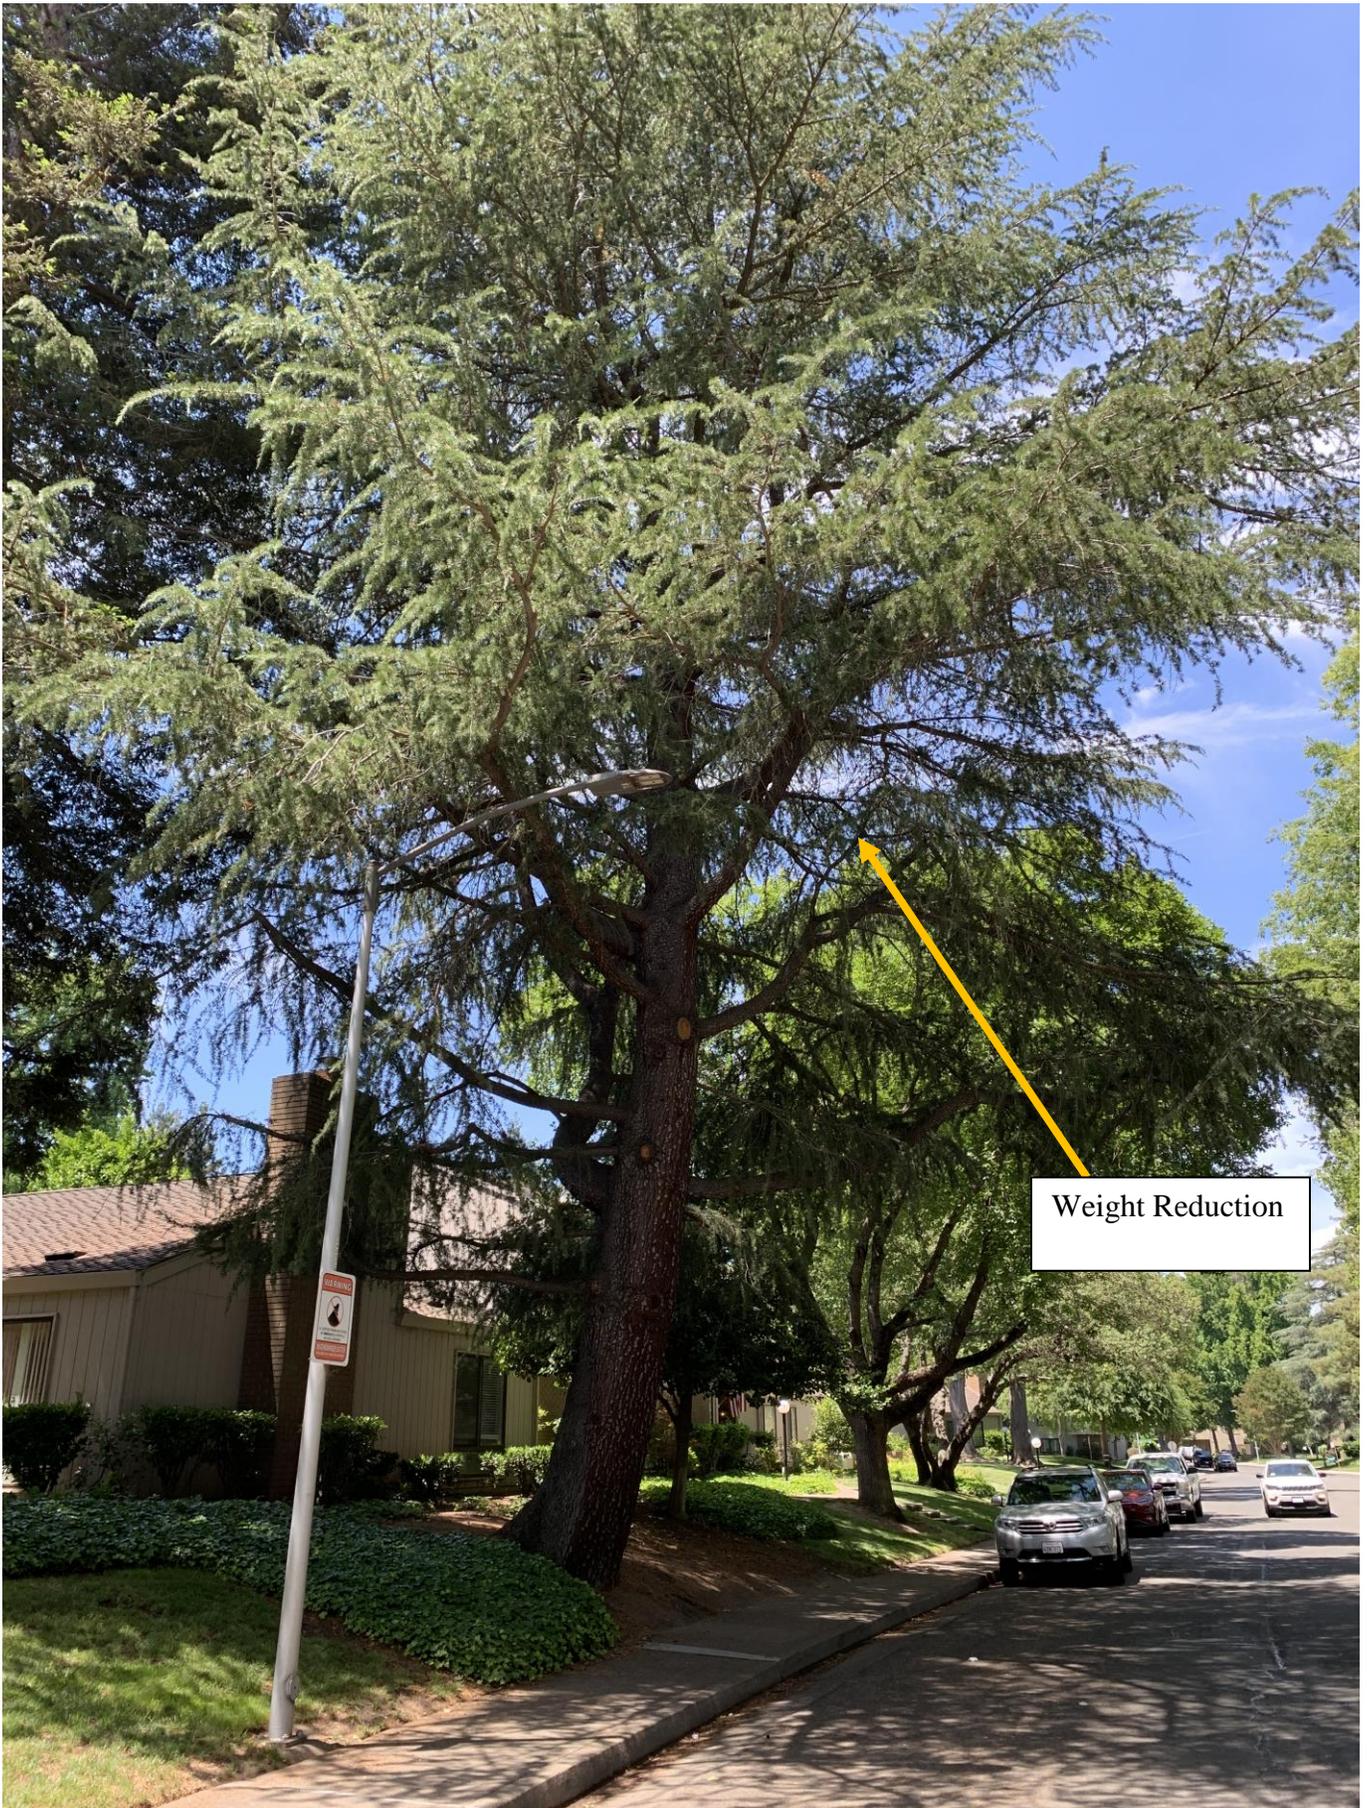
Figure 6

- (Zone 3) Tree #882 Deodar Cedar (*Cedrus deodara*), 2318 Swarthmore. (Figure 6) Trees canopy is full and heavy I recommend weight reduction pruning to avoid limb failure

Weight Reduction

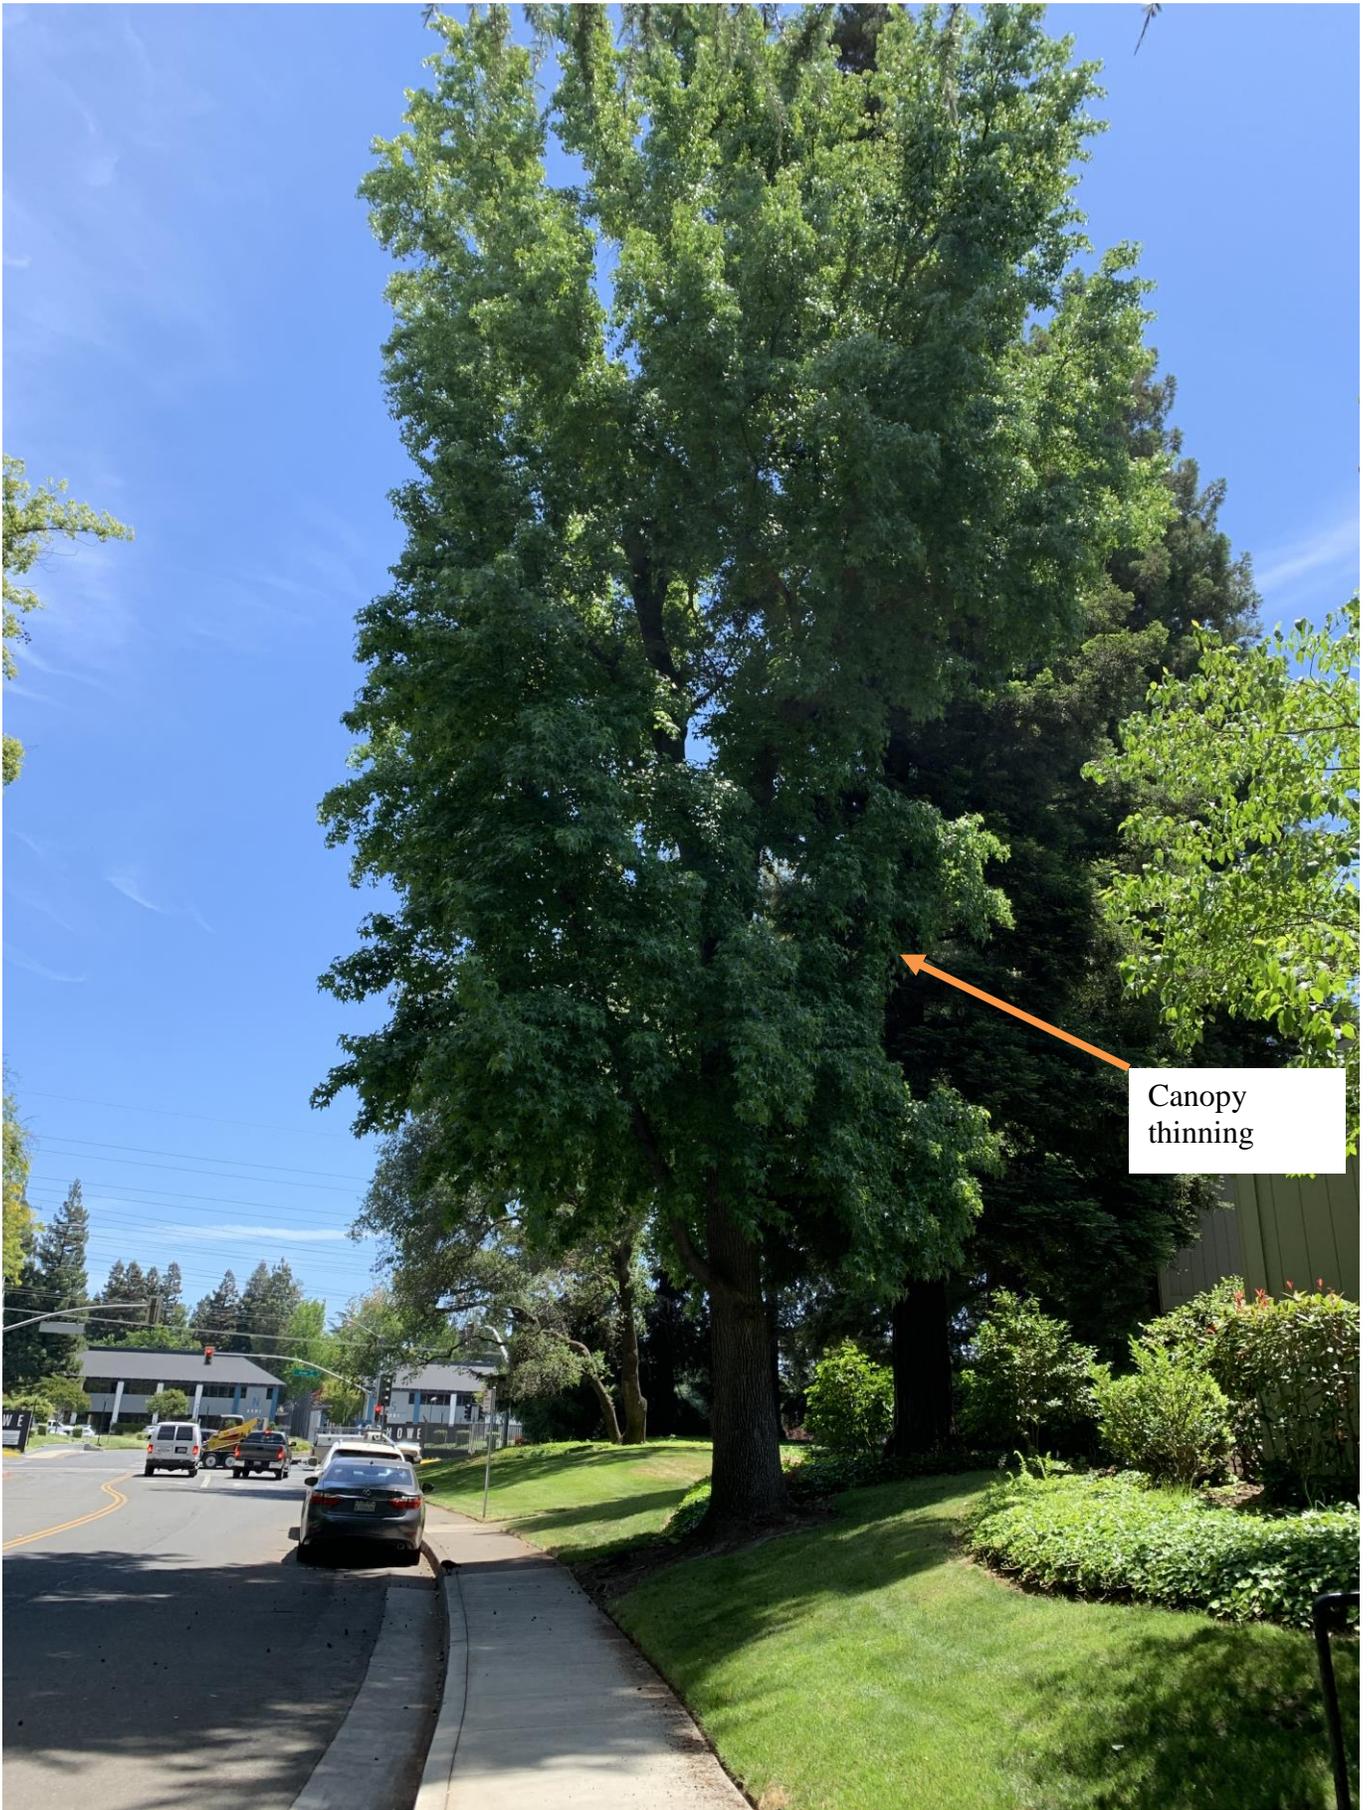
Figure 7

- (Zone 3) Tree #877, Sweet Gum (*Liquidambar styraciflua*) near to 2320 Swarthmore (Figure 7). I recommend weight reduction pruning of trees canopy.
- (Zone 3) Tree #867 Interior Live Oak (*Quercus wislizeni*), 2326 Swarthmore (Figure 8). This tree has sustained 3 major failures. It was addressed last year for weight reduction. I recommend light

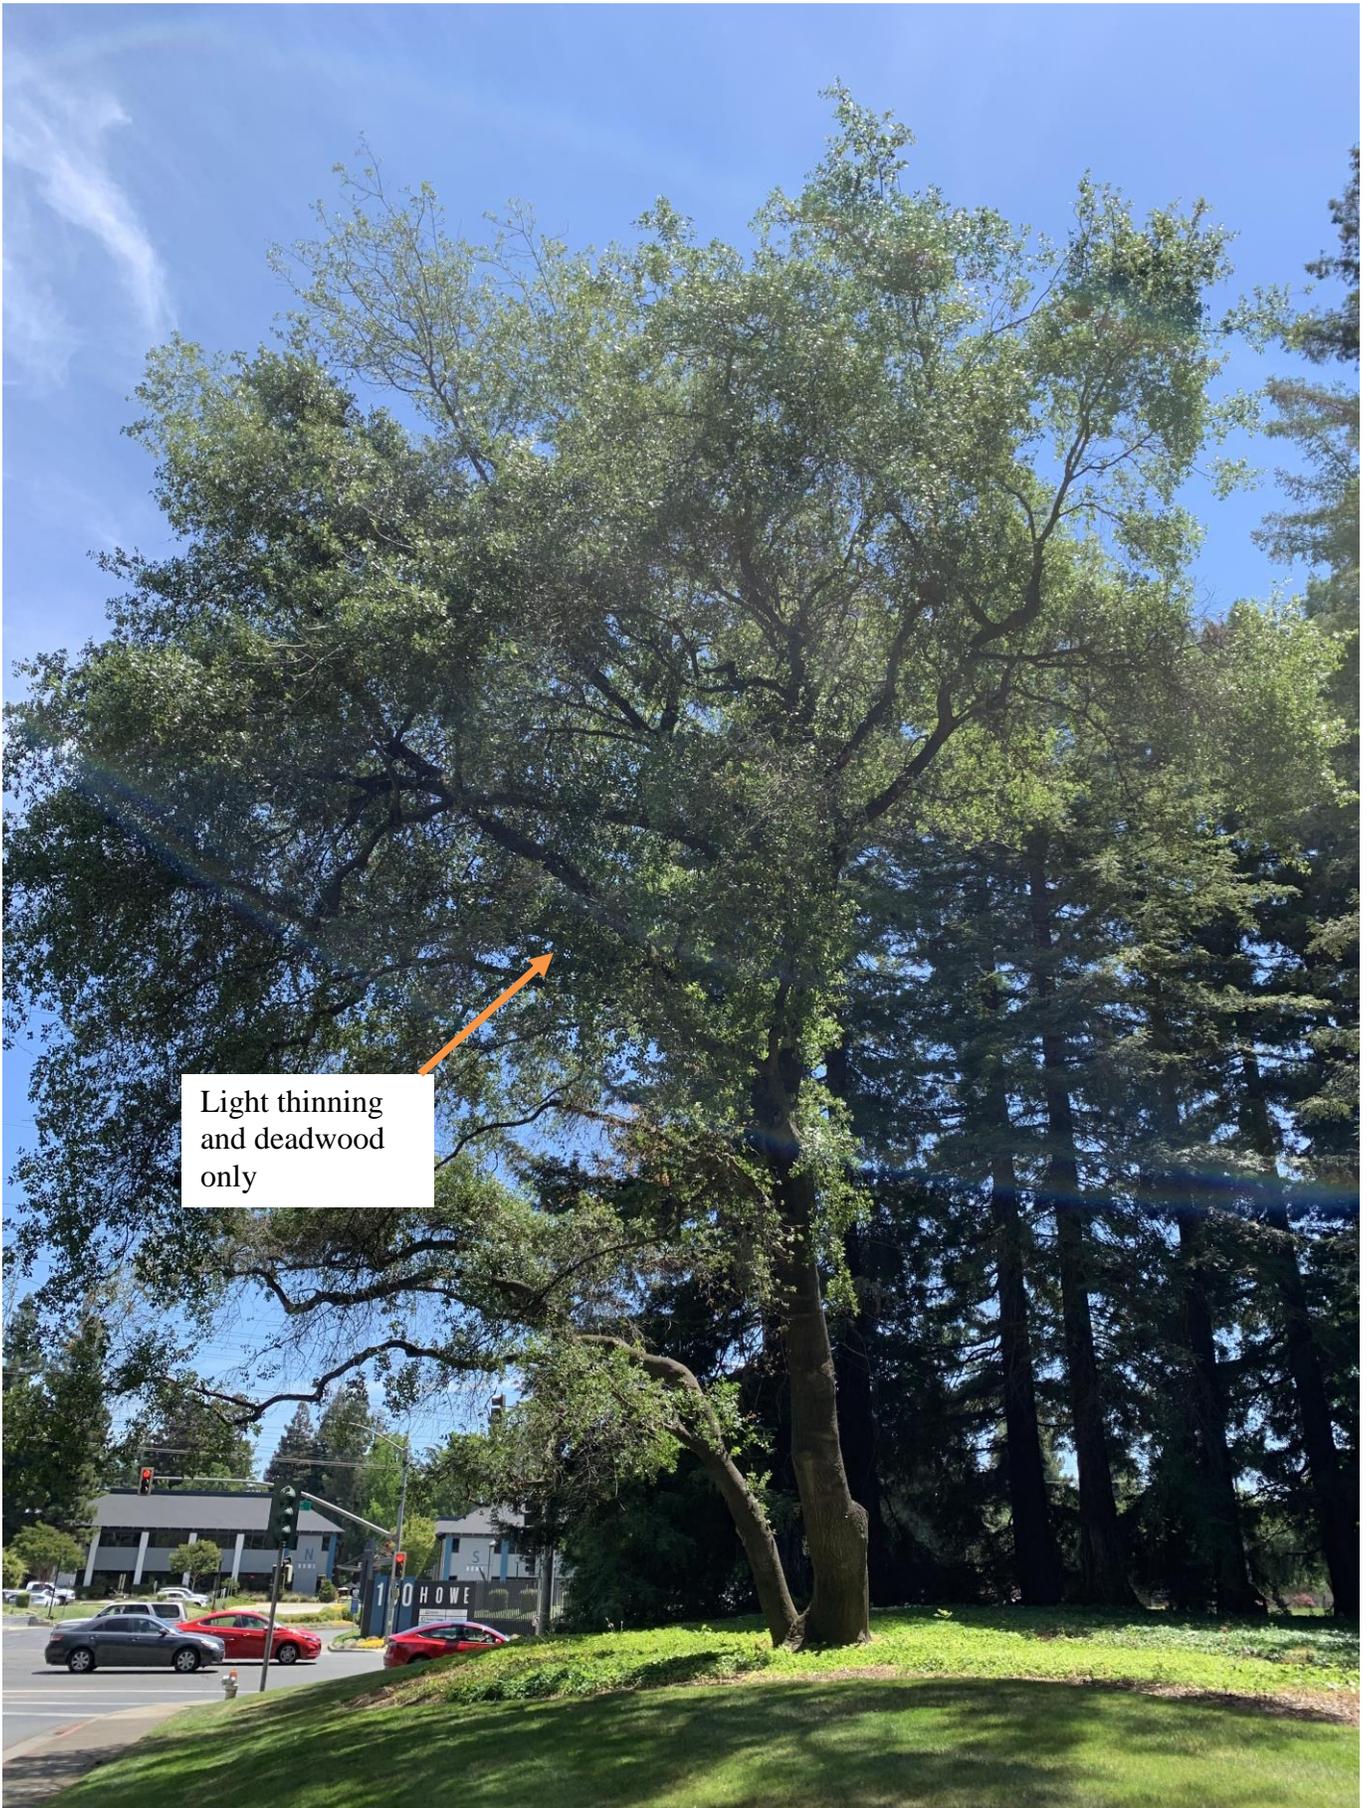
Figure 8

thinning throughout the canopy and the removal of deadwood. Continue to monitor this trees health.

Light thinning
and deadwood
only

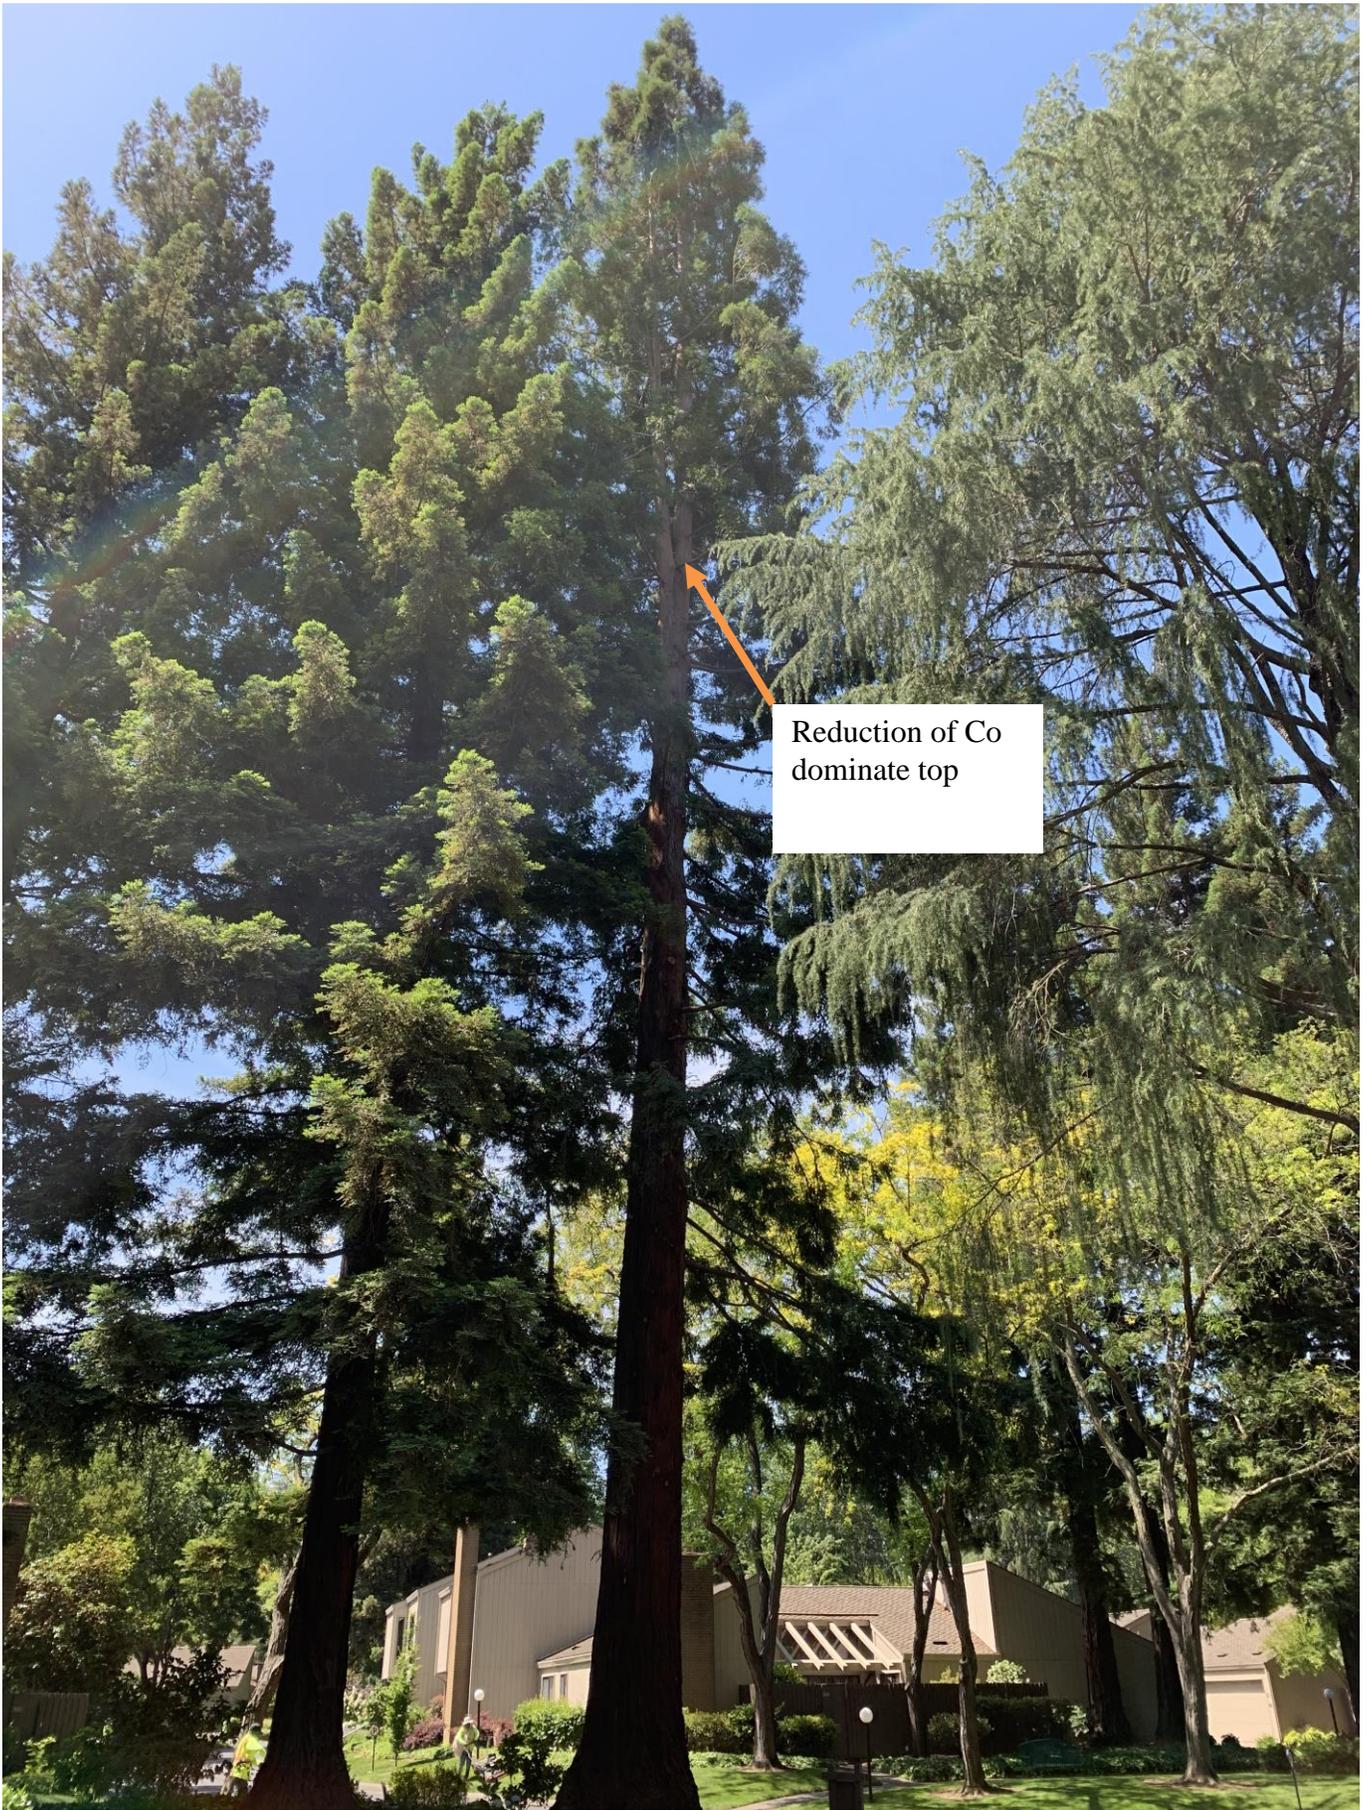
Figure 9

- (Zone 3) Tree #No Tag Redwood (*Sequoia sempervirens*) next to 411 Dunbarton Circle. (Figure 9). The tree has co dominant tops. This is a common failure point and we have had success with reducing these throughout the community to prevent failure. I recommend selective reduction of the codominant tops.
