June 3, 2021

The Nepenthe Association
Bettsi Ledesma
1131 Commons Dr.
Sacramento, CA 95825
Phone: (916) 929-8380
Email: Bettsi.Ledesma@fsresidential.com

On May 28, 2021, I inspected several trees on the Nepenthe property during the monthly tree walk. The focus of the walk was to address resident/management concerns regarding mature trees on the property. The purpose of this report is to develop mitigation plans for the following trees and my recommendations are below. My recommendations are based on a Basic Visual Inspection. All decisions made based on the recommendations of this report are at the discretion of the Nepenthe Association.

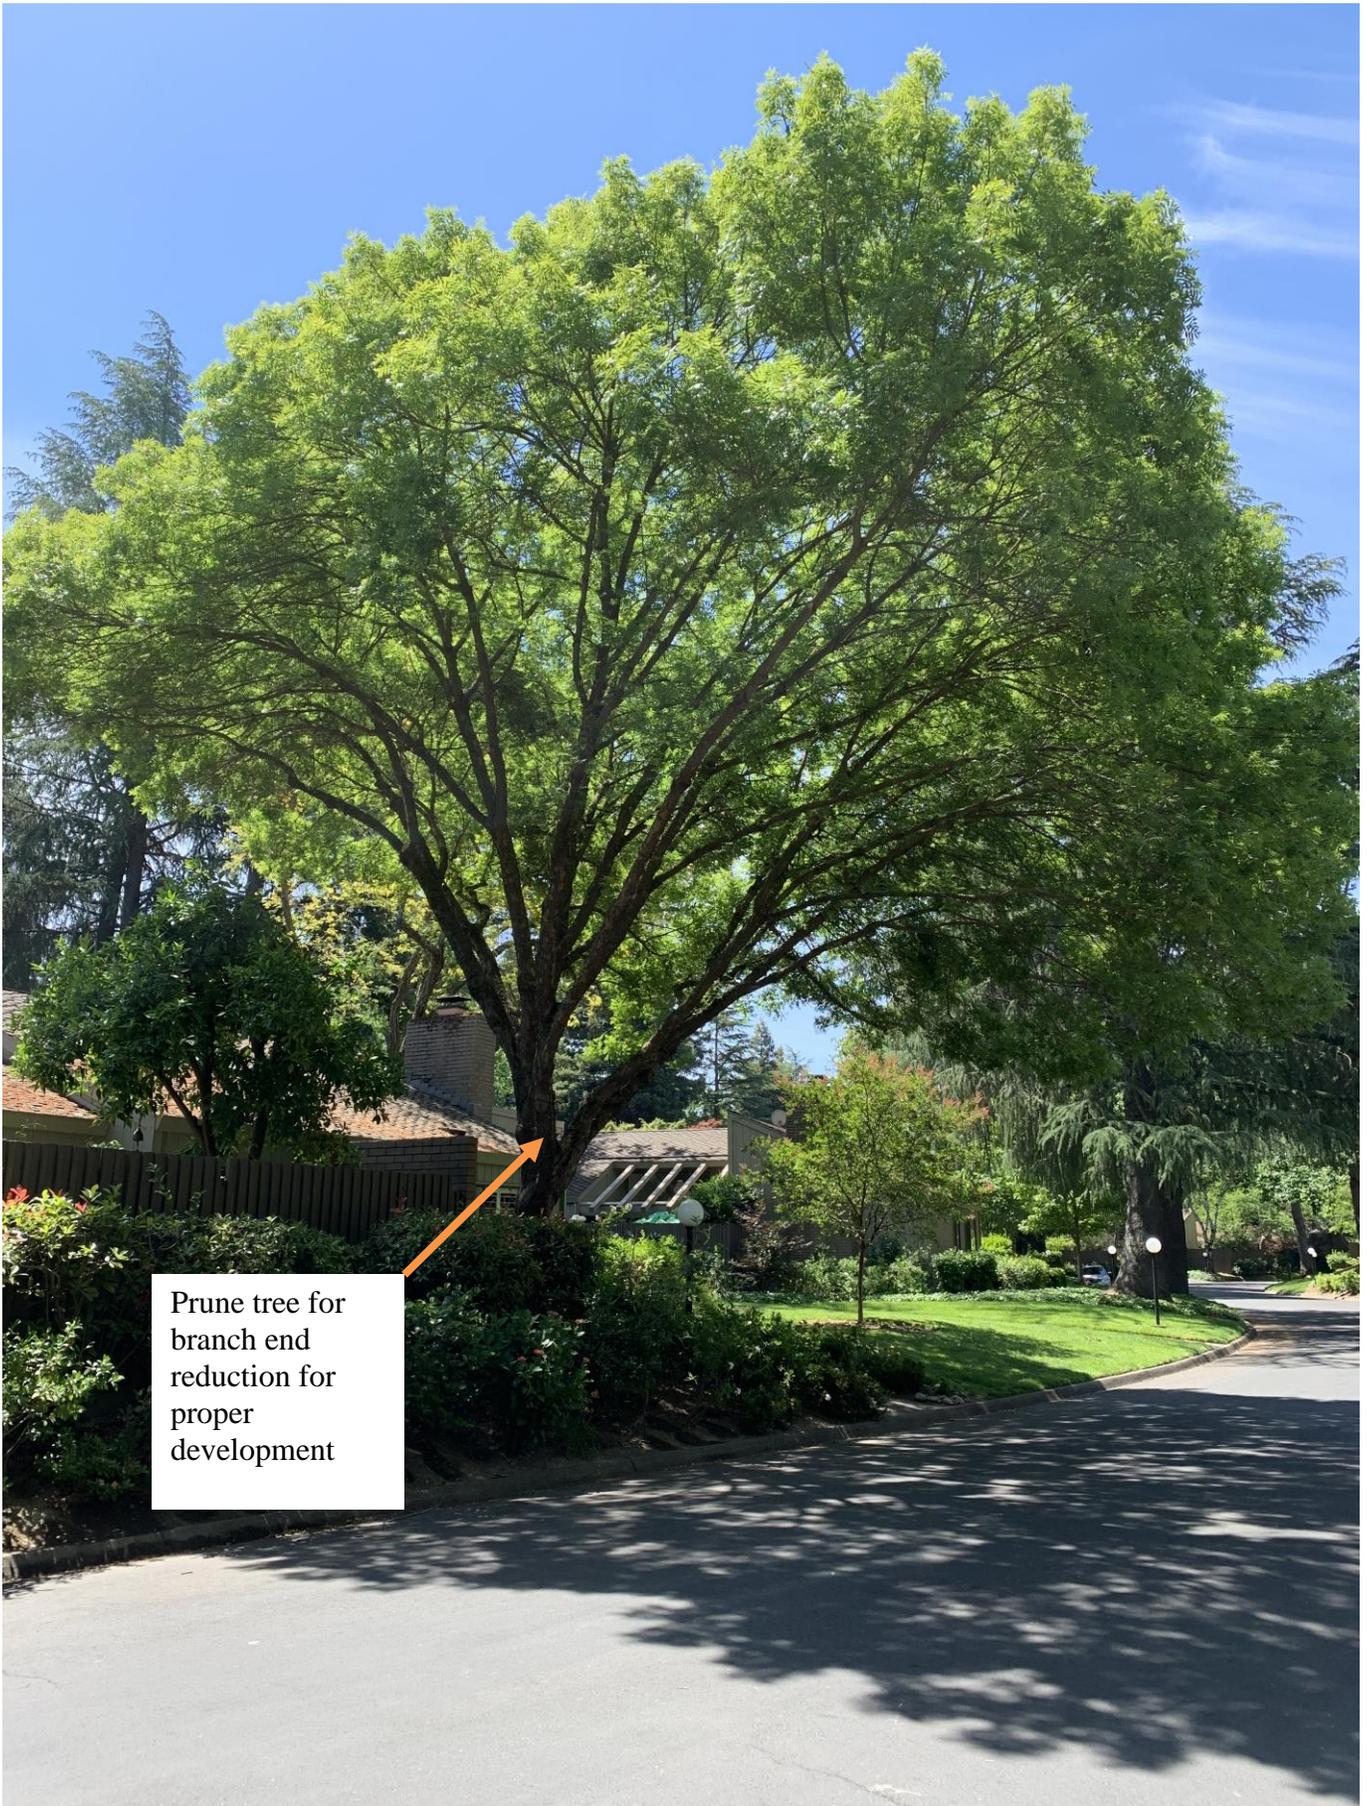
Figure 10

- (Zone 3) Tree #988 Chinese pistache (*Pistacia chinensis*), 615 Dunbarton Circle. Trees have long and over extended branching in canopy, I recommend branch reduction pruning through the canopy to reduce stress on branching attachments. (Figures 10).

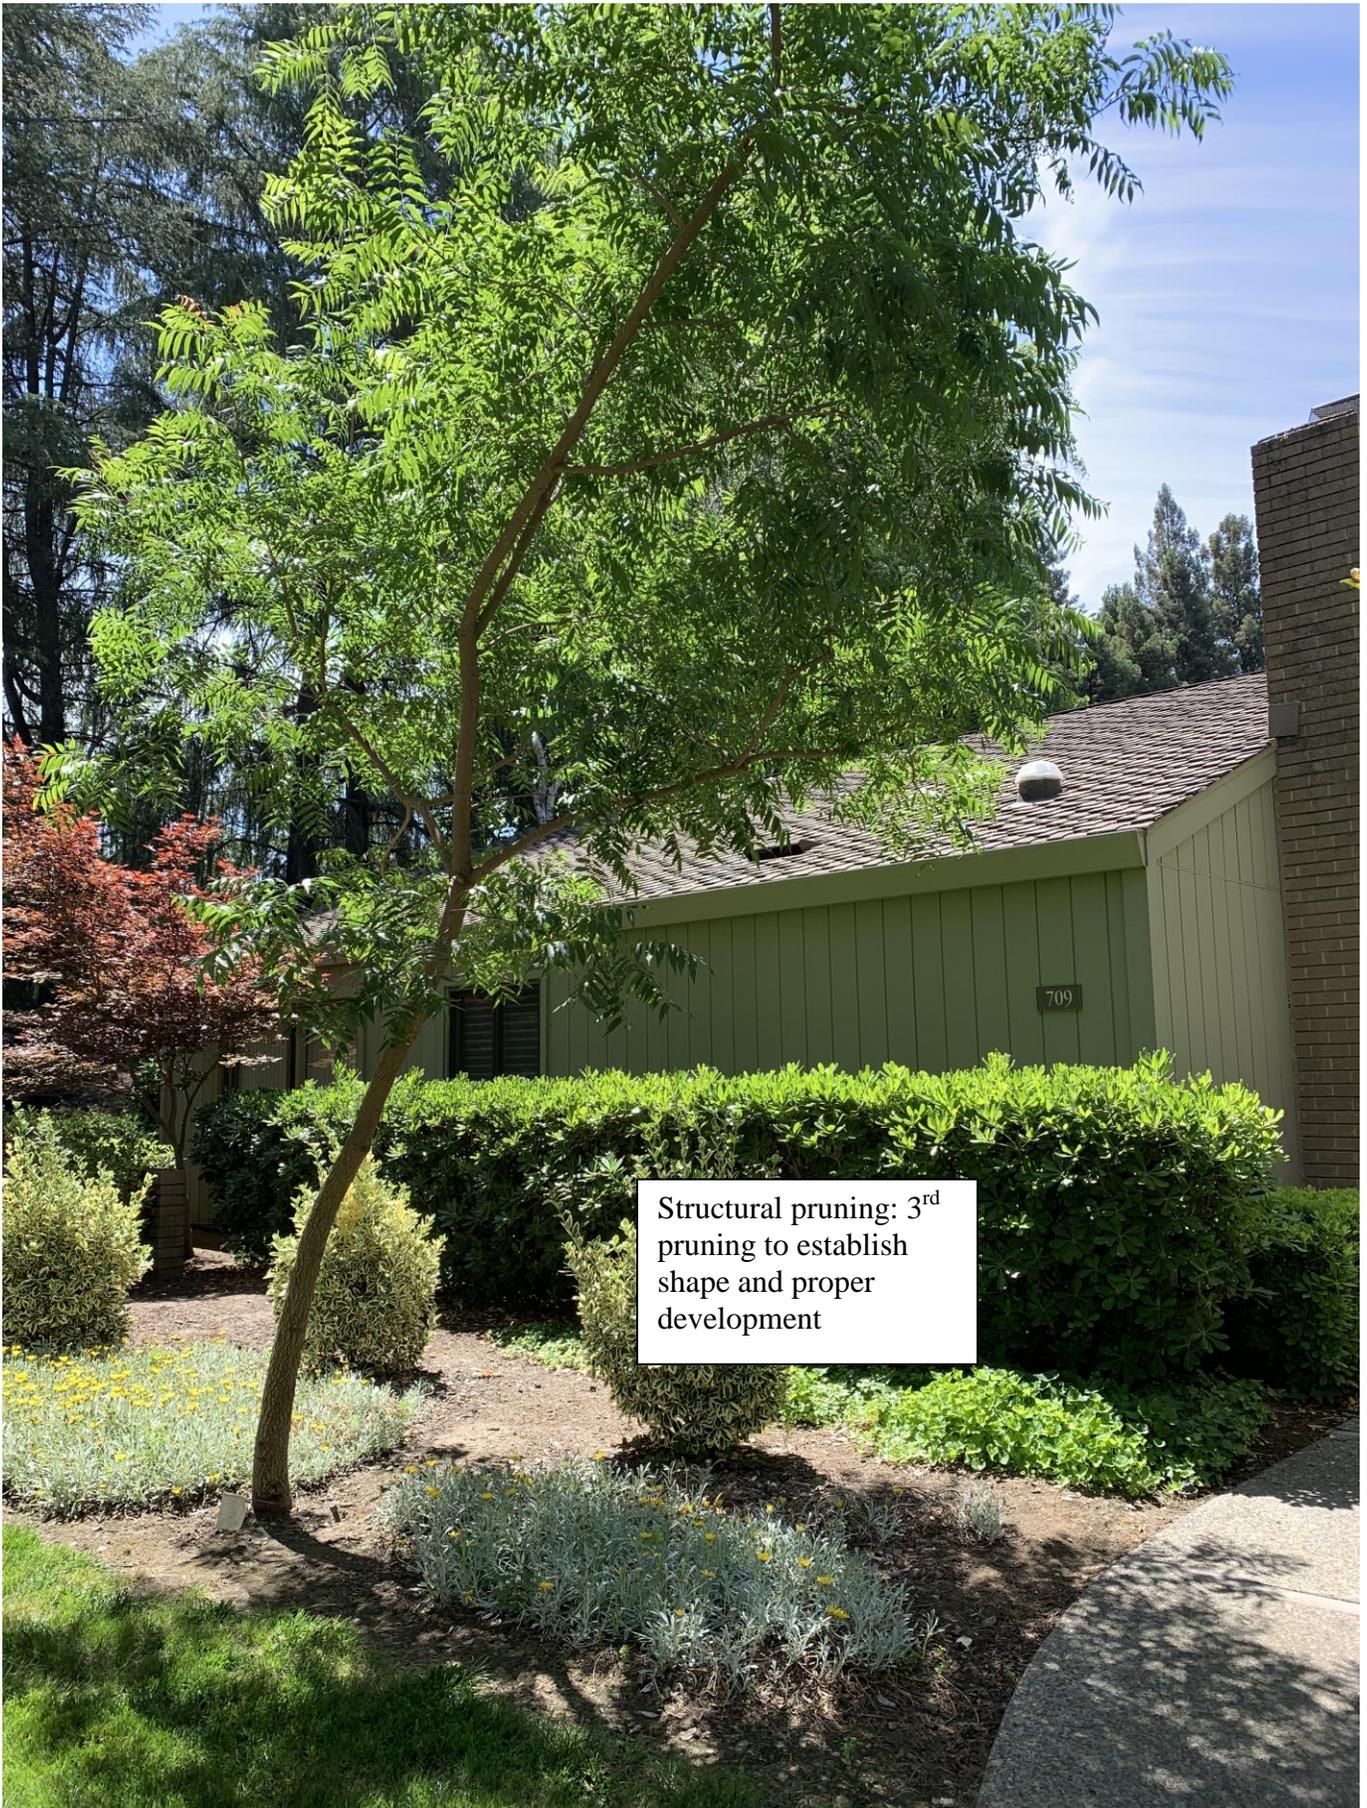
Figure 11

- (Zone 3) Tree No Tag Chinese pistache (*Pistacia chinensis*), 709 Dunbarton Circle. (Figure 11) This tree has had issues with stability and we've been pruning this tree for growth training. There has been some degree of success in redirecting this trees growth. I recommend additional pruning to direct growth to retain tree.

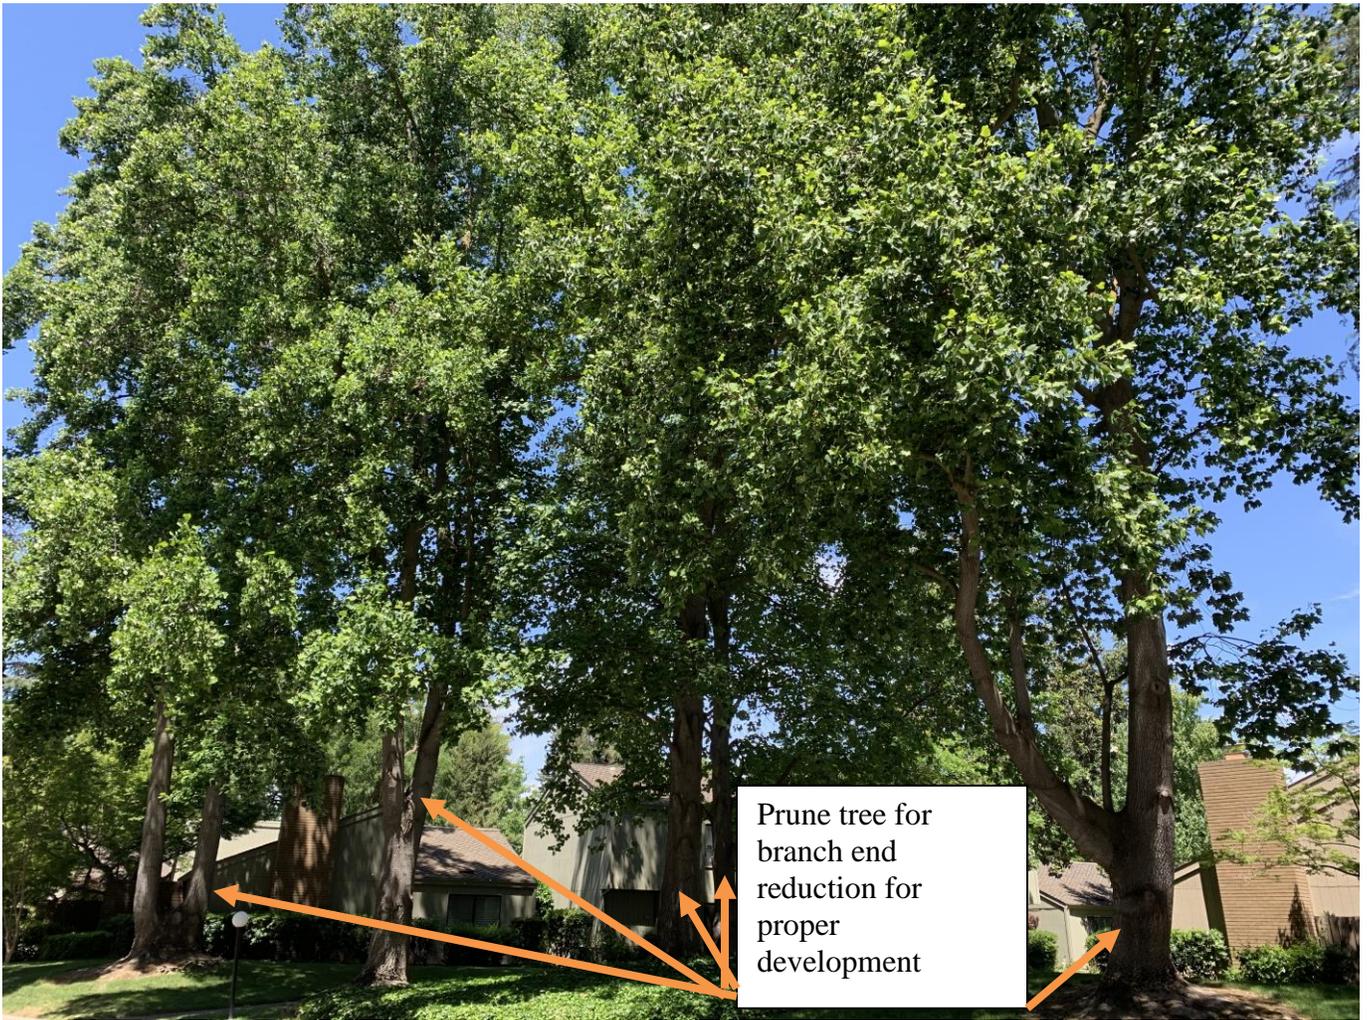
Figure 12

- (Zone 3) 5 Trees #711, 716, 717, 718, 719 Tulip tree (*Liriodendron tulipifera*) in greenbelt near 1005 Dunbarton Circle. Trees have a full and over weighted canopy (Figure 12). I recommend full prune of trees canopy to reduce canopy failure issues.

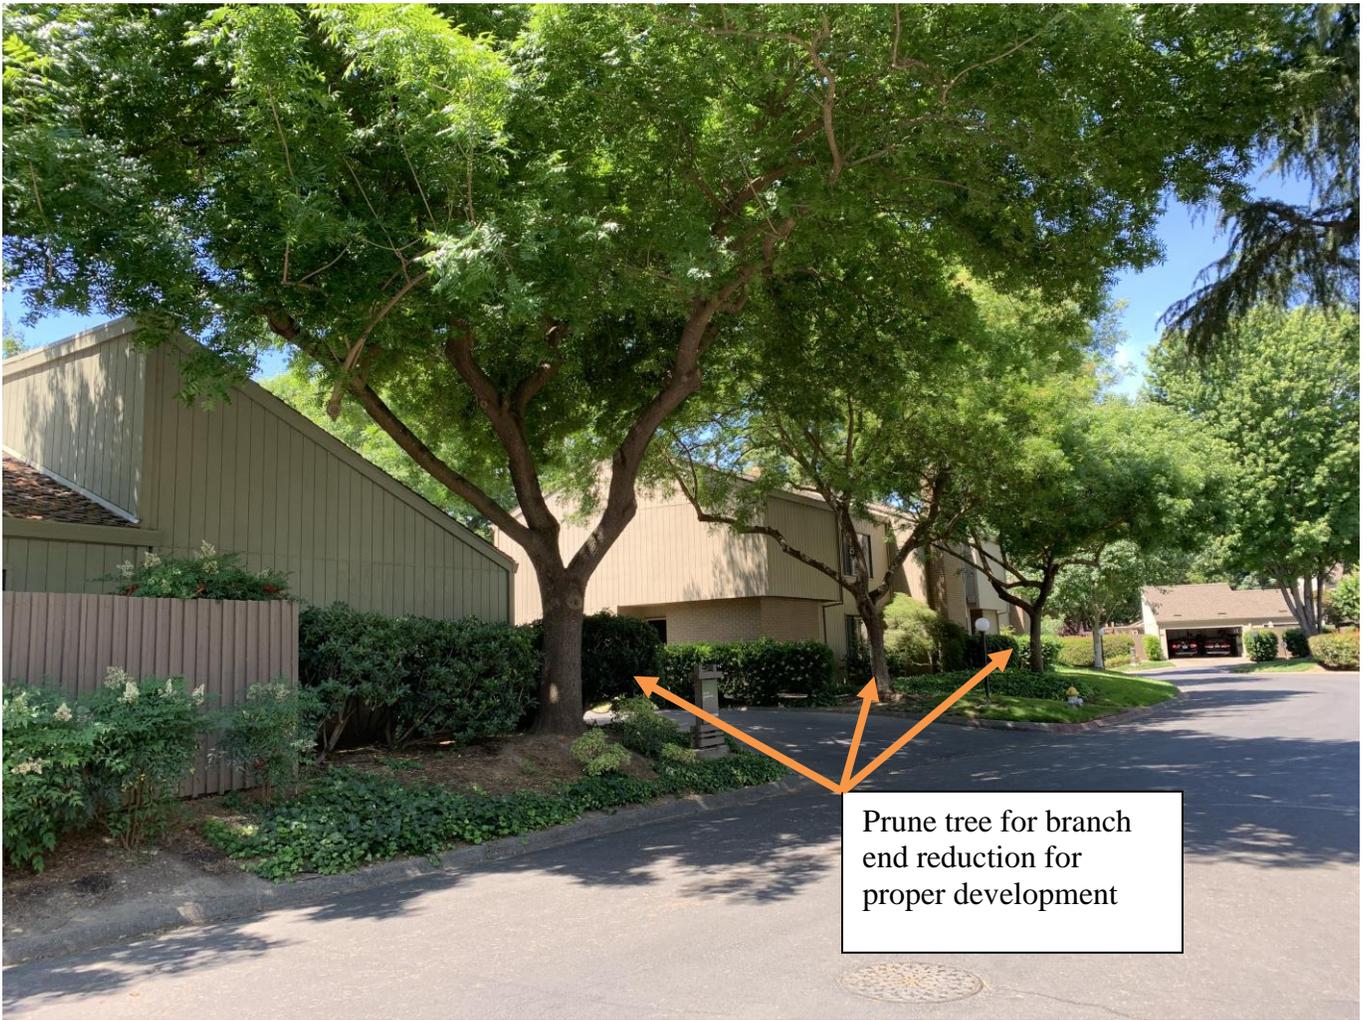
Figure 13

- (Zone 3) 3 Trees #1051, 1062, 1063 Chinese pistache (*Pistacia chinensis*), 1015 Dunbarton Circle. Trees have long and over extended branching in canopy, I recommend branch reduction pruning through the canopy to reduce stress on branching attachments. (Figures 13).

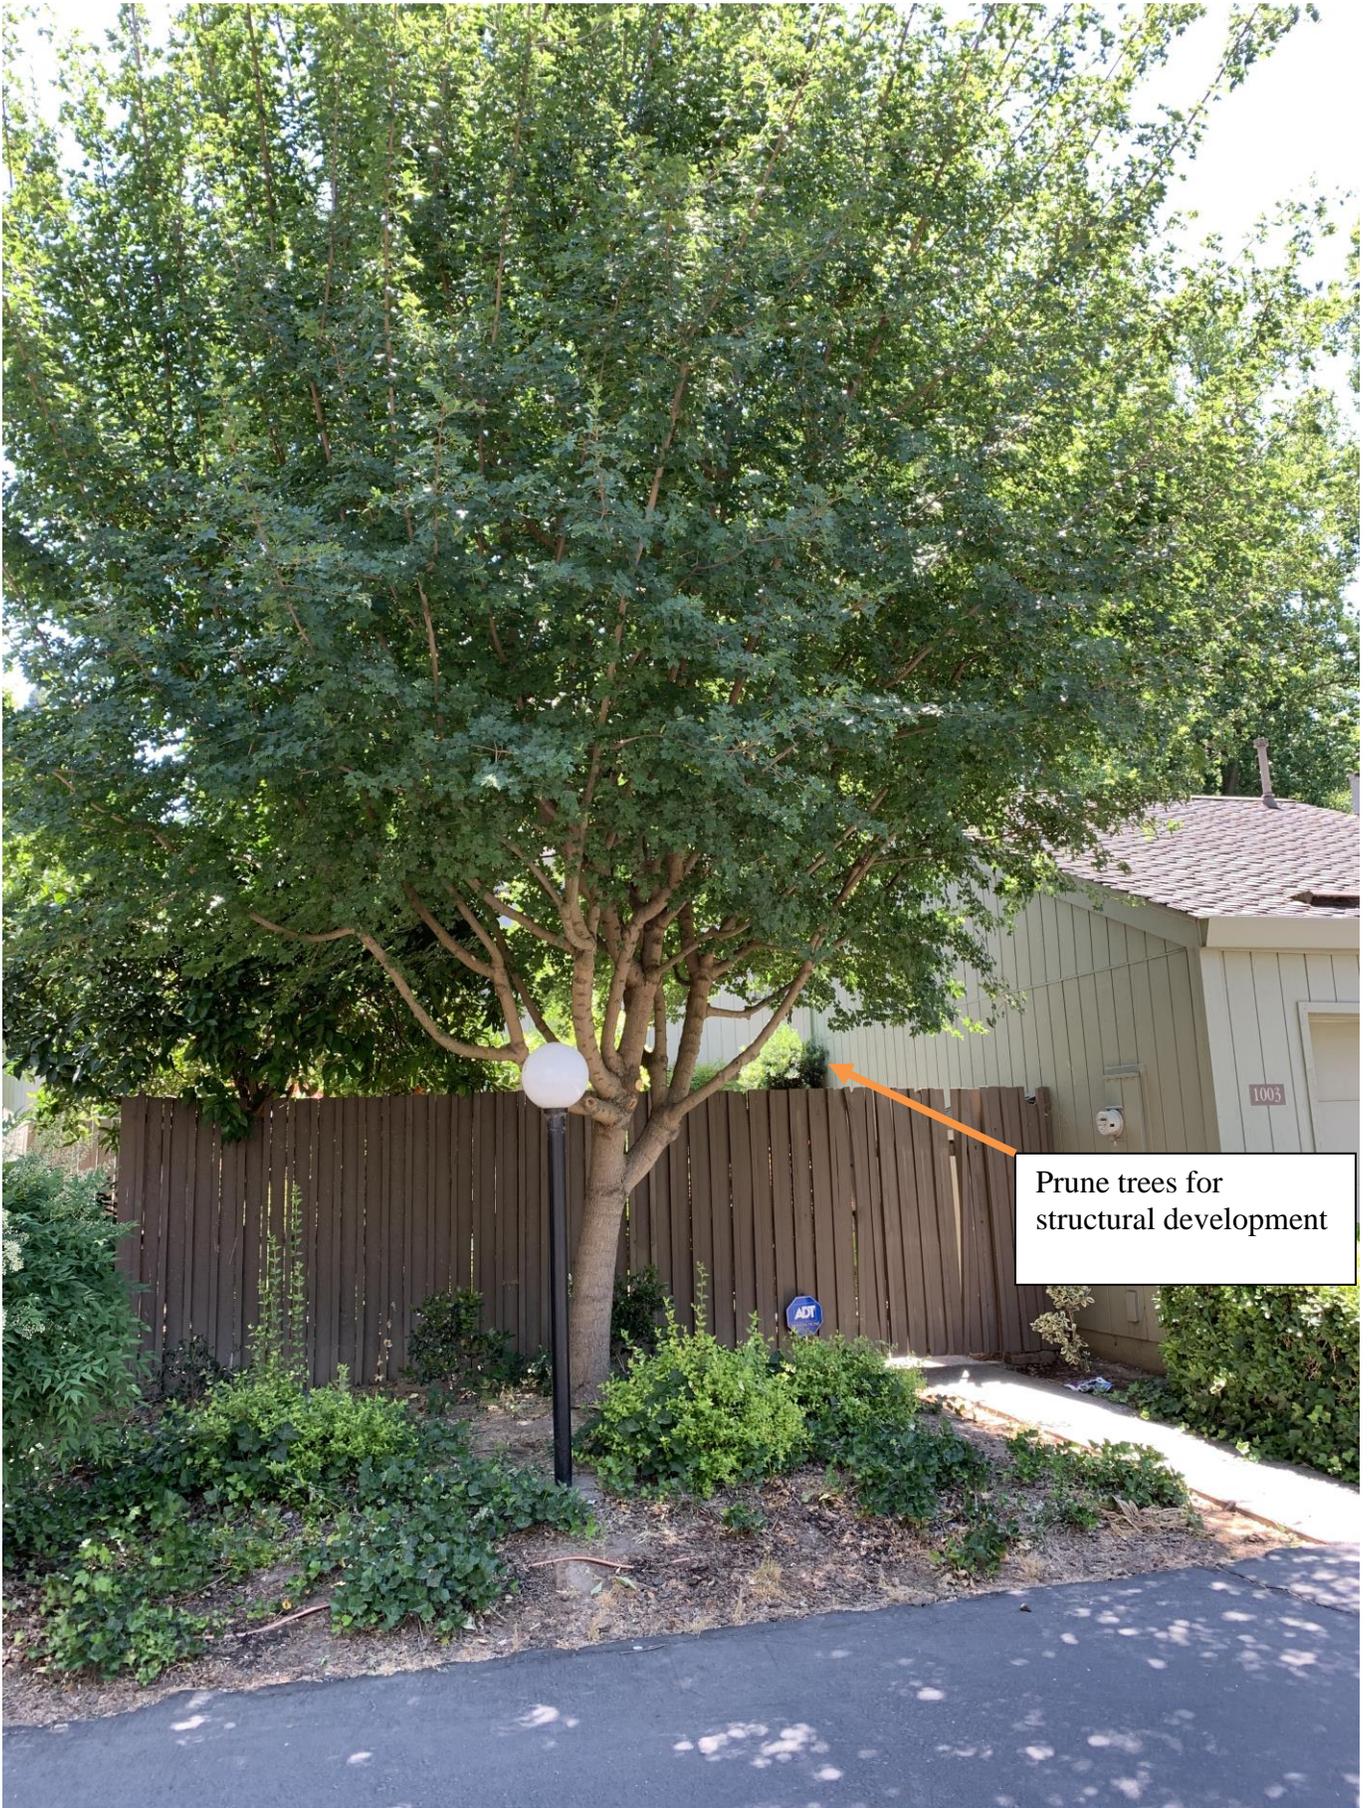
Figure 14

- (Zone 3) Tree #279, Trident Maple (*Acer buergerianum*), 1003 Dunbarton Circle. Trees need structural pruning to help with proper development (Figure 14)

Prune trees for structural development

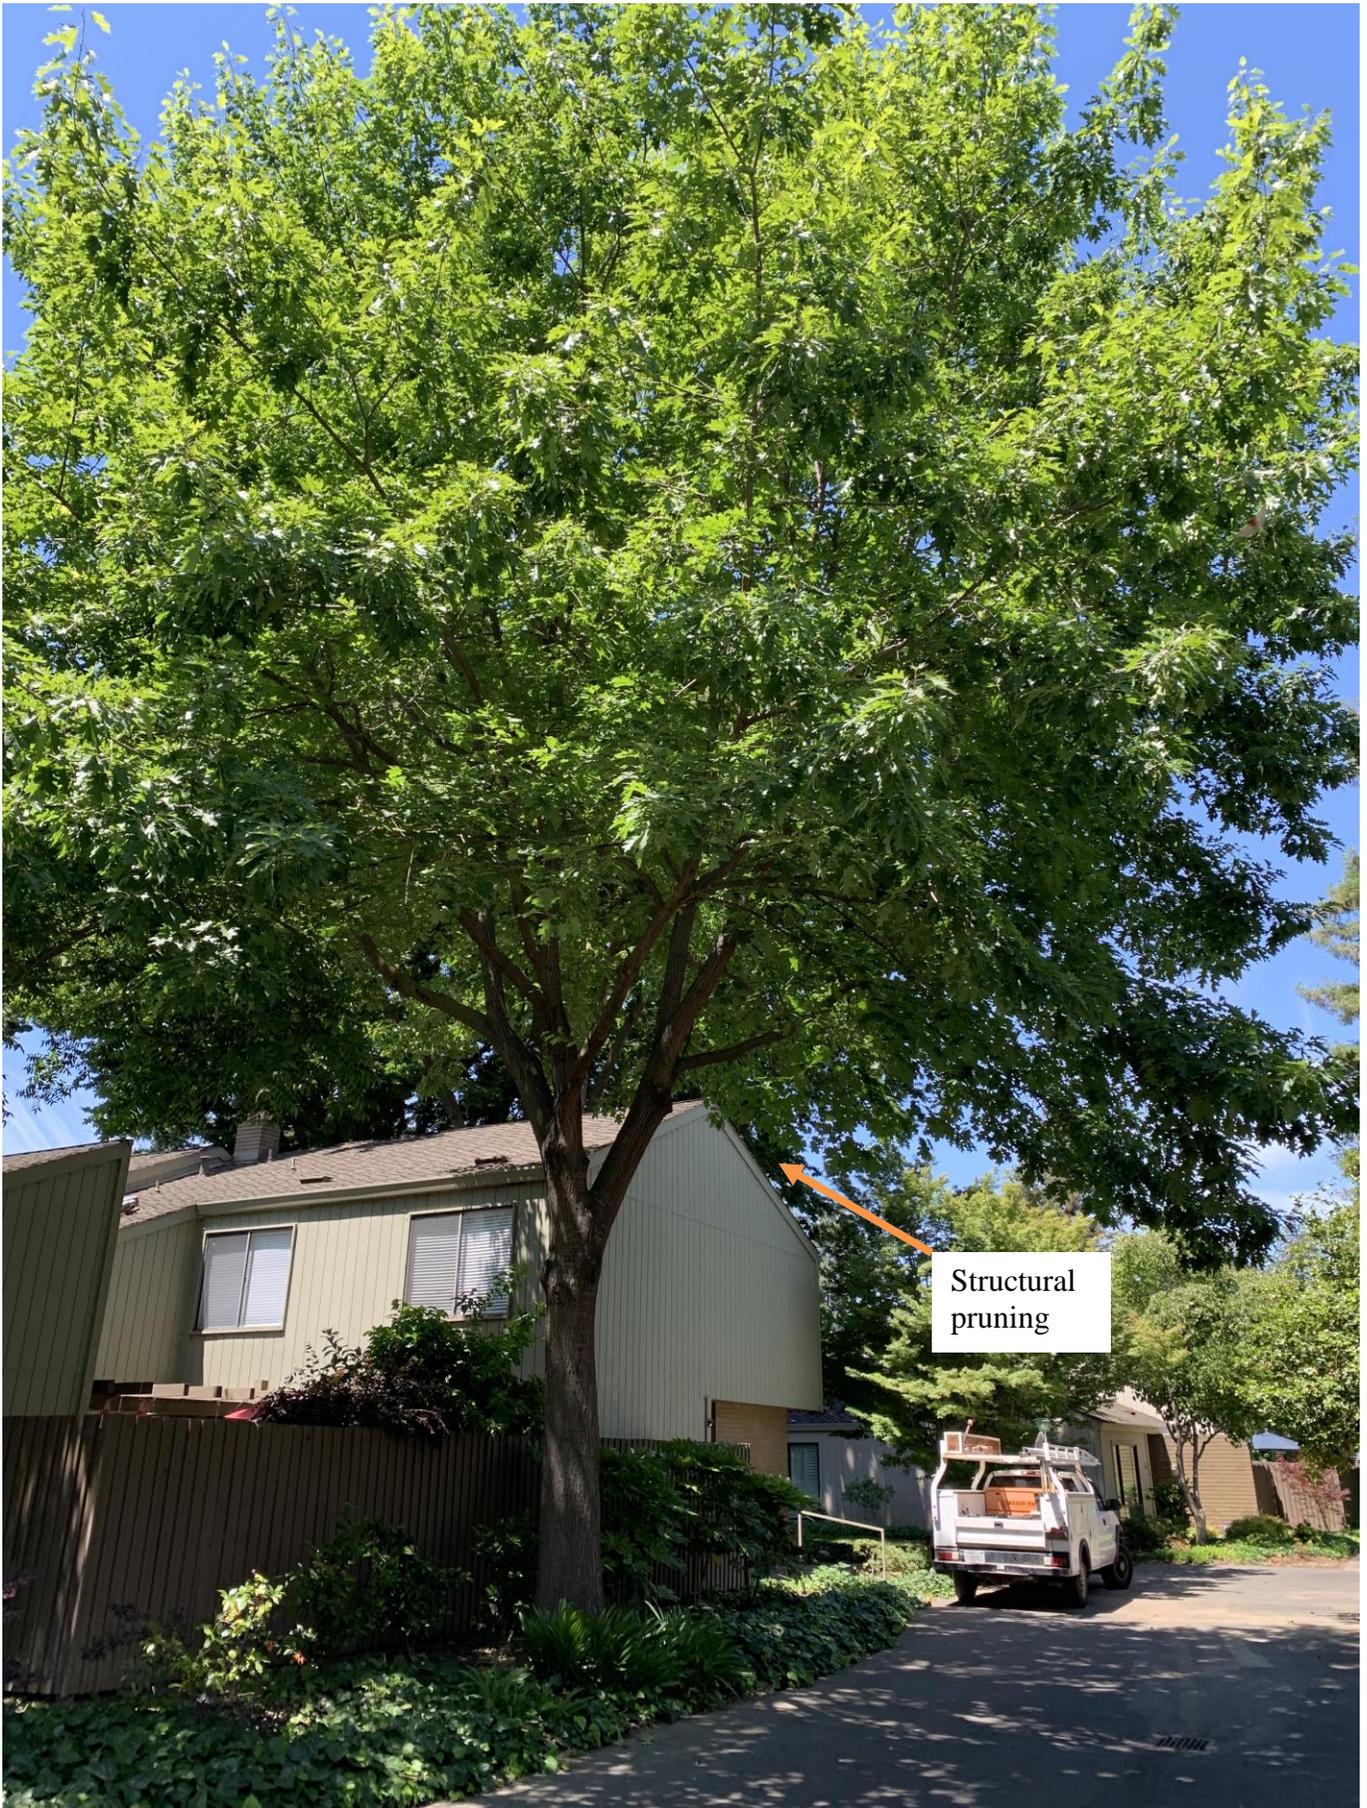
Figure 15

- (Zone 3) Tree #1055 Red oak (*Quercus rubra*) near 1013 Dunbarton Circle. Young tree needs structural pruning to encourage proper development.(Figure 15)

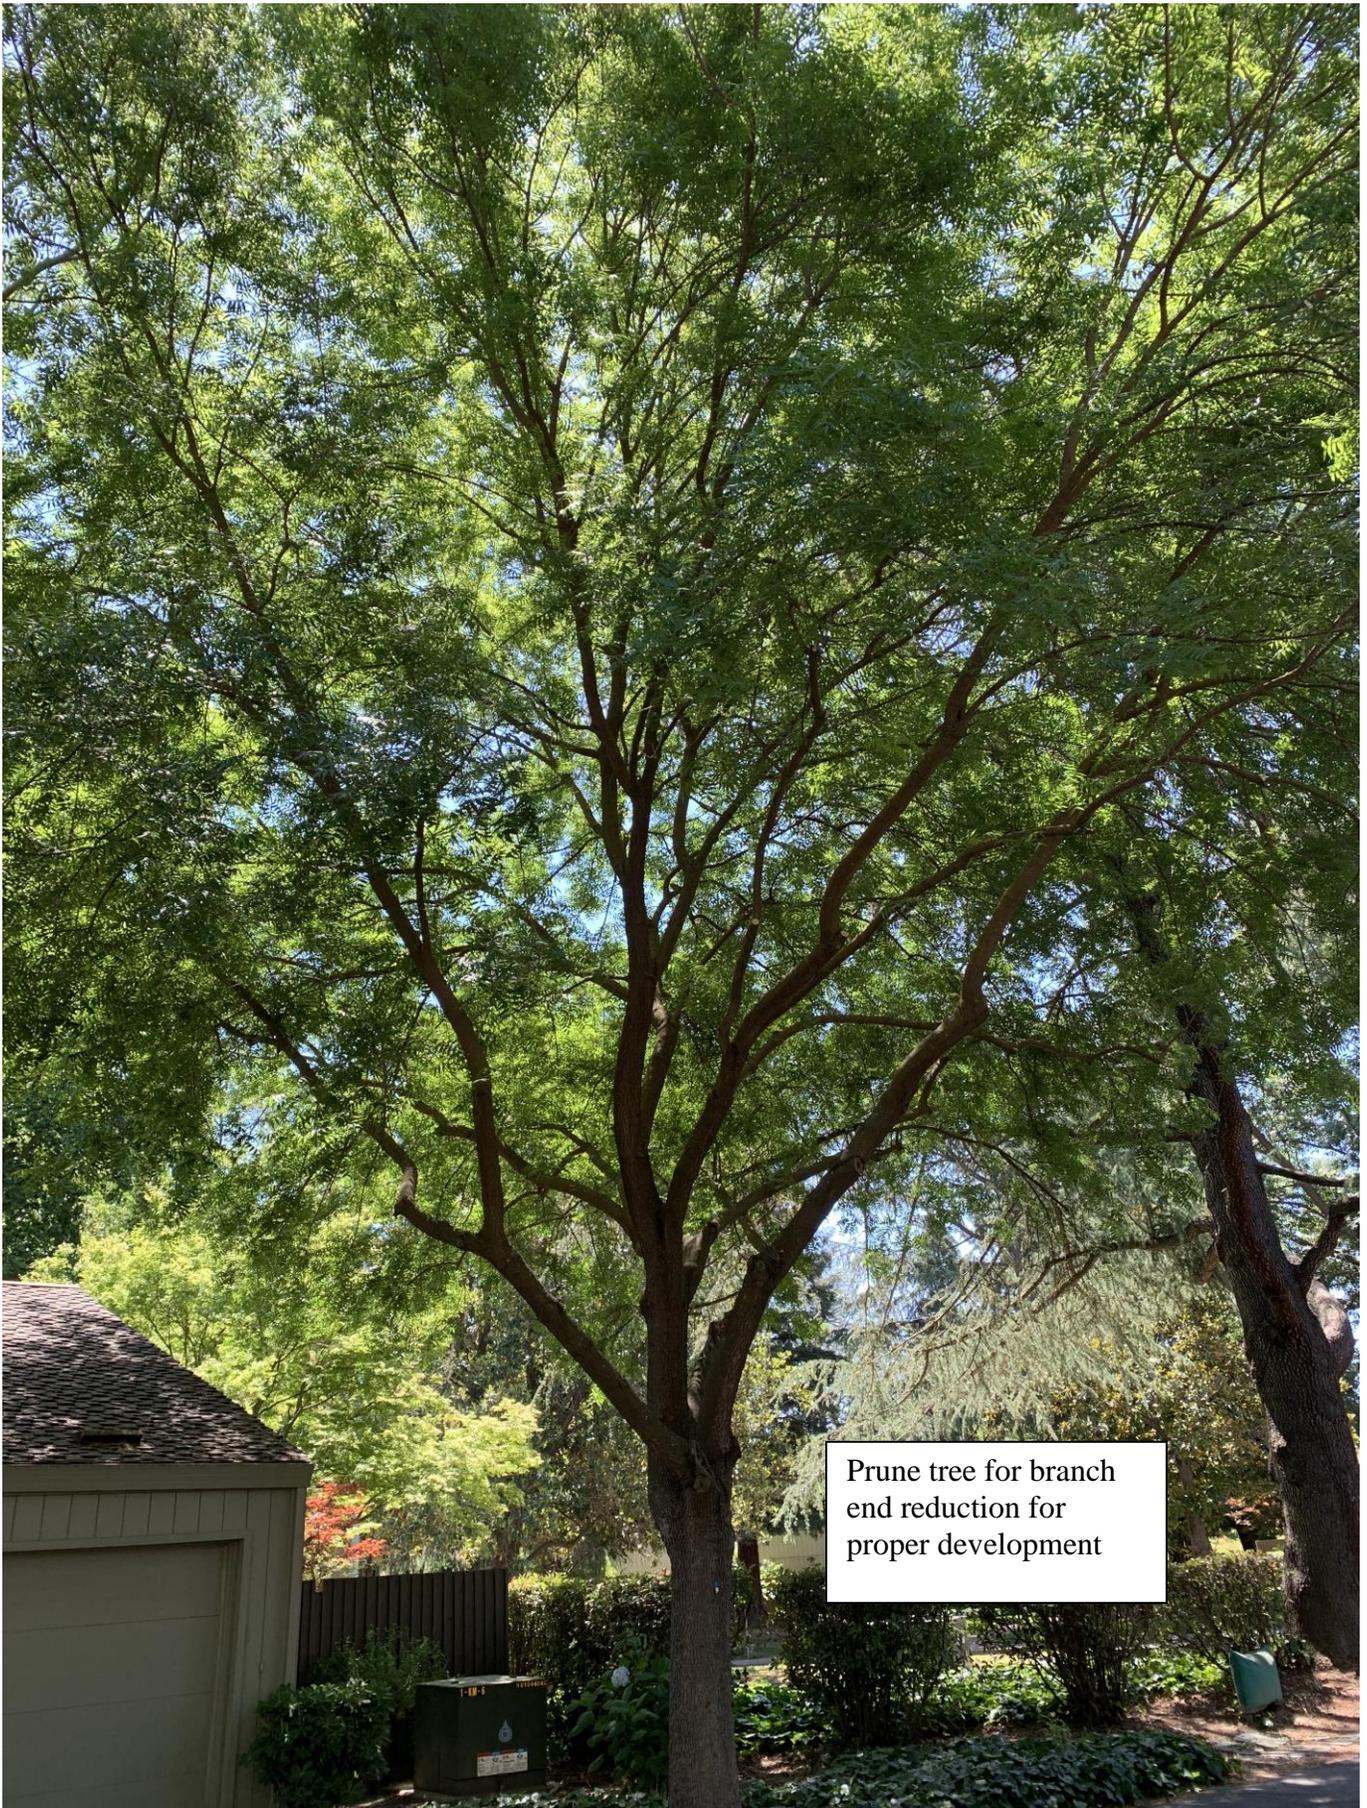
Figure 16

- (Zone 3) Tree #1053 Chinese pistache (*Pistacia chinensis*), 1007 Dunbarton Circle. Tree has long and over extended branching in canopy, I recommend branch reduction pruning through the canopy to reduce stress on branching attachments. (Figures 16).

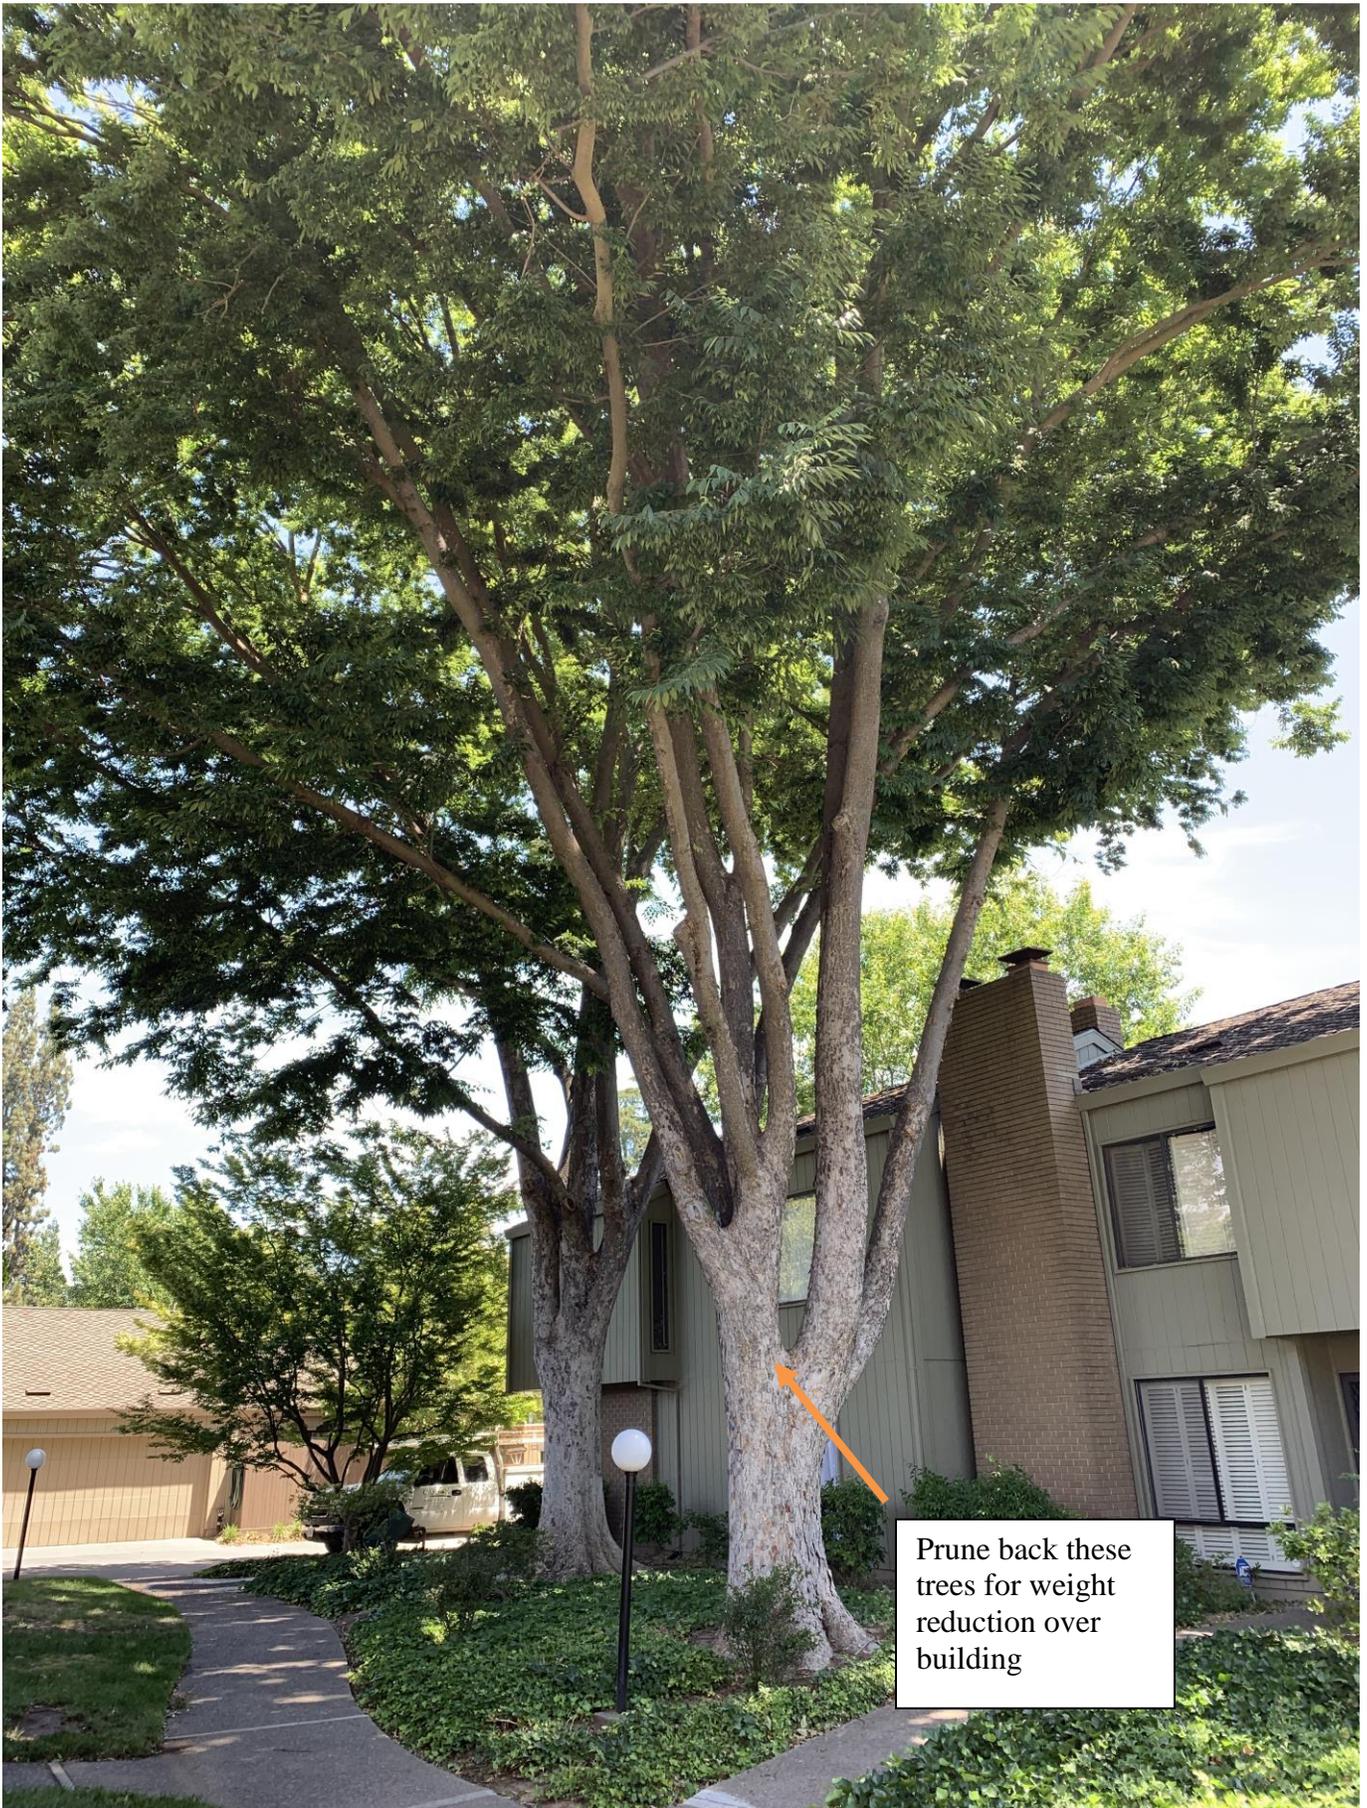
Figure 17

- (Zone 3) 2 Trees #1058, #1059 Zelcova (*Zelcova serrata*), 1011 Dunbarton Circle (Figure 17). These trees have full and over weighted canopy I recommend weight reduction pruning to reduce the potential of limb failure.

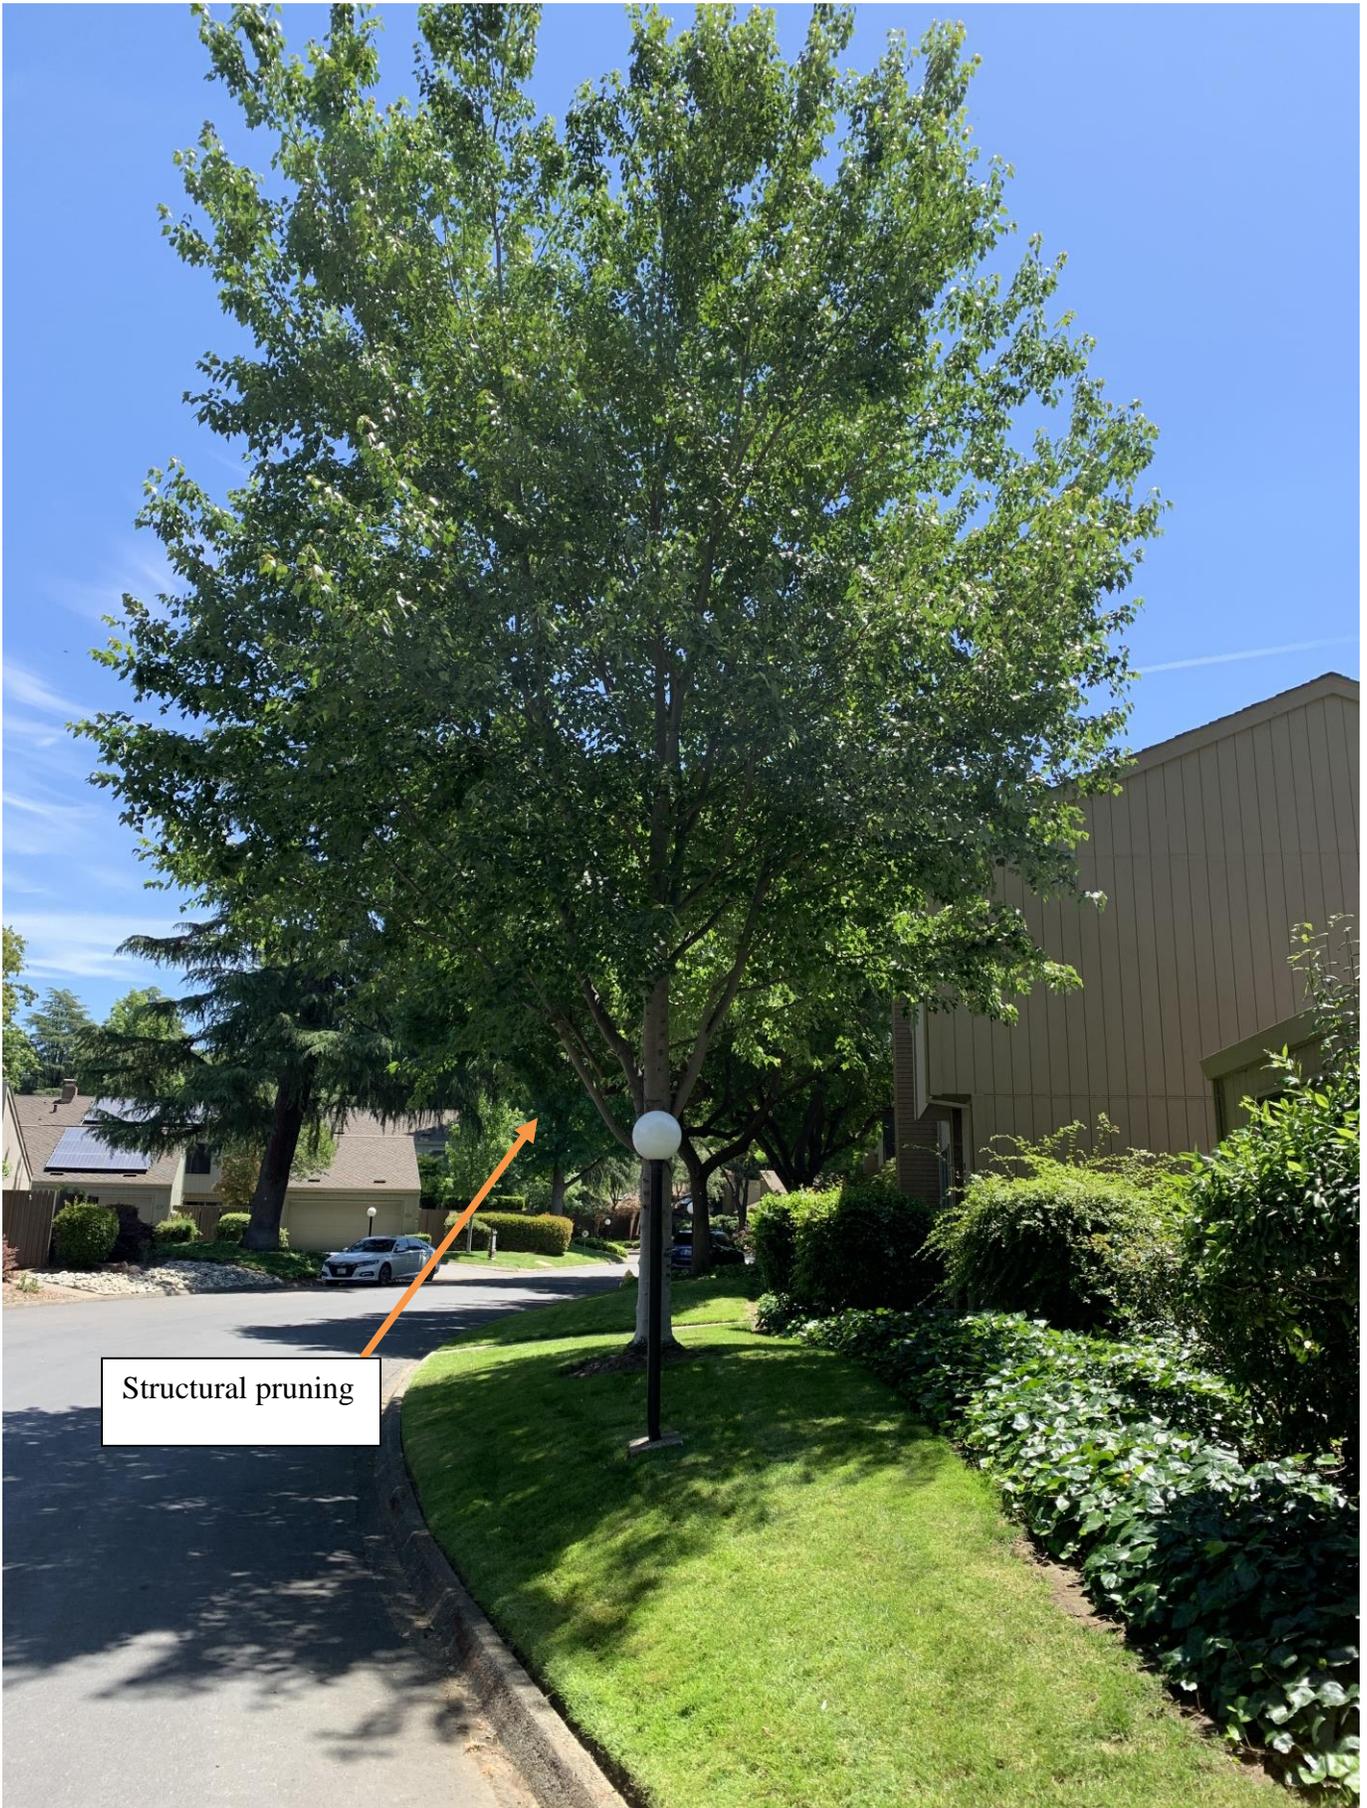
Figure 18

- (Zone 3) Tree #No Tag Red Maple (*Acer rubrum*) 1017 Dunbarton Circle Young tree needs structural pruning to encourage proper development (Figure 18).

Structural pruning

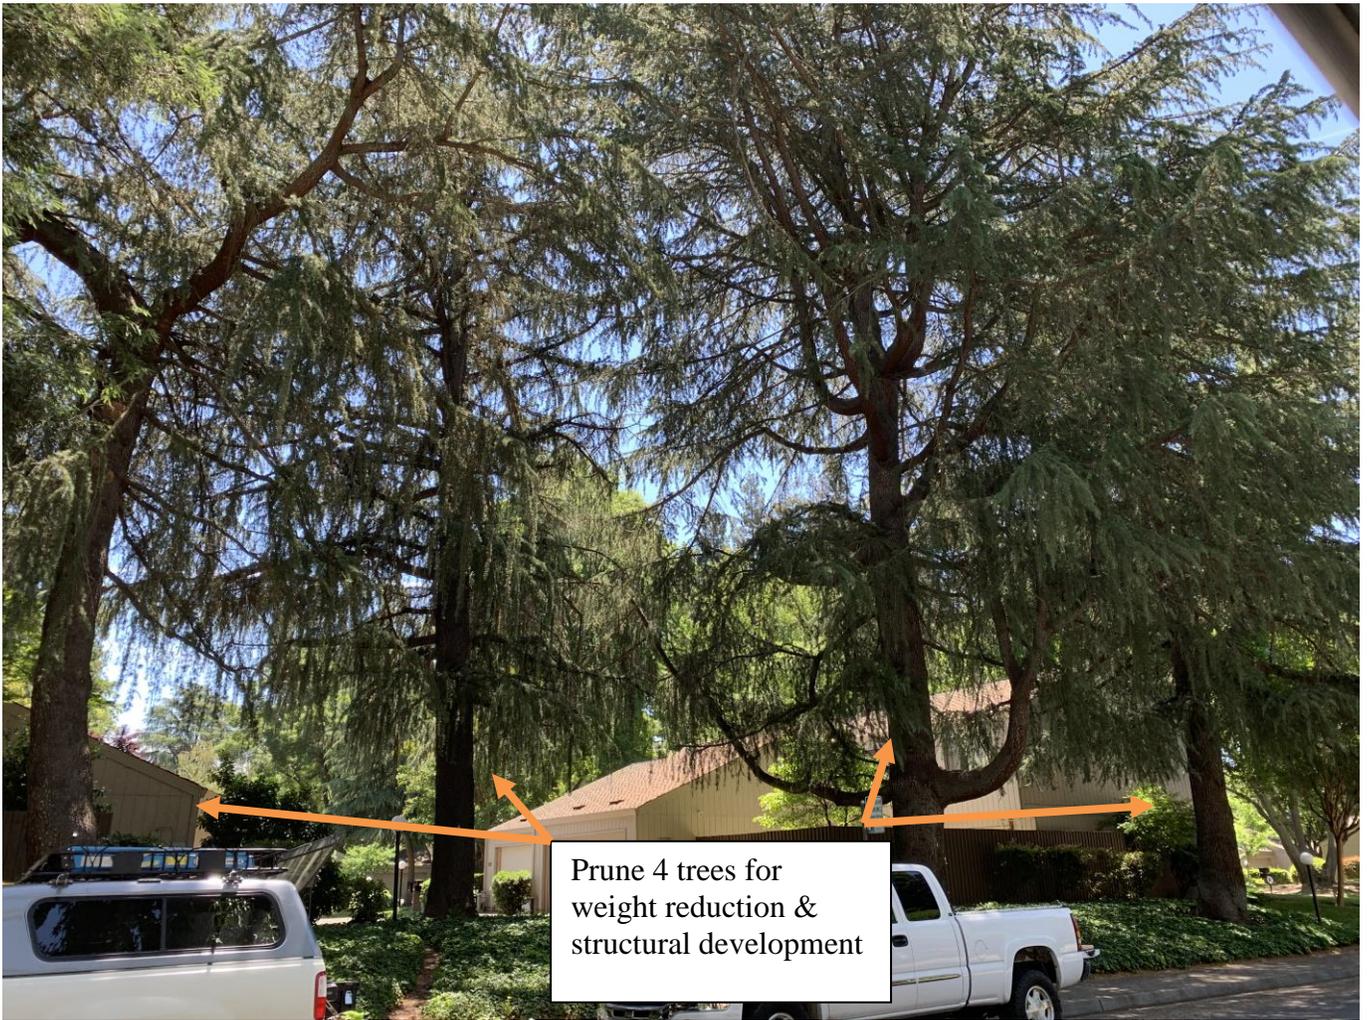
Figure 19

- (Zone 3) 4 Trees # 916, 917, 918, 919 Deodar cedar (*Cedrus deodara*) 1395, 1371 Commons Dr. (Figure 19) trees have full and heavy canopy I recommend weight reduction pruning. (Figure 19).
