June 3, 2021

The Nepenthe Association
Bettsi Ledesma
1131 Commons Dr.
Sacramento, CA 95825
Phone: (916) 929-8380
Email: Bettsi.Ledesma@fsresidential.com

On May 28, 2021, I inspected several trees on the Nepenthe property during the monthly tree walk. The focus of the walk was to address resident/management concerns regarding mature trees on the property. The purpose of this report is to develop mitigation plans for the following trees and my recommendations are below. My recommendations are based on a Basic Visual Inspection. All decisions made based on the recommendations of this report are at the discretion of the Nepenthe Association.

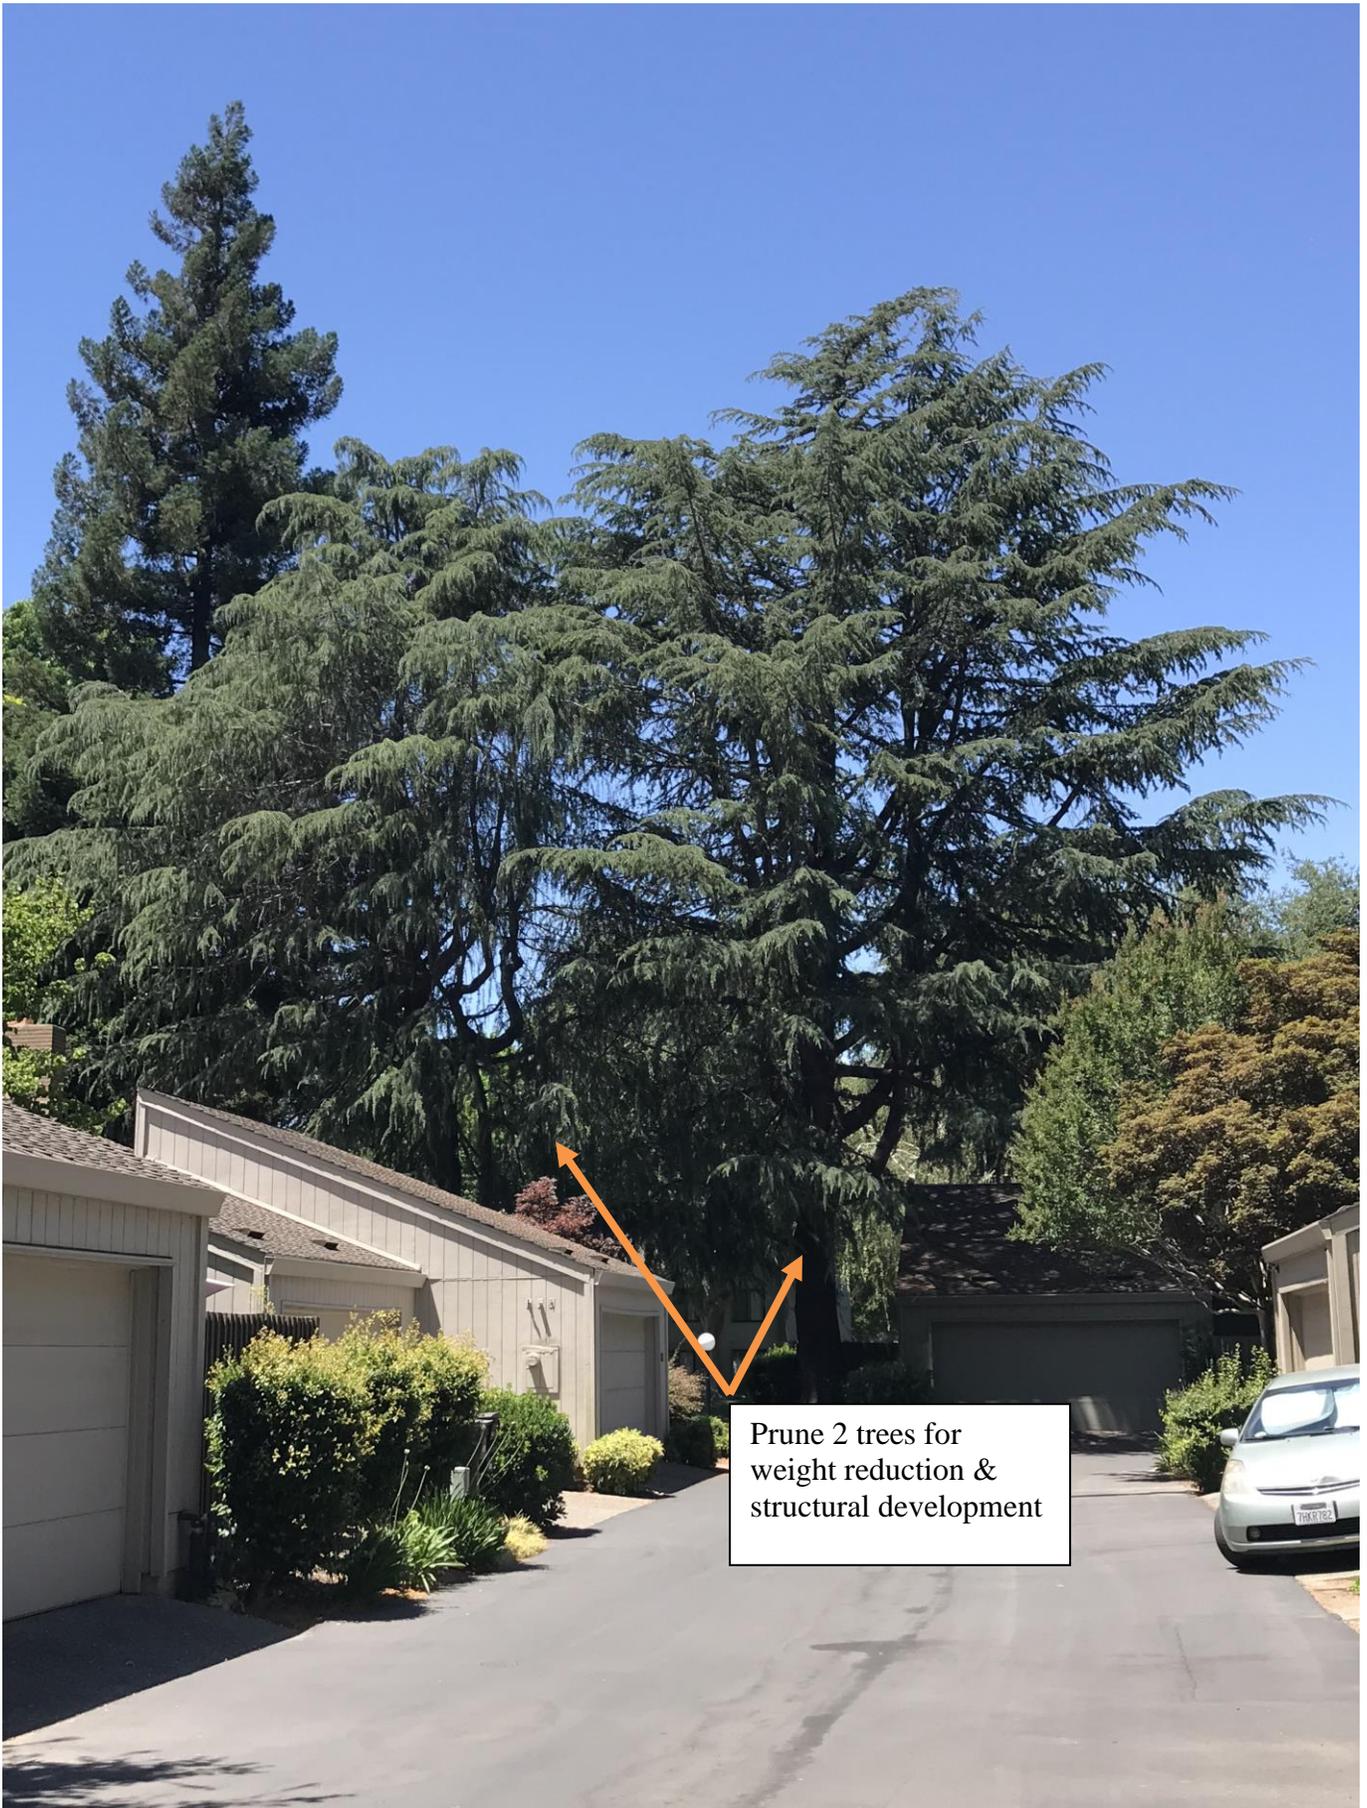
Figure 20

- (Zone 3) 2 Trees # 899, 900 Deodar cedar (*Cedrus deodara*) 1333, 1355 Commons Dr. (Figure 19) trees have full and heavy canopy I recommend weight reduction pruning. (Figure 20).

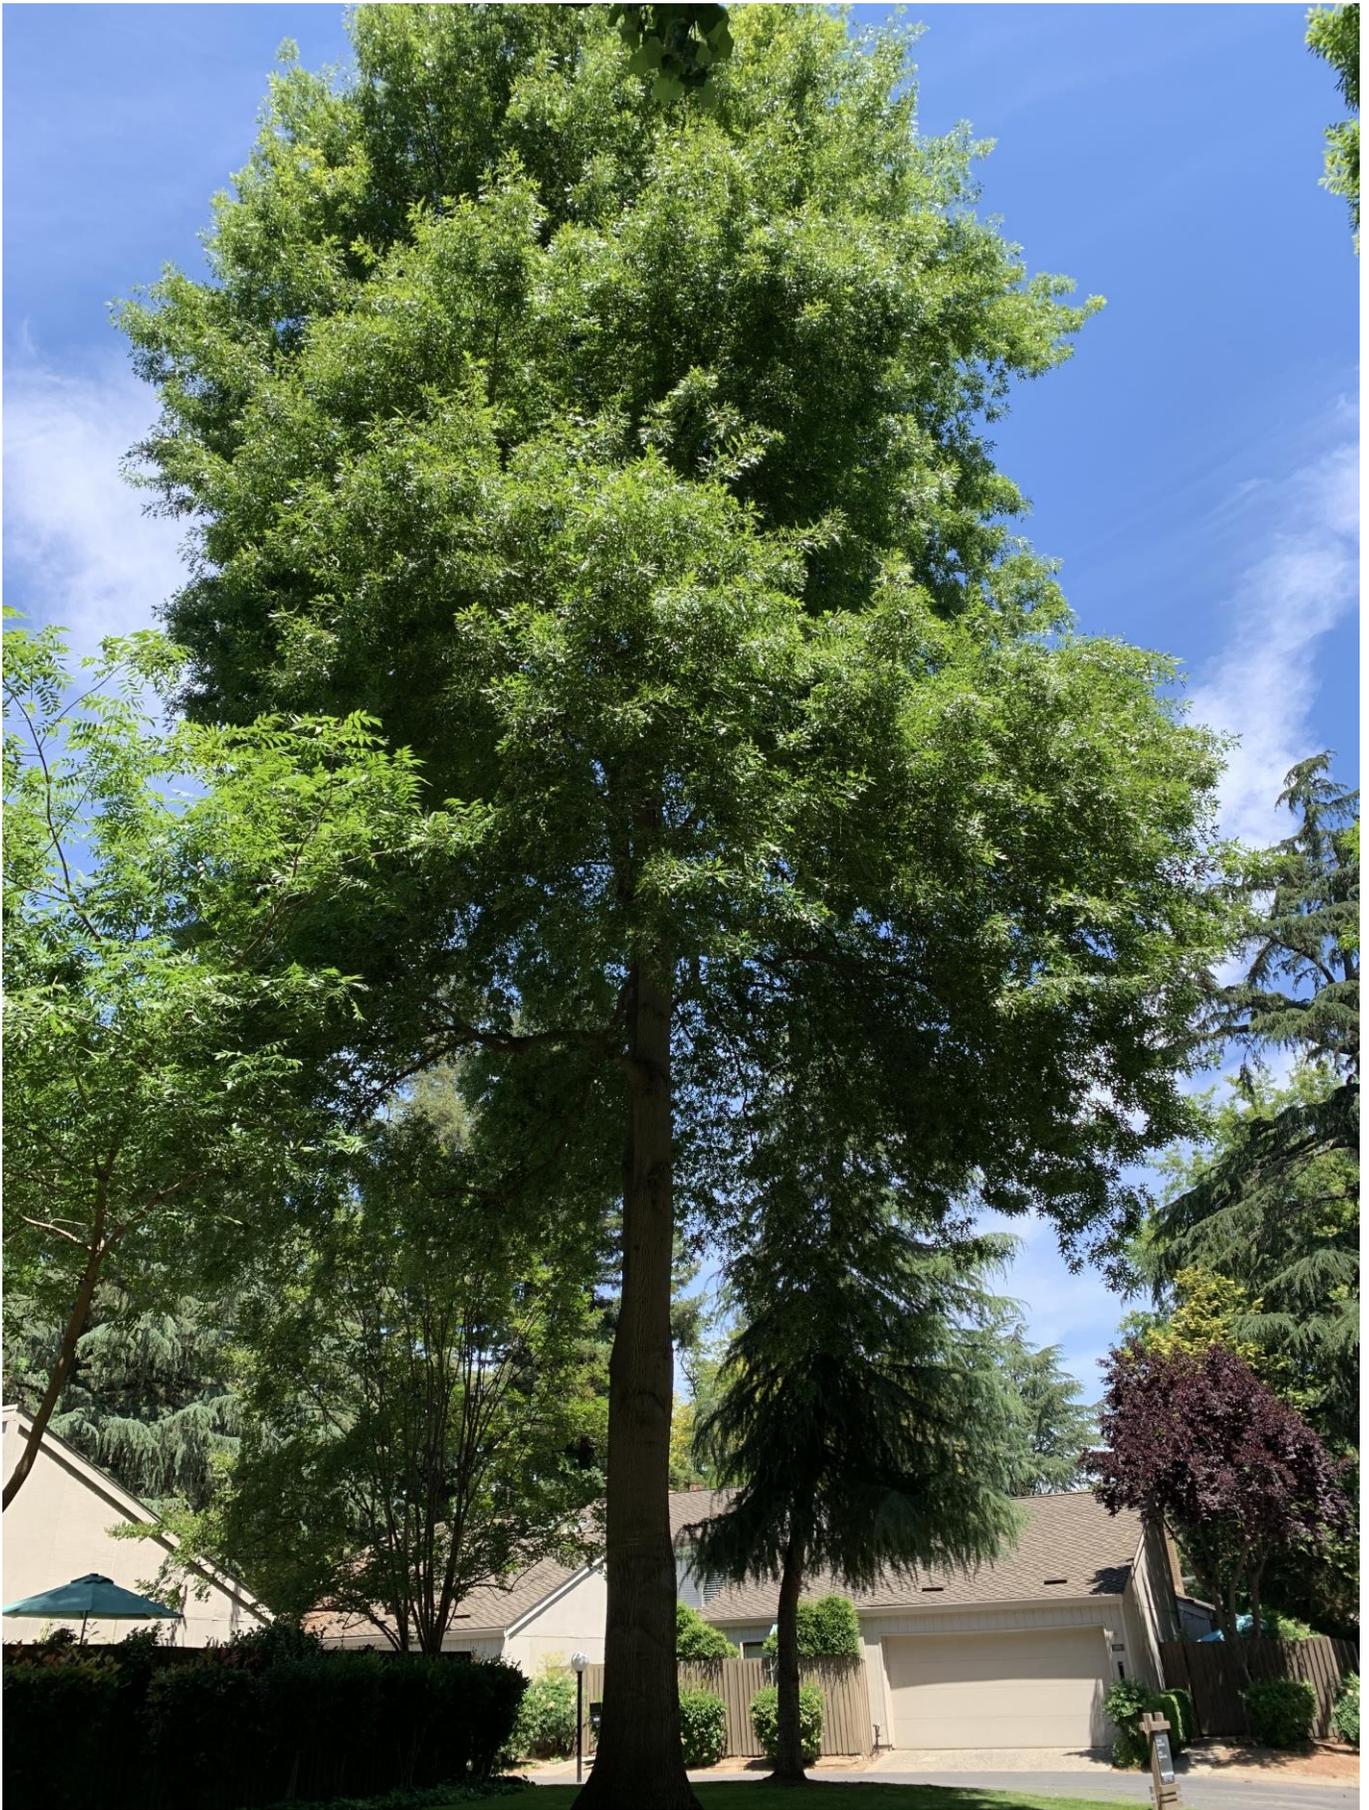
Figure 21

- (Zone 3) Tree # 926, Red Oak (*Quercus rubrum*), 101 Dunbarton Circle. (Figure 21). The tree canopy is full and heavy I recommend weight reduction pruning.

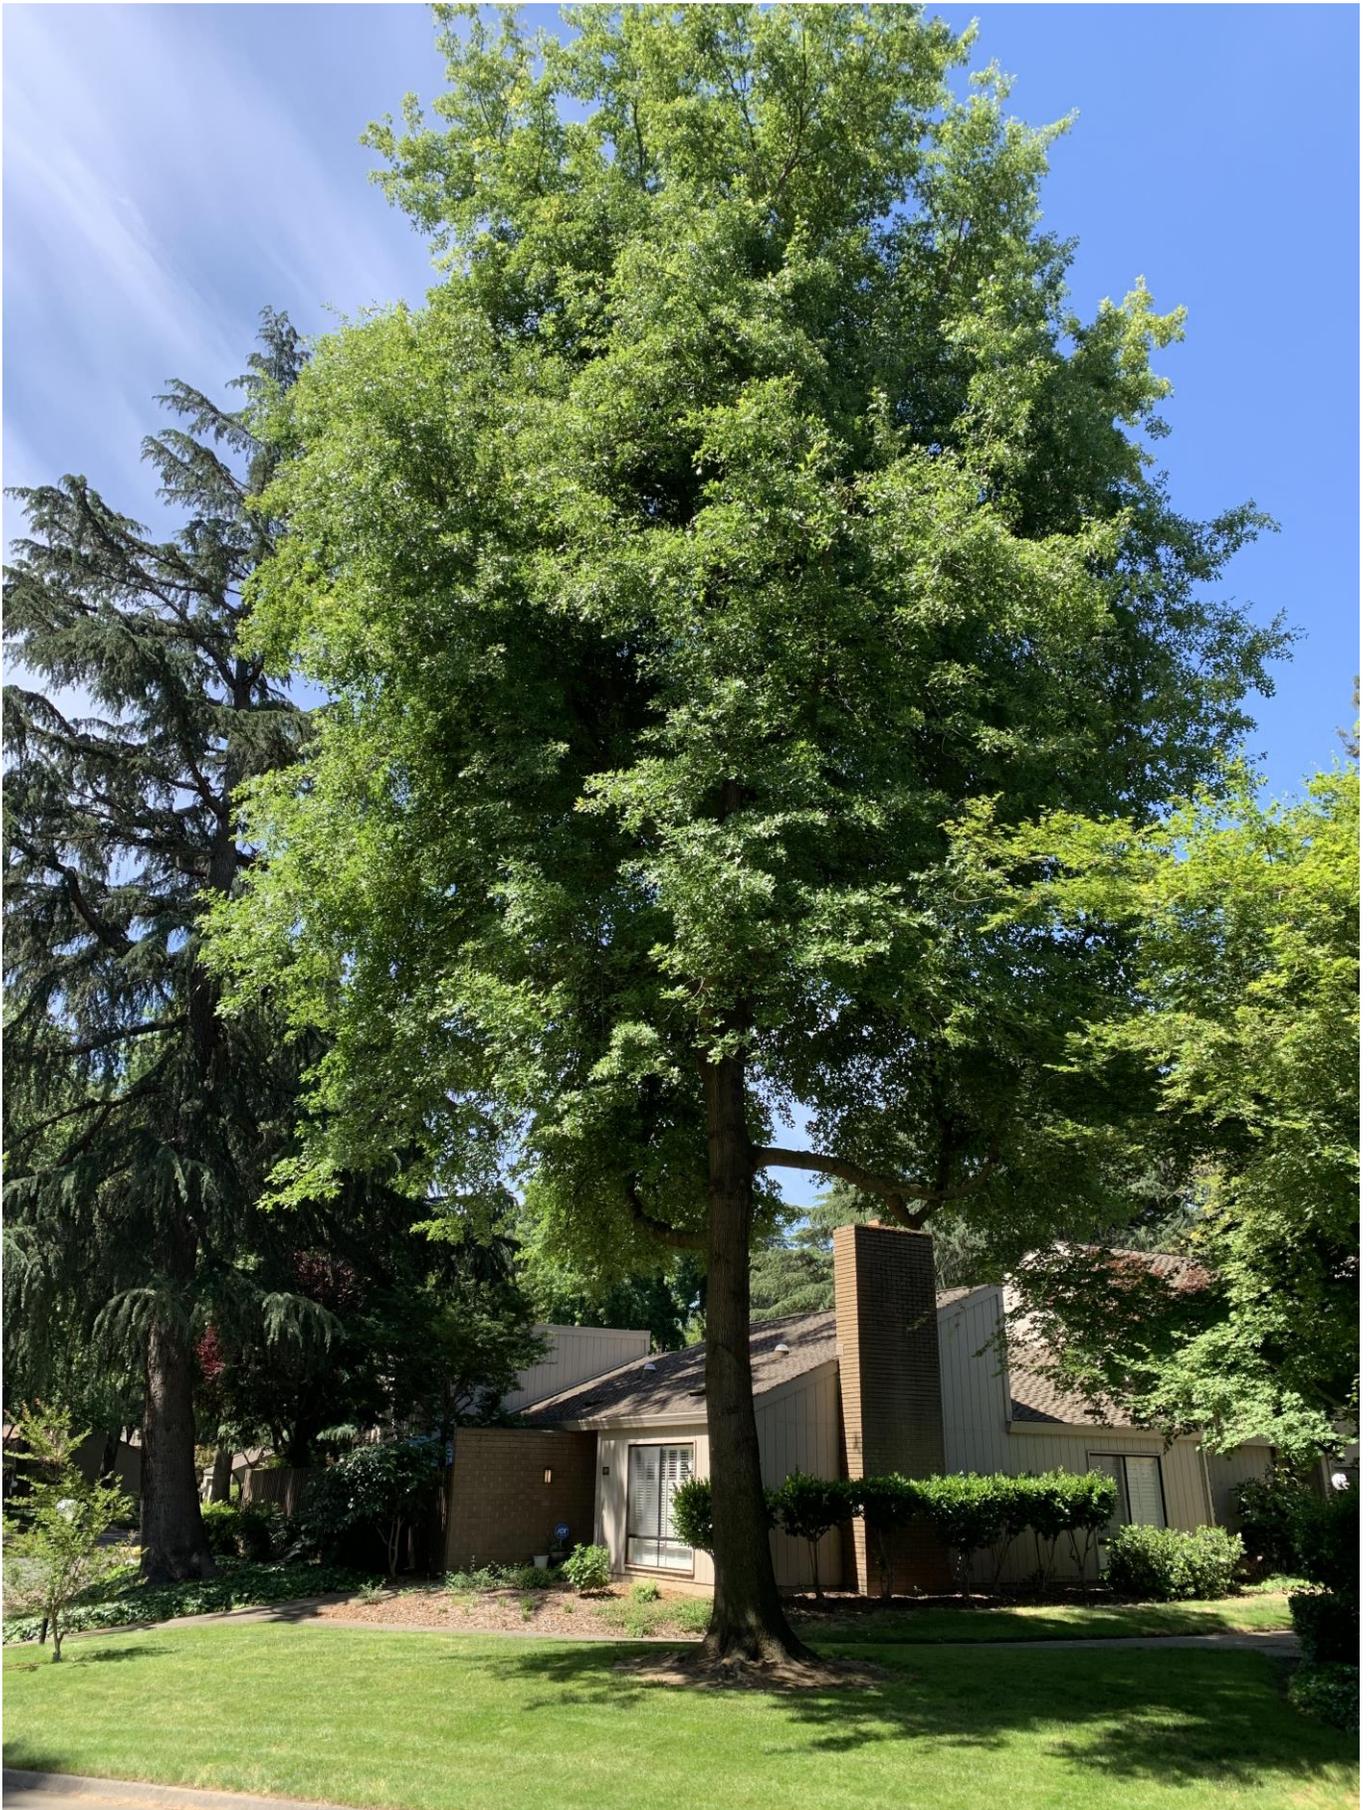
Figure 22

- (Zone 3) Tree # Tag, Red Oak (*Quercus rubrum*), 109 Dunbarton Circle. (Figure 22). The tree canopy is full and heavy I recommend weight reduction pruning.
- (Zone 3) 2 Trees #925, #No Tag Sweetgum (*Liquidambar styraciflua*) 1395 Commons Dr. (Figure 23) these two trees were pruned heavy last year reducing the overall height and weight of the trees due to multiple limb failure. The trees have responded well to the pruning and require additional pruning to redirect the new growth.
