Irrigation Repair – Zone 2

Project Address: **Commons Dr. - 1131**
Project Name: **Nepenthe Association**
On-Site Location: **See attached map and photos**

Work Description

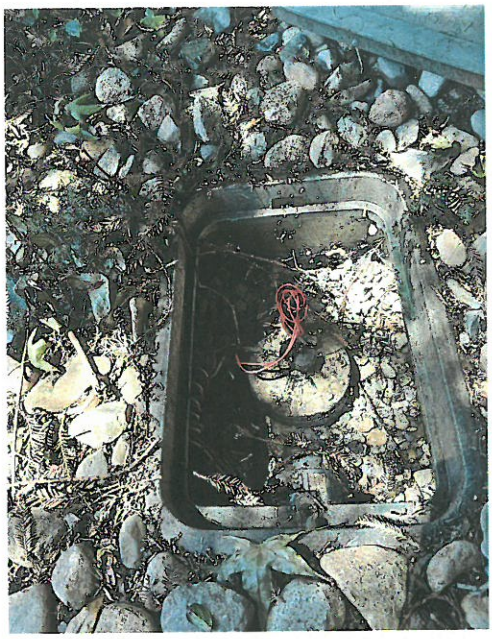
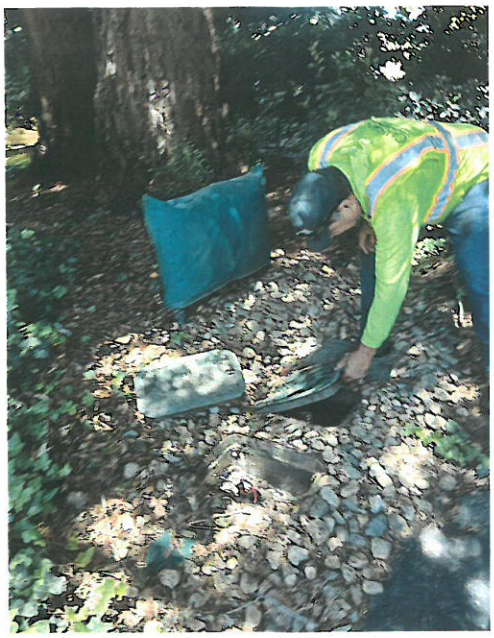
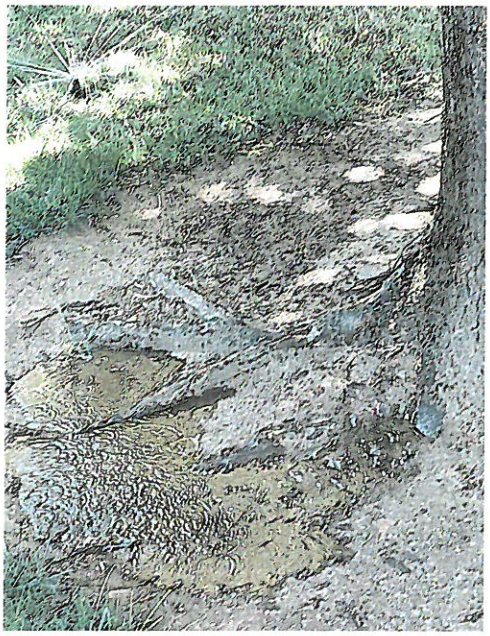
- Zone 2 – St. 25 – repair (1) broken fitting and replace 93) clogged rotary nozzles by 1350 Commons
  - St.44 – Repair (1) broken Netafim line by 2276 Swatmore
  - St.47 – Repair (1) broken lateral line by 2232 Swatmore
  - St. 64 – Replace old malfunctioning solenoid
