May 1, 2017

The Nepenthe Association
Bettie Ledesma
1131 Commons Dr.
Sacramento, CA 95825
Phone: (916) 929-8380
Email: Bettie.Ledesma@fsresidential.com

On April 25, 2017, I inspected several trees on the Nepenthe property during the monthly tree walk. The focus of the walk was to address resident/management concerns regarding mature trees on the property. The purpose of this report is to develop mitigation plans for the following trees and my recommendations are below. My recommendations are based on a Basic Visual Inspection. All decisions made based on the recommendations of this report are at the discretion of the Nepenthe Association.

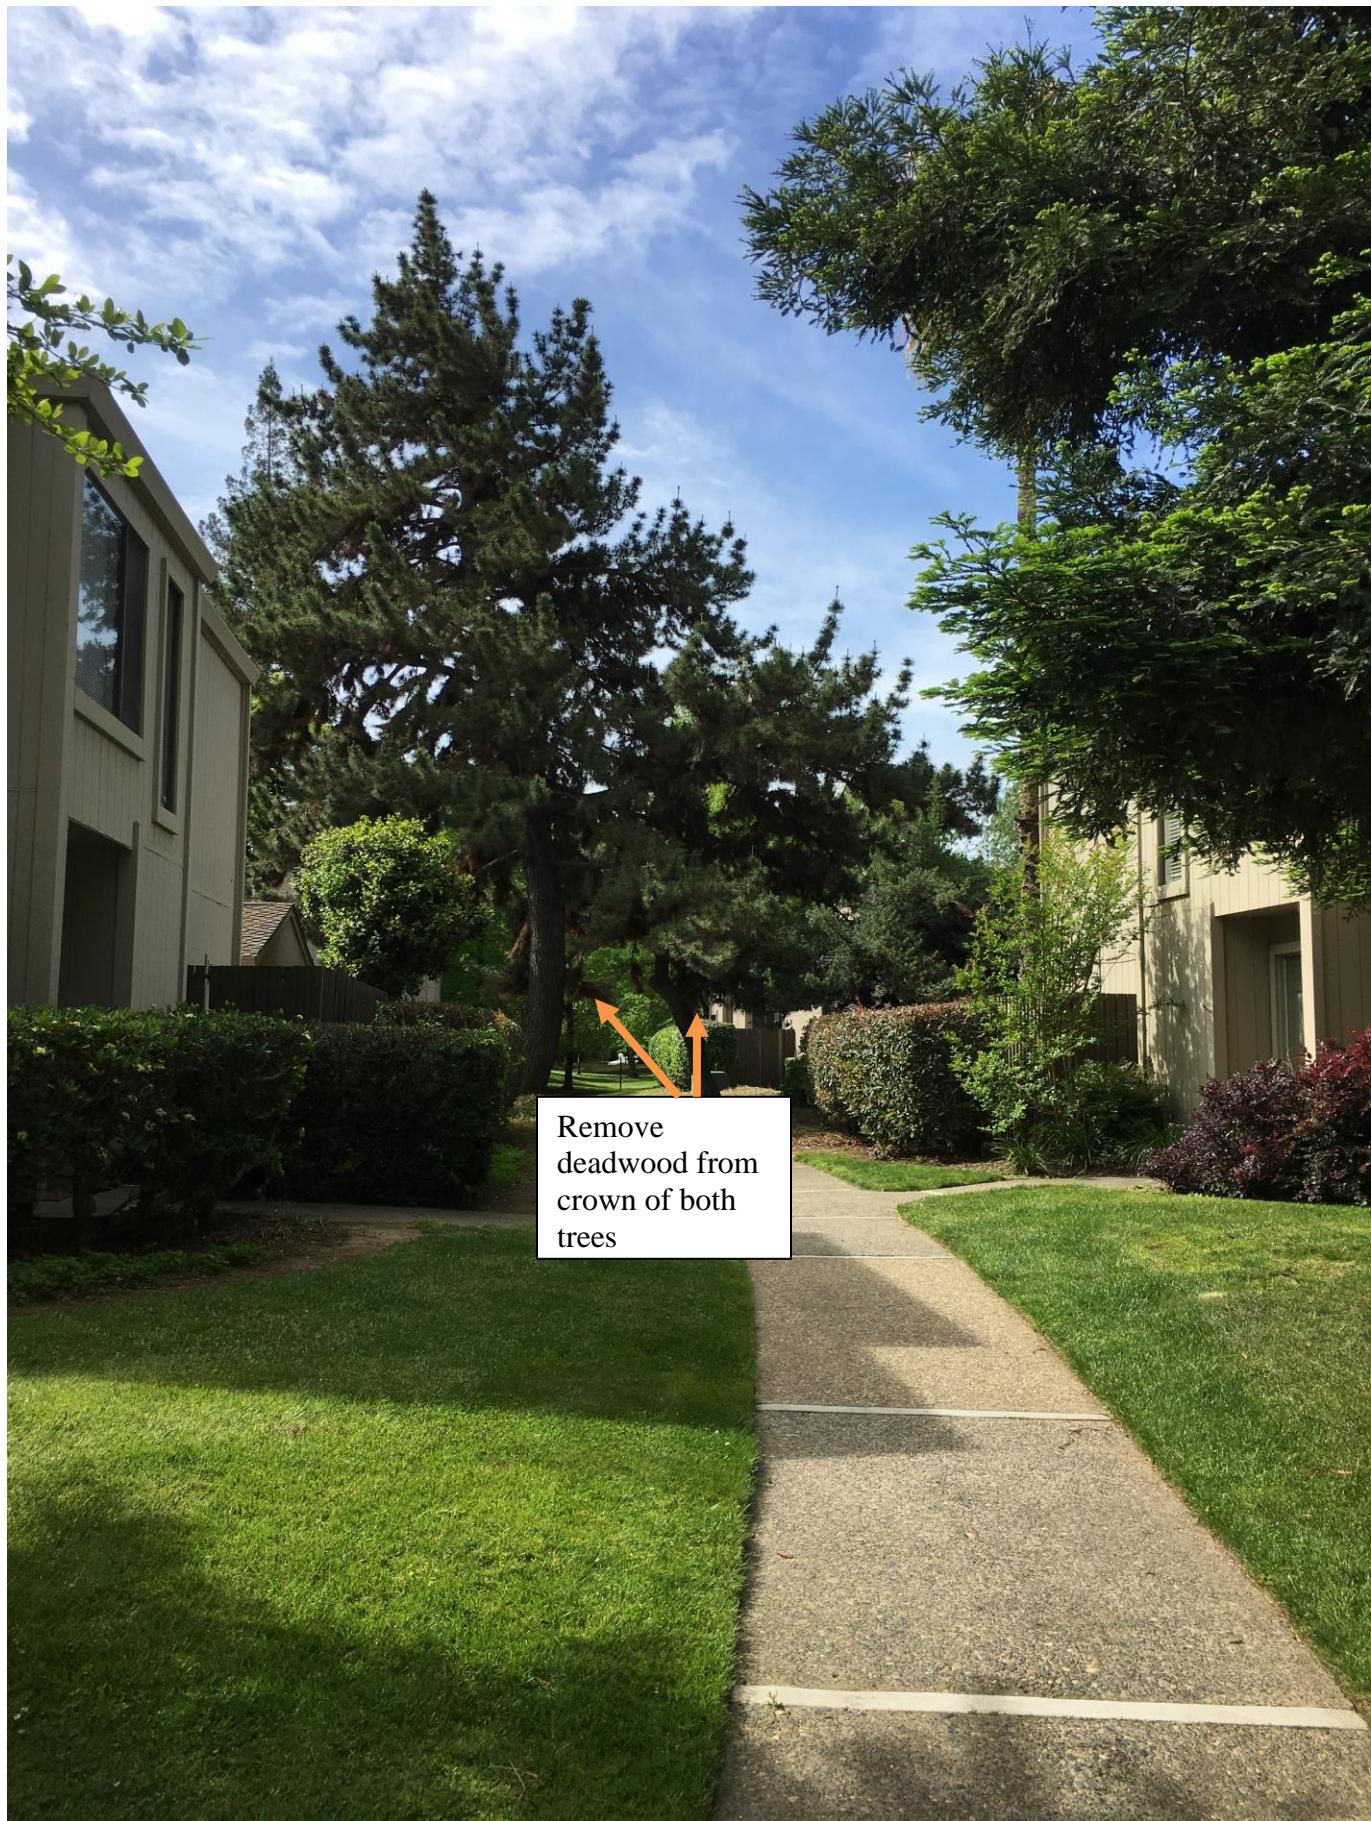
Figure 19

- (Zone 1) Tree #328 Saucer Magnolia (*Magnolia soulangeana*) on island on Colby Ct. Tree needs some corrective pruning to develop good structure. Tree has some girdling roots that need to be corrected as well. (Figure 18)
- (Zone 1) Tree's #318 & #319 Pine (*Sequoia sempervirens*), 2 trees next to 1109 Commons Drive (Figure 19). Trees would benefit cleaning canopy of dead wood. Trimming should be done in fall to prevent sap.
- (Zone 1) No Tree Tag Japanese Blueberry tree (*Elaeocarpus decipens*) Next to club house in pool area (Figure 20). This tree is healthy and full and needs some corrective pruning to develop good structure.
