## Irrigation Evaluation and Repair Proposal

**Commons Dr. - 1131**

# Irrigation System Evaluation

## Battery Controllers Map

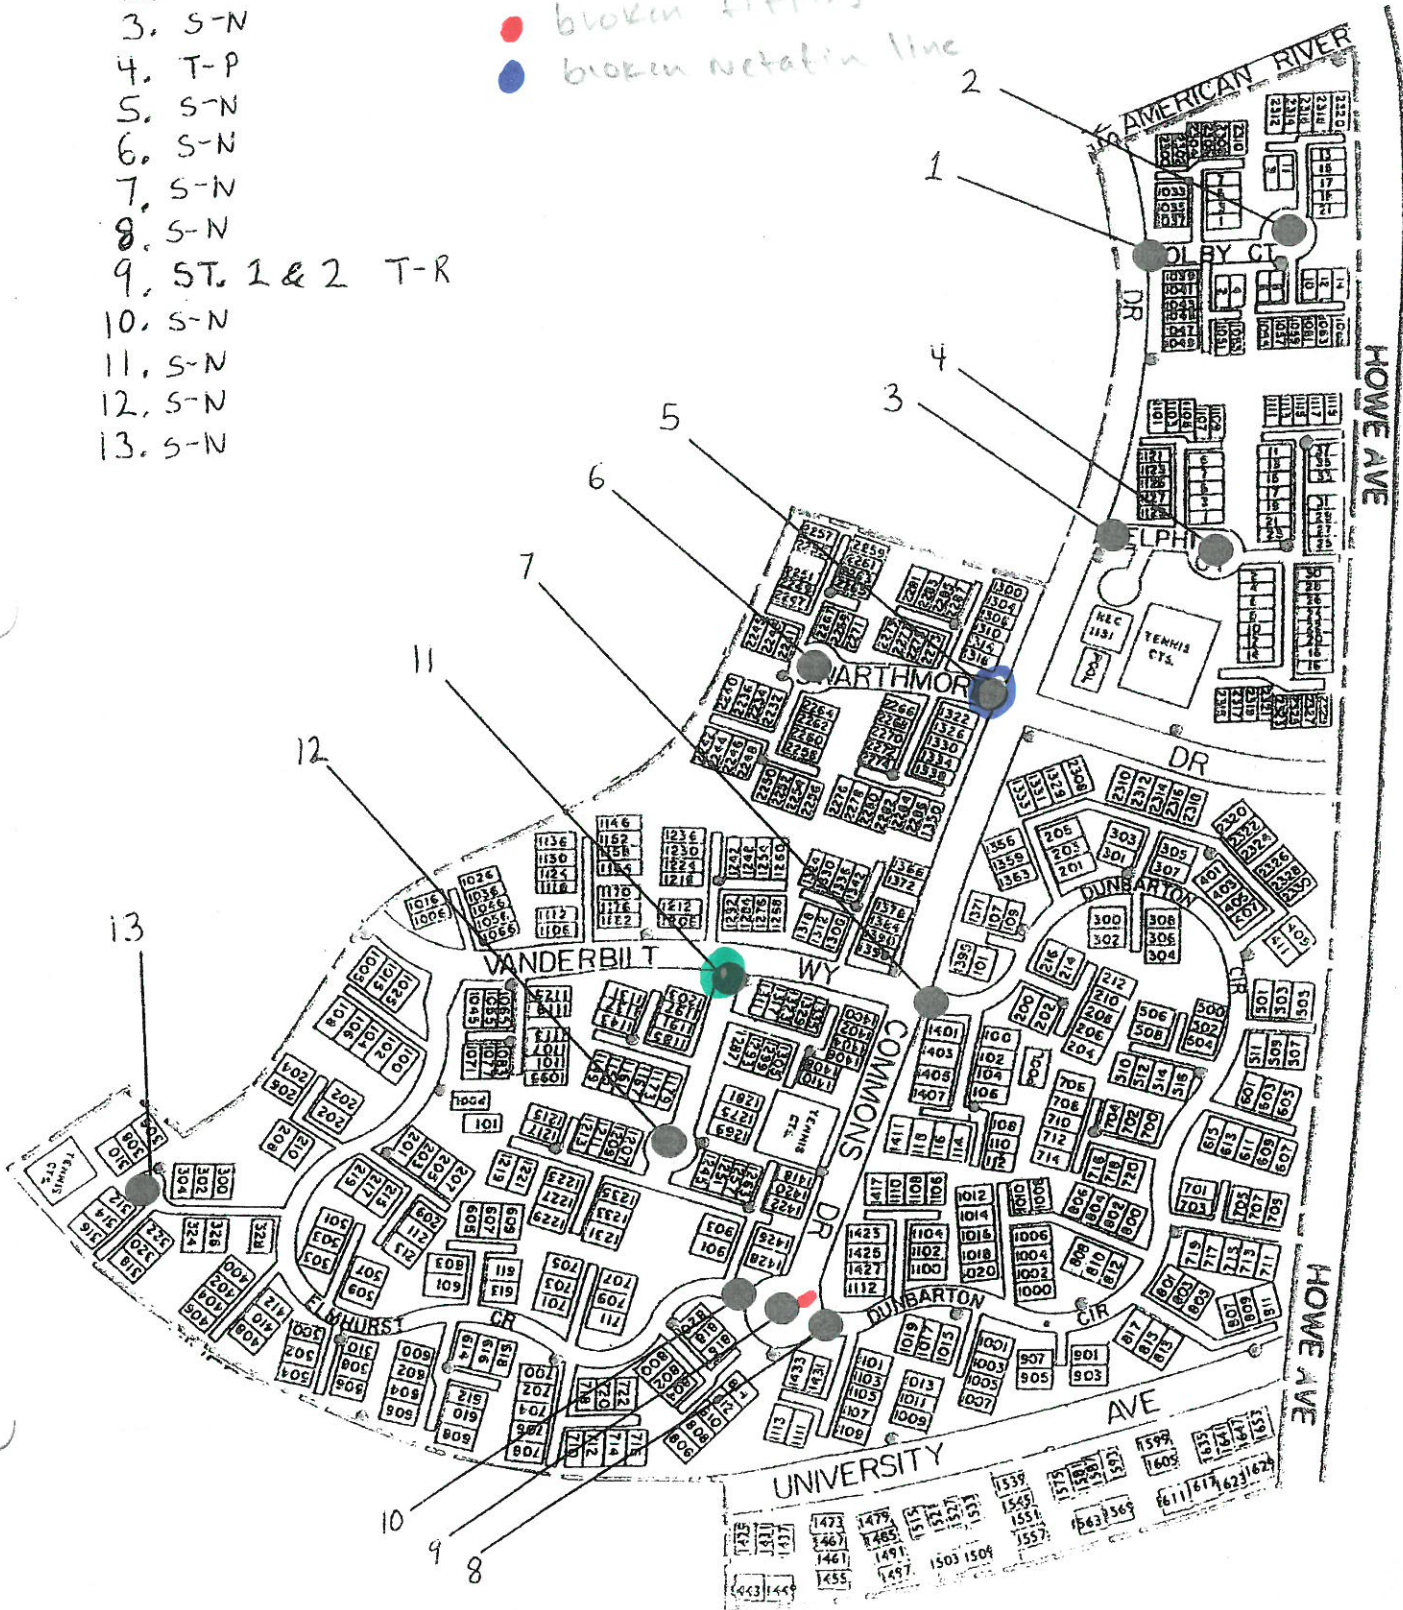
1. S-N
2. T-P
3. S-N
4. T-P
5. S-N
6. S-N
7. S-N
8. S-N
9. ST. 1 & 2 T-R
10. S-N
11. S-N
12. S-N
13. S-N

- broken 6" box
- broken fittings
- broken netatin line

<b>5</b>	Shrubs	Netafim (Drip)	
Repair the drip irrigation system. It has broken lines, tubing, and/or more emitters need to be added.			
<b>9</b>	Turf	Popup Rotary	
Replace broken fitting below 1 sprinkler head.			
<b>11</b>	Shrubs	Netafim (Drip)	Replace 6" Box
Replace 1 square broken valve box(es).
